## **Inspection Report**

**Property Address:**  
12 Sussex Ct  
Rancho Mirage CA 92270

**Livingston Home Inspections**

<b>Date:</b> 4/27/2020	<b>Time:</b> 09:30 AM	<b>Report ID:</b> 20200427-12-Sussex-Ct
<b>Property:</b> 12 Sussex Ct Rancho Mirage CA 92270	<b>Customer:</b> Pro-Com Products Inc Johnny Zhu James Park	<b>Real Estate Professional:</b> Joe Chung Compass

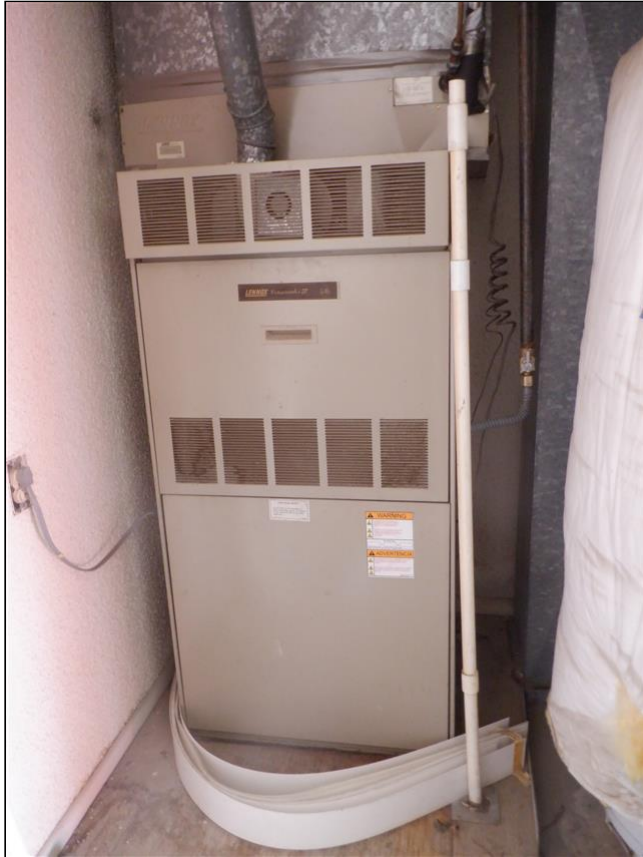
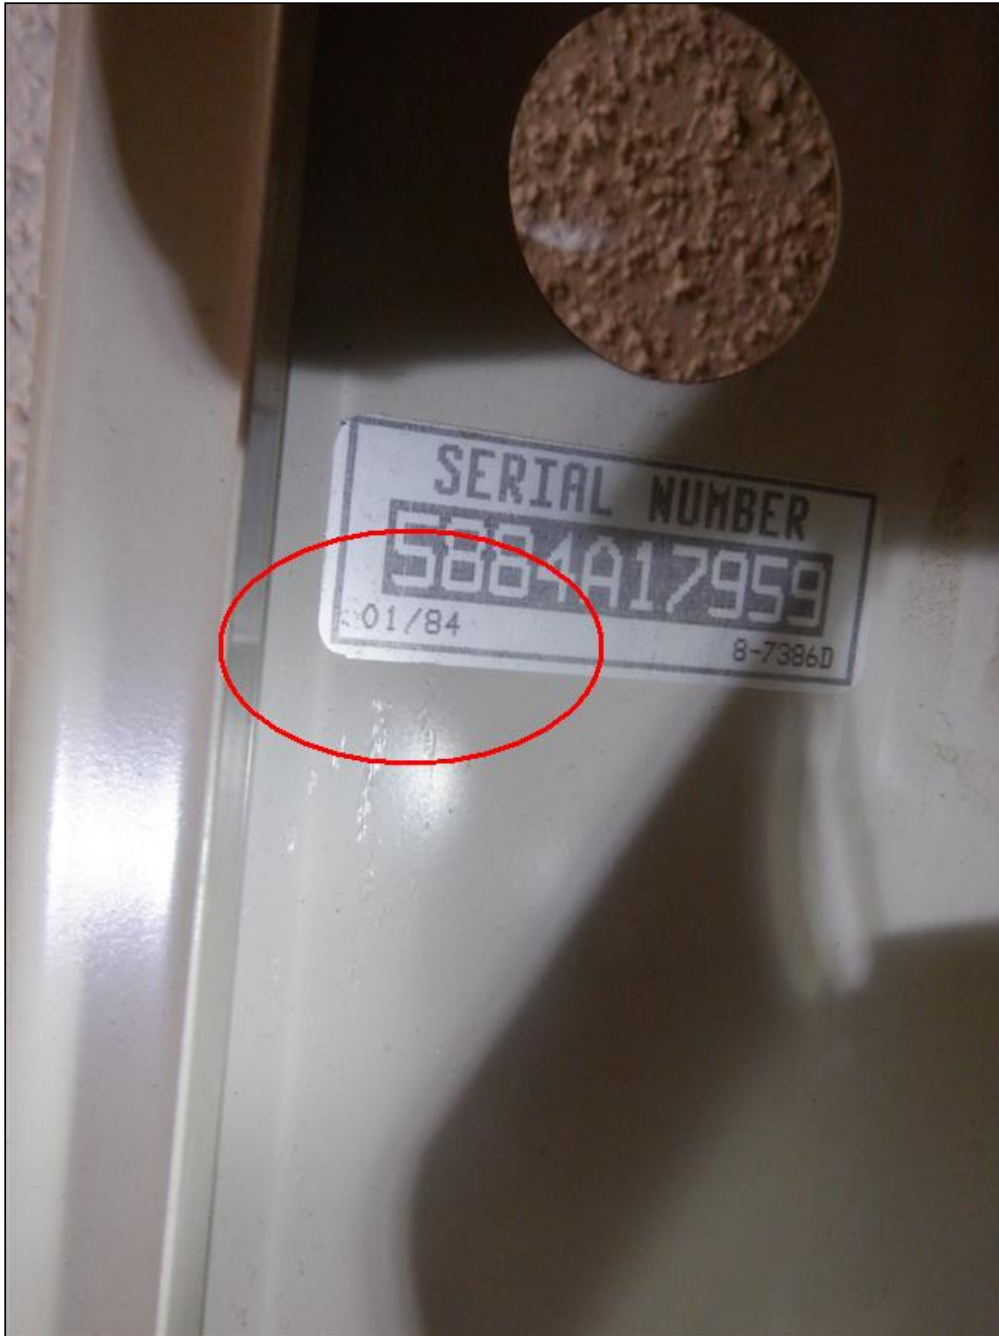
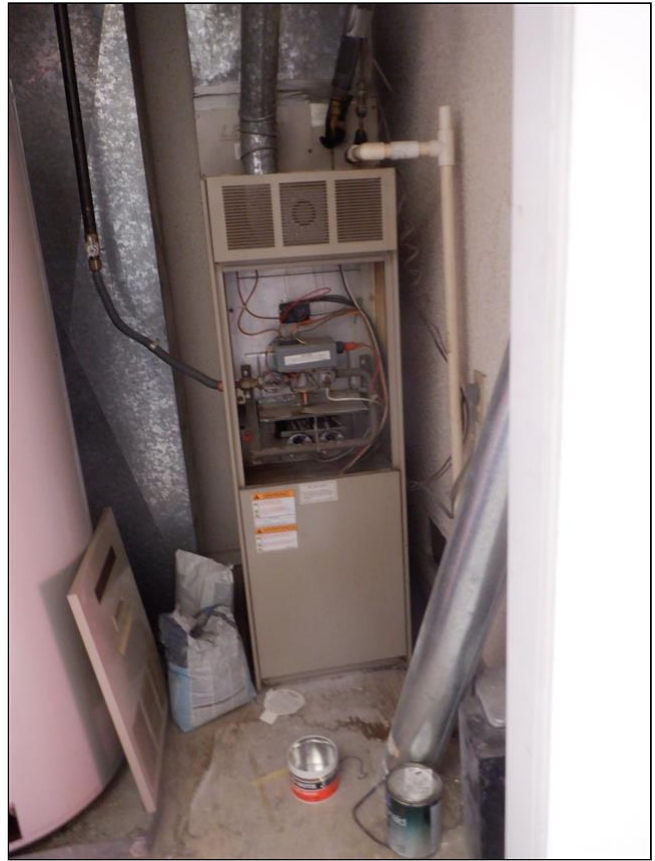
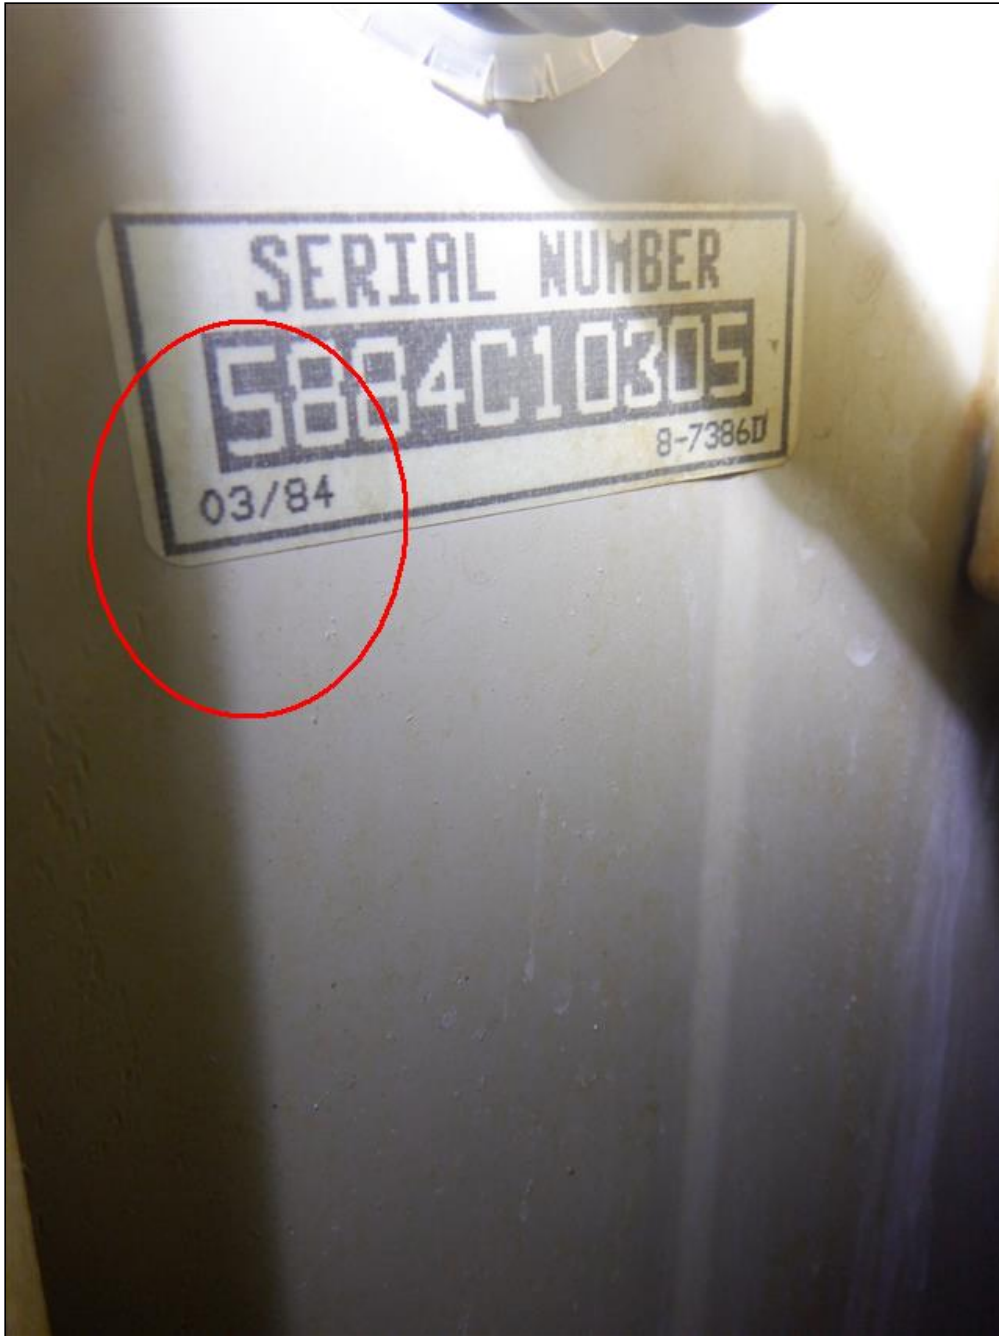
Although these heater were functioning properly at time of inspection we noted the Installation of a flex hose for the fuel line through the cabinet wall and without some kind of protection this is considered dangerous. Although possibly not a requirement at the time of construction a solid pipe should be installed through the cabinet wall where the flex hose can be used or some kind of impact resistant none flammable protective sleeve should be installed over this flex hose. This safety concern should be corrected one way or another. Recommend evaluation/repair/replace by an licensed HVAC contractor. FYI these units are older at 36 years.

10.0.A Item 1(Picture) Heating Unit 1

10.0.A Item 2(Picture) Heating Unit 1 MFG Date

10.0.A Item 4(Picture) Heating Unit 2

10.0.A Item 5(Picture) Heating Unit 2 MFG Date

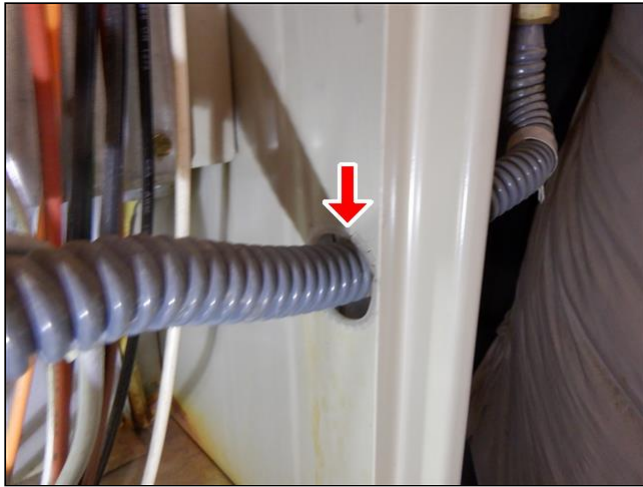
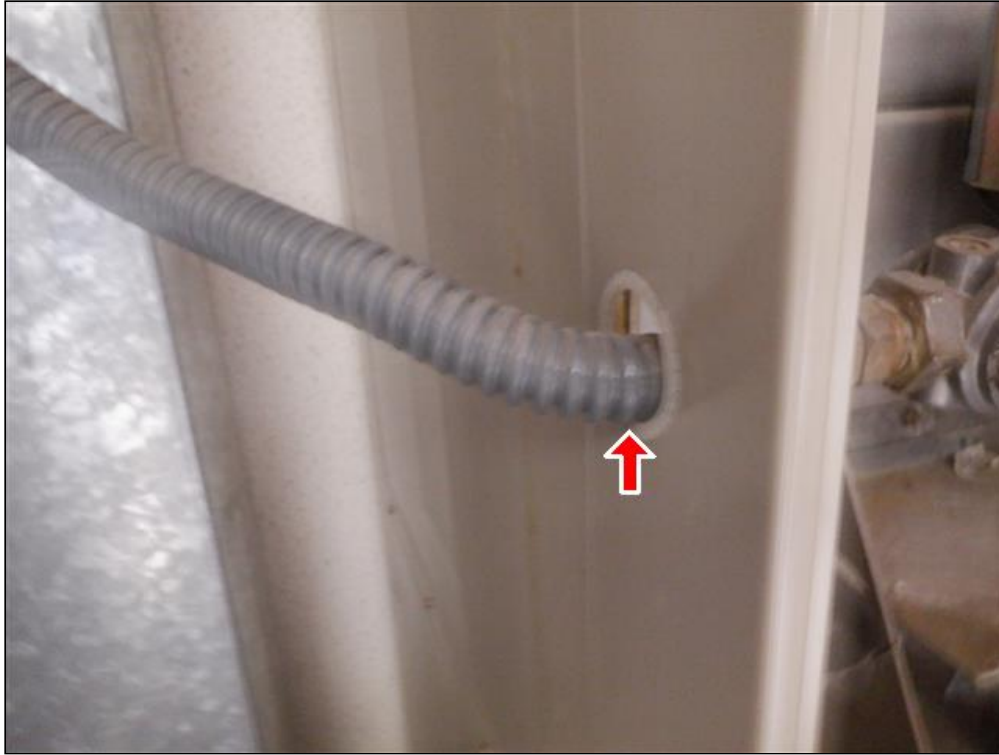
10.0.A Item 3(Picture) Heating Unit 1 Flex Fuel Line

10.0.A Item 6(Picture) Heating Unit 2 Flex Fuel Line
