Inspection Report

Property Address: 3304 Gibson Pl Redondo Beach CA 90278

Ferguson Home Inspections

Date: 12/7/2023	Time: 02:30 PM	Report ID: 12072023Gibson
Property: 3304 Gibson Pl Redondo Beach CA 90278	Customer: Ed Frazier	Real Estate Professional: Julie DeCoste

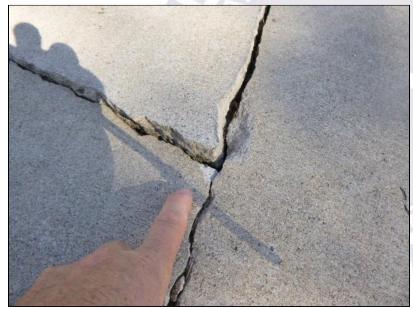
1.0 Item 1(Picture)

1.0 Settling, expansion cracks and heaving noted at various areas, this is a potential trip hazard. Suggest review with a licensed contractor for repair/replacement costs as needed.

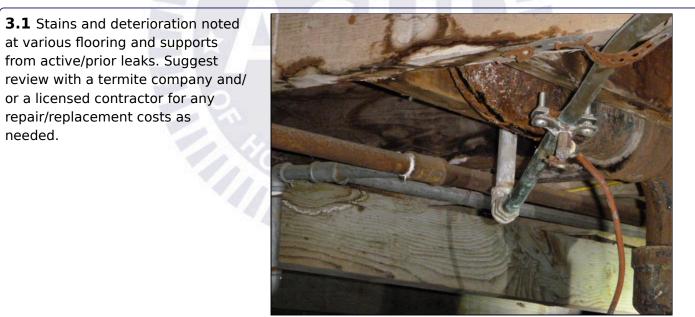
3.1 Item 1(Picture)

Stains and deterioration noted at various flooring and supports from active/prior leaks. Suggest review with a termite company and/or a licensed contractor for any repair/replacement costs as needed.

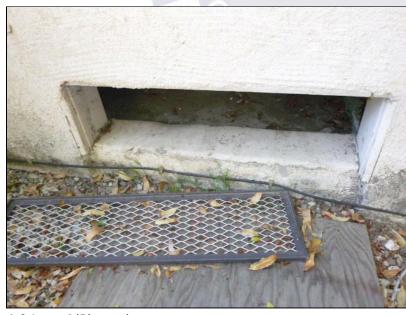
4.0 Item 1(Picture)

4.0 (1) Suggest review with a licensed contractor for costs to install a crawl access port door/screen as required.

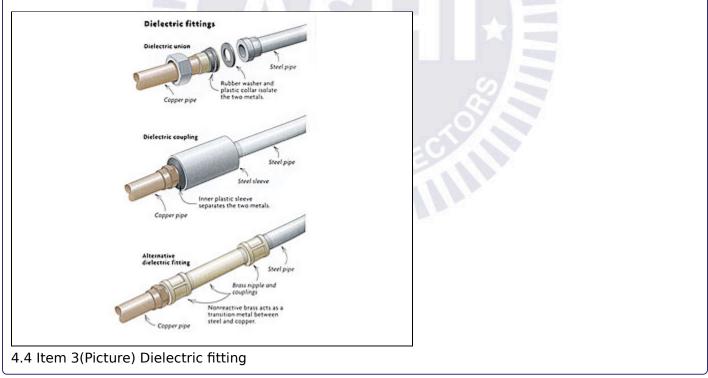
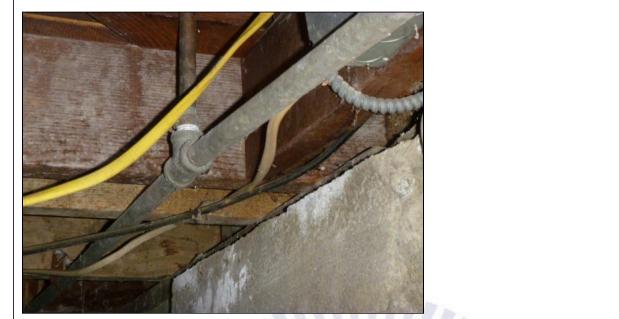
4.4 Item 4(Picture)

4.4 (3) No dielectric connections installed between the different types of plumbing. Suggest review by licensed plumber and repair as necessary.

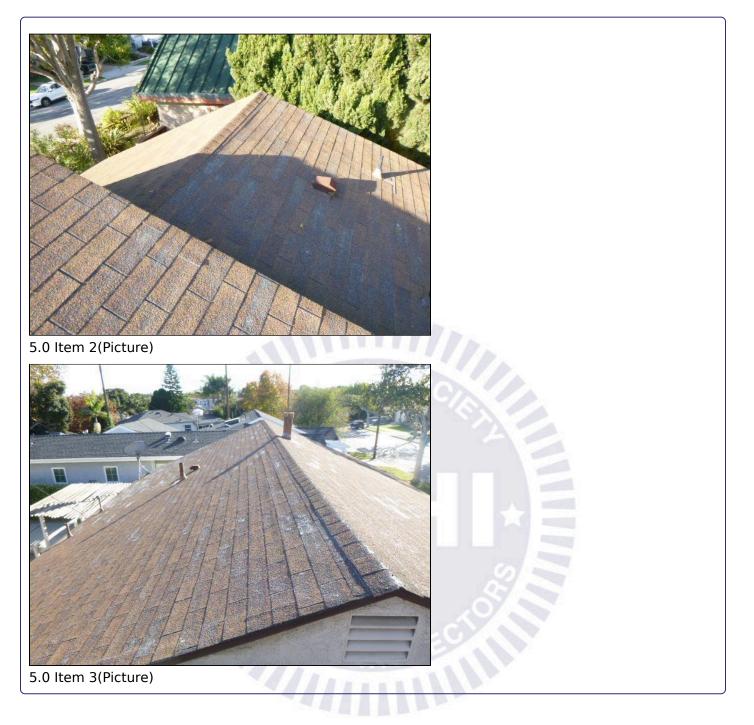
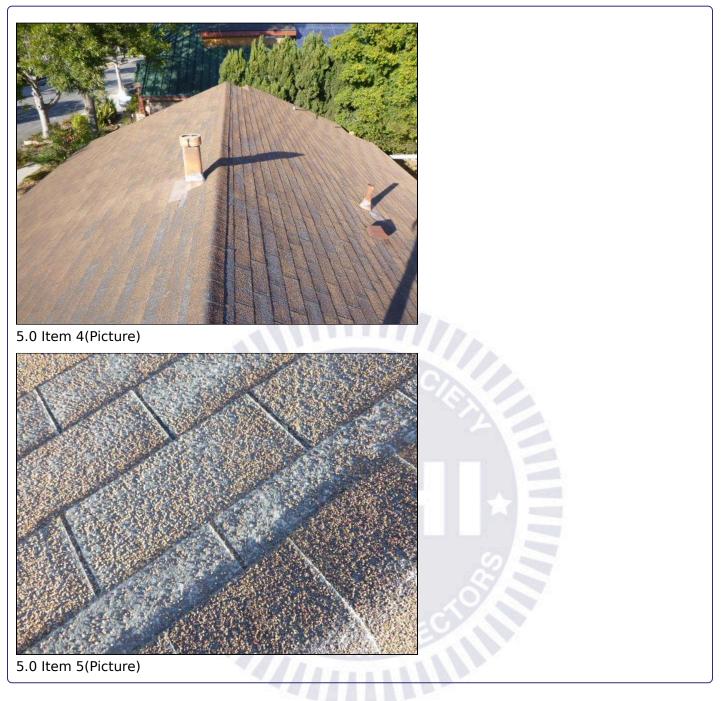
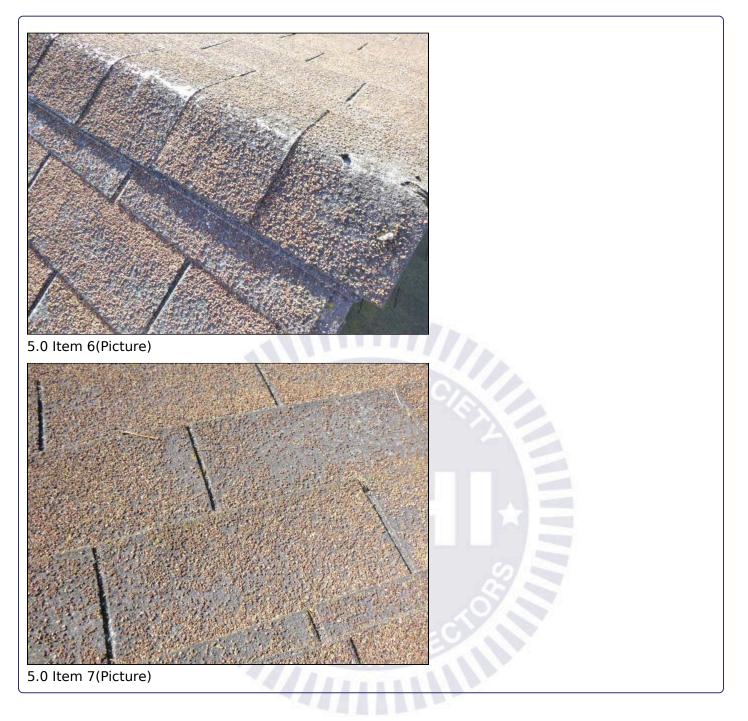
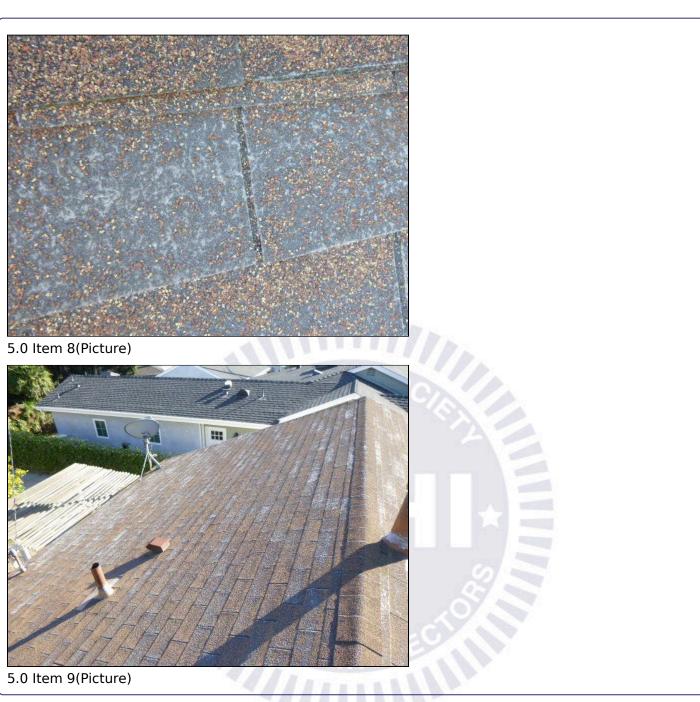
5.0 Item 1(Picture)

5.0 The roof covering is old and deteriorated. It is nearing the end of its useful life and the covering will need to be replaced. While it could last a year or so, some areas may need patching/repairs as leaks develop. Please review with a licensed roofer to determine the remaining life expectancy and for costs to repair/remove and replace the existing roofing material as needed.

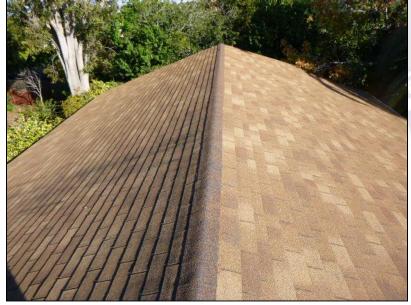
7.1 Item 2(Picture)

7.1 (1) The roof shows normal wear for its age and type, suggest periodic review with a licensed roofer for maintenance as needed.

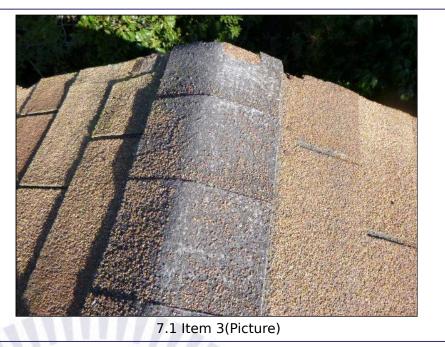
7.1 (2) Deteriorated/worn ridge caps were noted at the pitched roof. Suggest review by licensed roofer for replacement costs as needed to prevent future leakage at these areas.

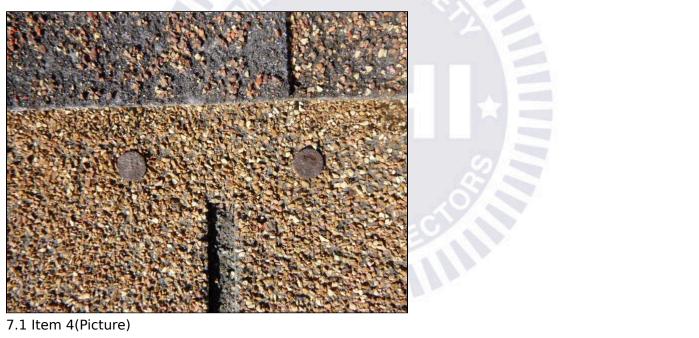
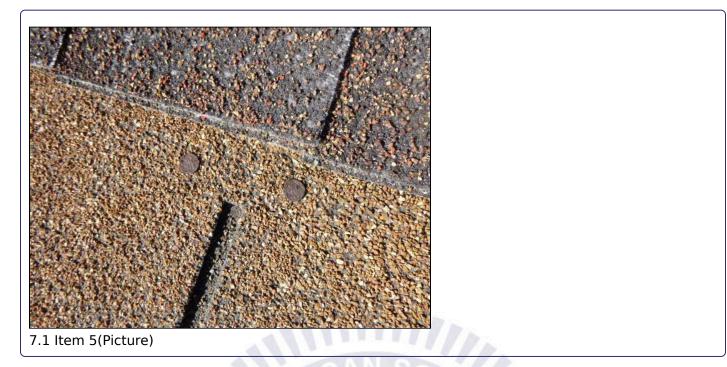
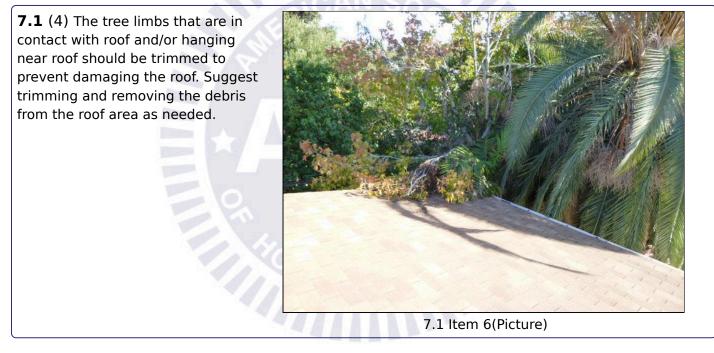
7.1 (3) Exposed nail heads noted at various areas of the roof, suggest review with a licensed roofer for repairs as needed.

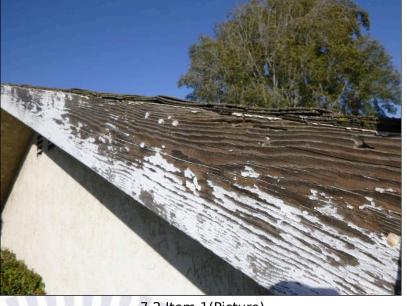
7.2 Item 1(Picture)

7.2 No eave drip flashings installed, suggest review with a licensed roofer for installation costs as needed.

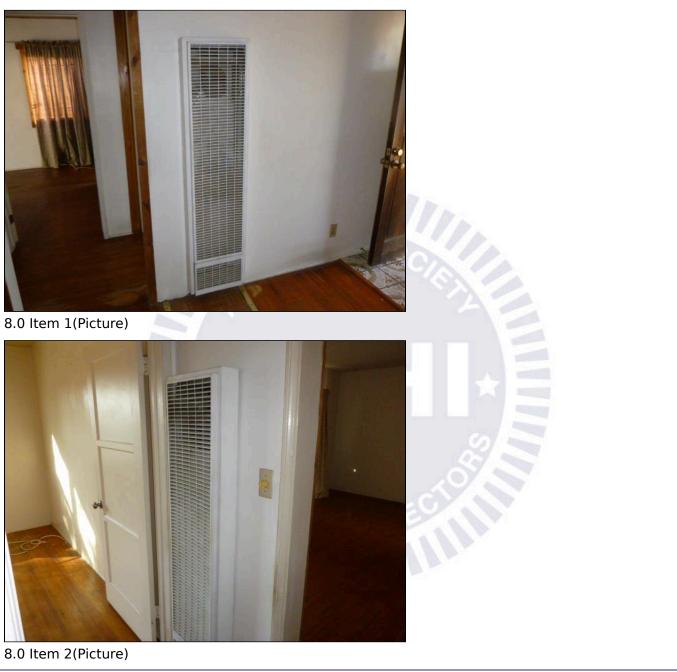
8.0 (1) Unable to test the heating system as the gas was turned off to the unit at the time of the inspection. Suggest review by the Gas Company or a licensed heating company for further review to determine if the unit is operational/usable, the remaining life of the unit and/or any repair/replacement costs as needed.

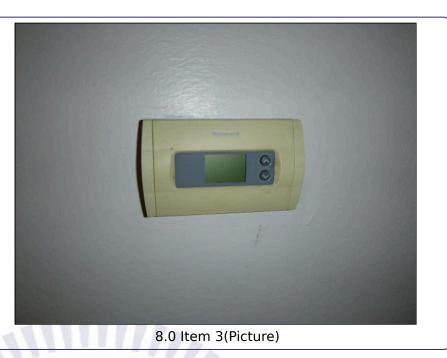
8.0 (2) The inspector was unable to test the heating system as the thermostat was inoperable at the time of the inspection. Suggest review by the Gas Company and/or a licensed heating company for review to determine if the unit is operational, any repair/replacement costs and confirm correct operation as needed.

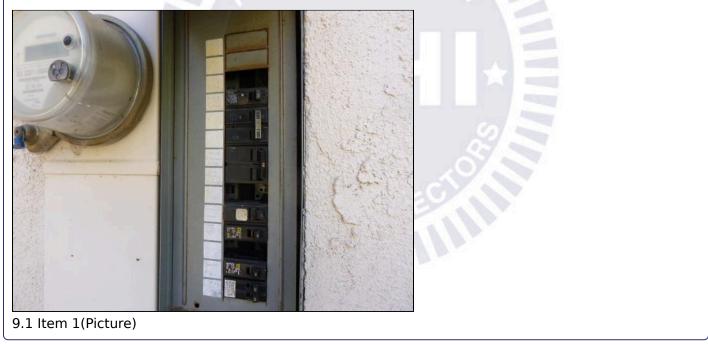
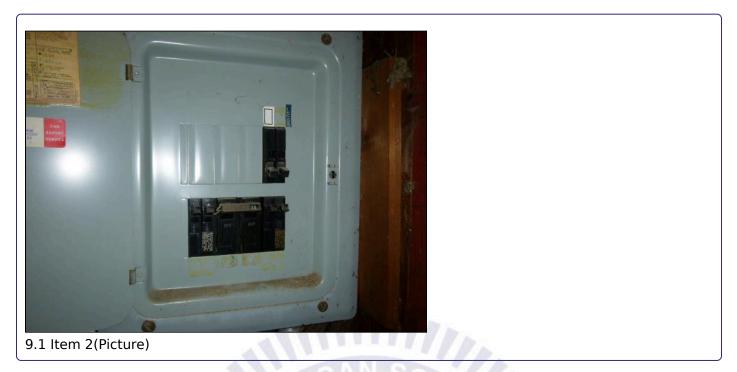
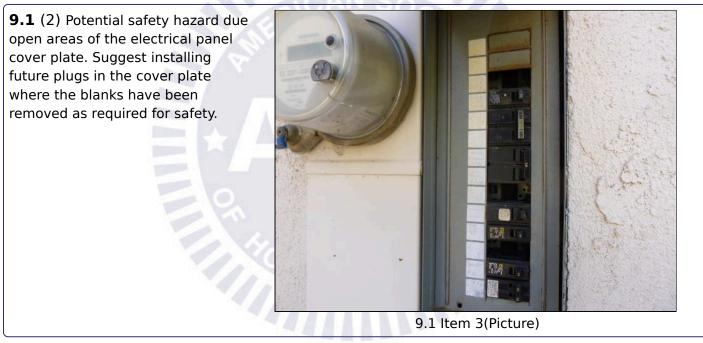
9.1 (1) Suggest adding correct/complete indexing/labelling to all breakers for indentification of each circuit for safety.

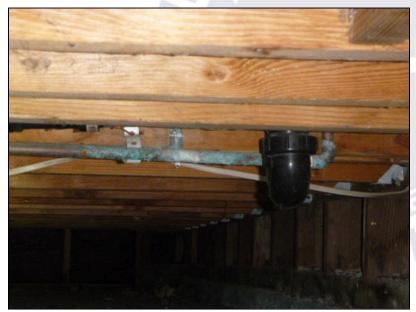
10.0 Item 2(Picture)

10.0 (1) Corroded plumbing and fittings noted at various areas within the dwelling. Suggest further review by a licensed plumber for repair/replacement costs as needed to prevent future leakage, pin hole leaks and possible stains/damage to the interior of the dwelling.

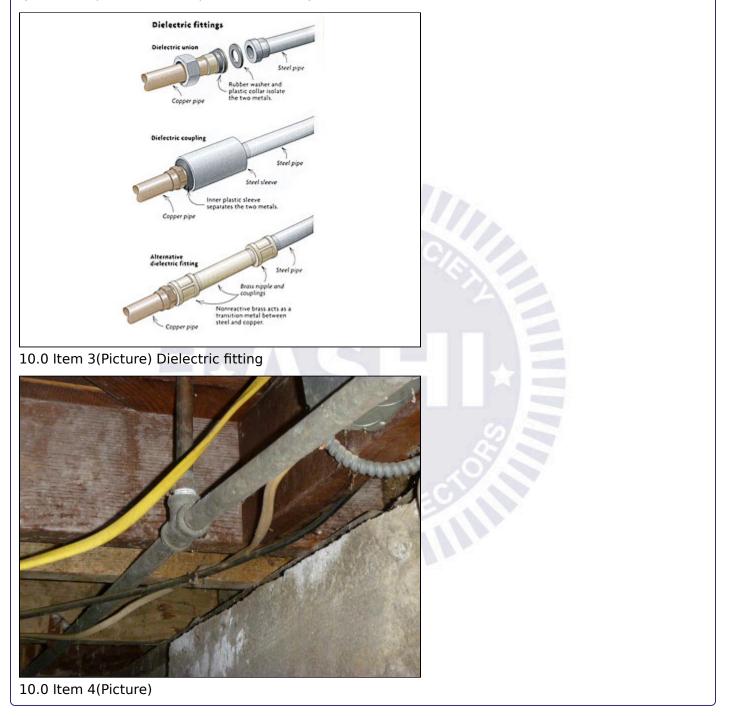
10.0 (3) No dielectric connections installed between the different types of plumbing. Suggest review by licensed plumber and repair as necessary.

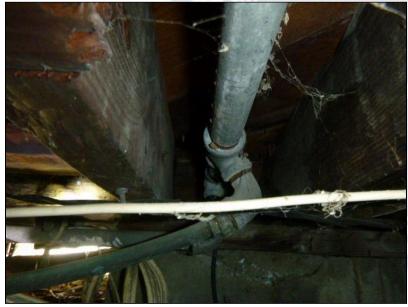
10.0 Item 6(Picture)

10.0 (4) Water flow fluctuation noted at water supply lines due to galvanized piping and restrictions when flow tested. Suggest review by a licensed plumber for costs to replace the galvanized plumbing as needed.

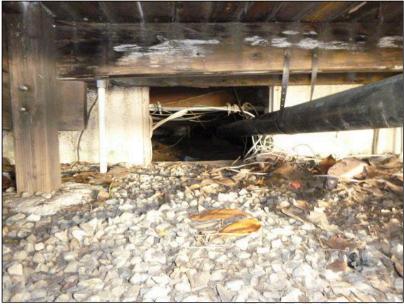
4.0 Item 2(Picture)

(2) Suggest removal of debris and construction items from the crawl area.

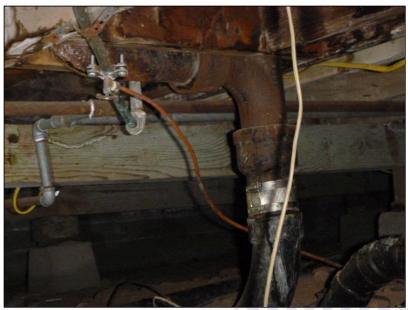
4.4 Item 2(Picture)

(1) Rust and corrosion noted at various cast iron drain lines within the crawl space, common for the age, active leaking visible at the hallway toilet drain at the time of the inspection. Suggest review by a licensed plumbing contractor for repair/replacement costs as needed.

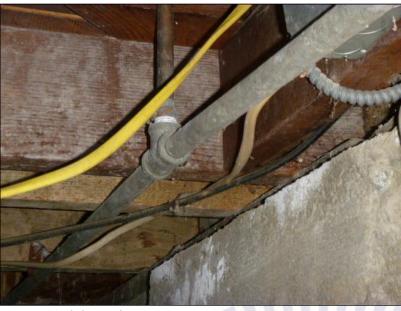
4.4 Item 4(Picture)

(3) No dielectric connections installed between the different types of plumbing. Suggest review by licensed plumber and repair as necessary.

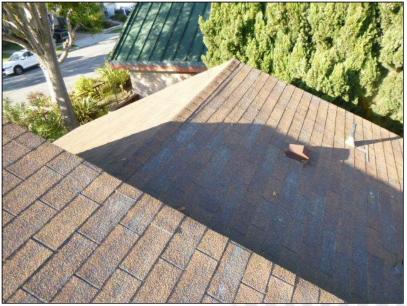
5.0 Item 2(Picture)

The roof covering is old and deteriorated. It is nearing the end of its useful life and the covering will need to be replaced. While it could last a year or so, some areas may need patching/repairs as leaks develop. Please review with a licensed roofer to determine the remaining life expectancy and for costs to repair/remove and replace the existing roofing material as needed.

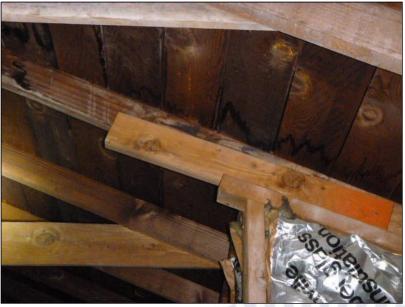
6.0 Item 1(Picture)

Moisture stains noted at various areas of the attic sheathing/framing, see roof comments and repair as needed.

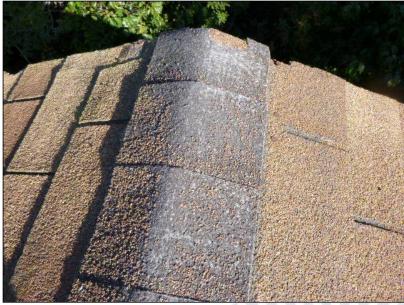
7.1 Item 3(Picture)

(2) Deteriorated/worn ridge caps were noted at the pitched roof. Suggest review by licensed roofer for replacement costs as needed to prevent future leakage at these areas.

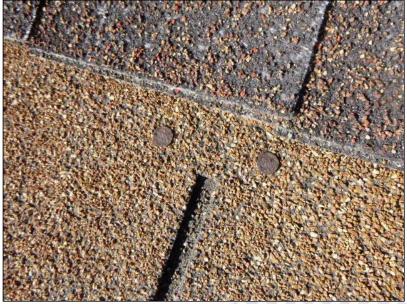
7.1 Item 5(Picture)

(3) Exposed nail heads noted at various areas of the roof, suggest review with a licensed roofer for repairs as needed.

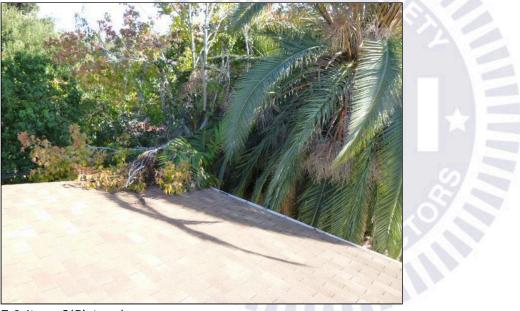
7.1 Item 6(Picture)

(4) The tree limbs that are in contact with roof and/or hanging near roof should be trimmed to prevent damaging the roof. Suggest trimming and removing the debris from the roof area as needed.

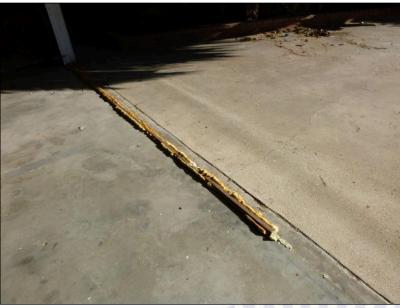
7.4 Item 1(Picture)

The main garage door does not seal to the slab correctly. Suggest replacing the door seal and/or installation of a berm strip to prevent possible water, insect and rodent intrusion.

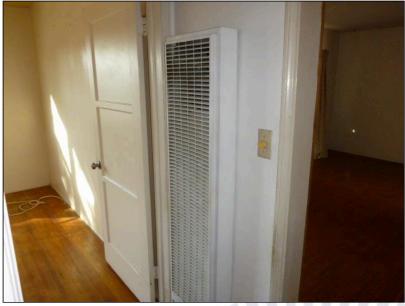
8.0 Item 2(Picture)

(1) Unable to test the heating system as the gas was turned off to the unit at the time of the inspection. Suggest review by the Gas Company or a licensed heating company for further review to determine if the unit is operational/usable, the remaining life of the unit and/or any repair/ replacement costs as needed.

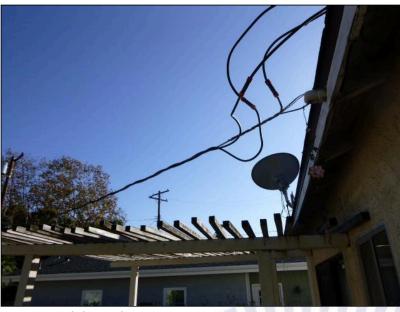
9.0 Item 1(Picture)

Potential safety hazard due to the electrical service conductors clearance (outside) from the ground is lower than 12 feet. Suggest review with a licensed contractor and/or the utility company for repair/ replacement/relocation costs as required for safety.

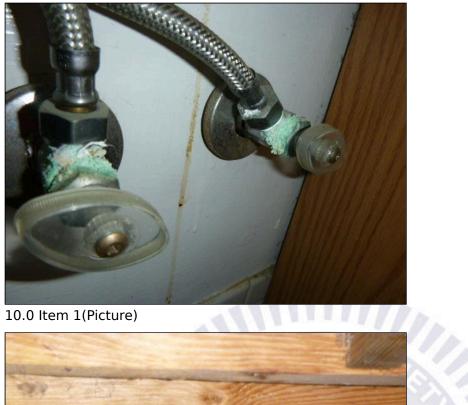
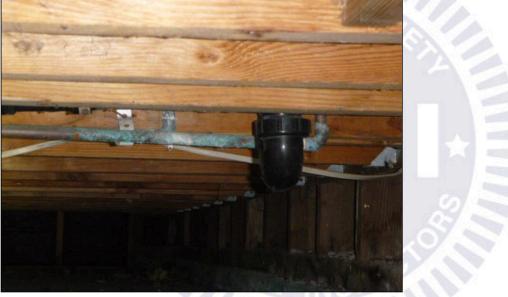
10.0 Item 2(Picture)

(1) Corroded plumbing and fittings noted at various areas within the dwelling. Suggest further review by a licensed plumber for repair/replacement costs as needed to prevent future leakage, pin hole leaks and possible stains/damage to the interior of the dwelling.

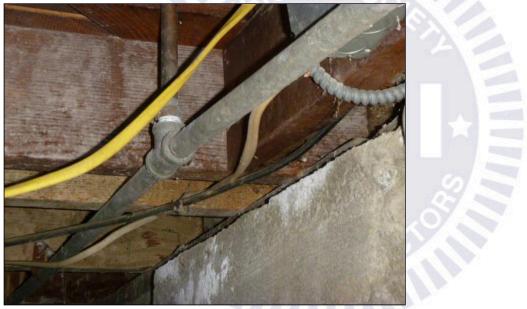
10.0 Item 4(Picture)

(3) No dielectric connections installed between the different types of plumbing. Suggest review by licensed plumber and repair as necessary.

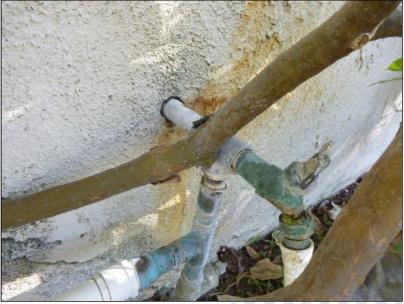
10.0 Item 5(Picture)

(4) Water flow fluctuation noted at water supply lines due to galvanized piping and restrictions when flow tested. Suggest review by a licensed plumber for costs to replace the galvanized plumbing as needed.

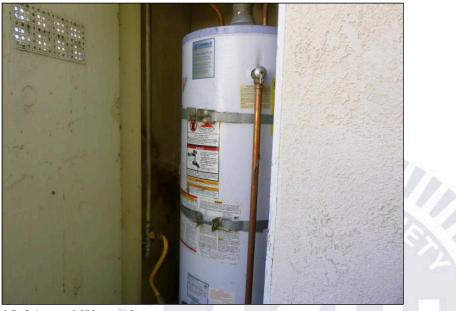
12.0 Item 1(Picture)

(1) Due to the age of this unit, suggest review with a licensed plumber for replacement costs as it has exceeded it's intended life span (12-15 years).

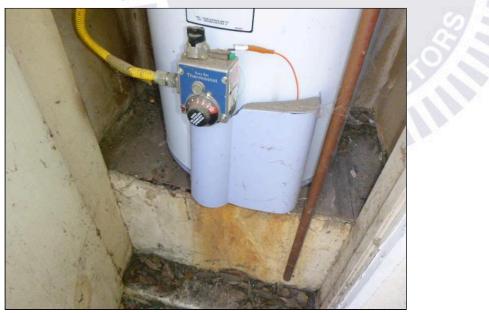
12.0 Item 2(Picture)

(2) No spill pan or drain line installed at the time of inspection. Suggest installation of a spill pan with a drain line to the exterior of the dwelling as required as leakage would cause damage to the stand and surrounding area.

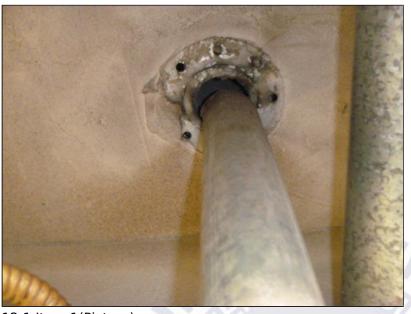
12.1 Item 1(Picture)

(1) A poor fitting/disconnected vent pipe was noted, this is a safety hazard requiring immediate attention. Suggest review by a licensed plumbing contractor for repair/replacement costs as required for safety.
