# WOOD DESTROYING PESTS AND ORGANISMS INSPECTION REPORT

| BUILDING NO.<br>3144 | STREET<br>MARWICK | CITY<br>LONG BEACH | ZIP<br>90808 | Date of Inspection<br>07/28/2025 | NUMBER OF PAGES<br>1 of 11 |
| GENERAL DESCRIPTION:<br>This is a one story stucco and wood single family residence with an attached metal patio. It has a detached 2 car garage/two story guest house. It has a composition roof and was vacant at the time of inspection. | | | | Inspection Tag Posted:<br>Attic.<br>Other Tags Posted: | |

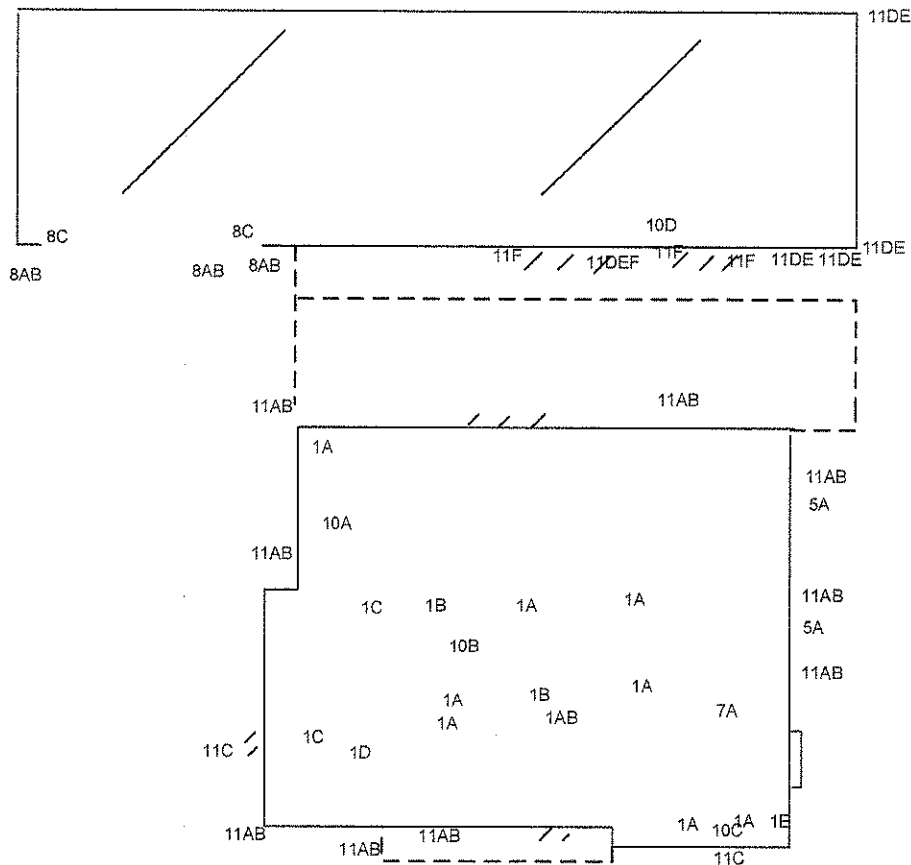
**NOTE: If diagram is not displayed here, please see the report.**

Evidence of drywood termite damage was noted as 11E as indicated on the diagram near or at guest house gable facia, rafter tails, and trim.

Rot damage noted as 11F on diagram. The damage was in or near: guest house trim.

**RECOMMENDATION:** Repair and/or replace damage as deemed necessary by this company. If during the course of repair damage is found to extend beyond visible area a supplemental report with additional costs and findings will be issued. Exposed lumber repaired or replaced by this company will be painted with one coat of primer only. If requested prior to start of work a color matched finish coat of paint can be applied to for an additional charge. Due to varying rates of aging and fading around a property an exact match with existing paint may not be made.

**RECOMMENDATION** Cut out rotted timbers. Repair and/or replace damage as deemed necessary by this company. If during the course of repair damage is found to extend beyond visible area a supplemental report with additional costs and findings will be issued. Exposed lumber repaired or replaced by this company will be painted with one coat of primer only. If requested prior to start of work a color matched finish coat of paint can be applied to for an additional charge. Due to varying rates of aging and fading around a property an exact match with existing paint may not be made.
