Address: 447 E Hullett St, Long Beach

Date of Inspection: 3-22-24

Main Sewer Line Inspection Report

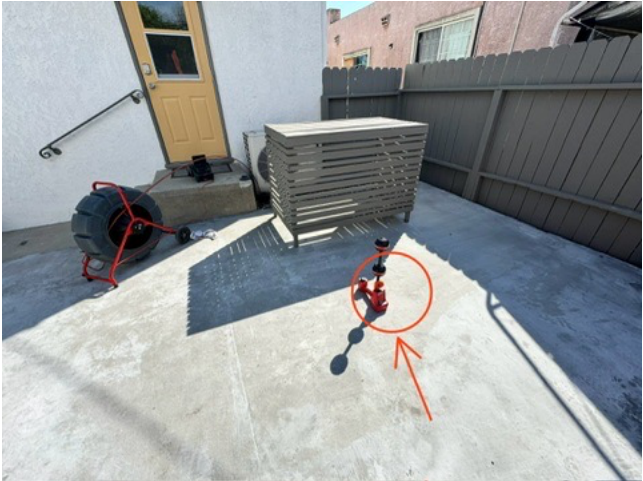
Areas Needing Attention: A portion of the clay pipe sewer line underneath the rear patio area has a very large offset/shift. The shifting of the pipe is more extensive than could be considered acceptable and it is failed to the degree that some sewer will likely be able to escape the system into the surrounding soil. The most effective and cost-efficient method of repairing the line can best be determined with the assistance of your sewer contractor of choice who will be performing the work.

Location of offset/shifted clay pipe 3.2' deep.

Estimated Costs for Repairs: To repair the offset/shifted clay pipe it might cost \$3,200 - \$3,500.
