# **Cornerstone Inspection**

## **Property Inspection Report**

**1556 Gulf St, San Luis Obispo, CA 93405**

**Date of Inspection: 10/7/2025 Time: 1:00 PM**

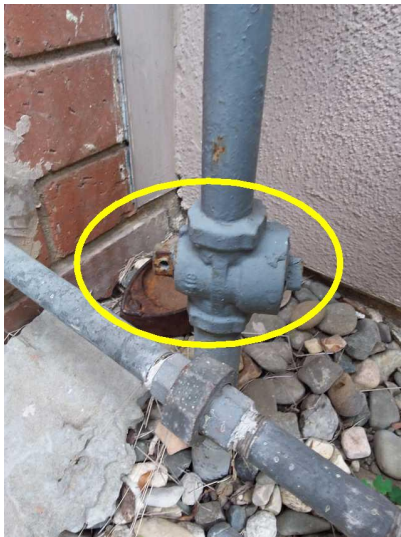
The gas main shut-off is located on left side of the home, unit or building.

2.4. Some of the gas lines at the meter are rusted and should be painted to prevent further corrosion.
