### *Inspection Report*

Address: 3437 Shearer Ave Cayucos, CA 93430

02/12/2026

Inspector: Taylor Vreeken, CCI  
P.O. Box 415 Templeton, CA 93465 | O: 805.462.1978 C: 805.441.9727

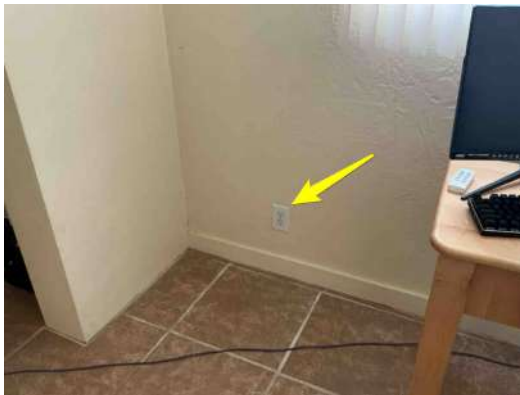
**SC s-147:** Miswired electrical outlet (Reverse polarity) found TWO IN BEDROOM-1. Have electrician check all outlets and correct as needed.

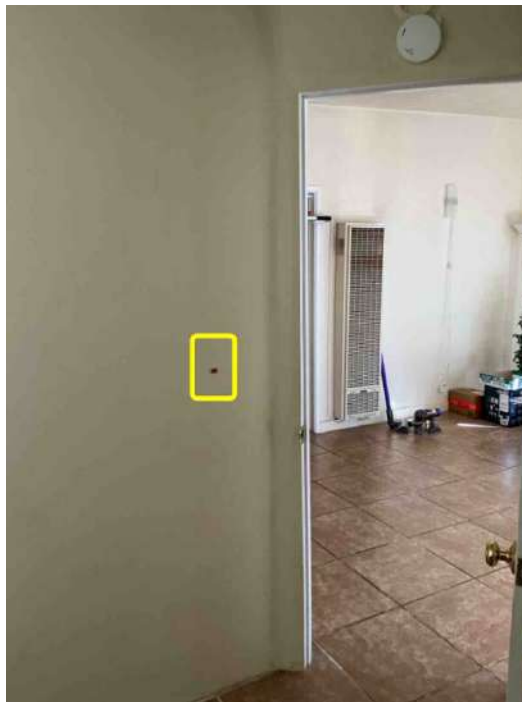
BEDROOM-1

**s-151:** Missing the required light switches for interior lighting off the ENTRY DOOR, BEDROOM-1, and BEDROOM-2 BACK DOOR. Upgrades recommended per minimum standards.

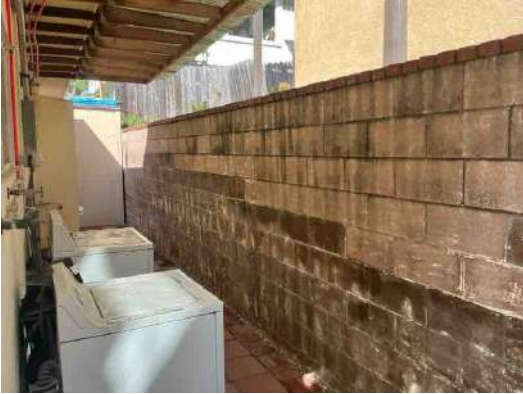
### 38: Masonry

**FI DS** s-39: The masonry wall was observed to be leaning approximately 3% (roughly 3 inches out of plumb over 8 feet). This exceeds typical construction tolerances for masonry walls and may indicate structural movement or lateral pressure. Further evaluation by a qualified structural engineer is recommended to determine cause and corrective measures.

**FI DS 39:** The masonry wall was observed to be leaning approximately 3% (roughly 3 inches out of plumb over 8 feet). This exceeds typical construction tolerances for masonry walls and may indicate structural movement or lateral pressure. Further evaluation by a qualified structural engineer is recommended to determine cause and corrective measures.

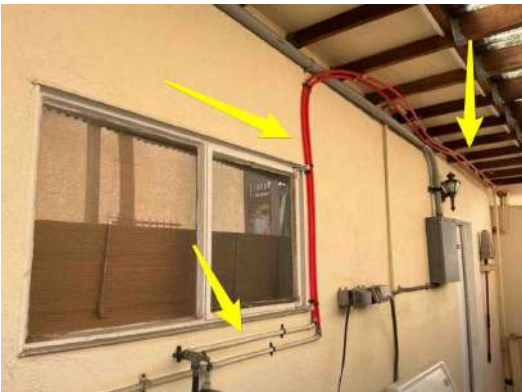
**E&C FI 60:** Improper use of PEX plastic piping at the exterior EAST SIDE. PEX piping is sensitive to UV deterioration and damage and is not to be used on the exterior subject to exposure. Corrections needed. Contact a licensed plumber.

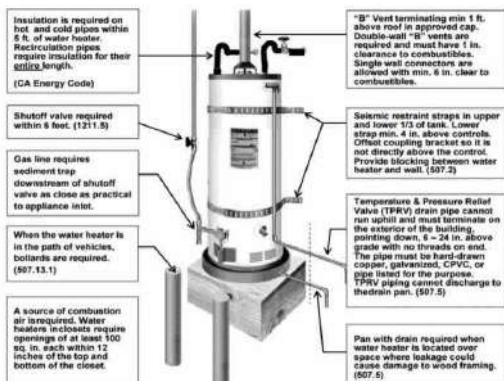
**MR SU 68: CONDITION:** The water heater operated when tested. However, some maintenance and repairs are recommended. Contact a qualified and licensed plumbing professional.

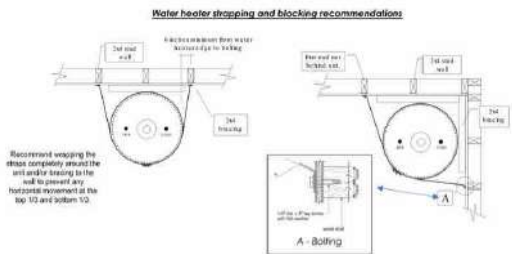
**E&C 71:** The Water heater is loosely strapped & not secured well - moves when pushed . Recommend adding BRACING OR BLOCKING to the wall to properly secure the tank per Uniform Plumbing Code and State Architect Requirements.

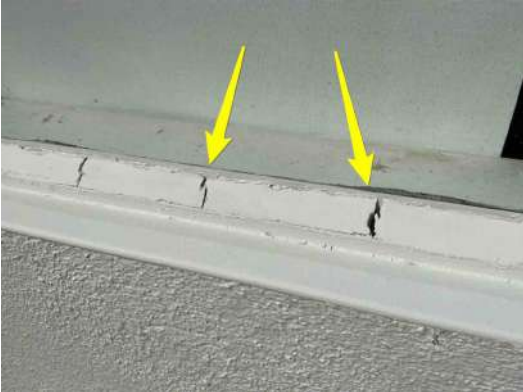
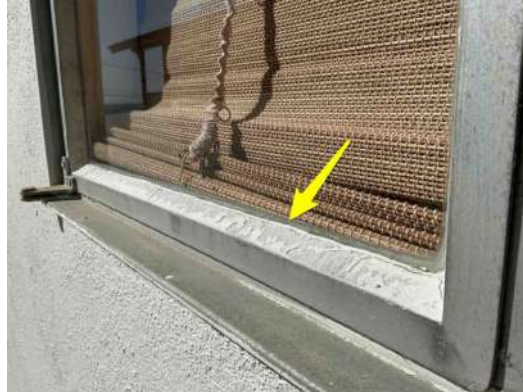
**MR 121:** Deteriorated window glazing putty at some older windows.

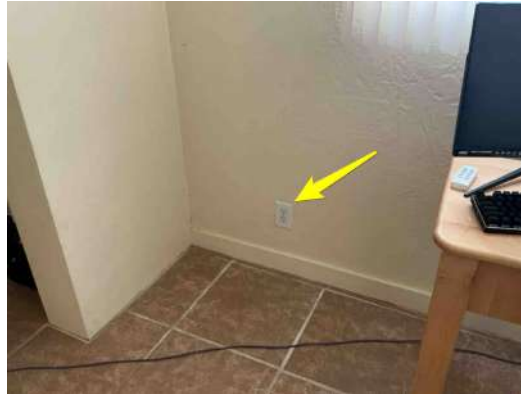
**SC 147:** Miswired electrical outlet (Reverse polarity) found TWO IN BEDROOM-1. Have electrician check all outlets and correct as needed.

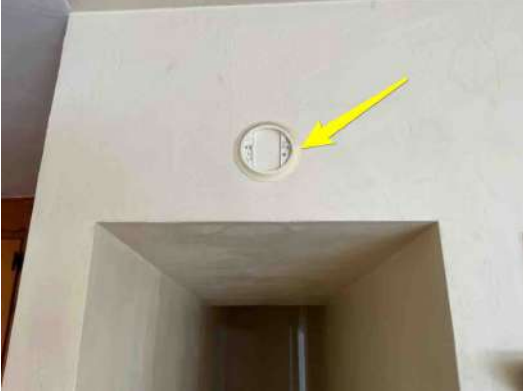
**SC s-156: Smoke detector AND Carbon Monoxide detector are missing at required location: BEDROOM HALLWAY**

**SC 156: Smoke detector AND Carbon Monoxide detector are missing at required location: BEDROOM HALLWAY**
