# Inspection Report

**Property Address:**  
2104 Chestnut Ave  
Manhattan Beach CA 90266

**Ferguson Home Inspections**

<b>Date:</b> 1/11/2025	<b>Time:</b> 09:00 AM	<b>Report ID:</b> 01112025ChestnutAve
<b>Property:</b> 2104 Chestnut Ave Manhattan Beach CA 90266	<b>Customer:</b> Yvonne Peltz	<b>Real Estate Professional:</b> Marlene Ramirez

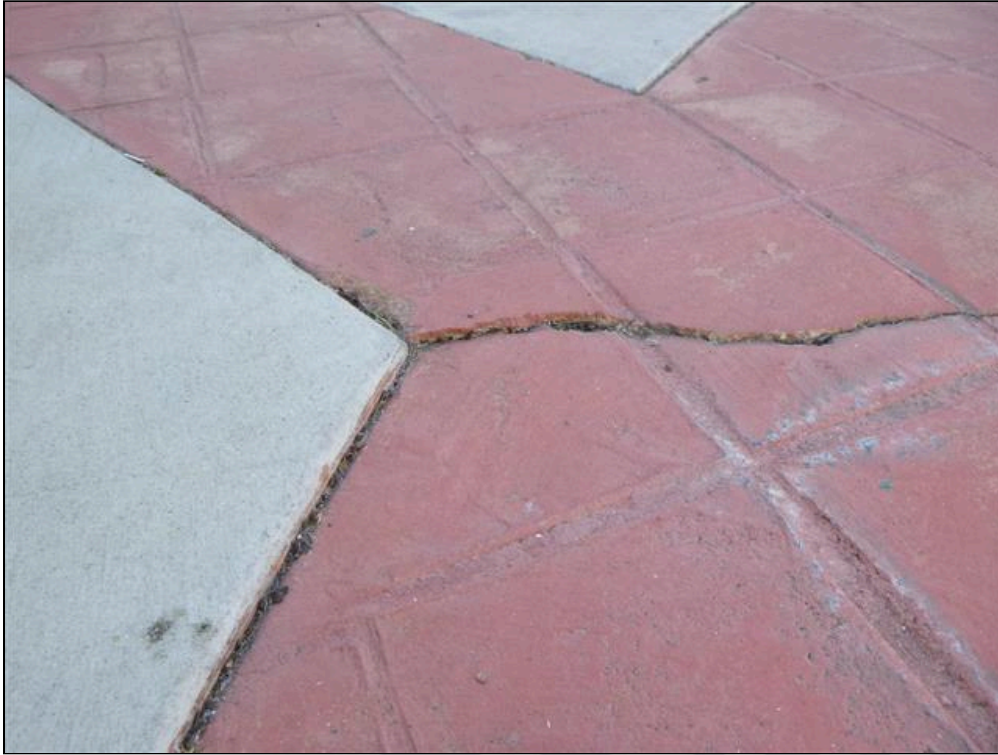
1.0 Item 1(Picture)

**1.0** (1) Settling, expansion cracks and heaving noted at various areas, this is a potential trip hazard. Suggest review with a licensed contractor for any repair/replacement costs as needed.

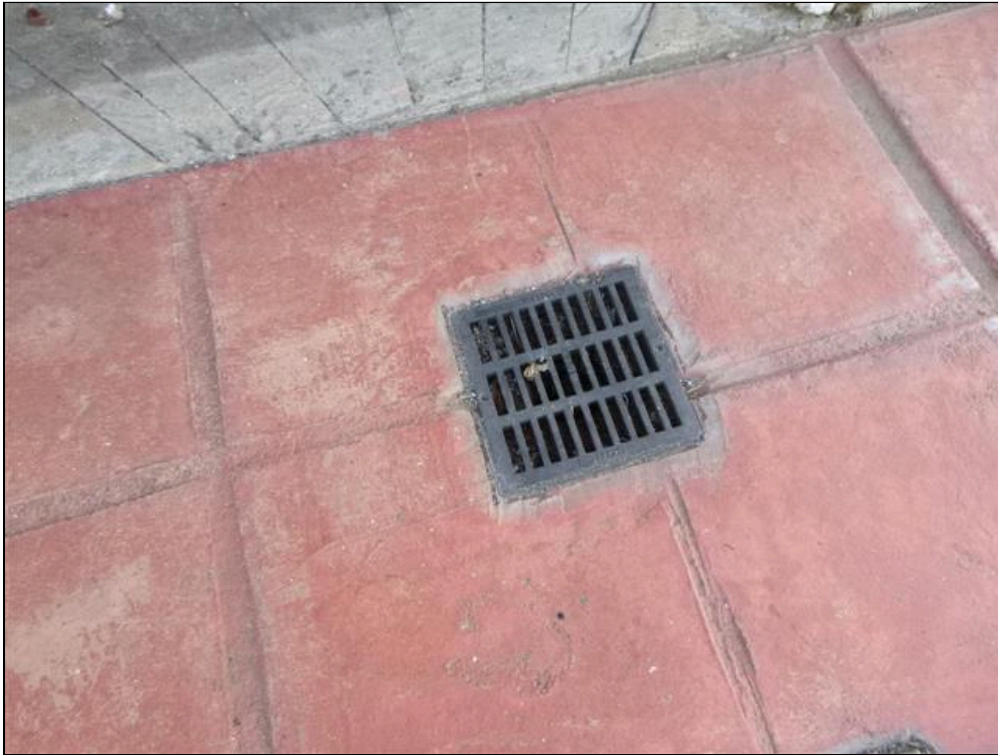
1.0 Item 2(Picture)

**1.0 (2)** Suggest cleaning the driveway drain and drain transition to street prior to the rainy season to prevent blockages which could result in water intrusion into the garage/dwelling.

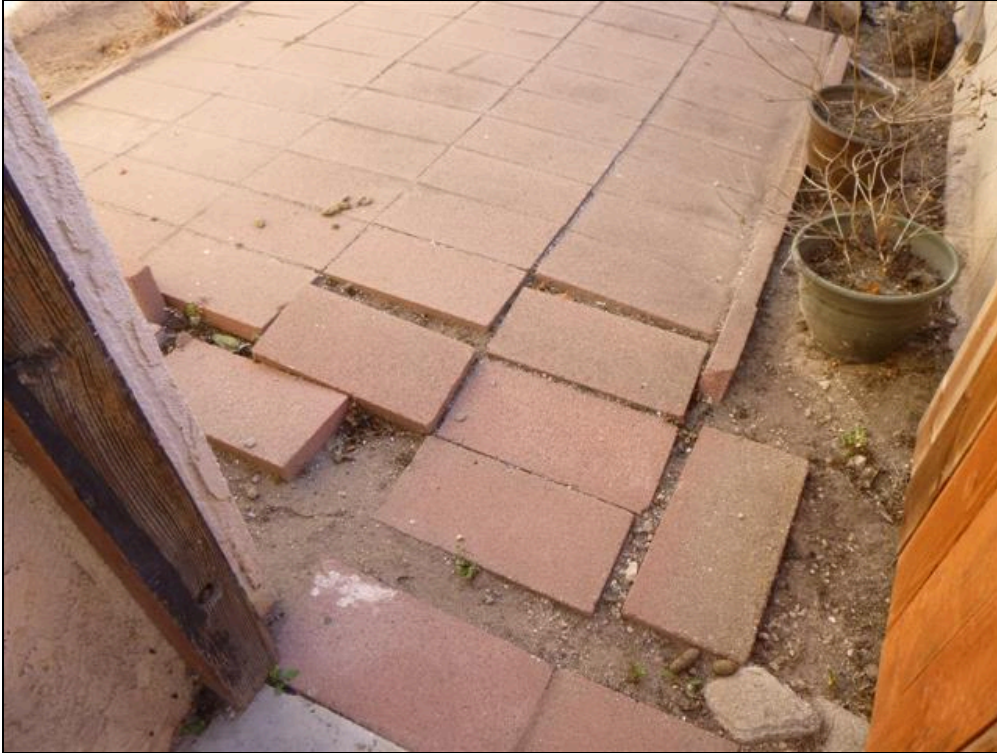
1.1 Item 1(Picture)

**1.1** Settling, expansion cracks, loose and heaving noted at various areas, this is a potential trip hazard. Suggest review with a licensed contractor for any repair/replacement costs as needed.

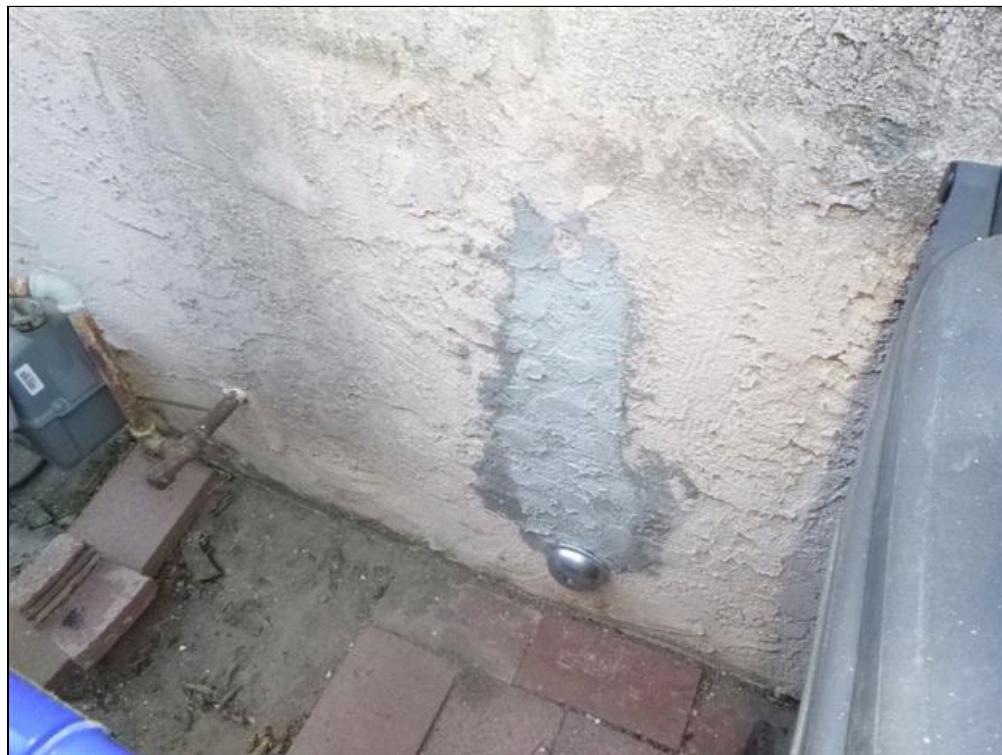
1.4 Item 1(Picture)

**1.4** (1) Deteriorated and blistering stucco noted at various areas. See the Lot/Drainage comments and review with a licensed contractor to repair as needed and divert water away from the foundation areas.

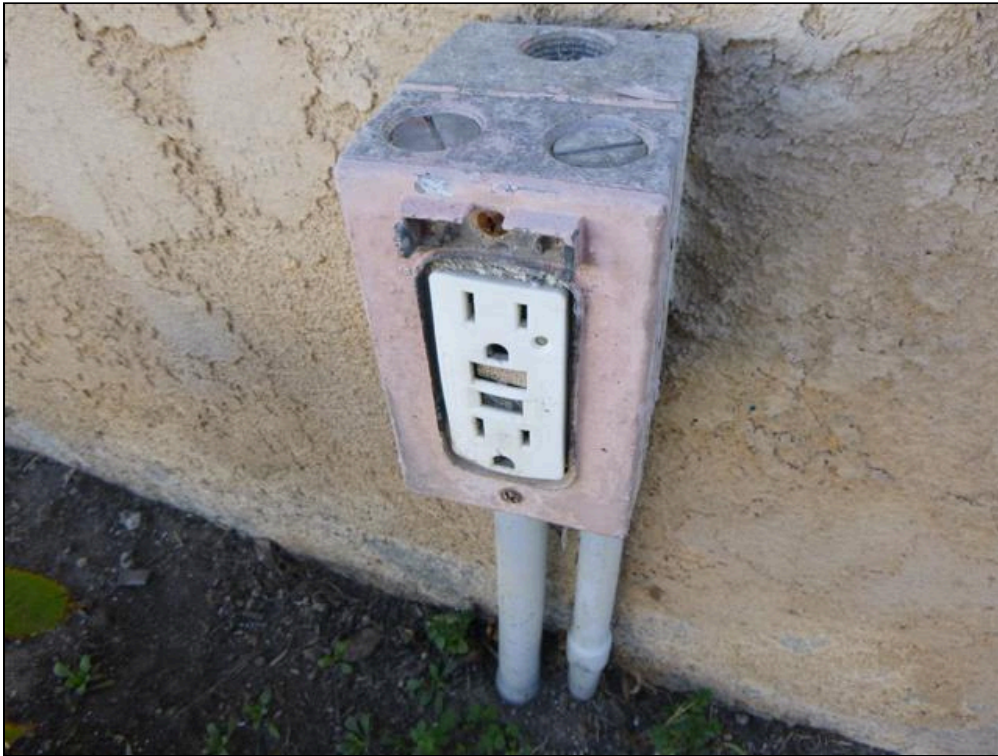
1.8 Item 1(Picture)

**1.8** (1) Various exterior outlet(s) are missing the weather cover(s). Suggest installation for safety and as required.

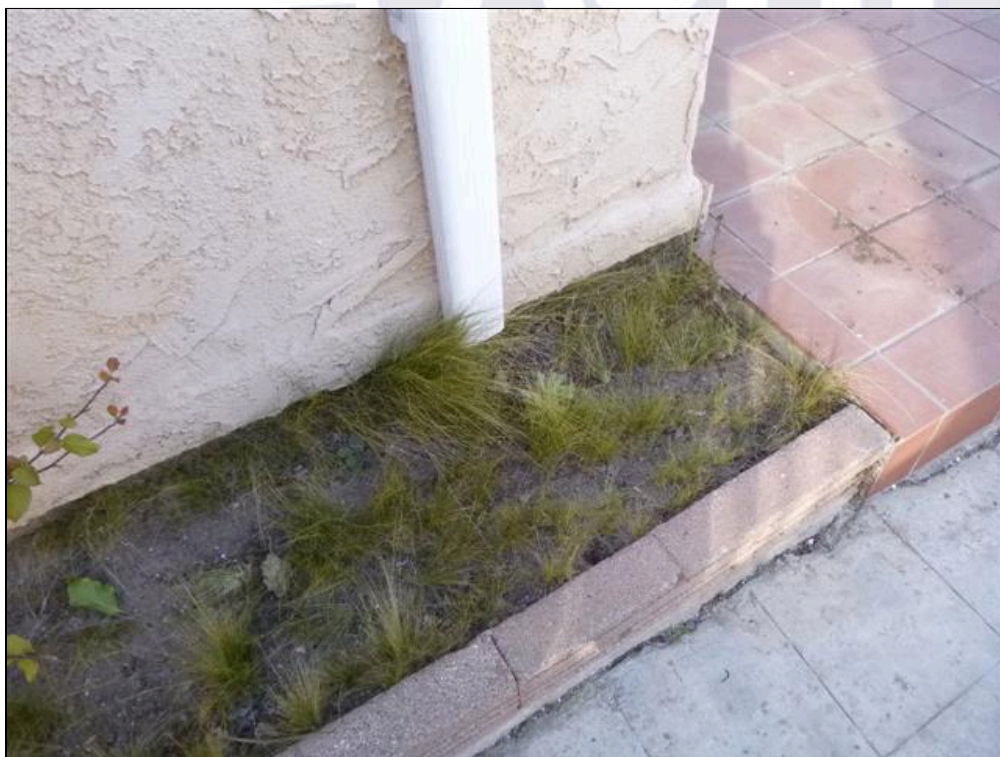
1.9 Item 2(Picture)

**1.9** (2) Suggest redirecting the downspouts out of the planters to reduce ponding during the rainy season.

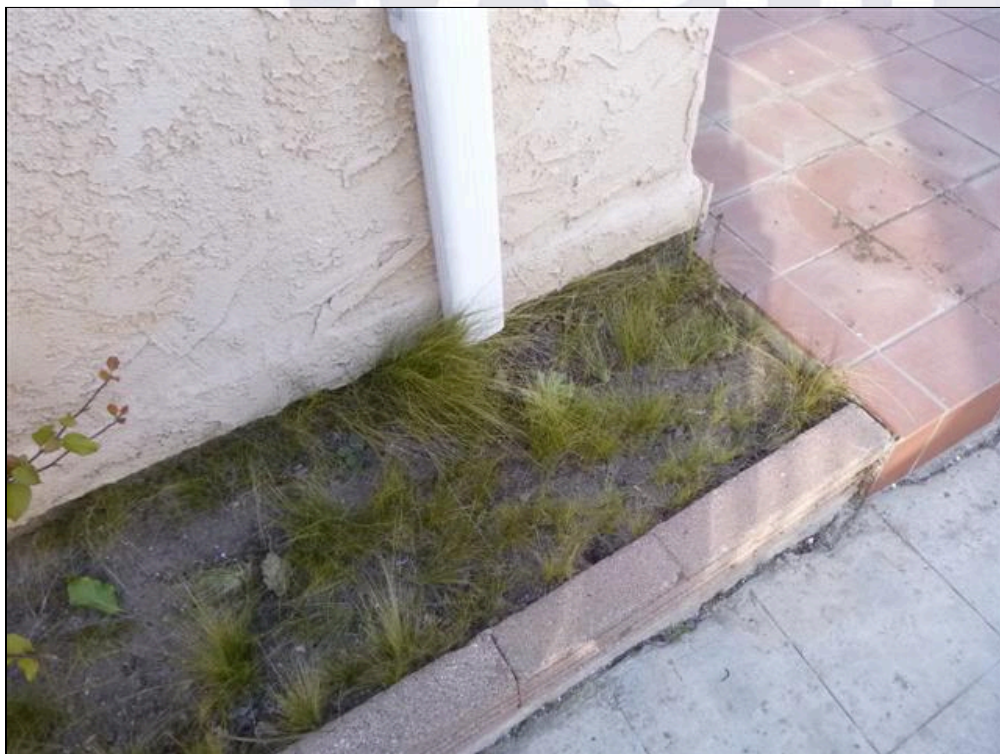
1.11 Item 1(Picture)

**1.11** No drains and/or drain holes noted/visible at the planter(s). Suggest installing drains/weep holes to prevent ponding and/or excessive moisture buildup at the foundation during the rainy season.

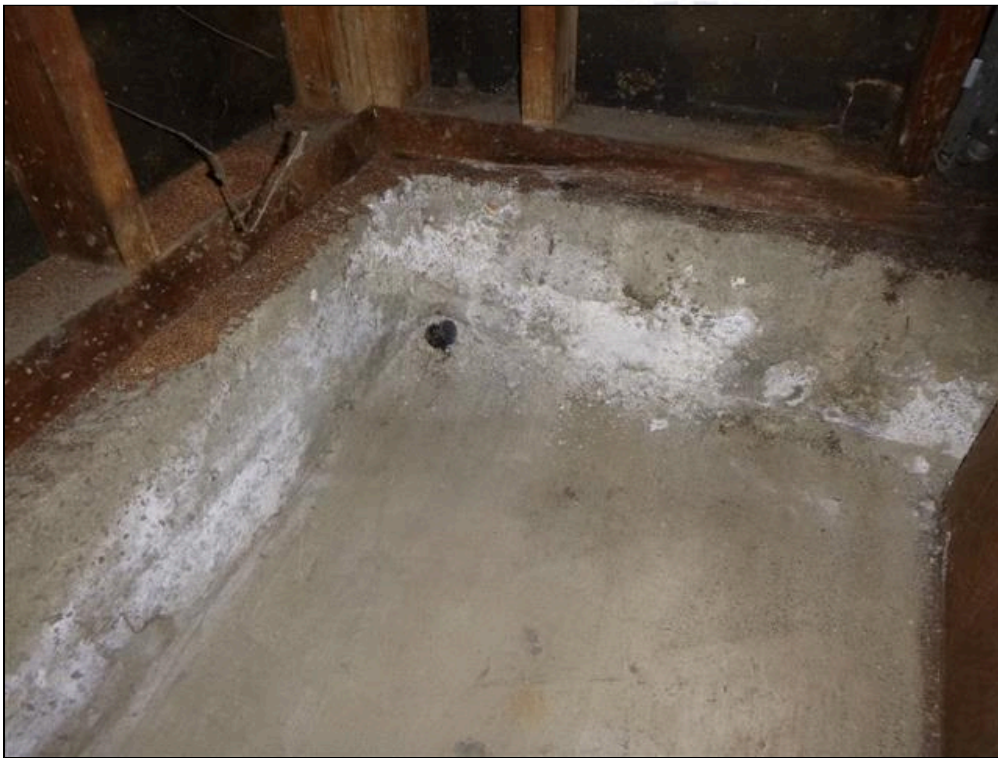
3.0 Item 1(Picture)

**3.0** (2) White efflorescence (powder substance) on foundation footings indicates prior, and possibly ongoing, excessive moisture build up at the exterior of the foundation. Ongoing water intrusion at the foundations can, in some cases, cause the steel in the foundations to rust, called spawling, which can lead to horizontal cracking of the foundation ( currently there are no major cracks visible at the foundation ). Any future cracking/damaged can be an expensive repair as the foundation is now structurally weak and susceptible to horizontal movement. Suggest review of the Lot/Grade/ drainage and sewer drainage systems, including rain gutters, to reduce and prevent further and future water buildup at the exterior of the dwellings foundations.

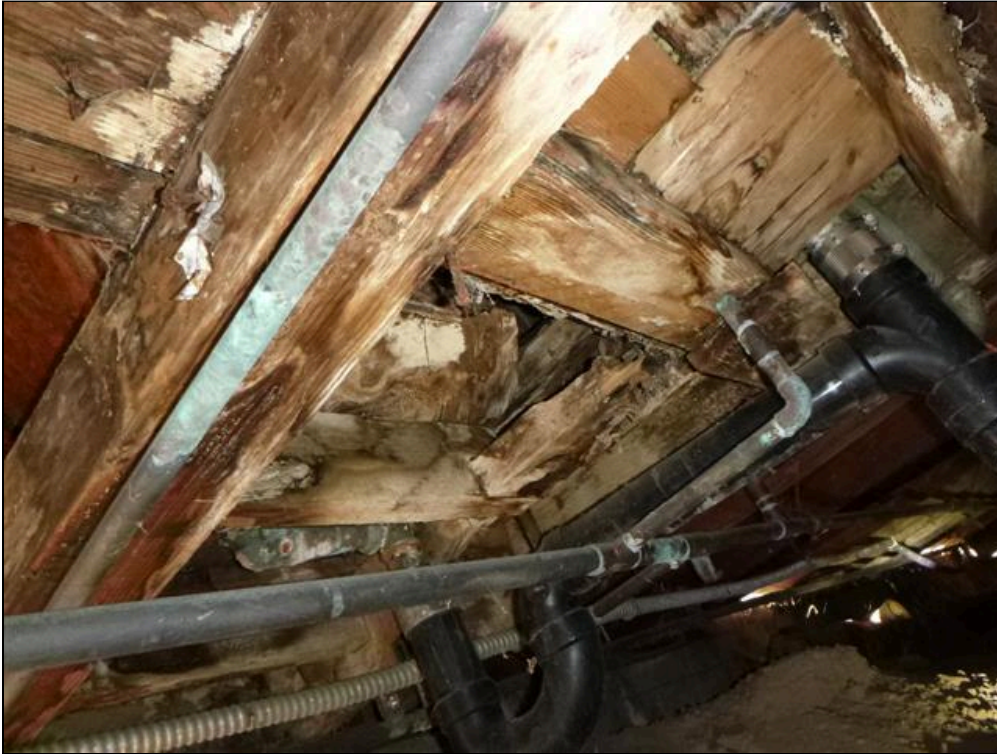
3.1 Item 1(Picture)

**3.1** Excessive stains and deterioration noted at various flooring and supports from prior leaks. Suggest review with a termite company and/or a licensed contractor for any repair/replacement costs as needed.

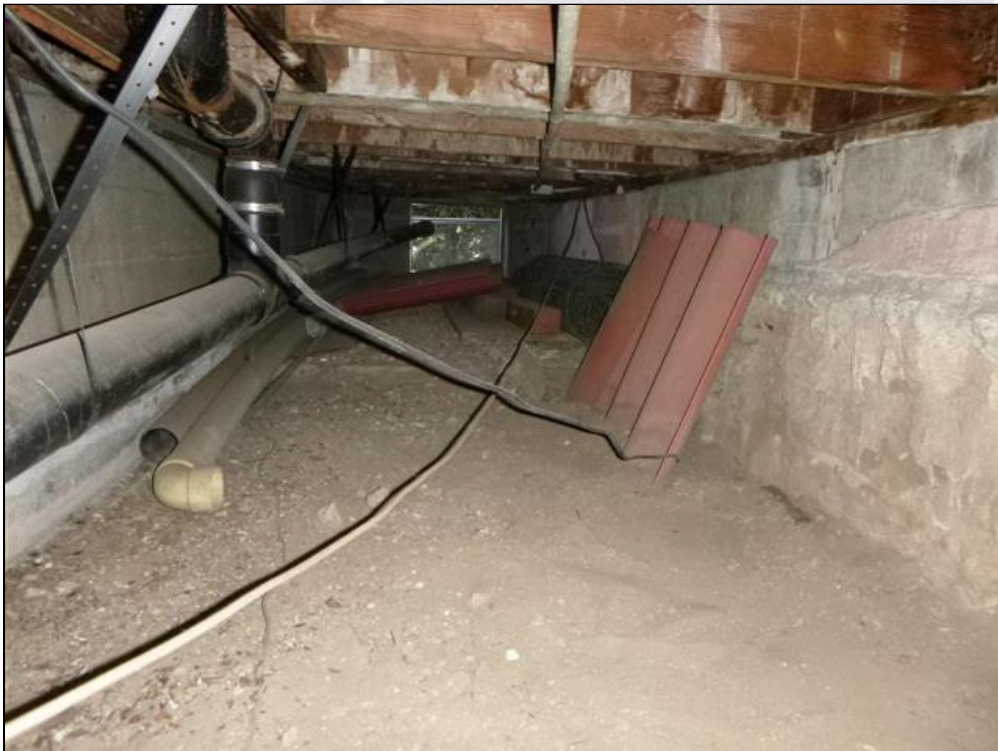
4.0 Item 1(Picture)

**4.0** Suggest removal of debris and construction items from the crawl area.

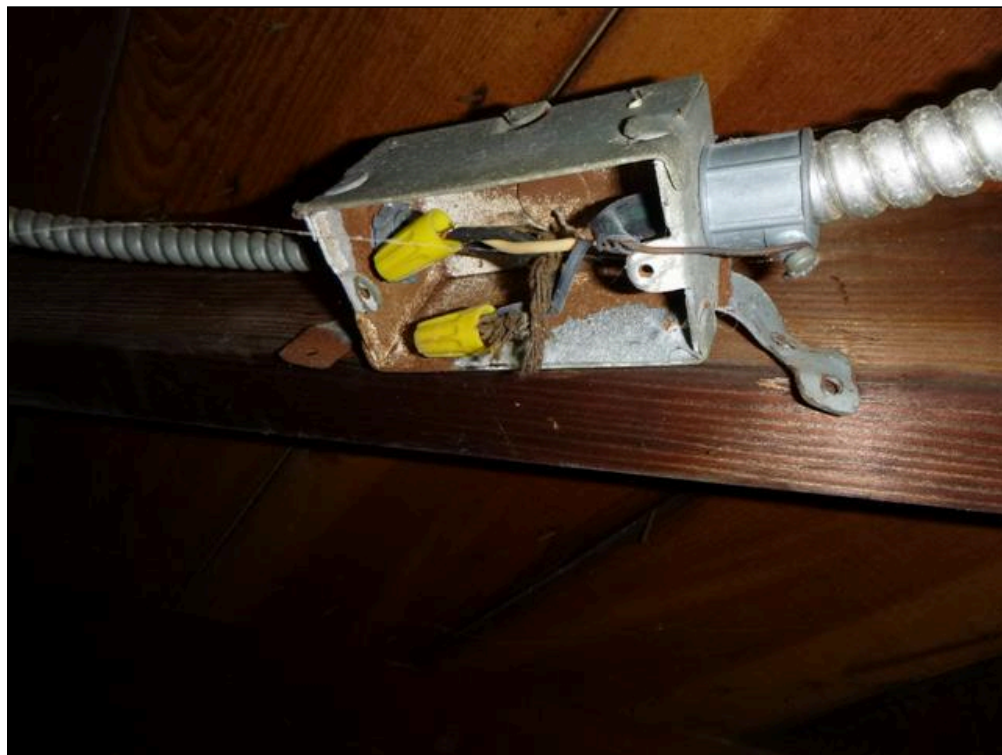
4.3 Item 2(Picture)

**4.3** (1) Open junction boxes were noted. This is a safety concern. Whenever an electrical wire is cut and re-connected, the 'splice' should be encased in a covered junction box to prevent shocks and separation of the splice. Suggest review by a licensed electrician and repair as needed.

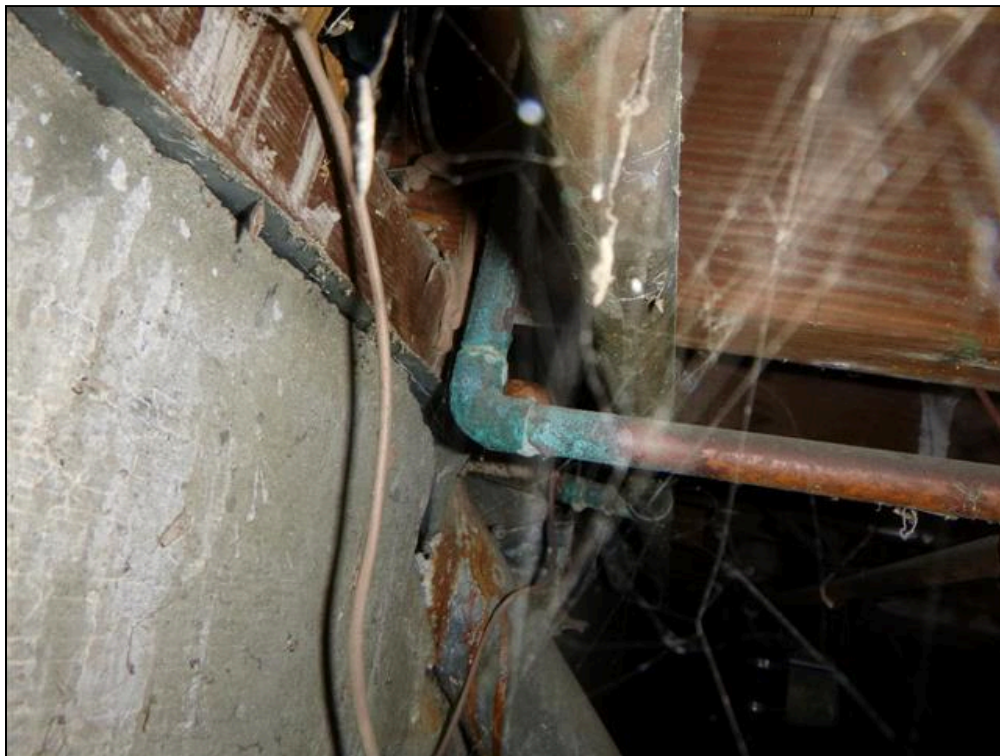
4.4 Item 1(Picture)

**4.4** (1) Corroded areas of the copper plumbing was noted throughout the crawl area, this can be a pre-cursor to 'pin hole' leaks. Suggest review with a licensed plumber for any repair/replacement costs as needed.

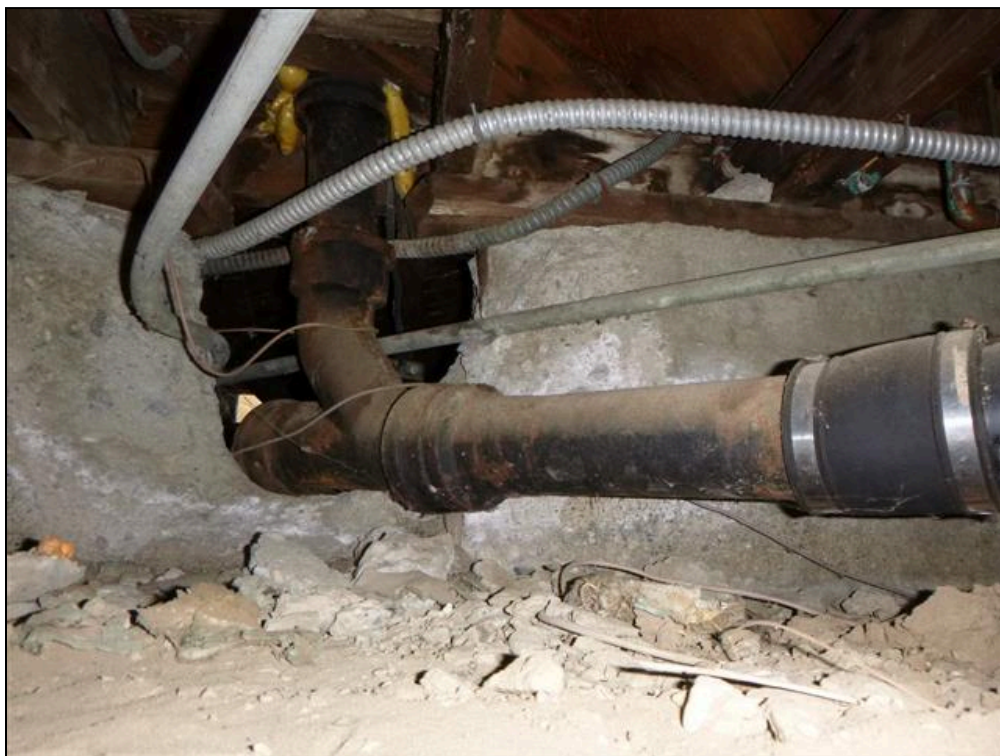
4.4 Item 2(Picture)

**4.4** (2) Rust and corrosion noted at various cast iron drain lines within the crawl space, common for the age, no leaking visible at the time of the inspection. Suggest review by a licensed plumbing contractor for repair/replacement costs as needed.

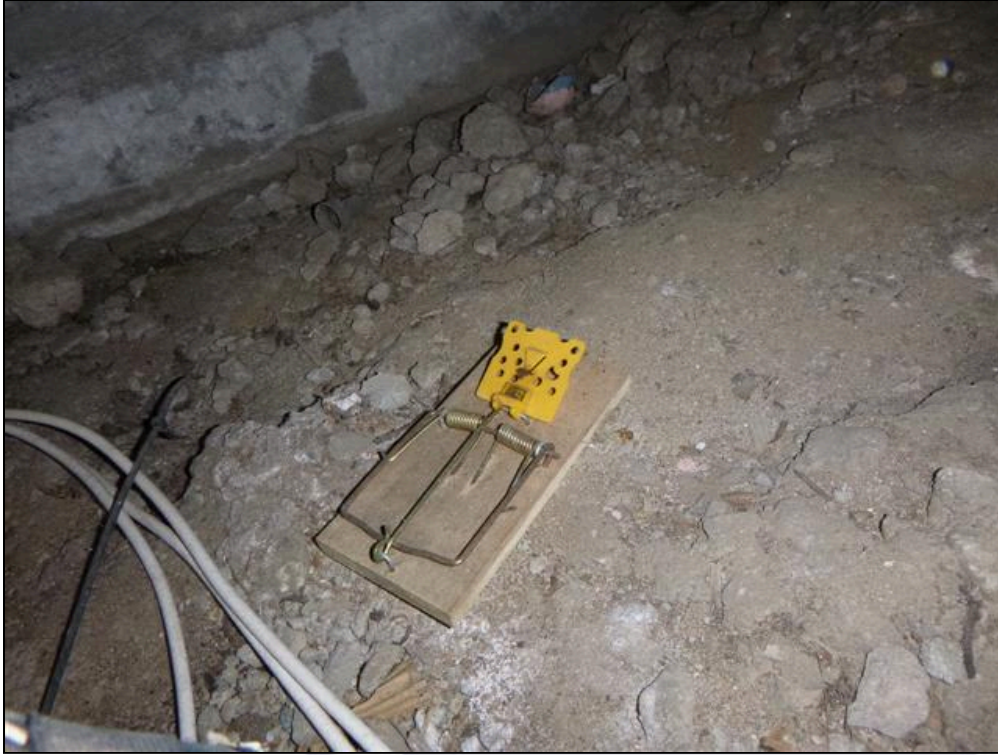
4.5 Item 1(Picture)

**4.5** Excessive pest droppings and traps noted within the crawl area. Suggest review with a qualified pest control company and/or a licensed contractor for removal costs of the droppings as needed.

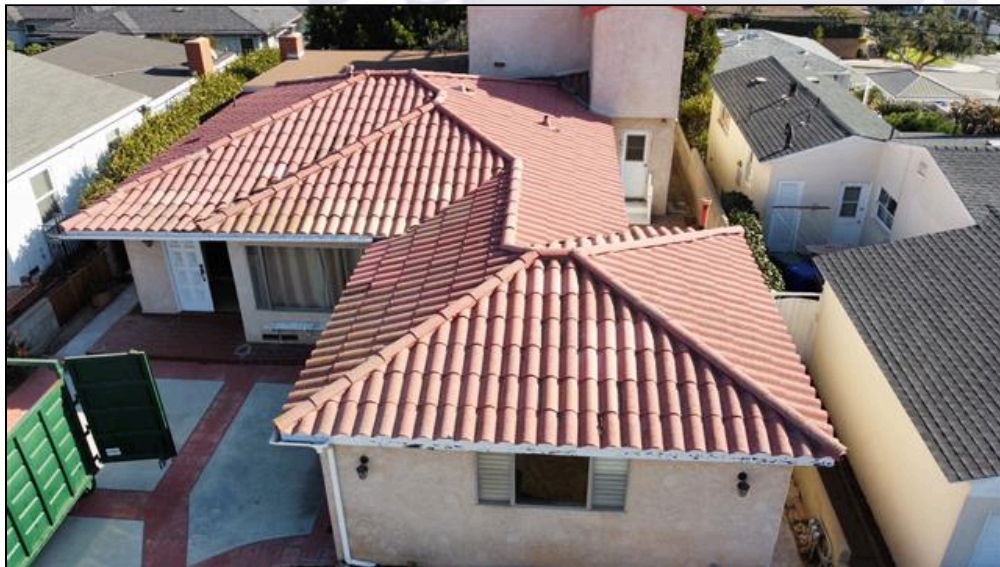
5.0 Item 1(Picture)

**5.0 (1)** Deteriorated, cracked, loose and missing sections of the roof tiles was noted. Suggest review by a licensed roofer for any repair/replacement costs as needed to prevent any future leakage during the rainy season.

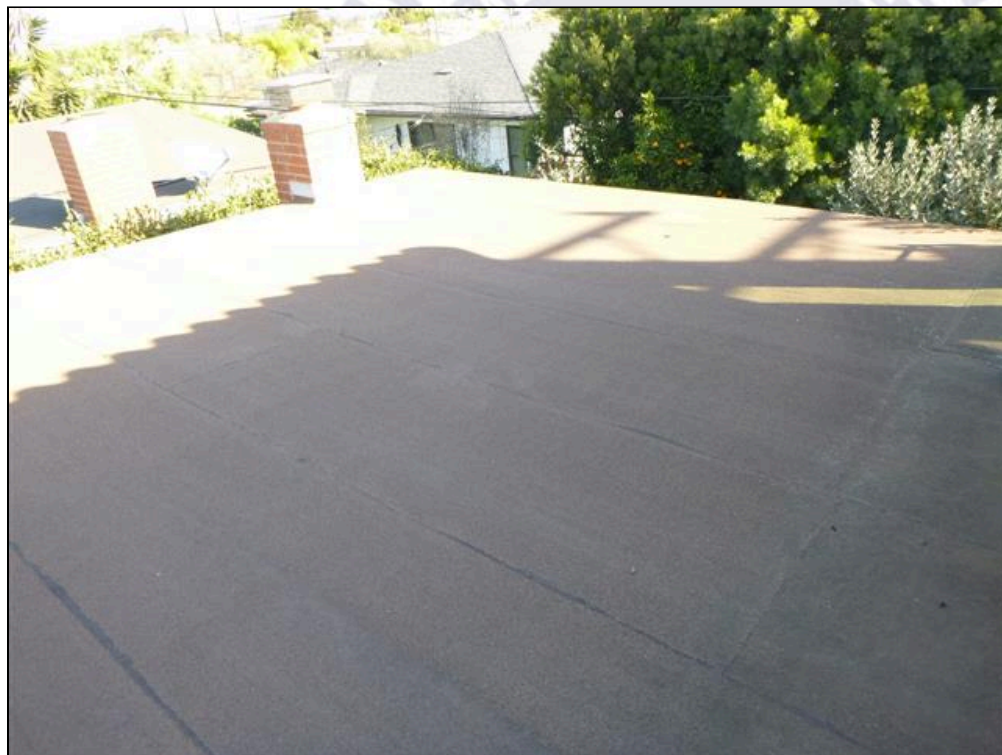
5.0 Item 7(Picture)

**5.0** (2) Soft, uneven, wrinkling and worn areas of the sloped roof was noted. Suggest review with a licensed roofer for any repair/removal/replacement costs as needed.

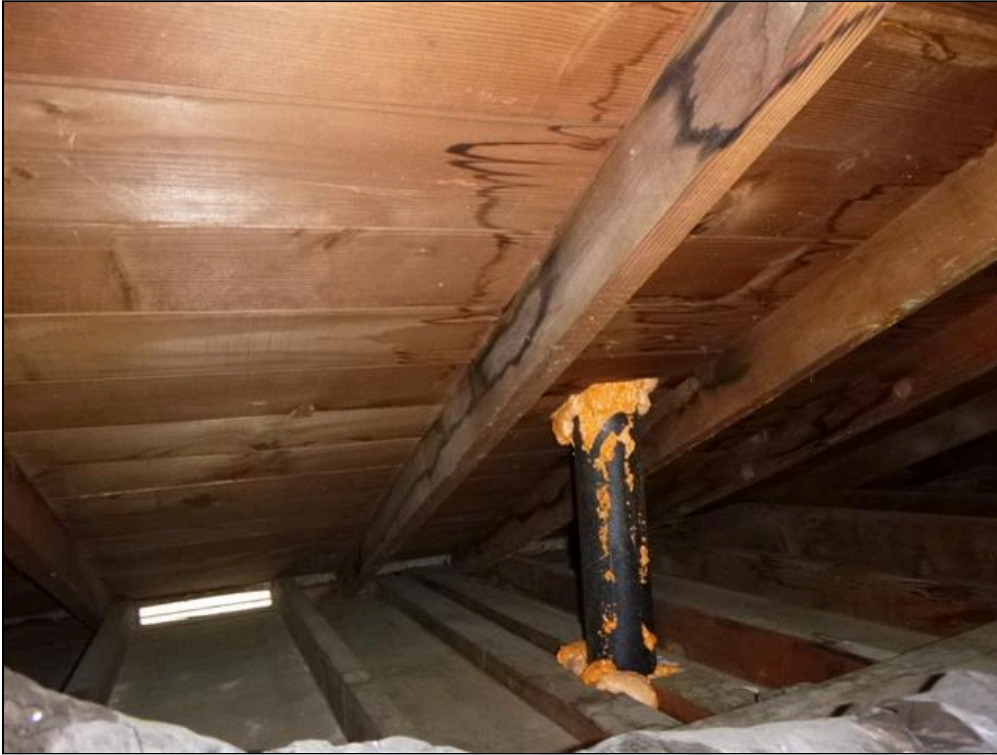
6.0 Item 1(Picture)

**6.0** (1) Moisture stains noted at various areas of the attic sheathing/framing, see roof comments and repair as needed.

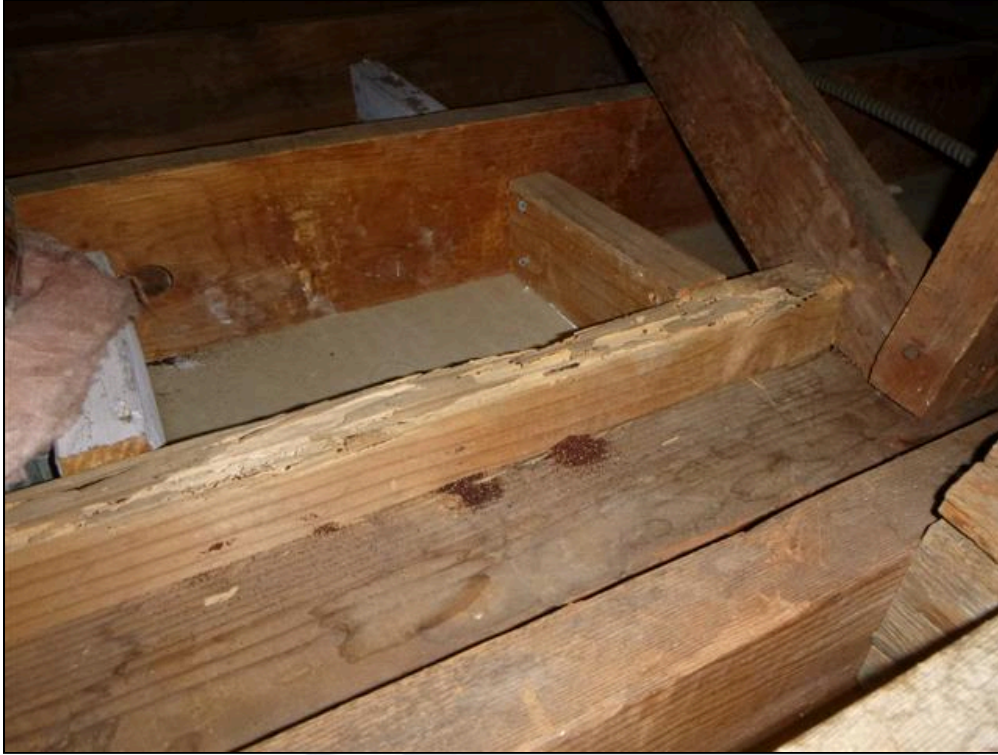
6.0 Item 2(Picture)

**6.0** (2) Wood deterioration noted at various areas of the roof framing, suggest review with a termite company and/or a licensed contractor for repairs as needed.

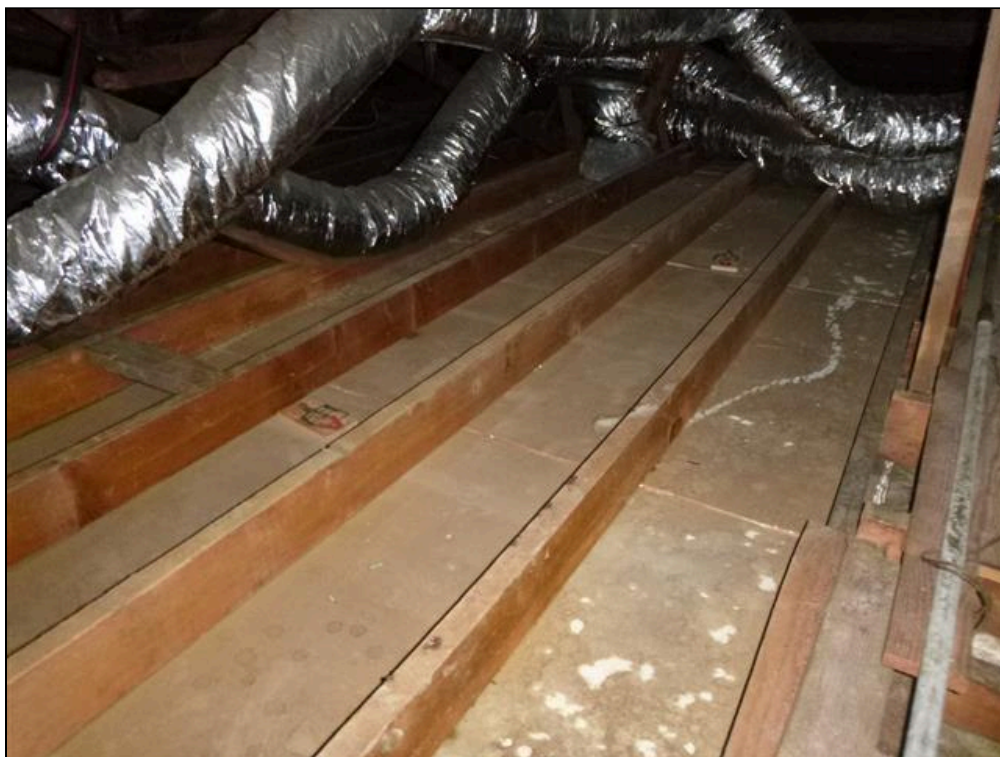
6.1 Item 1(Picture)

**6.1** No Insulation installed at the attic area ( this is common for the original age of the home ). Suggest review by a licensed contractor for costs to add/install insulation as an upgrade ( adding/ installing insulation will help/reduce the heat buildup within the dwelling during the summer/hot months and reduce the heat loss during the winter/cold months ).

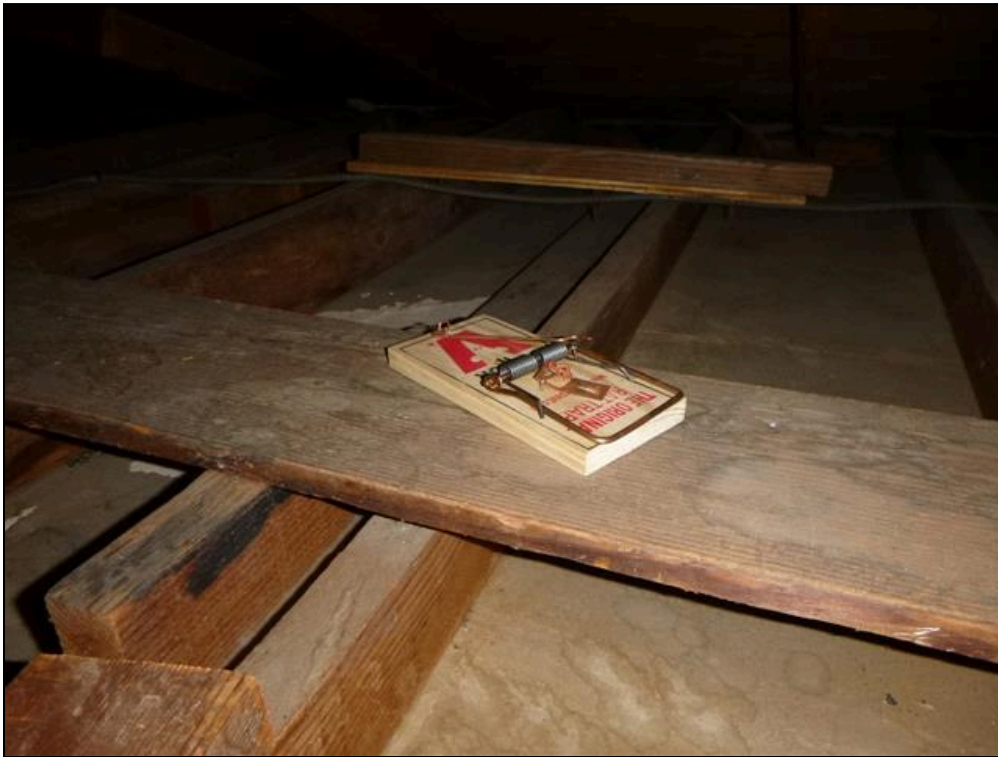
6.6 Item 2(Picture)

**6.6** (3) Pest traps were noted within the attic. Suggest review with a qualified pest control company and/or a licensed contractor for removal costs of the droppings, re-screening of the vents and any removal/replacement of the attic insulation as needed.

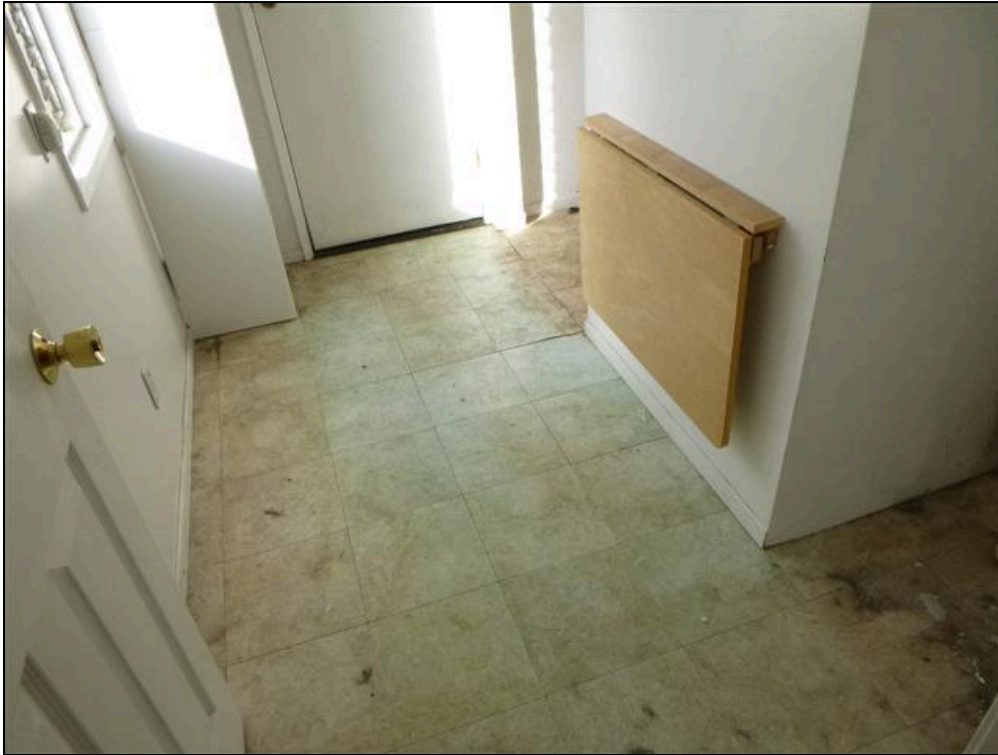
7.0 Item 1(Picture)

**7.0** Deteriorated and loose sections noted at the laundry floor, suggest repair/replace as needed.

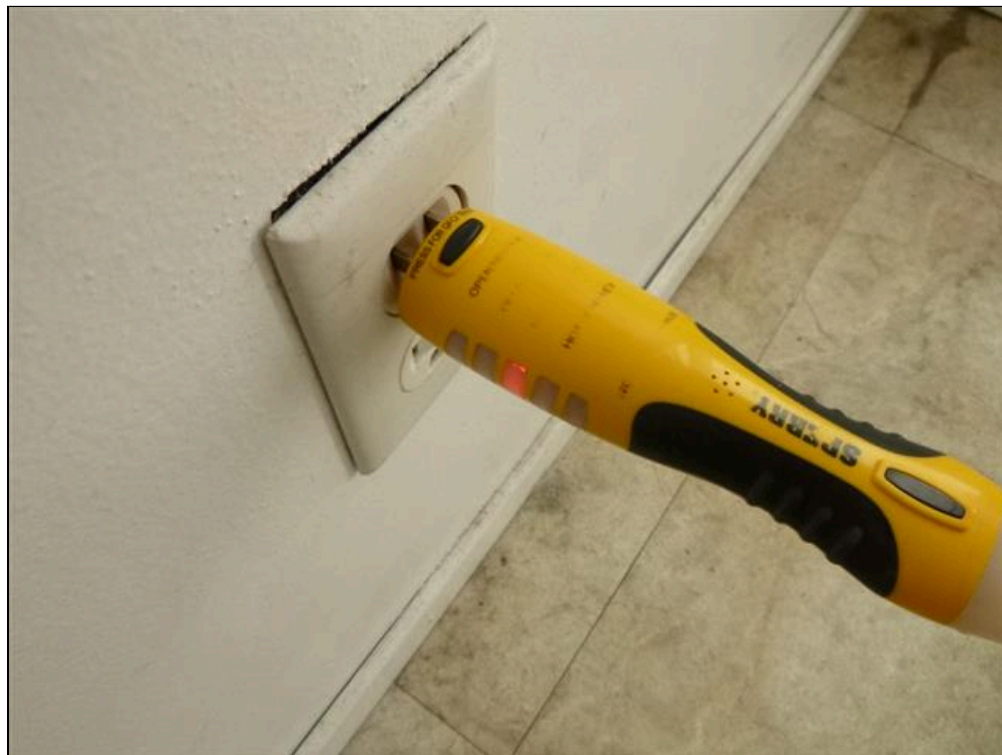
7.6 Item 1(Picture)

**7.6** Reversed polarity noted at various outlets. Reversed polarity, hot and ground reversed and other terms used for electric outlets are usually easily corrected by minor wiring adjustments at the specified item. Suggest review with a licensed electrician for repair/replacement costs and confirm correct operation as needed.

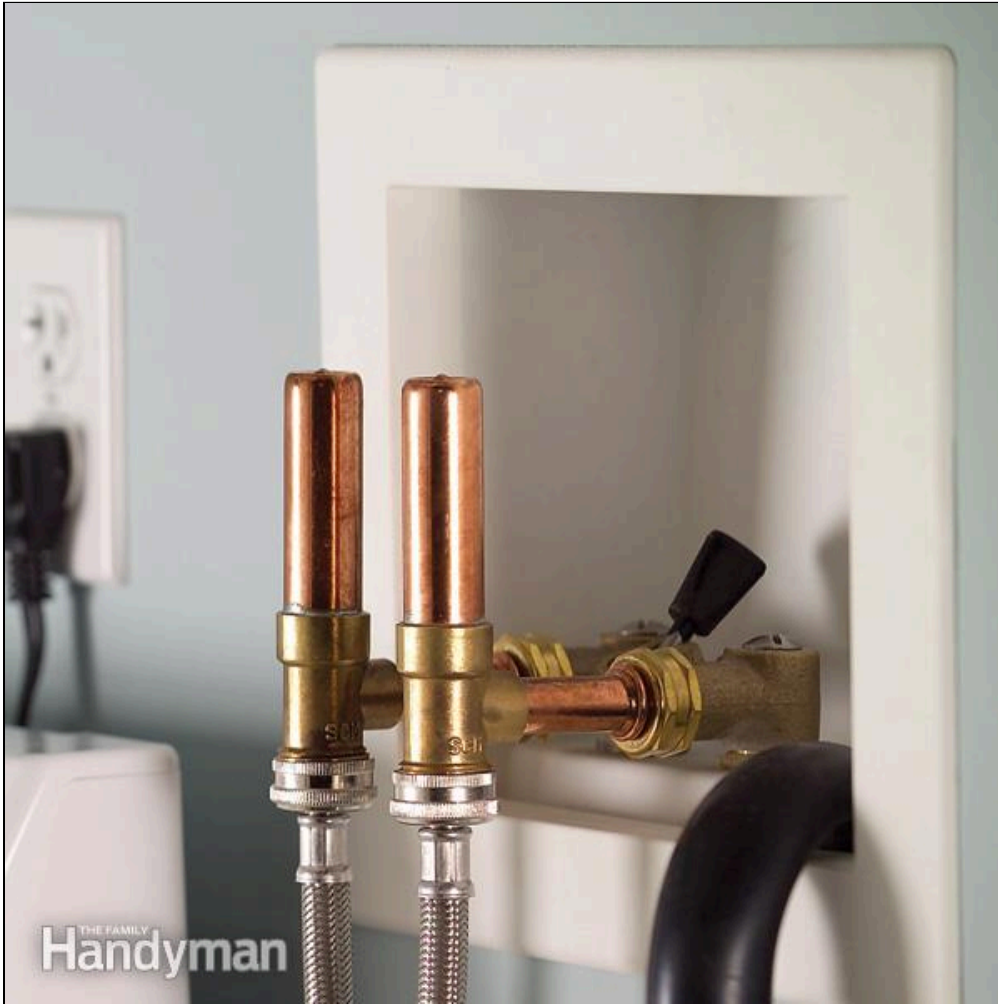
7.7 Item 1(Picture) HV

7.7 (1) Suggest upgrading with 'hammer valve' plumbing supply systems if a water sensor/efficient/ smart washing machine is to be installed at this area.

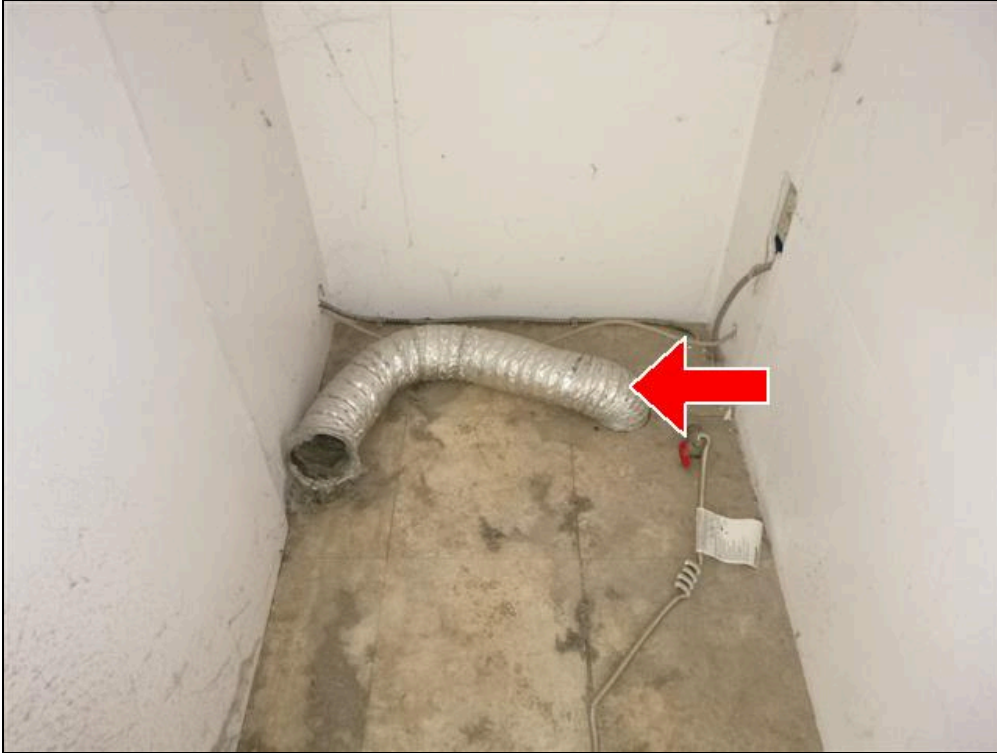
7.8 Item 1(Picture)

**7.8** (1) Improper aluminum/vinyl flex vent installed to the exterior of the dwelling, this is a potential

fire/safety hazard. Suggest remove the existing material and installation of a rigid metal vent pipe/duct and vent cap to the exterior as required.

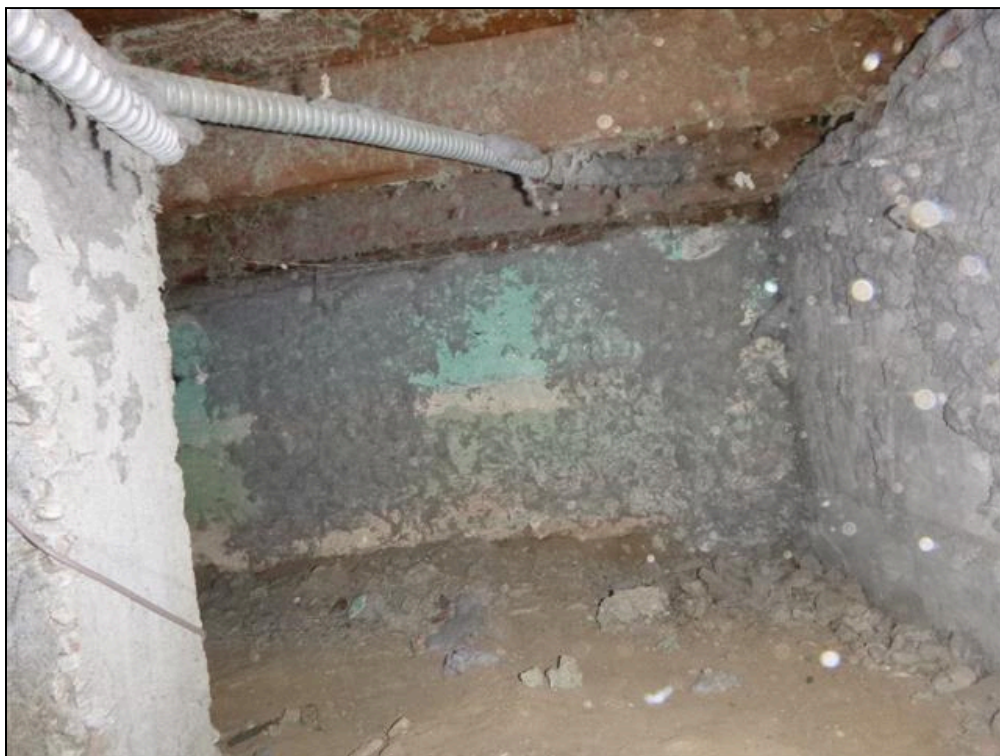
7.8 Item 3(Picture)

**7.8** (2) The dryer vent is pulled apart/leaking within the crawl space, this is a potential fire safety hazard. Suggest repairs as needed and vent to the exterior of dwelling with approved rigid materials and removal of all lint from the crawl area.

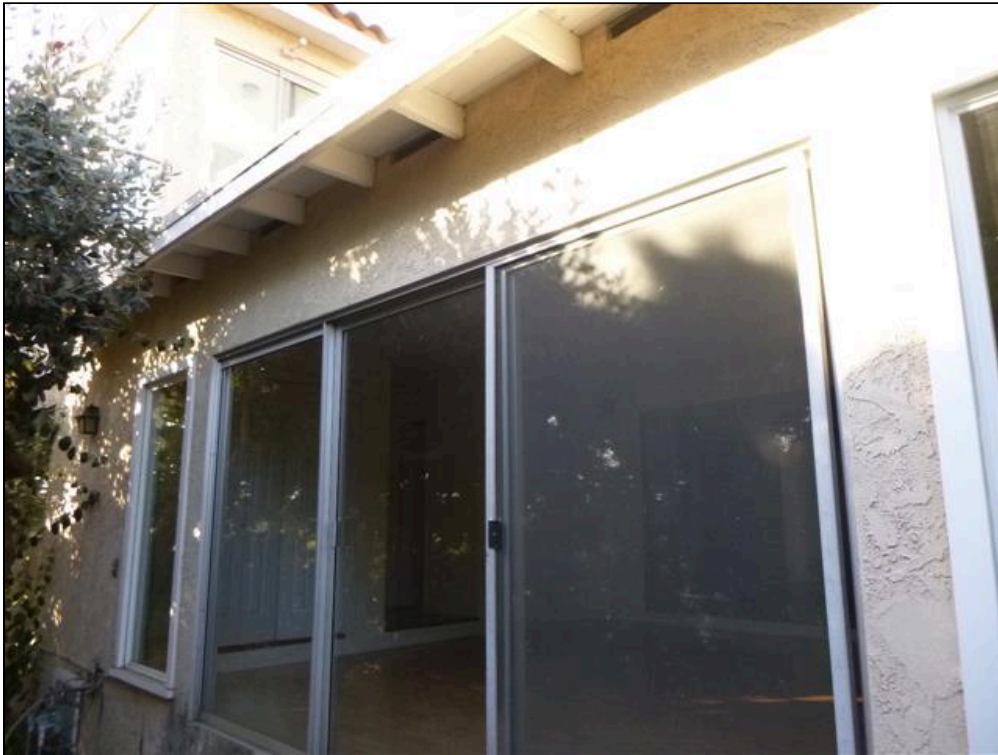
10.2 Item 1(Picture)

**10.2** No light fixture installed at the door area, this is a possible safety hazard. Suggest review with a licensed electrician for costs to install a light fixture as required for safety.

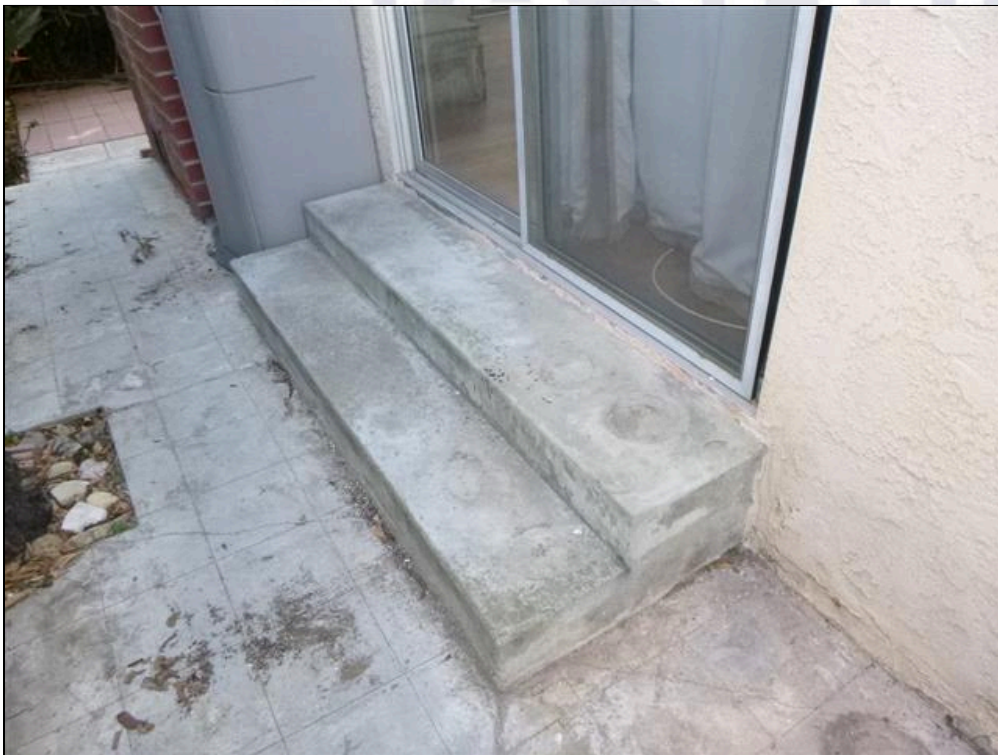
11.0 Item 1(Picture)

**11.0** A potential trip/safety hazard was noted due an inadequate sized deck/landing prior to the step(s) ( this is common for the age of the home/dwelling ). Generally a 36' landing is required at any exterior door prior to any step(s). Suggest review by a licensed contractor for any repair/replacement costs as needed.
