# Inspection Report

**Property Address:**  
2104 Chestnut Ave  
Manhattan Beach CA 90266

**Ferguson Home Inspections**

<b>Date:</b> 1/11/2025	<b>Time:</b> 09:00 AM	<b>Report ID:</b> 01112025ChestnutAve
<b>Property:</b> 2104 Chestnut Ave Manhattan Beach CA 90266	<b>Customer:</b> Yvonne Peltz	<b>Real Estate Professional:</b> Marlene Ramirez

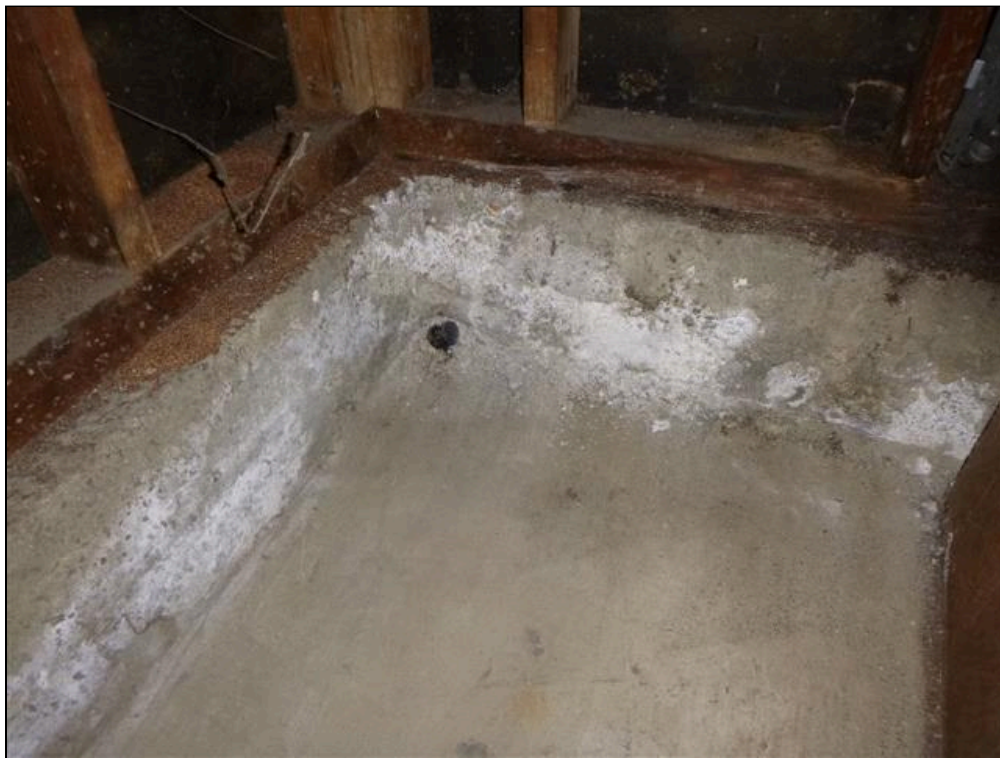
12.0 Item 1(Picture)

**12.0 (1)** Minor settling/movement/shrinkage cracks were noted.

**12.0 (2)** White efflorescence (powder substance) on foundation footings indicates prior, and possibly ongoing, excessive moisture build up at the exterior of the foundation. Ongoing water intrusion at the foundations can, in some cases, cause the steel in the foundations to rust, called spawling, which can lead to horizontal cracking of the foundation ( currently there are no major cracks visible at the foundation ). Any future cracking/damaged can be an expensive repair as the foundation is now structurally weak and susceptible to horizontal movement. Suggest review of the Lot/Grade/ drainage and sewer drainage systems, including rain gutters, to reduce and prevent further and future water

buildup at the exterior of the dwellings foundations.

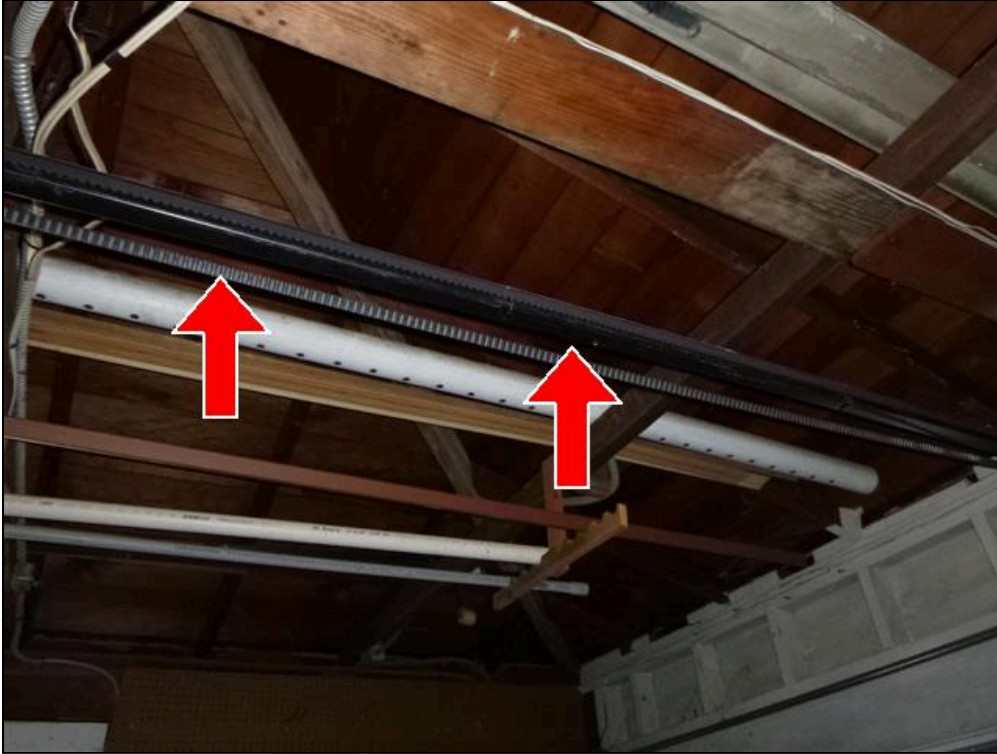
12.3 Item 1(Picture)

**12.3** (1) Unreasonable resistance was required to stop the main garage door(s) in motion, this is a safety concern. Suggest adjusting door opener(s) so the safety reverse operates as required. The US Product Safety Commission recommends these devices be checked monthly.

**12.3** (2) The garage door opener(s) pull chain/rubber is excessively loose and periodically catches on the railing mount(s). Suggest review with a licensed contractor for costs to correctly tighten/tension the system as required and confirm correct operation as needed.

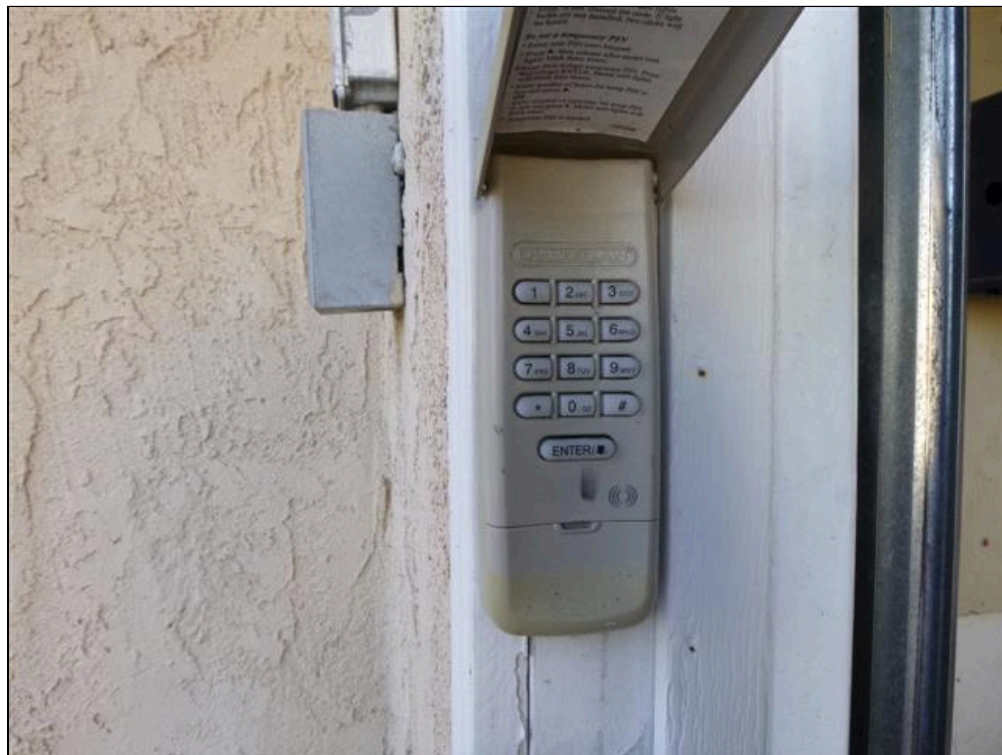
12.3 Item 2(Picture)

**12.3** (3) Suggest obtaining the garage door opener keypad door code from the seller and confirm correct operation as needed.

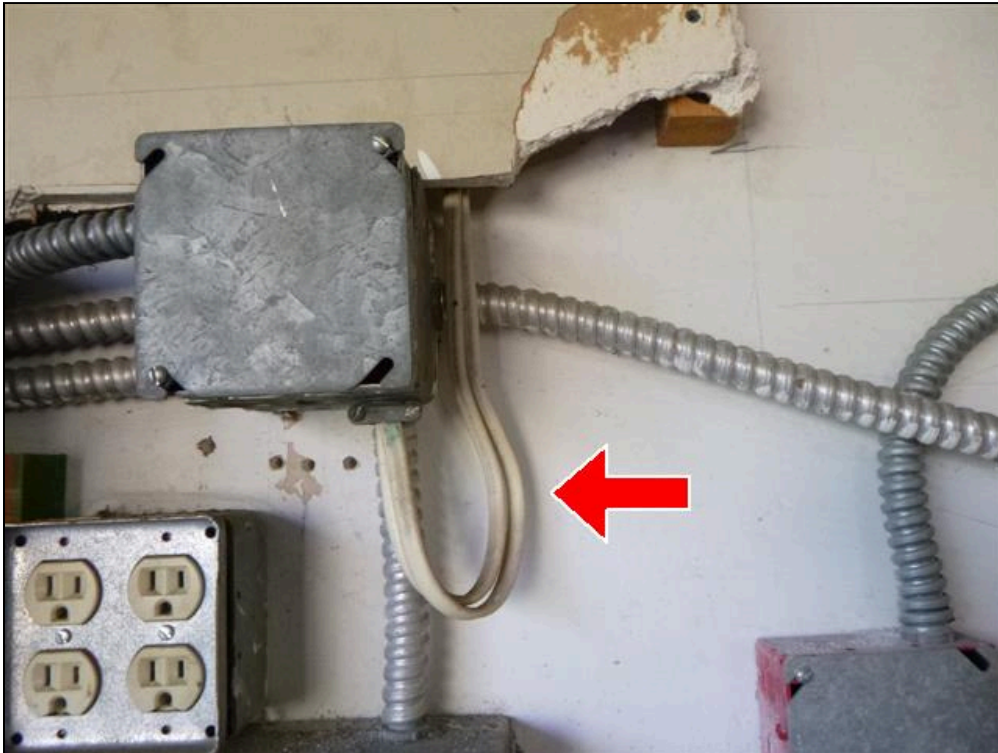
12.6 Item 2(Picture)

**12.6 (3)** Exposed romex wiring located in accessible areas. This is a safety concern as it could be subject to physical damage. Romex wiring is allowed in inaccessible areas such as attics, crawl spaces and within walls provided that all proper protective materials and required tie-downs are in place. Suggest review by a licensed electrician for repair/replacement costs as needed.

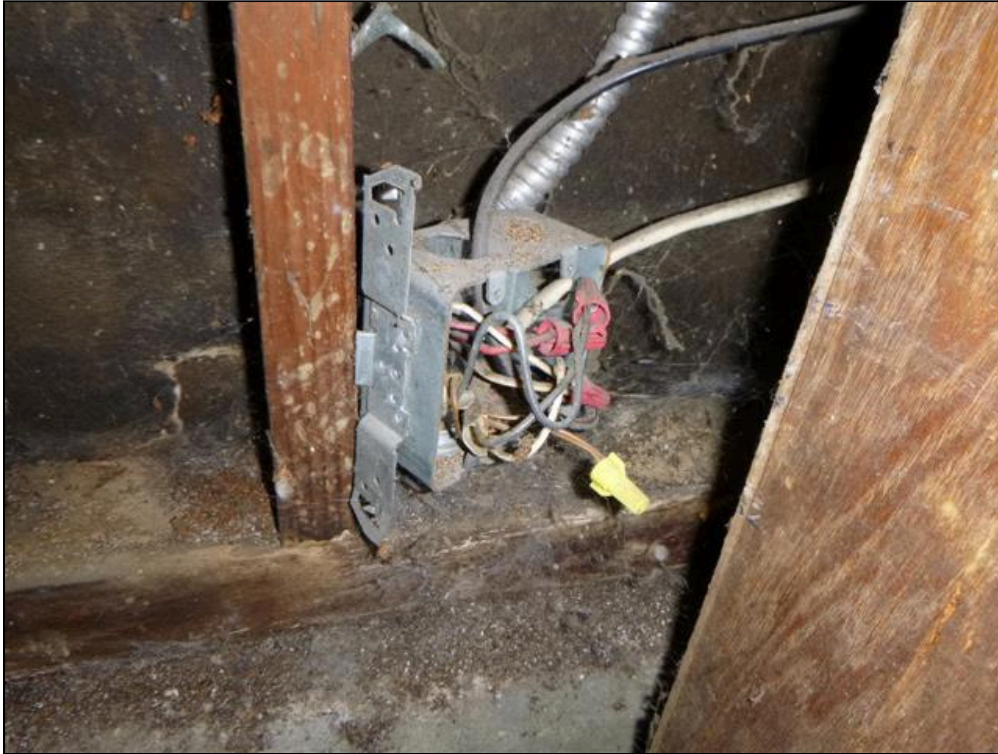
12.6 Item 3(Picture)

**12.6** (4) Open junction boxes/conduit was noted, this is a potential safety hazard. Whenever an electrical wire is cut and re-connected, the 'splice' should be encased in a covered junction box to prevent shocks and separation of the splice. Suggest review by a licensed electrician for repair/ replacement costs as needed.

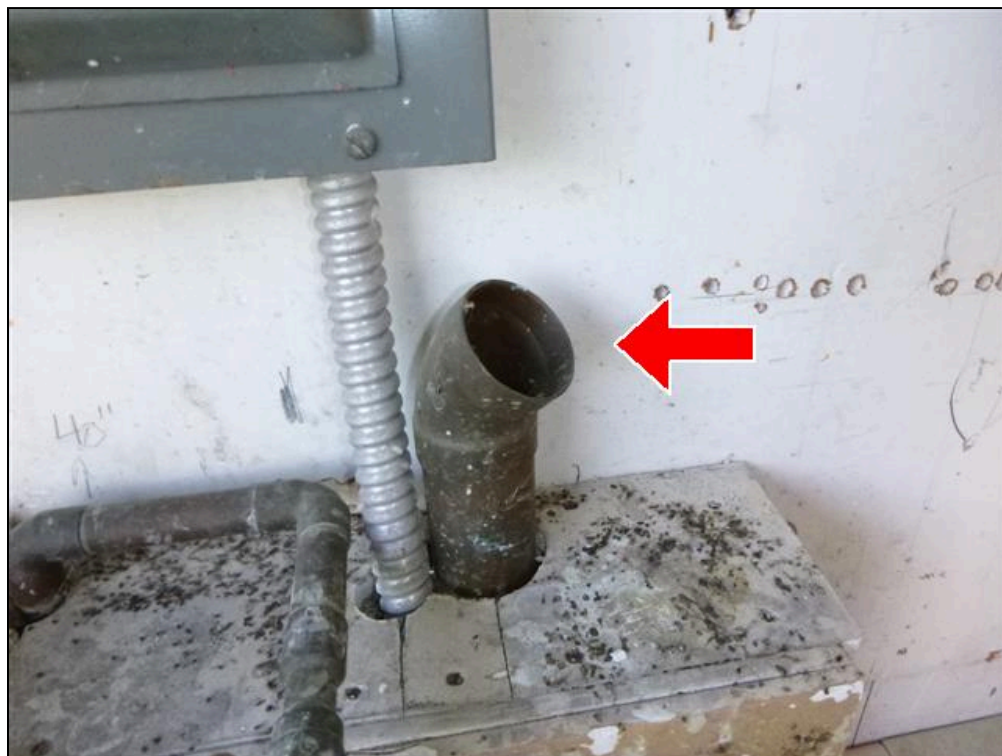
12.8 Item 1(Picture)

**12.8** The sink drainage vent does not transfer through the roof as required, but terminates inside the garage area. Suggest review by a licensed plumber for costs to complete the installation as required for safety.

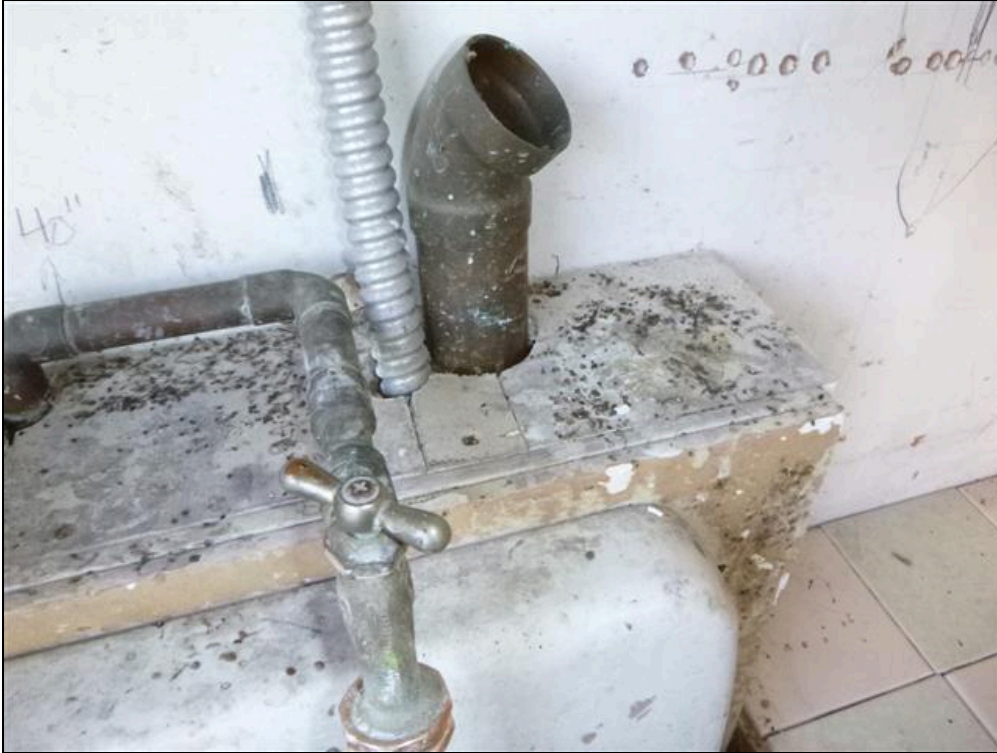
12.9 Item 1(Picture)

**12.9** Excessive pest droppings noted within the garage area. Suggest review with a qualified pest control company and/or a licensed contractor for removal costs of the droppings as needed.

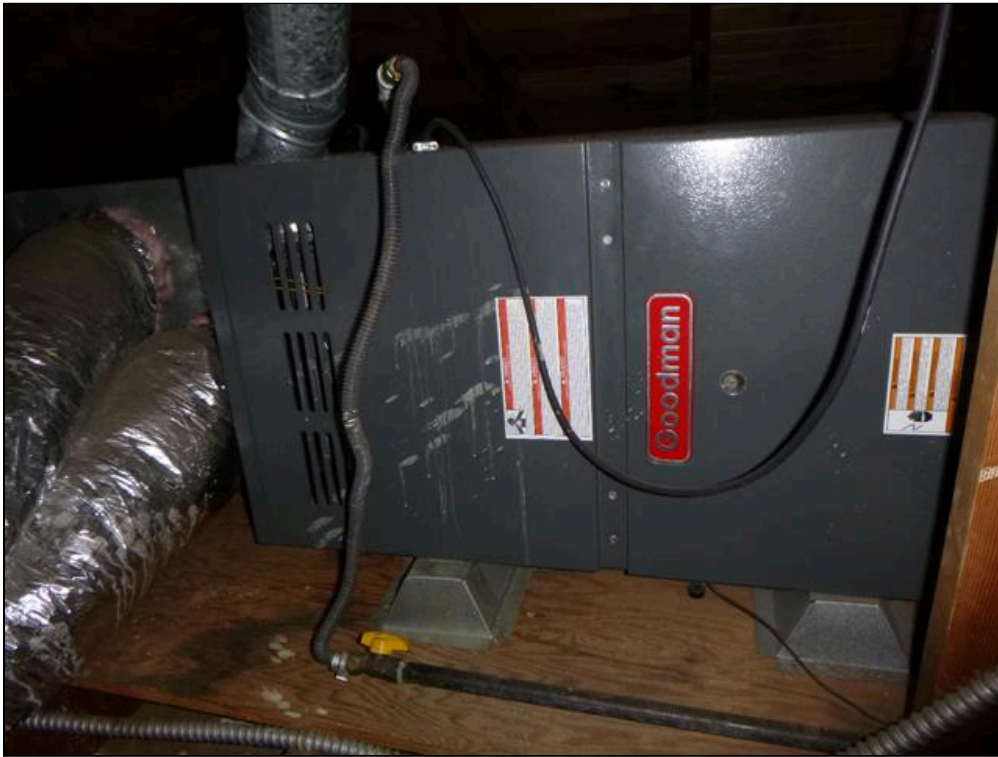
13.0 Item 1(Picture)

13.0 (1) The inspector was unable to test the heating system as the thermostat was inoperable at the time of the inspection. Suggest review by the Gas Company and/or a licensed heating company for review to determine if the unit is operational, any repair/replacement costs and confirm correct operation as needed.

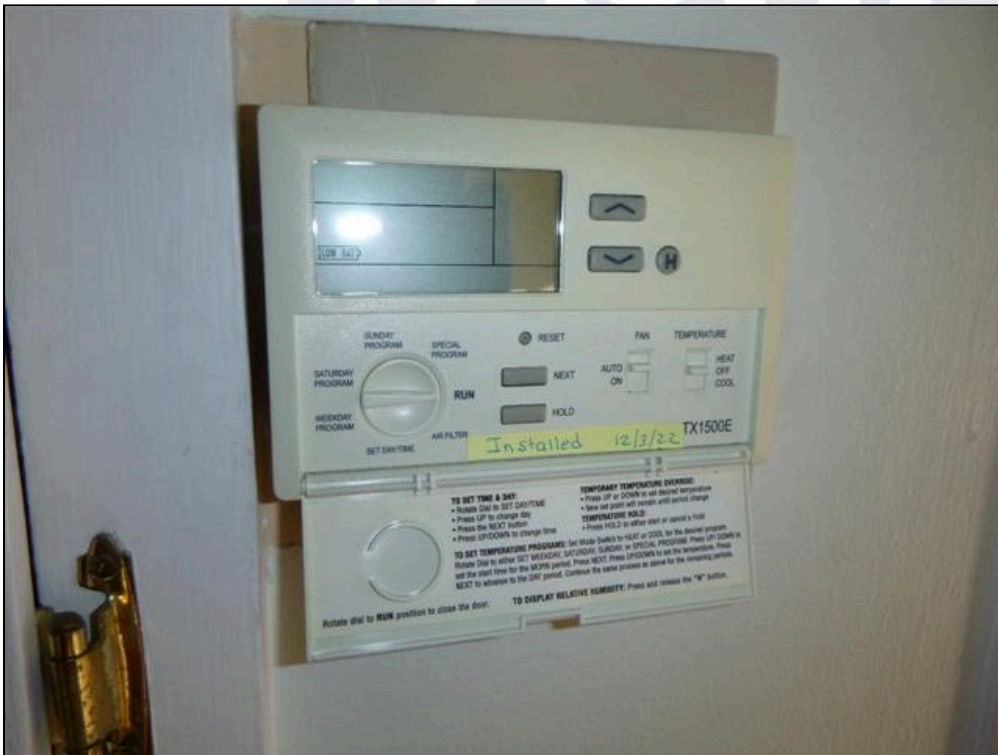
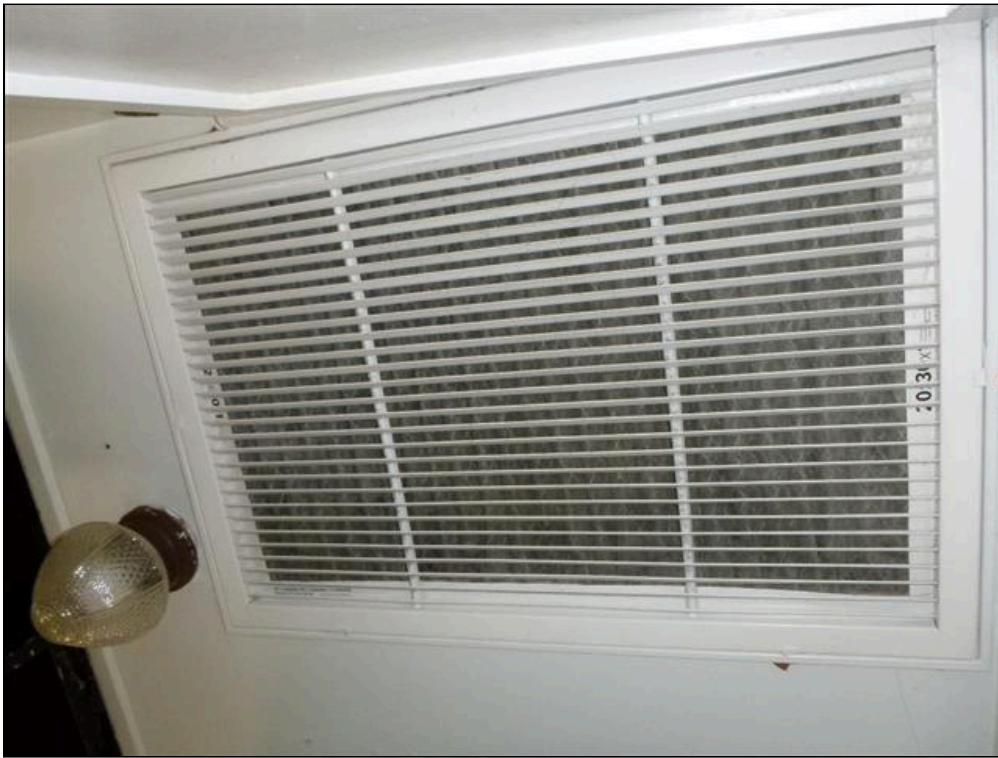
13.0 Item 2(Picture)

13.0 (2) Suggest replacing/cleaning the filter(s) as needed.

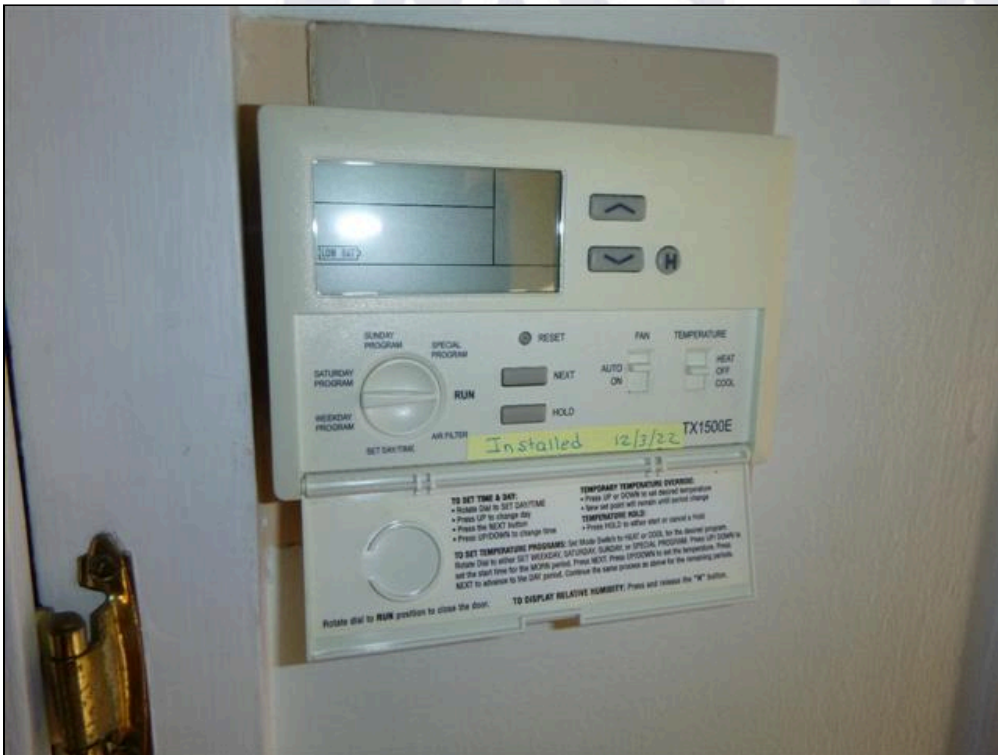
13.2 Item 1(Picture)

13.2 Unable to test/operate the thermostat at the time of the inspection, see the heating comments.

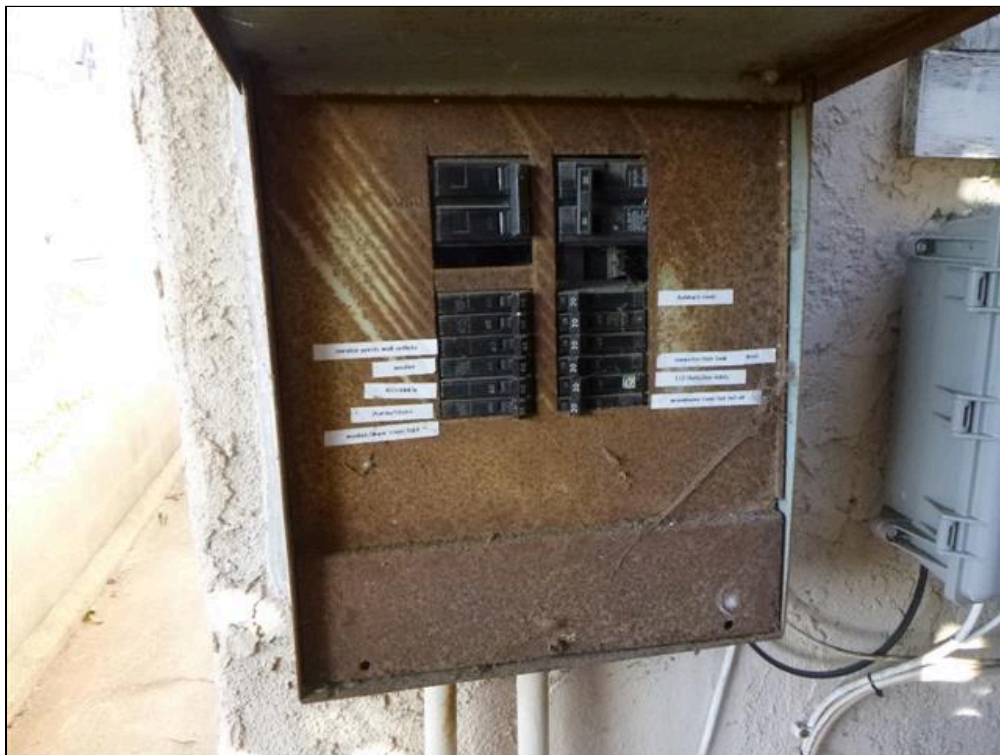
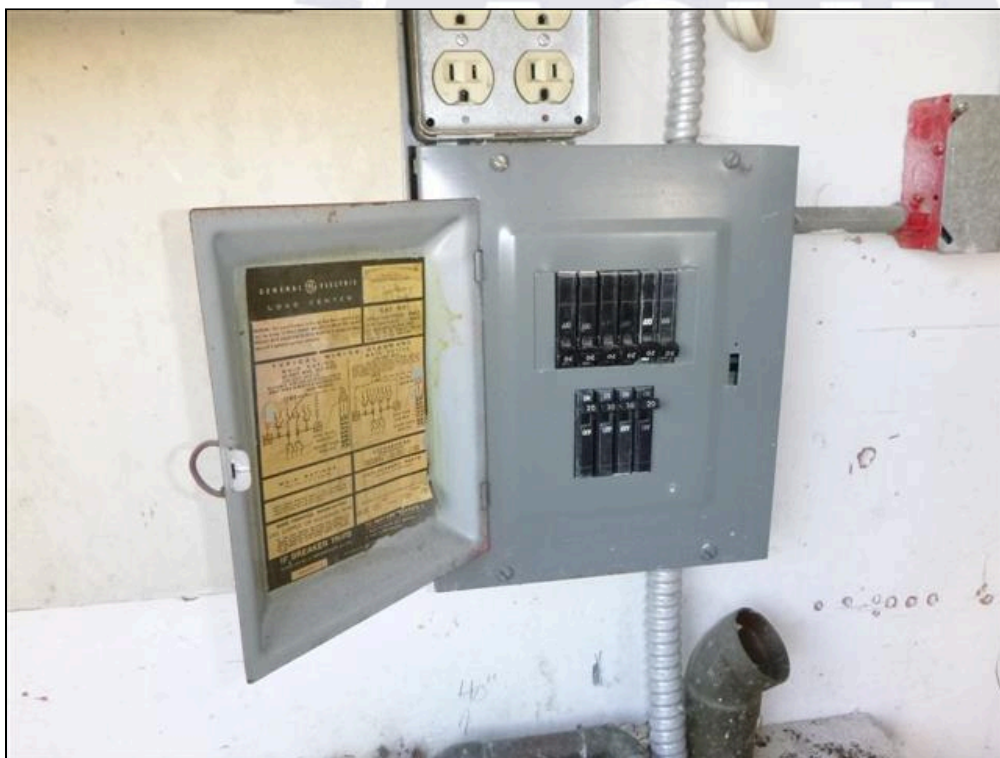
14.1 Item 1(Picture)

**14.1 (1)** Suggest adding correct/complete indexing/labelling to all breakers for identification of each circuit for safety.

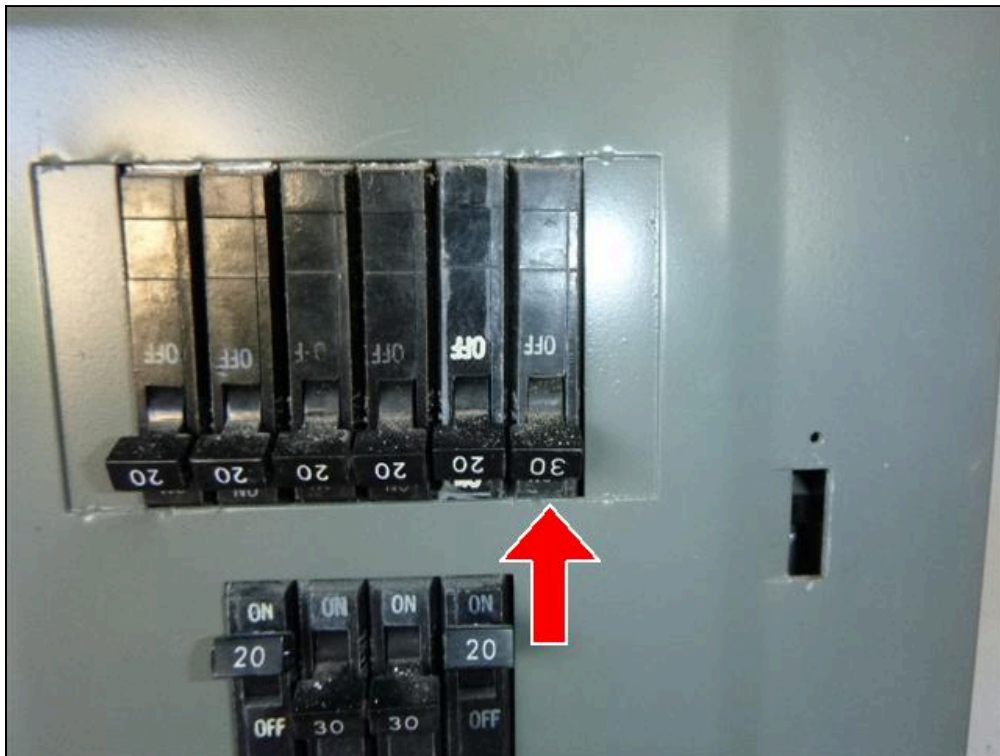
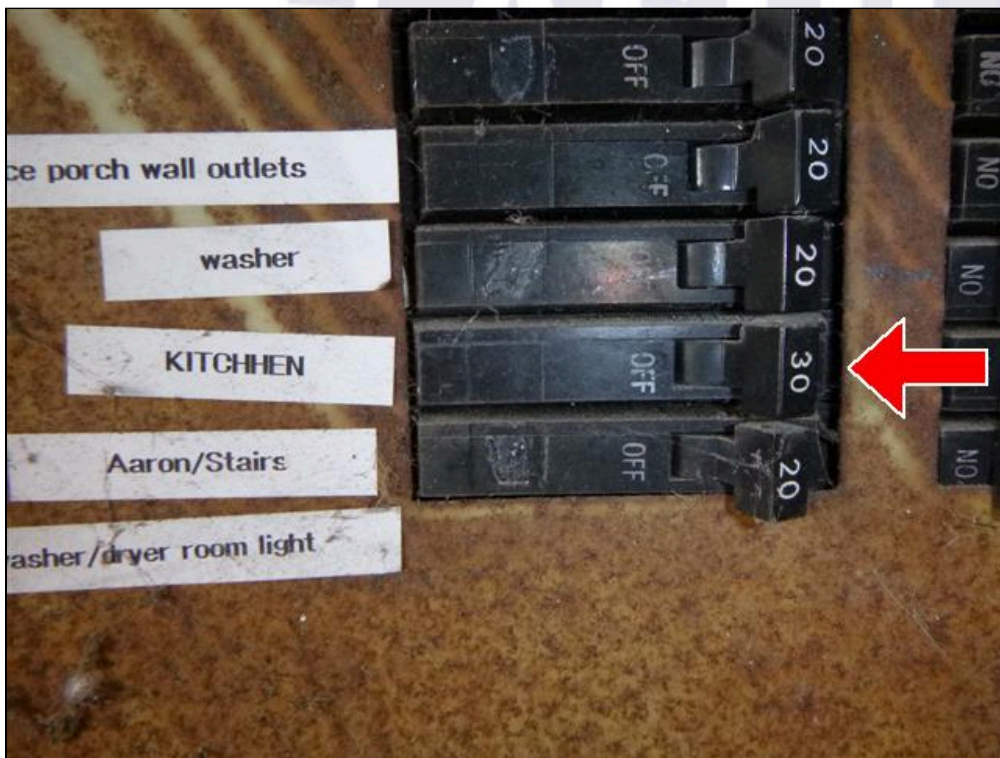
14.2 Item 1(Picture)

**14.2** (1) Single 30 amp breakers are currently being used for a 110 volt circuits at the main and sub panels. This is a potential fire safety hazard. Suggest review with a licensed electrician for repair/ replacement costs as needed for safety.

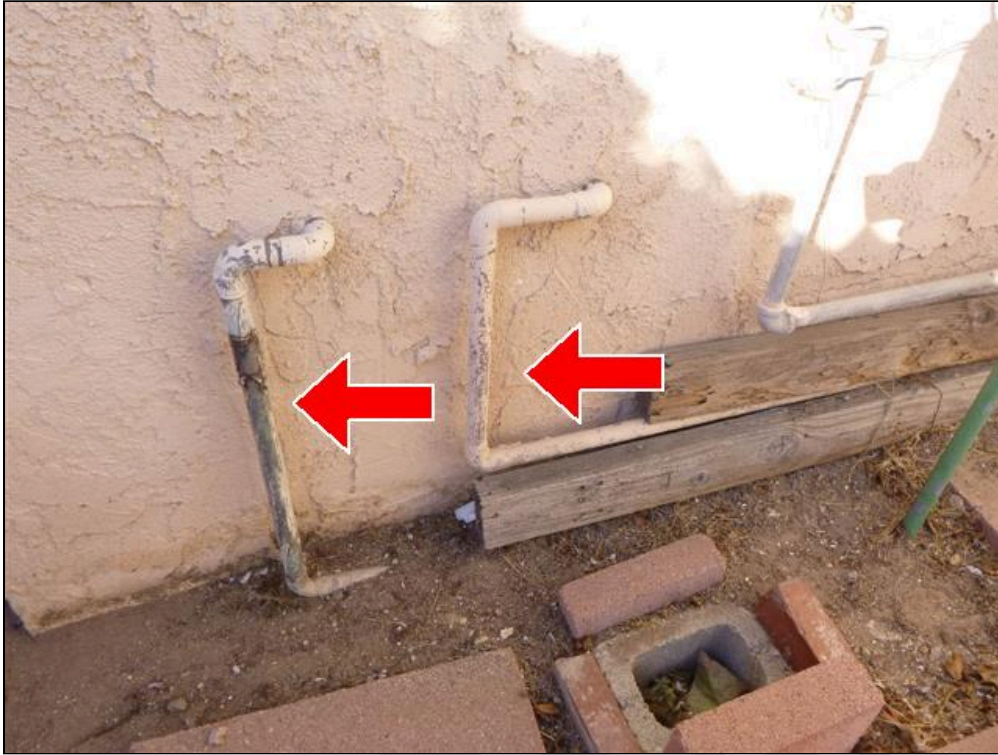
15.0 Item 1(Picture)

**15.0** (1) Exposed and un-insulated surface mounted plumbing noted at the right side exterior of the dwelling. Suggest review with a licensed plumber for repair/replacement costs as needed.

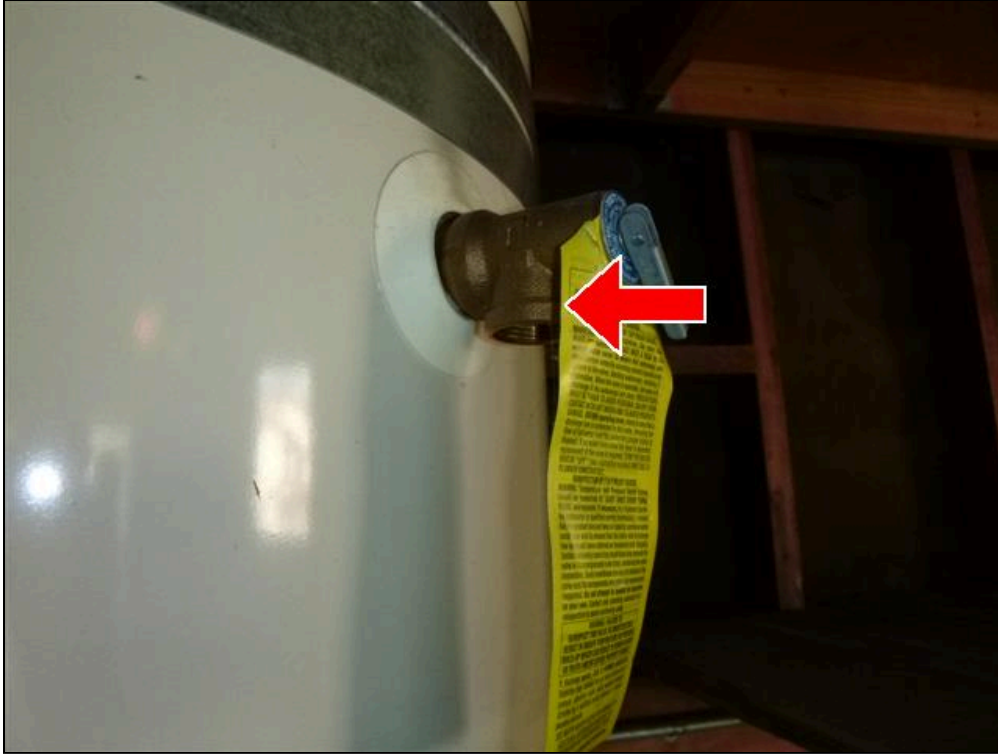
17.0 Item 2(Picture)

**17.0 (3)** No discharge pipe connected to the TP&R valve, this is a potential safety hazard. Suggest review by a licensed plumber for costs to install the TP discharge drain down to within 4-6 inches of the exterior grade/deck as required for safety.

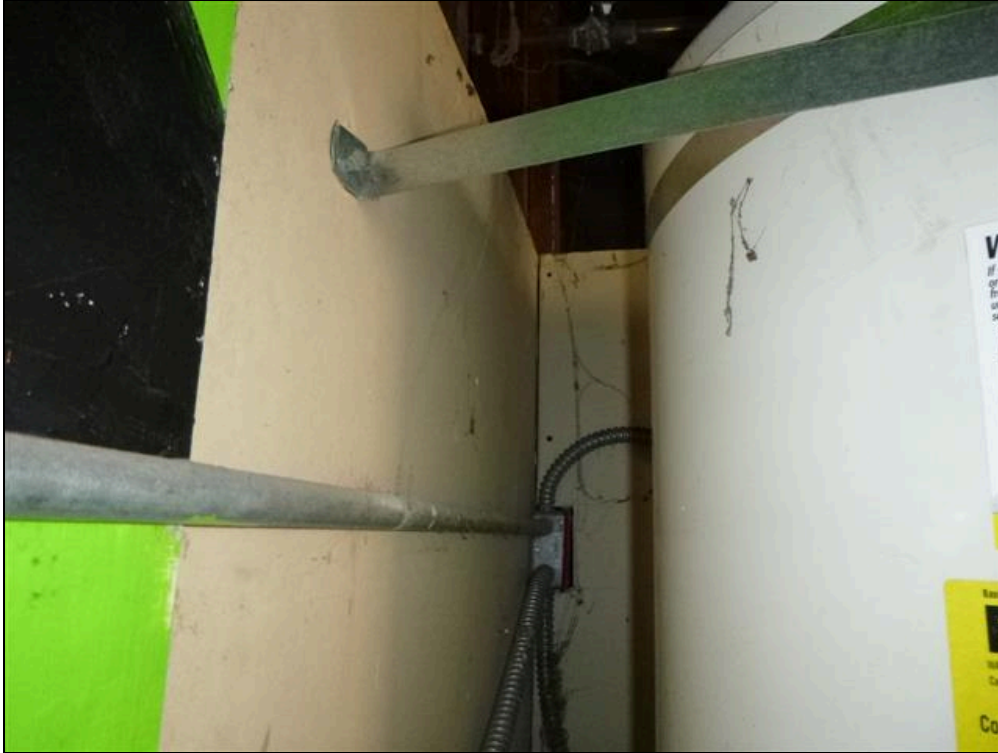
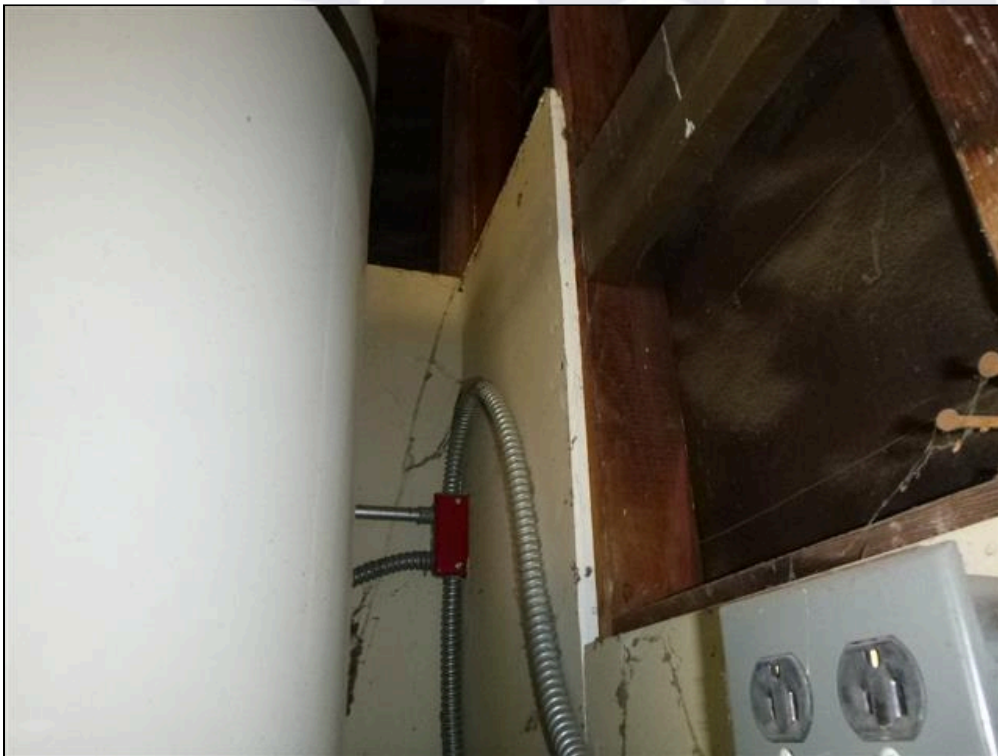
17.0 Item 4(Picture)

**17.0** (5) The water heating strapping is missing the rear bracing at the time of the inspection, suggest review by licensed plumber for installation costs as required.

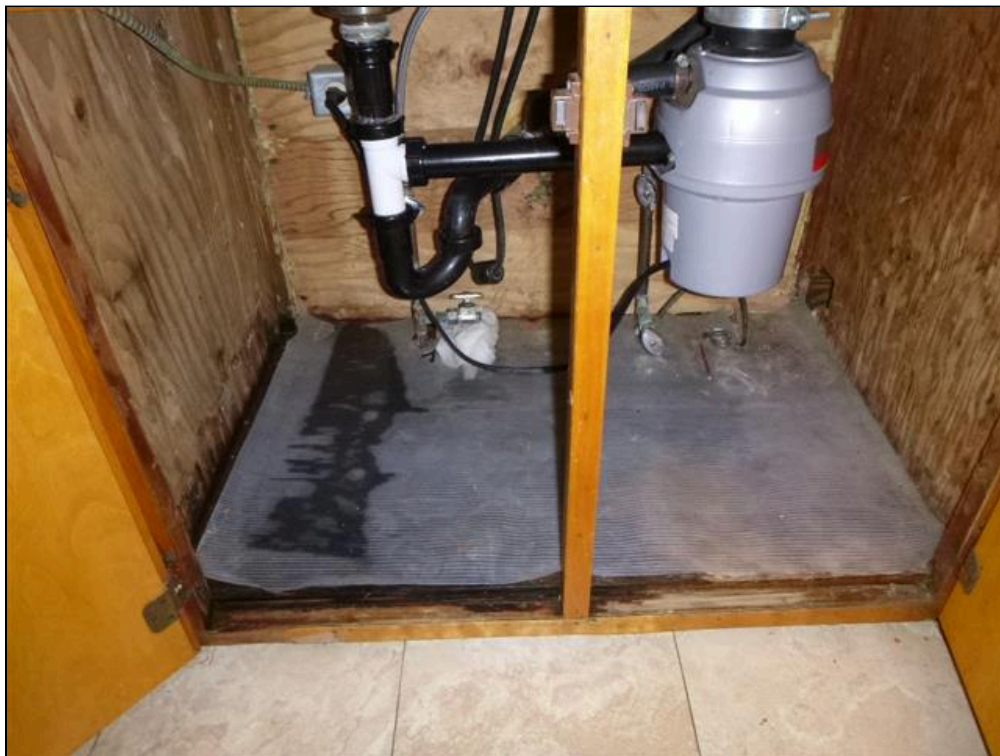
18.5 Item 1(Picture)

**18.5** (1) The cabinet below the sink is wet, deteriorated and mold/mildew was noted. Suggest review

by a licensed contractor and plumber for repair/replacement costs as needed.

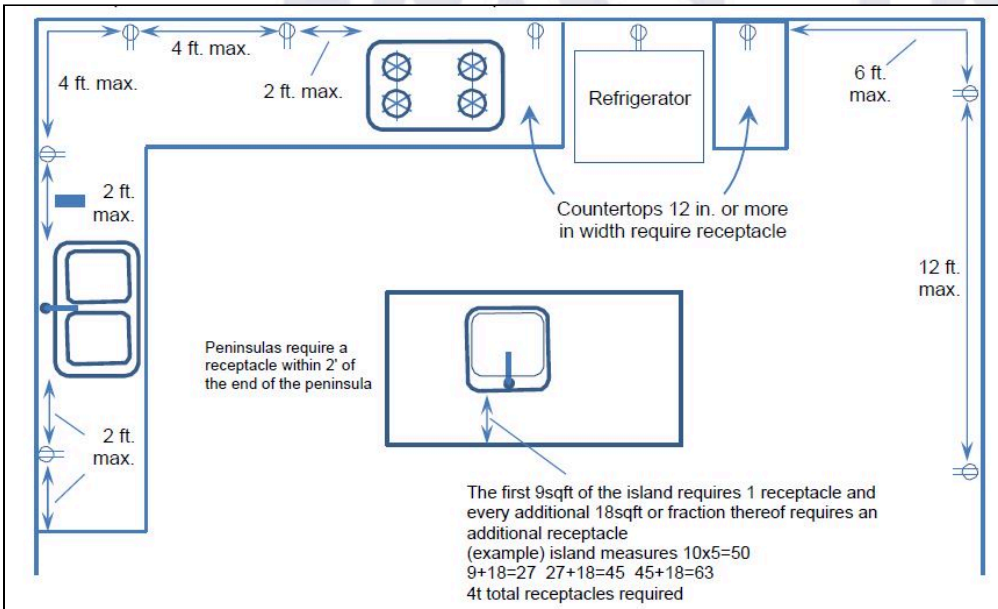
18.7 Item 3(Picture) Kitchen outlets

**18.7 (2)** Inadequate/incorrectly installed countertop/appliance outlets/circuits were noted, suggest review with a licensed electrician for installation costs as needed/required.

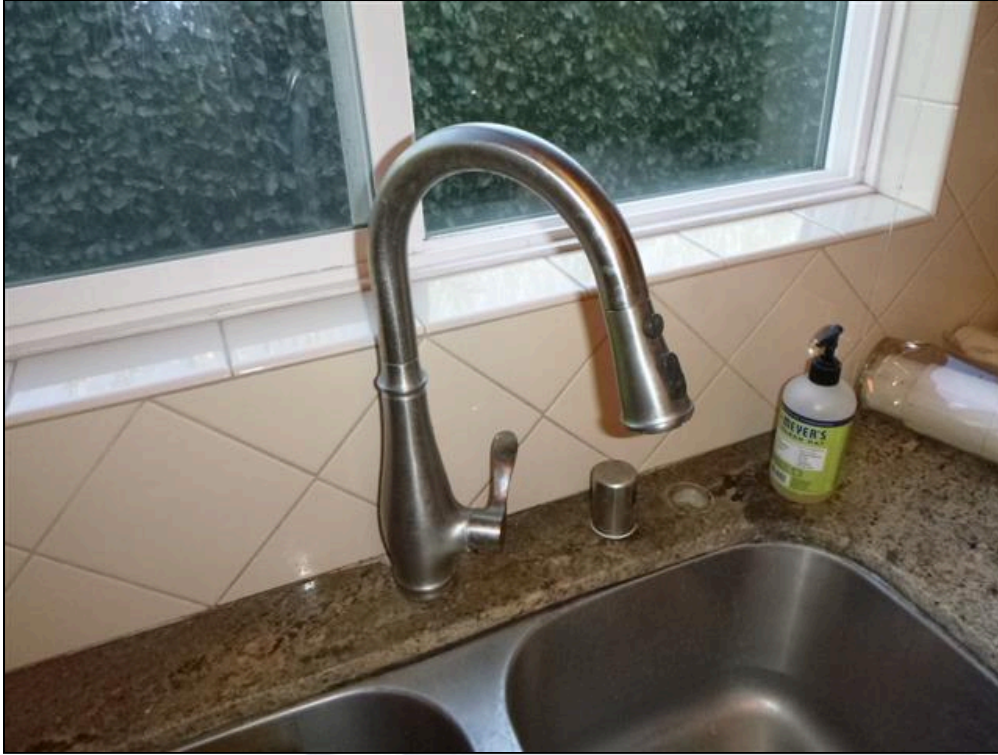
18.9 Item 1(Picture)

**18.9** Unable to test the faucet as the water was either off or inoperable at this area. Suggest review with a licensed plumber for any repair/replacement costs as needed.

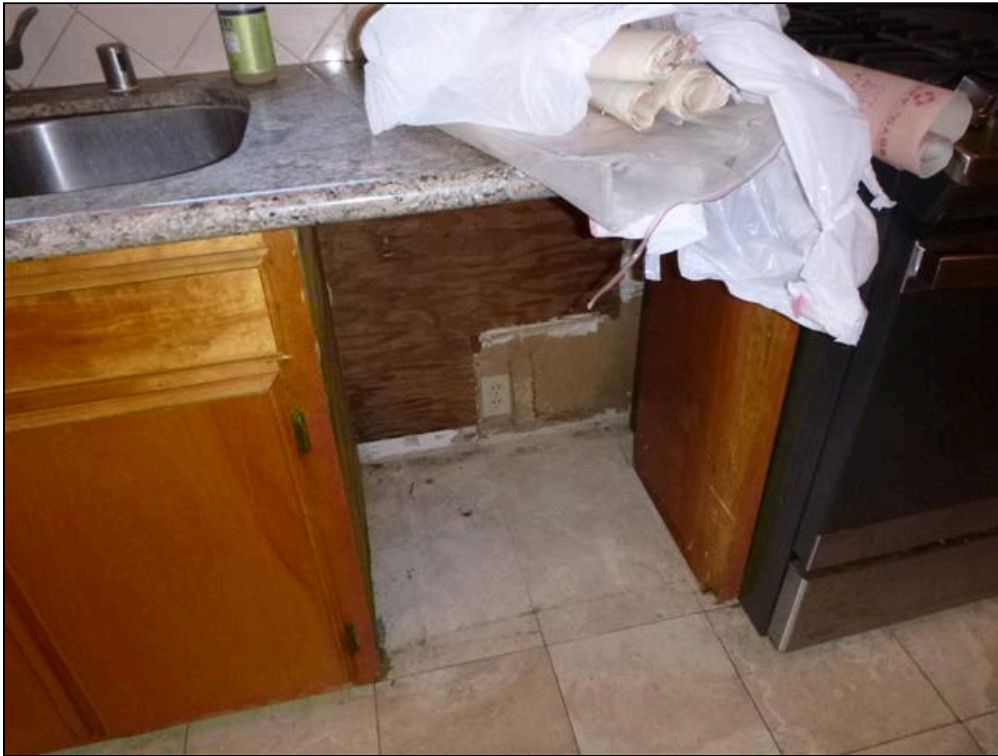
18.11 Item 1(Picture)

**18.11** No dishwasher was installed at the time of the inspection. Suggest review with the seller and/or a licensed contractor for installation costs as needed.

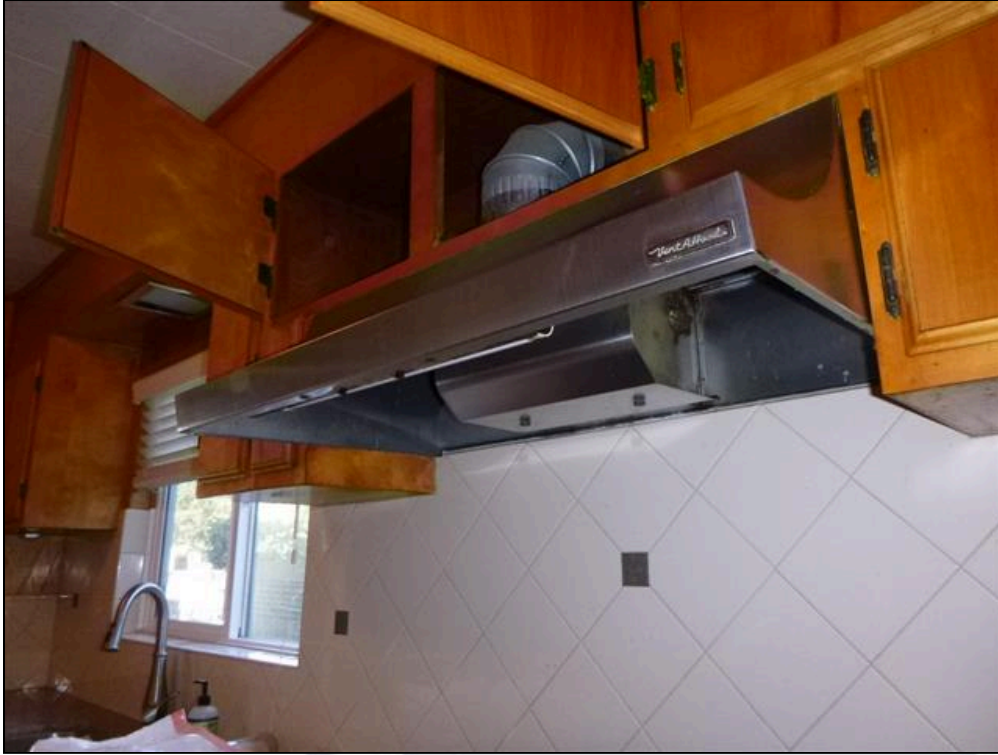
18.14 Item 1(Picture)

**18.14** The range/hood vent is inoperable at the time of the inspection, suggest review with a licensed contractor and repair/replace as required for safety.

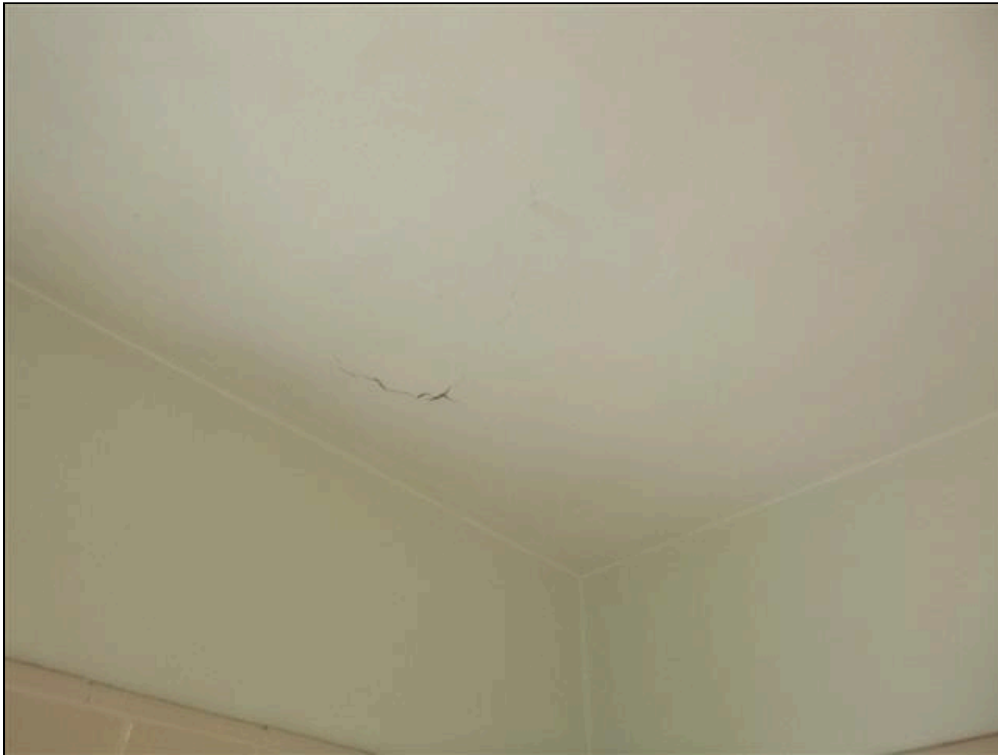
19.2 Item 1(Picture)

**19.2** Blistering and minor deterioration noted at the ceiling due to inadequate ventilation. See the exhaust fan comment and repair/install as needed.

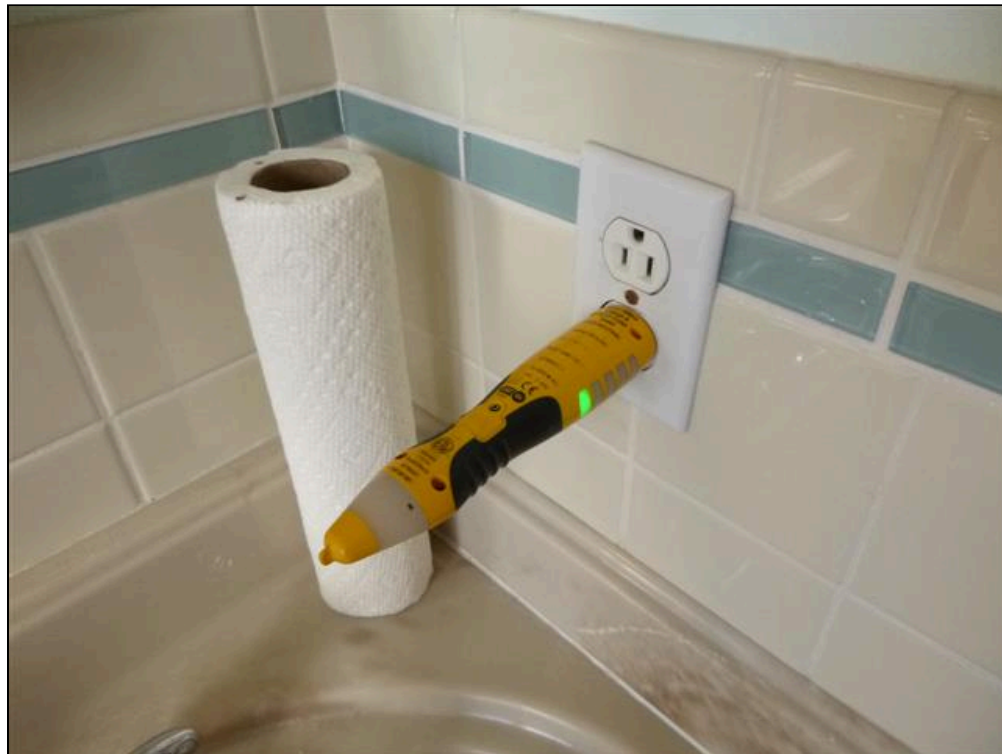
19.6 Item 1(Picture)

**19.6** No GFCI outlet or protection installed in this bathroom. GFCI protection has been required in bathrooms since 1975, suggest review by a licensed electrician for installation as required for safety.

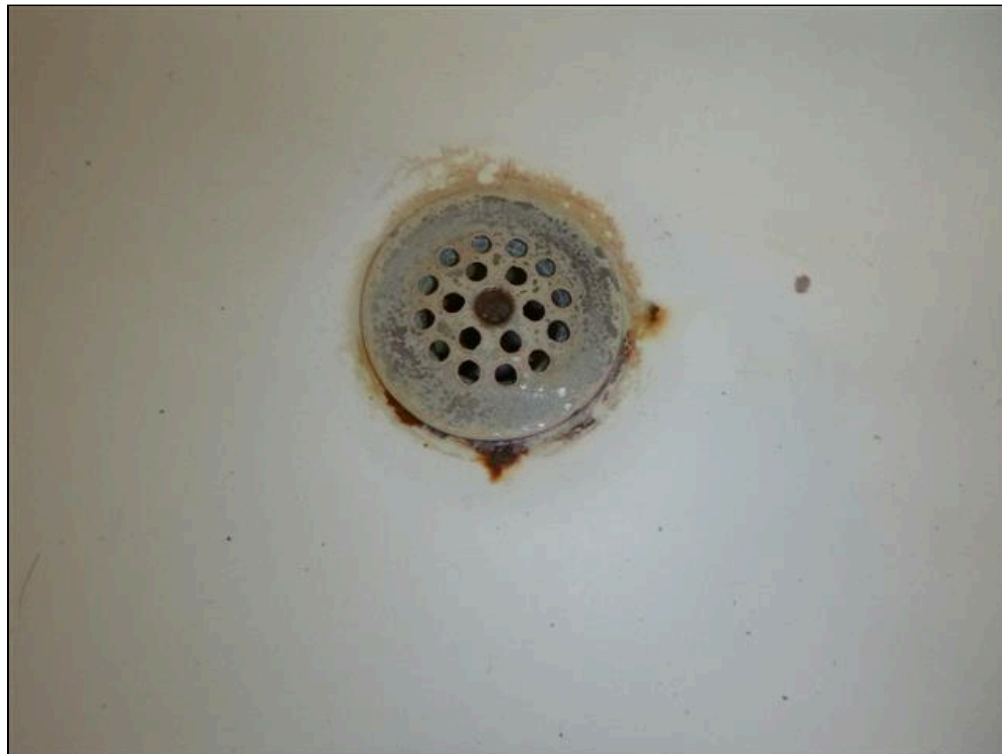
19.9 Item 1(Picture)

**19.9** Minor deterioration and rust noted at the tub and surround, no visible evidence of leakage noted at the time of the inspection. Suggest repair/replace as needed.

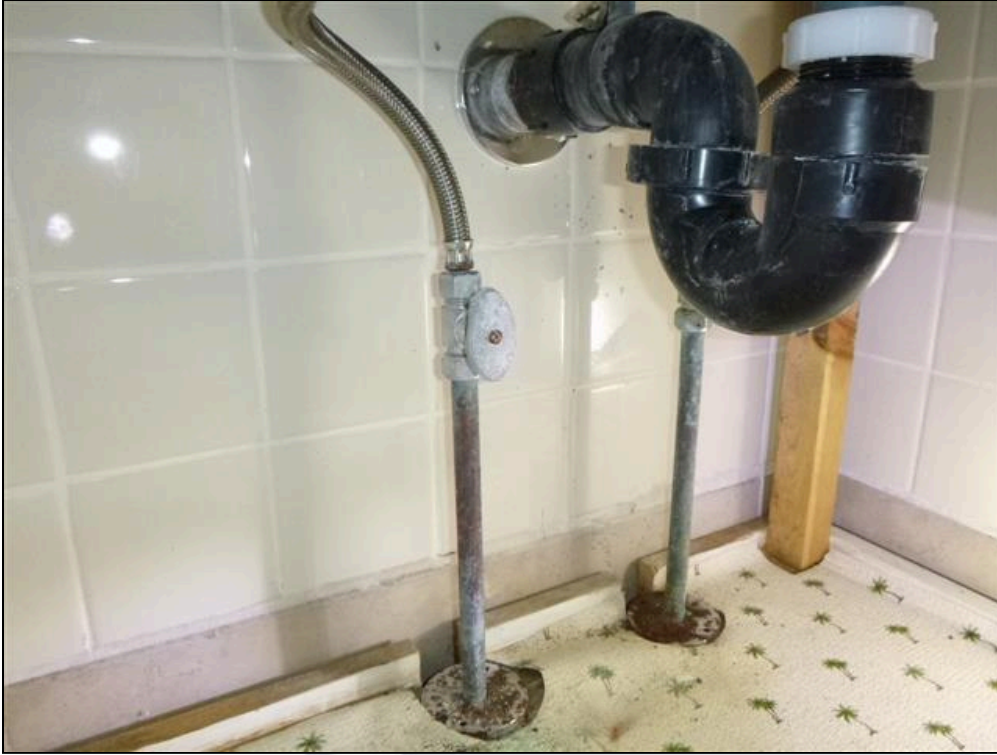
19.16 Item 1(Picture)

**19.16** (1) Corrosion noted at the sink angle valve(s), no leaking noted at the time of the inspection. Suggest review by a licensed plumber for repair/replacement costs as needed.
