# Inspection Report

**Property Address:**  
2104 Chestnut Ave  
Manhattan Beach CA 90266

**Ferguson Home Inspections**

<b>Date:</b> 1/11/2025	<b>Time:</b> 09:00 AM	<b>Report ID:</b> 01112025ChestnutAve
<b>Property:</b> 2104 Chestnut Ave Manhattan Beach CA 90266	<b>Customer:</b> Yvonne Peltz	<b>Real Estate Professional:</b> Marlene Ramirez

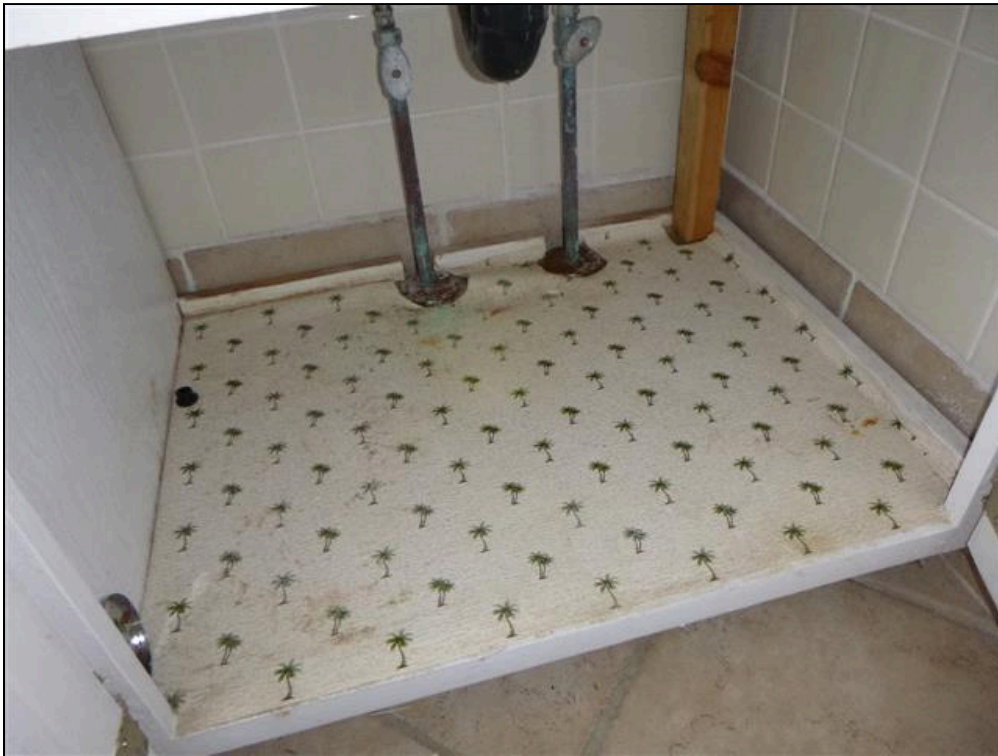
19.18 Item 1(Picture)

**19.18** The base cabinet under the sink is deteriorated/stained from previous leaks, suggest repair/replace as needed.

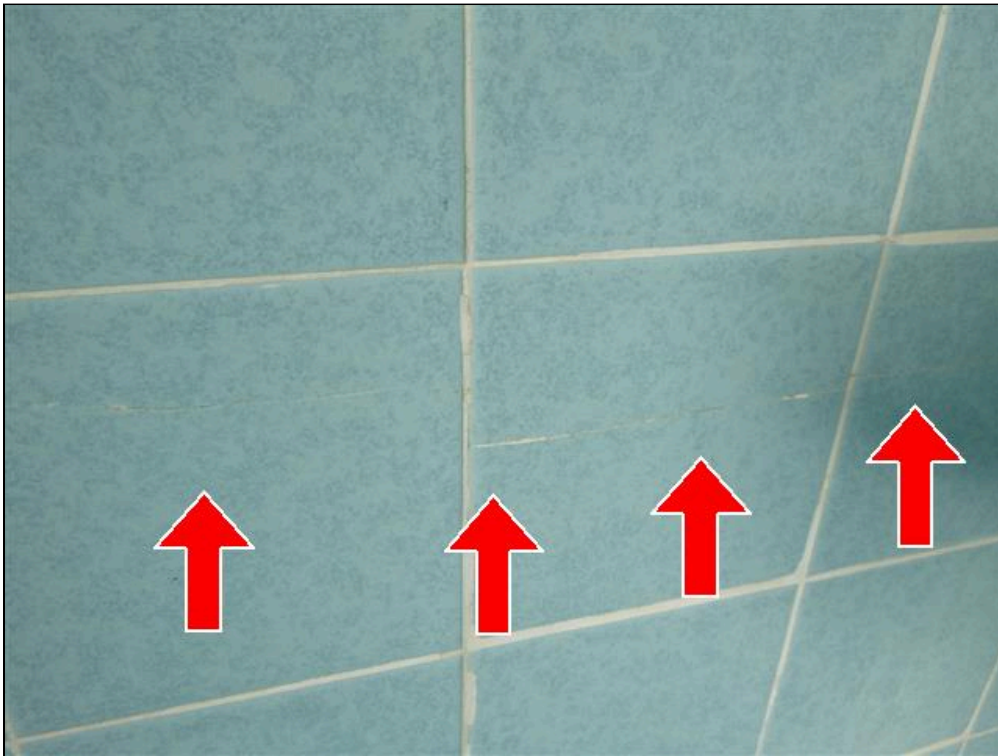
20.10 Item 1(Picture)

**20.10** Hairline cracks noted at the tile areas, suggest repair/replace as needed.

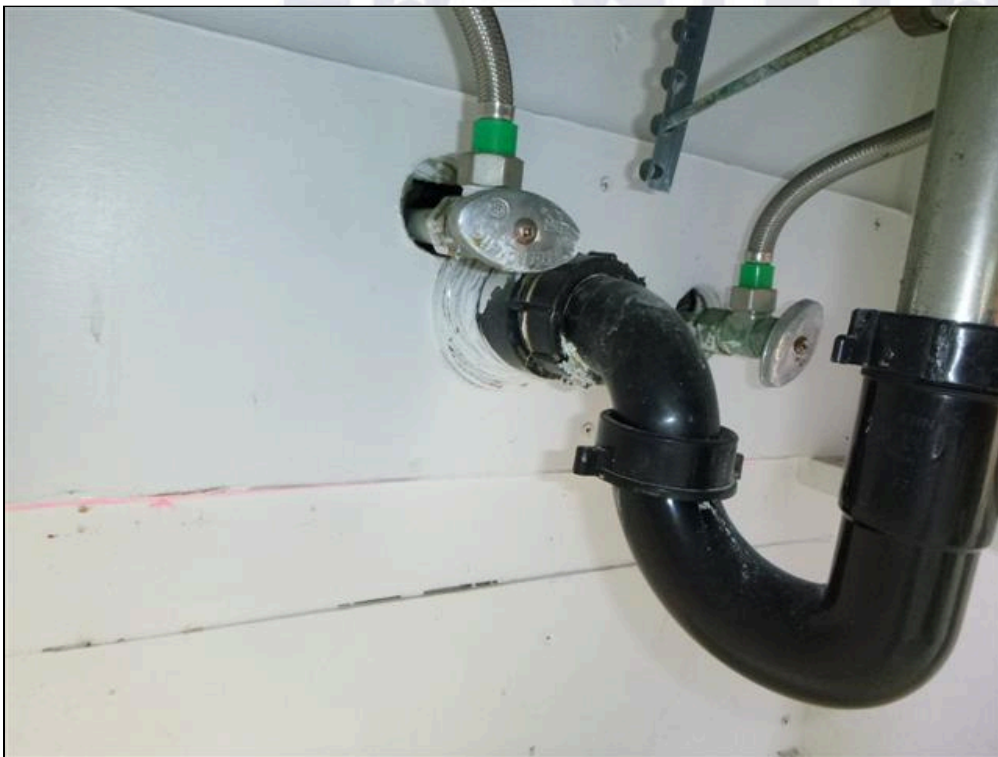
20.15 Item 1(Picture)

**20.15** (1) Corrosion/stains noted at the sink drain and angle valve(s), no leaking noted at the time of the inspection. Suggest review by a licensed plumber for repair/replacement costs as needed.

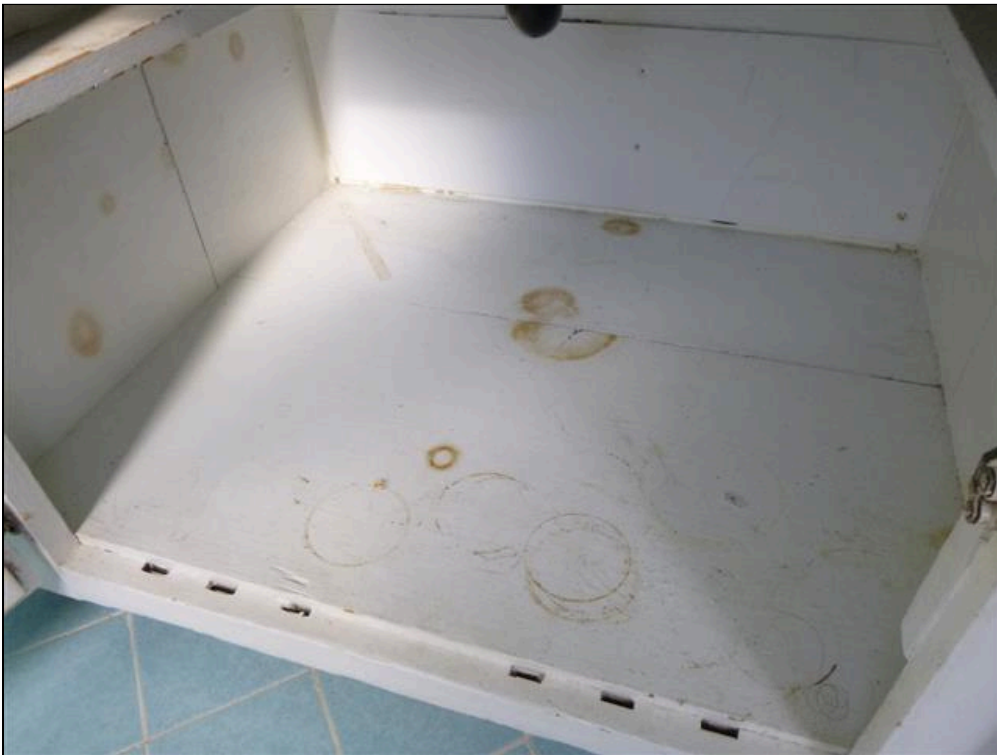
20.17 Item 1(Picture)

**20.17** The base cabinet under the sink is deteriorated/stained from previous leaks, suggest repair/replace as needed.

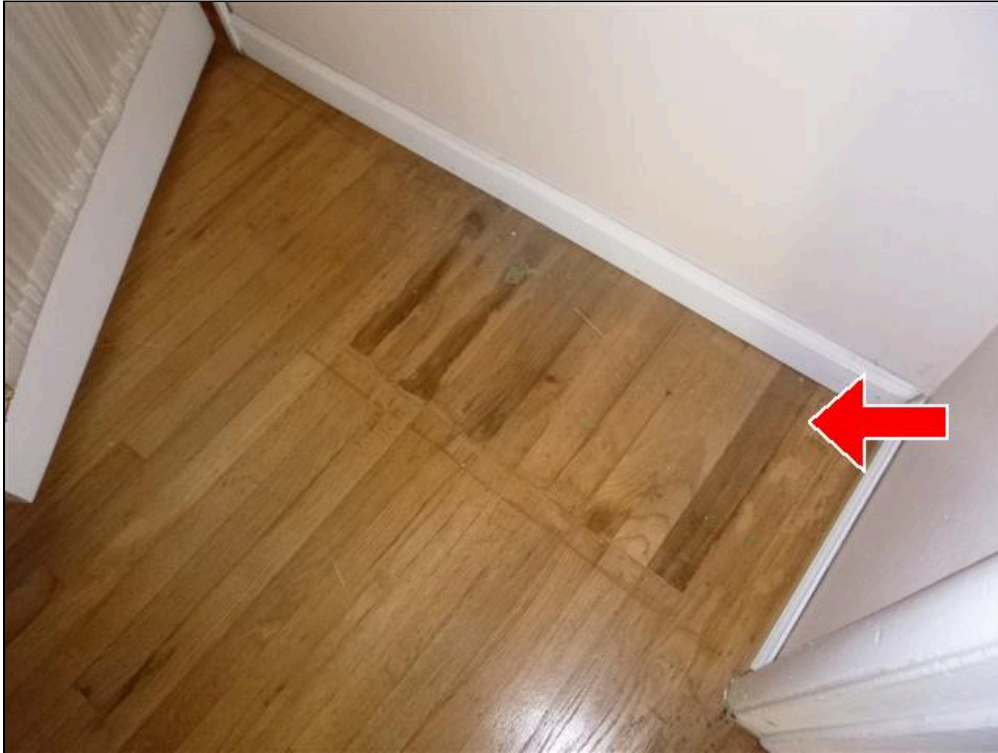
23.0 Item 1(Picture)

**23.0** (2) Patched areas of the floor were noted at the original floor heater location. Suggest repair/replace as needed.

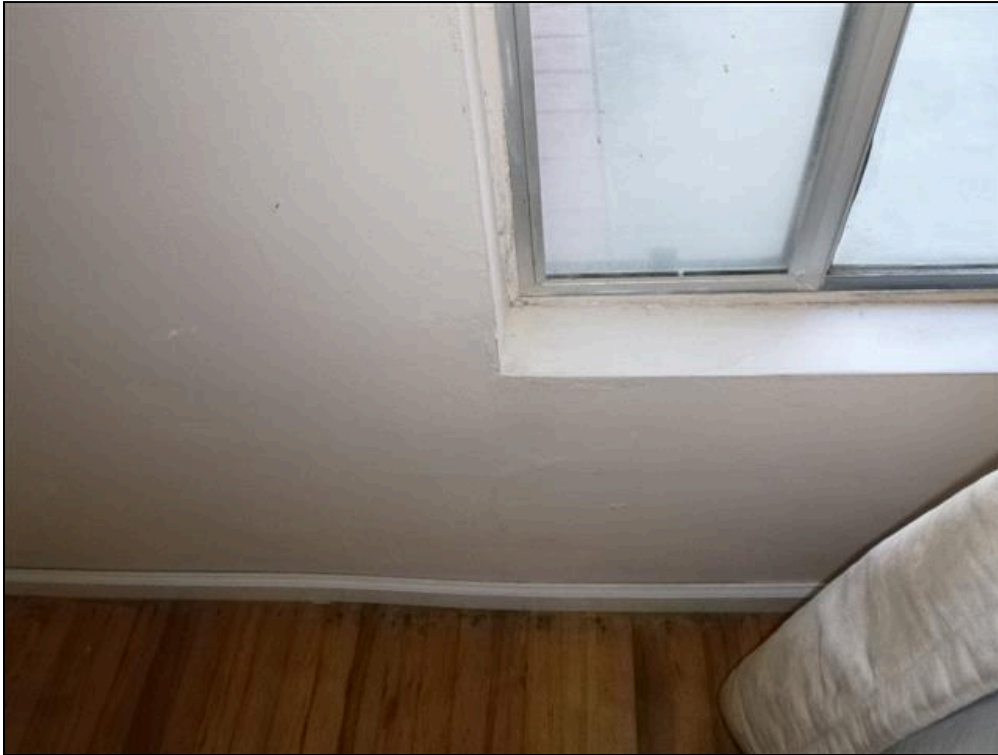
23.1 Item 1(Picture)

**23.1** Patched areas of the walls were noted, suggest review with the seller for the cause and any repairs needed. Suggest review with a licensed contractor for any repair/removal/replacement costs as needed.

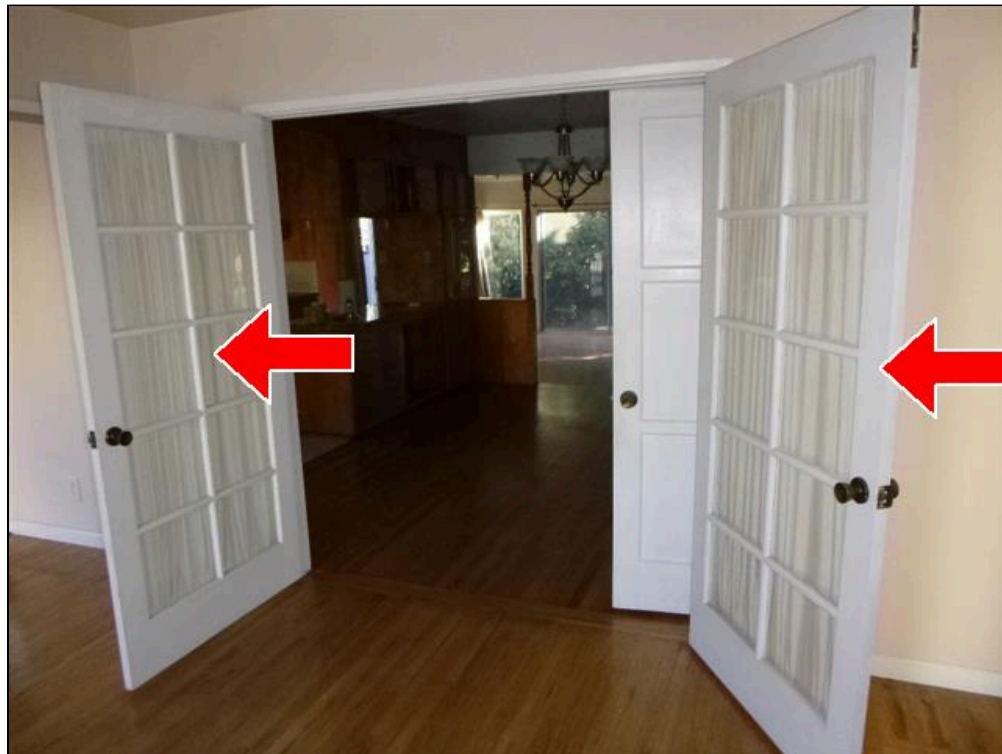
23.3 Item 1(Picture)

**23.3** (2) The inspector was unable to verify/determine if tempered/safety glass is installed at the window/door glass at this area ( no labelling/etching is visible ). Windows and doors with glass 18 inches off the floor area or windows within doors should have safety glass. Suggest review of these areas for possible costs to upgrade for safety.

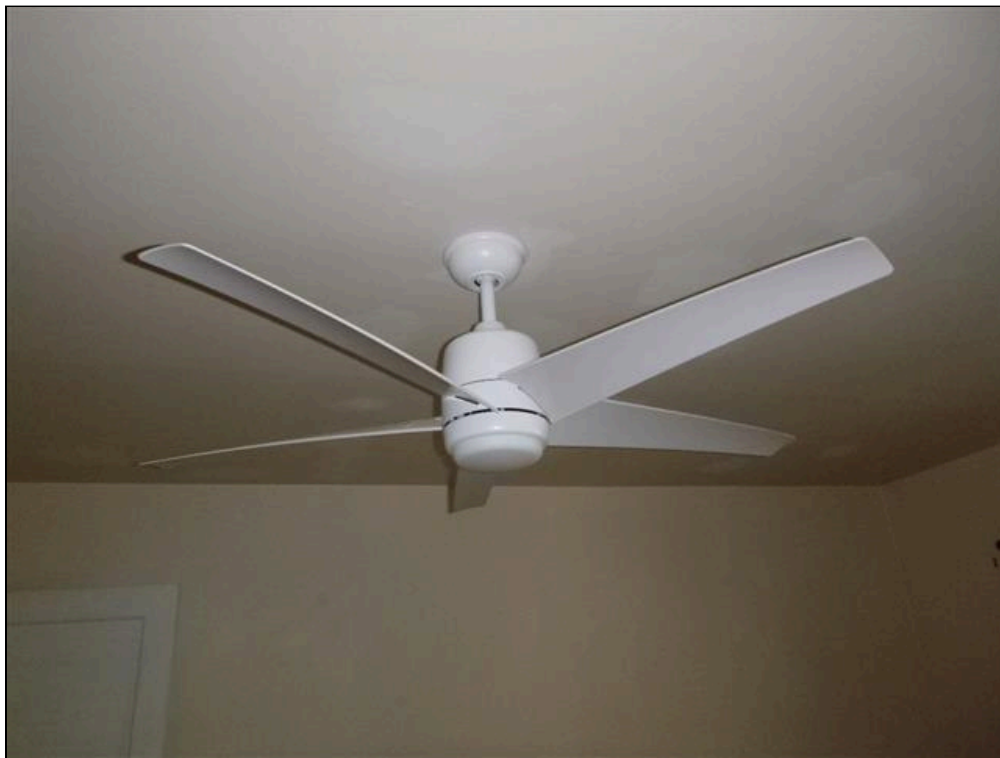
23.7 Item 1(Picture)

23.7 The ceiling fan system was operational at the time of the inspection.

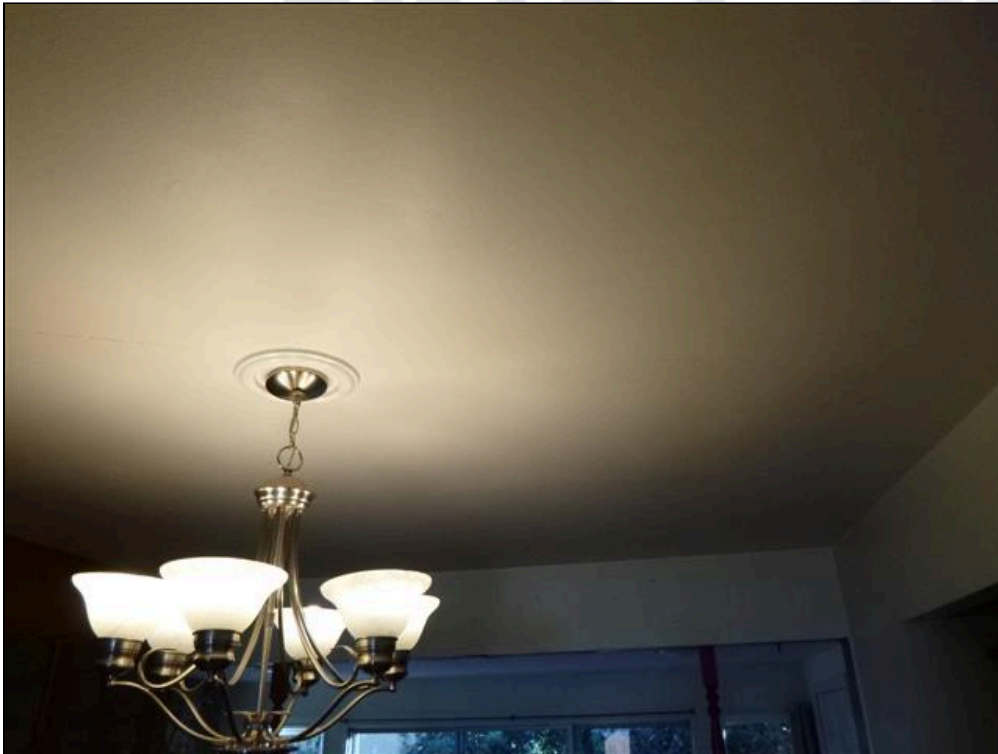
24.2 Item 1(Picture)

**24.2** (1) Patched and uneven areas of the ceiling was noted, suggest review with the seller on the cause and any repairs needed. Suggest review with a licensed contractor for any repair/removal/ replacement costs as needed.

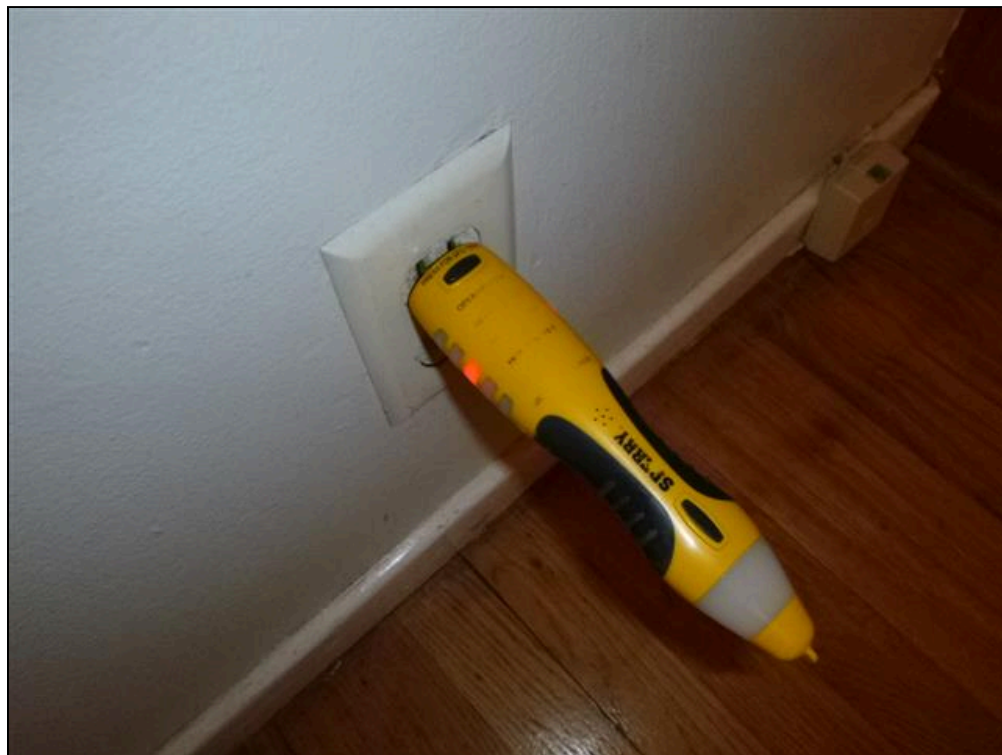
24.4 Item 1(Picture)

**24.4 (2)** Reversed polarity noted at various outlets. Reversed polarity, hot and ground reversed and other terms used for electric outlets are usually easily corrected by minor wiring adjustments at the specified item. Suggest review with a licensed electrician for repair/replacement costs and confirm correct operation as needed.

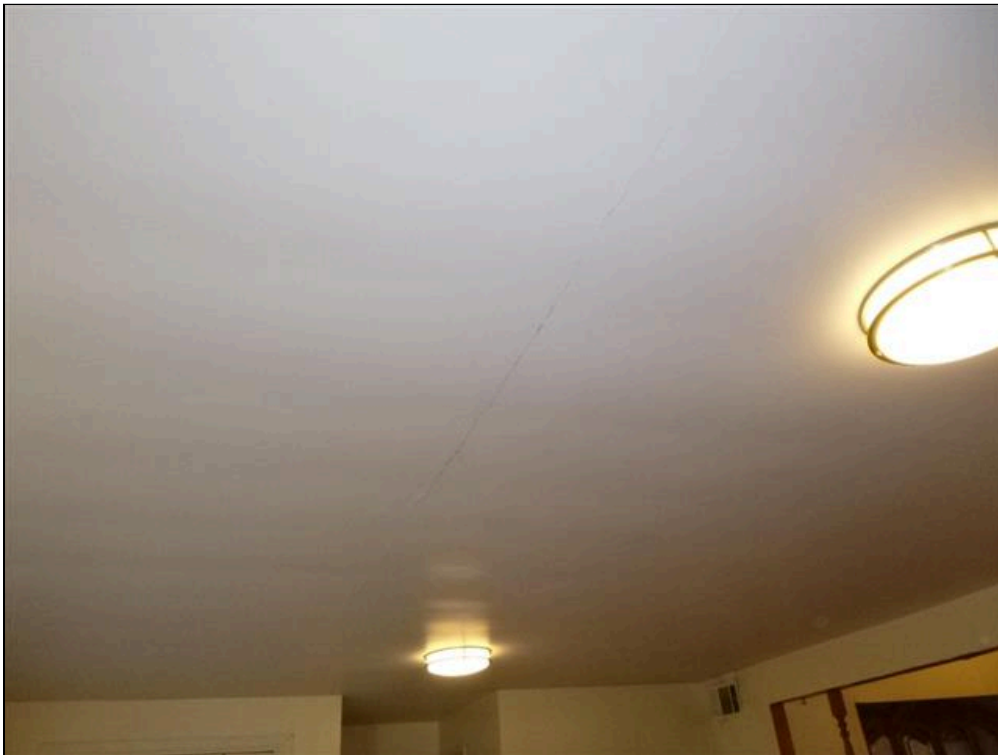
25.2 Item 1(Picture)

**25.2 (1)** Settling cracks and patching noted, suggest repair as needed.

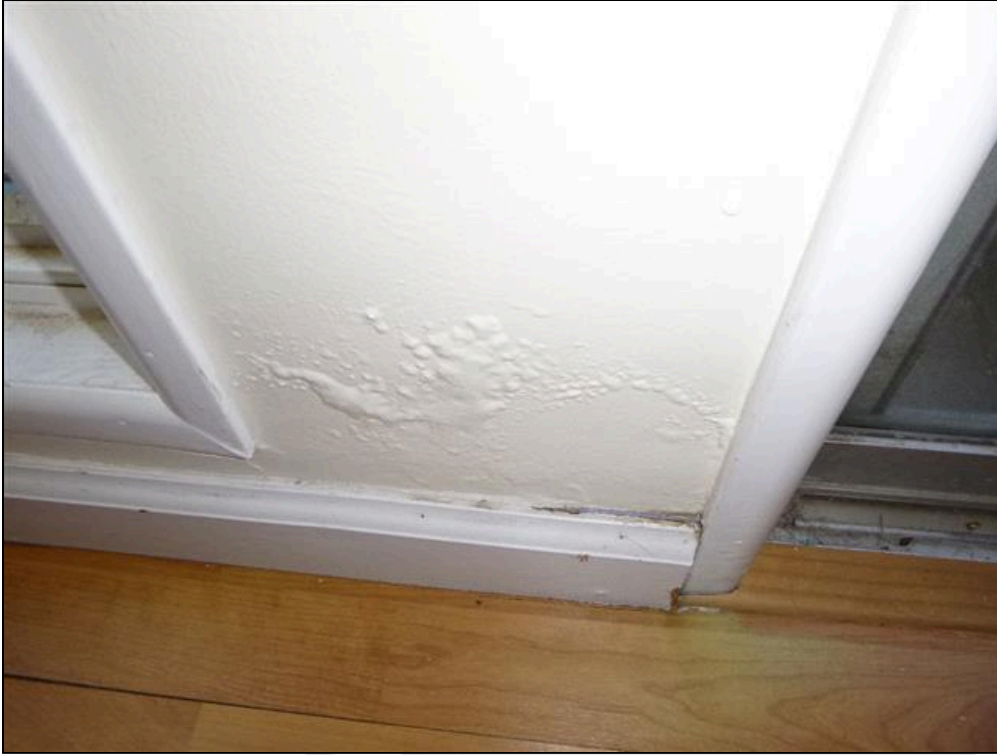
25.3 Item 2(Picture)

**25.3** (2) Evidence of previous and possible on-going water intrusion was noted at the door(s) to the exterior. Suggest review with a licensed contractor for repair/replacement costs as needed.

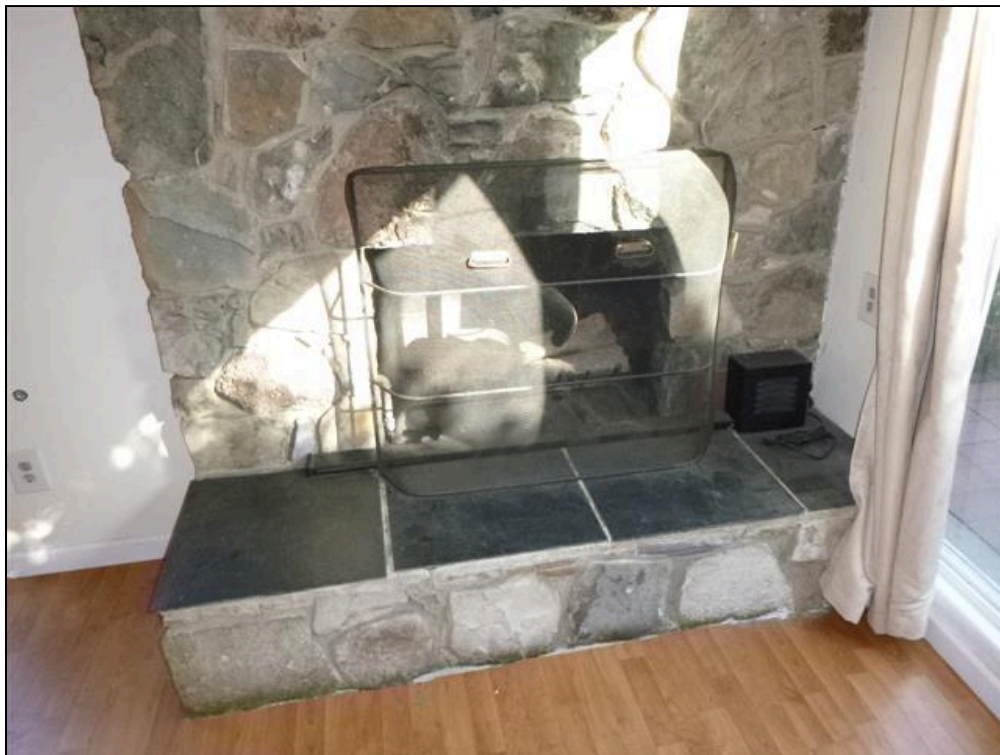
25.7 Item 1(Picture)

**25.7 (1)** The fireplace damper was operational at the time of the inspection. Suggest securing the damper to a fixed open position due to the gas installation per current requirements.

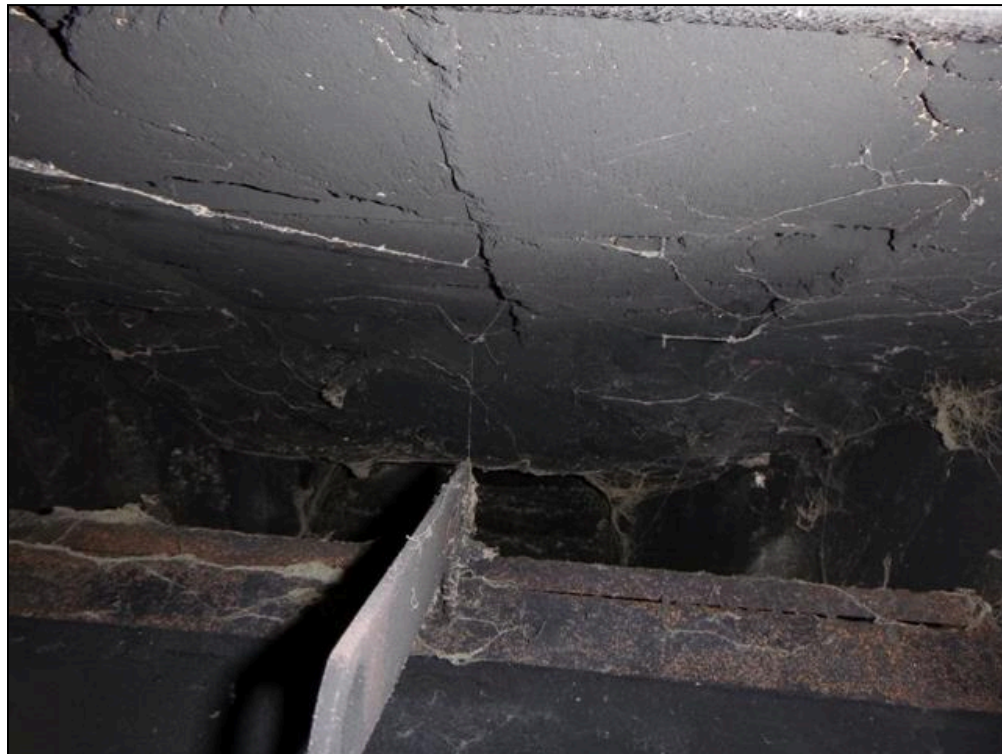
25.7 Item 3(Picture)

**25.7** (2) Minor creosote noted within the firebox, smoke chamber or chimney areas. Creosote build-up can cause chimney fires if not removed from voids, open seams or open mortar joints within the fireplace and chimney. This inspection is a 'Level 1' inspection and is limited to visible and accessible areas only. 'Level 2' and 'Level 3' inspections are invasive inspections performed by qualified personnel only with equipment designed for fireplace/chimney inspections, cleaning or repairs. Suggest periodic cleaning of the fireplace/chimney and remove the creosote and debris within the fireplace and chimney. Suggest review by a professional chimney sweep for estimates, repairs or cleaning.

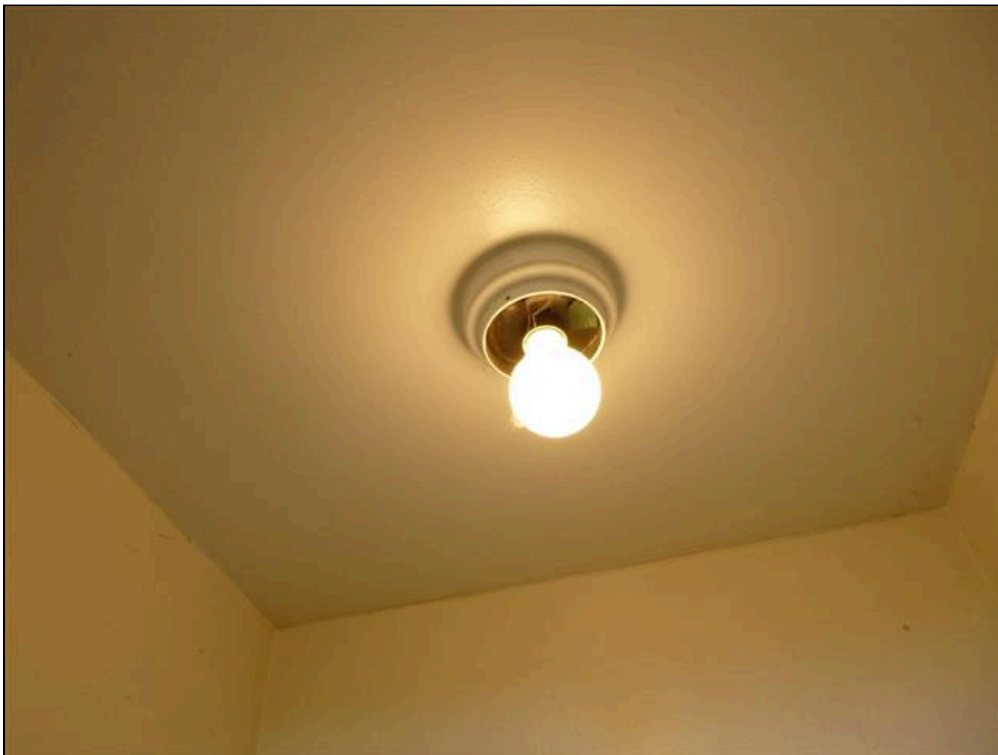
28.6 Item 1(Picture)

**28.6 (2)** The cover globe(s) are missing at light fixture(s) at the time of the inspection. Suggest replacing the missing cover globe(s) for safety.

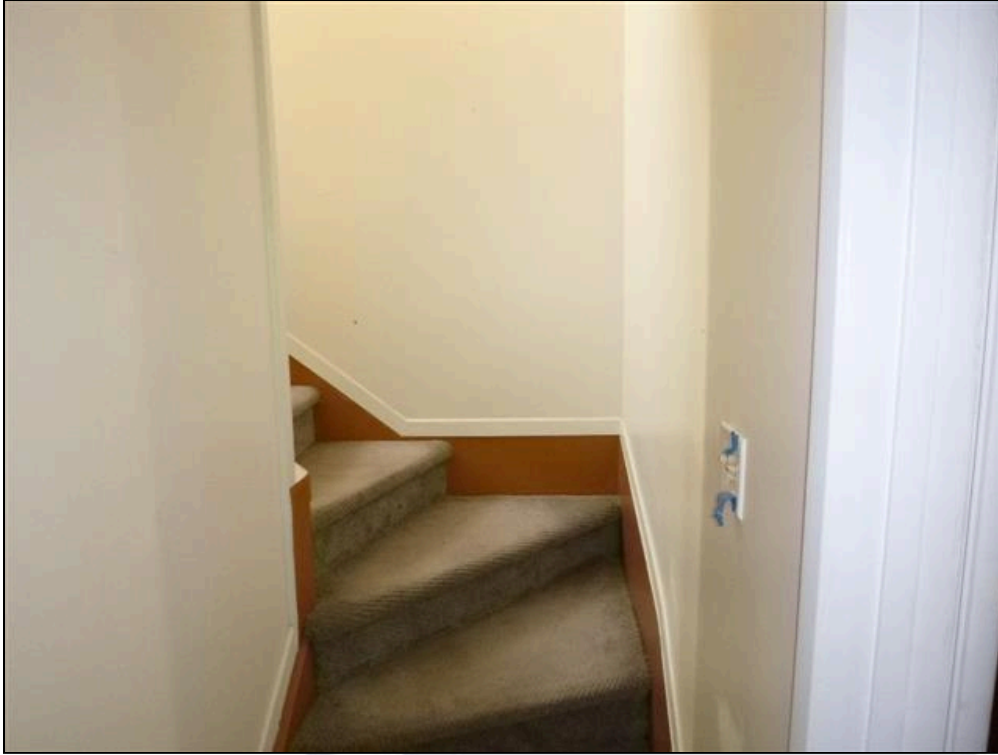
28.7 Item 1(Picture)

**28.7** (1) No graspable hand railing(s) installed at the stair area(s). Suggest review with a licensed contractor for costs to install graspable railing(s) to current standards as required for safety.

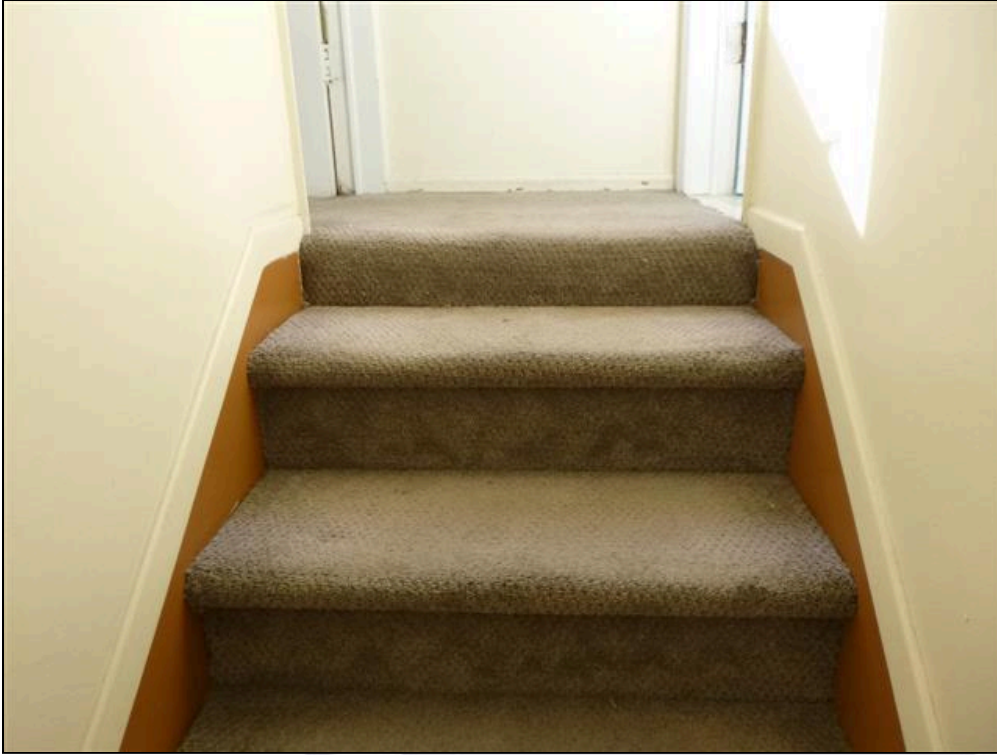
28.7 Item 3(Picture)

**28.7** (2) A potential trip hazard was noted due to the uneven rise height at various steps. Suggest review with a licensed contractor for any repair/replacement costs as needed.

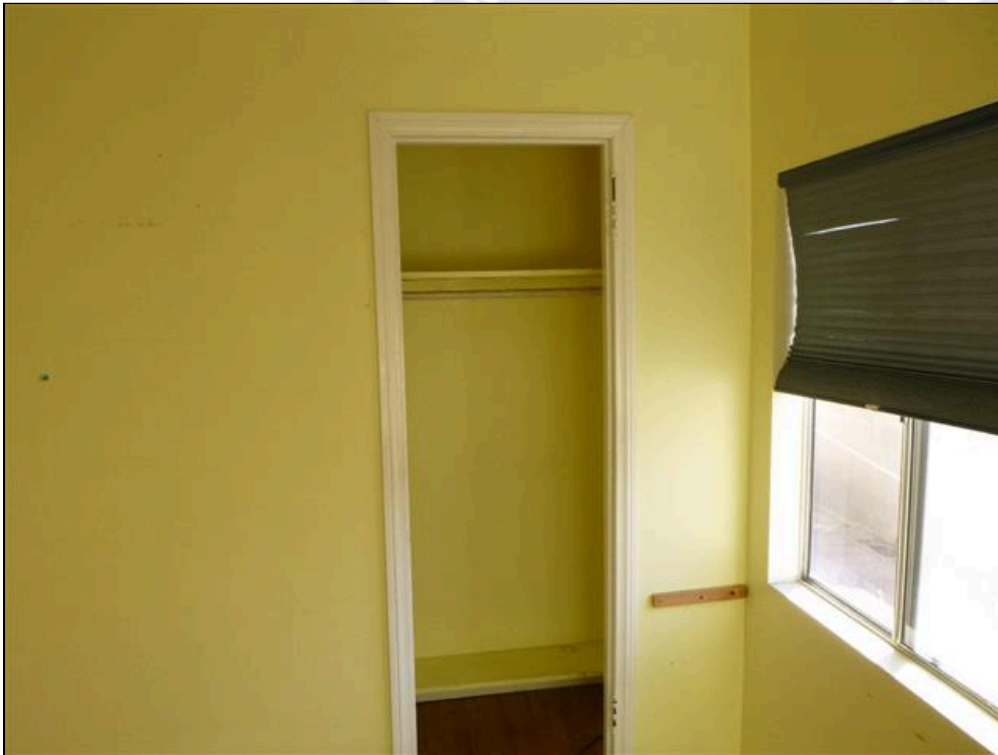
29.7 Item 1(Picture)

**29.7** The closet door(s) were missing/not installed at the time of the inspection, suggest replacing/installing as needed.

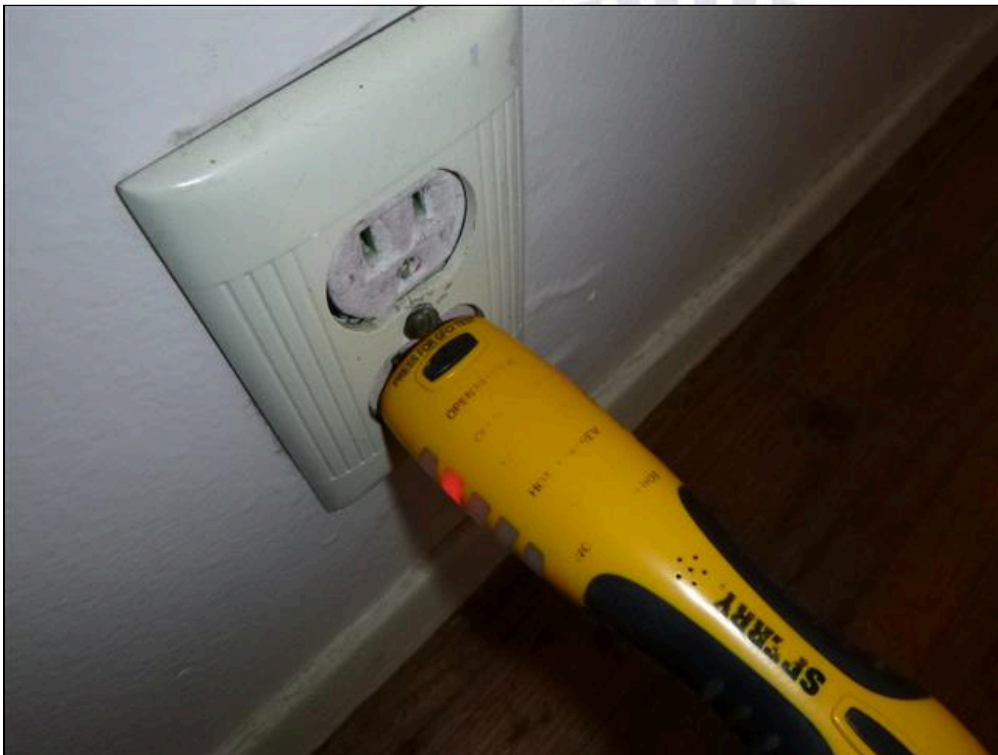
30.6 Item 1(Picture)

**30.6** (1) Ungrounded three prong outlets noted at this area. Suggest review with a licensed electrician for costs to ground the outlets as needed as an upgrade and/or protect the outlet(s) on a GFCI circuit where recommended.

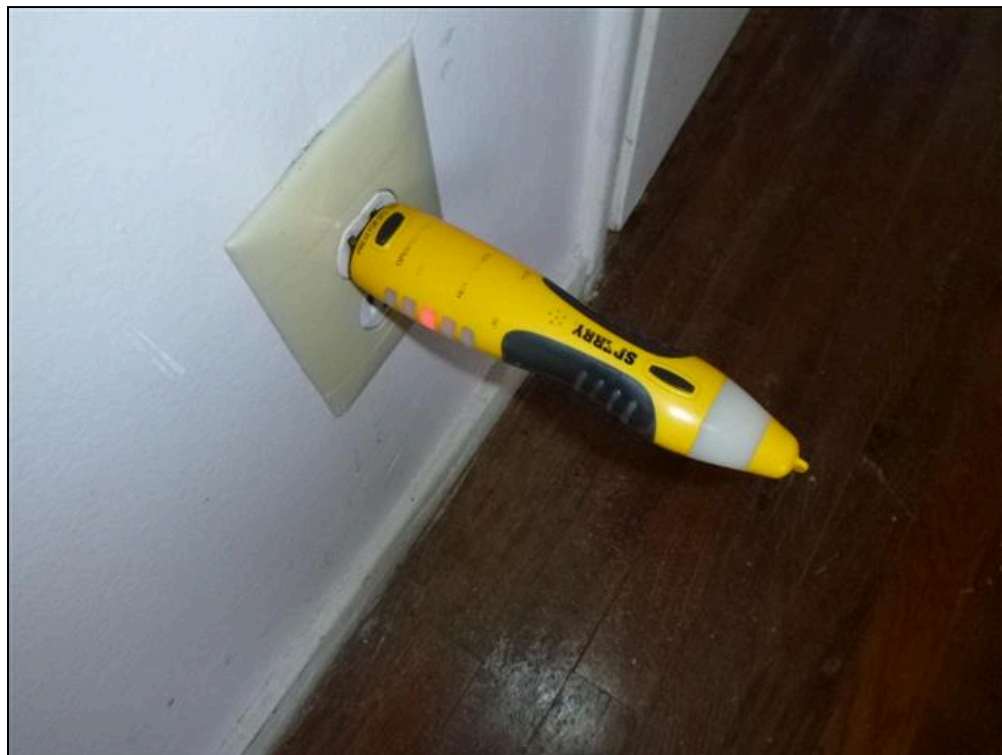
30.6 Item 2(Picture)

**30.6** (3) Reversed polarity noted at various outlets. Reversed polarity, hot and ground reversed and other terms used for electric outlets are usually easily corrected by minor wiring adjustments at the specified item. Suggest review with a licensed electrician for repair/replacement costs and confirm correct operation as needed.

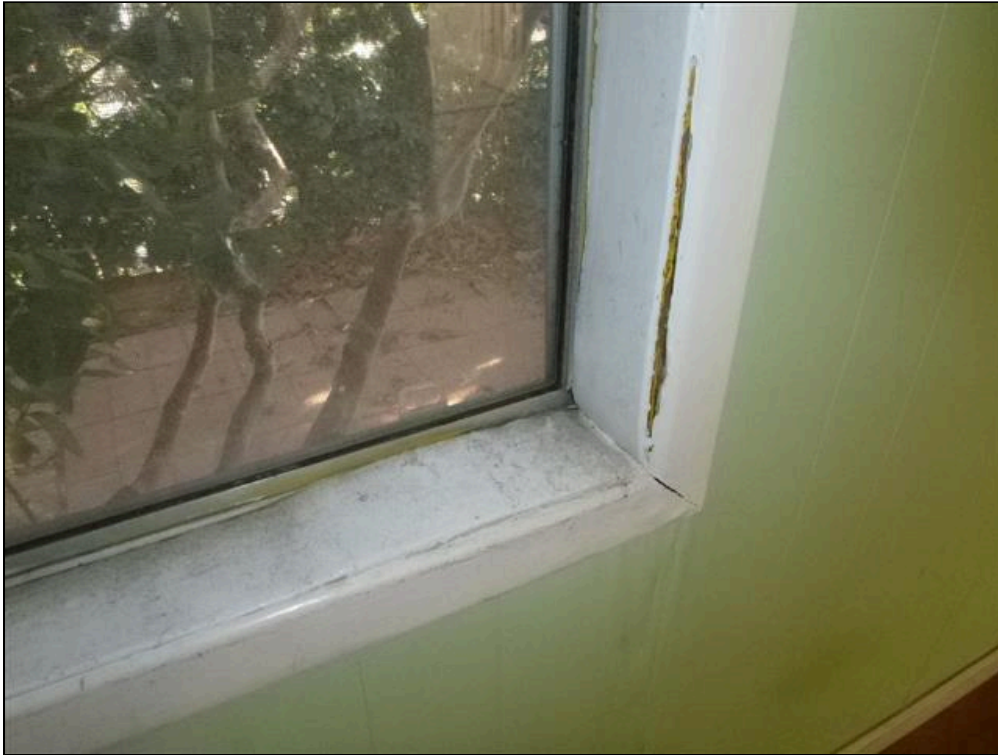
31.1 Item 2(Picture)

**31.1** Stained, patched and damaged areas of the walls were noted at the windows ( evidence of previous/on-going water intrusion was noted ). Suggest review with the seller for the cause and any repairs needed. Suggest review with a licensed contractor for any repair/removal/replacement costs as needed.

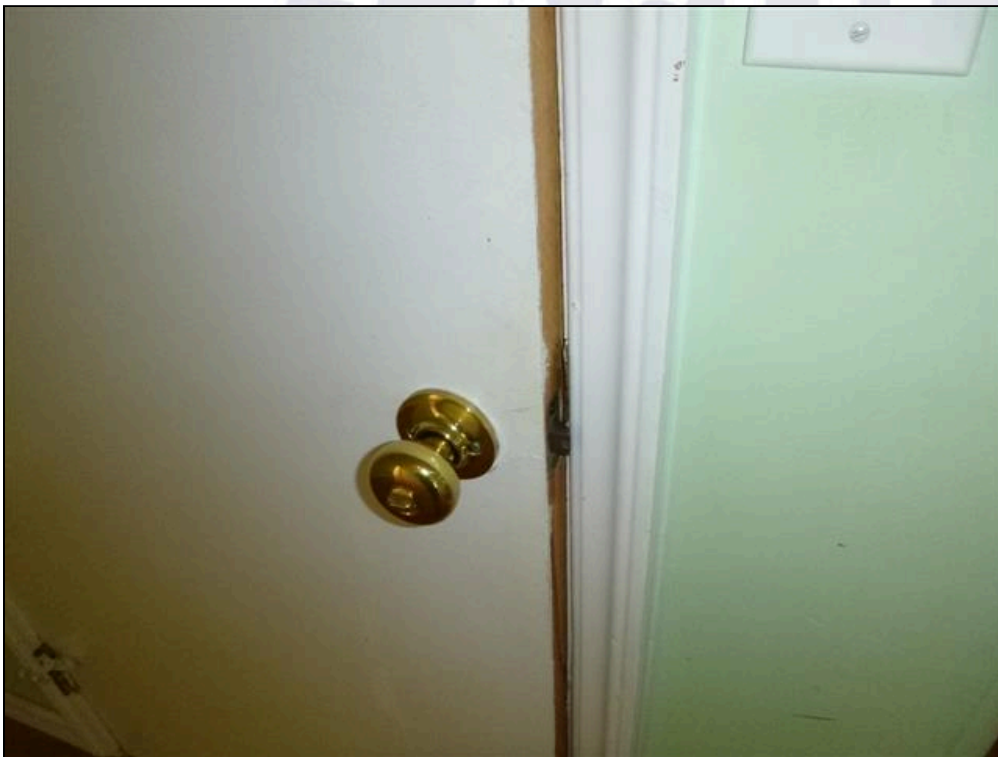
31.3 Item 1(Picture)

**31.3** (1) The door will not close and latch correctly, suggest repair as needed.

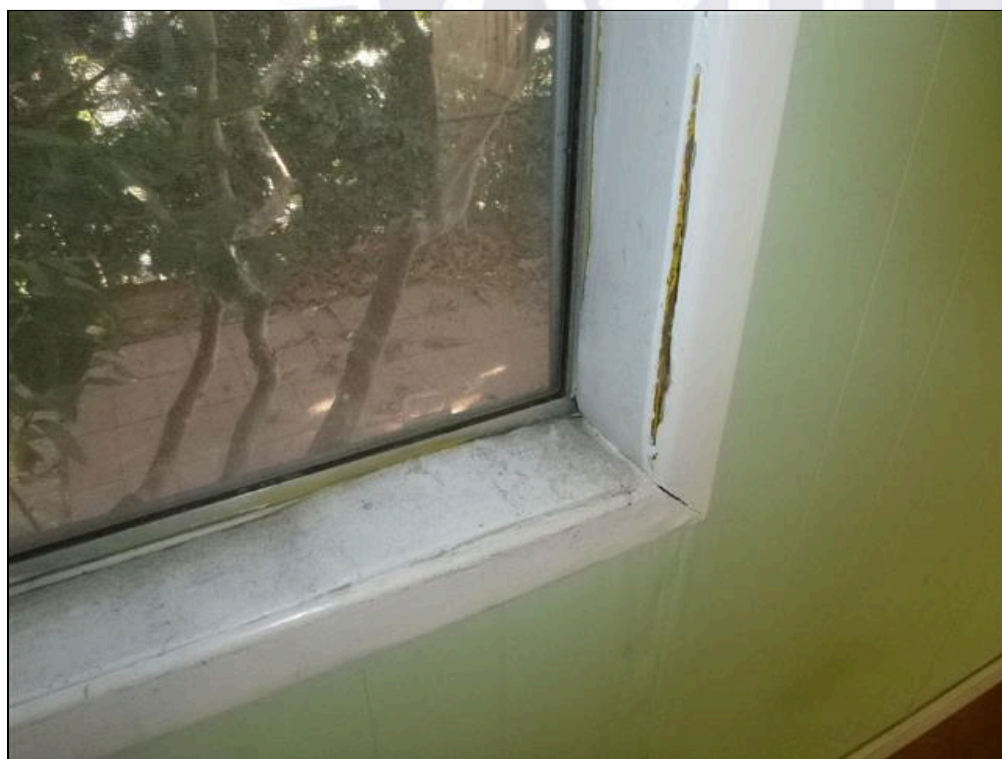
31.4 Item 2(Picture)

**31.4** (2) Excessive deterioration, satins and evidence of previous/on-going leakage was noted at the windows. Suggest review with a licensed contractor for any repair/replacement costs as needed.

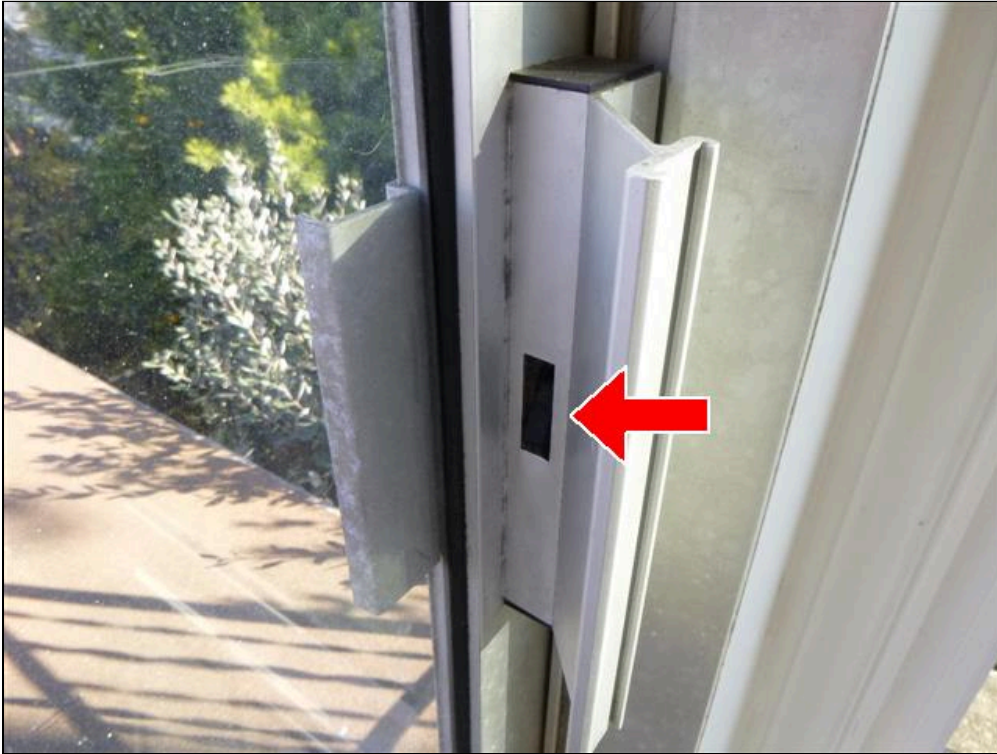
32.3 Item 1(Picture)

**32.3** (2) The sliding door lock handle is broken/damaged, suggest repair/replace as needed.

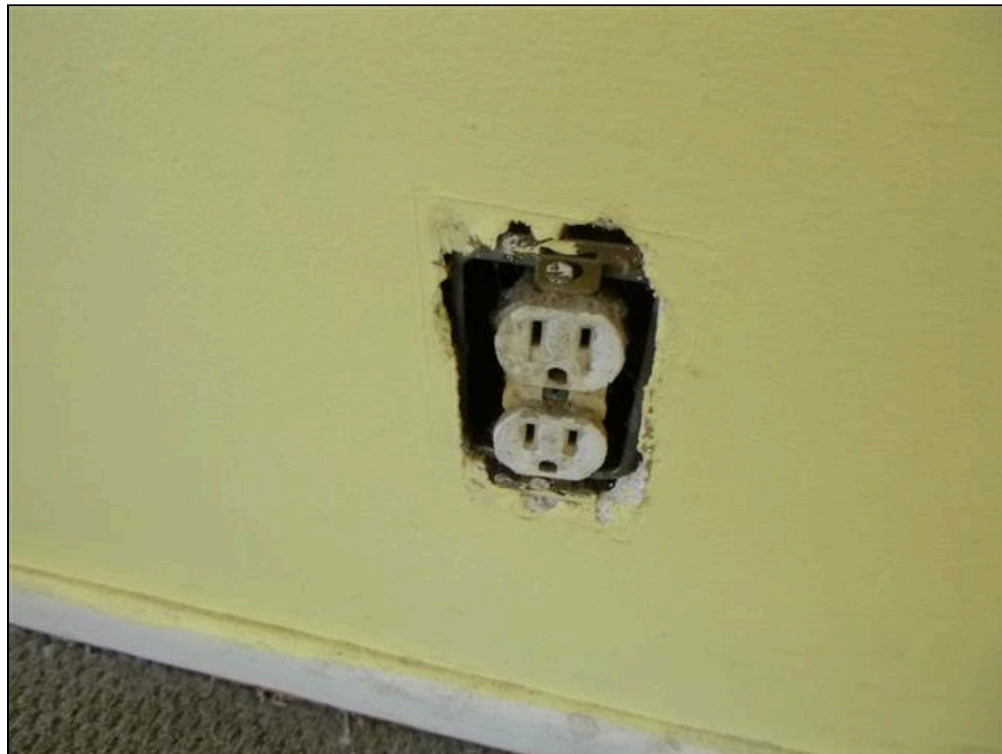
32.6 Item 1(Picture)

**32.6 (1)** Various outlet cover(s) are missing, suggest installation for safety.

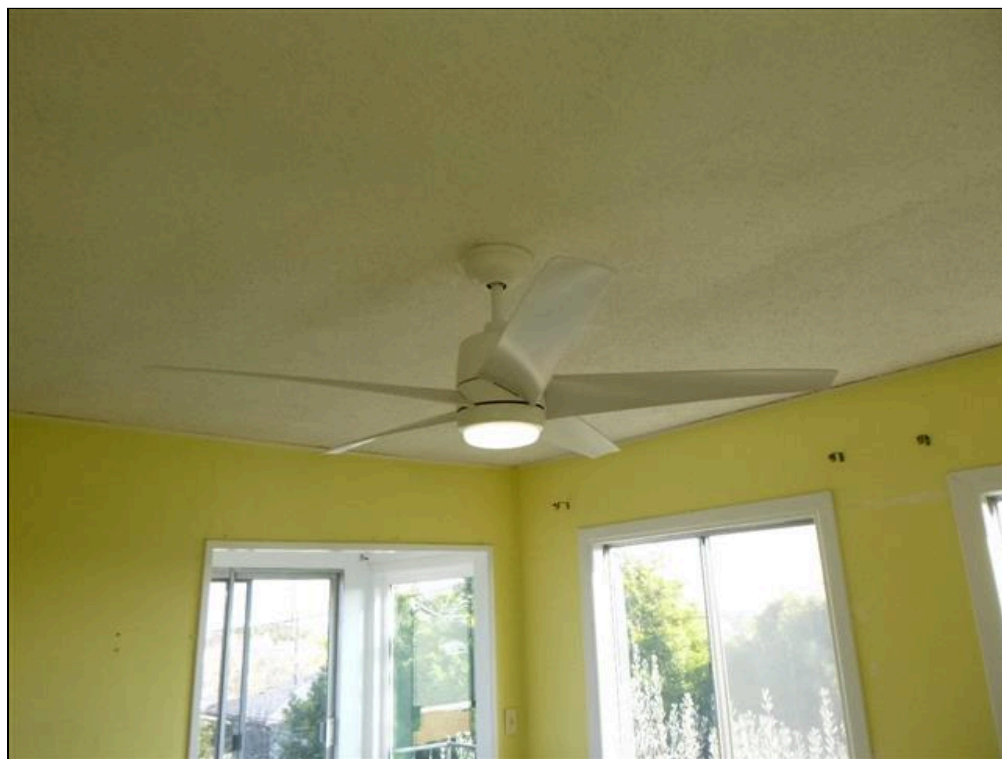
32.8 Item 1(Picture)

**32.8** (1) The ceiling fan system was operational at the time of the inspection.

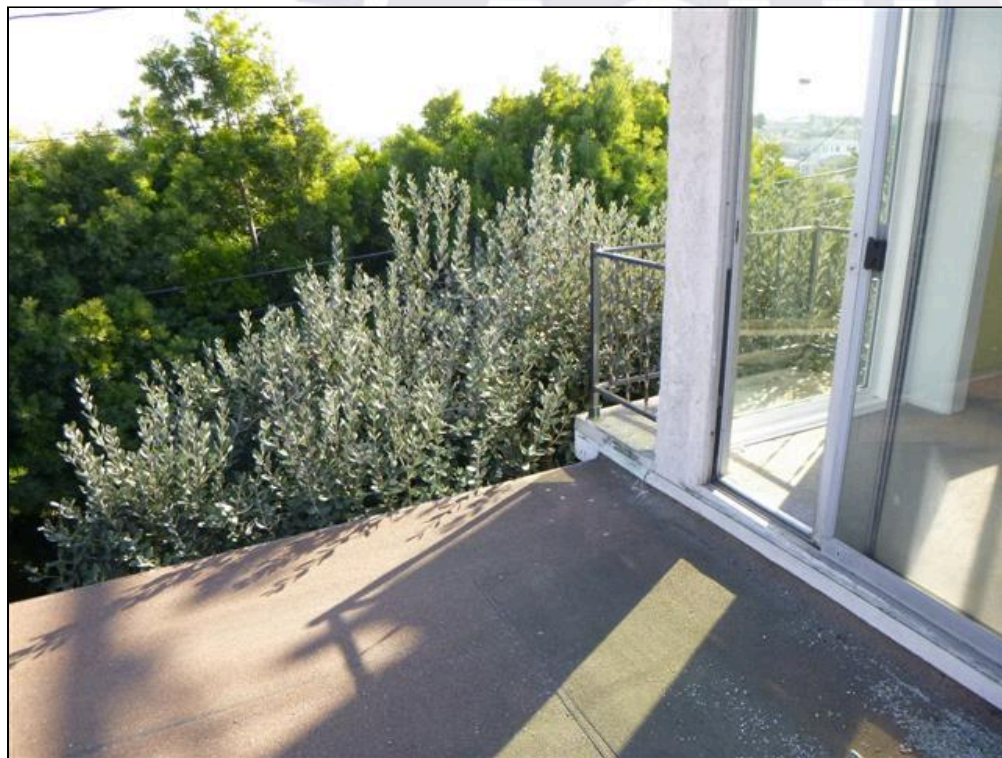
32.8 Item 4(Picture)

**32.8** (2) A potential safety/fall hazard was noted due to the sliding door exits/leads out to the sloped

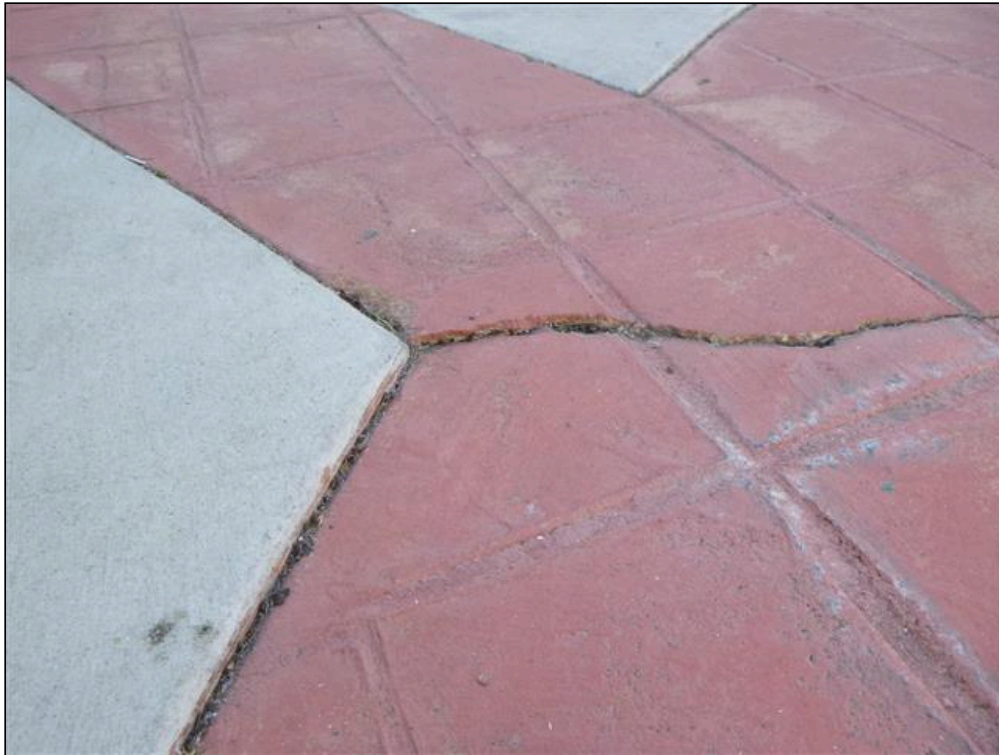
1.0 Item 1(Picture)

(1) Settling, expansion cracks and heaving noted at various areas, this is a potential trip hazard. Suggest review with a licensed contractor for any repair/replacement costs as needed.
