# Inspection Report

**Property Address:**  
2104 Chestnut Ave  
Manhattan Beach CA 90266

**Ferguson Home Inspections**

<b>Date:</b> 1/11/2025	<b>Time:</b> 09:00 AM	<b>Report ID:</b> 01112025ChestnutAve
<b>Property:</b> 2104 Chestnut Ave Manhattan Beach CA 90266	<b>Customer:</b> Yvonne Peltz	<b>Real Estate Professional:</b> Marlene Ramirez

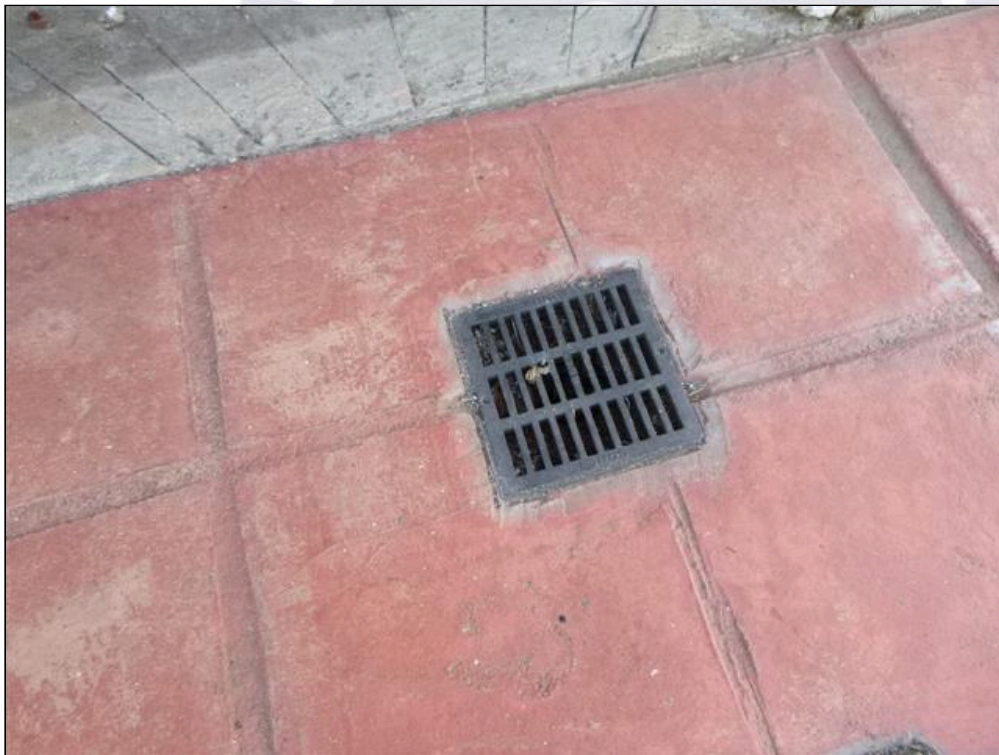
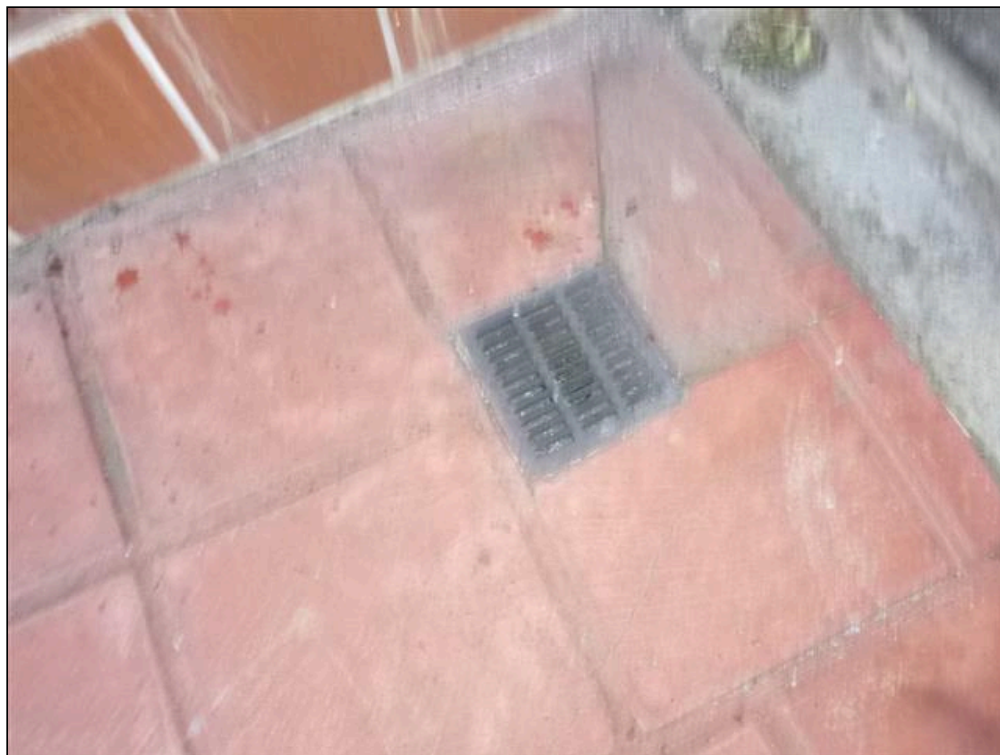
1.0 Item 2(Picture)

(2) Suggest cleaning the driveway drain and drain transition to street prior to the rainy season to prevent blockages which could result in water intrusion into the garage/dwelling.

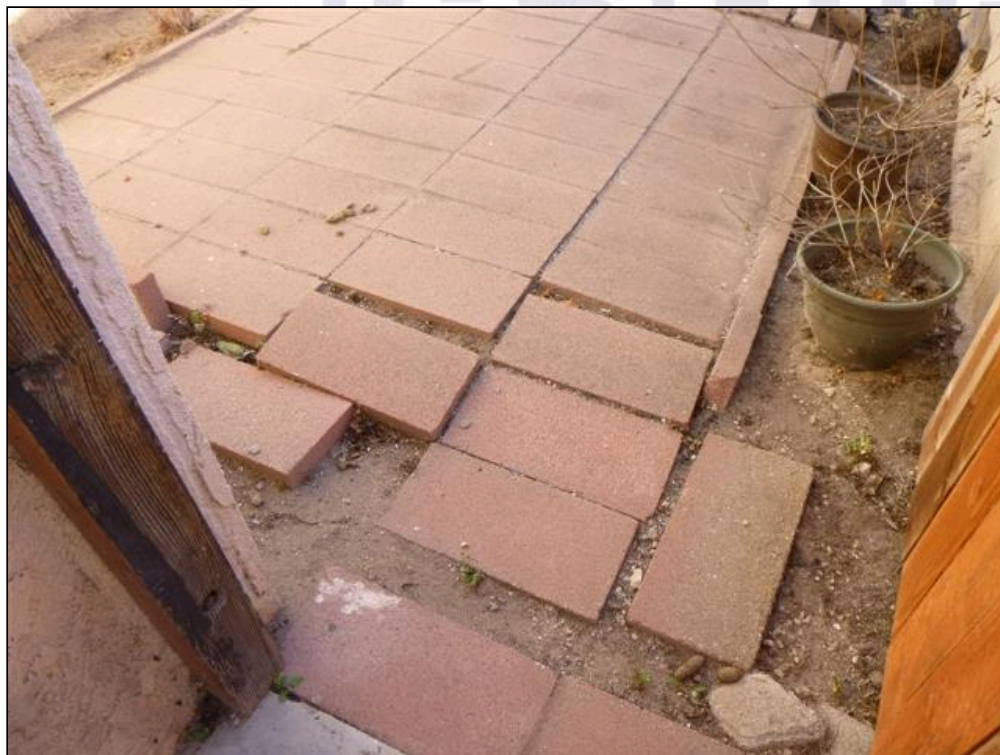
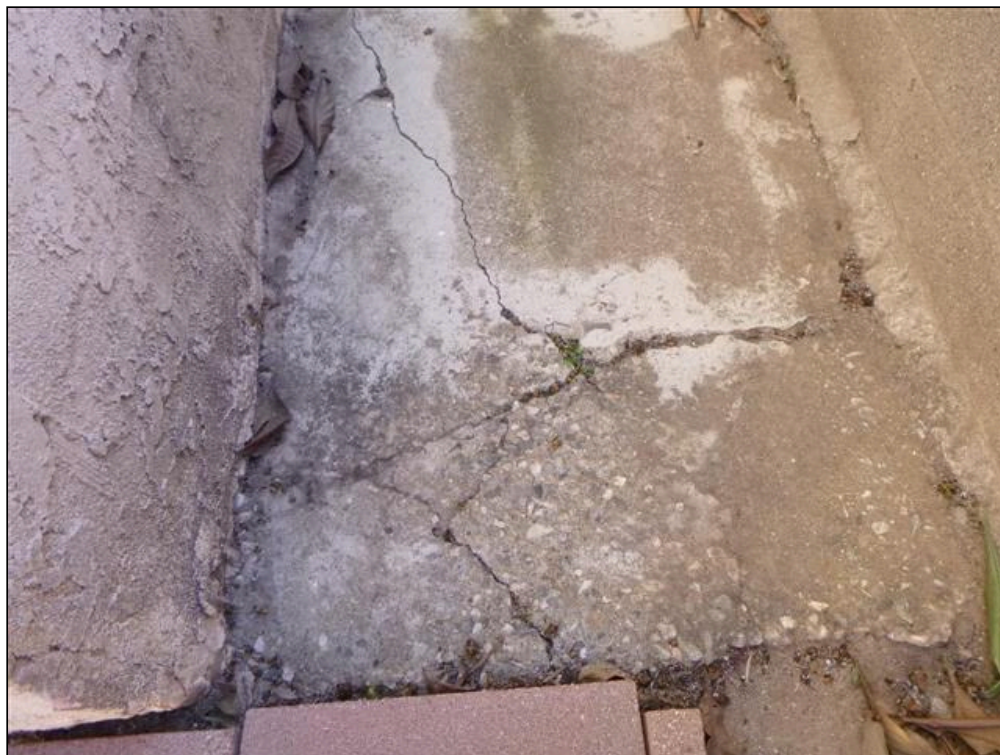
1.1 Item 1(Picture)

Settling, expansion cracks, loose and heaving noted at various areas, this is a potential trip hazard. Suggest review with a licensed contractor for any repair/replacement costs as needed.

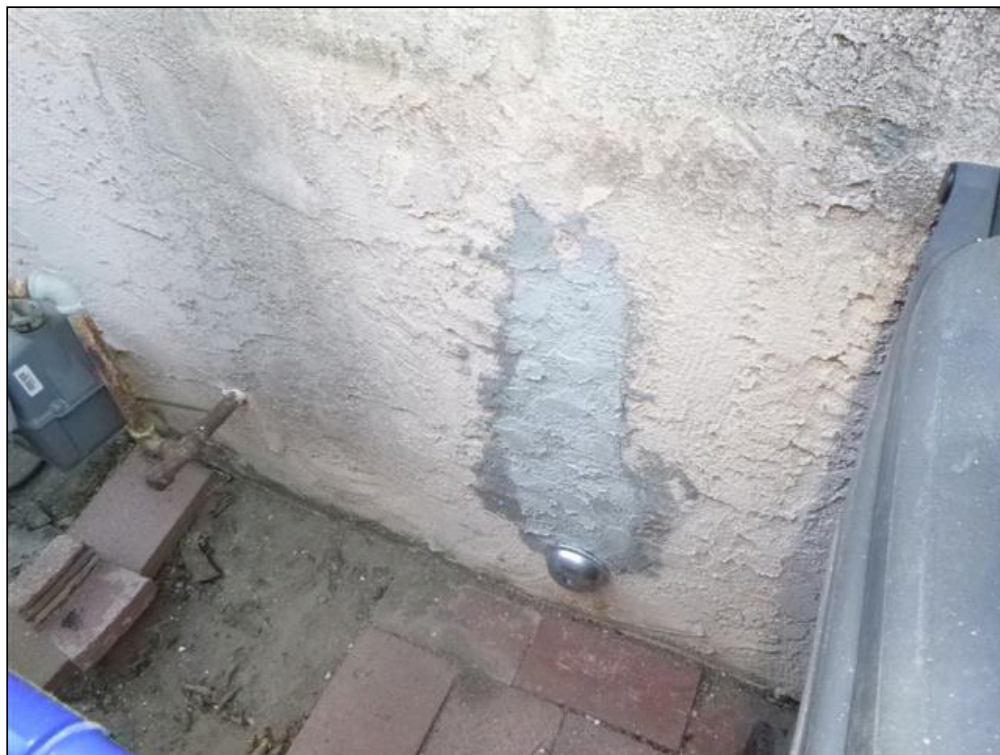
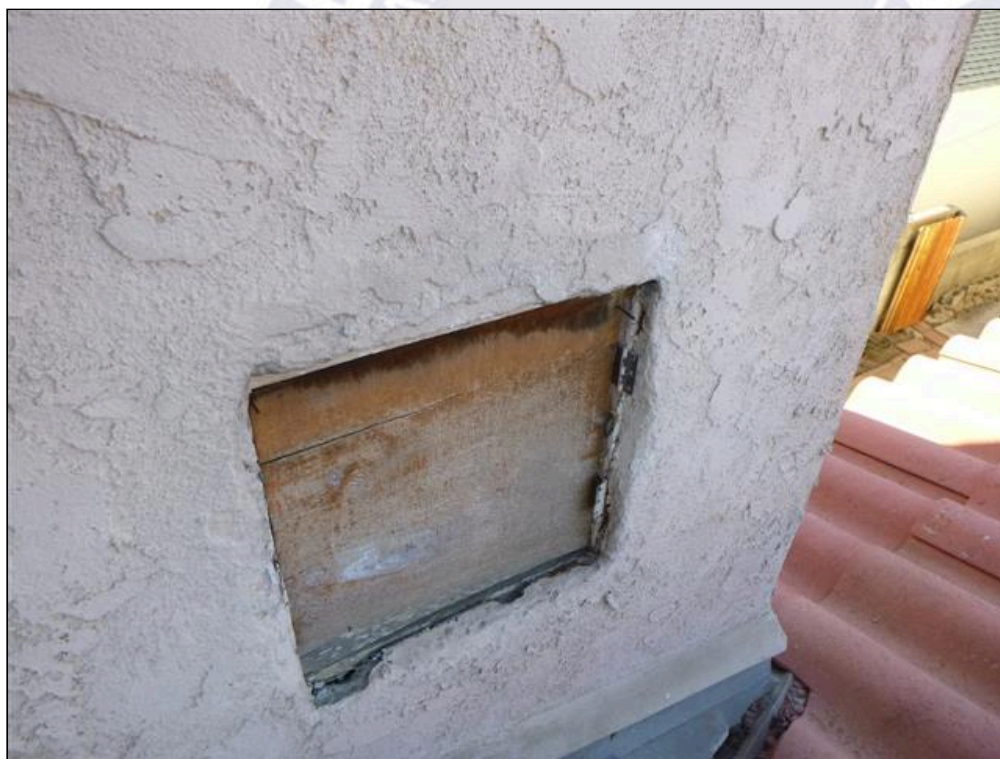
1.4 Item 1(Picture)

(1) Deteriorated and blistering stucco noted at various areas. See the Lot/Drainage comments and review with a licensed contractor to repair as needed and divert water away from the foundation areas.

(2) Multiple trees and bushes are in contact with the siding. Suggest trimming them away from the siding to prevent any future damage.

(3) Various areas of the siding have been patched, suggest review with the seller on the cause and any repairs needed.

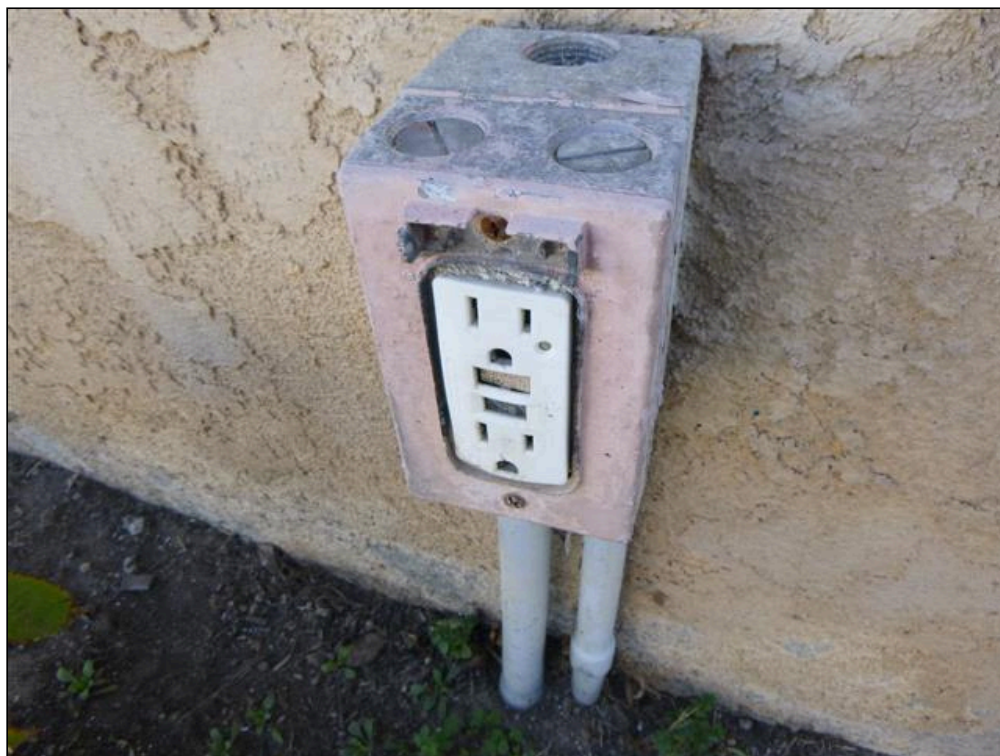
1.8 Item 1(Picture)

(1) Various exterior outlet(s) are missing the weather cover(s). Suggest installation for safety and as required.

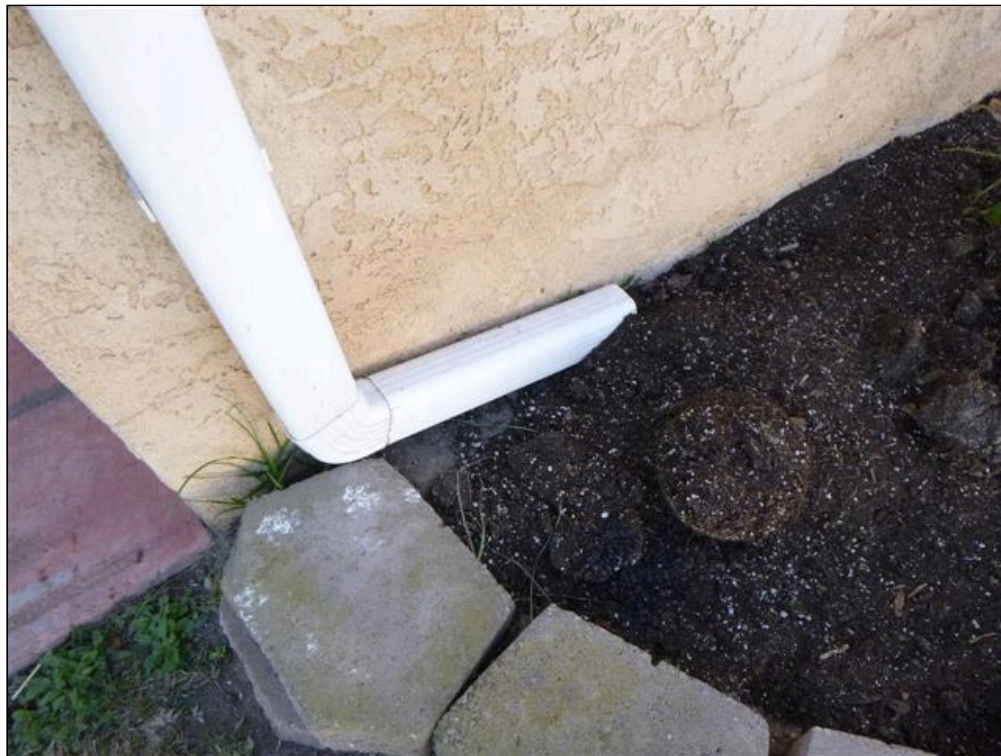
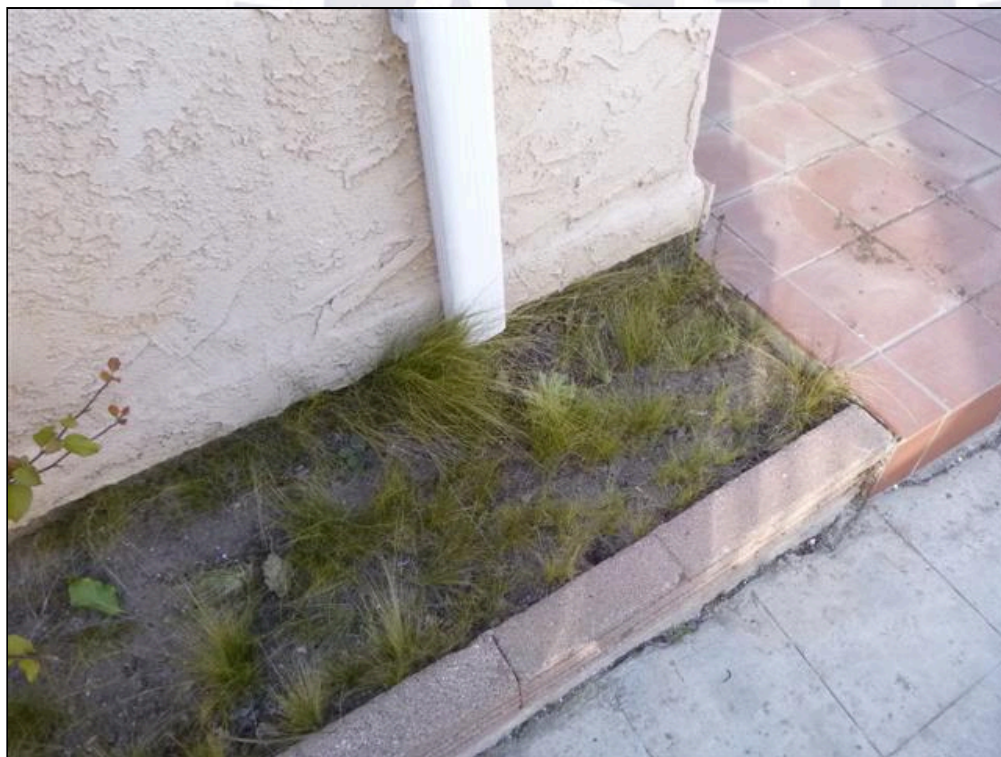
1.9 Item 1(Picture)

- (1) Suggest installation of gutters throughout all eave areas and installation of an area drainage system to divert the water away from the foundation to the street as an upgrade.
- (2) Suggest redirecting the downspouts out of the planters to reduce ponding during the rainy season.

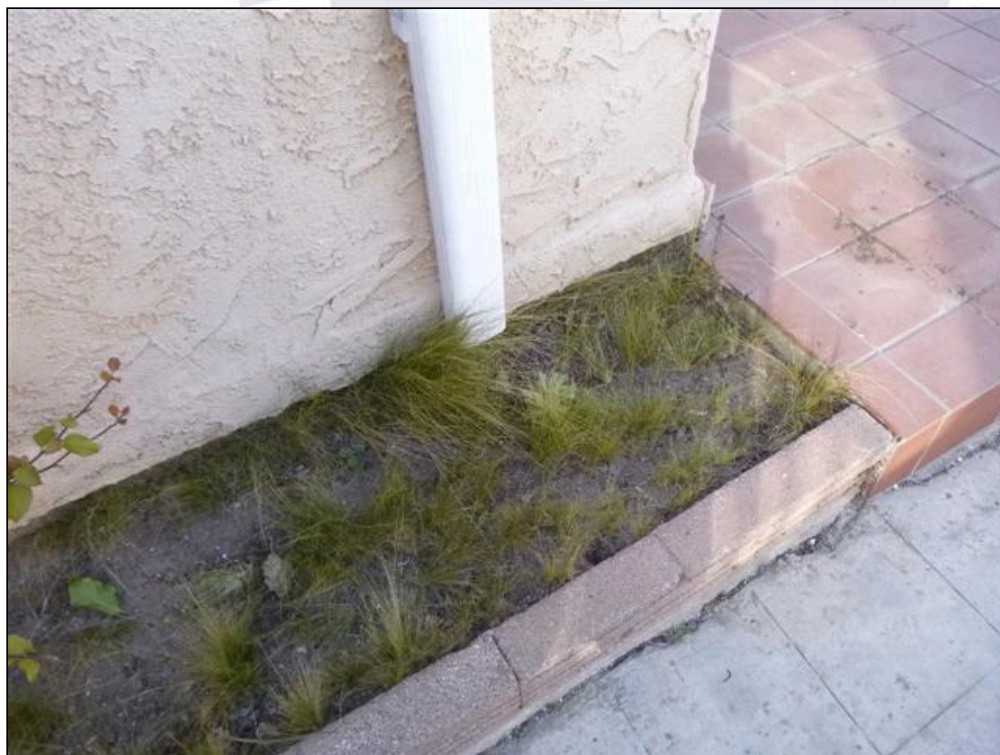
1.11 Item 1(Picture)

No drains and/or drain holes noted/visible at the planter(s). Suggest installing drains/weep holes to prevent ponding and/or excessive moisture buildup at the foundation during the rainy season.

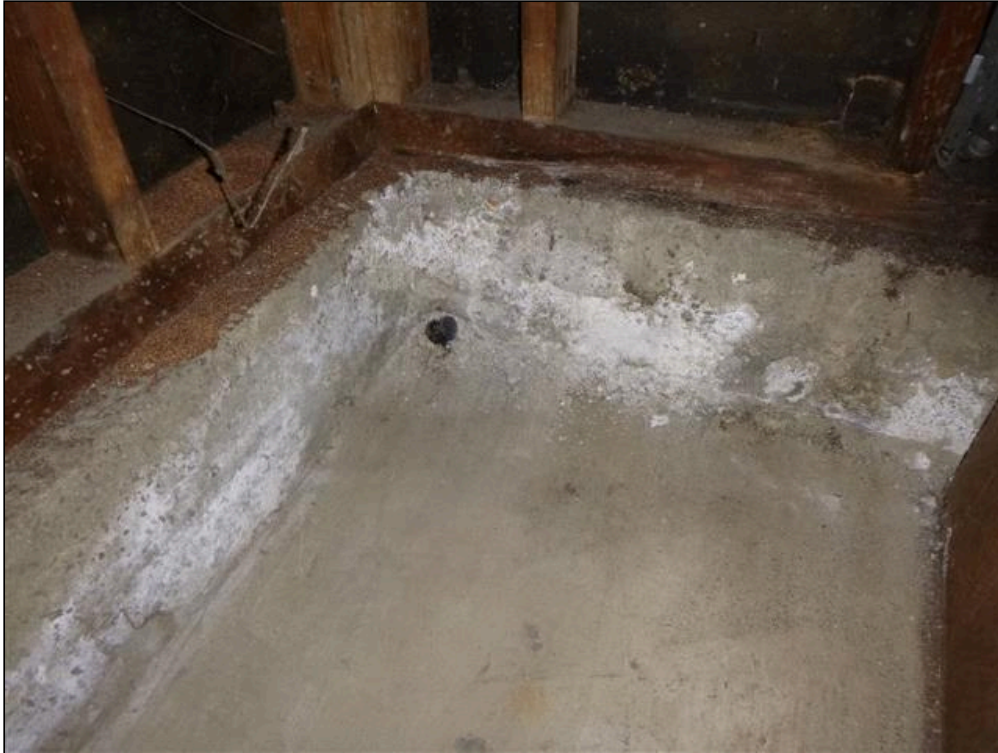
3.0 Item 1(Picture)

(1) Re-grading where needed is recommended to assure all water drains away from the home's foundation. The inadequate drainage has caused minor settling/movement to the foundation. Suggest review with a licensed contractor for installation of perimeter concrete walkways/barriers, rain gutters and an area drainage/sump pump system to divert all the water away from the foundation.

(2) White efflorescence (powder substance) on foundation footings indicates prior, and possibly ongoing, excessive moisture build up at the exterior of the foundation. Ongoing water intrusion at the foundations can, in some cases, cause the steel in the foundations to rust, called spawling, which can lead to horizontal cracking of the foundation ( currently there are no major cracks visible at the foundation ). Any future cracking/damaged can be an expensive repair as the foundation is now structurally weak and susceptible to horizontal movement. Suggest review of the Lot/Grade/ drainage and sewer drainage systems, including rain gutters, to reduce and prevent further and future water buildup at the exterior of the dwellings foundations.

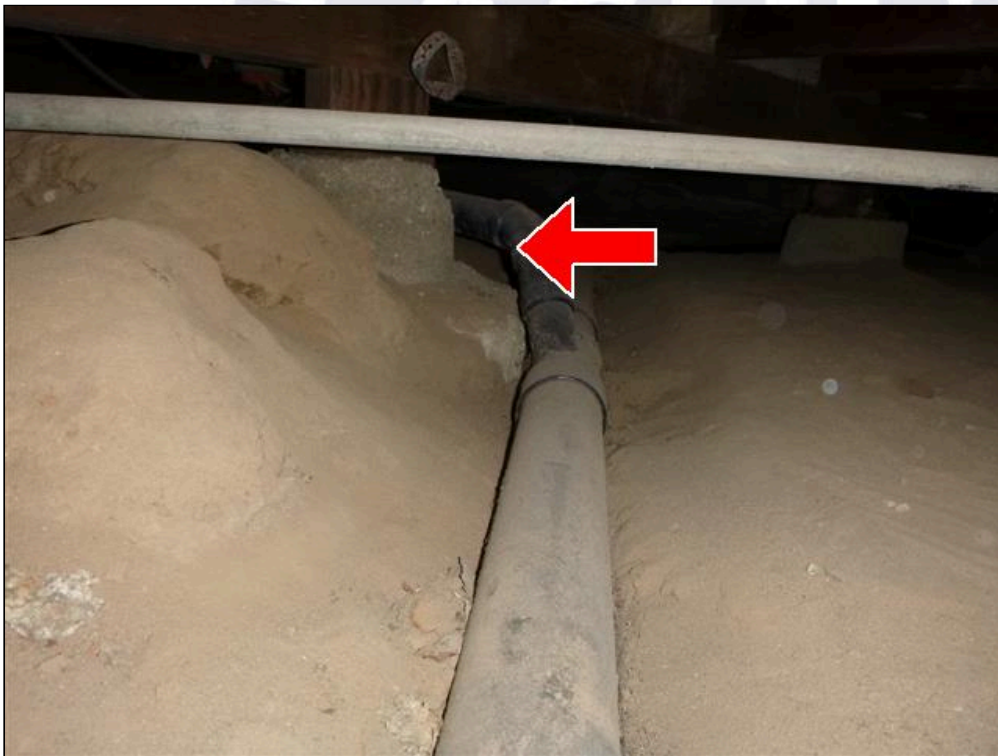
3.0 Item 2(Picture)

(3) Undermining of the foundation was noted due to the new sewer drain installation. Suggest review by a licensed contractor for costs to re-install/compact the removed dirt from this area to prevent possible future movement of the foundation.

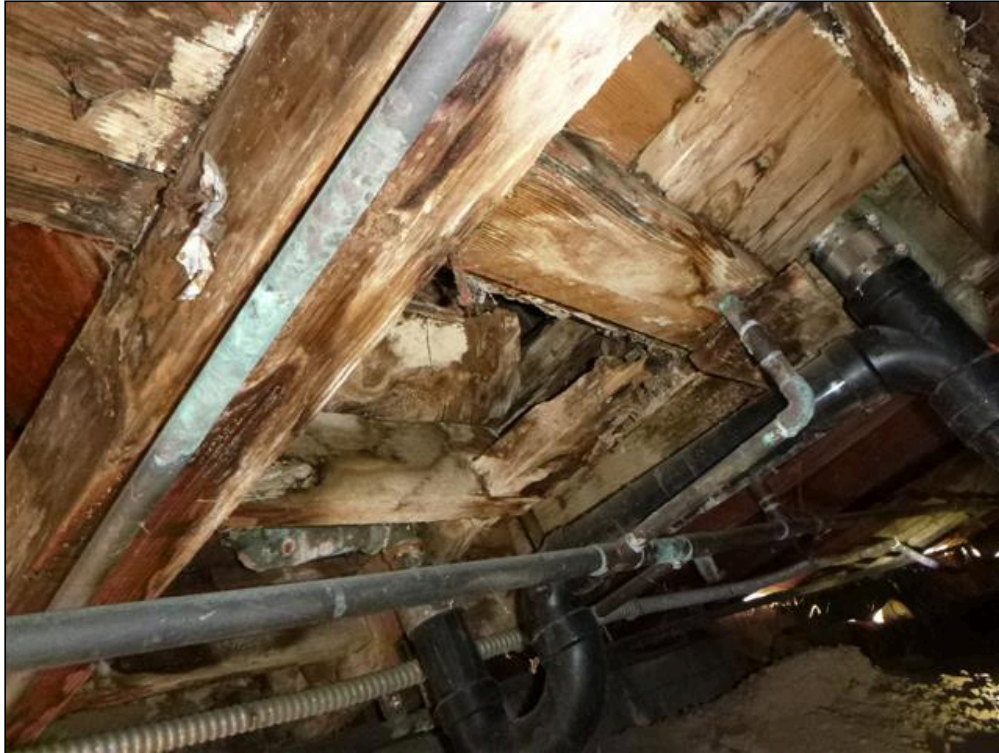
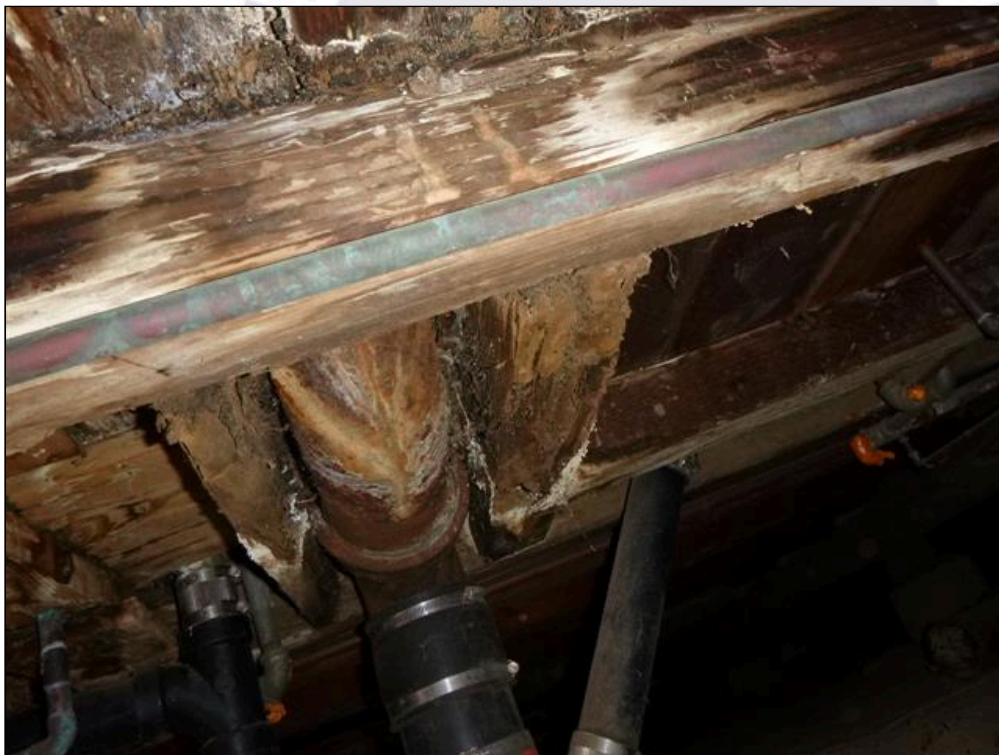
3.1 Item 1(Picture)

Excessive stains and deterioration noted at various flooring and supports from prior leaks. Suggest

review with a termite company and/or a licensed contractor for any repair/replacement costs as needed.

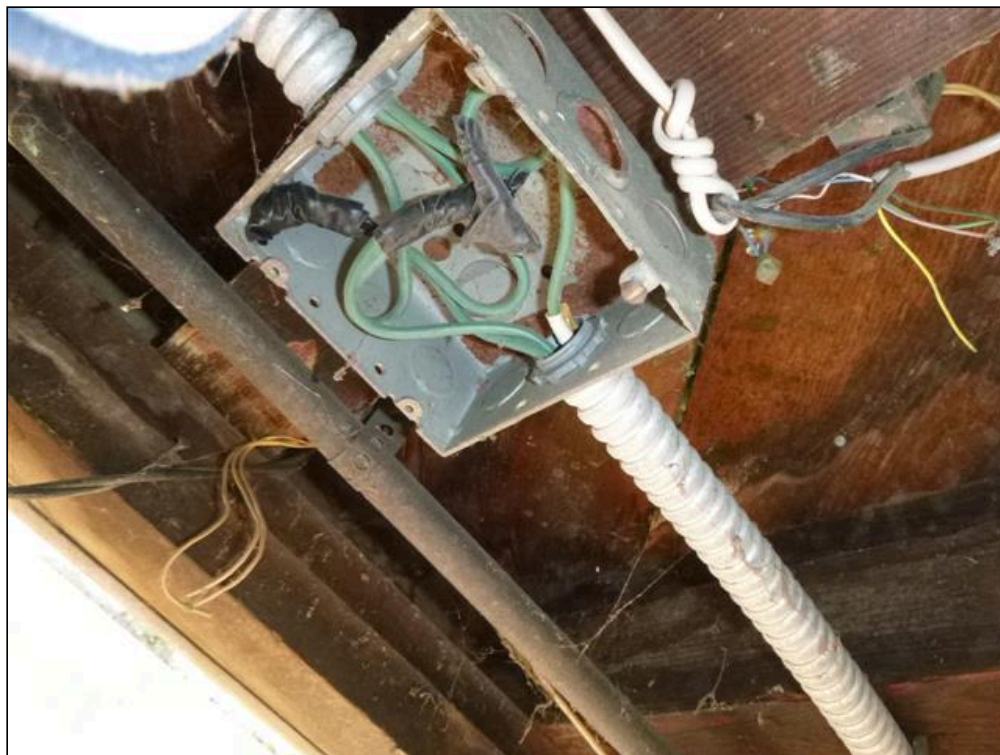
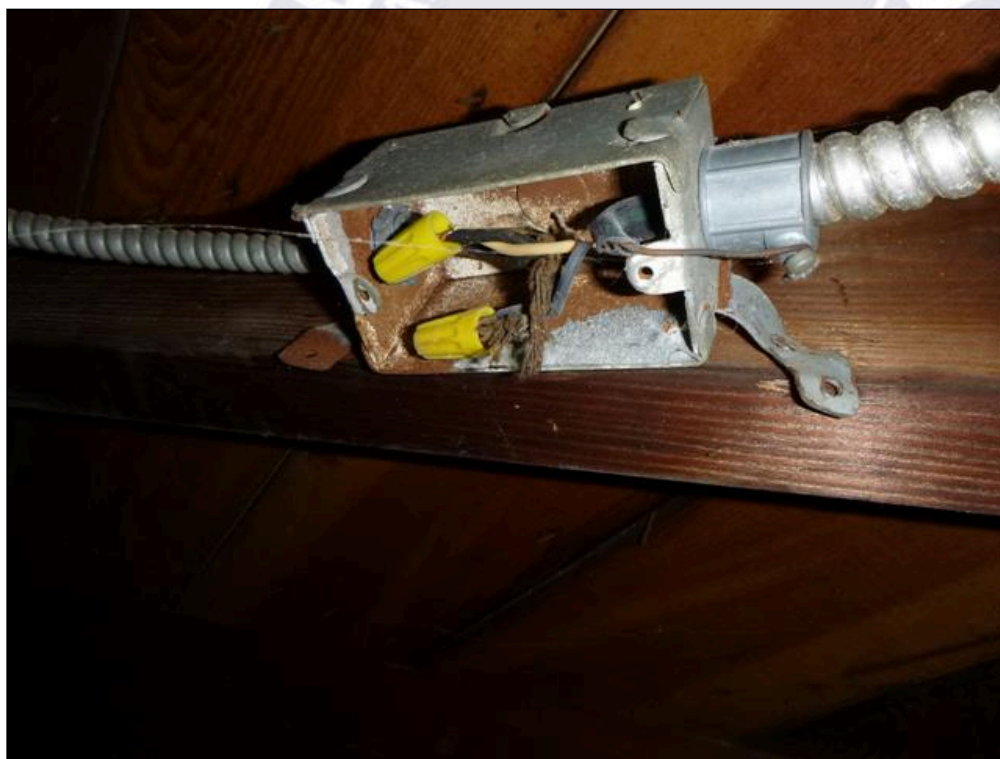
4.3 Item 1(Picture)

(1) Open junction boxes were noted. This is a safety concern. Whenever an electrical wire is cut and re-connected, the 'splice' should be encased in a covered junction box to prevent shocks and separation of the splice. Suggest review by a licensed electrician and repair as needed.

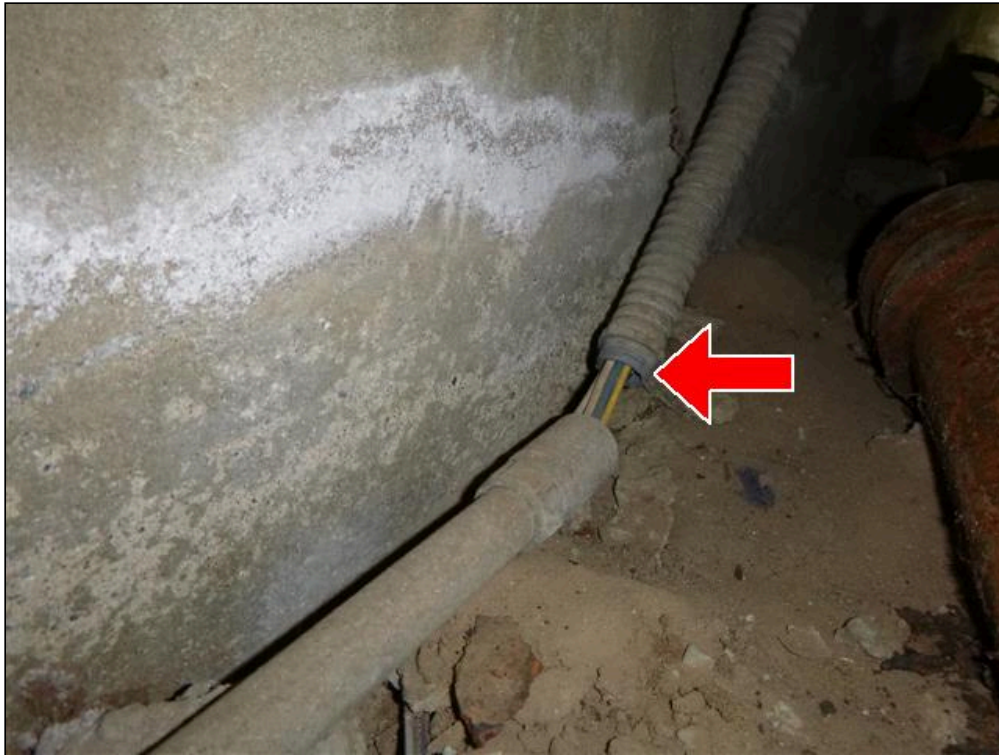
4.3 Item 3(Picture)

(2) The electrical wiring in the crawl area has been inadequately secured. The romex/conduit is in contact with the ground at various areas, suggest review with a licensed electrician to repair/secure as needed for safety and as required.

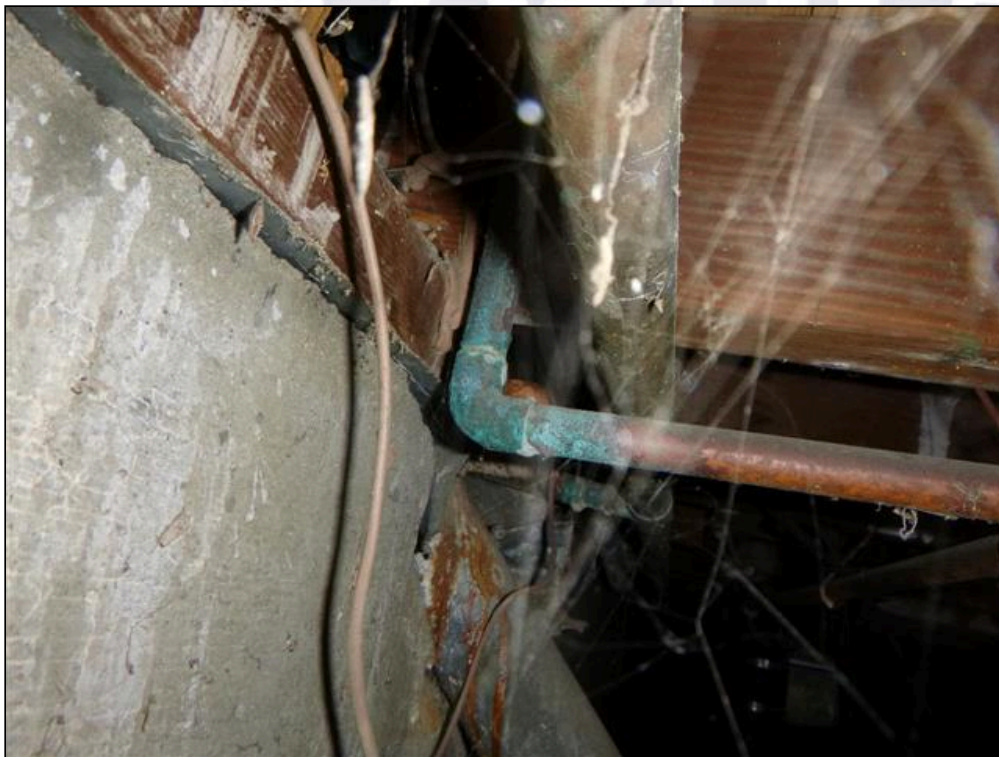
4.4 Item 1(Picture)

(1) Corroded areas of the copper plumbing was noted throughout the crawl area, this can be a precursor to 'pin hole' leaks. Suggest review with a licensed plumber for any repair/replacement costs as needed.

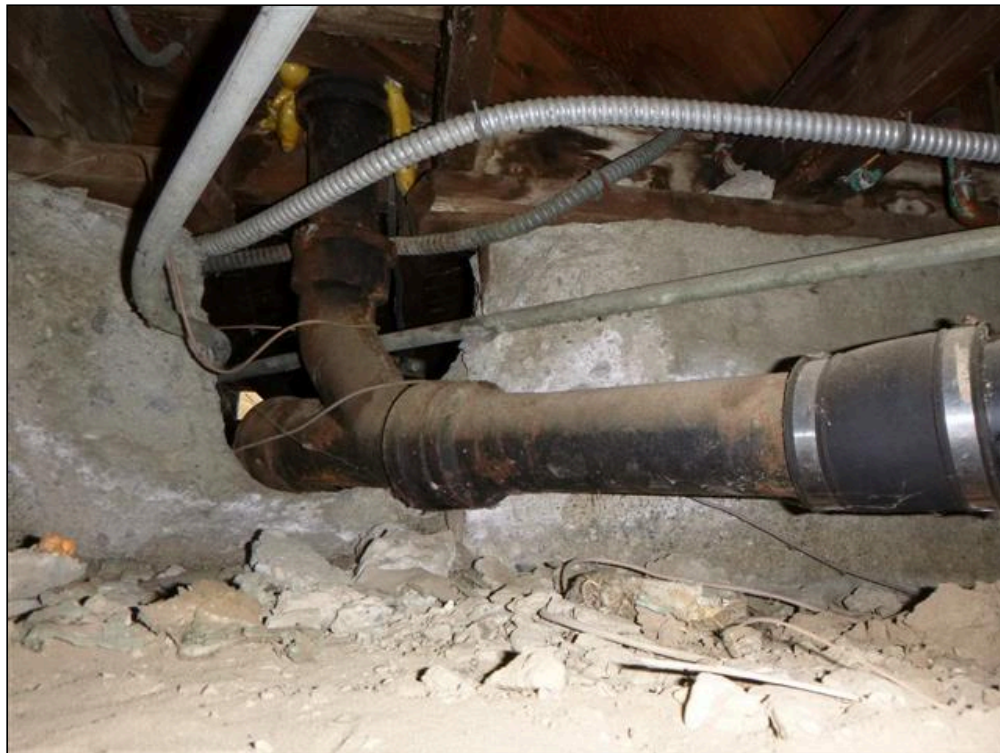
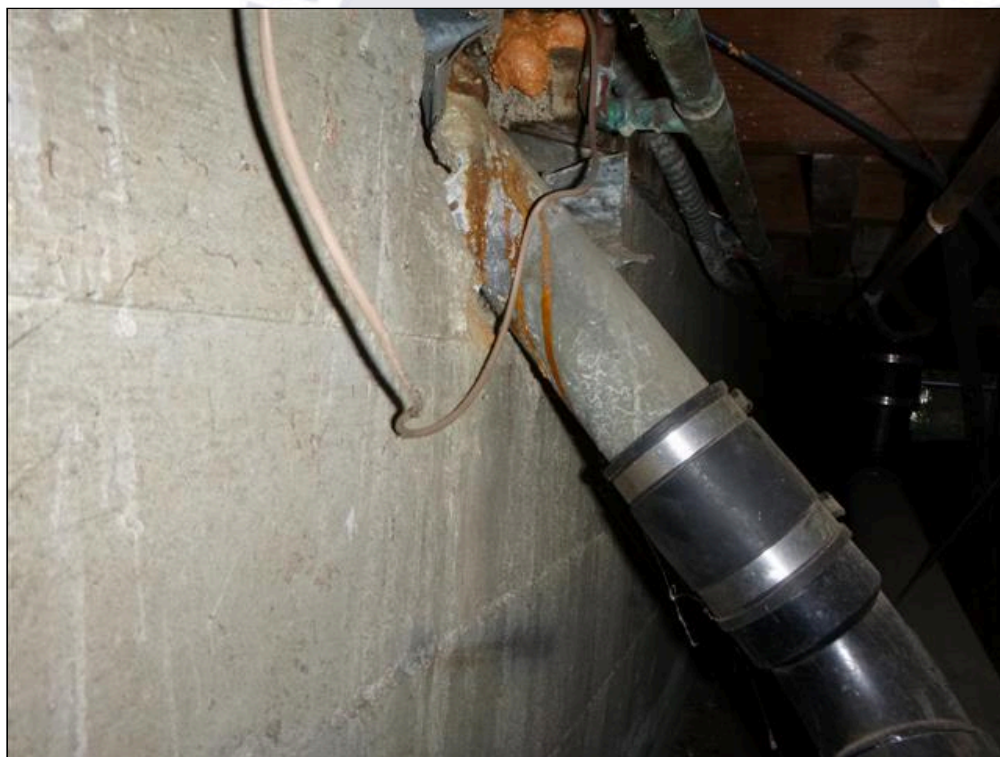
4.4 Item 2(Picture)

(2) Rust and corrosion noted at various cast iron drain lines within the crawl space, common for the

age, no leaking visible at the time of the inspection. Suggest review by a licensed plumbing contractor for repair/replacement costs as needed.

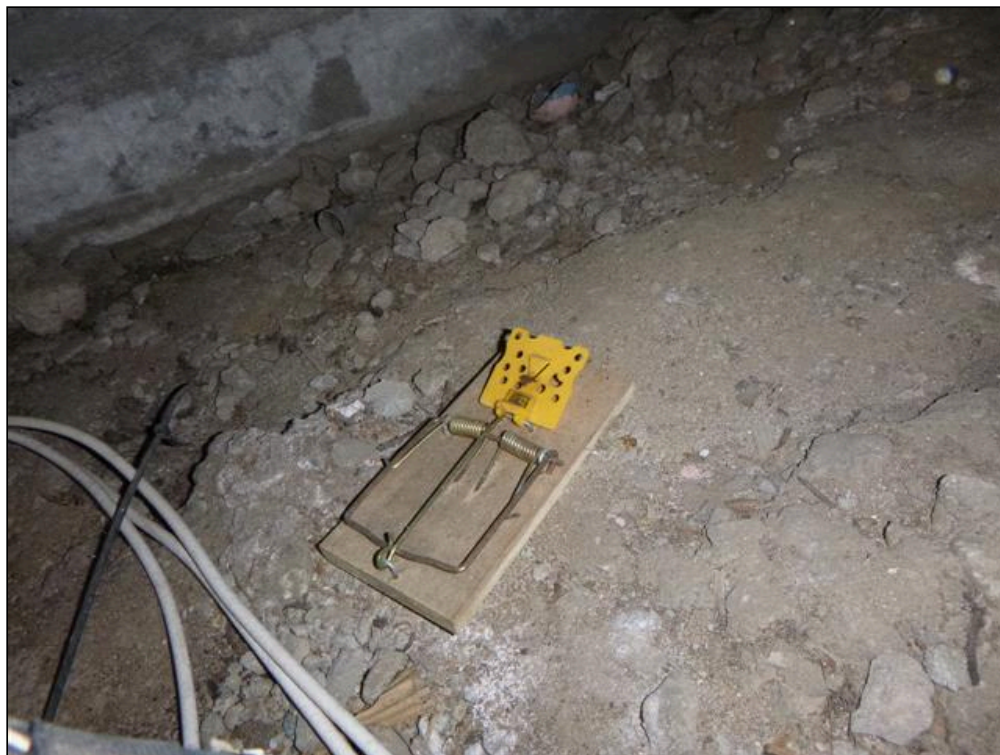
4.5 Item 1(Picture)

Excessive pest droppings and traps noted within the crawl area. Suggest review with a qualified pest control company and/or a licensed contractor for removal costs of the droppings as needed.

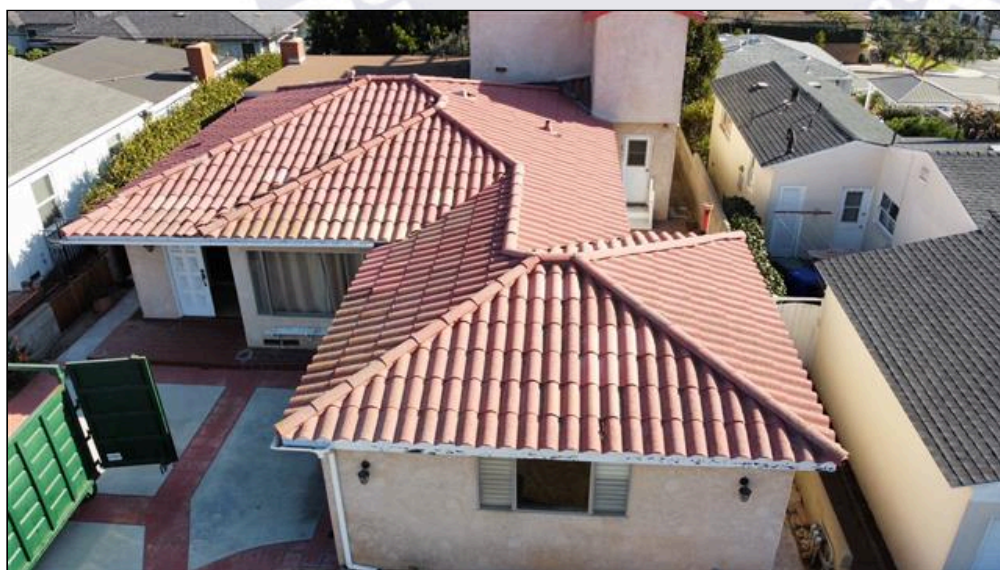
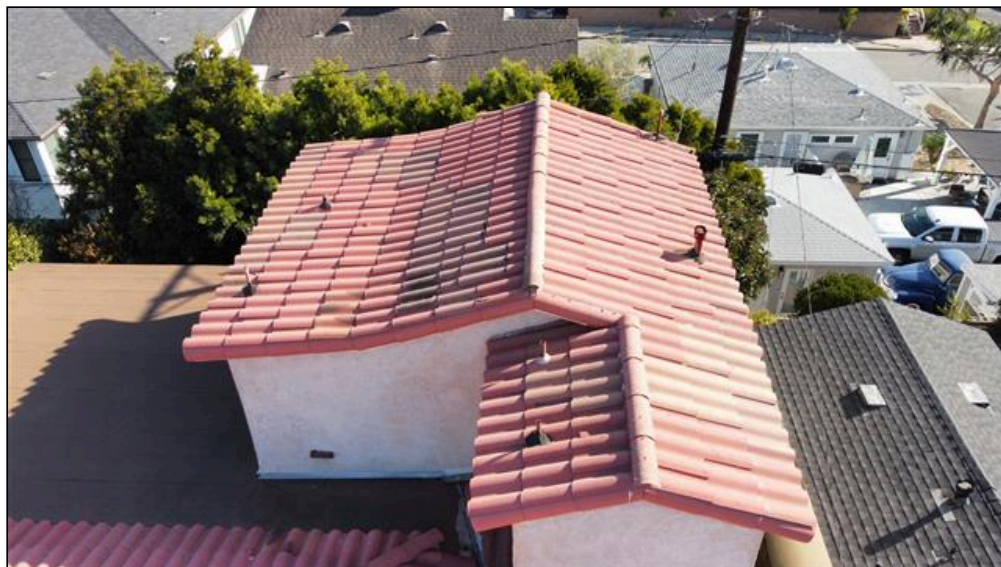
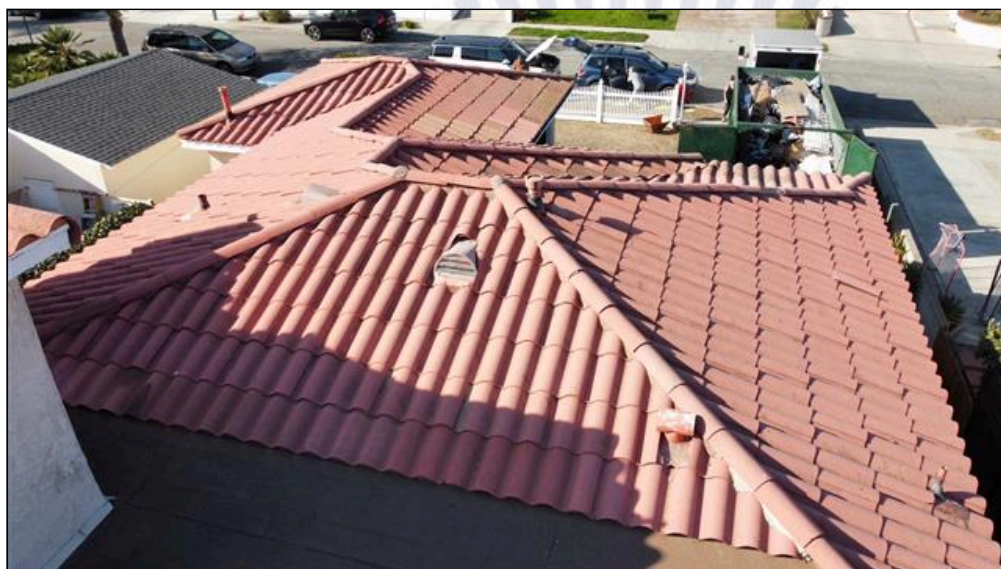
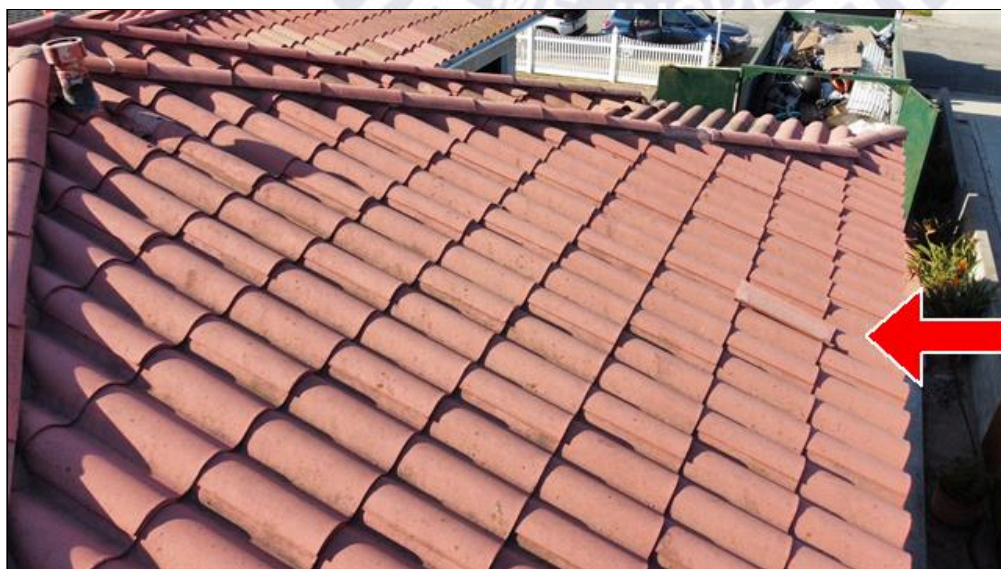
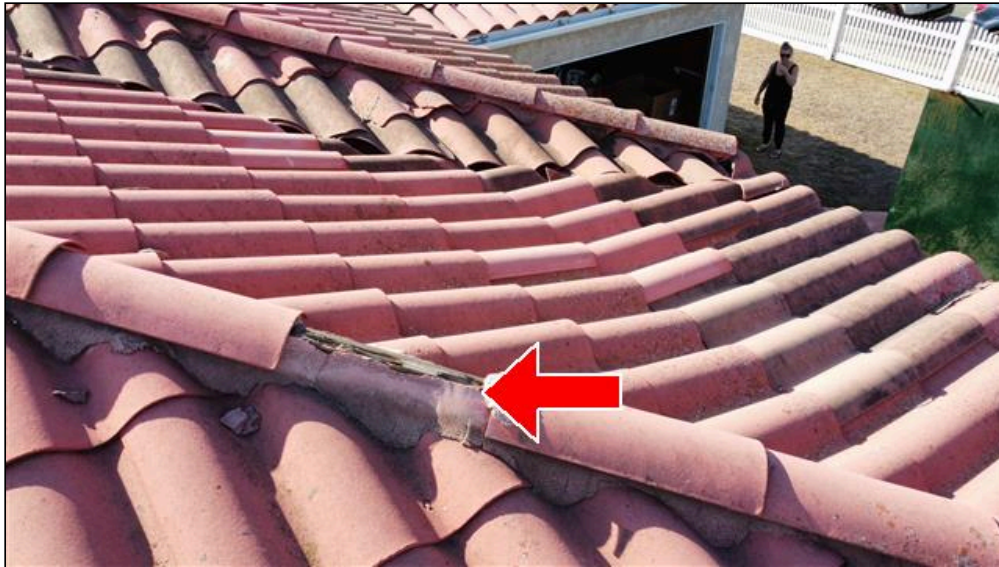
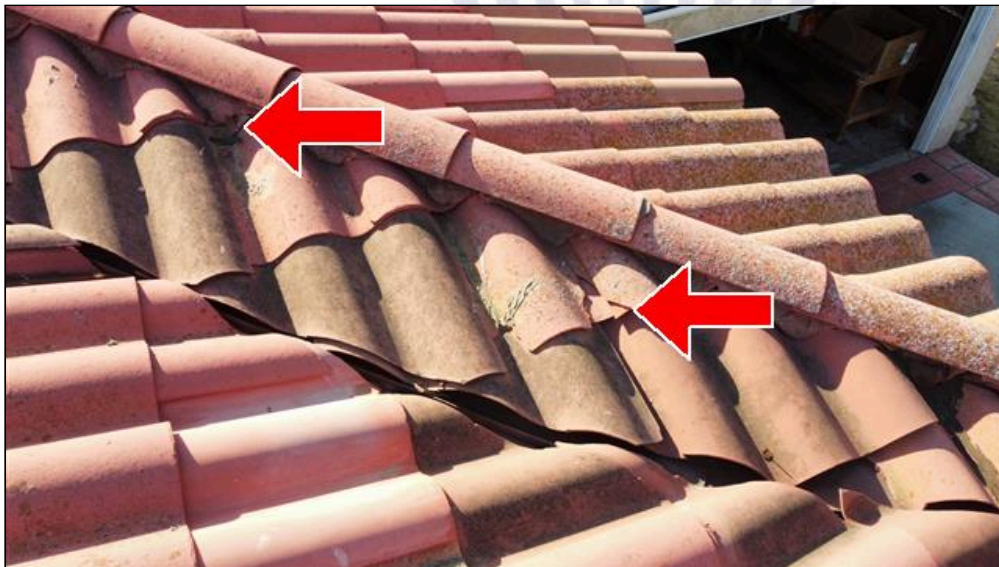
5.0 Item 1(Picture)

(1) Deteriorated, cracked, loose and missing sections of the roof tiles was noted. Suggest review by a licensed roofer for any repair/replacement costs as needed to prevent any future leakage during the rainy season.

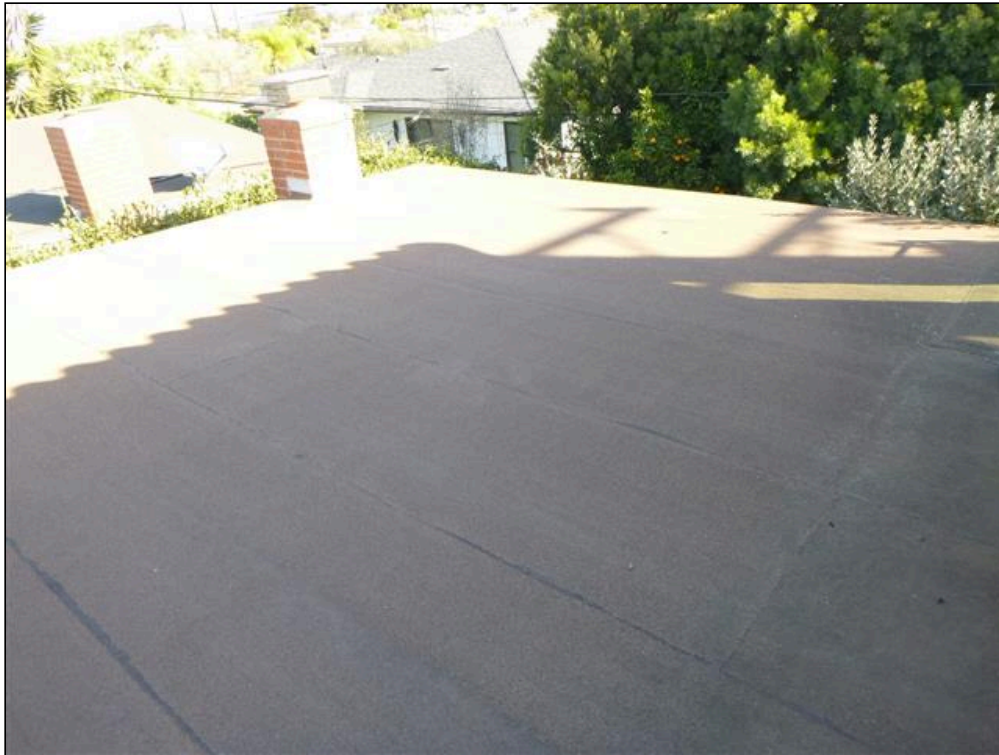
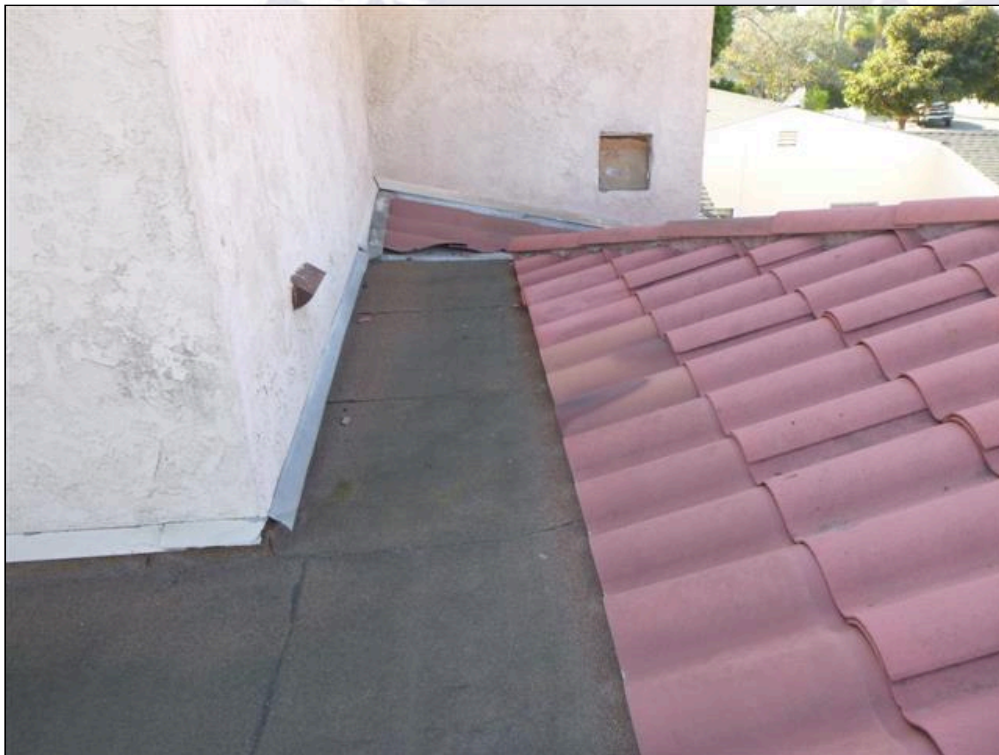
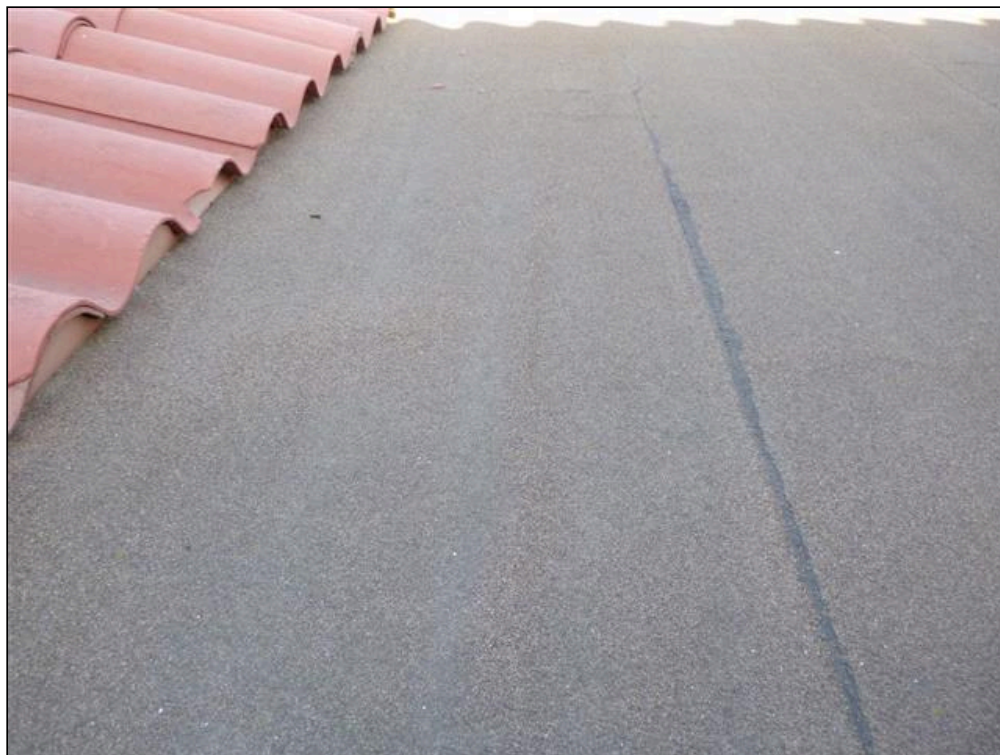
5.0 Item 7(Picture)

(2) Soft, uneven, wrinkling and worn areas of the sloped roof was noted. Suggest review with a licensed roofer for any repair/removal/replacement costs as needed.
