# Inspection Report

**Property Address:**  
2104 Chestnut Ave  
Manhattan Beach CA 90266

**Ferguson Home Inspections**

<b>Date:</b> 1/11/2025	<b>Time:</b> 09:00 AM	<b>Report ID:</b> 01112025ChestnutAve
<b>Property:</b> 2104 Chestnut Ave Manhattan Beach CA 90266	<b>Customer:</b> Yvonne Peltz	<b>Real Estate Professional:</b> Marlene Ramirez

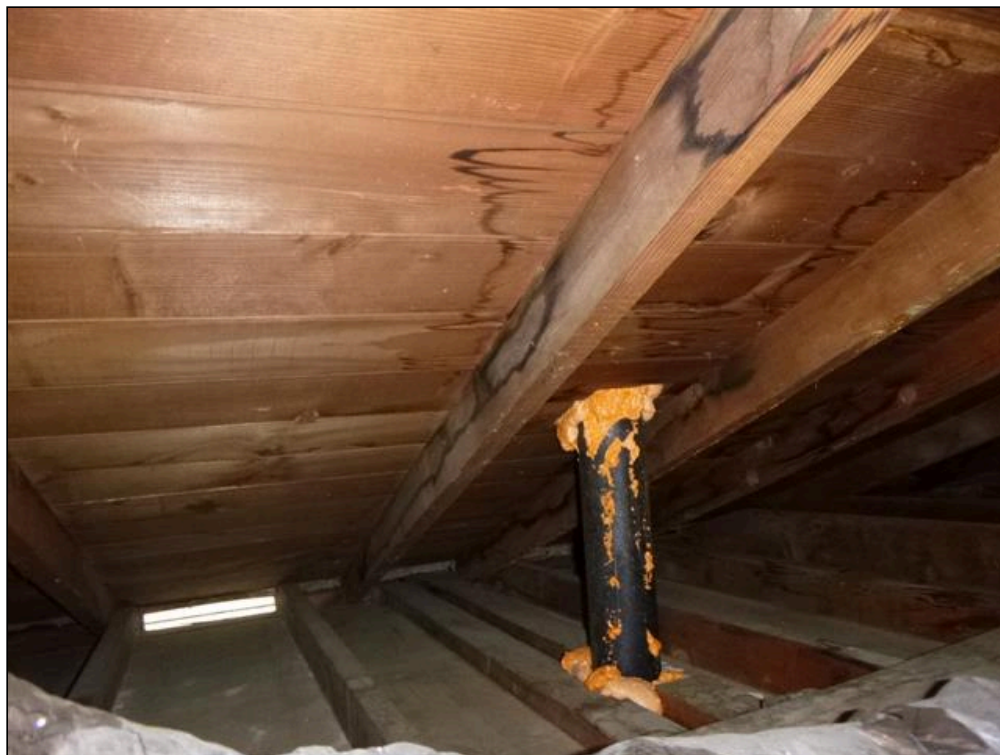
6.0 Item 1(Picture)

(1) Moisture stains noted at various areas of the attic sheathing/framing, see roof comments and repair as needed.

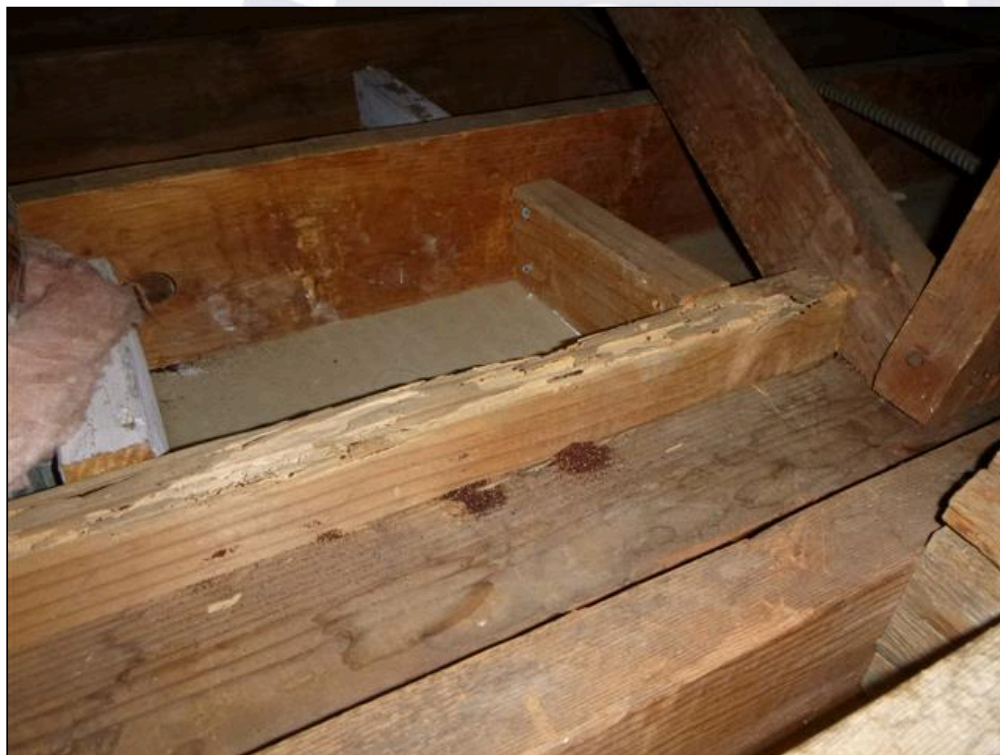
6.0 Item 2(Picture)

(2) Wood deterioration noted at various areas of the roof framing, suggest review with a termite company and/or a licensed contractor for repairs as needed.

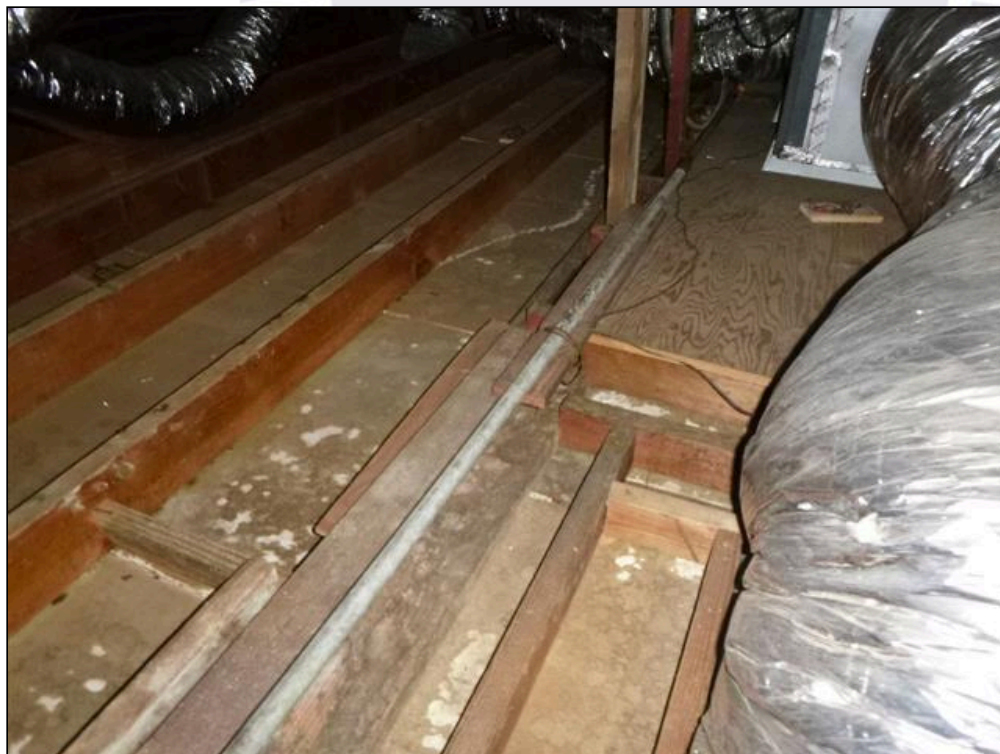
6.6 Item 1(Picture)

- (1) The attic access ladder is deteriorated/damaged, suggest replacing as needed.
- (2) No heater access platform is currently installed, suggest review with a licensed contractor for installation as required.

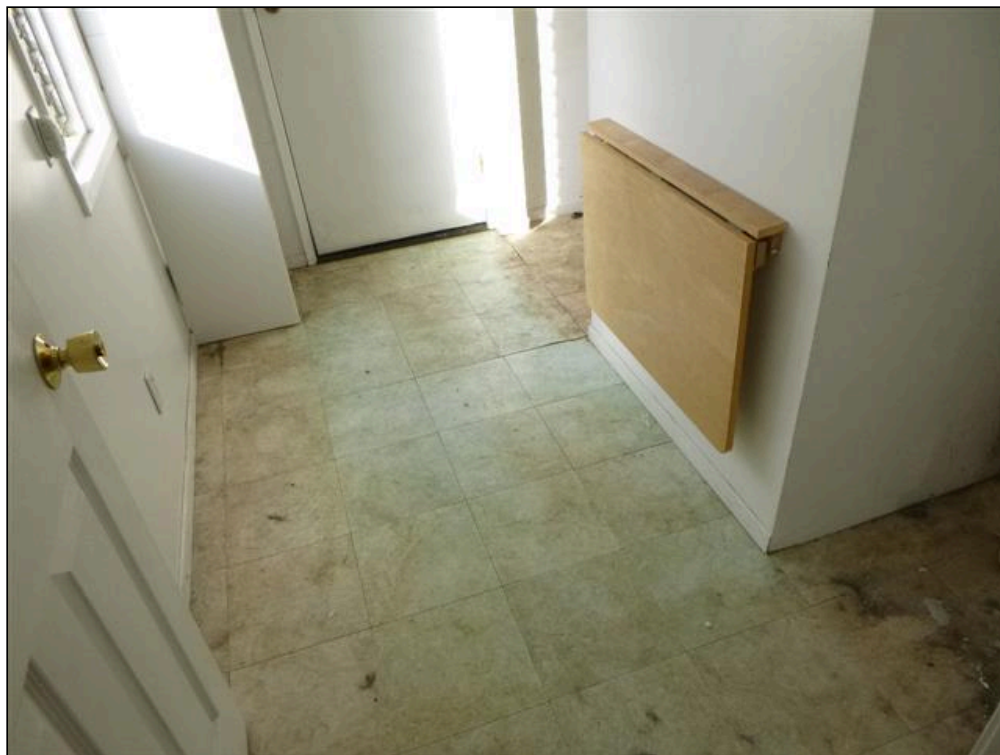
7.0 Item 1(Picture)

Deteriorated and loose sections noted at the laundry floor, suggest repair/replace as needed.

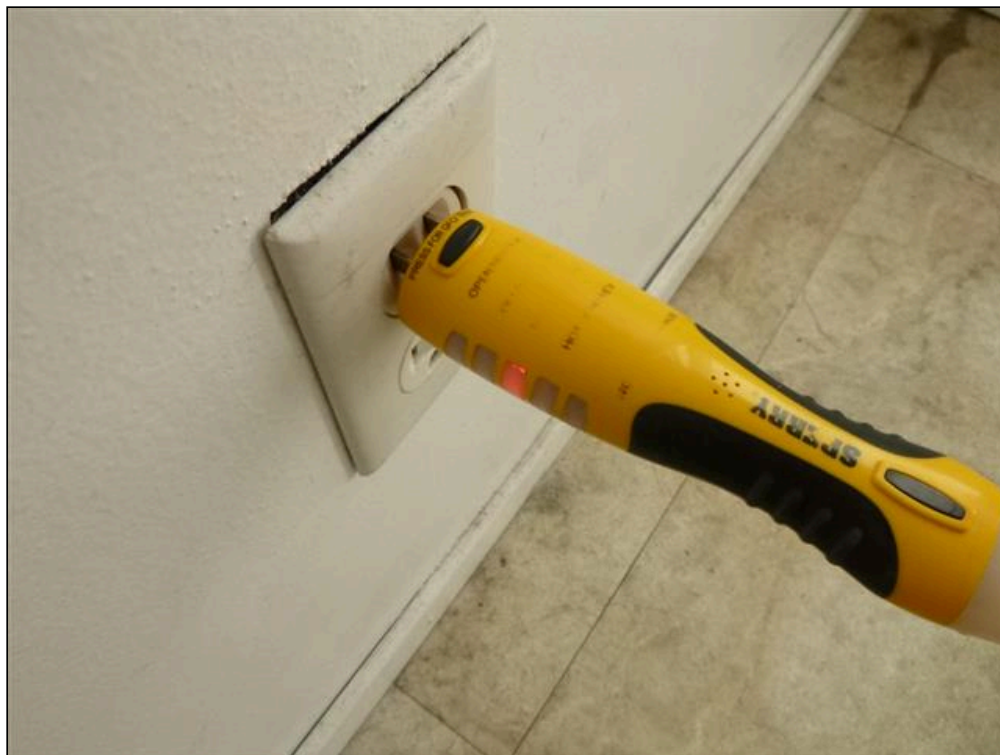
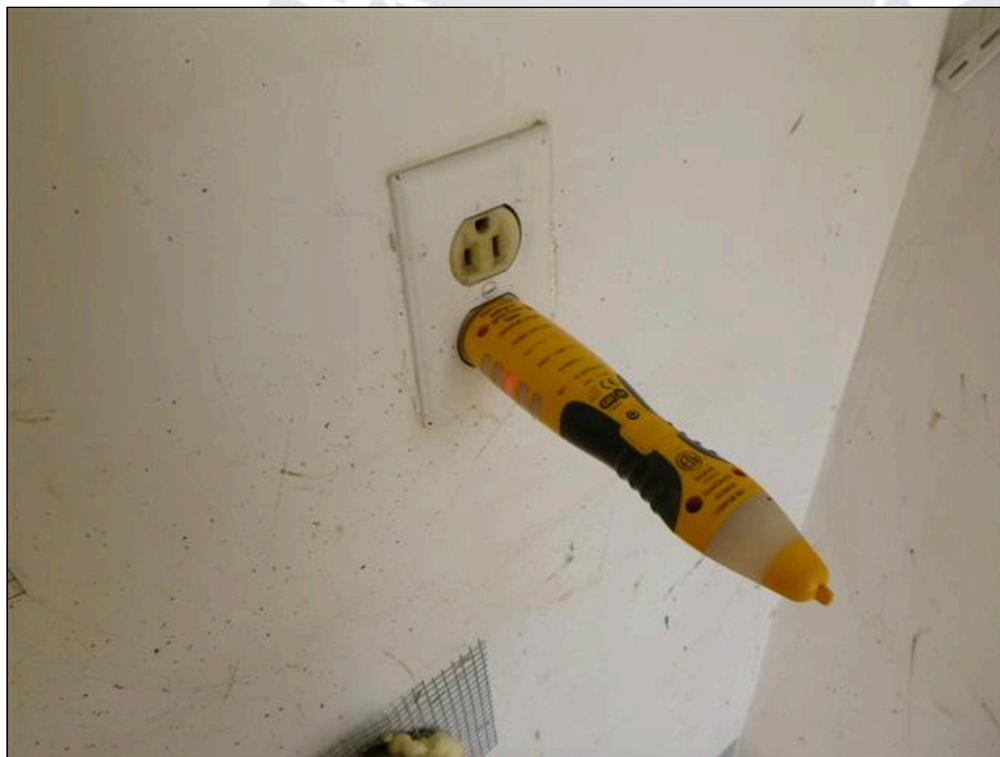
7.6 Item 1(Picture)

Reversed polarity noted at various outlets. Reversed polarity, hot and ground reversed and other terms used for electric outlets are usually easily corrected by minor wiring adjustments at the specified item. Suggest review with a licensed electrician for repair/replacement costs and confirm correct operation as needed.

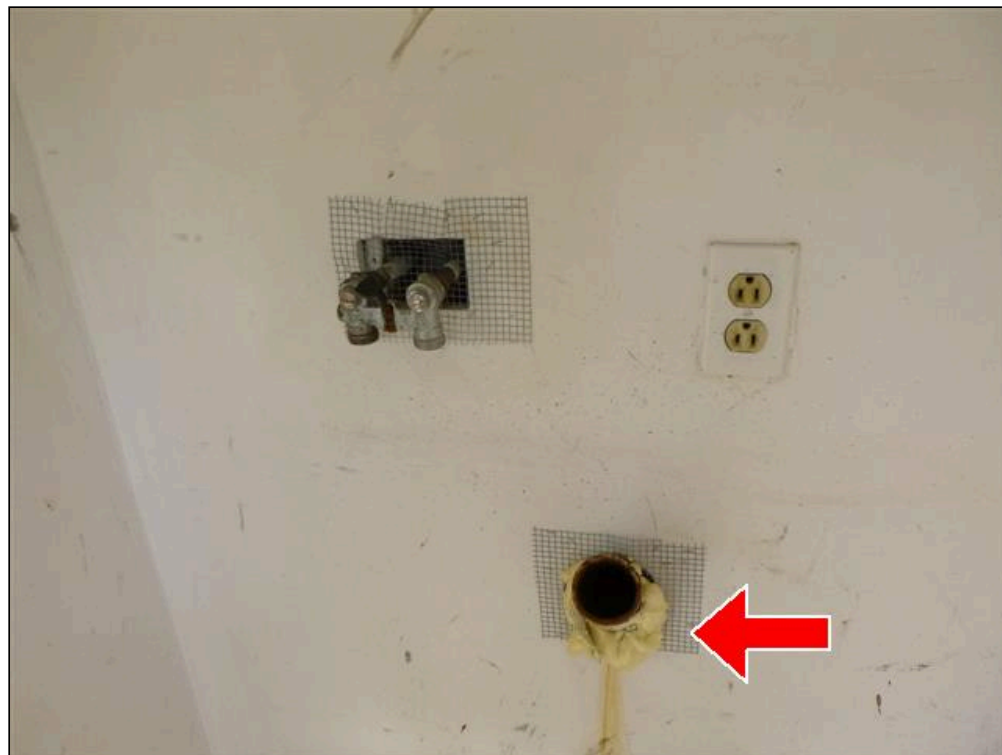
7.7 Item 4(Picture)

(2) Corrosion noted at the washing machine drain, no leaking noted at the time of the inspection. Suggest review with a licensed plumber and repair/replace as needed.

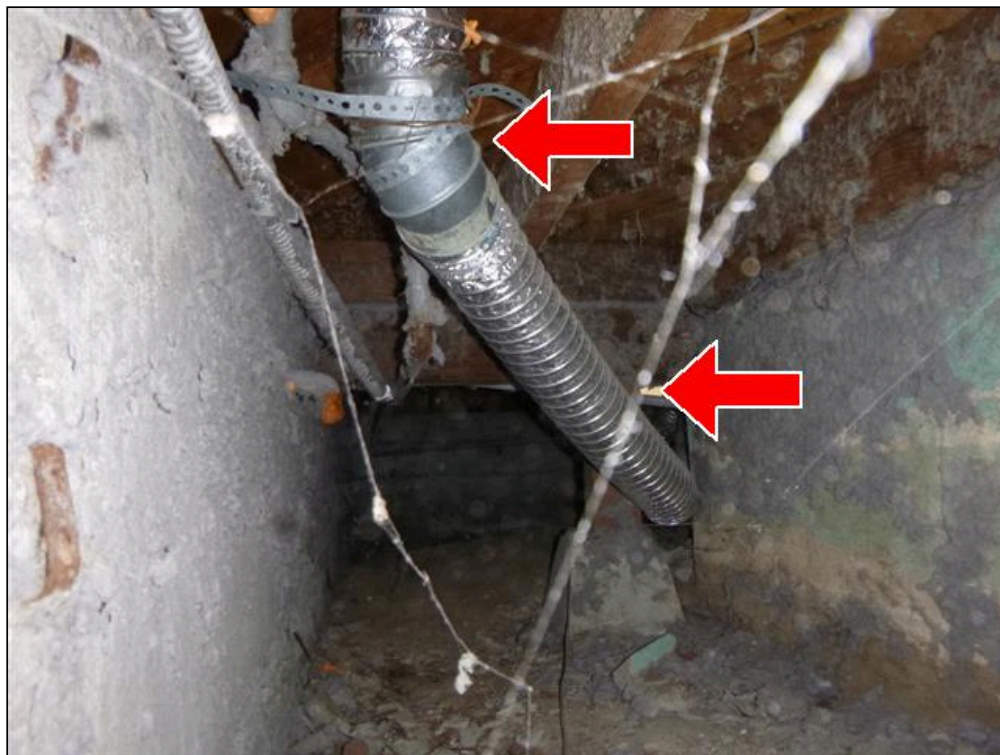
7.8 Item 2(Picture)

(2) The dryer vent is pulled apart/leaking within the crawl space, this is a potential fire safety hazard. Suggest repairs as needed and vent to the exterior of dwelling with approved rigid materials and removal of all lint from the crawl area.

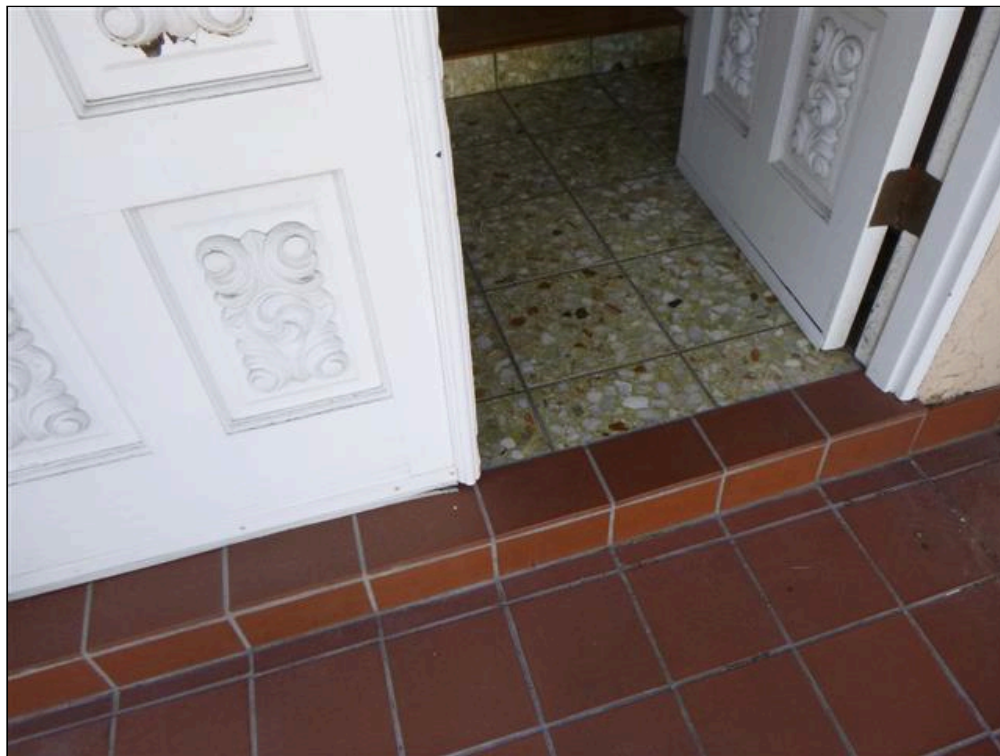
8.5 Item 1(Picture)

(1) The doors are weathered and deteriorated, suggest maintenance and repairs as needed.

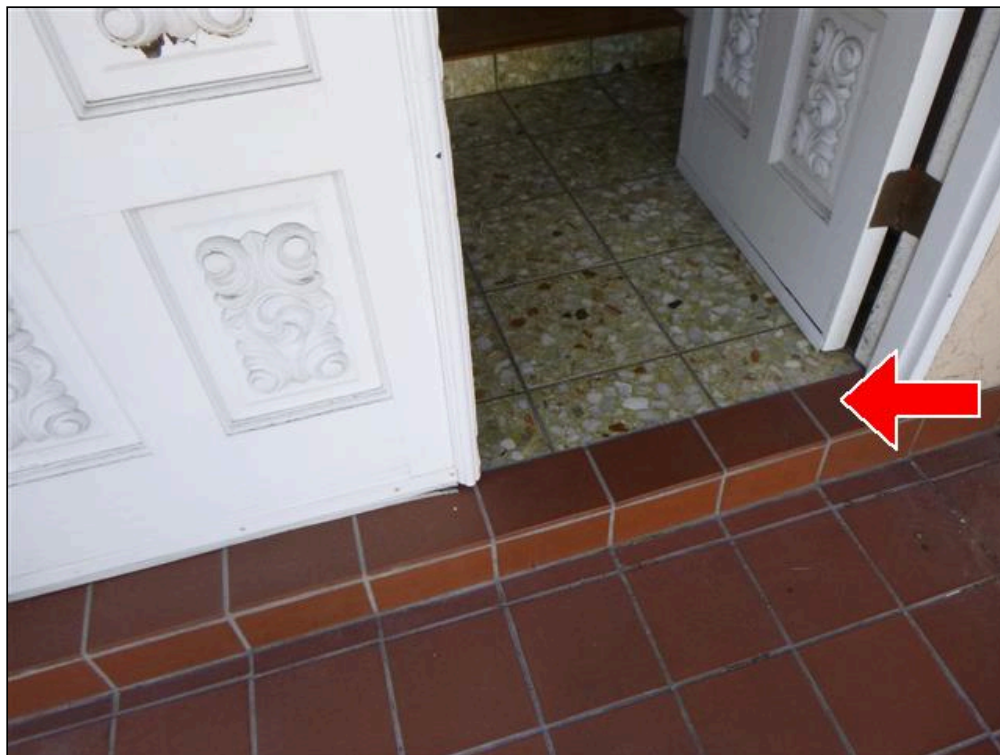
8.5 Item 2(Picture)

(2) Suggest review with a licensed contractor for costs to install a door threshold and weather seals as needed.

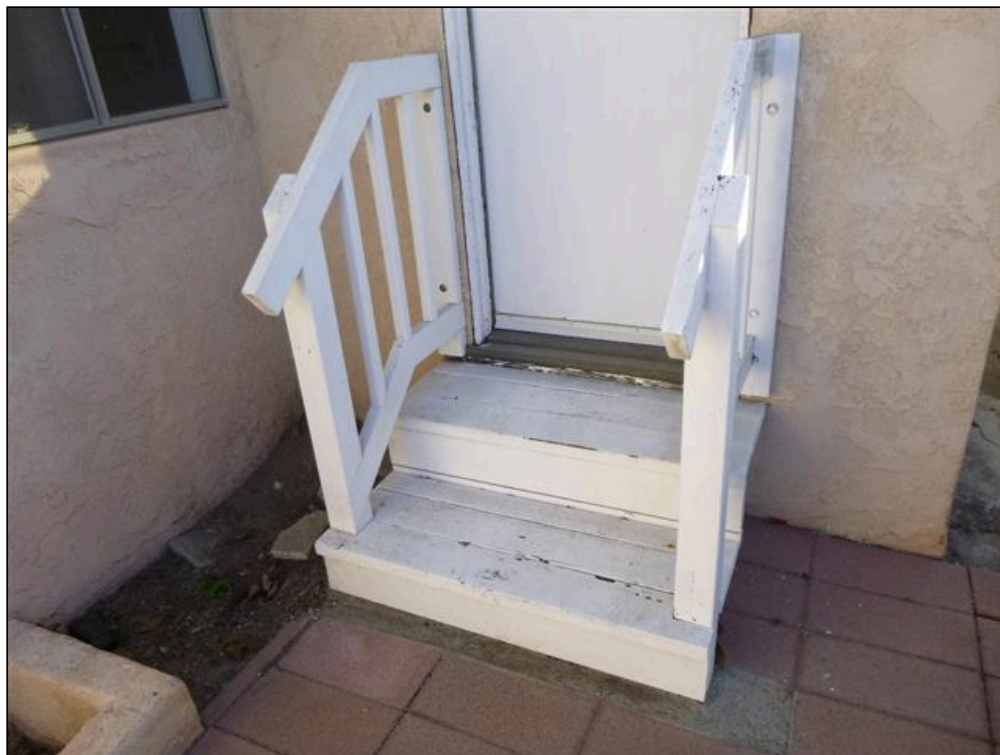
9.0 Item 1(Picture)

A potential trip/safety hazard was noted due an inadequate sized deck/landing prior to the step(s) ( this is common for the age of the home/dwelling ). Generally a 36' landing is required at any exterior door prior to any step(s). Suggest review by a licensed contractor for any repair/replacement costs as needed.

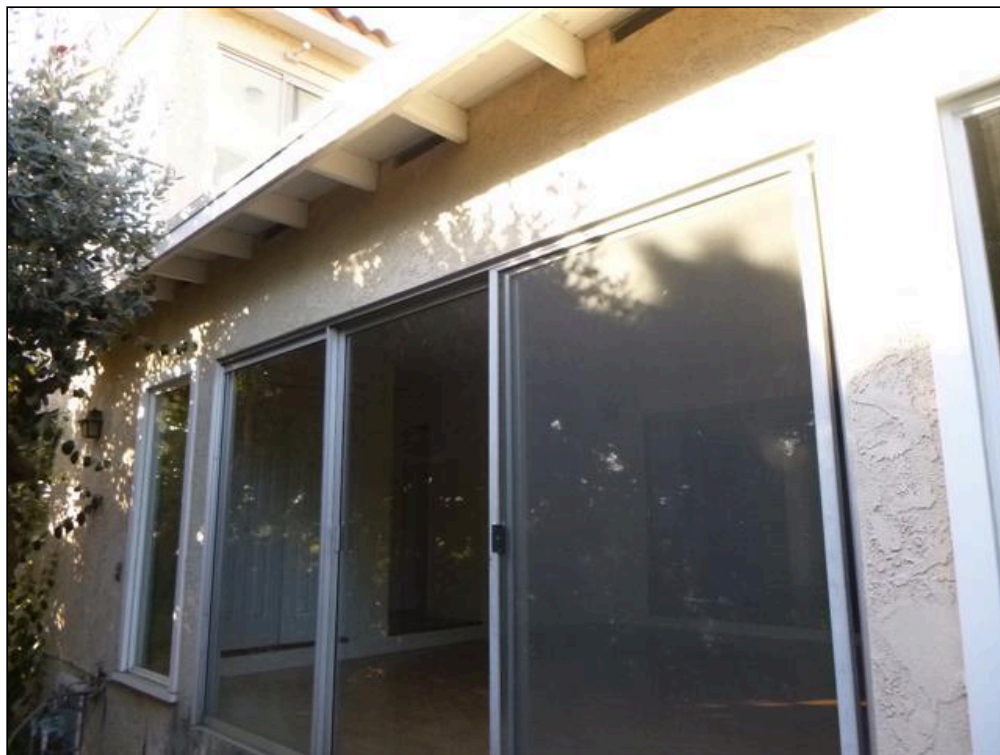
10.2 Item 1(Picture)

No light fixture installed at the door area, this is a possible safety hazard. Suggest review with a licensed electrician for costs to install a light fixture as required for safety.

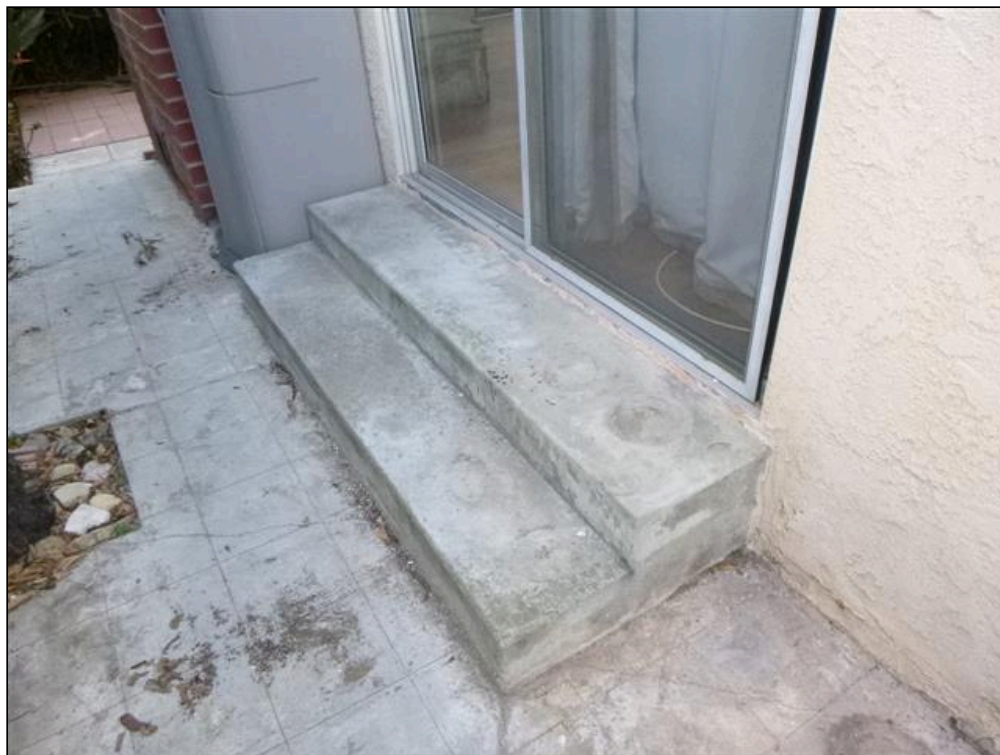
11.0 Item 1(Picture)

A potential trip/safety hazard was noted due an inadequate sized deck/landing prior to the step(s) ( this is common for the age of the home/dwelling ). Generally a 36" landing is required at any exterior door prior to any step(s). Suggest review by a licensed contractor for any repair/replacement costs as needed.

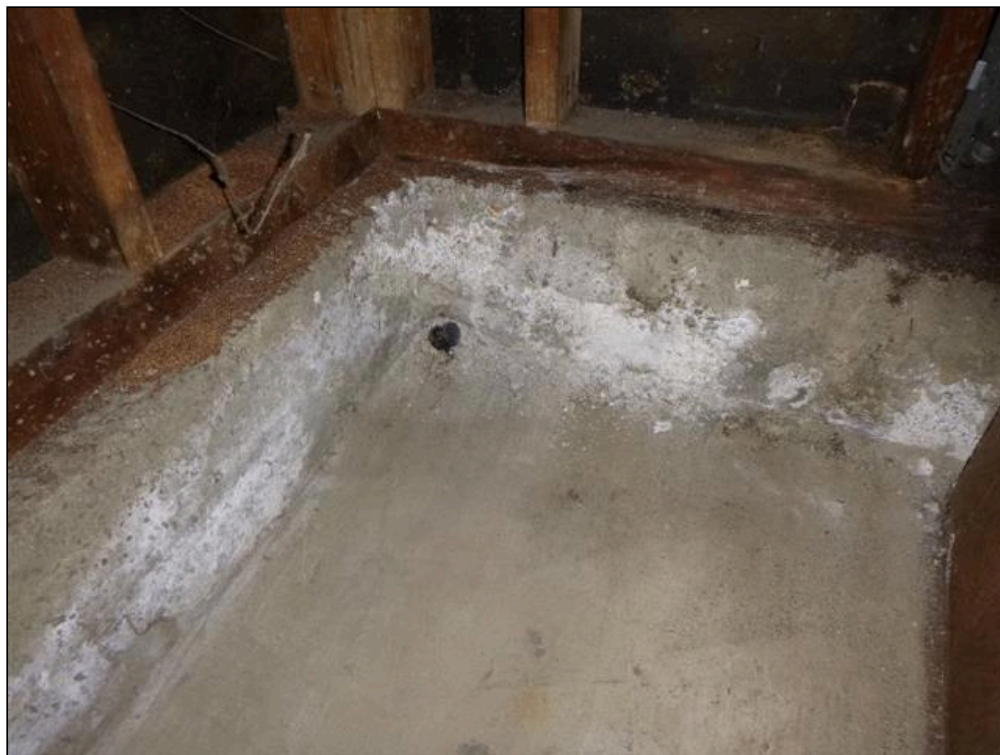
12.0 Item 1(Picture)

(2) White efflorescence (powder substance) on foundation footings indicates prior, and possibly ongoing, excessive moisture build up at the exterior of the foundation. Ongoing water intrusion at the foundations can, in some cases, cause the steel in the foundations to rust, called spawling, which can lead to horizontal cracking of the foundation ( currently there are no major cracks visible at the foundation ). Any future cracking/damaged can be an expensive repair as the foundation is now structurally weak and susceptible to horizontal movement. Suggest review of the Lot/Grade/ drainage and sewer drainage systems, including rain gutters, to reduce and prevent further and future water buildup at the exterior of the dwellings foundations.

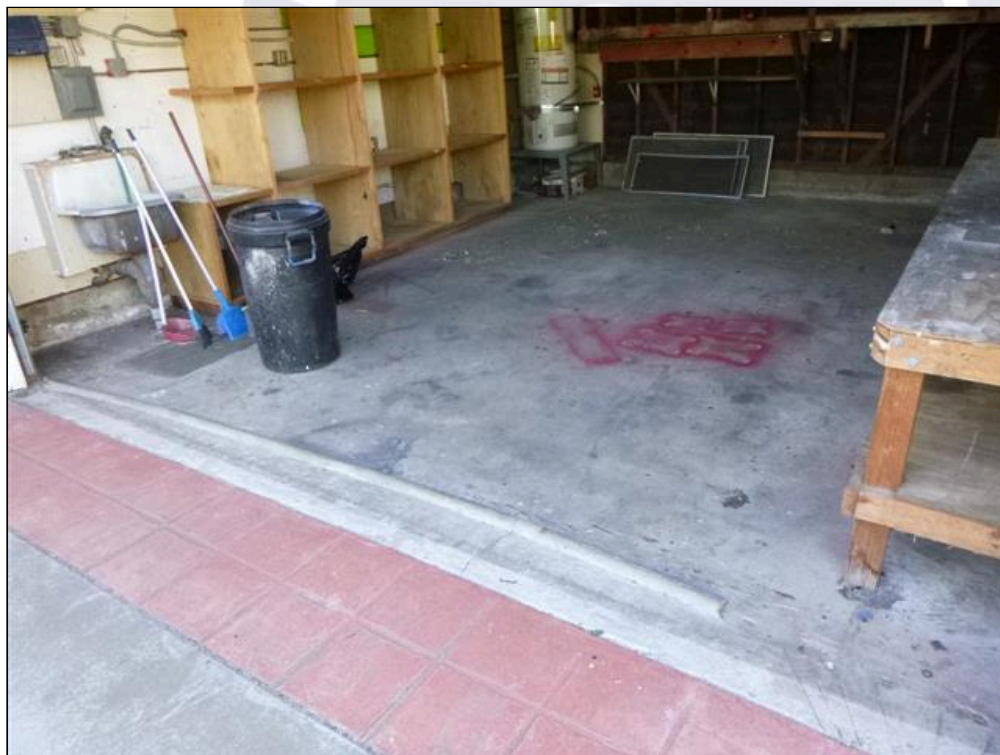
12.0 Item 2(Picture)

(3) Evidence of previous water intrusion into the garage was noted. See the driveway comment and suggest review with a licensed contractor for repair costs as needed.

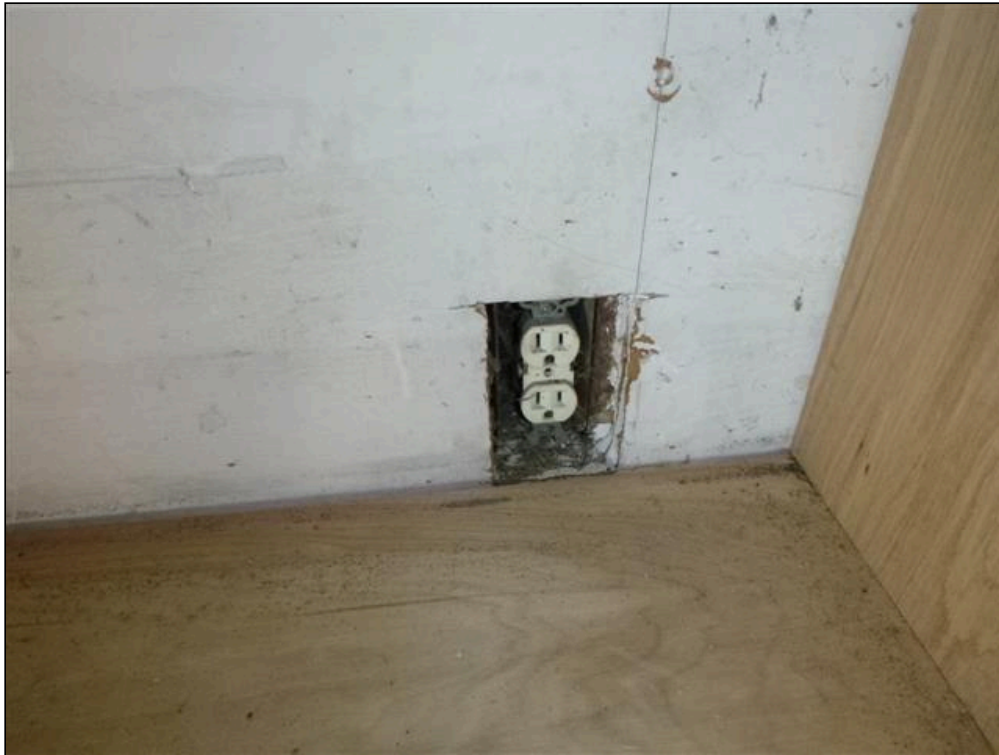
12.6 Item 1(Picture)

(1) Various outlet cover(s) are missing, suggest installation for safety.

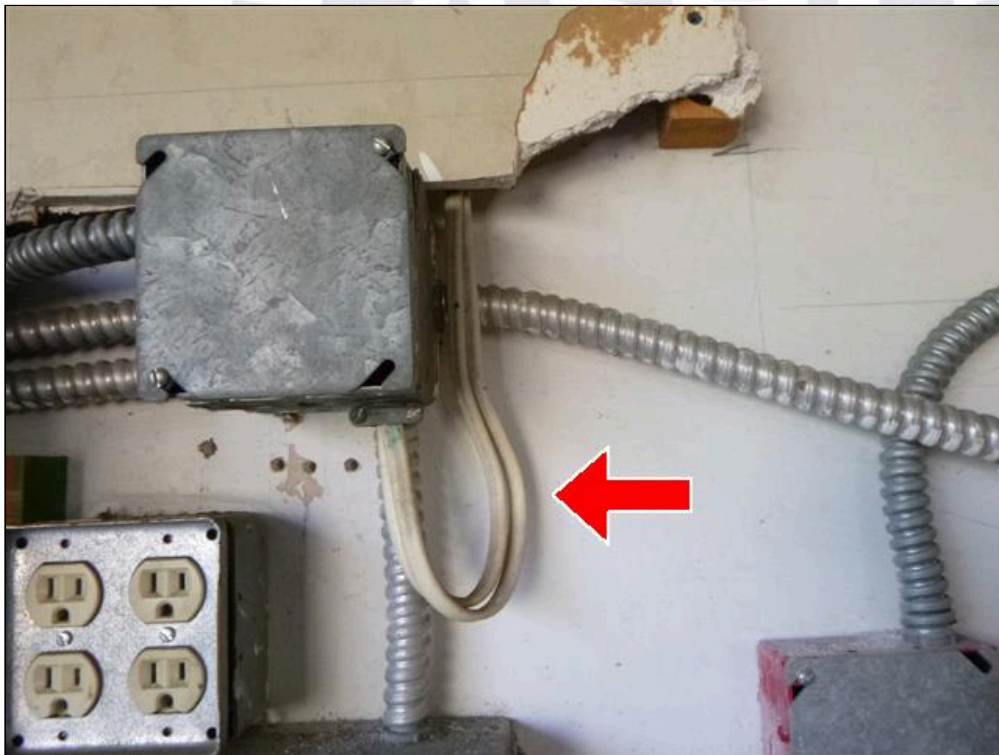
12.6 Item 2(Picture)

(3) Exposed romex wiring located in accessible areas. This is a safety concern as it could be subject to physical damage. Romex wiring is allowed in inaccessible areas such as attics, crawl spaces and within walls provided that all proper protective materials and required tie-downs are in place. Suggest review by a licensed electrician for repair/replacement costs as needed.

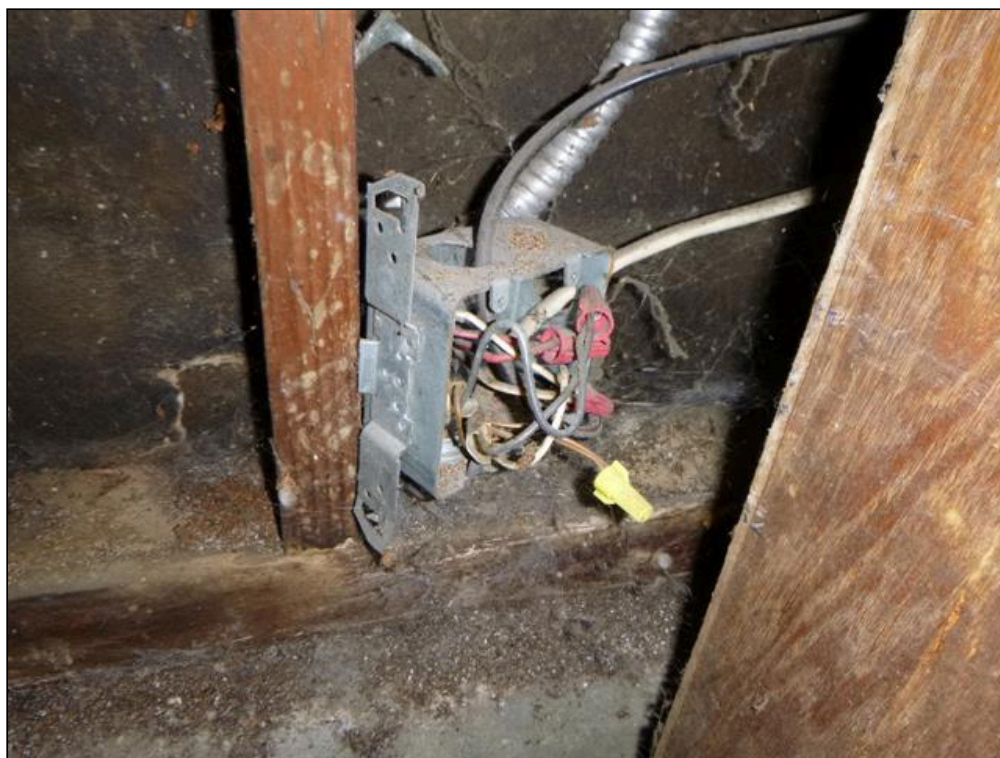
12.6 Item 3(Picture)

(4) Open junction boxes/conduit was noted, this is a potential safety hazard. Whenever an electrical wire is cut and re-connected, the 'splice' should be encased in a covered junction box to prevent shocks and separation of the splice. Suggest review by a licensed electrician for repair/replacement

costs as needed.

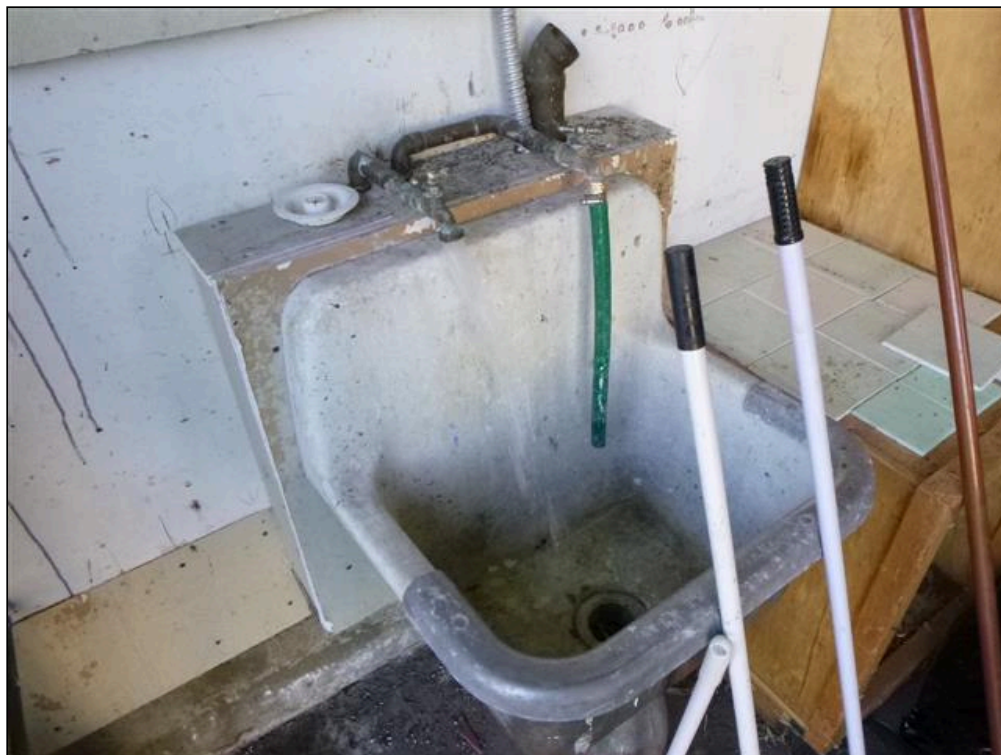
12.7 Item 1(Picture)

The existing sink faucet(s) are not low-flow systems as required. Suggest review with a licensed plumber for costs to replace the existing faucets with low flow faucets (2.2 gallons per minute) as required by the State of California as of January 1st, 2017. See the plumbing system comments for further details and a link to the State of California plumbing ordinance.

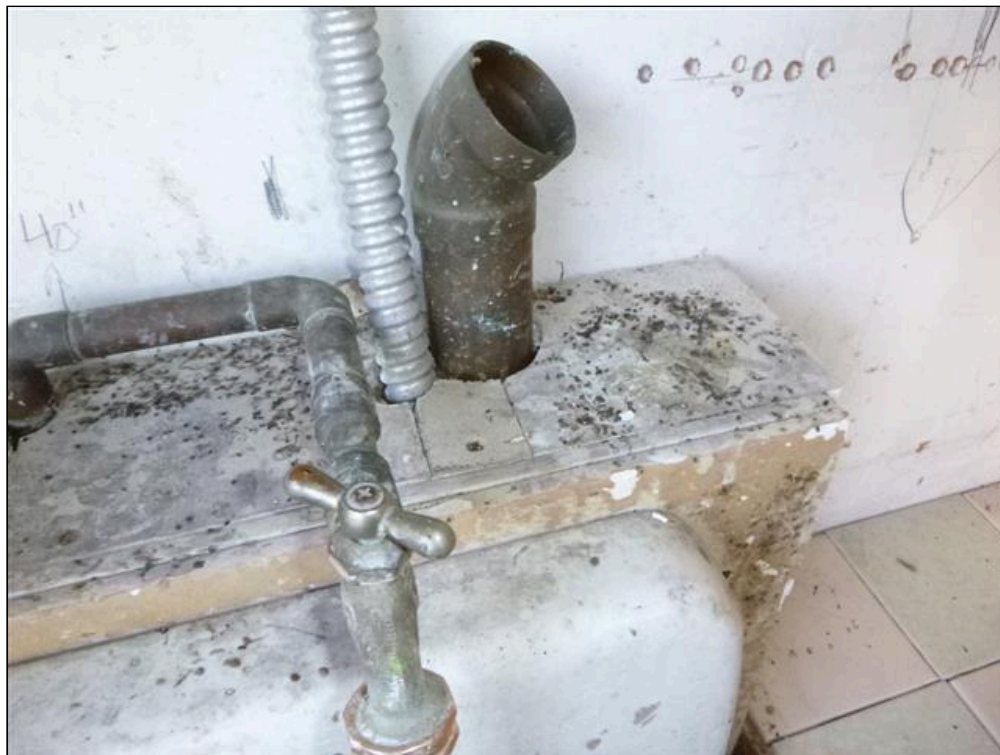
12.9 Item 1(Picture)

Excessive pest droppings noted within the garage area. Suggest review with a qualified pest control company and/or a licensed contractor for removal costs of the droppings as needed.

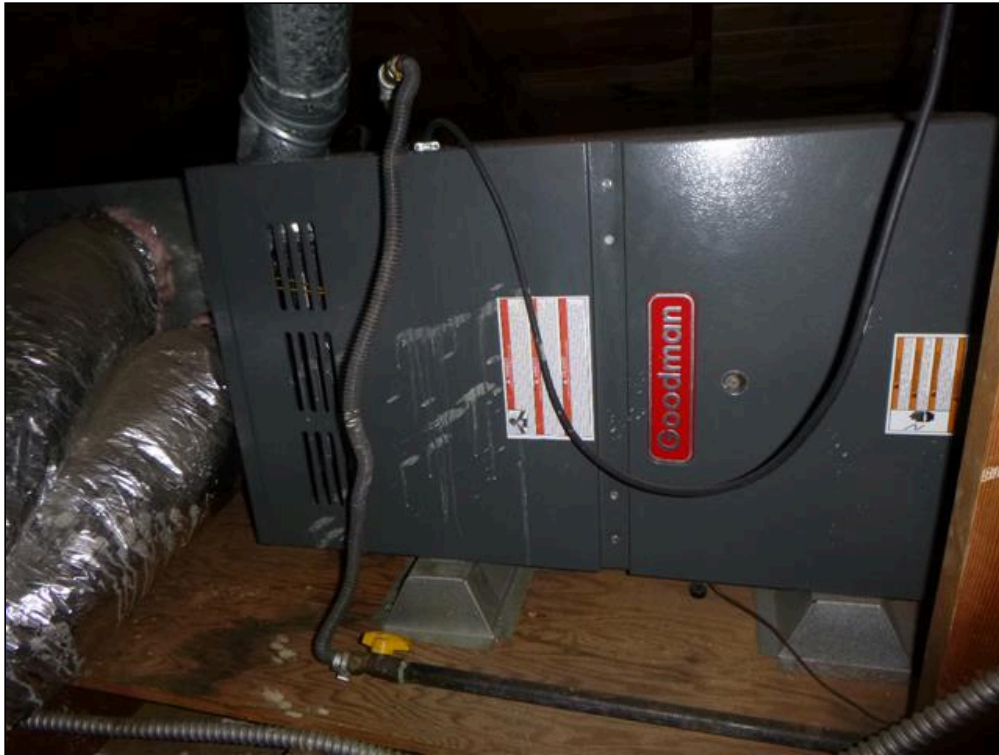
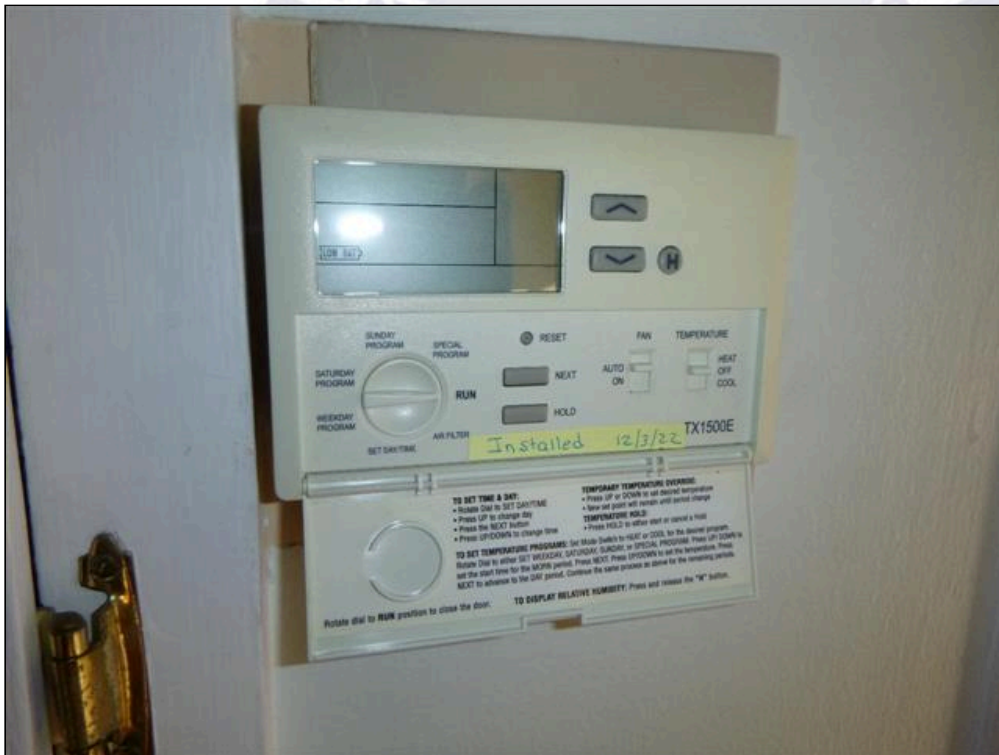
(1) The inspector was unable to test the heating system as the thermostat was inoperable at the time of the inspection. Suggest review by the Gas Company and/or a licensed heating company for review to determine if the unit is operational, any repair/replacement costs and confirm correct operation as needed.

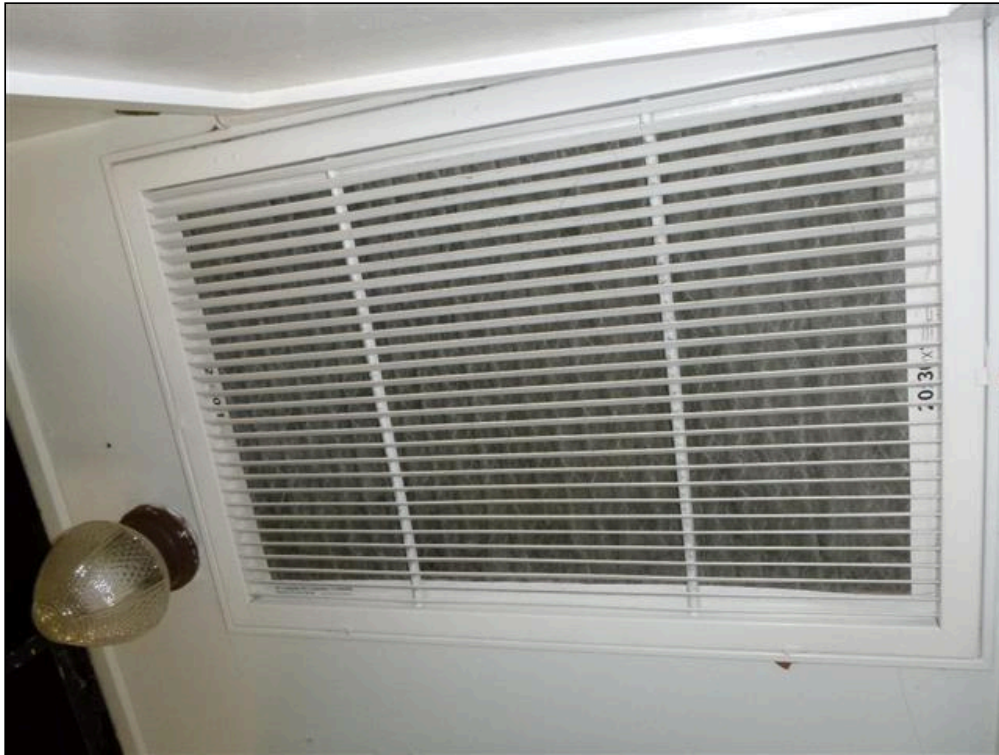
13.0 Item 3(Picture)

(2) Suggest replacing/cleaning the filter(s) as needed.

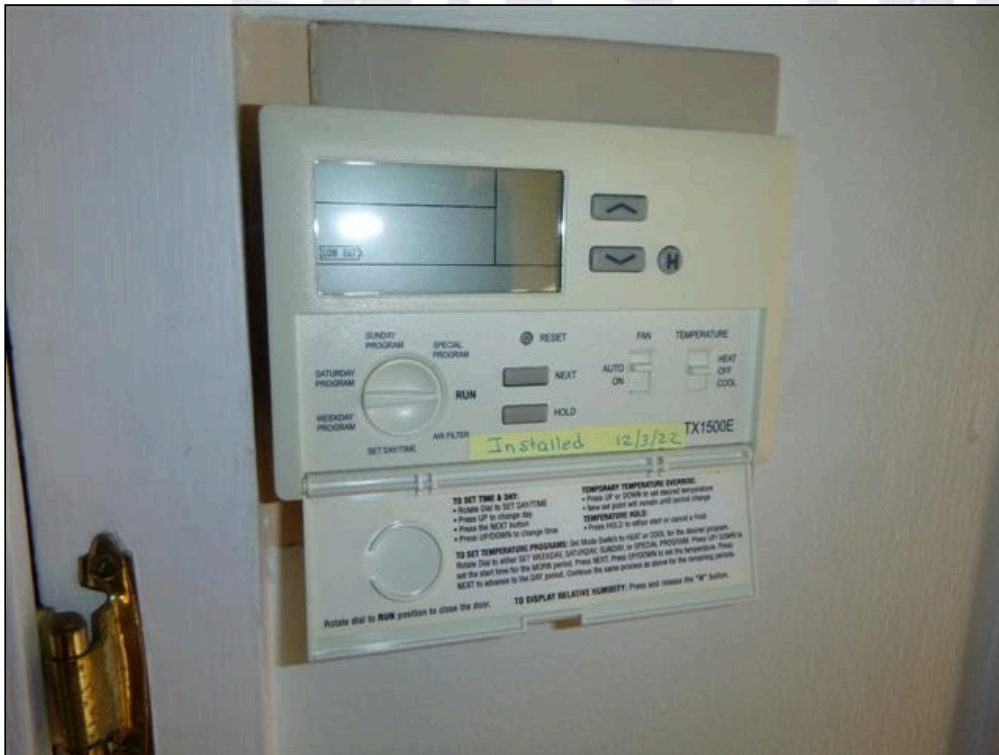
13.2 Item 1(Picture)

Unable to test/operate the thermostat at the time of the inspection, see the heating comments.

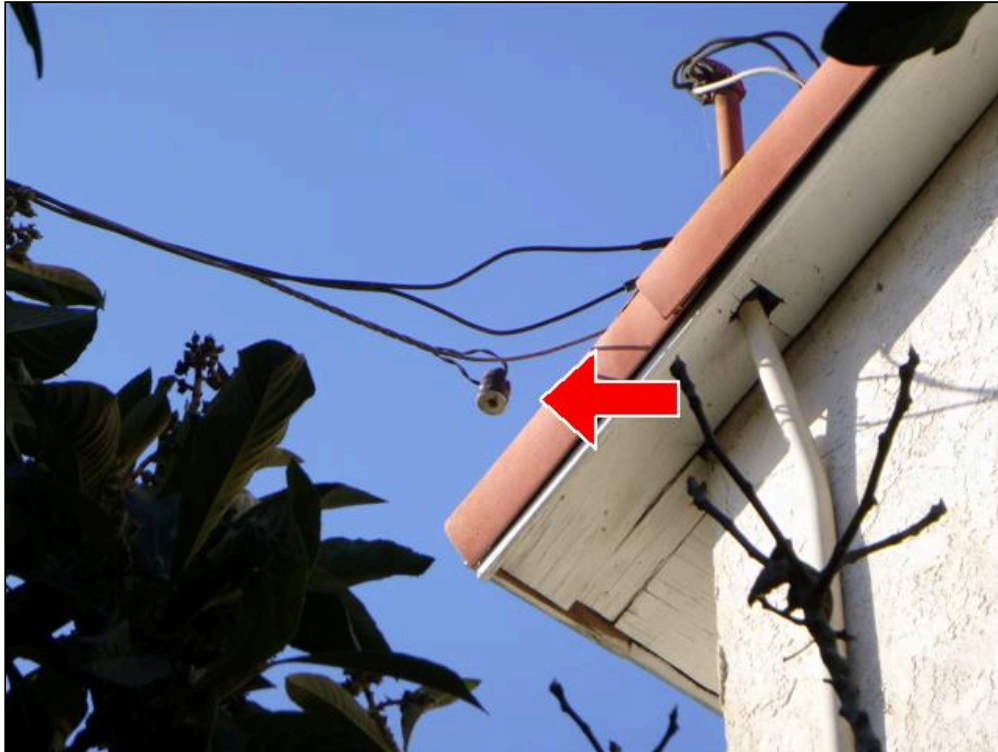
14.0 Item 1(Picture)

The electrical service wiring mount is broken and detached from the roof, this is a potential safety hazard. Suggest review with a licensed electrician and/or the local utility company for repair/replacement costs as required for safety.

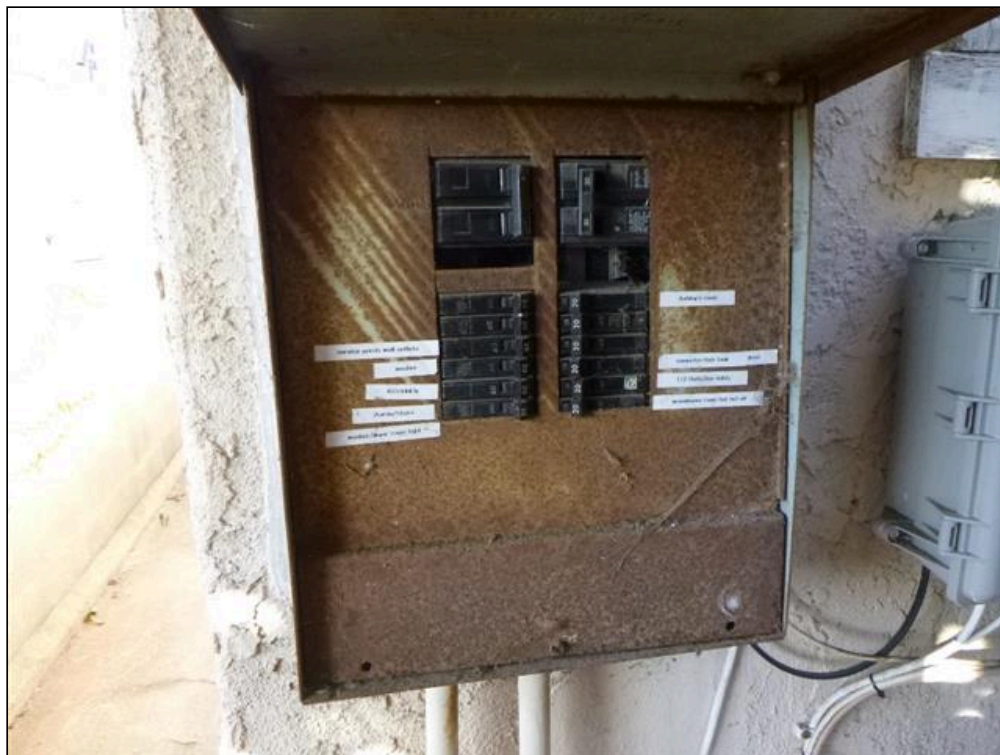
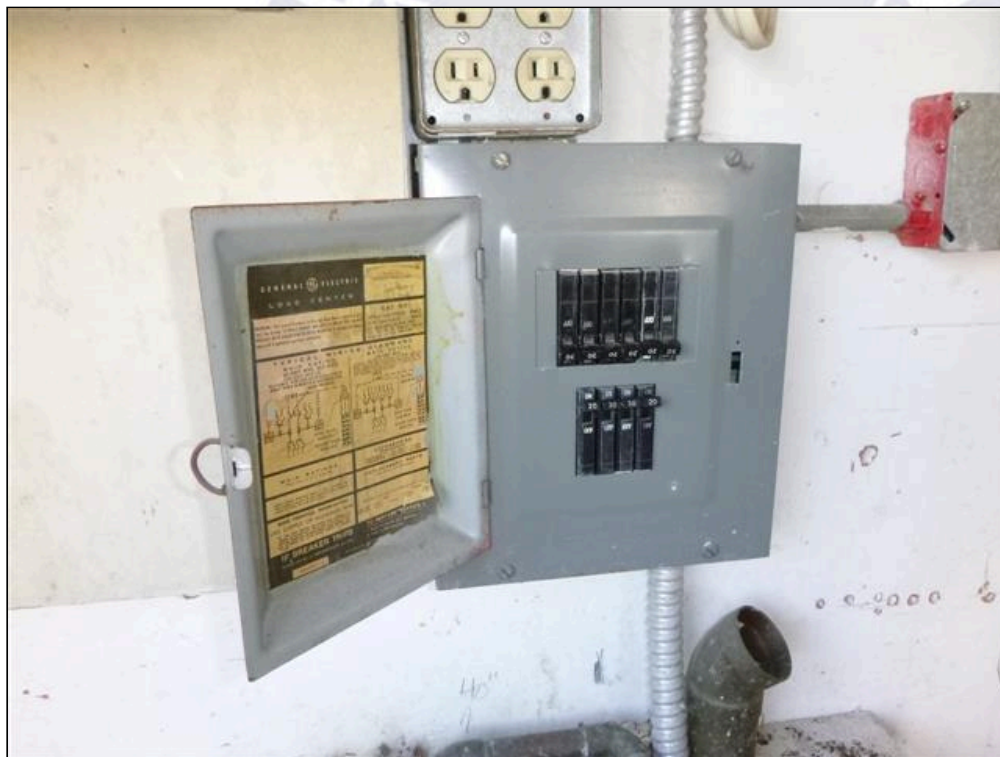
(1) Suggest adding correct/complete indexing/labelling to all breakers for identification of each circuit for safety.

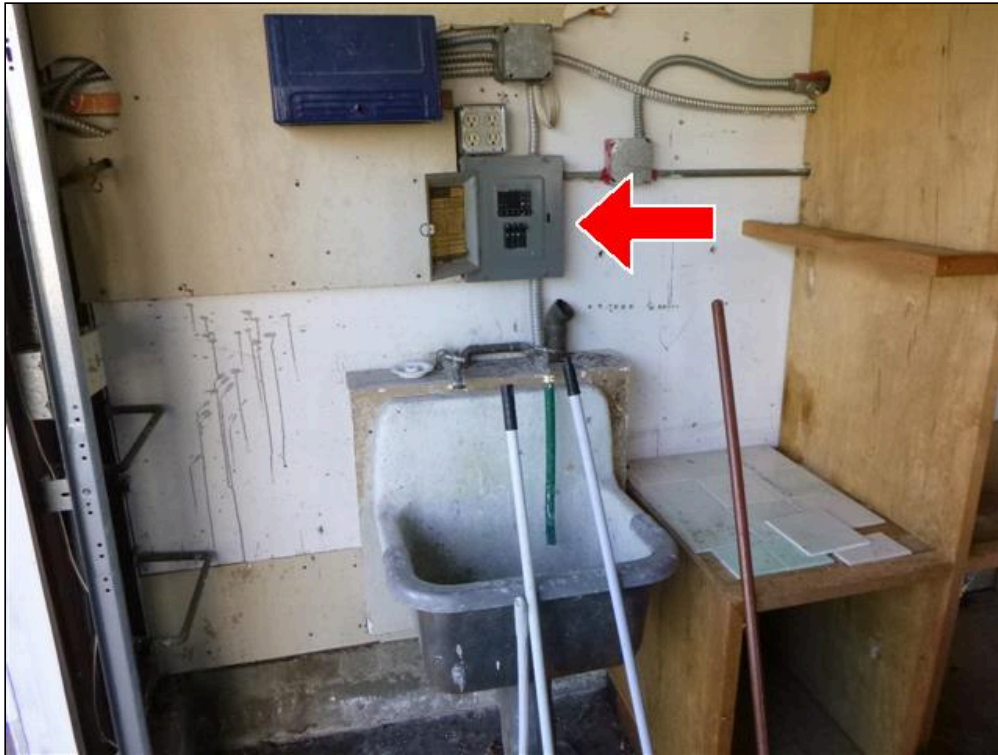
14.1 Item 3(Picture)

(2) Inadequate clearance to the front of the garage sub panel. A minimum of 36 inches of clear working space is required at the front side of the electrical panel. Suggest review with a licensed electrical contractor for repair/relocation costs as required.
