# Inspection Report

**Property Address:**  
2104 Chestnut Ave  
Manhattan Beach CA 90266

**Ferguson Home Inspections**

<b>Date:</b> 1/11/2025	<b>Time:</b> 09:00 AM	<b>Report ID:</b> 01112025ChestnutAve
<b>Property:</b> 2104 Chestnut Ave Manhattan Beach CA 90266	<b>Customer:</b> Yvonne Peltz	<b>Real Estate Professional:</b> Marlene Ramirez

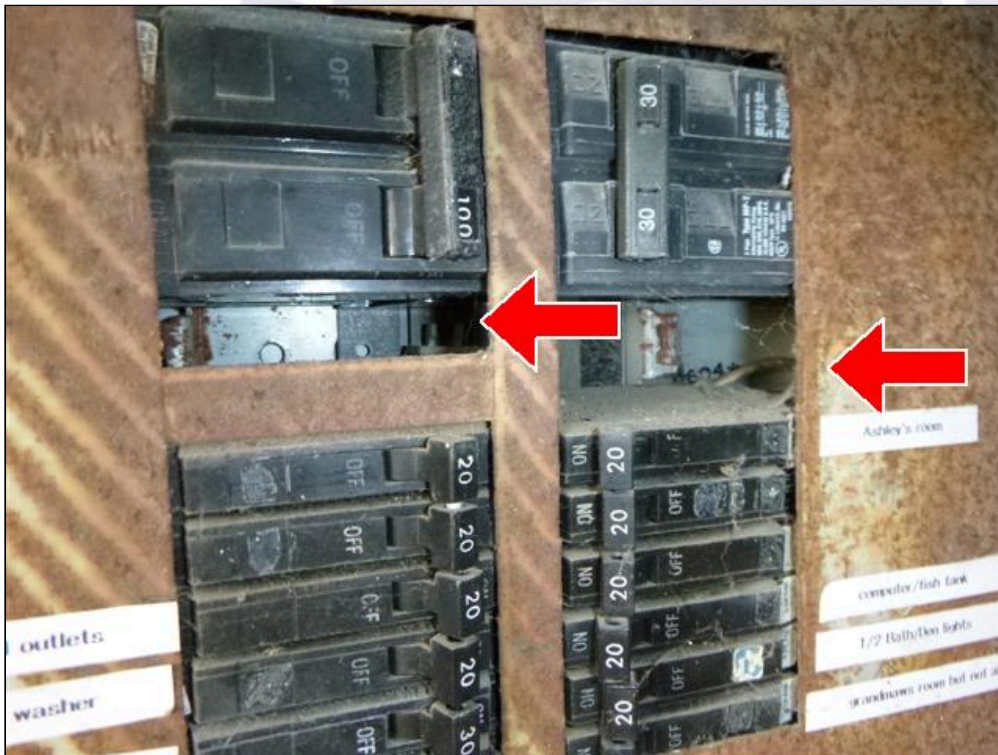
14.1 Item 4(Picture)

(3) Potential safety hazard due open areas of the electrical panel cover plate. Suggest installing future plugs in the cover plate where the blanks have been removed as required for safety.

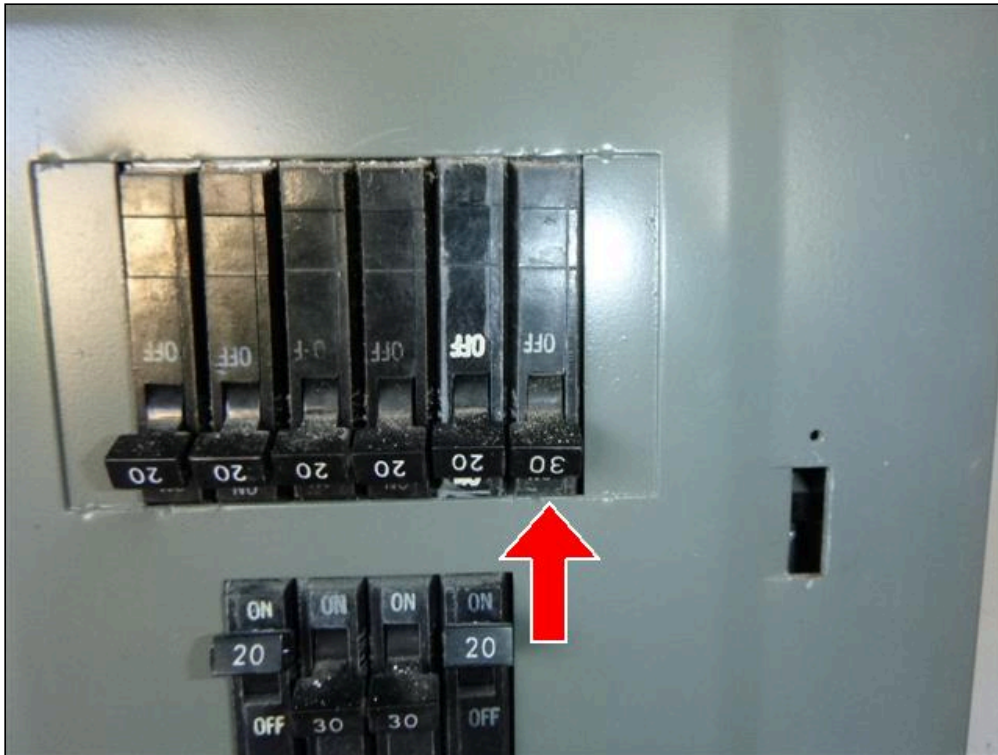
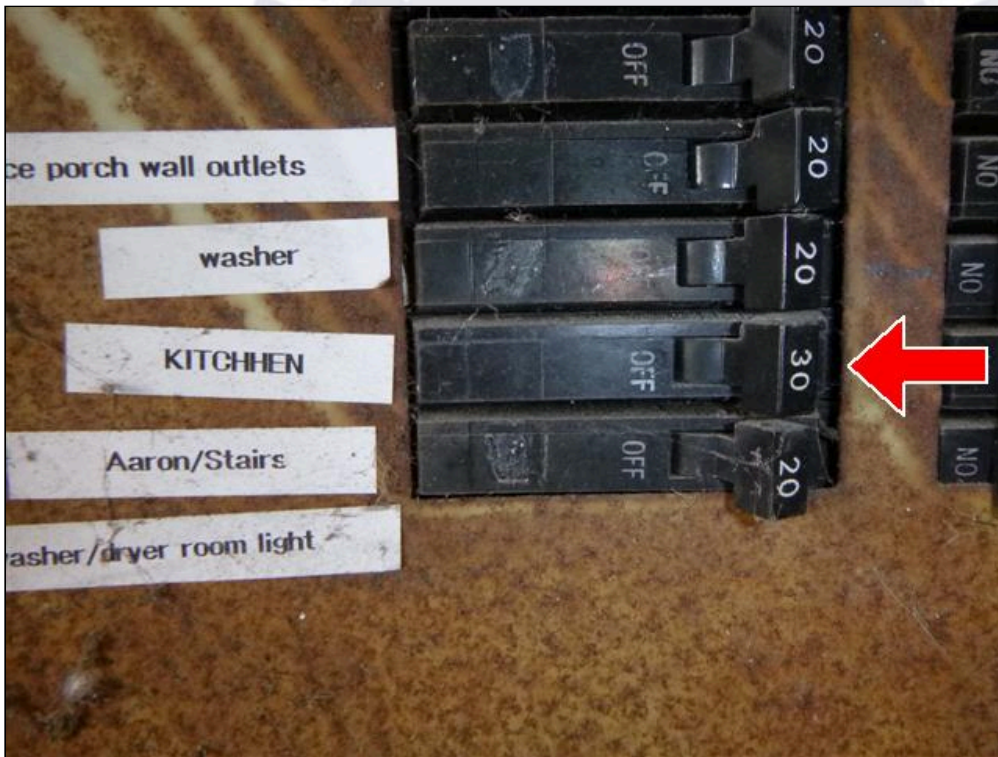
(1) Single 30 amp breakers are currently being used for a 110 volt circuits at the main and sub panels. This is a potential fire safety hazard. Suggest review with a licensed electrician for repair/replacement

costs as needed for safety.

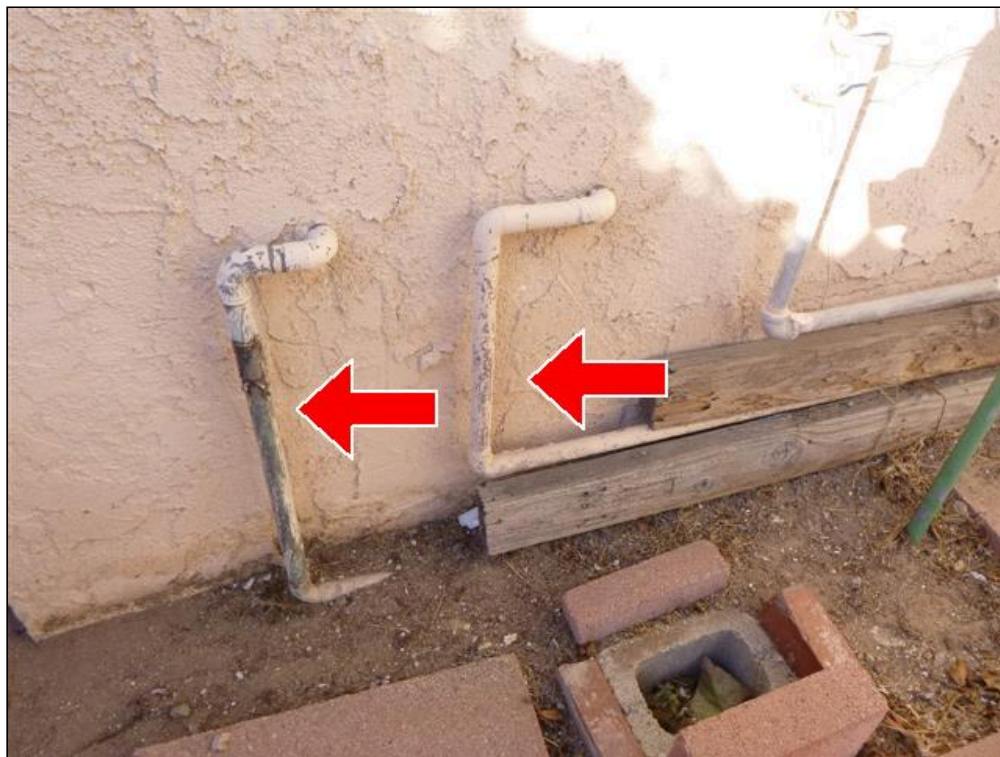
15.0 Item 1(Picture)

(1) Exposed and un-insulated surface mounted plumbing noted at the right side exterior of the dwelling. Suggest review with a licensed plumber for repair/replacement costs as needed.

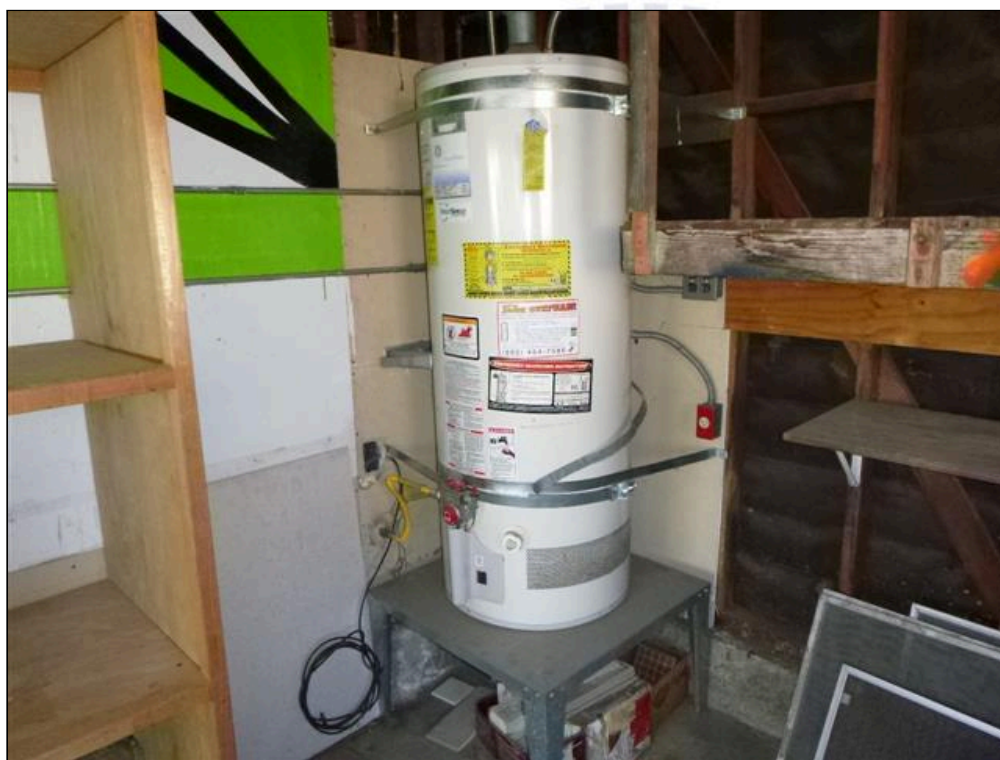
17.0 Item 1(Picture)

(1) Due to the age of this unit, suggest review with a licensed plumber for replacement costs as it has exceeded it's intended life span ( 12-15 years ).

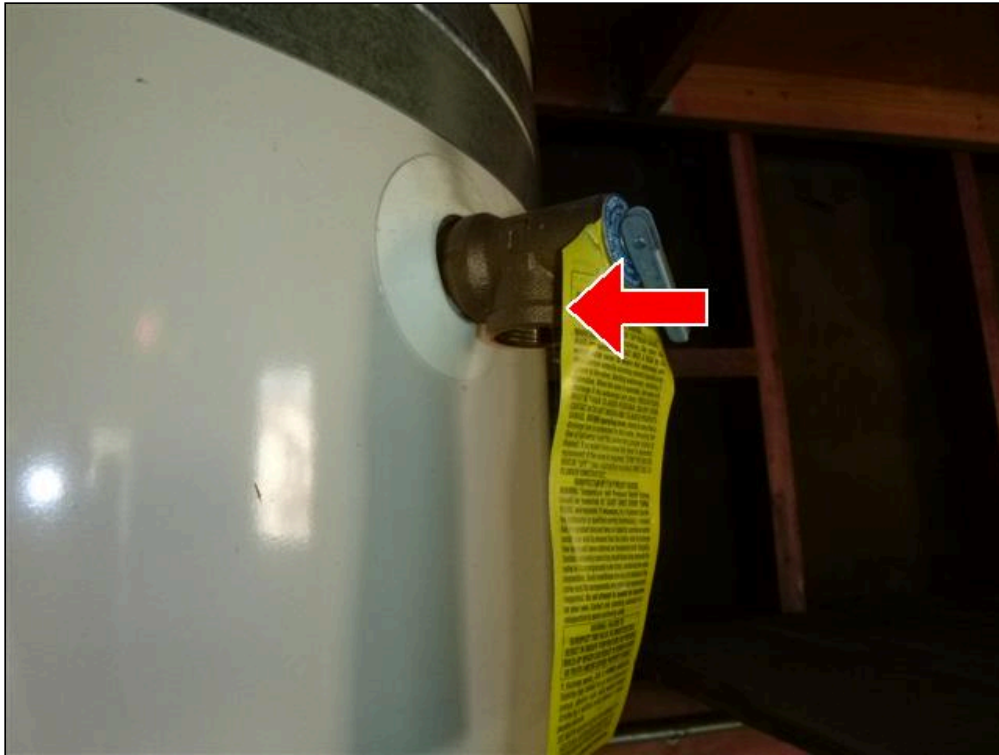
17.0 Item 2(Picture)

(3) No discharge pipe connected to the TP&R valve, this is a potential safety hazard. Suggest review by a licensed plumber for costs to install the TP discharge drain down to within 4-6 inches of the exterior grade/deck as required for safety.

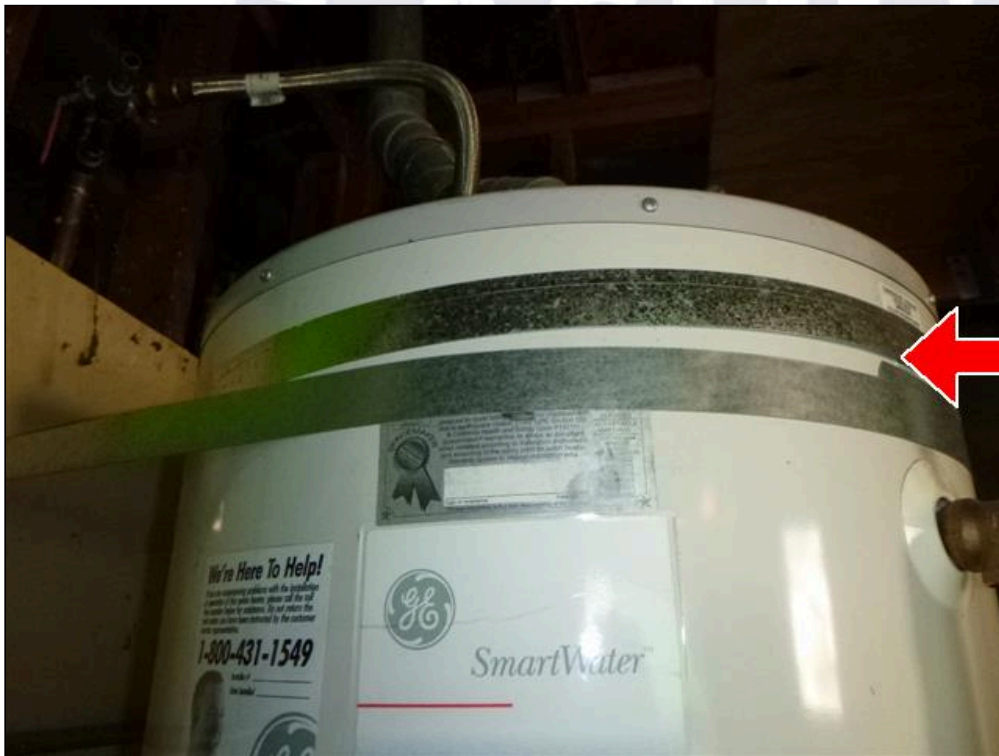
17.0 Item 3(Picture)

(4) The earthquake strapping has been installed incorrectly, the upper strap is required to be 1/3 down from the top of the tank. Suggest review with a licensed plumber and repair as required for safety.

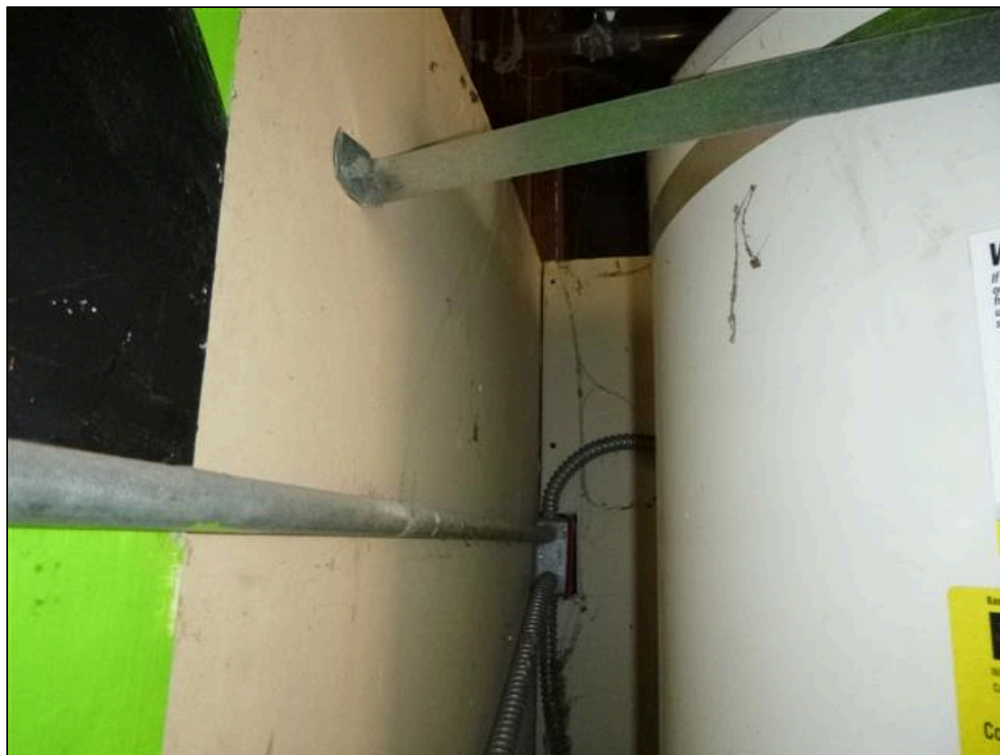
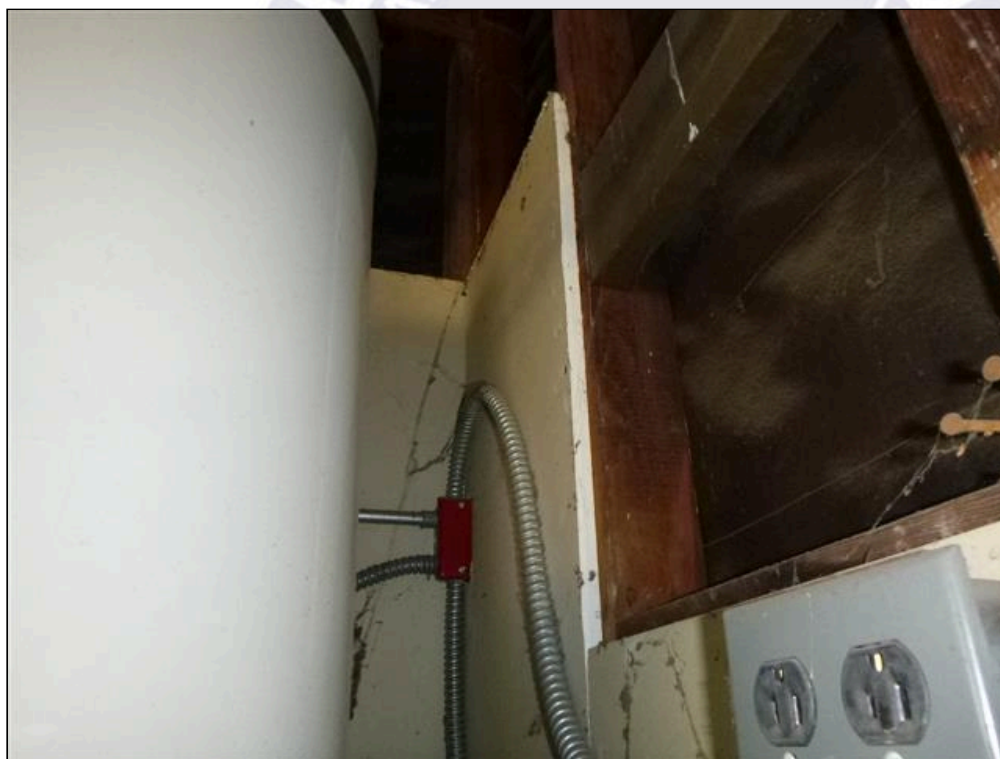
(5) The water heating strapping is missing the rear bracing at the time of the inspection, suggest review by licensed plumber for installation costs as required.

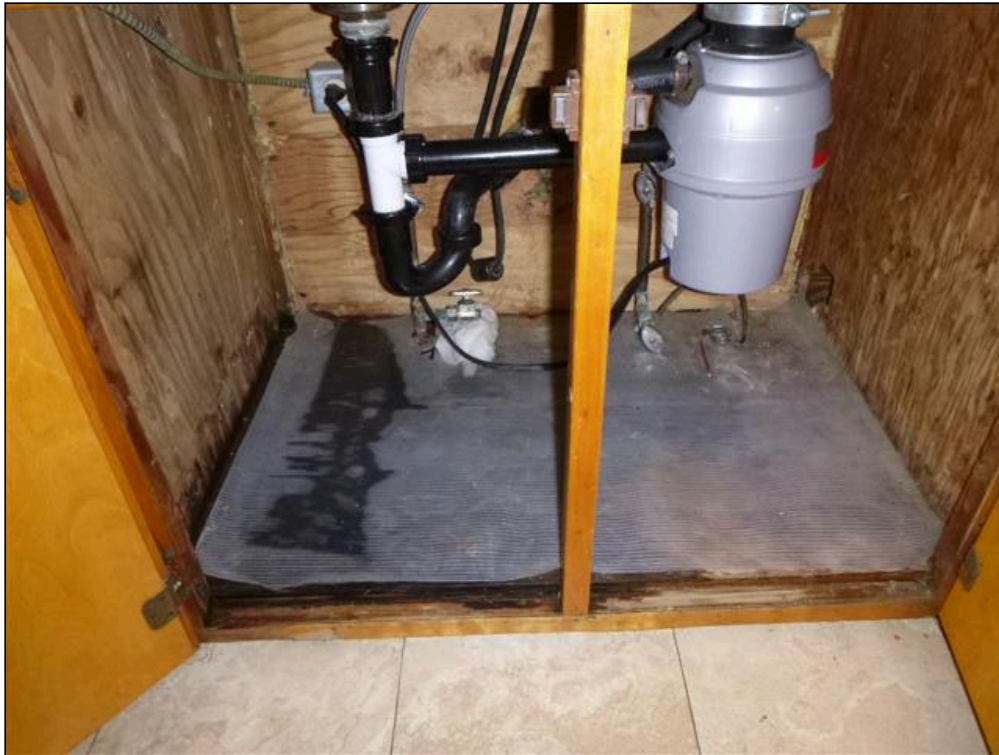
18.5 Item 1(Picture)

(1) The cabinet below the sink is wet, deteriorated and mold/mildew was noted. Suggest review by a licensed contractor and plumber for repair/replacement costs as needed.

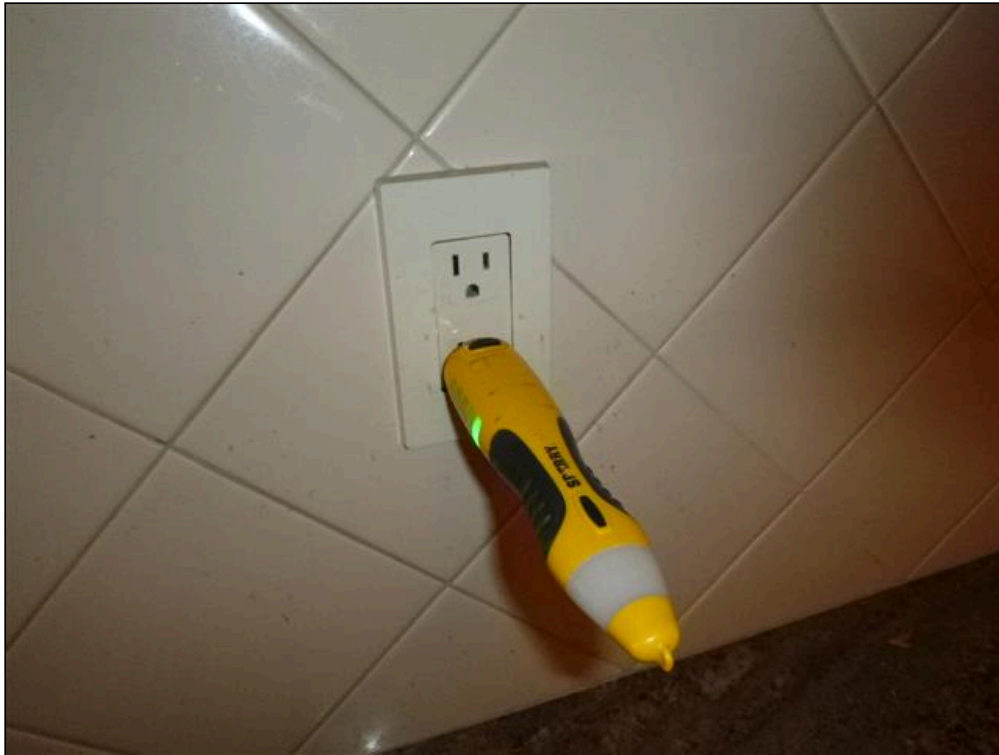
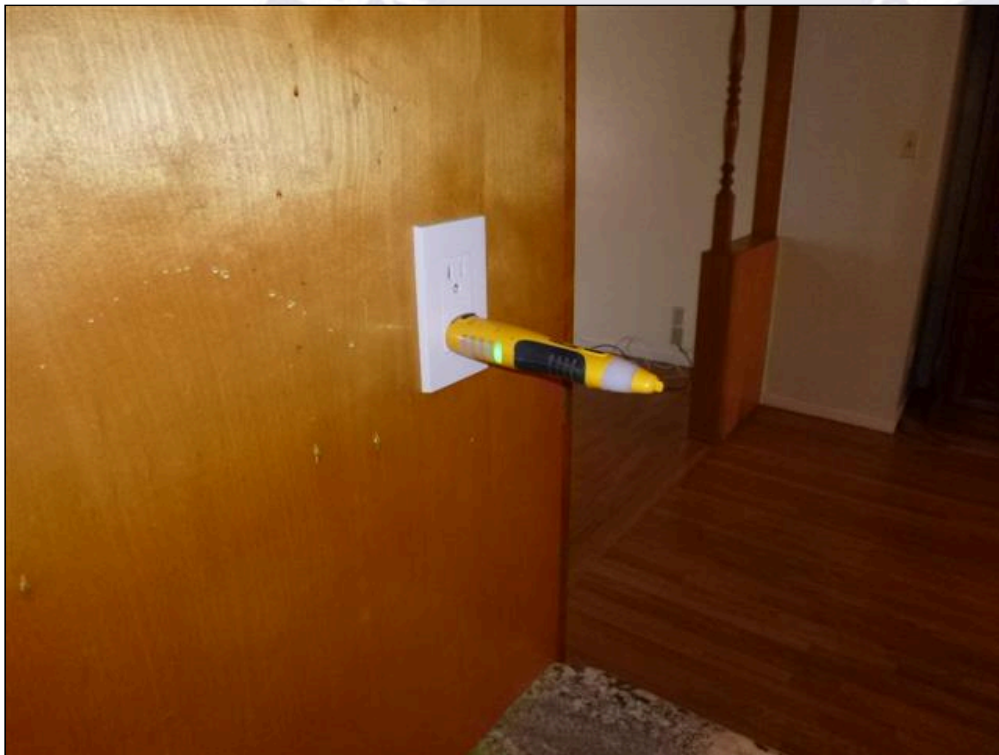
(1) Various countertop outlets are not GFCI protected as required. Countertop GFCI outlet(s)/protection has been required within six feet of the sink since 1987 and all countertop outlets since 1996. Suggest review by a licensed electrician for installation costs as required for safety.

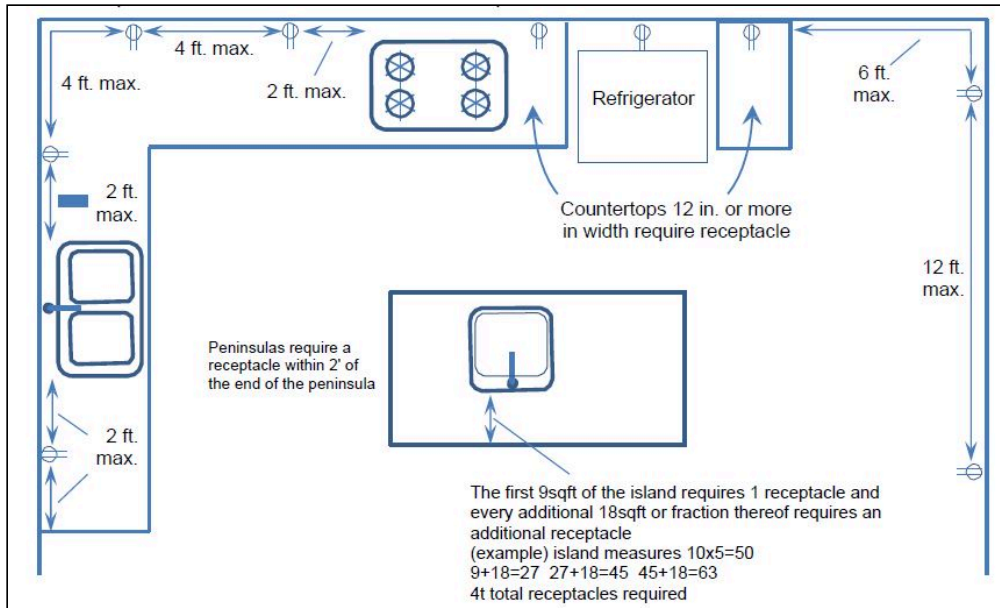
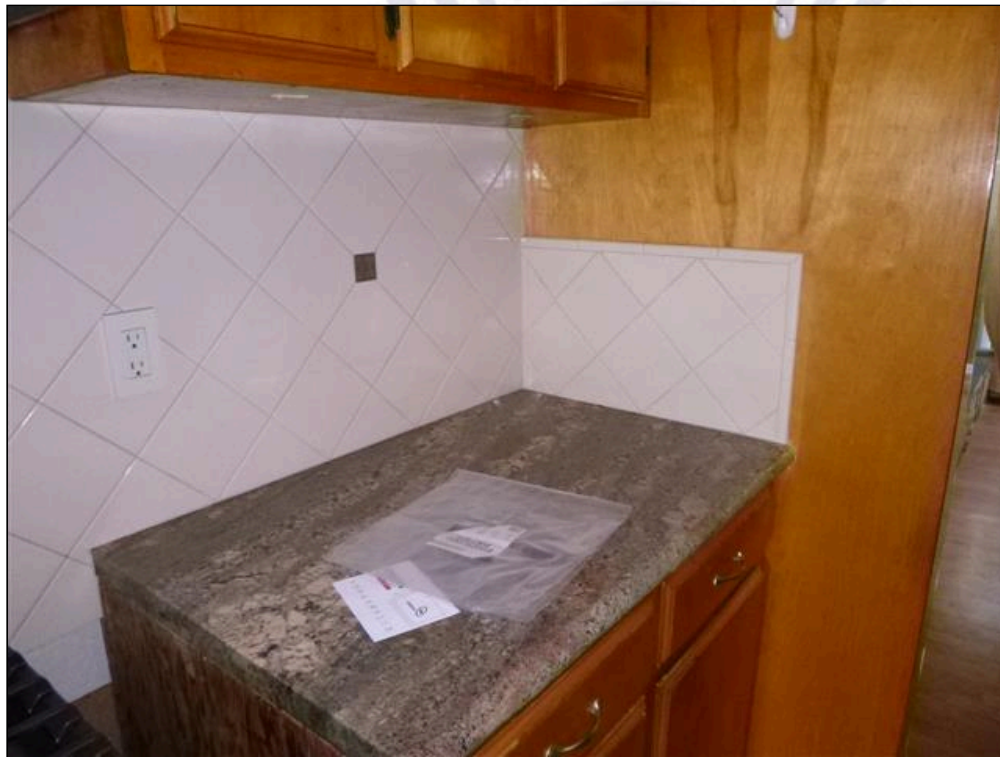
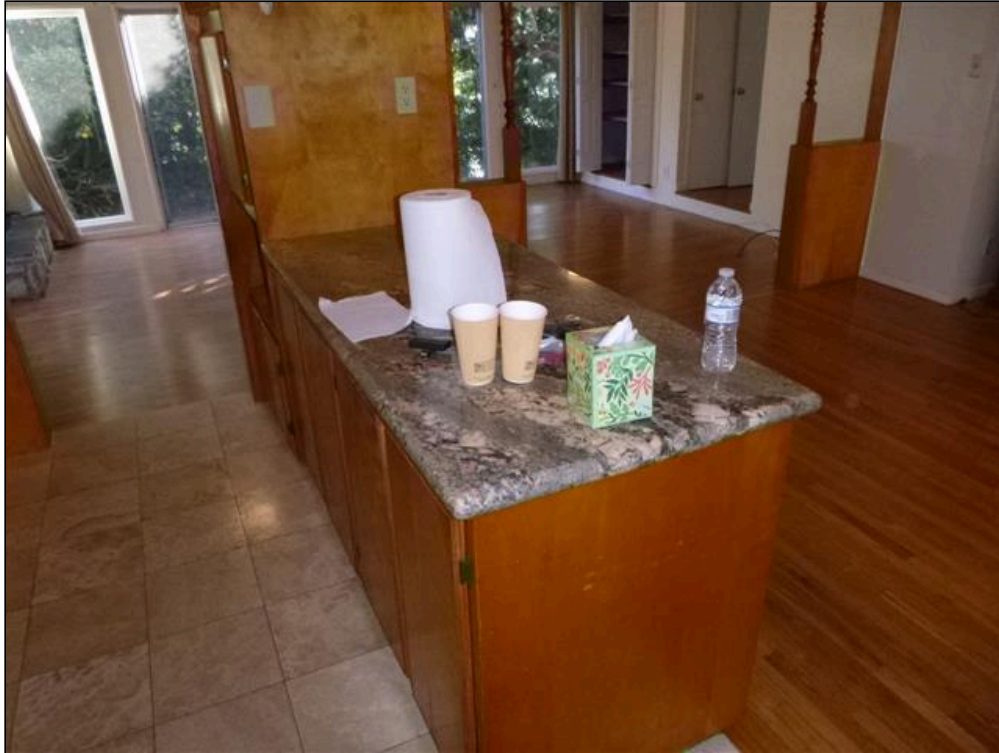
(2) Inadequate/incorrectly installed countertop/appliance outlets/circuits were noted, suggest review with a licensed electrician for installation costs as needed/required.

18.7 Item 3(Picture) Kitchen outlets

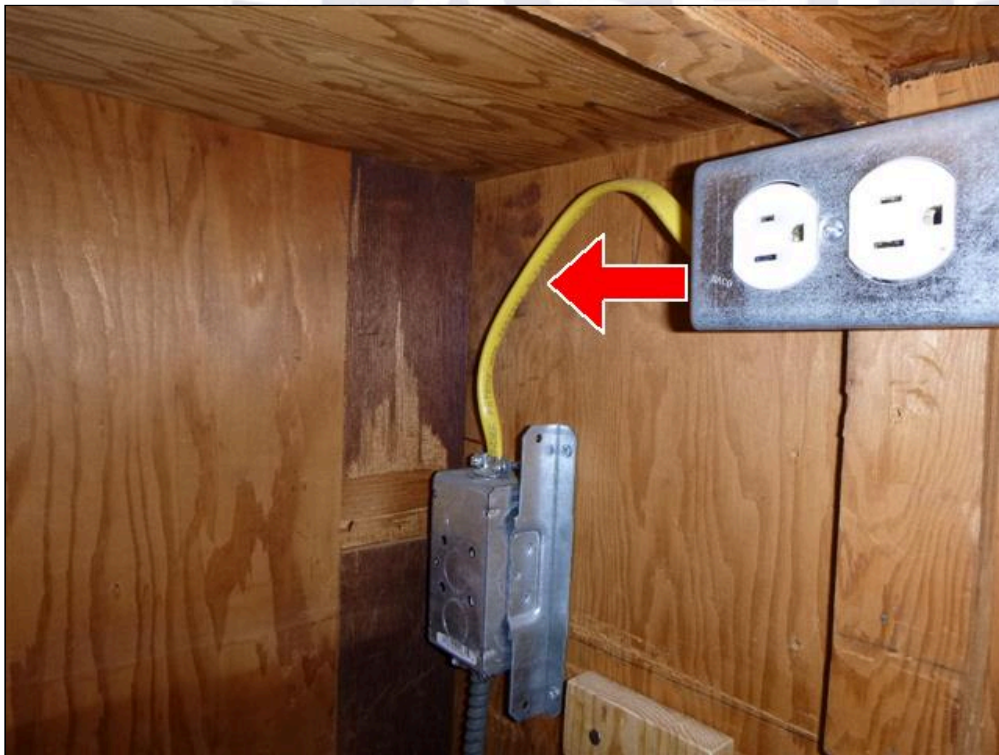
18.7 Item 6(Picture)

(3) Exposed romex wiring located in accessible areas. This is a safety concern as it could be subject to physical damage. Romex wiring is allowed in inaccessible areas such as attics, crawl spaces and within walls provided that all proper protective materials and required tie-downs are in place. Suggest review by a licensed electrician for repair/replacement costs as needed.

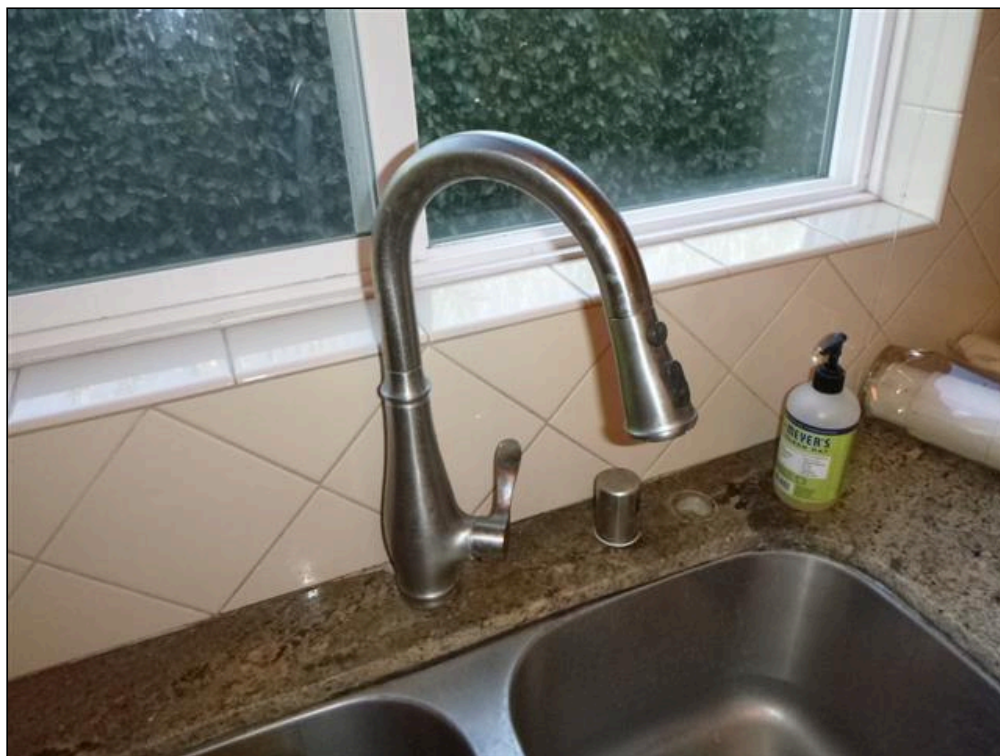
18.9 Item 1(Picture)

Unable to test the faucet as the water was either off or inoperable at this area. Suggest review with a licensed plumber for any repair/replacement costs as needed.

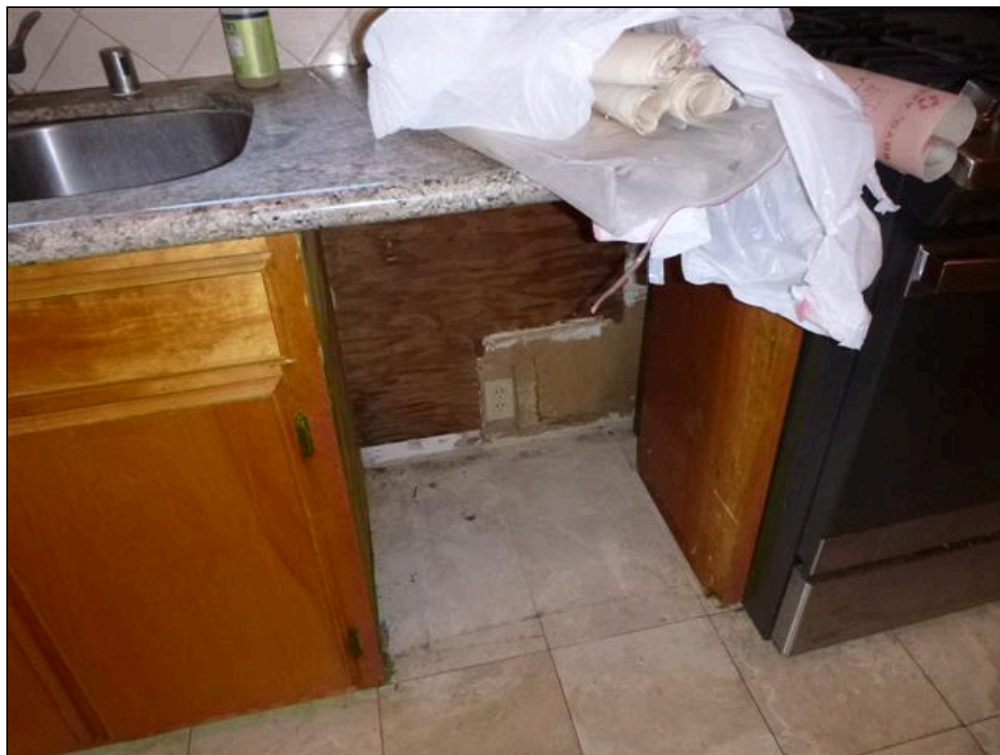
18.11 Item 1(Picture)

No dishwasher was installed at the time of the inspection. Suggest review with the seller and/or a licensed contractor for installation costs as needed.

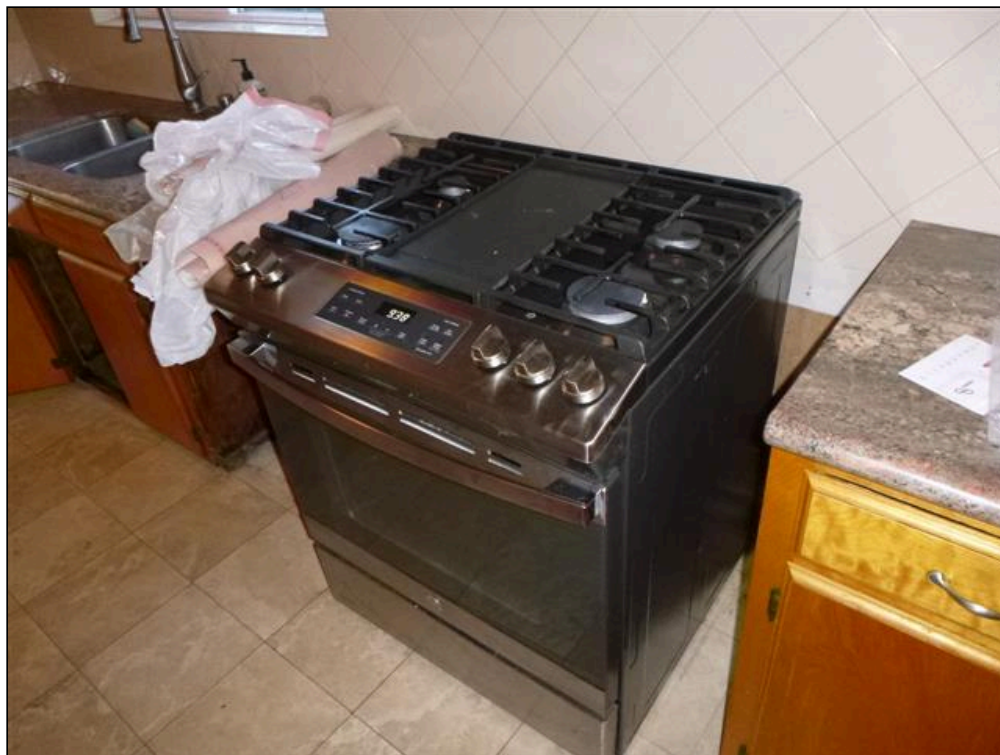
18.13 Item 1(Picture)

The anti-tip bracket is not currently installed correctly. An anti-tip bracket is usually installed on the floor and against the wall (towards the back of the stove) for one of the rear legs to slide into. Its purpose is to prevent the stove from tipping when a heavy load is placed on the door ( possible child ) or slide-out racks upsetting the center of gravity. Suggest review with a licensed contractor for costs to relocate/install the bracket correctly for safety as required since 1991.

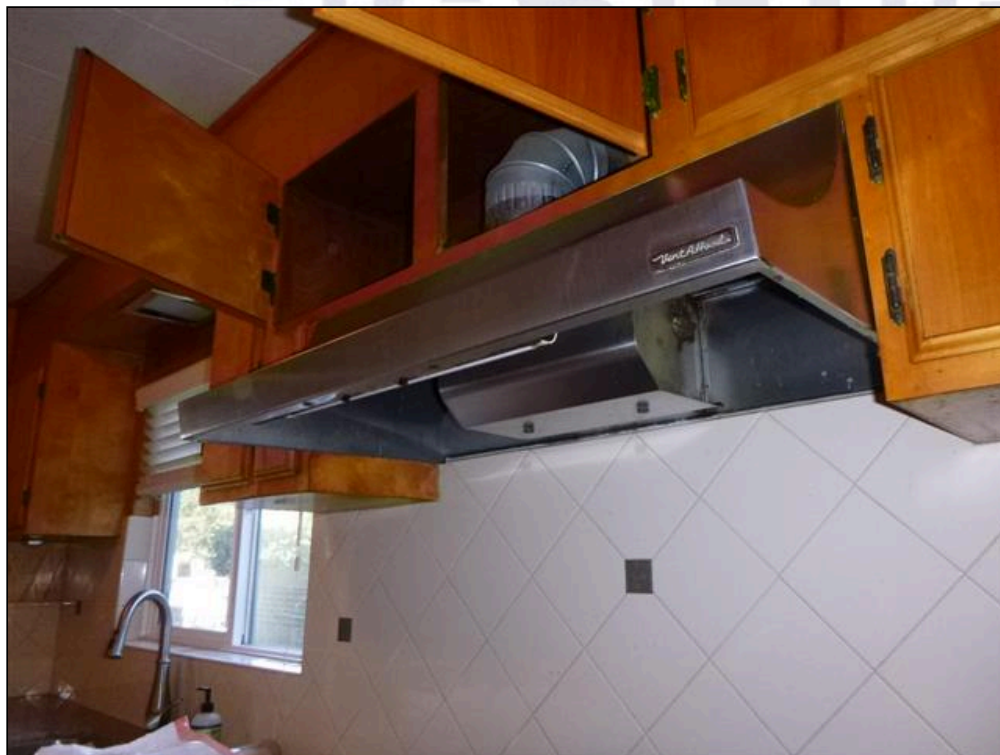
18.14 Item 1(Picture)

The range/hood vent is inoperable at the time of the inspection, suggest review with a licensed contractor and repair/replace as required for safety.

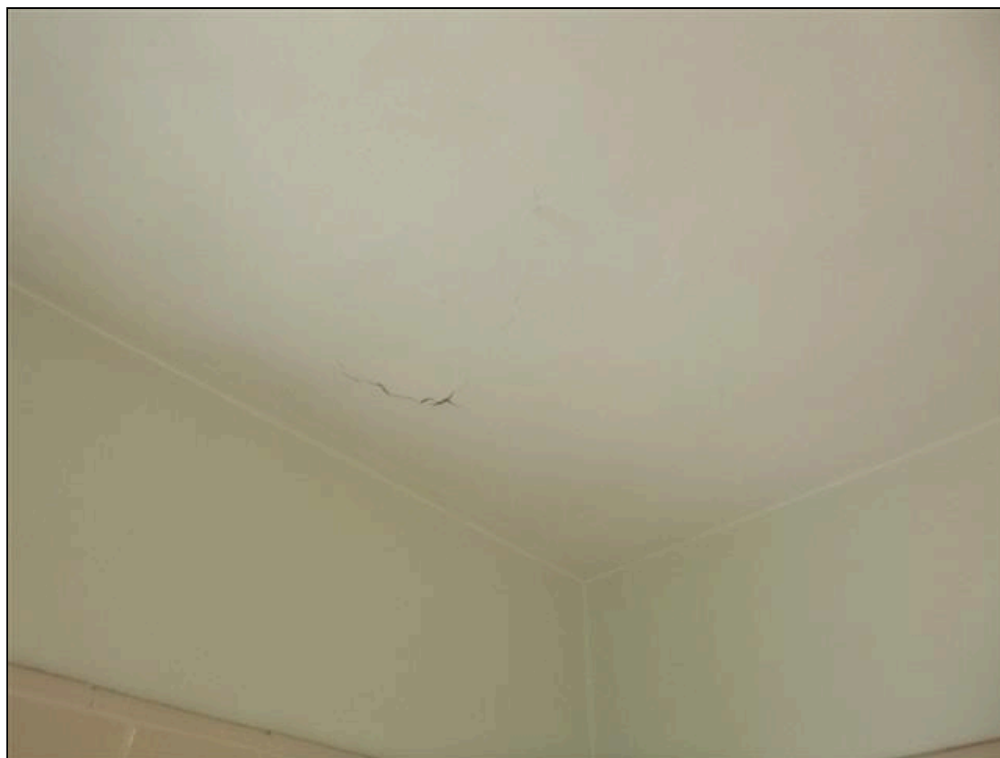
19.2 Item 1(Picture)

Blistering and minor deterioration noted at the ceiling due to inadequate ventilation. See the exhaust fan comment and repair/install as needed.

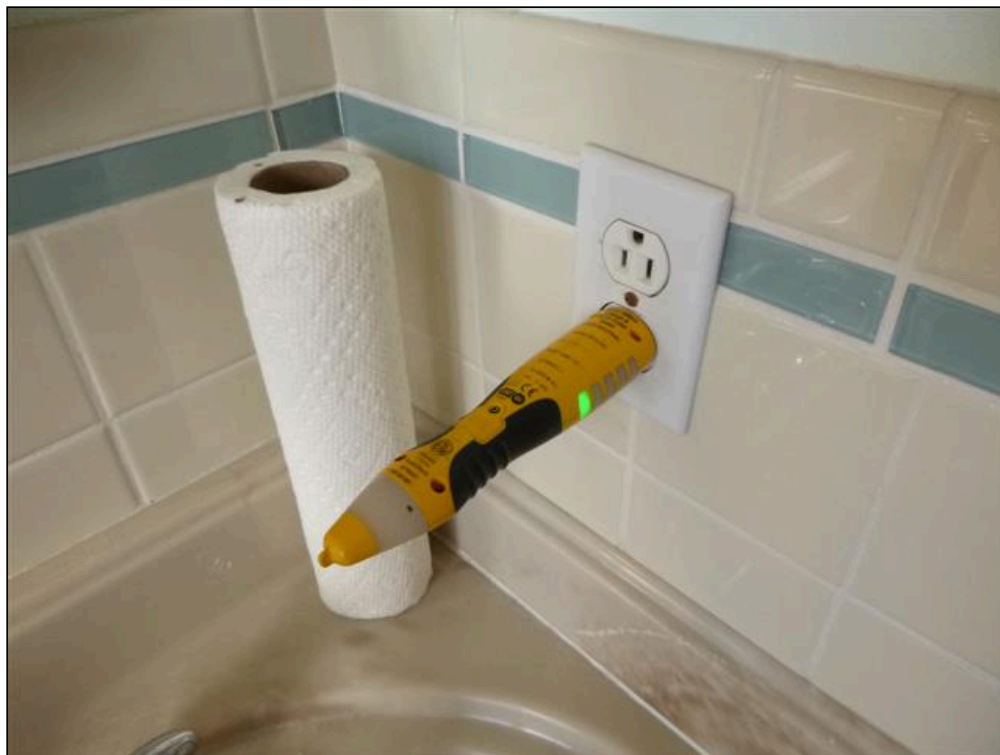
19.6 Item 1(Picture)

No GFCI outlet or protection installed in this bathroom. GFCI protection has been required in bathrooms since 1975, suggest review by a licensed electrician for installation as required for safety.

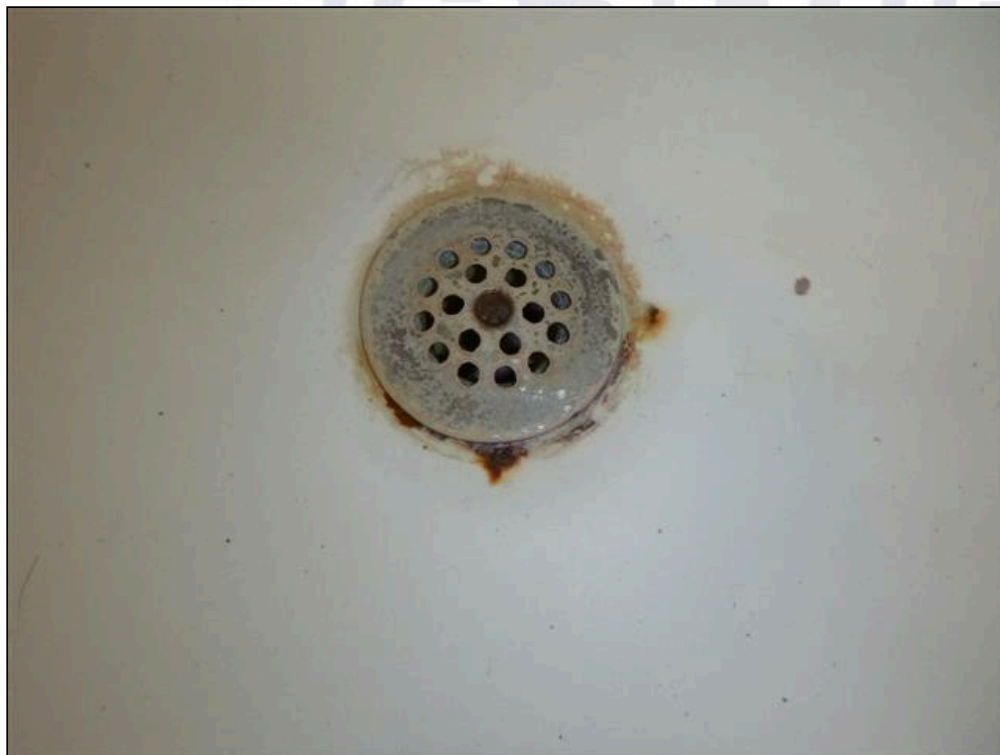
19.9 Item 1(Picture)

Minor deterioration and rust noted at the tub and surround, no visible evidence of leakage noted at the time of the inspection. Suggest repair/replace as needed.

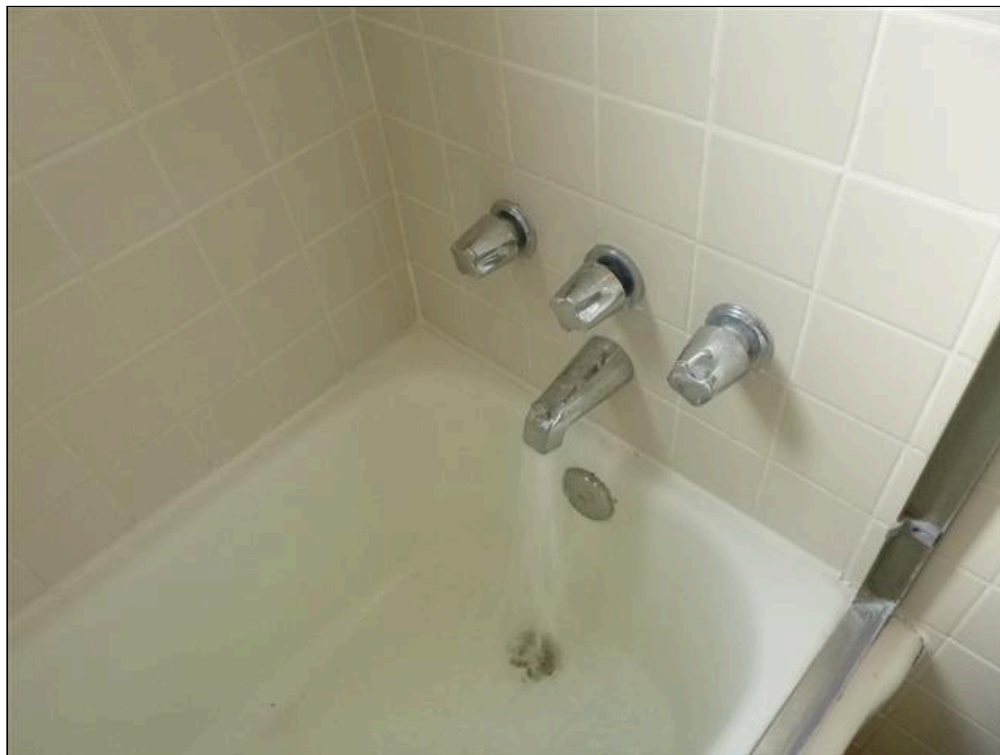
19.10 Item 1(Picture)

The existing tub faucet is not a low-flow system as required. Suggest review with a licensed plumber for costs to replace the existing tub faucet with a low flow faucet (2.2 gallons per minute) as required by the State of California as of January 1st, 2017. See the plumbing system comments for further details and a link to the State of California plumbing ordinance. Most retrofit companies/cities do not enforce the low flow tub faucet requirements due to it can take an excessive amount of time to fill the tub ( you will use the same amount of water irrelevant of how long it takes to fill the tub ).

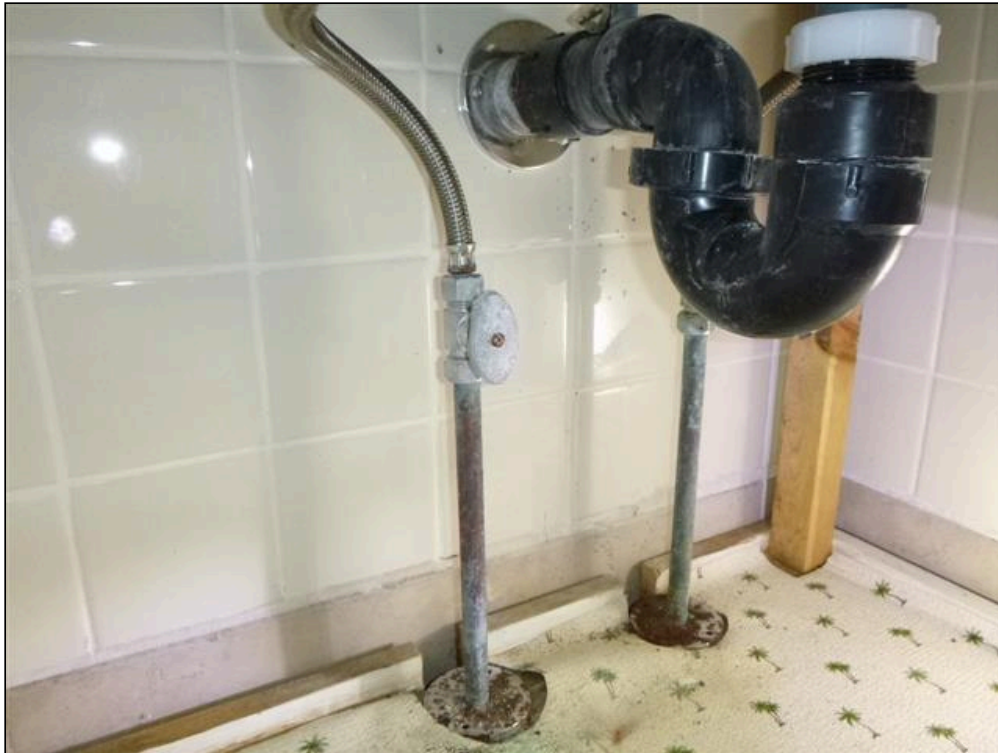
19.16 Item 1(Picture)

(1) Corrosion noted at the sink angle valve(s), no leaking noted at the time of the inspection. Suggest review by a licensed plumber for repair/replacement costs as needed.

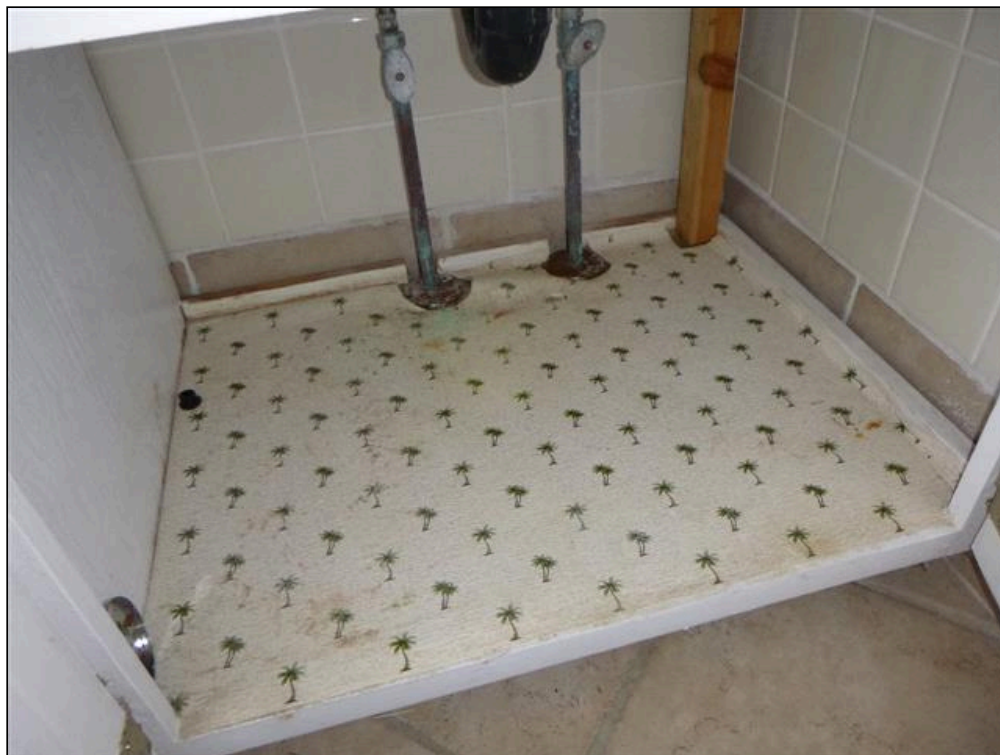
19.18 Item 1(Picture)

The base cabinet under the sink is deteriorated/stained from previous leaks, suggest repair/replace as needed.

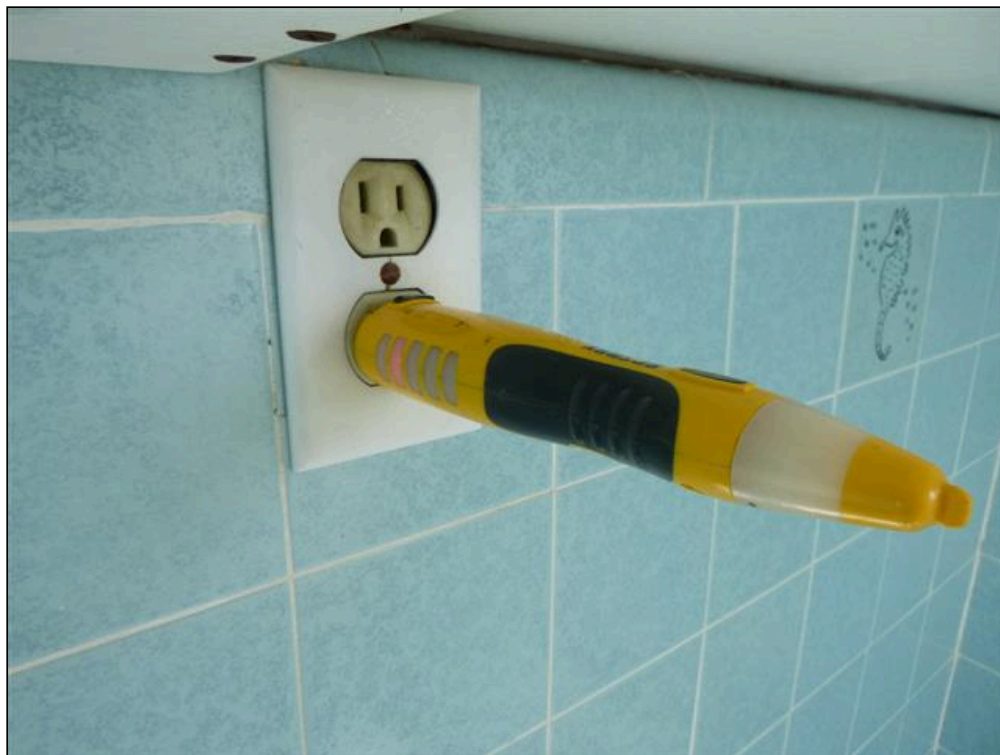
20.6 Item 1(Picture)

No GFCI outlet or protection installed in this bathroom. GFCI protection has been required in bathrooms since 1975, suggest review by a licensed electrician for installation as required for safety.

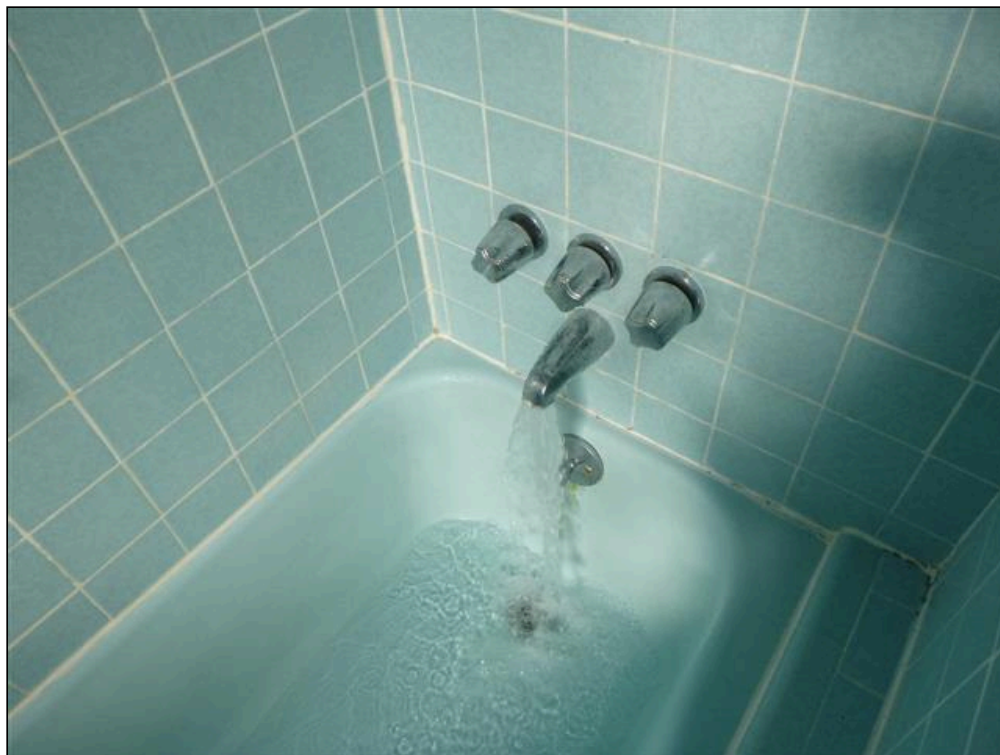
20.9 Item 1(Picture)

The existing tub faucet is not a low-flow system as required. Suggest review with a licensed plumber for costs to replace the existing tub faucet with a low flow faucet (2.2 gallons per minute) as required by the State of California as of January 1st, 2017. See the plumbing system comments for further details and a link to the State of California plumbing ordinance. Most retrofit companies/cities do not enforce the low flow tub faucet requirements due to it can take an excessive amount of time to fill the tub ( you will use the same amount of water irrelevant of how long it takes to fill the tub ).
