# Inspection Report

**Property Address:**  
2104 Chestnut Ave  
Manhattan Beach CA 90266

**Ferguson Home Inspections**

<b>Date:</b> 1/11/2025	<b>Time:</b> 09:00 AM	<b>Report ID:</b> 01112025ChestnutAve
<b>Property:</b> 2104 Chestnut Ave Manhattan Beach CA 90266	<b>Customer:</b> Yvonne Peltz	<b>Real Estate Professional:</b> Marlene Ramirez

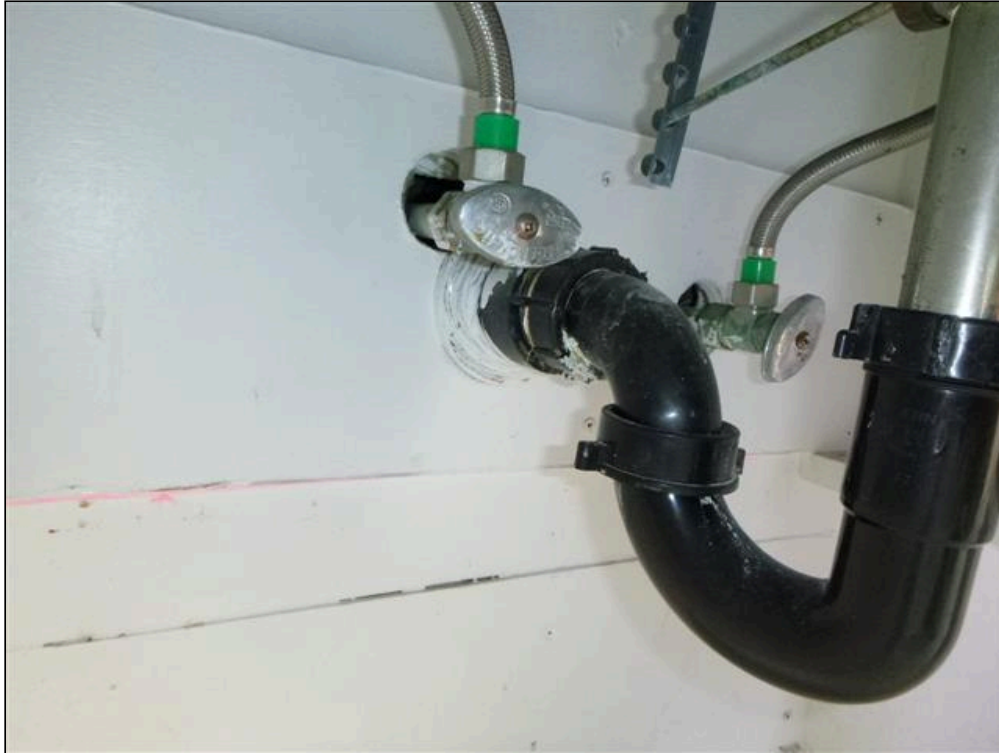
20.15 Item 1(Picture)

(1) Corrosion/stains noted at the sink drain and angle valve(s), no leaking noted at the time of the inspection. Suggest review by a licensed plumber for repair/replacement costs as needed.

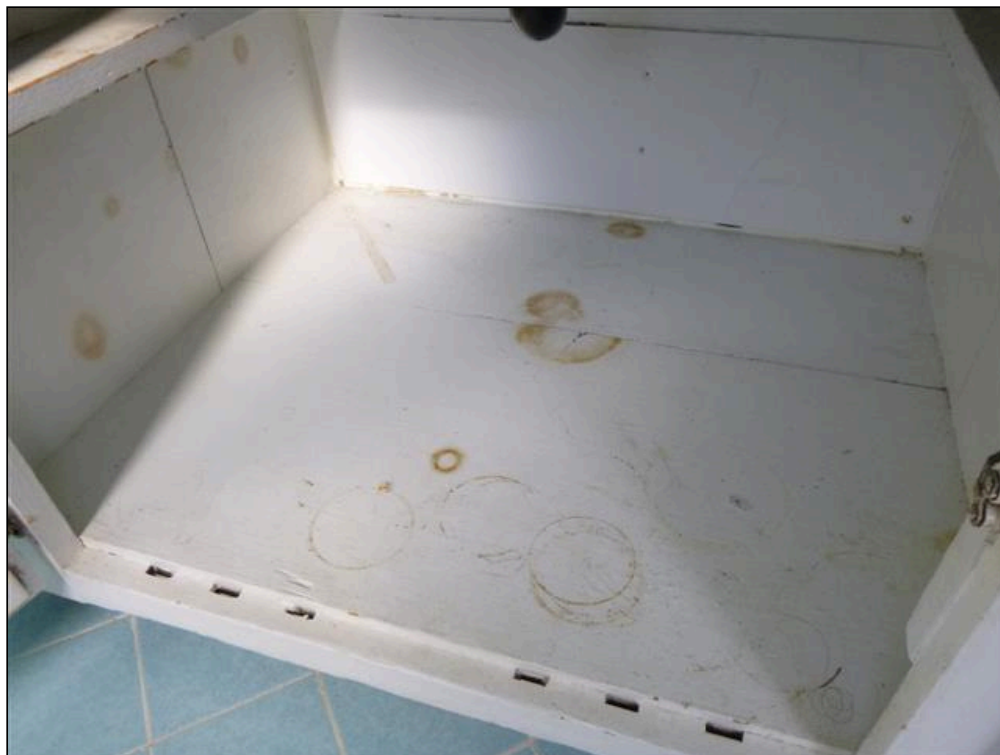
20.17 Item 1(Picture)

The base cabinet under the sink is deteriorated/stained from previous leaks, suggest repair/replace as needed.

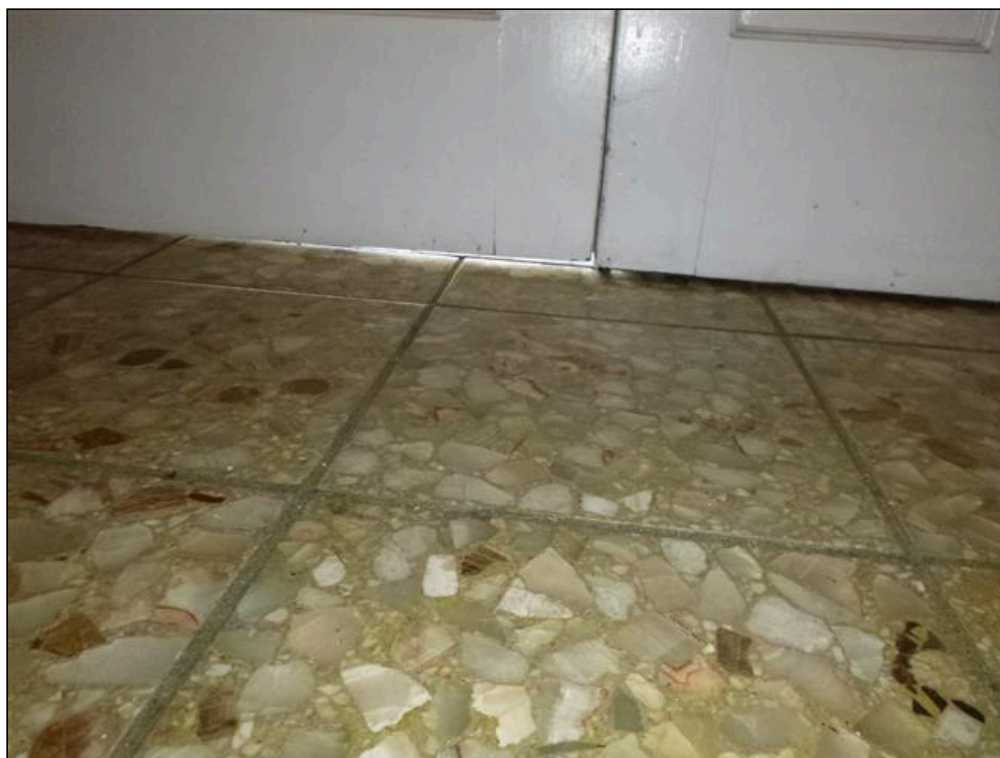
22.3 Item 1(Picture)

- (1) Suggest installation of door stops to prevent damage to the walls and/or surrounding area.
- (2) Excessive gaps and light noted at the door(s) to the exterior when in the closed position. Suggest review with a licensed contractor for repair/replacement costs as needed to prevent future water,

draft and insect/rodent intrusion at this area.

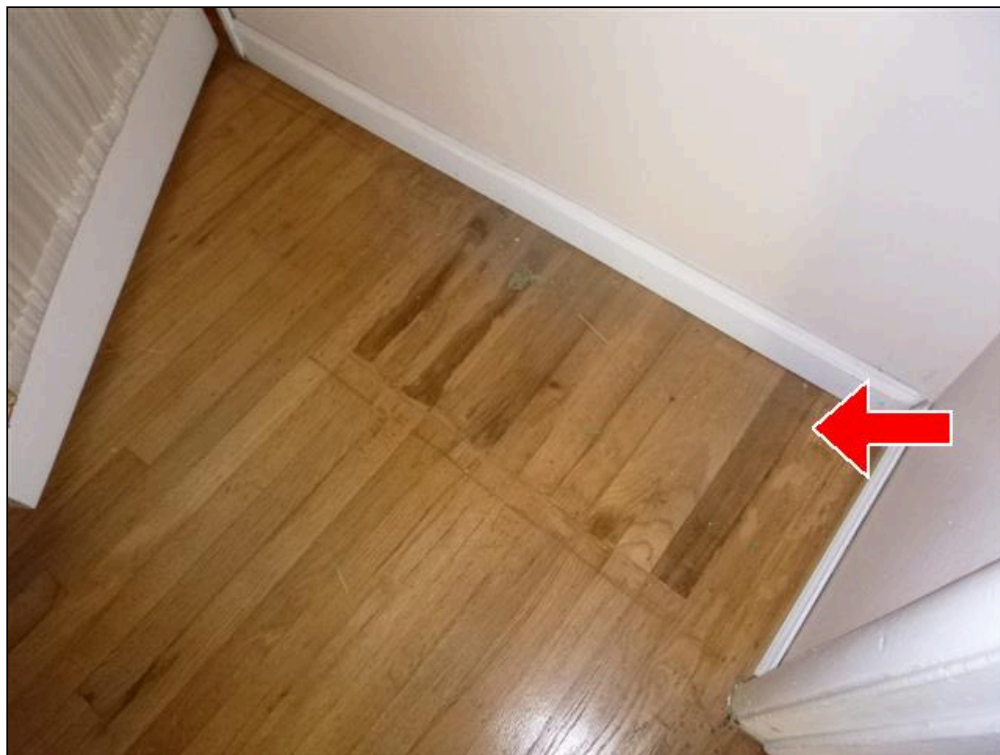
23.0 Item 1(Picture)

- (1) Floor slope, squeaky/noisy and uneven floors noted, suggest repairs as needed.
- (2) Patched areas of the floor were noted at the original floor heater location. Suggest repair/replace as needed.

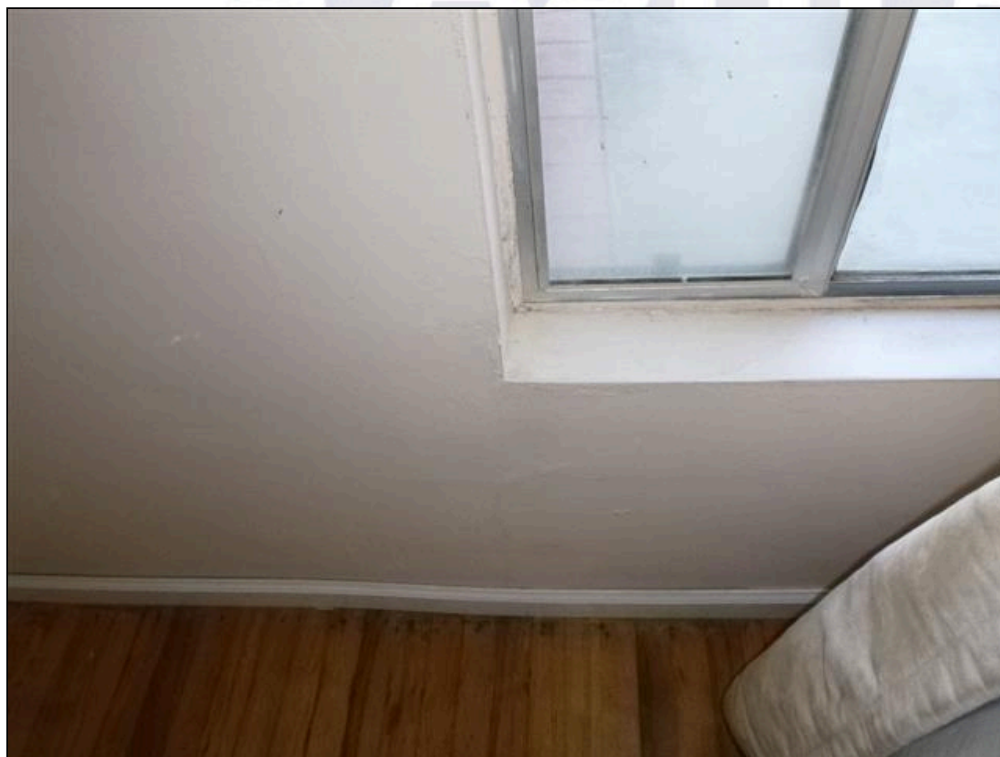
23.1 Item 1(Picture)

Patched areas of the walls were noted, suggest review with the seller for the cause and any repairs needed. Suggest review with a licensed contractor for any repair/removal/replacement costs as needed.

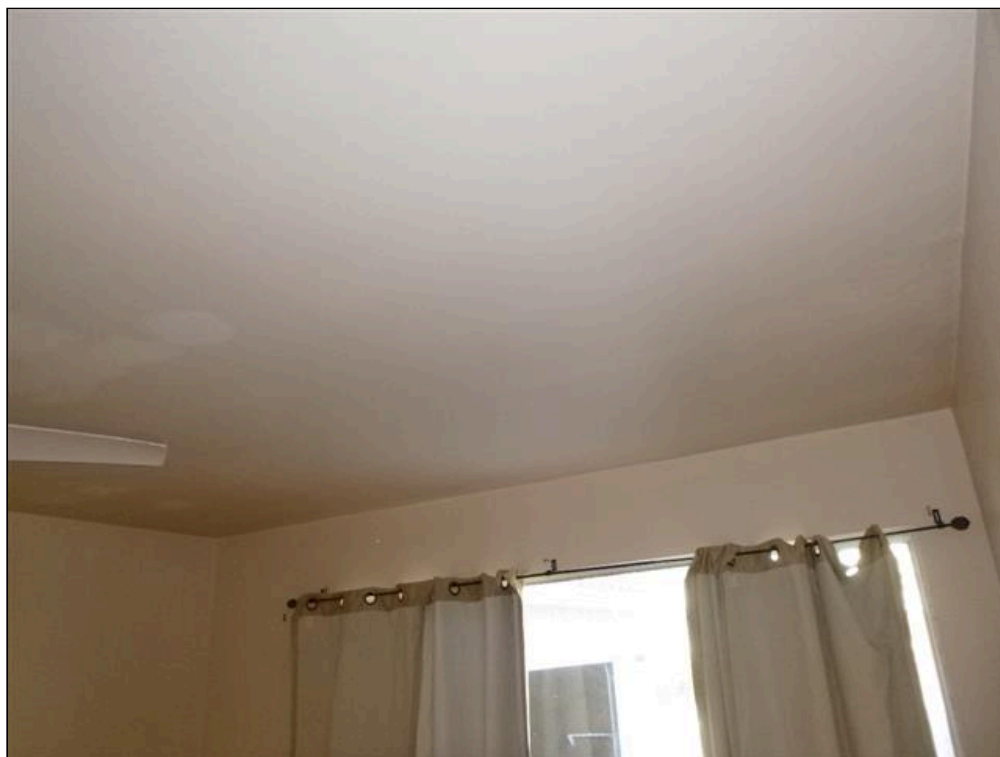
23.2 Item 1(Picture)

Patched and uneven areas of the ceiling was noted, suggest review with the seller on the cause and any repairs needed. Suggest review with a licensed contractor for any repair/removal/replacement costs as needed.

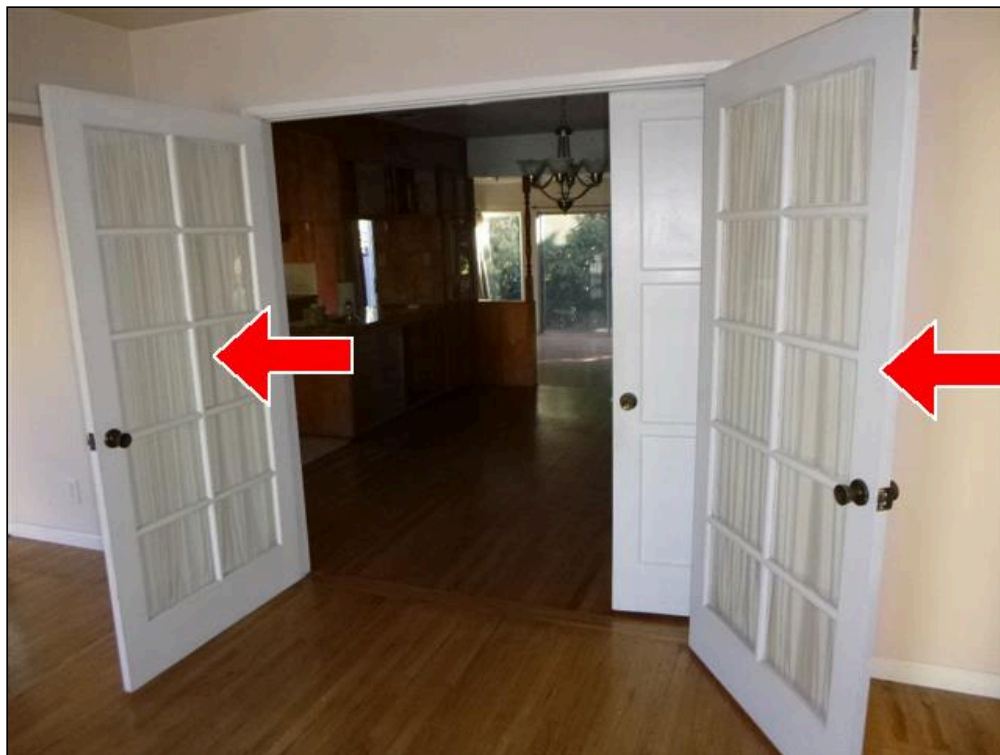
23.3 Item 1(Picture)

- (1) Suggest installation of door stops to prevent damage to the walls and/or surrounding area.
- (2) The inspector was unable to verify/determine if tempered/safety glass is installed at the window/door glass at this area ( no labelling/etching is visible ). Windows and doors with glass 18 inches off the floor area or windows within doors should have safety glass. Suggest review of these areas for possible costs to upgrade for safety.

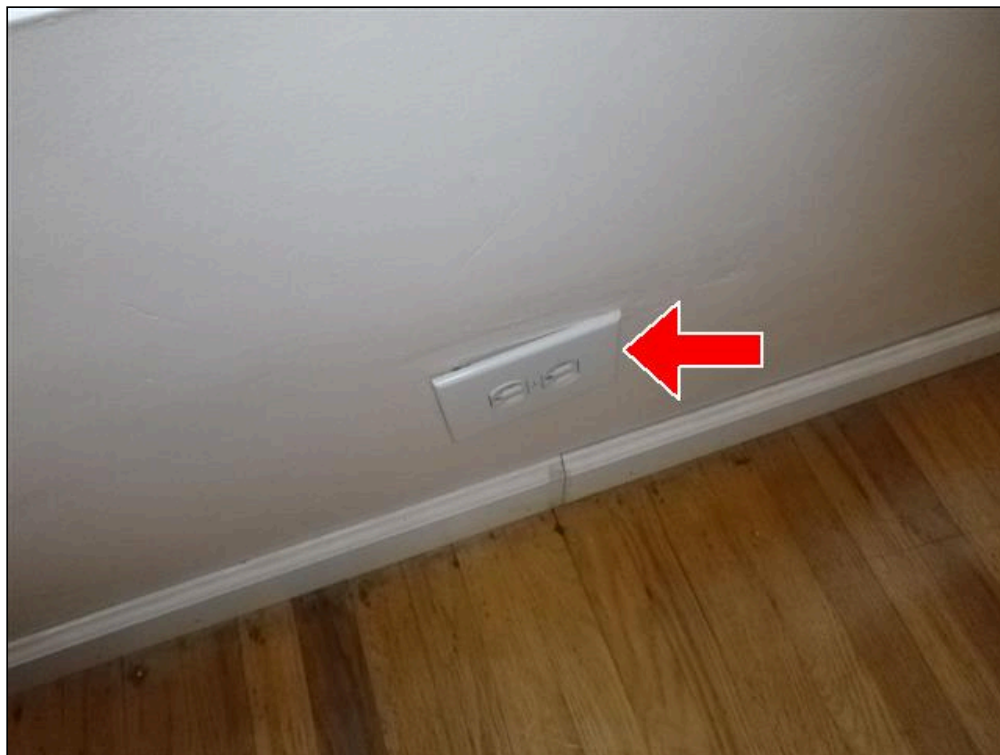
23.6 Item 1(Picture)

The outlet at the front wall is loose at the wall mount, suggest review with a licensed electrician for repair/replacement costs as needed.

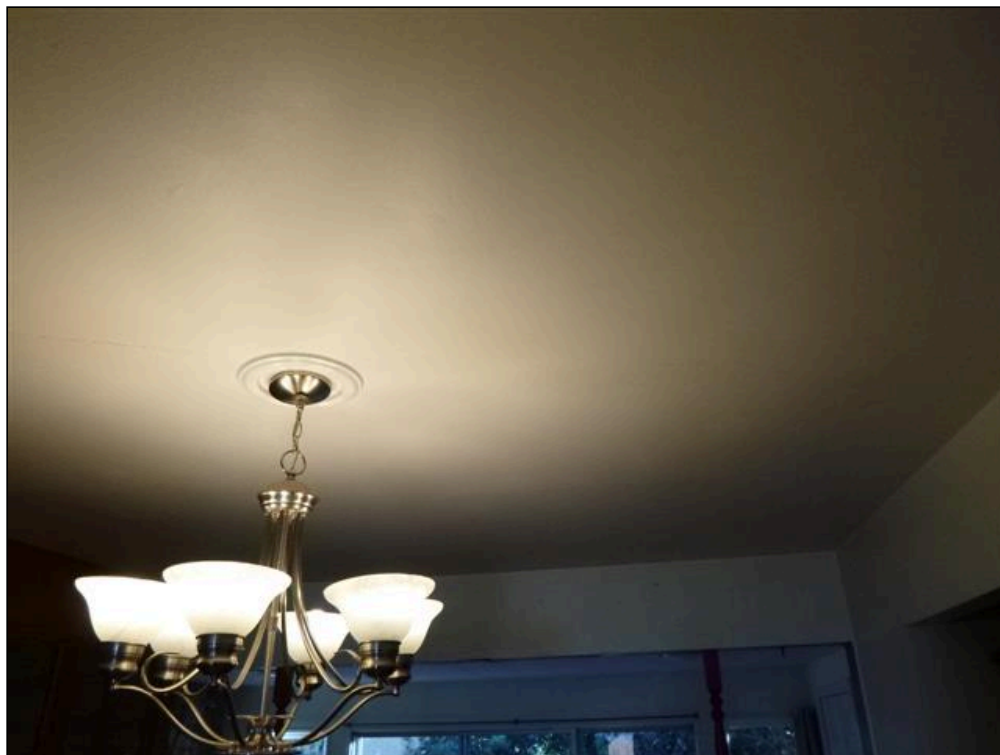
24.2 Item 1(Picture)

(1) Patched and uneven areas of the ceiling was noted, suggest review with the seller on the cause and any repairs needed. Suggest review with a licensed contractor for any repair/removal/replacement costs as needed.

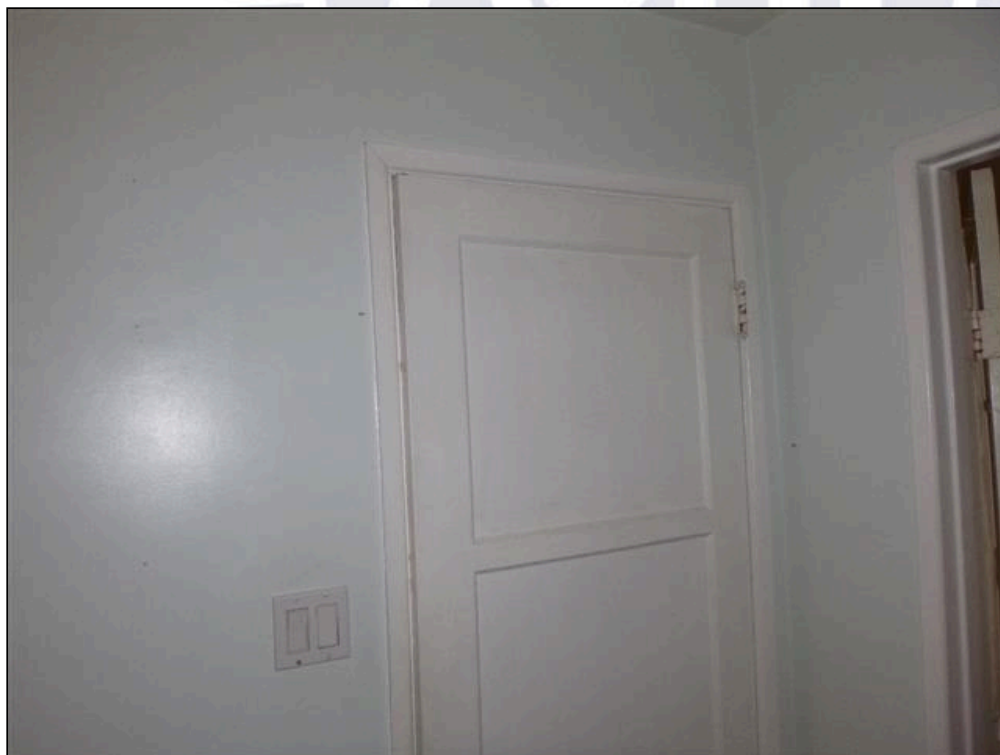
24.3 Item 1(Picture)

(1) Suggest installation of door stops to prevent damage to the walls and/or surrounding area.

(2) The door sticks/impacts on the jamb when operating, suggest repair as needed.

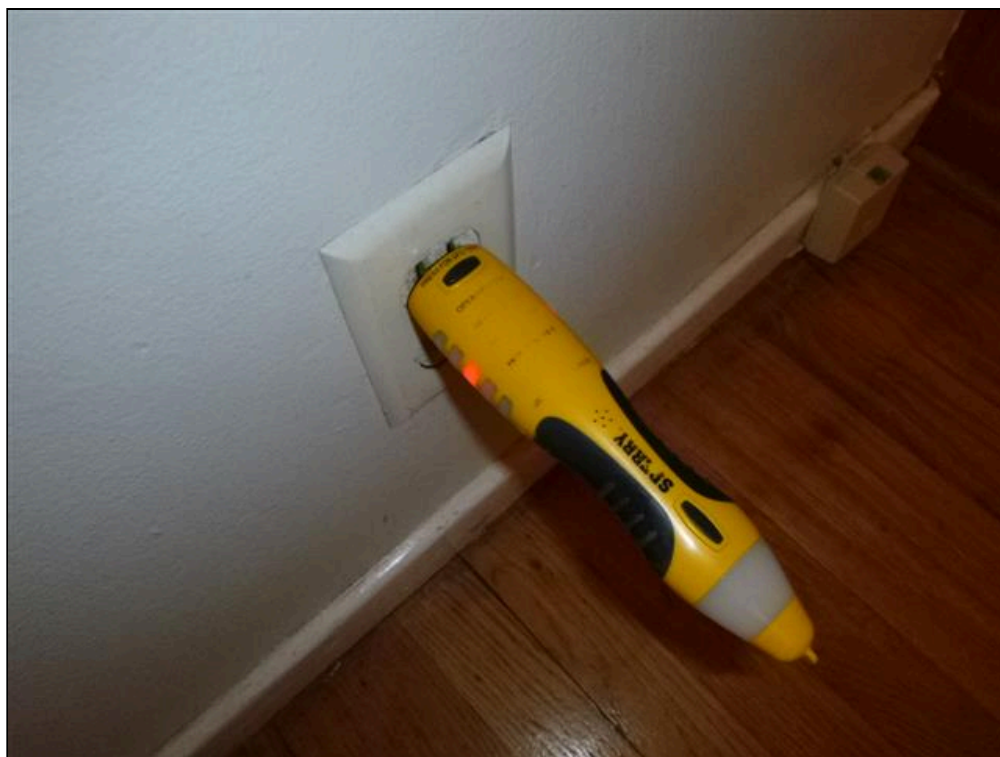
24.4 Item 1(Picture)

(2) Reversed polarity noted at various outlets. Reversed polarity, hot and ground reversed and other terms used for electric outlets are usually easily corrected by minor wiring adjustments at the specified item. Suggest review with a licensed electrician for repair/replacement costs and confirm correct operation as needed.

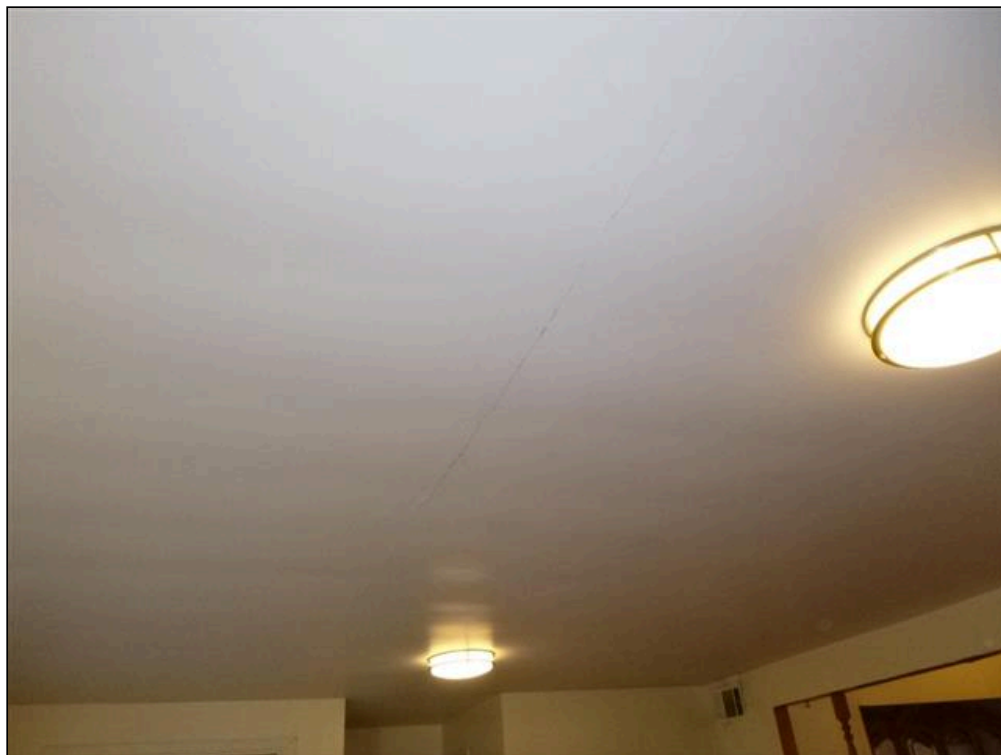
25.2 Item 1(Picture)

(1) Settling cracks and patching noted, suggest repair as needed.

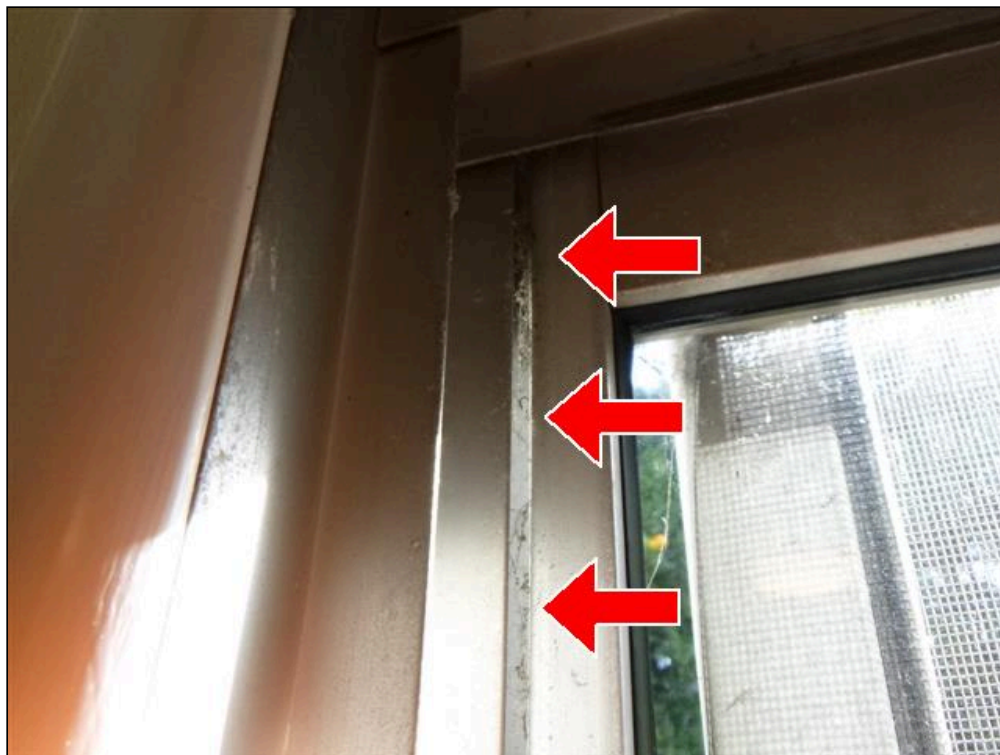
25.3 Item 1(Picture)

(1) The fixed section of the rear sliding door is not currently installed level with the frame and excessive gaps were noted. Suggest review with a licensed contractor for any repair/replacement costs as needed to prevent future water, draft and insect intrusion at this area.

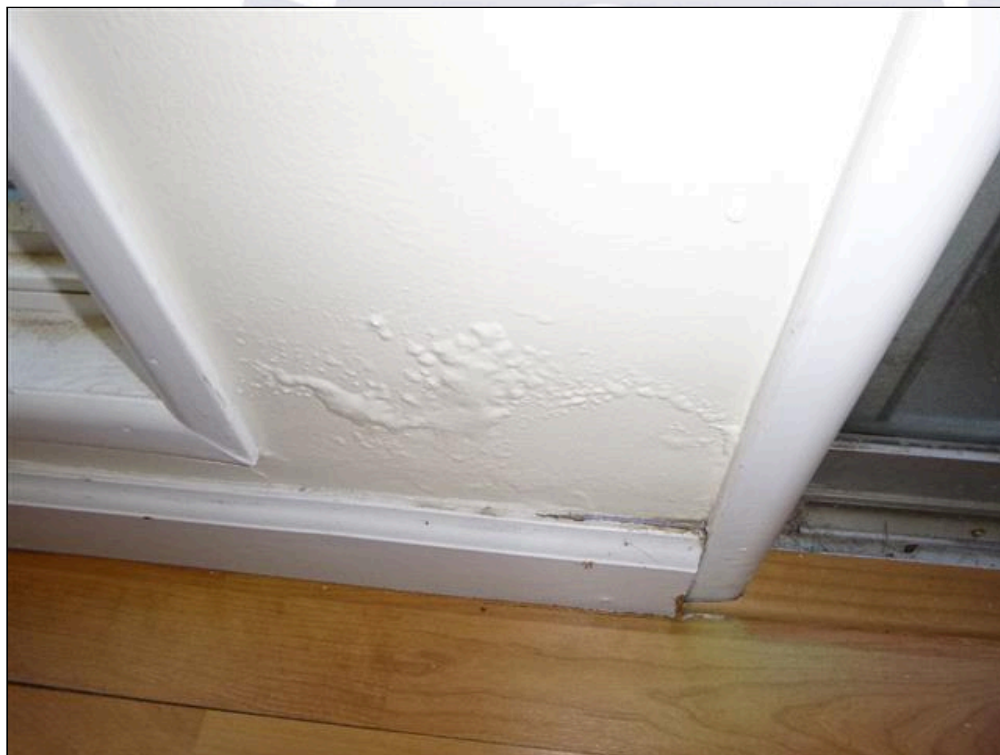
25.3 Item 2(Picture)

(2) Evidence of previous and possible on-going water intrusion was noted at the door(s) to the exterior. Suggest review with a licensed contractor for repair/replacement costs as needed.

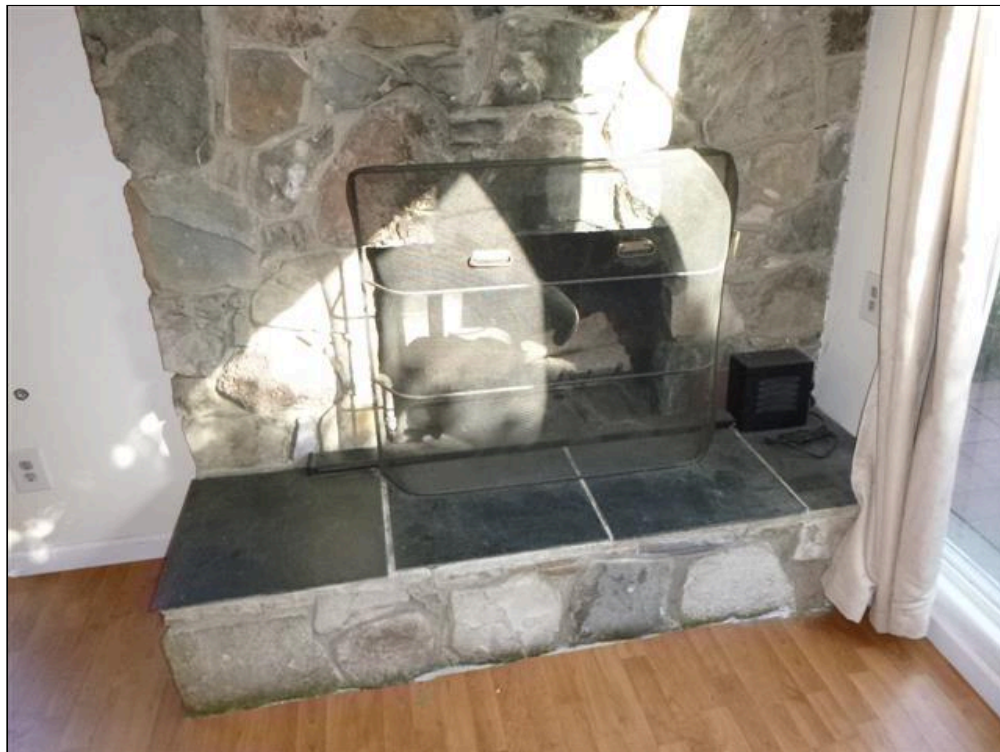
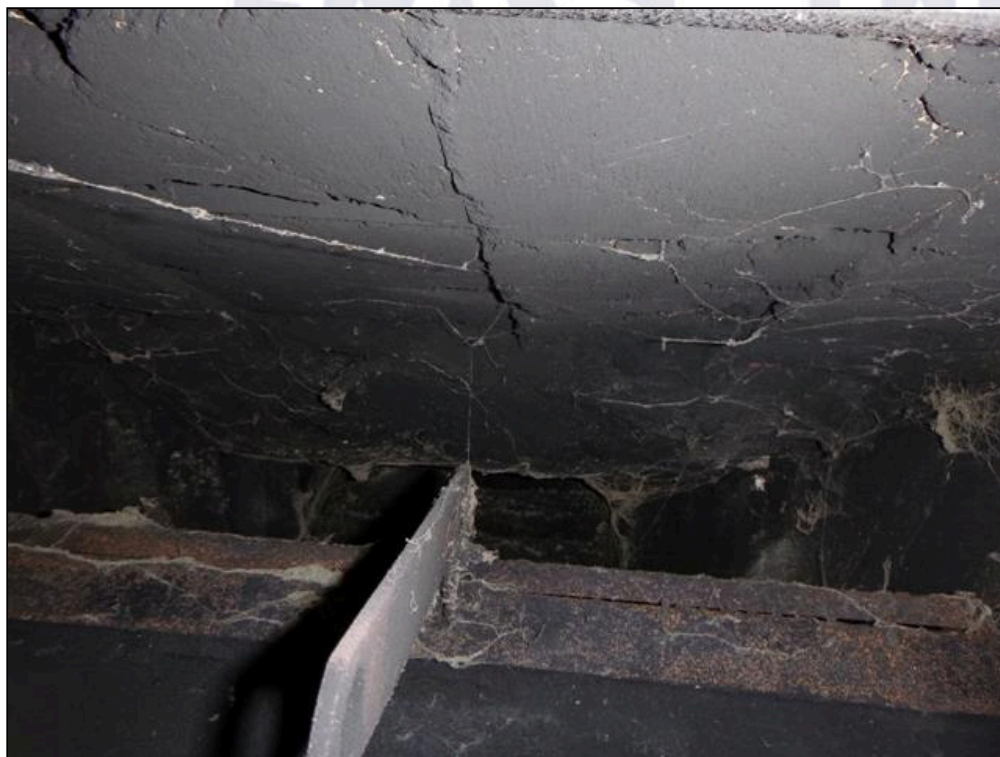
(1) The fireplace damper was operational at the time of the inspection. Suggest securing the damper to a fixed open position due to the gas installation per current requirements.

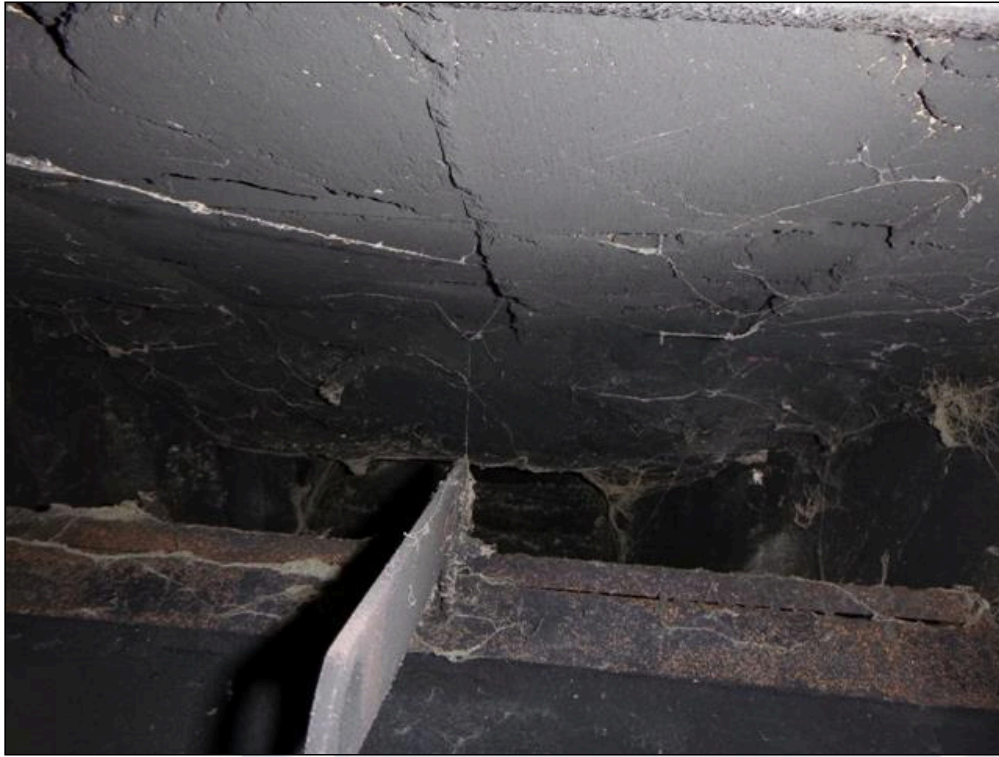
25.7 Item 3(Picture)

(2) Minor creosote noted within the firebox, smoke chamber or chimney areas. Creosote build-up can cause chimney fires if not removed from voids, open seams or open mortar joints within the fireplace and chimney. This inspection is a 'Level 1' inspection and is limited to visible and accessible areas

only. 'Level 2' and 'Level 3' inspections are invasive inspections performed by qualified personnel only with equipment designed for fireplace/chimney inspections, cleaning or repairs. Suggest periodic cleaning of the fireplace/chimney and remove the creosote and debris within the fireplace and chimney. Suggest review by a professional chimney sweep for estimates, repairs or cleaning.

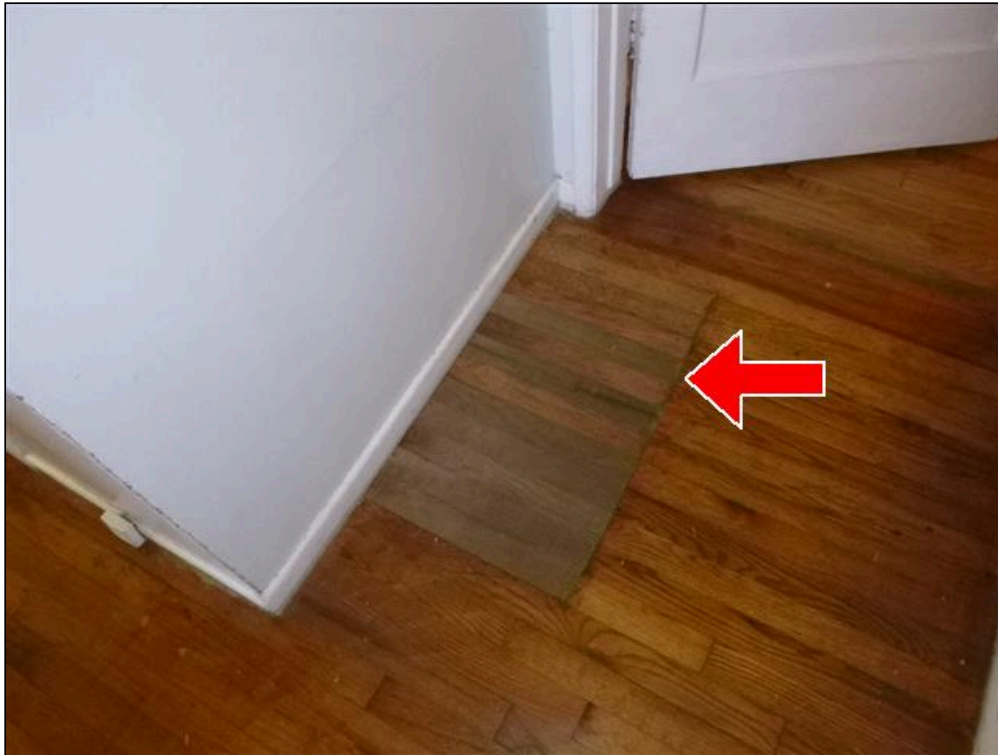
26.0 Item 1(Picture)

- (1) Floor slope, squeaky/noisy and uneven floors noted, suggest repairs as needed.
- (2) Patched areas of the floor were noted at the original floor heater location. Suggest repair/replace as needed.

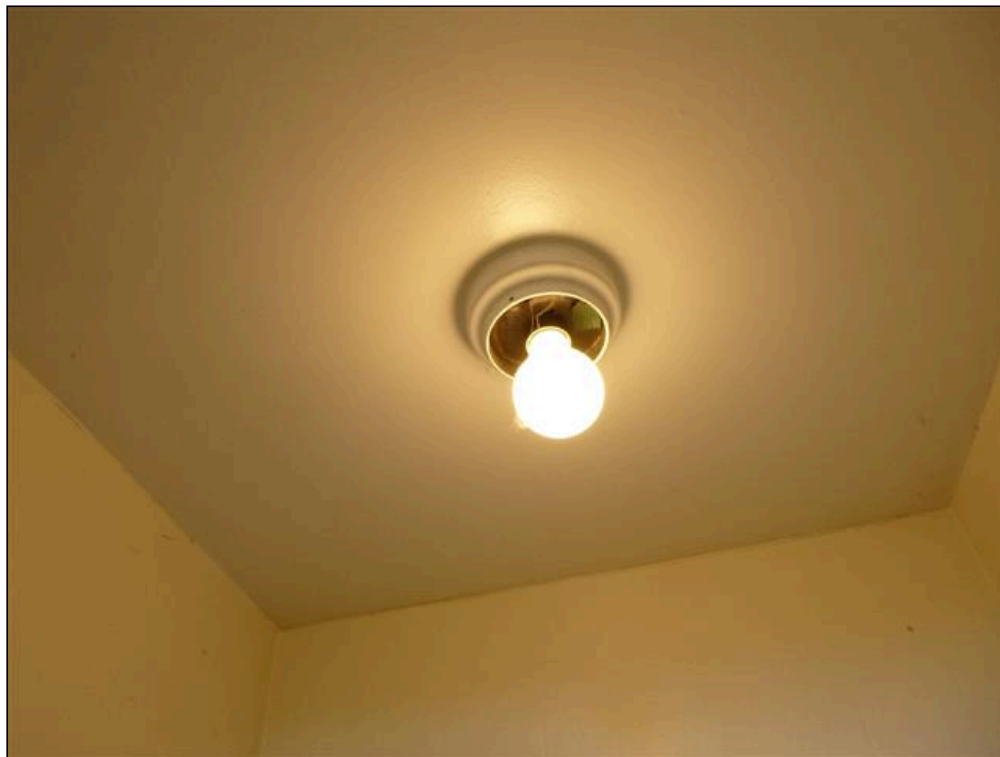
28.6 Item 1(Picture)

(2) The cover globe(s) are missing at light fixture(s) at the time of the inspection. Suggest replacing the missing cover globe(s) for safety.

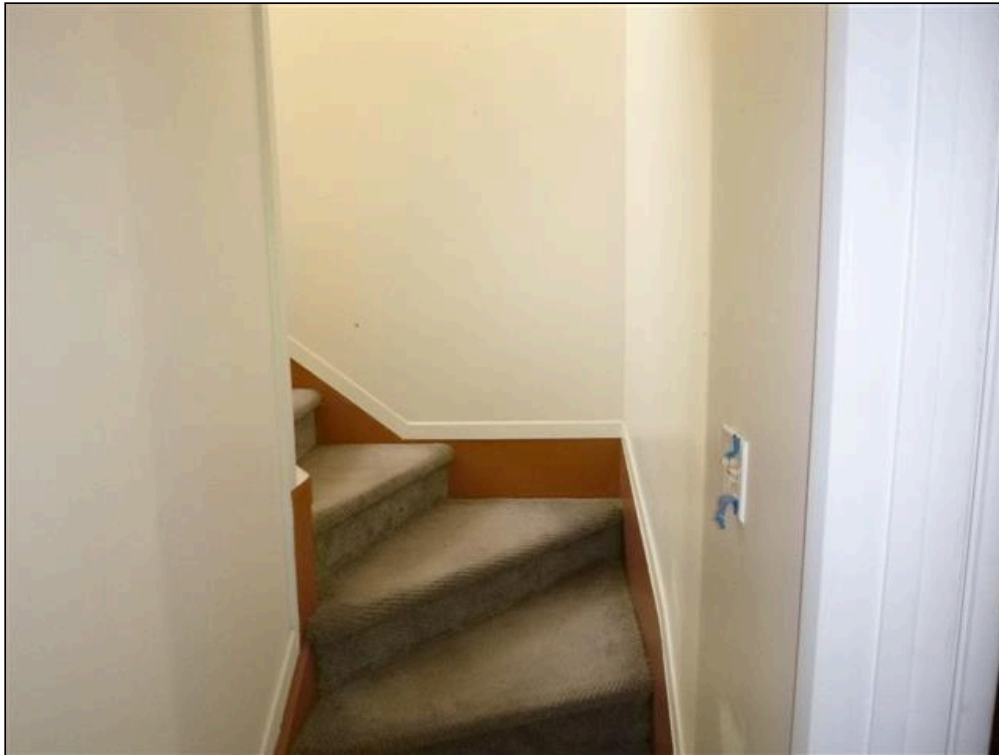
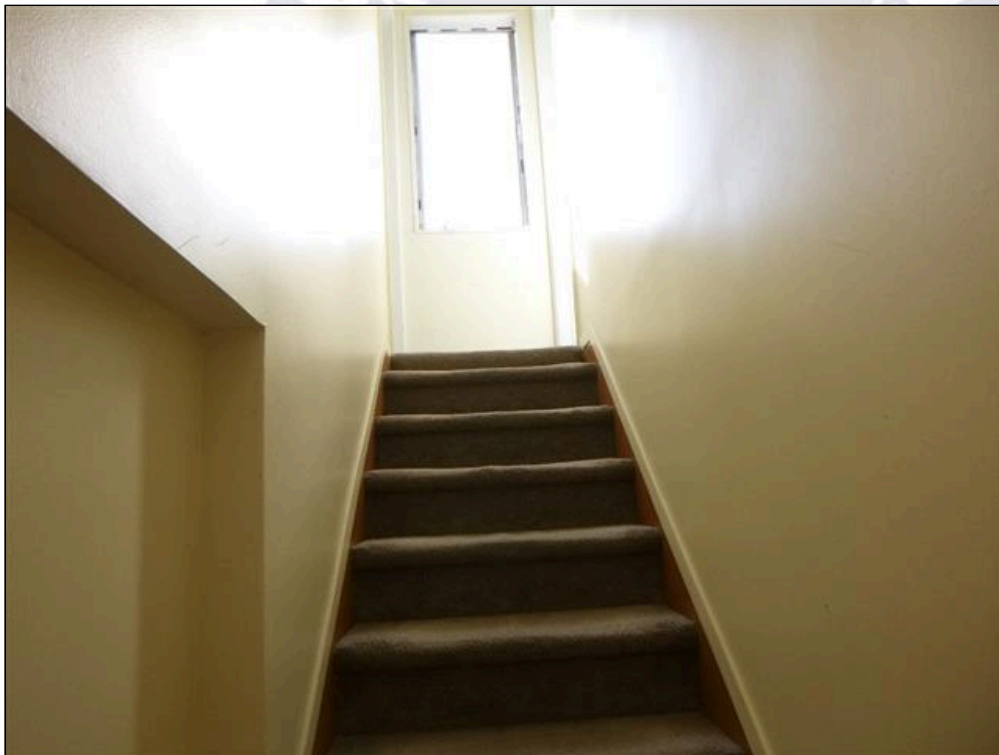
(1) No graspable hand railing(s) installed at the stair area(s). Suggest review with a licensed contractor for costs to install graspable railing(s) to current standards as required for safety.

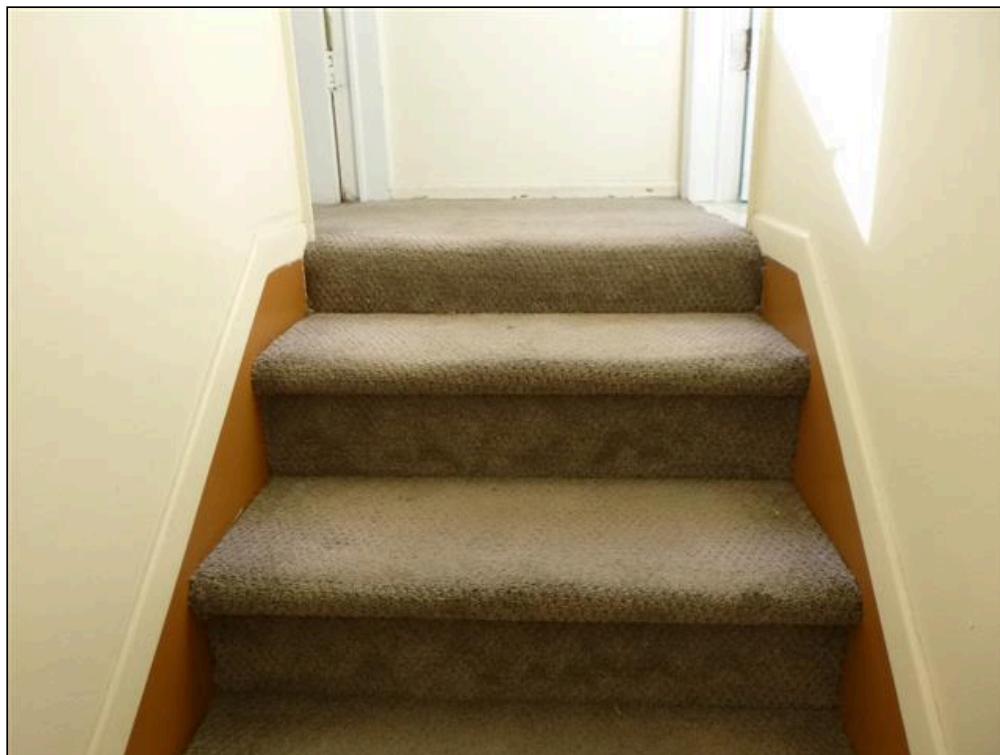
28.7 Item 3(Picture)

(2) A potential trip hazard was noted due to the uneven rise height at various steps. Suggest review with a licensed contractor for any repair/replacement costs as needed.

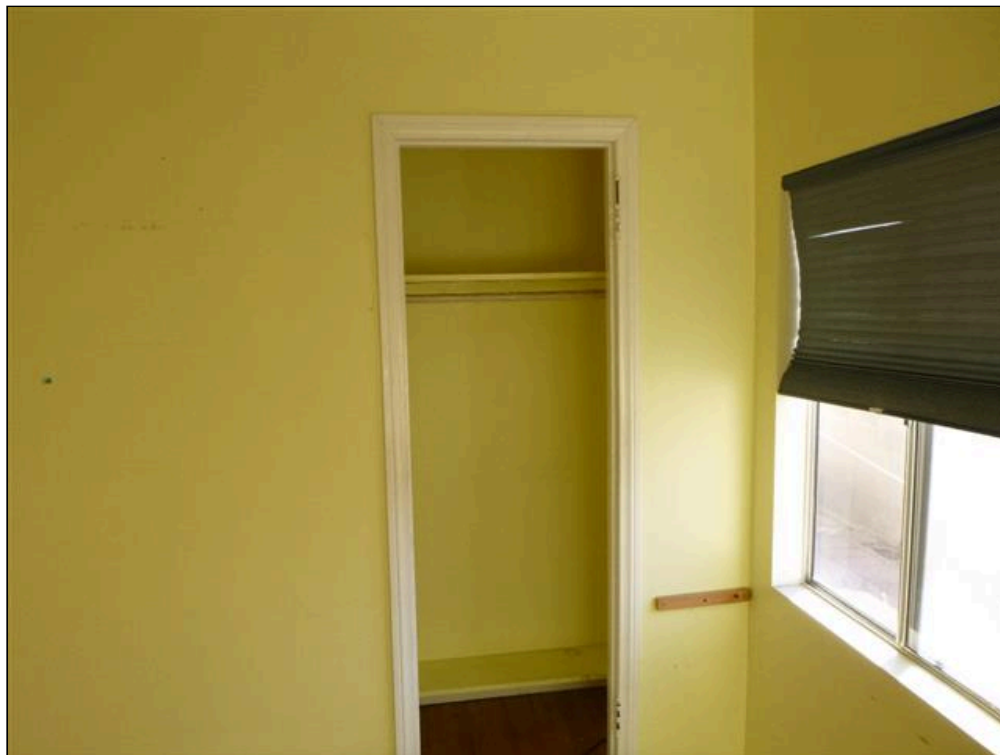
29.7 Item 1(Picture)

The closet door(s) were missing/not installed at the time of the inspection, suggest replacing/installing as needed.

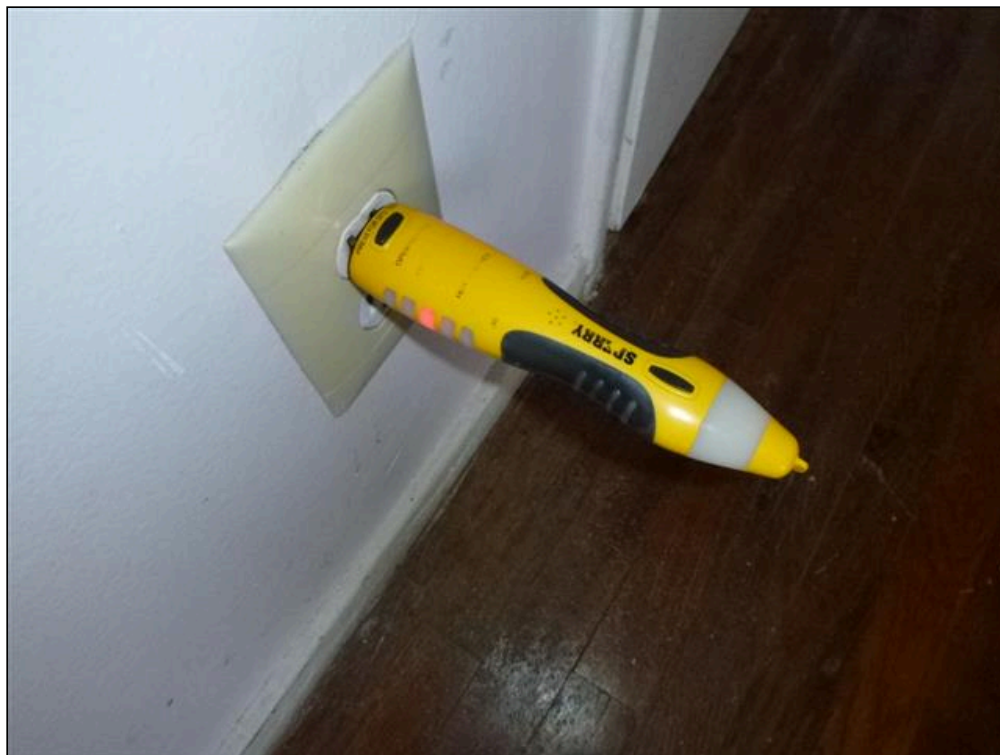
30.6 Item 2(Picture)

(3) Reversed polarity noted at various outlets. Reversed polarity, hot and ground reversed and other terms used for electric outlets are usually easily corrected by minor wiring adjustments at the specified item. Suggest review with a licensed electrician for repair/replacement costs and confirm correct operation as needed.

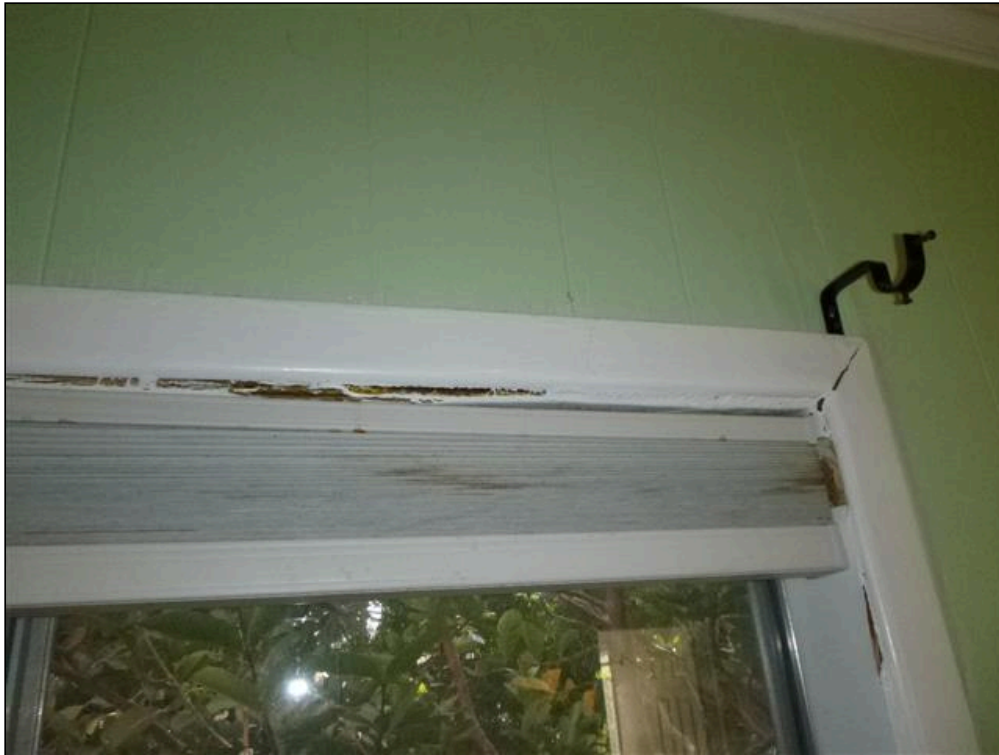
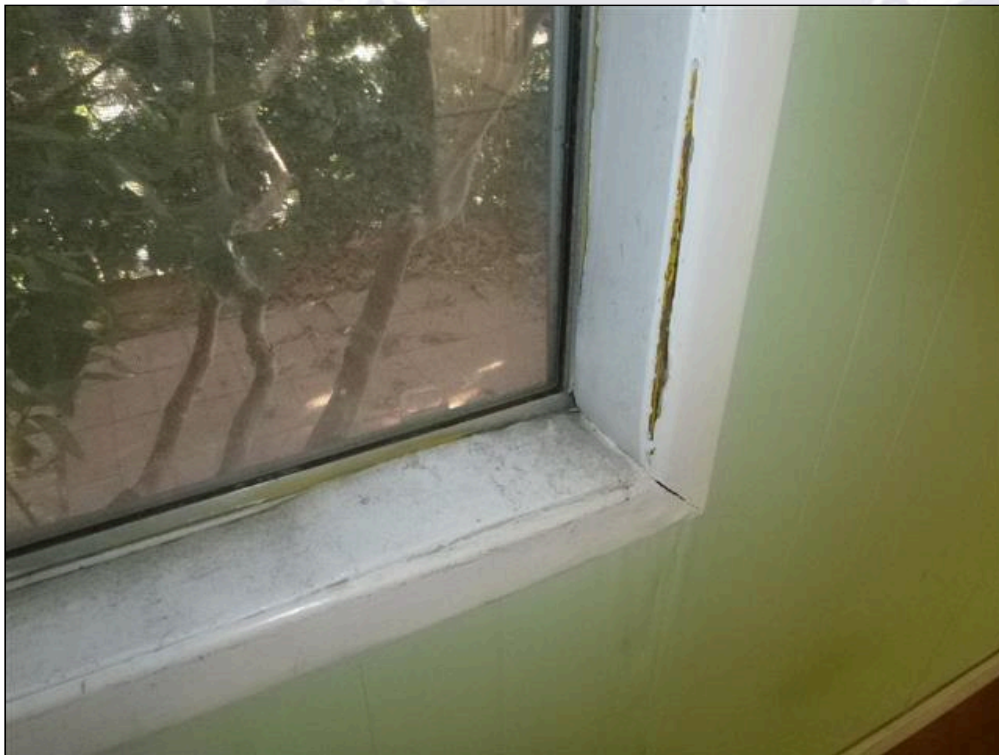
Stained, patched and damaged areas of the walls were noted at the windows ( evidence of previous/ on-going water intrusion was noted ). Suggest review with the seller for the cause and any repairs needed. Suggest review with a licensed contractor for any repair/removal/replacement costs as needed.

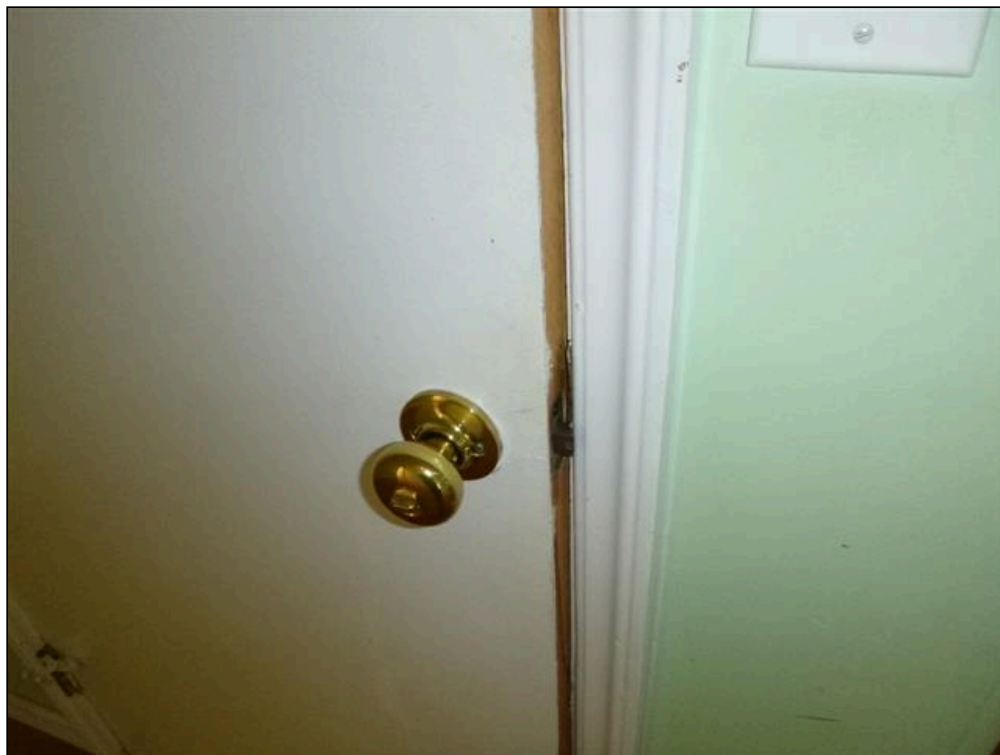
31.3 Item 1(Picture)

(1) The door will not close and latch correctly, suggest repair as needed.

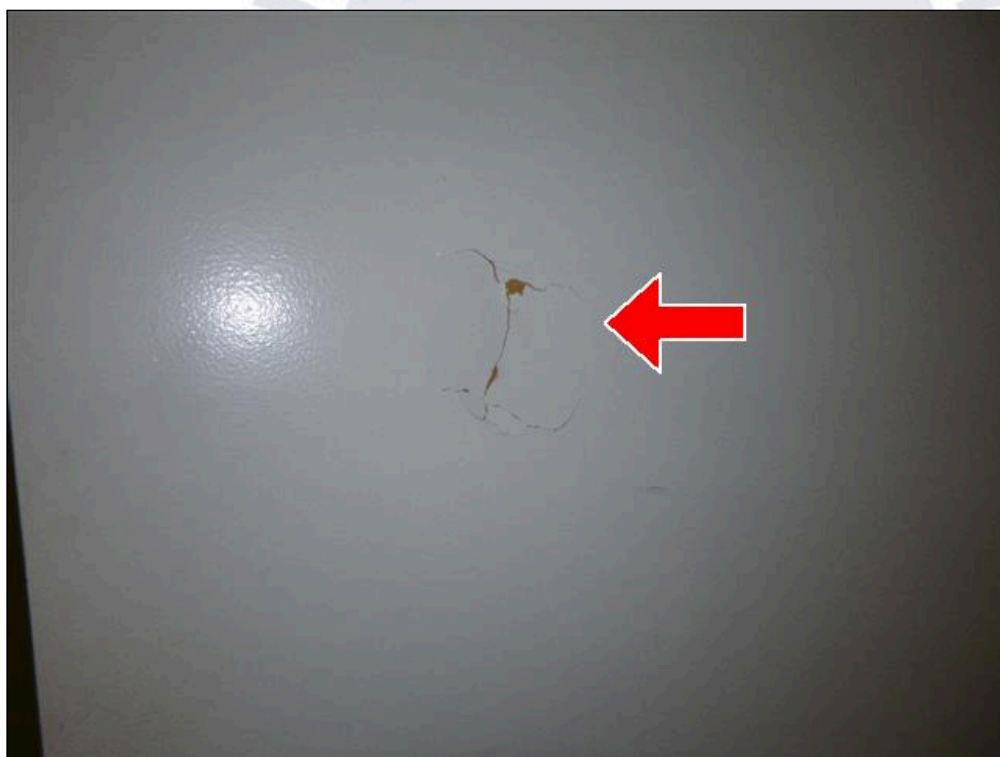
31.3 Item 2(Picture)

(2) The door to the hallway is damaged/holes noted, suggest repair as needed.
