# Inspection Report

**Property Address:**  
2104 Chestnut Ave  
Manhattan Beach CA 90266

**Ferguson Home Inspections**

<b>Date:</b> 1/11/2025	<b>Time:</b> 09:00 AM	<b>Report ID:</b> 01112025ChestnutAve
<b>Property:</b> 2104 Chestnut Ave Manhattan Beach CA 90266	<b>Customer:</b> Yvonne Peltz	<b>Real Estate Professional:</b> Marlene Ramirez

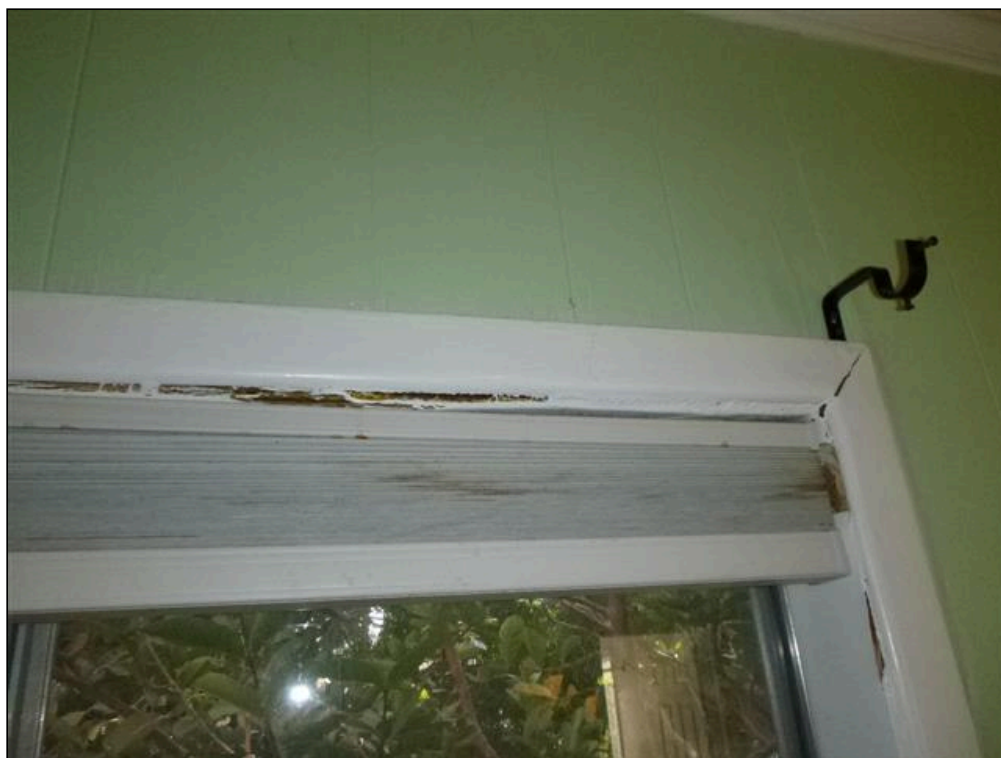
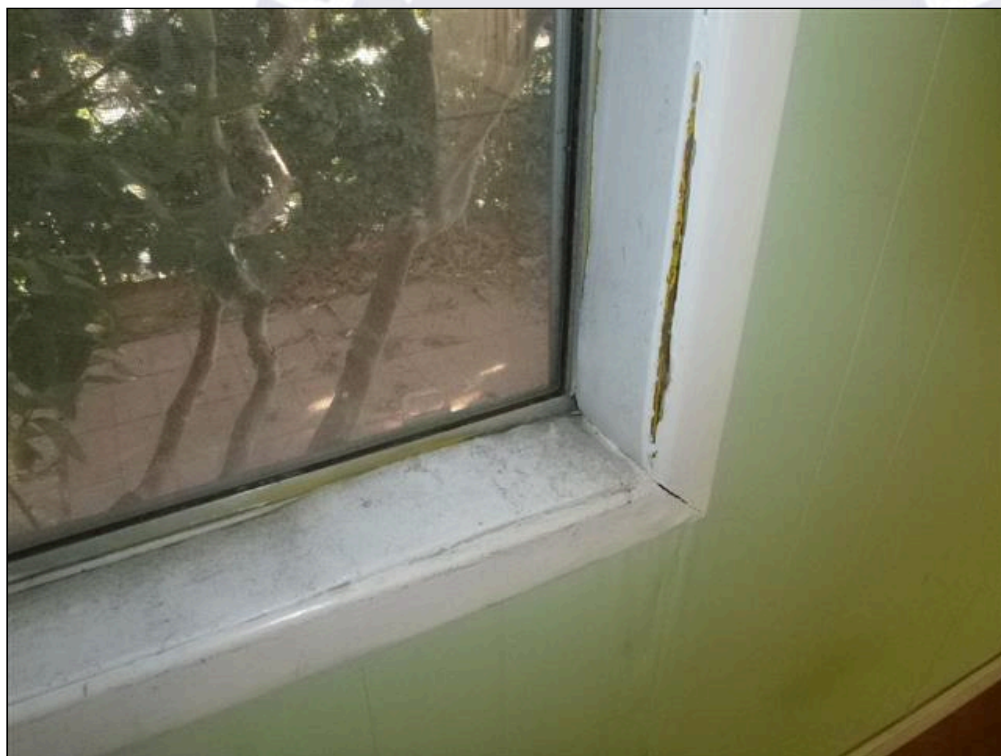
(2) Excessive deterioration, satins and evidence of previous/on-going leakage was noted at the

windows. Suggest review with a licensed contractor for any repair/replacement costs as needed.

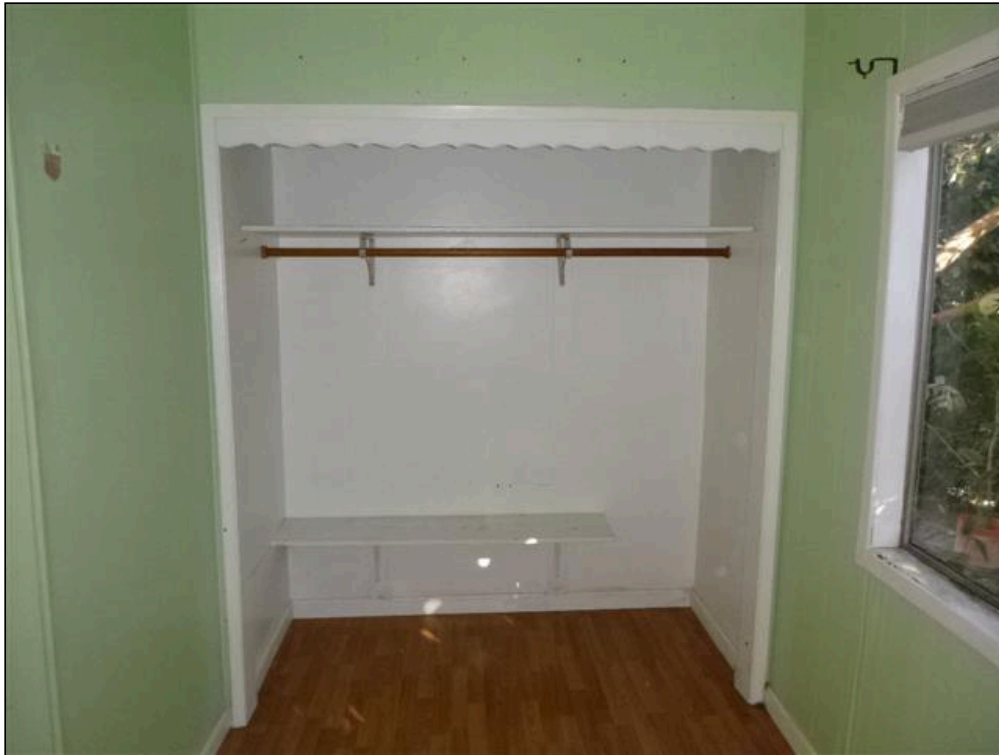
31.7 Item 1(Picture)

The closet door(s) were missing/not installed at the time of the inspection, suggest replacing/installing as needed.

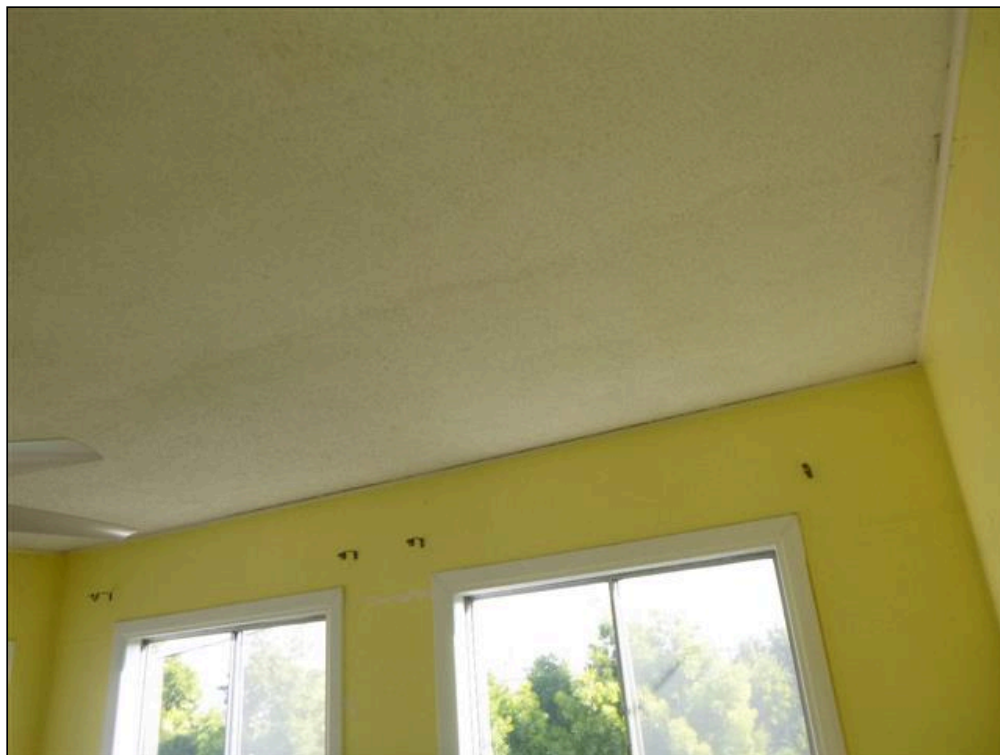
32.2 Item 1(Picture)

Patched and uneven areas of the ceiling was noted, suggest review with the seller on the cause and any repairs needed. Suggest review with a licensed contractor for any repair/removal/replacement costs as needed.

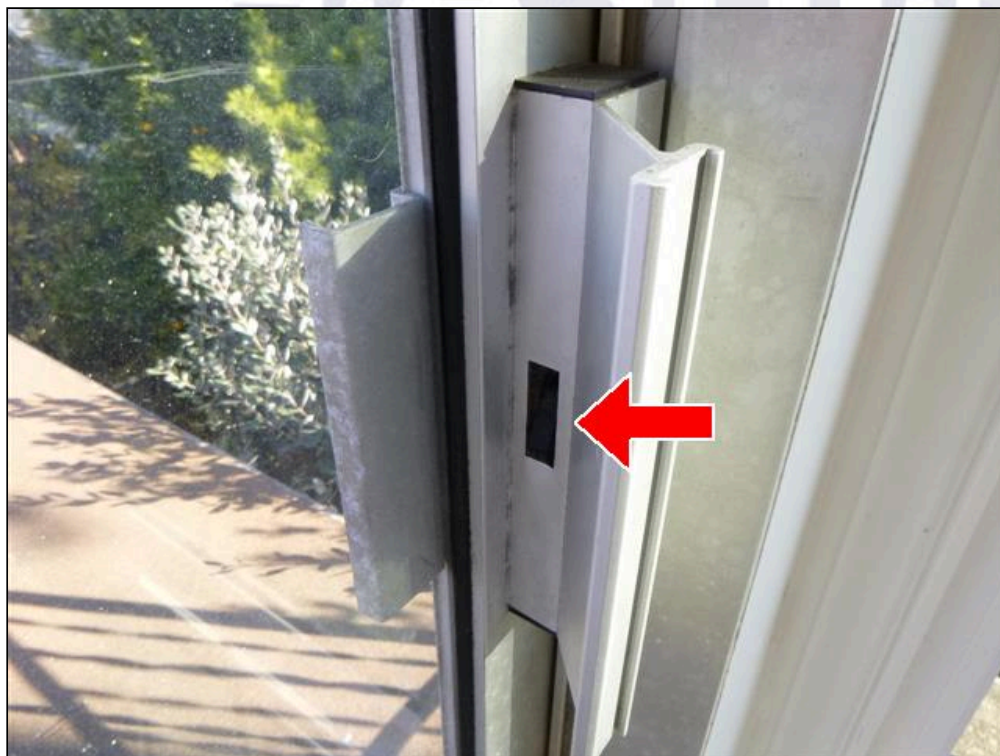
32.3 Item 1(Picture)

- (1) Suggest installation of door stops to prevent damage to the walls and/or surrounding area.
- (2) The sliding door lock handle is broken/damaged, suggest repair/replace as needed.

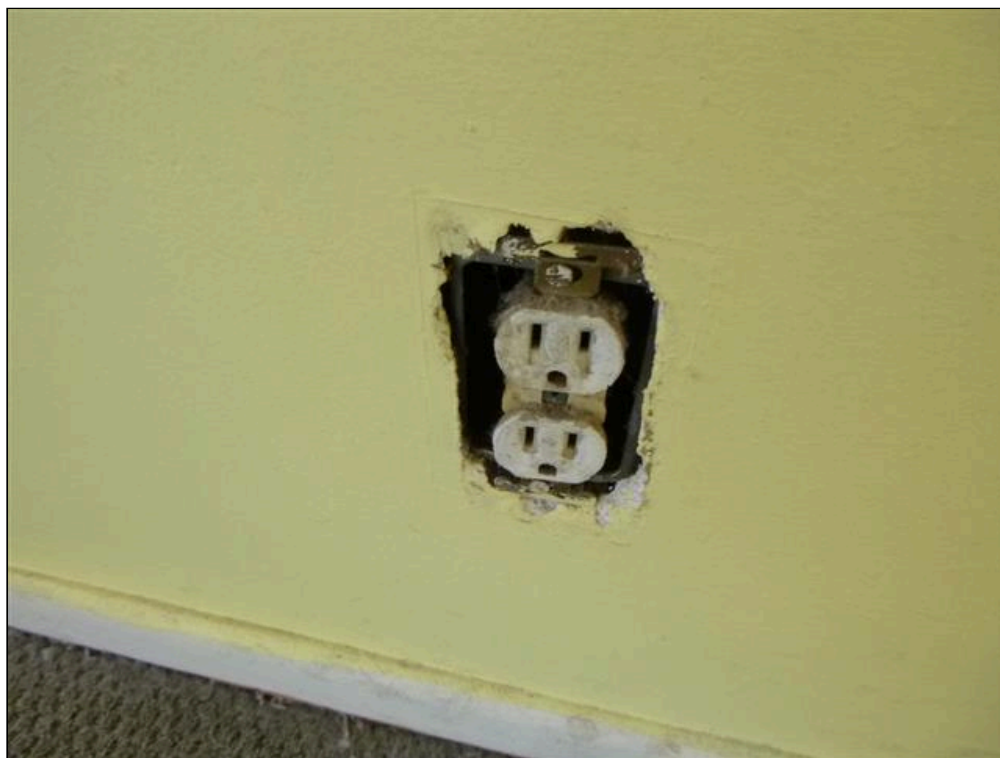
32.6 Item 1(Picture)

(1) Various outlet cover(s) are missing, suggest installation for safety.

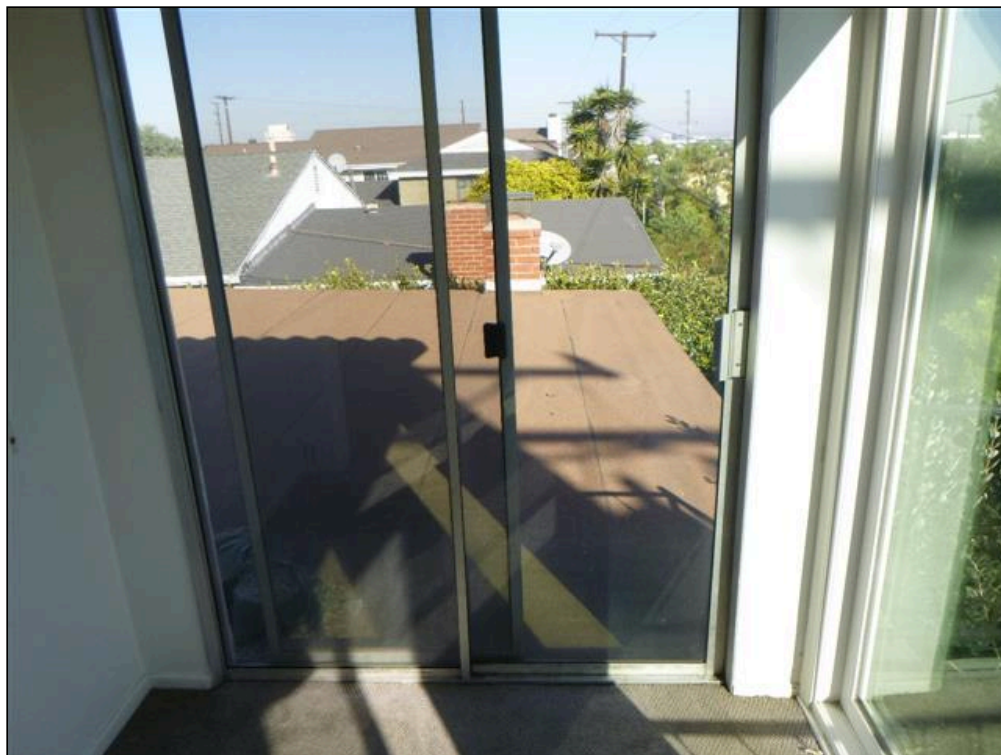
32.8 Item 3(Picture)

(2) A potential safety/fall hazard was noted due to the sliding door exits/leads out to the sloped roof area ( no railing is installed at the roof area ). Suggest review with a licensed contractor to seal/screw the door closed to prevent access to the roof area as needed.
