Inspection report for the property at  
1421 Pontiac Street, Oakdale, CA 95361

This report is prepared exclusively for **Garrett Maxwell**  
Inspected On: **04-26-2024**

Baker Inspection Group  
209-522-5320

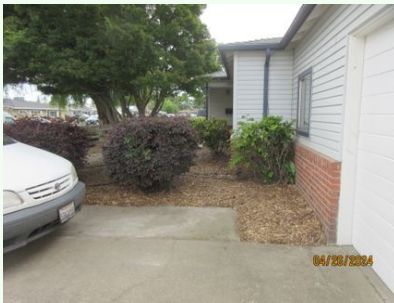
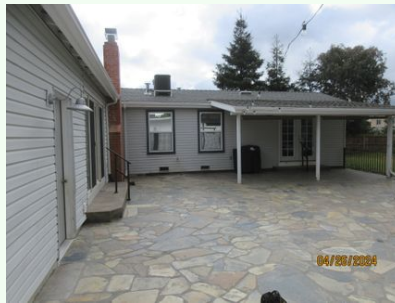
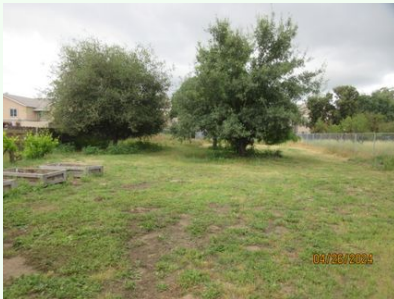
**Q (SEF-1) Due Diligence:** The building is situated on a generally flat lot. This could lead to seasonal drainage problems. Recommend inquiring with the sellers and or building department for any history of water problems on the site.

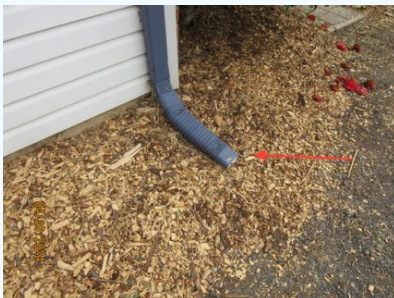
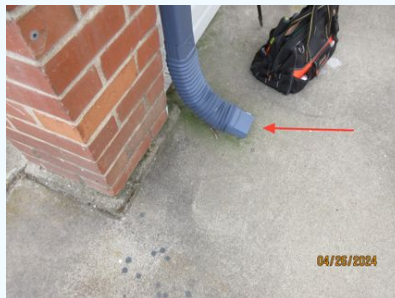
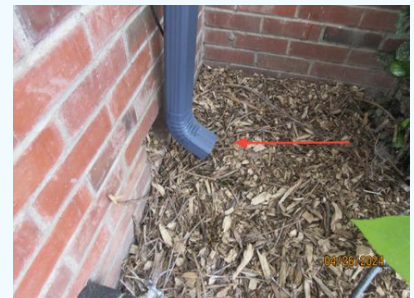
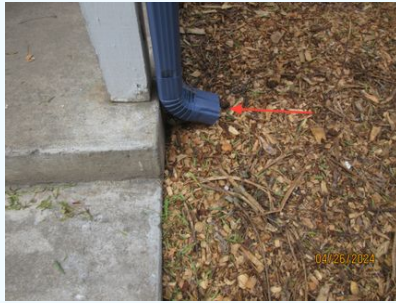
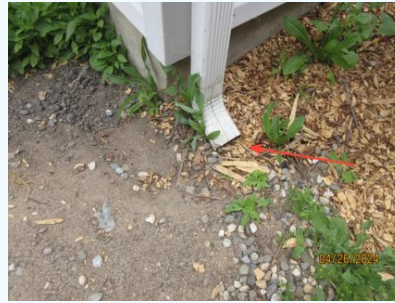
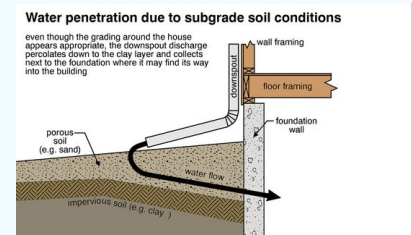
**🏠 (SEF-2) Improvement:** Downspouts were discharging adjacent to the foundation. This can cause foundation settlement or Crawlspace moisture problems. Make sure all downspouts discharge into a proper tight-line system that diverts water at least 5-feet away from the foundation.

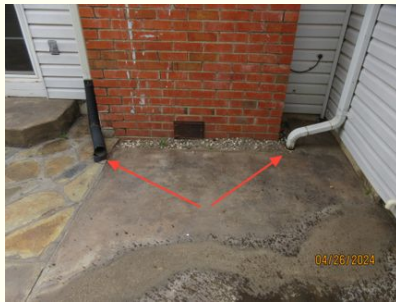
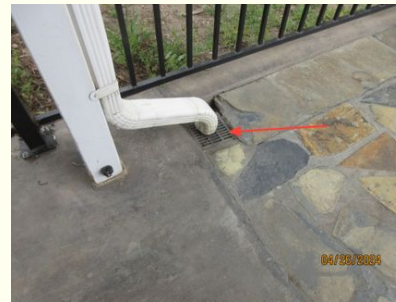
**(SEF-3) Recommended Maintenance:** Some of the downspouts on this home were noted to be discharging into area drains. No evidence of failure was noted, but these pipes are prone to clogging, backing up and below ground failure. Monitor after heavy rains. Failing sub-surface storm drains are one of the most common reasons for concrete slab and Crawlspcace moisture problems and can even lead to structural settlement.

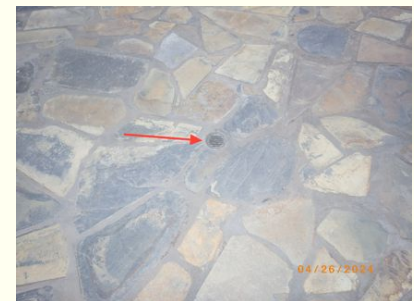
**(SEF-4) Recommended Maintenance:** Important area drains were noted around the property at the rear of the house. These are designed to capture surface runoff and divert water around the building. Be sure to keep these drains clear, especially before large rain storms.

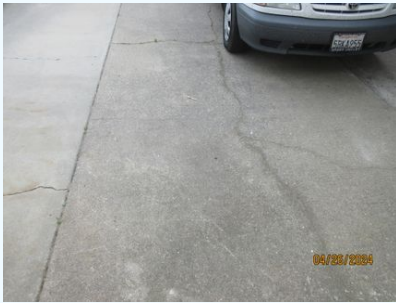
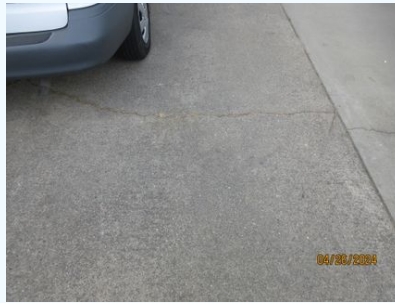
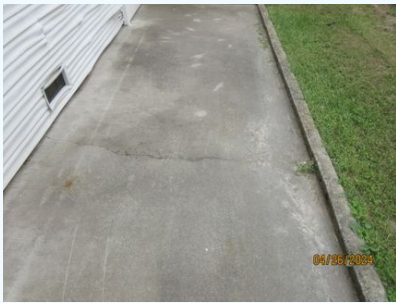
**(SEF-6) Improvement:** Cracks were noted in the driveway and walkway flatwork at the front and right side of the house. No immediate repair appears necessary, though water will continue to deteriorate the surface until the flatwork is repaired or replaced.

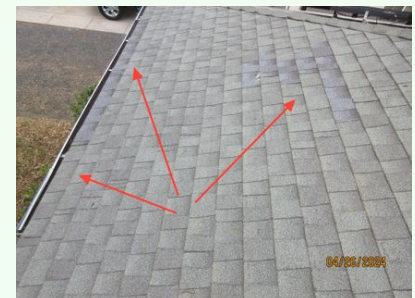
**Q (RC-4) Due Diligence:**  
The asphalt composition roof shingles have been repaired. We were unable to determine if these repairs will prevent damage to the underlying roof structure from moisture intrusion. Recommend further evaluation as needed.

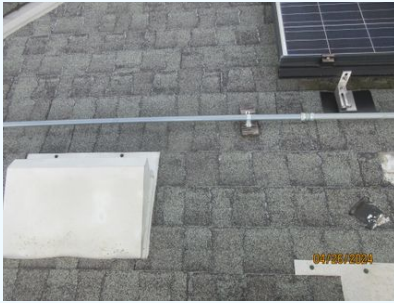
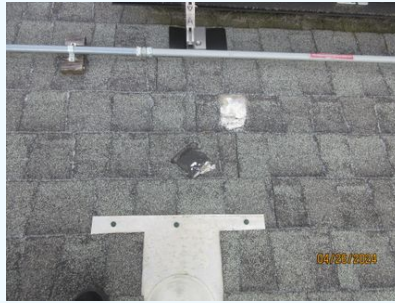
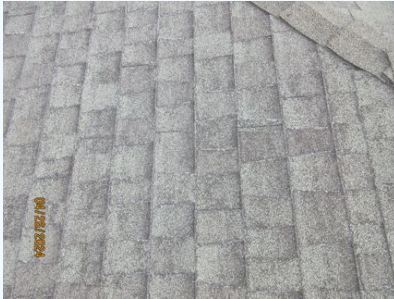
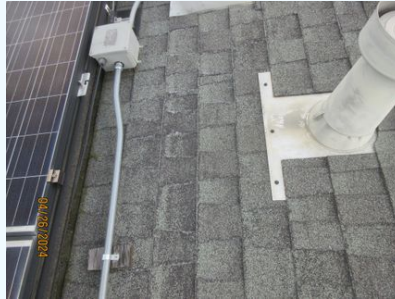
**🏠 (RC-5) Improvement:** The asphalt composition shingles covering the roof of this house were old, appeared to be past the mid point of their long-term service life. Recommend further

evaluation as needed.

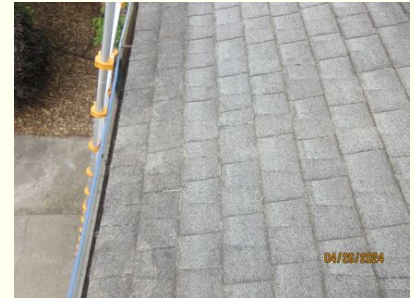
#### (RC-6) Recommended Maintenance:

Moss build-up was noted on the roof. This is bad for the roof covering and decking as it can trap moisture on the roof and can inhibit drainage off the roof. Moss removal is recommended. Products such as Tide are not recommended as the bleach in these products can deteriorate the shingles. Pressure washers should not be used to clean the moss as they can damage the shingles unless the moss has been killed prior to washing. Only low pressure should be used to clean the roof of moss and chemicals should be used to kill the moss prior to removal. One product people use to kill the moss is baking soda. Recommend a professional clean and service this roof to ensure proper control of roof runoff and proper drainage off the roof.

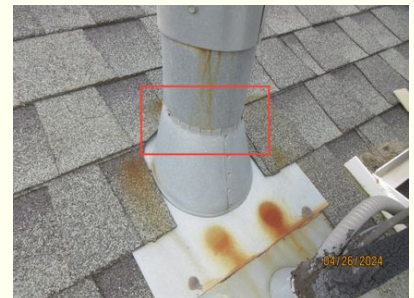
### **(RC-10) Recommended Maintenance:**

The vent at the roof required proper sealing around the perimeter of the piping / vent and the roof flashing.

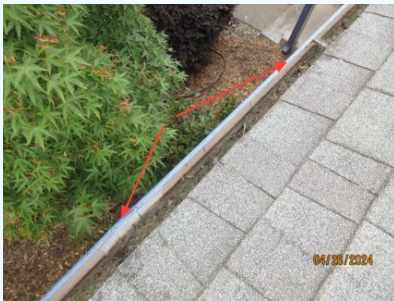
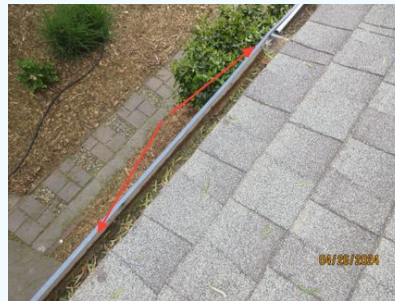
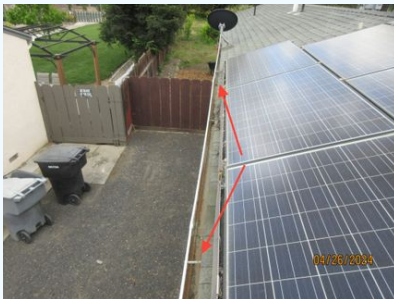
**(RC-13) Improvement:** The gutters had corrosion visible at the areas around the house. Continued corrosion will eventually result in leaking gutters. Good maintenance practices will help extend the long-term service life of the gutters.

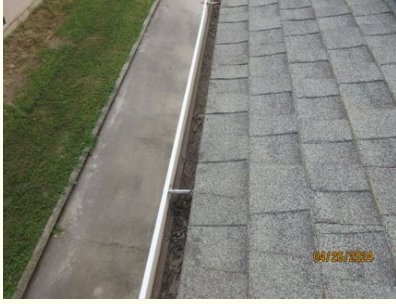
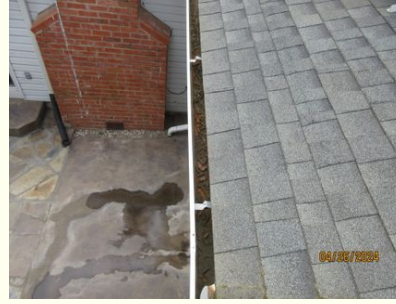
**(RC-15) Recommended Maintenance:** The gutters were filled with organic debris at the areas around the house and require cleaning to ensure proper control of roof runoff. Clean the gutters and ensure they are unobstructed and leak free, this should be routine house maintenance.

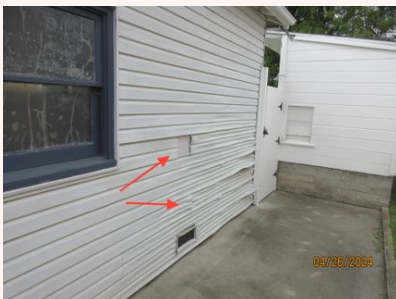
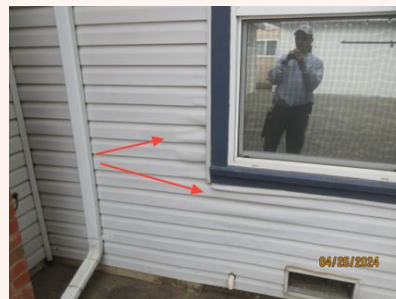
✂ **(EWC-3) Repair/Replace:** The exterior vinyl siding at the right side and rear of the house had areas of damage that should be repaired to prevent moisture intrusion of the exterior wall structure.

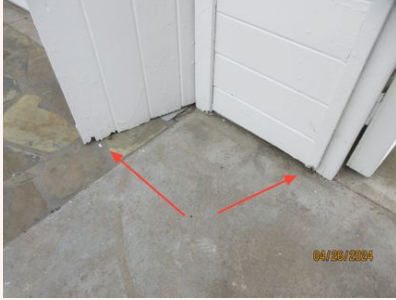
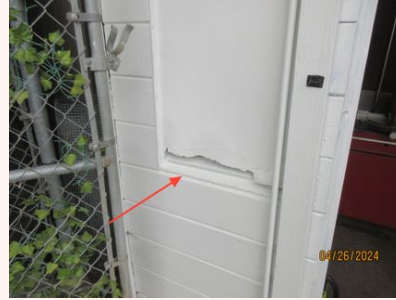
✂ **(EWC-5) Repair/Replace:**

The exterior walls and door at the shop had areas of deteriorated wood siding that should be repaired or replaced to help prevent damage from moisture intrusion.

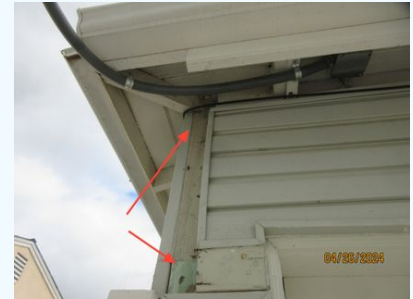
#### **(EWC-4) Improvement:**

The vinyl siding was not properly finished at the rear left corner. Repair as needed.

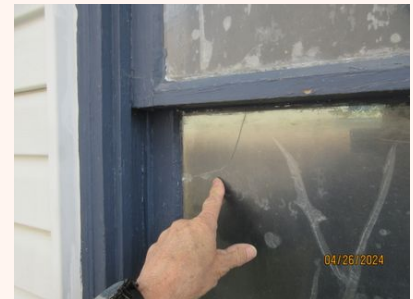
#### **(EWC-6) Repair/Replace:**

A cracked window pane was noted at the right side of the house. This requires window glass replacement for a proper repair. Recommend further evaluation and repairs as needed.

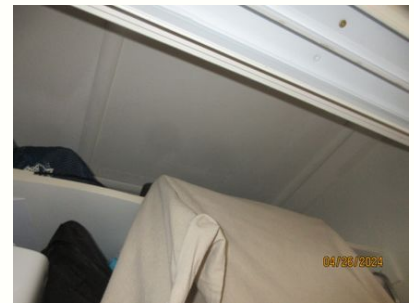
### ✧ (AC-1) Note:

The Attic was accessed through a hatch in the ceiling at the 2nd Bedroom closet.

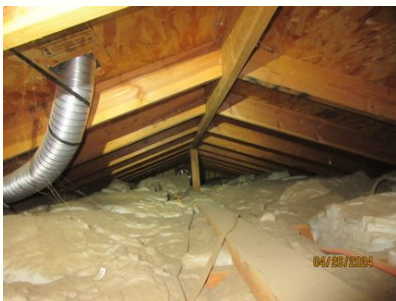
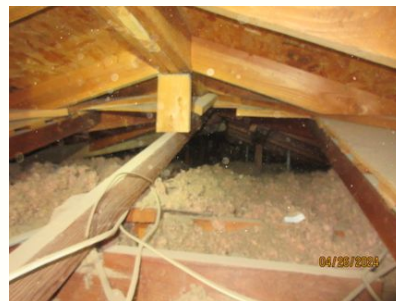
✧ (AC-3) Note: The Attic space lacked adequate headroom for safe entry. As a result, inspection of the Attic space was done from the access hatch location only. Attics may contain potential fire or health hazards, other safety issues, damage, or defects that have the potential to cause damage to the home.

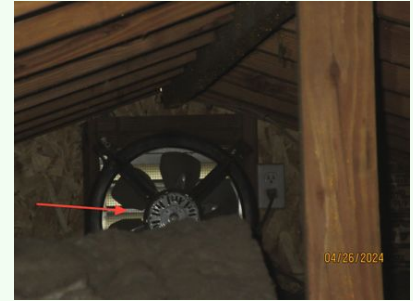
### 🔍 (AC-5) Due Diligence:

Thermostatically controlled vent fan in the Attic may work, but due to the low temperature the unit was not on. Baker Inspection Group could not access or inspect this unit.

*Rear of the house*

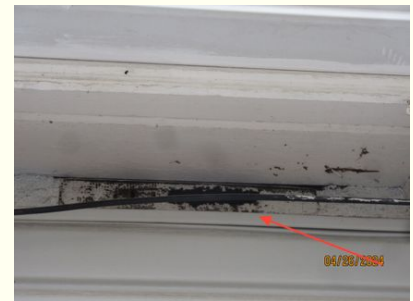
### 🔧 (AC-4) Recommended Maintenance:

The screens that protect the vent openings appeared to be obstructed and require repair to ensure adequate roof cavity ventilation. Use 1/4-inch wire mesh to seal-up openings from rodents and birds and make sure screens are not blocked by paint or other debris. Refrain from using tight-mesh window screen as this can obstruct air flow.

*Left side of the house*

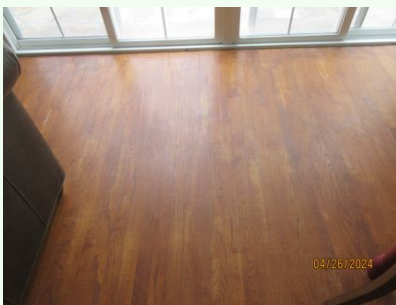
🔍 **(SF-2) Due Diligence:** Minor floor settlement was noted in the house. Inquire with the seller for any history of repairs or movement. No signs of recent movement were visible at the time of inspection.

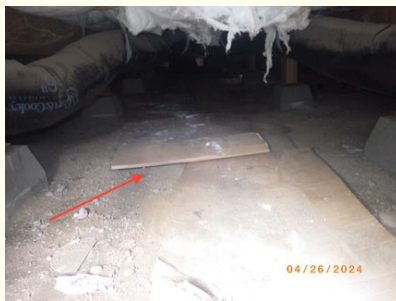
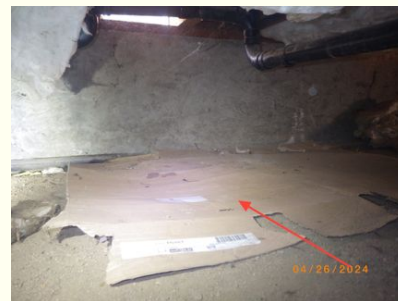
**🔧 (CC-3) Recommended Maintenance:** Clean construction debris from the Crawlspace to eliminate a condition conducive to wood destroying organisms, especially the wood / cellulose debris.

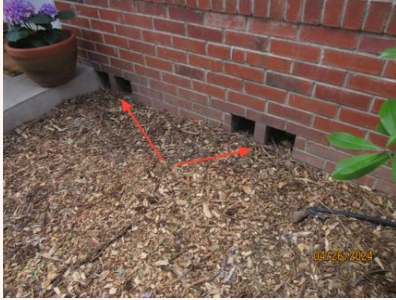
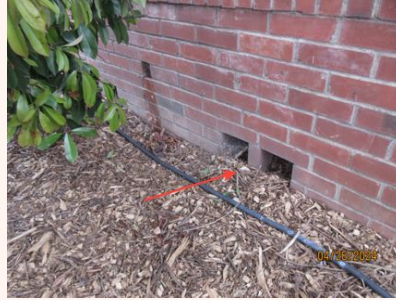
**🔧 (CC-4) Repair/Replace:** The Crawlspace vents have been installed at grade at the front of the

house. The risk here is water entry into the vents. Recommend correcting the grade here so water cannot flow into the vents. Often, digging a small well around the vents can help.

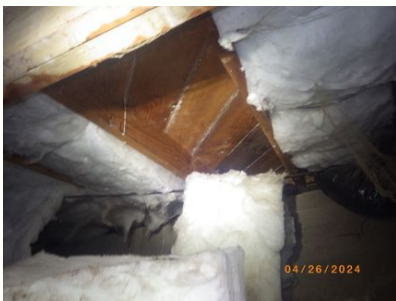
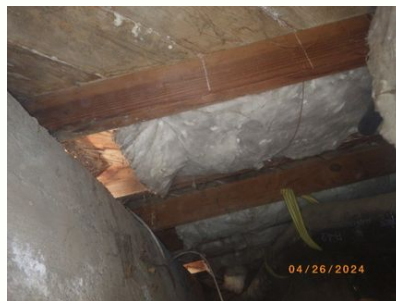
🍃 (CC-6) Energy Efficiency & IAQ: The subfloor insulation was noted to be falling out of the joist bays in a few spots. Implement localized repair and re-support as needed.

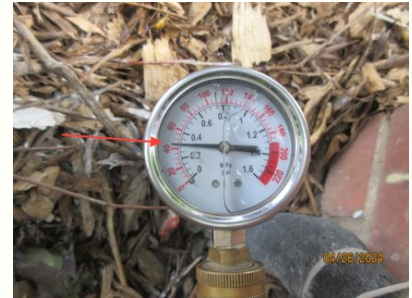
☆ **(PS-5) Note:**

This shows the water pressure (45 PSI) tested during inspection. Generally, "normal water pressure," should be between 40-80 PSI, though pressures near or below 40 PSI can result in poor functional flow to fixtures. Water pressures in excess of 80 PSI risk damaging supply piping components and should be controlled with a pressure reducing valve.

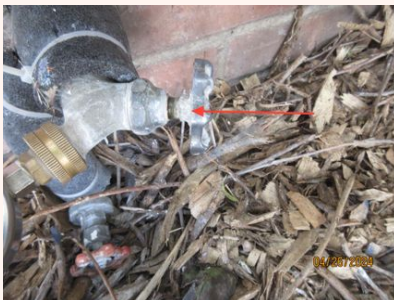
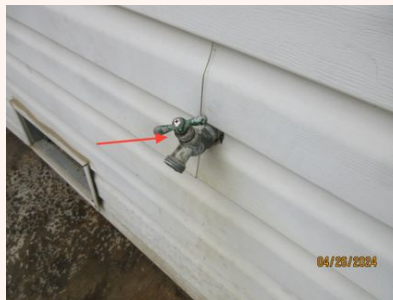
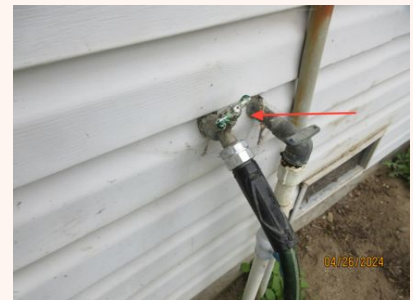
✂ **(PS-11) Repair/Replace:** The leaky hose bibs at the front and rear of the house require repair or replacement - they leaked from the hose bib handle when the water was turned on and under pressure. This often requires tightening the packing around the handle stem.

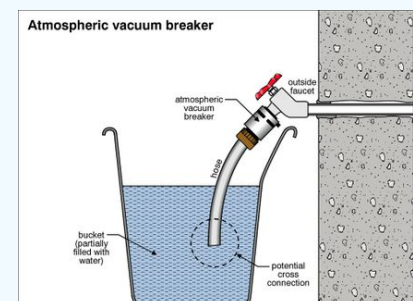
The hose bibs noted on this house were missing anti siphon devices and updating is recommended. Modern hose bibs are typically anti siphon style which can prevent water from your hoses backing into your water supply system. Consider installing anti siphon hose bibs or adding an anti siphon device to the existing hose bibs. The following video shows a vacuum breaker.

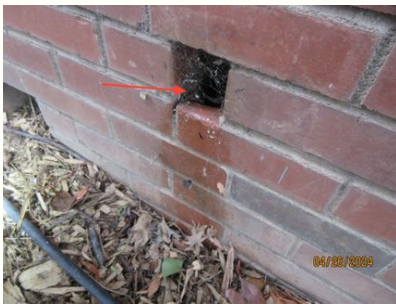
*Front of the house*

☆ **(PS-16) Note:** This shows the location of the sewer cleanouts at the areas around the house.

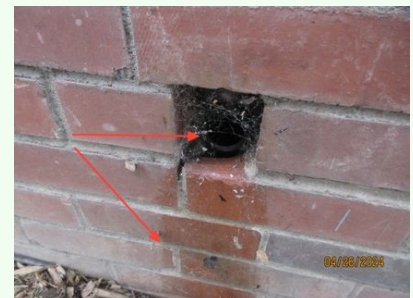
**A video camera sewer scope is recommended.** An evaluation of the sewer line below the ground is beyond the scope of this inspection. A sewer scope is always recommended to further evaluate the sewer line and the below ground connections between the house and the municipal sewer line or septic tank. Sewer scopes are done using video cameras and can reveal the materials, condition and reliability of the sewer line. The front wall cleanout was missing the cap and the wall below

the opening was visibly damp. Prior to closing confirm with the seller on the reasons and if the sewer system has drainage issues.

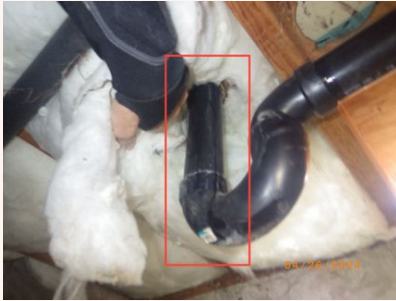
*Main bathroom*

✂ (PS-18) **Repair/Replace:** The drain, waste and/or vent pipes were visibly leaking in the Crawlspace under the Main and Hallway Bathrooms at the time of the inspection should be repaired to prevent the development of unhealthy conditions. Recommend repairs as needed.

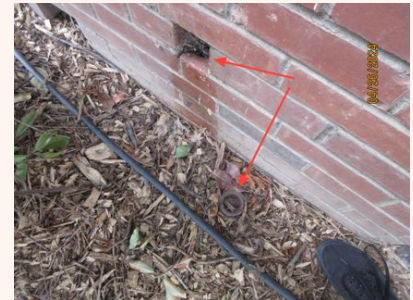
✂ (PS-19) **Repair/Replace:**  
The sewer cleanout in the front of the house was missing a proper cap. This could be a safety hazard and could also lead to debris clogging the waste piping. Recommend repairs as needed.

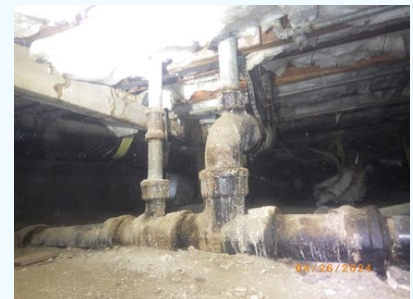
🏠 (PS-20) **Improvement:**  
Drain, waste and/or vent pipes visible in the Crawlspace were corroded. Monitor the pipes on a regular basis to prevent future damage from active leaking. To avoid problems in the future you may wish to have the corroded sections replaced.

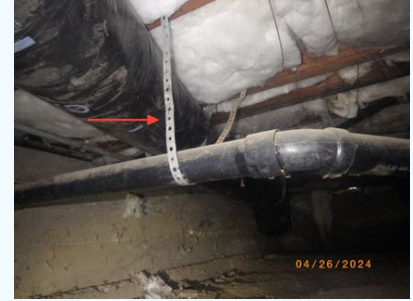
The plastic drain or vent pipes visible at the Crawlspace were supported by wire or plumbers tape. These are improper materials as they may cut the plastic pipe and will not resist upward thrust. Recommend repairs as needed.

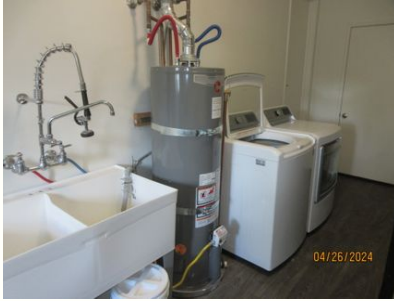
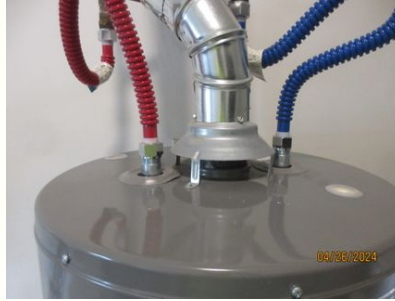
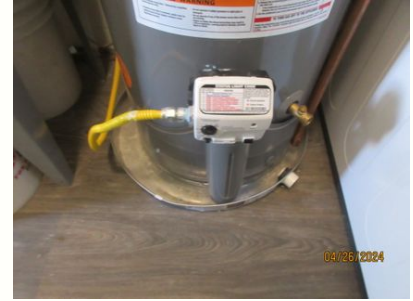
**(WH-1) Note:** This shows the location of the water heater at the Laundry area.

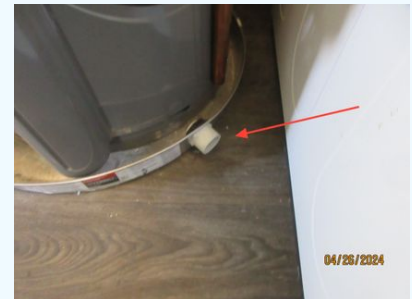
A drain pan has been installed below the water heater, but no drain piping was noted for the pan. A drain pan is recommended under water heaters that are located in finished spaces or where a leak could damage finishes. A pan without drain piping is often of limited benefit / protection. For improved protection from accidental water heater leaks, and where a drain is difficult to install, consider a pan with a moisture alarm and a flood-safe device such as this: [Watts Water Heater Leak Prevention](#).

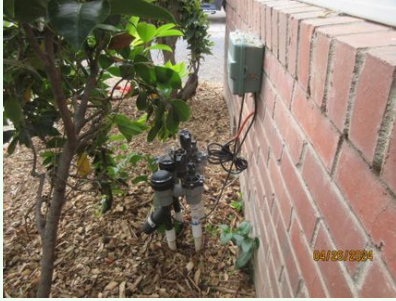
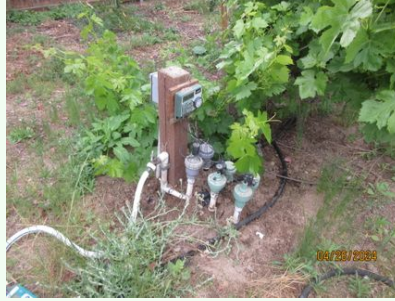
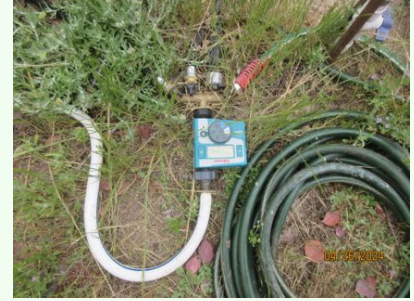
🔍 **(AP-1) Due Diligence:** An exterior irrigation system was noted. Sprinkler systems are beyond the scope of this inspection. Irrigation systems require annual attention / repair / servicing after every winter. When testing the system, be sure sprinkler heads are adjusted so the system is not watering the side of the house. Recommend further evaluation as needed.

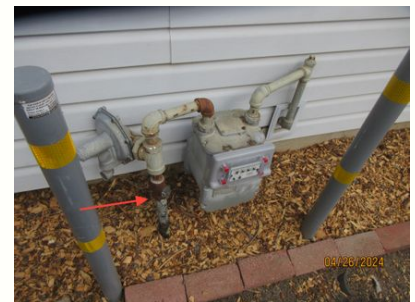
This shows the location of the gas main valve shut off at the left side of the house.

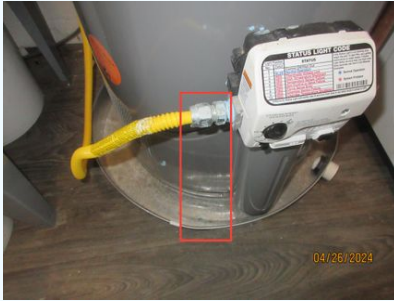
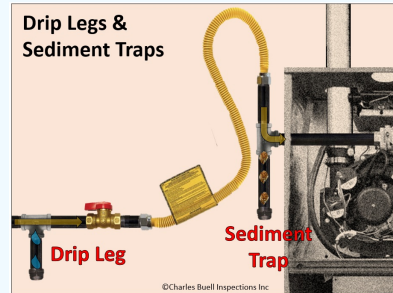
**(FDS-3) Improvement:** There was no sediment trap found for the gas pipe at the gas water heater. Sediment traps are designed to prevent fouling of gas equipment by allowing sediment to fall out of the gas supply. [Sediment traps](#) are required at all automatically controlled gas appliances. Recommend further evaluation and repairs as needed.

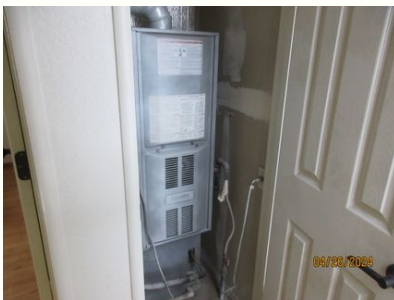
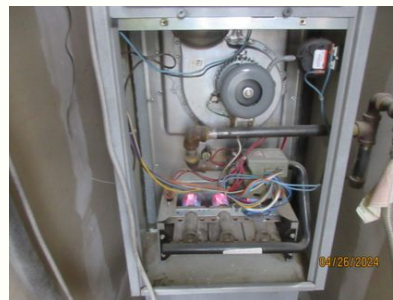
**(HS-1) Note:** This shows the location of the heating system at the interior closet.

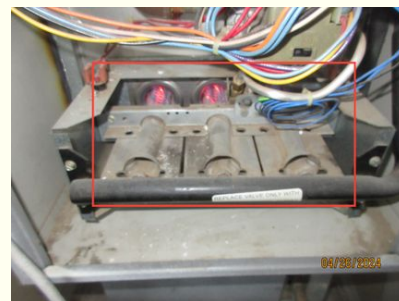
The furnace burner assembly needed cleaning at the time of the inspection. This condition can reduce heating efficiency and increase heating costs.

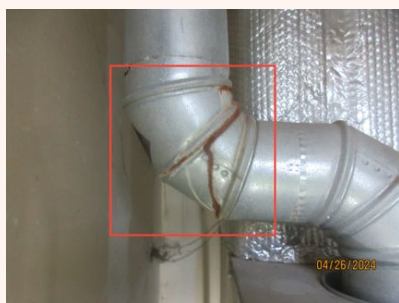
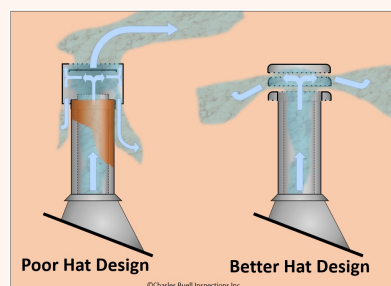
🔧 **(HS-7) Repair/Replace:** The metal flue for the furnace was corroded and requires repair or replacement. Have this further evaluated and repaired as recommended. Please note that often a poor cap design can result in premature deterioration of the flue.

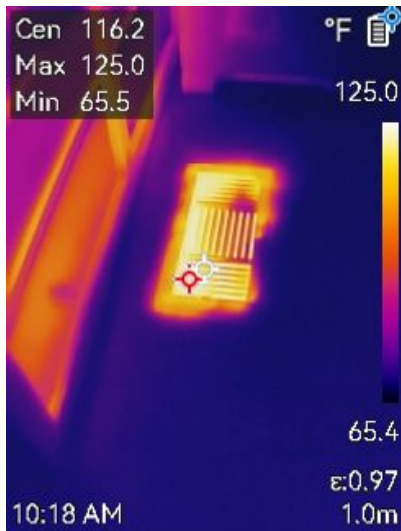
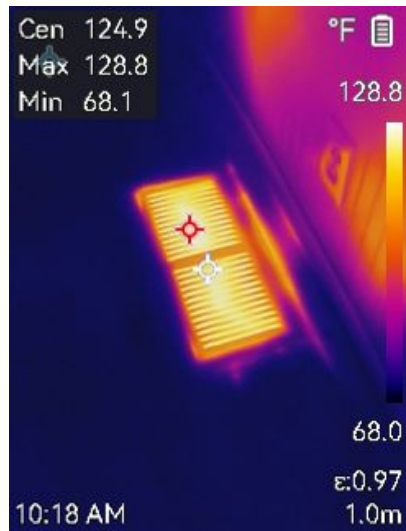
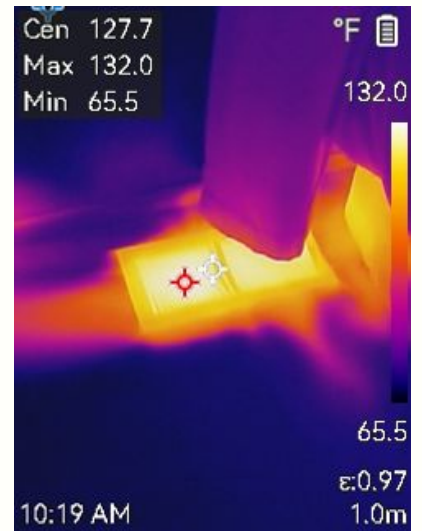
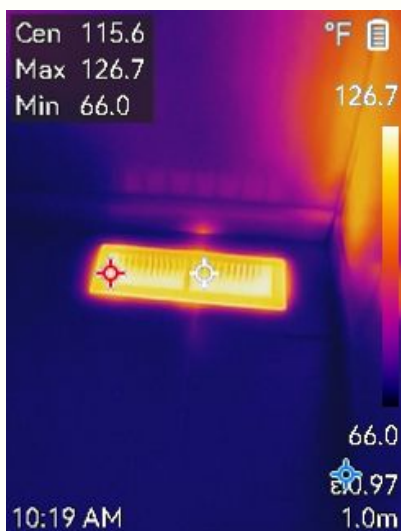
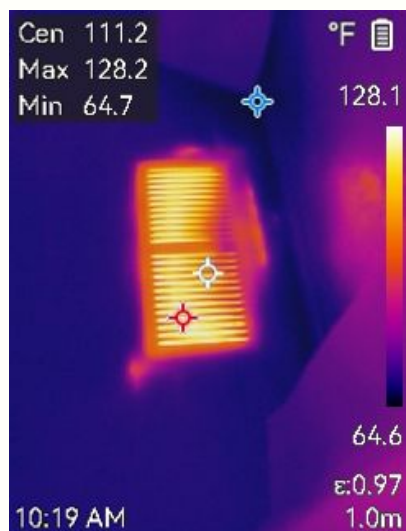
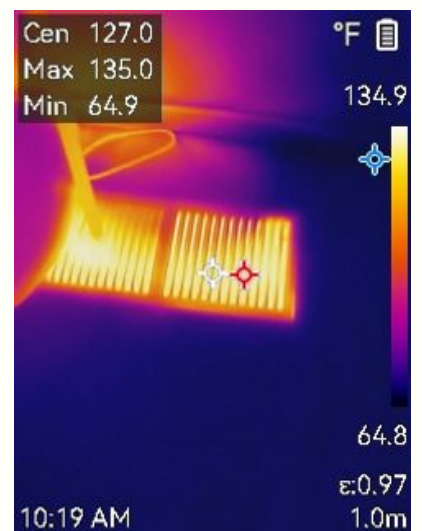
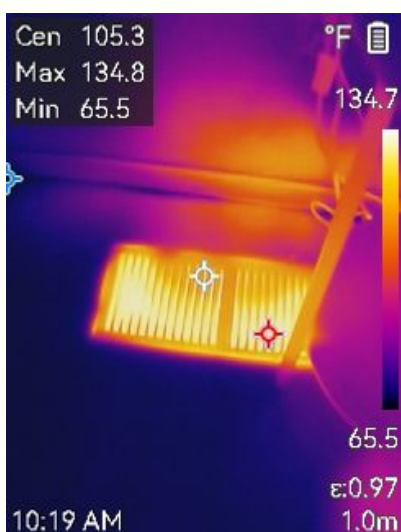
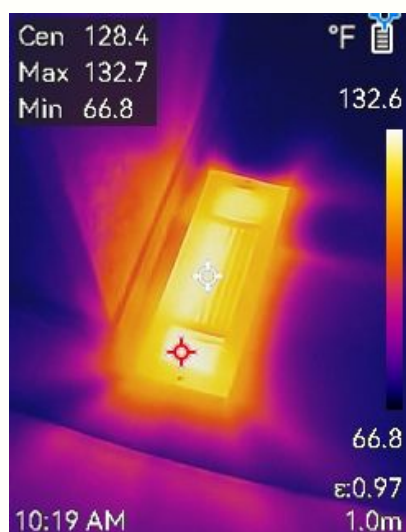
☆ **(HS-8) Note:** The pictures illustrate that the heating equipment responded to operating controls at the thermostat when placed in the heating mode. Heated air was discharging from all supply air registers (representative amount shown) unless otherwise noted. No further equipment diagnostics were performed as part of this home inspection.

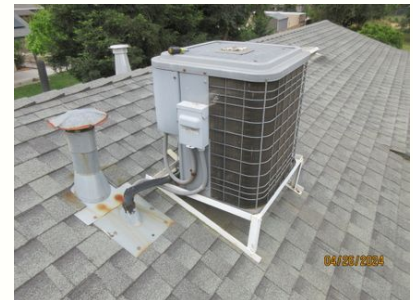
This shows the location of the cooling system at the rooftop.

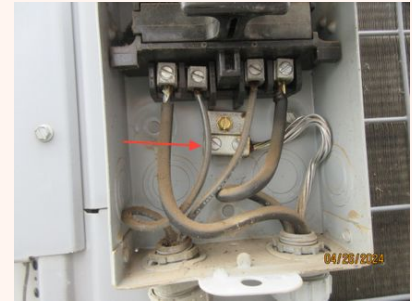
The air conditioner was missing a grounding conductor (only two visible) at the electrical disconnect. Recommend further evaluation and repairs as needed.

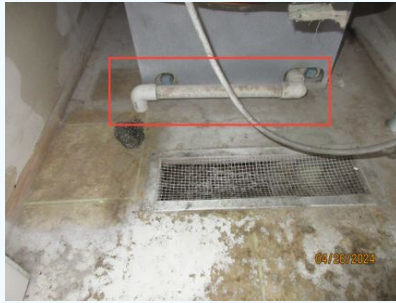
🏠 **(CS-7) Improvement:** The condensation line designed to properly dispose of condensate produced by the operation of the air-conditioning evaporator coils was improperly configured. Recommend repairs as needed.

The cooling system evaporator coil had no condensate overflow warning/shutoff device installed. If the condensate drainage system should fail, this condition could result in moisture damage to the home. Recommend that a proper condensate overflow/shutoff device be installed. [Click here for information](#)

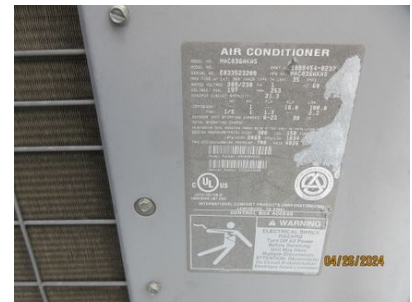
This shows the data plate for the air conditioner.

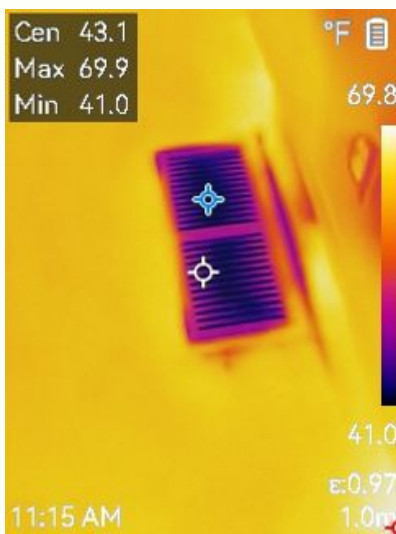
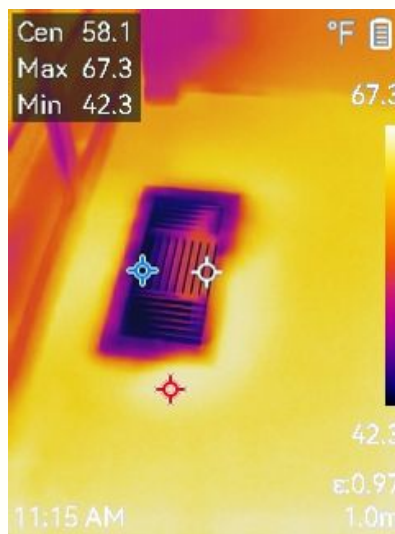
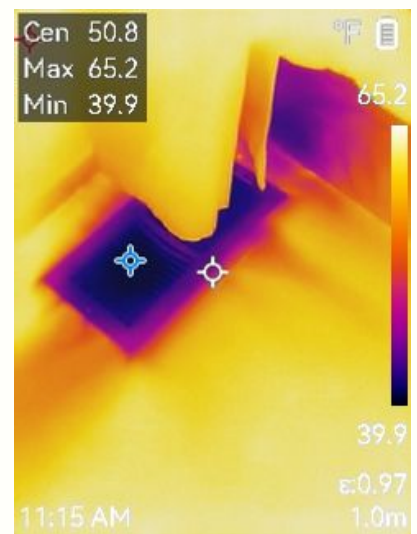
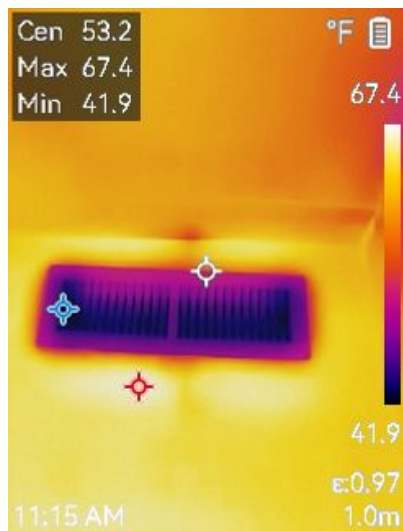
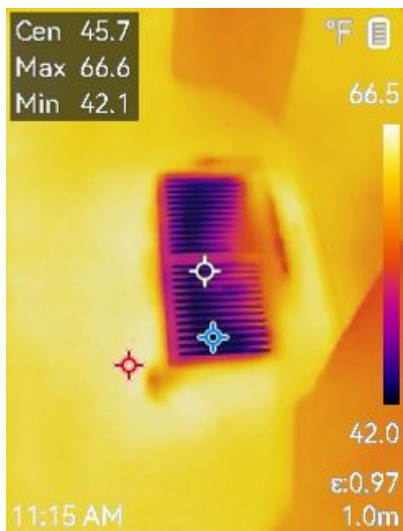
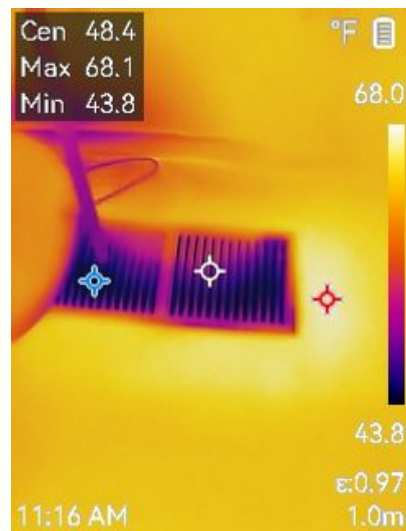
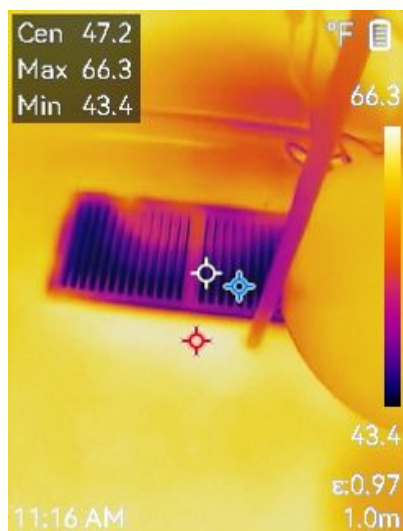
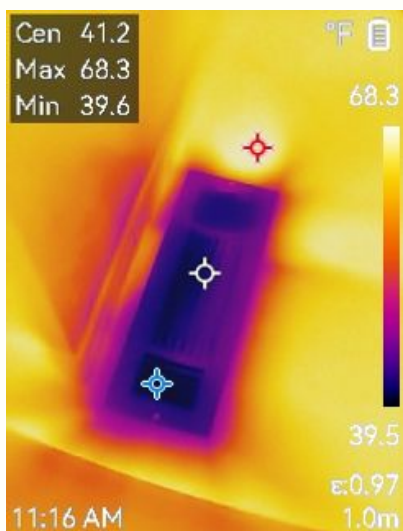
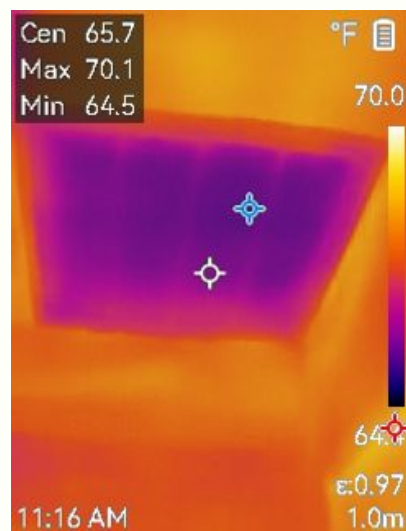
☆ **(CS-9) Note:** Thermal images show approximate temperatures at the cooling registers. These images just show the system was generally functioning during inspection. These are representative photos.

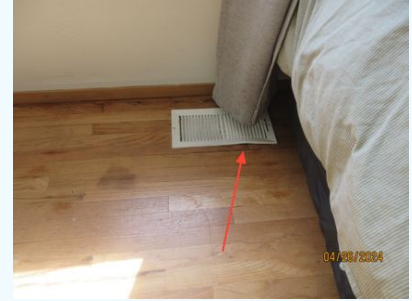
The heating / cooling register cover was bent at the 3rd Bedroom.  
Repair as needed.

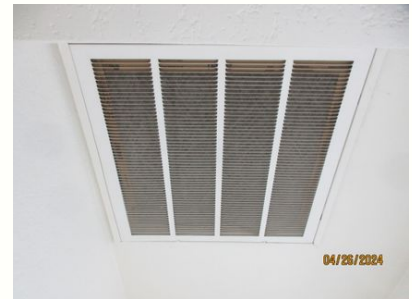
The furnace filter was located at the cold air return.

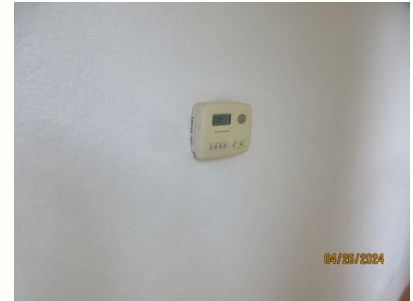
The heating and cooling systems were controlled by a programmable thermostat. Heating and cooling costs can be reduced by programming the thermostat to raise and lower home temperatures at key times.

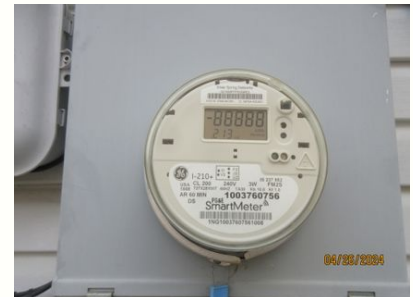
This shows the electrical meter.

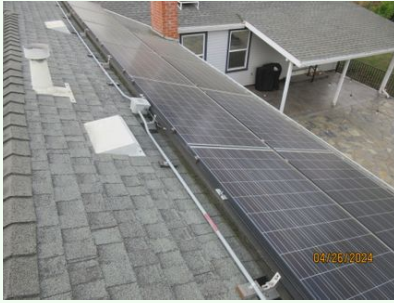
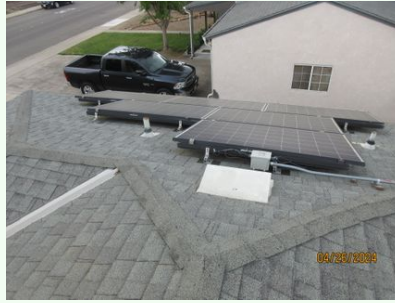
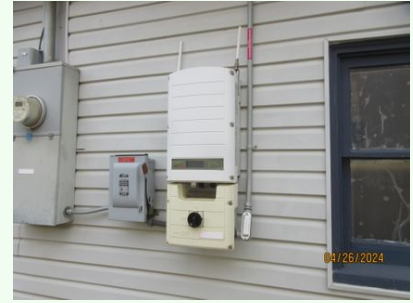
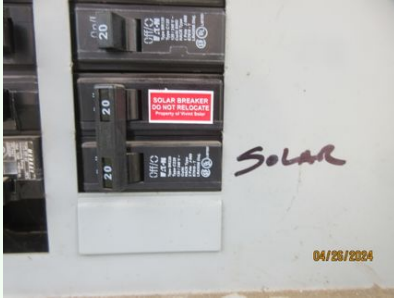
🔍 **(MES-2) Due Diligence:** This house had a solar photovoltaic system installed. Photovoltaic or

PV systems convert the sun's energy into electricity. Inspection and evaluation of solar installations are beyond the scope of this inspection. Recommend inquiring with the seller for any additional maintenance, installer, and warranty information.

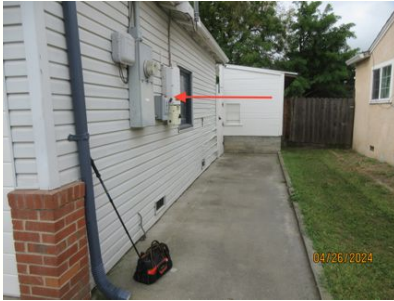
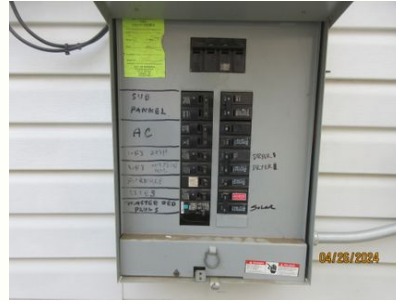
✧ **(MES-4) Note:** This shows the location of the main electrical panel at the right side of the house.

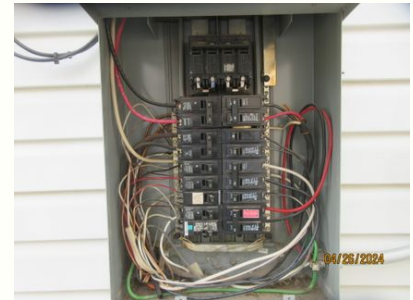
✧ **(MES-5) Note:**  
Main electrical panel wiring.

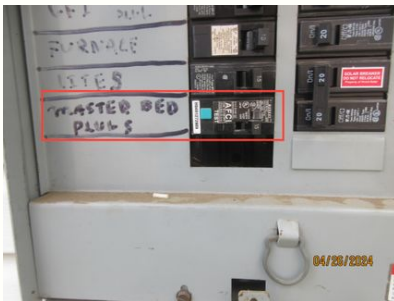
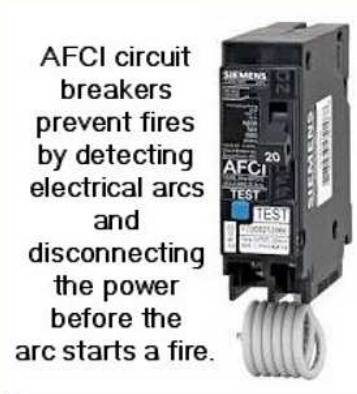
✧ **(MES-6) Note:** The main electrical panel contained Arc Fault Circuit Interrupter (AFCI) breakers designed to provide fire protection by shutting off current flow should sensors detect arcing at outlets on the protected circuit. AFCI protection of electrical outlets in sleeping rooms is required in new construction.

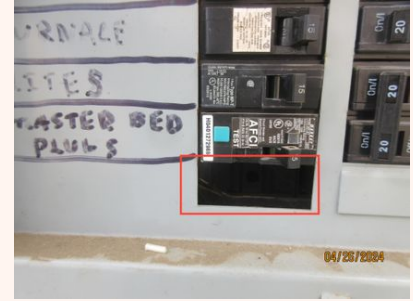
Openings were noted in the sub-panel dead front cover. This is unsafe as it does not adequately protect the energized area of the electric panel. Cover all open knock-outs with listed covers.

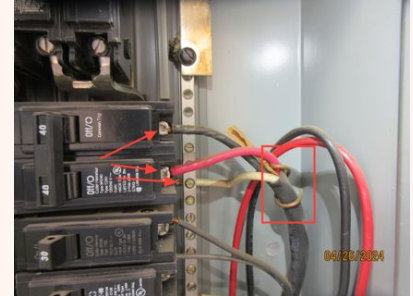
The upper 40 Amp 2 pole breaker feed did not have the grounding conductor landed in the panel, it was coiled around the wiring. Recommend further evaluation to determine if this is proper.

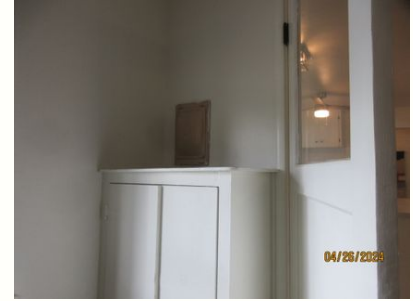
This shows the location of the electrical sub-panel at the Laundry area.

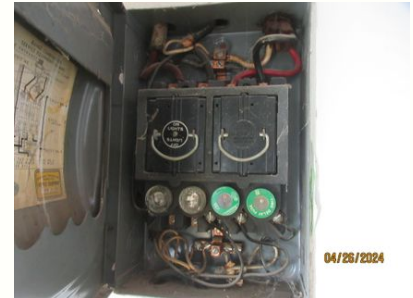
Sub-panel wiring at the Laundry area.

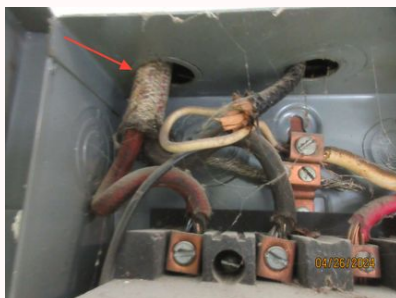
⚠ **(S-4) Major Concern:** Currently all sub-panels are required to be fed with four wires (two hots, a neutral and a ground). The fourth ground conductor can be done with metal conduit, no metal conduit was visible here. The sub-panel here appears to be a three-wire feed. Recommend further evaluation and repair by a Qualified Electrical Contractor. On sub-panels it is important that neutrals and equipment grounds be separated to control stray voltage. To accomplish this, you generally need a four-wire feed. There are some cases where three-wire feeds can be used for outbuildings, but never when the sub-panel is located within the same structure.

*Undetermined if this is incoming line*

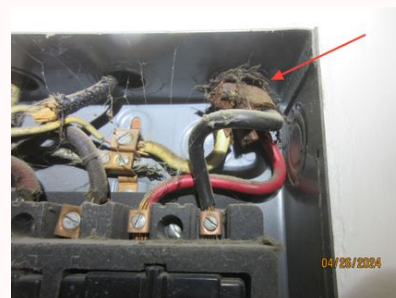
*Undetermined if this is incoming line*

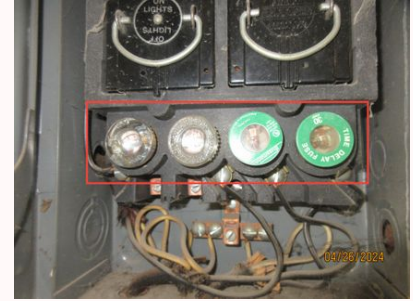
Fuse socket(s) in the sub-panel contained fuses that exceeded the typical installation standards. Branch wiring circuits are typically rated at 15 Amp or 20 Amp, the fuses in the panel were 25 Amp or 30 Amp. This condition is typical of a circuit in which fuses constantly burn out due to an electrical problem with the circuit. The fuse is removed and a fuse of a higher rating is inserted in its place to provide constant power to the affected circuit. Without the correct fuse, this circuit is no longer protected from overheating and is a potential fire hazard. Recommend evaluation and any necessary repairs be performed by a Qualified Electrical Contractor.

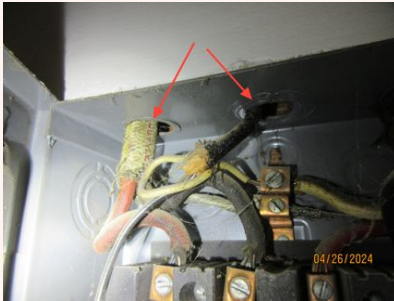
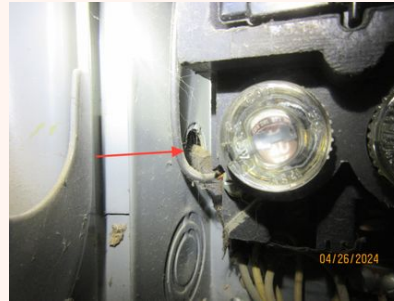
🔧 (S-6) Repair/Replace: Grommets or bushings were missing at the sub-panel and are needed to protect the non-metallic sheathed cable where the wiring enters the electrical panel and provide strain relief. Recommend further evaluation and repairs as needed.

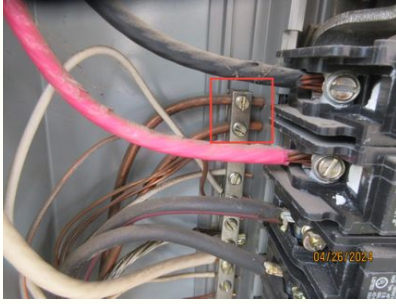
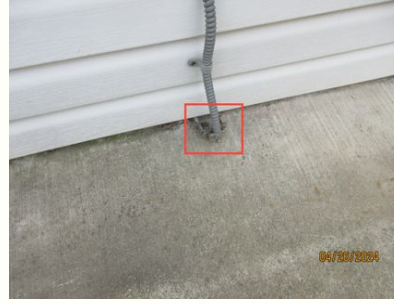
✦ (GB-1) Note: Ground rod connections were noted at the exterior. The ground rods looked to be fully driven and connections looked standard,

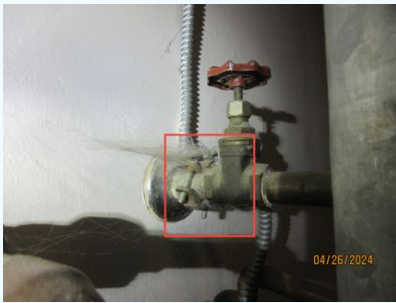
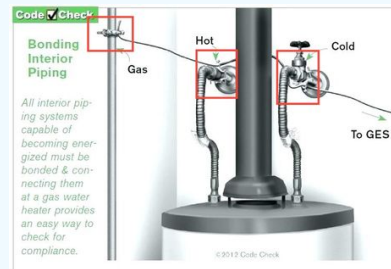
**(GB-2) Improvement:** Metal cold water distribution pipes appeared to be properly bonded. Metal hot water pipes were not bonded. Electrical bonding of the water pipes helps to ensure that safe conditions exist if the pipes somehow come into contact with electrical wiring and become energized. Bonding of water pipes is required in new homes by generally-accepted modern safety standards. Although it may not have been required at the time the building was originally constructed, as a safety measure the Inspector recommends that the hot water pipes be bonded also.

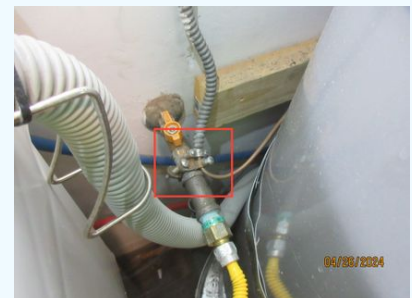
**(GB-3) Improvement:** At the time of the inspection, the gas piping appeared to be bonded to the water piping only.

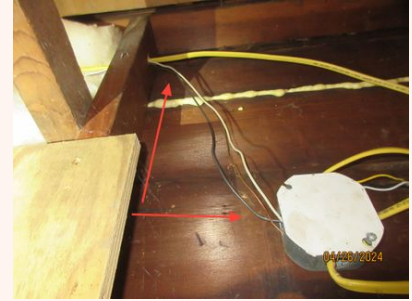
The wiring was not properly protected by a sheathing or conduit at the shop. This is a potential safety hazard. Repair as needed.

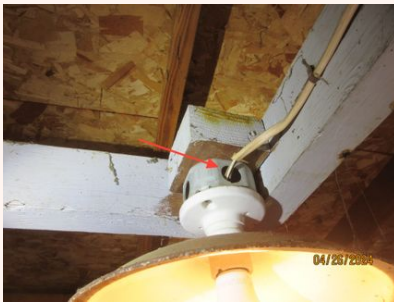
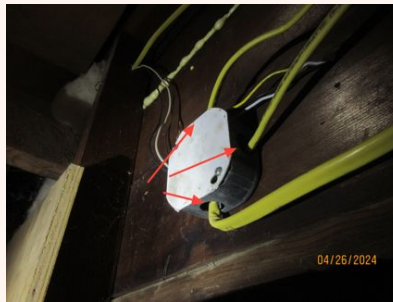
✂ (EDF-5) Repair/Replace: The non-metallic sheathed cable was poorly run into the junction boxes at the shop and has not been properly restrained, protected or sleeved. Also, check for additional boxes that could have a similar condition as most boxes are not visible to inspection. Wiring cable should have proper clamps to protect and secure the wire where it enters the junction box. Recommend further evaluation and repairs as needed.

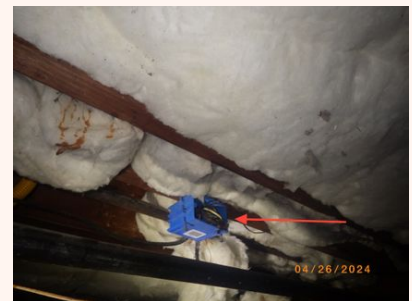
At the time of the inspection, cover plates were missing at the Crawlspace. This condition left energized electrical components exposed to touch. Recommend that listed cover plates be installed.

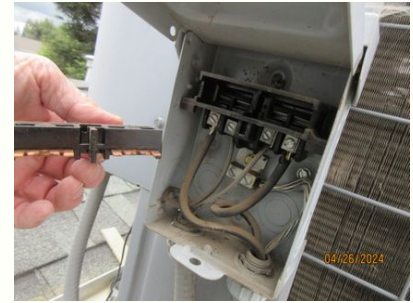
This shows the electrical disconnect for the A/C compressor unit.

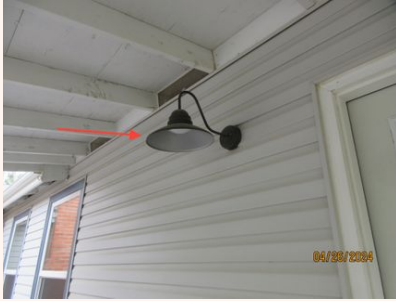
*Rear of the house*

✂ **(EDF-10) Repair/Replace:** Multiple inoperative lights were noted at the rear of the house, Garage and shop. This is likely due to bulbs being burned out or functional with a photo sensor, but could be due to an inoperative fixture, circuit or switch. Replace bulbs or repair lights as needed.

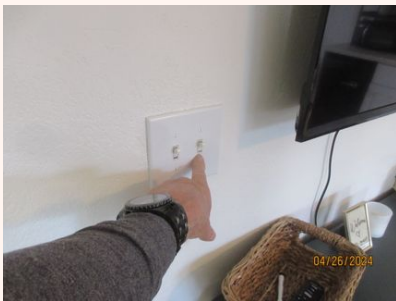
*Main bedroom*

✂️ **(EDF-11) Repair/Replace:** I was unable to determine what device was controlled by switches at the Main Bedroom, Garage and shop. They may connect to future ceiling fans. Switches sometimes control exterior lights which are controlled by photo sensors and will operate only at night or only the upper or lower half of an interior switchable receptacle. Tracing the devices controlled by all switches exceeds the scope of the general home inspection. Recommend further evaluation as needed.

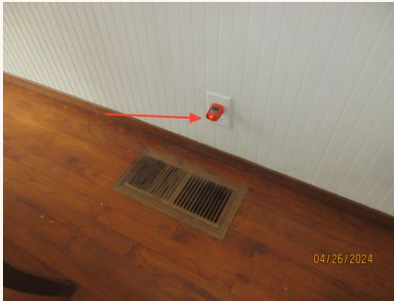
*Dining room*

✂ (EDF-12) **Repair/Replace: Recommend a Qualified Electrical Contractor repair all open grounds** throughout the house. This is a common condition in older buildings (prior to 1962) where three prong receptacles have been installed on an older two wire system. This creates a safety hazard; appliances that rely on an equipment ground to discharge a fault can be plugged into ungrounded circuits. This disables the important safety feature of an equipment ground. Proper repair can include:

- Running an equipment grounding conductor or a new three-wire circuit
- Restoring a two-prong receptacle or
- Installing GFCI protection for this circuit and labeling the open ground receptacles

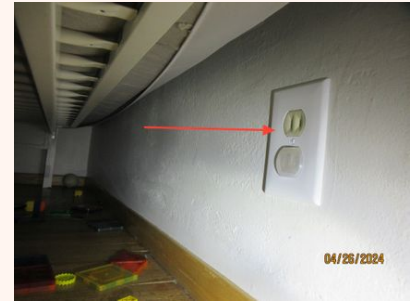
*3rd bedroom*

Several electric receptacles in the house were an older, ungrounded, two wire system. Though there is nothing wrong with this configuration you may find it inconvenient in some areas, especially in offices and media areas. In general, this indicates an older electrical system that has not been updated and may not safely or reliably meet modern demands and expectations for the wiring system. Recommend further consultation about options for updating this older wiring.

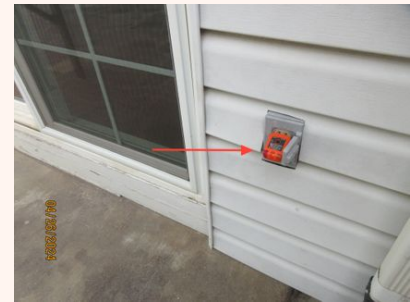
Reverse polarity was noted at the rear of the house electrical receptacle. This is when the hot and the neutral wires have been wired backwards. This is a potential safety issue that should be further evaluated and corrected as needed.
