Inspection report for the property at  
1421 Pontiac Street, Oakdale, CA 95361

This report is prepared exclusively for **Garrett Maxwell**  
Inspected On: **04-26-2024**

Baker Inspection Group  
209-522-5320

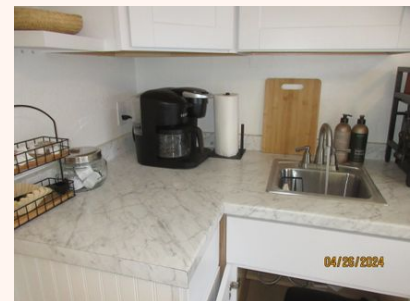
The house interior had ground fault circuit interrupter (GFCI) protection where needed except for the Kitchen, Hallway Bathroom, Laundry area, Garage and bar sink which had none. Although GFCI protection may not have been required at the time the home was built, for safety reasons, Baker Inspection Group recommends that electrical receptacles located in Basements, Cellars, Crawlspace, Garages, and interior receptacles located within 6-feet of a plumbing fixture be provided with ground fault circuit interrupter (GFCI) protection in good working order to avoid potential electric shock or electrocution hazards. This can be achieved relatively inexpensively by: 1. Replacing an individual standard receptacle with a GFCI receptacle. 2. Replacing the electrical circuit receptacle located closest to the overcurrent protection device (usually a breaker) with a GFCI receptacle. 3. Replacing the breaker currently protecting the electrical circuit that contains the receptacles of concern with a GFCI breaker.

*Missing at bar sink*

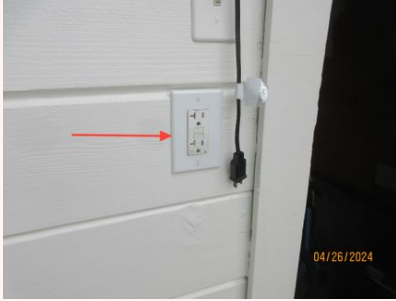
⚡ (EDF-16) Repair/Replace: The exterior electrical receptacles at the shop were not enclosed in weather-resistant covers. Recommend repairs as needed.

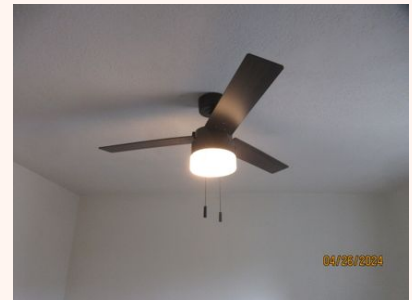
The ceiling fan blades were not functional at the 2nd Bedroom. Recommend further evaluation and repairs as needed.

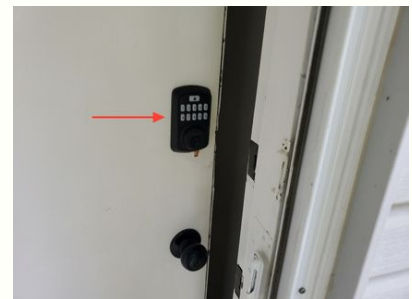
The front door had a combination code actuated deadbolt.

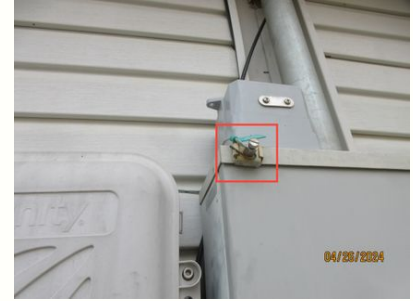
Current regulations require an "Inter-System Bonding Terminal" to be installed as a place for the low voltage utilities to run their ground wires to. It will be attached to a #6 minimum copper ground wire run to the location from the service equipment. Such a terminal was found during inspection.

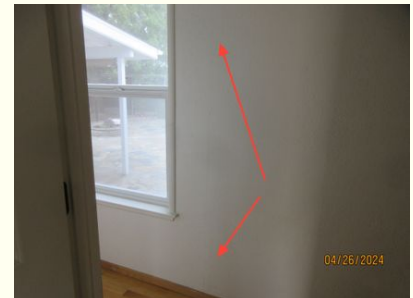
Cracks were noted in the walls at the Hallway. These were straight line cracks and no other indications were found to indicate settlement. Cracking lines like these can be due to routine settlement or moderate seasonal expansion and contraction of the structure. Cracks like these can also be related to workmanship and nailing of framing and sheetrock or deflection from the framing. The seasonal types of cracking can be most problematic as they will tend to re-open after repair. Repair and paint cracks as needed and monitor.

*At the addition?*

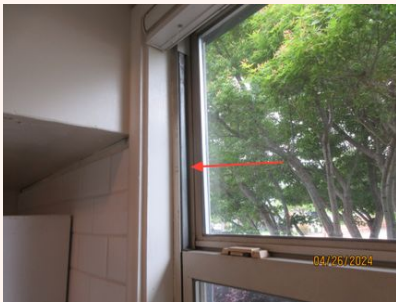
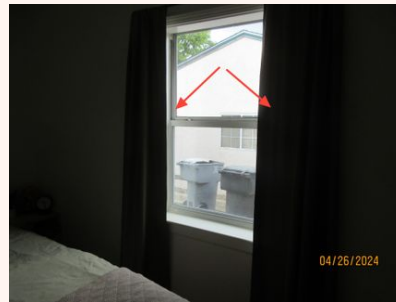
**🔧 (IC-4) Repair/Replace:** The window balancers that help the single hung windows to move up and down were damaged or disconnected at the Kitchen and 2nd Bedroom and need to be repaired so the windows will operate smoothly. Please note that these windows are designed to be able to disengage the springs so that the window frames can be removed for cleaning and balancers can be replaced.  
[CLICK HERE](#) for a how to video.

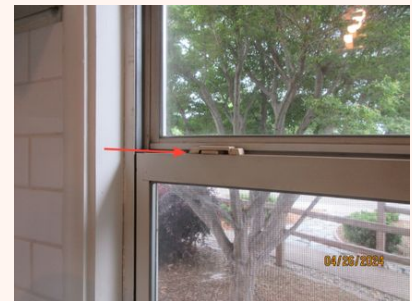
**🔧 (IC-5) Repair/Replace:**  
The window lock hardware at the Kitchen was damaged. Recommend repairs as needed.

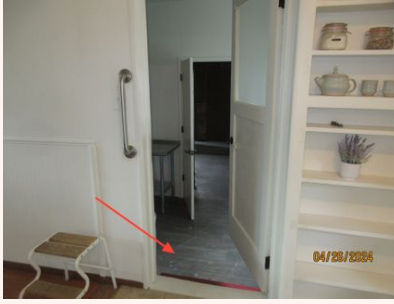
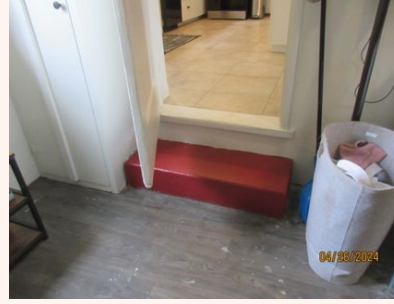
**🔧 (IC-6) Repair/Replace:** The door at the Laundry area opened over a drop down, but did not open over a landing. This condition is improper and a fall hazard. Recommend that this door be replaced with one which opens away from the steps or that a landing which complies with generally-accepted current standards.

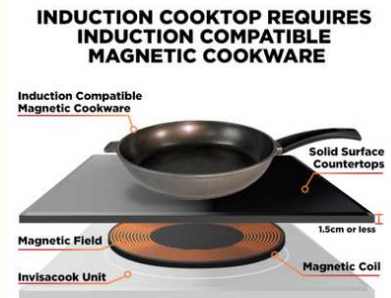
The Kitchen had an induction range. These are unique cooking systems and are very energy efficient. Induction cooking uses induction heating to directly heat a cooking vessel, as opposed to using heat transfer from electrical coils or burning gas as with a traditional cooking stove. For nearly all models of induction cooktop, a cooking vessel must be made of a ferromagnetic metal, or placed on an interface disk which enables non-induction cookware to be used on induction cooking surfaces. In an induction cooker, a coil of copper wire is placed underneath the cooking pot. An alternating electric current flows through the coil, which produces an oscillating magnetic field. This field induces an electric current in the pot. Current flowing in the metal pot produces resistive heating which heats the food. While the current is large, it is produced by a low voltage. An induction cooker is faster and more energy-efficient than a traditional electric cooking surface. It allows instant control of cooking energy similar to gas burners. Other cooking methods use flames or red-hot heating elements; induction heating heats only the pot. Because the surface of the cook top is heated only by contact with the vessel, the possibility of burn injury is significantly less than with other methods. The induction effect does not directly heat the air around the vessel, resulting in further energy efficiencies. Cooling air is blown through the electronics but emerges only a little warmer than ambient temperature. The magnetic properties of a steel vessel concentrate the induced current in a thin layer near its surface, which makes the heating effect stronger. In non-magnetic materials like aluminum, the magnetic field penetrates too far, and the induced current encounters little resistance in the metal.[1] At least one high-frequency "all metal" cooker is available, that works with lower efficiency on non-magnetic metal cookware. The Inspector was not able to operate the burners.

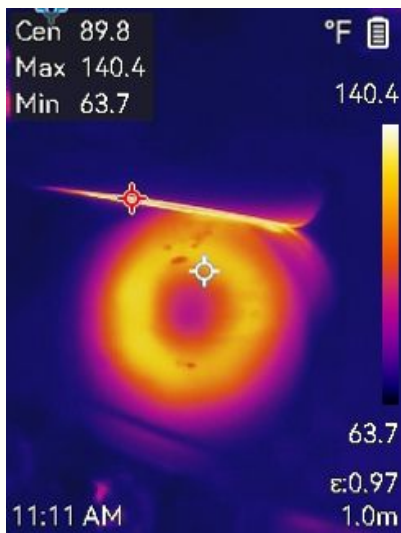
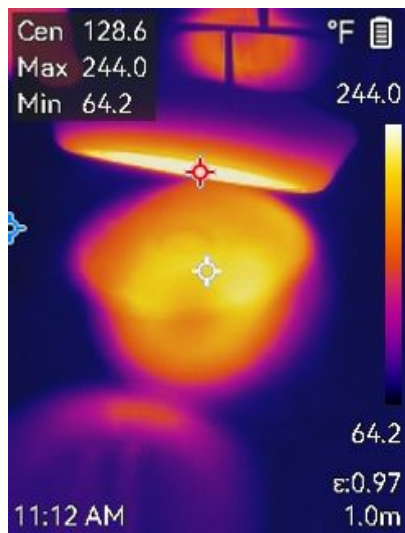
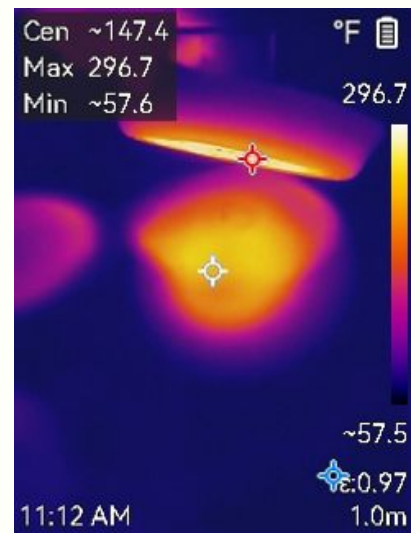
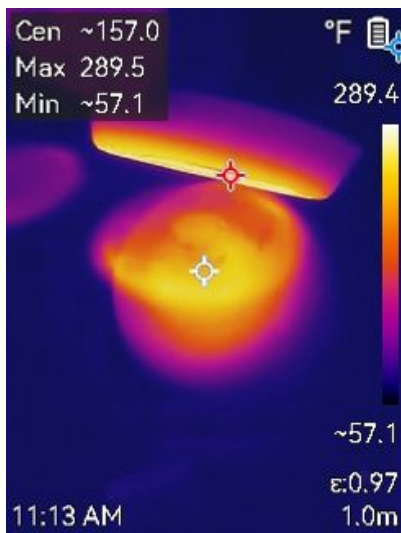
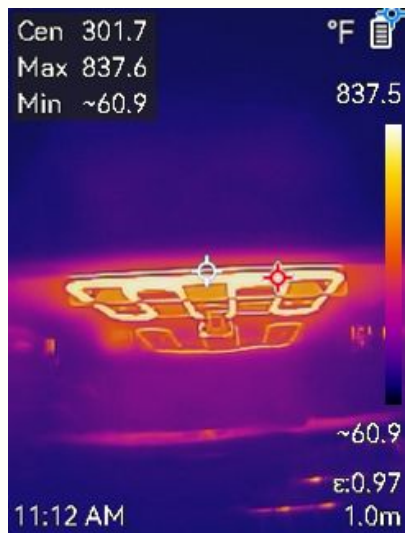
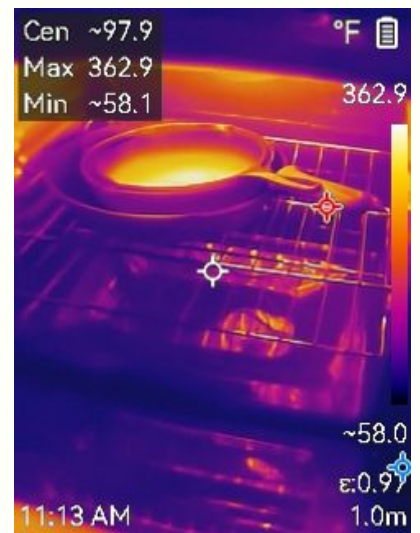
★ (KA-2) Note: Thermal images show the induction range was tested and working during the

inspection.

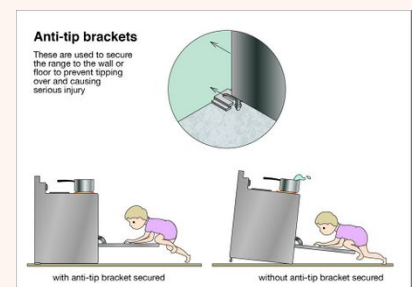
An anti-tip device is needed to prevent the range from tipping during operation of the oven door. This is a small clip that secured the back adjustable feet of the range to the floor. Recommend repairs as needed.

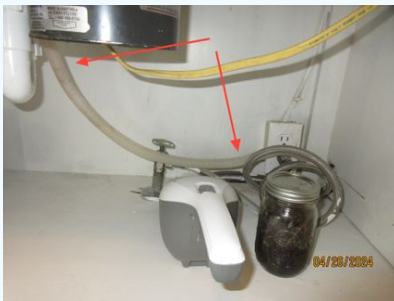
🏠 **(KA-7) Improvement:** An [air gap](#) is recommended to protect the dishwasher from accidental contamination if the sewer line were to back up. If an air gap cannot be installed, at least run the drain line above the level of the sink drain to create a high loop. This was an older way of protecting the dishwasher. Recommend further evaluation to determine if the dishwasher has an internal air gap / high loop or repair as needed to install an air gap.

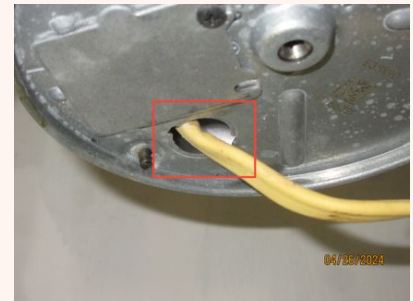
The garbage disposal wiring was missing the electrical housing (anti-strain device) clamp. Clamps are electrical connectors designed to protect and secure conductors where they pass through sheet metal. Recommend that a proper clamp be installed.

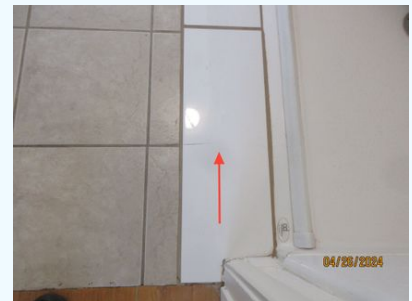
The tile floor in the Main Bathroom was cracked. This is a cosmetic defect but would require tile replacement to repair, a significant expense. It can also indicate that the tile was not set properly, cracking may continue to get worse.

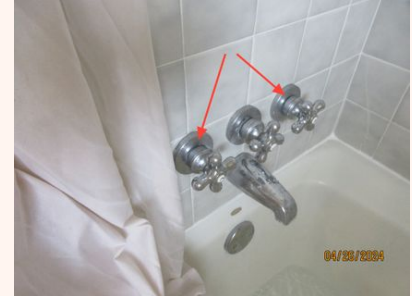
The mixing valves in the Hallway Bathroom bathtub was installed so that hot and cold were backwards. This can lead to confusion when turning on and off the water and should be repaired as needed.

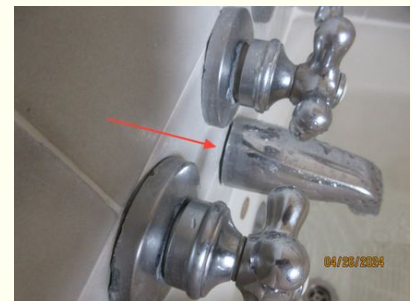
Recommend sealing the Hallway Bathroom bathtub spout between the shower wall and the spout to prevent water leakage.

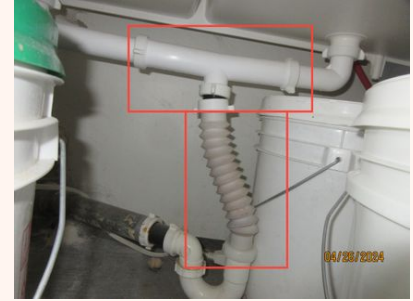
The sink plumbing had been done in an improper configuration. A straight "tee" fitting was used horizontally to connect the two sink drain lines to the waste line. The water will drain over the "tee" fitting instead of down into it. A corrugated section of drain line was also used. These tend to clog more easily than smooth wall piping. Recommend repairs as needed.

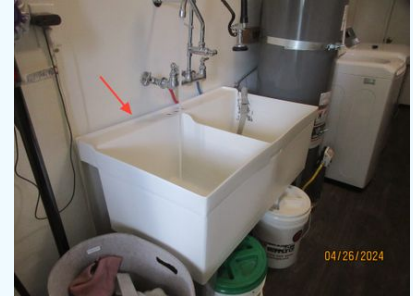
The sink in the Laundry area was loose and needs to be secured to prevent accidental damage to the sink or plumbing.

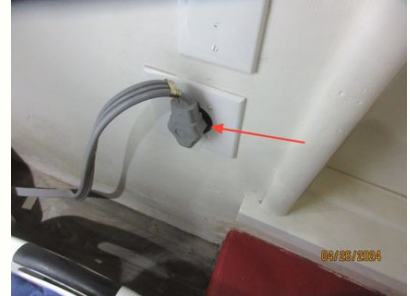
The electric receptacle to the clothes dryer was a three-prong or three-wire system. This is an older configuration. Modern electric dryers circuits require a four-wire system. These older three-wire circuits are still allowed, but be sure that you have a three prong outlet so the cord can be swapped out and the appliance appropriately bonded.

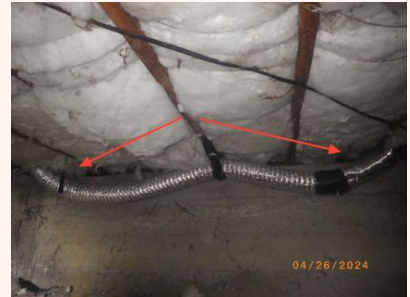
The dryer vent was improperly installed and used improper material in the Crawlspace. Failure to correct the vent piping may result in lint and moisture accumulation within the vent pipe. Lack of proper dryer venting can also result in the accumulation of lint in the home. Lint is combustible and its accumulation is a potential fire hazard and a possible health hazard from the inhalation of particulates. Recommend the proper installation of an Underwriter's Laboratory (UL)-approved dryer vent for safety reasons.

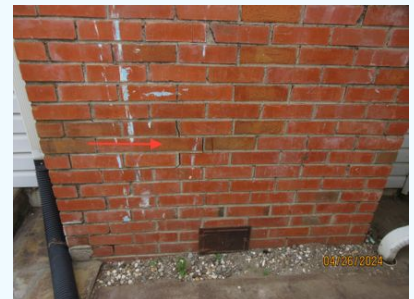
Cracks and mortar separation were noted in the masonry chimney. These were small and minor at the time of inspection. Recommend repairs as needed.

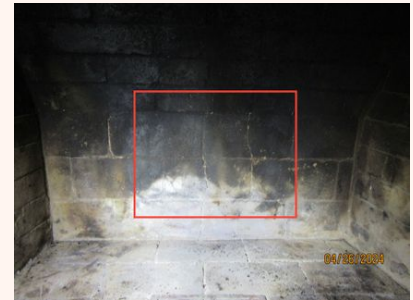
Damaged / cracked brick were noted to the walls of the fireplace firebox. This can make the fireplace unsafe for fires. Recommend further evaluation of this condition and repairs as needed to ensure safe and reliable performance from the fireplace. Firebox repairs need to be made using firebrick and proper refractory mortars designed for high temperatures.

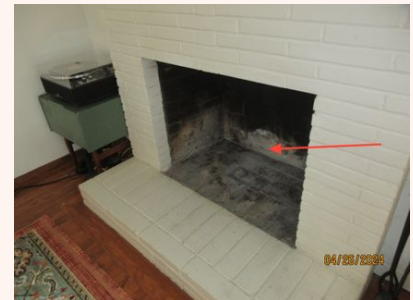
The wood-burning fireplace lacked a spark barrier. This condition is a potential fire hazard as it may allow sparks from the firebox to ignite the combustible floor-covering material. Recommend the installation of a means for containing fireplace sparks, such as a screen.

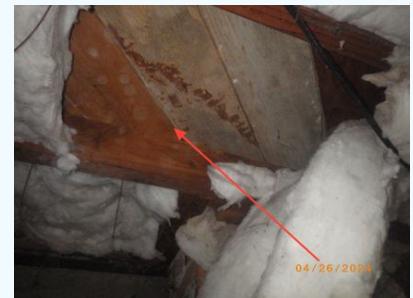
There was not an adequate non-combustible hearth under the fireplace (typical in older houses), the hearth was supported by combustible wood (as seen in the Crawlspace). Generally, a 20-inch deep hearth is recommended in front of all fireplaces greater than 6 sq. ft. The hearth should extend 12-inches to the sides of the firebox. For smaller fireplaces, minimum recommended clearances are 16-inches deep and 8-inches on either side. Recommend further evaluation and repairs as needed.

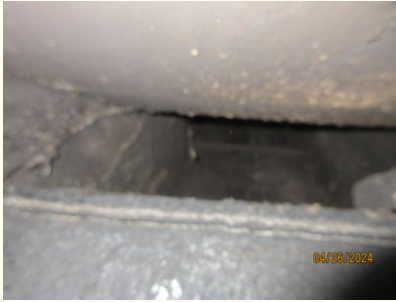
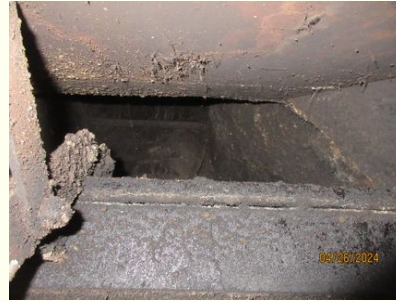
**🔧 (CF-7) Recommended Maintenance:** The exhaust flue of the fireplace appeared to need cleaning. Dirty flues are potential fire hazards. The flue should be cleaned by a Qualified Contractor. Accurate inspection of the chimney flue lies beyond the scope of the General Home Inspection. Although the Inspector may make comments on the condition of the portion of the flue readily visible, a full, accurate evaluation of the flue condition would require the services of a specialist. Because the accumulation of flammable materials in the flue as a natural result of the wood-burning process is a potential fire hazard, we recommend that you have the flue inspected by a Qualified Contractor.

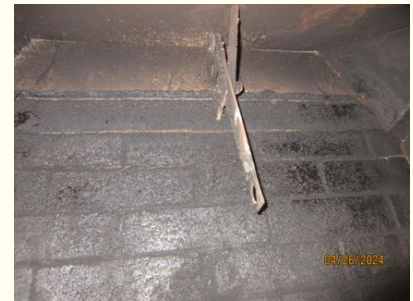
**🔧 (CF-8) Recommended Maintenance:** The firebox of the wood-burning fireplace needed cleaning at the time of the inspection. This condition is a potential fire hazard. Recommend cleaning as needed.

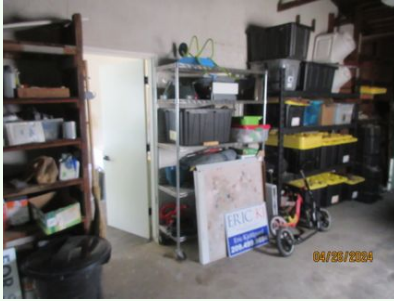
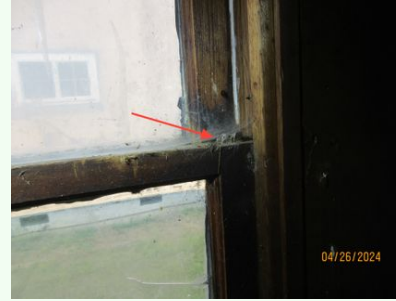
**🔍 (G-1) Due Diligence:** Storage in the Garage inhibited the view of the Garage and limited visual inspection of this space. Recommend further inspection of the Garage when the area is cleared of personal belongings.

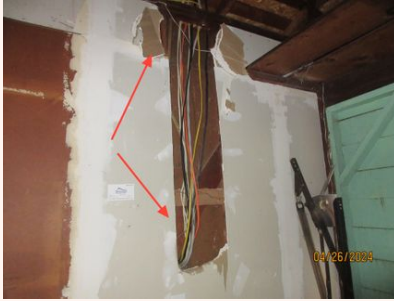
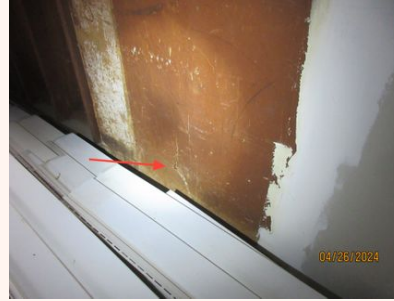
✂ (G-4) Repair/Replace: The Garage wall had damage visible at the time of the inspection. Recommend repairs as needed.

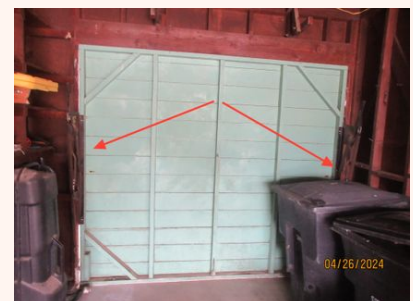
### ✂ **(G-6) Repair/Replace:**

Recommend having the rear tilt up Garage door serviced and repaired as recommended. During visual inspection and testing, the door would not stay open correctly. This is an indication that the torsion springs require adjustment, repair or replacement.

***The door should be able to stay open on its own.***

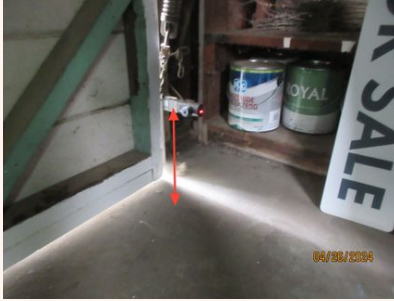
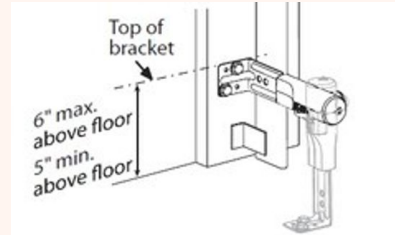
✂ **(G-7) Repair/Replace:** The laser eye safety mechanisms for the overhead Garage doors had been set too high, this sensor should be 5 to 6-inches off of the floor to perform as intended and prevent entrapment. Have this repaired as needed.

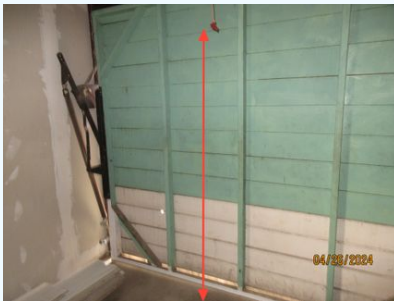
**(G-8) Improvement:** The handle that attaches to the overhead Garage door detaching mechanism was located too high off the floor. These release handles should be accessible, less than 6-feet off the ground. Repair as needed for improved safety.

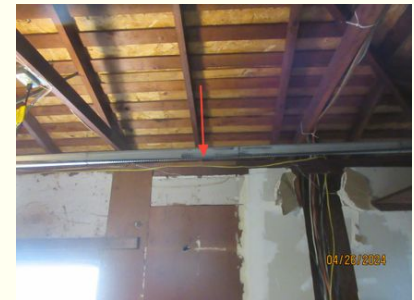
### **(G-9) Recommended Maintenance:**

The automatic overhead Garage door opener had a loose belt. This can eventually affect the performance of the automatic opener. Recommend repairs as needed.

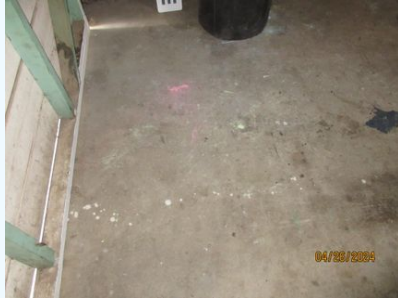
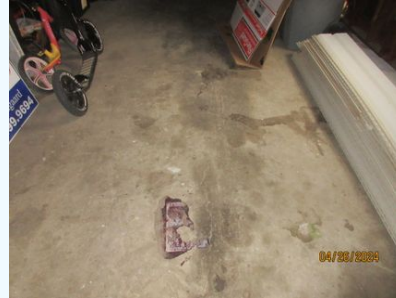
**(G-11) Improvement:** Typical cracks were noted in the concrete Garage slab. You can fill the cracks with a masonry rated caulking, but no repair is needed at this time; this is a cosmetic defect.

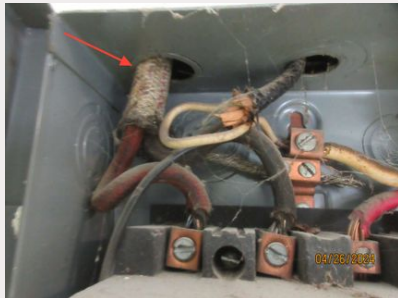
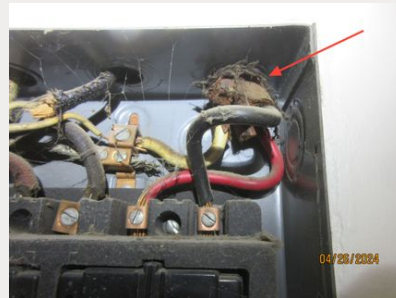
### ⚠️ **S-4 Sub-Panels - Sub-Panel:**

Currently all sub-panels are required to be fed with four wires (two hots, a neutral and a ground). The fourth ground conductor can be done with metal conduit, no metal conduit was visible here. The sub-panel here appears to be a three-wire feed. Recommend further evaluation and repair by a Qualified Electrical Contractor. On sub-panels it is important that neutrals and equipment grounds be separated to control stray voltage. To accomplish this, you generally need a four-wire feed. There are some cases where three-wire feeds can be used for outbuildings, but never when the sub-panel is located within the same structure.

*Undetermined if this is incoming line*

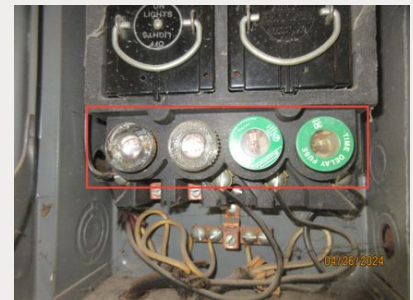
### ⚠️ **S-5 Sub-Panels - Sub-Panel:**

Fuse socket(s) in the sub-panel contained fuses that exceeded the typical installation standards. Branch wiring circuits are typically rated at 15 Amp or 20 Amp, the fuses in the panel were 25 Amp or 30 Amp. This condition is typical of a circuit in which fuses constantly burn out due to an electrical problem with the circuit. The fuse is removed and a fuse of a higher rating is inserted in its place to provide constant power to the affected circuit. Without the correct fuse, this circuit is no longer protected from overheating and is a potential fire hazard. Recommend evaluation and any necessary repairs be performed by a Qualified Electrical Contractor.

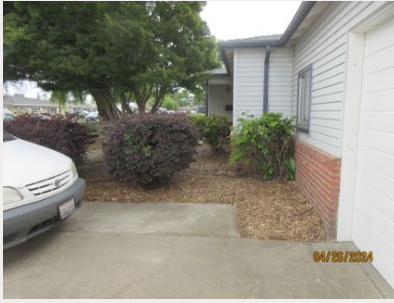
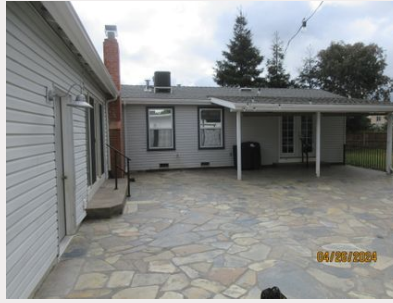
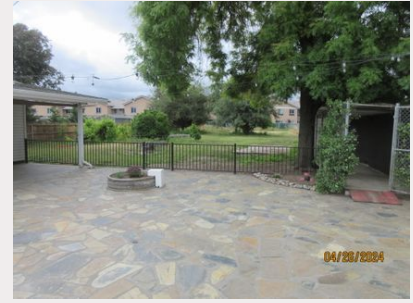
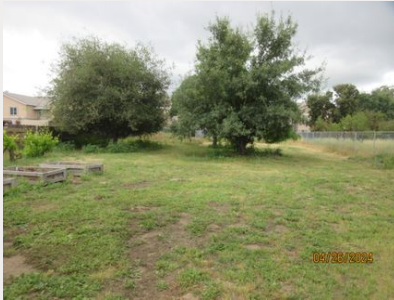
### 🔍 **SEF-1 Site and Exterior Features - Site Grading and Drainage:**

The building is situated on a generally flat lot. This could lead to seasonal drainage problems.

Recommend inquiring with the sellers and or building department for any history of water problems on the site.

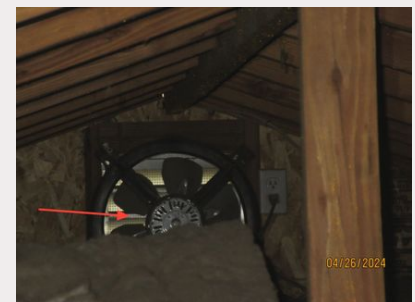
### **AC-5 Attic and Components - Ventilation Type:**

Thermostatically controlled vent fan in the Attic may work, but due to the low temperature the unit was not on. Baker Inspection Group could not access or inspect this unit.

*Rear of the house*

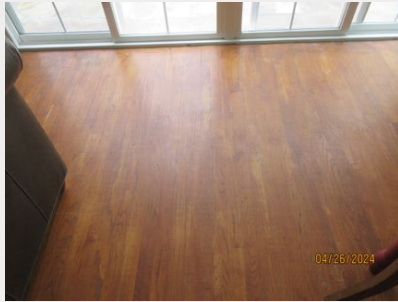
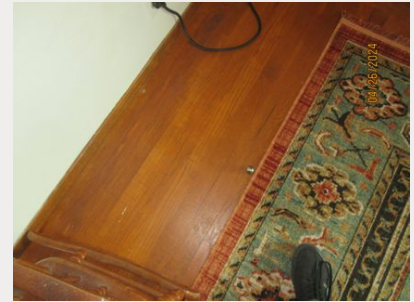
### **SF-2 Structure and Foundation - Ceiling, Wall and Floor Structures:**

Minor floor settlement was noted in the house. Inquire with the seller for any history of repairs or

movement. No signs of recent movement were visible at the time of inspection.

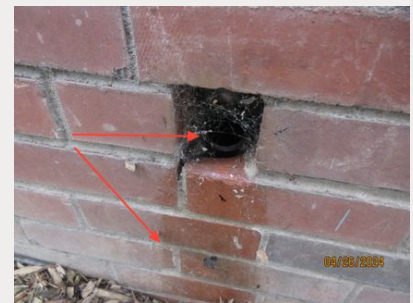
### **PS-17 Plumbing System - Drain, Waste and Vent Systems:**

**A video camera sewer scope is recommended.** An evaluation of the sewer line below the ground is beyond the scope of this inspection. A sewer scope is always recommended to further evaluate the sewer line and the below ground connections between the house and the municipal sewer line or septic tank. Sewer scopes are done using video cameras and can reveal the materials, condition and reliability of the sewer line. The front wall cleanout was missing the cap and the wall below the opening was visibly damp. Prior to closing confirm with the seller on the reasons and if the sewer system has drainage issues.

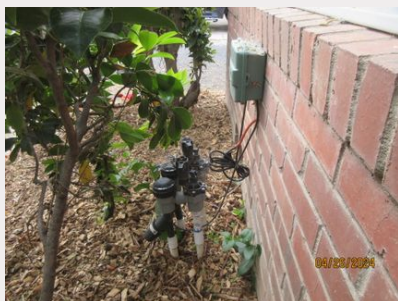
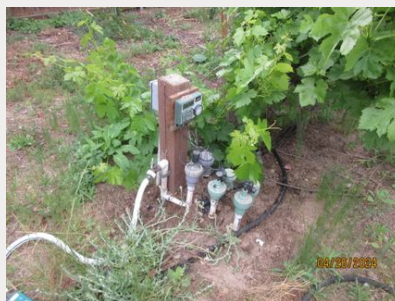
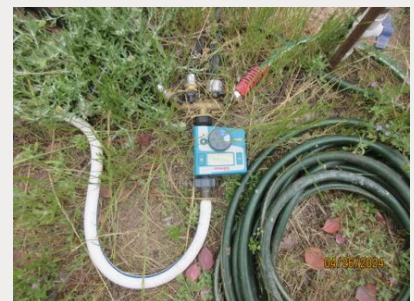
### **AP-1 Additional Plumbing - Landscape Irrigation:**

An exterior irrigation system was noted. Sprinkler systems are beyond the scope of this inspection. Irrigation systems require annual attention / repair / servicing after every winter. When testing the system, be sure sprinkler heads are adjusted so the system is not watering the side of the house. Recommend further evaluation as needed.

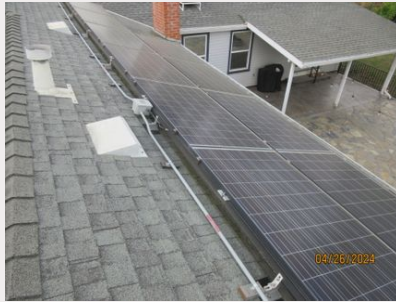
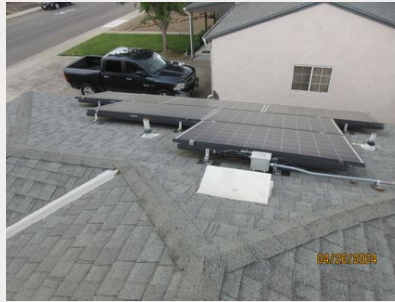
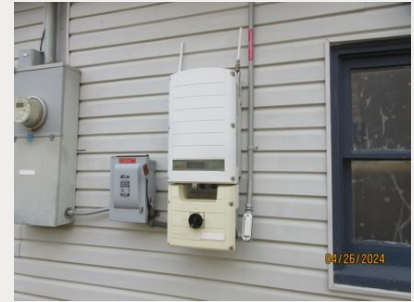
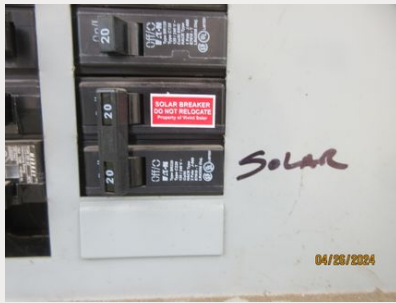
### **MES-2 Main Electrical System - Solar/Photovoltaic Systems:**

This house had a solar photovoltaic system installed. Photovoltaic or PV systems convert the sun's energy into electricity. Inspection and evaluation of solar installations are beyond the scope of this inspection. Recommend inquiring with the seller for any additional maintenance, installer, and

warranty information.

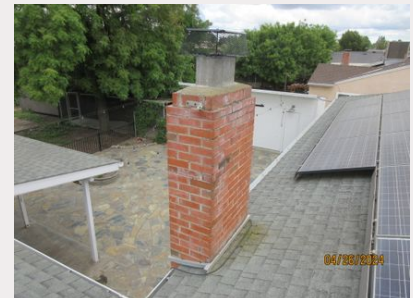
### **CF-1 Chimneys and Fireplaces - Chimney At Roof:**

Accurate inspection of the chimney flue lies beyond the scope of the General Home Inspection. Although the Inspector may make comments on the condition of the portion of the flue readily visible, a full, accurate evaluation of the flue condition would require the services of a specialist. Because the accumulation of flammable materials in the flue as a natural result of the wood-burning process is a potential fire hazard, recommend you have the flue inspected by a Qualified Contractor.

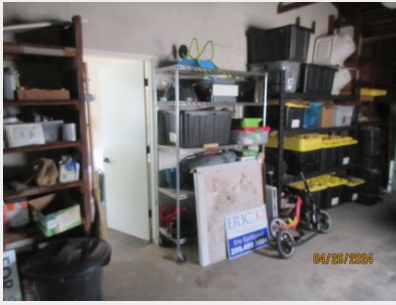
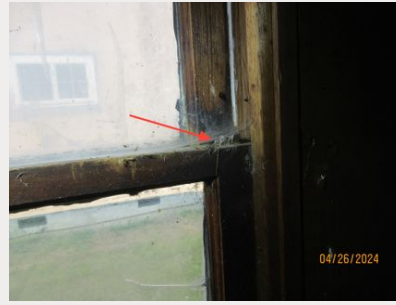
### **G-1 Garage - General Garage Conditions:**

Storage in the Garage inhibited the view of the Garage and limited visual inspection of this space. Recommend further inspection of the Garage when the area is cleared of personal belongings.

*Window screwed closed*

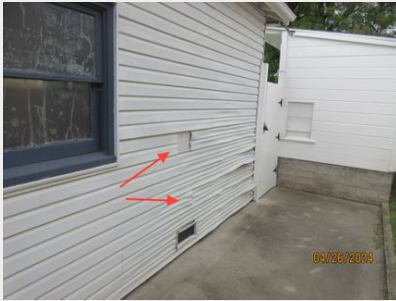
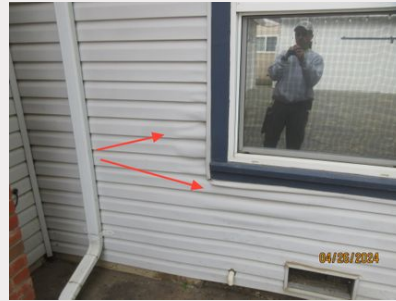
### **EWC-3 Exterior Wall Components - Siding and Trim:**

The exterior vinyl siding at the right side and rear of the house had areas of damage that should be repaired to prevent moisture intrusion of the exterior wall structure.

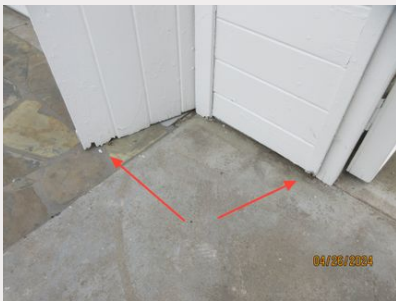
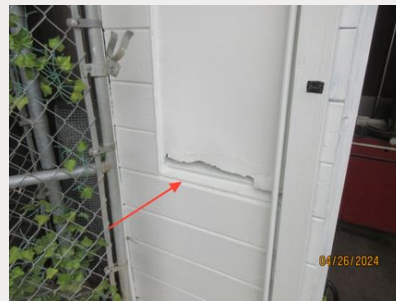
### **EWC-5 Exterior Wall Components - Siding and Trim:**

The exterior walls and door at the shop had areas of deteriorated wood siding that should be repaired or replaced to help prevent damage from moisture intrusion.

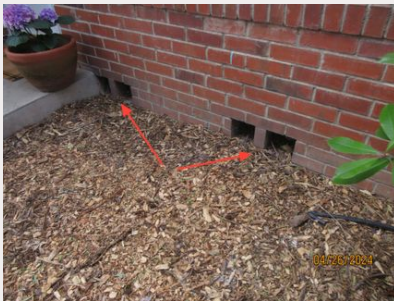
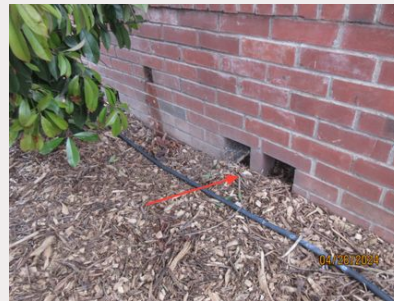
### **CC-4 Crawlspace / Cellar - Ventilation Type:**

The Crawlspace vents have been installed at grade at the front of the house. The risk here is water entry into the vents. Recommend correcting the grade here so water cannot flow into the vents. Often, digging a small well around the vents can help.

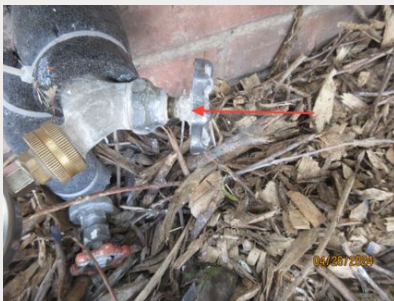
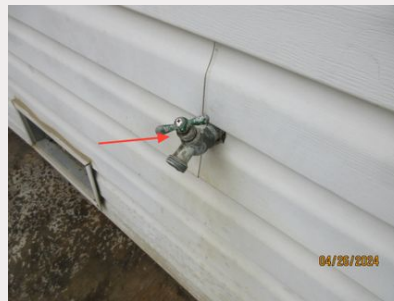
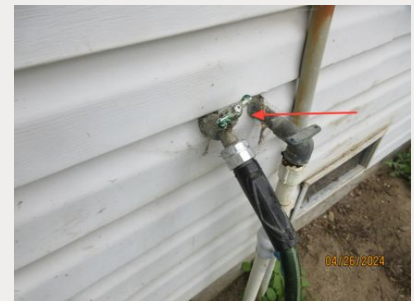
### **PS-11 Plumbing System - Exterior Hose Bibs:**

The leaky hose bibs at the front and rear of the house require repair or replacement - they leaked from the hose bib handle when the water was turned on and under pressure. This often requires tightening the packing around the handle stem.

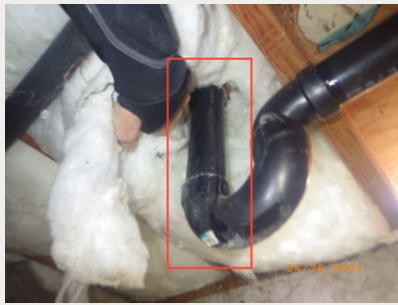
*Main bathroom*

The drain, waste and/or vent pipes were visibly leaking in the Crawlspace under the Main and Hallway Bathrooms at the time of the inspection should be repaired to prevent the development of unhealthy conditions. Recommend repairs as needed.

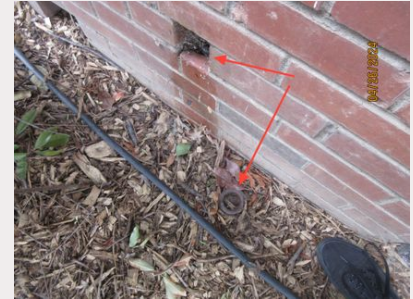
The sewer cleanout in the front of the house was missing a proper cap. This could be a safety hazard and could also lead to debris clogging the waste piping. Recommend repairs as needed.

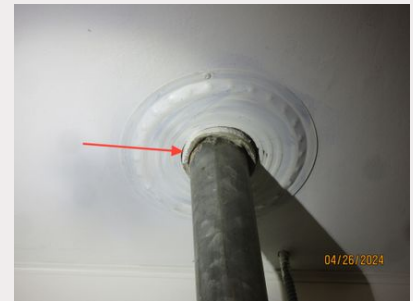
A partial amount of the exhaust flue visible was insulated with a material which had a strong possibility of containing Asbestos. A newer section of metal flue was connected to it from the appliance. A Qualified Contractor should inspect this connection further and correct as needed. Although Asbestos is considered to be a known carcinogen, it is not considered to be a health hazard unless it is in a form in which it can be inhaled. Confirming the presence of Asbestos requires testing by a Qualified Laboratory. Consider consulting with a Qualified Contractor about importance of the presence of this material and the need for removal.

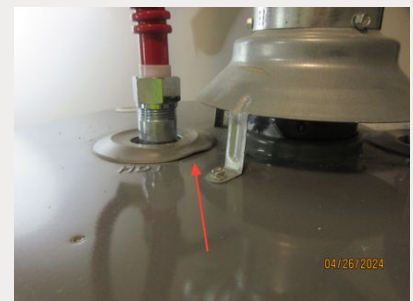
Signs of back-drafting or combustion roll out were noted at the water heater. This is a safety hazard that indicates the unit is not venting as intended. This could allow moisture and carbon monoxide to enter the house. Have this water heater serviced and repaired or replaced as recommended to ensure safe and reliable performance. Examples of specific observations noted during inspection include:

*Distorted plastic bushing*

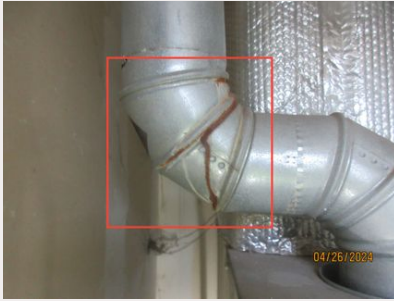
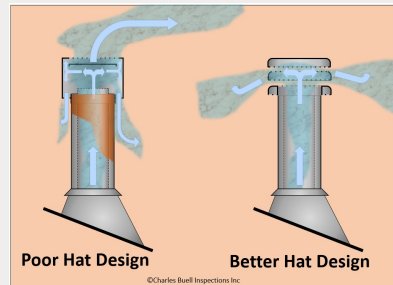
The metal flue for the furnace was corroded and requires repair or replacement. Have this further

evaluated and repaired as recommended. Please note that often a poor cap design can result in premature deterioration of the flue.

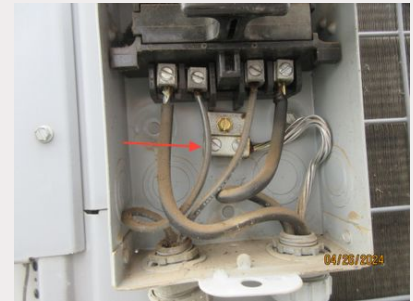
The air conditioner was missing a grounding conductor (only two visible) at the electrical disconnect. Recommend further evaluation and repairs as needed.

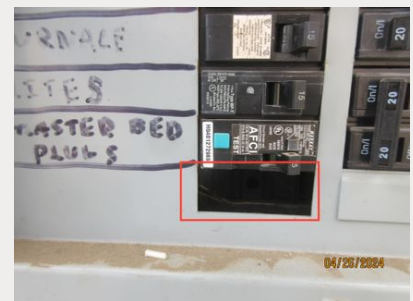
Openings were noted in the sub-panel dead front cover. This is unsafe as it does not adequately protect the energized area of the electric panel. Cover all open knock-outs with listed covers.

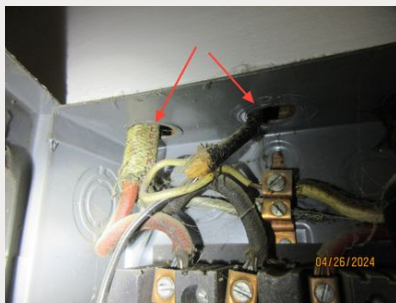
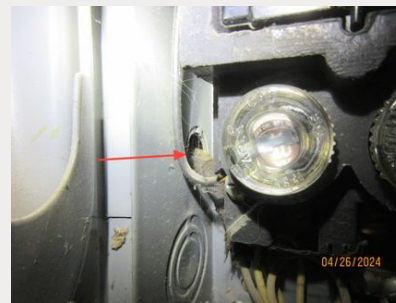
Grommets or bushings were missing at the sub-panel and are needed to protect the non-metallic sheathed cable where the wiring enters the electrical panel and provide strain relief. Recommend further evaluation and repairs as needed.

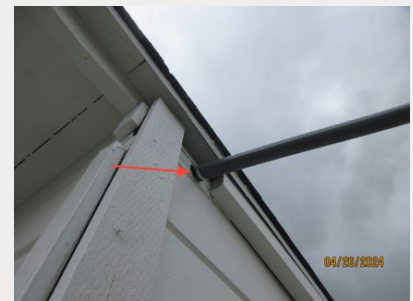
The electrical conduit had been disconnected at the shop and requires repair. Repair as needed.

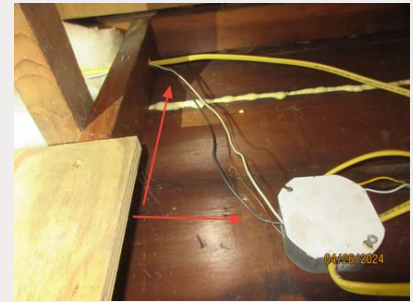
The wiring was not properly protected by a sheathing or conduit at the shop. This is a potential safety hazard. Repair as needed.

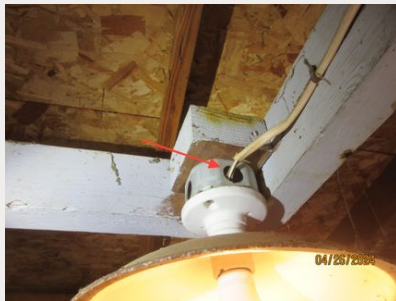
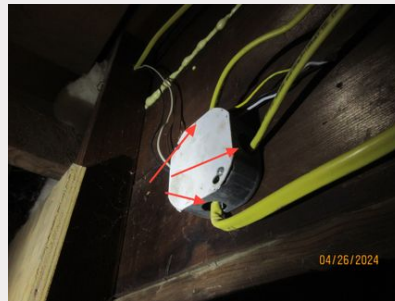
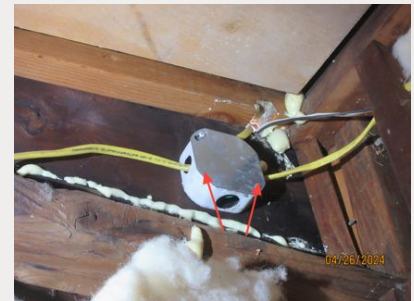
The non-metallic sheathed cable was poorly run into the junction boxes at the shop and has not been properly restrained, protected or sleeved. Also, check for additional boxes that could have a similar condition as most boxes are not visible to inspection. Wiring cable should have proper clamps to protect and secure the wire where it enters the junction box. Recommend further evaluation and repairs as needed.

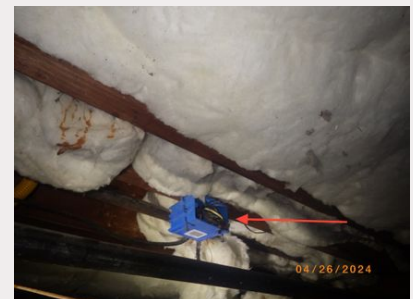
At the time of the inspection, cover plates were missing at the Crawlspace. This condition left energized electrical components exposed to touch. Recommend that listed cover plates be installed.

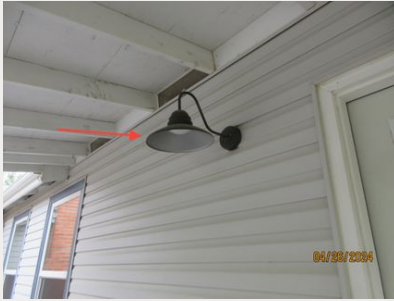
*Rear of the house*

Multiple inoperative lights were noted at the rear of the house, Garage and shop. This is likely due

to bulbs being burned out or functional with a photo sensor, but could be due to an inoperative fixture, circuit or switch. Replace bulbs or repair lights as needed.

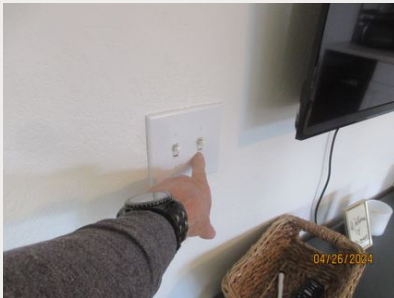
*Main bedroom*

I was unable to determine what device was controlled by switches at the Main Bedroom, Garage and shop. They may connect to future ceiling fans. Switches sometimes control exterior lights which are controlled by photo sensors and will operate only at night or only the upper or lower half of an interior switchable receptacle. Tracing the devices controlled by all switches exceeds the scope of the general home inspection. Recommend further evaluation as needed.

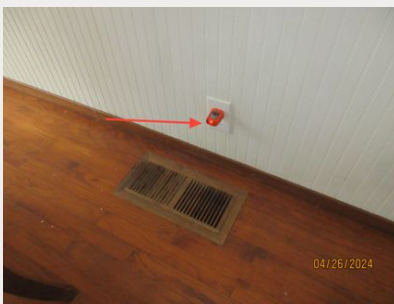
*Dining room*

**Recommend a Qualified Electrical Contractor repair all open grounds** throughout the house. This is a common condition in older buildings (prior to 1962) where three prong receptacles have been installed on an older two wire system. This creates a safety hazard; appliances that rely on an equipment ground to discharge a fault can be plugged into ungrounded circuits. This disables the important safety feature of an equipment ground. Proper repair can include:

- Running an equipment grounding conductor or a new three-wire circuit
- Restoring a two-prong receptacle or
- Installing GFCI protection for this circuit and labeling the open ground receptacles

If GFCI protection is used, the outlets on this circuit should be labeled so it is clear they are protected. Examples of locations where open grounds were found include:

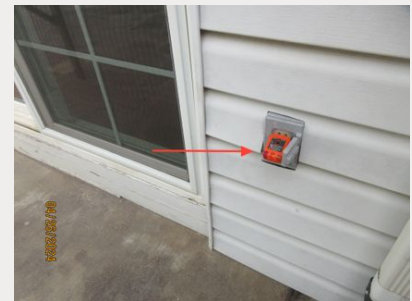
Reverse polarity was noted at the rear of the house electrical receptacle. This is when the hot and the neutral wires have been wired backwards. This is a potential safety issue that should be further evaluated and corrected as needed.

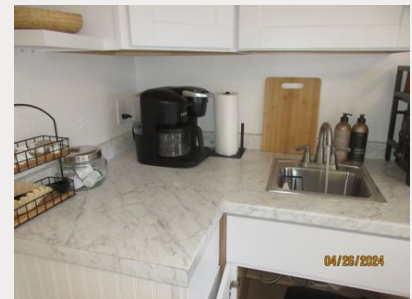
The house interior had ground fault circuit interrupter (GFCI) protection where needed except for the Kitchen, Hallway Bathroom, Laundry area, Garage and bar sink which had none. Although GFCI protection may not have been required at the time the home was built, for safety reasons, Baker Inspection Group recommends that electrical receptacles located in Basements, Cellars, Crawlspace, Garages, and interior receptacles located within 6-feet of a plumbing fixture be provided with ground fault circuit interrupter (GFCI) protection in good working order to avoid potential electric shock or electrocution hazards. This can be achieved relatively inexpensively by: 1. Replacing an individual standard receptacle with a GFCI receptacle. 2. Replacing the electrical circuit receptacle located closest to the overcurrent protection device (usually a breaker) with a GFCI receptacle. 3. Replacing the breaker currently protecting the electrical circuit that contains the receptacles of concern with a GFCI breaker.

*Missing at bar sink*

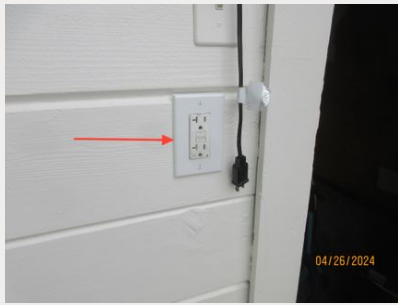
The exterior electrical receptacles at the shop were not enclosed in weather-resistant covers. Recommend repairs as needed.

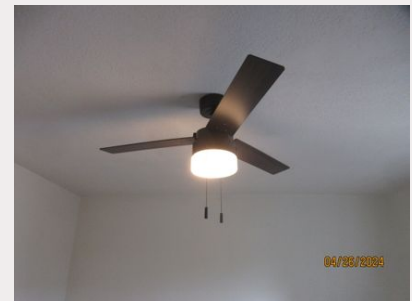
The ceiling fan blades were not functional at the 2nd Bedroom. Recommend further evaluation and repairs as needed.

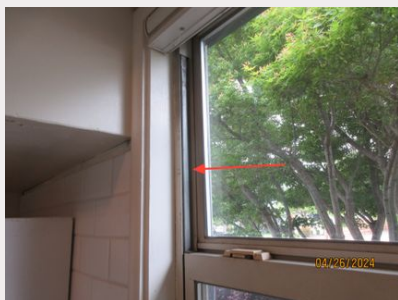
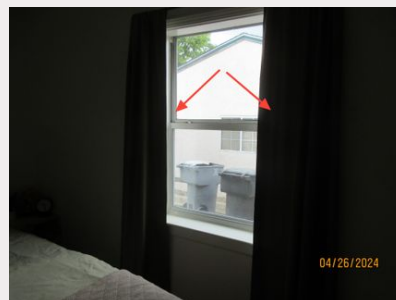
### **IC-4 Interior Components - Windows:**

The window balancers that help the single hung windows to move up and down were damaged or disconnected at the Kitchen and 2nd Bedroom and need to be repaired so the windows will operate smoothly. Please note that these windows are designed to be able to disengage the springs so that the window frames can be removed for cleaning and balancers can be replaced. [CLICK HERE](#) for a how to video.

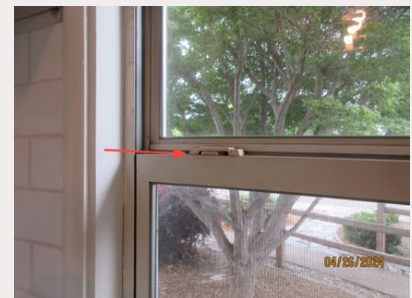
### **IC-5 Interior Components - Windows:**

The window lock hardware at the Kitchen was damaged. Recommend repairs as needed.

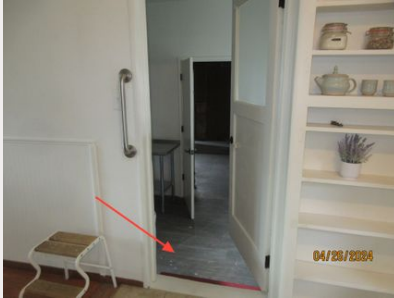
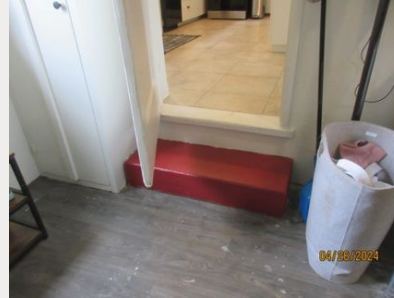
### **IC-6 Interior Components - Doors:**

The door at the Laundry area opened over a drop down, but did not open over a landing. This condition is improper and a fall hazard. Recommend that this door be replaced with one which opens away from the steps or that a landing which complies with generally-accepted current standards.

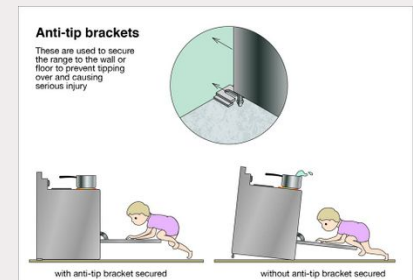
### **KA-3 Kitchen Appliances - Range, Cooktop and Oven:**

An anti-tip device is needed to prevent the range from tipping during operation of the oven door. This is a small clip that secured the back adjustable feet of the range to the floor. Recommend repairs as needed.

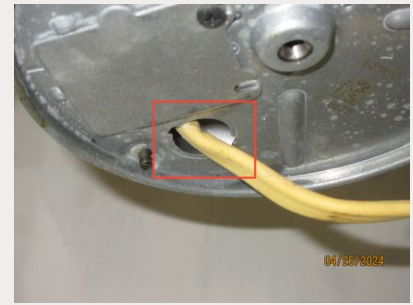
### **KA-9 Kitchen Appliances - Garbage Disposal:**

The garbage disposal wiring was missing the electrical housing (anti-strain device) clamp. Clamps are electrical connectors designed to protect and secure conductors where they pass through sheet metal. Recommend that a proper clamp be installed.

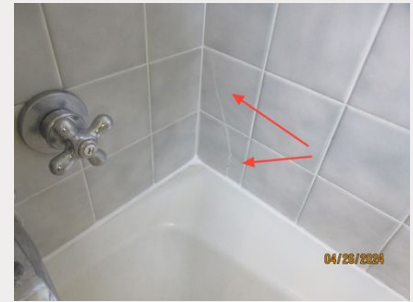
### **B-3 Bathrooms - Showers and Bathtubs:**

Cracked tile were noted in the Hallway Bathroom [shower surround](#). This can lead to water intrusion behind the tile and subsequent tile failure and water damage. Recommend further investigation and repairs to the cracked tiles as recommended. Please note that the ability to repair this tile depends on what the tile is mounted on and what type of adhesives were used to mount the tile.

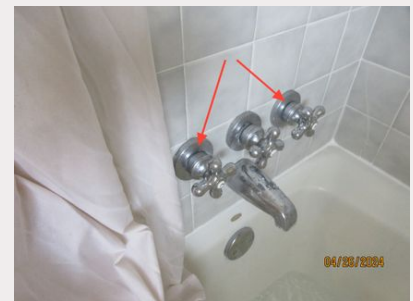
### **B-4 Bathrooms - Showers and Bathtubs:**

The mixing valves in the Hallway Bathroom bathtub was installed so that hot and cold were backwards. This can lead to confusion when turning on and off the water and should be repaired as needed.

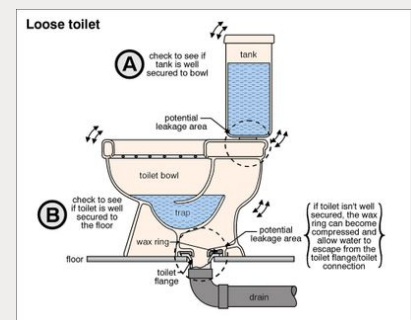
### **B-7 Bathrooms - Toilets:**

The loose toilets in the Bathrooms need to be reset and the wax rings and flanges should be replaced to prevent hidden plumbing leaks. This is a simple job unless the bolts that fasten the toilet also require repair. Sometimes, loose toilets can even be shimmed for a tight and proper seal and sometimes simply caulking can help prevent the toilet from rocking and twisting.

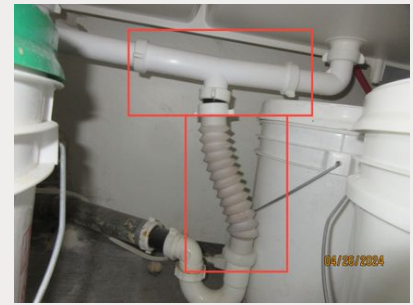
### **LA-2 Laundry Area - Sinks, Countertops and Cabinets:**

The sink plumbing had been done in an improper configuration. A straight "tee" fitting was used horizontally to connect the two sink drain lines to the waste line. The water will drain over the "tee" fitting instead of down into it. A corrugated section of drain line was also used. These tend to clog more easily than smooth wall piping. Recommend repairs as needed.

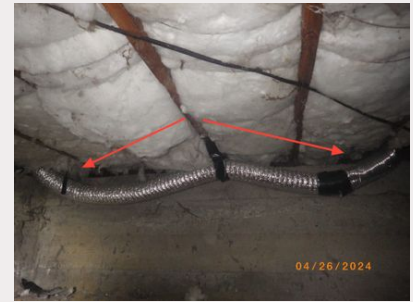
### **LA-8 Laundry Area - Clothes Dryer and Connections:**

The dryer vent was improperly installed and used improper material in the Crawlspace. Failure to correct the vent piping may result in lint and moisture accumulation within the vent pipe. Lack of proper dryer venting can also result in the accumulation of lint in the home. Lint is combustible and its accumulation is a potential fire hazard and a possible health hazard from the inhalation of particulates. Recommend the proper installation of an Underwriter's Laboratory (UL)-approved dryer vent for safety reasons.

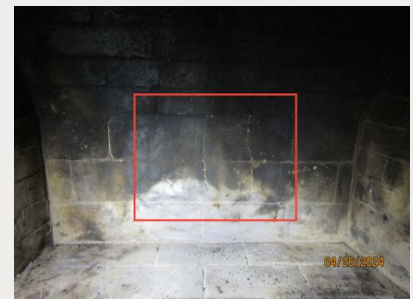
### **CF-4 Chimneys and Fireplaces - Solid Fuel Fireplaces:**

Damaged / cracked brick were noted to the walls of the fireplace firebox. This can make the fireplace unsafe for fires. Recommend further evaluation of this condition and repairs as needed to ensure safe and reliable performance from the fireplace. Firebox repairs need to be made using firebrick and proper refractory mortars designed for high temperatures.

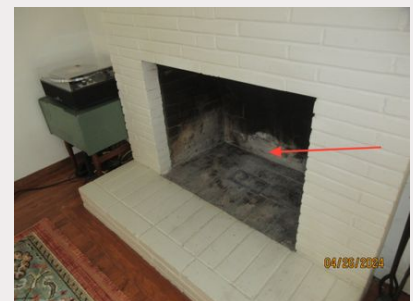
### **CF-6 Chimneys and Fireplaces - Solid Fuel Fireplaces:**

The wood-burning fireplace lacked a spark barrier. This condition is a potential fire hazard as it may allow sparks from the firebox to ignite the combustible floor-covering material. Recommend the installation of a means for containing fireplace sparks, such as a screen.

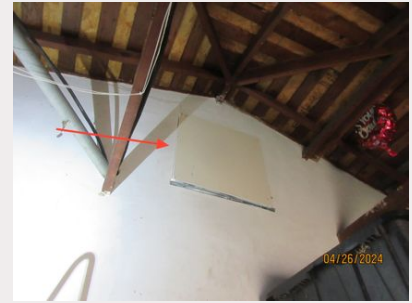
## **G-2 Garage - General Garage Conditions:**

An unprotected opening was found in the Garage wall finishes. This should be repaired to complete the [fire separation](#) between the house and the Garage. Large holes should be repaired with the proper sheetrock materials. Small holes and openings should be sealed with mud or high temperature of "fire stop" caulking. Openings with doors should employ listed fire-rated doors.
