Inspection report for the property at  
1421 Pontiac Street, Oakdale, CA 95361

This report is prepared exclusively for **Garrett Maxwell**  
Inspected On: **04-26-2024**

Baker Inspection Group  
209-522-5320

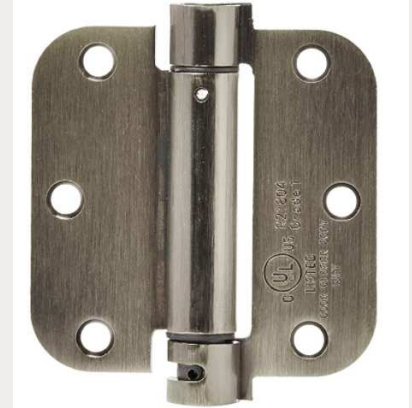
## **G-3 Garage - General Garage Conditions:**

The self-closing hinges on the Garage occupant door were missing. This safety device is recommend to ensure the door to the Garage is closed to keep pollutants and even fire from spreading into the house. This is a requirement that has been enforced and then removed from building standards over the years. It is currently recommended considered best-practices for improved safety.

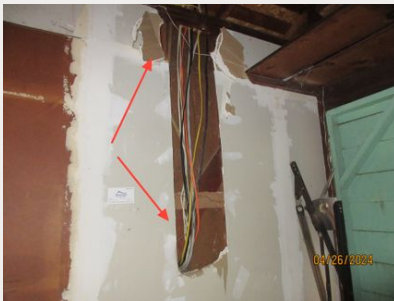
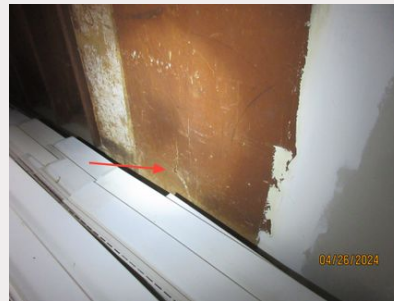
## **G-4 Garage - General Garage Conditions:**

The Garage wall had damage visible at the time of the inspection. Recommend repairs as needed.

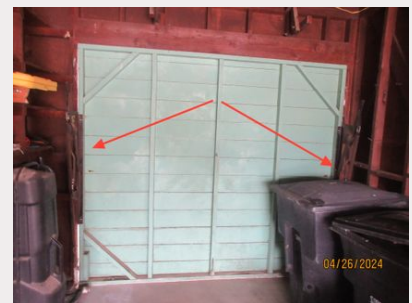
## **G-6 Garage - Vehicle Doors and Automatic Openers:**

Recommend having the rear tilt up Garage door serviced and repaired as recommended. During visual inspection and testing, the door would not stay open correctly. This is an indication that the torsion springs require adjustment, repair or replacement. ***The door should be able to stay open on its own.***

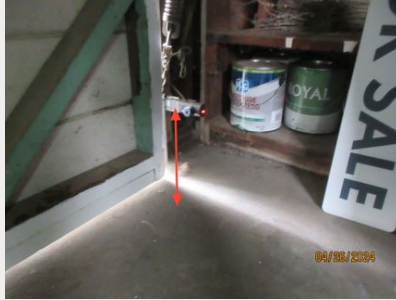
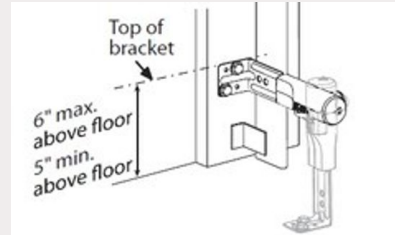
## **G-7 Garage - Vehicle Doors and Automatic Openers:**

The laser eye safety mechanisms for the overhead Garage doors had been set too high, this sensor should be 5 to 6-inches off of the floor to perform as intended and prevent entrapment. Have this

repaired as needed.

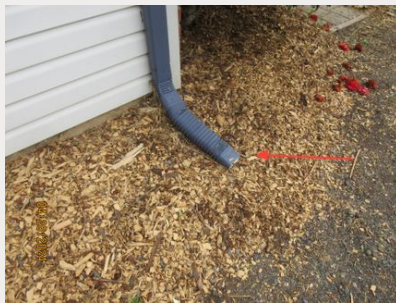
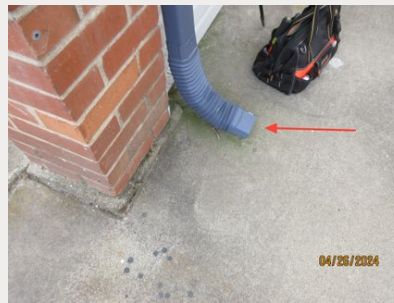
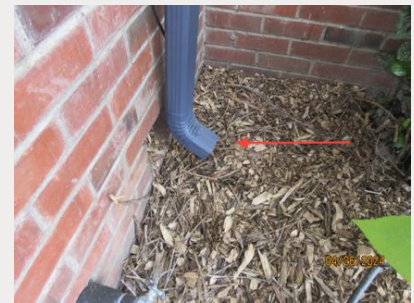
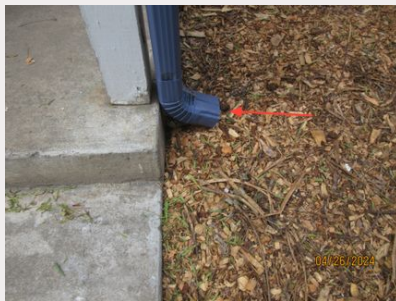
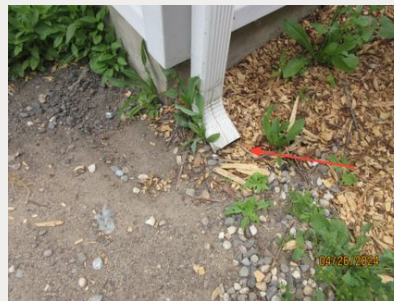
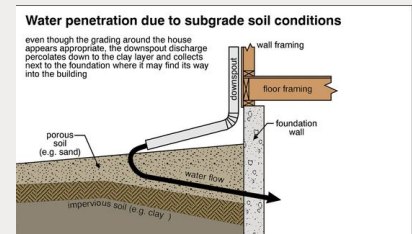
### **SEF-2 Site and Exterior Features - Site Grading and Drainage:**

Downspouts were discharging adjacent to the foundation. This can cause foundation settlement or Crawlspace moisture problems. Make sure all downspouts discharge into a proper tight-line system that diverts water at least 5-feet away from the foundation.

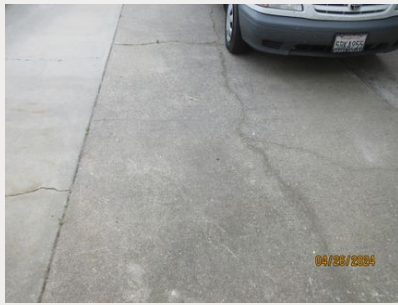
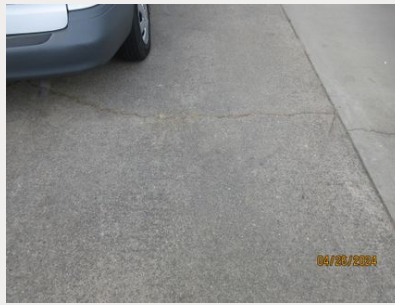
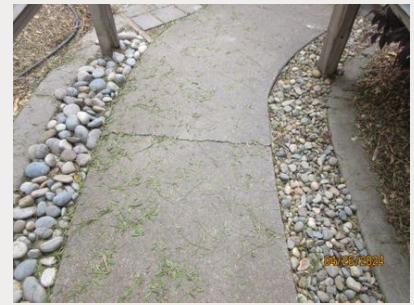
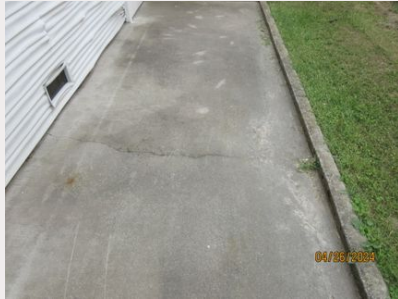
### **SEF-6 Site and Exterior Features - Driveways and Walkways:**

Cracks were noted in the driveway and walkway flatwork at the front and right side of the house. No immediate repair appears necessary, though water will continue to deteriorate the surface until the flatwork is repaired or replaced.

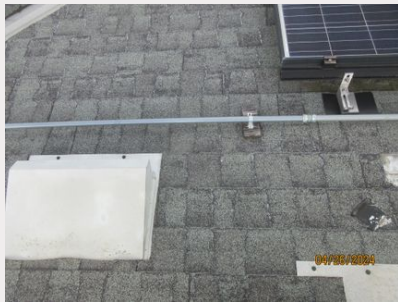
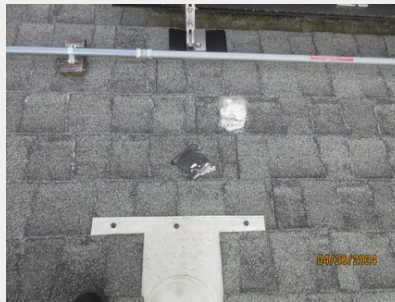
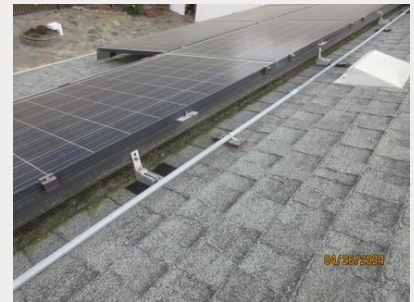
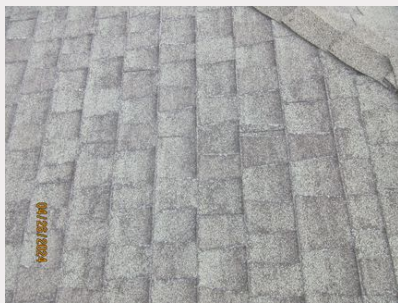
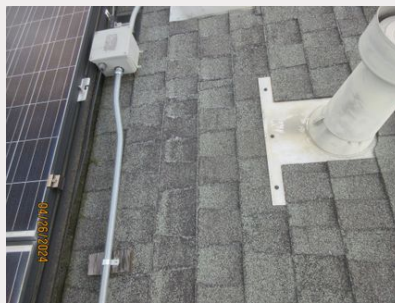
### **RC-5 Roofing and Components - Roofing Materials:**

The asphalt composition shingles covering the roof of this house were old, appeared to be past the mid point of their long-term service life. Recommend further evaluation as needed.

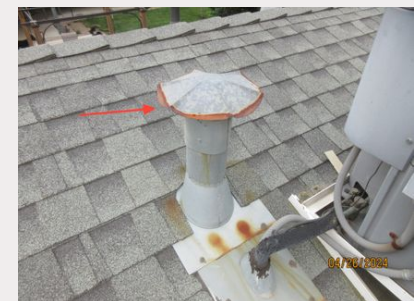
### **RC-9 Roofing and Components - Roof Flashings:**

The vents on the roof had corrosion visible and will need to be replaced soon to avoid damage from leakage.

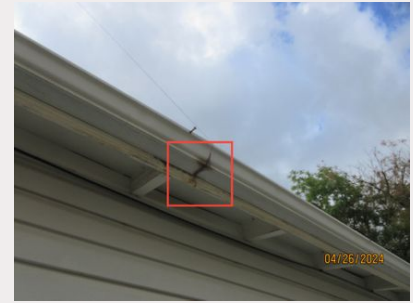
### **RC-12 Roofing and Components - Roof Drainage System:**

Leaks were noted in the gutters at the right side of the house that need to be repaired to control roof runoff. Seal-up all leaking areas and tune-up to ensure gutters are properly secured and sloped to drain.

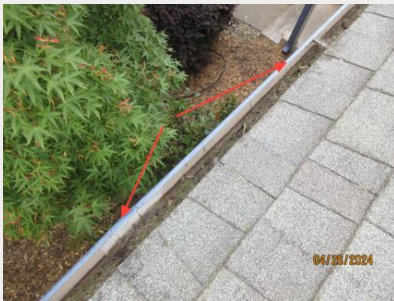
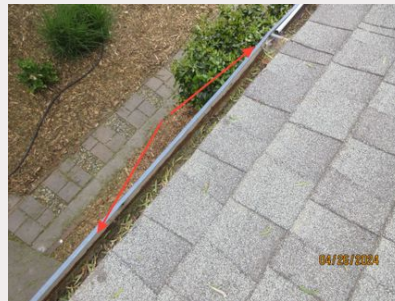
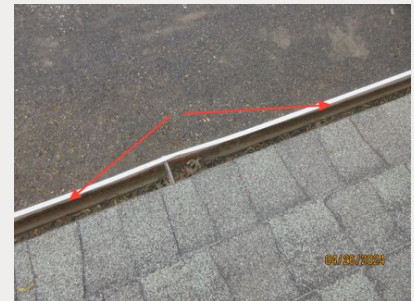
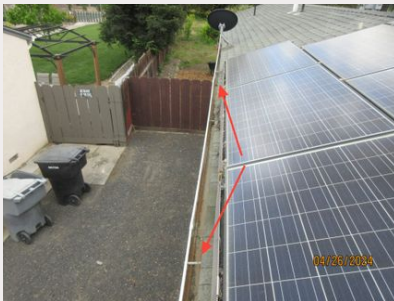
### **RC-13 Roofing and Components - Roof Drainage System:**

The gutters had corrosion visible at the areas around the house. Continued corrosion will eventually result in leaking gutters. Good maintenance practices will help extend the long-term service life of the gutters.

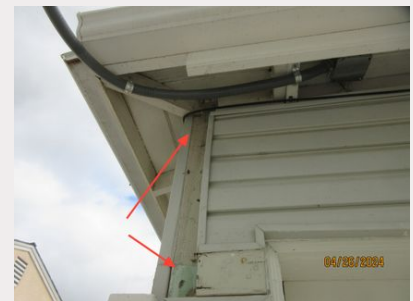
### **EWC-4 Exterior Wall Components - Siding and Trim:**

The vinyl siding was not properly finished at the rear left corner. Repair as needed.

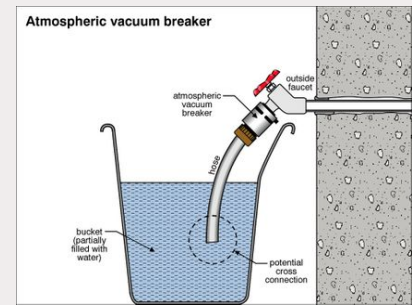
## **PS-12 Plumbing System - Exterior Hose Bibs:**

The hose bibs noted on this house were missing anti siphon devices and updating is recommended. Modern hose bibs are typically anti siphon style which can prevent water from your hoses backing into your water supply system. Consider installing anti siphon hose bibs or adding an anti siphon device to the existing hose bibs. The following video shows a vacuum breaker. [Click Here](#)

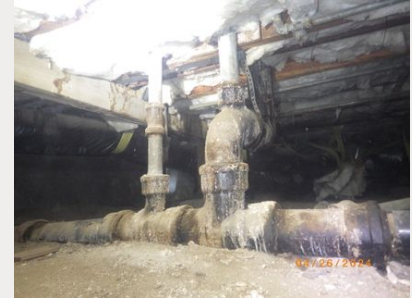
## **PS-20 Plumbing System - Drain, Waste and Vent Systems:**

Drain, waste and/or vent pipes visible in the Crawlspace were corroded. Monitor the pipes on a regular basis to prevent future damage from active leaking. To avoid problems in the future you may wish to have the corroded sections replaced.

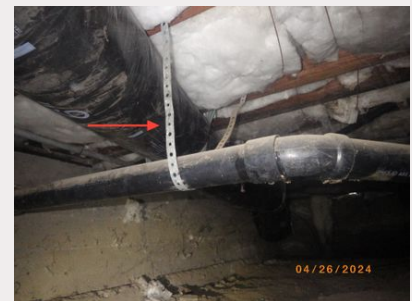
## **PS-21 Plumbing System - Drain, Waste and Vent Systems:**

The plastic drain or vent pipes visible at the Crawlspace were supported by wire or plumbers tape. These are improper materials as they may cut the plastic pipe and will not resist upward thrust. Recommend repairs as needed.

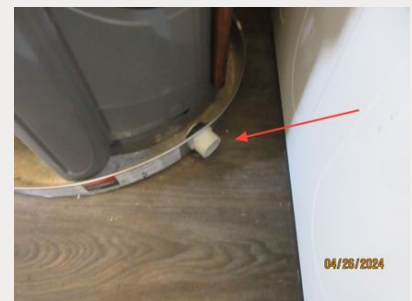
## **WH-6 Water Heater - Water Heater:**

A drain pan has been installed below the water heater, but no drain piping was noted for the pan. A drain pan is recommended under water heaters that are located in finished spaces or where a leak could damage finishes. A pan without drain piping is often of limited benefit / protection. For improved protection from accidental water heater leaks, and where a drain is difficult to install, consider a pan with a moisture alarm and a flood-safe device such as this: [Watts Water Heater Leak Prevention](#).

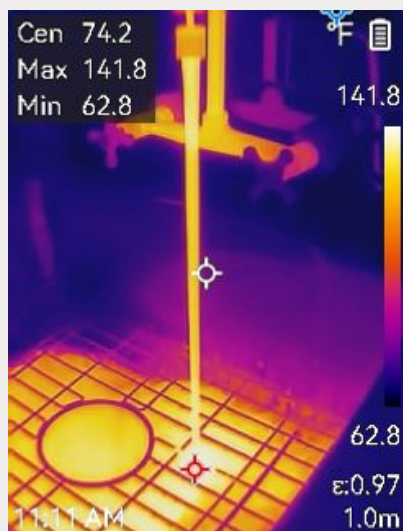
## **WH-9 Water Heater - Water Temperature:**

Testing of the plumbing system today, the water tested as too hot - 142 degrees F. This is a scalding hazard. To prevent scalding, standards recommend indoor hot water temperatures do not exceed 120 degrees F. There is some evidence that hot water temperatures should be greater than 130 degrees F to prevent Legionnaires' disease from developing in the water heater. If this is a concern, you can heat the water in the tank to 140 degrees F and have a tempering valve installed at the hot

water tank. Have this further evaluated and repaired or simply turn down the temperature as desired to eliminate a scald hazard. Please note that during inspection it is difficult to accurately test the water temperature as it can vary between fixtures. Testing is done in multiple locations during inspection and a median temperature is taken.

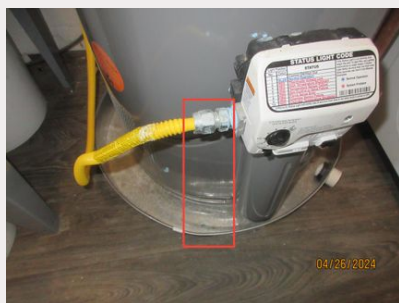
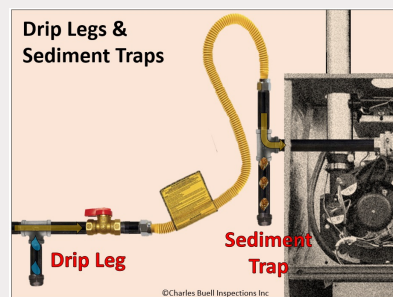
### **FDS-3 Fuel Distribution System - Fuel Distribution Systems:**

There was no sediment trap found for the gas pipe at the gas water heater. Sediment traps are designed to prevent fouling of gas equipment by allowing sediment to fall out of the gas supply. [Sediment traps](#) are required at all automatically controlled gas appliances. Recommend further evaluation and repairs as needed.

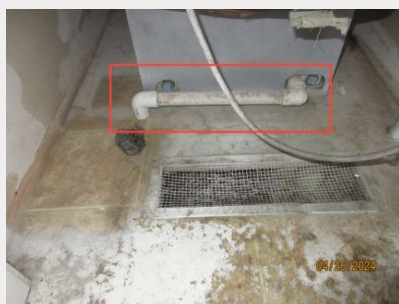
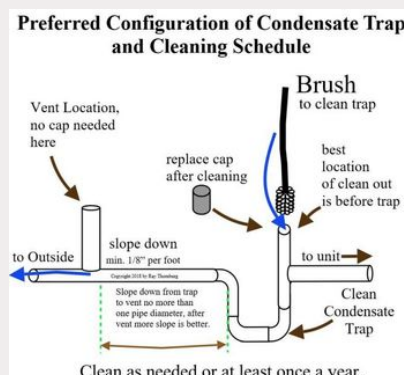
### **CS-7 Cooling System - Cooling System:**

The condensation line designed to properly dispose of condensate produced by the operation of the air-conditioning evaporator coils was improperly configured. Recommend repairs as needed. The cooling system evaporator coil had no condensate overflow warning/shutoff device installed. If the condensate drainage system should fail, this condition could result in moisture damage to the home. Recommend that a proper condensate overflow/shutoff device be installed. [Click here for information](#)

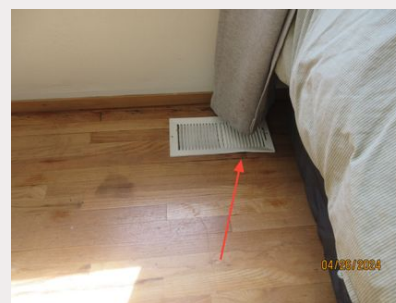
### **HDV-1 HVAC Distribution and Ventilation - Distribution Systems:**

The heating / cooling register cover was bent at the 3rd Bedroom. Repair as needed.

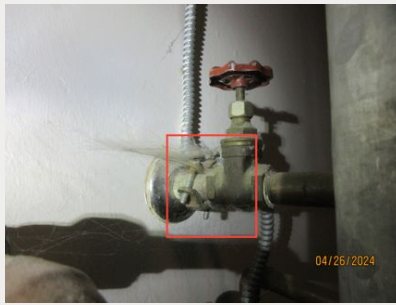
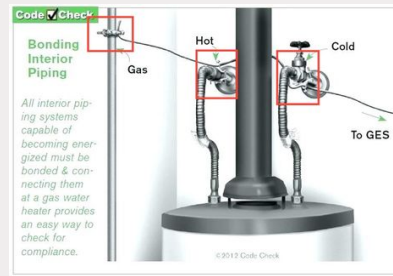
### **GB-2 Grounding / Bonding - Water Bonding:**

Metal cold water distribution pipes appeared to be properly bonded. Metal hot water pipes were not bonded. Electrical bonding of the water pipes helps to ensure that safe conditions exist if the pipes should somehow come into contact with electrical wiring and become energized. Bonding of water pipes is required in new homes by generally-accepted modern safety standards. Although it may not have been required at the time the building was originally constructed, as a safety measure the Inspector recommends that the hot water pipes be bonded also.

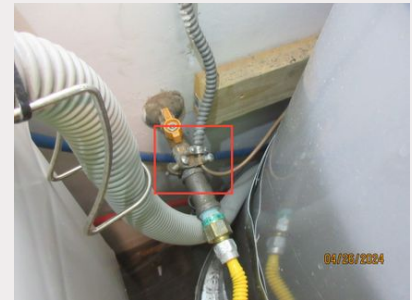
### **GB-3 Grounding / Bonding - Gas Bonding:**

At the time of the inspection, the gas piping appeared to be bonded to the water piping only.

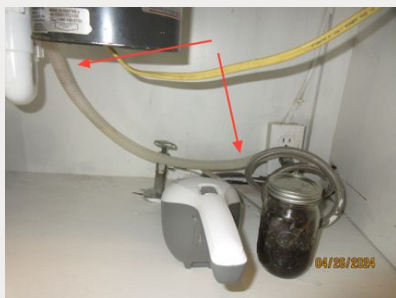
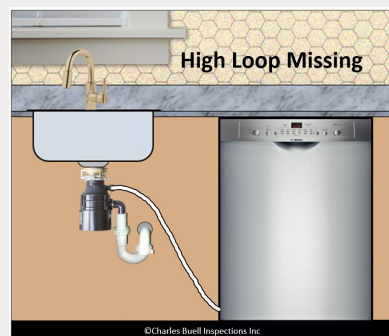
### **KA-7 Kitchen Appliances - Dishwasher:**

An **air gap** is recommended to protect the dishwasher from accidental contamination if the sewer line were to back up. If an air gap cannot be installed, at least run the drain line above the level of the sink drain to create a high loop. This was an older way of protecting the dishwasher. Recommend further evaluation to determine if the dishwasher has an internal air gap / high loop or repair as needed to install an air gap.

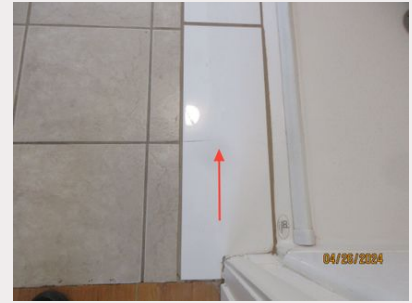
## **B-2 Bathrooms - Ceiling, Wall and Floor Finishes:**

The tile floor in the Main Bathroom was cracked. This is a cosmetic defect but would require tile replacement to repair, a significant expense. It can also indicate that the tile was not set properly, cracking may continue to get worse.

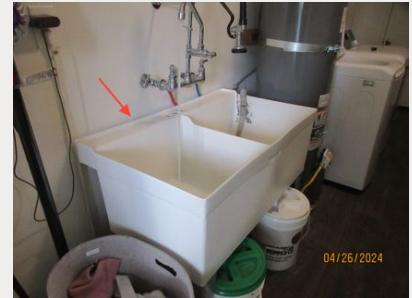
## **LA-3 Laundry Area - Sinks, Countertops and Cabinets:**

The sink in the Laundry area was loose and needs to be secured to prevent accidental damage to the sink or plumbing.

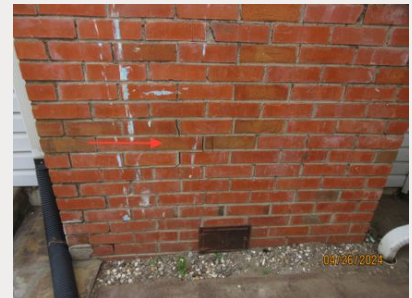
## **CF-2 Chimneys and Fireplaces - Chimney Exterior:**

Cracks and mortar separation were noted in the masonry chimney. These were small and minor at the time of inspection. Recommend repairs as needed.

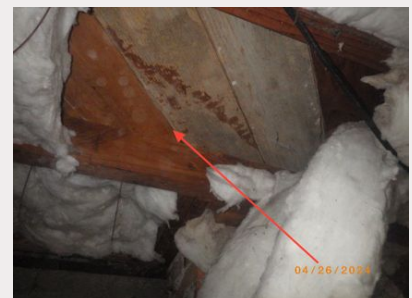
## **CF-5 Chimneys and Fireplaces - Solid Fuel Fireplaces:**

There was not an adequate non-combustible hearth under the fireplace (typical in older houses), the hearth was supported by combustible wood (as seen in the Crawlspace). Generally, a 20-inch deep hearth is recommended in front of all fireplaces greater than 6 sq. ft. The hearth should extend 12-inches to the sides of the firebox. For smaller fireplaces, minimum recommended clearances are 16-inches deep and 8-inches on

either side. Recommend further evaluation and repairs as needed.

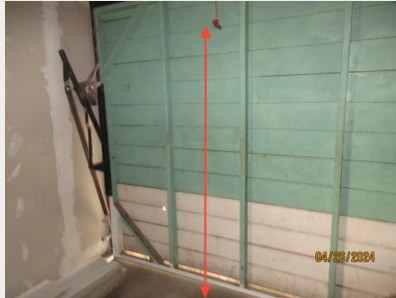
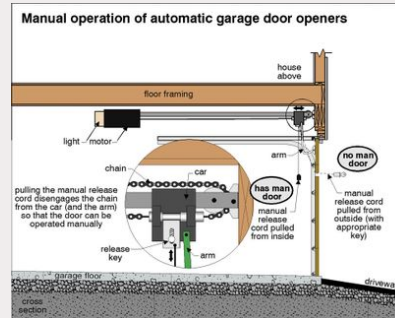
### **G-8 Garage - Vehicle Doors and Automatic Openers:**

The handle that attaches to the overhead Garage door detaching mechanism was located too high off the floor. These release handles should be accessible, less than 6-feet off the ground. Repair as needed for improved safety.

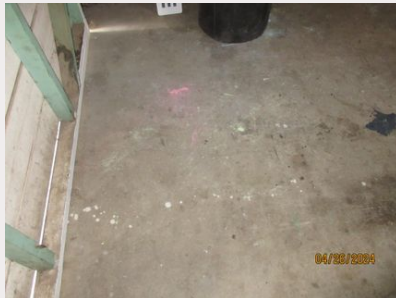
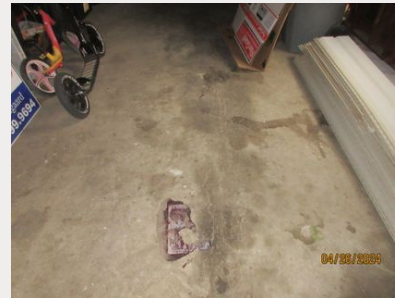
### **G-11 Garage - Floor:**

Typical cracks were noted in the concrete Garage slab. You can fill the cracks with a masonry rated caulking, but no repair is needed at this time; this is a cosmetic defect.
