# Inspection Report

**Property Address:**  
813 & 813-1/2 Bayview Dr  
Manhattan Beach CA 90266

**Ferguson Home Inspections**

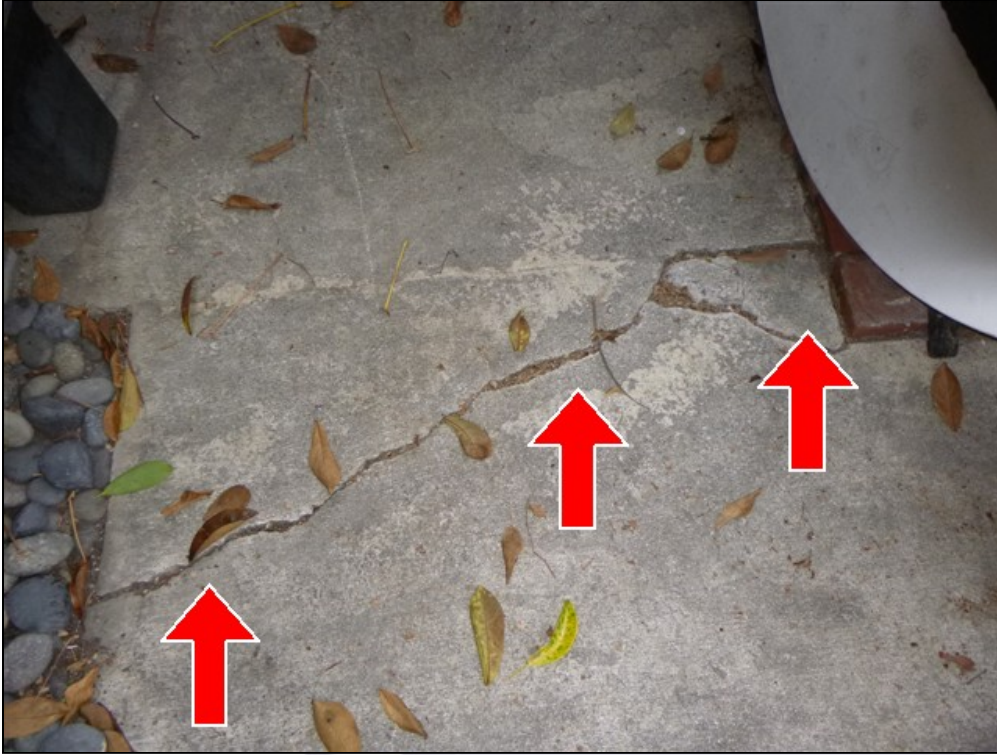
1.1 Item 3(Picture)

**1.1** (3) Settling, expansion cracks and heaving noted at various areas, this is a potential trip hazard. Suggest review with a licensed contractor for any repair/replacement costs as needed.

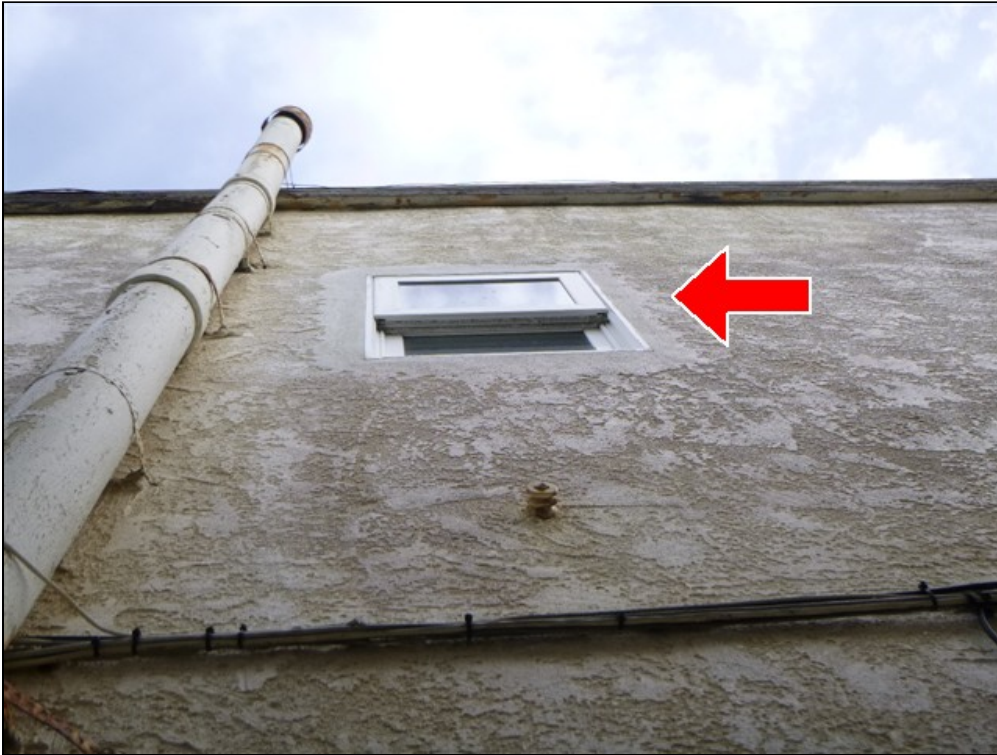
1.4 Item 2(Picture)

**1.4** (1) Various areas of the siding have been patched, suggest review with the seller on the cause and any repairs needed.

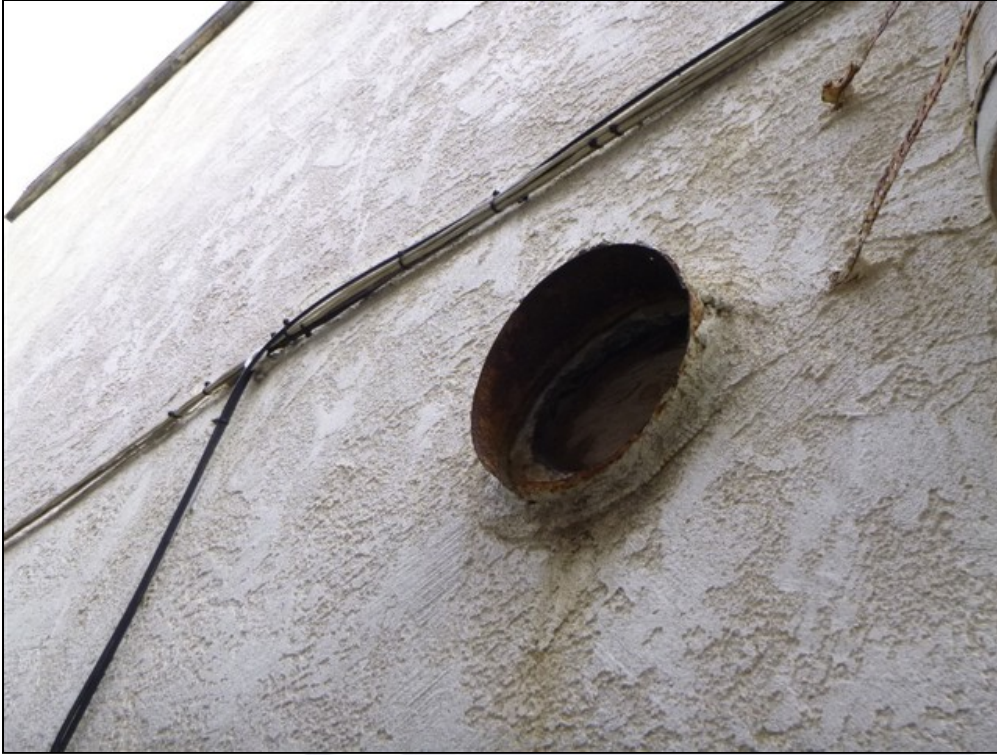
1.4 Item 4(Picture)

**1.4** (2) Suggest sealing around the siding holes/penetration's to prevent future water/insect/rodent intrusion at these areas.

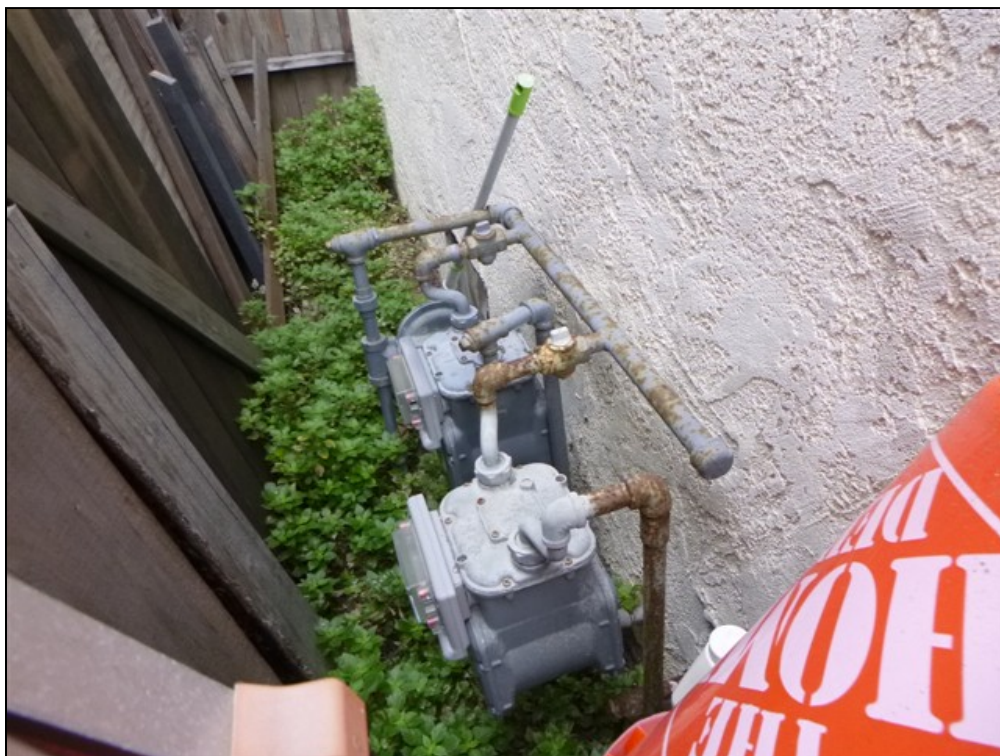
1.11 Item 1(Picture)

**1.11** (1) The gas meters are not currently individually labelled/markd as per each unit. Suggest review with the owner/plumber and/or the gas company to label/mark each gas meter per unit as required for safety.

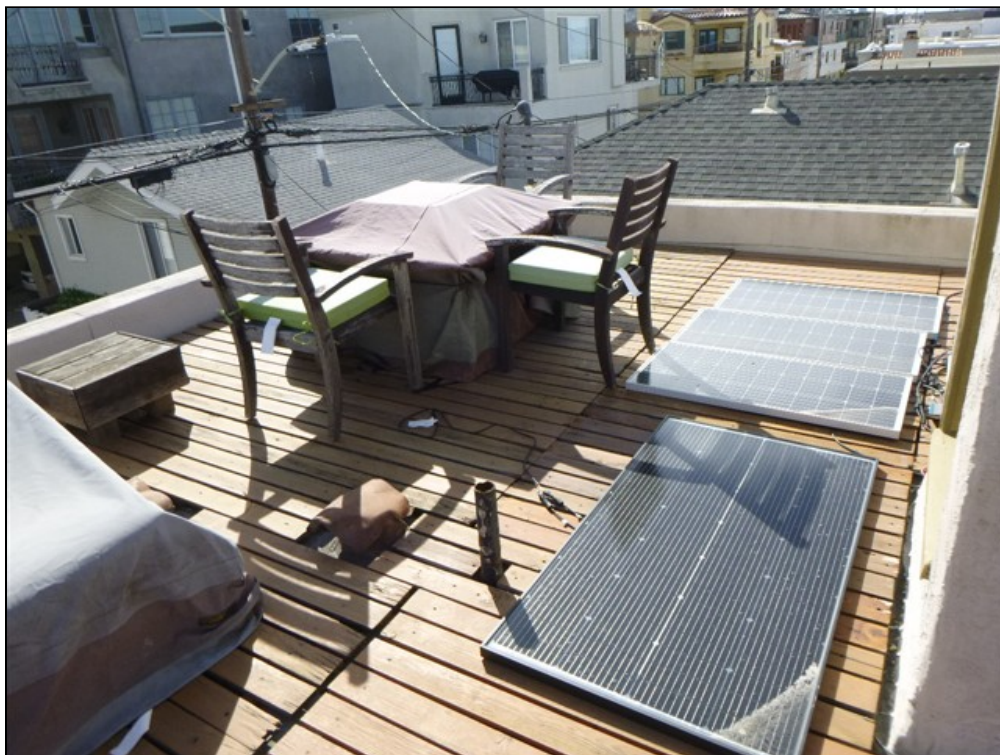
5.0 Item 2(Picture)

**5.0** (1) The roof covering is old and deteriorated. It is nearing the end of its useful life and the covering will need to be replaced. While it could last a year or so, some areas may need patching/repairs as leaks develop ( evidence of leakage to the interior was noted ). Please review with a licensed roofer to determine the remaining life expectancy and for costs to repair/remove and replace the existing roofing material as needed.

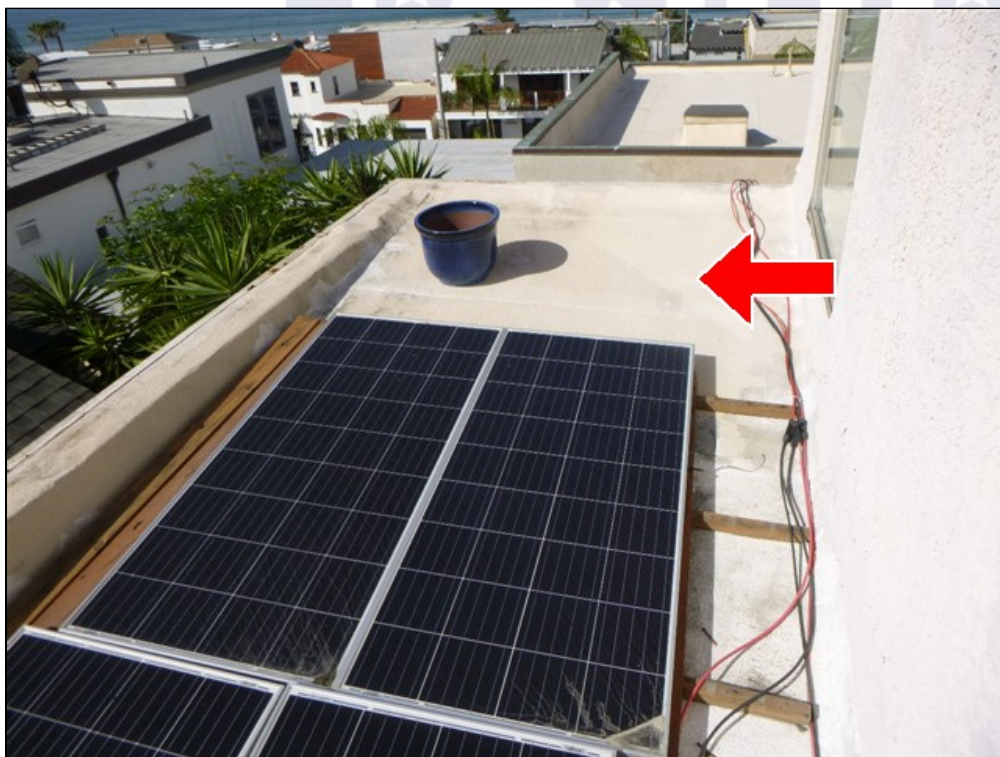
5.0 Item 7(Picture)

**5.0** (2) Various sloped areas of the roof have been coated with reflective/sealant/membrane. Suggest review with the seller to determine when the membrane was installed and the life expectancy as needed.

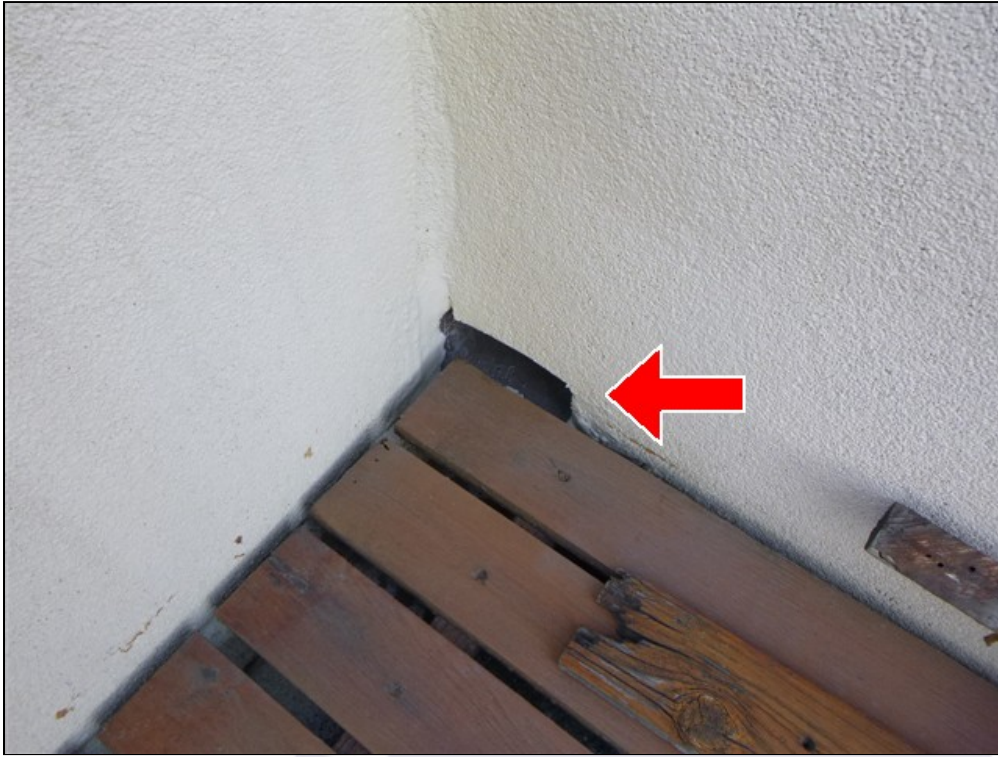
5.0 Item 8(Picture)

**5.0** (3) Suggest review with a licensed roofer for installation costs for a scupper/over flow drain to the roof as an upgrade. Any blockages to the roof drain will result in excessive water ponding/flooding at the roof area.

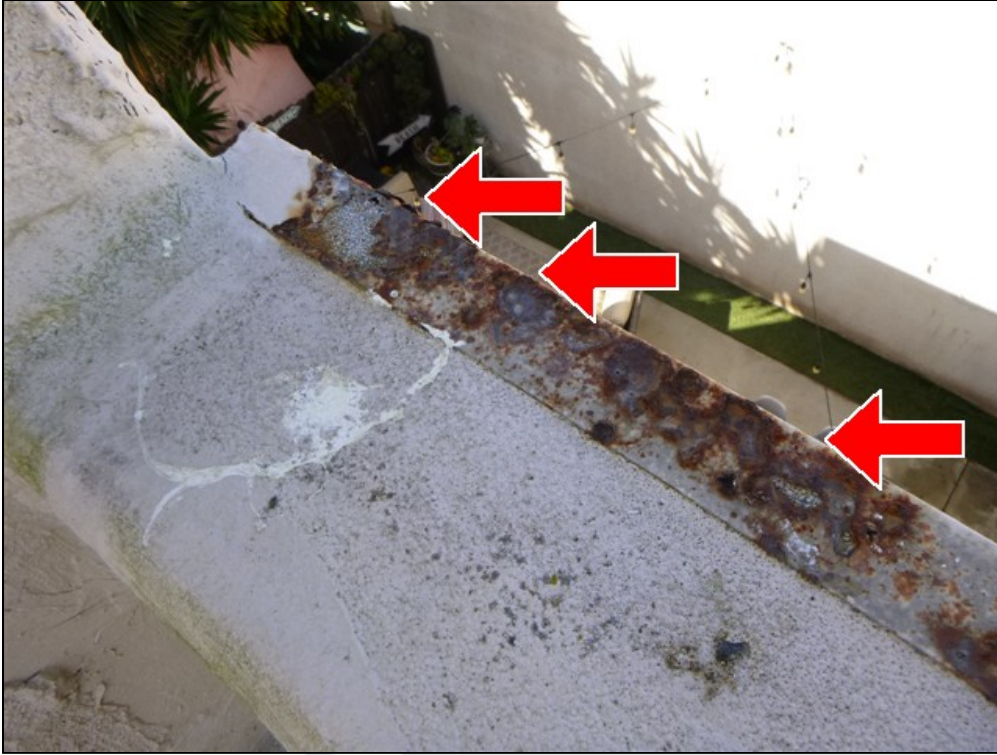
5.1 Item 1(Picture)

**5.1** Deteriorated and rusted stem wall flashings were noted at various areas. Suggest review with a licensed roofer for any repair/replacement costs as needed.

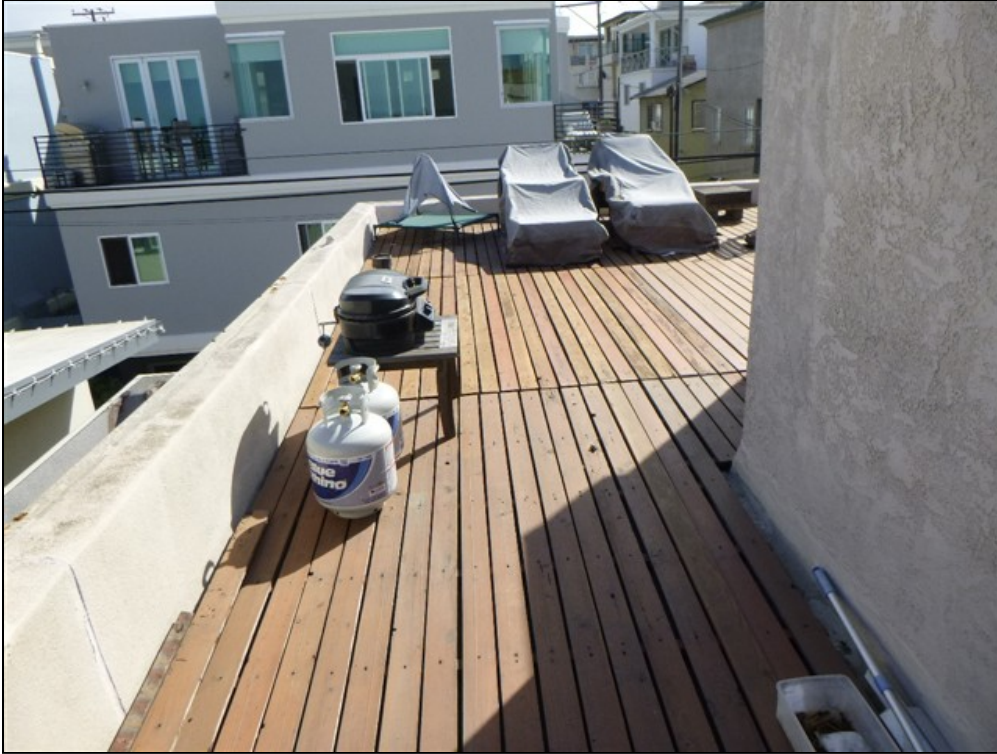
5.3 Item 1(Picture)

**5.3** (1) A potential fall/safety hazard was noted due to the additional wood decking over the roof but no handrailings are currently installed at the perimeter of the roof area ( excessive wood deterioration was noted at the wood decking ). Suggest review with a licensed contractor for any repair/removal/ replacement costs as needed for safety.

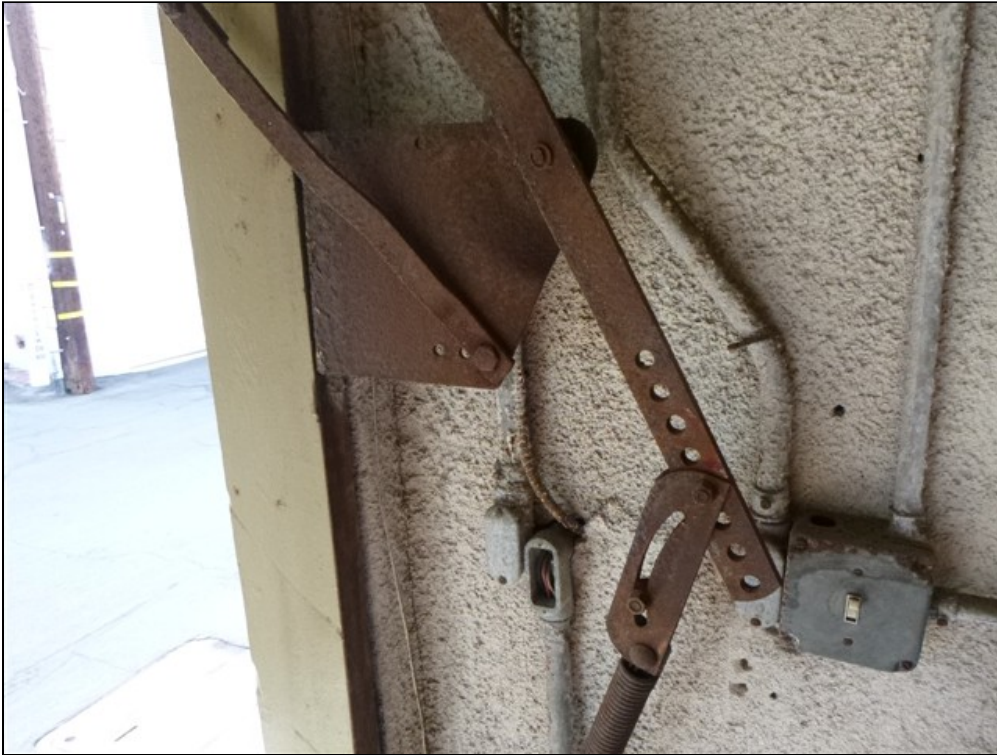
7.2 Item 2(Picture)

**7.2** Bent and damaged hinge hardware was noted, this is a potential safety hazard. Suggest review with a licensed contractor for repair/replacement costs as needed.

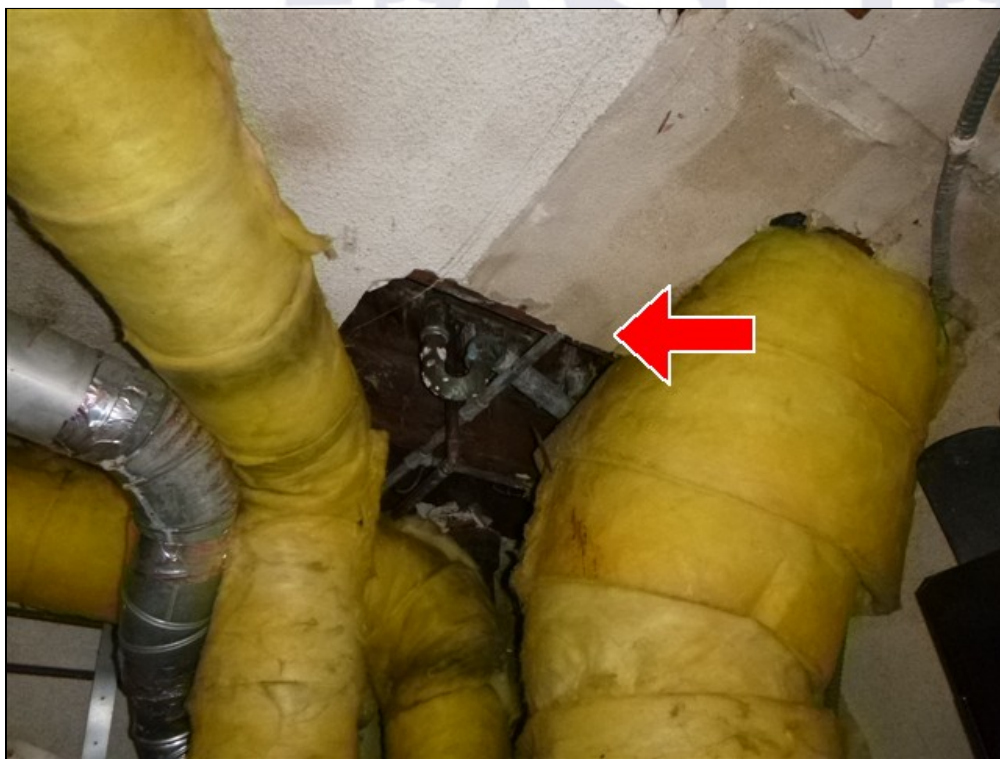
7.4 Item 3(Picture)

**7.4** (2) Holes and unfinished sections of the firewall/ceiling were noted, this is a potential fire spread hazard. 5/8 inch sheetrock may be installed as a minimum standard material and as a requirement for a one hour burn through rating for the firewall/ceiling. Suggest review by licensed contractor for repair/ installation costs as needed.

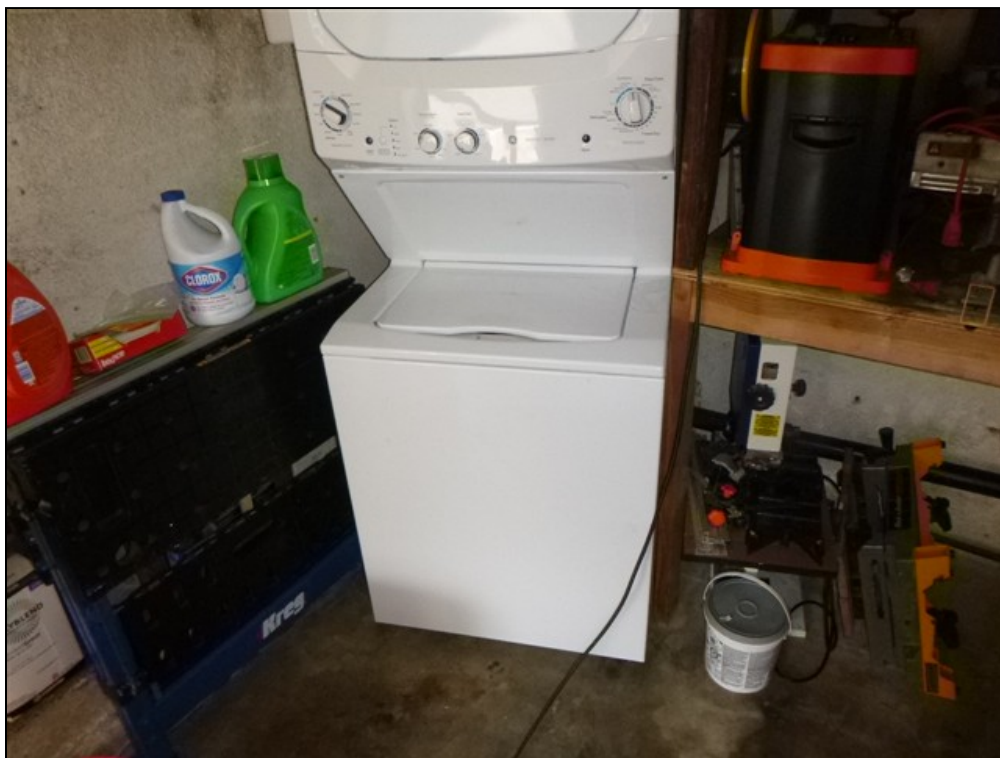
7.6 Item 2(Picture)

**7.6** (2) No impact barrier installed as required due to the location of the laundry and heating appliance(s) in the garage ( this is common for the original age of the dwelling ). Suggest review with a licensed contractor for installation costs as needed as an upgrade.

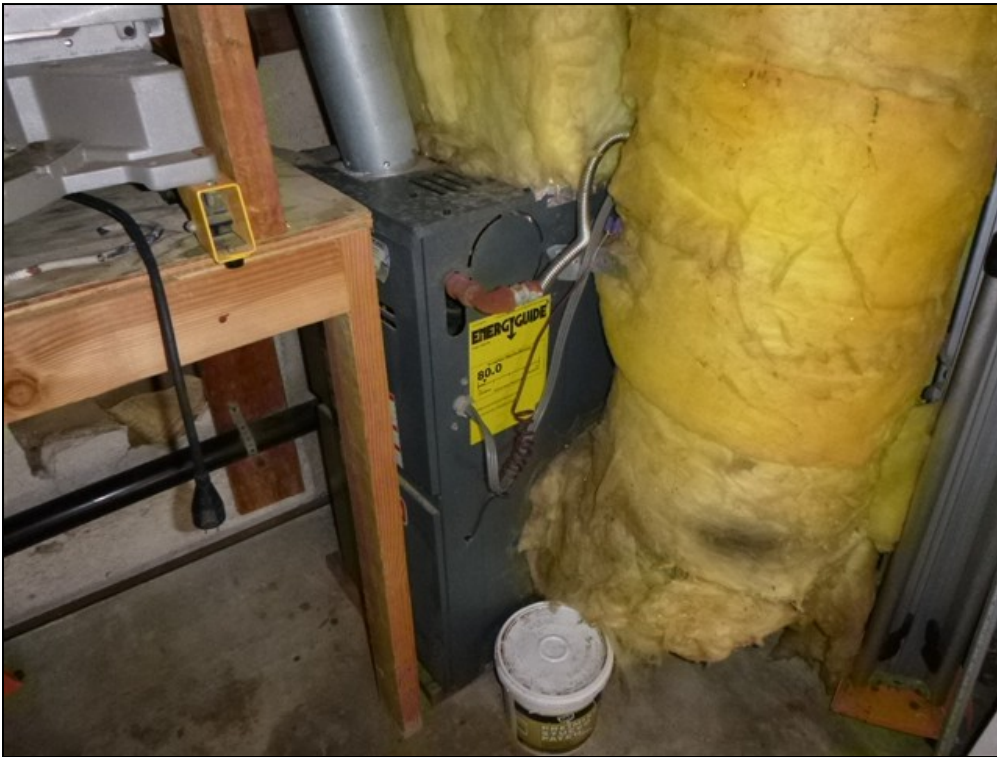
14.0 Item 1(Picture)

**14.0** (1) The heating unit was tested and was operational at the time of the inspection.

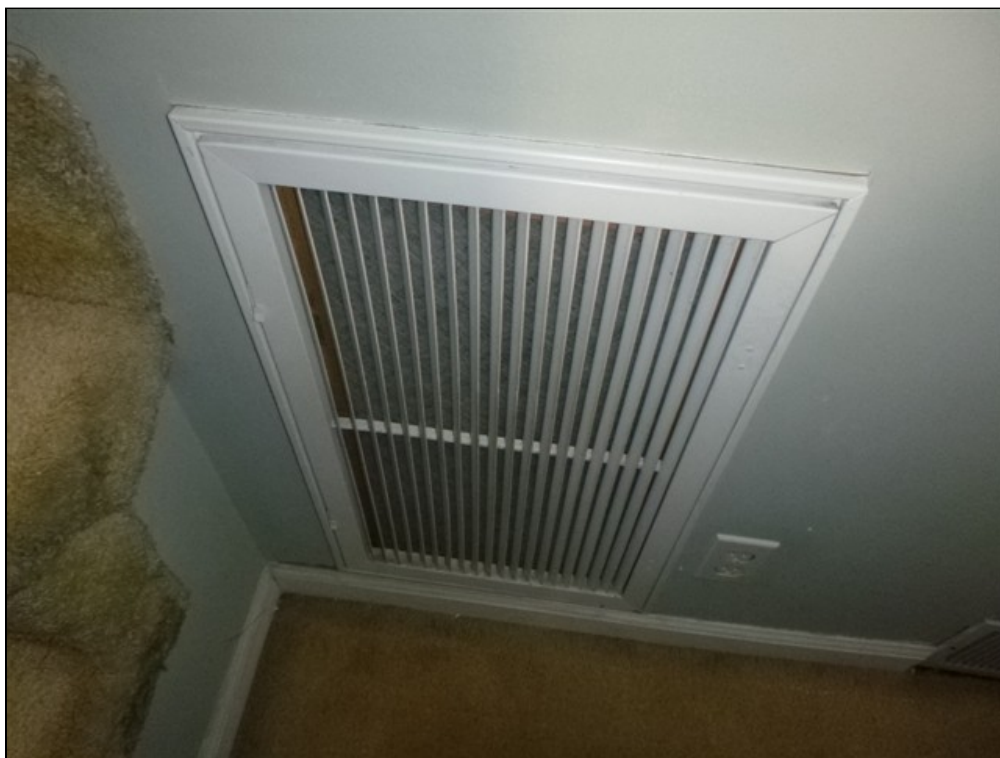
14.0 Item 3(Picture)

**14.0** (2) Suggest replacing/cleaning the filter(s) as needed.

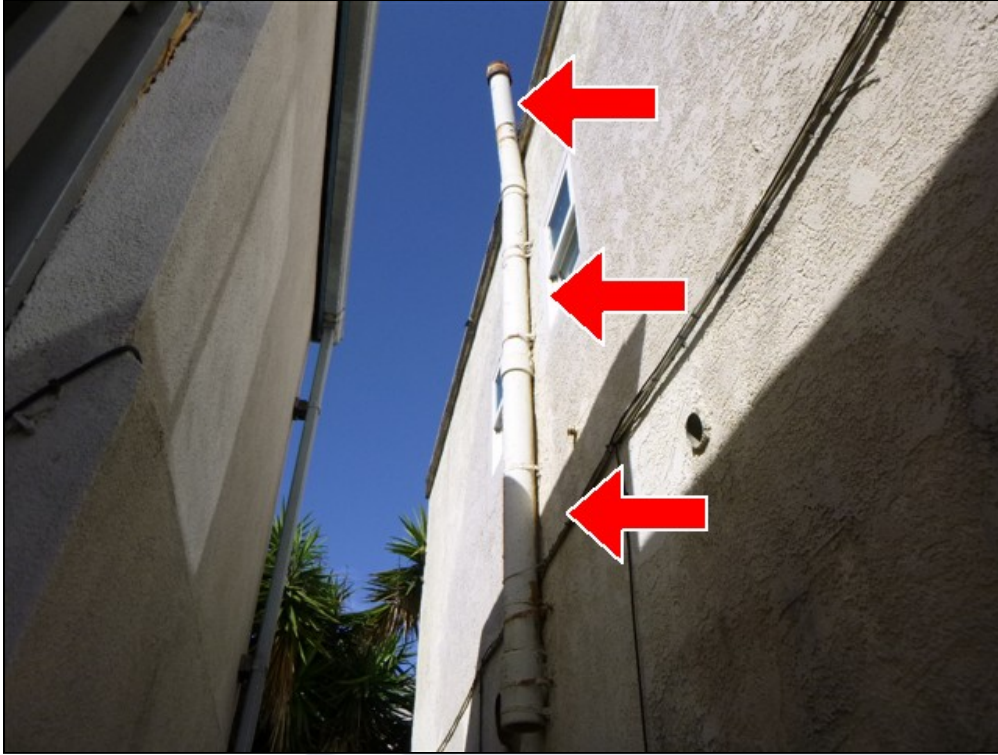
14.1 Item 1(Picture)

**14.1** An original asbestos-like material transit pipe/vent was noted ( this is common for the age of the dwelling ). No damage visible at the transit pipe at the time of the inspection.

**15.1** Asbestos-like material transit pipe/vent noted. Common for the age of the dwelling. No damage visible at the transit pipe at the time of the inspection.

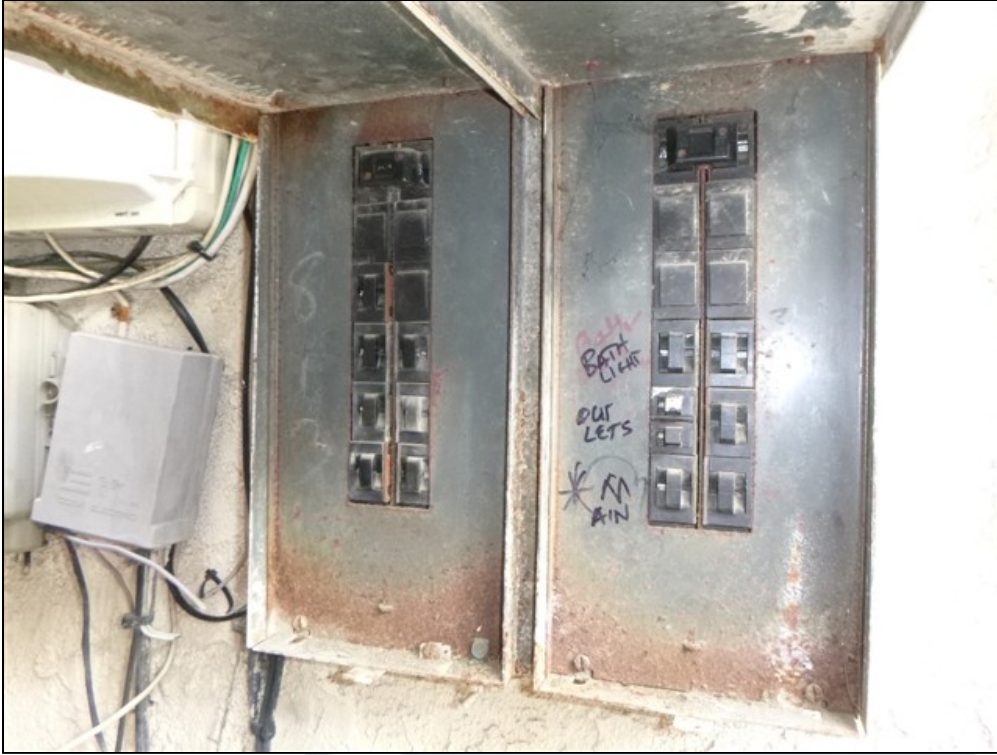
16.1 Item 1(Picture)

**16.1** (1) The main panel/breakers are not labelled as per each unit, suggest review with the utility company and label as needed for identification purposes.

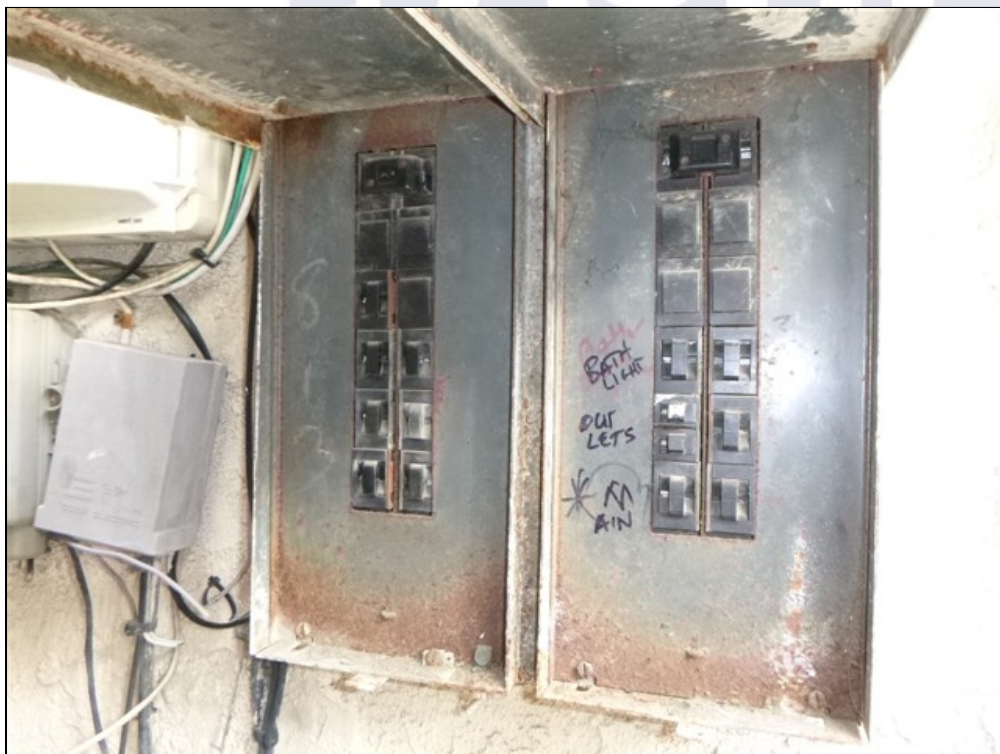
22.1 Item 2(Picture)

**22.1** (2) Suggest adding correct/complete indexing/labelling to all breakers for indentification of each circuit for safety.

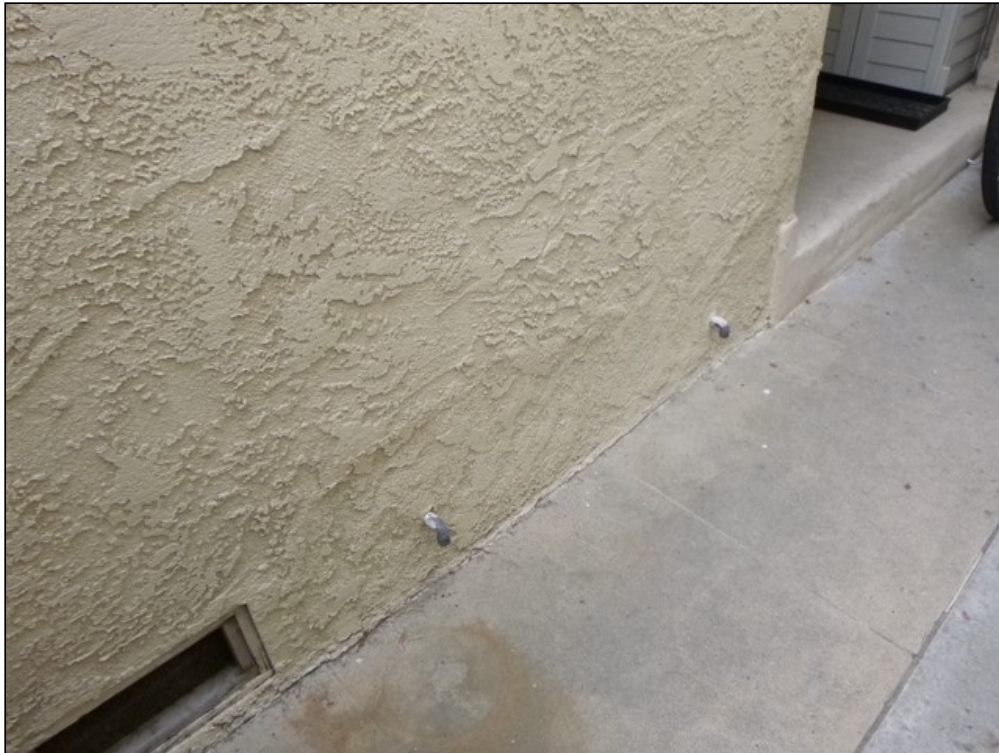
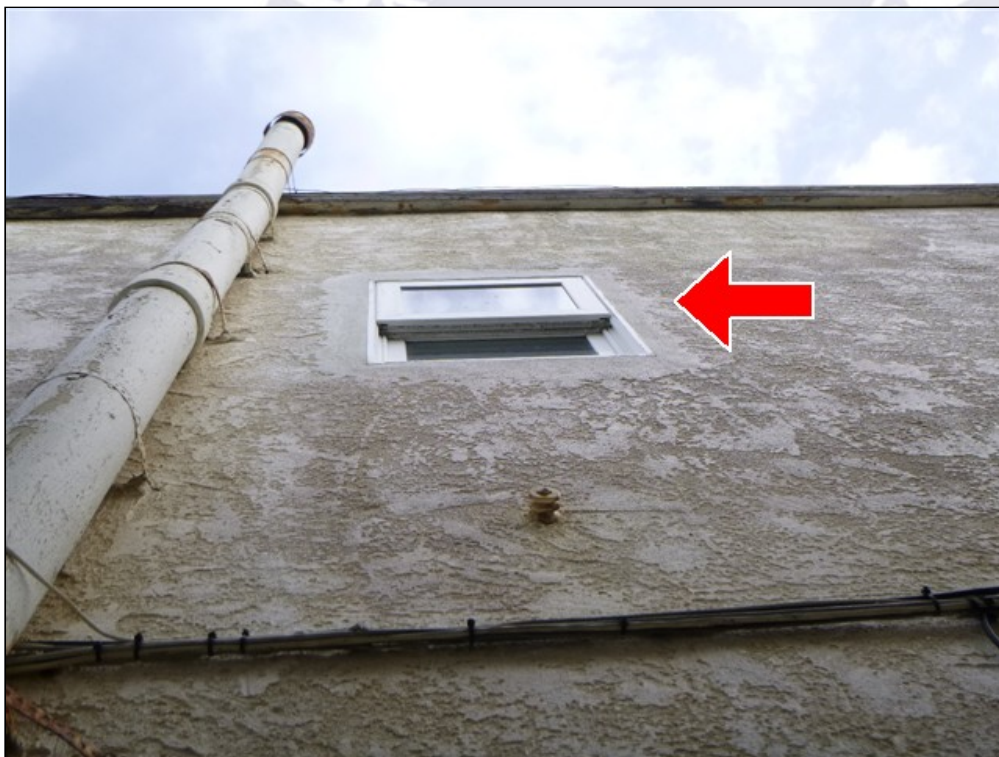
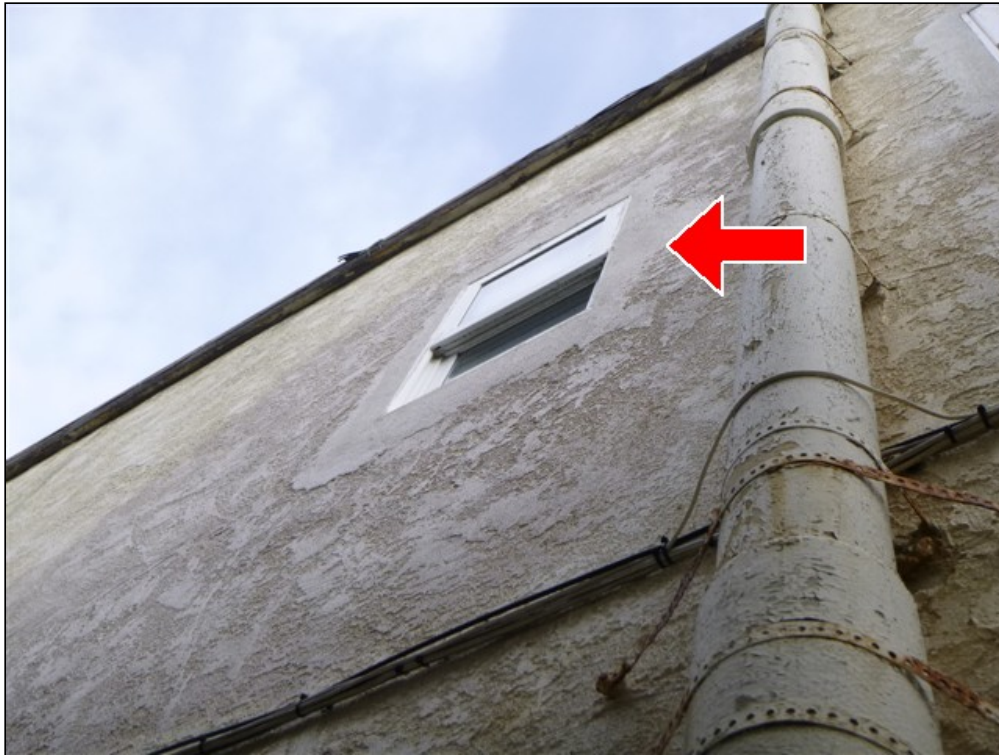
(1) Various areas of the siding have been patched, suggest review with the seller on the cause and any repairs needed.

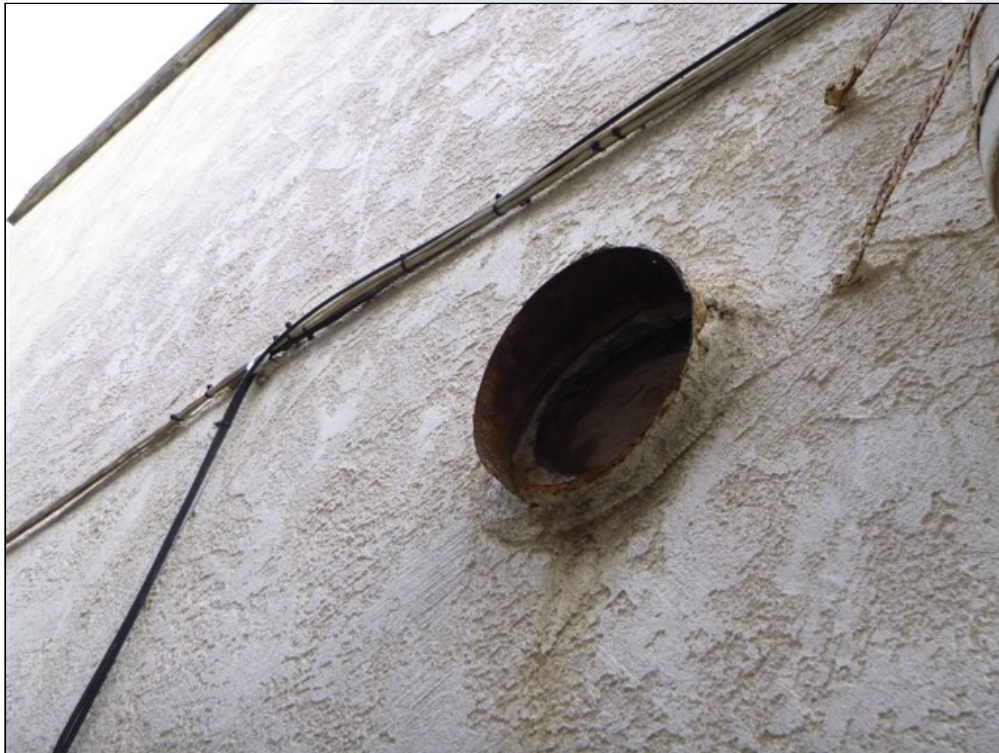
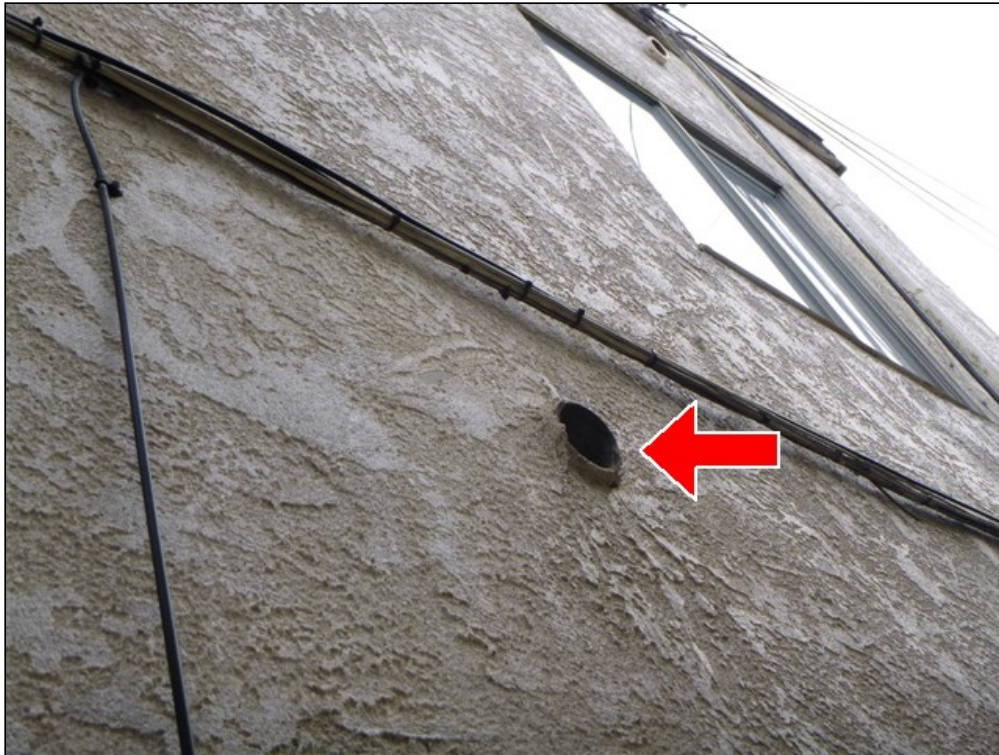
(2) Suggest sealing around the siding holes/penetration's to prevent future water/insect/rodent intrusion at these areas.

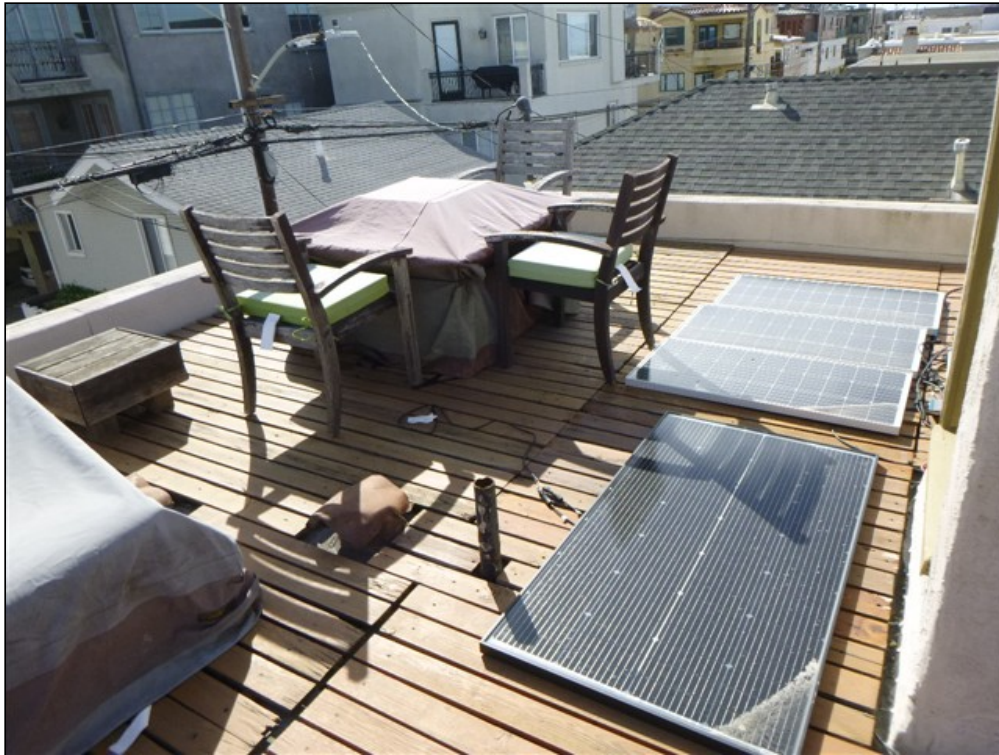
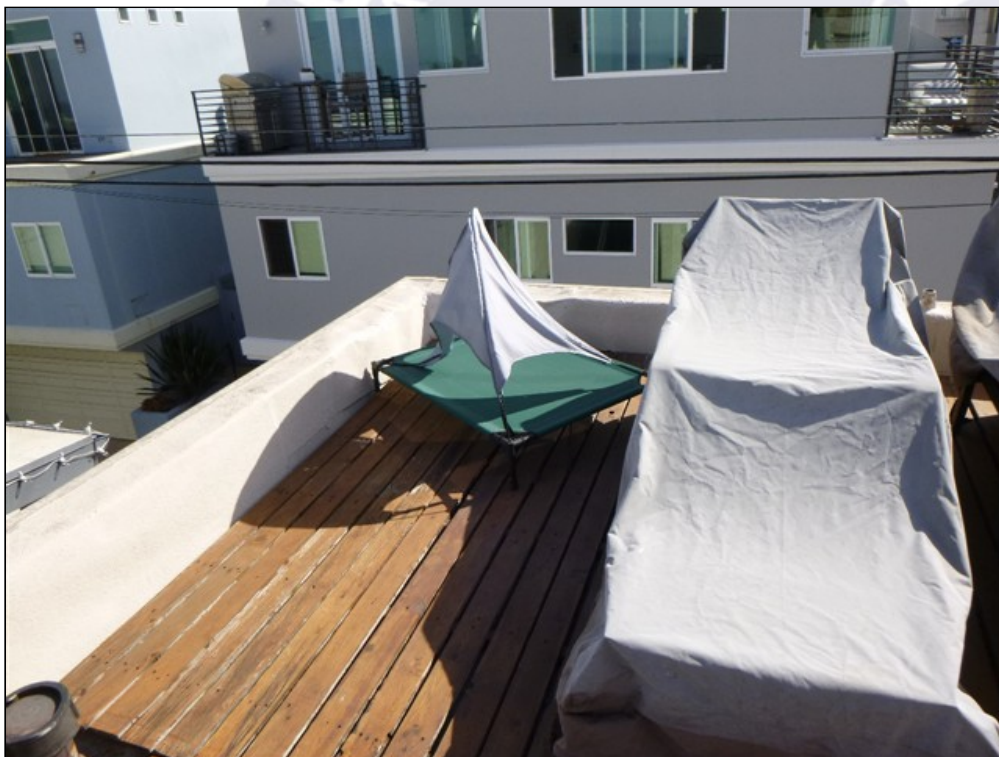
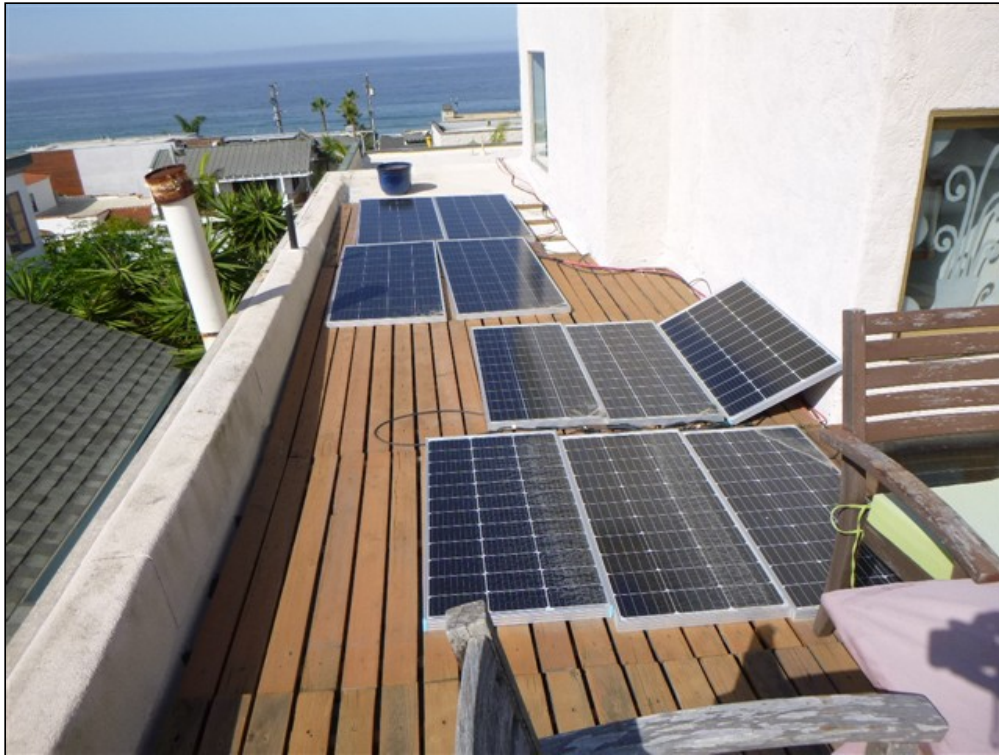
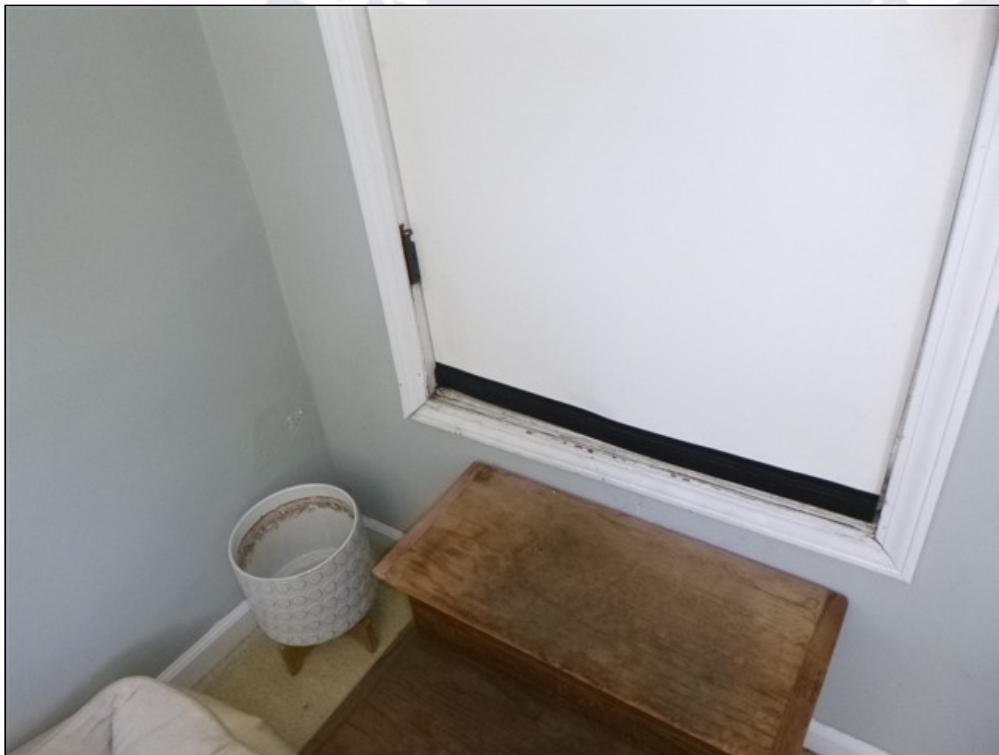
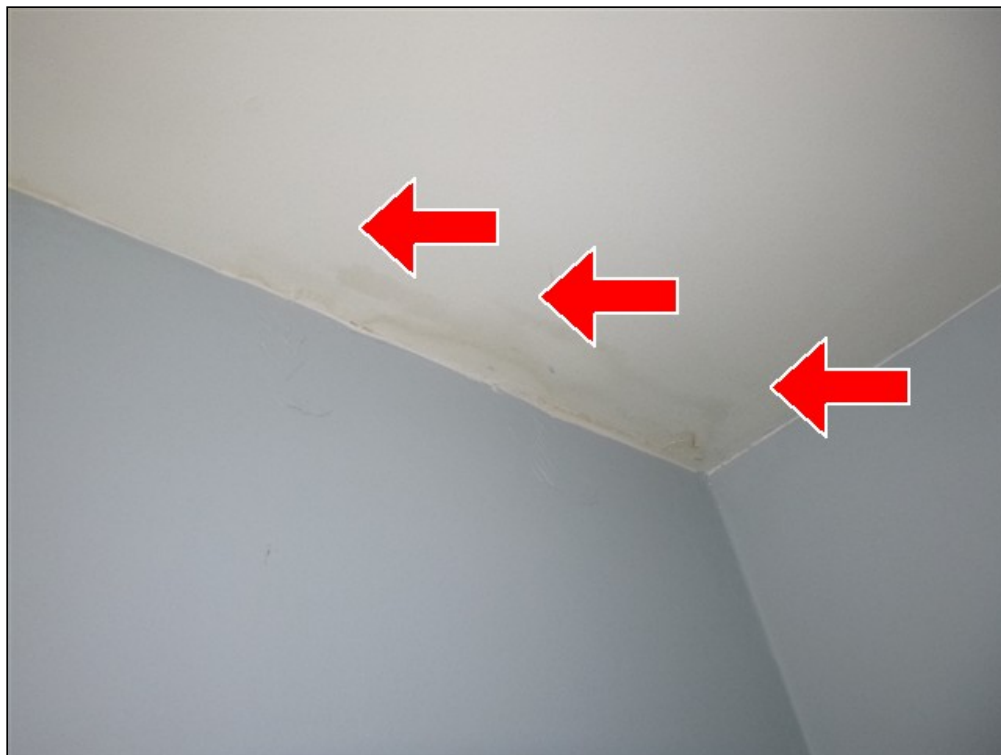
(1) The roof covering is old and deteriorated. It is nearing the end of its useful life and the covering will need to be replaced. While it could last a year or so, some areas may need patching/repairs as leaks develop ( evidence of leakage to the interior was noted ). Please review with a licensed roofer to determine the remaining life expectancy and for costs to repair/remove and replace the existing roofing material as needed.

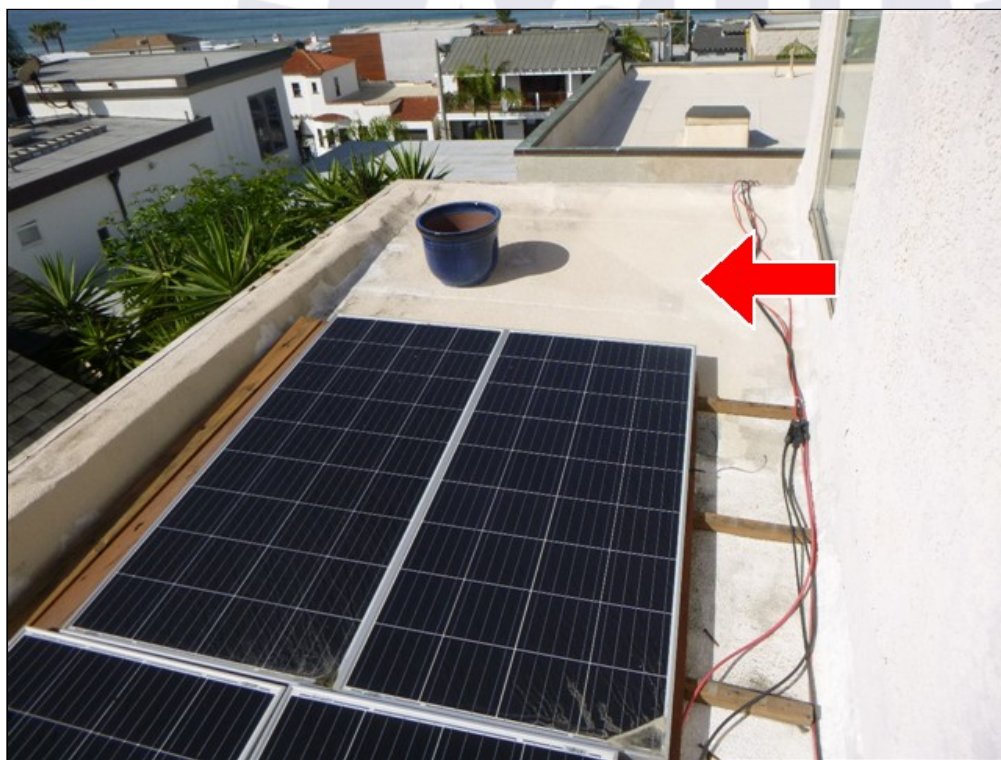
5.0 Item 7(Picture)

(2) Various sloped areas of the roof have been coated with reflective/sealant/membrane. Suggest review with the seller to determine when the membrane was installed and the life expectancy as needed.
