# Inspection Report

**Property Address:**  
813 & 813-1/2 Bayview Dr  
Manhattan Beach CA 90266

**Ferguson Home Inspections**

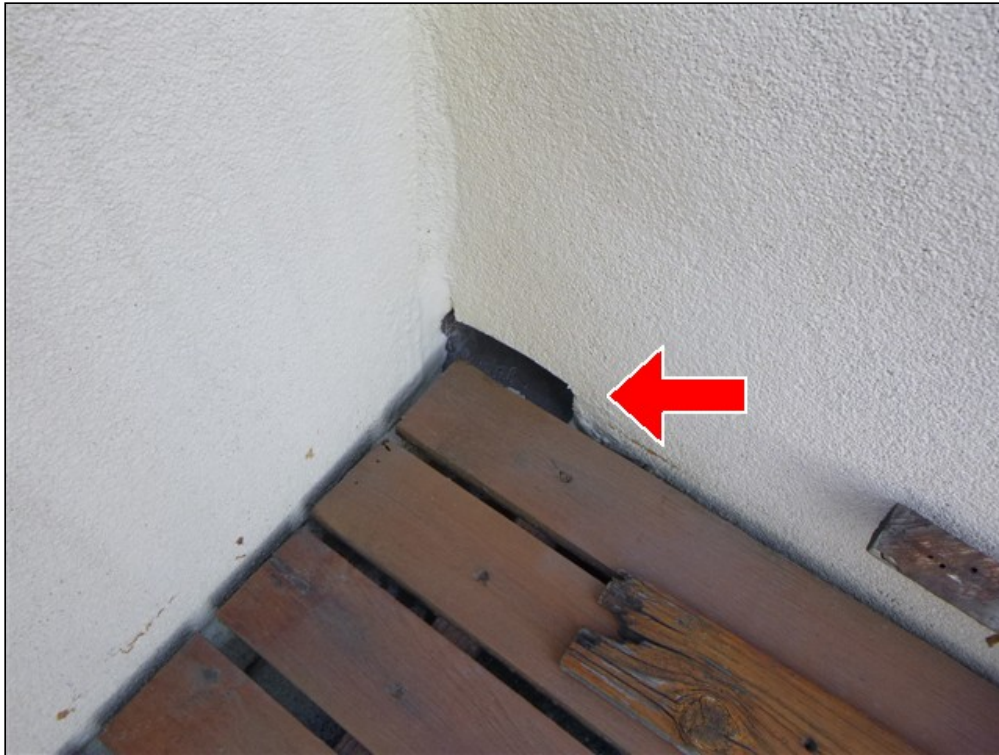
5.0 Item 8(Picture)

(3) Suggest review with a licensed roofer for installation costs for a scupper/over flow drain to the roof as an upgrade. Any blockages to the roof drain will result in excessive water ponding/flooding at the roof area.

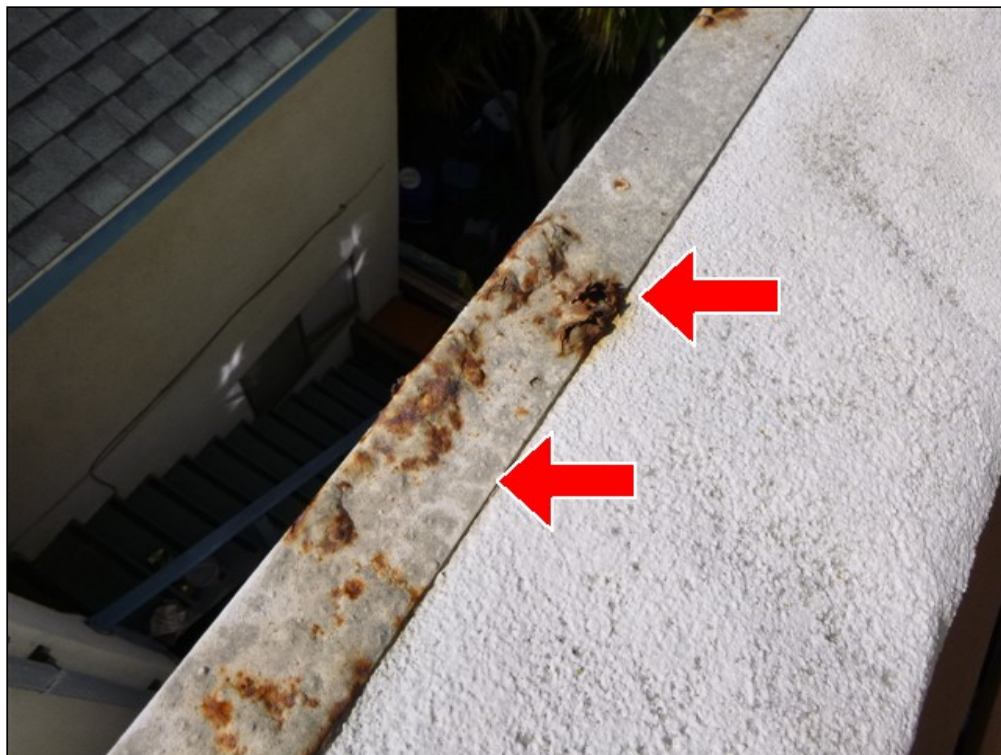
5.1 Item 2(Picture)

Deteriorated and rusted stem wall flashings were noted at various areas. Suggest review with a licensed roofer for any repair/replacement costs as needed.

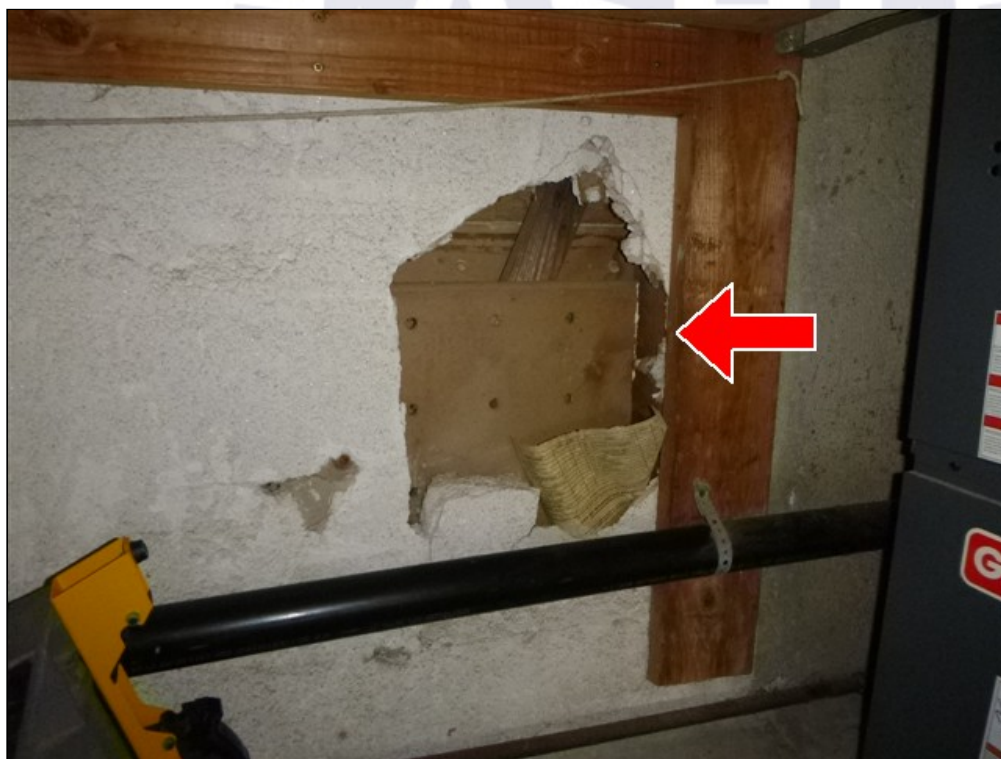
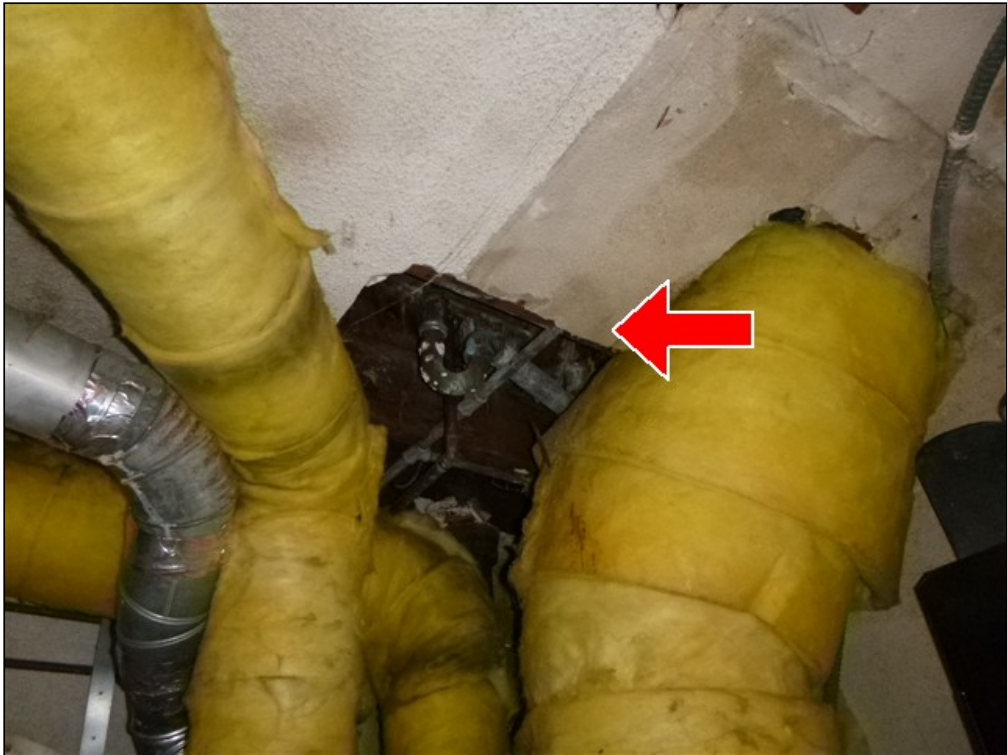
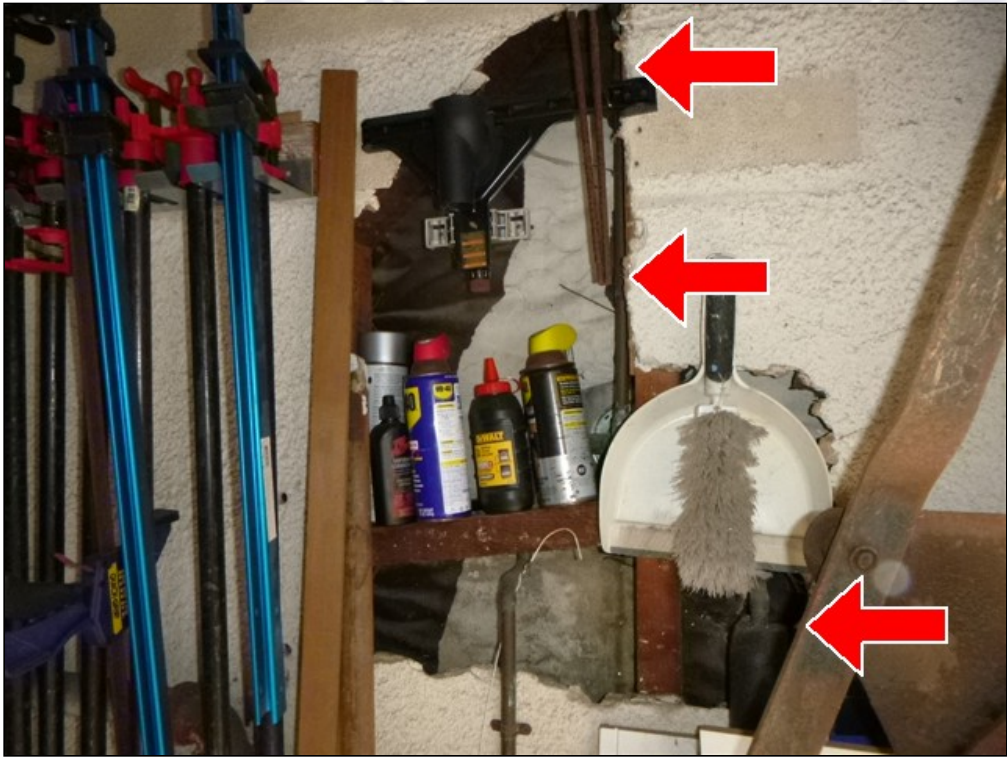
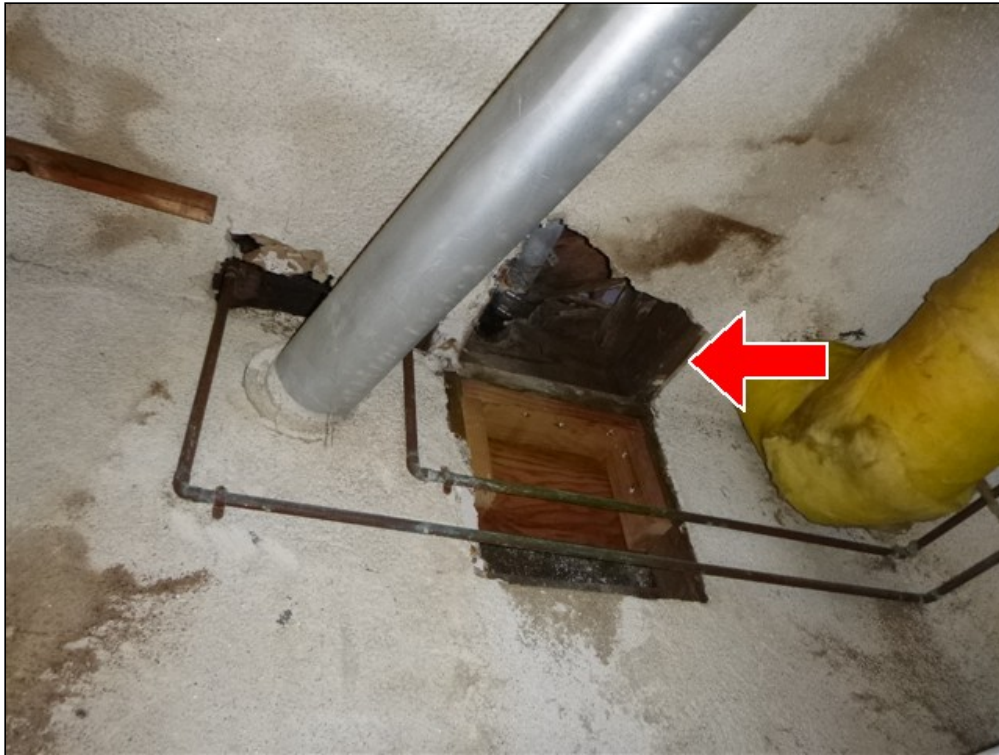
(2) Holes and unfinished sections of the firewall/ceiling were noted, this is a potential fire spread hazard. 5/8 inch sheetrock may be installed as a minimum standard material and as a requirement for a one hour burn through rating for the firewall/ceiling. Suggest review by licensed contractor for repair/installation costs as needed.

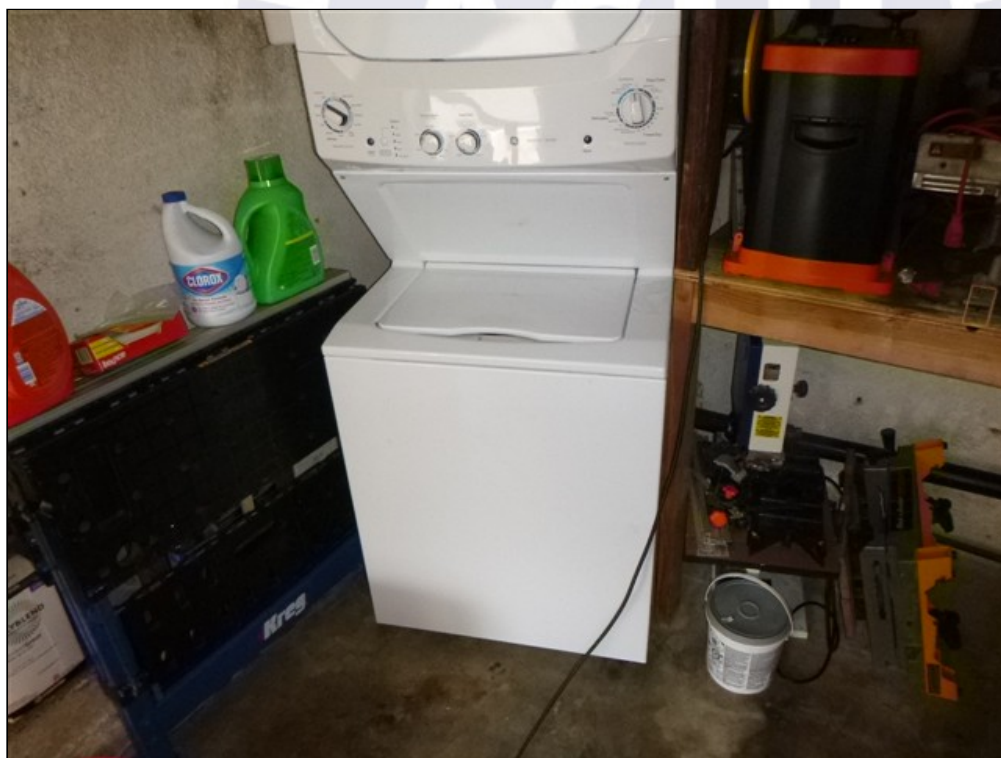
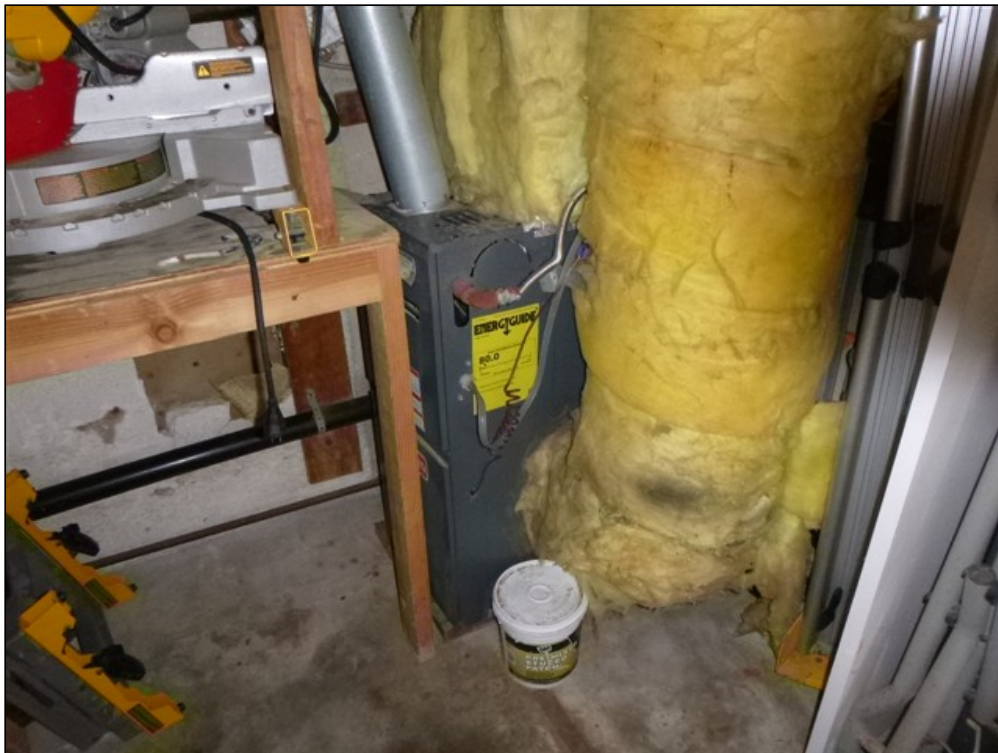
(2) No impact barrier installed as required due to the location of the laundry and heating appliance(s) in the garage ( this is common for the original age of the dwelling ). Suggest review with a licensed contractor for installation costs as needed as an upgrade.

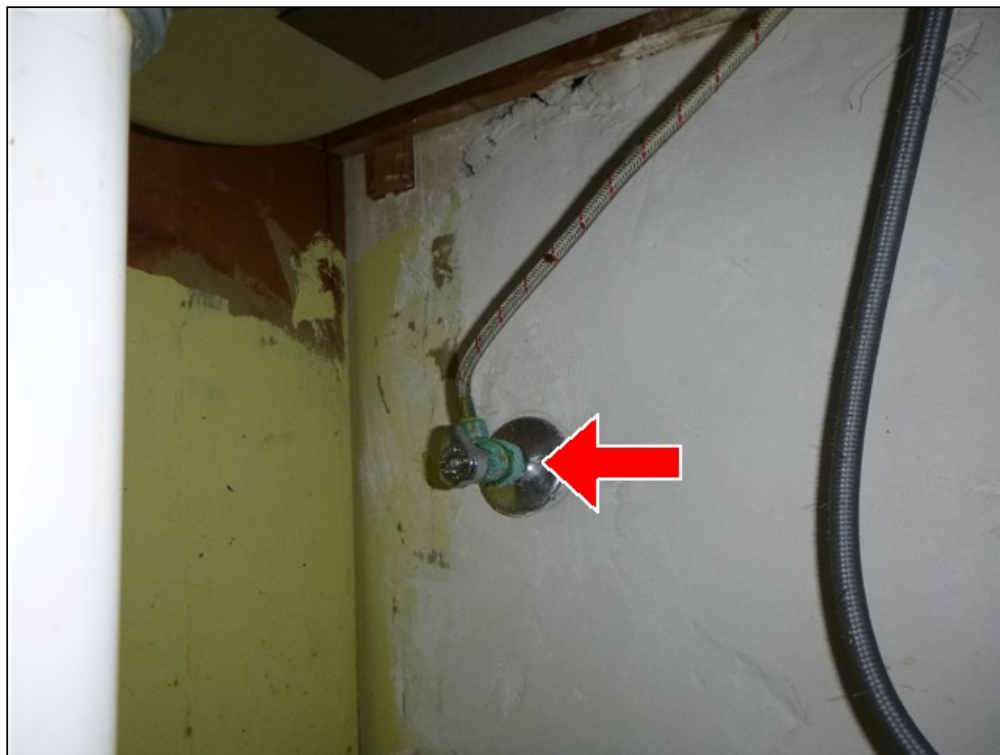
8.0 Item 1(Picture)

- (4) Replaced sections of the plumbing supply lines were noted throughout the dwelling/structure(s). Suggest review with the seller to determine/confirm when the plumbing was replaced, the extent of replacement plumbing, the cause and any other repairs needed.
- (5) Corroded plumbing and fittings noted at various areas within the dwelling/structure(s). Suggest further review by a licensed plumber for repair/replacement costs as needed to prevent future leakage, pin hole leaks and possible stains/damage to the interior of the dwelling.

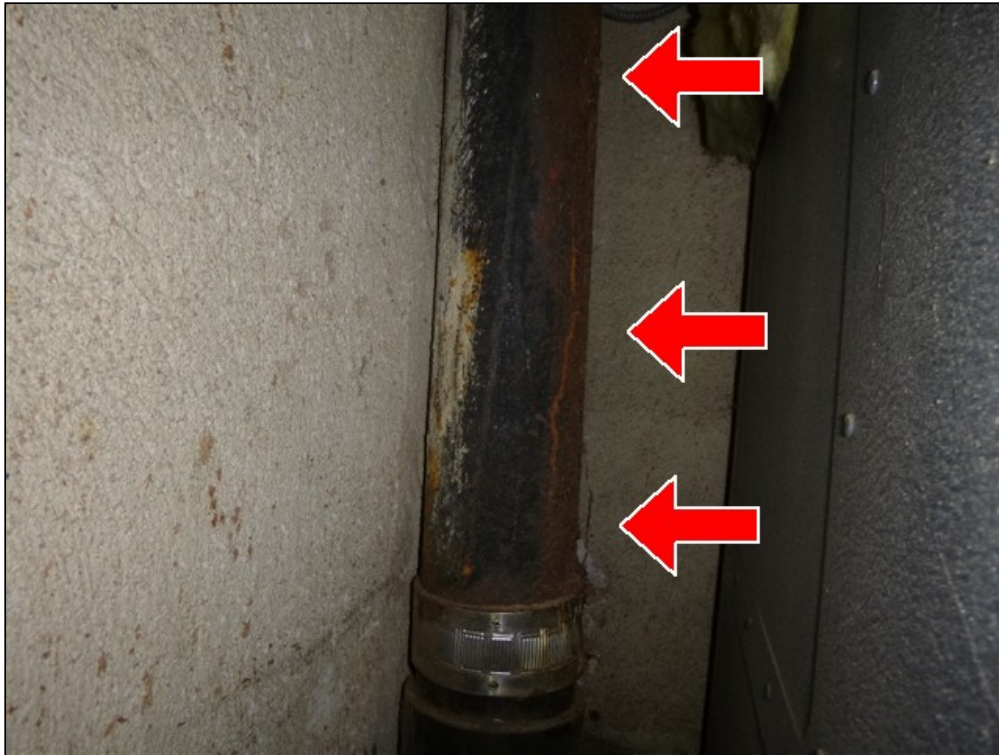
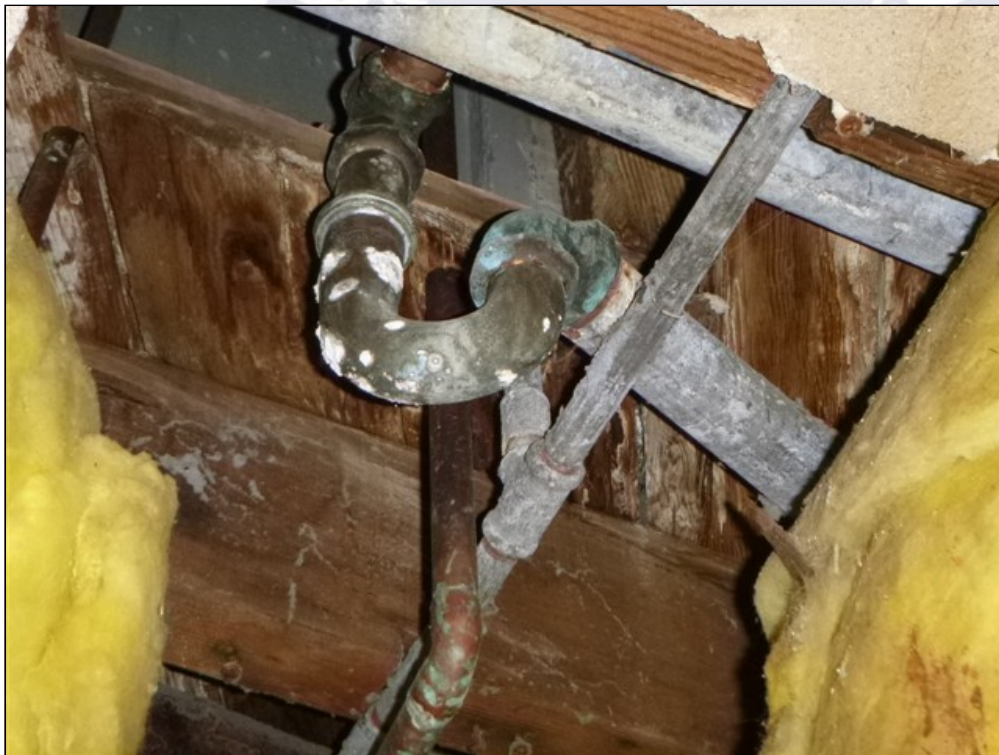
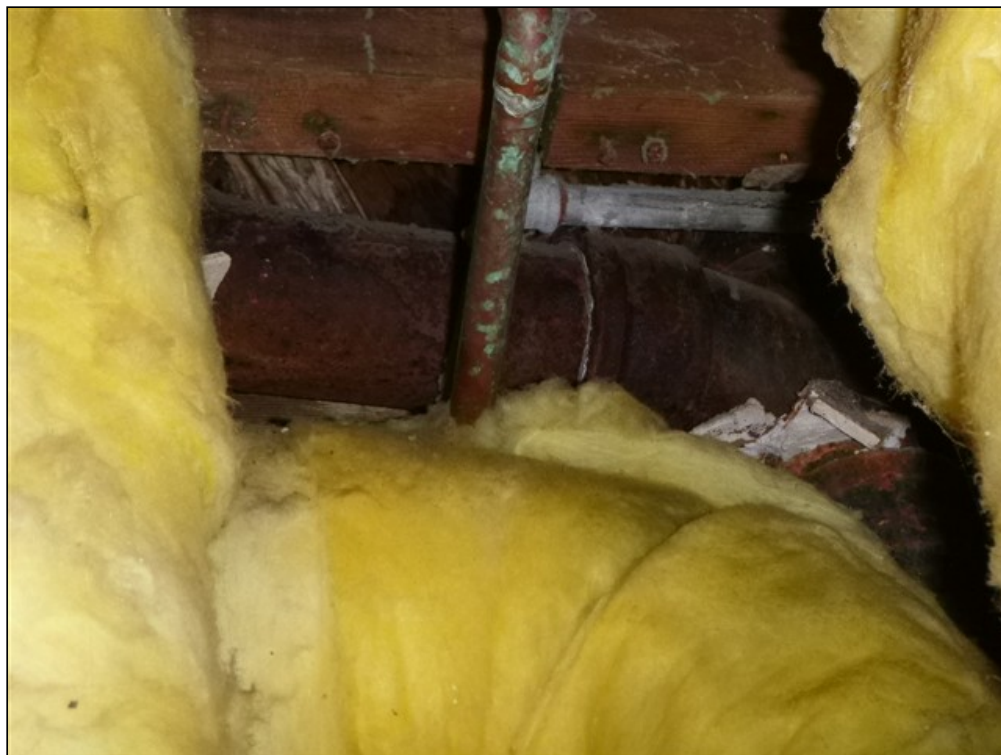
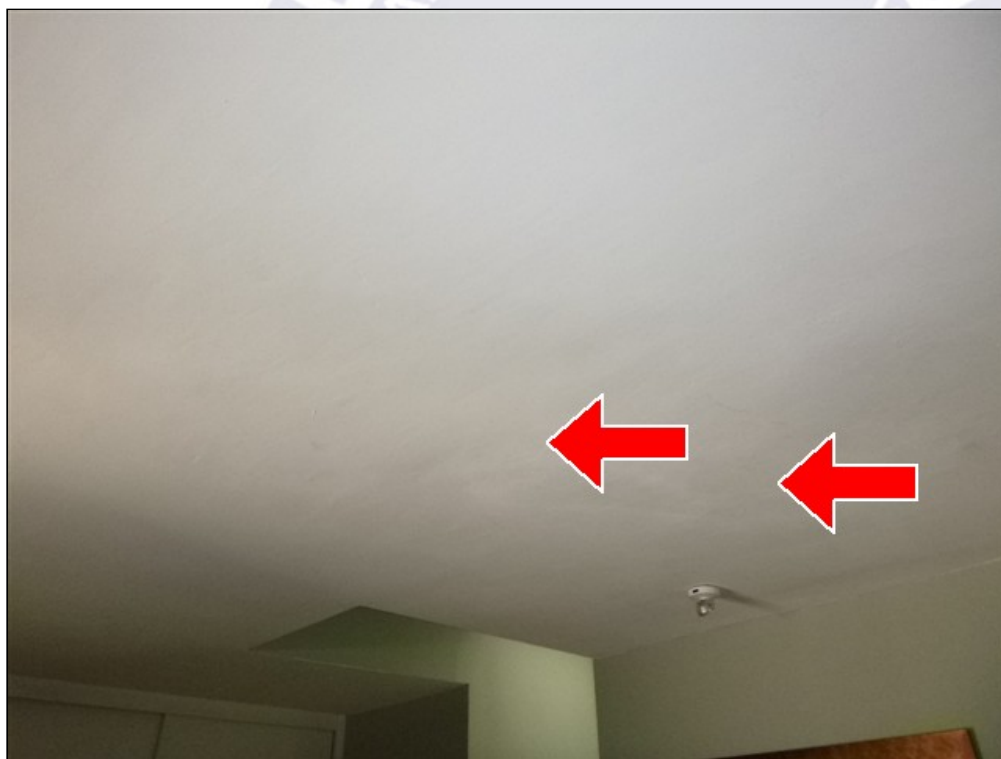
(1) Excessive rust/corrosion and evidence of previous/on-going leakage at the noted at the drains within the units/dwellings and the common garage area(s). Suggest review with a licensed plumbing contractor for any repair/removal/replacement costs as needed.

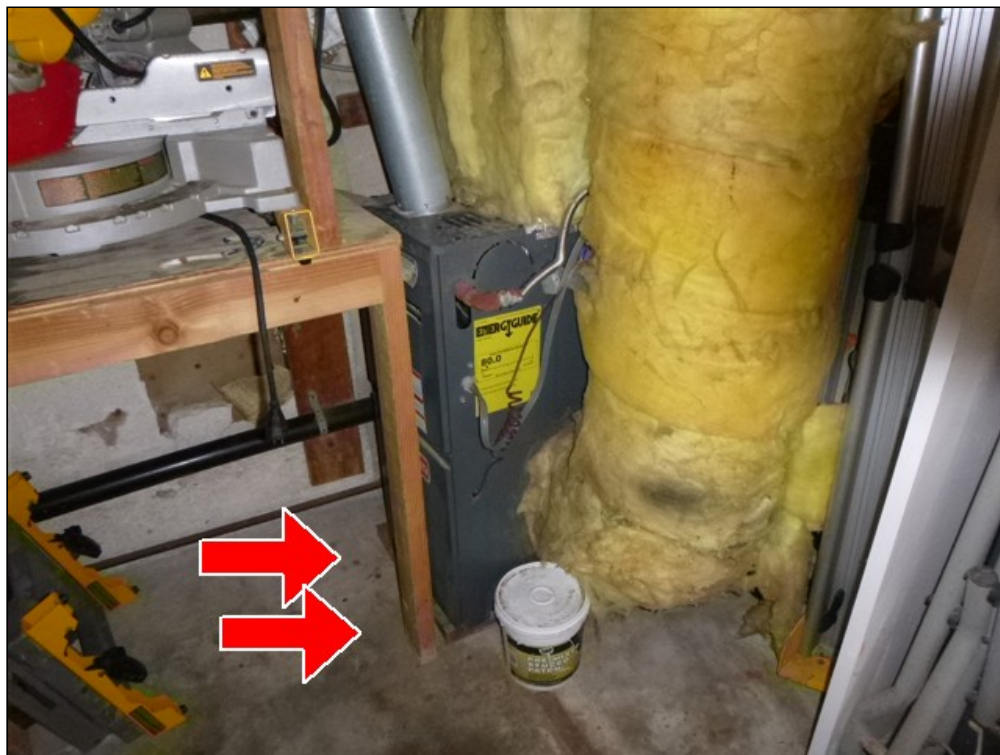
14.0 Item 4(Picture)

(3) The heating unit has been installed on wooden stands, suggest review by a licensed heating contractor for installation on non-combustible stands as required.

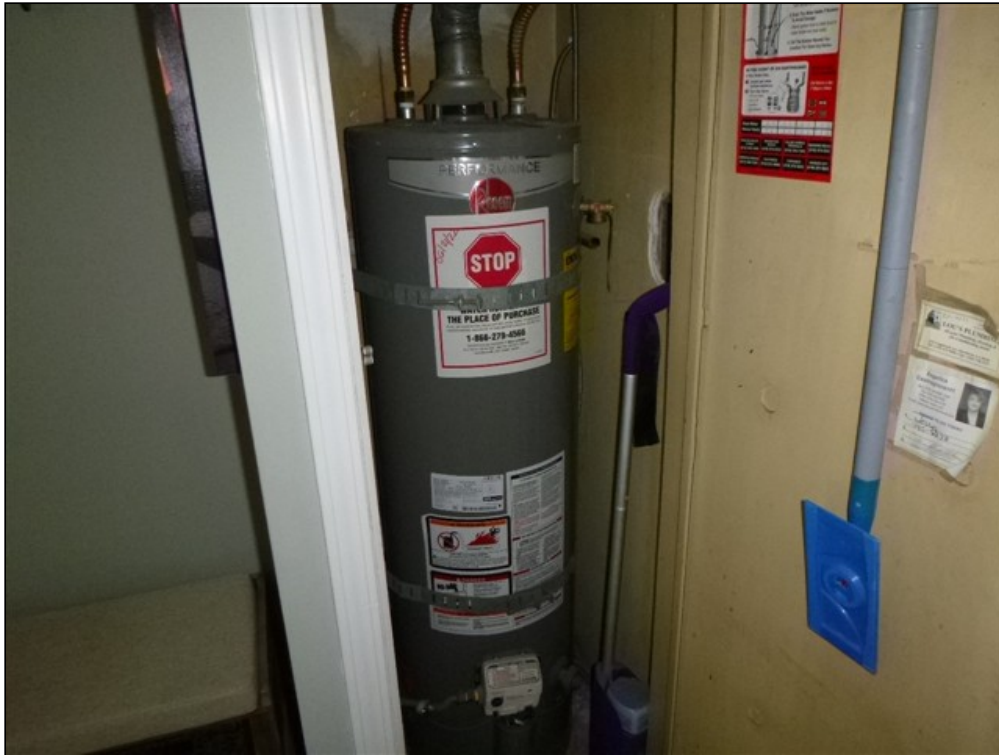
15.0 Item 2(Picture)

**15.0** (2) The capacity of the existing water heater is below plumbing standards for adequate hot water heating for this size dwelling ( based on the number of beds/bathrooms ). Suggest review by a licensed plumbing contractor for evaluation of this dwellings water heating system for replacement costs as needed.

(2) The capacity of the existing water heater is below plumbing standards for adequate hot water heating for this size dwelling ( based on the number of beds/bathrooms ). Suggest review by a licensed plumbing contractor for evaluation of this dwellings water heating system for replacement costs as needed.

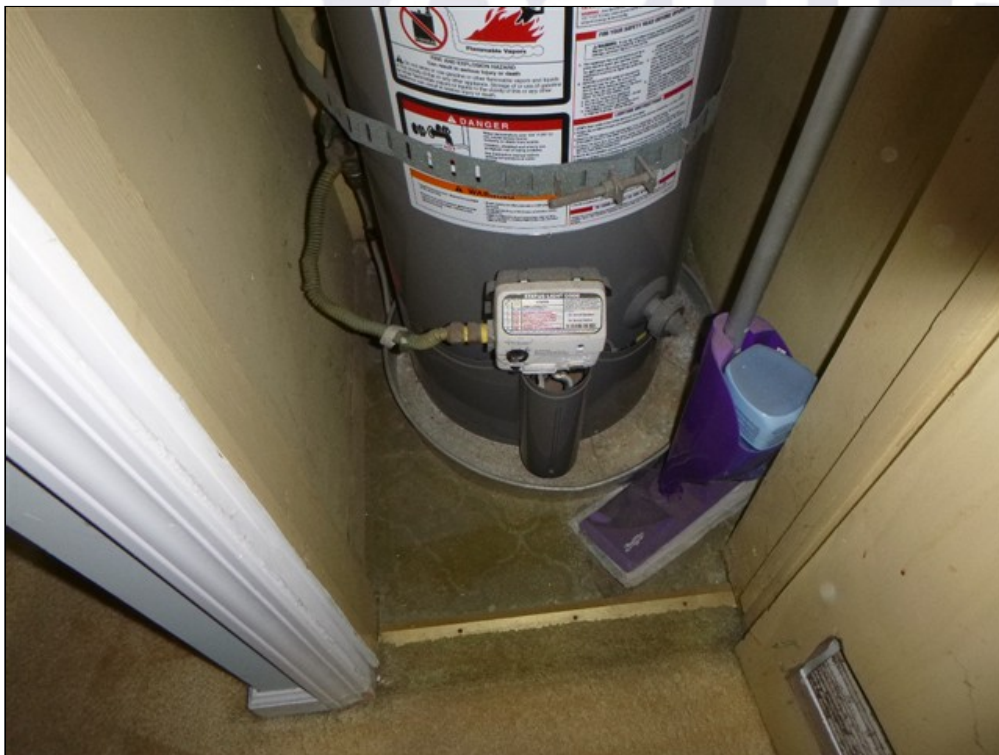
15.0 Item 3(Picture)

(4) A spill pan is installed under the water heater but no drain line is currently installed. Suggest installing the drain line to the exterior of the closet/dwelling as required when the water heater was installed.

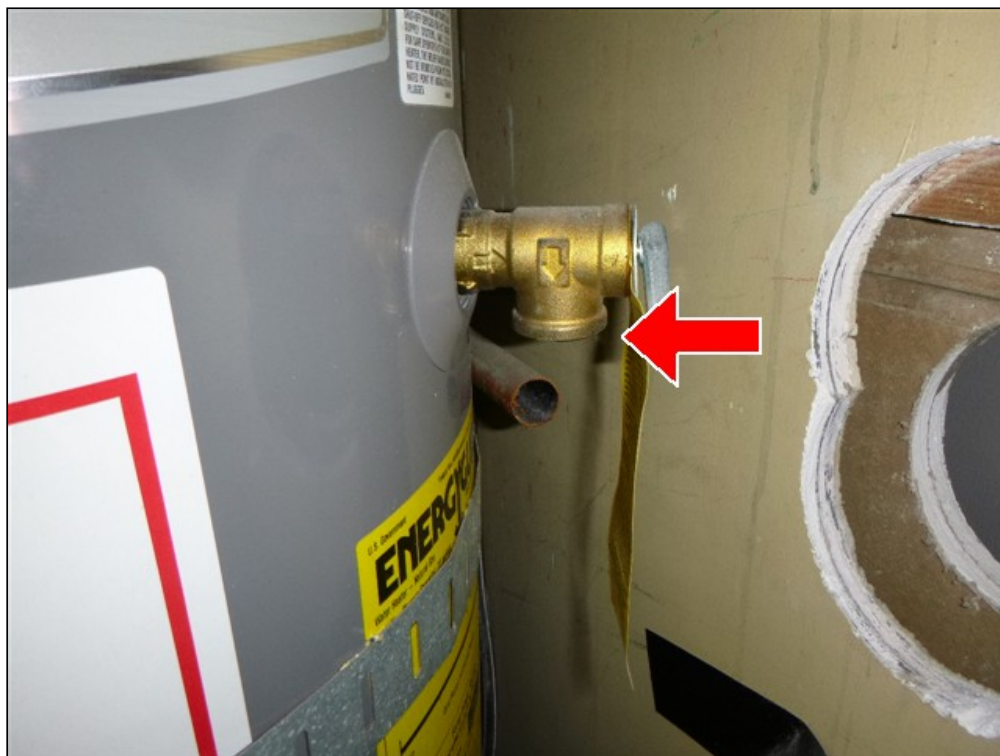
15.0 Item 4(Picture)

**15.0** (5) No discharge pipe connected to the TP&R valve, this is a potential safety hazard. Suggest review by a licensed plumber for costs to install the TP discharge drain down to within 4-6 inches of the exterior grade/deck as required for safety.

(5) No discharge pipe connected to the TP&R valve, this is a potential safety hazard. Suggest review

by a licensed plumber for costs to install the TP discharge drain down to within 4-6 inches of the exterior grade/deck as required for safety.

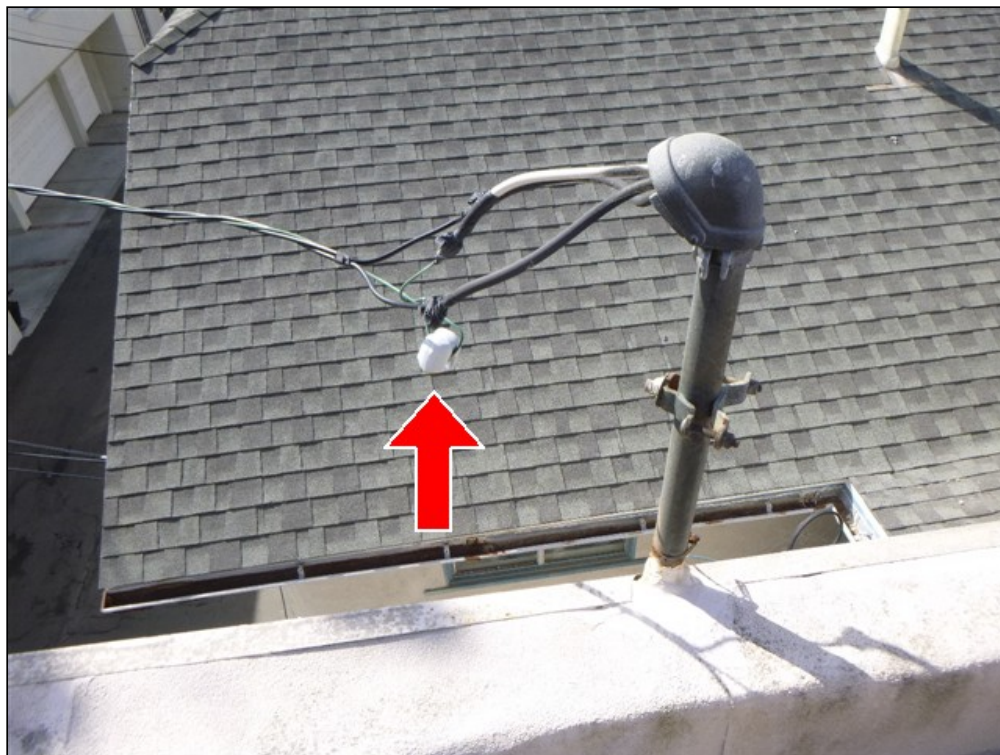
16.0 Item 1(Picture)

The electrical service wiring mount is broken and detached from the roof, this is a potential safety hazard. Suggest review with a licensed electrician and/or the local utility company for repair/ replacement costs as required for safety.

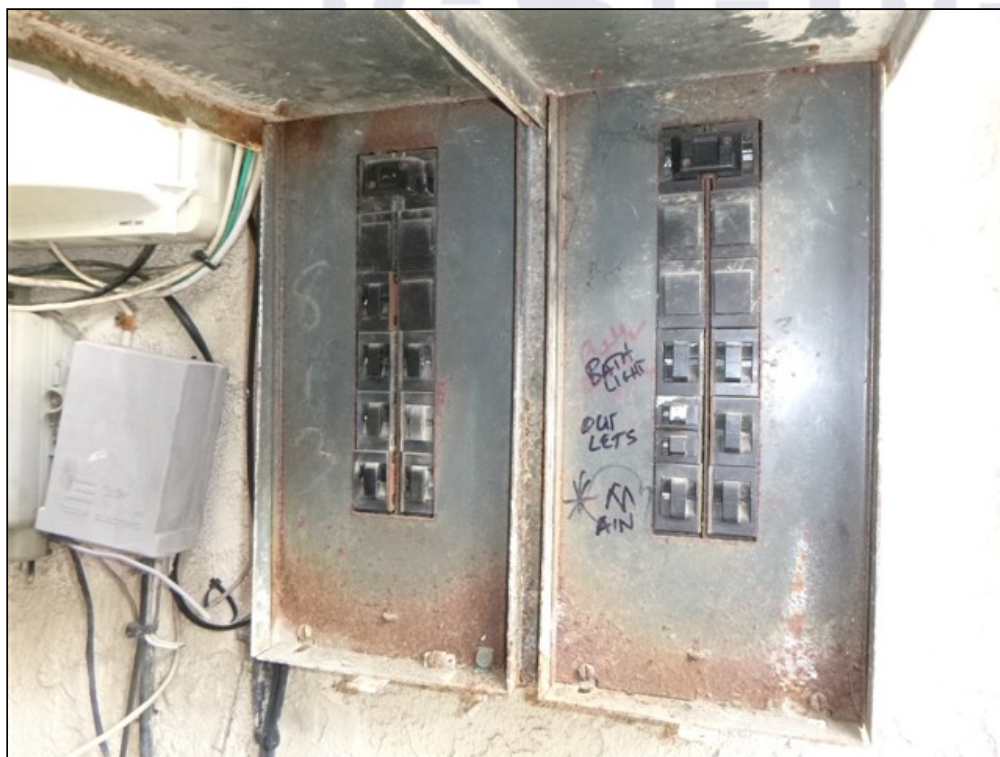
16.1 Item 1(Picture)

(1) The main panel/breakers are not labelled as per each unit, suggest review with the utility company and label as needed for identification purposes.

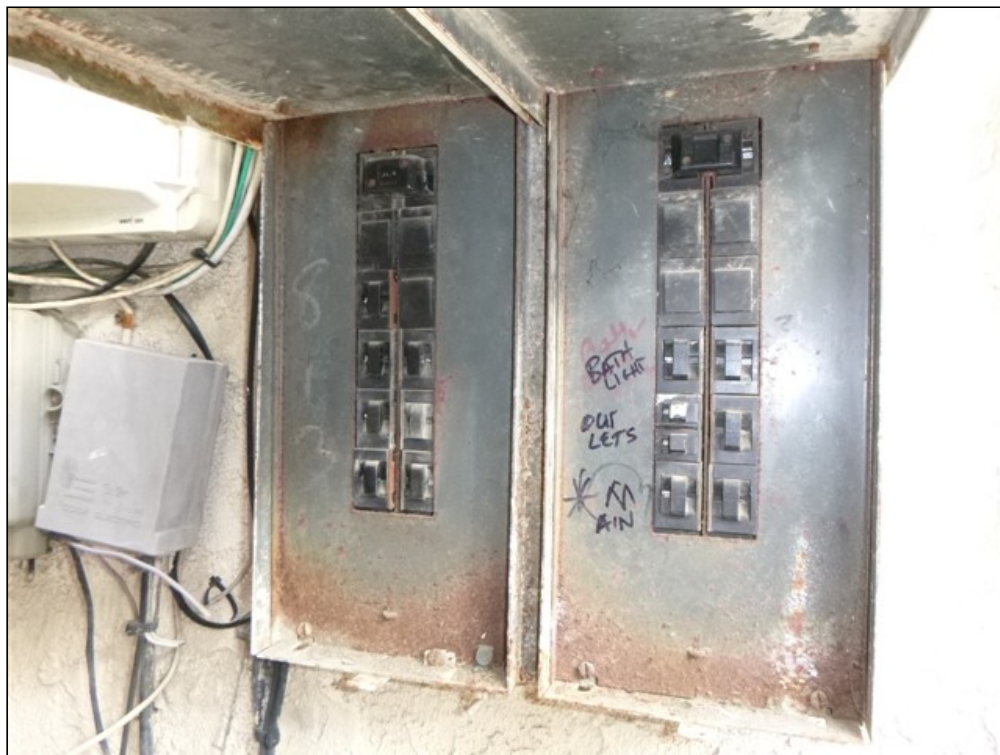
16.1 Item 2(Picture)

(2) The electrical panel(s) are a Bulldog breaker system. Problems with this style panel include circuit breakers (depending on the vintage) with a dismal performance record and the possibility of

unbalanced multi-wire circuits. Also, please be aware that various insurance companies will not insure homes with this style of electrical panel. Suggest review by a licensed electrician for replacement costs as needed.

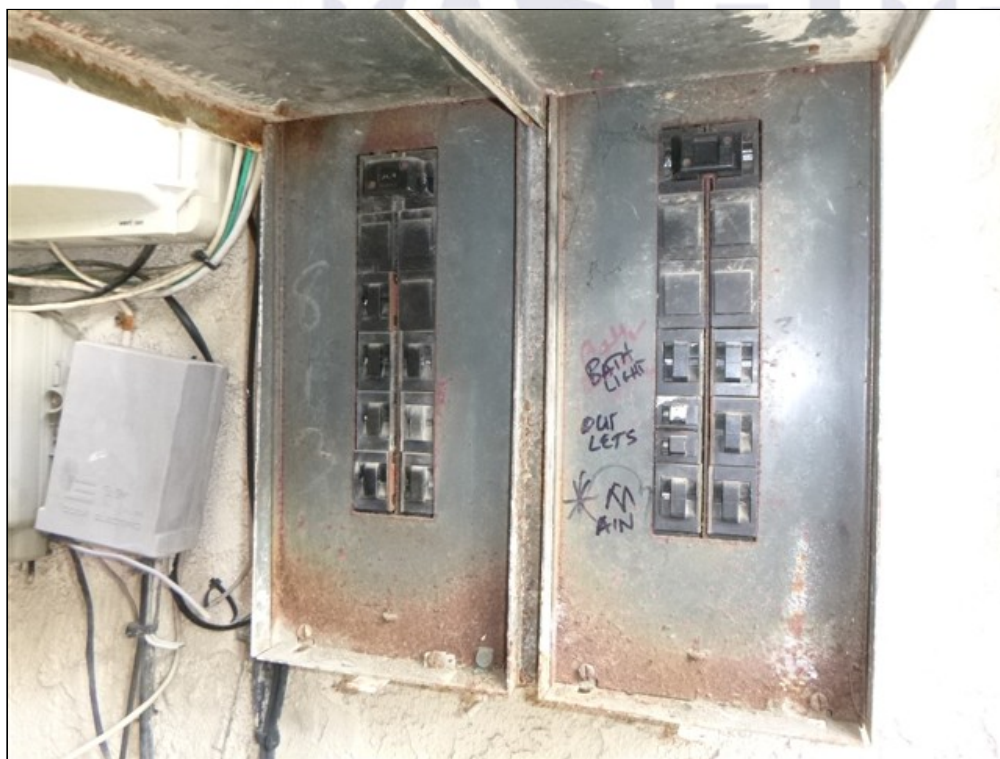
16.1 Item 3(Picture)

(3) Suggest adding correct/complete indexing/labelling to all breakers for indentification of each circuit for safety.

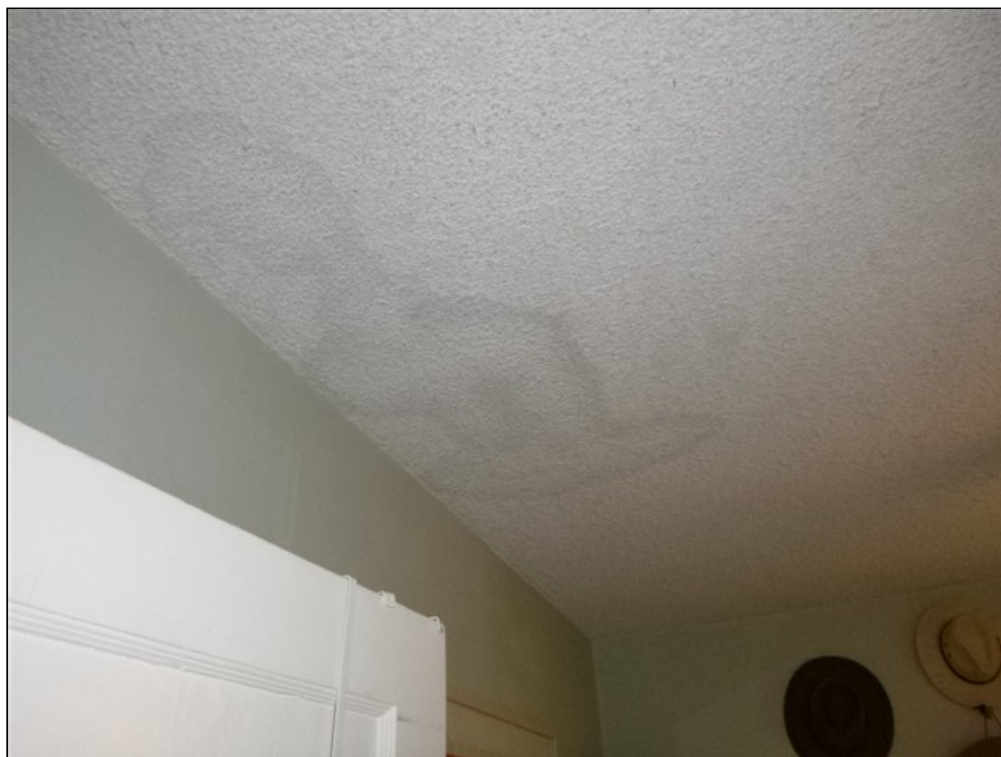
19.0 Item 1(Picture)

(3) Rust and corrosion noted at the drains within the garage and crawl space ( evidence of previous-ongoing leakage was noted at the interior of the units ). Suggest review with a licensed plumbing contractor for any repair/removal/replacement costs as needed.

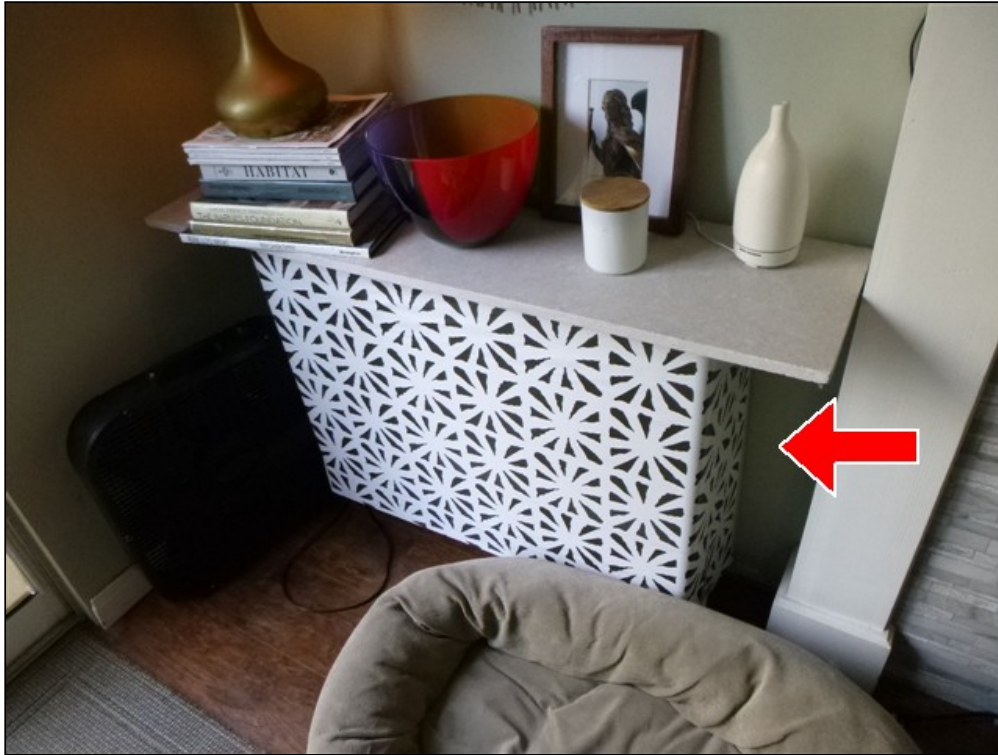
20.0 Item 1(Picture)

Unable to test the heating system as the gas was turned off to the unit at the time of the inspection. Suggest review by the Gas Company or a licensed heating company for further review to determine if the unit is operational/usable, the remaining life of the unit and/or any repair/replacement costs as needed.

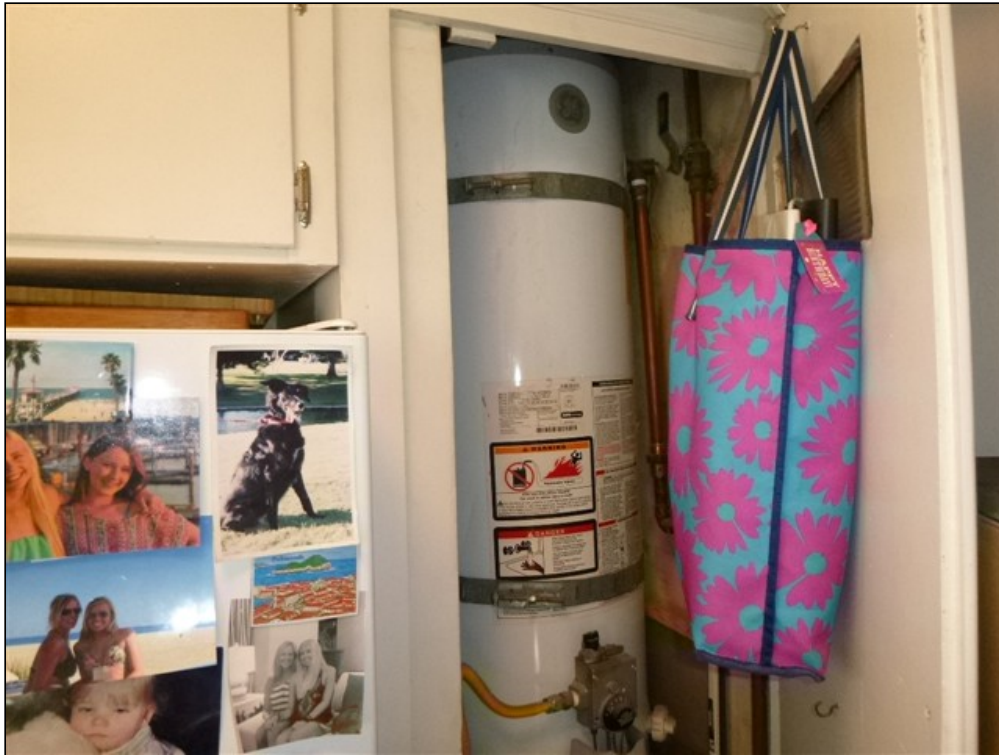
21.0 Item 1(Picture)

(1) Due to the age of this unit , suggest review with a licensed plumber for replacement costs as it is nearing the end of it's intended life span ( 12-15 years ).

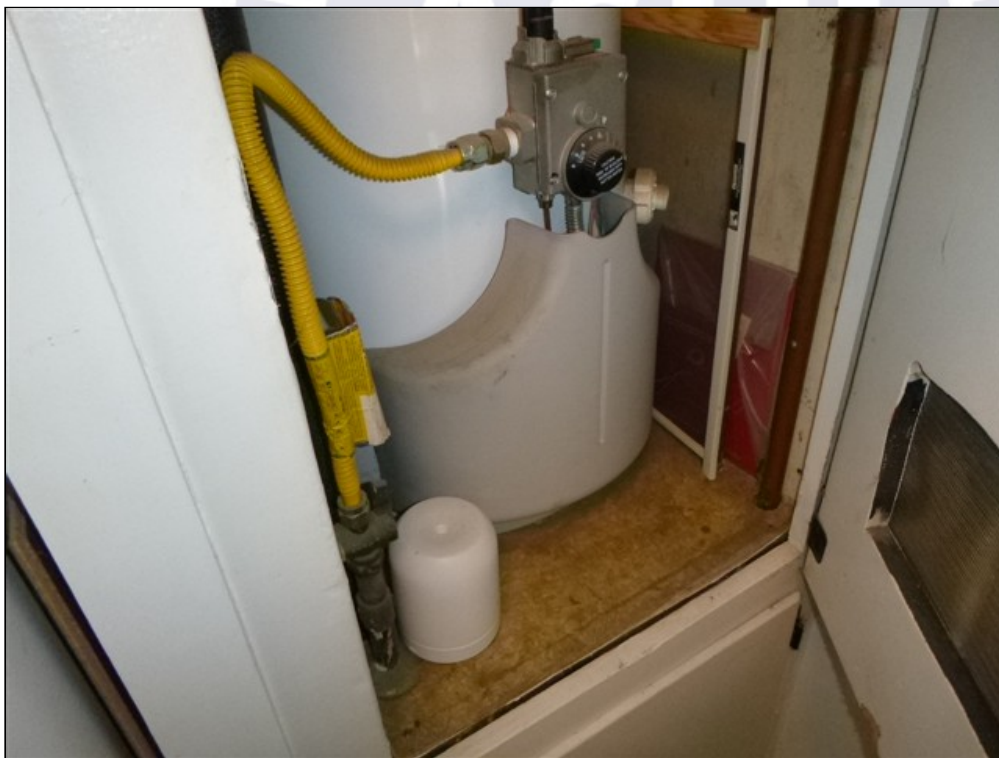
21.0 Item 2(Picture)

(2) No spill pan or drain line installed at the time of inspection. Suggest installation of a spill pan with a drain line to the exterior of the dwelling as required as leakage would cause damage to the stand and surrounding area.

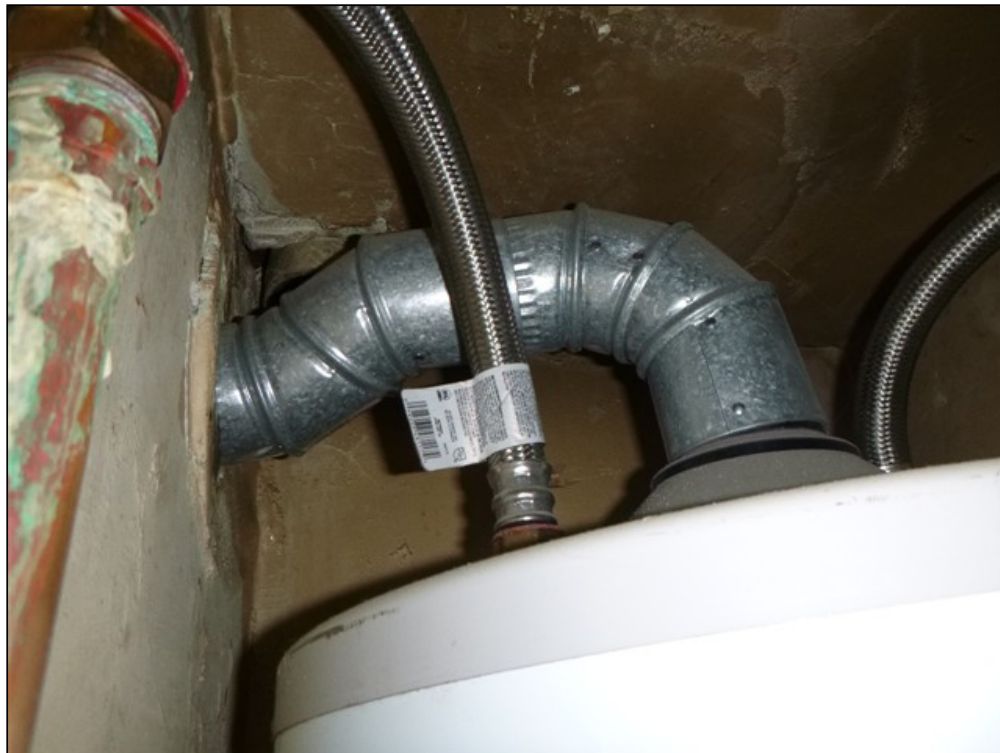
21.1 Item 1(Picture)

Negative slope and a poor fitting vent pipe was noted. Loose, disconnected or improperly sloped vent pipes will not allow for products of combustion to escape. This is a potential safety hazard requiring immediate attention. Suggest review by a licensed plumbing/heating contractor for repairs/ replacement costs as required for safety.

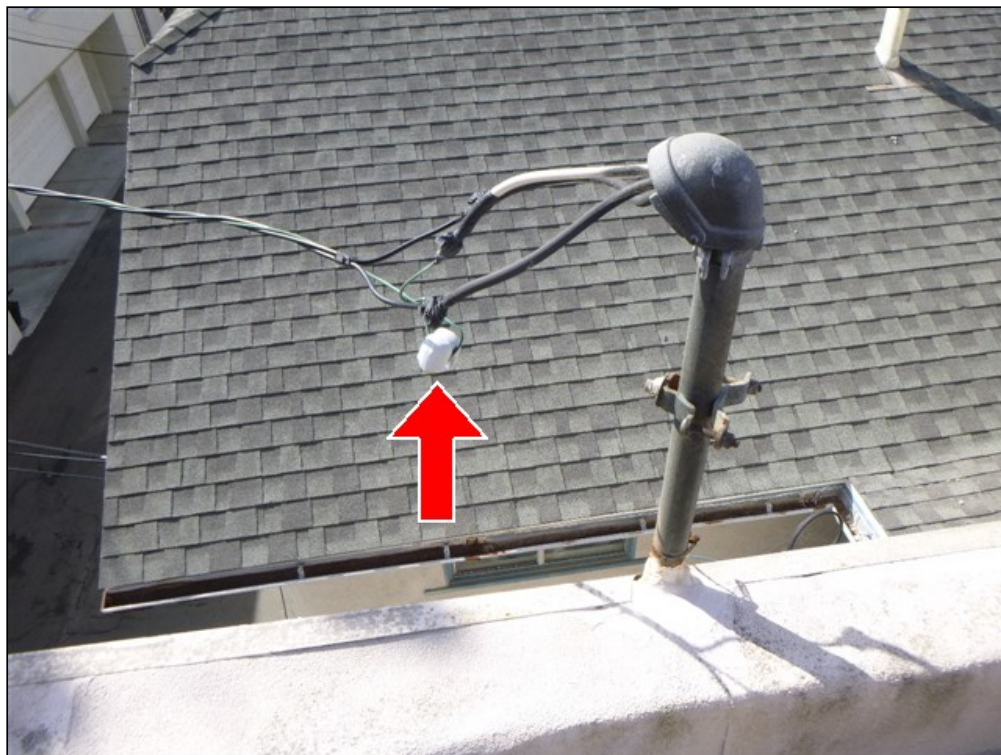
22.0 Item 1(Picture)

The electrical service wiring mount is broken and detached from the roof, this is a potential safety hazard. Suggest review with a licensed electrician and/or the local utility company for repair/ replacement costs as required for safety.

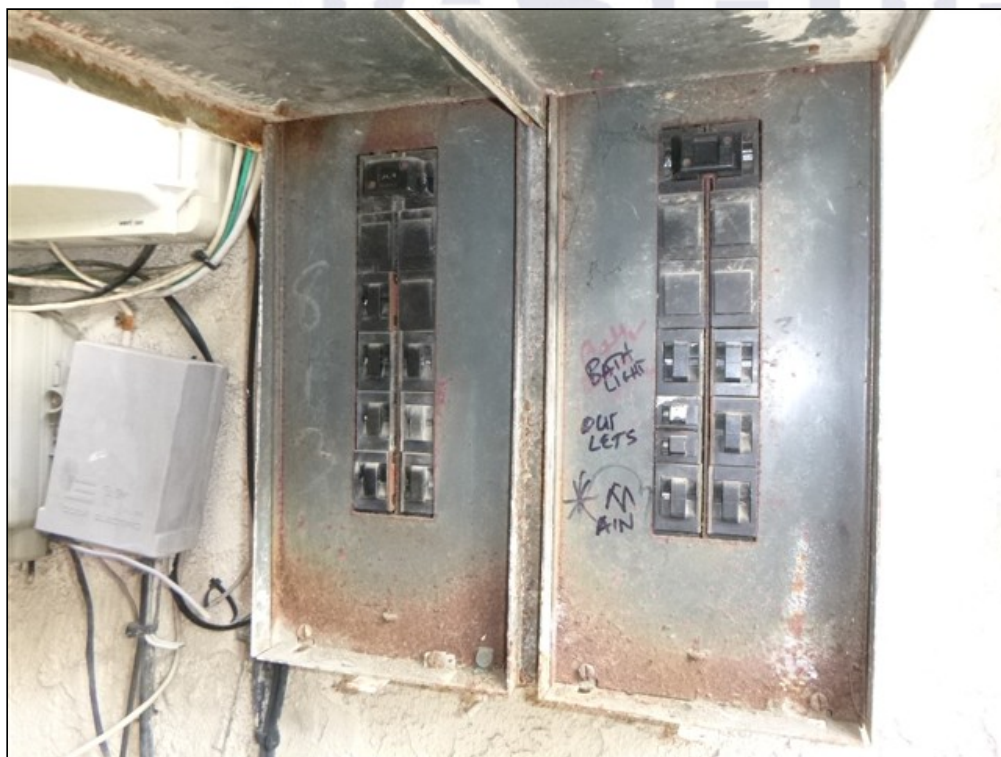
22.1 Item 1(Picture)

(1) The main panel/breakers are not labelled as per each unit, suggest review with the utility company and label as needed for identification purposes.
