# Inspection Report

**Property Address:**  
813 & 813-1/2 Bayview Dr  
Manhattan Beach CA 90266

**Ferguson Home Inspections**

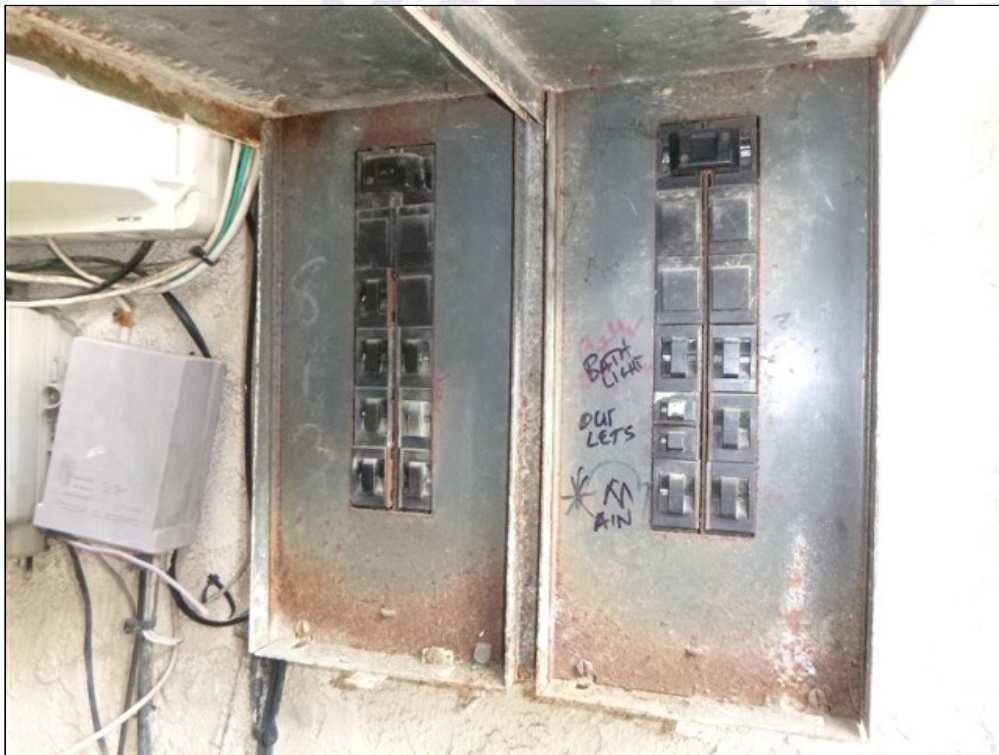
22.1 Item 3(Picture)

(3) The electrical panel(s) are a Bulldog breaker system. Problems with this style panel include circuit breakers (depending on the vintage) with a dismal performance record and the possibility of unbalanced multi-wire circuits. Also, please be aware that various insurance companies will not insure homes with this style of electrical panel. Suggest review by a licensed electrician for replacement costs as needed.
