RESIDENTIAL INSPECTION

3360 Kallin Ave Long Beach, CA 90808

Frank Anarumo
Certified Master Inspector; NACHI14090311
(CPI); CREIA #166950; IAC2 Cert. #IAC2-03-7334; CRT # 2019121114; CCPIA-000545, Branch 2 & 3 Field Representative 65837
(Green Mantis Pest Control), NFPA Member 1113628417
3109256664

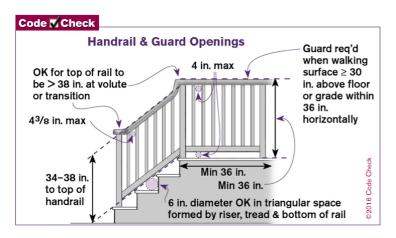
Suggest closing all balusters to within 4 inches of each other, for safety.

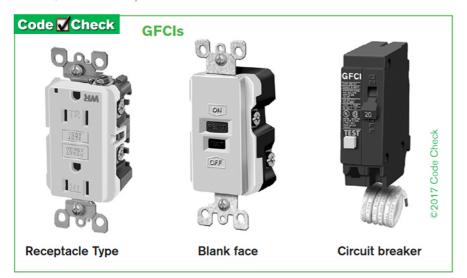
A GFCI receptacle can provide protection for other receptacles downstream on the circuit. GFCI protection can be provided by GFCI breakers, blank face devices, or GFCI receptacles

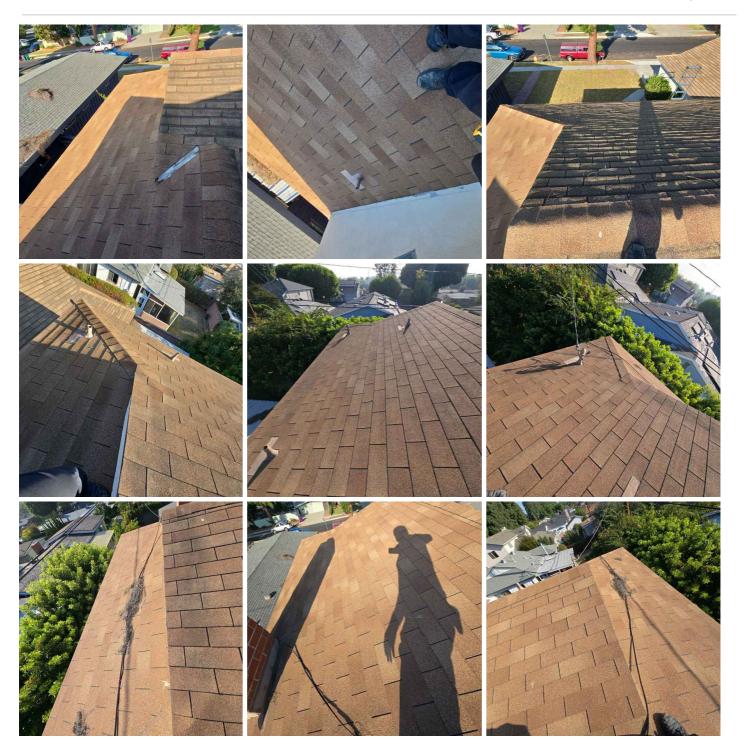
Chimneys / Skylights: Addition

This area appears to be an addition to the original structure. We are unable to determine if permits were issued at the time of construction. We advise checking city records to verify the existence of permits before the close of escrow.

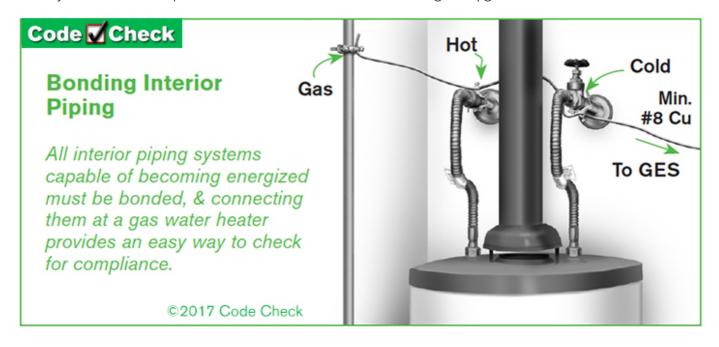
Main Water Shut-off Device & Water Supply Lines: Bonding Interior Piping

This may not have been required at the time this home was built. It is a good upgrade.

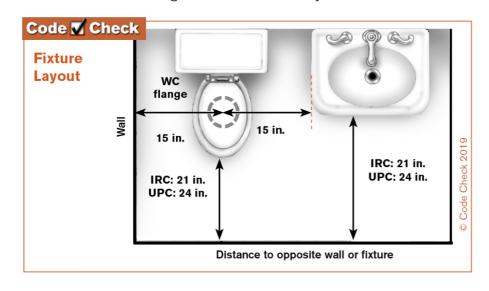
toilet flange at least 15-1/2 inches from the center of the flange to the wall framing. The standard distance from the back wall is 12 inches, or 12-1/2 inches. Taking into account 1/2" drywall
