Inspection Report

Property Address:
447 E Hullett St
Long Beach CA 90805

Ferguson Home Inspections

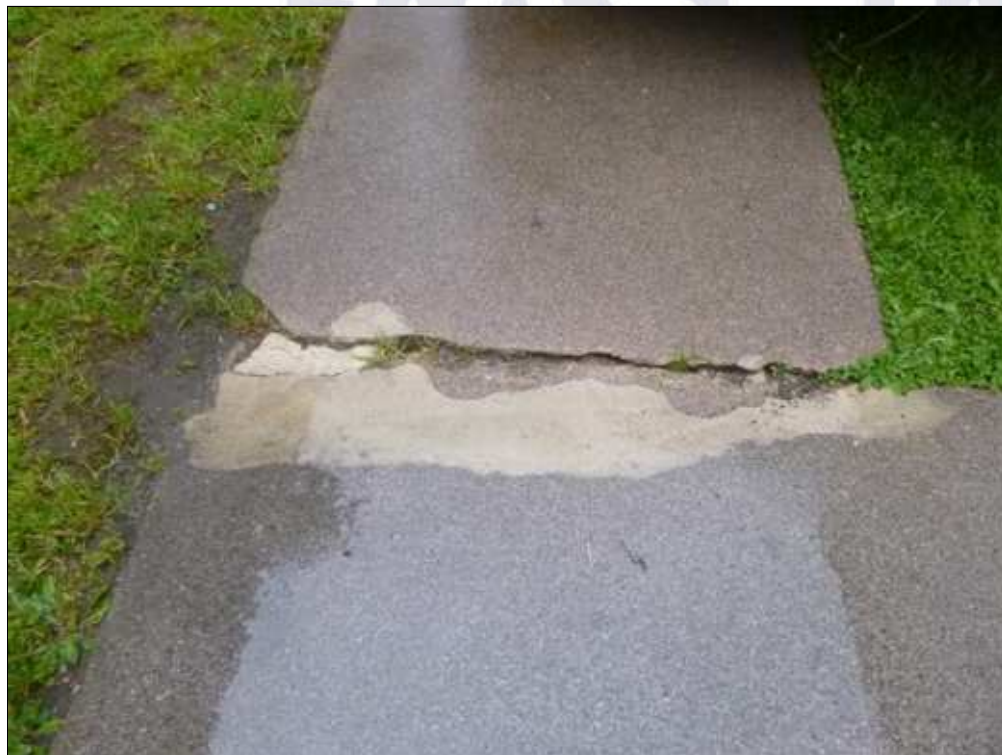
1.0 Item 2(Picture)

1.0 Settling, expansion cracks and heaving noted at various areas, this is a potential trip hazard. Suggest review with a licensed contractor for repair/replacement costs as needed.

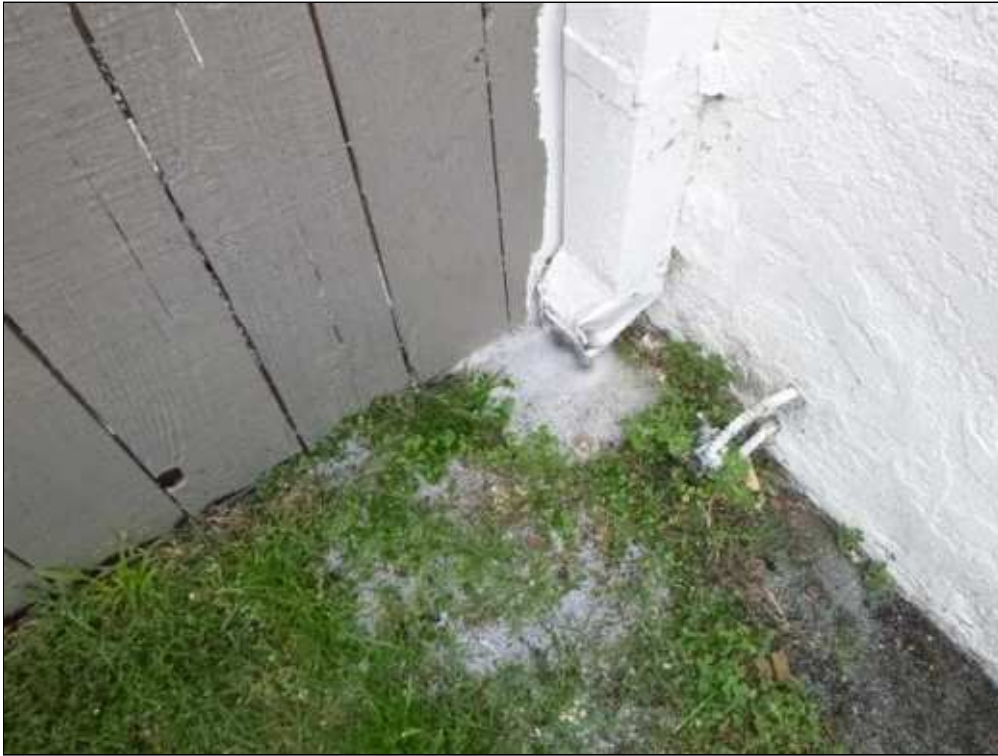
1.9 Item 1(Picture)

1.9 (1) Suggest review by a licensed contractor for possible installation of an area drainage system to

divert drainage away from the foundation.

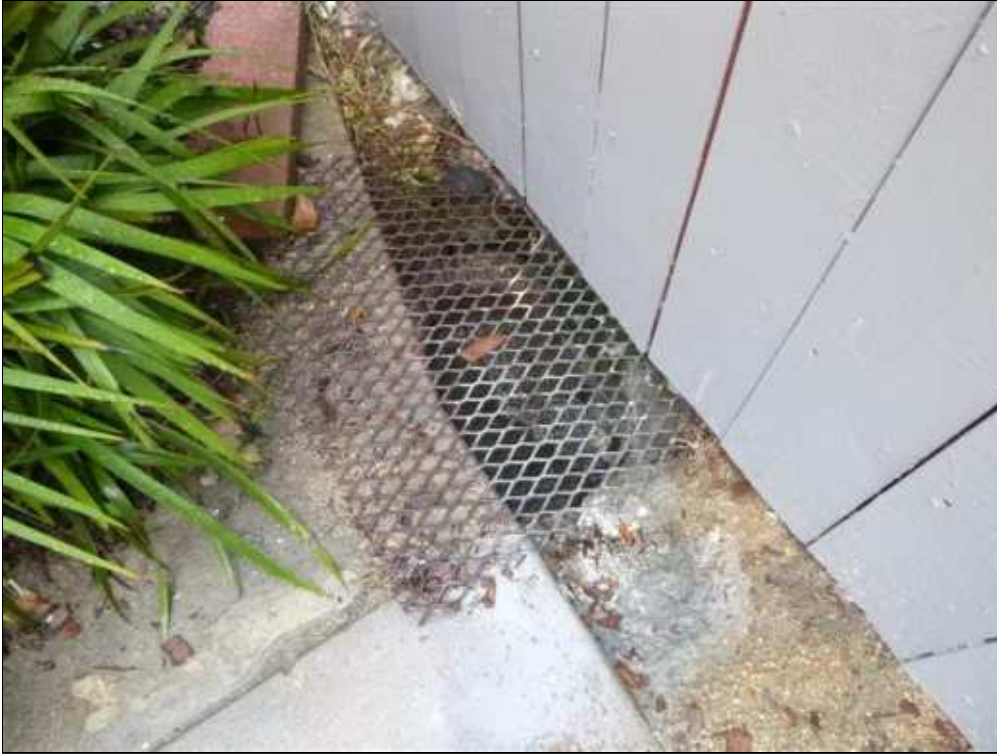
1.11 Item 2(Picture)

1.11 (4) A large hole was noted at the rear of the driveway by the fence/ADU. Suggest review with the seller/neighbor and/or a licensed contractor on this item and any repair/filling/patching costs as needed.

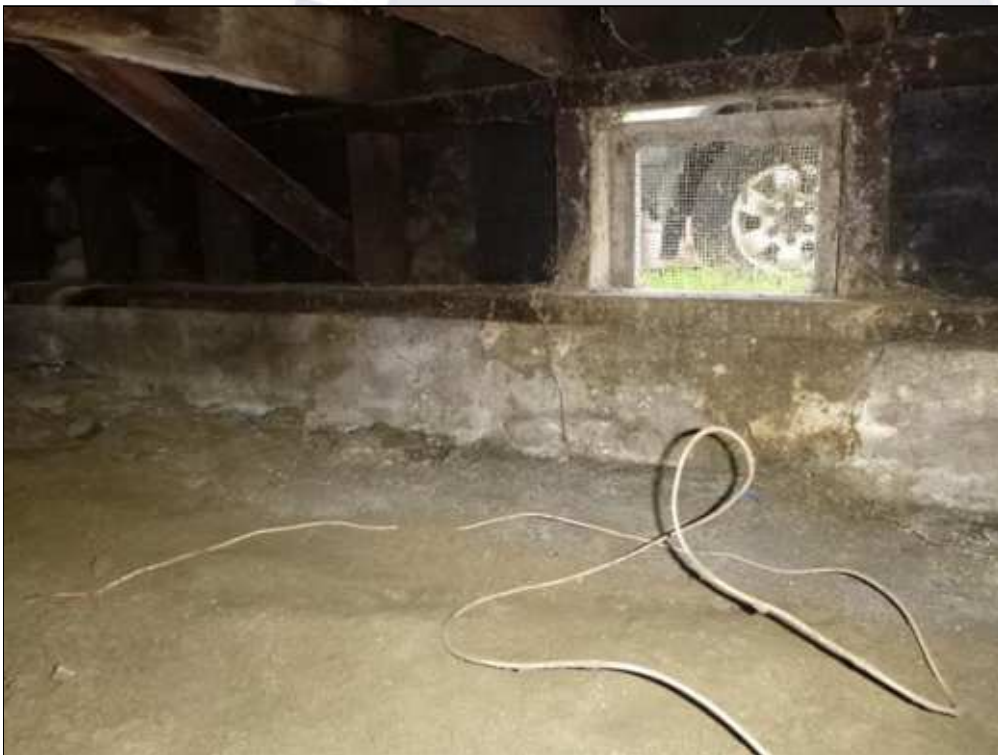
2.0 Item 1(Picture)

2.0 Re-grading where needed is recommended to assure all water drains away from the home's foundation. The inadequate drainage has caused the excessive moisture buildup at the foundation and intrusion into the crawl area. Suggest review with a licensed contractor for installation of concrete walkways/barriers, water proofing membranes, rain gutters and an area drainage/sump pump system to divert all the water away from the foundation/structure.

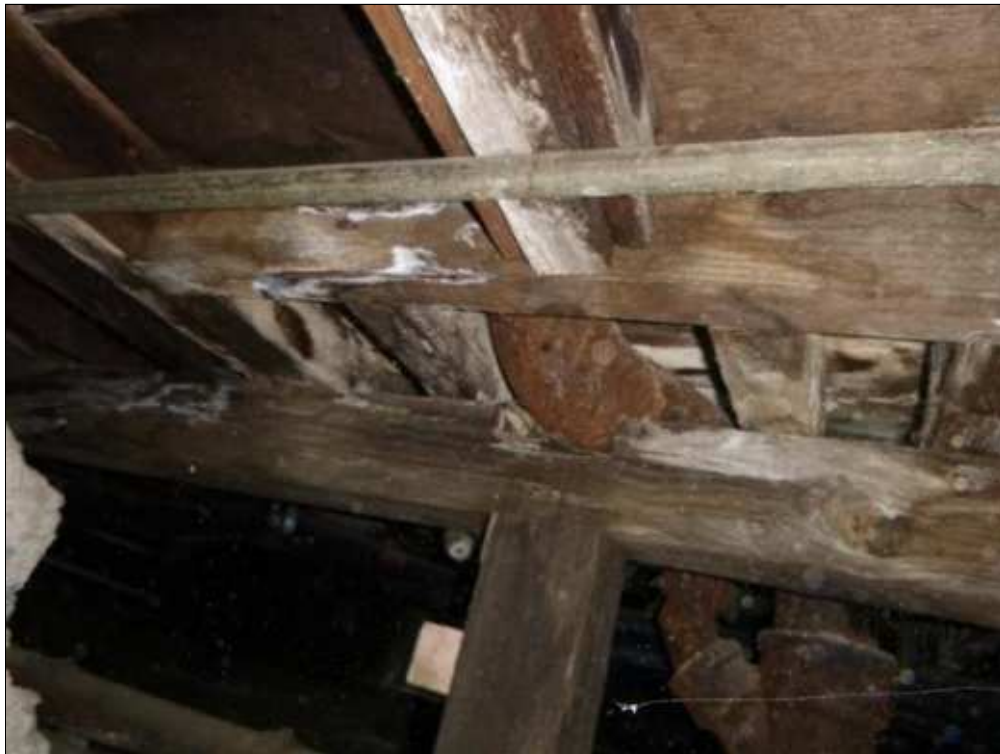
3.1 Item 1(Picture)

3.1 (1) Stains and deterioration noted at various flooring and supports from prior leaks. Suggest review with a termite company and/or a licensed contractor for any repair/replacement costs as needed.

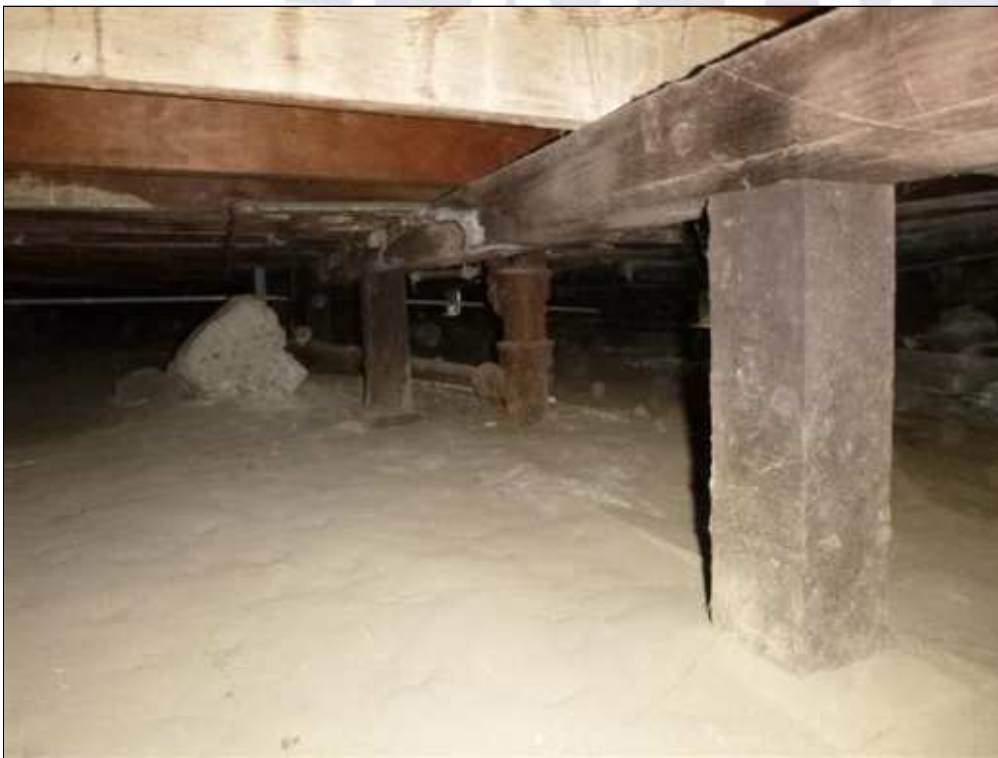
3.1 Item 5(Picture)

3.1 (2) Inadequate support noted at various girder beams due to the excessive span and inadequate support posts, common for the original age of the dwelling. Suggest review by a licensed contractor for costs to add additional supports to prevent possible future structural and floor movement as needed.

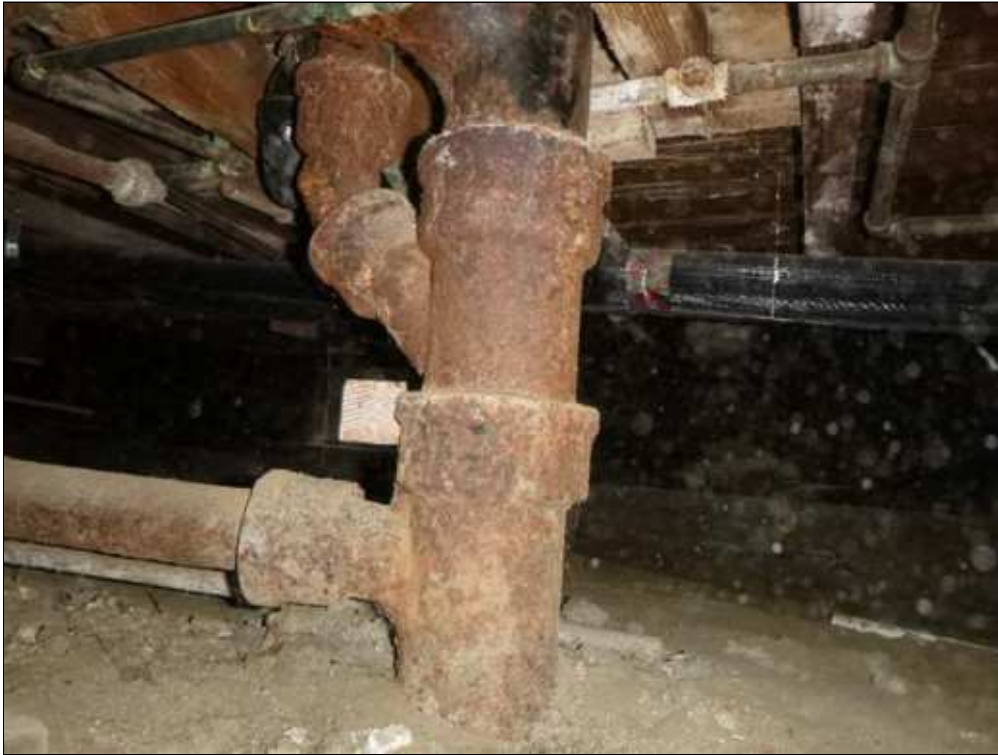
4.3 Item 1(Picture)

4.3 (1) Excessive rust, seepage and corrosion noted at various cast iron drain lines within the crawl space. Suggest review by a licensed plumbing contractor for replacement costs as needed to prevent future leakage at the crawl area.

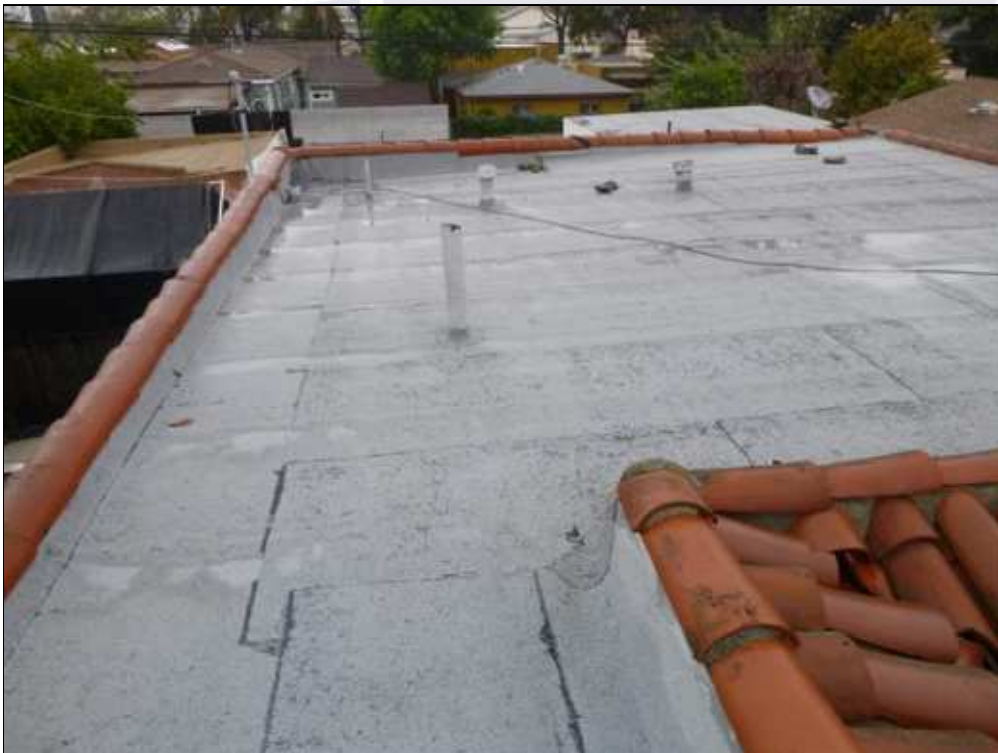
5.0 Item 1(Picture)

5.0 (1) The sloped roof covering is old and deteriorated. It is nearing the end of its useful life and the covering will need to be replaced. While it could last a year or so, some areas may need patching/repairs as leaks develop. Please review with a licensed roofer to determine the remaining life expectancy and for costs to repair/remove and replace the existing roofing material as needed.

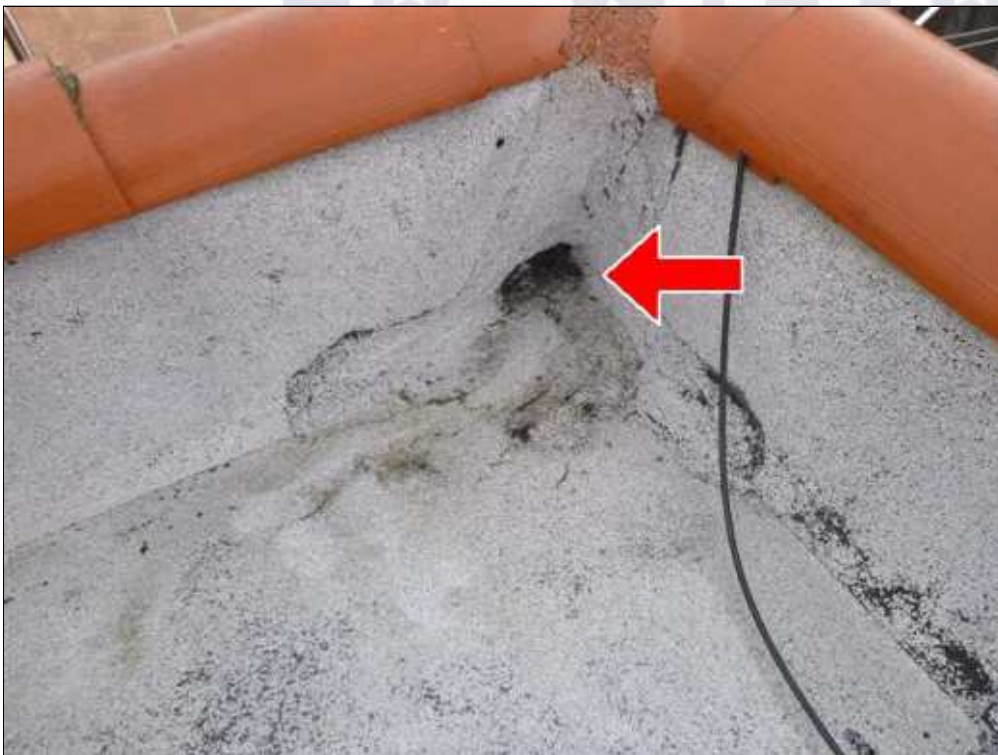
5.0 Item 7(Picture)

5.0 (2) Suggest review with a licensed roofer for installation costs for a scupper/over flow drain to the roof as an upgrade. Any blockages to the roof drain will result in excessive water ponding/flooding at the roof area.

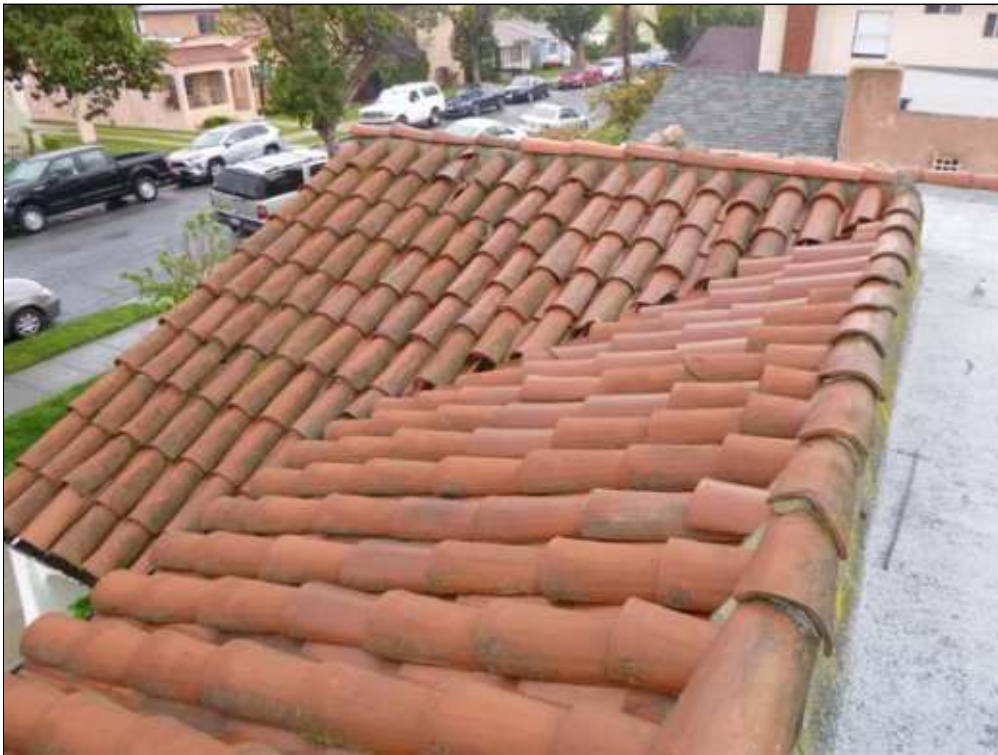
5.0 Item 8(Picture)

5.0 (3) Multiple layers of roof covering exist on the current roof, generally two layers of roofing is the maximum allowable. Additional layers of roofing causes a lot of excessive weight on the roof support structure. Suggest review with a licensed roofer to determine the remaining life expectancy and for costs to remove and replace the existing roofing material as needed.

5.0 (4) Excessive 'Ramping', lifting/inadequately/incorrectly installed areas of the sloped roof was noted. Suggest review with a licensed roofer for repair/removal/replacement costs as needed.

5.0 (5) Deteriorated, cracked, loose and missing sections of the roof tiles was noted, suggest review by a licensed roofer for repair/replacement costs as needed to prevent any future leakage during the rainy season.

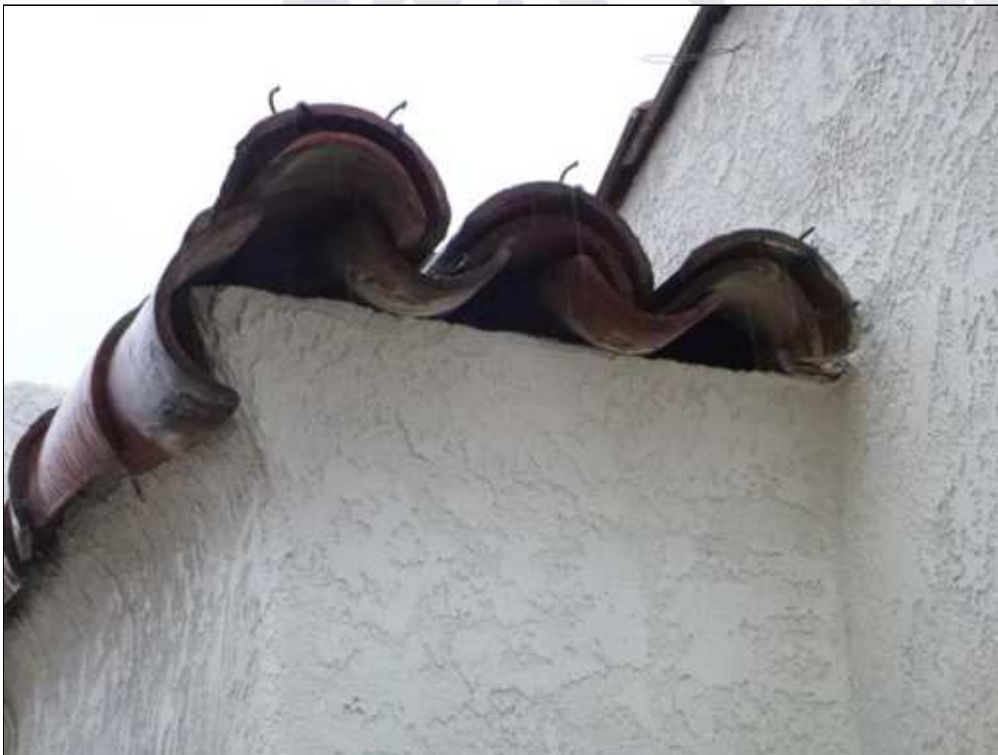
5.0 Item 16(Picture)

5.0 (6) No 'bird stops' were installed at the tile roof time of the inspection. Suggest review with a licensed roofer for installation costs as needed.

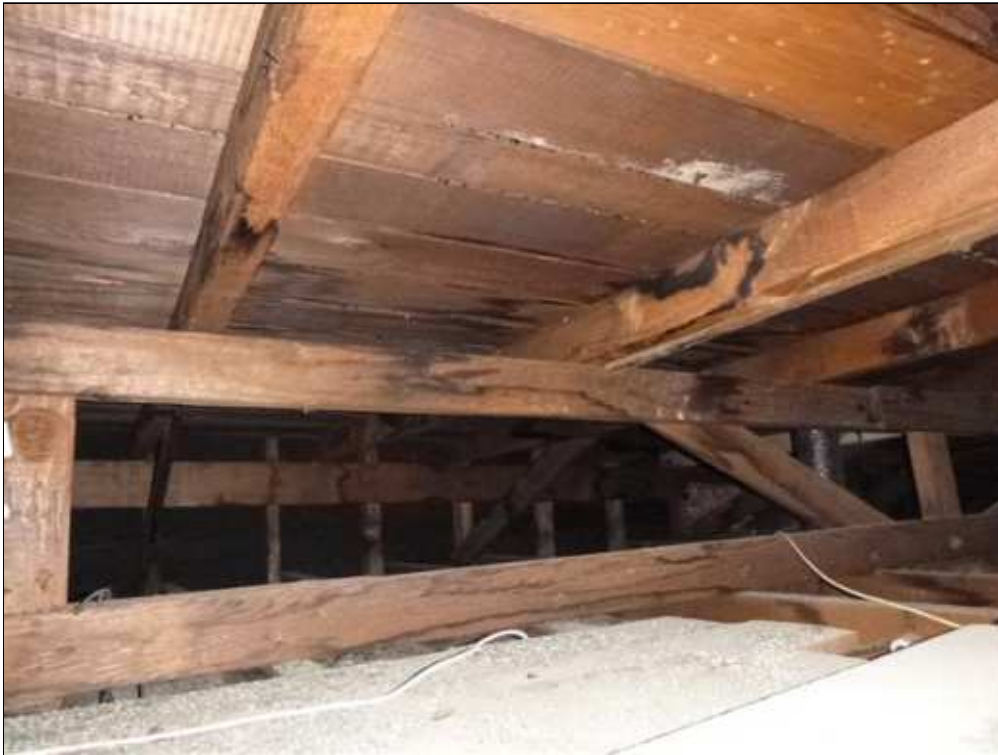
6.0 Item 1(Picture)

6.0 Moisture stains noted at various areas of the attic sheathing/framing, see roof comments and repair as needed.

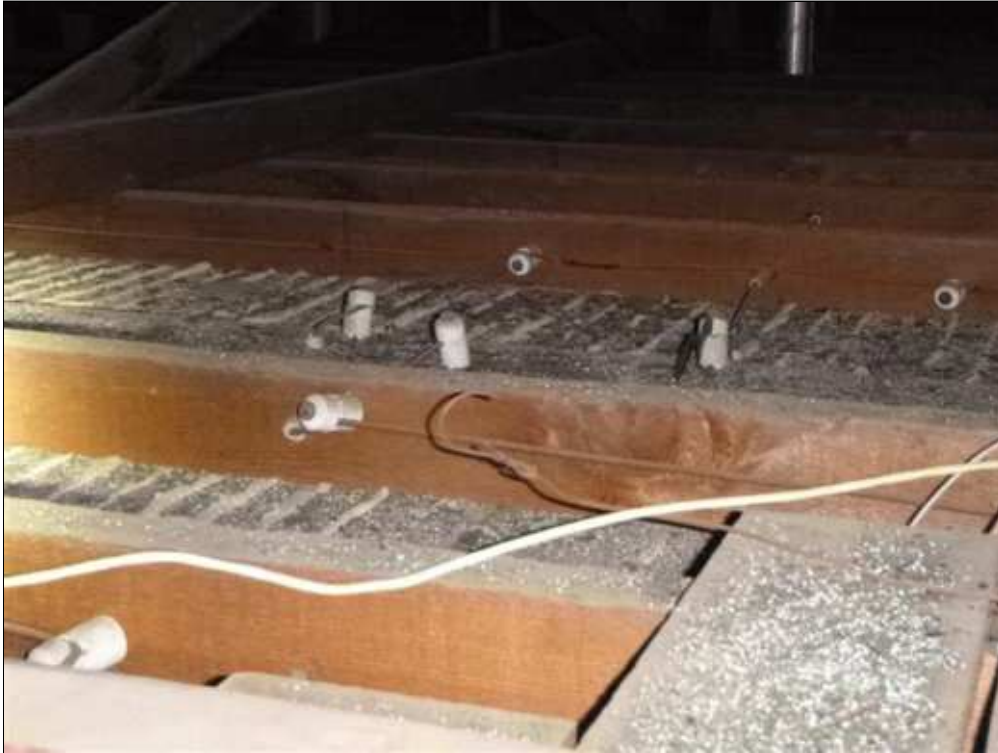
6.3 Item 1(Picture)

6.3 Knob & Tube wiring noted throughout the attic area, this is common for the original age of the dwelling. Suggest review by a licensed electrician for replacement costs to upgrade the wiring to todays standards for safety.

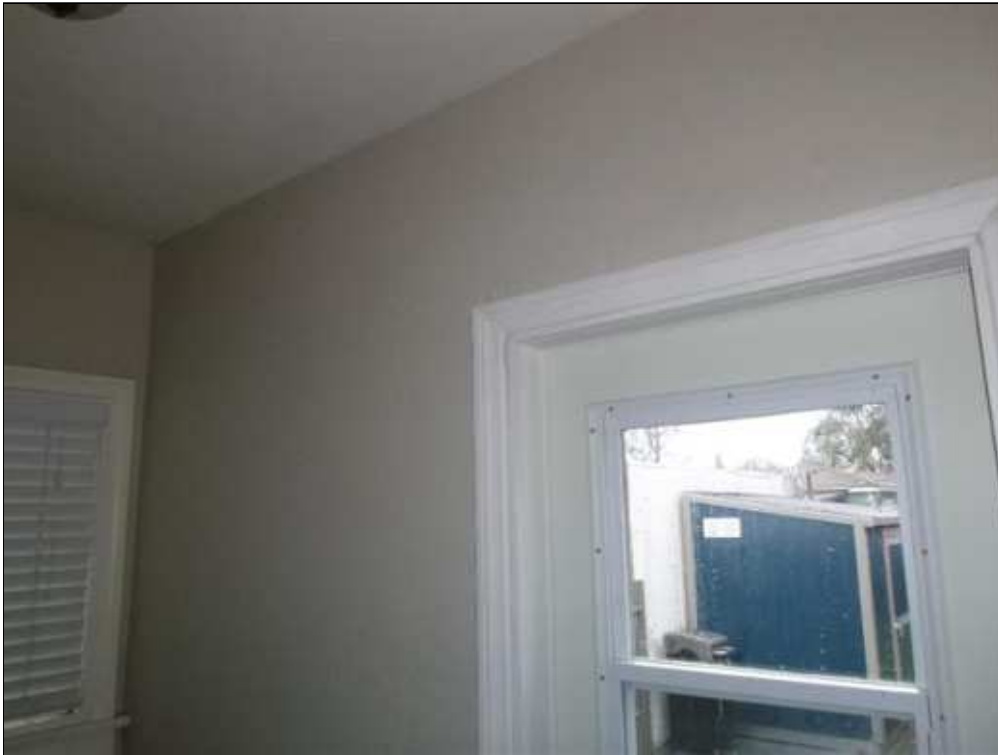
7.1 Item 1(Picture)

7.1 Patched areas of the walls was noted, suggest review with the seller for the cause and any repairs needed. Suggest repair as needed.

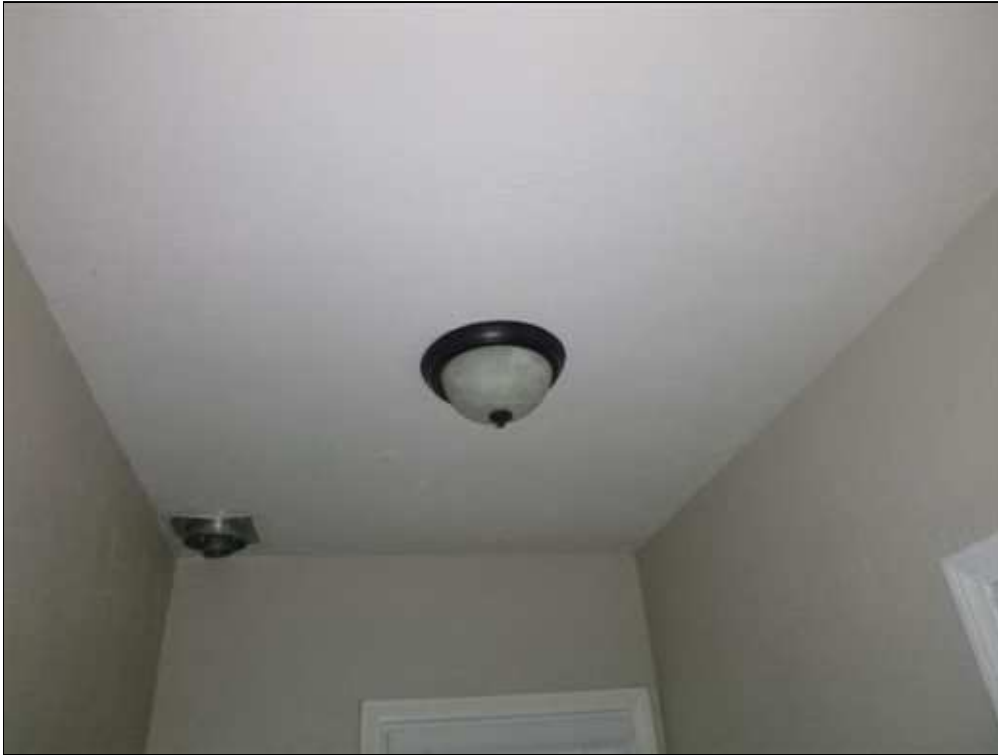
7.2 Item 1(Picture)

7.2 Patched and uneven areas of the ceiling was noted, suggest review with the seller on the cause and any repairs needed. Suggest review with a licensed contractor for any repair/removal/replacement costs as needed.

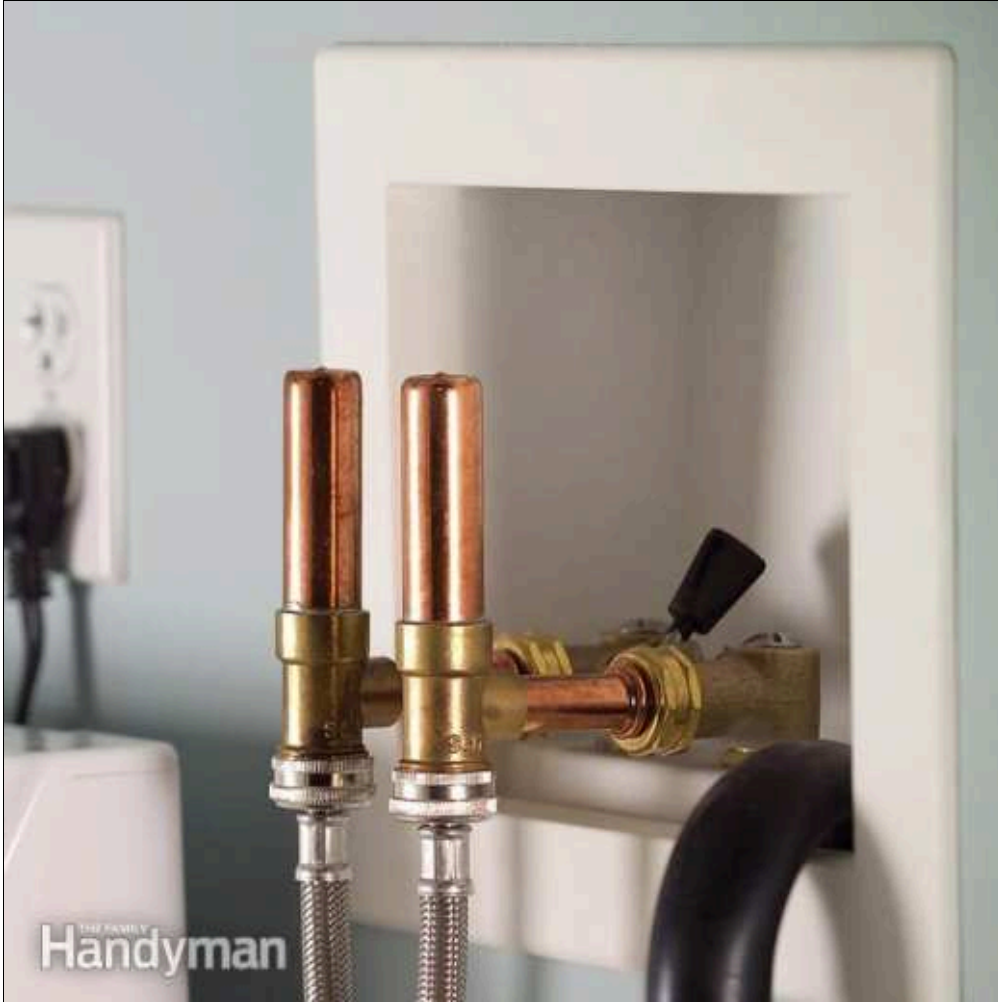
7.7 Item 1(Picture) HV

7.7 Suggest upgrading with 'hammer valve' plumbing supply systems if a water sensor/efficient/smart washing machine is to be installed at this area.

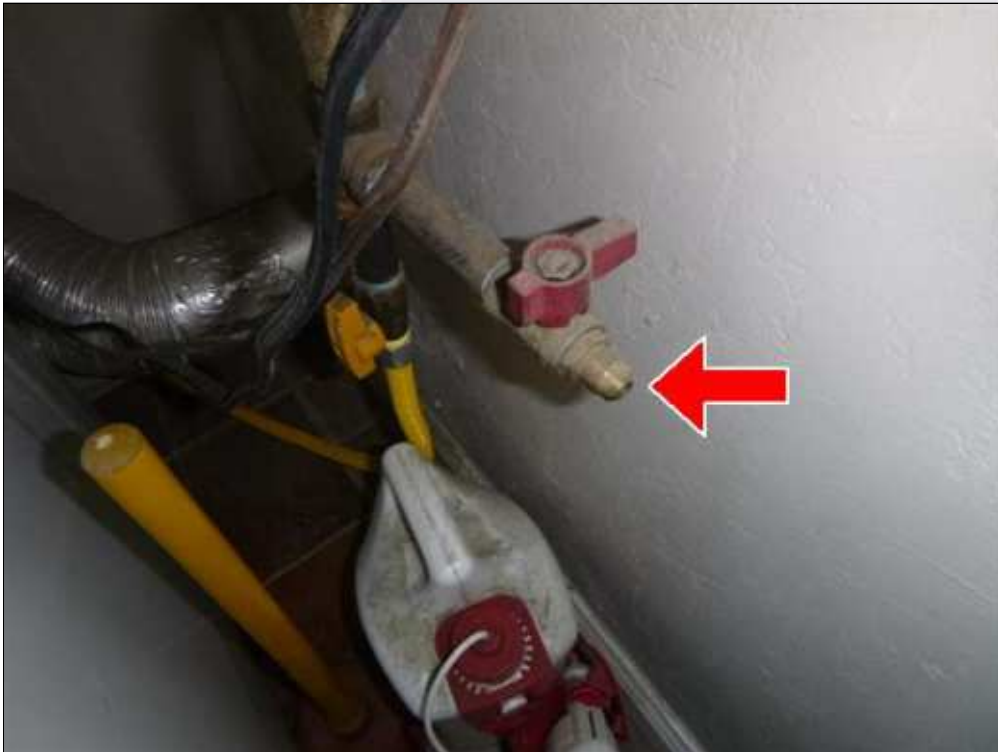
7.8 Item 1(Picture)

7.8 (1) Suggest periodic cleaning of dryer vent to exterior to prevent blockages, which can result in extended drying times and leakage.

7.8 (2) Suggest capping the unused gas line/valve as required for safety.

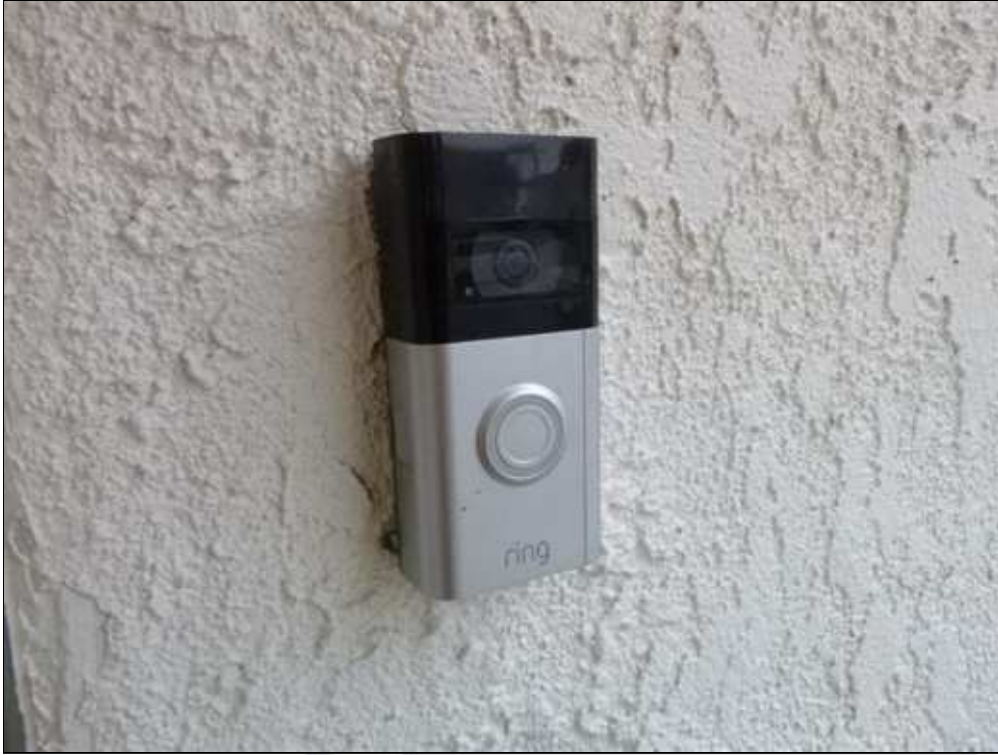
8.7 Item 1(Picture)

8.7 A 'Ring' door bell was noted at the front door. Suggest review with the seller to confirm if this unit is remaining with the property/dwelling, confirm correct operation and request operational manual.

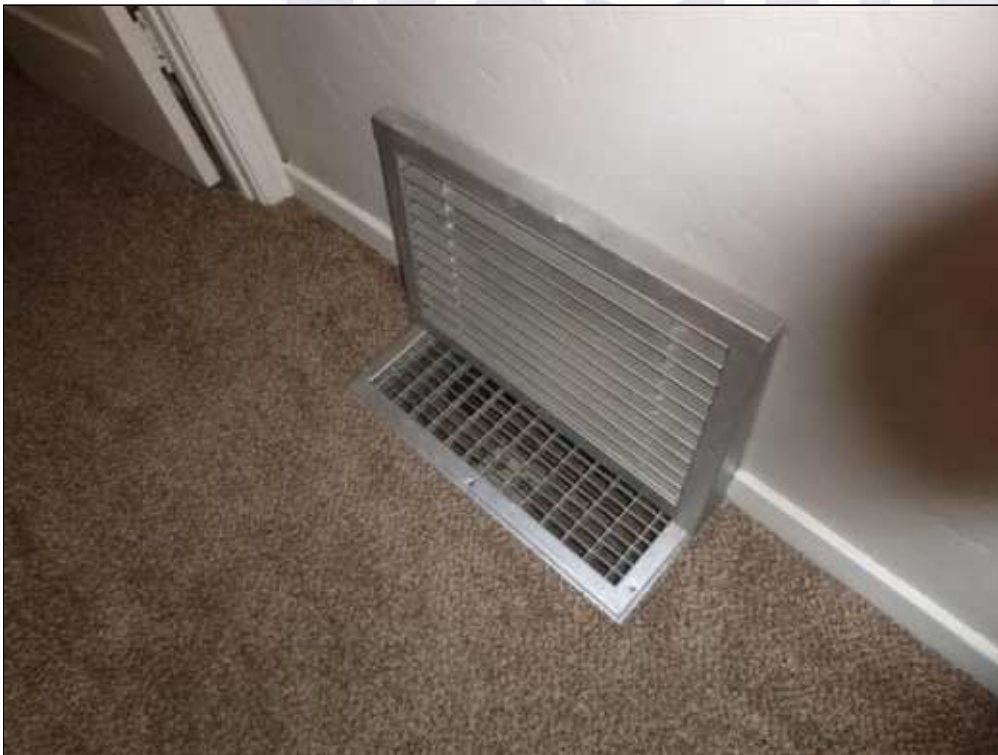
10.0 Item 2(Picture)

10.0 (1) The heater/furnace is very old but did work at the time of inspection. The inspector is unable to determine remaining life expectancy of this system. Due to the age and style of this system, suggest review with the Gas company and/or a licensed heating company for further review to determine the remaining life expectancy of the unit and any repair/replacements costs as needed

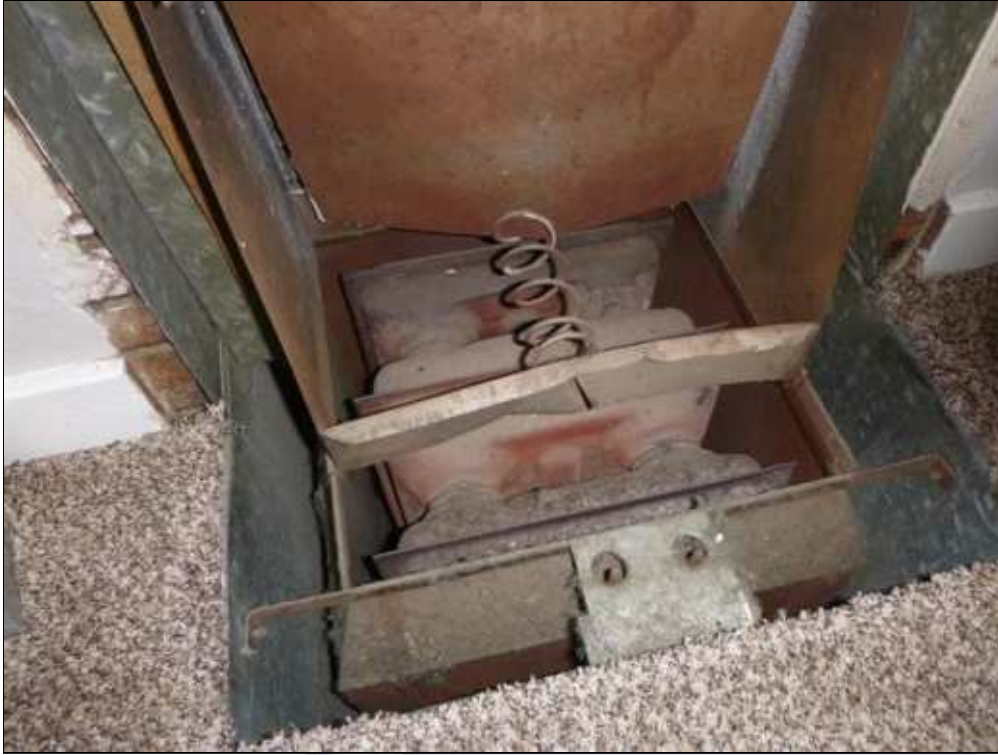
10.0 Item 3(Picture)

10.0 (2) A potential fire spread hazard was noted due to the excessive hair and debris at the base of the heating unit, suggest cleaning/removal as needed.

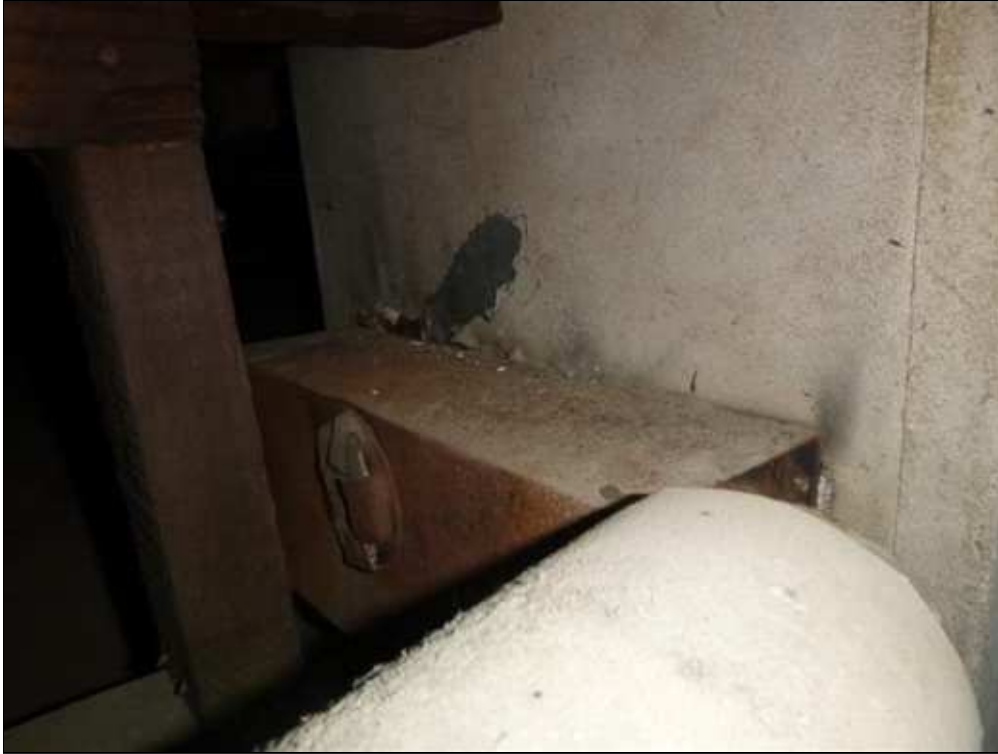
10.1 Item 1(Picture)

10.1 Potential safety hazard due to the heater draft diverter is rusted, deteriorated and large holes were noted. This will allow heater fumes/carbon monoxide to escape into the crawl area and possibly into the dwelling. Suggest review with a licensed heater company for replacement costs as required for safety.

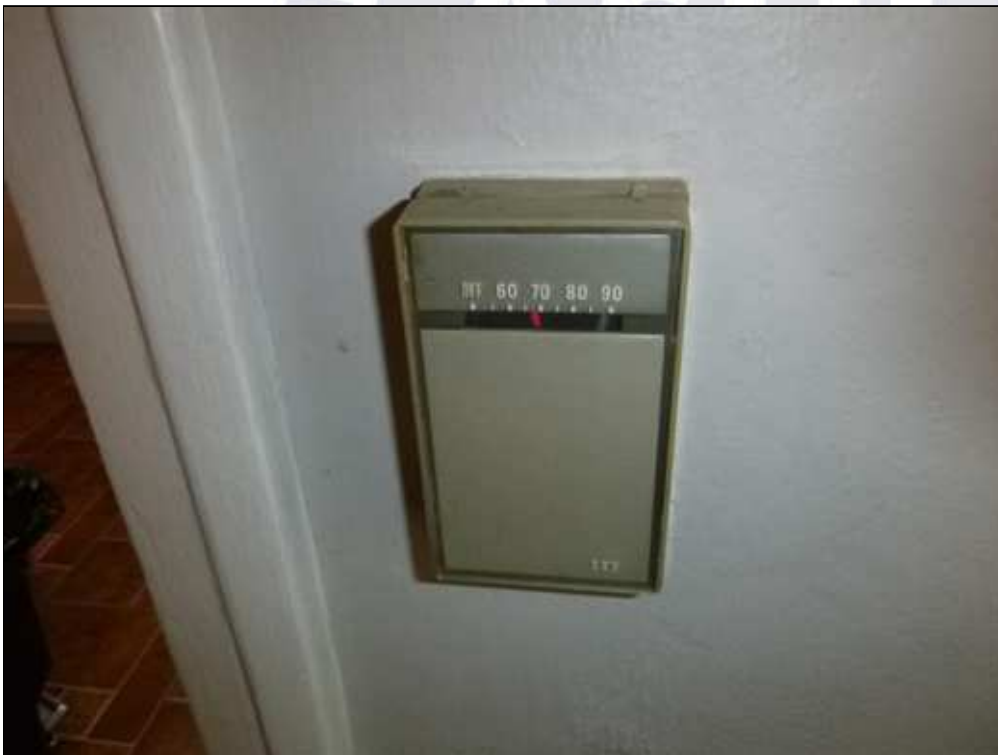
10.2 Item 1(Picture)

10.2 Suggest upgrading with digital programmable thermostat as needed.

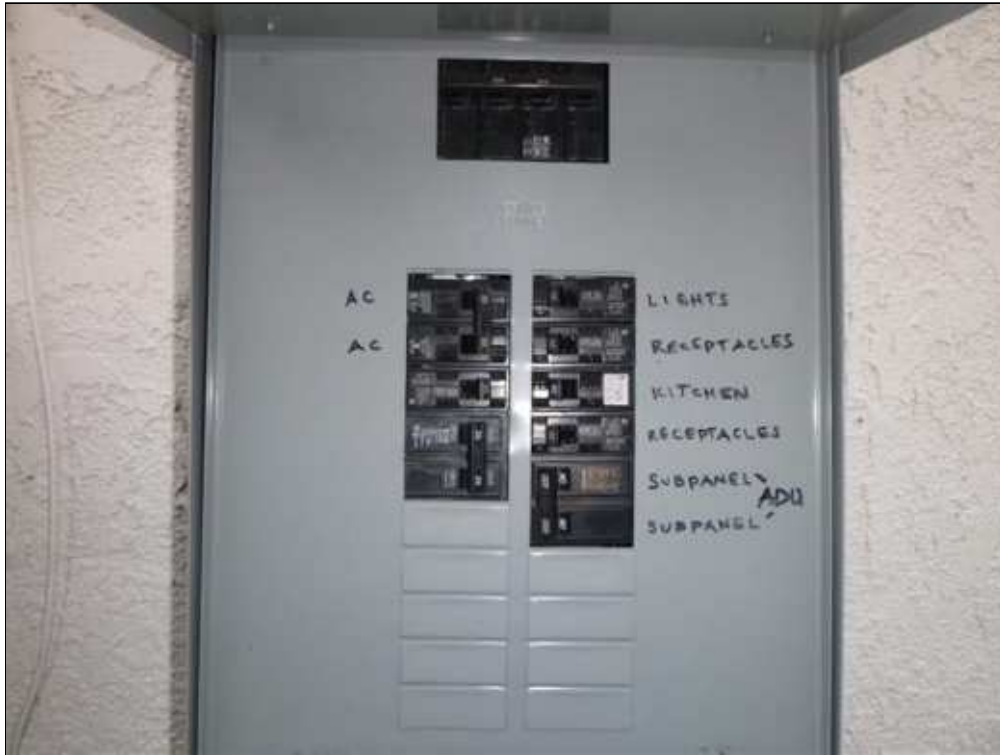
12.1 Item 1(Picture)

12.1 Suggest adding correct/complete indexing/labelling to all breakers for identification of each circuit for safety.

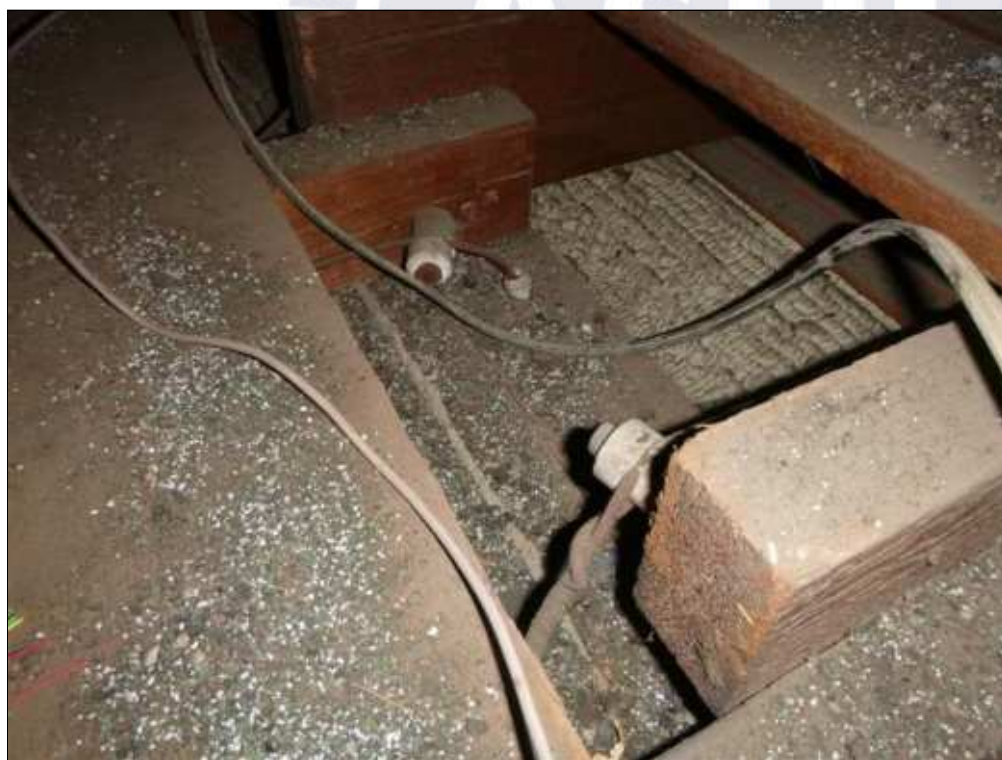
12.2 Item 3(Picture)

12.2 (3) Knob & Tube wiring noted throughout the attic area, this is common for the original age of the dwelling. Suggest review by a licensed electrician for replacement costs to upgrade the wiring to today's standards for safety.

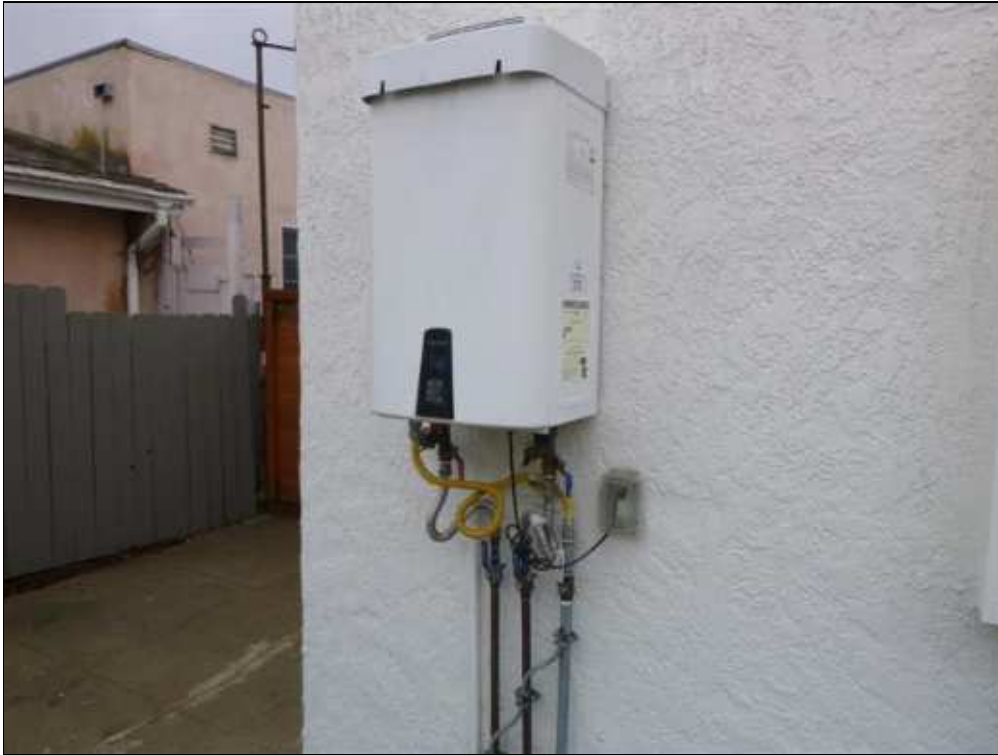
15.0 Item 1(Picture)

15.0 (1) The water heater was operational at the time of the inspection.

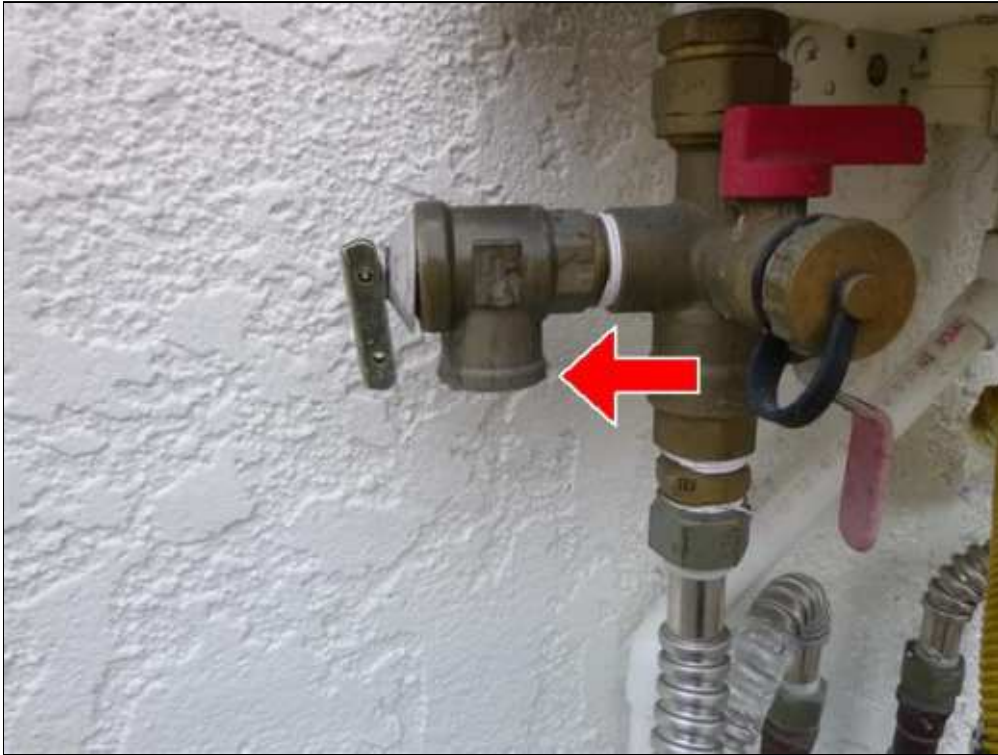
15.0 Item 3(Picture)

15.0 (4) No discharge pipe connected to the TP&R valve, this is a potential safety hazard. Suggest review by a licensed plumber for costs to install the TP discharge drain down to within 4-6 inches of the exterior grade/deck as required for safety.

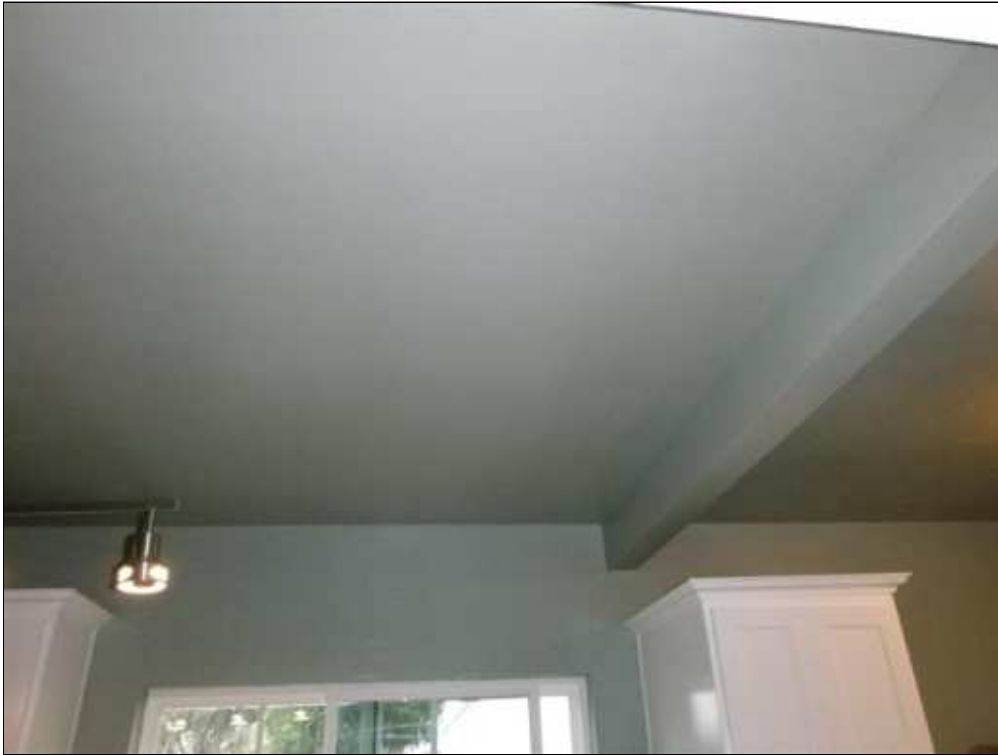
16.2 Item 1(Picture)

16.2 Patched and uneven areas of the ceiling was noted, suggest review with the seller on the cause and any repairs needed. Suggest review with a licensed contractor for any repair/removal/replacement costs as needed.
