Inspection Report

Property Address:
447 E Hullett St
Long Beach CA 90805

Ferguson Home Inspections

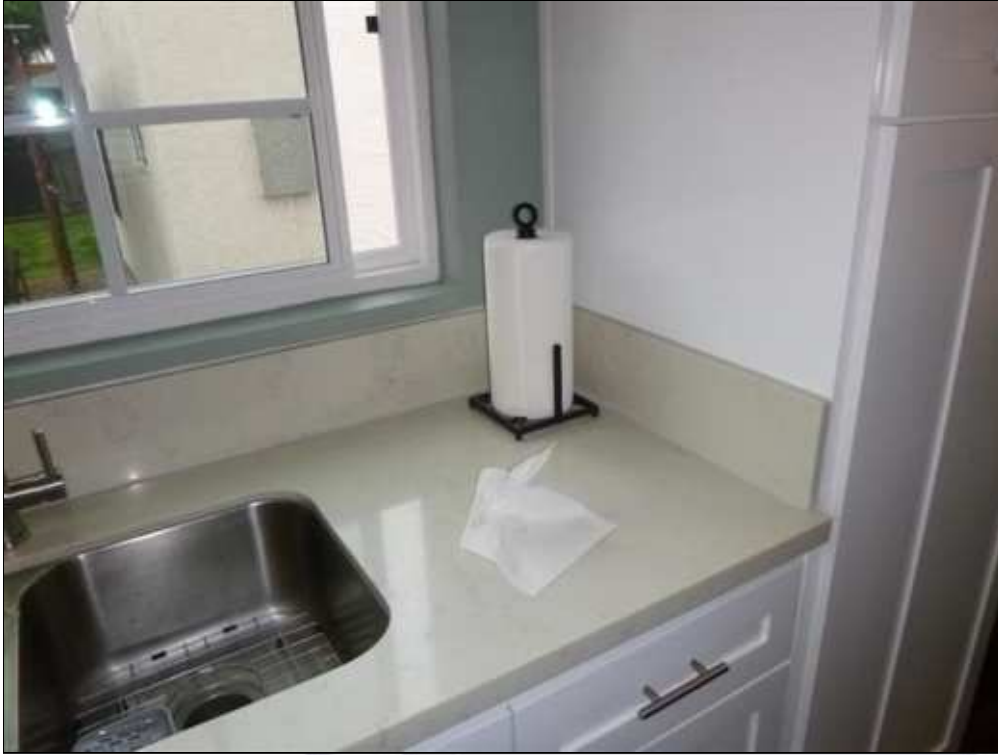
16.7 Item 1(Picture)

16.7 (1) Inadequate/incorrectly installed countertop/appliance outlets/circuits were noted, suggest review with a licensed electrician for installation costs as needed/required.

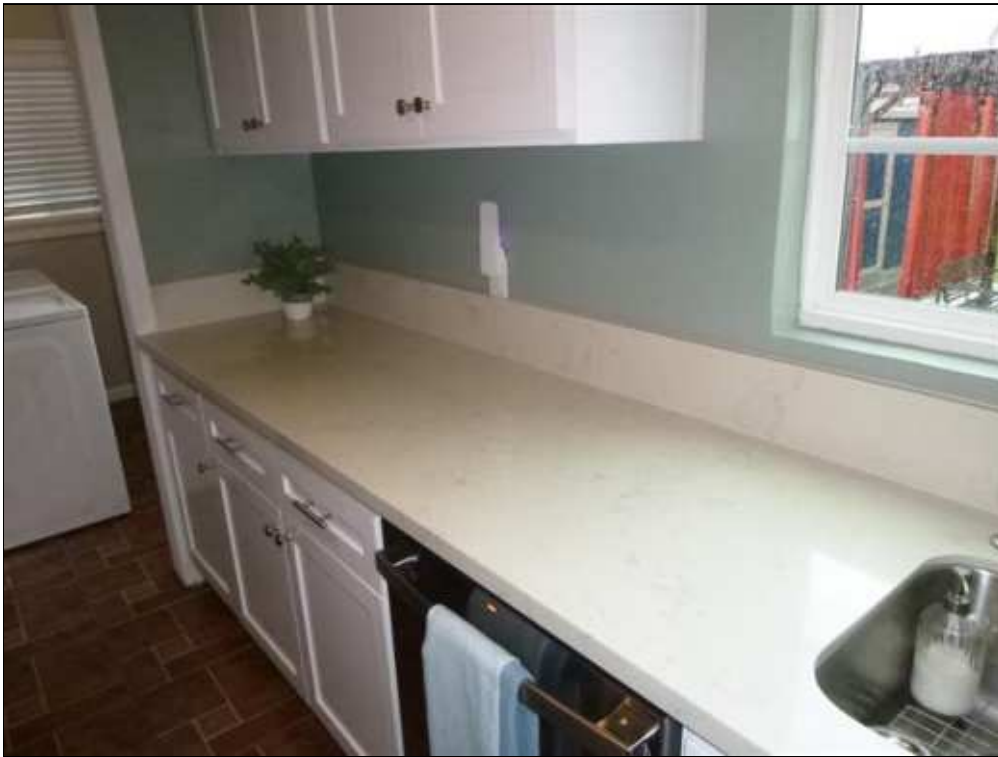
16.7 Item 2(Picture)

16.7 (2) A minimum number of outlets were installed at this area at the time of the inspection, this is common for the original age of dwelling. Suggest review by a licensed electrician for installation costs for additional outlets if desired as an upgrade.

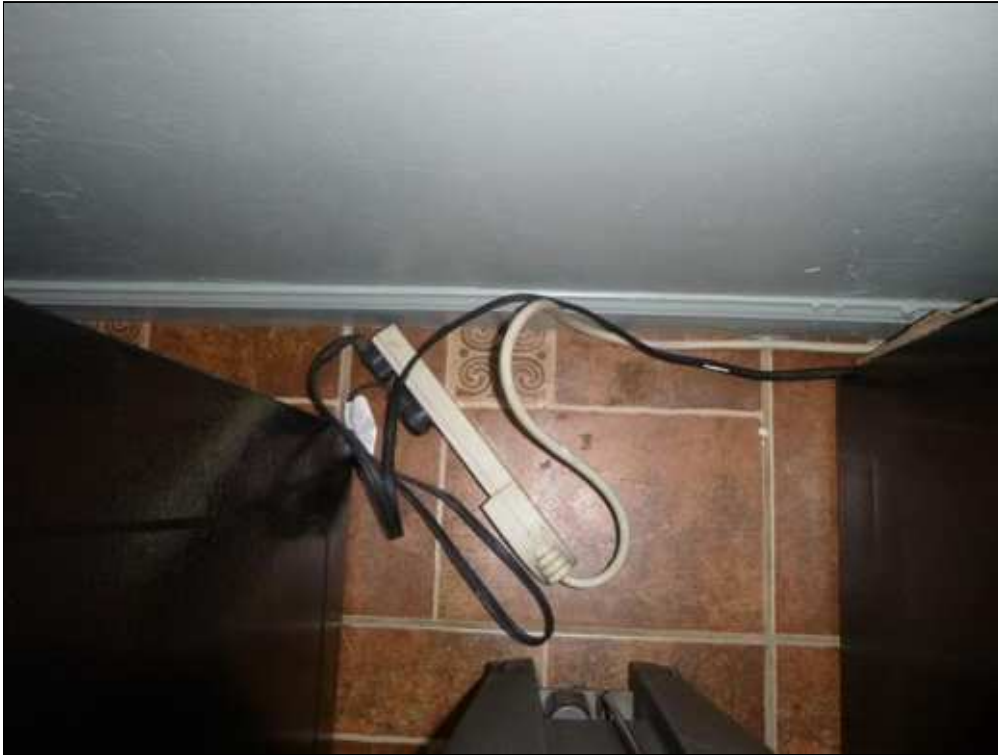
16.7 Item 4(Picture)

16.7 (4) Excessive use of electrical plugs strips/extension cords used at this area, this is a potential fire safety hazard. Suggest review with a licensed electrician for additional electrical circuits/outlets costs as needed for safety.

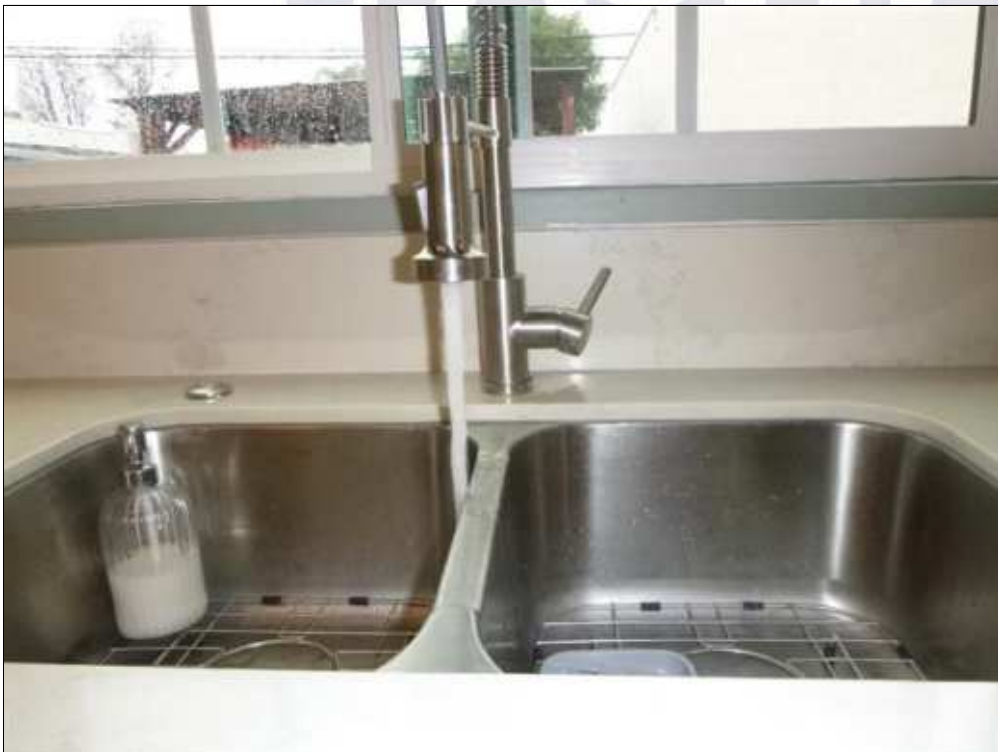
16.9 Item 1(Picture)

16.9 The sink faucet is loose at the countertop, suggest repair as needed.

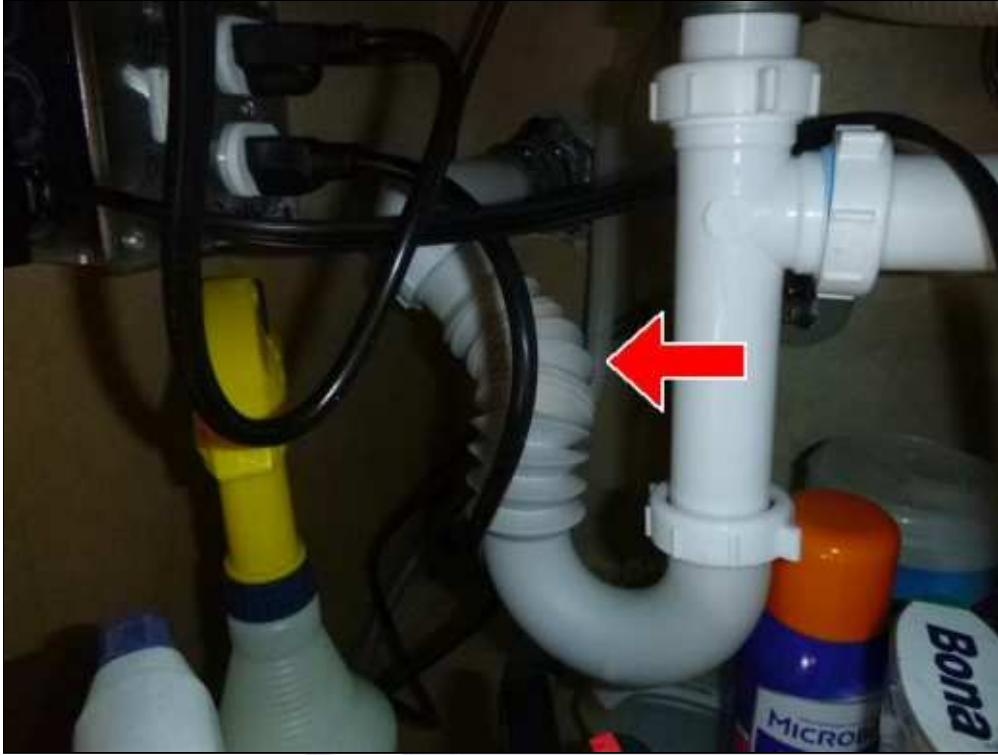
16.10 Item 1(Picture)

16.10 Suggest review by a licensed plumber for costs to replace the sink flex drain(s) with the appropriate materials as required.

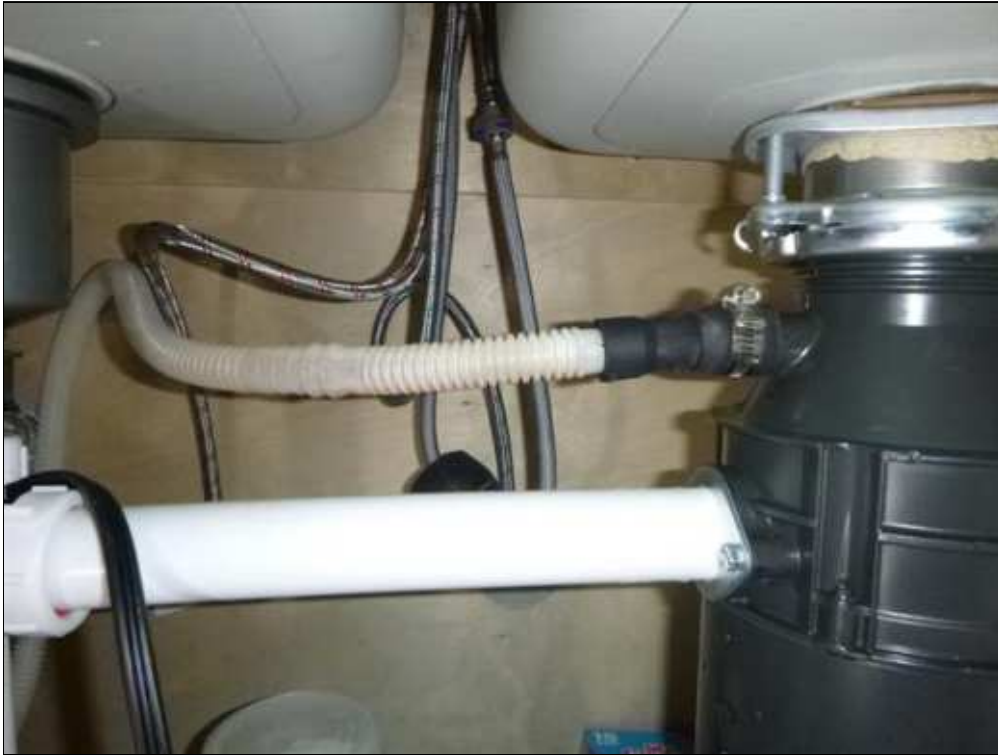
16.11 Item 1(Picture)

16.11 There is no air gap installed for the dishwasher as required, the system currently drains directly into the disposal. Suggest review by a licensed plumber for costs to install the air gap and drain as required by the State of California.

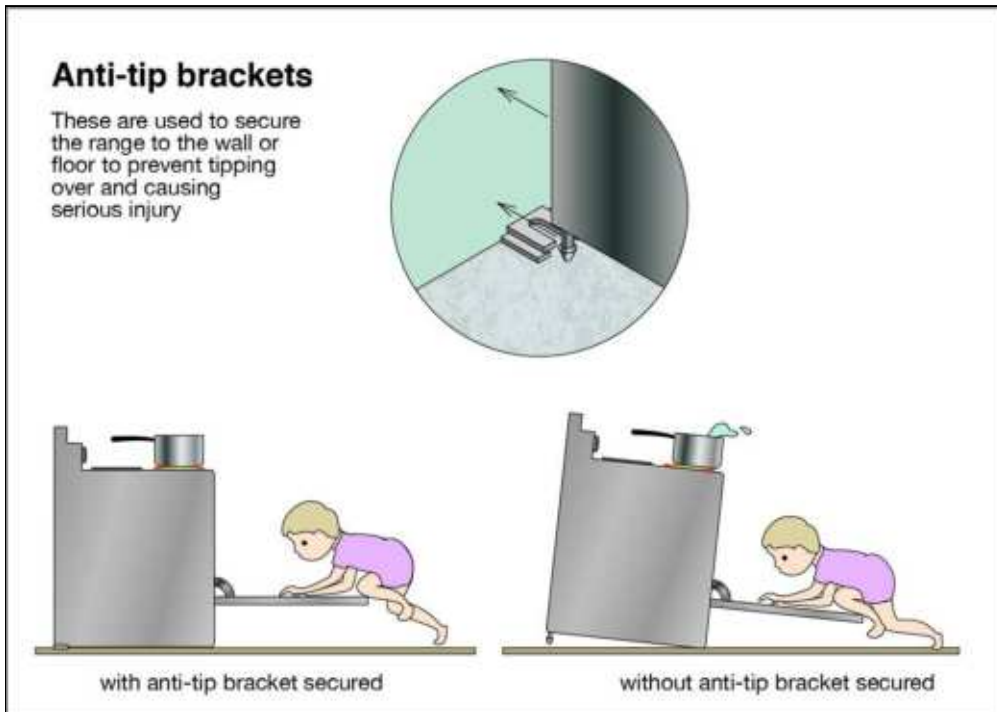
16.13 Item 1(Picture)

16.13 (1) The anti-tip bracket/chain is not currently installed. An anti-tip bracket is usually installed on the floor and against the wall (towards the back of the stove) for one of the rear legs to slide into.

Its purpose is to prevent the stove from tipping when a heavy load is placed on the door (possible child) or slide-out racks upsetting the center of gravity. Suggest installation for safety as required since 1991.

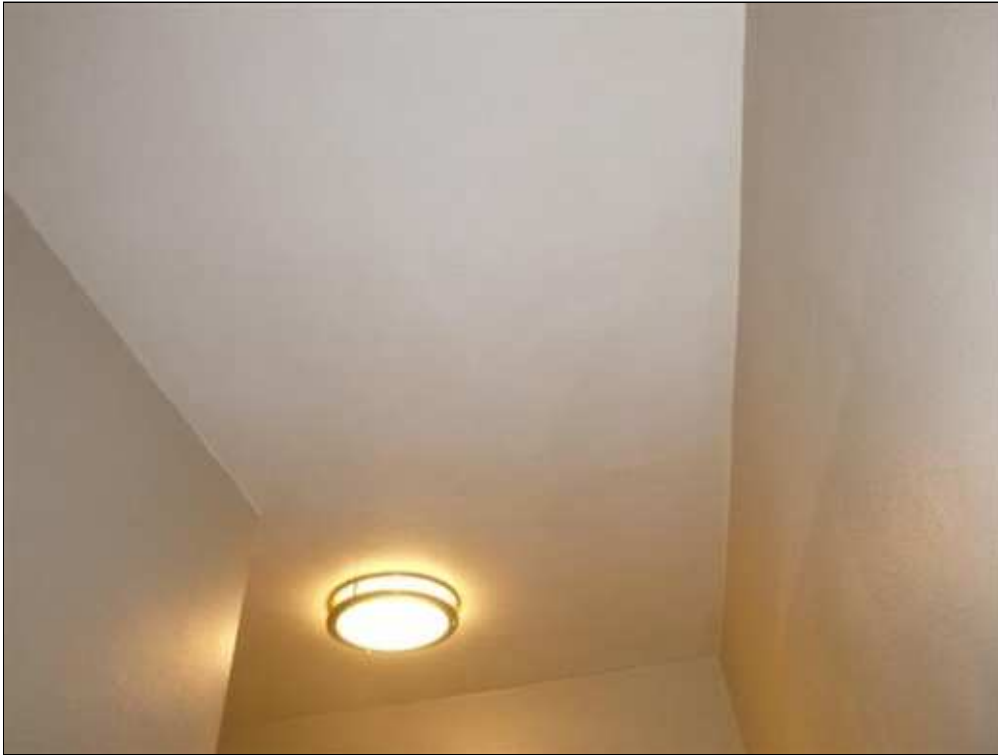
17.2 Item 1(Picture)

17.2 Patched and uneven areas of the ceiling was noted, suggest review with the seller on the cause and any repairs needed. Suggest review with a licensed contractor for any repair/removal/replacement costs as needed.

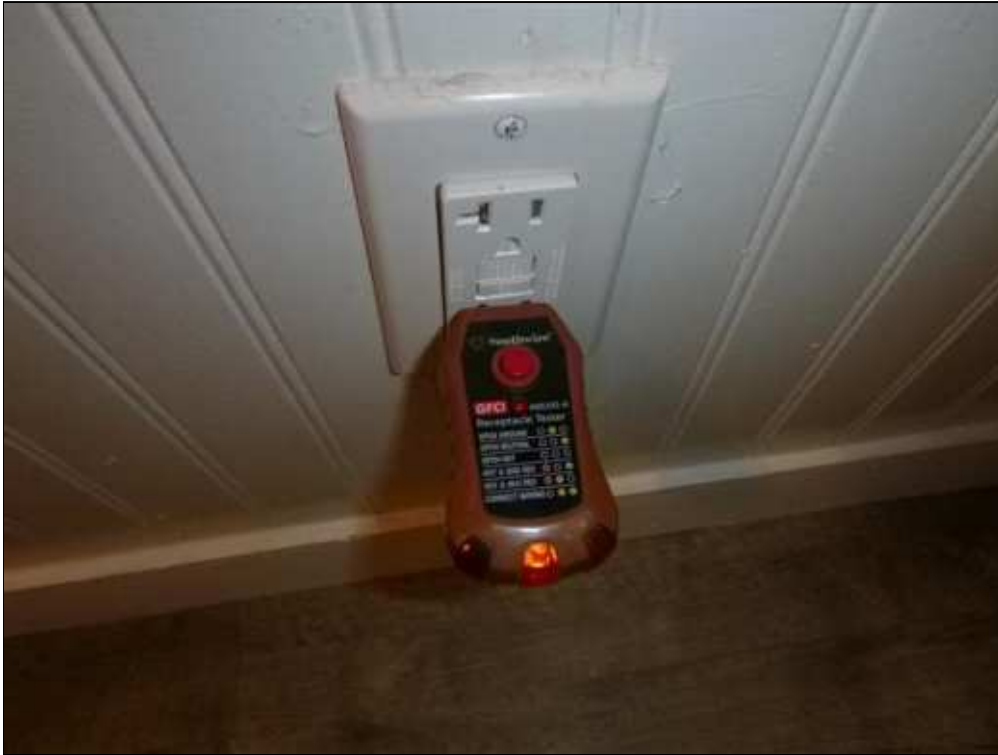
17.6 Item 1(Picture)

17.6 The GFCI outlet(s) at this area are not grounded. The GFCI should still provide GFCI protection but the outlet should generally be grounded. Suggest review by a licensed electrician for repair/grounding cost as needed and required for safety.

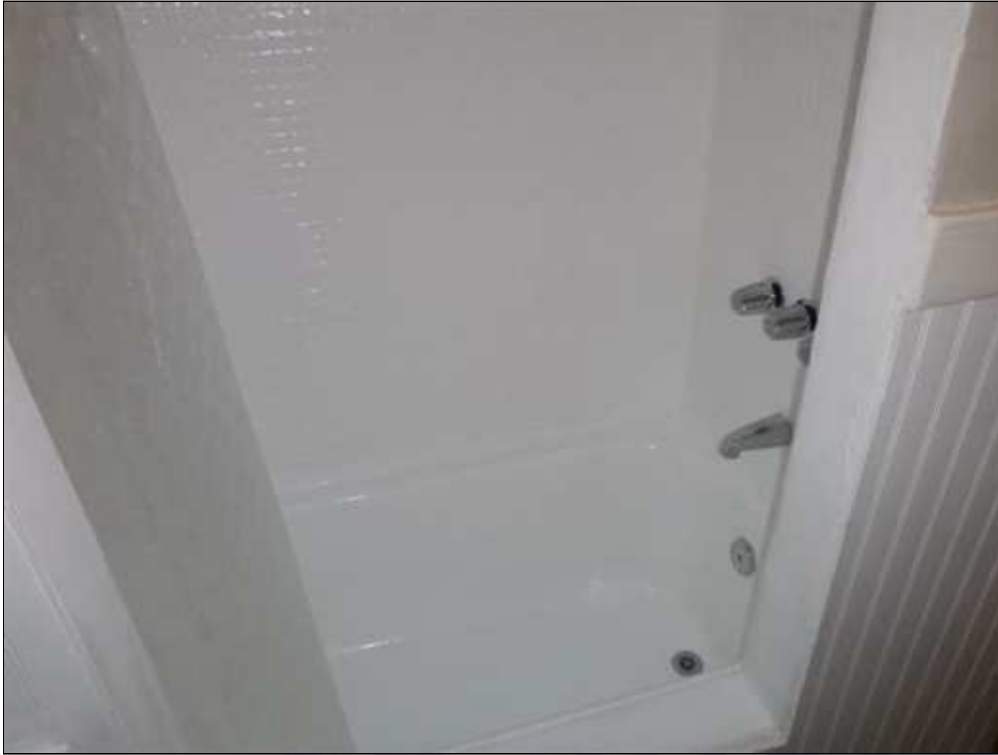
17.8 Item 1(Picture)

17.8 The tub has been re-glazed, suggest review with the seller and/or installation company for care and maintenance requirements.

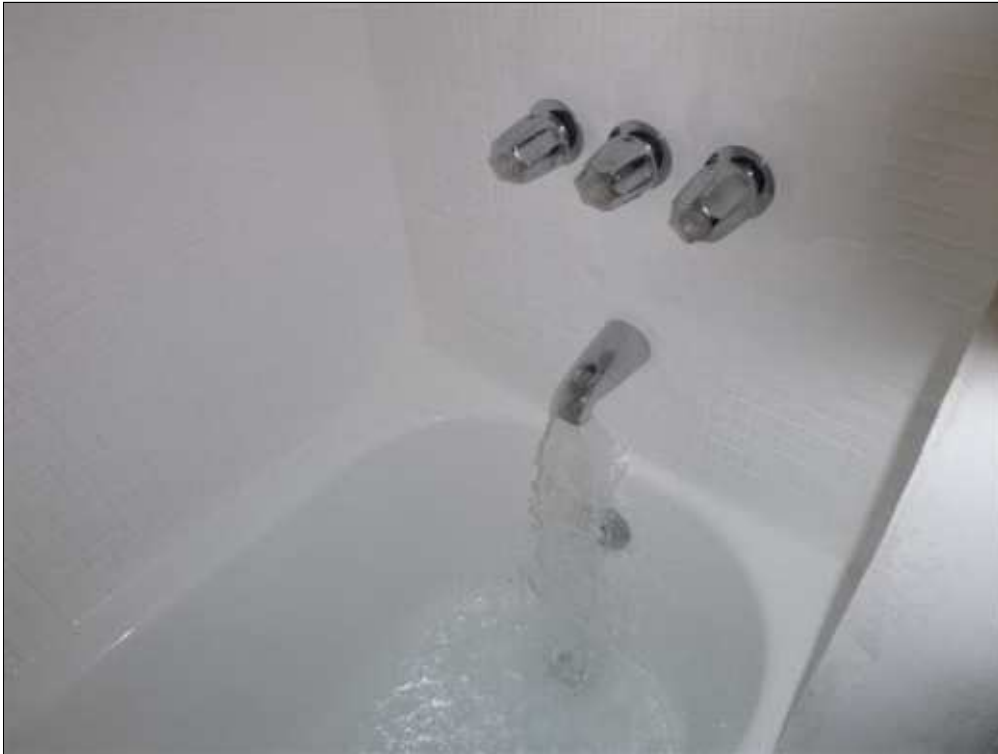
17.9 Item 1(Picture)

17.9 (1) The existing tub faucet is not a low-flow system as required. Suggest review with a licensed plumber for costs to replace the existing tub faucet with a low flow faucet (2.2 gallons per minute) as required by the State of California as of January 1st, 2017. See the plumbing system comments for further details and a link to the State of California plumbing ordinance. Most retrofit companies/cities do not enforce the low flow tub faucet requirements due to it can take an excessive amount of time to fill the tub (you will use the same amount of water irrelevant of how long it takes to fill the tub).

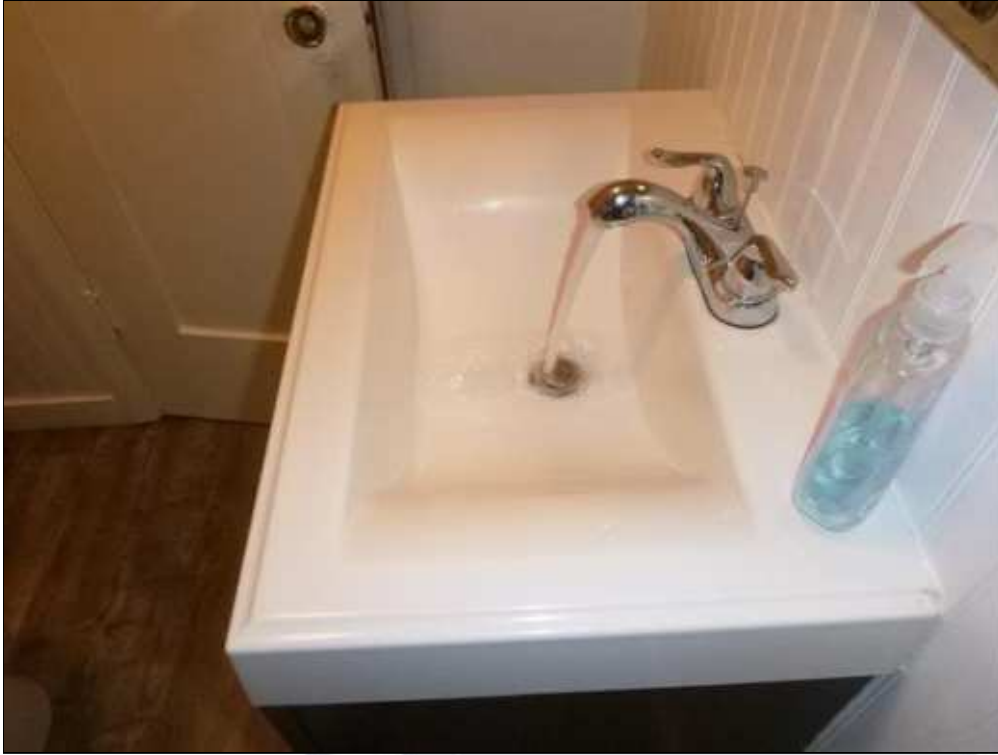
17.13 Item 1(Picture)

17.13 No drainage overflow system installed at the sink(s) as required, suggest review with a licensed plumber for repair/replacement costs as required.

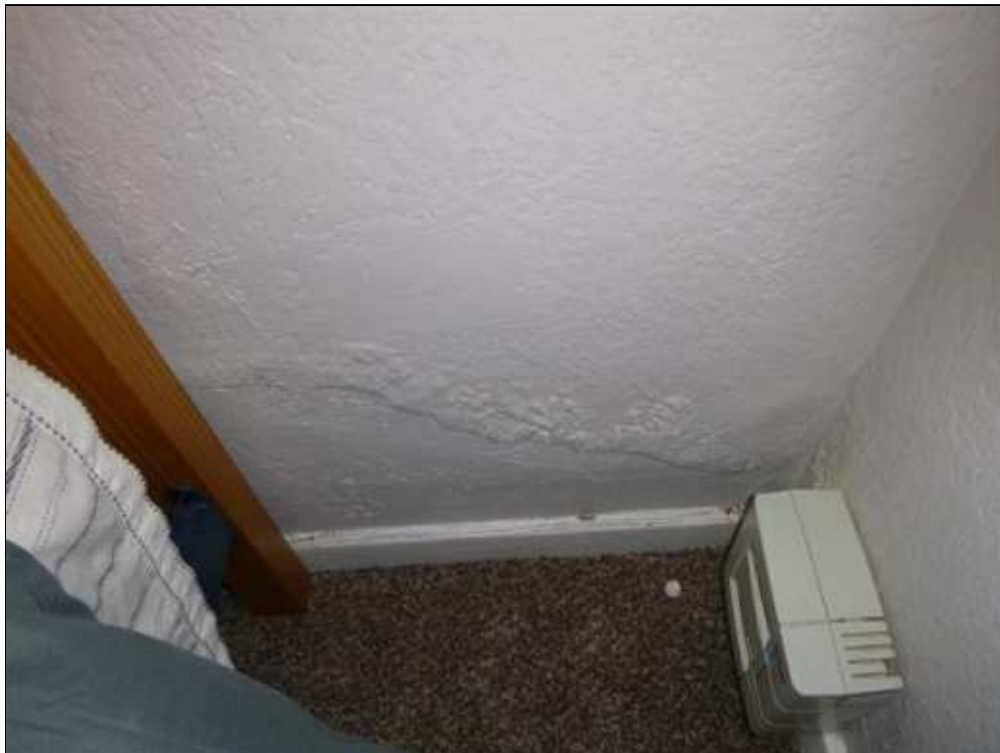
17.18 Item 1(Picture)

17.18 Excessive deterioration/damaged areas of the wall in bedroom #2 was noted noted which is adjacent to the tub/shower area. Suggest review with the seller and/or a licensed contractor for any repair/removal/replacement costs as needed.

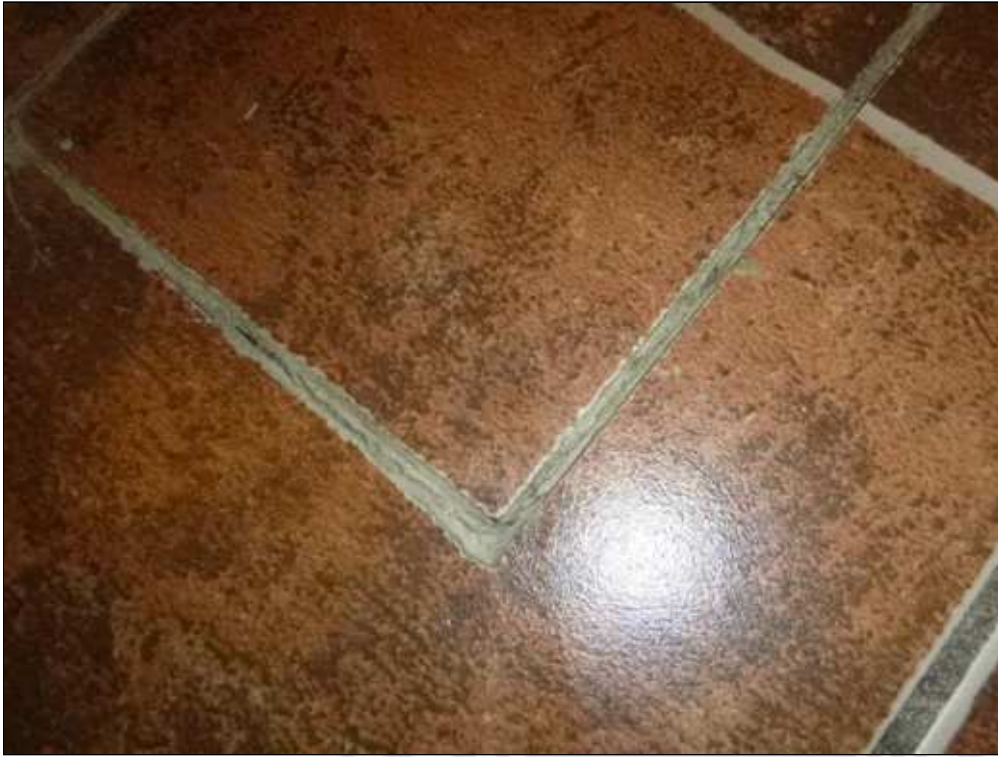
21.0 Item 2(Picture)

21.0 Patched repaired areas of the tile flooring was noted (this appears to be from a removed wall). Suggest review with the seller and/or a licensed contractor on this item as needed.

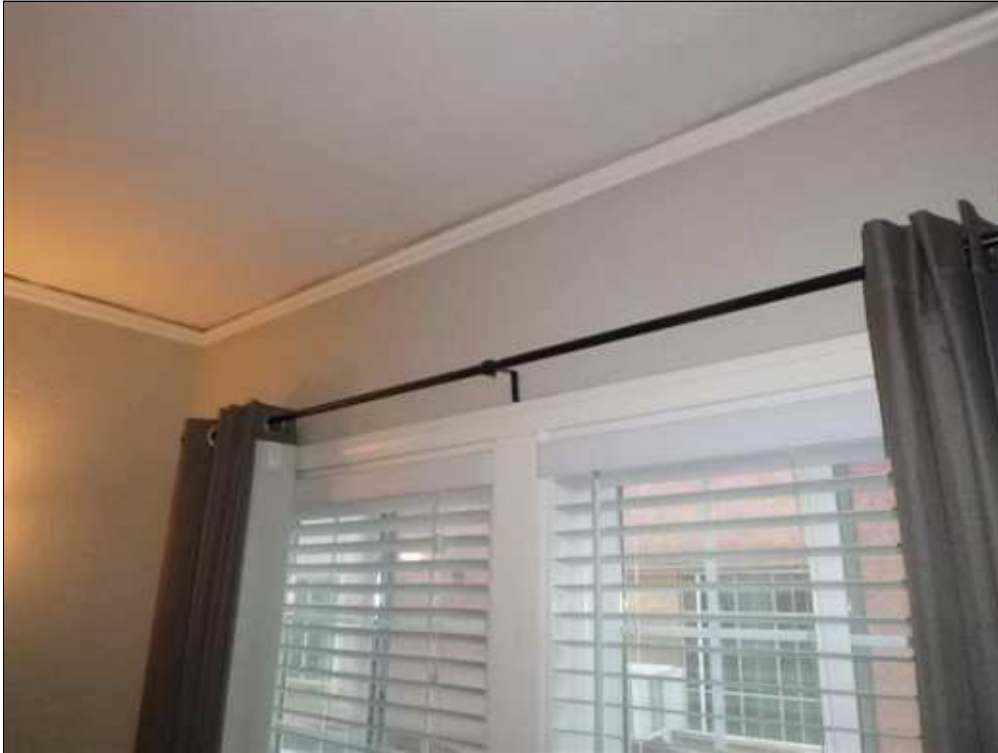
24.1 Item 1(Picture)

24.1 (1) Patched areas of the walls was noted, suggest review with the seller for the cause and any repairs needed. Suggest repair as needed.

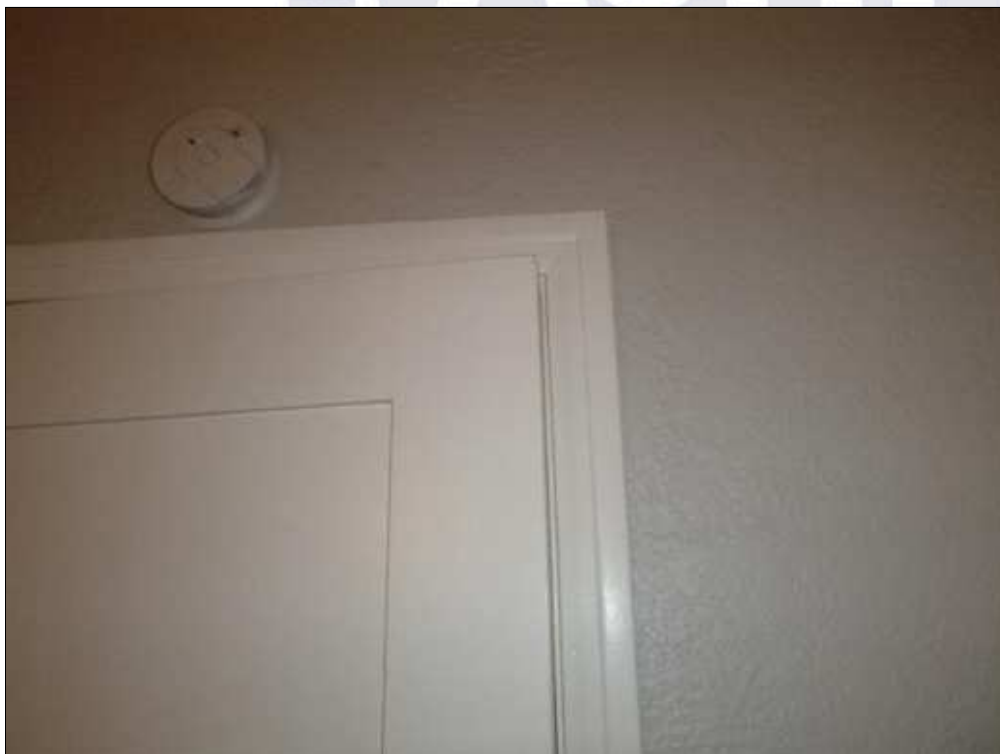
24.3 Item 1(Picture)

24.3 The door sticks/impacts on the jamb when operating, suggest repair as needed.

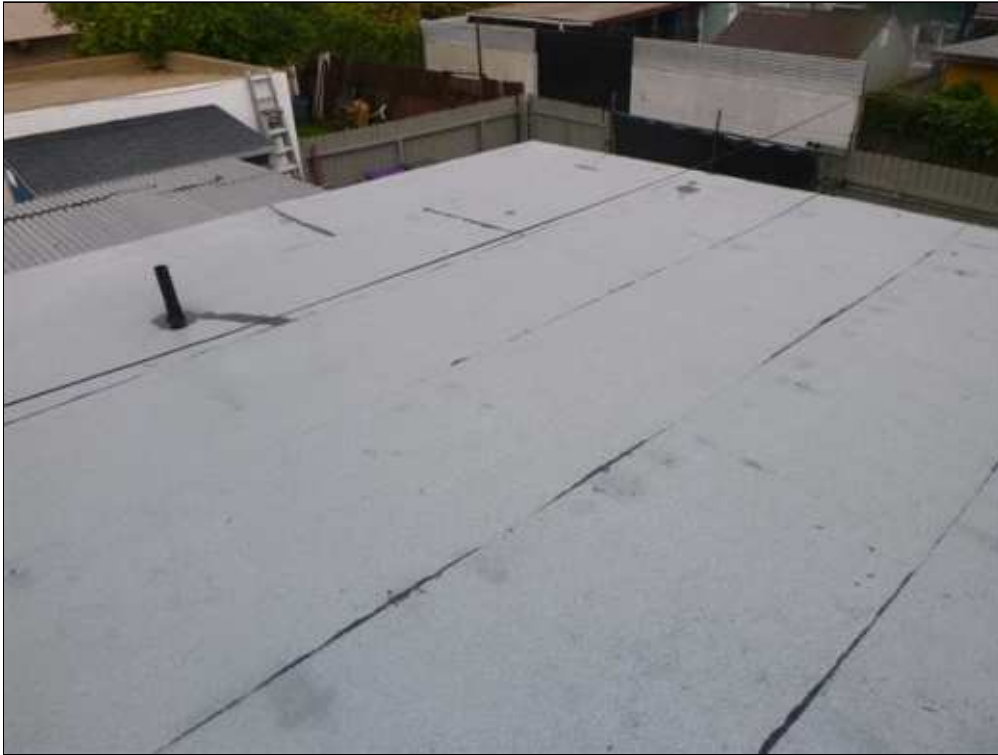
27.0 Item 2(Picture)

27.0 Patched and repaired areas of the roofing was noted. Suggest review with a licensed roofing contractor for any repair/replacement costs as needed and to determine the remaining life expectancy of the roof.

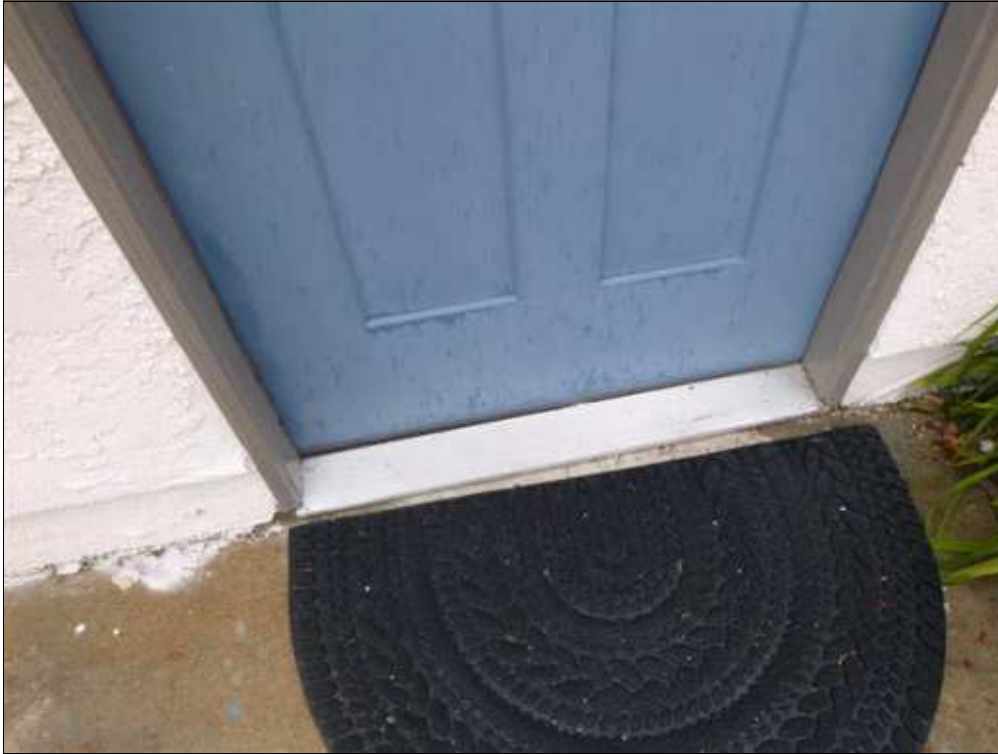
28.3 Item 2(Picture)

28.3 (2) The existing threshold for the doorway is set at/below the deck level. Water entry may occur at these areas and cause damaged within the structure. Current requirements for doorway/thresholds are two inches minimum height above the hard deck or exterior surface/grade. Suggest review with a licensed contractor for repair/replacement costs needed to eliminate water entry into the structure.

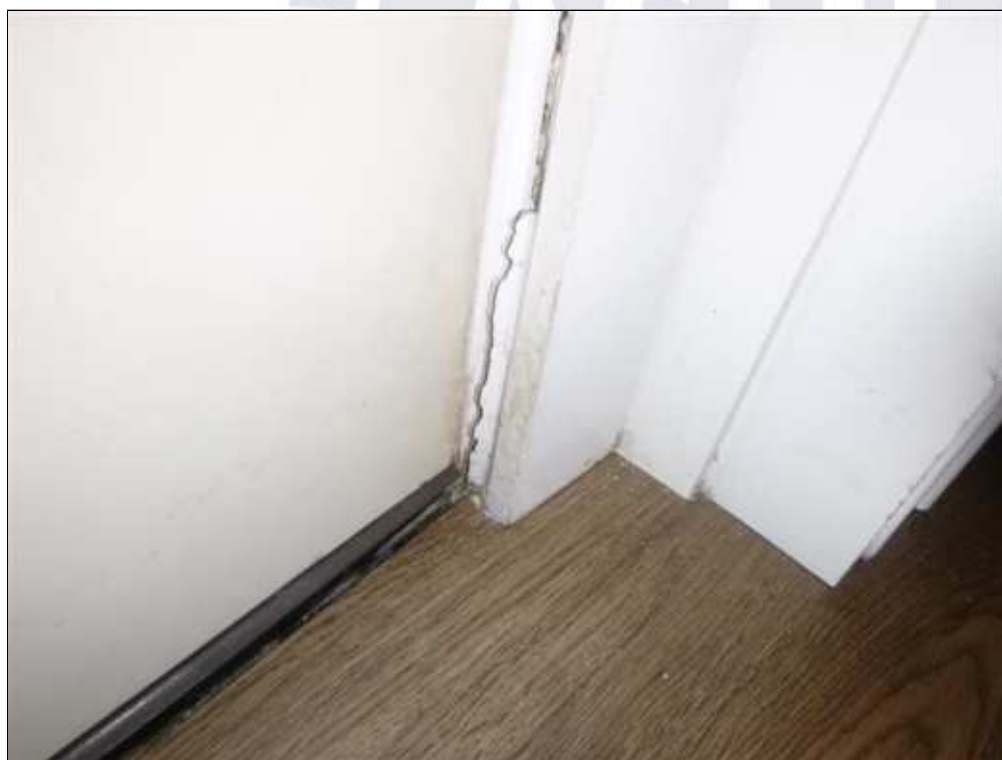
28.3 Item 4(Picture)

28.3 (3) Evidence of previous and ongoing water intrusion noted at the door(s) to the interior. Deteriorated and loose door trim/casings were noted. Suggest review with a licensed contractor for any repair/replacement costs as needed to prevent further and future water intrusion at this area.

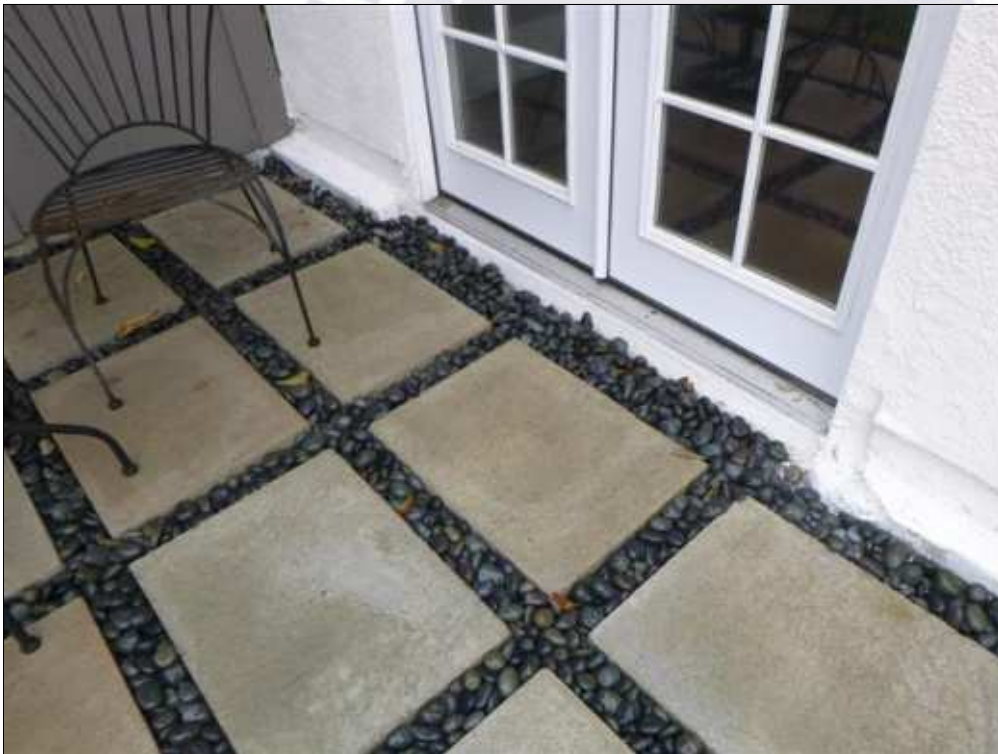
29.0 Item 1(Picture)

29.0 An inadequate/incomplete sized deck/landing was noted at the exterior doorway. Generally a 36' formed landing is required at an exterior door. Suggest review with the seller/city and/or a licensed contractor for installation costs as needed.

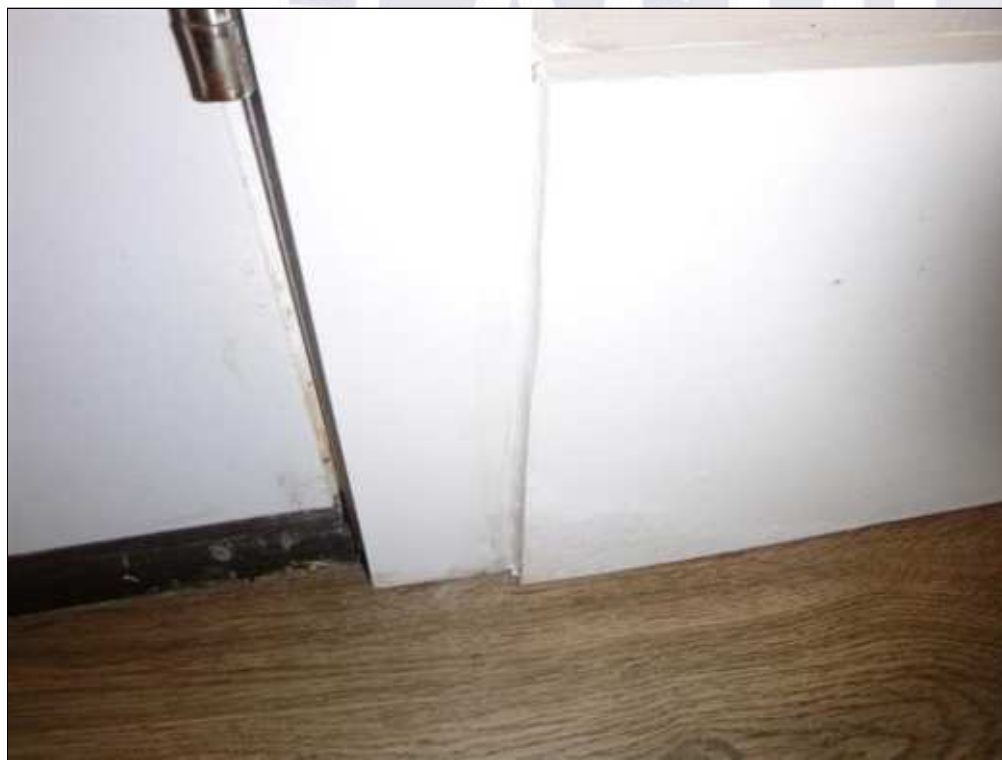
29.2 Item 2(Picture)

29.2 Evidence of previous and ongoing water intrusion noted at the door(s) to the interior. Deteriorated and stained flooring/baseboards noted. Suggest review with a licensed contractor for any repair/replacement costs as needed to prevent further and future water intrusion at this area.

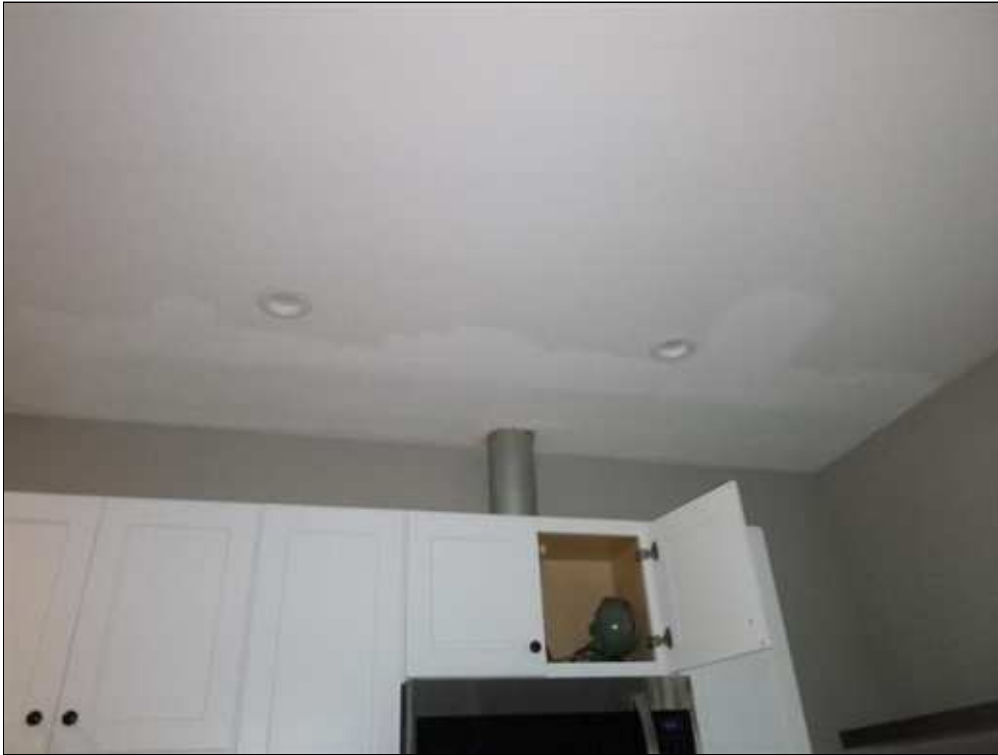
33.2 Item 1(Picture)

33.2 Patched and repaired areas of the ceiling was noted, suggest review with the seller on the cause and any repairs needed. Suggest review with a licensed contractor for any repair/removal/replacement costs as needed.

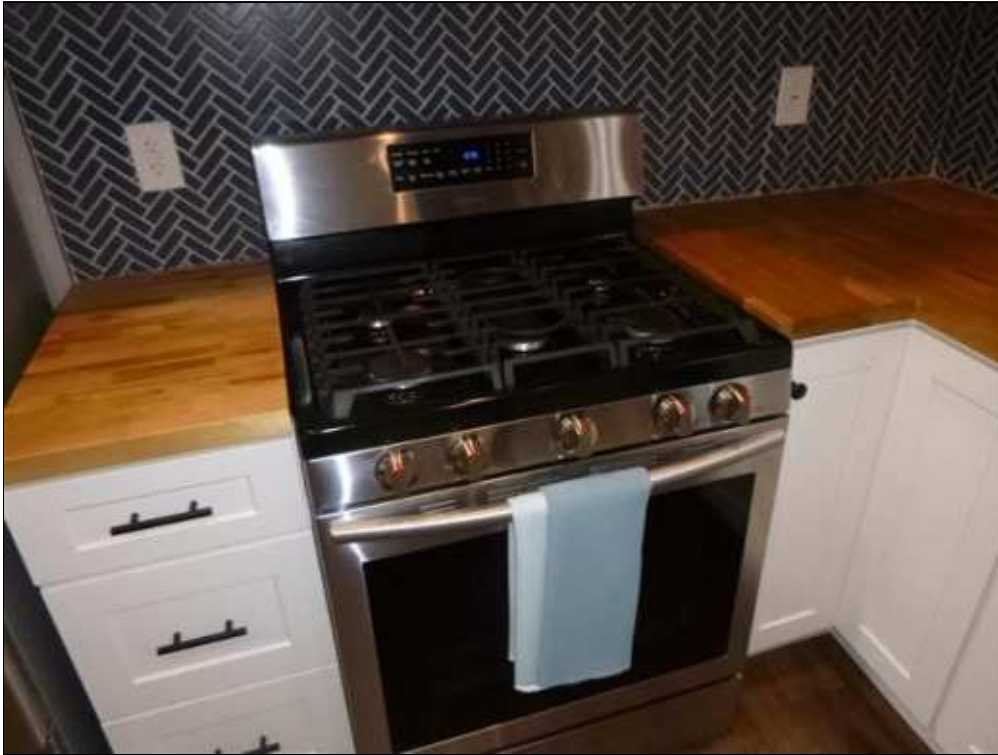
33.7 Item 1(Picture)

33.7 Suggest review with the seller/city and/or a licensed contractor on the installation of the wood block countertop due to the proximity to the gas fueled stove.

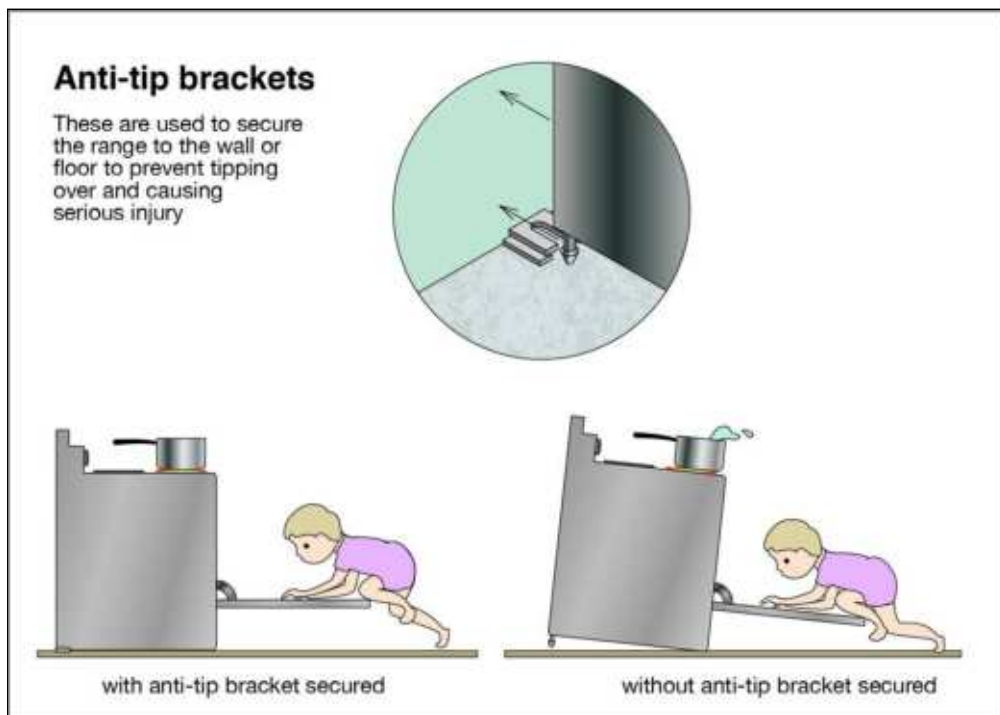
33.13 Item 1(Picture)

33.13 (1) The anti-tip bracket/chain is not currently installed. An anti-tip bracket is usually installed on the floor and against the wall (towards the back of the stove) for one of the rear legs to slide into. Its purpose is to prevent the stove from tipping when a heavy load is placed on the door (possible child) or slide-out racks upsetting the center of gravity. Suggest installation for safety as required since 1991.

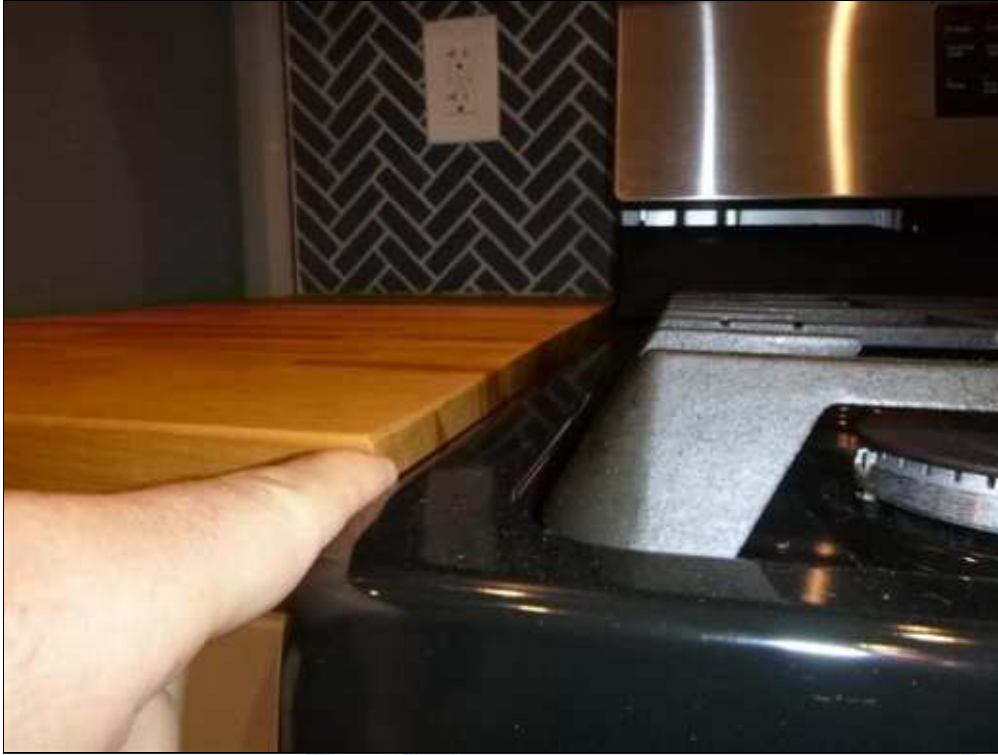
33.13 Item 3(Picture)

33.13 (2) Potential fire spread hazard due to the stove is currently below the countertop height.

Suggest review with a licensed contractor for cost to raise and level the stove to above the countertop height as required for safety.

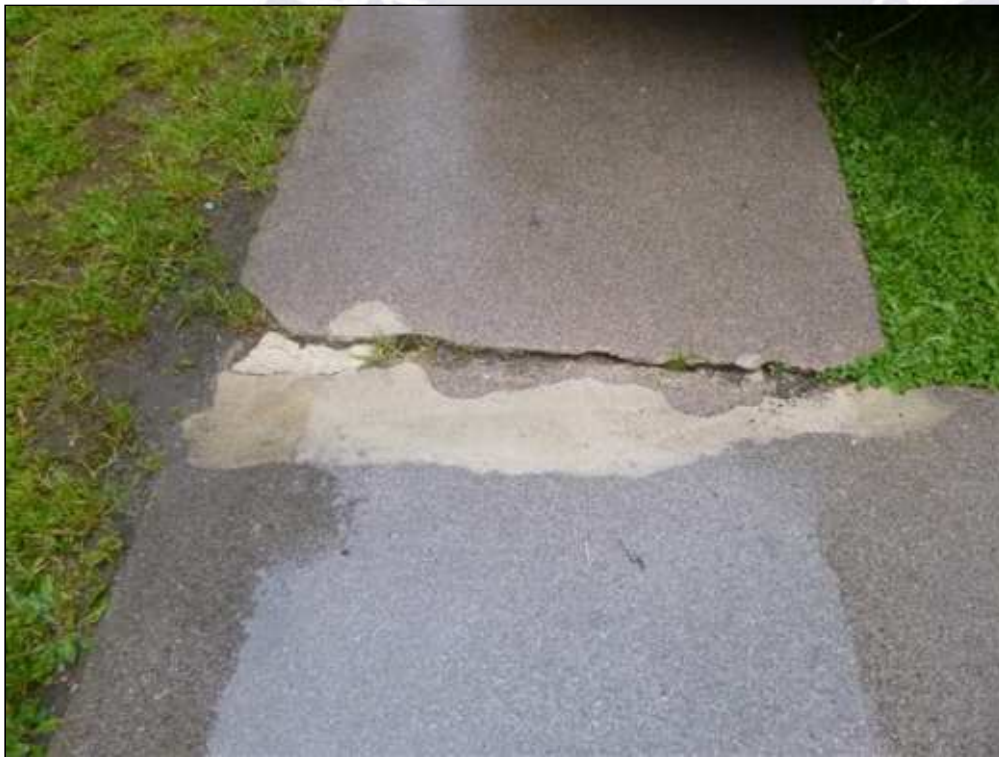
1.0 Item 2(Picture)

Settling, expansion cracks and heaving noted at various areas, this is a potential trip hazard. Suggest review with a licensed contractor for repair/replacement costs as needed.

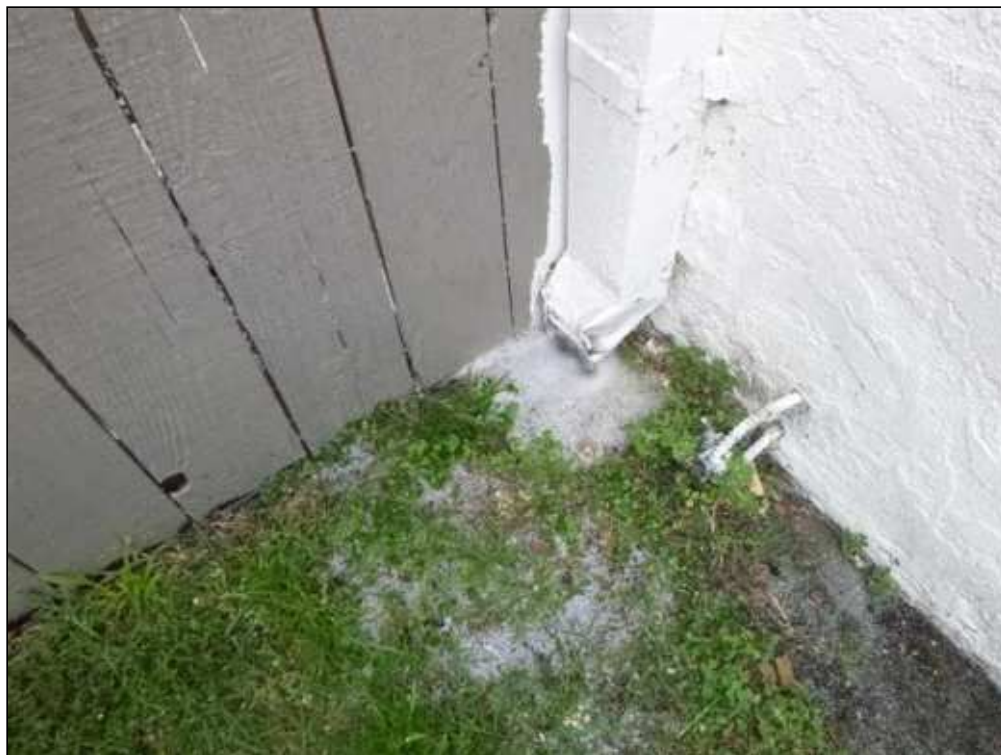
1.9 Item 1(Picture)

(1) Suggest review by a licensed contractor for possible installation of an area drainage system to divert drainage away from the foundation.

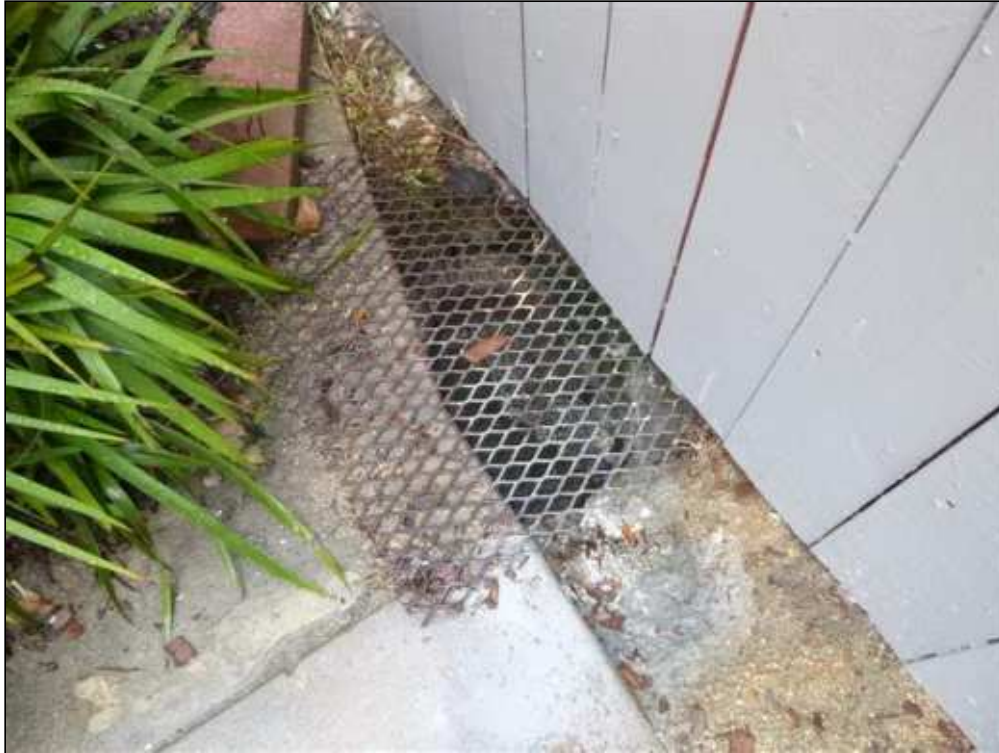
1.11 Item 2(Picture)

(4) A large hole was noted at the rear of the driveway by the fence/ADU. Suggest review with the seller/neighbor and/or a licensed contractor on this item and any repair/filling/patching costs as needed.
