Inspection Report

Property Address:
447 E Hullett St
Long Beach CA 90805

Ferguson Home Inspections

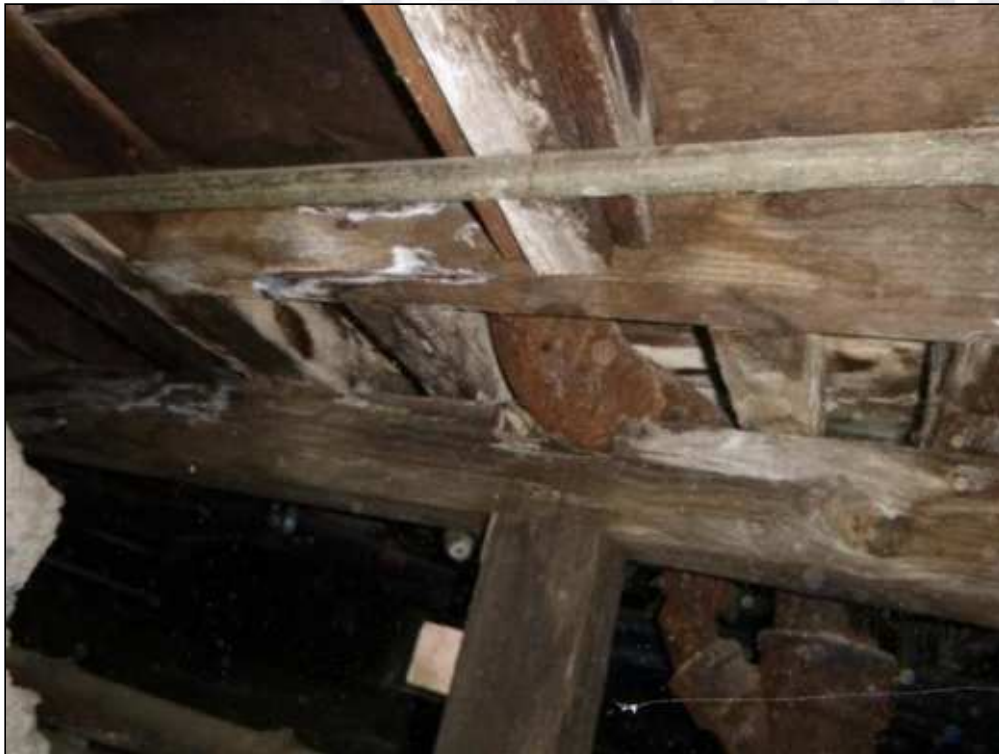
3.1 Item 1(Picture)

(1) Stains and deterioration noted at various flooring and supports from prior leaks. Suggest review with a termite company and/or a licensed contractor for any repair/replacement costs as needed.

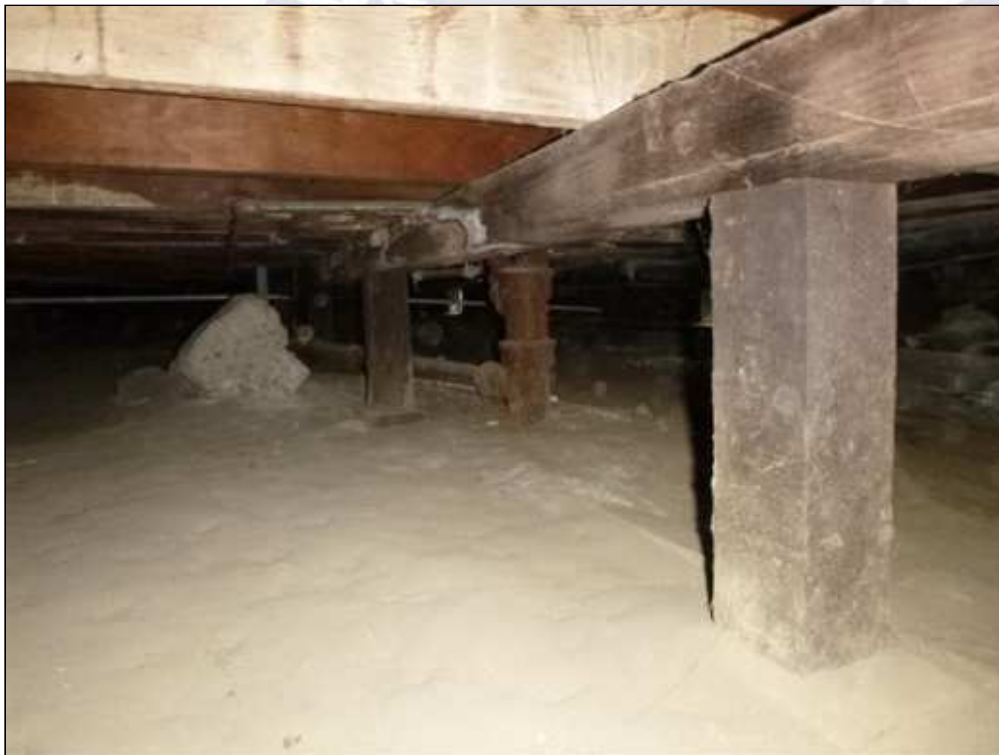
3.1 Item 5(Picture)

(2) Inadequate support noted at various girder beams due to the excessive span and inadequate support posts, common for the original age of the dwelling. Suggest review by a licensed contractor for costs to add additional supports to prevent possible future structural and floor movement as needed.

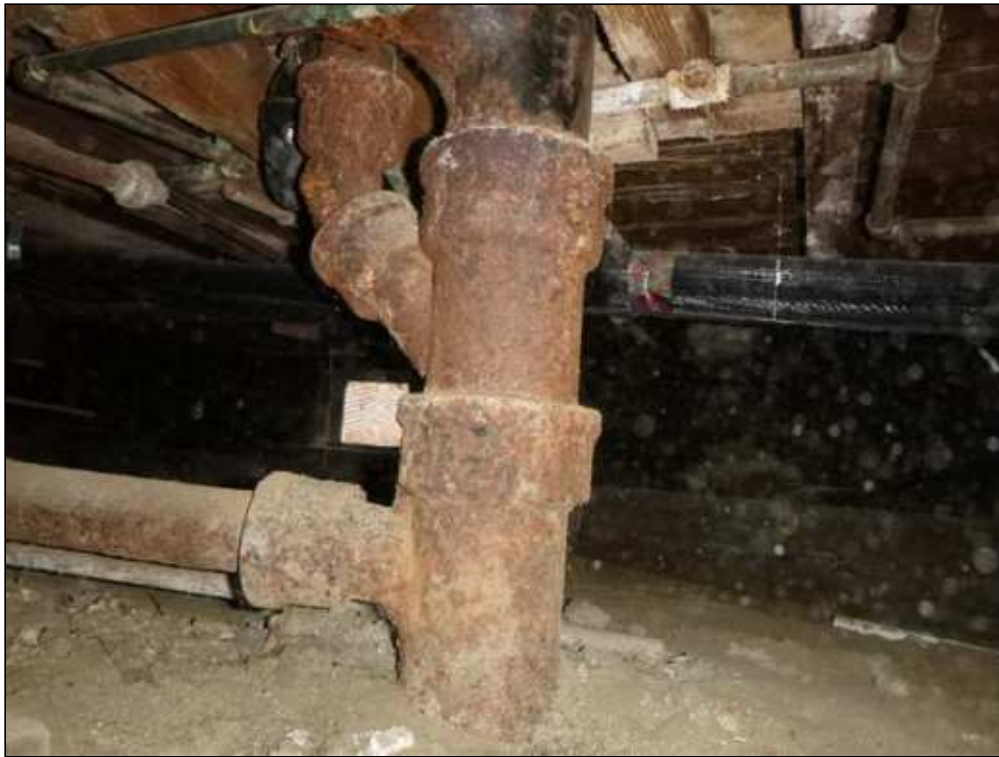
4.3 Item 1(Picture)

(1) Excessive rust, seepage and corrosion noted at various cast iron drain lines within the crawl space. Suggest review by a licensed plumbing contractor for replacement costs as needed to prevent future

leakage at the crawl area.

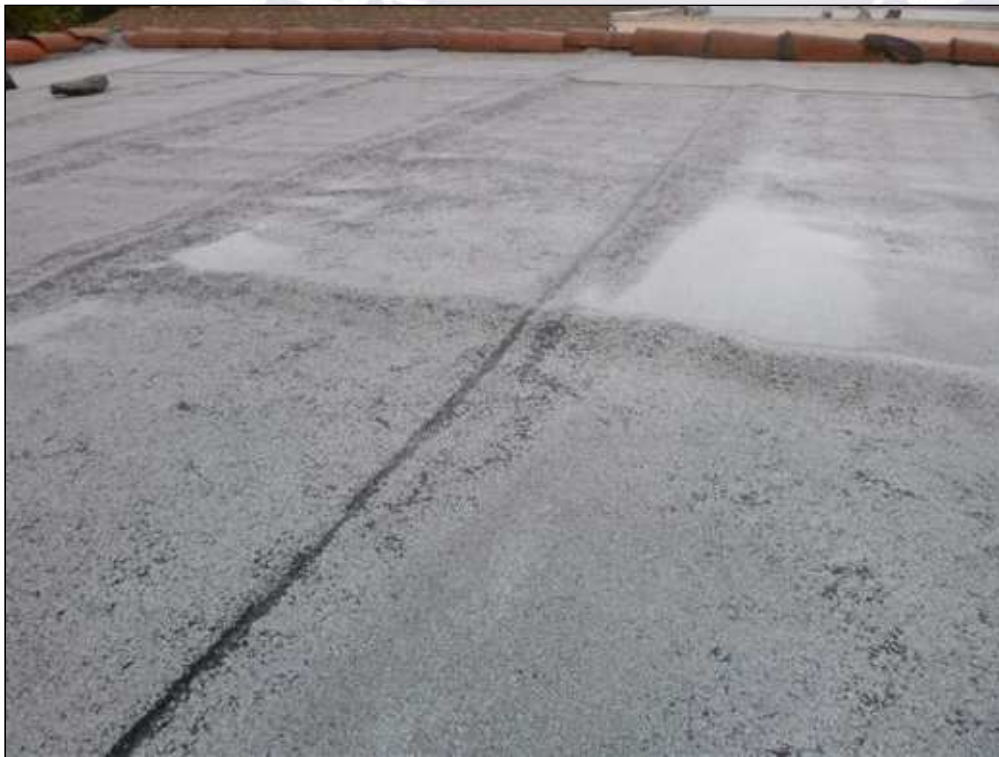
5.0 Item 2(Picture)

(1) The sloped roof covering is old and deteriorated. It is nearing the end of its useful life and the covering will need to be replaced. While it could last a year or so, some areas may need patching/repairs as leaks develop. Please review with a licensed roofer to determine the remaining life expectancy and for costs to repair/remove and replace the existing roofing material as needed.

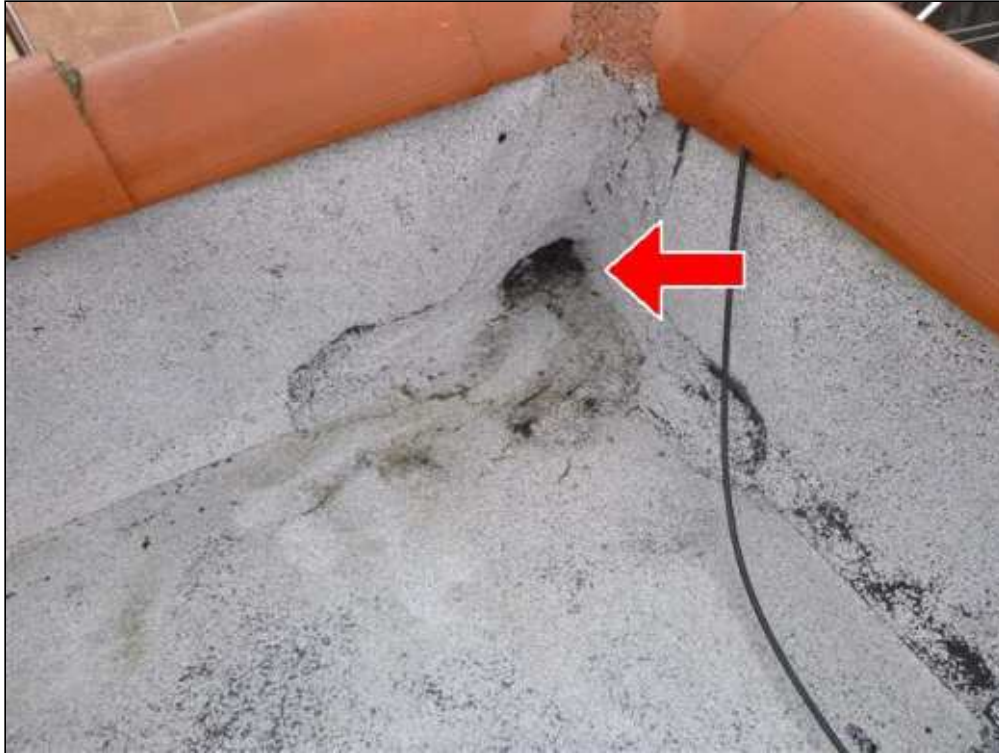
5.0 Item 7(Picture)

(2) Suggest review with a licensed roofer for installation costs for a scupper/over flow drain to the roof as an upgrade. Any blockages to the roof drain will result in excessive water ponding/flooding at the roof area.

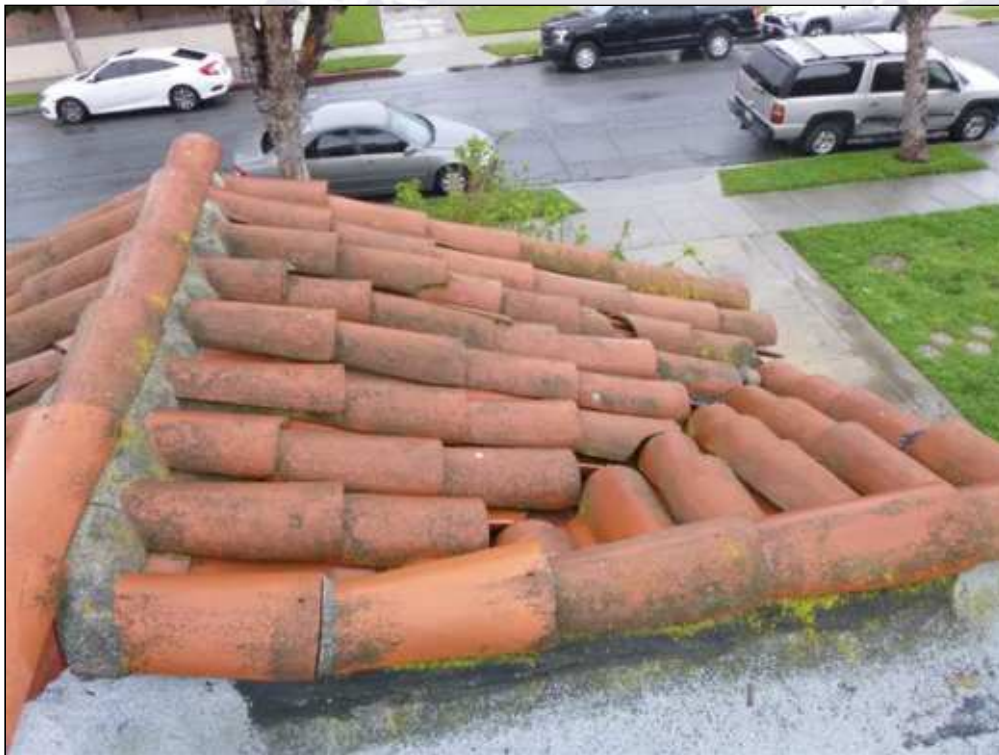
5.0 Item 9(Picture)

(5) Deteriorated, cracked, loose and missing sections of the roof tiles was noted, suggest review by a licensed roofer for repair/replacement costs as needed to prevent any future leakage during the rainy season.

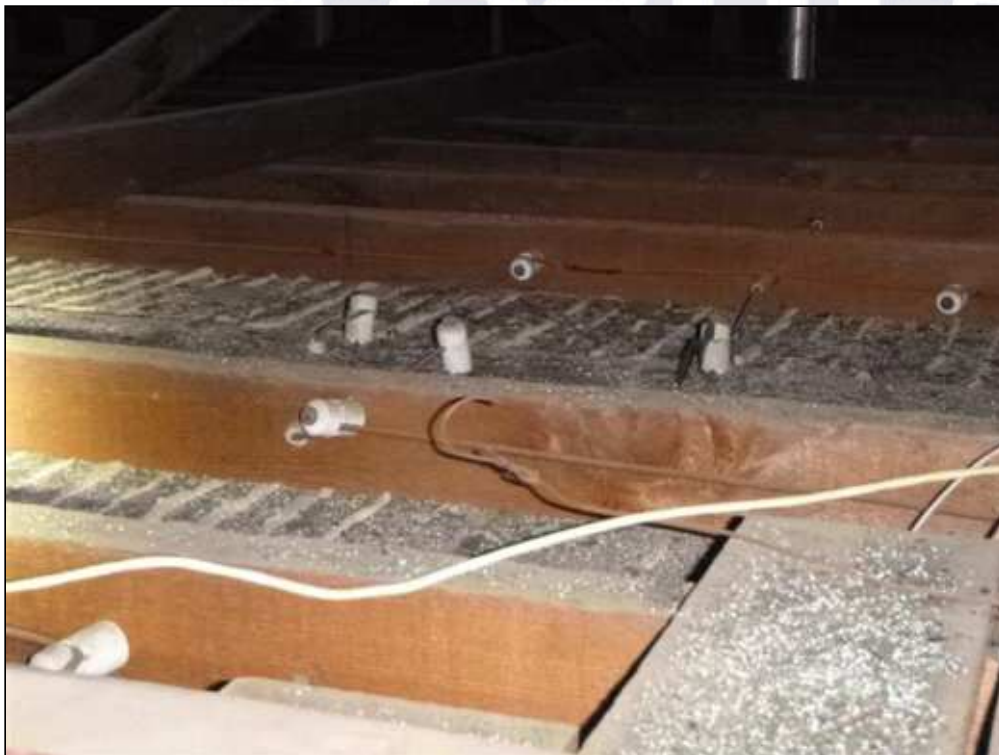
6.3 Item 1(Picture)

Knob & Tube wiring noted throughout the attic area, this is common for the original age of the dwelling. Suggest review by a licensed electrician for replacement costs to upgrade the wiring to todays standards for safety.

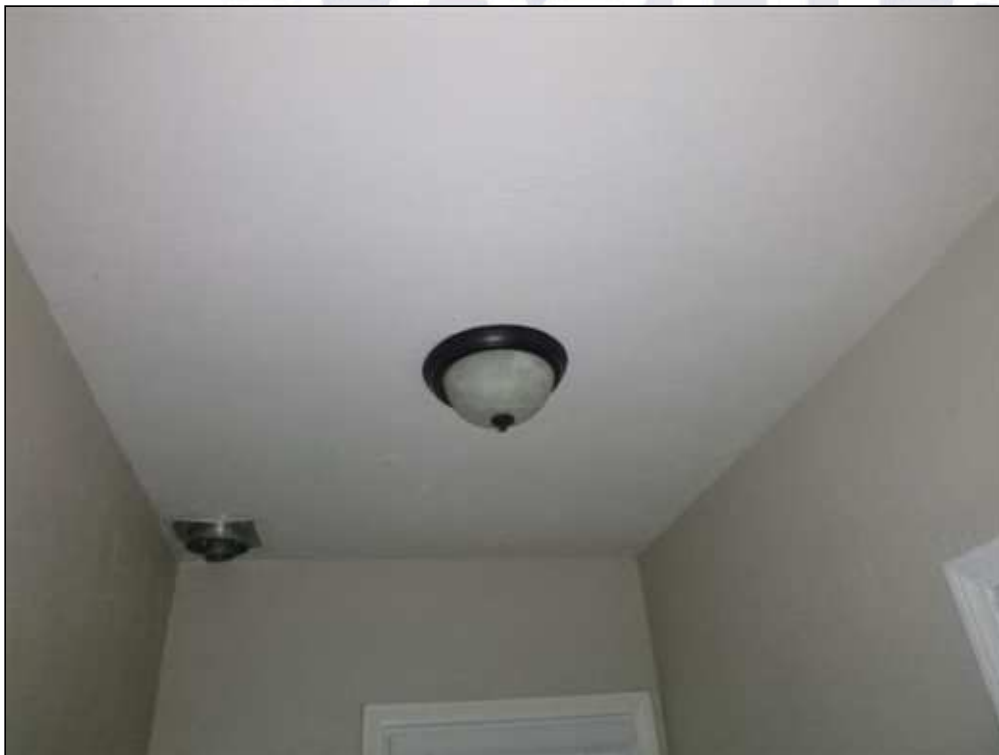
7.2 Item 1(Picture)

Patched and uneven areas of the ceiling was noted, suggest review with the seller on the cause and any repairs needed. Suggest review with a licensed contractor for any repair/removal/replacement costs as needed.

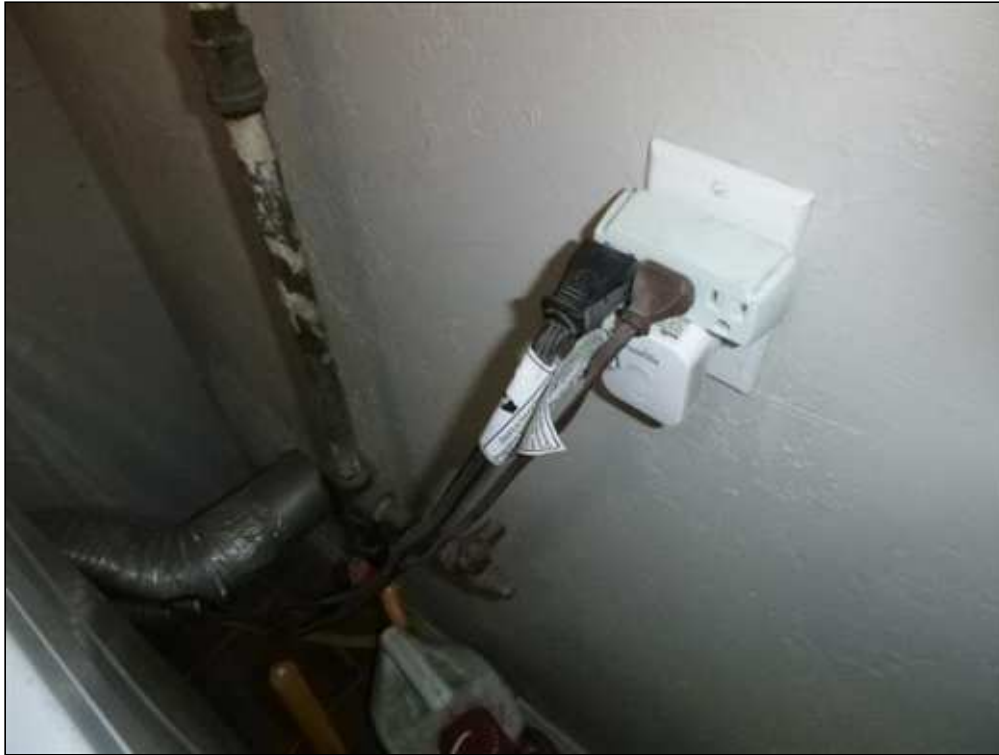
7.6 Item 1(Picture)

The appliances are currently being powered off a plug strip/extension cord, this is a potential fire hazard. Suggest remove the plug strip/extension cord and review by a licensed electrician for costs to install additional outlets as needed/required for safety.

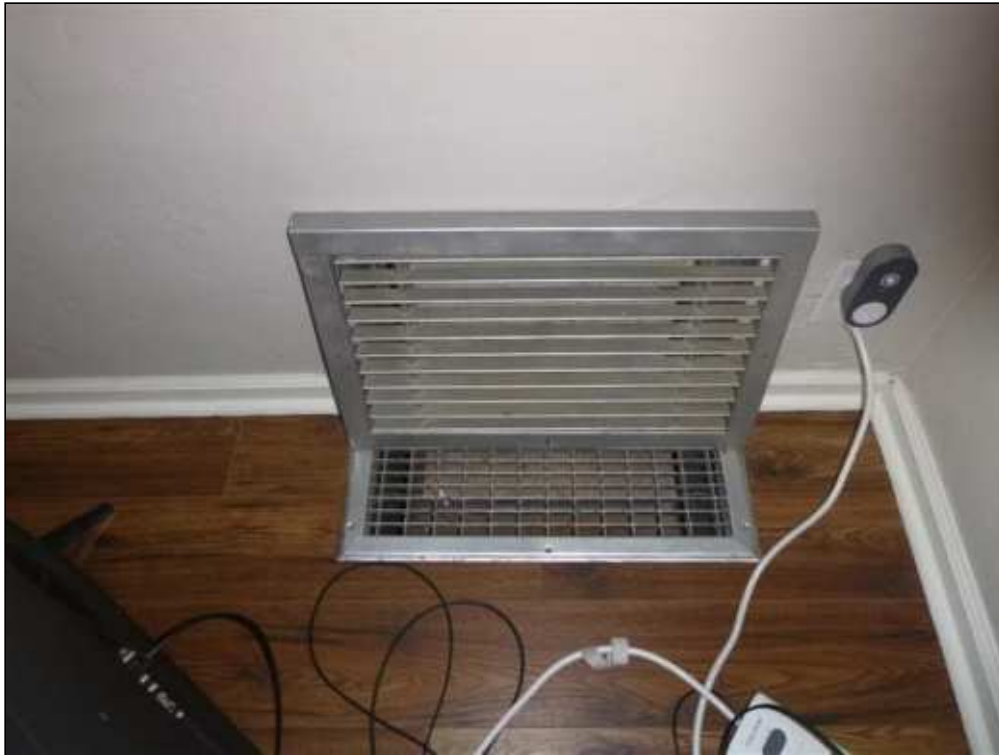
10.0 Item 1(Picture)

(1) The heater/furnace is very old but did work at the time of inspection. The inspector is unable to determine remaining life expectancy of this system. Due to the age and style of this system, suggest review with the Gas company and/or a licensed heating company for further review to determine the remaining life expectancy of the unit and any repair/replacements costs as needed

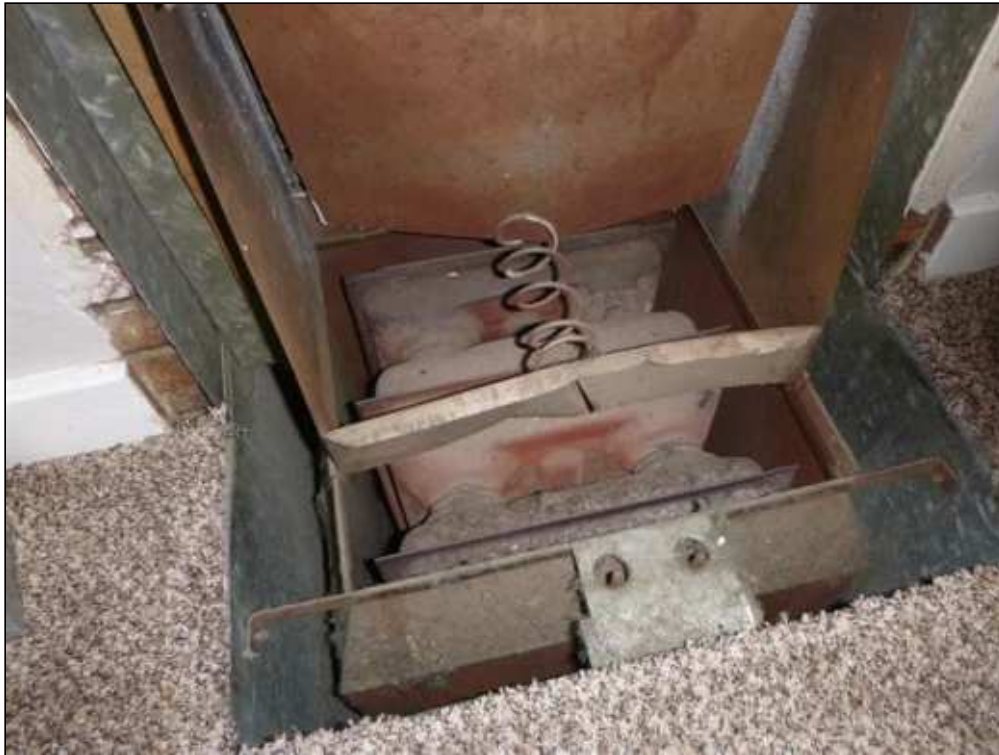
10.0 Item 3(Picture)

(2) A potential fire spread hazard was noted due to the excessive hair and debris at the base of the heating unit, suggest cleaning/removal as needed.

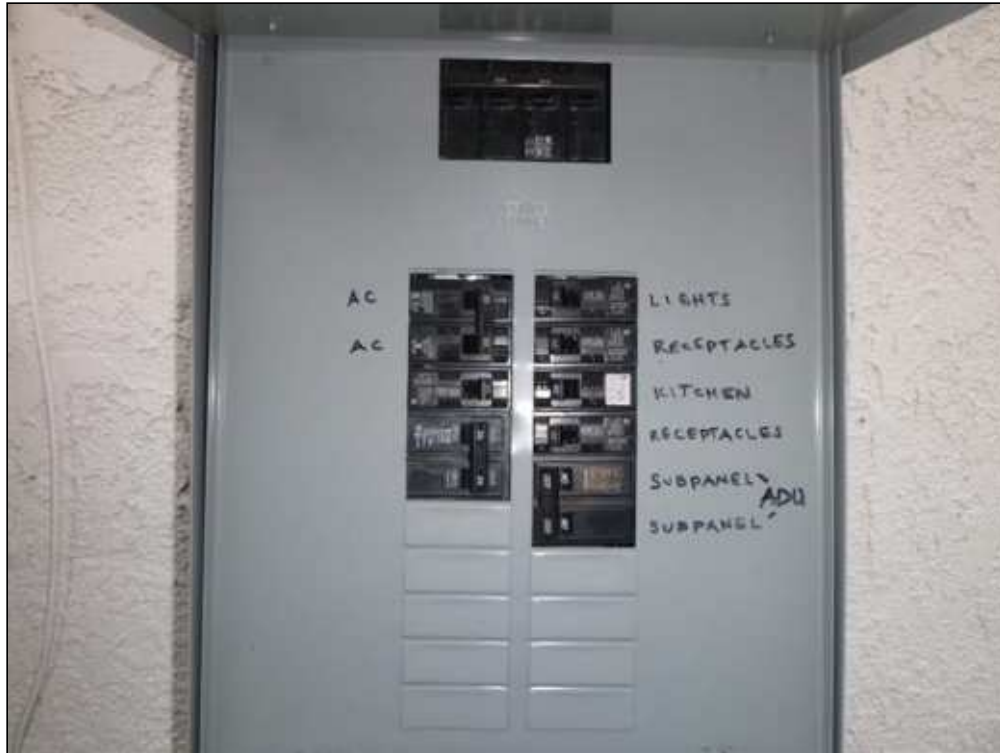
12.1 Item 1(Picture)

Suggest adding correct/complete indexing/labelling to all breakers for identification of each circuit for safety.

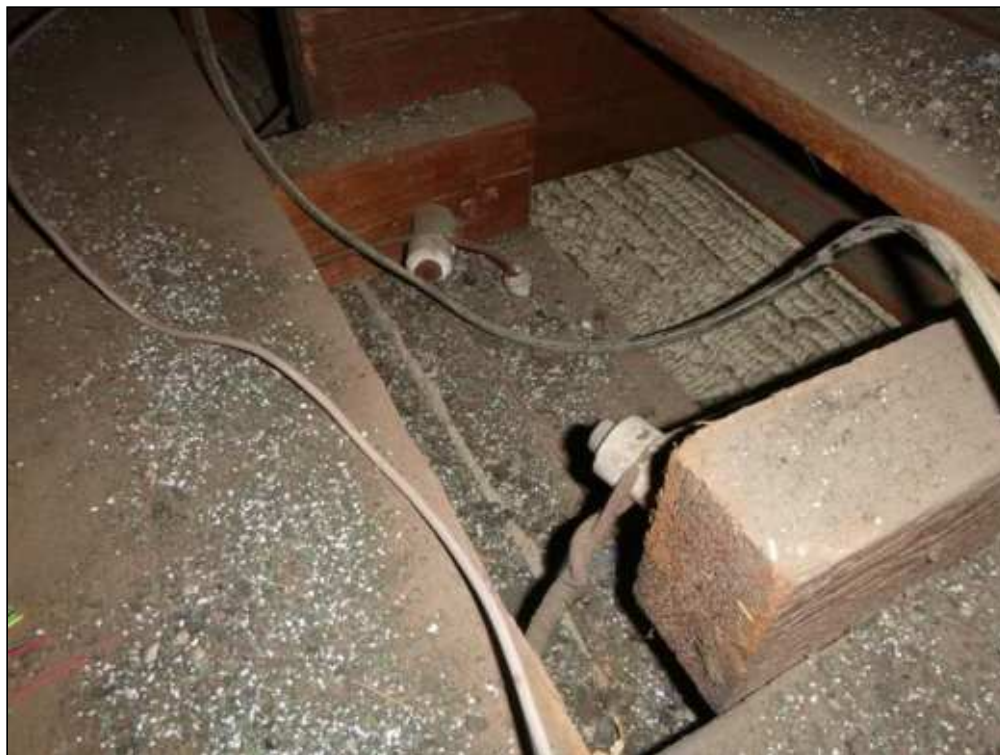
12.2 Item 3(Picture)

(3) Knob & Tube wiring noted throughout the attic area, this is common for the original age of the dwelling. Suggest review by a licensed electrician for replacement costs to upgrade the wiring to todays standards for safety.

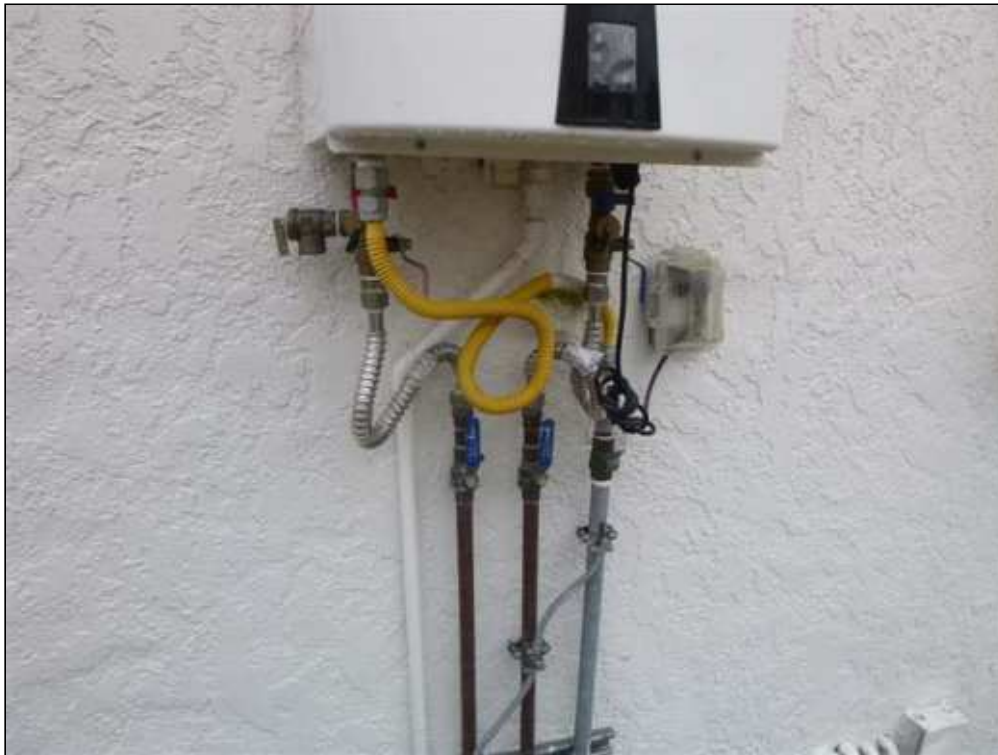
15.0 Item 2(Picture)

(3) The current water heater does not have a "Thermal Expansion tank" which is generally installed to prevent a possible leak at the T&P or "pop-off" valve and/or excessive pressure build-up at the internal plumbing, fixtures and joints. Recent changes (2012) require one when a new water heater is installed, but various cities do not enforce this installation for multiple reasons (the home is not on a closed system and various tankless units do not require it) . There were no leaks or drips at the T&P valve during inspection. If your water heater does begin to drip or leak, then a thermal expansion tank may be needed. Suggest review with the city and/or a licensed plumber to determine if this installation is required and install as needed.

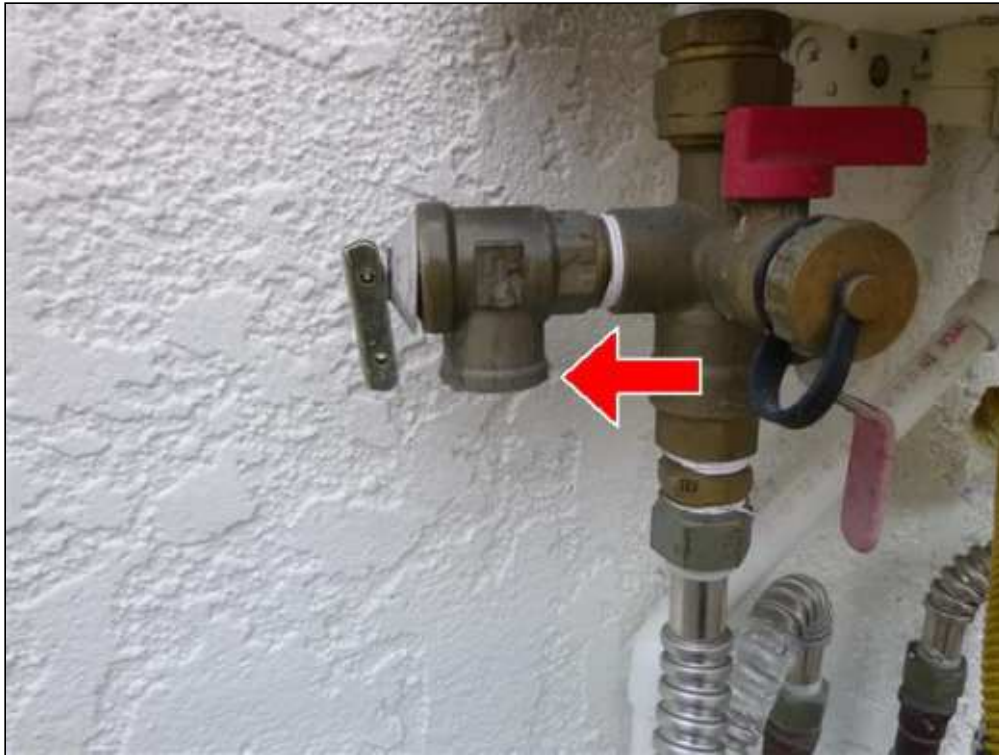
15.0 Item 3(Picture)

(4) No discharge pipe connected to the TP&R valve, this is a potential safety hazard. Suggest review by a licensed plumber for costs to install the TP discharge drain down to within 4-6 inches of the exterior grade/deck as required for safety.

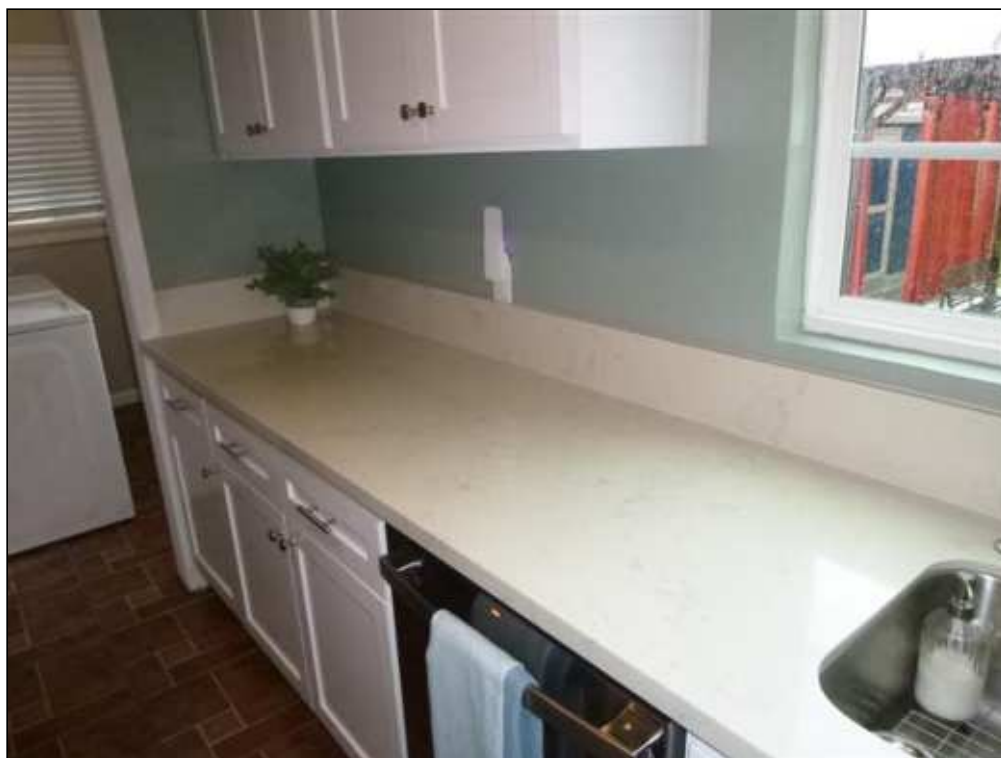
16.7 Item 2(Picture)

for additional outlets if desired as an upgrade.

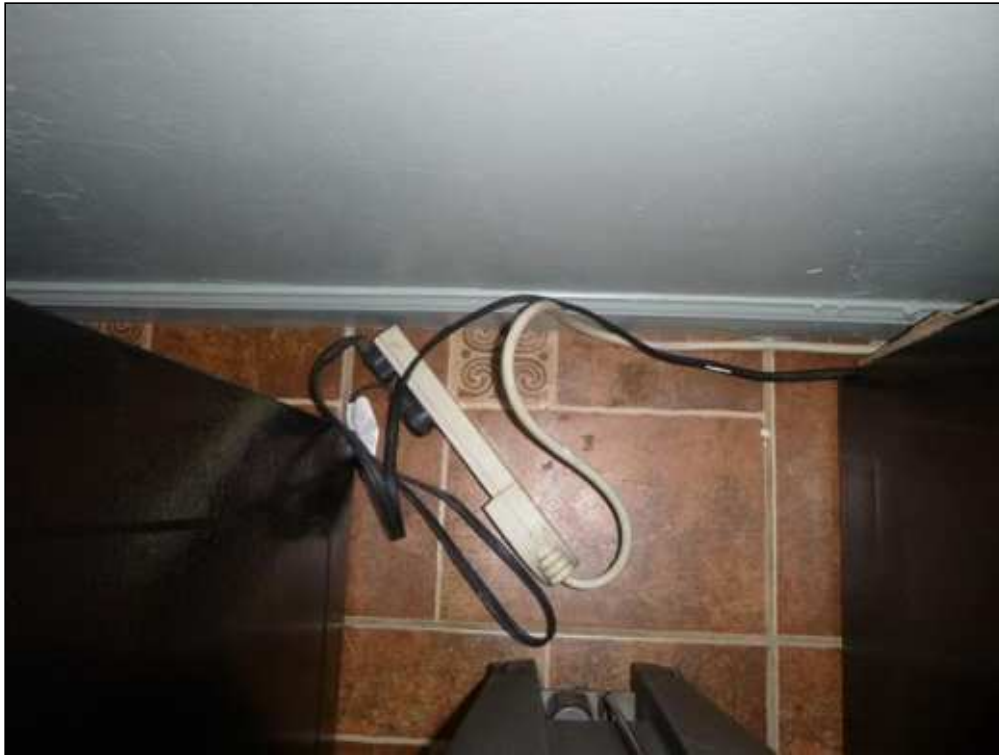
16.7 Item 4(Picture)

(4) Excessive use of electrical plugs strips/extension cords used at this area, this is a potential fire safety hazard. Suggest review with a licensed electrician for additional electrical circuits/outlets costs as needed for safety.

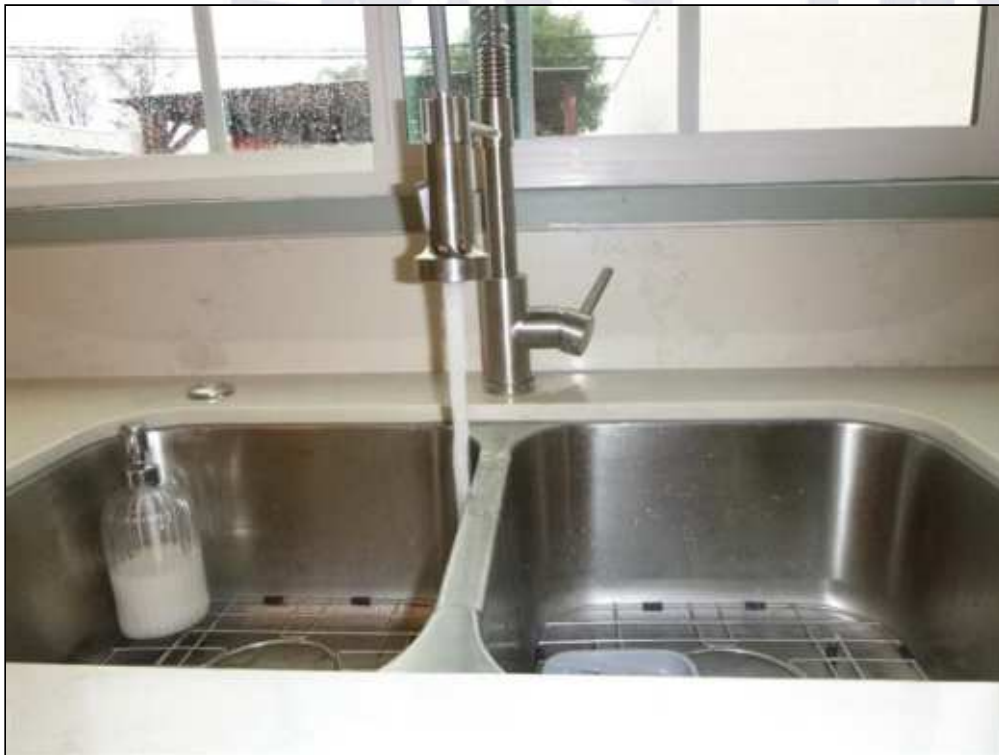
16.9 Item 1(Picture)

The sink faucet is loose at the countertop, suggest repair as needed.

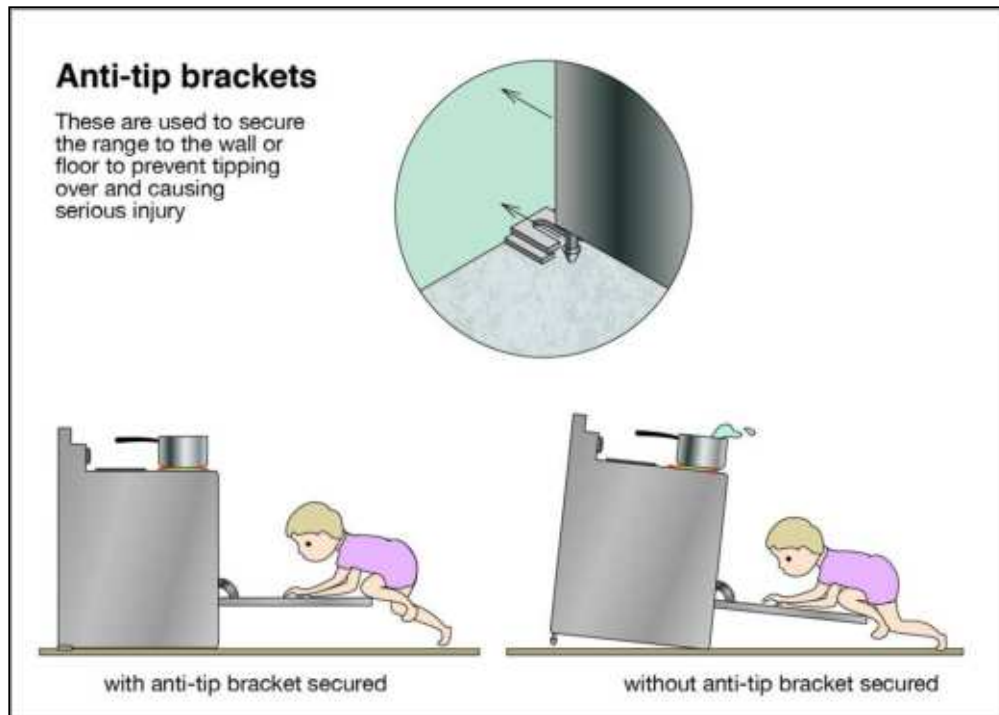
16.13 Item 1(Picture)

(1) The anti-tip bracket/chain is not currently installed. An anti-tip bracket is usually installed on the floor and against the wall (towards the back of the stove) for one of the rear legs to slide into. Its purpose is to prevent the stove from tipping when a heavy load is placed on the door (possible child) or slide-out racks upsetting the center of gravity. Suggest installation for safety as required since 1991.

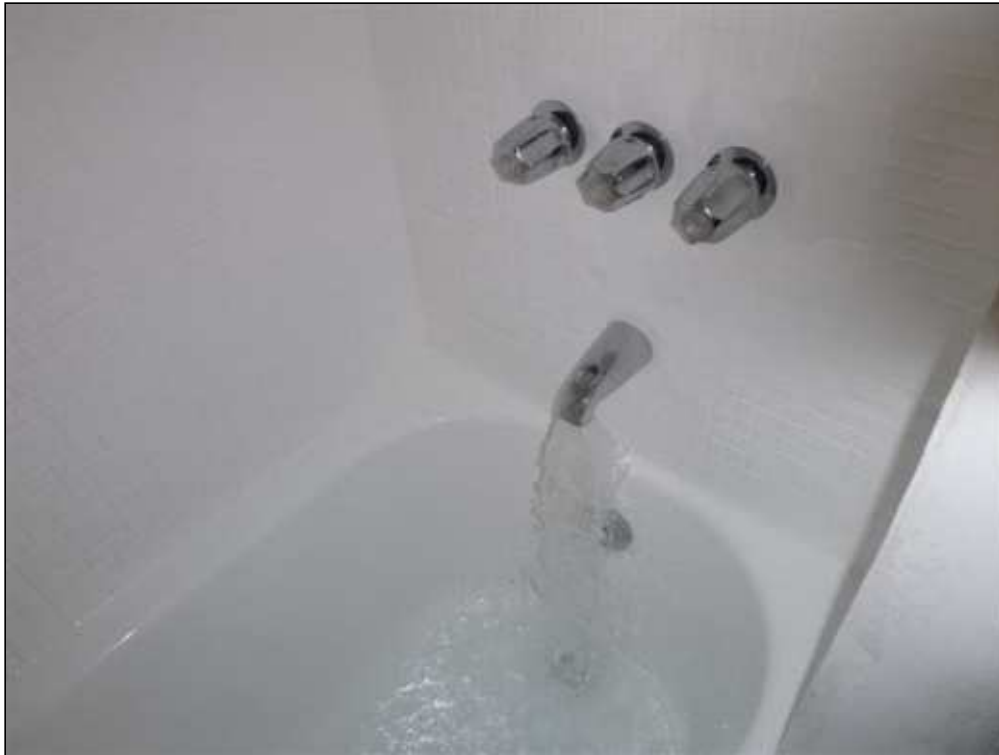
17.9 Item 1(Picture)

(1) The existing tub faucet is not a low-flow system as required. Suggest review with a licensed plumber for costs to replace the existing tub faucet with a low flow faucet (2.2 gallons per minute) as required by the State of California as of January 1st, 2017. See the plumbing system comments for further details and a link to the State of California plumbing ordinance. Most retrofit companies/cities do not enforce the low flow tub faucet requirements due to it can take an excessive amount of time to fill the tub (you will use the same amount of water irrelevant of how long it takes to fill the tub).

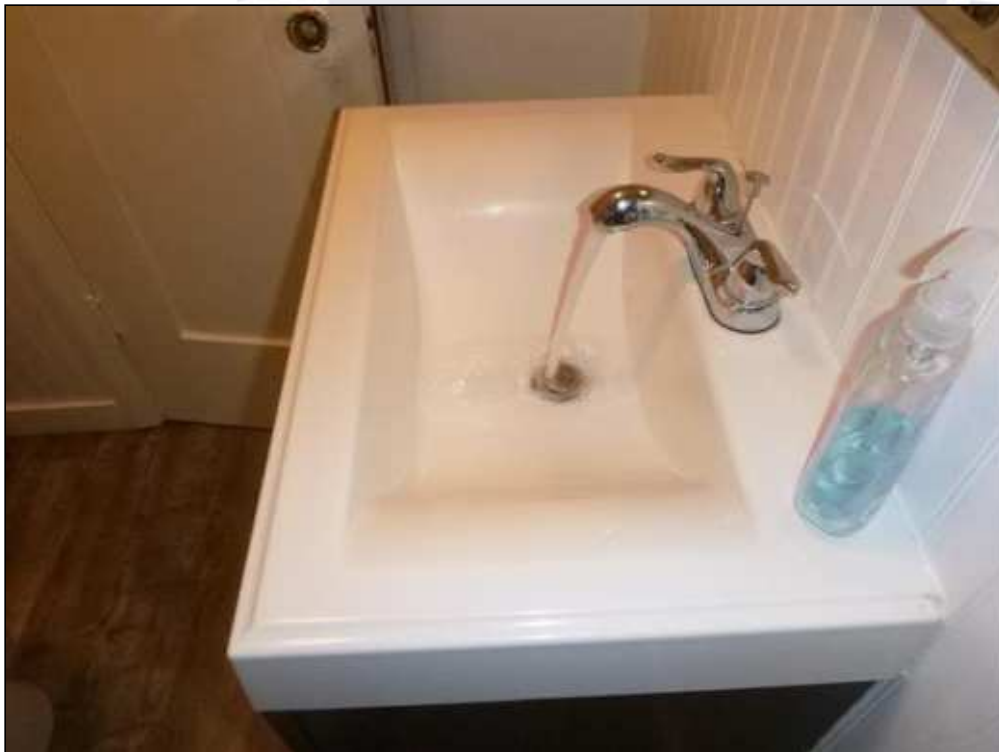
17.13 Item 1(Picture)

No drainage overflow system installed at the sink(s) as required, suggest review with a licensed plumber for repair/replacement costs as required.

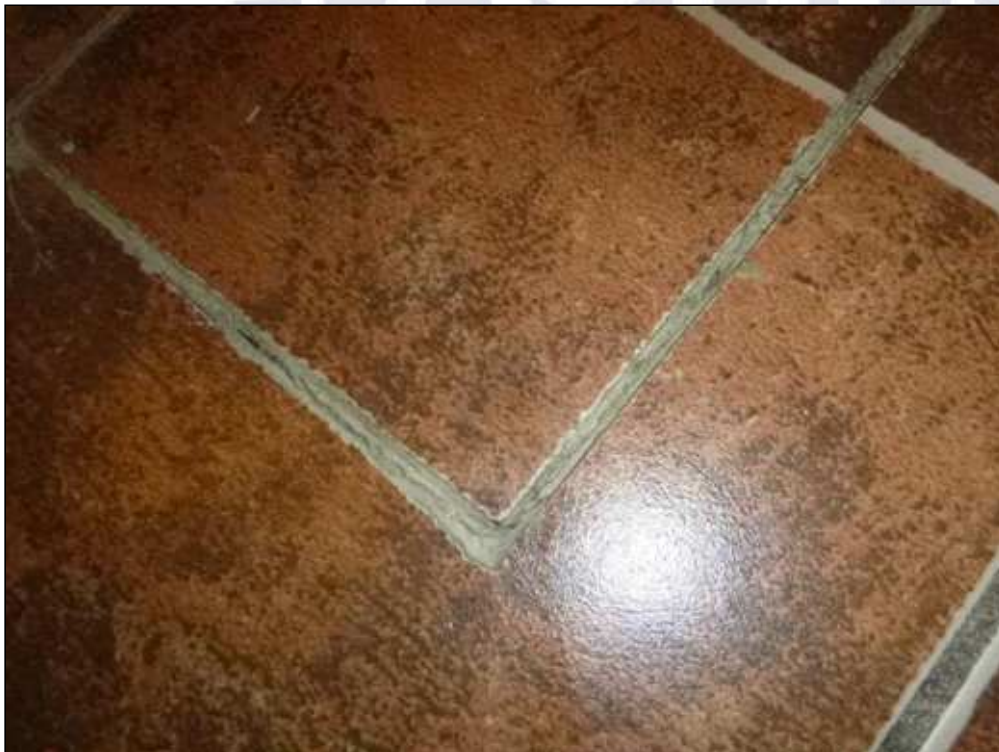
21.0 Item 2(Picture)

Patched repaired areas of the tile flooring was noted (this appears to be from a removed wall). Suggest review with the seller and/or a licensed contractor on this item as needed.

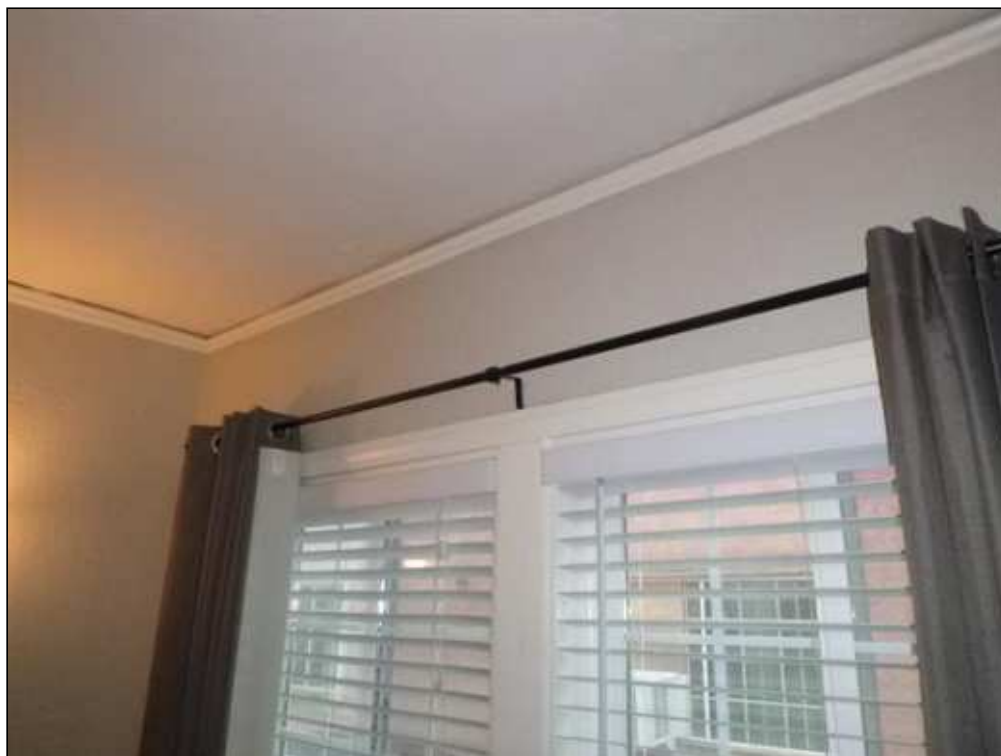
24.1 Item 1(Picture)

(1) Patched areas of the walls was noted, suggest review with the seller for the cause and any repairs needed. Suggest repair as needed.

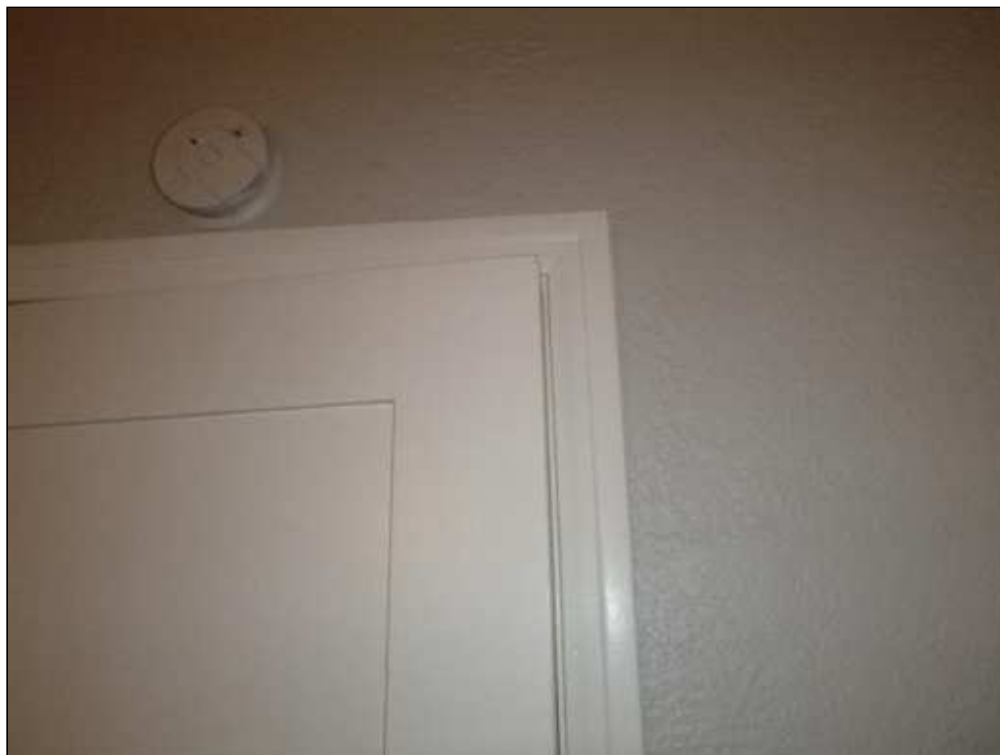
24.3 Item 1(Picture)

The door sticks/impacts on the jamb when operating, suggest repair as needed.

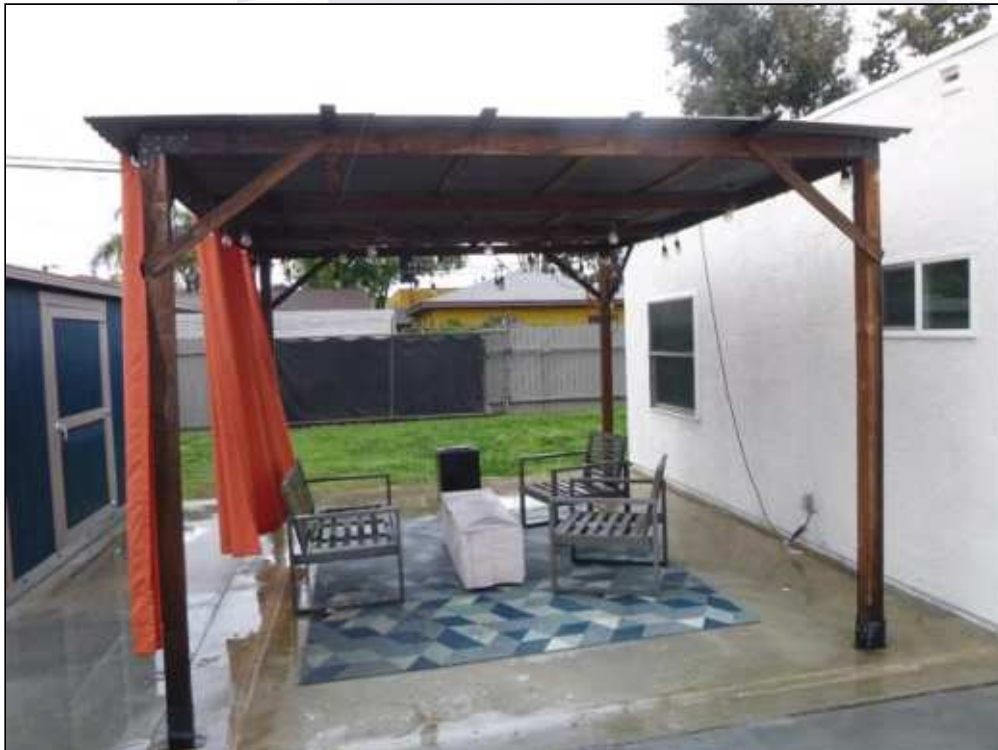
25.6 Item 1(Picture)

The wood awning at the left side is not currently bolted/secured to the concrete slab. Suggest review with the seller and/or a licensed contractor for costs to bolt/secure the awning as needed.

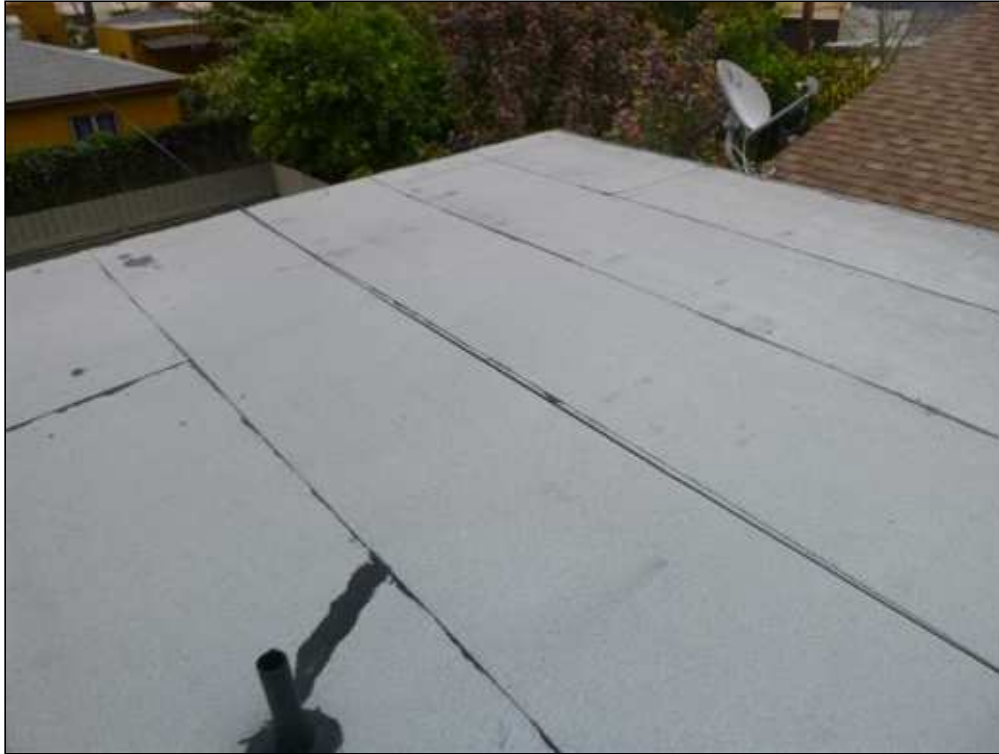
27.0 Item 1(Picture)

Patched and repaired areas of the roofing was noted. Suggest review with a licensed roofing contractor for any repair/replacement costs as needed and to determine the remaining life expectancy of the roof.

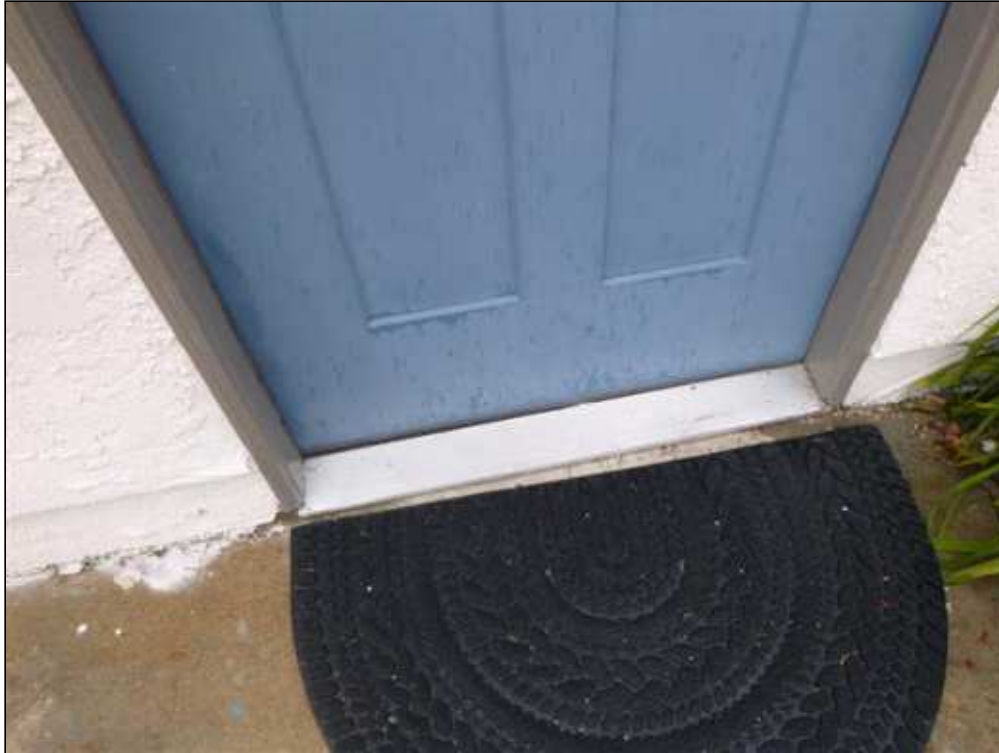
28.3 Item 2(Picture)

(2) The existing threshold for the doorway is set at/below the deck level. Water entry may occur at these areas and cause damaged within the structure. Current requirements for doorway/thresholds are two inches minimum height above the hard deck or exterior surface/grade. Suggest review with a licensed contractor for repair/replacement costs needed to eliminate water entry into the structure.
