Inspection Report

Property Address:
447 E Hullett St
Long Beach CA 90805

Ferguson Home Inspections

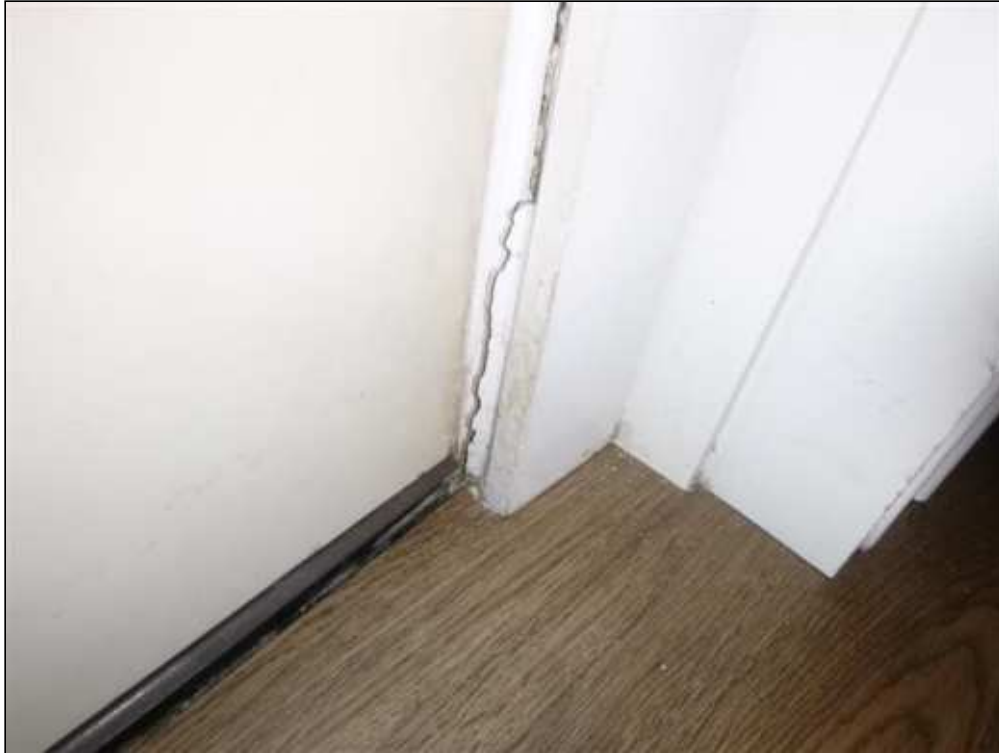
28.3 Item 4(Picture)

(3) Evidence of previous and ongoing water intrusion noted at the door(s) to the interior. Deteriorated and loose door trim/casings were noted. Suggest review with a licensed contractor for any repair/ replacement costs as needed to prevent further and future water intrusion at this area.

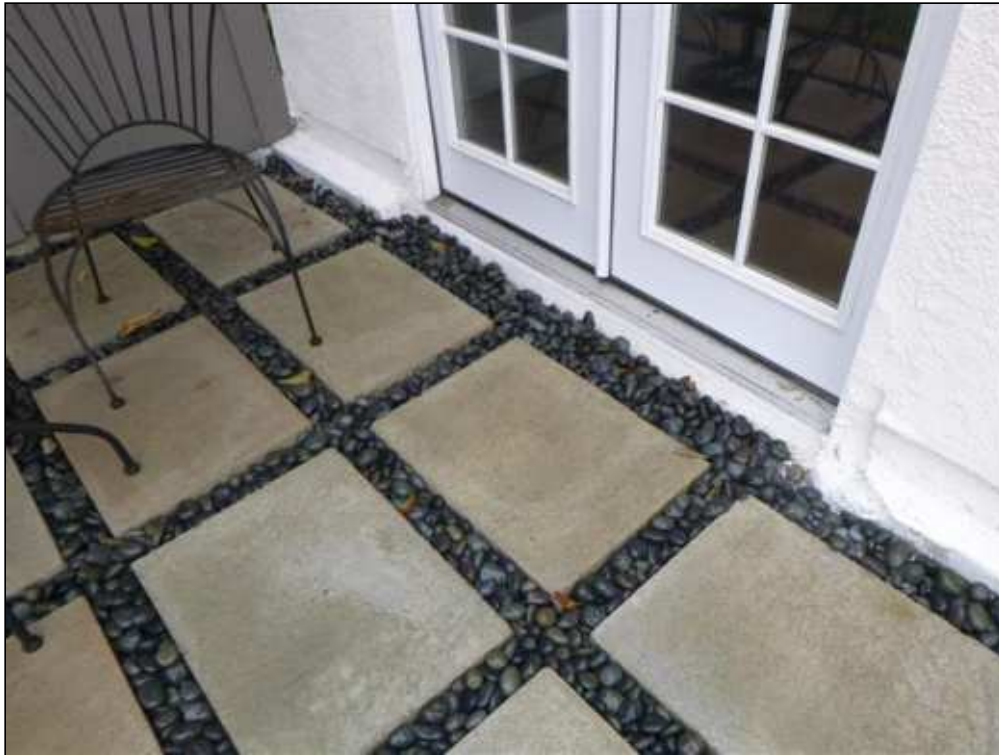
29.0 Item 1(Picture)

An inadequate/incomplete sized deck/landing was noted at the exterior doorway. Generally a 36' formed landing is required at an exterior door. Suggest review with the seller/city and/or a licensed contractor for installation costs as needed.

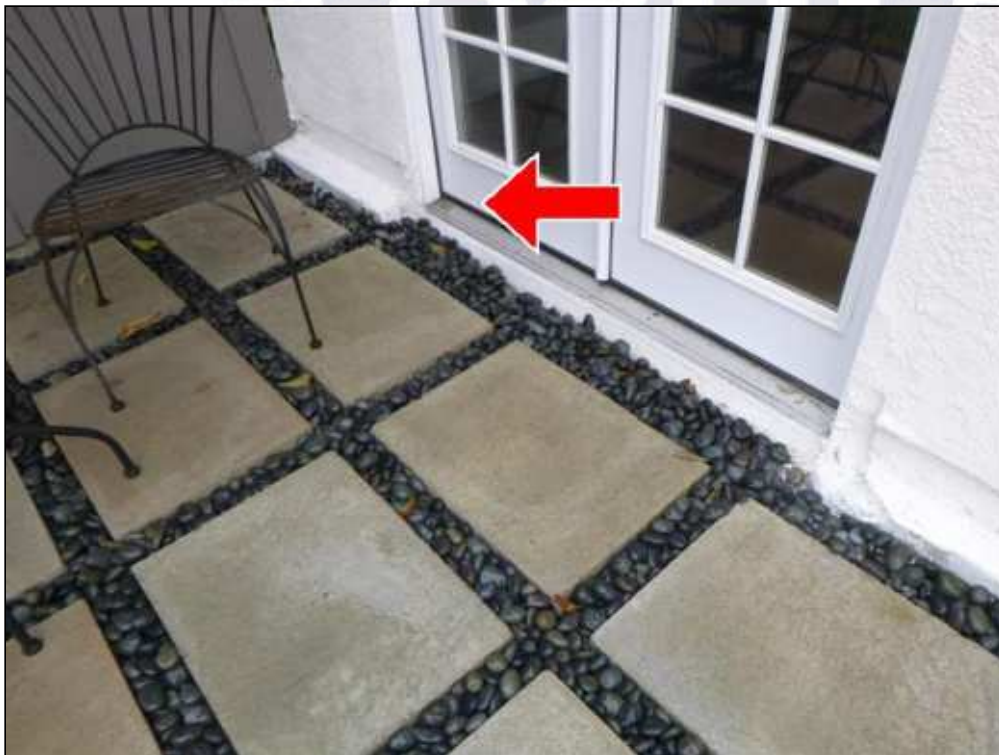
29.2 Item 1(Picture)

Evidence of previous and ongoing water intrusion noted at the door(s) to the interior. Deteriorated and stained flooring/baseboards noted. Suggest review with a licensed contractor for any repair/ replacement costs as needed to prevent further and future water intrusion at this area.

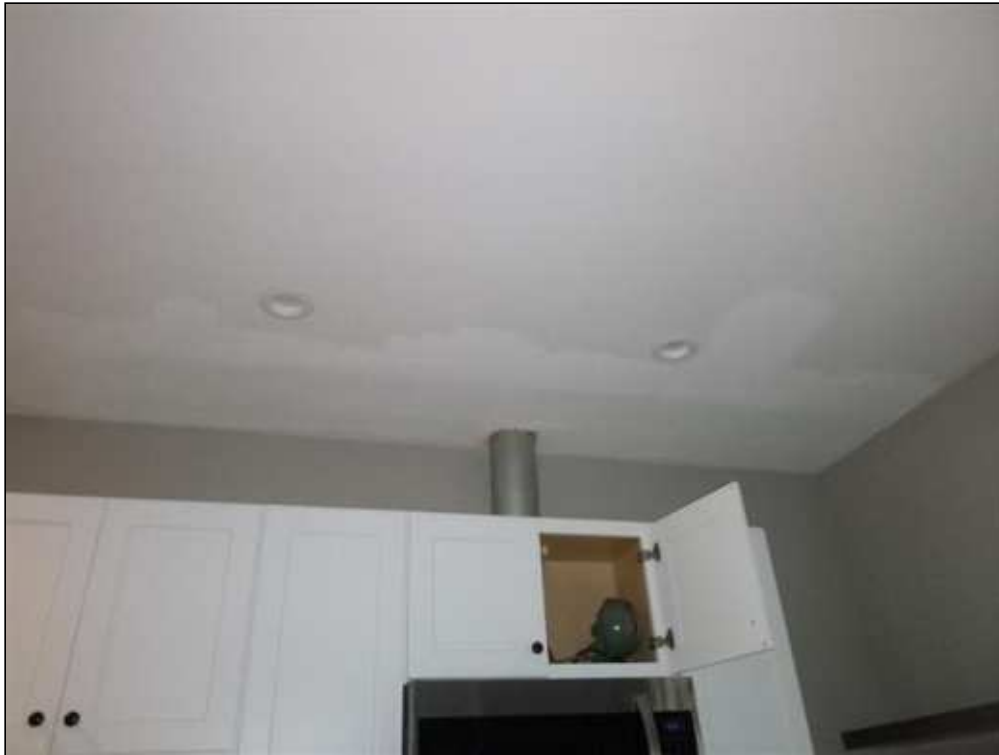
33.2 Item 1(Picture)

Patched and repaired areas of the ceiling was noted, suggest review with the seller on the cause and any repairs needed. Suggest review with a licensed contractor for any repair/removal/replacement costs as needed.

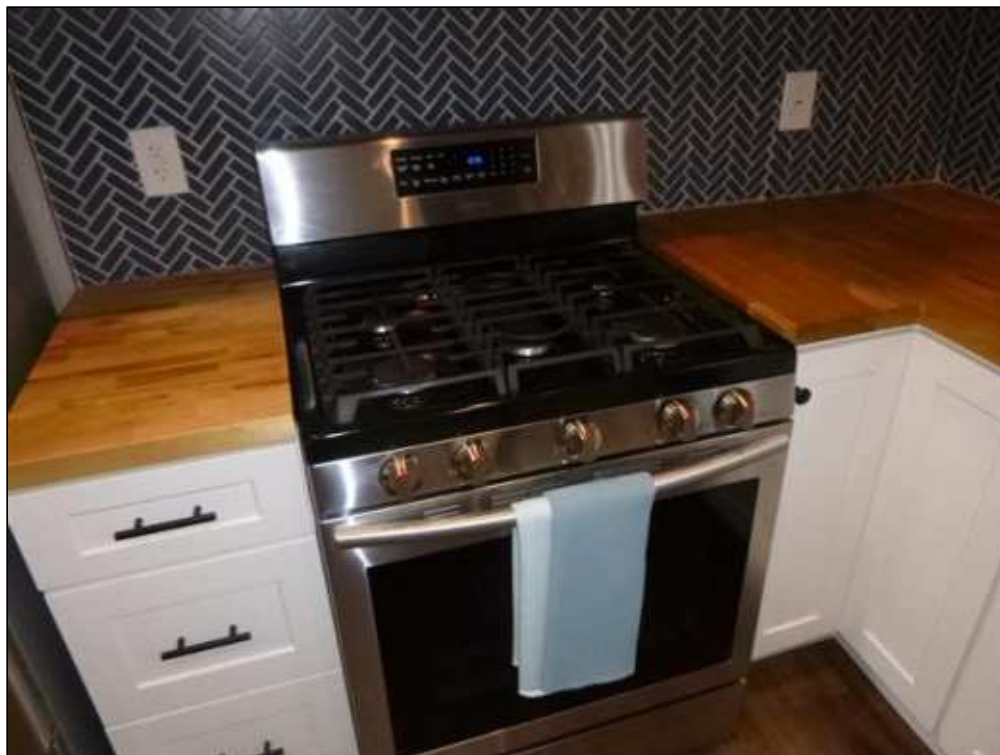
33.7 Item 1(Picture)

Suggest review with the seller/city and/or a licensed contractor on the installation of the wood block countertop due to the proximity to the gas fueled stove.

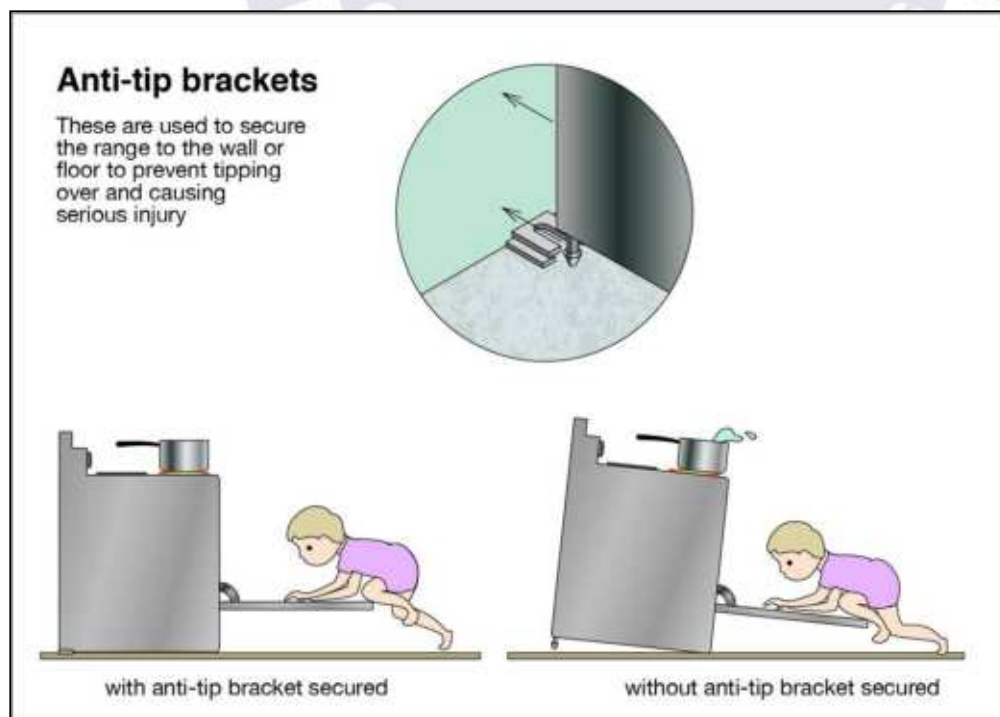
33.13 Item 1(Picture)

(1) The anti-tip bracket/chain is not currently installed. An anti-tip bracket is usually installed on the floor and against the wall (towards the back of the stove) for one of the rear legs to slide into. Its purpose is to prevent the stove from tipping when a heavy load is placed on the door (possible child) or slide-out racks upsetting the center of gravity. Suggest installation for safety as required since 1991.

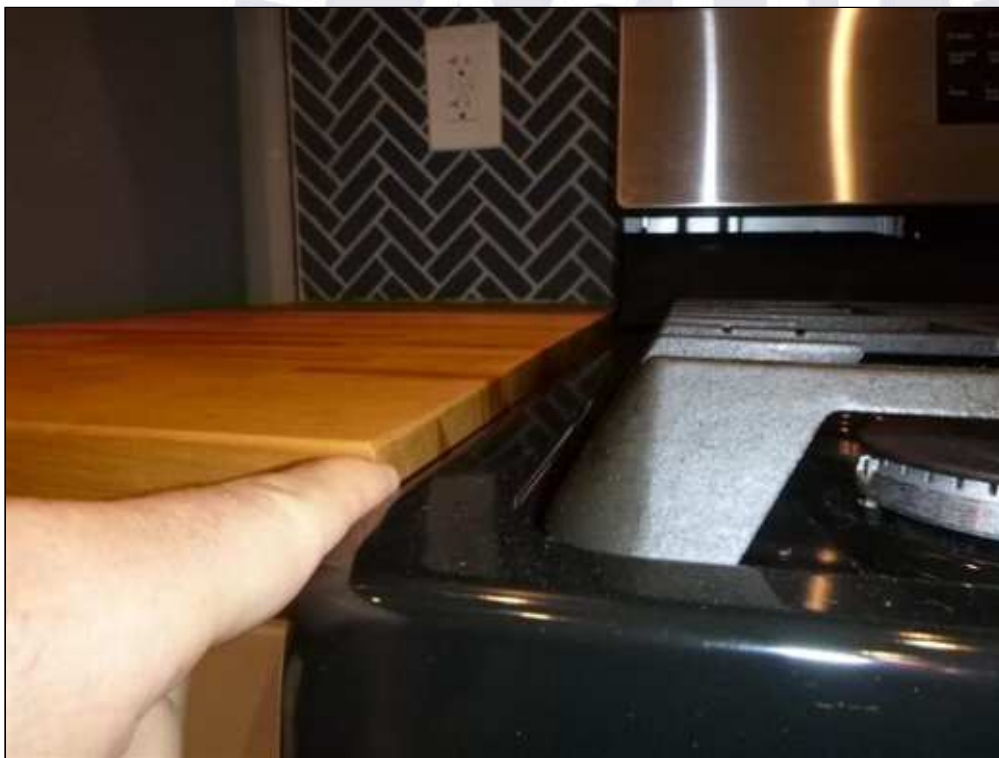
33.13 Item 3(Picture)

(2) Potential fire spread hazard due to the stove is currently below the countertop height. Suggest review with a licensed contractor for cost to raise and level the stove to above the countertop height as required for safety.

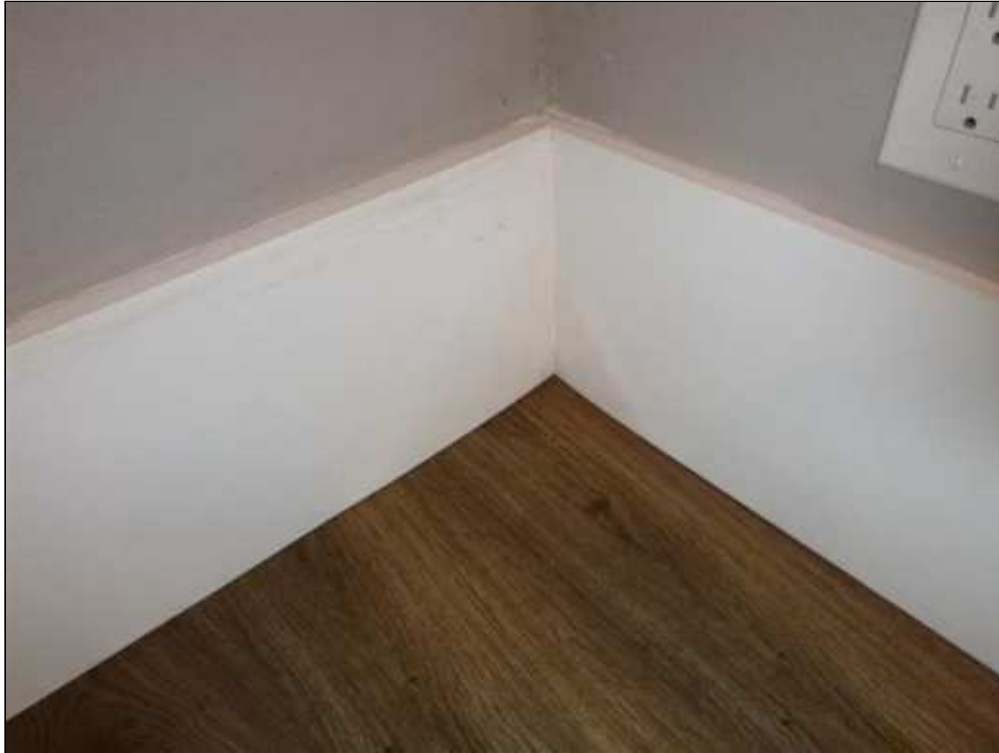
35.1 Item 1(Picture)

Stains, deterioration and water damage noted at the walls (this area tested positive for moisture at the time of the inspection). Suggest review with the seller and/or a licensed contractor to determine/ verify the source of the leak and any repairs needed. Suggest review with a licensed contractor for repair/removal/replacement costs as needed.

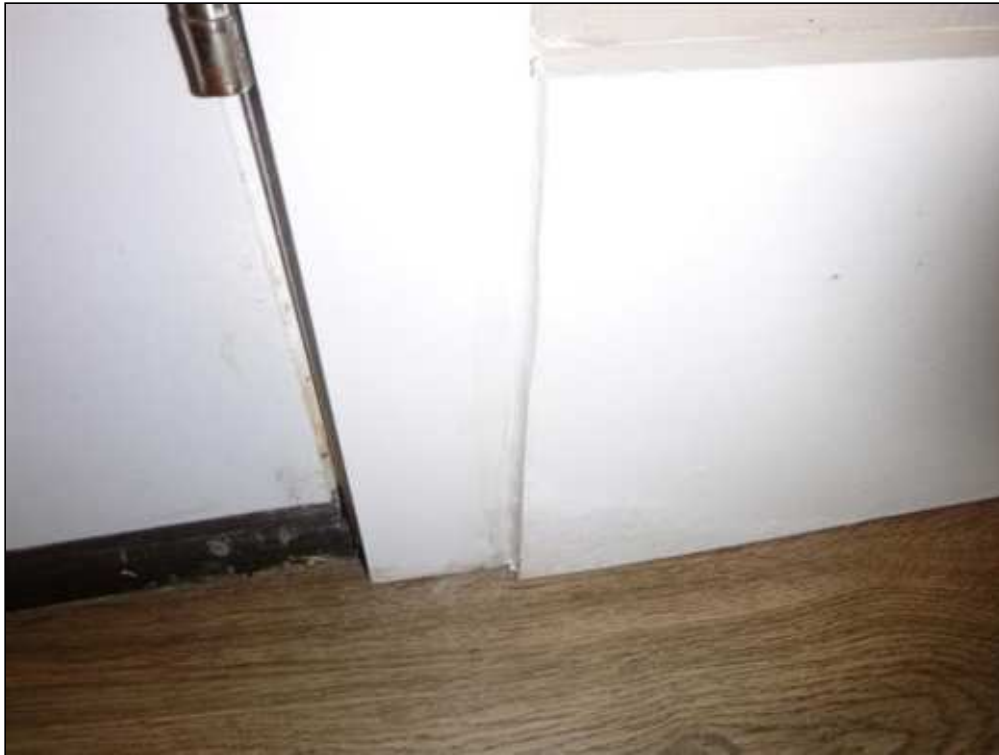
35.3 Item 1(Picture)

(1) Suggest installation of door stops to prevent damage to the walls and/or surrounding area.
(2) Evidence of previous and possible on-going water intrusion was noted at the door(s) to the exterior (this area tested positive for moisture at the time of the inspection). Suggest review with a licensed contractor for any repair/removal/replacement costs as needed.

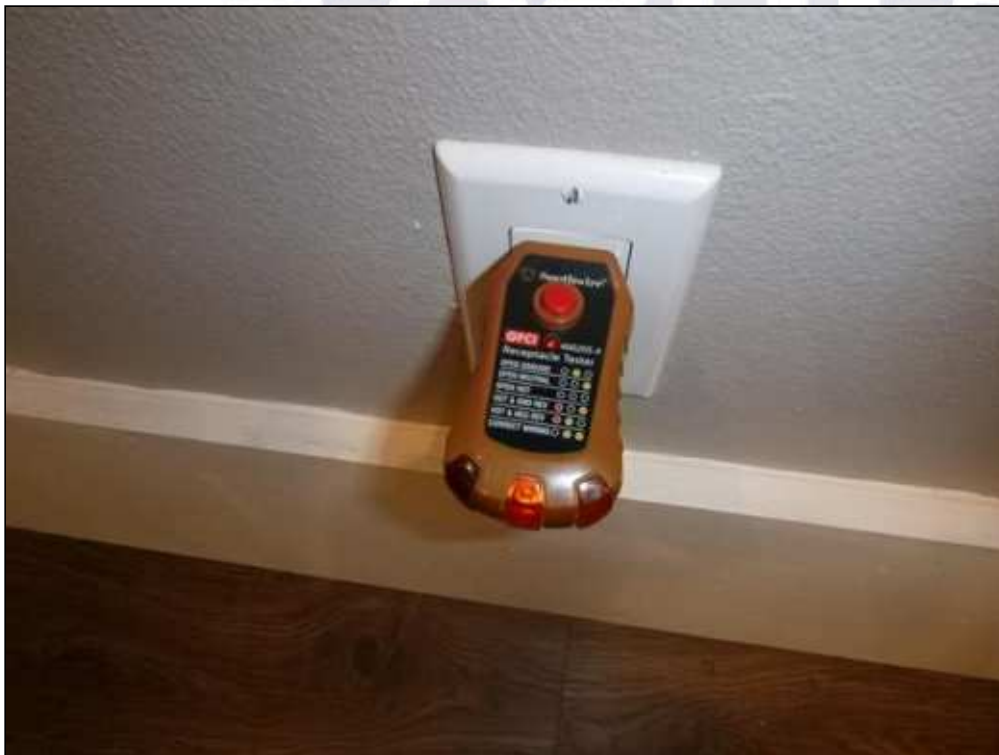
35.6 Item 1(Picture)

Ungrounded three prong outlets noted at this area. Suggest review with a licensed electrician for costs to ground the outlets as needed as an upgrade and/or protect the outlet(s) on a GFCI circuit where recommended.
