F.N. 1-20-0013

Subject: STRUCTURAL EVALUATION OF SINGLE FAMILY RESIDENCE
6347 Tarragon Road, Rancho Palos Verdes, CA 90275

PALOS VERDES ENGINEERING CORPORATION

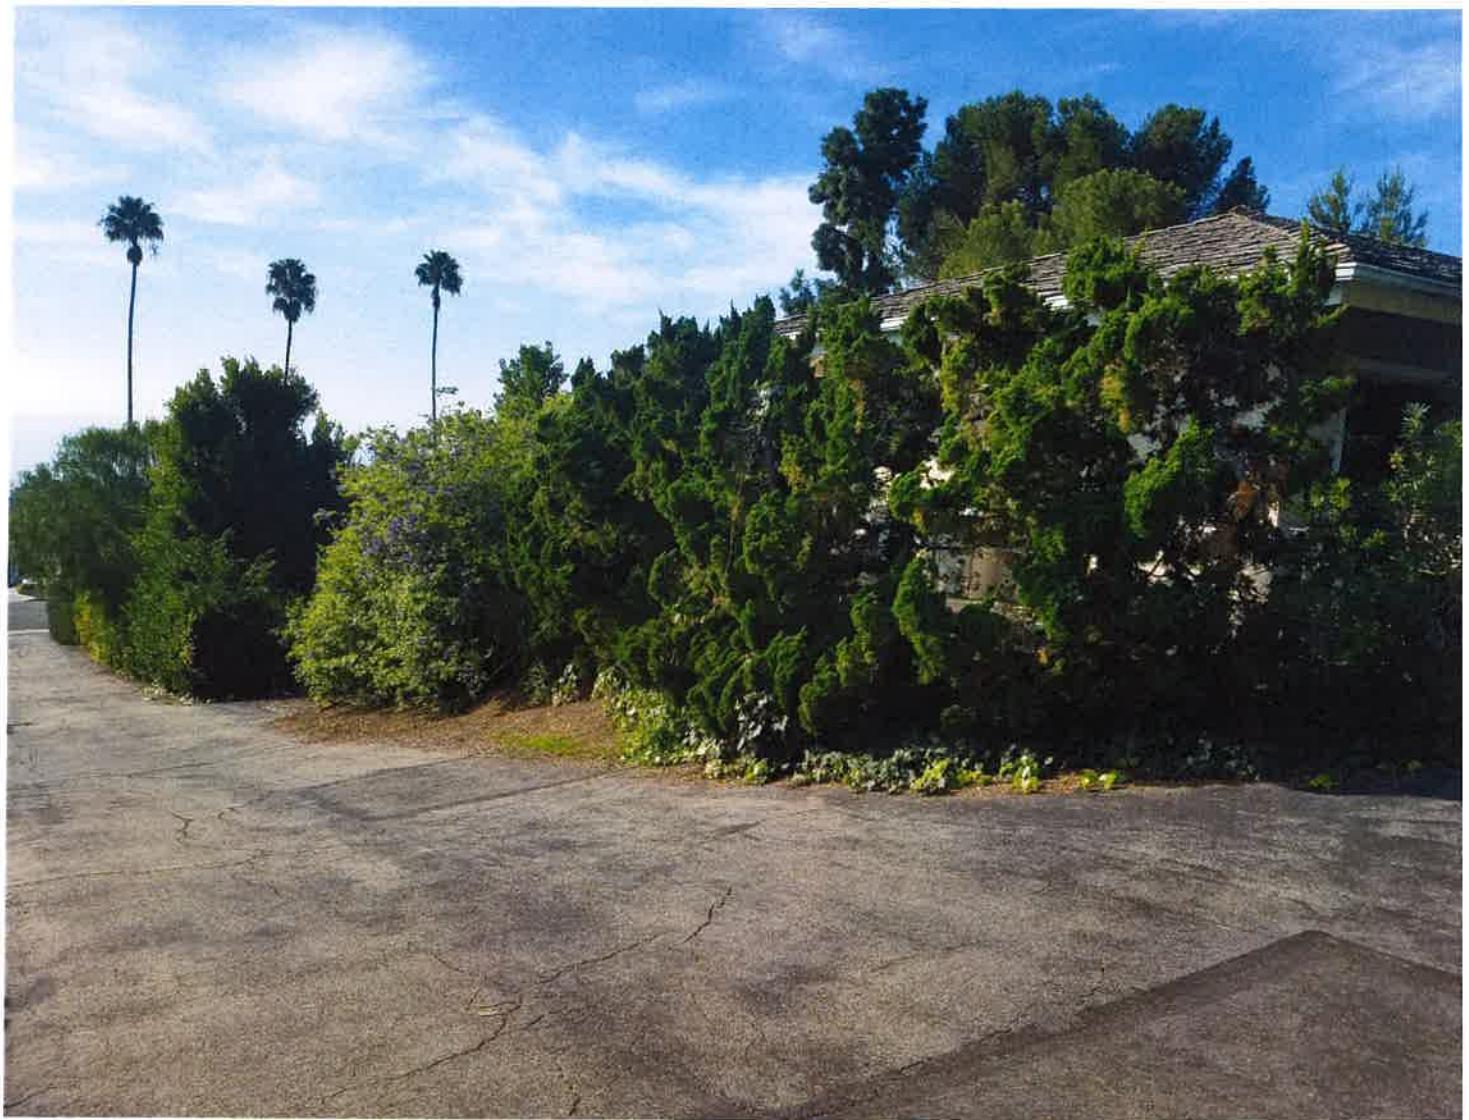
4

A view of the asphalt driveway that leads up to the subject property from Tarragon Road is depicted on Photograph 4.

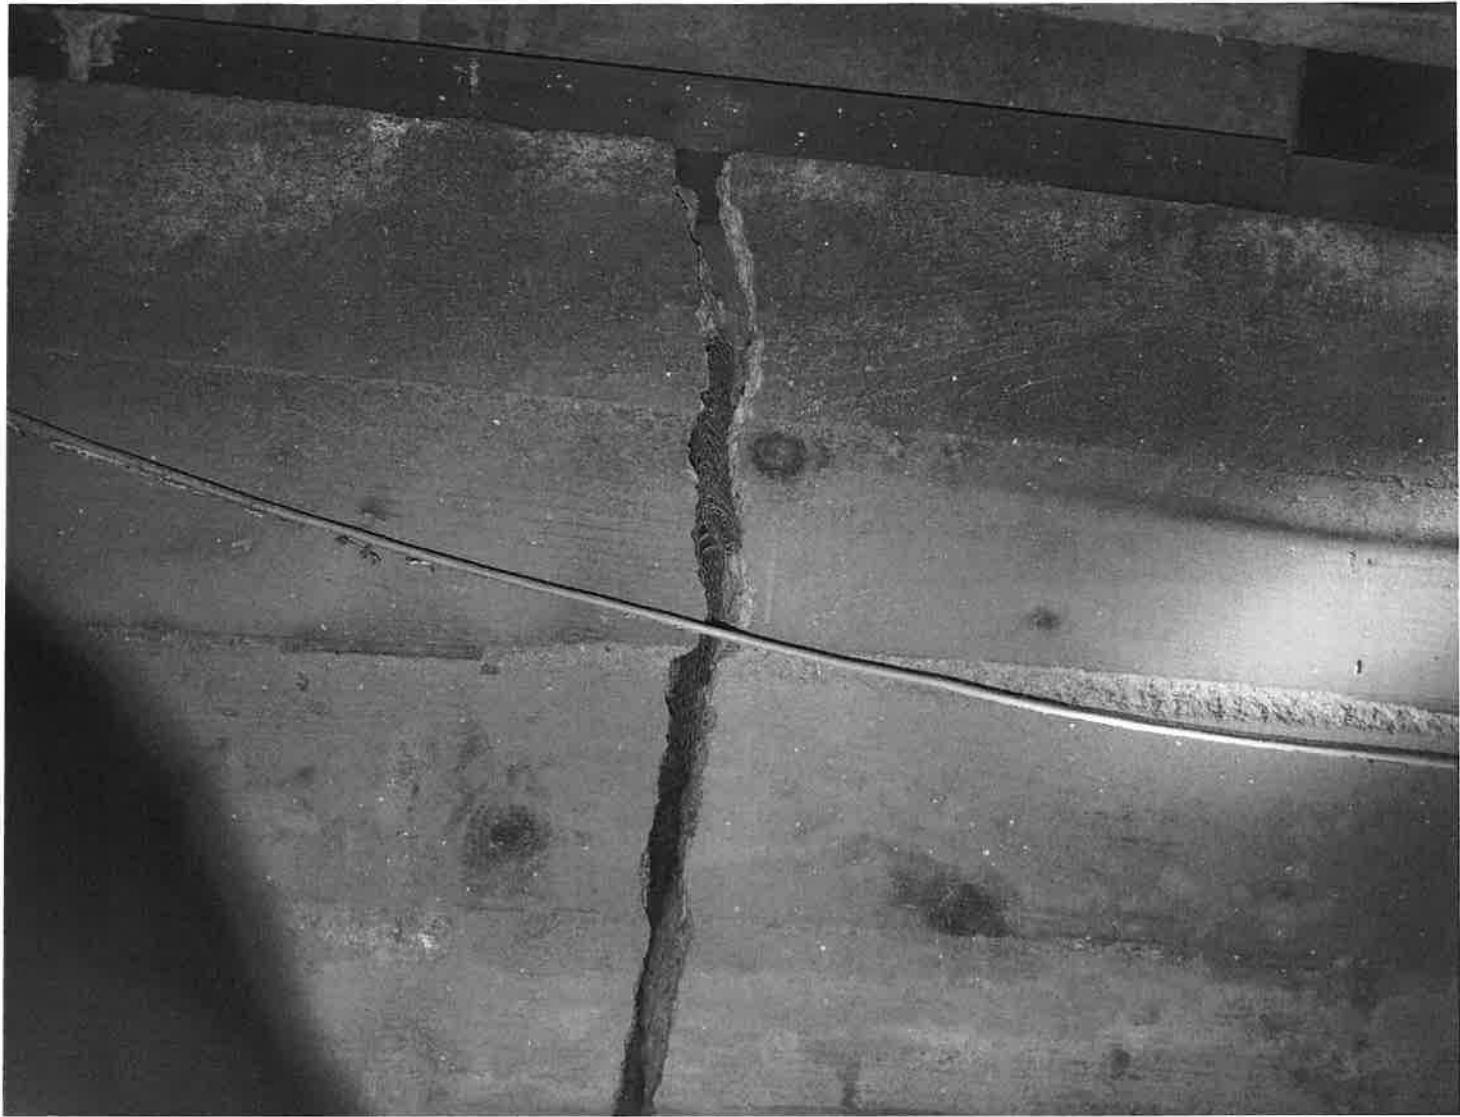
60

There are wide cracks in the footings that reveal no horizontal rebar as shown on Photographs 60, 67 & 68.

It is our recommendation that a geotechnical engineer be consulted to perform a soils investigation to provide recommendations to stabilize the existing foundations. It is expected that they will also recommend improving the site drainage condition to reduce the amount of runoff that can be directed beneath the residence. A French Drain system should be constructed along the base of the north ascending slope to collect subsurface runoff. This French Drain should have a minimum 5 foot depth and should contain a 6 inch diameter perforated drain line covered in clean gravel and wrapped with a Mirafi filter fabric.
