# Inspection Report

**Property Address:**  
11102 Whitebark Ln  
Corona CA 92883

**A New Day Home Inspections**

<b>Property Address</b> 11102 Whitebark Ln Corona CA 92883	<b>Date of Inspection</b> 3/22/2022	<b>Report ID</b> 20220322-11102-Whitebark-Ln
<b>Customer(s)</b> William & Yana Debbaneh	<b>Time of Inspection</b> 01:00 PM	<b>Real Estate Agent</b> Julie Adams Real Broker

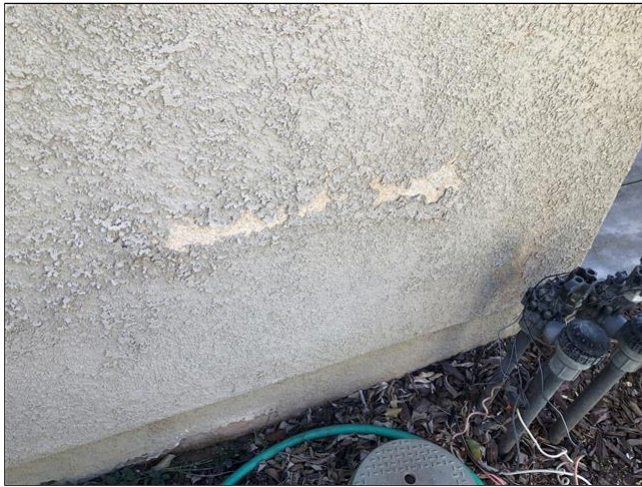
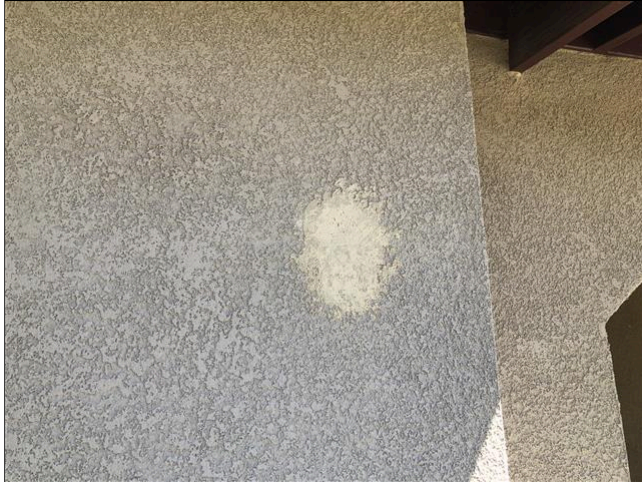
- ➡ Sections of the stucco at the front & left side of the building are deteriorated.  
- A qualified plastering technician should evaluate the stucco and make repairs or modifications as necessary.

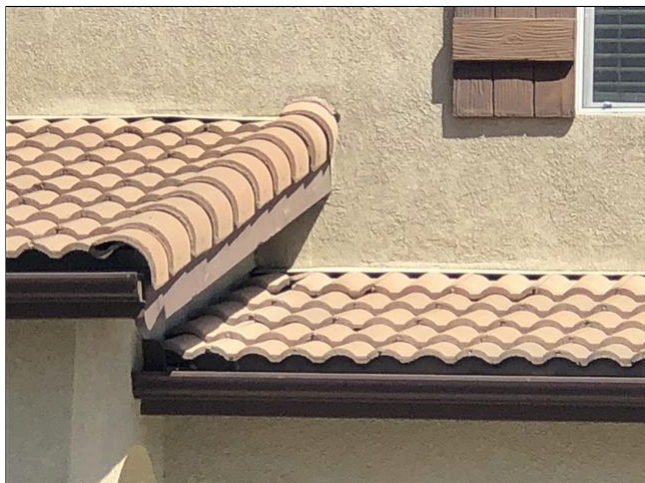
4.2 Item 2(Picture)

➔ (1) Two concrete tiles are cracked and/or broken at the front of the home. A qualified roofing contractor should inspect further and make any needed repairs.

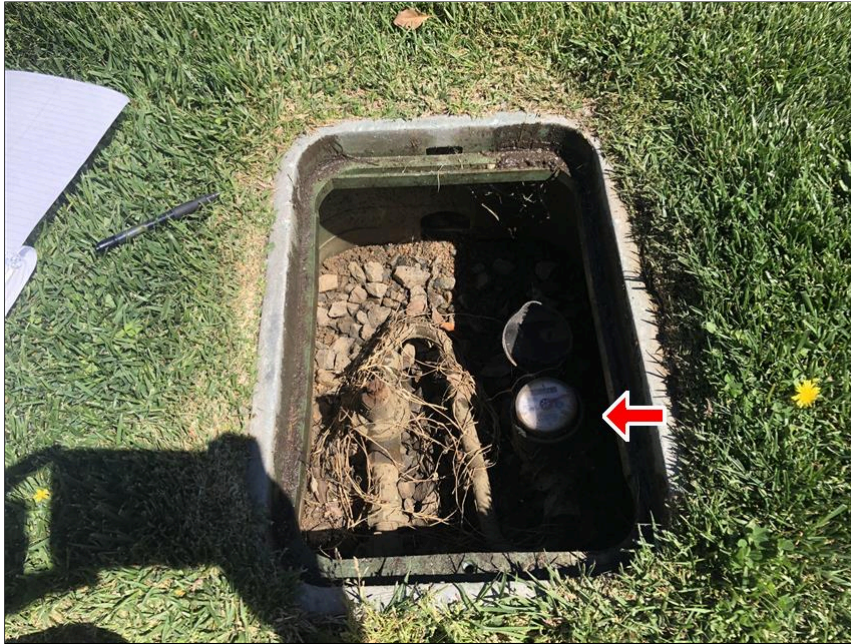
5.0 Item 1(Picture)

(1) The water meter was inspected, no water movement noted at the time of the inspection. This should be checked annually

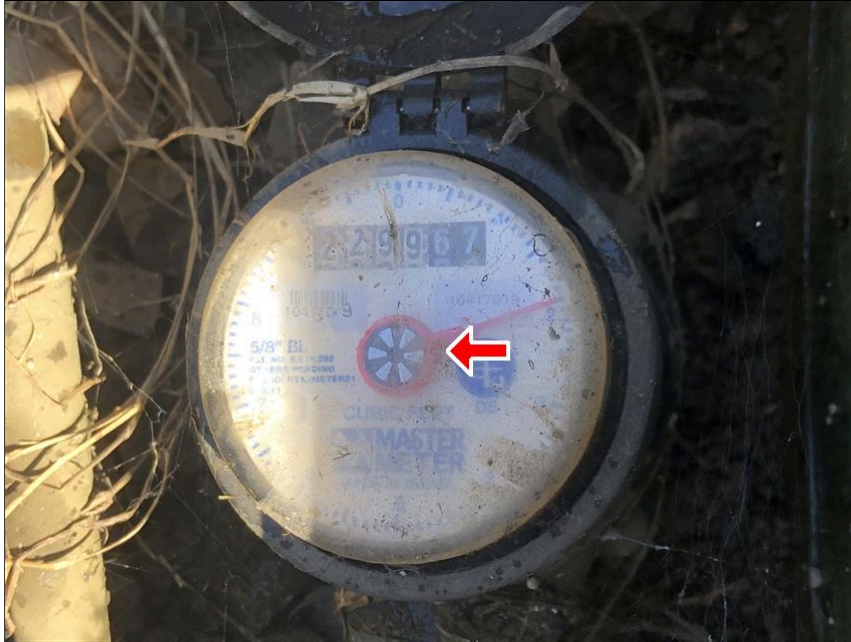
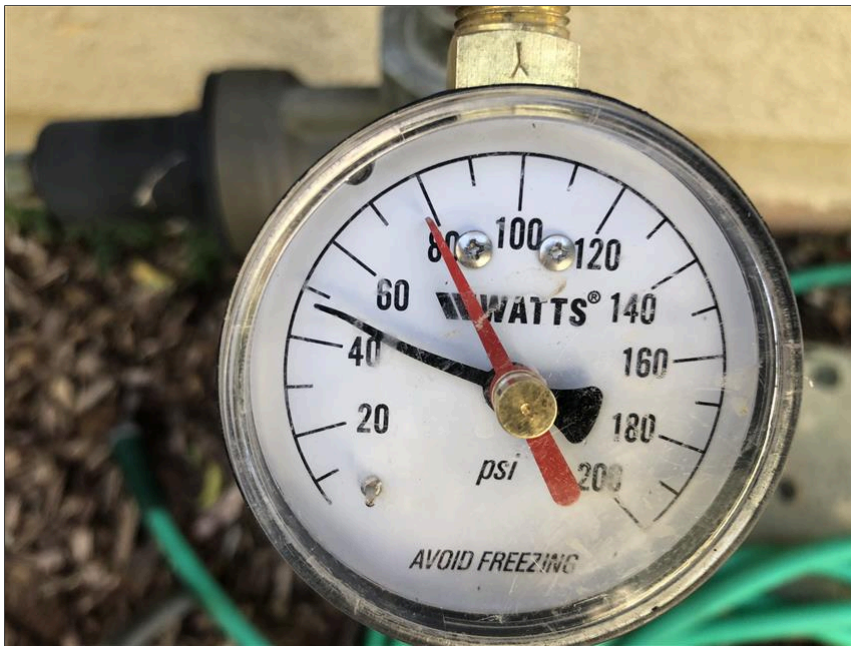
(2) The water pressure, as measured from an exterior hose bibb, was approximately 48 p.s.i. at the time of this inspection.

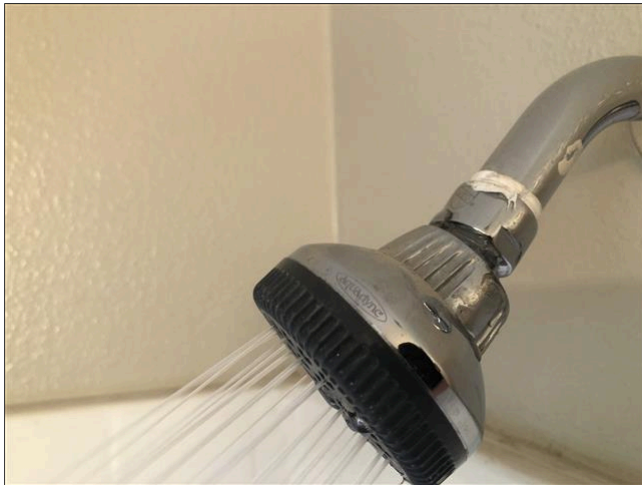
5.4 Item 2(Picture)

➔ The shower head leaks at its base at the hall bathroom. A qualified technician should repair or correct as needed.

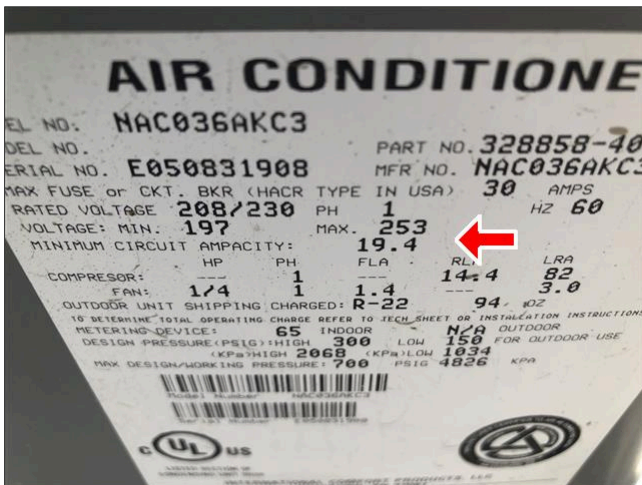
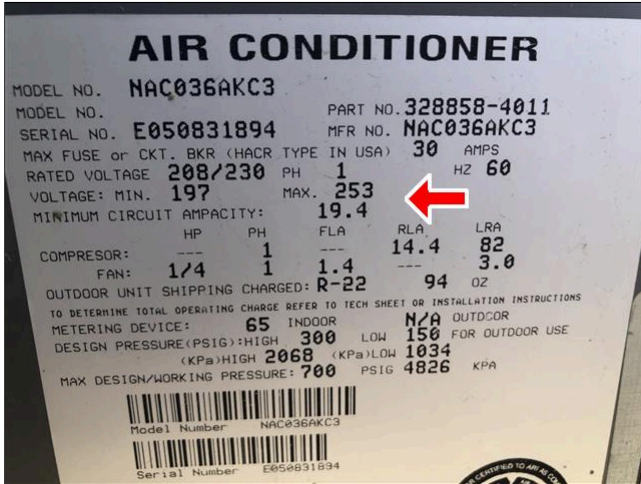
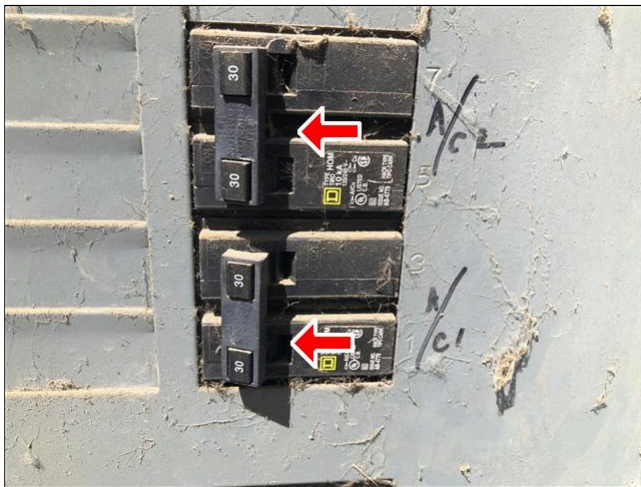
➔ The local disconnect is over fused. Have a licensed electrician install a breaker/fuse that meets the manufacturer's installation instructions.

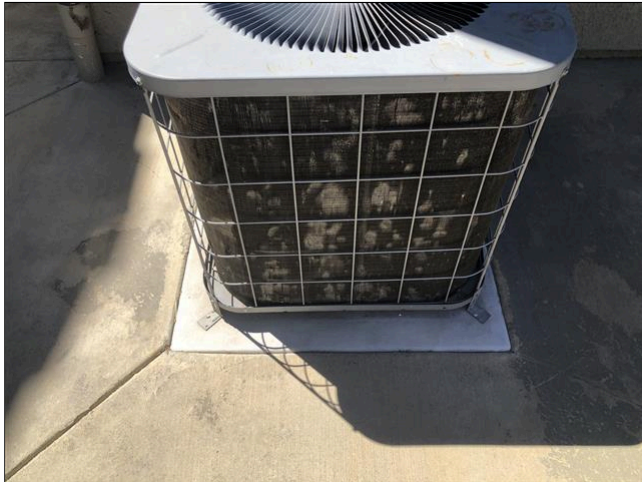
7.12 Item 4(Picture)

(2) Air Conditioning Unit #1 is located at the rear. The capacity of the unit is three tons. The approximate age of the unit is 17 years old as determined by the data plate.

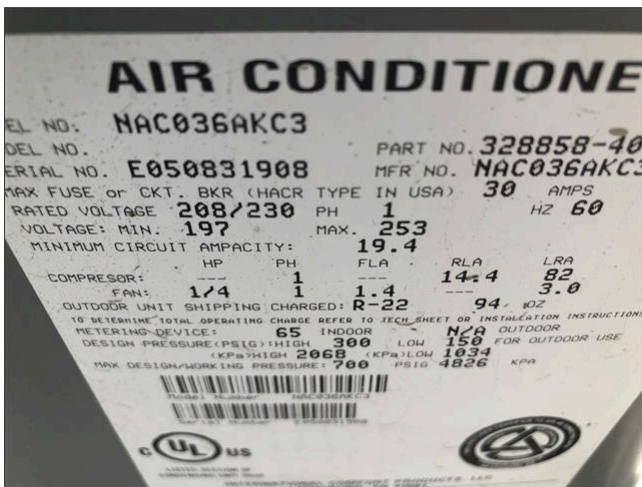
7.12 Item 5(Picture)

(3) Air Conditioning Unit #2 is located at the rear. The capacity of the unit is three tons. The approximate age of the unit is 17 years old as determined by the data plate.

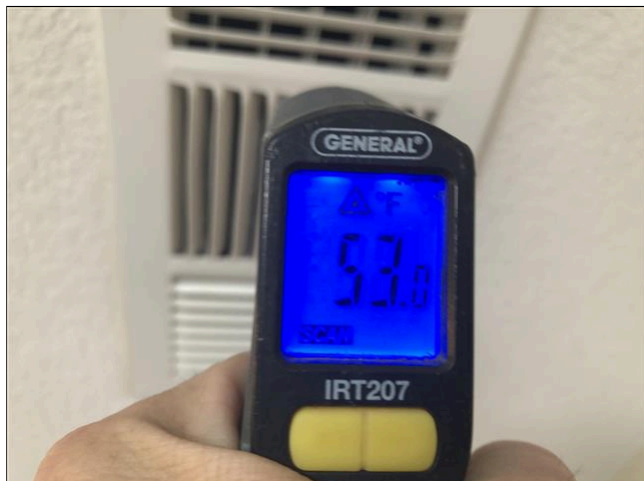
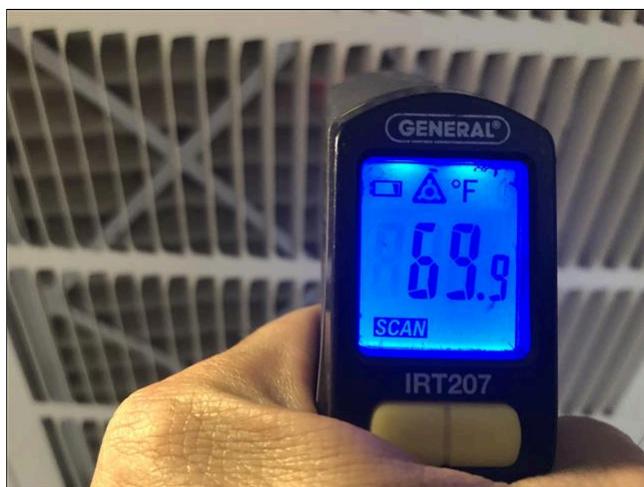
- ➡ (6) An ambient air test was performed by using a thermometer on the air handler of air conditioner to determine if the difference in temperatures of the supply and return air are between 14 degrees and 22 degrees which indicates that the unit is cooling as intended. The supply air temperature on your system read 48 degrees, and the return air temperature was 67 degrees. This indicates **the range in temperature drop is normal.**

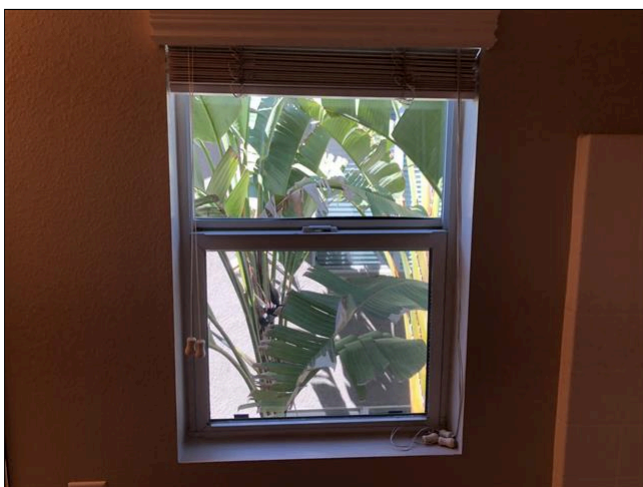
10.4 Item 2(Picture)

- ➡ (2) One or more windows do not operate smoothly, are difficult to latch or are in need of adjustment. All poorly or non-operating windows and their associated hardware should be cleaned, lubricated, and adjusted for smoother operation. Where needed, essential hardware, such as operator cranks, sash balances and latches should be replaced with compatible components. ( Master bedroom )

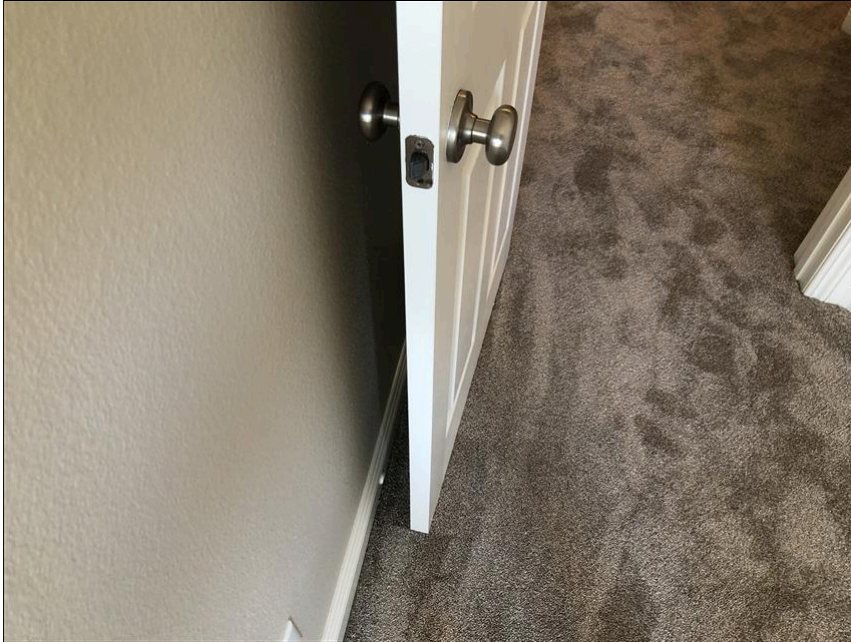
10.6 Item 1(Picture)

One or more interior doors have no door stop. A stop or bumper should be installed on each door to help prevent damage to the surfaces behind the door.

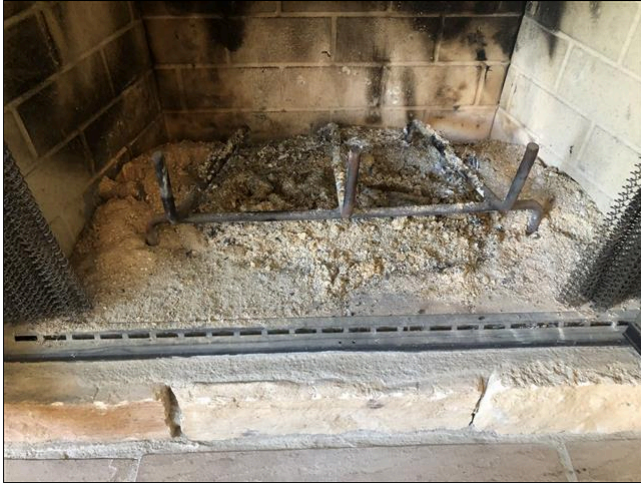
10.11 Item 1(Picture)

The fire box in the family room is filled with ash. This should be cleaned. A qualified technician should make this repair.

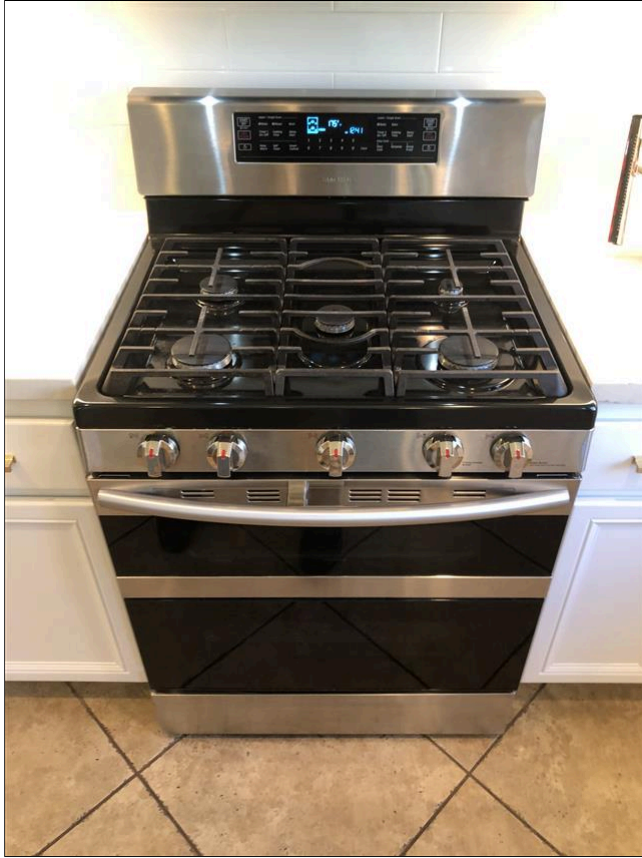
11.3 Item 1(Picture)

(1) Anti-tip hardware is not installed on this range. This is a safety feature that prevents the oven from falling over if a child climbs on the open oven door. Although this safety feature may not have been required when the unit was manufactured or installed, it is needed for safety. We strongly recommend the hardware be installed as a safety upgrade.

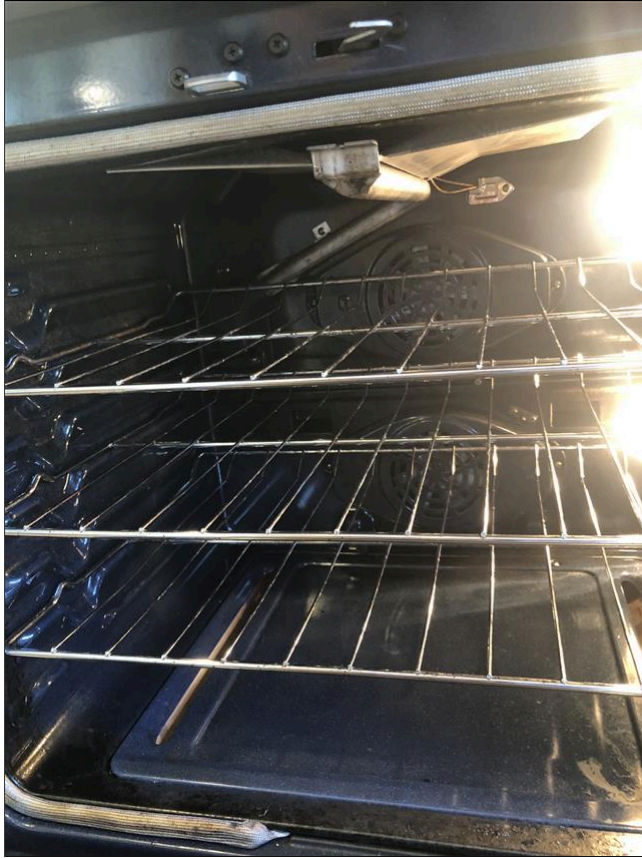
11.3 Item 2(Picture)

- ➔ (2) The convection fans did not work when tested. A qualified technician should repair as needed.

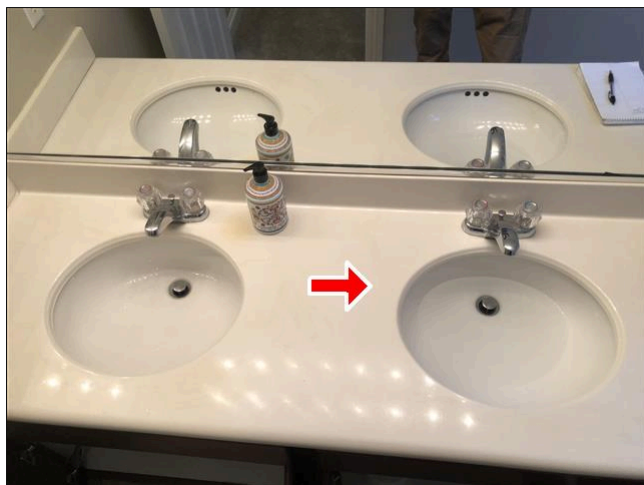
12.4 Item 1(Picture)

The drain at the hall bathroom sink is slow. The trap on the wash basin should be cleaned or snaked. A qualified technician should do the work. ( Right sink )

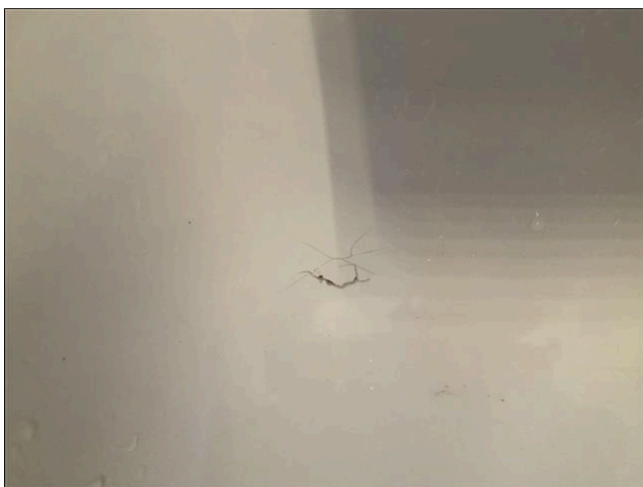
12.10 Item 2(Picture)

➡ The bathtub at the hall bathroom is chipped. A qualified technician should make any needed repairs.

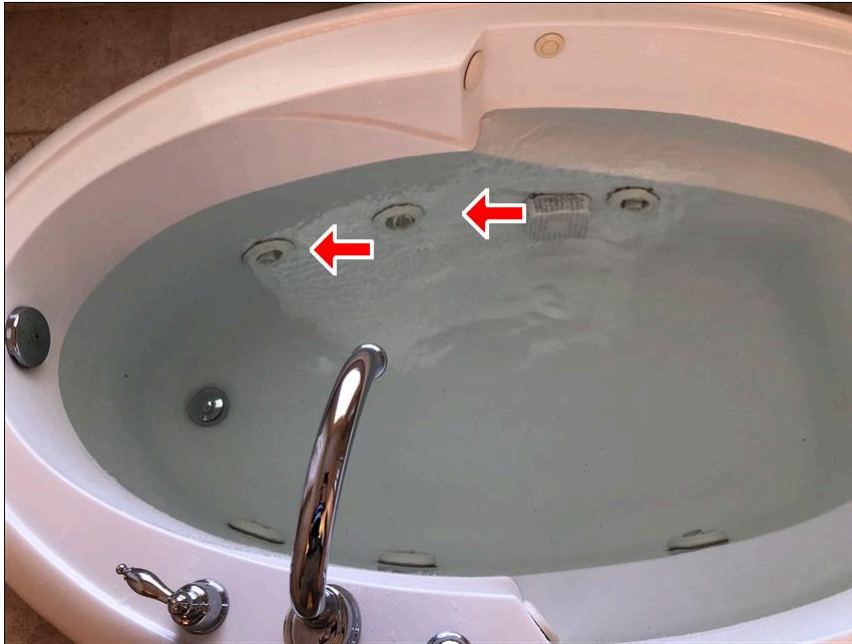
12.11 Item 1(Picture)

➡ One or more of the whirlpool tub jets are not functional. A qualified technician should evaluate the system and make repairs or modifications as necessary.

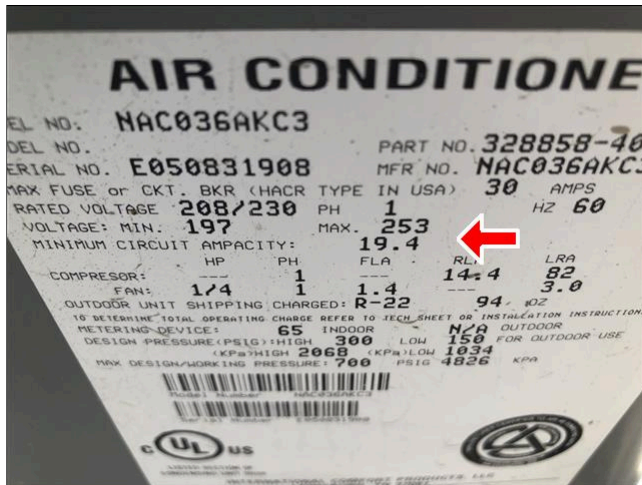
6.11 Item 1(Picture)

➔ The local disconnect is over fused. Have a licensed electrician install a breaker/fuse that meets the manufacturer's installation instructions.

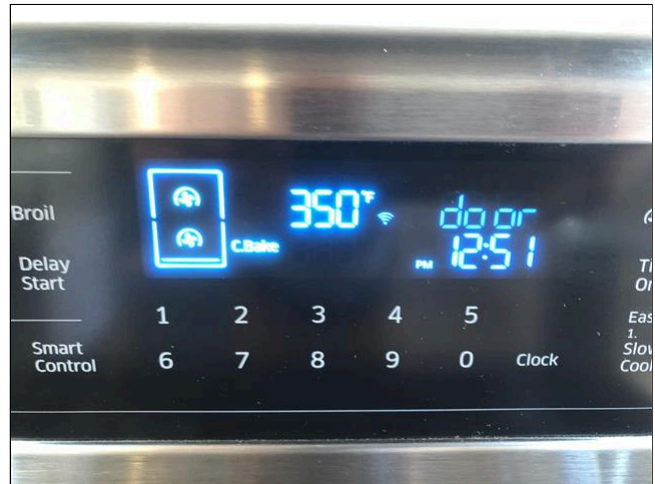
11.3 Item 3(Picture)

- ➔ (2) The convection fans did not work when tested. A qualified technician should repair as needed.

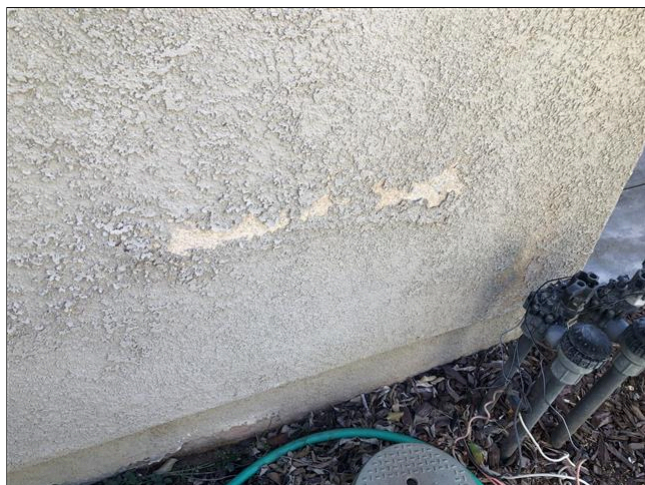
3.7 Item 2(Picture)

Sections of the stucco at the front & left side of the building are deteriorated.  
- A qualified plastering technician should evaluate the stucco and make repairs or modifications as necessary.

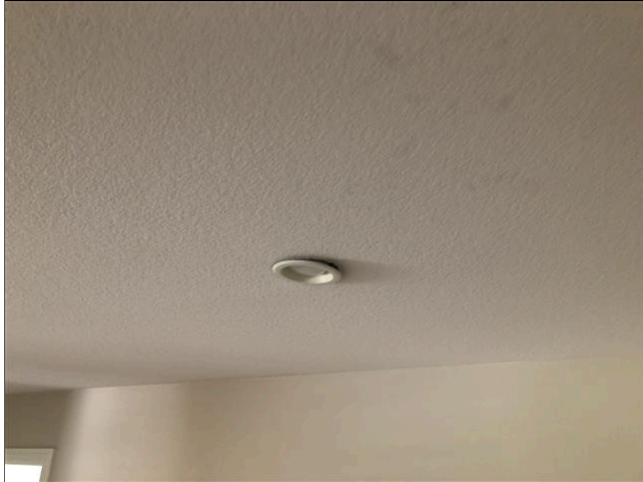
6.10 Item 7(Picture)

- ➔ (4) The can light at the second floor landing is not sealed to the ceiling. A qualified technician should make this repair.

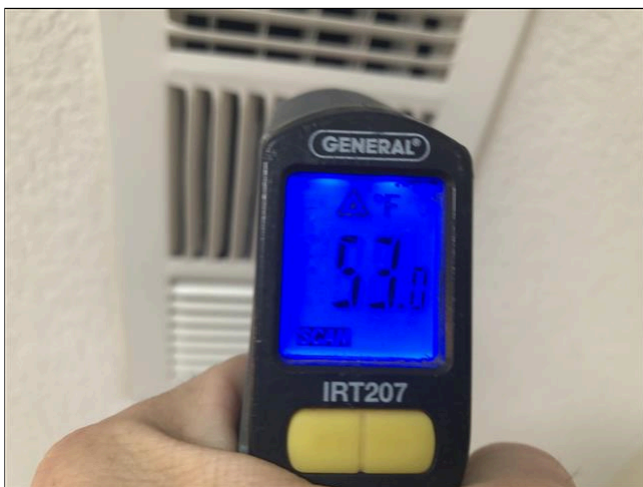
7.12 Item 8(Picture)

➔ (5) An ambient air test was performed by using a thermometer on the air handler of air conditioner to determine if the difference in temperatures of the supply and return air are between 14 degrees and 22 degrees which indicates that the unit is cooling as intended. The supply air temperature on your system read 53 degrees, and the return air temperature was 69 degrees. This indicates **the range in temperature drop is normal.** ( second floor )

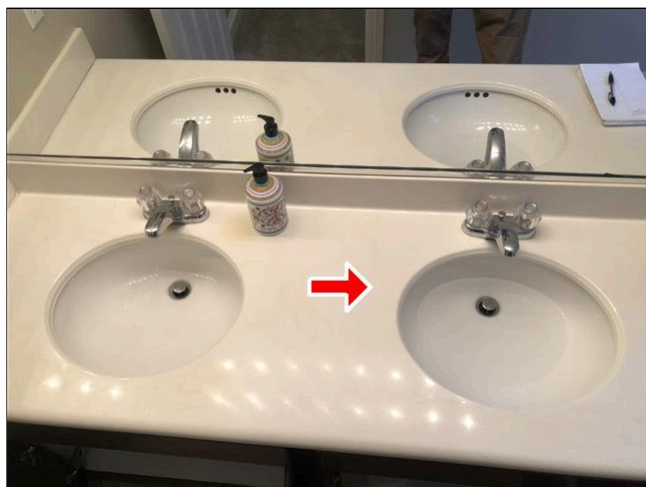
12.4 Item 1(Picture)

- ➔ The drain at the hall bathroom sink is slow. The trap on the wash basin should be cleaned or snaked. A qualified technician should do the work. ( Right sink )
