# Inspection Report

**Property Address:**  
9191 San Diego Way #47  
Atascadero CA 93422

9/17/2025

**Harper Homes: Home Inspection Services**

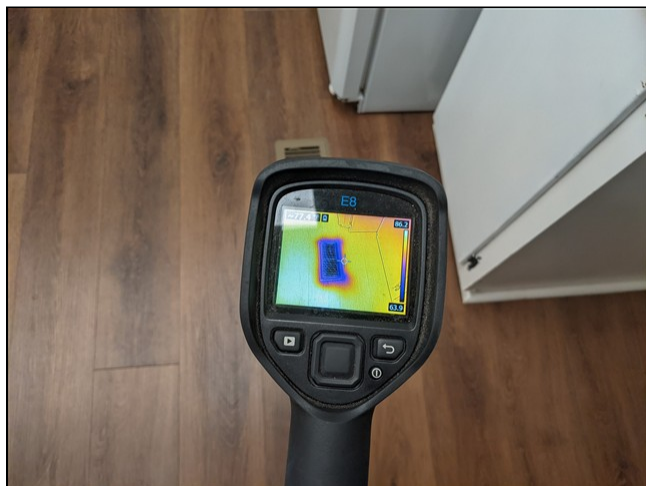
3.4 Item 1(Picture)

The cooling system was tested and functional at the time of the inspection.

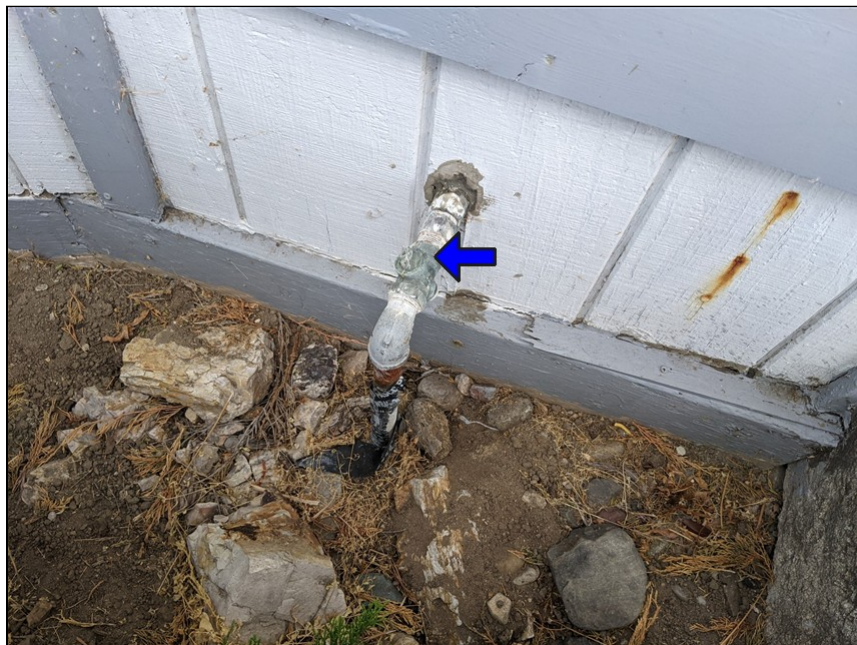
4.3 Item 1(Picture)

The gas shutoff is located at the front exterior of the home. To turn the gas off turn the valve perpendicular to the piping.

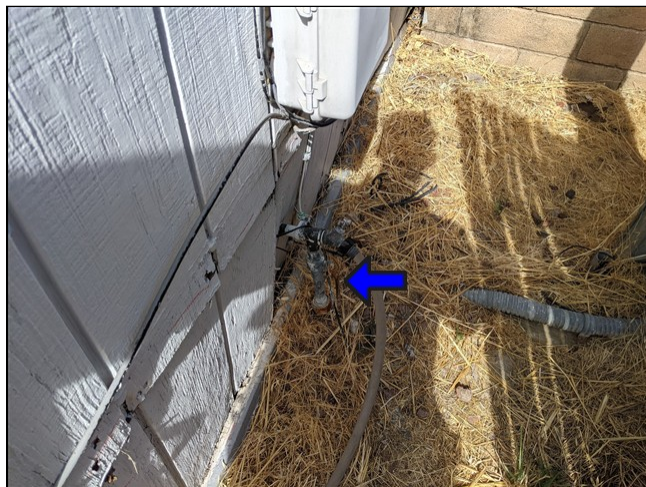
4.4 Item 1(Picture)

The water shutoff is located at the left exterior of the home. To turn the water off turn the handle perpendicular to the piping.
