## RESIDENTIAL HOME INSPECTION REPORT

1628 Freeman Dr  
Pine Mountain Club,, CA 93222

11/07/2025

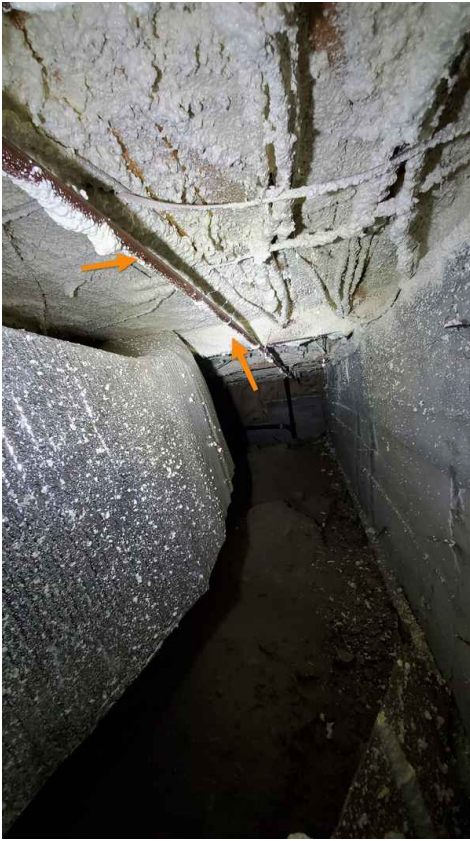
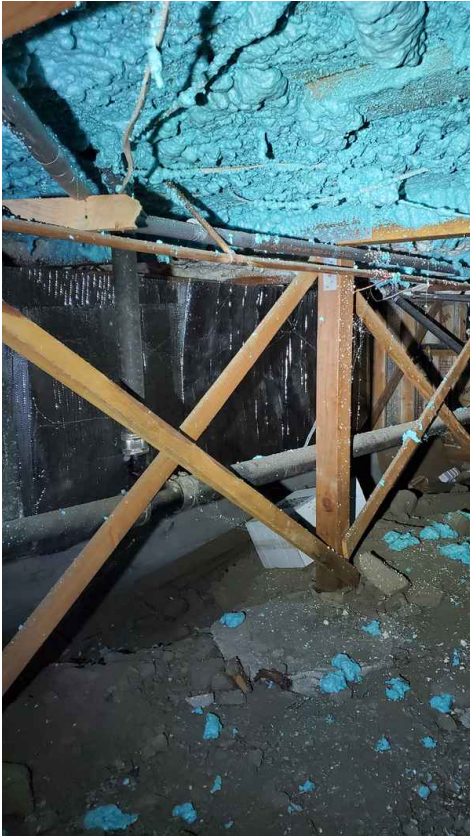
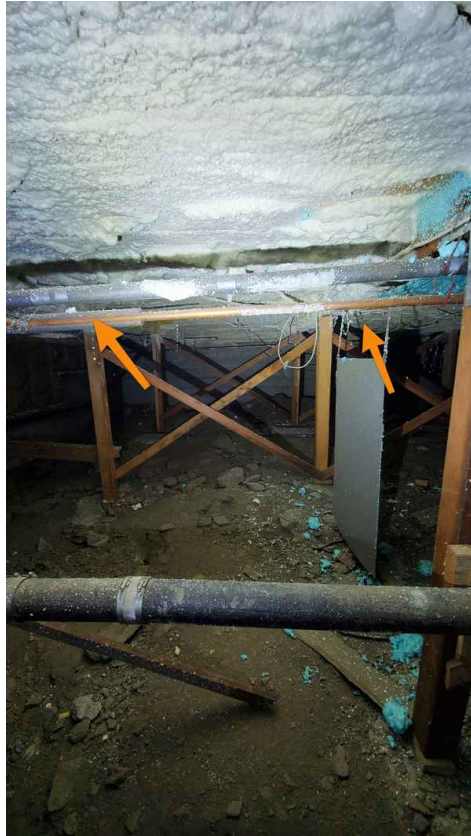
#### WATER SUPPLY LINES: INSULATION MISSING

There are water supply lines in the crawlspace that are uninsulated. These lines are out side the thermal envelope and could freeze in extreme cold. It is recommended these lines be insulated to prevent a hard freeze and potentially burst.

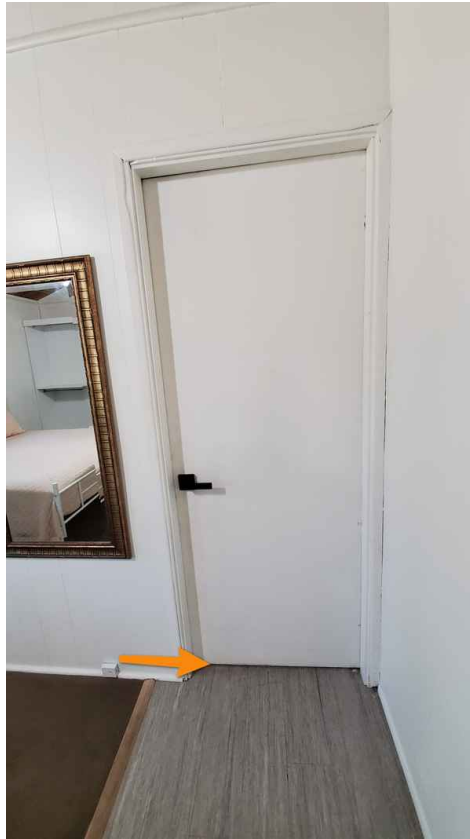
Primary bed to garage

##### **DOOR: THRESHOLD- WEATHER-STRIPPING MISSING**

There was thresholds and weather stripping missing on exterior doors.

This can lead to less comfort, insect intrusion and possible water damage.

Recommend installing the appropriate thresholds and weather-stripping in the locations where it is lacking.

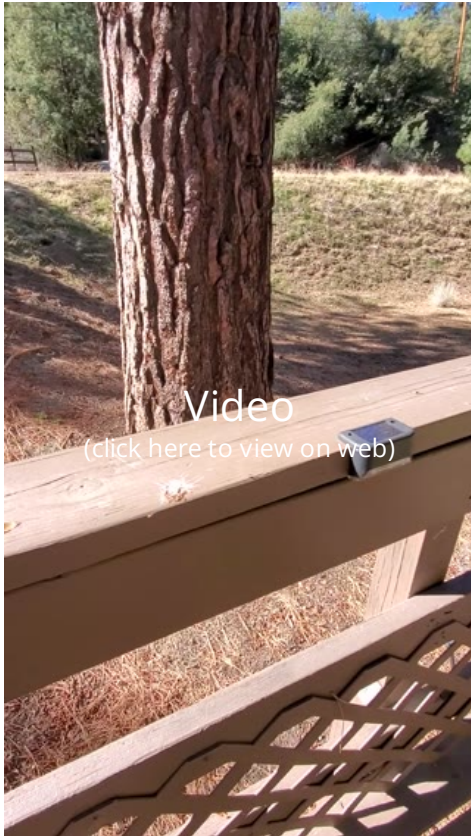
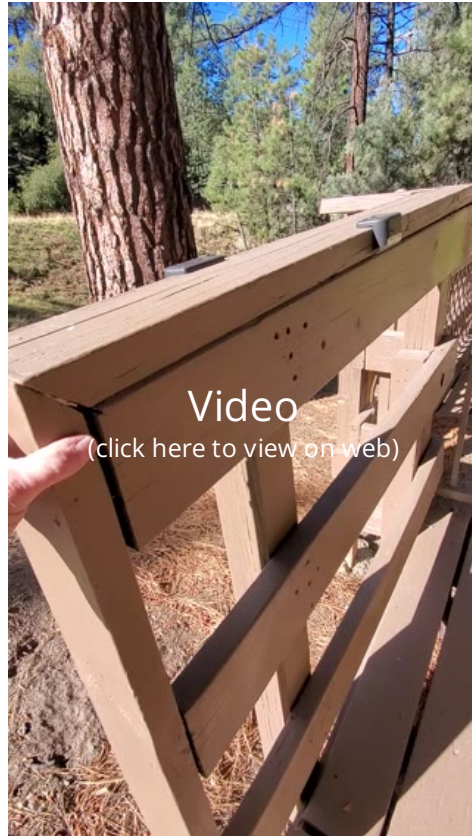
### **GUARDRAILS: LOOSE**

Deck guardrail assemblies were loose and should be made secure by a qualified contractor.

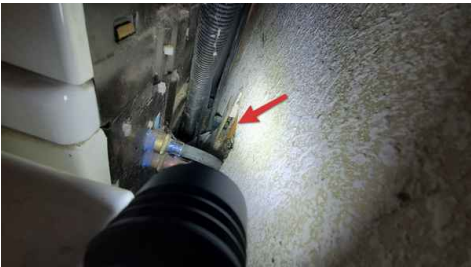
This is the fire wall and it needs to be complete.

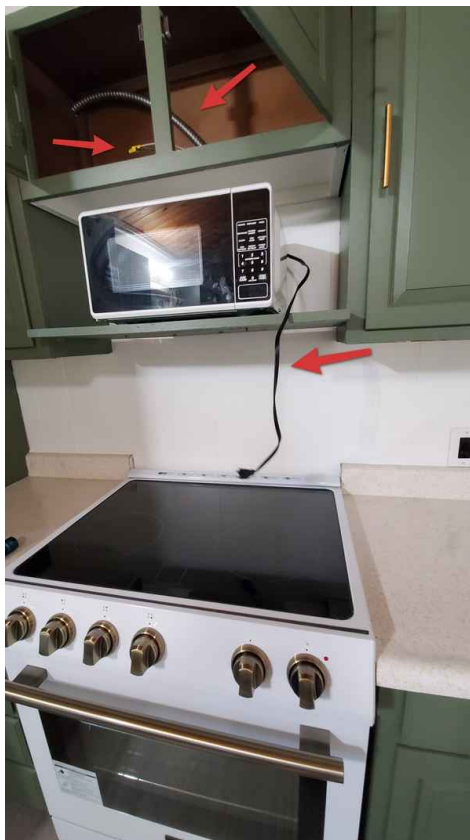
**ELECTRICAL FUTURE: MICROWAVE- UNFINISHED**

There appeared to be an electrical service for the microwave started but not completed. The exposed wires are not terminated and have wire nuts on hot wires.

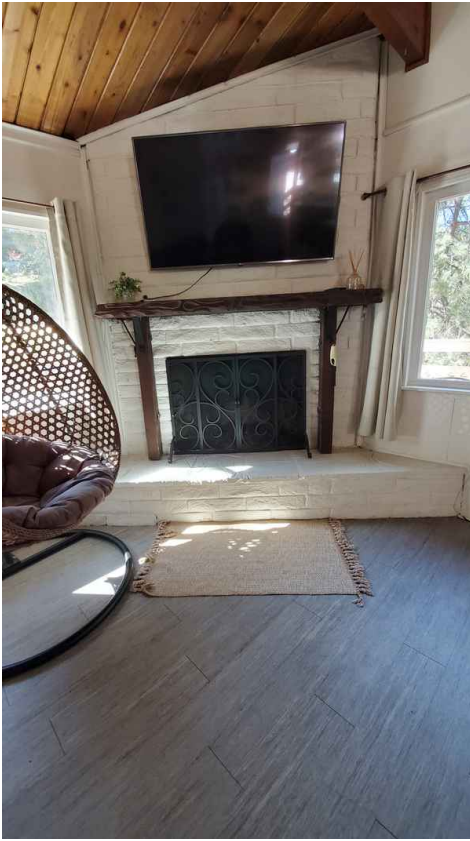
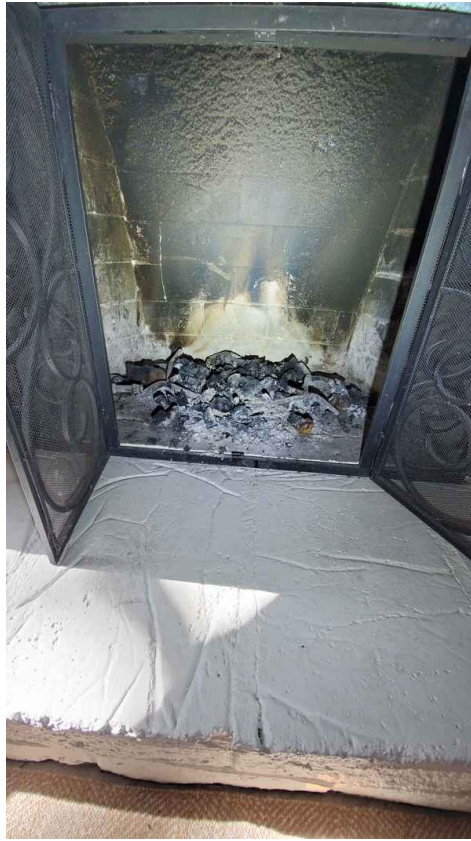
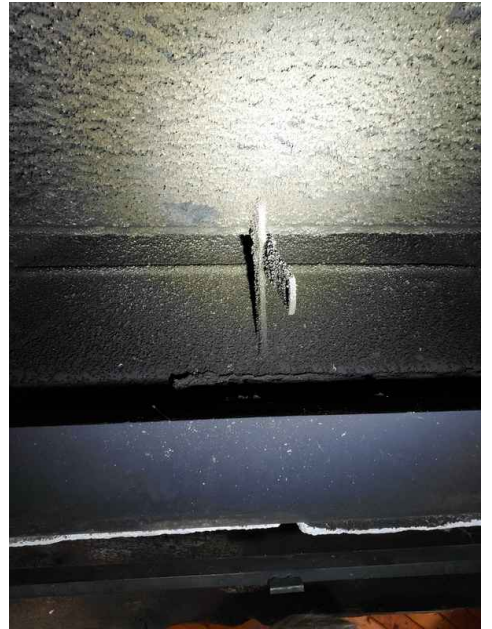
### WOOD-BURNING FIREPLACE: DISCLAIMER

The home contained a wood-burning fireplace. It was not operated. Full inspection of wood-burning fireplaces exceeds the scope of the General Home Inspection. The Inspector recommends that before the expiration of your Inspection Objection Deadline and first use you should have this fireplace inspected by an inspector certified by the Chimney Safety Institute of America (CSIA). Find a CSIA-certified inspector near you at <http://www.csia.org/search>
