# **Cornerstone Inspection**

## **Property Inspection Report**

**2400 El Camino Real, Atascadero, CA 93422**

**Date of Inspection: 8/26/2025 Time: 9:00 AM**

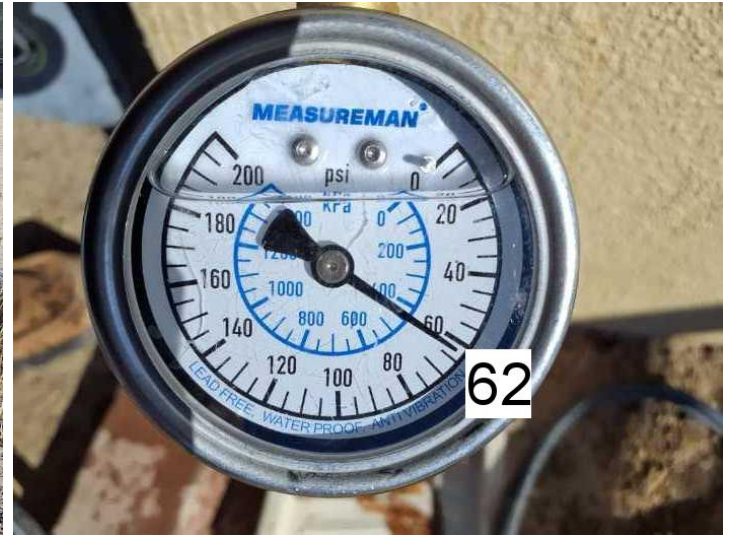
There is no apparent shut-off valve at the residence to facilitate an emergency shut-off of the water. This means that the water would have to be turned off at the street with a large specialized tool called a plumbers key.

The water pressure entering the residence is under 80 PSI and a regulator is not required on the plumbing system.

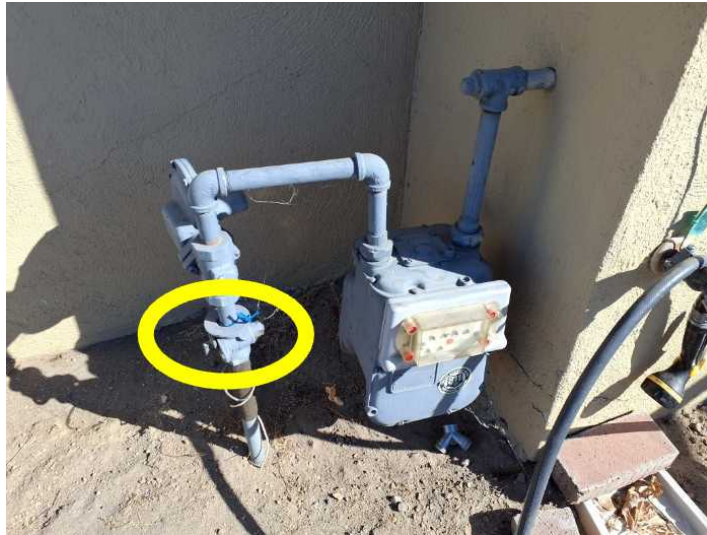
The gas main shut-off is located on the left side of the home, unit or building.

2.4. We recommend that a wrench, designed to fit the gas shut-off valve, be located on or adjacent to the gas meter to facilitate an emergency shut off.

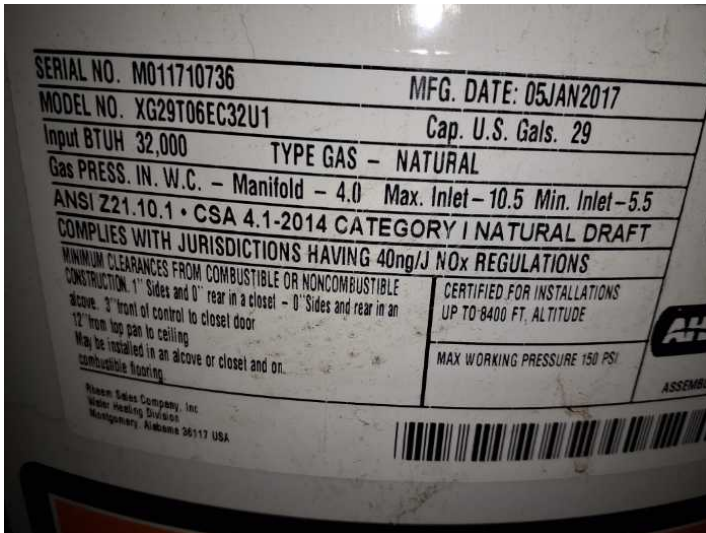
- 4.16. The hot water heater is strapped but not braced properly and should be serviced. Current standards require that the water heater must be strapped AND braced to resist seismic motion.

Hot water is provided by a 29 gallon gas water heater that is located in the laundry room.

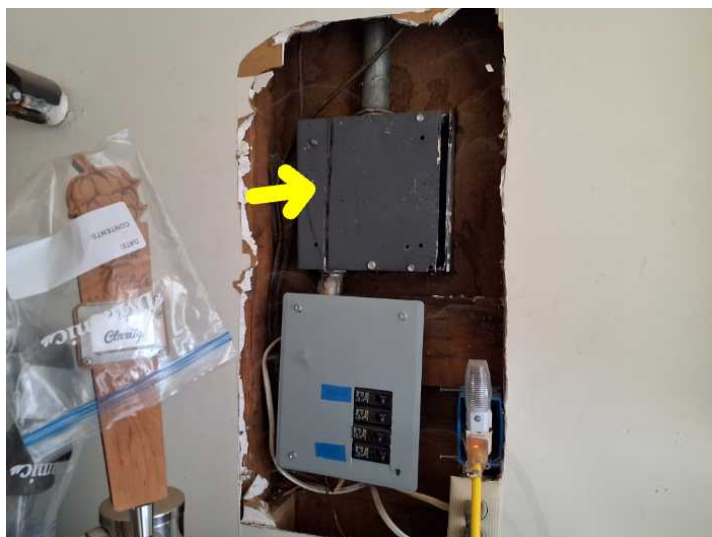
1.12. The panel does not have a main disconnect, which is required by current standards. We recommend an evaluation by a qualified electrical contractor and service as necessary,

The residence is served by a main electrical panel located within the laundry room.

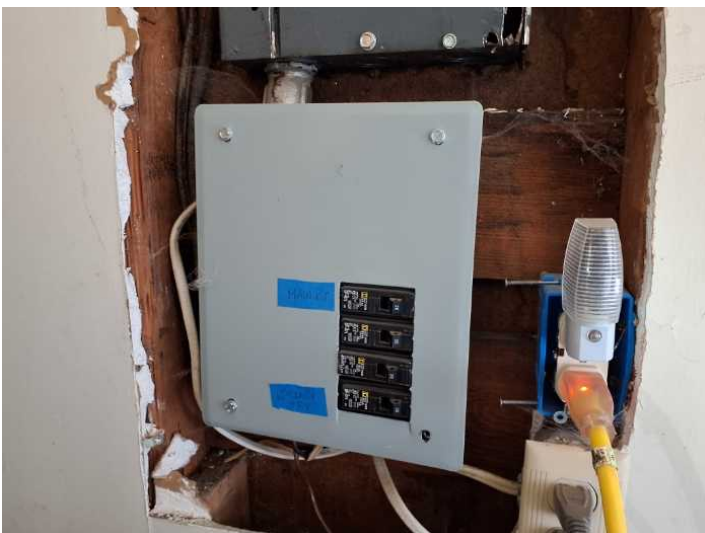
2.7. One or more of the breakers do not properly fit within the buss bar. Because of this the breaker is loose, which can cause arcing and should be evaluated and serviced by a qualified electrical contractor.

2.8. The neutral and ground wires are together on the same buss bar and should be separate. The ground wires should be bonded to the panel and the neutral wires should be separate and "floating" from the panel. We recommend that a licensed electrician evaluate and service the sub panel.

The sub panel is located adjacent to the main panel.
