Inspection Report

Property Address:
1102 7th Place
Hermosa Beach CA 90254

Ferguson Home Inspections

Date: 10/13/2022	Time: 02:00 PM	Report ID: 10132022Prospect
Property: 1102 7th Place Hermosa Beach CA 90254	Customer: Wendy & Scott Fletcher	Real Estate Professional: Amy Teitelbaum

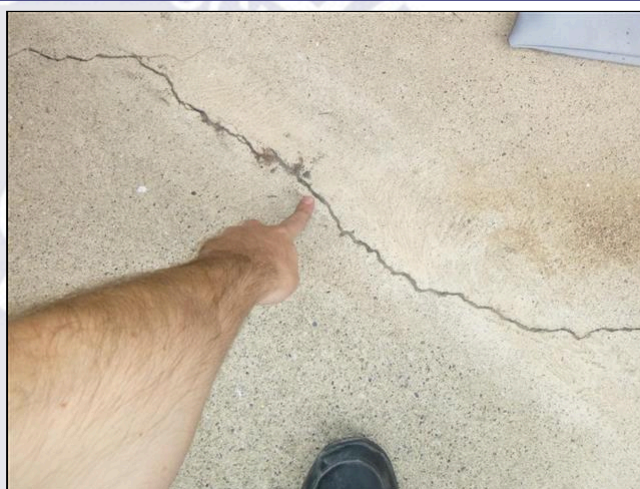
1.1 Item 1 (Picture)

1.1 Minor settling cracks noted at various areas, suggest repairs as needed.

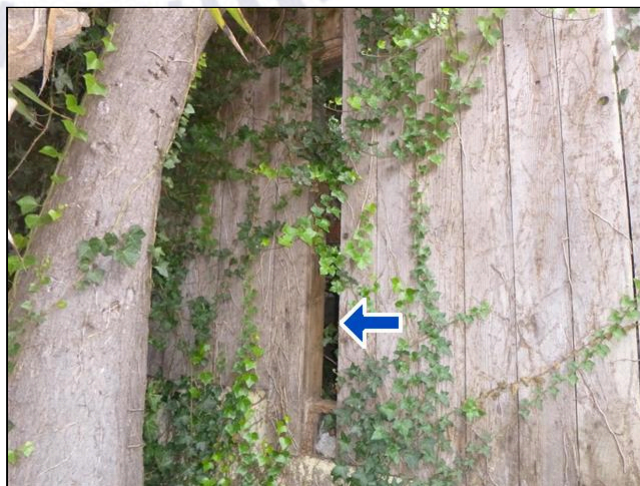
1.2 Item 1 (Picture)

1.2 (1) Deteriorated areas of the wood fence noted at the rear, suggest repair/replace as needed.

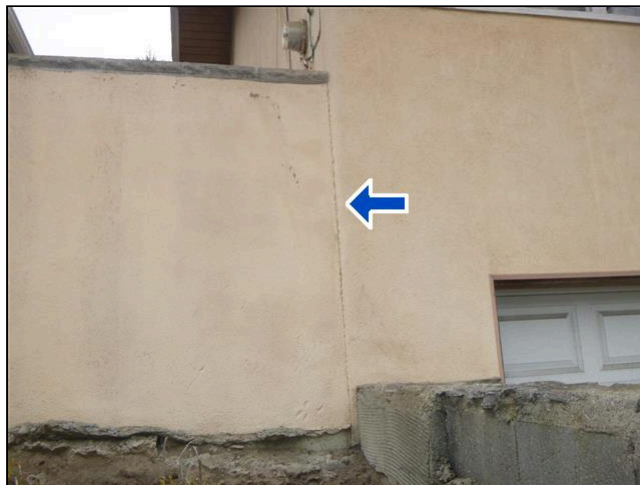
1.2 Item 2 (Picture)

1.2 (2) Cracks noted at the block fences, areas stable at the time of the inspection. Suggest repairs/maintenance as needed.

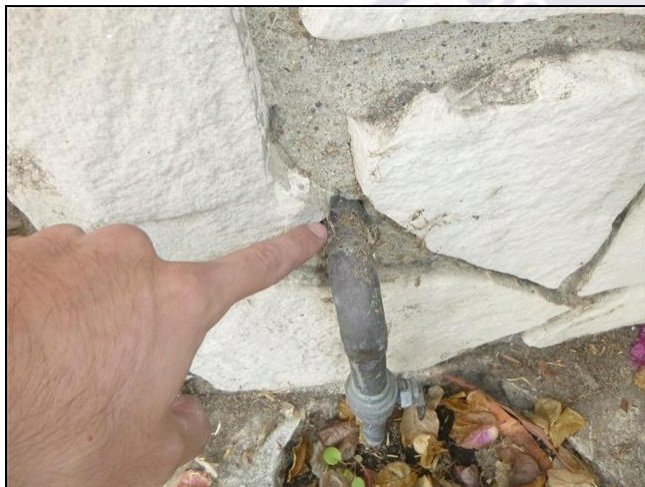
1.4 Item 2 (Picture)

1.4 (2) Suggest sealing around the siding penetration's to prevent future water/insect/rodent intrusion at these areas.

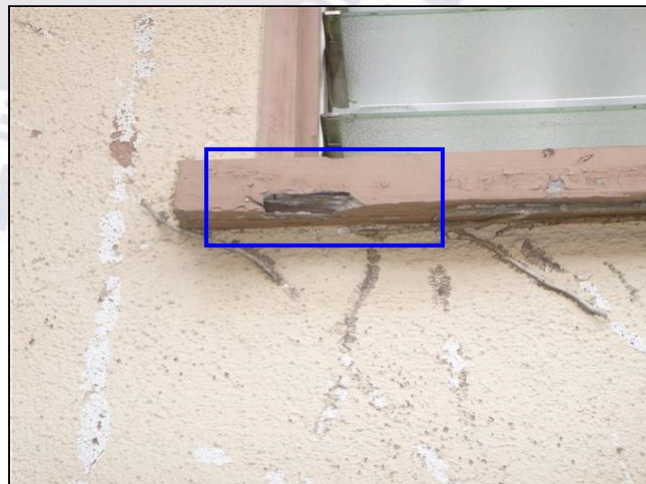
1.6 Item 2 (Picture)

1.6 (2) Wood deterioration noted at various windows. Suggest review with termite company and/or a licensed contractor and repair/replace as needed.

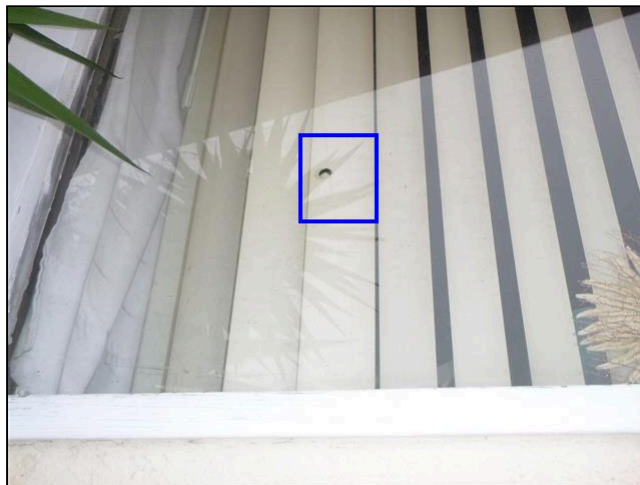
1.6 Item 3 (Picture)

1.6 (3) Cracked/damaged areas of the window glass was noted, suggest review with the seller and/or a glazier for replacement costs as needed.

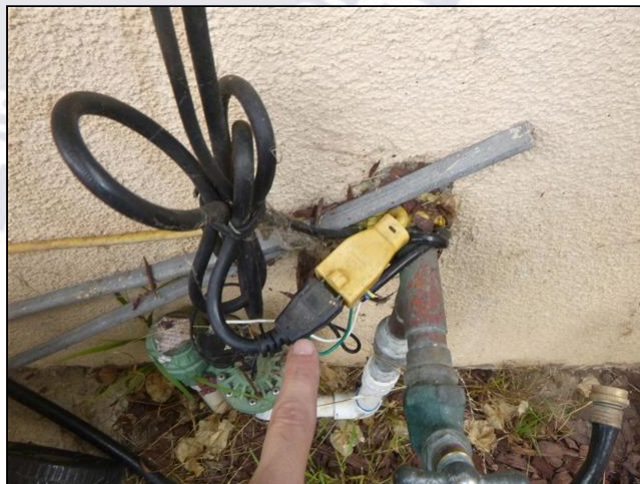
1.8 Item 2 (Picture)

1.8 (2) The outside outlet is using an extension cord as permanent wiring, and needs to be properly wired or removed.

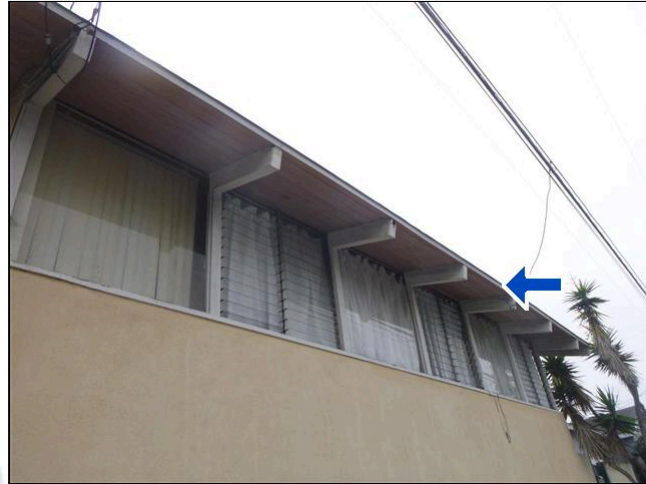
1.9 Item 1 (Picture)

1.9 Suggest installation of gutters throughout all eave areas and installation of an area drainage system to divert the water away from the foundation to the street as an upgrade.

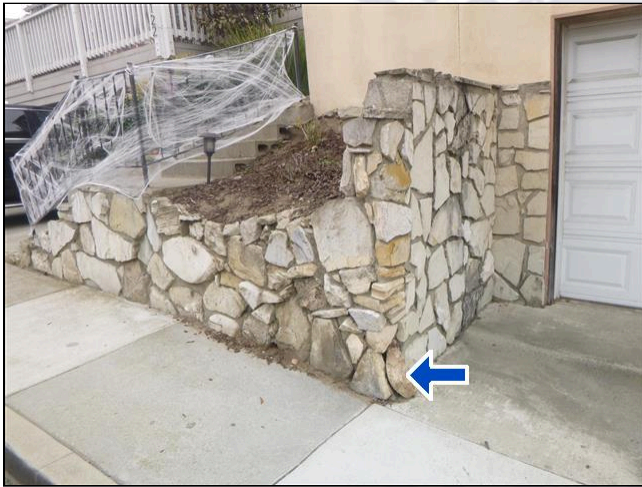
1.10 Item 1 (Picture)

1.10 A stone was loose at the front retaining wall, suggest repairs as needed.

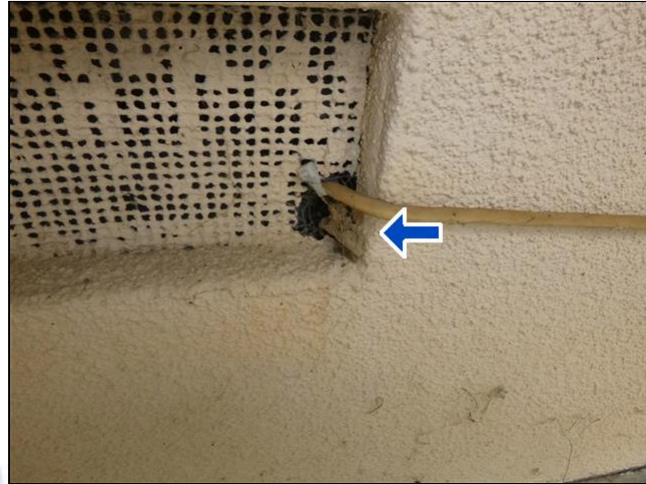
1.13 Item 1 (Picture)

1.13 (2) The vent to the garage area is deteriorated, suggest repairs/ replacement as needed.

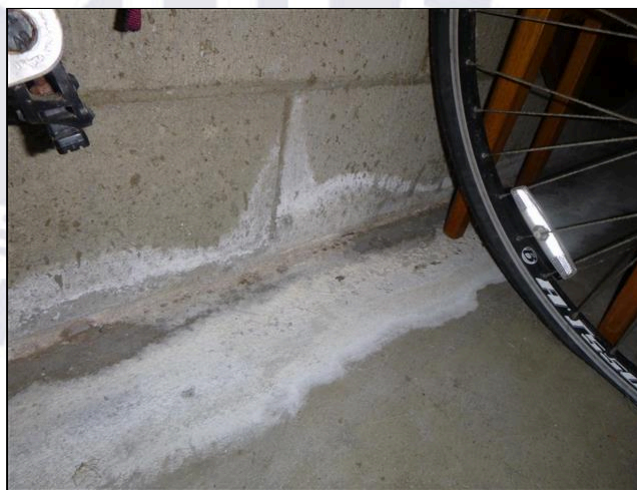
3.0 Item 1 (Picture)

3.0 (2) White efflorescence (powder substance) on foundation footings indicates prior, and possibly ongoing, excessive moisture build up at the exterior of the foundation. Ongoing water intrusion at the foundations can, in some cases, cause the steel in the foundations to rust, called spalling, which can lead to horizontal cracking of the foundation (currently there are no major horizontal cracks visible at the foundation). Any future horizontal cracking/damage can be an expensive repair as the foundation would be considered structurally weak and susceptible to horizontal movement. Suggest review of the Lot/Grade and drainage systems, including rain gutters, to reduce and prevent further and future water buildup at the exterior of the dwellings foundations.

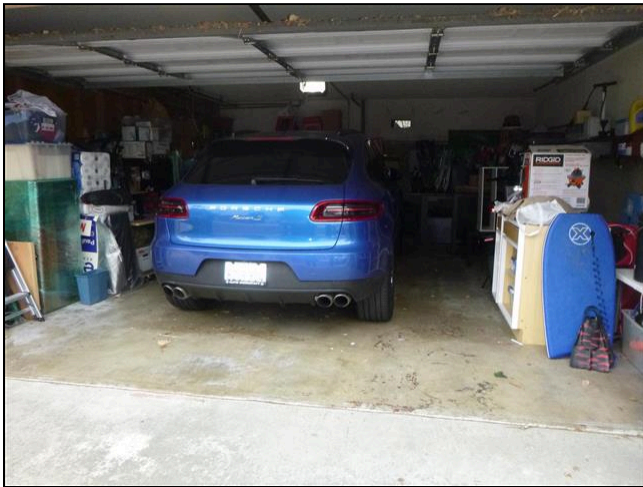
3.0 Item 2 (Picture)

3.0 (3) Limited review of the foundation and interior wood support members due to the excessive personal items

within the garage. Suggest review with a licensed contractor once the items have been removed.

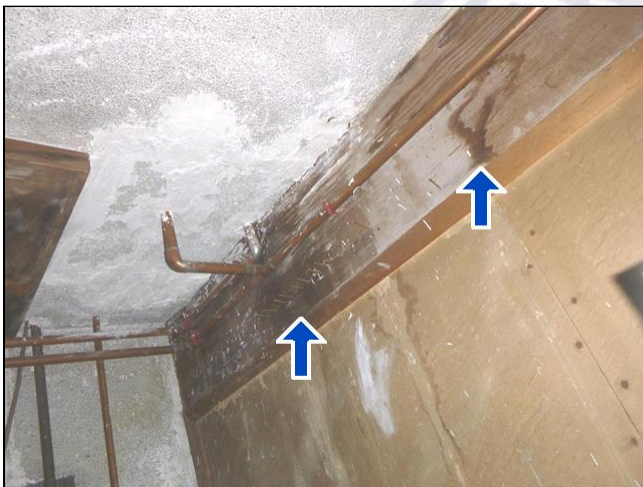
3.1 Item 1 (Picture)

3.1 (1) Water staining/deterioration noted at the interior floor support system at the garage area, suggest review with a licensed contractor and a licensed termite contractor as needed.

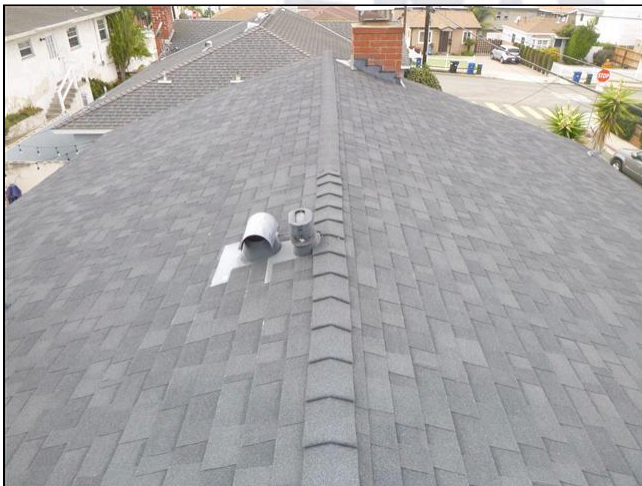
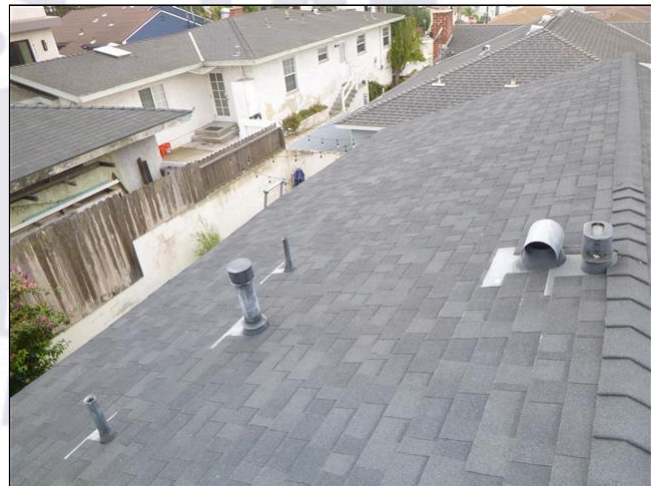
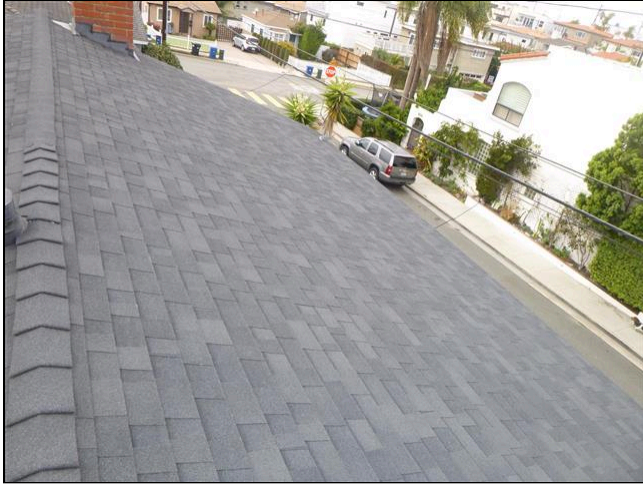
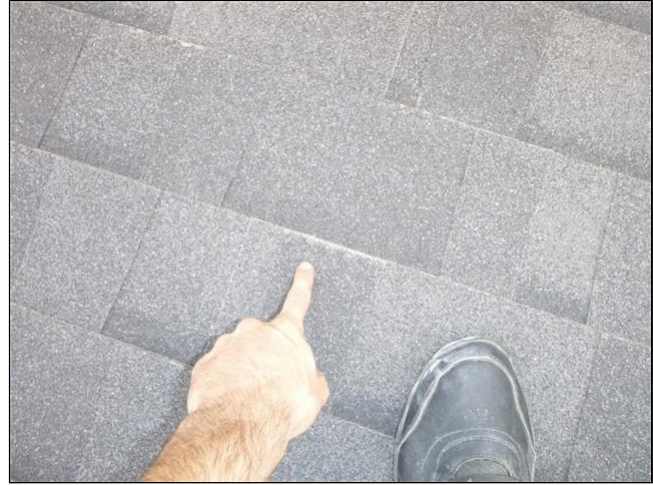
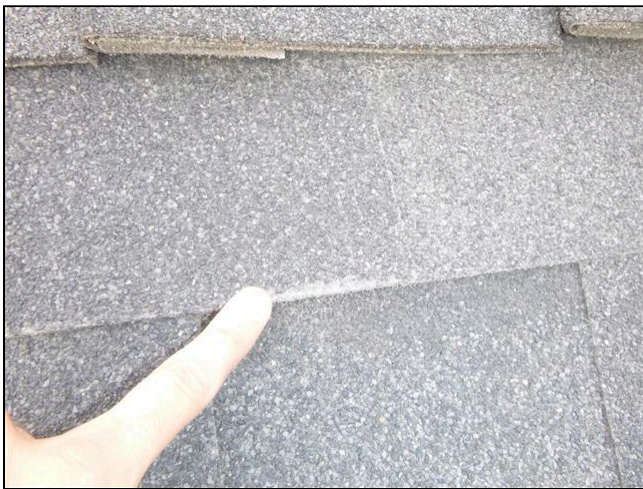
4.0 (1) Minor deterioration of the roofing was noted, suggest review with a licensed roofing contractor for repairs, periodic maintenance and to determine the remaining life expectancy of the roof.

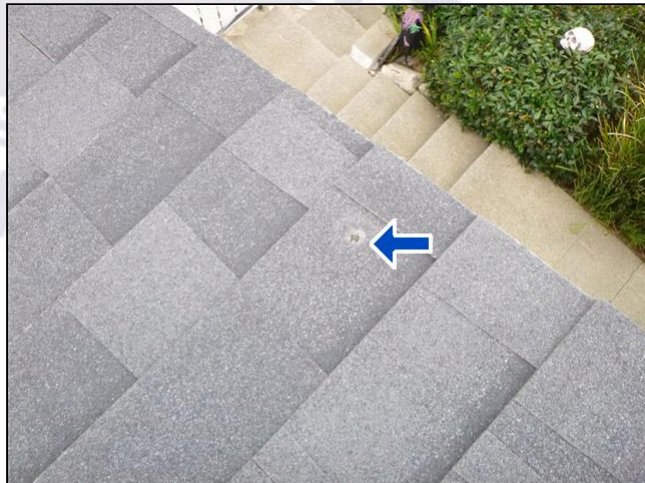
4.0 Item 6 (Picture)

4.0 (2) An exposed nail head was noted, suggest repairs as needed to prevent future leakage.

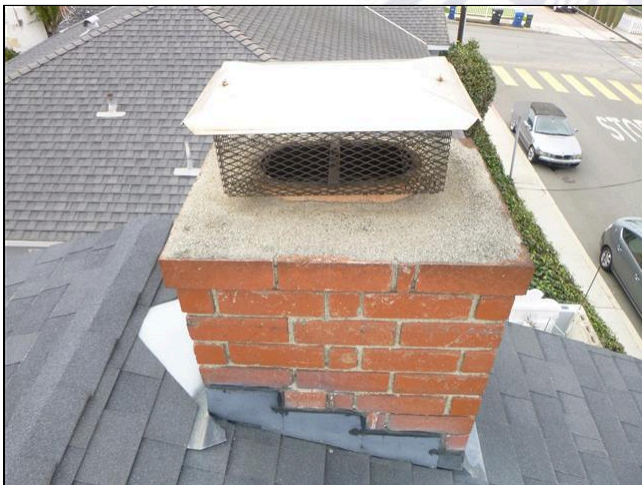
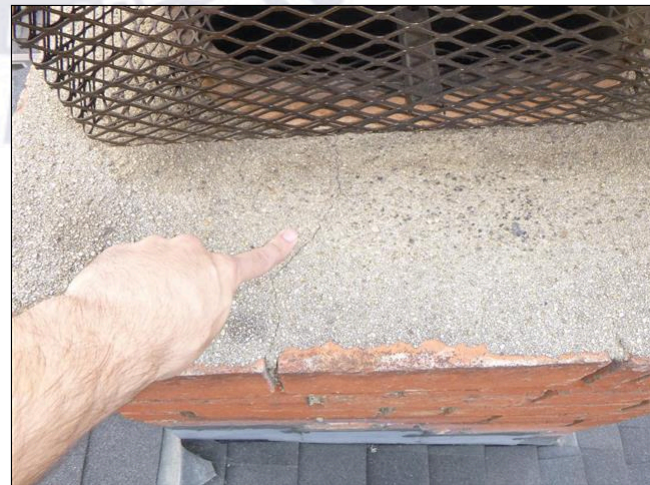
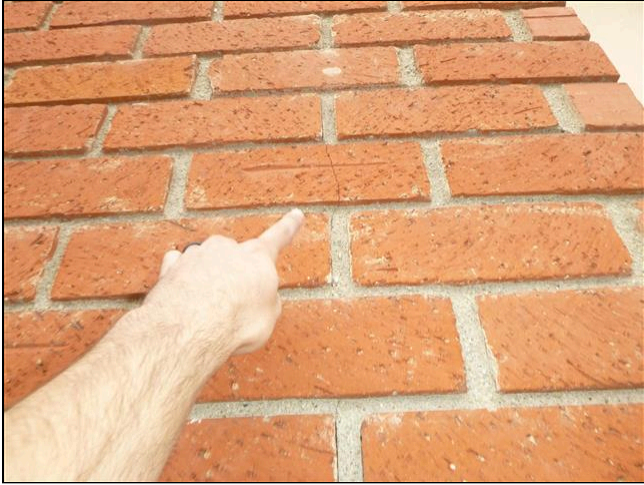
4.2 (2) Minor cracks noted at the chimney crown and base, suggest repairs/sealing as needed to prevent future water intrusion and deterioration.

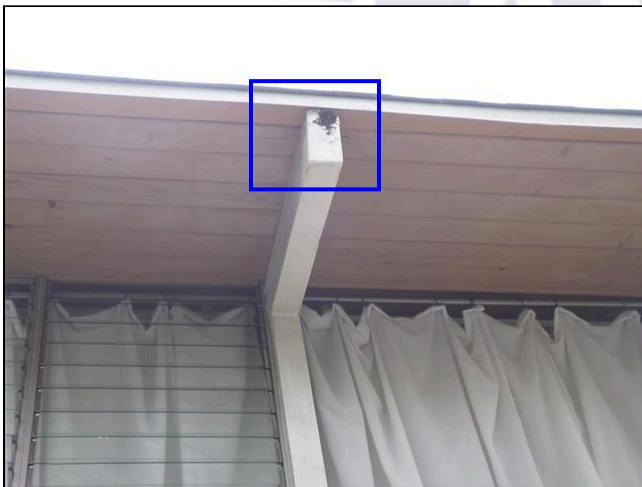
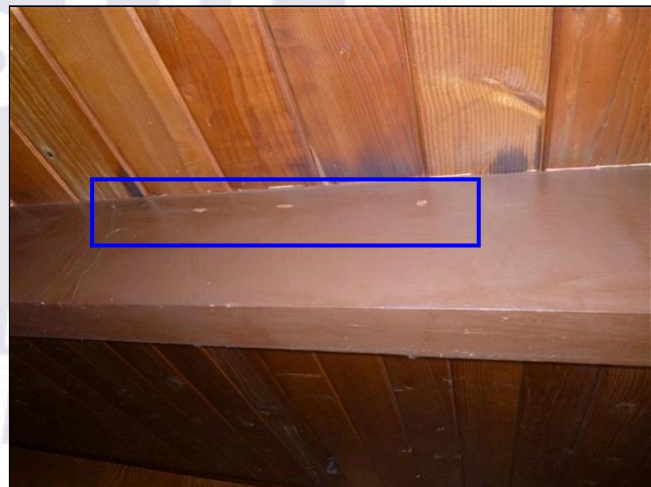
5.0 Wood deterioration was noted at the interior and exterior of the dwelling at the wood framing, suggest review with a licensed contractor and a licensed termite contractor for repair/replacement costs as needed.

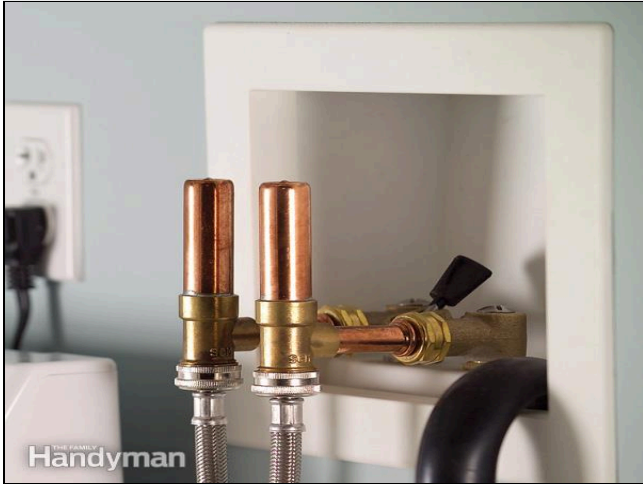
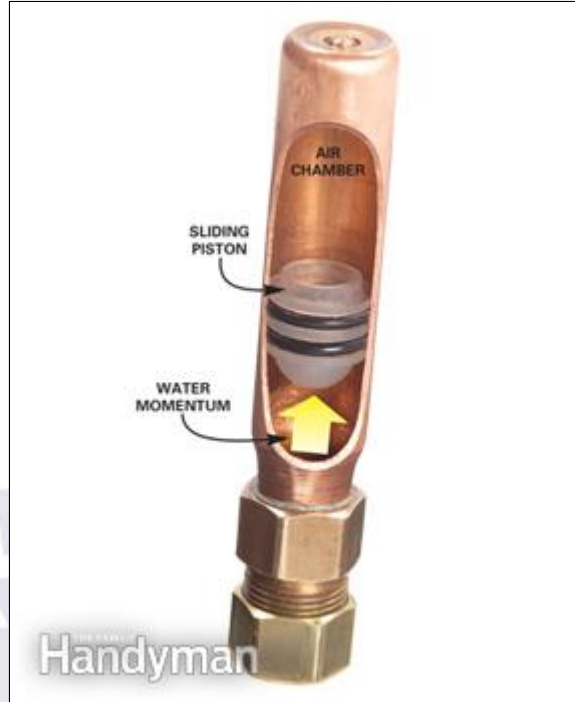
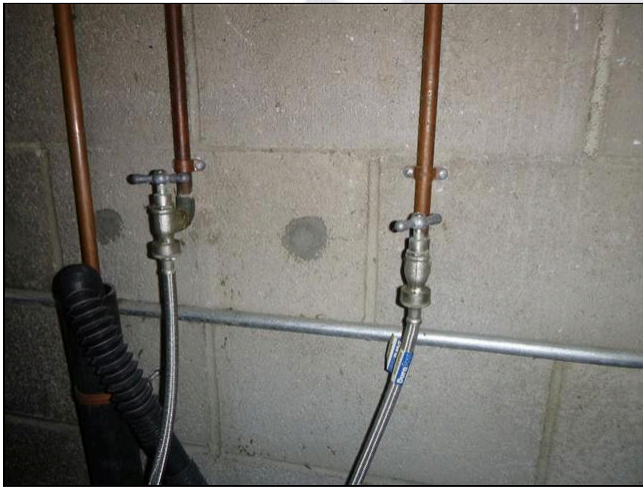
6.3 Suggest upgrading with 'hammer valve' plumbing supply systems if a water sensor/efficient/smart washing machine is to be installed at this area.

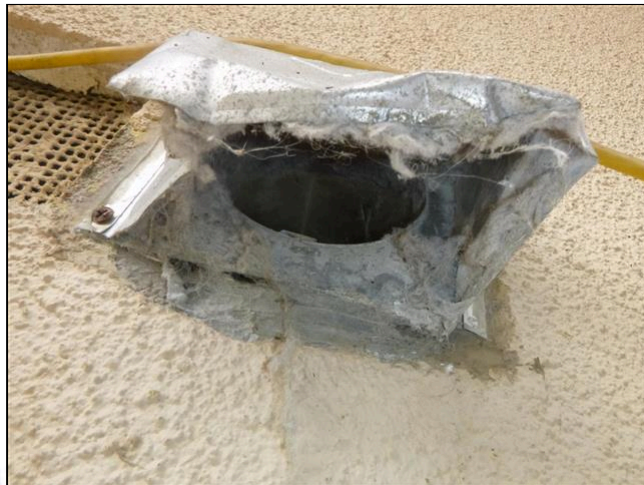
6.4 Item 1 (Picture)

6.4 (2) The dryer vent was loose and deteriorated at the exterior, suggest replacement as needed.

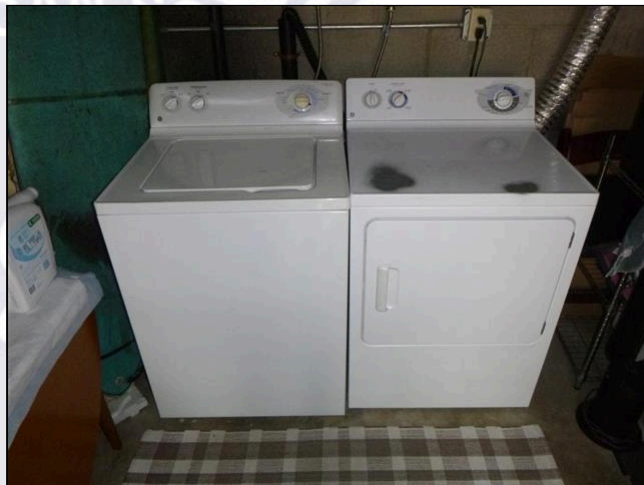
6.5 Item 1 (Picture)

6.5 (1) No impact barrier installed as required due to the location of the appliance(s) in the garage. This is common for the original age of the dwelling. Suggest review with a licensed contractor for installation costs as needed as an upgrade.

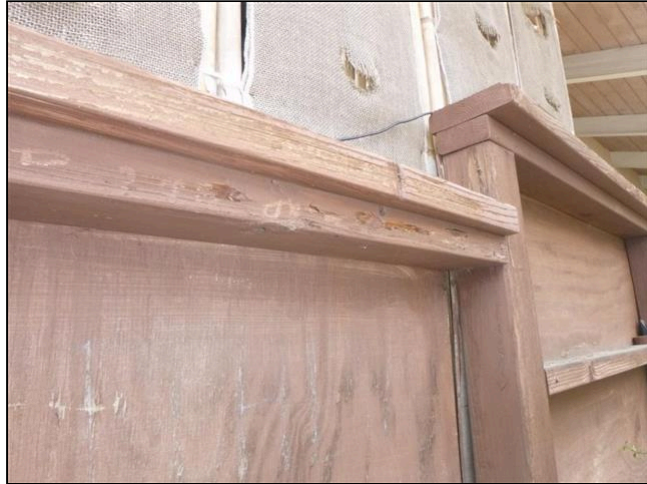
7.2 Item 2 (Picture)

7.2 (2) Wood deterioration noted at various areas of the railing, suggest review with a termite company and/or a licensed contractor for repairs as needed.

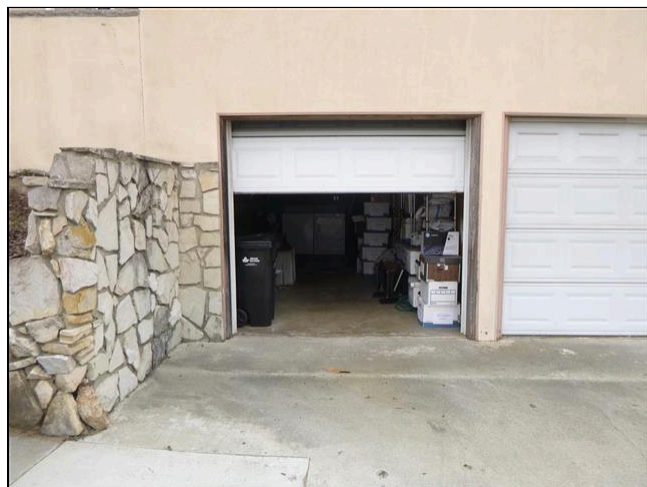
8.0 Item 1 (Picture)

8.0 (1) Access within this area was blocked or severely limited at the time of the inspection. An inspection of this area can be performed by appointment and at an additional cost when the area is made accessible.

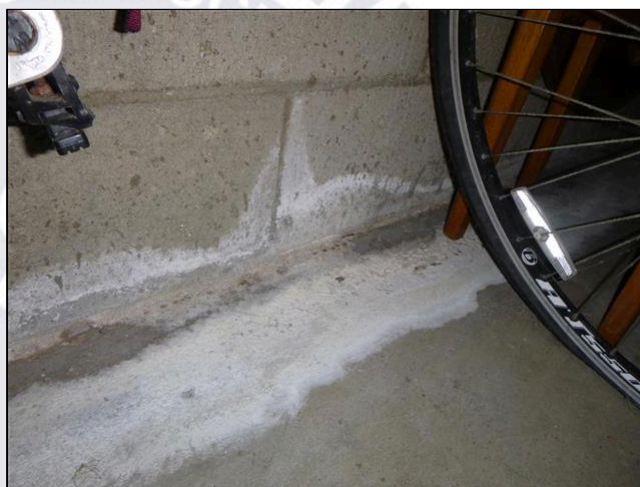
8.0 Item 3 (Picture)

8.0 (2) White efflorescence (powder substance) on foundation footings indicates prior, and possibly ongoing, excessive moisture build up at the exterior of the foundation. Ongoing water intrusion at the foundations can, in some cases, cause the steel in the foundations to rust, called spalling, which can lead to horizontal cracking of the foundation (currently there are no major horizontal cracks visible at the foundation). Any future horizontal cracking/damage can be an expensive repair as the foundation would be considered structurally weak and susceptible to horizontal movement. Suggest review of the Lot/Grade and drainage systems, including rain gutters, to reduce and prevent further and future water buildup at the exterior of the dwellings foundations.

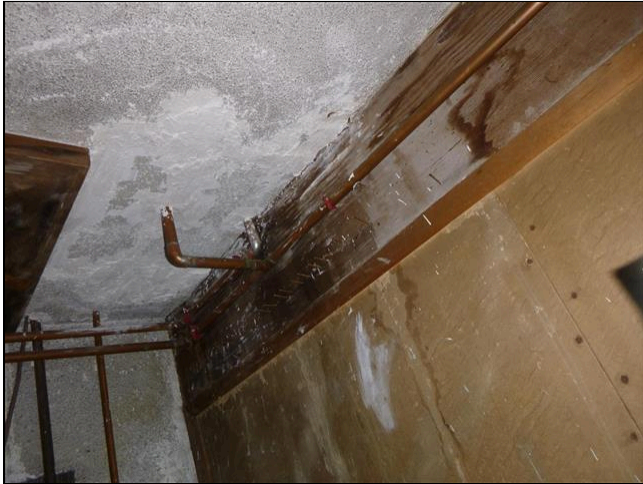
8.4 Item 1 (Picture)

8.4 (1) Patched and uneven areas of the ceiling noted (likely from past water damage), suggest review with the seller on the cause and any repairs needed. Suggest repair as needed.

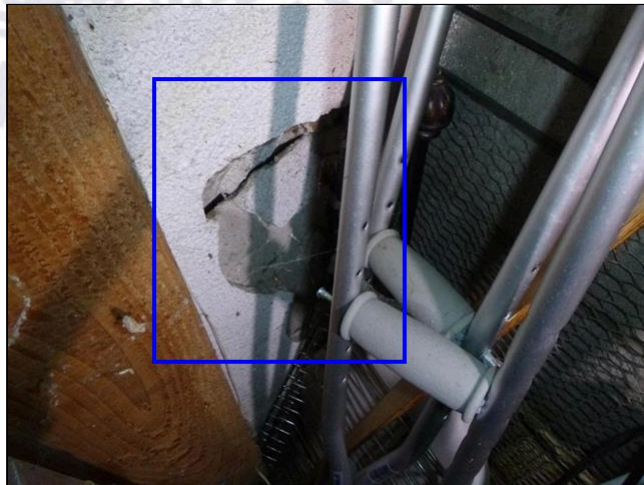
8.4 Item 4 (Picture)

8.4 (3) Holes and unfinished sections of the walls were noted, suggest review by licensed contractor for repair/ replacement costs as needed.

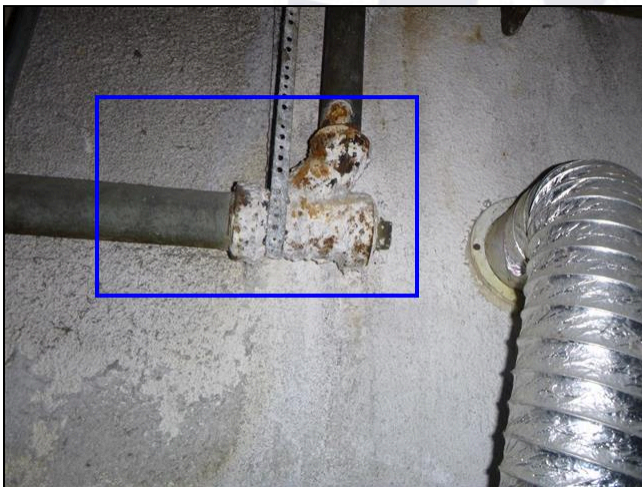
8.6 Item 1 (Picture)

8.6 Excessive corrosion noted at the drains and supply lines at this area. Suggest review with a licensed plumber and repair/replace as needed.

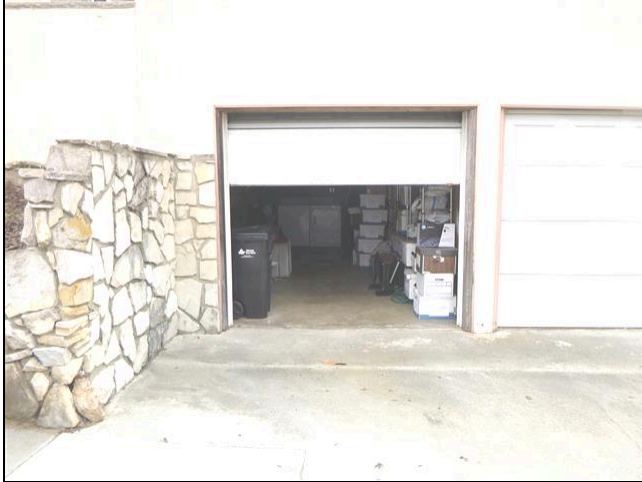
8.7 Item 1 (Picture)

8.7 Access within this area was blocked or severely limited at the time of the inspection. An inspection of this area can be performed by appointment and at an additional cost when the area is made accessible.

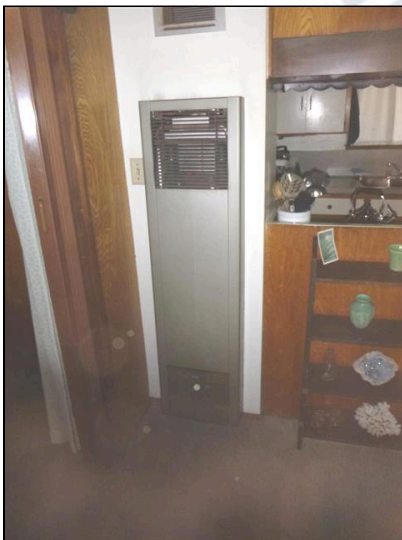
9.0 Item 1 (Picture)

9.0 The heater/furnace is very old but did work at the time of inspection. The inspector is unable to determine remaining life expectancy of this system. Due to the age and style of this system, suggest review with the Gas company and/or a licensed heating company for further review to determine the remaining life expectancy of the unit and any repair/replacements costs as needed.

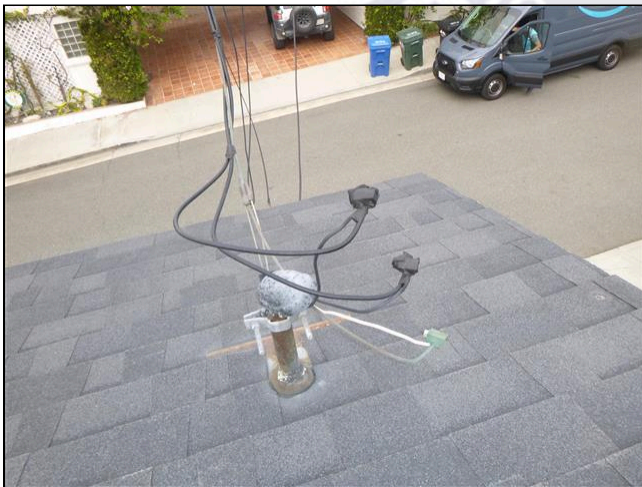
10.0 Item 1 (Picture)

10.0 Inadequate drip loop was noted, suggest review with a licensed electrician for repairs as needed.

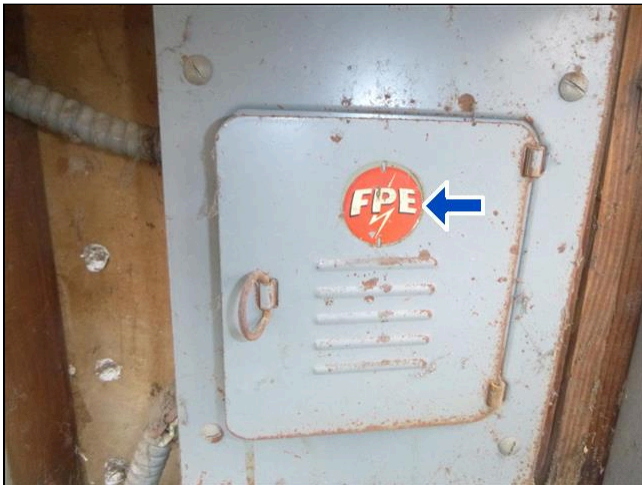
10.1 Item 1 (Picture)

10.1 (1) Currently a Federal Pacific electrical panel is installed, please be aware that there is a possibility that the circuit breakers may not trip when shorted possibly causing an electrical hazard. There are problems with these panels that can, in some cases, be serious. Some Federal Pacific panels have aluminum bus bars (the bars that run down the middle of the panel to which the breakers connect). Over a period of years, oxide forms on the aluminum causing a poor connection with the breakers and leading to arcing, overheating, and, eventually, breaker failure. Other problems with Federal Pacific panels include circuit breakers (depending on the vintage) with a dismal performance record and the possibility of unbalanced multi-wire circuits. Also, please be aware that various insurance companies will not insure homes with this style of electrical panel. Suggest review by a licensed electrician for replacement costs as needed.

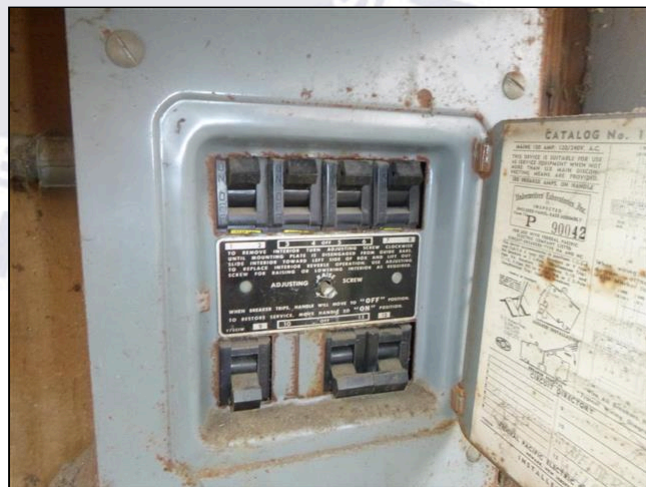
10.1 Item 3 (Picture)

10.1 (2) Suggest adding correct/complete indexing/labelling to all breakers for identification of each circuit for safety.

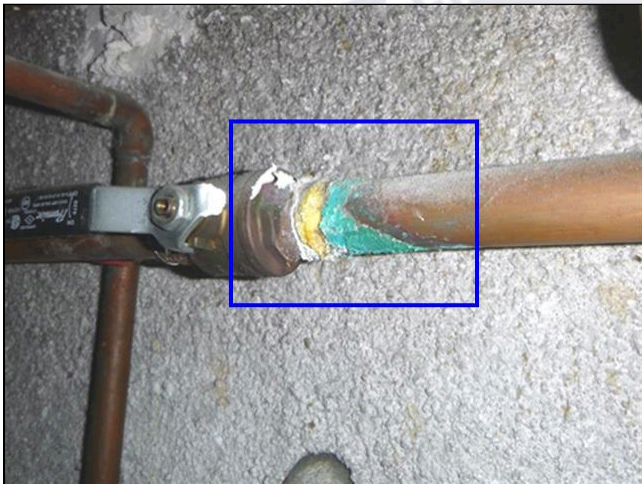
11.0 Item 1 (Picture)

11.0 (1) Corroded plumbing and fittings noted at various areas within the dwelling/garage. Suggest further review by a licensed plumber for repair/replacement costs as needed to prevent future leakage, pin hole leaks and possible stains/damage to the interior of the dwelling.

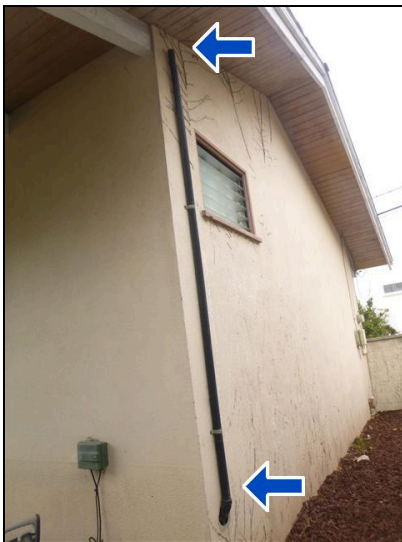
12.0 Item 1 (Picture)

12.0 (3) The plumbing vent at the rear left is installed incorrectly and does not extend 12 inches past the roof as required. Suggest review with a licensed plumber for repairs as needed.

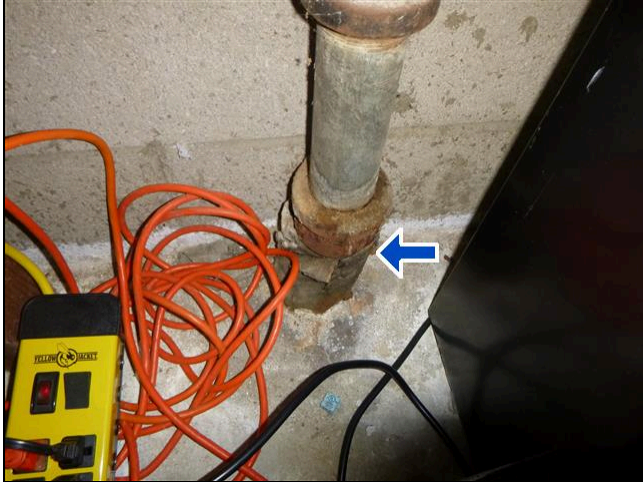
12.0 Item 4 (Picture)

12.0 (5) Rust and corrosion was noted at the various cast iron drain lines that are embedded/installed within the slab

foundation. Suggest review by a licensed plumbing contractor to evaluate the condition of the cast iron drain lines and for removal/repair/replacement costs as needed.

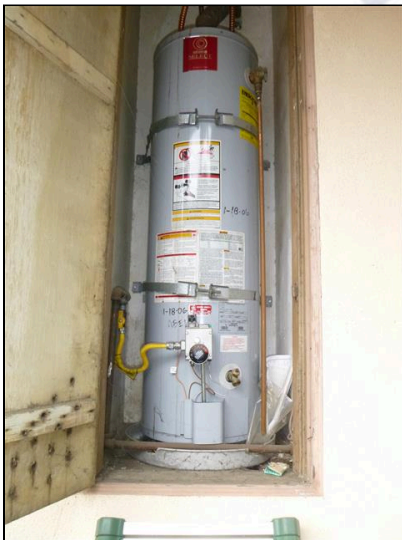
13.0 Item 1 (Picture)

13.0 (1) Due to the age of this unit, suggest review with a licensed plumber for replacement costs as it has exceeded it's intended life span (12-15 years).

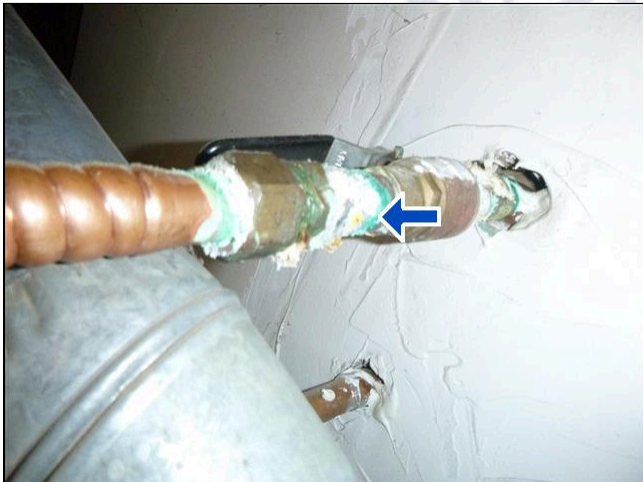
13.0 Item 4 (Picture)

13.0 (2) Rust and corrosion was noted at the cold water shut off and fittings, no leaking was visible at the time of the inspection. Suggest review by a licensed plumber for repair/replacement costs as needed.

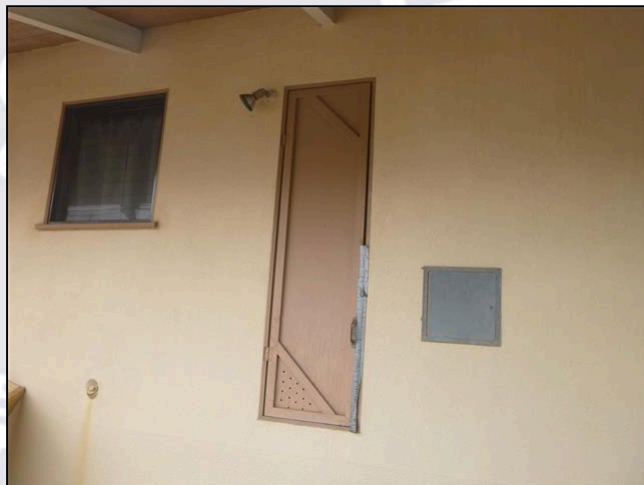
13.2 Item 1 (Picture)

13.2 (1) Water stains noted at the water heater closet walls/ceiling, this area tested dry at the time of the inspection. Suggest review with the seller to verify/determine the cause of the leak and any repairs needed. Suggest review with a licensed contractor for any repair/removal/replacement costs as needed.

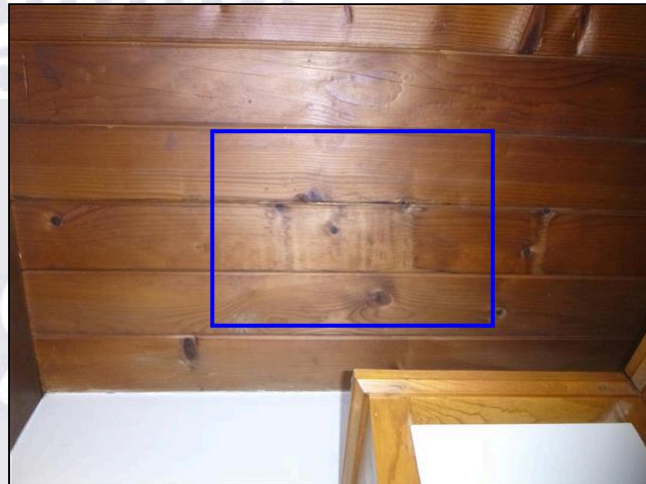
14.2 Item 1 (Picture)

14.2 Water stains and deterioration noted at the ceiling, suggest repairs as needed.

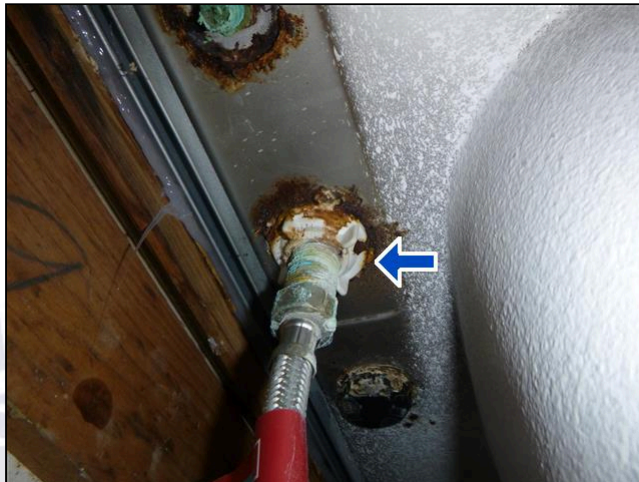
14.9 Item 1 (Picture)

14.9 Rust and corrosion noted at the base of the faucet, suggest replacement as needed.

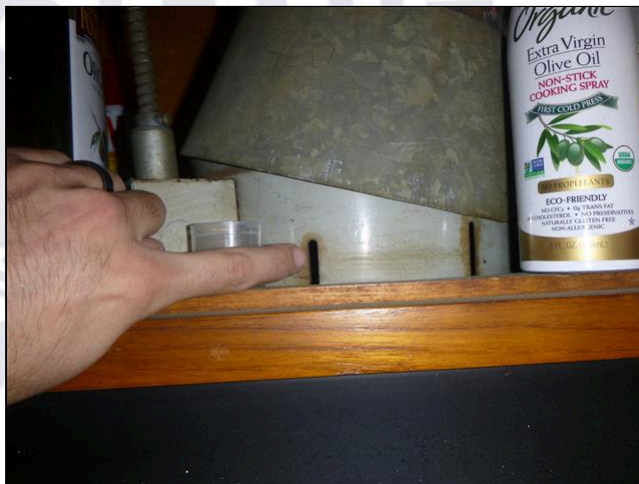
14.13 Item 1 (Picture)

14.13 Excessive air leakage at the ducting connection in the upper cabinet, this is a potential fire spread hazard, suggest review with a licensed contractor and repair/replace as needed for safety.

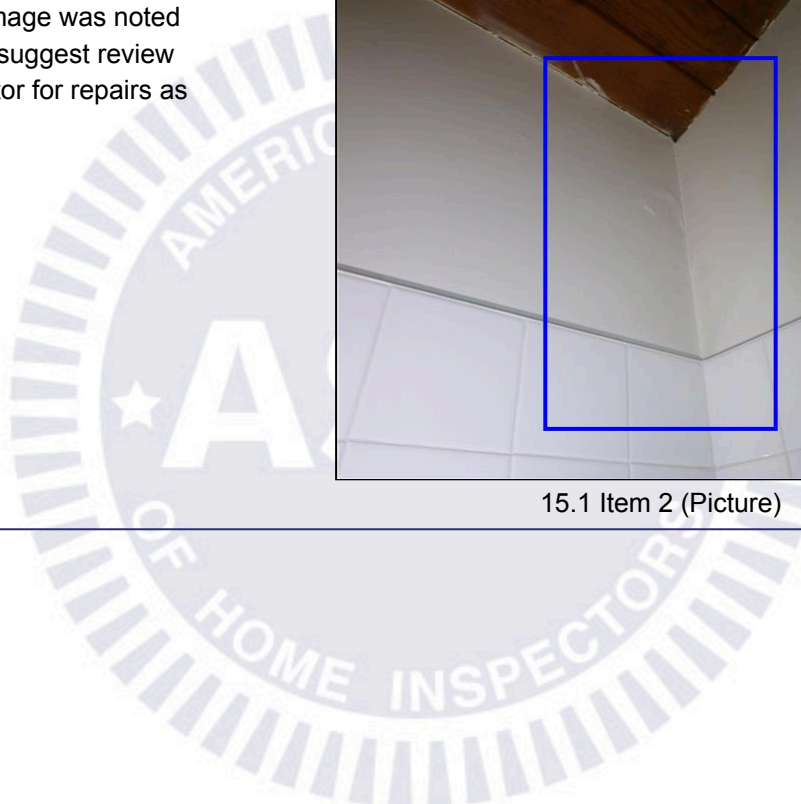
15.1 Item 2 (Picture)

15.1 (2) Old water damage was noted at the rear wall/corner, suggest review with a licensed contractor for repairs as needed.

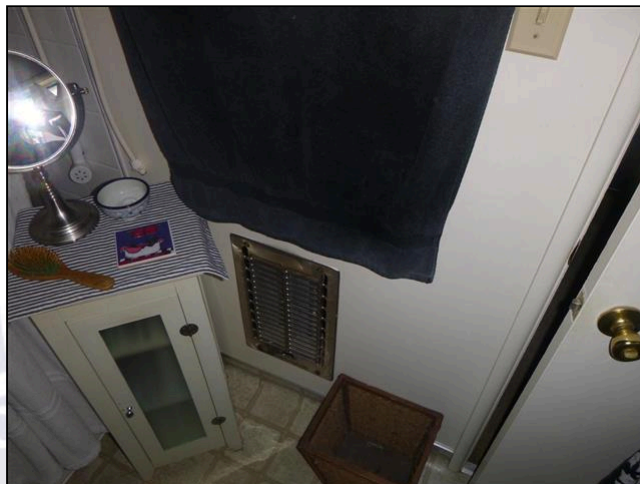
15.8 Item 1 (Picture)

15.8 Due to the possible child safety hazard and possibly fire hazard due to proximity to towel racks, suggest review with a licensed contractor for costs to disconnect and/or remove the wall heat coil unit.

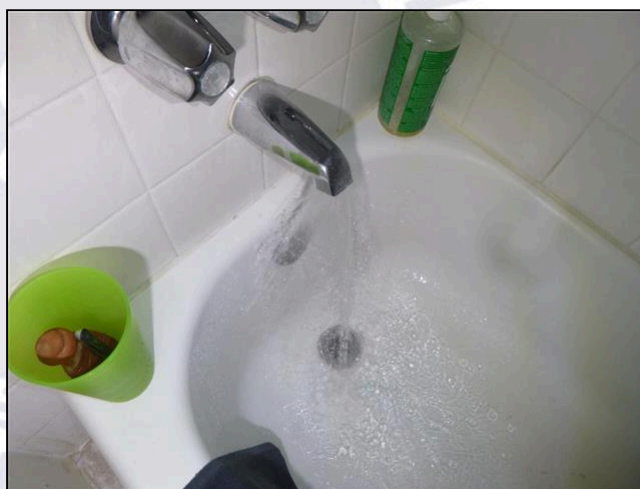
15.10 Item 1 (Picture)

15.10 The existing tub faucet is not a low-flow system as required. Suggest review with a licensed plumber for costs to replace the existing tub faucet with a low flow faucet (2.2 gallons per minute) as required by the State of California as of January 1st, 2017. See the plumbing system comments for further details and a link to the State of California plumbing ordinance.

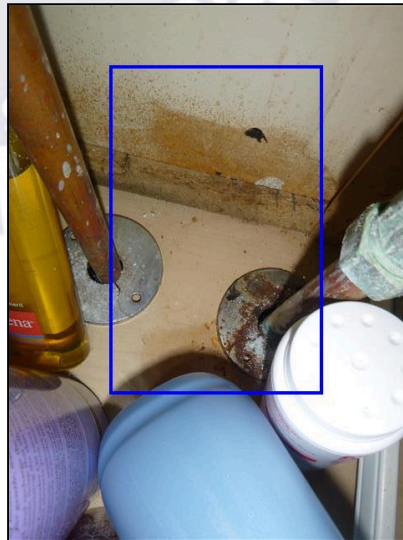
15.18 Item 1 (Picture)

15.18 The base cabinet under the sink is deteriorated/stained from previous leaks, suggest repair/replace as needed.

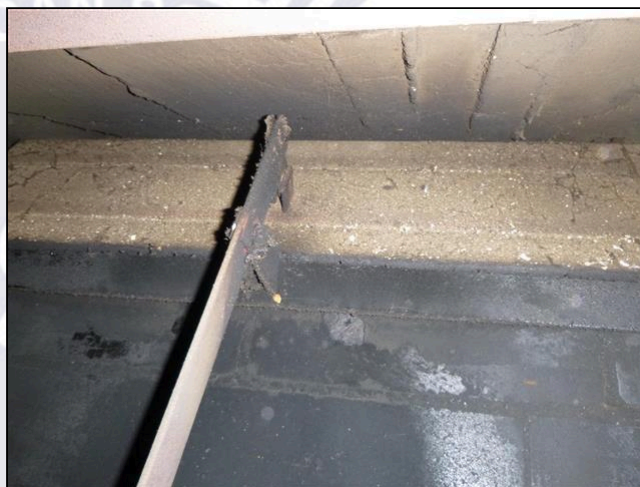
17.6 Item 1 (Picture)

17.6 (1) The fireplace damper was operational at the time of the inspection. Suggest securing the damper to a fixed open position due to the gas installation per current requirements.

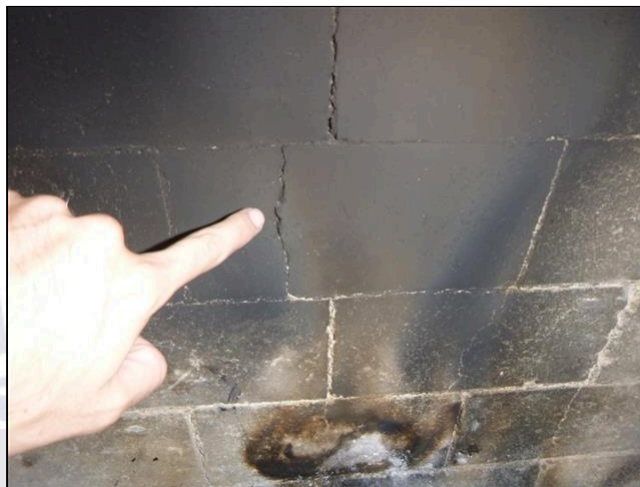
17.6 Item 2 (Picture)

17.6 (2) Excessive creosote noted within the firebox, smoke chamber or chimney areas. Creosote build-up can cause chimney fires if not removed from voids, open seams or open mortar joints within the fireplace and chimney. This inspection is a 'Level 1' inspection and is limited to visible and accessible areas only. 'Level 2' and 'Level 3' inspections are invasive inspections performed by qualified personnel only with equipment designed for fireplace/ chimney inspections, cleaning or repairs. Suggest periodic cleaning of the fireplace/chimney and remove the creosote and debris within the fireplace and chimney. Suggest review by a professional chimney sweep for estimates, repairs or cleaning.

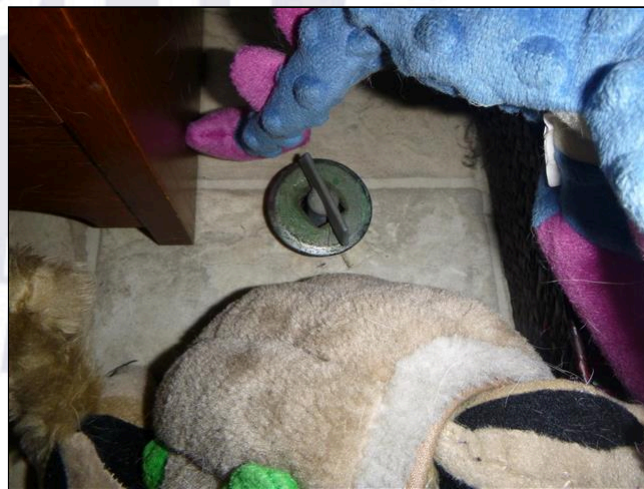
17.6 Item 4 (Picture)

17.6 (4) The tenant advised the inspector that the gas line was previously "Red Tagged" by the gas company which indicates a safety hazard. The tenant also advised that the tag was removed but no repairs were done/completed. Suggest review with the gas company as needed for safety.

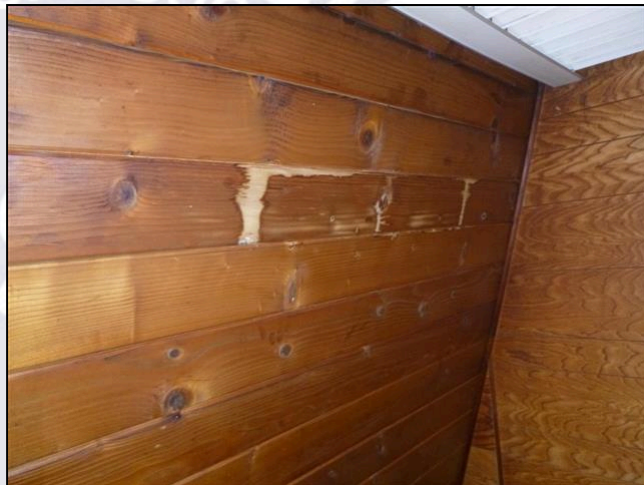
18.2 Item 1 (Picture)

18.2 (1) Water stains and deterioration noted at the ceiling, suggest repairs as needed.

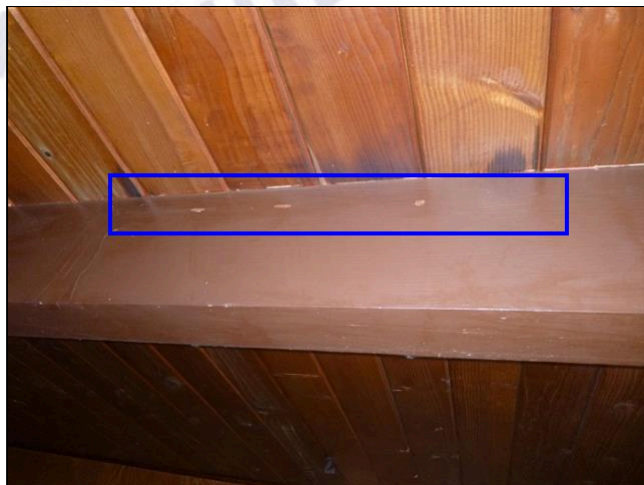
18.2 Item 2 (Picture)

18.2 (2) Wood deterioration noted at the vaulted ceiling, suggest review with a licensed contractor/licensed termite contractor as needed.

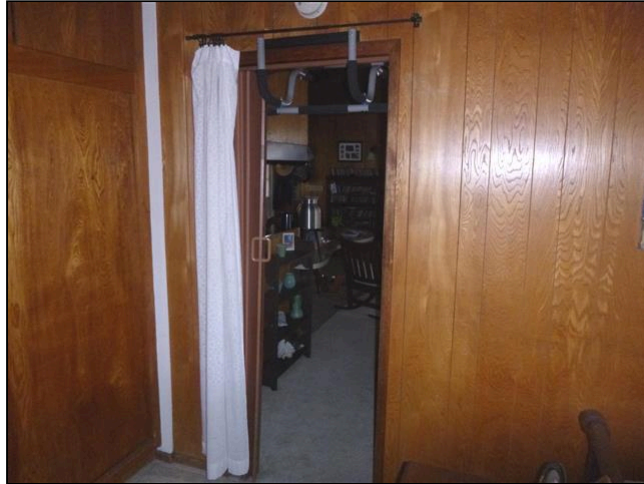
18.3 Item 1 (Picture)

18.3 Generally a vinyl sliding door is not an acceptable door for a bedroom. A bedroom door should be able to be closed and blocked/barricaded at the interior for safety if required. Suggest review with the city and/or a licensed contractor for repairs/replacement as needed.

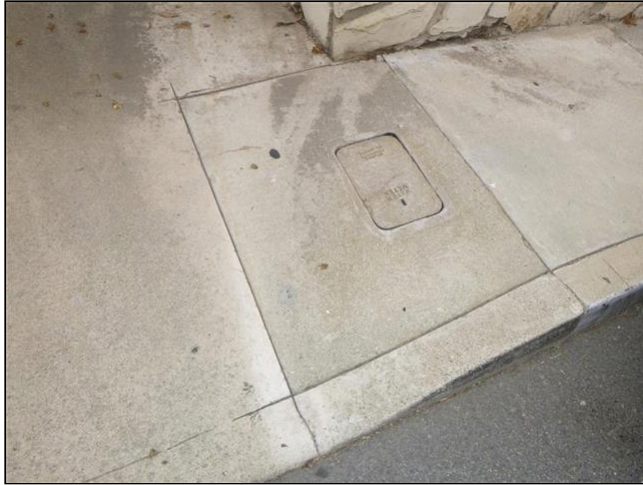
1.0 Item 1 (Picture)

Patched and repaired areas of the driveway was noted. Suggest review with the seller on the cause and any repairs needed. Suggest repair as needed.

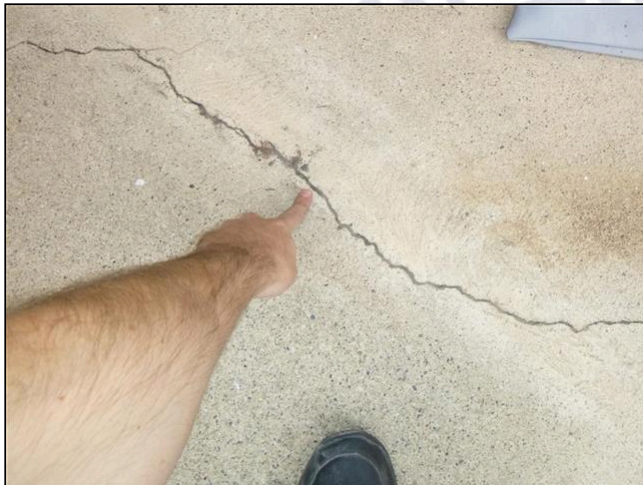
1.1 Item 1 (Picture)

Minor settling cracks noted at various areas, suggest repairs as needed.

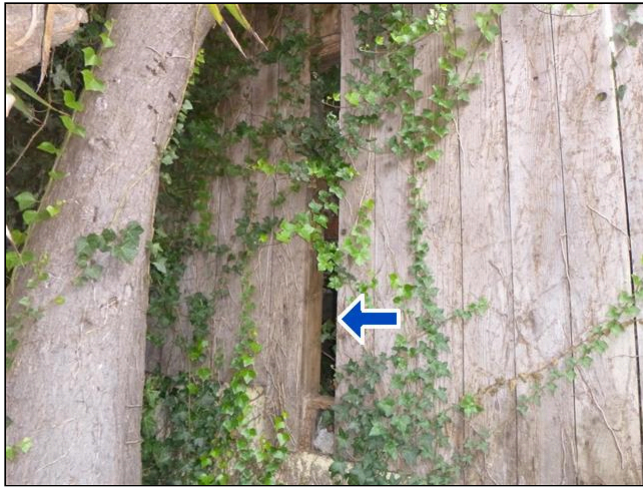
1.2 Item 1 (Picture)

(1) Deteriorated areas of the wood fence noted at the rear, suggest repair/replace as needed.
