Inspection Report

Property Address:
1102 7th Place
Hermosa Beach CA 90254

Ferguson Home Inspections

Date: 10/13/2022	Time: 02:00 PM	Report ID: 10132022Prospect
Property: 1102 7th Place Hermosa Beach CA 90254	Customer: Wendy & Scott Fletcher	Real Estate Professional: Amy Teitelbaum

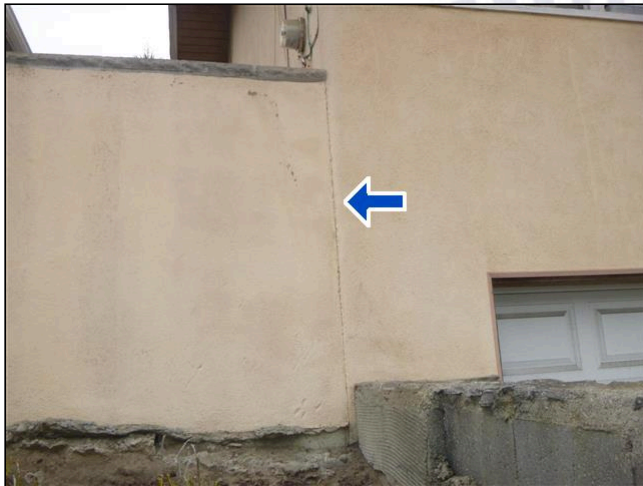
1.2 Item 2 (Picture)

(2) Cracks noted at the block fences, areas stable at the time of the inspection. Suggest repairs/maintenance as needed.

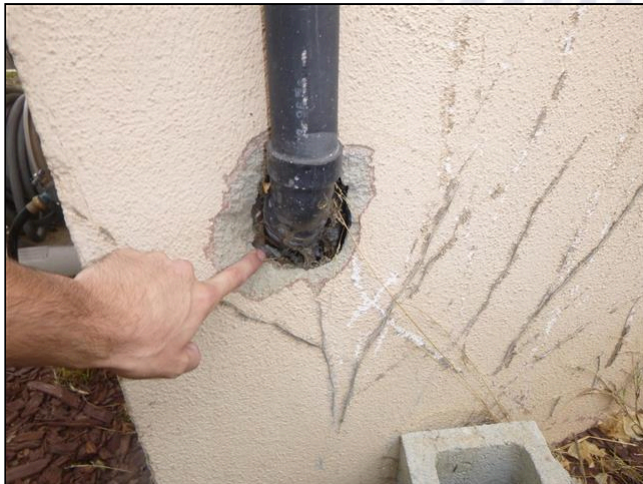
1.4 Item 1 (Picture)

(1) A large hole/gaps were noted at the stucco siding at the rear left near the plumbing vent. Suggest sealing around the siding penetration's to prevent future water/insect/rodent intrusion at these areas.

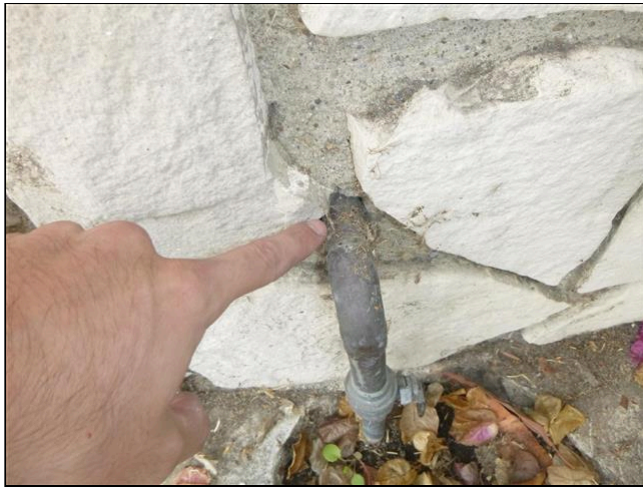
1.4 Item 2 (Picture)

(2) Suggest sealing around the siding penetration's to prevent future water/insect/rodent intrusion at these areas.

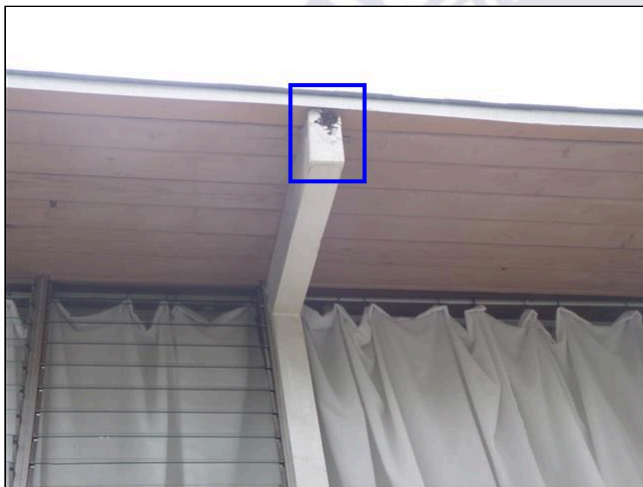
1.5 Item 1 (Picture)

Paint blistering, peeling and wood deterioration noted at various trim areas. Suggest review with a termite company and/or a licensed contractor and repair/replace as needed.

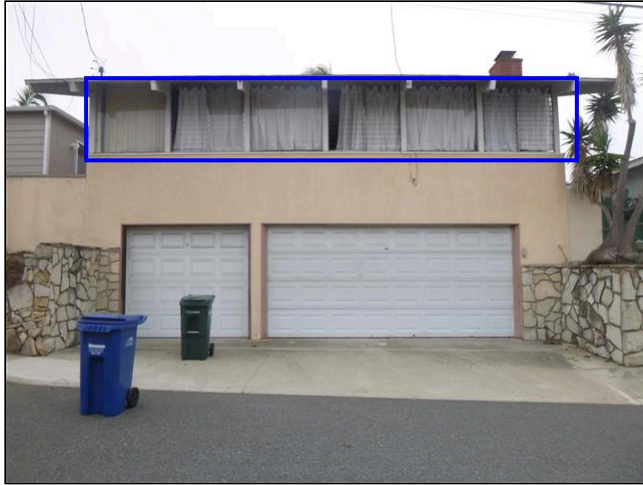
1.6 Item 1 (Picture)

(1) Aluminum louvered windows noted throughout the dwelling. These style windows, due to the style and construction, are susceptible to leak during heavy and direct rain. Due this issue and that the glass is also non-tempered, please review with a licensed contractor for replacement costs as needed.

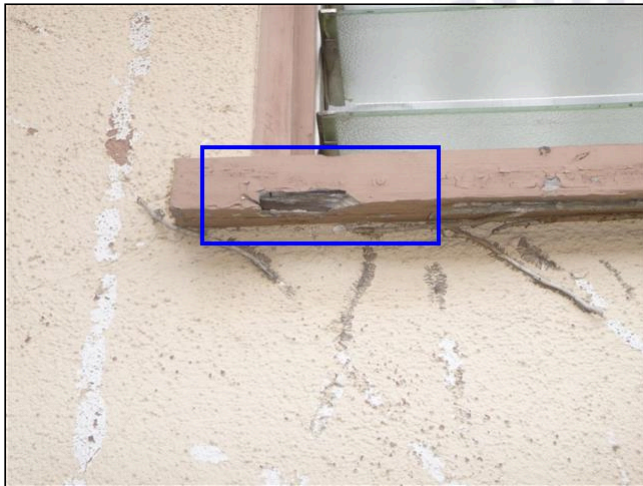
1.6 Item 2 (Picture)

(2) Wood deterioration noted at various windows. Suggest review with termite company and/or a licensed contractor and repair/replace as needed.

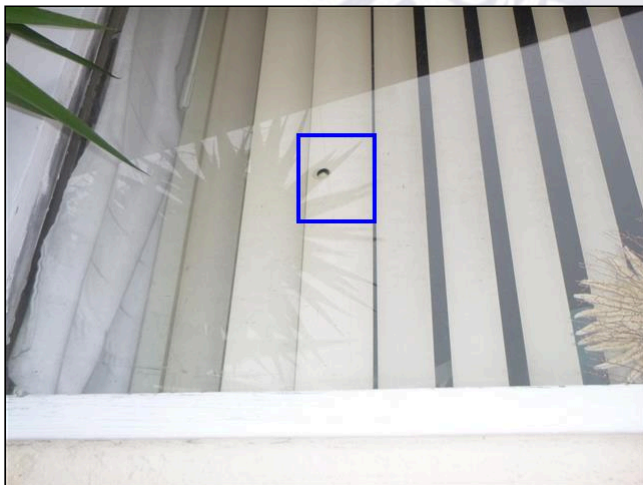
1.6 Item 3 (Picture)

(3) Cracked/damaged areas of the window glass was noted, suggest review with the seller and/or a glazier for replacement costs as needed.

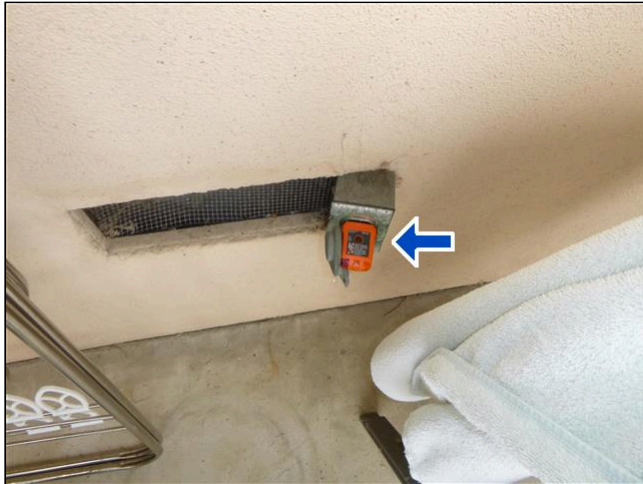
1.8 Item 1 (Picture)

(1) Unable to test the outlet at the rear exterior area as there was no power to the outlet. Suggest review with a licensed electrician for repair/replacement cost and confirm correct operation as needed.

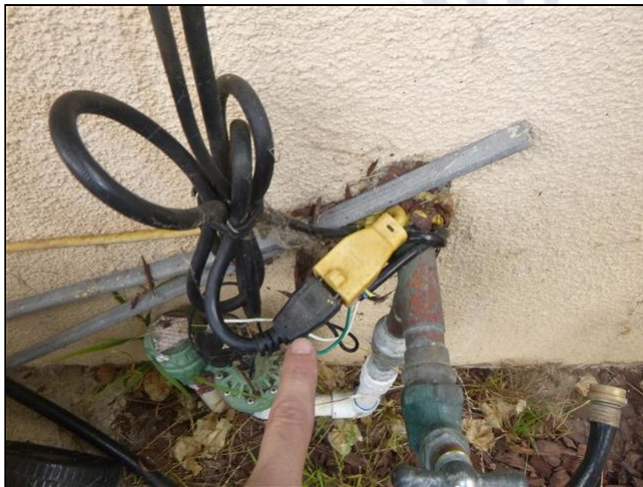
1.8 Item 2 (Picture)

(2) The outside outlet is using an extension cord as permanent wiring, and needs to be properly wired or removed.

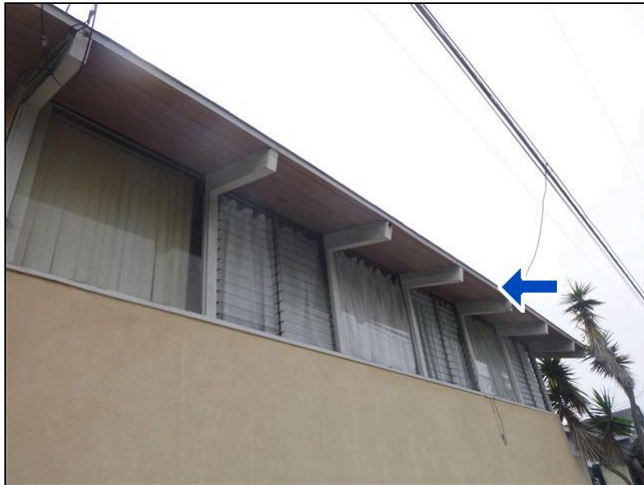
1.9 Item 1 (Picture)

Suggest installation of gutters throughout all eave areas and installation of an area drainage system to divert the water away from the foundation to the street as an upgrade.

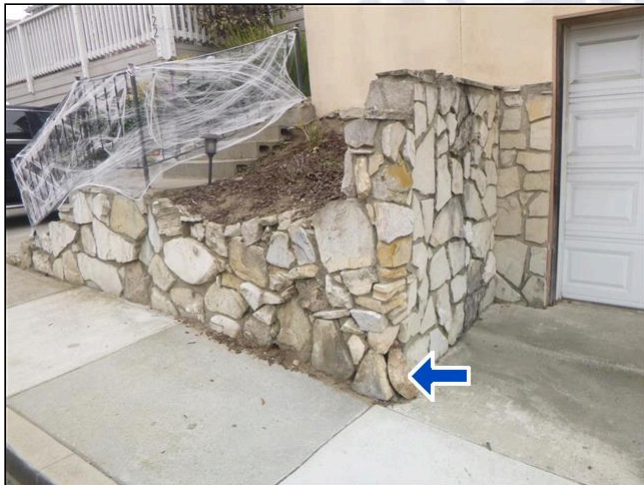
1.10 Item 1 (Picture)

A stone was loose at the front retaining wall, suggest repairs as needed.

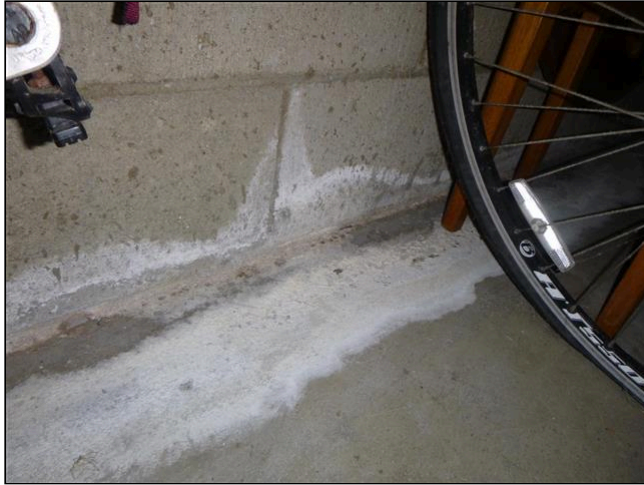
3.0 Item 1 (Picture)

(2) White efflorescence (powder substance) on foundation footings indicates prior, and possibly ongoing, excessive moisture build up at the exterior of the foundation. Ongoing water intrusion at the foundations can, in some cases, cause the steel in the foundations to rust, called spalling, which can lead to horizontal cracking of the foundation (currently there are no major horizontal cracks visible at the foundation). Any future horizontal cracking/damage can be an expensive repair as the foundation would be considered structurally weak and susceptible to horizontal movement. Suggest review of the Lot/Grade and drainage systems, including rain gutters, to reduce and prevent further and future water buildup at the exterior of the dwellings foundations.

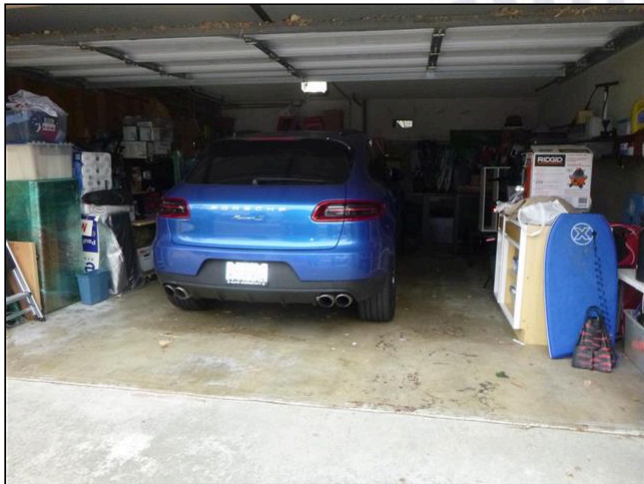
3.0 Item 2 (Picture)

(3) Limited review of the foundation and interior wood support members due to the excessive personal items within the garage. Suggest review with a licensed contractor once the items have been removed.

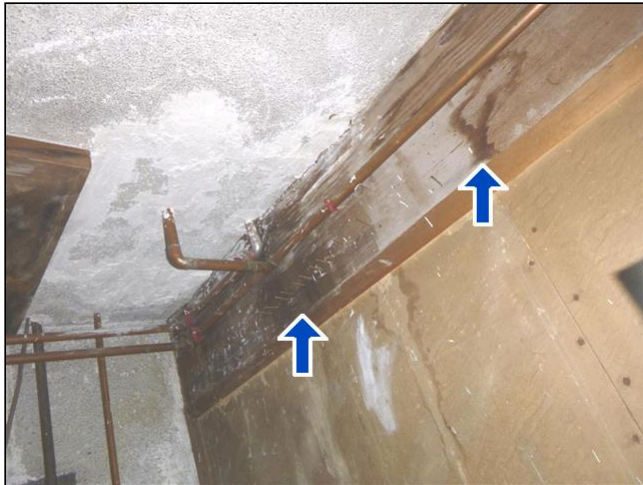
3.1 Item 1 (Picture)

(1) Water staining/deterioration noted at the interior floor support system at the garage area, suggest review with a licensed contractor and a licensed termite contractor as needed.

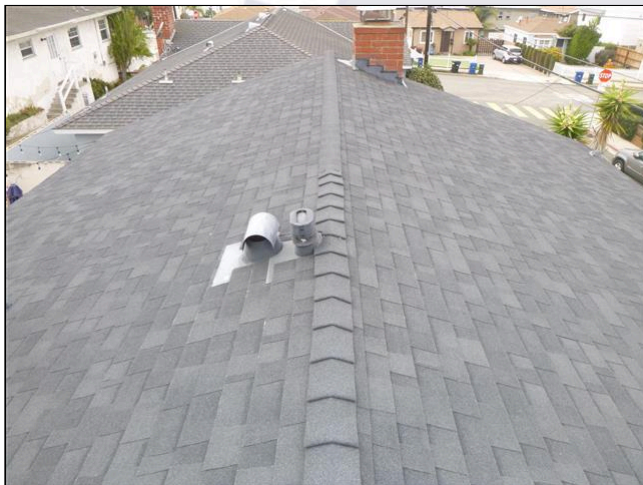
4.0 Item 1 (Picture)

(1) Minor deterioration of the roofing was noted, suggest review with a licensed roofing contractor for repairs, periodic maintenance and to determine the remaining life expectancy of the roof.

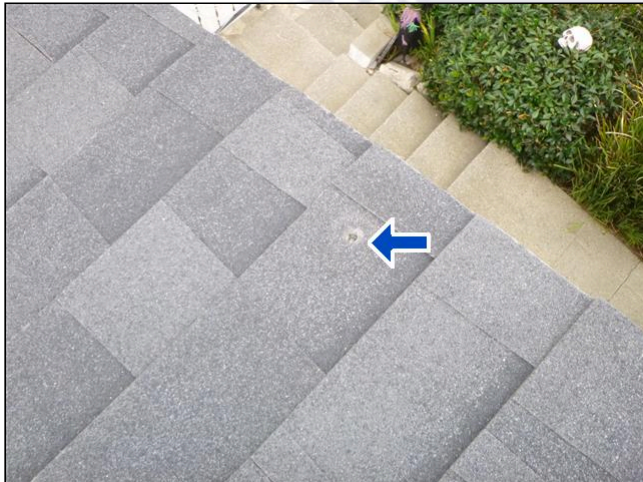
4.0 Item 6 (Picture)

(2) An exposed nail head was noted, suggest repairs as needed to prevent future leakage.

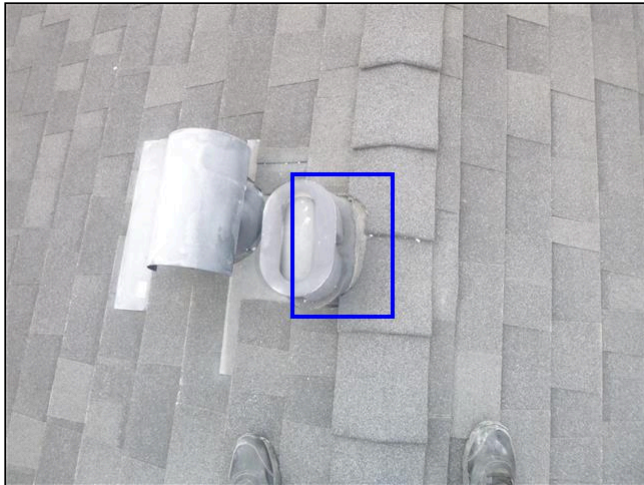
4.1 Item 1 (Picture)

A flashing is incorrectly installed on the ridge (penetrations should not be installed on a ridge). Suggest review with a licensed roofer for repair/relocation costs as needed to prevent future leakage.

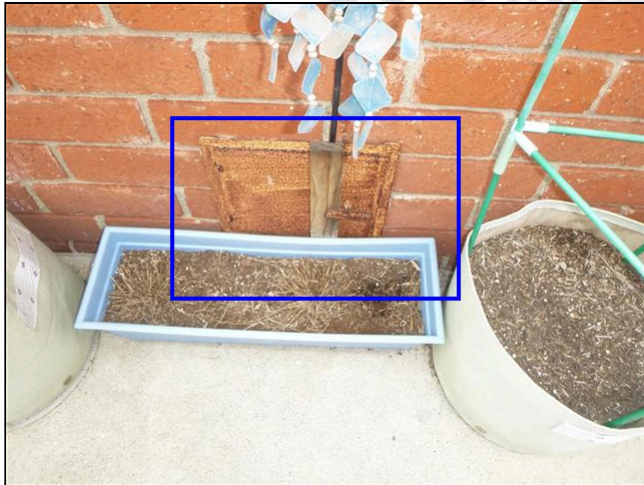
4.2 Item 1 (Picture)

(1) The chimney ash clean out port door was deteriorated/rusted/loose at the time of the inspection, this is a possible fire spread hazard. Suggest repair/replace as needed.

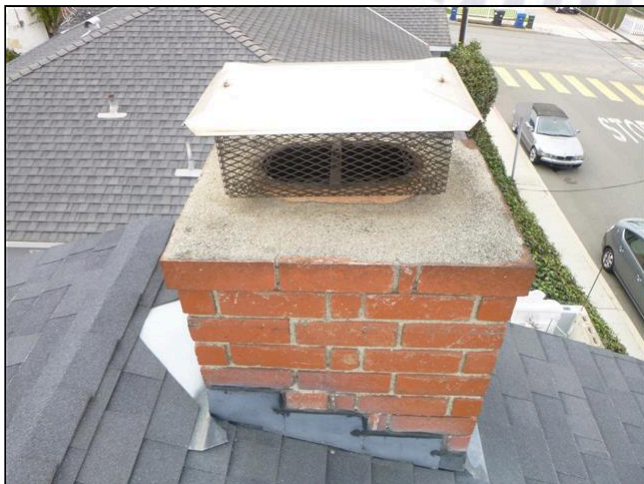
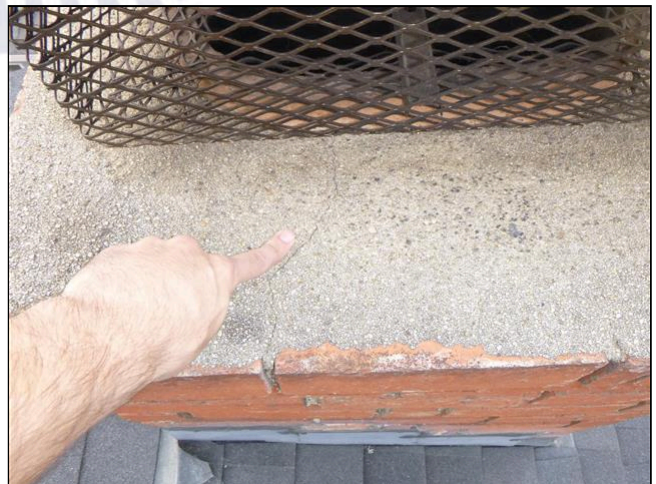
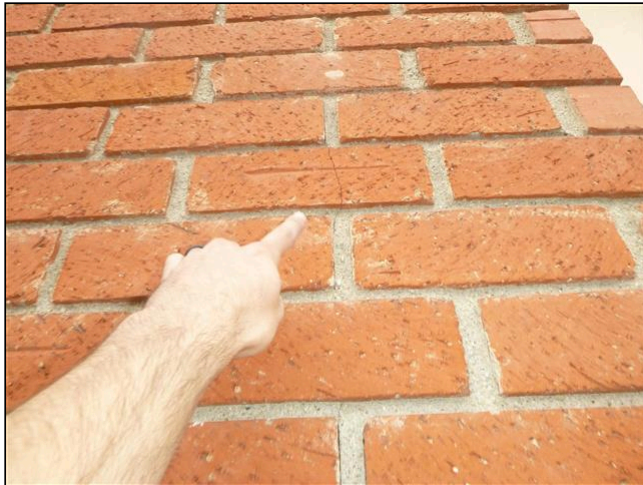
(2) Minor cracks noted at the chimney crown and base, suggest repairs/sealing as needed to prevent future water intrusion and deterioration.

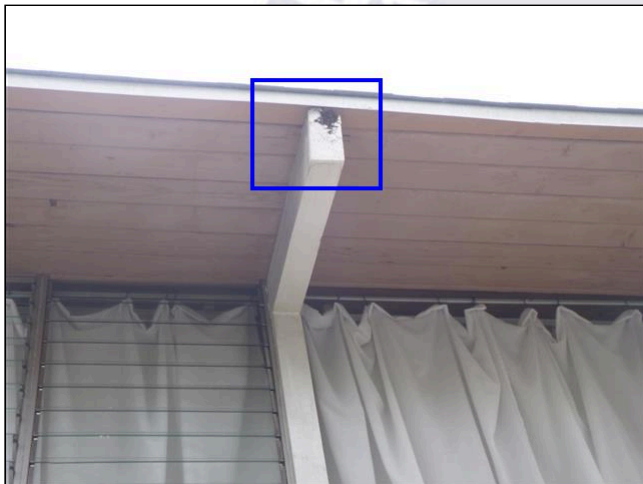
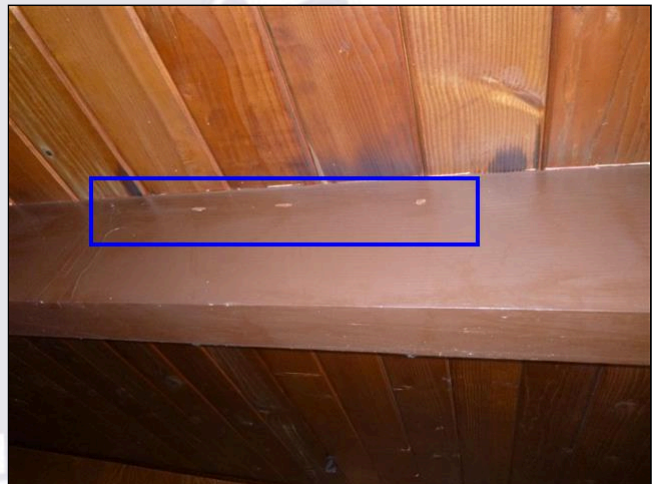
Wood deterioration was noted at the interior and exterior of the dwelling at the wood framing, suggest review with a licensed contractor and a licensed termite contractor for repair/replacement costs as needed.

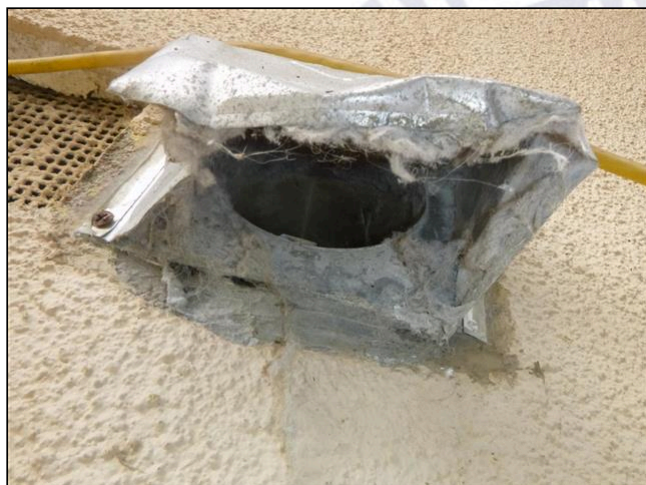
6.4 Item 1 (Picture)

(2) The dryer vent was loose and deteriorated at the exterior, suggest replacement as needed.

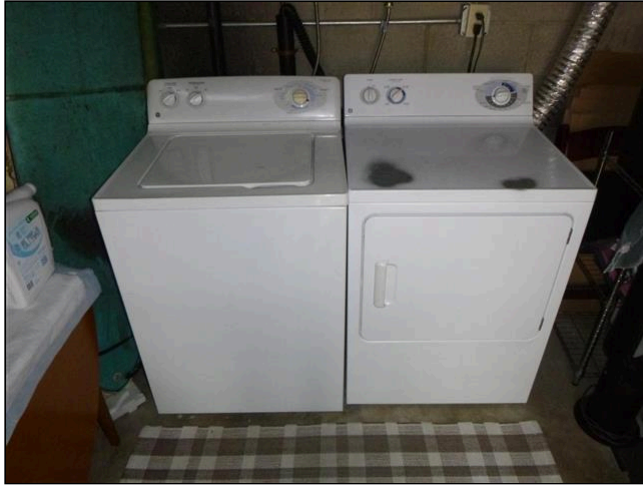
6.5 Item 1 (Picture)

(1) No impact barrier installed as required due to the location of the appliance(s) in the garage. This is common for the original age of the dwelling. Suggest review with a licensed contractor for installation costs as needed as an upgrade.

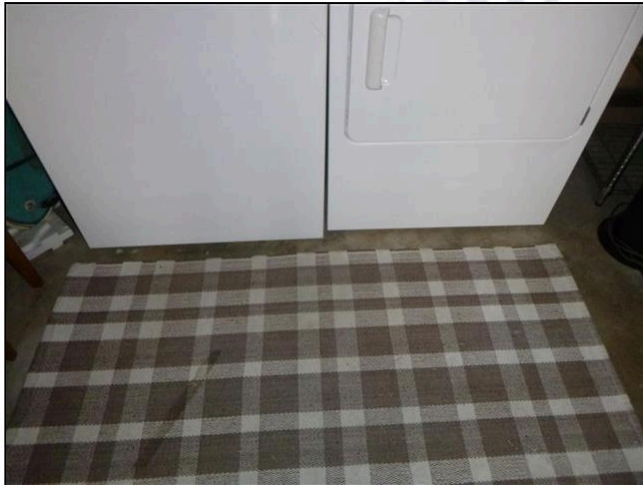
6.5 Item 2 (Picture)

(2) The dryer is not 18 inches above the garage floor level to ensure separation from combustibile materials as required. This is a potential safety hazard. Suggest review by a licensed plumber for repairs/relocation costs as required for safety.

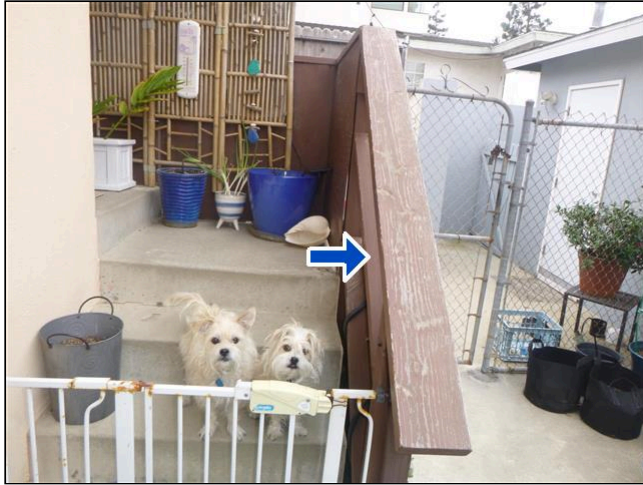
7.2 Item 1 (Picture)

(1) A non graspable handrail was noted at this area, this is a potential safety hazard. Suggest review with a licensed contractor for costs to upgrade to current standards for safety and/or as needed.

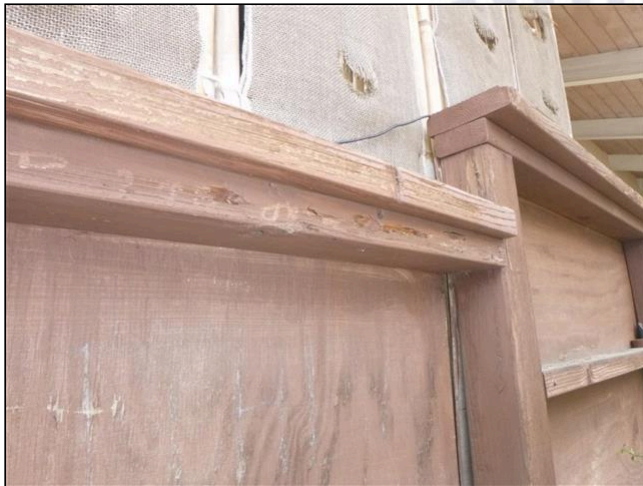
7.2 Item 2 (Picture)

(2) Wood deterioration noted at various areas of the railing, suggest review with a termite company and/or a licensed contractor for repairs as needed.

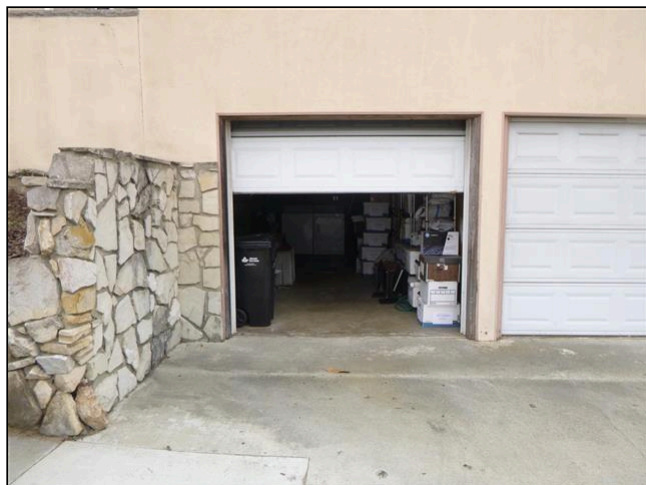
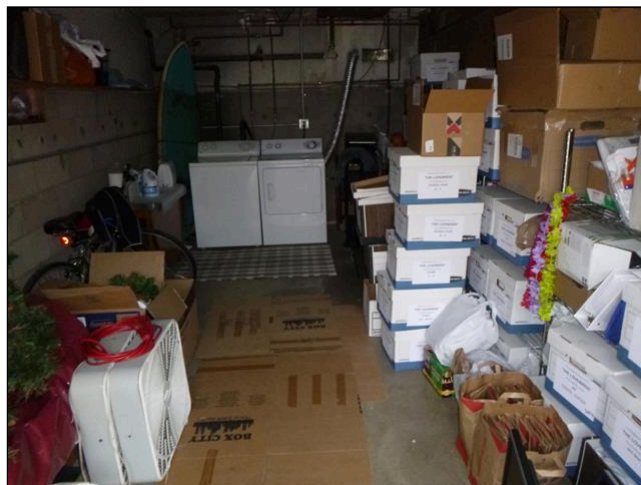
(1) Access within this area was blocked or severely limited at the time of the inspection. An inspection of this area can be performed by appointment and at an additional cost when the area is made accessible.

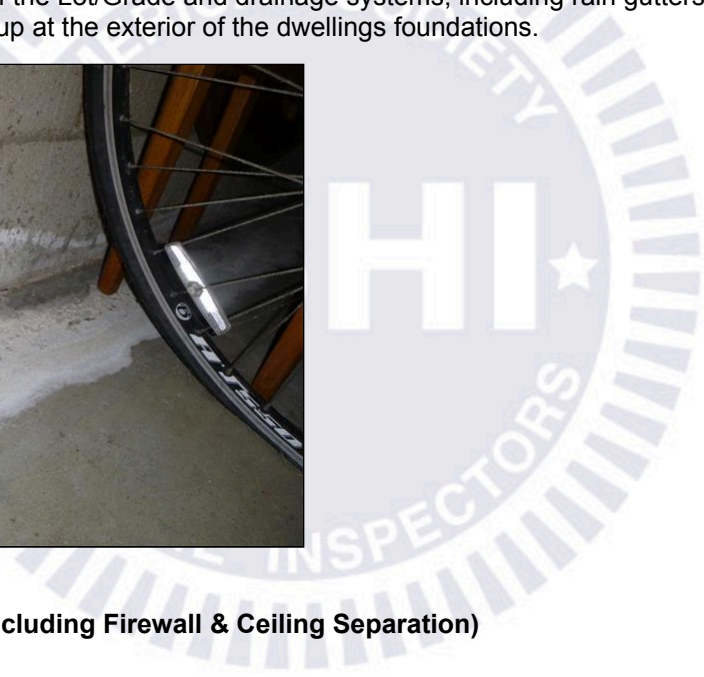
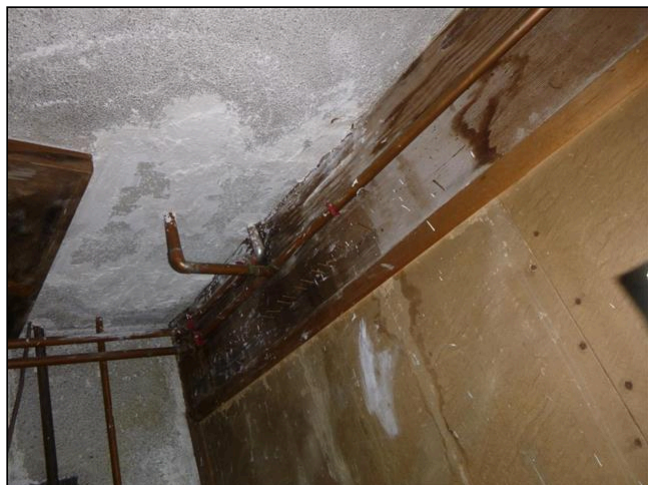
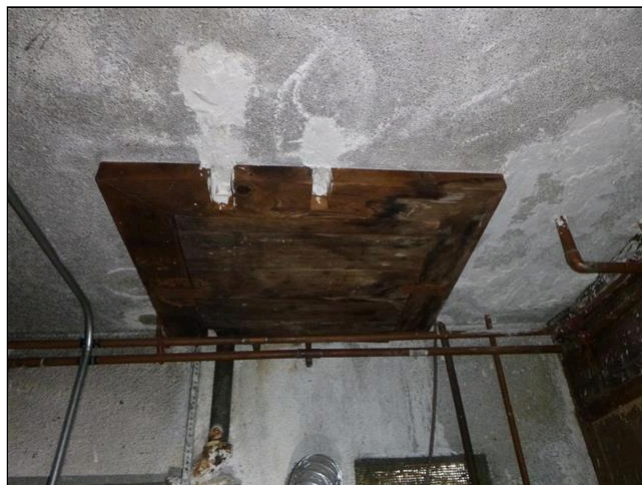
(1) Patched and uneven areas of the ceiling noted (likely from past water damage), suggest review with the seller on the cause and any repairs needed. Suggest repair as needed.

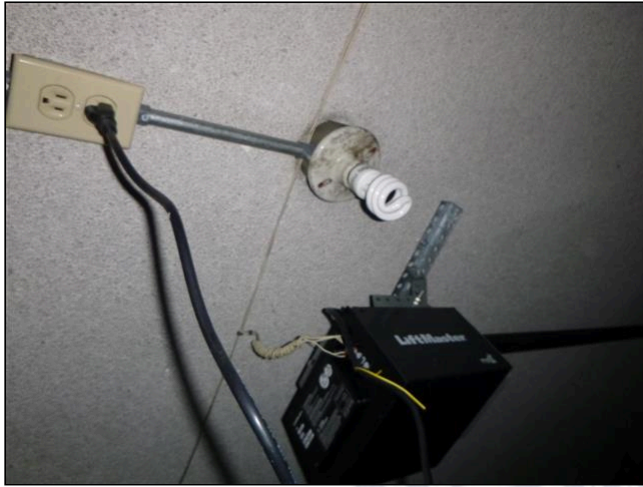
8.5 Item 1 (Picture)

(2) The cover globe(s) are missing at light fixture(s) at the time of the inspection. Suggest replacing the missing cover globe(s) for safety.

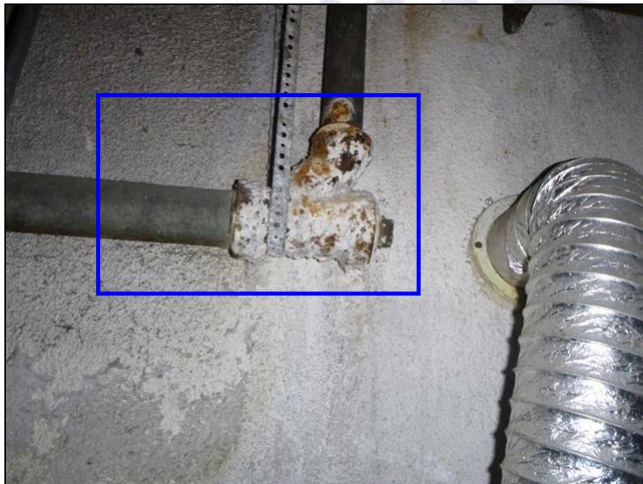
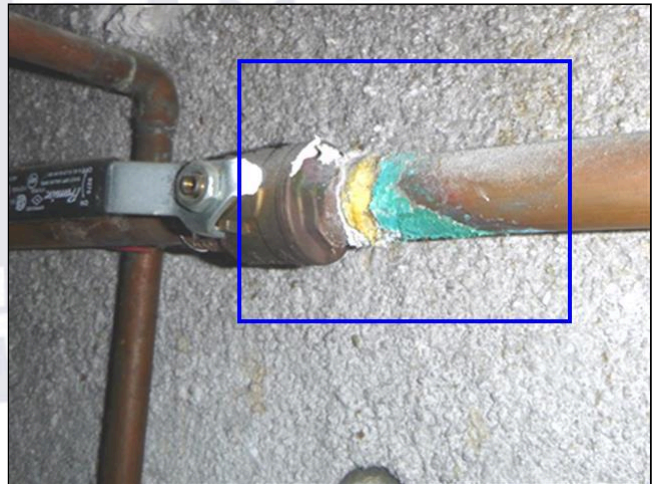
Excessive corrosion noted at the drains and supply lines at this area. Suggest review with a licensed plumber and repair/replace as needed.

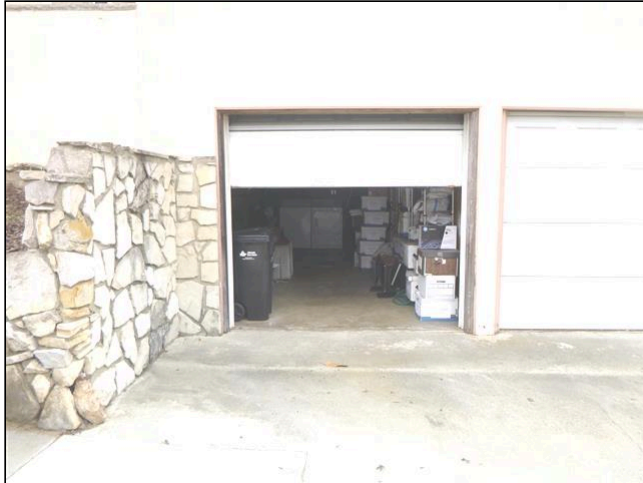
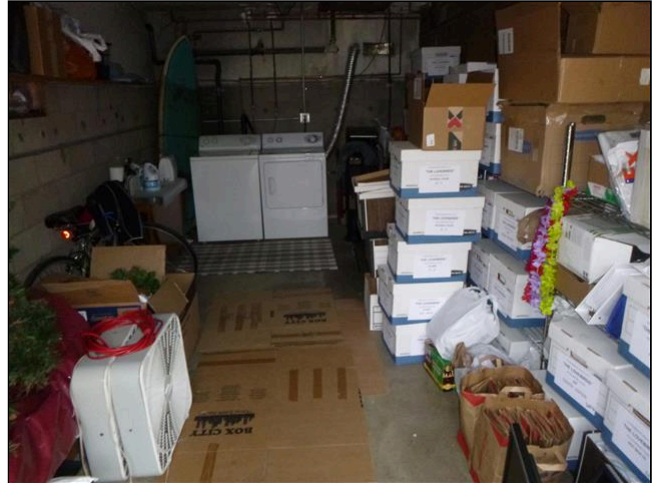
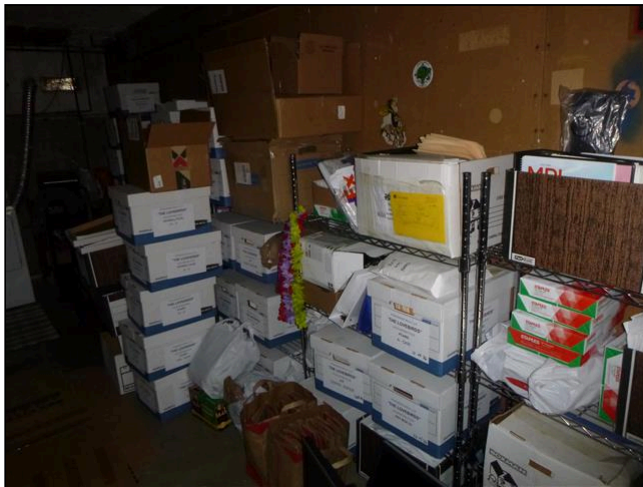
Access within this area was blocked or severely limited at the time of the inspection. An inspection of this area can be performed by appointment and at an additional cost when the area is made accessible.

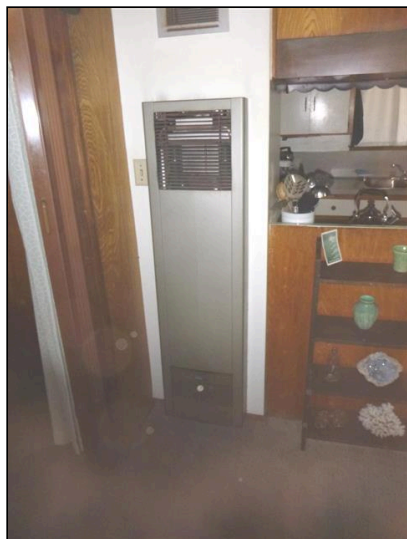
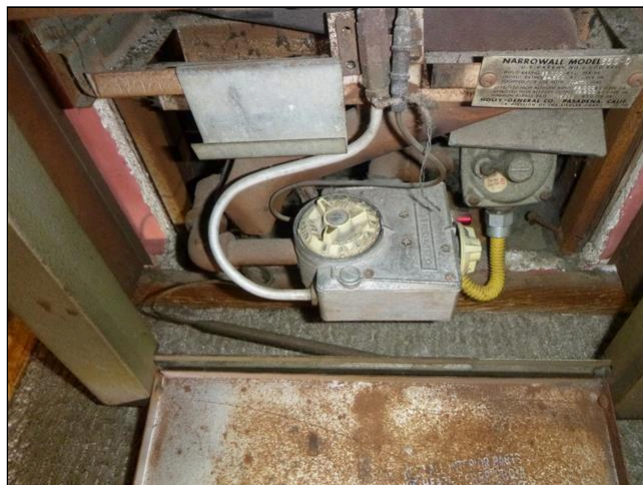
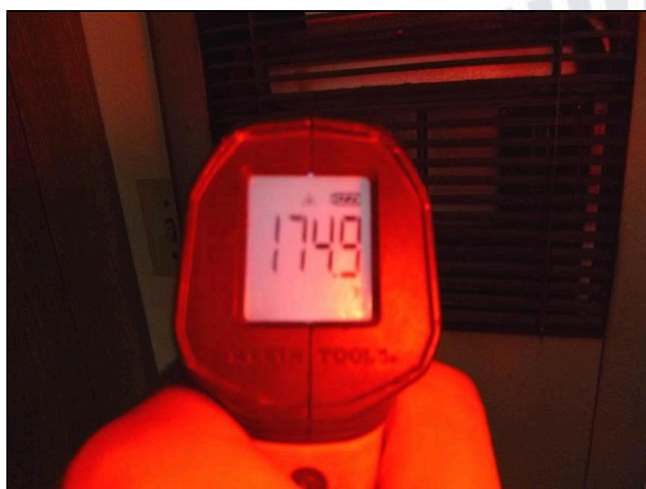
The heater/furnace is very old but did work at the time of inspection. The inspector is unable to determine remaining life expectancy of this system. Due to the age and style of this system, suggest review with the Gas company and/or a licensed heating company for further review to determine the remaining life expectancy of the unit and any repair/replacements costs as needed.

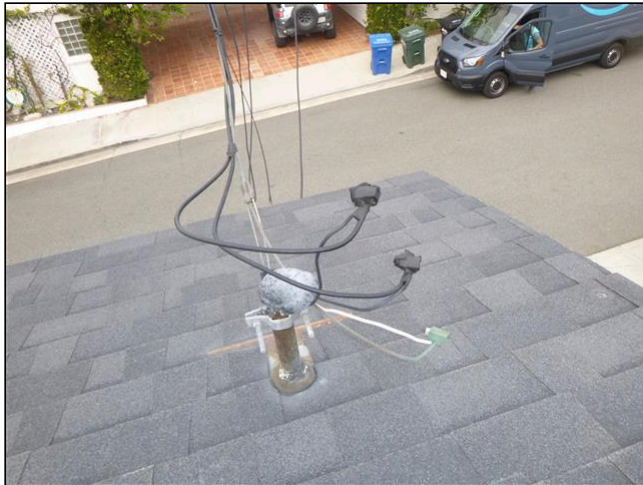
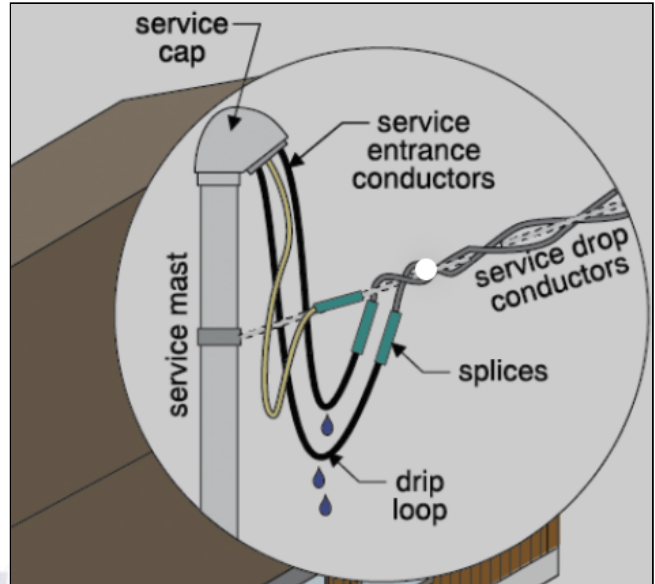
Inadequate drip loop was noted, suggest review with a licensed electrician for repairs as needed.

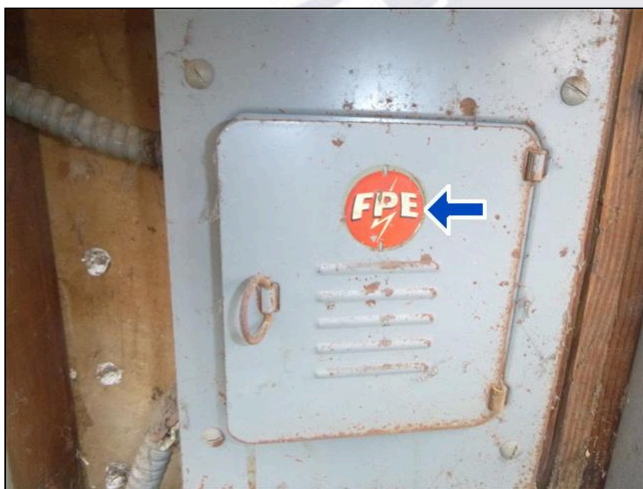
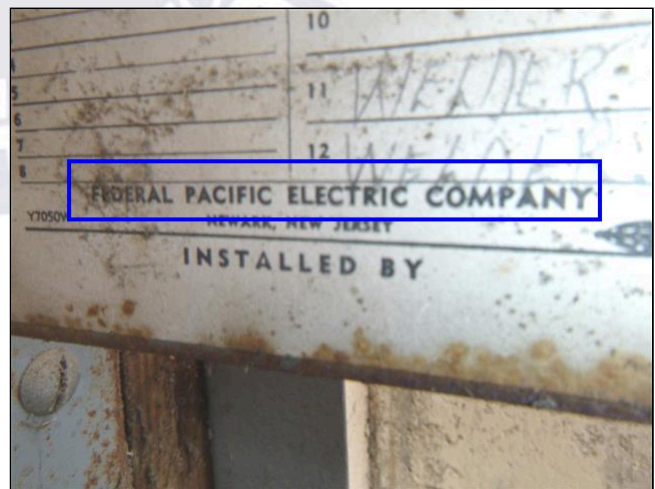
(1) Currently a Federal Pacific electrical panel is installed, please be aware that there is a possibility that the circuit breakers may not trip when shorted possibly causing an electrical hazard. There are problems with these panels that can, in some cases, be serious. Some Federal Pacific panels have aluminum bus bars (the bars that run down the middle of the panel to which the breakers connect). Over a period of years, oxide forms on the aluminum causing a poor connection with the breakers and leading to arcing, overheating, and, eventually, breaker failure. Other problems with Federal Pacific panels include circuit breakers (depending on the vintage) with a dismal performance record and the possibility of unbalanced multi-wire circuits. Also, please be aware that various insurance companies will not insure homes with this style of electrical panel. Suggest review by a licensed electrician for replacement costs as needed.

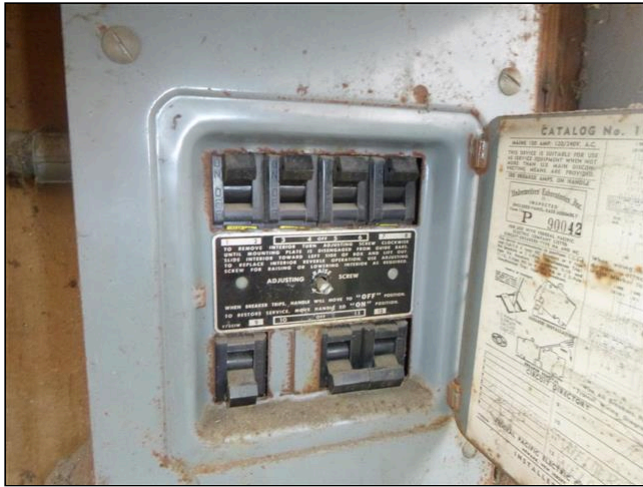
10.1 Item 3 (Picture)

(2) Suggest adding correct/complete indexing/labelling to all breakers for identification of each circuit for safety.

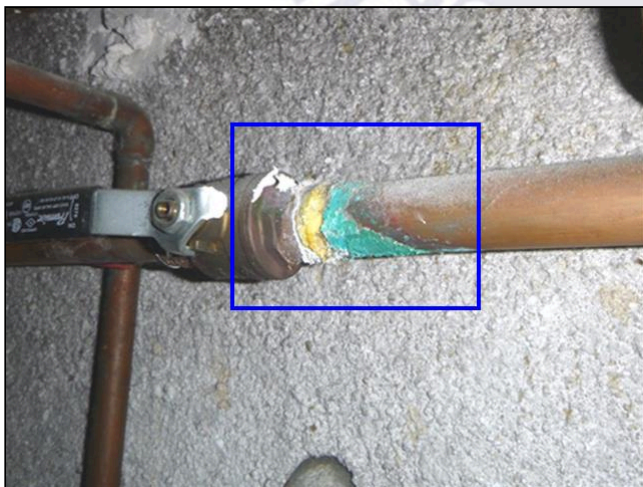
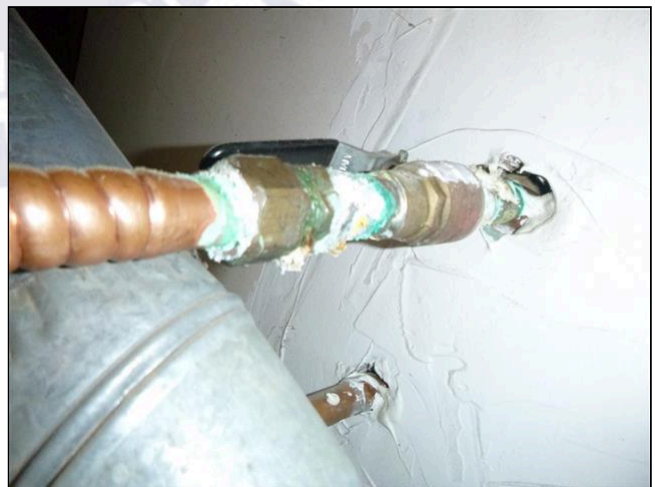
(1) Corroded plumbing and fittings noted at various areas within the dwelling/garage. Suggest further review by a licensed plumber for repair/replacement costs as needed to prevent future leakage, pin hole leaks and possible stains/damage to the interior of the dwelling.

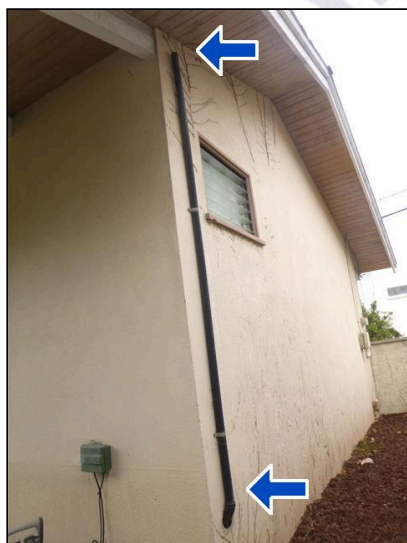
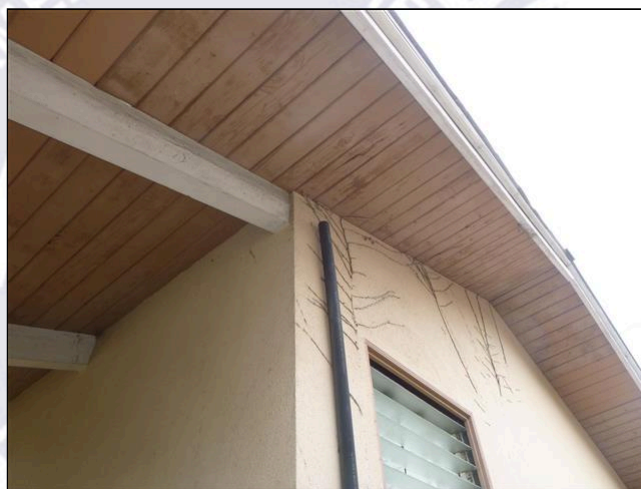
(3) The plumbing vent at the rear left is installed incorrectly and does not extend 12 inches past the roof as required. Suggest review with a licensed plumber for repairs as needed.

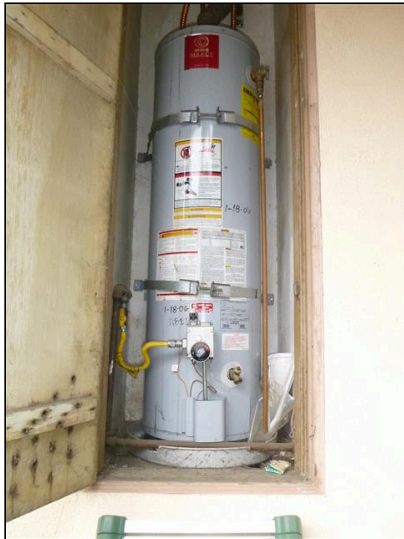
13.0 Item 1 (Picture)

(1) Due to the age of this unit, suggest review with a licensed plumber for replacement costs as it has exceeded it's intended life span (12-15 years).

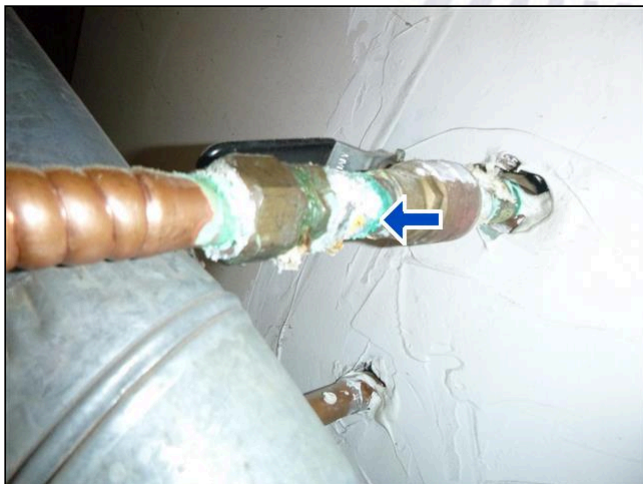
13.0 Item 4 (Picture)

(2) Rust and corrosion was noted at the cold water shut off and fittings, no leaking was visible at the time of the inspection. Suggest review by a licensed plumber for repair/replacement costs as needed.

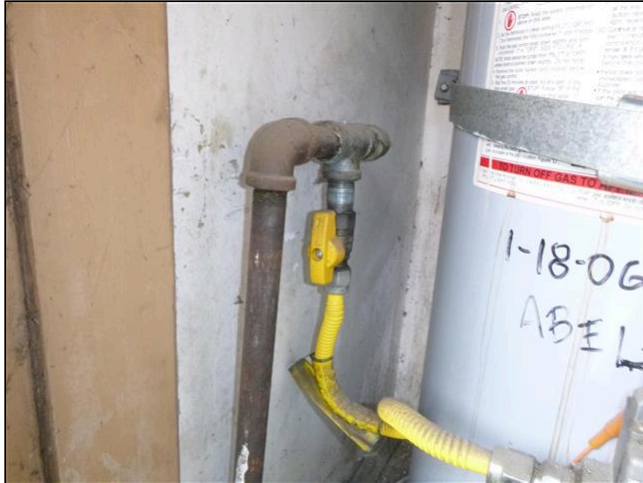
13.0 Item 6 (Picture)

(3) Currently no gas supply line drip leg/sediment trap is installed, please be aware that various cities do not enforce/require this installation. Suggest review with the local City Building Department and/or with a licensed plumbing contractor for installation costs as needed.

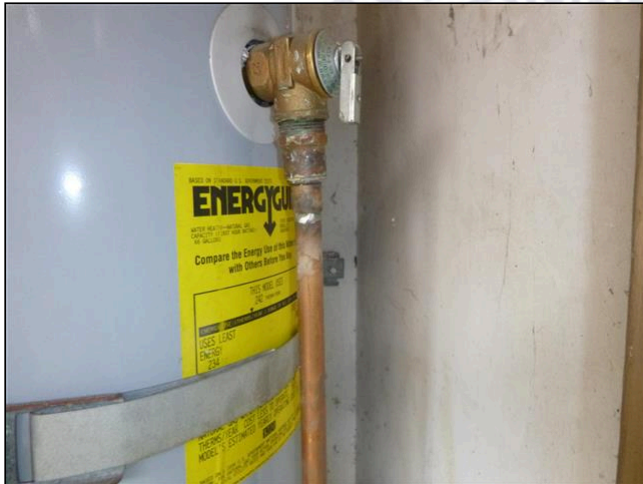
13.0 Item 7 (Picture)

(4) The pipe off the temperature pressure release valve is undersized, suggest review with a licensed plumber for replacement costs as required.

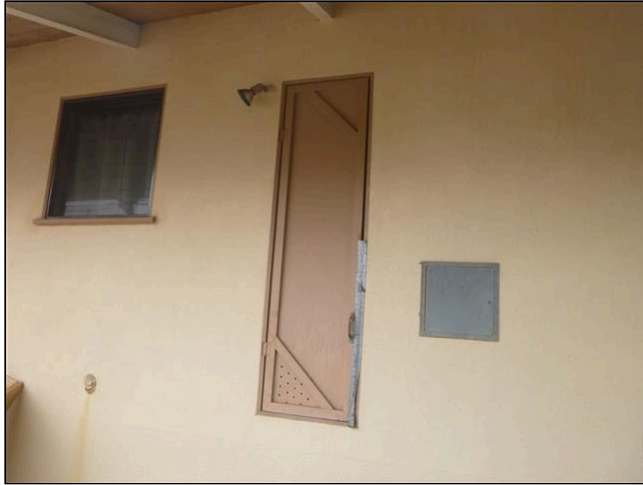
13.2 Item 1 (Picture)

(2) Inadequate combustion air source noted at the water heater closet, typically an upper and lower vent are required. Suggest review with a licensed contractor for installation costs as needed.

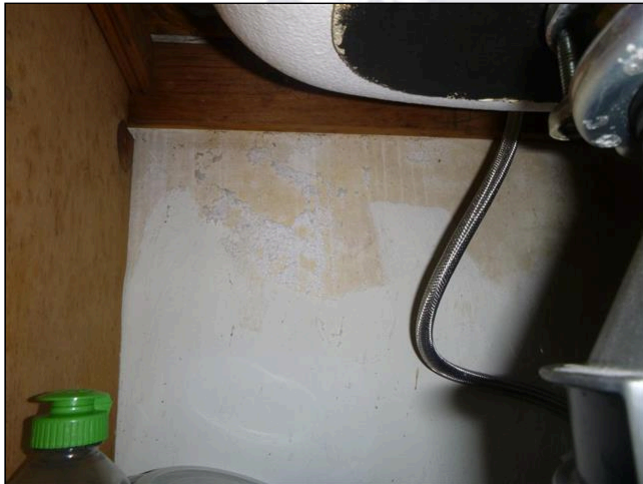
14.1 Item 1 (Picture)

Water damage/staining was noted under the sink, suggest review with a licensed contractor for removal/repair/replacement costs as needed.

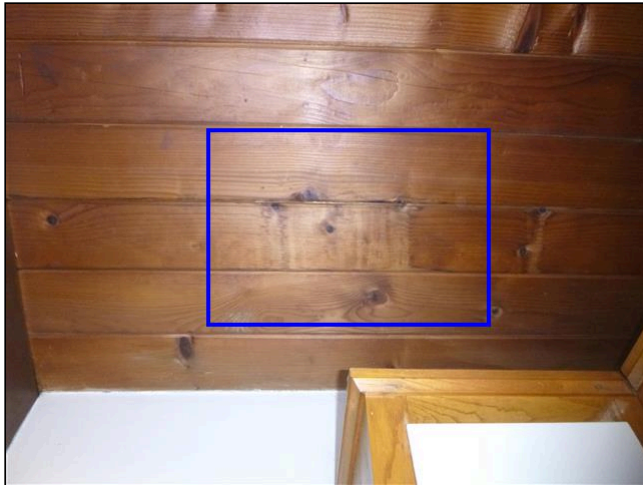
14.2 Item 1 (Picture)

Water stains and deterioration noted at the ceiling, suggest repairs as needed.

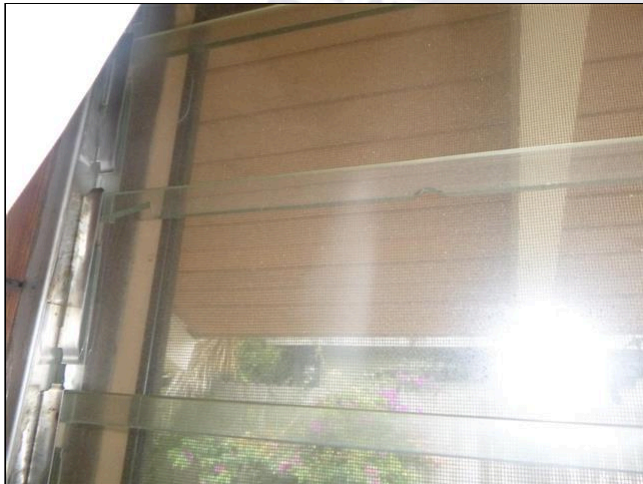
14.3 Item 1 (Picture)

(1) Aluminum louvered windows noted at this room and throughout the dwelling. These style windows, due to the style and construction, are susceptible to leak during heavy and direct rain. Due this issue and that the glass is also non-tempered, please review with a licensed contractor for replacement costs as needed.

(2) Chipped glass noted at the window(s), this is a potential safety hazard. Suggest review with a licensed contractor/glazing company for replacement costs as required for safety.

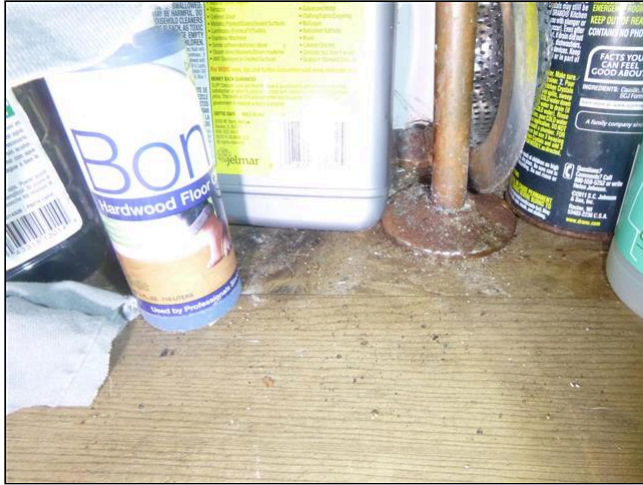
14.5 Item 1 (Picture)

The base cabinet under the sink is deteriorated/stained from previous leaks, suggest repair/replace as needed.

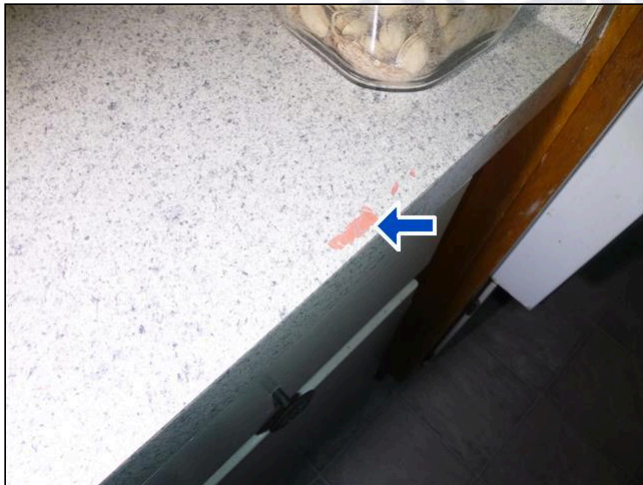
14.6 Item 1 (Picture)

Minor deterioration noted at the countertop, suggest repair/replace as needed.

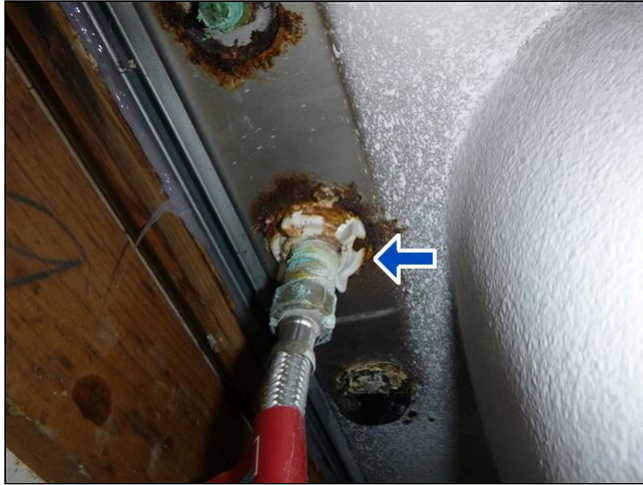
14.9 Item 1 (Picture)

Rust and corrosion noted at the base of the faucet, suggest replacement as needed.

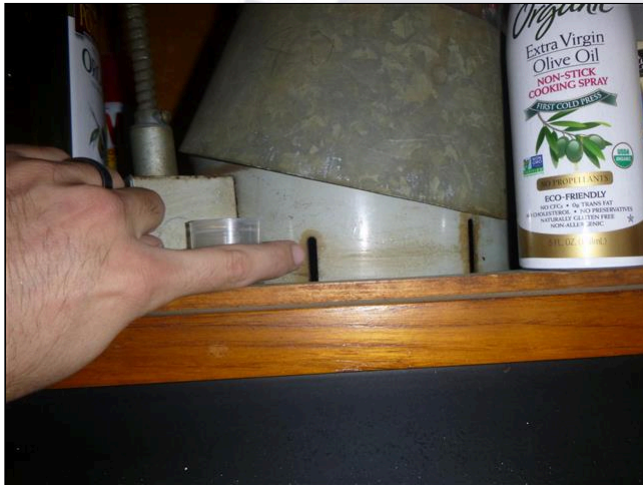
14.13 Item 1 (Picture)

Excessive air leakage at the ducting connection in the upper cabinet, this is a potential fire spread hazard, suggest review with a licensed contractor and repair/replace as needed for safety.

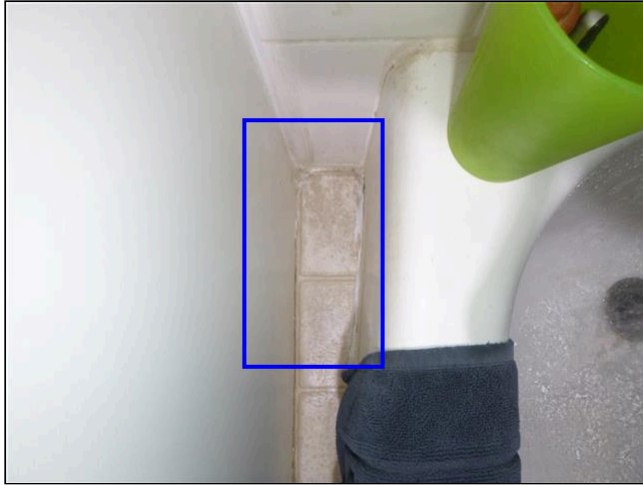
15.0 Item 1 (Picture)

The flooring is soft between the shower and the cabinet, this is likely due to water leaking from the shower area and damaging the subflooring. Suggest review with a licensed contractor for removal/repair/replacement costs as needed.
