Inspection Report

Property Address:
1102 7th Place
Hermosa Beach CA 90254

Ferguson Home Inspections

Date: 10/13/2022	Time: 02:00 PM	Report ID: 10132022Prospect
Property: 1102 7th Place Hermosa Beach CA 90254	Customer: Wendy & Scott Fletcher	Real Estate Professional: Amy Teitelbaum

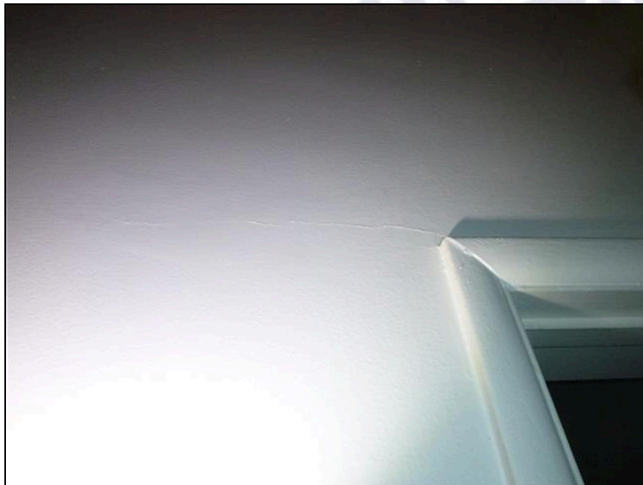
15.1 Item 1 (Picture)

(1) Settling cracks and patching was noted, suggest repair as needed.

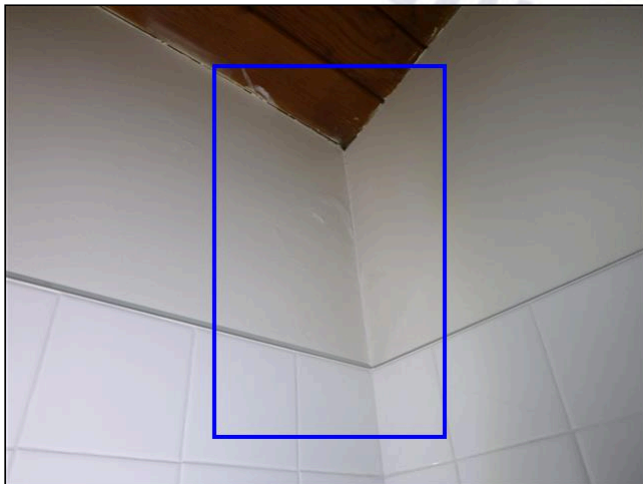
15.1 Item 2 (Picture)

(2) Old water damage was noted at the rear wall/corner, suggest review with a licensed contractor for repairs as needed.

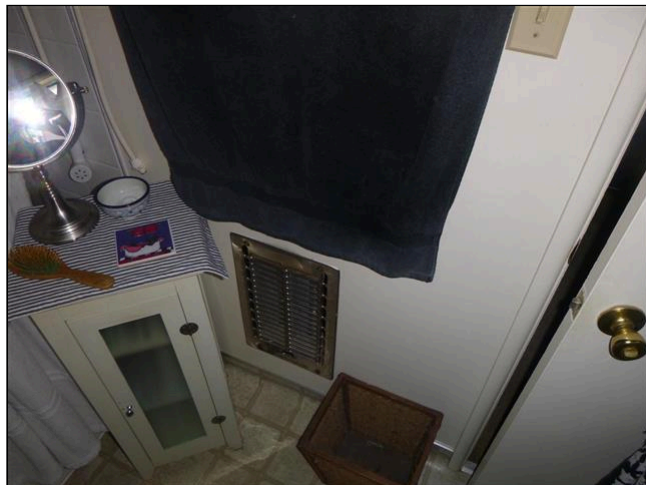
15.8 Item 1 (Picture)

Due to the possible child safety hazard and possibly fire hazard due to proximity to towel racks, suggest review with a licensed contractor for costs to disconnect and/or remove the wall heat coil unit.

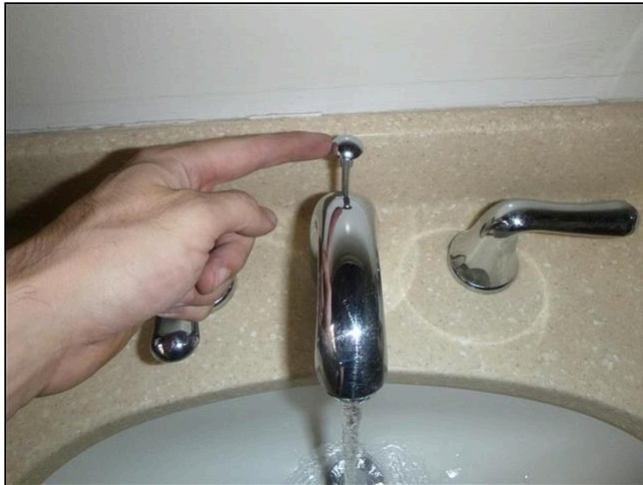
15.14 Item 1 (Picture)

The sink stopper is faulty/inoperable, suggest repair/replace as needed.

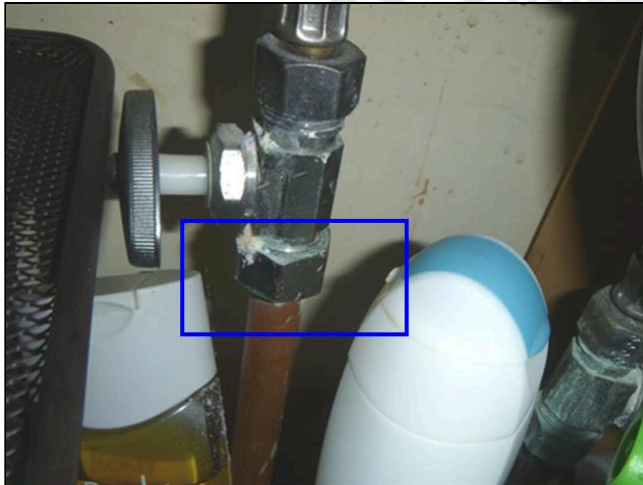
15.16 Item 1 (Picture)

Corrosion noted at the sink angle valve(s), no leaking noted at the time of the inspection. Suggest review with a licensed plumber and repair/replace as needed.

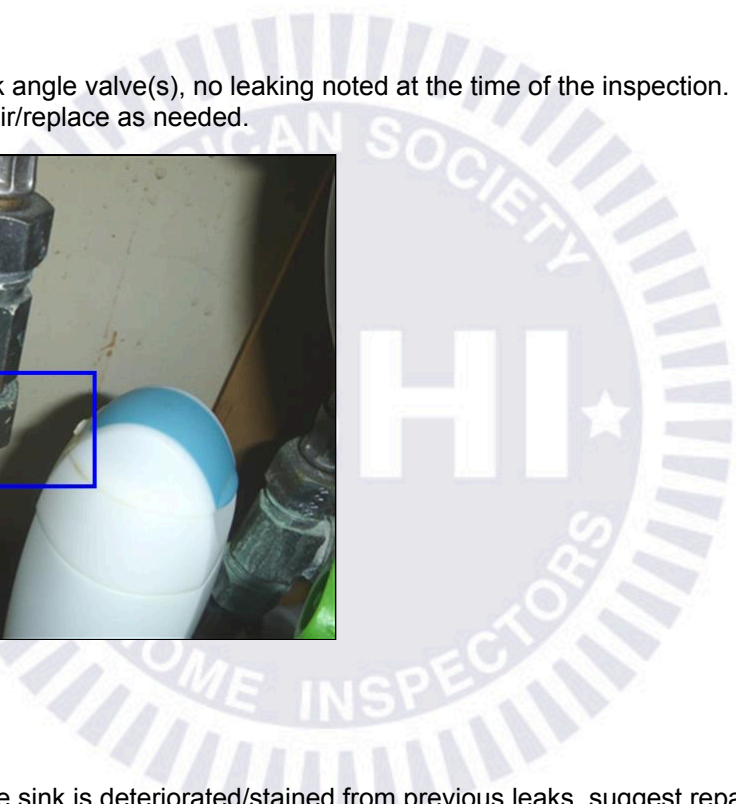
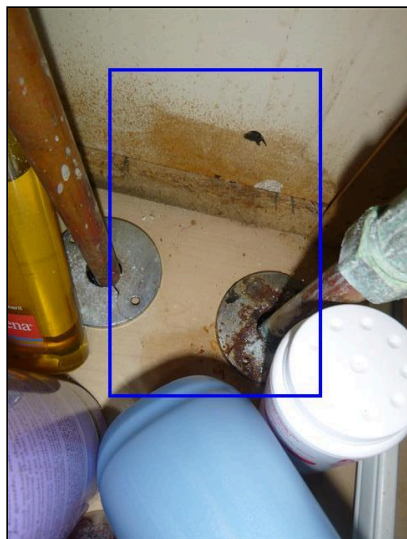
15.18 Item 1 (Picture)

The base cabinet under the sink is deteriorated/stained from previous leaks, suggest repair/replace as needed.

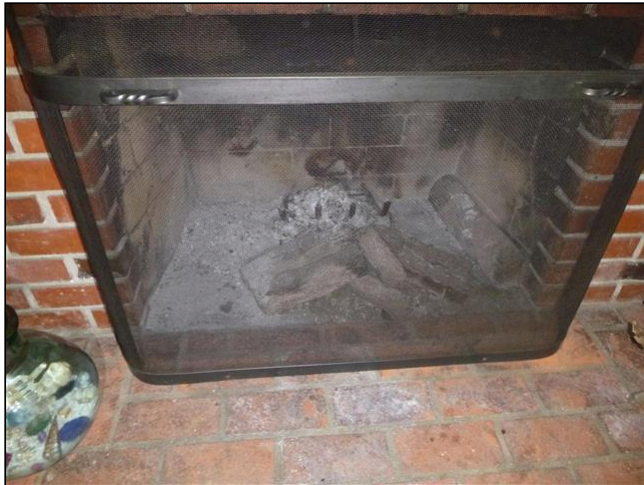
17.6 Item 3 (Picture)

(4) The tenant advised the inspector that the gas line was previously "Red Tagged" by the gas company which indicates a safety hazard. The tenant also advised that the tag was removed but no repairs were done/completed. Suggest review with the gas company as needed for safety.

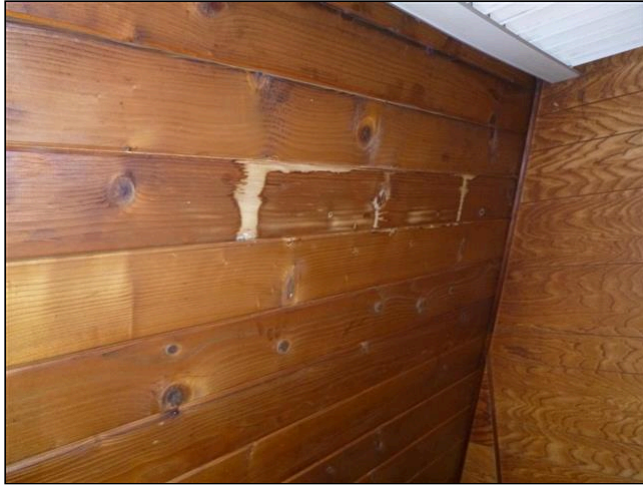
18.2 Item 1 (Picture)

- (1) Water stains and deterioration noted at the ceiling, suggest repairs as needed.

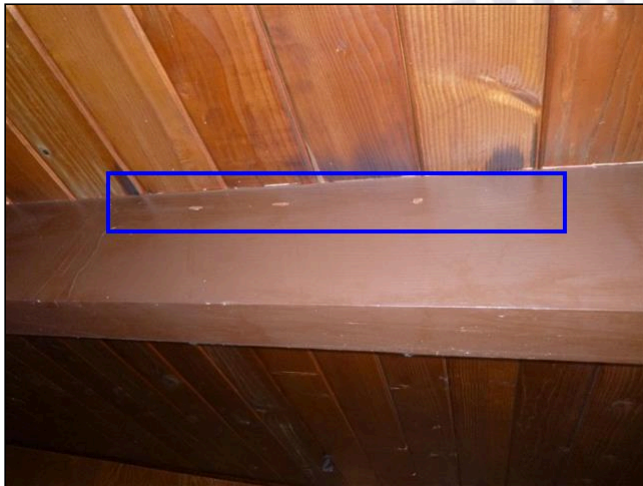
18.2 Item 2 (Picture)

(2) Wood deterioration noted at the vaulted ceiling, suggest review with a licensed contractor/licensed termite contractor as needed.

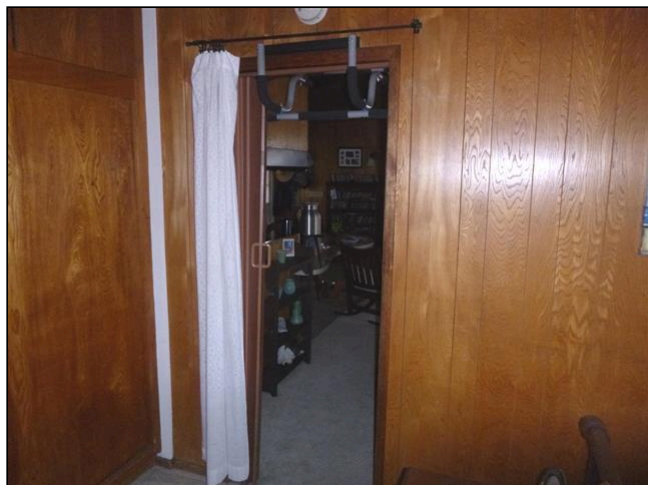
18.3 Item 1 (Picture)

Generally a vinyl sliding door is not an acceptable door for a bedroom. A bedroom door should be able to be closed and blocked/barricaded at the interior for safety if required. Suggest review with the city and/or a licensed contractor for repairs/replacement as needed.
