**Ferguson Home Inspections**

**Customer**  
Dan Broese

**Address**  
1619 Armour Ln  
Redondo Beach CA 90278

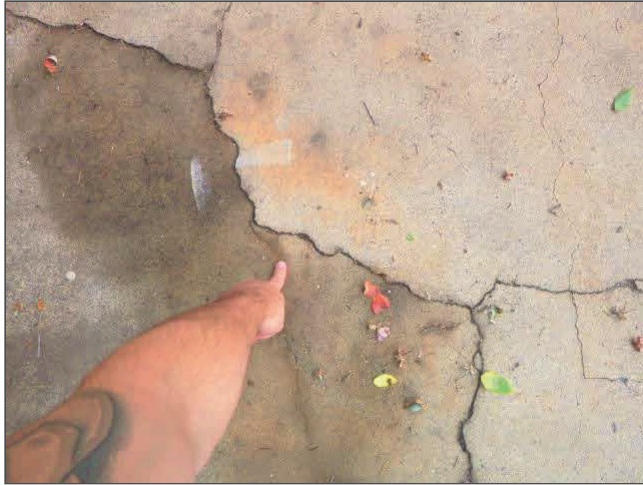
1.0 Item 1 (Picture)

Settling and heaving noted at various areas, this is a potential trip hazard. Suggest review with a licensed contractor for repair/replacement costs as needed.

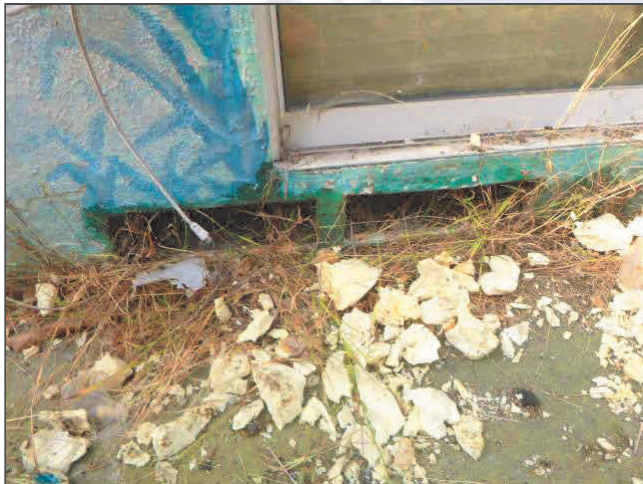
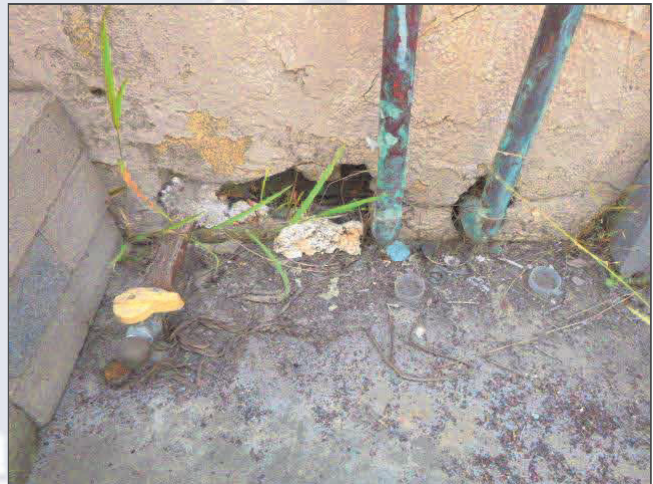
(1) Settling and heaving noted at various areas, this is a potential trip hazard. Suggest review with a licensed contractor for repair/replacement costs as needed.

(2) Suggest lowering the exterior walkway/grade and/or installation of exterior sub-surface drains at the rear and left side as needed to prevent the excessive/ongoing water intrusion into the crawlspace. Re-grading where needed is recommended to assure all water drains away from the home's foundation.

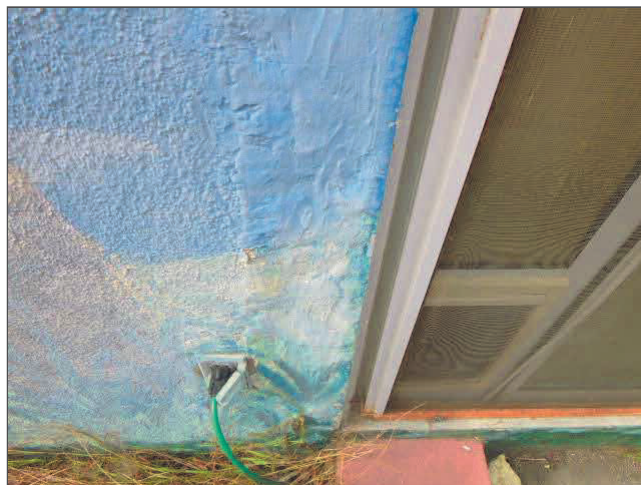
1.4 Item 2 (Picture)

(1) Various areas of the siding have been patched, suggest review with the seller on the cause and any repairs needed.

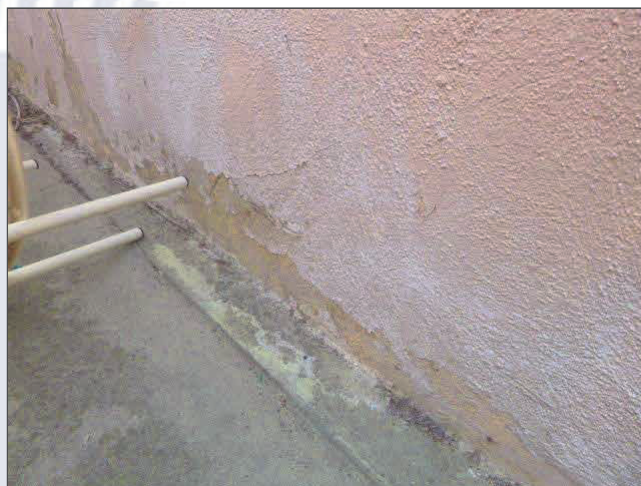
1.4 Item 4 (Picture)

(2) Deteriorated and blistering stucco noted at various areas. See the Lot/Drainage comments and review with a licensed contractor to repair as needed and divert water away from the foundation areas.

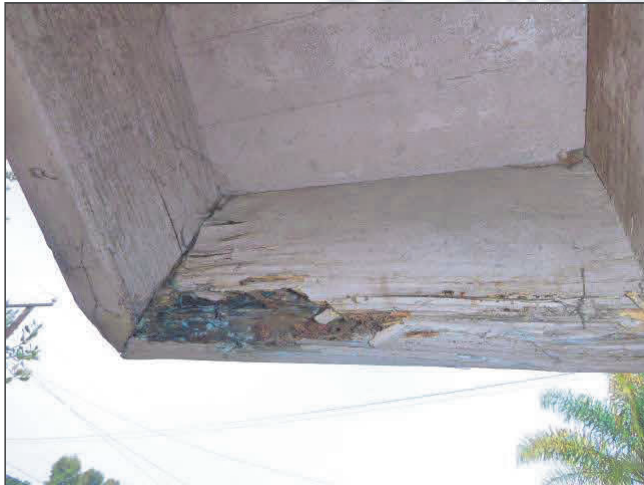
1.5 Item 1 (Picture)

(1) Paint blistering, peeling and wood deterioration noted at various trim areas. Suggest review with a termite company and/or a licensed contractor and repair/replace as needed.

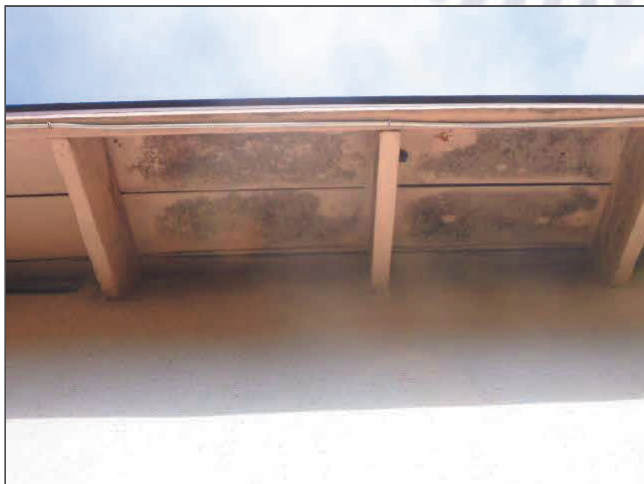
1.5 Item 3 (Picture)

(2) Excessive black staining noted at the roof line/eaves, suggest review with a licensed contractor for repairs as needed.

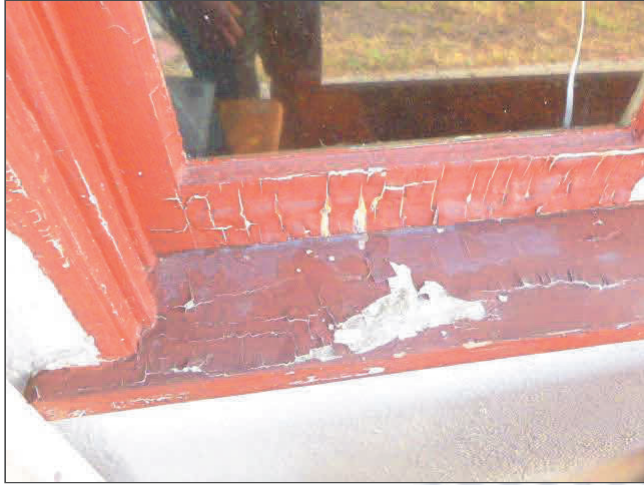
1.6 Item 1 (Picture)

(1) The wood window frames are peeling paint at most wood windows, further deterioration may occur if not repaired. Suggest review by a licensed contractor and repair/replace as needed.

**Repaired**

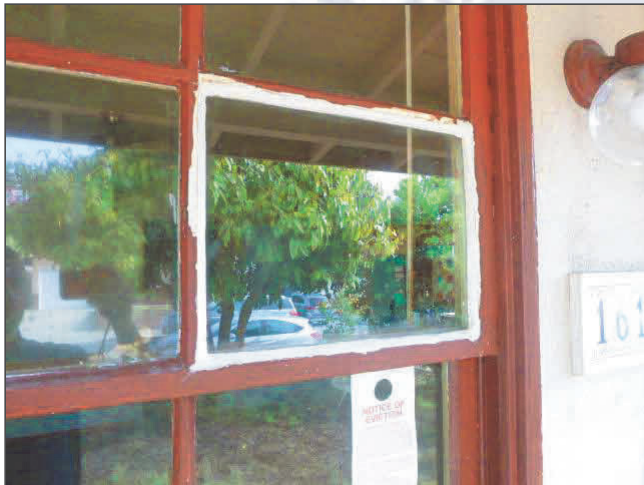
1.6 Item 2 (Picture)

(2) The glazing/wood frame is deteriorated at the wood windows, this is a potential safety hazard. Suggest review by a licensed contractor and repair/replace as needed.

**Repaired**

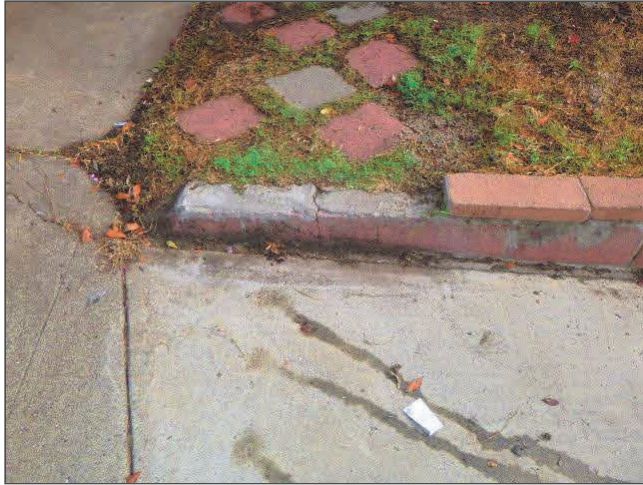
1.10 Item 1 (Picture)

(1) The front retaining wall is missing several top caps, suggest repairs as needed.

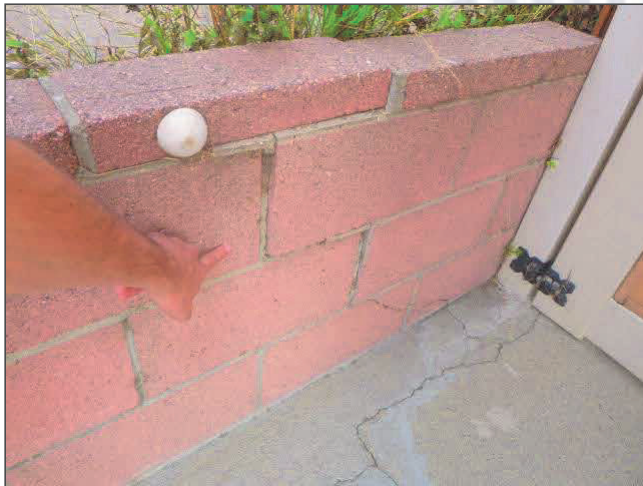
1.10 Item 2 (Picture)

(2) The retaining walls show some settlement and movement cracks, but appears stable. Suggest review with a licensed contractor for repair/replacement costs as needed.

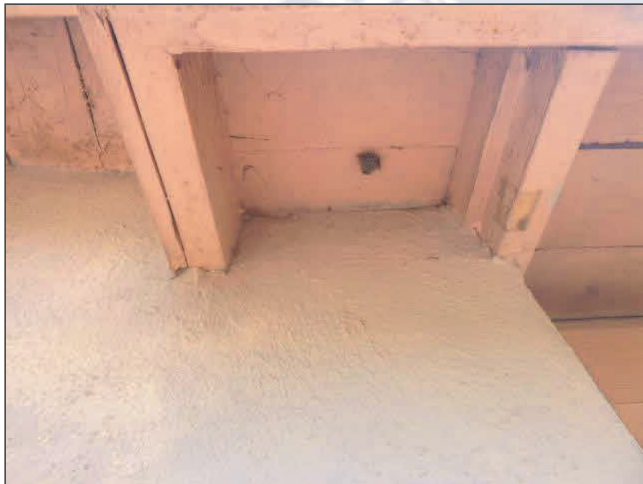
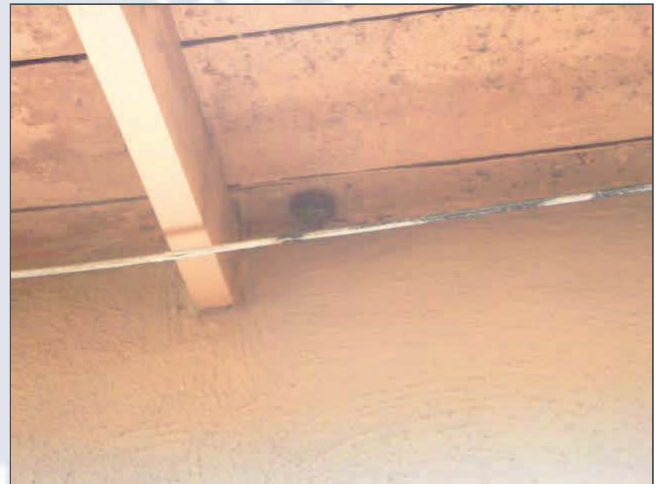
- (1) Suggest review of trees and root structures to prevent future damage to the property, drainage systems and structures.
- (2) Several wasp/bee nests were noted at various eave areas, suggest review with a pest control company for removal costs as needed.

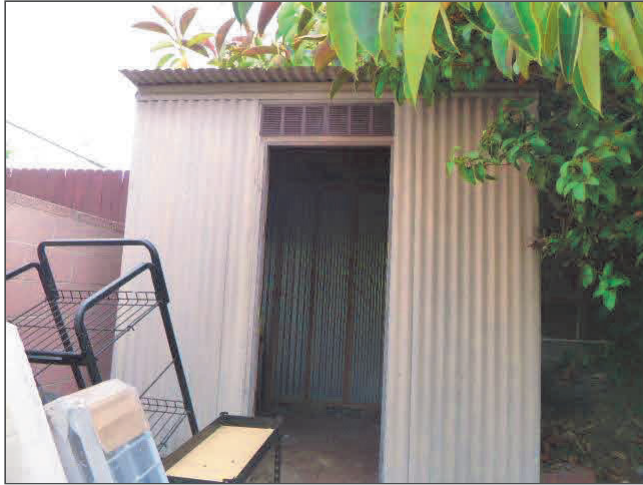
1.13 Item 3 (Picture)

- (3) The sheds and covered areas at the rear yard are beyond the scope of the inspection and were not inspected.

**Repaired**

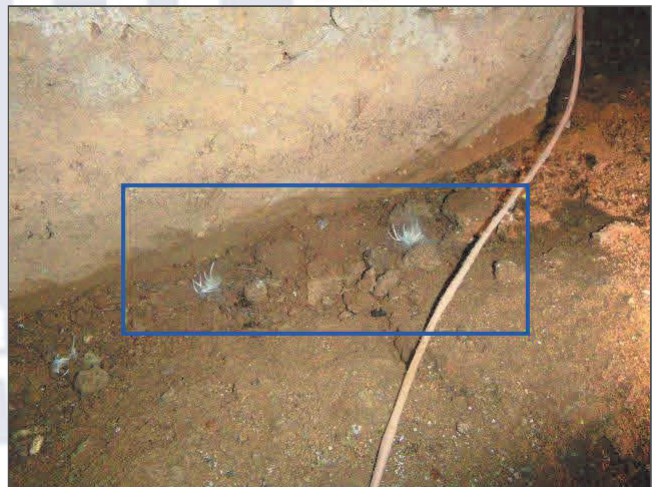
2.0 Item 2 (Picture)

(2) Re-grading where needed is recommended to assure all water drains away from the home's foundation. The inadequate drainage has caused the excessive moisture buildup at the foundation and intrusion into the crawl area, suggest review with a licensed contractor for foundation repairs and installation of rain gutters and an area drainage system to divert all the water away from the foundation.

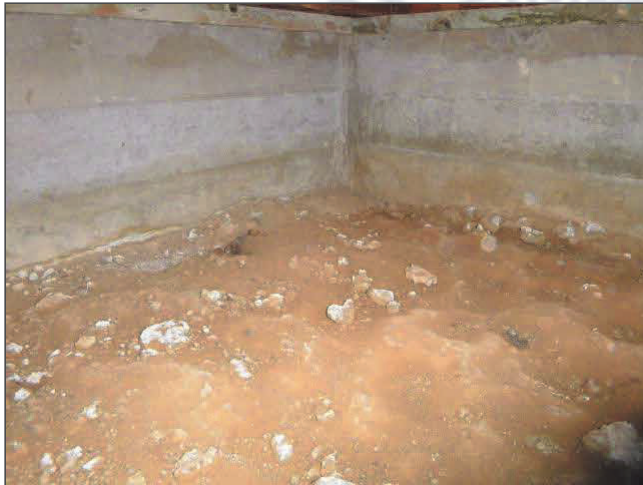
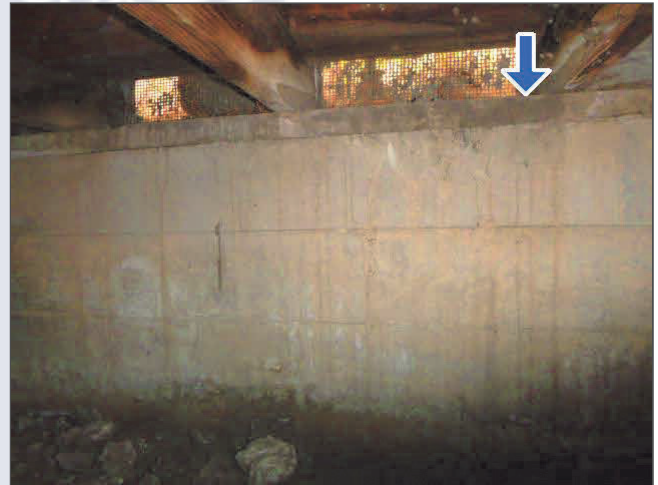
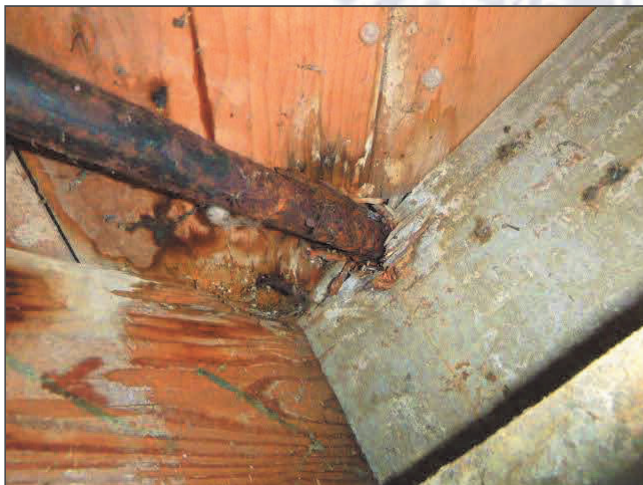
- (3) Suggest review by a licensed contractor for possible installation of an area drainage system to divert drainage away from the foundation.
- (4) Suggest lowering the exterior walkway/grade and/or installation of exterior sub-surface drains at the rear and left side as needed to prevent the excessive/ongoing water intrusion into the crawlspace. Re-grading where needed is recommended to assure all water drains away from the home's foundation.

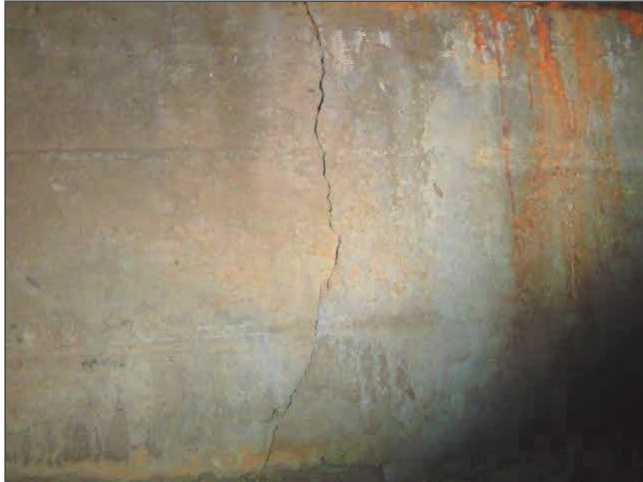
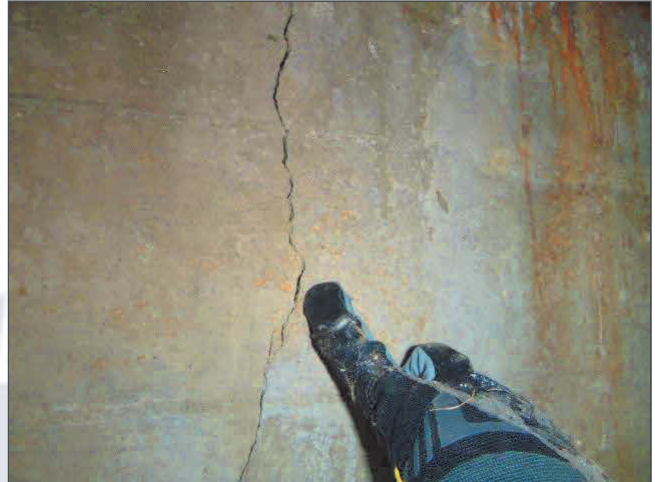
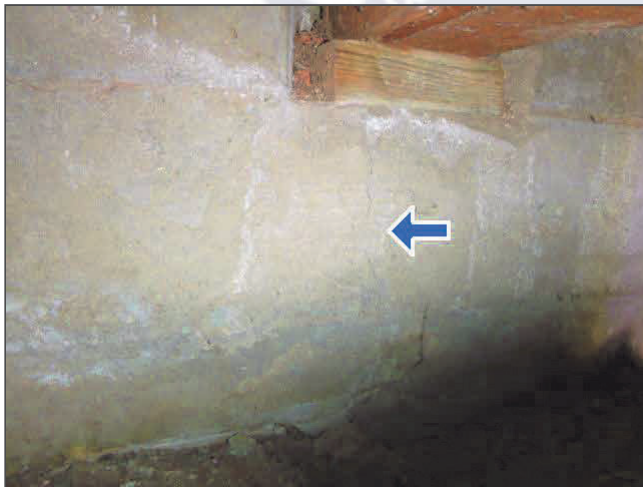
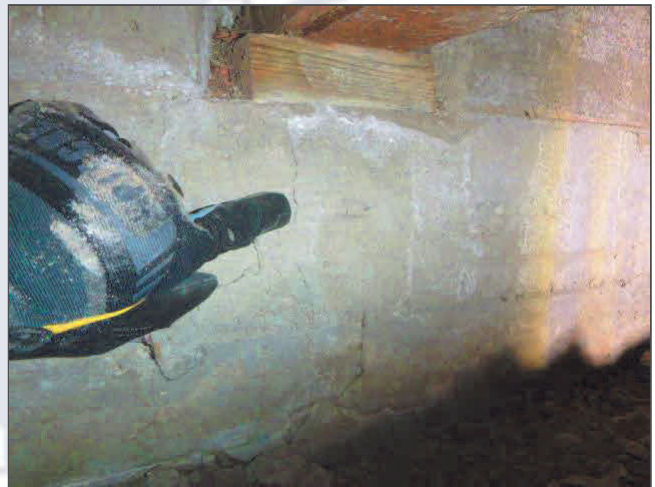
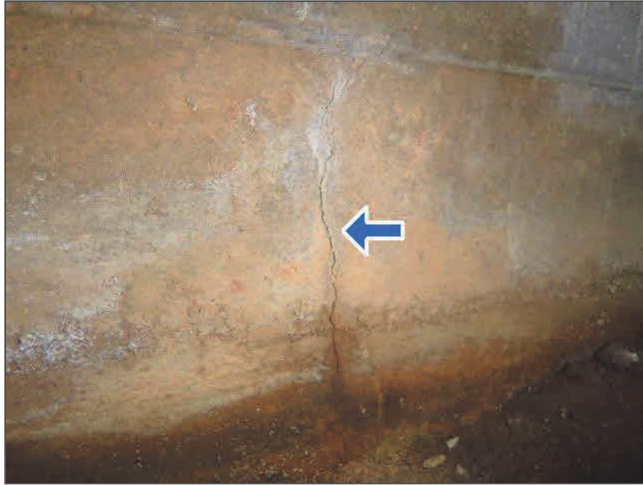
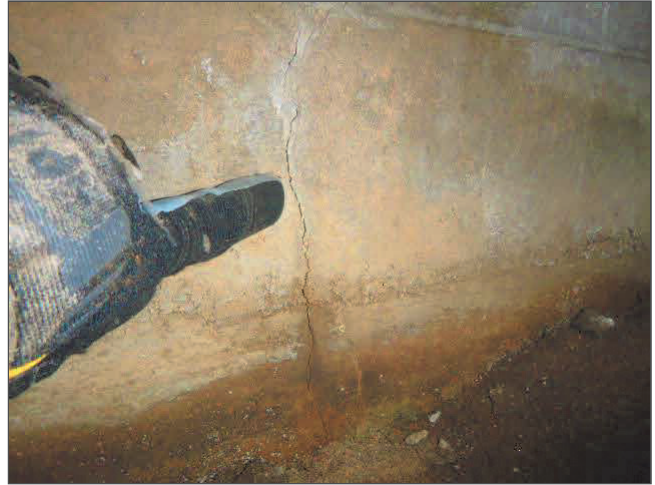
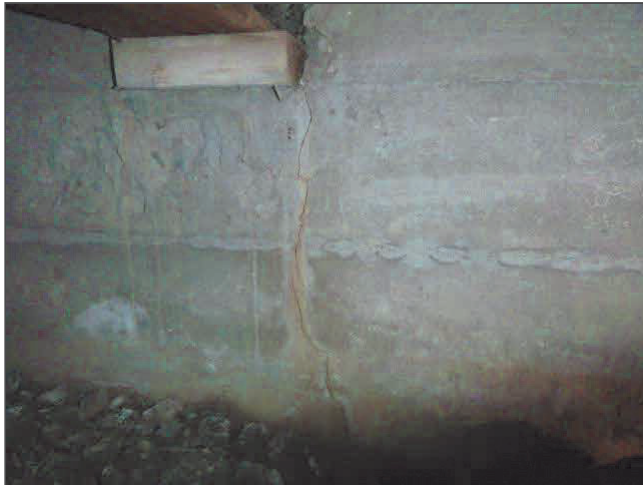
(1) Re-grading where needed is recommended to assure all water drains away from the home's foundation. The inadequate drainage has caused minor settling/cracking/movement to the foundation, suggest review with a licensed contractor for installation of perimeter concrete walkways/barriers, rain gutters and an area drainage system to divert all the water away from the foundation.

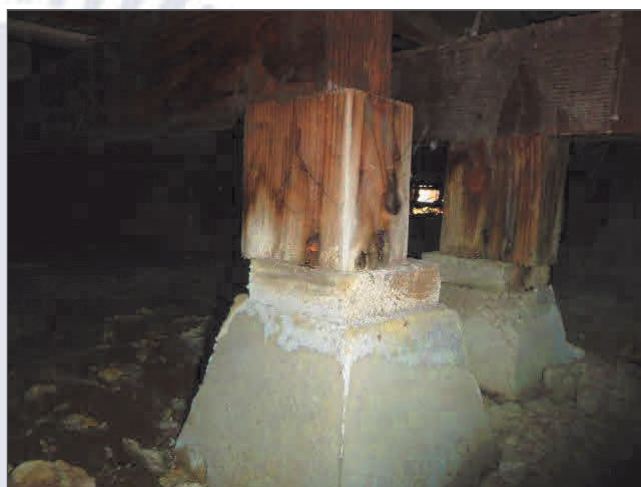
3.0 Item 11 (Picture)

(4) Excessive staining/saturation/deterioration of internal wood support members was noted due to excessive and ongoing water intrusion. Suggest review with a licensed foundation contractor for repair/replacement costs needed to prevent any future movement to the foundation and/or structure.

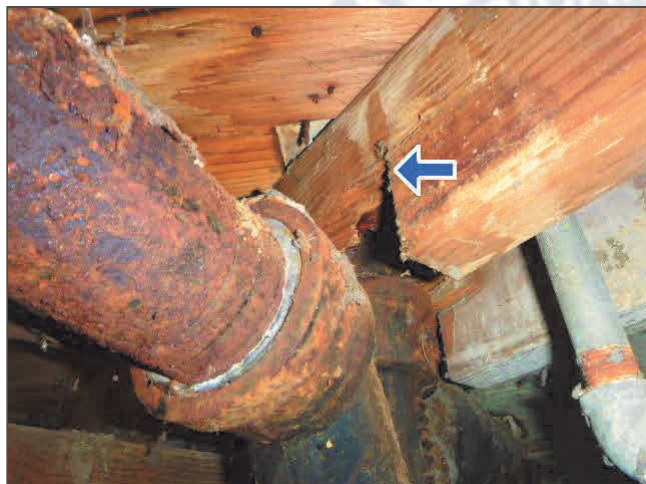
3.1 Item 1 (Picture)

(1) Excessive cutting and notching of various floor joists due to drainage installation. Suggest review by a licensed contractor for repair costs as needed.

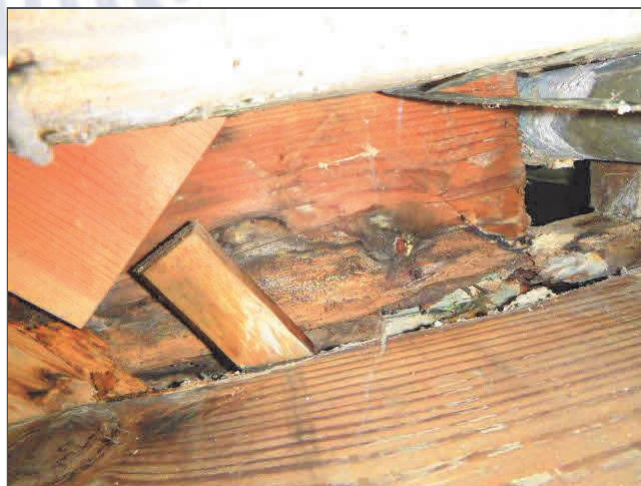
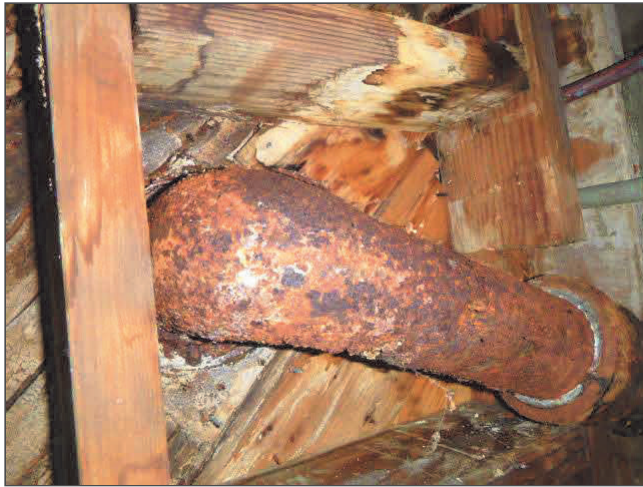
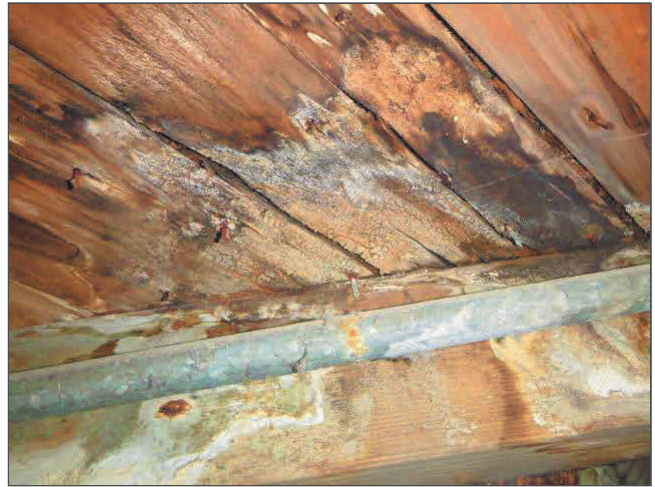
(2) Stains and deterioration noted at various flooring and supports from prior and ongoing leaks. Suggest review with a termite company and/or a licensed contractor and repair/replace as needed.

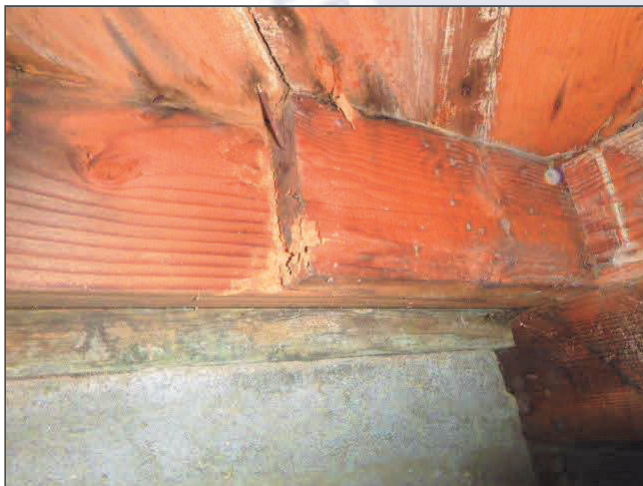
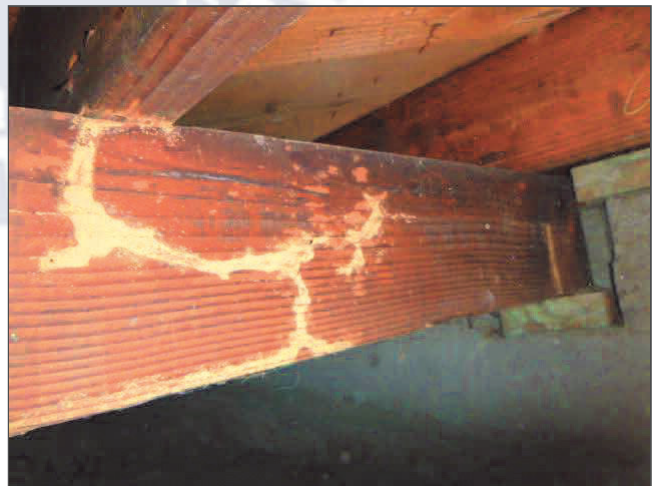
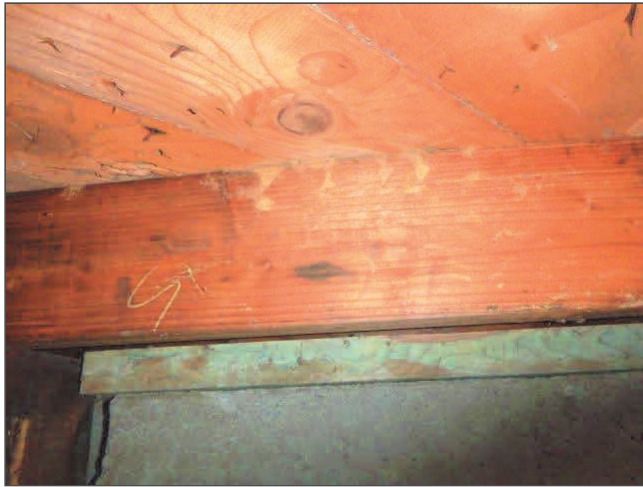
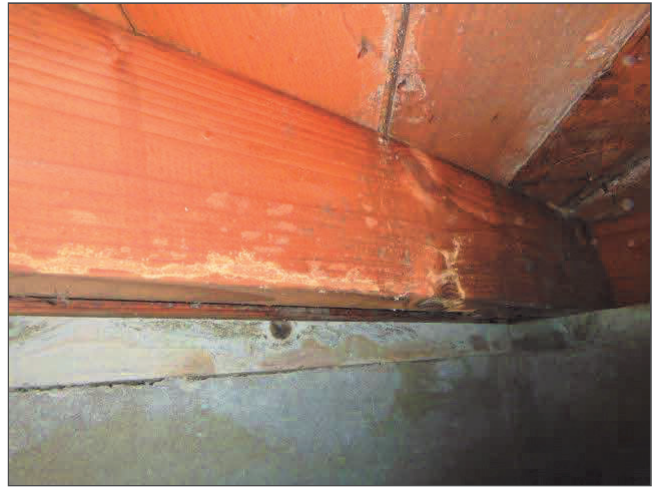
(3) Wood deterioration noted at various flooring and supports. Suggest review with a termite company and/or a licensed contractor and repair/replace as needed.

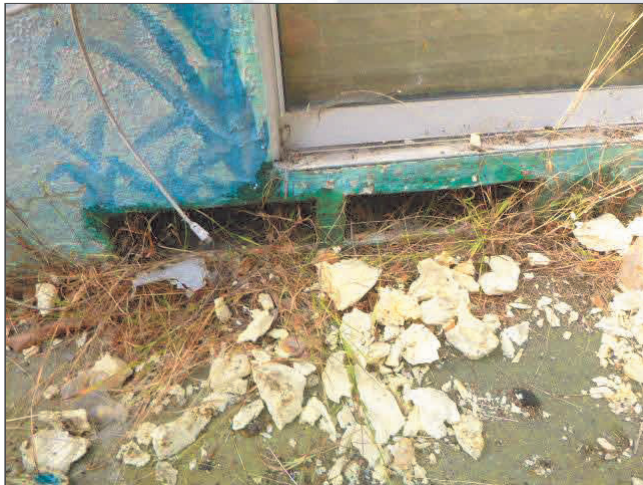
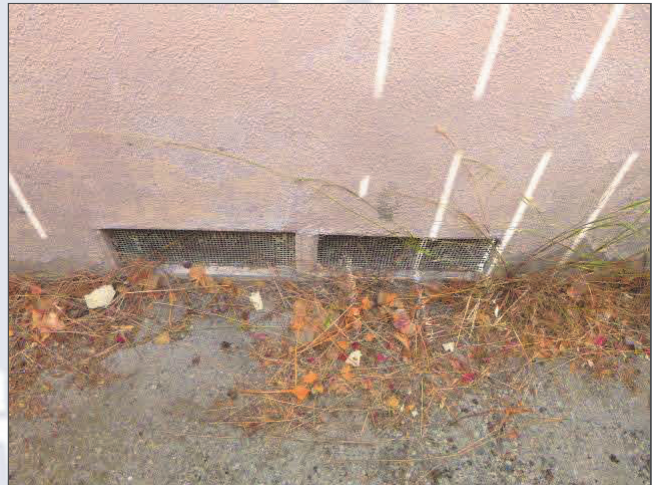
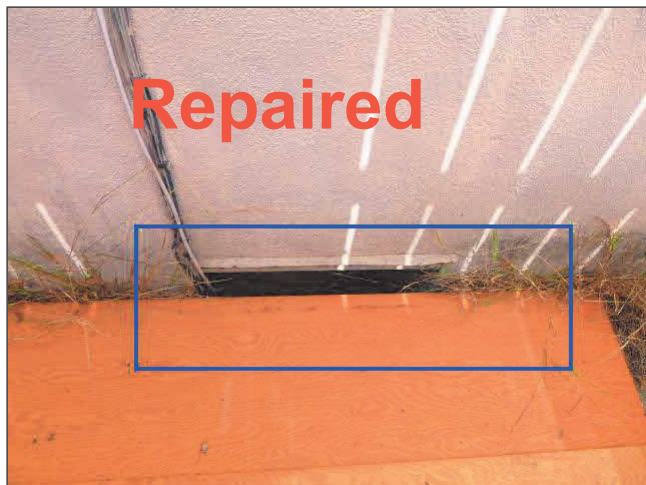
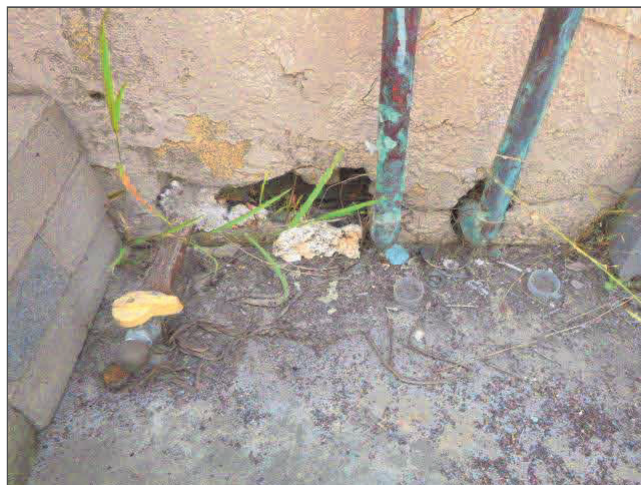
(1) The crawl space access port(s) and vent screens are below grade and evidence of water entry into the crawl space was noted. Suggest lowering the exterior grade or installing a brick or concrete berm to eliminate water entry into the crawl space. Suggest review by a licensed contractor for possible installation of an area drainage system to divert drainage away from the foundation.

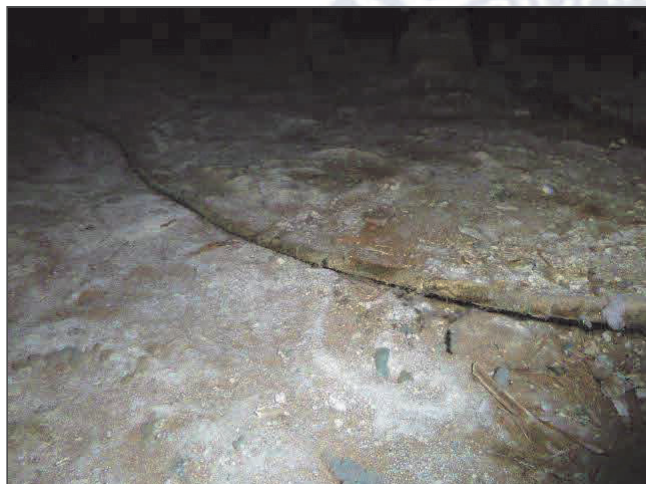
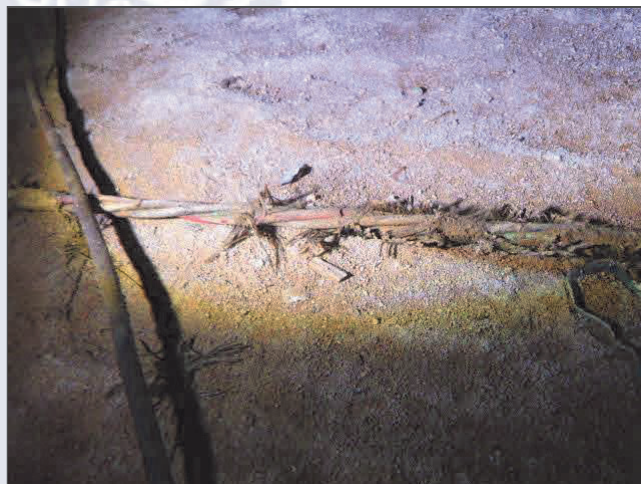
The electrical wiring is frayed/deteriorated and in contact with the wet ground within areas of the crawl areas, this is potential safety hazard. Suggest review with a licensed electrician for repair/replacement costs as needed.

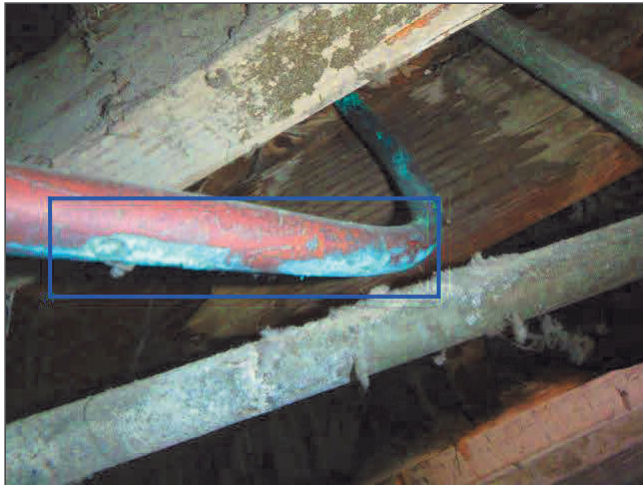
4.3 Item 1 (Picture)

(1) Corroded areas of the copper plumbing was noted throughout the crawl area, this can be a pre-cursor to 'pin hole' leaks. Suggest review with a licensed plumber for repair/replacement costs as needed.

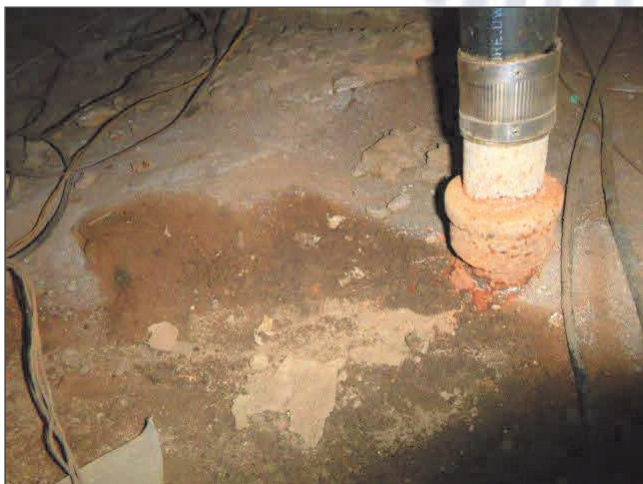
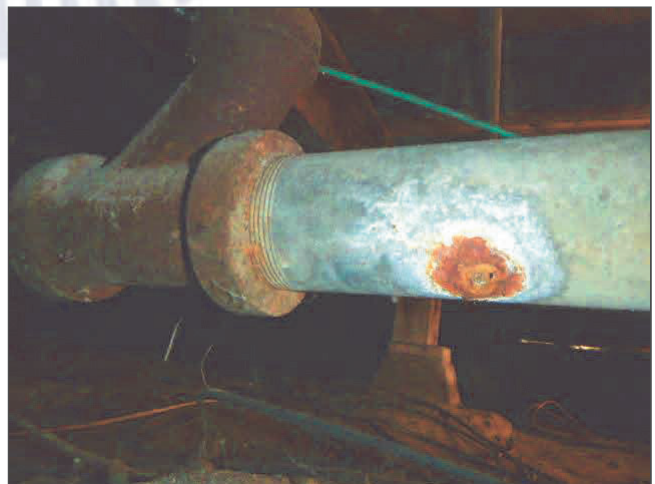
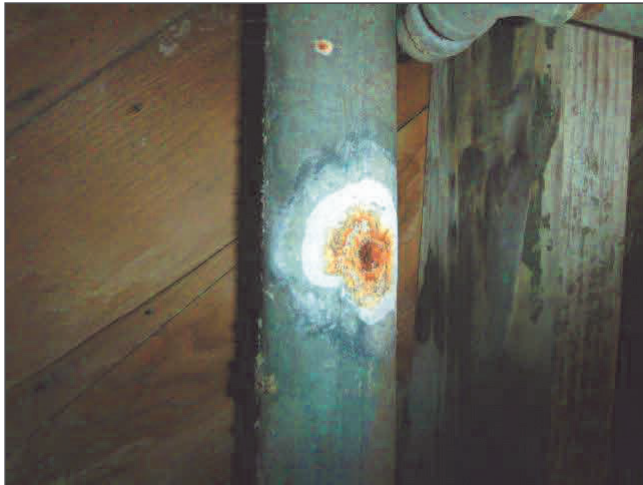
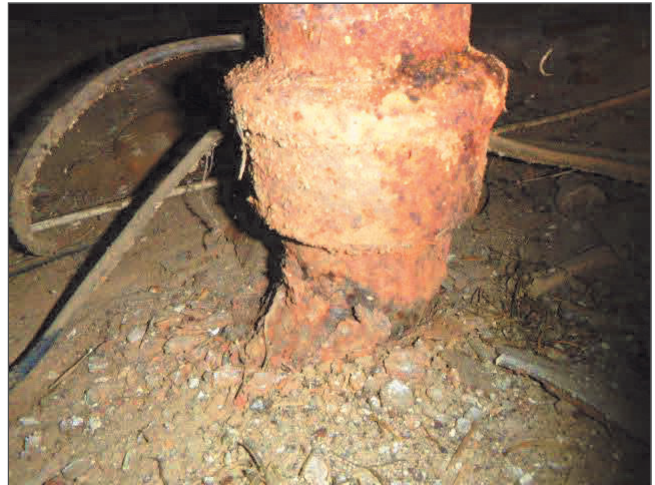
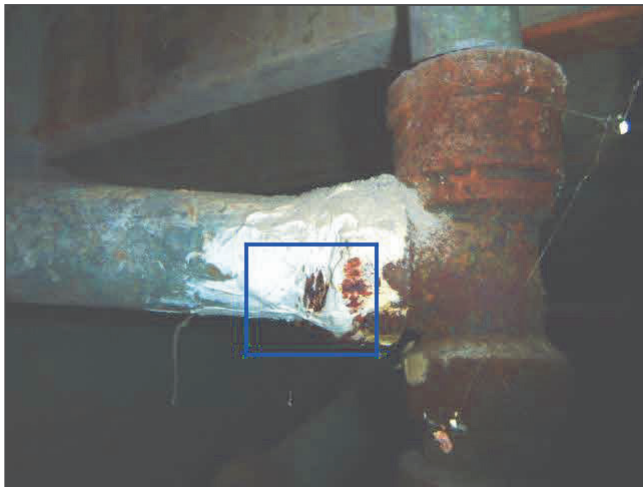
(3) Excessive rust, leaking and seepage/deterioration noted at various cast iron/galvanized drain lines within the crawl space. The excessive deterioration of the drain lines have caused leaking and saturation of the soil in the crawl area. Suggest review by a licensed plumbing contractor for replacement costs as needed to prevent on-going leakage at the crawl area.

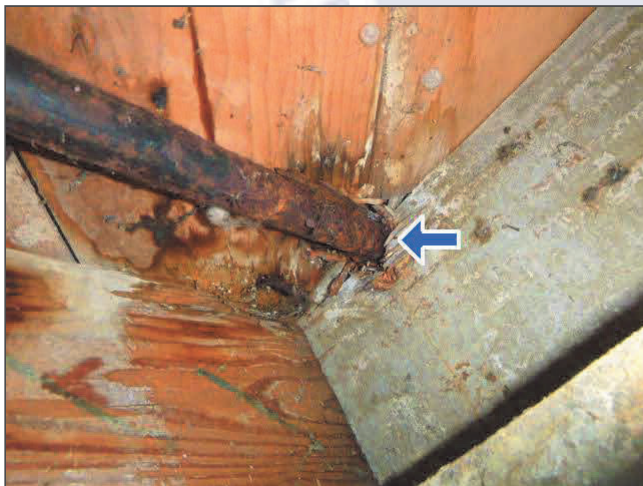
4.3 Item 11 (Picture)

(4) Excessive rust and corrosion was noted at the gas line at the left side due to the water intrusion. Suggest review with a licensed plumber for replacement costs as needed.

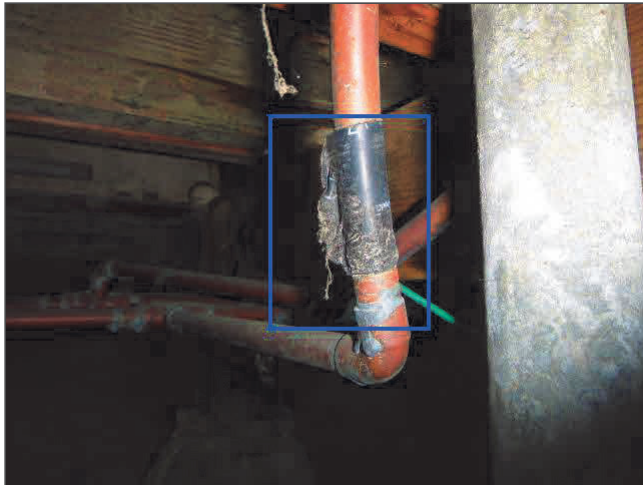
4.3 Item 12 (Picture)

(5) Non-typical and sporadic taping of the copper lines were noted, unable to determine if the tape/wrap is a temporary repair concealing deterioration, suggest review with a licensed plumber for replacement/repair as needed.

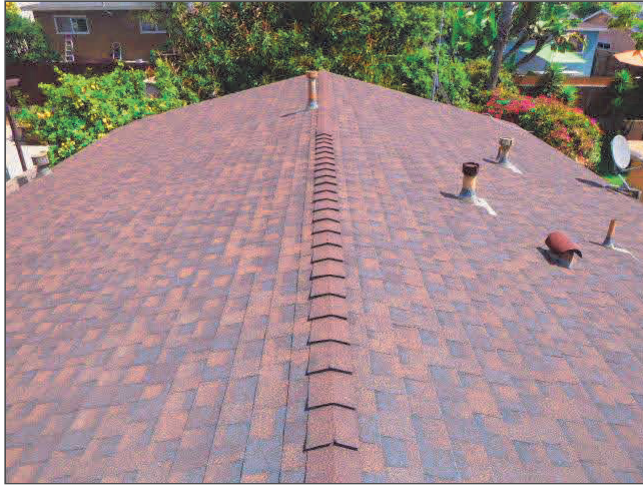
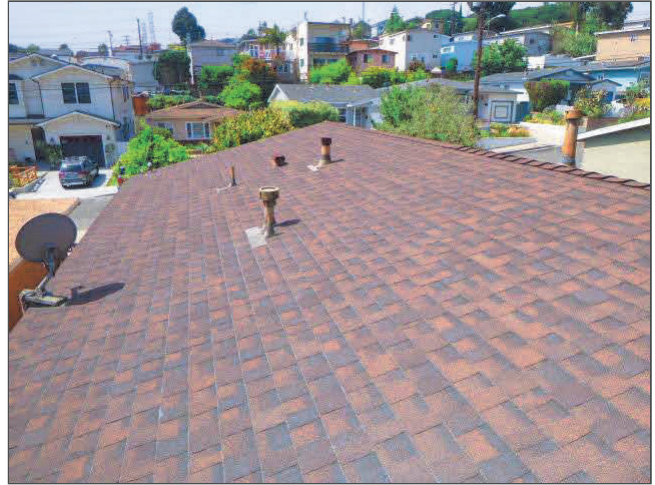
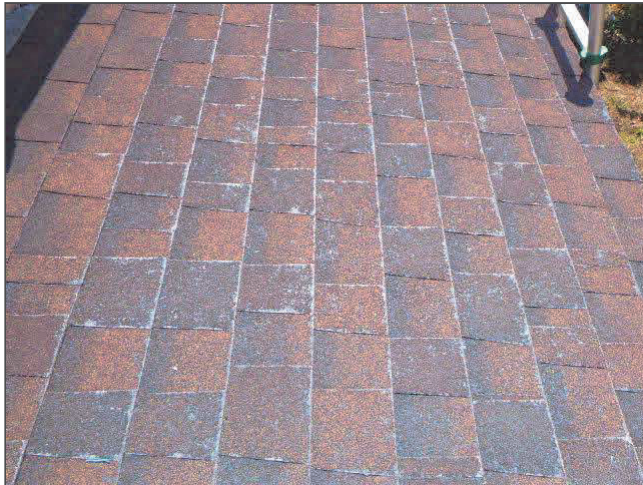
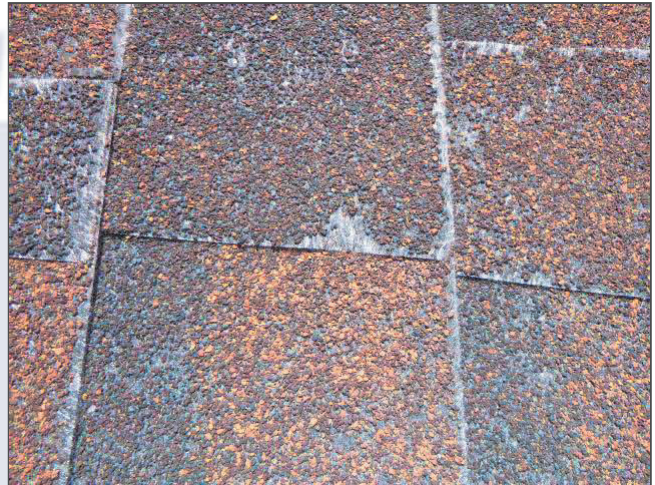
(1) Worn areas and deterioration of the roofing was noted, suggest review with a licensed roofing contractor for repairs, periodic maintenance and to determine the remaining life expectancy of the roof.

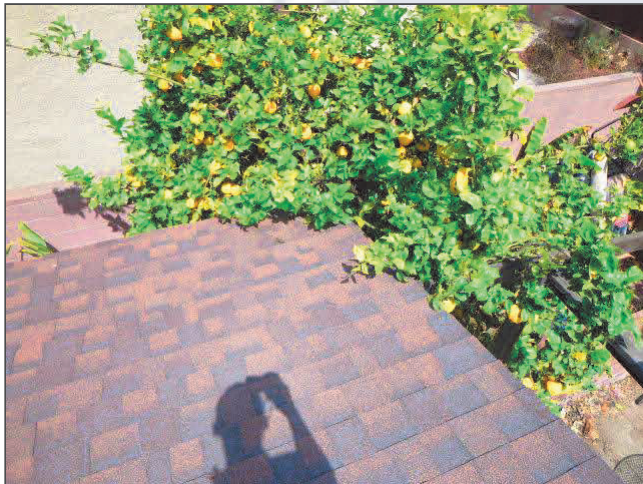
5.0 Item 5 (Picture)

(2) The tree limbs that are in contact with the roof or hanging near the roof should be trimmed to prevent damaging the roof. Suggest trimming as needed.

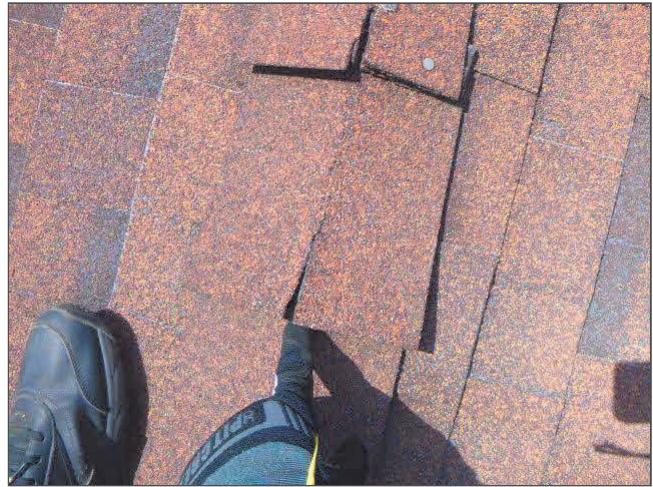
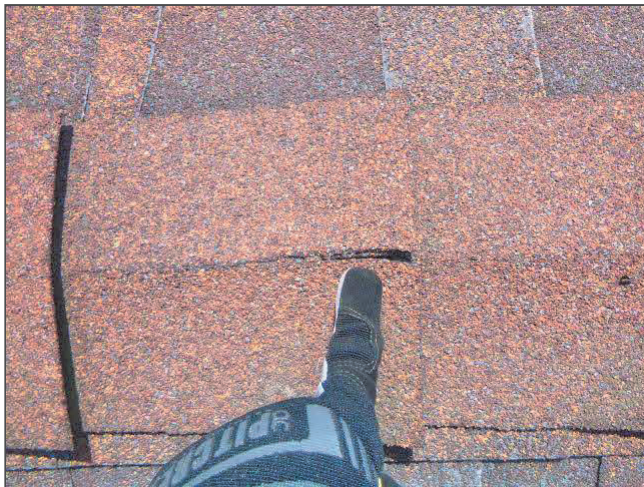
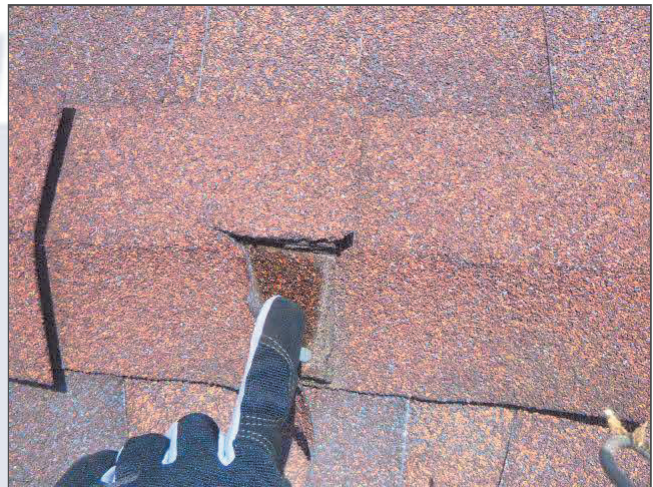
(3) Deteriorated ridge caps noted at the pitched roof, suggest review by licensed roofer for replacement costs and replace as needed.

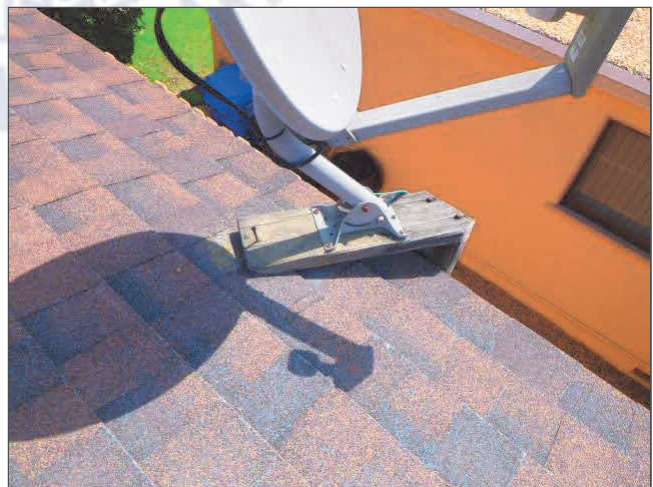
5.1 Item 2 (Picture)

(1) Loose/incorrect flashings/roof attachments were noted at various areas, suggest review with a licensed roofer for repairs as needed.

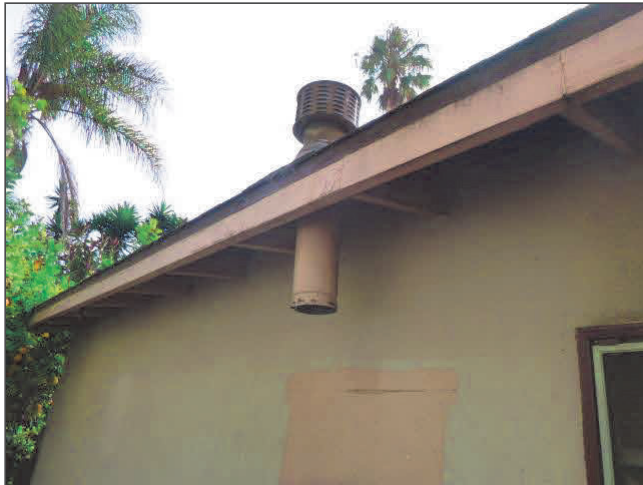
5.1 Item 3 (Picture)

(2) Suggest removal of the old/abandoned flashings/old vent pipes as needed.

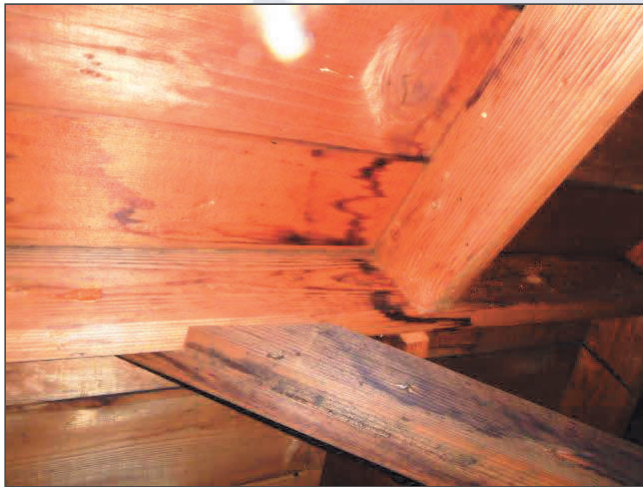
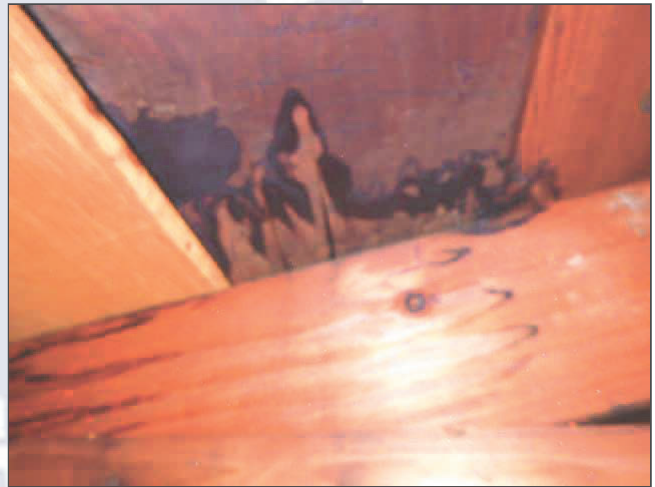
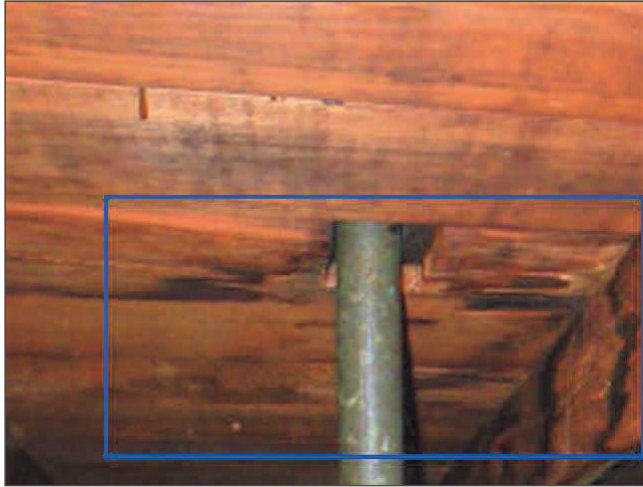
- (1) Minor wood deterioration noted at various areas of the roof framing, suggest review with a termite company and/or a licensed contractor for repairs as needed.
- (2) Moisture stains noted at various areas of the attic sheathing/framing, see roof comments and repair as needed.

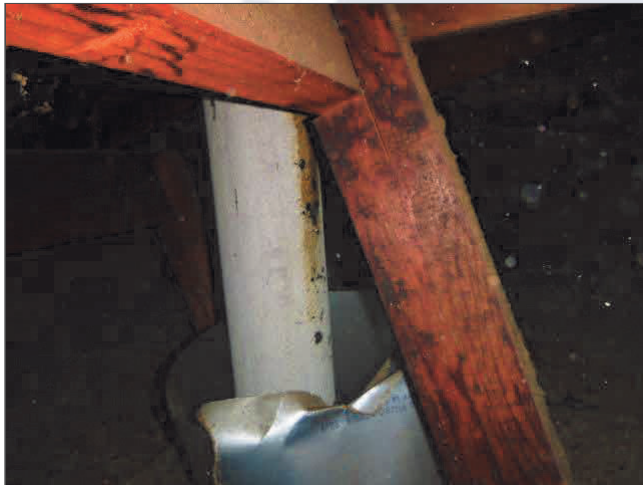
6.5 Item 1 (Picture)

Abandoned asbestos vent pipes noted in the attic area, suggest review with a licensed contractor for removal costs as needed.

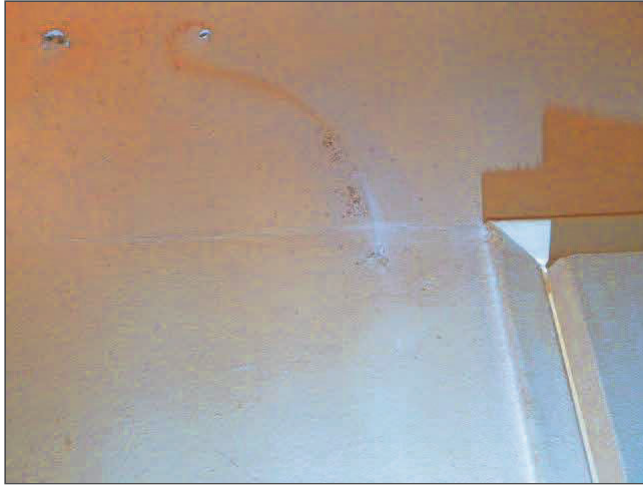
7.1 Item 1 (Picture)

(1) Settling cracks and patching was noted, suggest repair as needed.

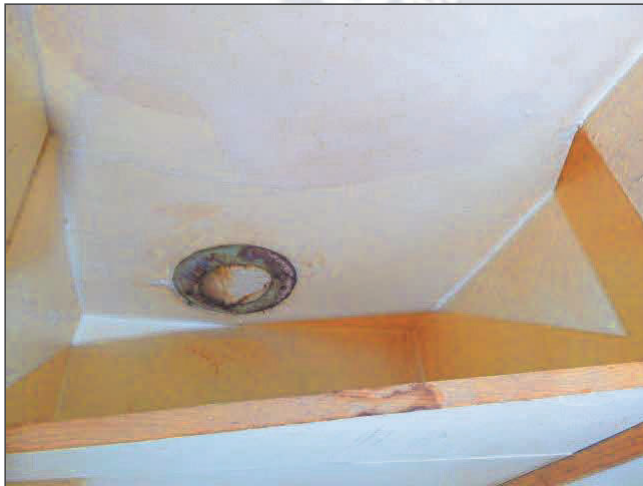
7.2 Item 1 (Picture)

(2) An old transite asbestos style vent pipe was noted at the ceiling of this area, suggest removal as needed.

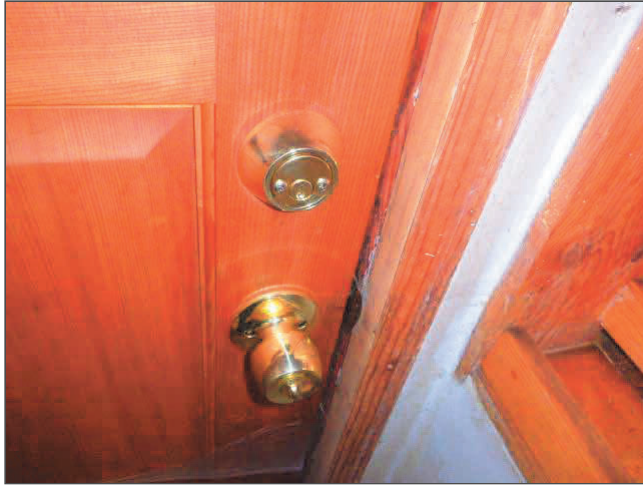
7.3 Item 1 (Picture)

A keyed interior lock is installed at the exterior door, suggest installing a thumb turn dead-bolt to enhance safety as an upgrade.

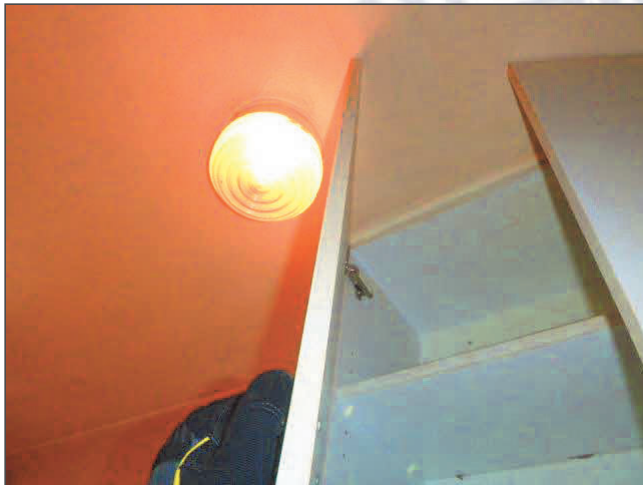
7.4 Item 1 (Picture)

(1) The cabinet door strikes the light fixture, suggest repairs as needed for safety.
