**Ferguson Home Inspections**

**Customer**  
Dan Broese

**Address**  
1619 Armour Ln  
Redondo Beach CA 90278

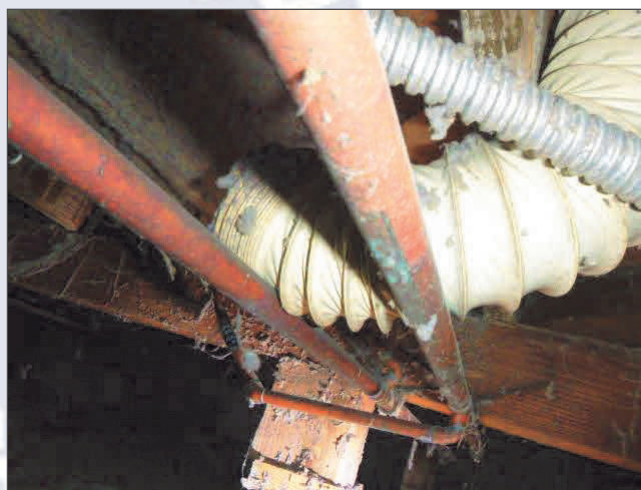
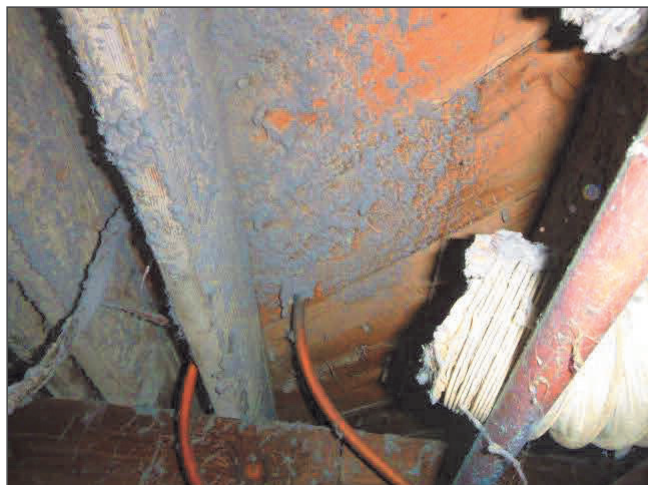
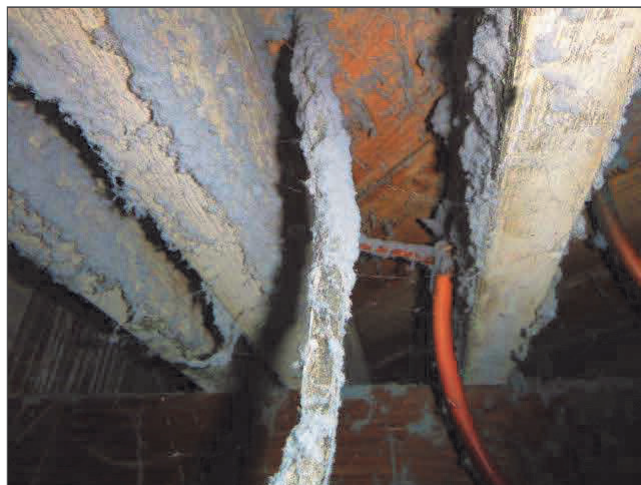
(2) Improper vinyl flex vent installed to the crawl space ( not installed to the exterior as required ). Suggest removal of the existing material and install a rigid vent pipe to the exterior as required. Excessive lint noted was noted in the crawl area due to the incomplete installation, this is a potential fire hazard. Suggest review by licensed contractor for costs to remove the lint form the crawl area as required for safety.

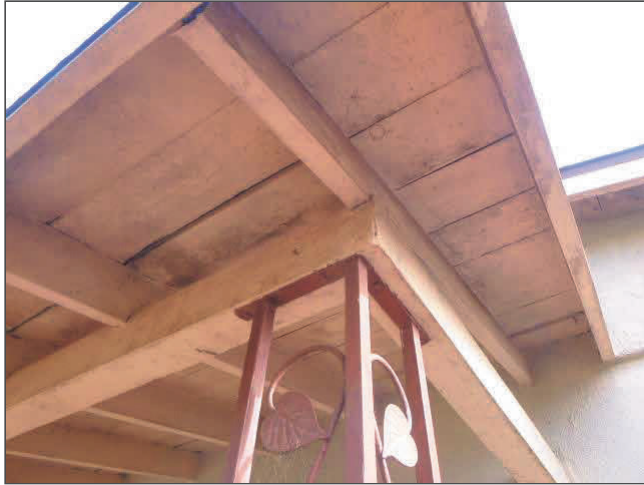
8.0 Item 1 (Picture)

(1) Paint blistering, peeling and wood deterioration noted at various trim areas. Suggest review with a termite company and/or a licensed contractor and repair/replace as needed.

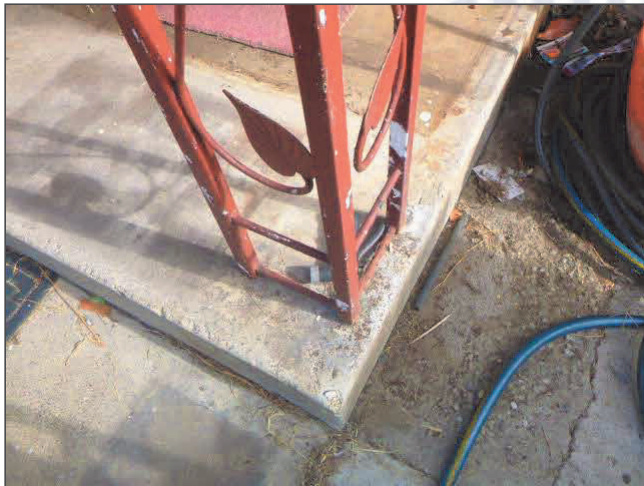
8.0 Item 2 (Picture)

(2) Rust/deterioration and loose areas noted at the corner roof post support, suggest review with a licensed contractor for repair/replacement costs as needed.

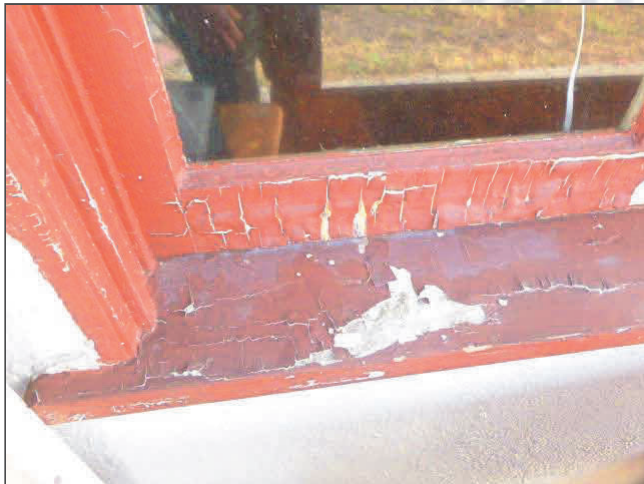
8.4 Item 1 (Picture)

Wood deterioration noted at various windows. Suggest review with termite company and/or a licensed contractor and repair/replace as needed.

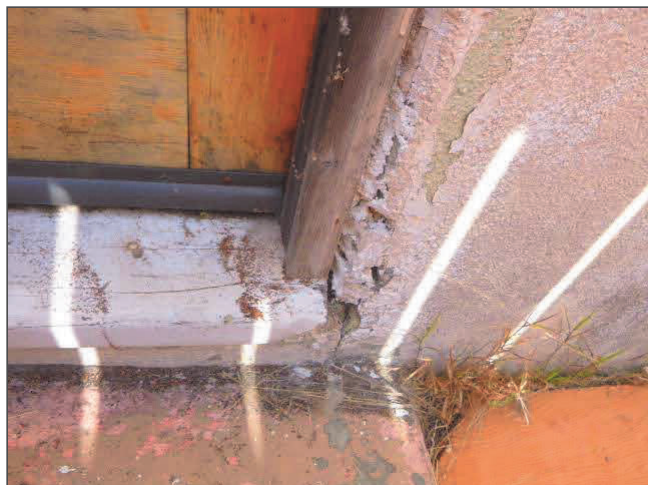
9.5 Item 1 (Picture)

Excessive wood deterioration noted at the door, door frame and threshold. Suggest review by a licensed contractor for repair/replacement costs as needed.

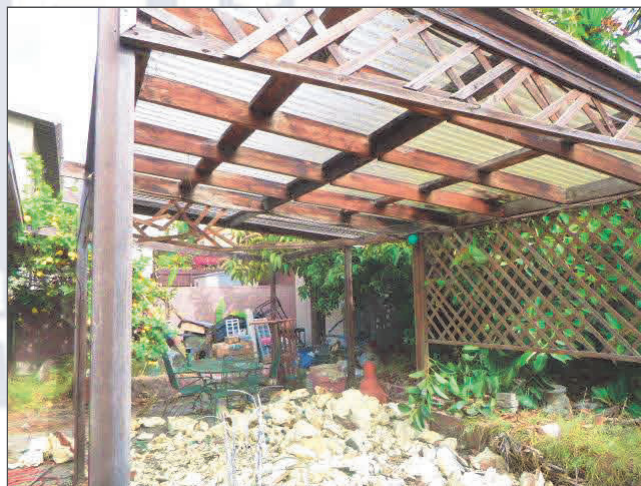
10.0 Item 2 (Picture)

(1) Paint blistering, peeling and wood deterioration noted at various trim areas. Suggest review with a termite company and/or a licensed contractor and repair/replace as needed.

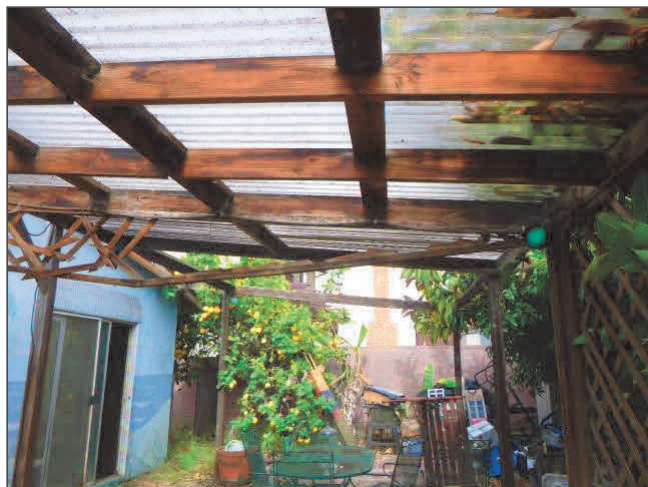
10.0 Item 3 (Picture)

(3) Excessive wood deterioration noted at the rear patio structure, suggest removal as needed.

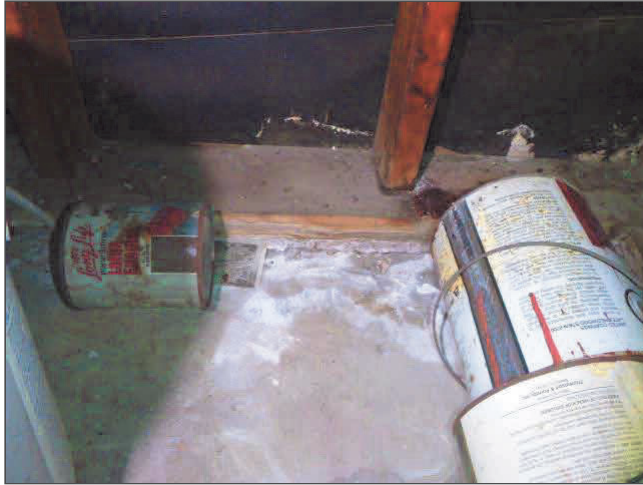
11.0 Item 2 (Picture)

(2) White efflorescence (powder substance) on foundation footings indicates prior, and possibly ongoing, excessive moisture build up at the exterior of the foundation. Ongoing water intrusion at the foundations can, in some cases, cause the steel in the foundations to rust, called spalling, which can lead to horizontal cracking of the foundation ( currently there are no major cracks visible at the foundation ). Any future cracking/damaged can be an expensive repair as the foundation is now structurally weak and susceptible to horizontal movement. Suggest review of the Lot/ Grade and drainage systems, including rain gutters, to reduce and prevent further and future water buildup at the exterior of the dwellings foundations.

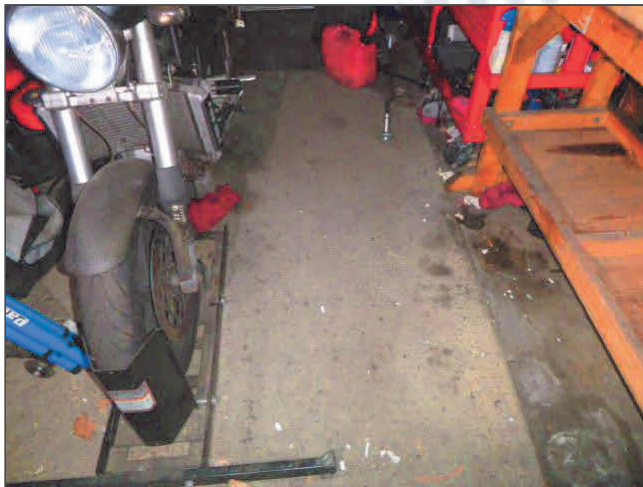
11.0 Item 3 (Picture)

(3) Suggest removal of the carpet if vehicles are to be parked in the garage. Non fire rated flooring at the garage area is a potential fire safety hazard. Suggest review with a licensed contractor for repair/replacement costs as needed.

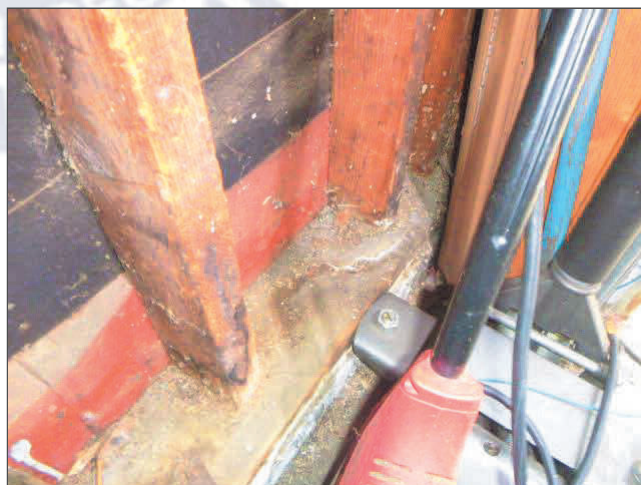
11.3 Item 4 (Picture)

(3) Water stains and deterioration noted at the lower section of the walls due to water intrusion. Suggest repair/replace as needed.

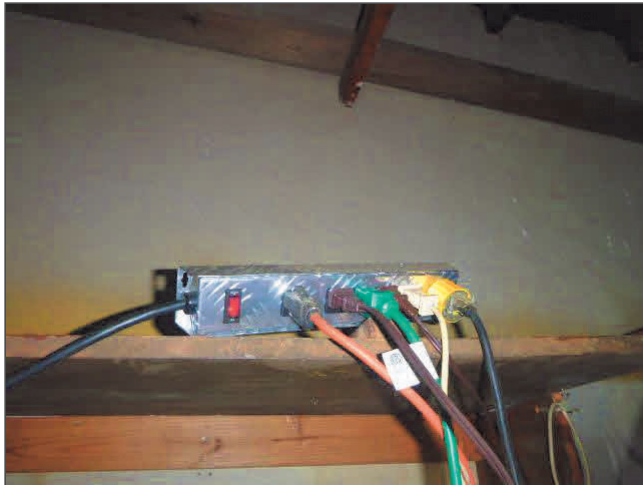
11.4 Item 2 (Picture)

(3) Excessive use of electrical plugs strips/extension cords used at this area, this is a potential fire safety hazard. Suggest review with a licensed electrician for additional electrical circuits/outlets costs as needed for safety.

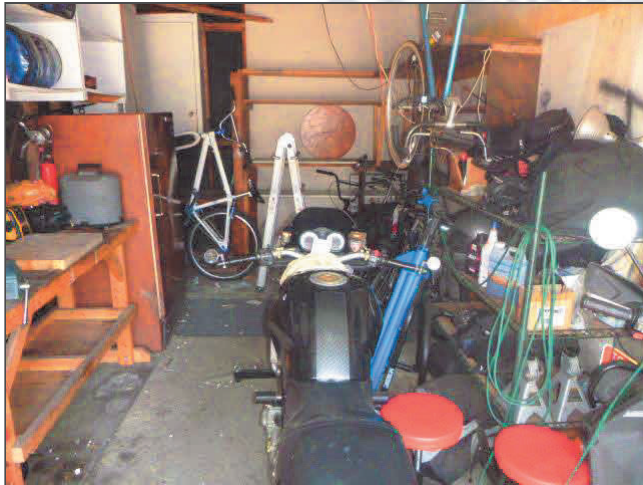
11.5 Item 1 (Picture)

(1) Access within this area was blocked or severely limited at the time of the inspection. An inspection of this area can be performed by appointment and at an additional cost when the area is made accessible.

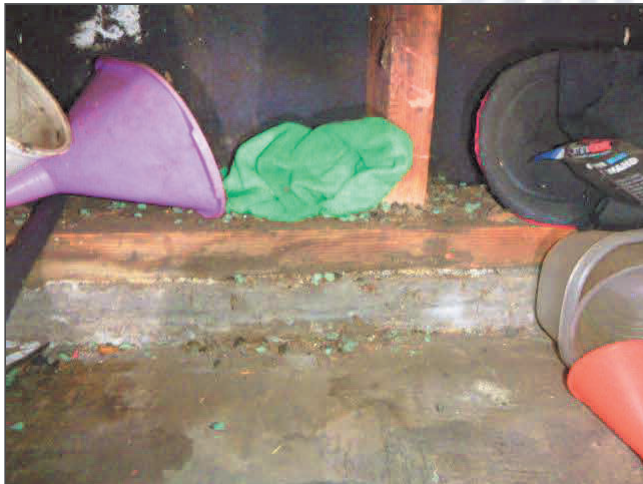
11.5 Item 2 (Picture)

(2) Pest droppings noted within the garage area. Suggest review with a qualified pest control company and/or a licensed contractor for removal costs of the droppings as needed.

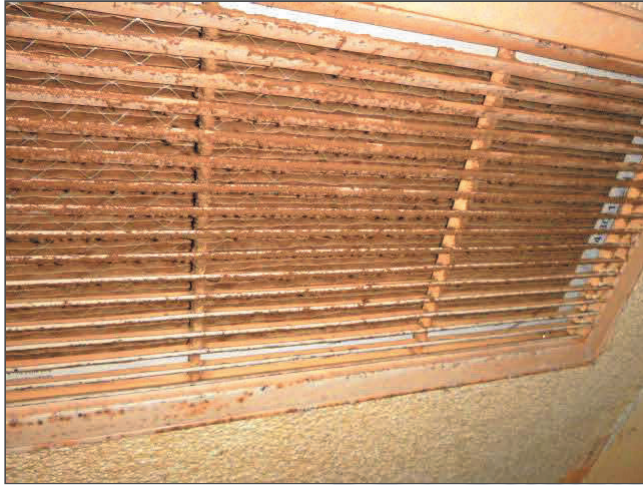
12.0 Item 3 (Picture)

(2) Suggest replacing/cleaning the filter(s) as needed.

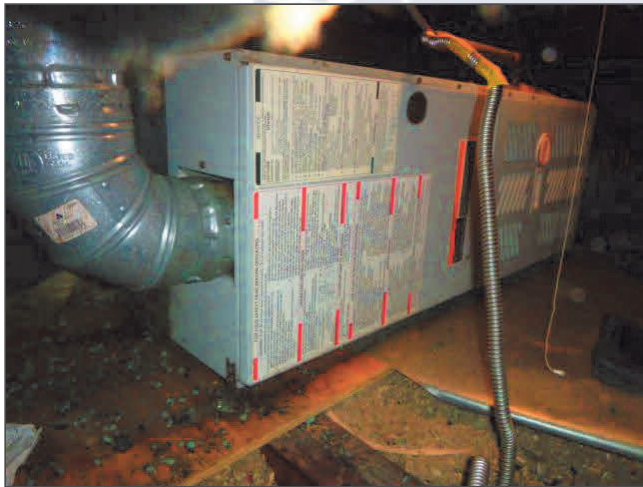
12.0 Item 4 (Picture)

(3) The heating unit has been installed on a plywood base, suggest review by a licensed heating contractor for installation on non-combustible stands as required.

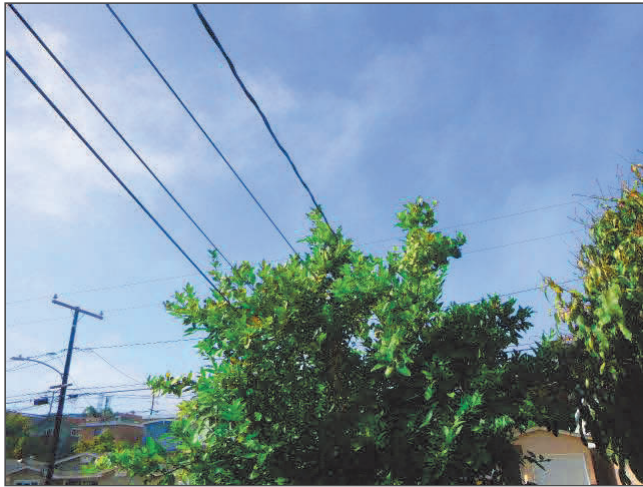
13.0 Item 1 (Picture)

(1) Utility wires are contacting foliage/tree limbs. When utility company wires coming into the service mast are sagging, frayed, strung through trees, they present a potential hazard, the utility company should be contacted to correct the condition.

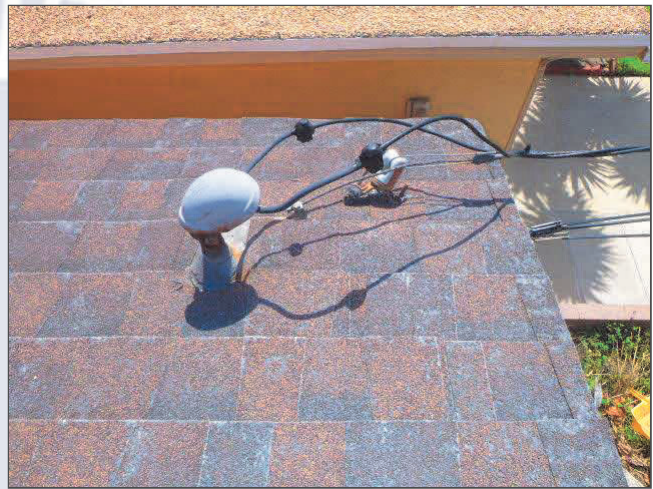
13.0 Item 3 (Picture)

(2) Inadequate drip loop was noted, suggest review with a licensed electrician for repairs as needed.

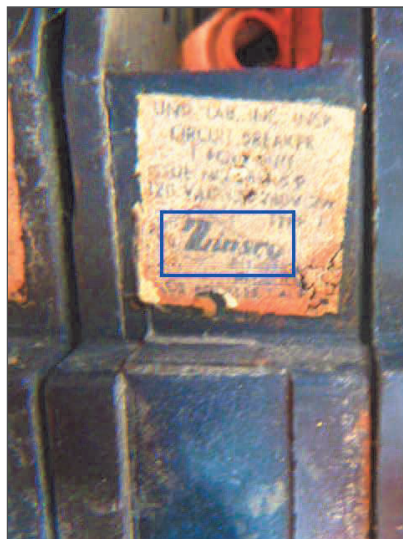
13.1 Item 2 (Picture)

(1) The main electrical panel is a Zinsco brand panel box, a product that hasn't been manufactured for many years. There are problems with these panels that can, in some cases, be serious. Some Zinsco panels have aluminum bus bars (the bars that run down the middle of the panel to which the breakers connect). Over a period of years, oxide forms on the aluminum causing a poor connection with the breakers and leading to arcing, overheating, and, eventually, breaker failure. Other problems with Zinsco panels include circuit breakers (depending on the vintage) with a dismal performance record and the possibility of unbalanced multi-wire circuits. Also, please be aware that various insurance companies will not insure homes with this style of electrical panel. Suggest review by a licensed electrician for replacement costs as needed.

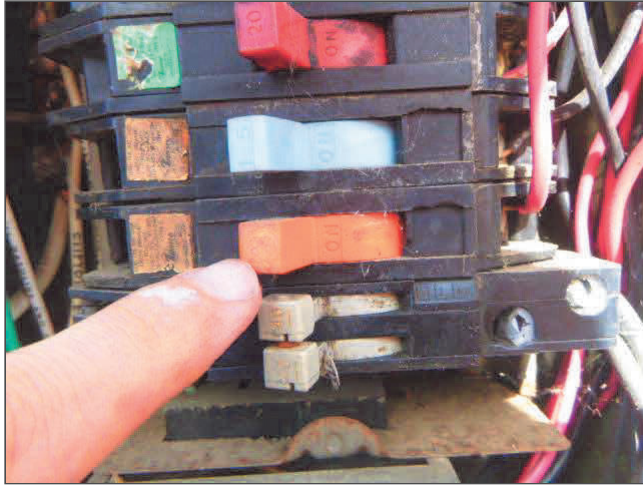
13.2 Item 1 (Picture)

(2) A damaged breaker was noted, suggest replacement as needed.

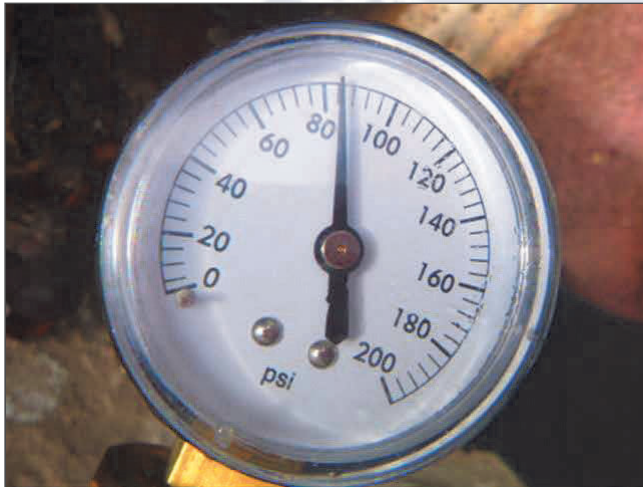
14.0 Item 1 (Picture)

(1) Suggest installation of a pressure regulator to reduce water pressure below 80 PSI to relieve stress on all plumbing joints and fittings.

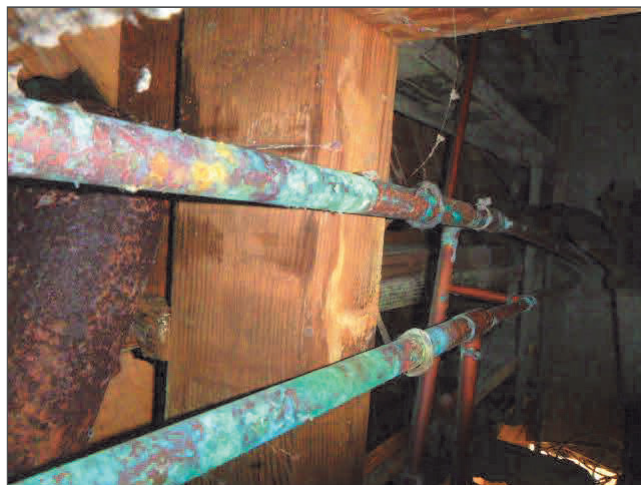
14.0 Item 3 (Picture)

(2) See the crawl space comments and repair as needed.

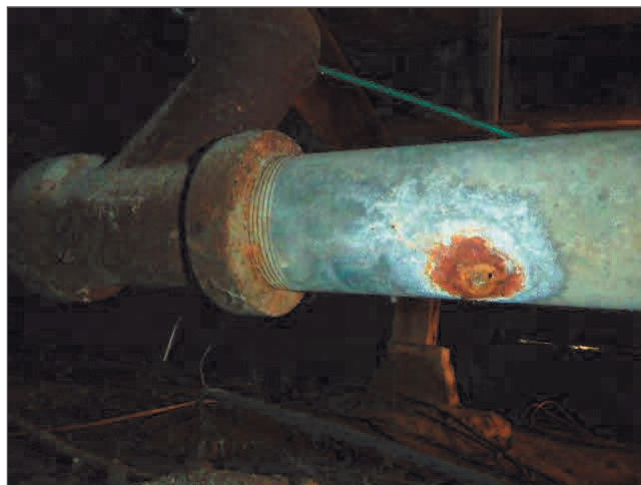
15.0 Item 2 (Picture)

(1) See the crawl space comments due to multiple cracks and leaking drains. Suggest review by licensed plumber for repair/replacement costs.

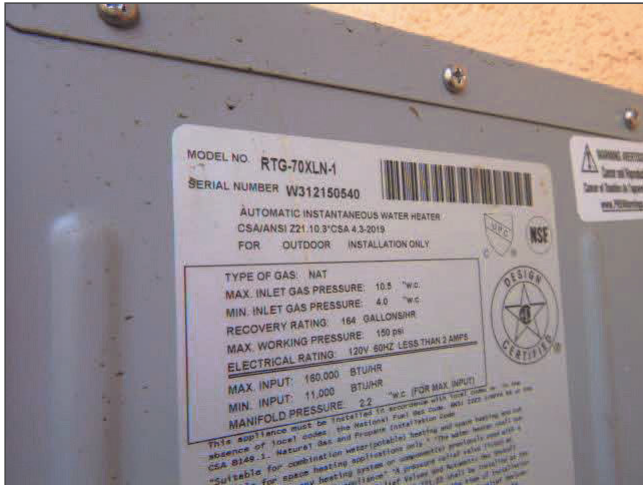
16.0 Item 1 (Picture)

(1) The water heater was operational at the time of the inspection.

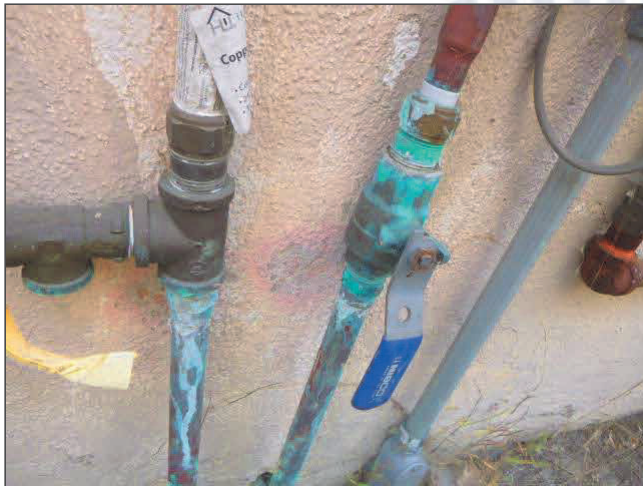
16.0 Item 2 (Picture)

(2) Rust and corrosion was noted at the cold water shut off, no leaking was visible at the time of the inspection. Suggest review by a licensed plumber for repair/replacement costs as needed.

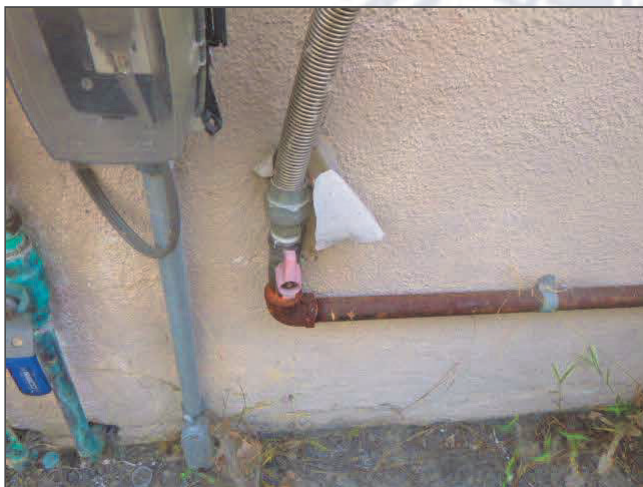
16.0 Item 3 (Picture)

(3) Currently no gas supply line drip leg/sediment trap is installed, please be aware that various cities do not enforce/require this installation. Suggest review with the local City Building Department and/or with a licensed plumbing contractor for installation costs as needed.

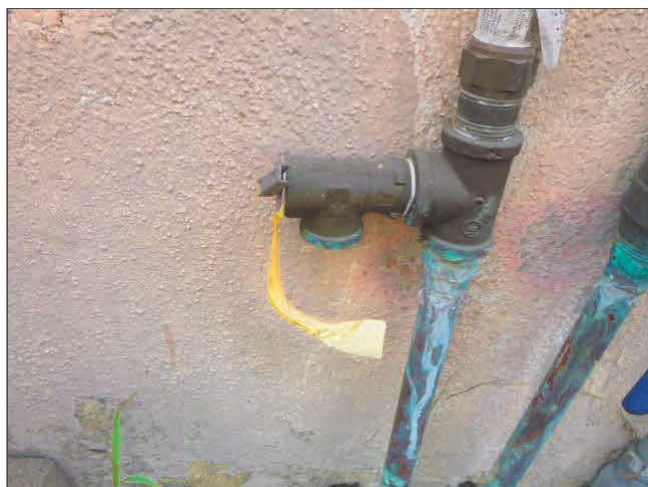
16.0 Item 4 (Picture)

(4) No discharge pipe connected to the TP&R valve, this is a potential safety hazard. Suggest review by a licensed plumber for costs to install the TP discharge drain down to within 4-6 inches of the exterior grade/deck as required

for safety.

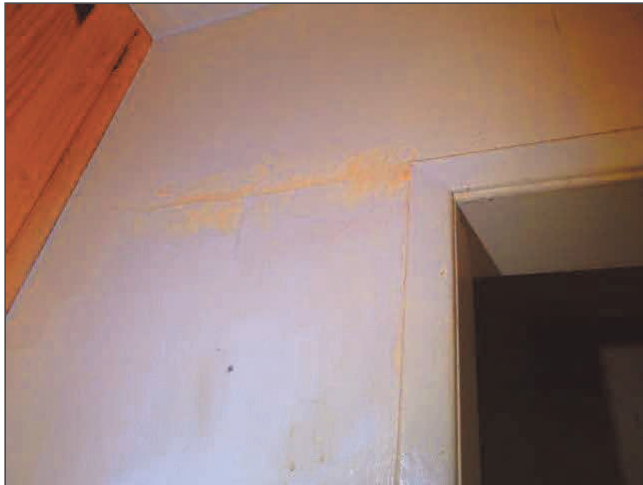
17.1 Item 1 (Picture)

(1) Settling cracks and patching was noted, suggest repair as needed.

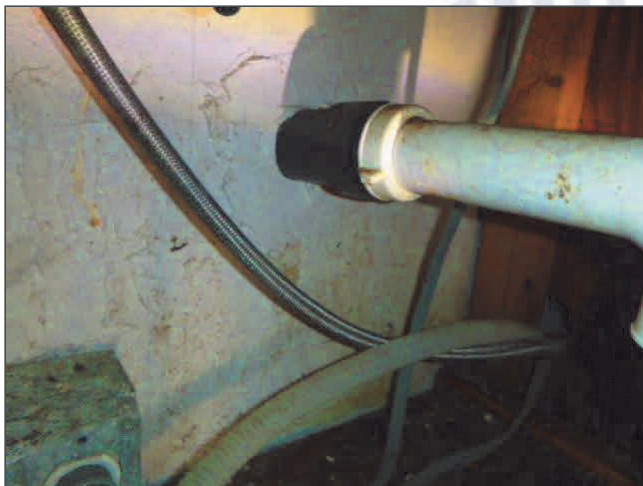
17.1 Item 2 (Picture)

(2) Patched areas of the walls was noted, suggest review with the seller for the cause and any repairs needed. Suggest repair as needed.

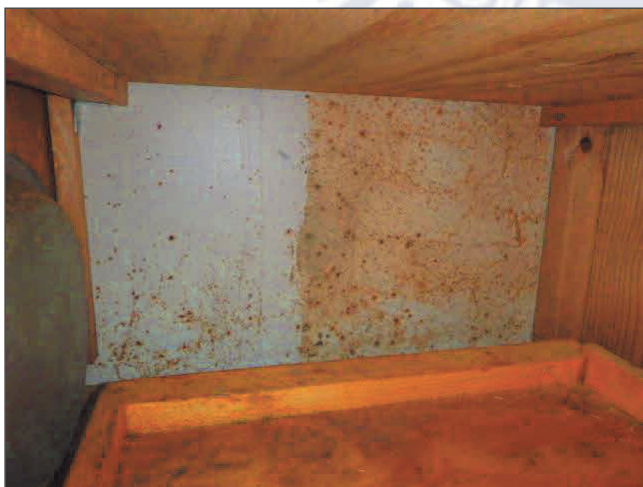
17.1 Item 3 (Picture)

(3) Excessively stained wall(s) noted in the cabinetry. Suggest review with the seller and a licensed contractor for removal/repair/replacement costs as needed.

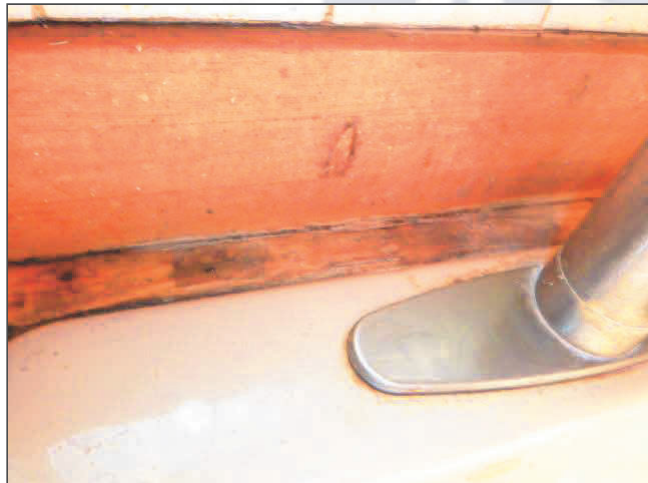
17.6 Item 1 (Picture)

Deterioration noted at various areas, suggest repair/replace as needed.

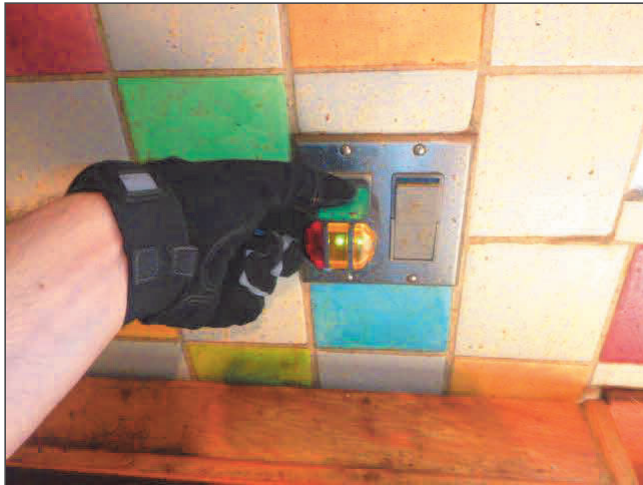
17.7 Item 1 (Picture)

Various countertop outlets are not GFCI protected as required. Countertop GFCI outlet(s)/protection has been required within six feet of the sink since 1987 and all countertop outlets since 1996. Suggest review by a licensed electrician for installation costs as required for safety.

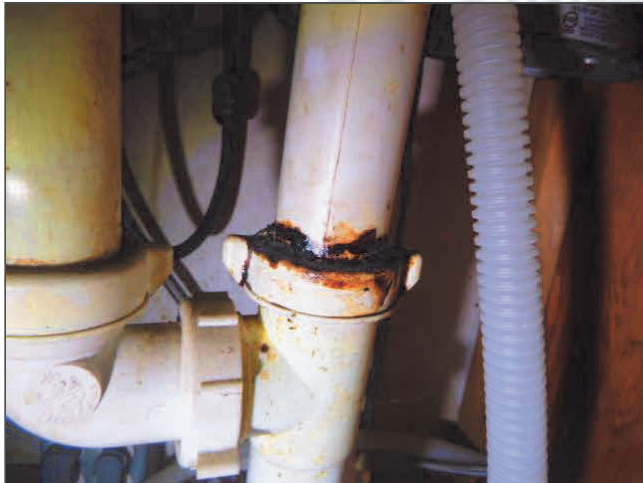
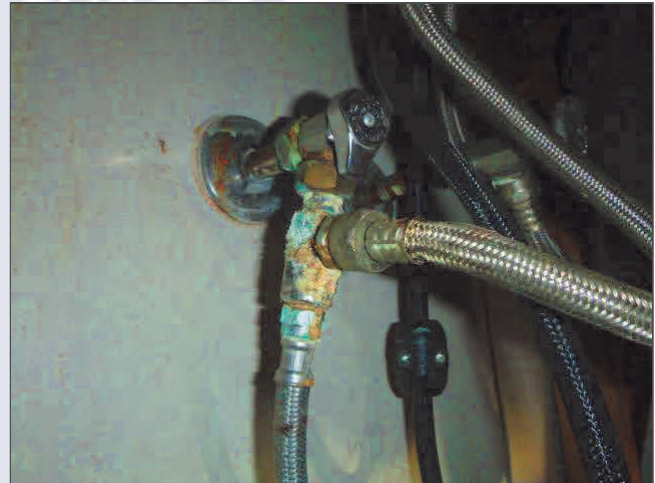
17.10 Item 1 (Picture)

Corrosion noted at the sink drain and angle valve(s), no leaking noted at the time of the inspection. Suggest review by a licensed plumber and repair/replace as needed.

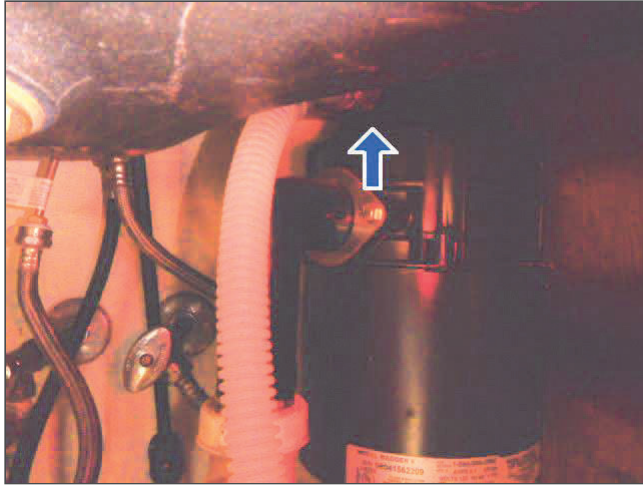
17.11 Item 1 (Picture)

(1) There is no air gap installed for the dishwasher as required, the system currently drains directly into the disposal. Suggest review by a licensed plumber for costs to install the air gap and drain as required.

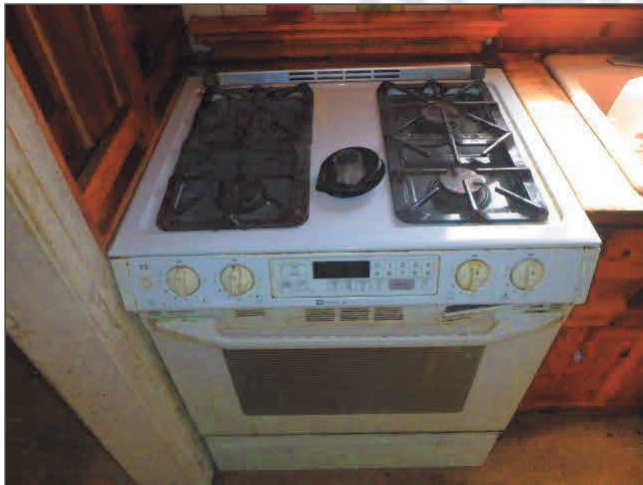
17.13 Item 1 (Picture)

(1) The oven is in disrepair and has a faulty ignition system, suggest replacement as needed.

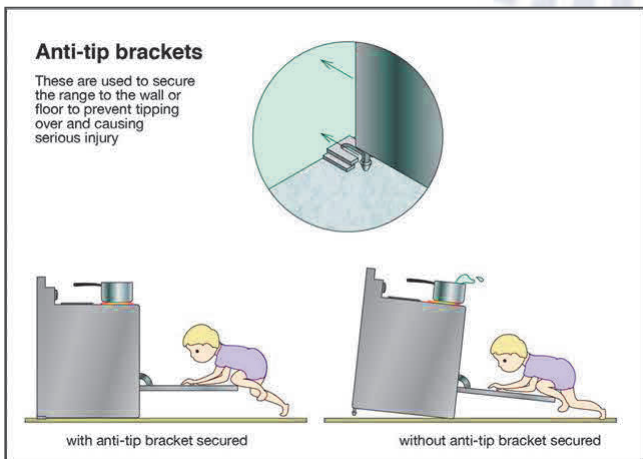
17.13 Item 2 (Picture)

(2) The anti-tip bracket is not currently installed. An anti-tip bracket is usually installed on the floor and against the wall (towards the back of the stove) for one of the rear legs to slide into. Its purpose is to prevent the stove from tipping when a heavy load is placed on the door ( possible child ) or slide-out racks upsetting the center of gravity. Suggest installation for safety as required since 1991.

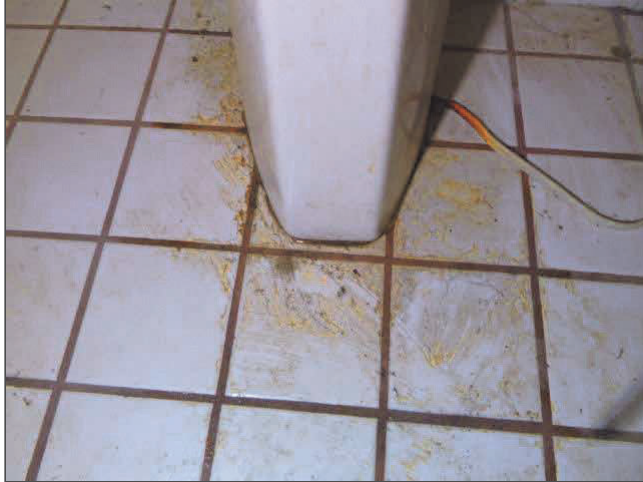
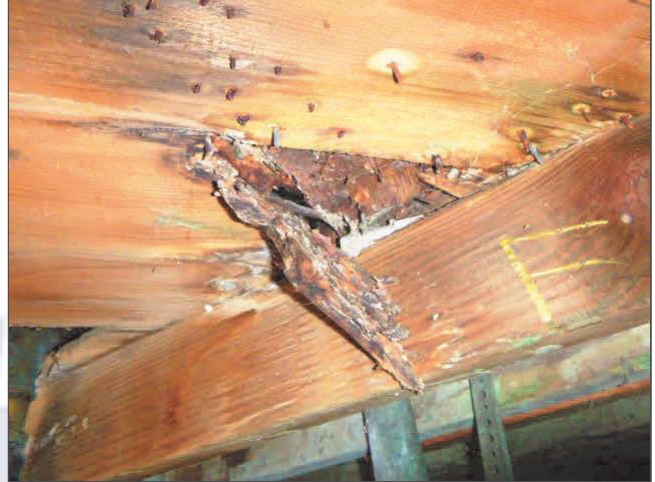
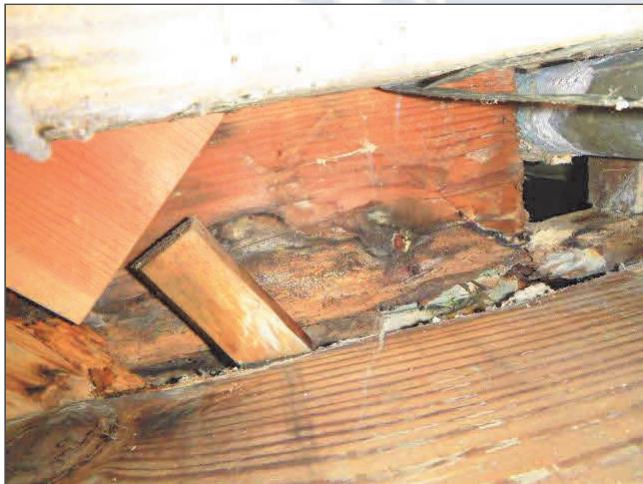
18.0 Item 1 (Picture)

Wet areas noted under the sink ( likely due to the leaking drain ), has caused sub floor damage. See the foundation comments and make repairs as needed.

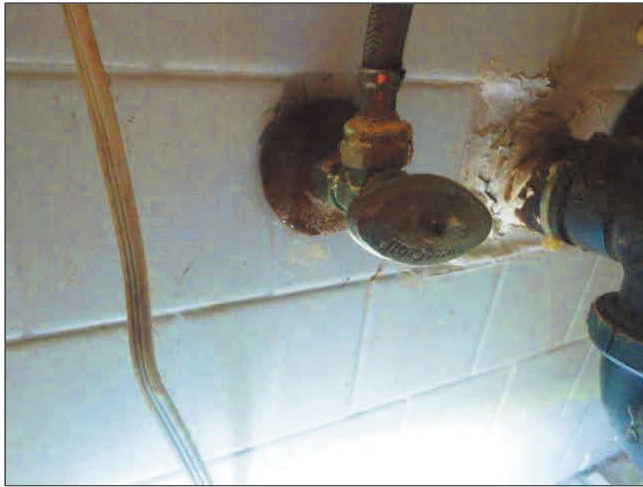
18.14 Item 1 (Picture)

(1) Corrosion noted at the sink angle valve(s), no leaking noted at the time of the inspection. Suggest review with a licensed plumber and repair/replace as needed.

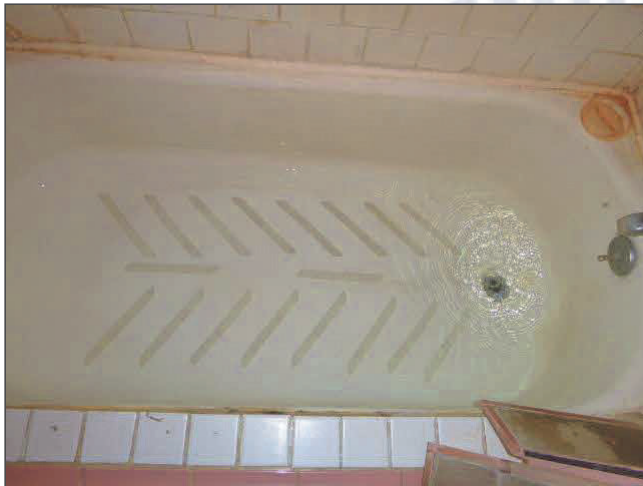
18.14 Item 2 (Picture)

(2) The tub drains slowly, suggest review with a licensed plumber for costs to clear the trap or drain as needed and confirm correct drainage as needed.

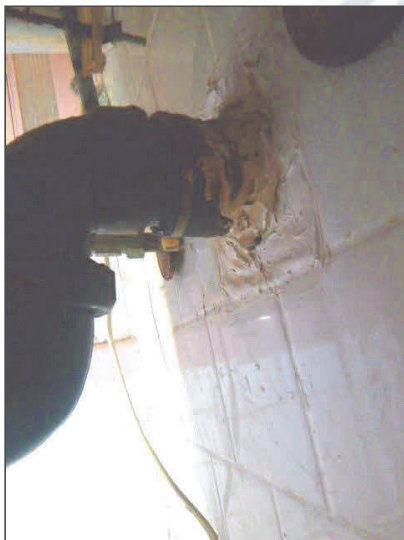
18.14 Item 3 (Picture)

(3) The sink drain appears to be rusted/deteriorated and leaking, suggest review with a licensed plumber for replacement costs as needed.

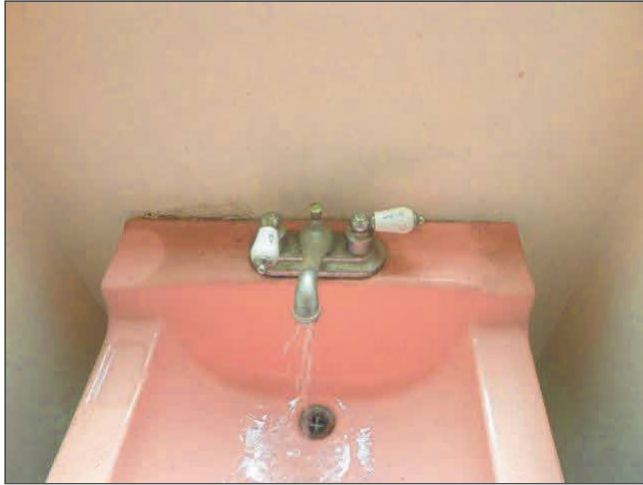
19.8 Item 1 (Picture)

Poor water flow noted at the faucet, suggest review with a licensed plumber for repair/replacement costs as needed.

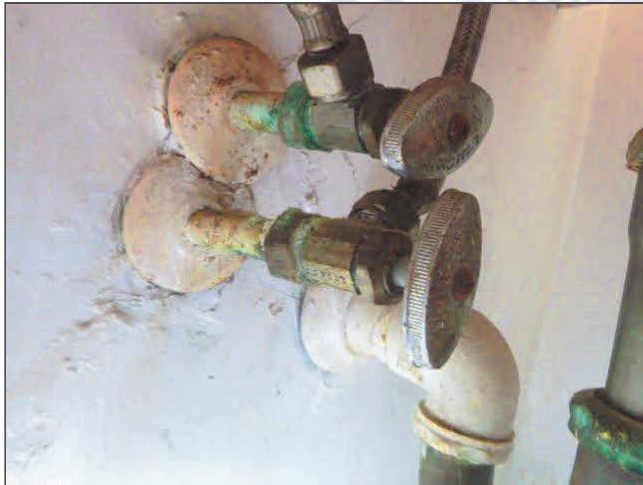
19.9 Item 1 (Picture)

Corrosion noted at the sink angle valve(s), no leaking noted at the time of the inspection. Suggest review with a licensed plumber and repair/replace as needed.

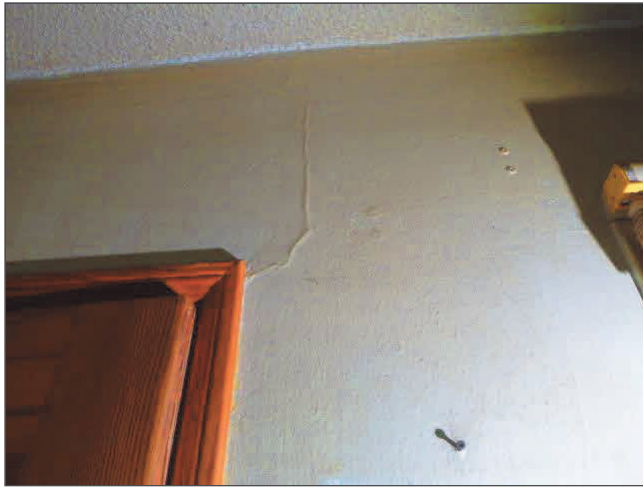
20.1 Item 1 (Picture)

(1) Settling cracks and patching was noted, suggest repair as needed.

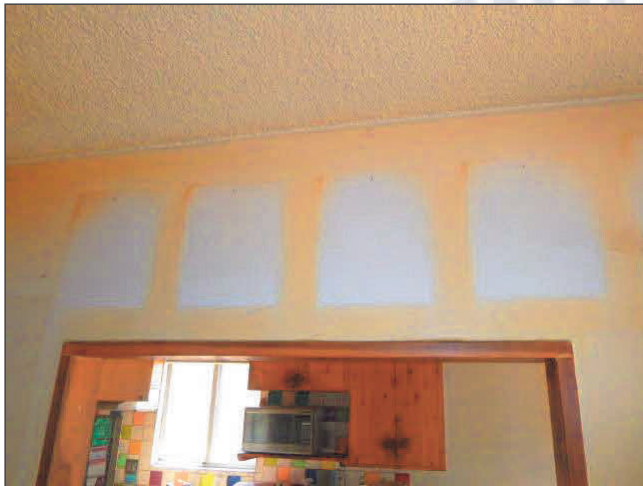
20.1 Item 2 (Picture)

(2) Excessive stains and smoke odor was noted due to potentially/likely excessive interior smoking, suggest review with the seller and a licensed contractor on this item as needed.

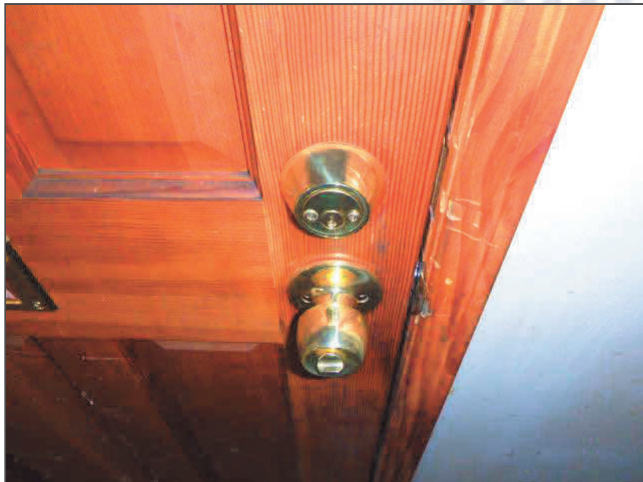
20.3 Item 1 (Picture)

(1) A keyed interior lock is installed at the exterior door, suggest installing a thumb turn dead-bolt to enhance safety as an upgrade.

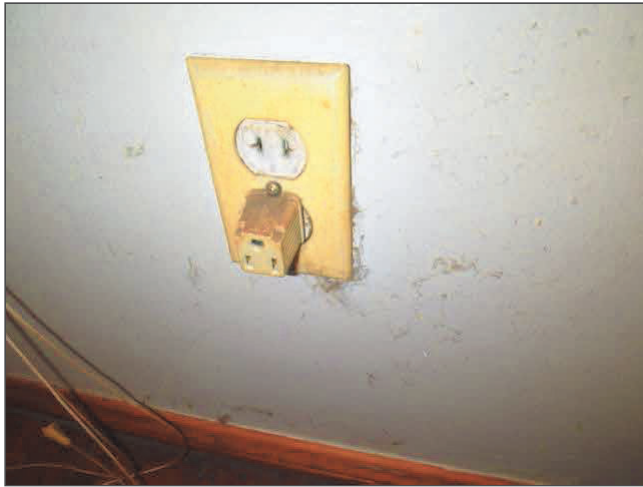
20.6 Item 1 (Picture)

(2) Two wire and two prong electrical receptacles noted. At the time of the original construction this type of system was the acceptable standard and appears to be intact. If three prong and GFCI receptacles are desired a ground source is required. Suggest review with a licensed electrician for costs to ground the outlets as needed as an upgrade and/or protected the outlet(s) on a GFCI circuit where recommended.

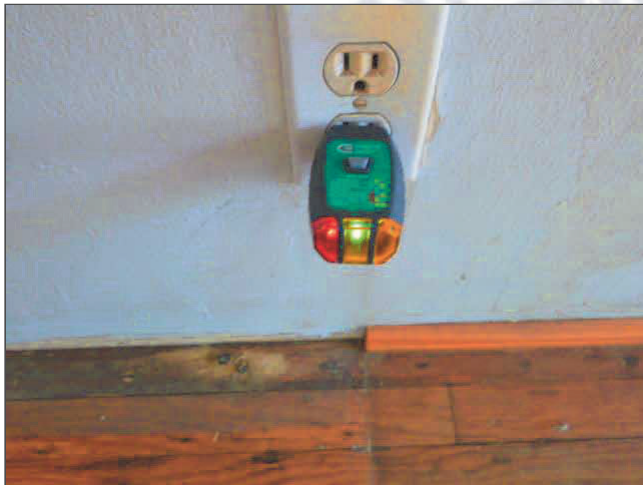
20.6 Item 2 (Picture)

(3) The front outlet is deteriorated and loose. Suggest repair or replace as needed.

(4) Reversed polarity noted at various outlets. Reversed polarity, hot and neutral are reversed, typically these issues for the electric outlets are usually easily corrected by minor wiring adjustments at the specified item. Suggest review with a licensed electrician for repair/replacement costs and confirm correct operation as needed.

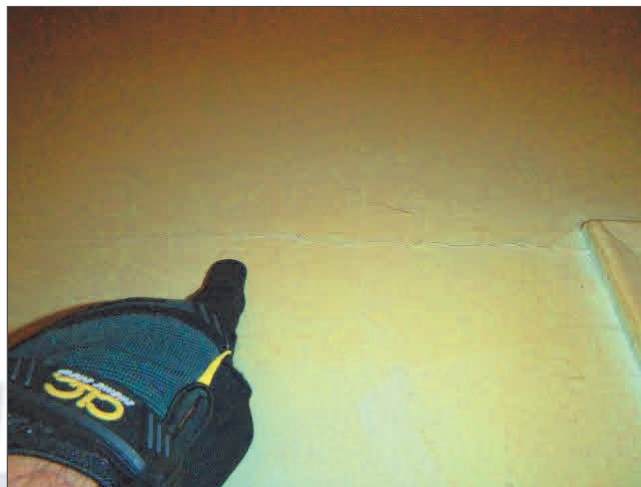
23.1 Item 2 (Picture)

(1) Excessive settling cracks noted, see the foundation and Lot/Drainage comments. Suggest review with a licensed contractor for repair/replacement costs as needed.

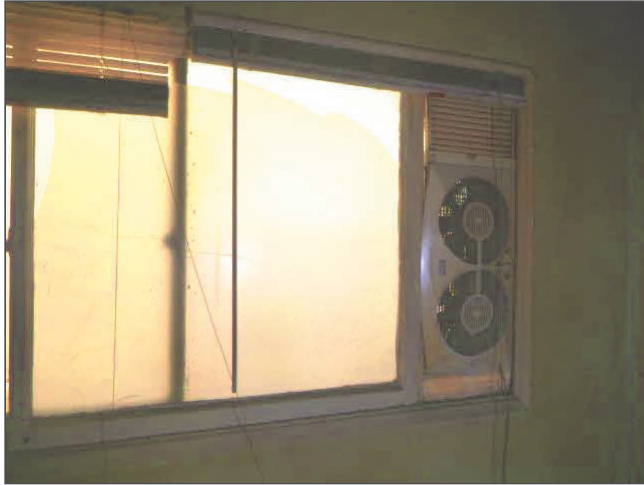
23.4 Item 1 (Picture)

(1) Unable to test the window due to the fan unit, suggest removal and make repairs as needed.

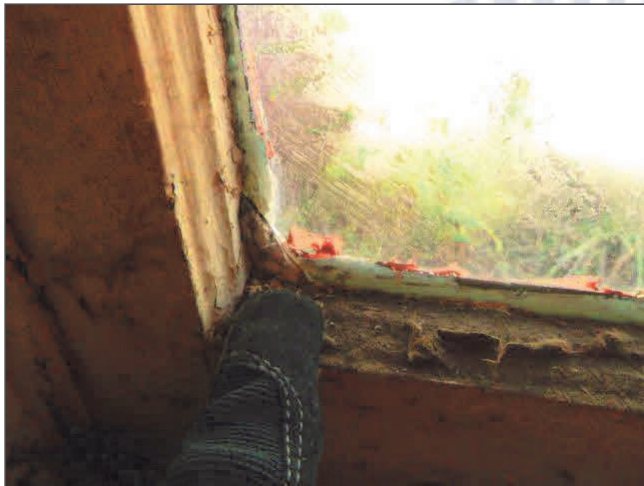
23.4 Item 2 (Picture)

(2) Cracked/broken glass noted at the window(s), this is a potential safety hazard. Suggest review with a licensed contractor/glazing company for replacement costs as required for safety.

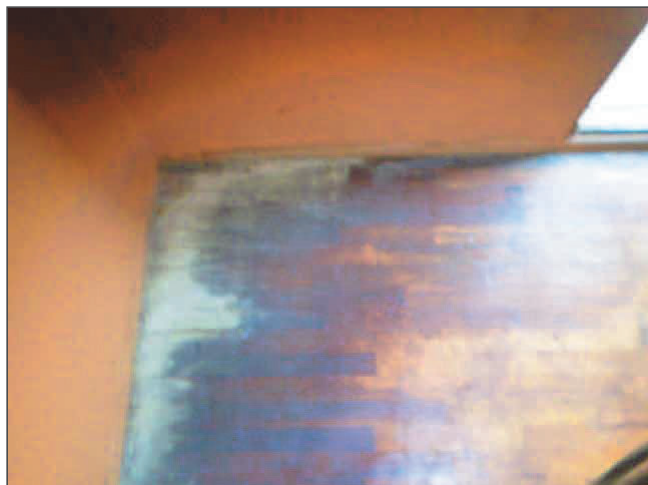
24.0 Item 1 (Picture)

(1) Floor slope and uneven flooring noted.

(2) Worn and deteriorated areas of the flooring were noted, suggest repair/refinish as needed.

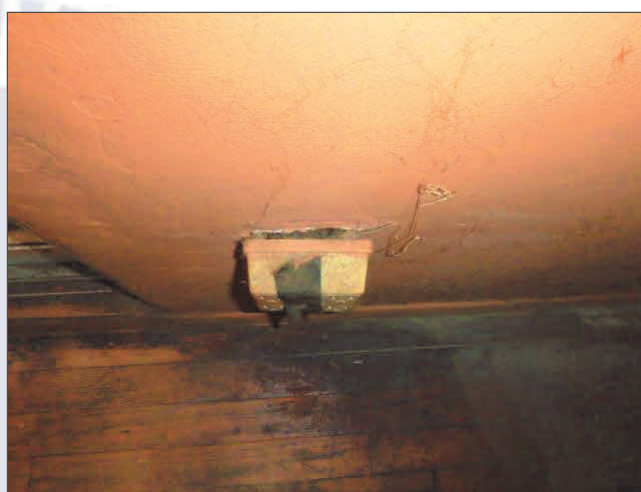
24.5 Item 3 (Picture)

(2) The outlets are deteriorated and loose. Suggest repair or replace as needed for safety.

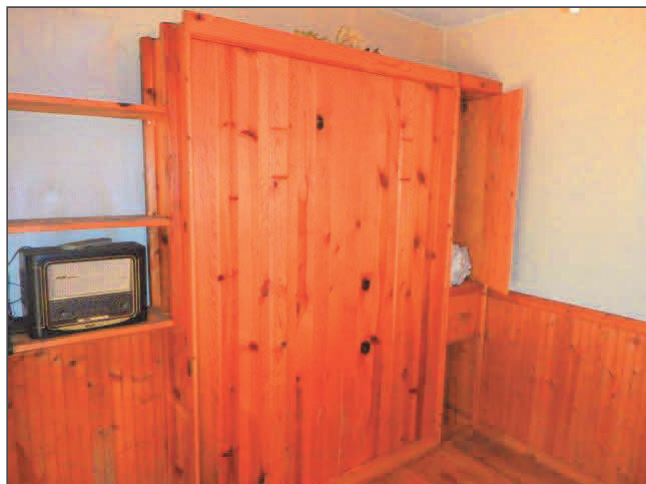
25.7 Item 1 (Picture)

The 'Murphy Bed' system is beyond the scope of the inspection and was not tested/inspected.
