Fireplace Inspection Report

LOCATED AT:
548 N Hartley St
West Covina, California 91790

INSPECTED ON:
Wednesday, May 22, 2024

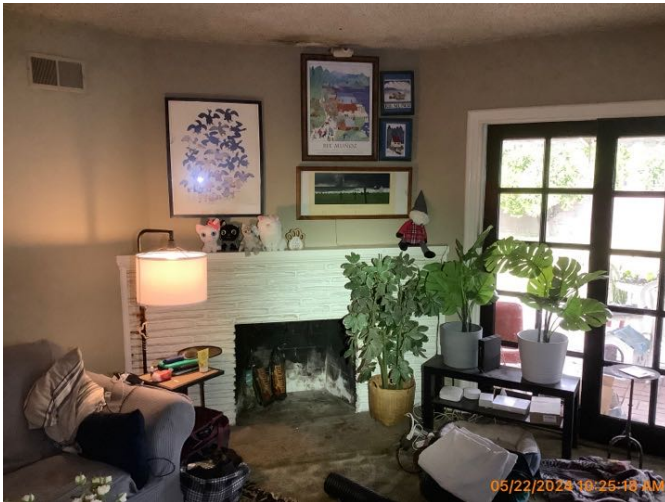
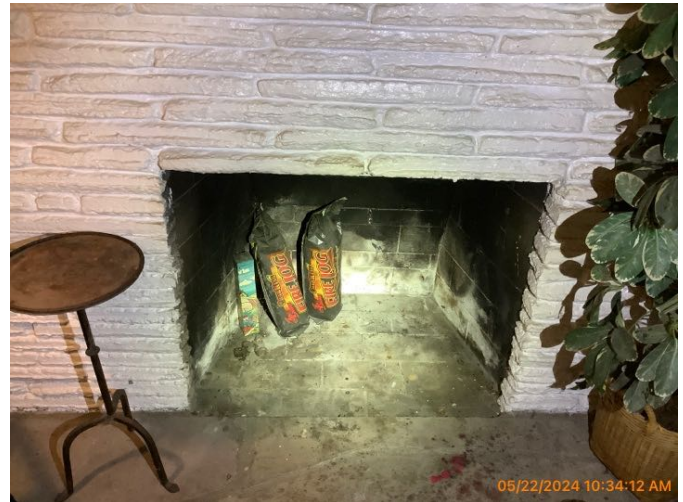
The fireplace is a masonry wood-burning structure, built on site with no gas line installed. It has an opening of approximately 32.75 inches wide by 26.25 inches tall.

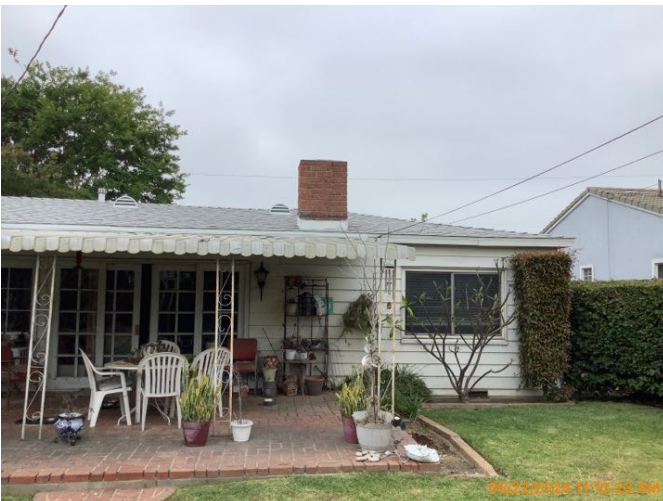
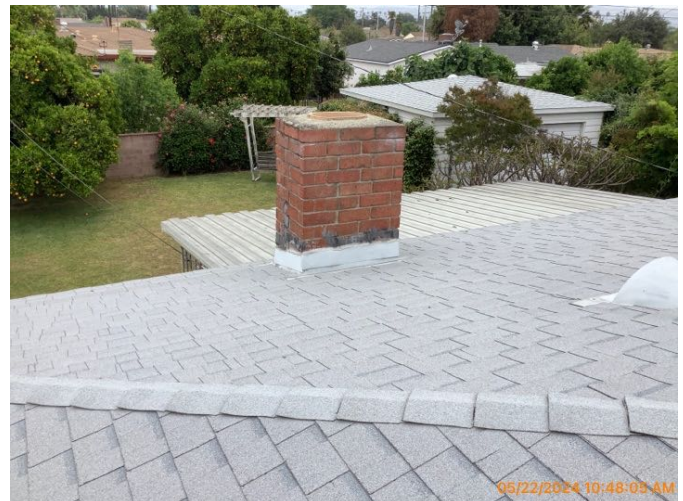
This is a one-story masonry structure and it may be reinforced with steel rebar based on its age and appearance.

There wasn't significant movement in the chimney when pressure was applied to it.

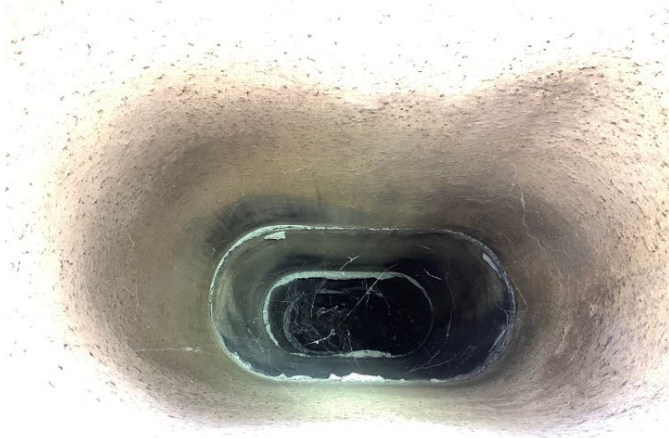
The inside of the chimney is lined with terra cotta clay liners. It has an oval opening of approximately 15.5 inches by 8 inches.

Looking down the flue
