**Exclusive Property Inspection Report Prepared For  
Edward Lee**

Property Address: 6919 Grovespring Dr. Rancho Palos Verdes CA.

Inspection Date: 5/23/2025

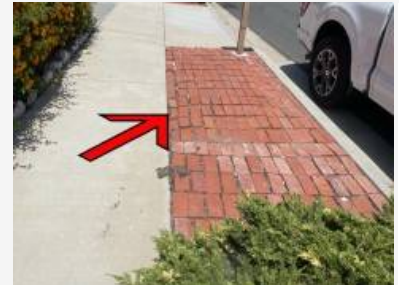
- Uneven surface joints are visible at multiple locations along the front parkway brick walkway. The condition poses a trip hazard. We recommend correction using appropriate methods by a qualified state licensed masonry contractor.

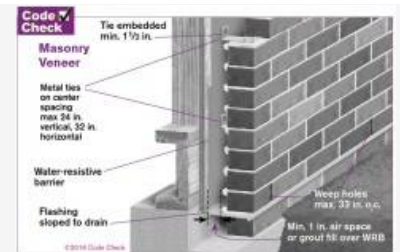
- A footing is absent at the base of the brick veneer. The condition can make the brick veneer wall unstable. The brick veneer also lacks flashings and weep openings to prevent moisture entrapment and subsequent damage between the veneer and its backing. We recommend correction using appropriate methods by a qualified state licensed masonry contractor. Determining if any damage exists behind the veneer as a result is beyond the scope of this inspection due to inaccessibility.

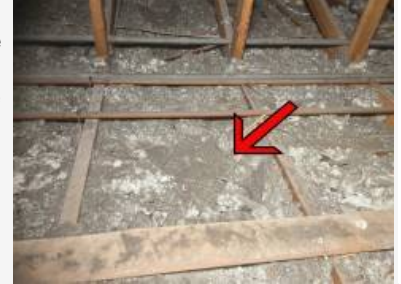
- The thickness of the existing insulation is poor by today's construction standards. The condition is conducive to thermal loss from the interior living space. Installation of additional insulation by a qualified state licensed insulation contractor should be considered.

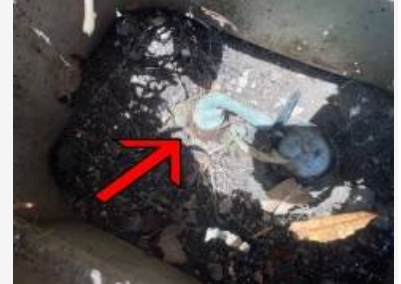
- Corrosion related damage caused by leakage is visible on the water shut off valve pipe fitting at the meter. Replacement of the valve by a qualified state licensed plumbing contractor is recommended.

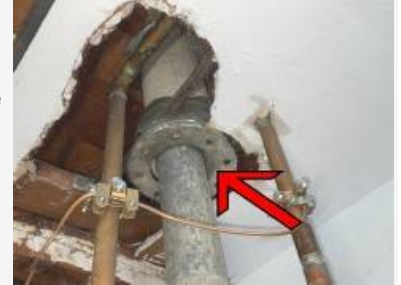
- A transition collar is absent where the vent connector attaches to the vent pipe. Spillage of hazardous exhaust gases can occur as a result, therefore a carbon monoxide poisoning hazard exists. We recommend correction using appropriate methods by a qualified state licensed plumbing contractor.

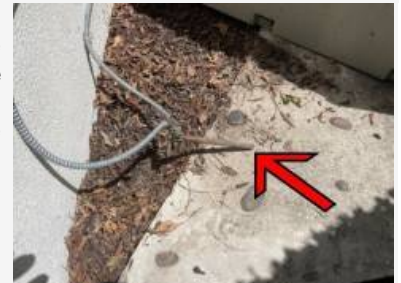
- The ground rod is cut to less than 12" in length, therefore not functional. The minimum length should be 8ft. buried vertically into the earth. The purpose of the grounding electrode system is for the safety of buildings and to protect people from electrical shock hazards. Replacement with an approved grounding electrode system by qualified state licensed electrical contractor is recommended.

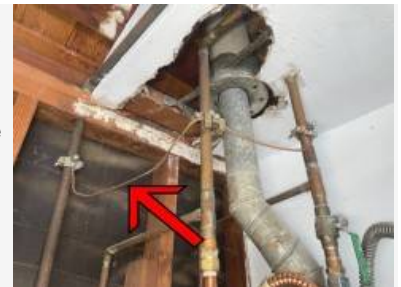
- The gauge of the bonding jumper wire is too small at the water heater, therefore may not function as intended. The bonding jumper wire should be of the same gauge as the service grounding electrode conductor. The function of the bonding jumper is to prevent electrical shock hazards in the event the water and gas pipes become energized. We recommend correction using appropriate methods by a qualified state licensed electrical contractor.

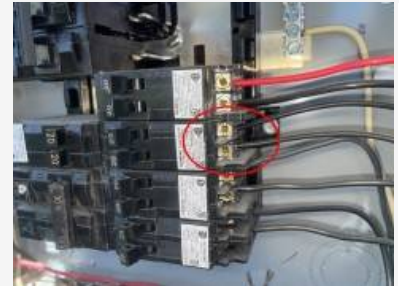
- #14 AWG wiring is connected to a 20 amp single pole circuit breakers which is improper as #14 AWG is rated for 15 amp maximum. Overheating of the wiring can occur as a result, therefore a risk of fire hazard exists. We recommend correction using appropriate methods by a qualified state licensed electrical contractor.

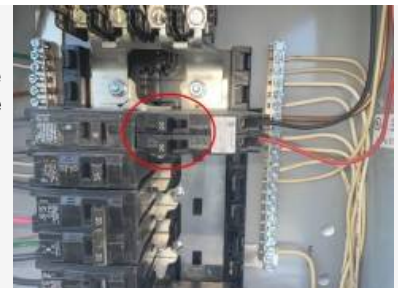
- Handle ties are absent from the multi-wire branch circuit breakers. Ties insure that the circuit breakers will simultaneously disconnect all ungrounded conductors on the circuit to prevent an electrical shock hazard when the breakers are tripped. We recommend correction using appropriate methods by a qualified state licensed electrical contractor.

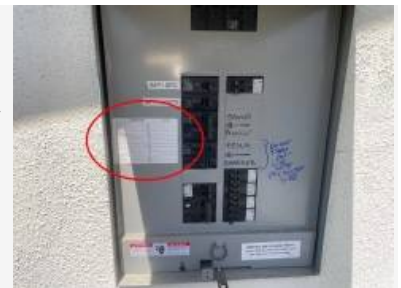
- The circuit breakers lack complete location labeling. We recommend that each breaker be properly labeled to allow persons to identify them for safe operation when and if necessary. We recommend correction using appropriate methods by a qualified state licensed electrical contractor.

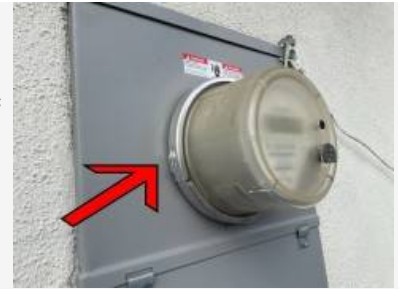
- A utility company locking device is absent from the meter. The purpose of a locking device is to prevent unauthorized access to the high voltage service wiring. The condition poses an electrical shock hazard. We recommend contacting the electric utility company that serves power to the building for further evaluation and correction.

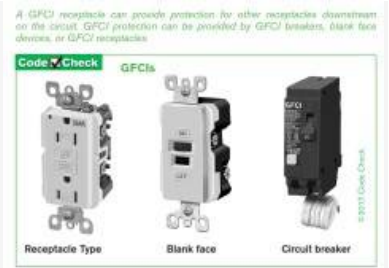
- Receptacles are not protected by a Ground Fault Circuit Interrupter (GFCI) at the garage interior, laundry area, kitchen counters, and kitchen appliances. The function of a Ground Fault Circuit Interrupter is to protect people from electrical shock hazards. We recommend correction using appropriate methods by a qualified state licensed electrical contractor.

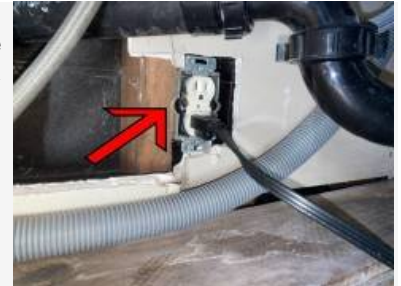
- Protection cover is absent from an outlet within the kitchen sink base cabinet. The condition exposes the energized receptacle components, therefore an electrical shock hazard exists. Replacement of any absent protection covers is recommended.

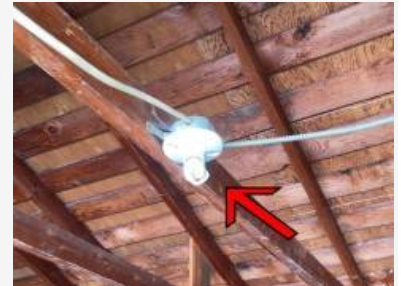
- Light bulb is broken off in the socket of a fixture at the garage interior. The condition poses an electrical shock hazard. We recommend correction using appropriate methods by a qualified state licensed electrical contractor.

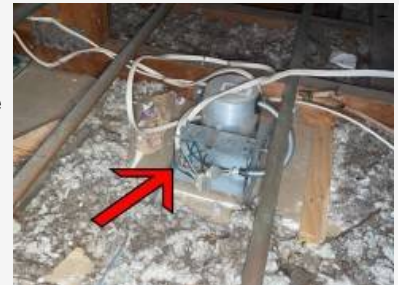
- Protection covers are absent from multiple junction boxes in the attic. The condition exposes the energized wiring within the boxes, therefore an electrical shock hazard exists. Calculating the wire fill in the boxes is beyond the scope of this inspection. We recommend correction using appropriate methods by a qualified state licensed electrical contractor.

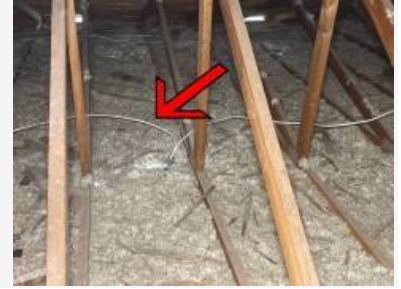
- Securing straps are absent from multiple cables within the attic and garage interior. We recommend correction using appropriate methods by a qualified state licensed electrical contractor.

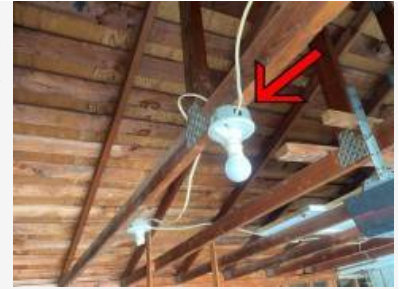
- Cable clamps are absent where cables enter outlet boxes as viewed at the garage interior. Damage to the wiring can occur as a result, therefore a potential electrical shock and risk of fire hazard exists. We recommend correction using appropriate methods by a qualified state licensed electrical contractor.

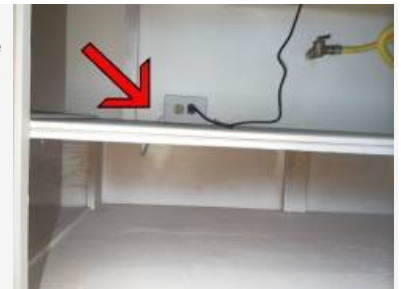
- Exposed cable subject to damage is visible with the kitchen base cabinet for the cooktop. We recommend correction using appropriate methods by a qualified state licensed electrical contractor.

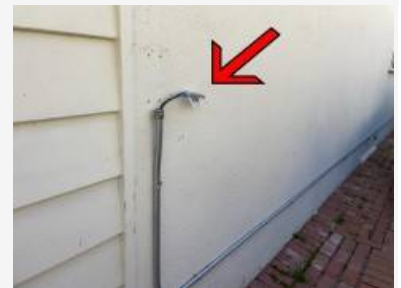
- Exposed conductors are visible from the open end of a conduit at the right side exterior wall. The condition poses an electrical shock hazard. We recommend correction using appropriate methods by a qualified state licensed electrical contractor.

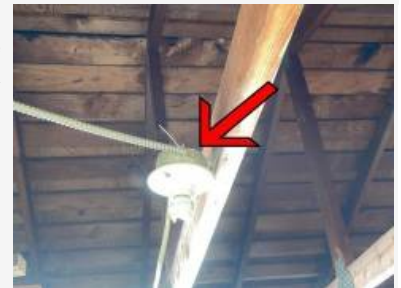
- Cable clamps are absent where cables enter outlet boxes as viewed at the garage interior. Damage to the wiring can occur as a result, therefore a potential electrical shock and risk of fire hazard exists. We recommend correction using appropriate methods by a qualified state licensed electrical contractor.

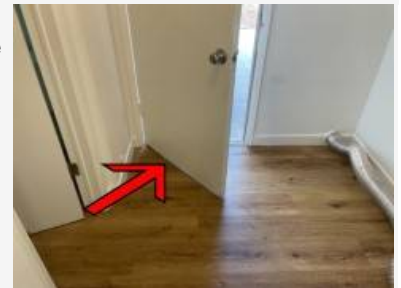
- The hollow core door is not an appropriate type for outdoor installation, therefore subject to moisture related damage. Damage is visible. Replacement with an appropriate exterior rated door by a qualified door specialist is recommended. We also recommend further evaluation by a qualified state licensed Structural Pest Control Operator to determine if any wood destroying organism conditions exist.

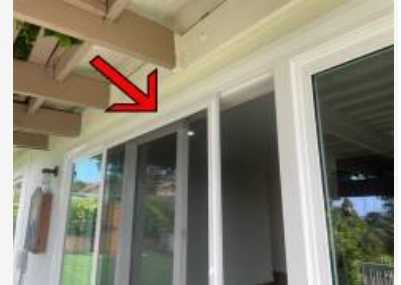
- The top of the screen door is off track. We recommend correction using appropriate methods.

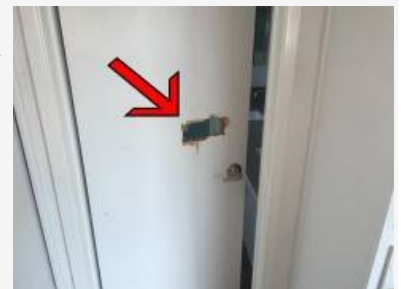
- Door panels are broken through at the primary bedroom bathroom. Replacement by a qualified door specialist is recommended.

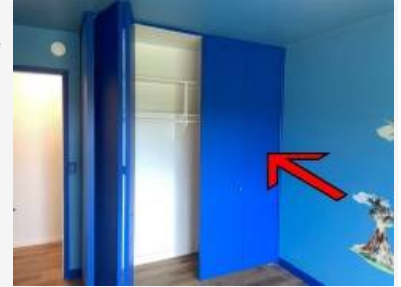
- Bi-fold closet door is stuck, therefore does not open at the left rear bedroom. We recommend correction using appropriate methods by a qualified door specialist.

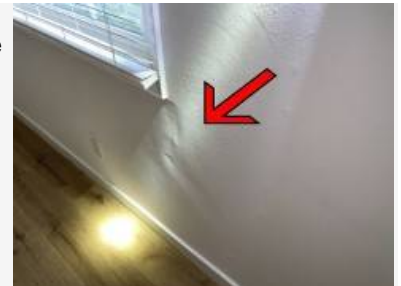
- Patching is visible to the wall cladding at each of the front bedrooms adjacent the windows. The condition may indicate structural movement of the building has occurred. We recommend further evaluation by a qualified state licensed geo-technical engineer.

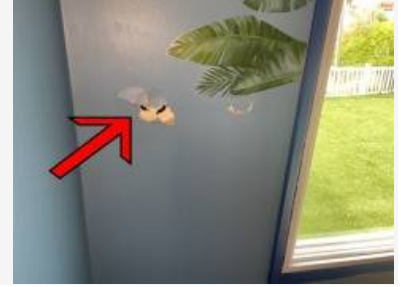
- Small holes are visible in the wall cladding at the left rear bedroom. We recommend correction using appropriate methods by a qualified state licensed drywall contractor.

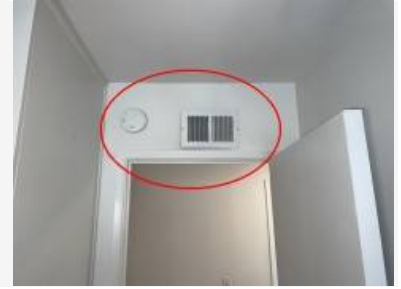
- The smoke alarms are located too close to forced air heating outlet registers (within 36" and within direct flow), therefore may not function as intended while the forced air system is running. We recommend correction using appropriate methods.

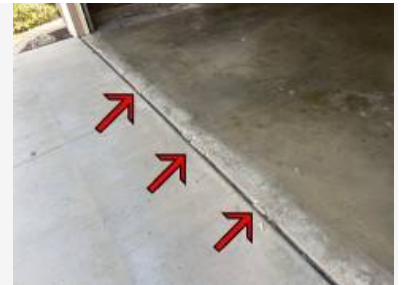
- Significant chip damage is visible along the interface joint to the driveway. The damage is likely caused by exposed rebar along the joint. We recommend correction using appropriate methods by a qualified state licensed concrete contractor.

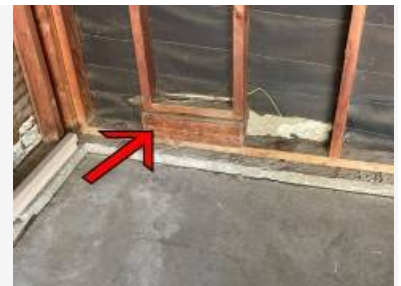
- One of the vents is blocked. The purpose of static ventilation is to reduce the risk of carbon monoxide hazards within the garage. We recommend removing the material that blocks the vent.

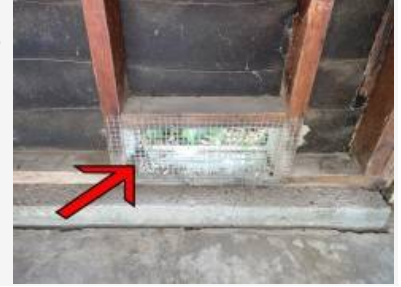
- The diameter of the vent screen mesh is too large. The condition is conducive to insect / vermin intrusion into the building. Replacement with an appropriate screening material is recommended.

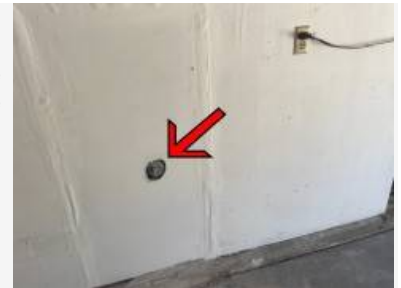
- Openings around pipes are not effectively sealed with an appropriate firestop material where they penetrate the fire separation cladding. The condition is a breach of the fire separation. We recommend correction using appropriate methods to prevent flame spread in the event of fire.

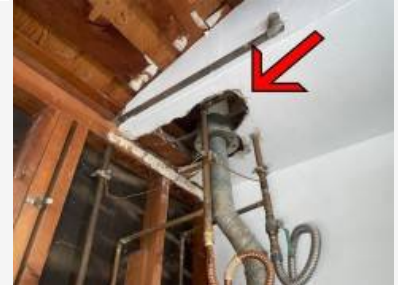
- Ceiling cladding is broken out around the water heater vent pipe. The condition is a breach of the fire separation. We recommend correction using appropriate methods to prevent flame spread in the event of fire.

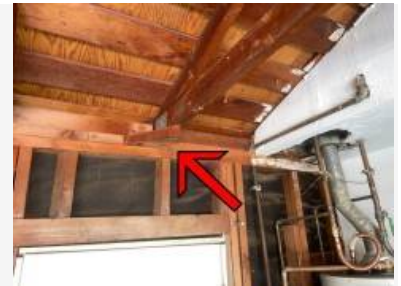
**Defects:**

- A corner tie brace is cut off from the top of the rear exterior wall. We recommend correction using appropriate methods by a qualified state licensed framing contractor.

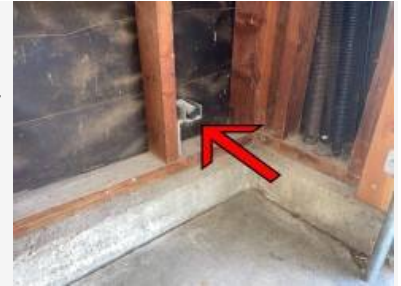
**Safety concerns:**

- Auto opener: The auto-reverse edge sensors are not within 6" of the floor for safety. We recommend correction using appropriate methods by a qualified garage door specialist. Refer to the auto opener manufacturers installation manual for instructions.

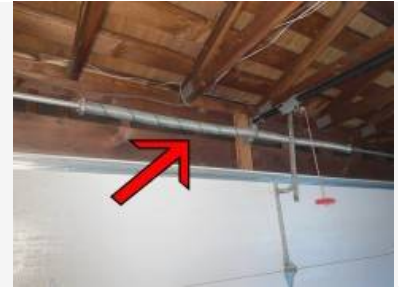
**Safety concerns:**

- Auto opener: Caution, spring warning labeling is absent at the torsion bar. Any replacement / repair / adjustment should be performed by a qualified garage door specialist only. We recommend correction using appropriate methods by a garage door specialist.

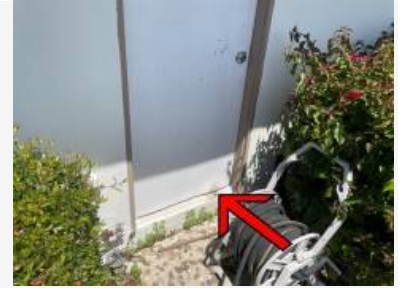
**Damage:**

- Moisture related damage is visible to the door which is causing the door skin to delaminate. We recommend correction using appropriate methods. We also recommend further evaluation by a qualified state licensed Structural Pest Control Operator to determine if any wood destroying organism conditions exist.

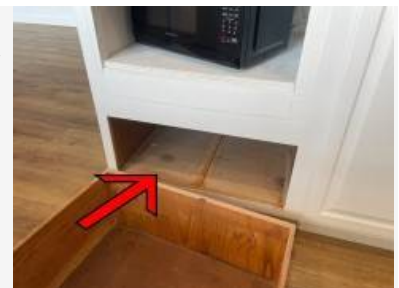
#### Safety concerns:

- Vermin droppings are visible with the cabinet below the oven. The condition poses a significant health hazard from contamination. Remediation is recommended. Determining active infestation is beyond the scope of this inspection. We recommend further evaluation by a qualified state licensed Pest Control Operator.

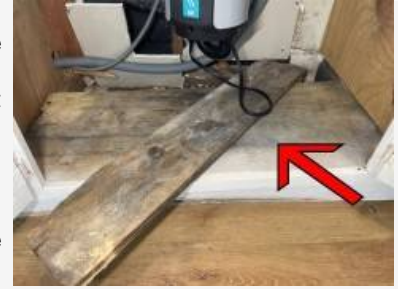
**Damage:**

- Moisture related damage is visible to the floor of the sink base cabinet. We recommend correction using appropriate methods by a qualified cabinet specialist. We also recommend further evaluation by a qualified state licensed Structural Pest Control Operator to determine if any wood destroying organism conditions exist.

- Moisture is conducive to adverse mold / microbial growth. Determining the presence of any type of mold / microbial growth is beyond the scope of this inspection. We recommend further evaluation by a qualified specialist to determine if such conditions exist.

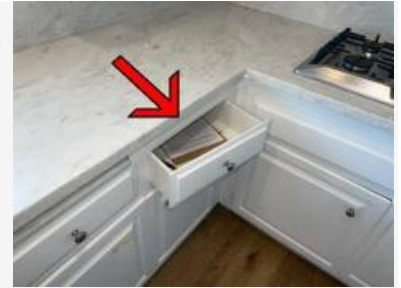
**Defects:**

- Multiple drawers are off the tracks. We recommend correction using appropriate methods by a qualified cabinet specialist.

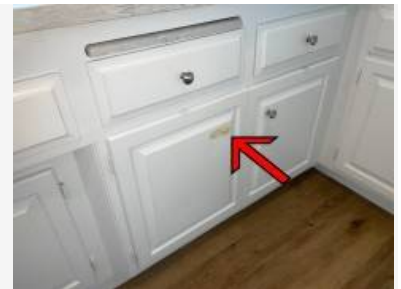
**Defects:**

- Pull knob is absent from one of the drawers. Replacement is recommended.

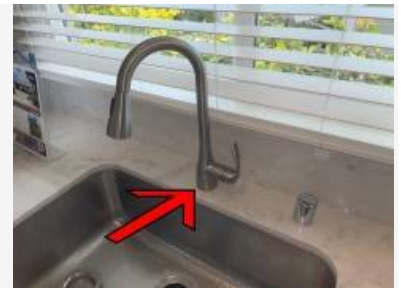
**Defects:**

- Faucet fixture: The fixture mount is loose. We recommend correction using appropriate methods by a qualified state licensed plumbing contractor.

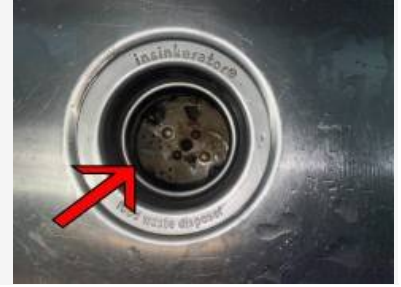
**Defects:**

- The splash guard is absent from the drain opening. We recommend correction using appropriate methods by a qualified state licensed plumbing contractor.

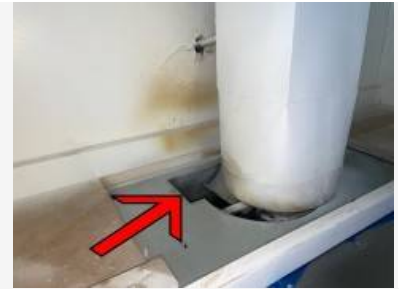
**Defects:**

- The vent connector manifold is absent, therefore the fan exhausts into the cabinet. We recommend correction using appropriate methods by a qualified appliance technician.

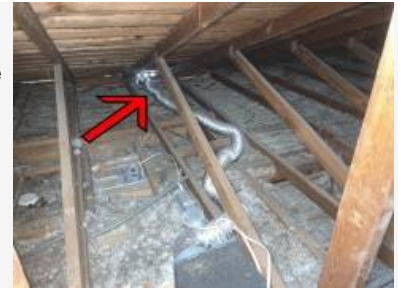
##### Defects:

- Exhaust duct: The exhaust duct terminates within the attic which is improper. The duct should terminate to the exterior through an appropriate termination hood. We recommend correction using appropriate methods.

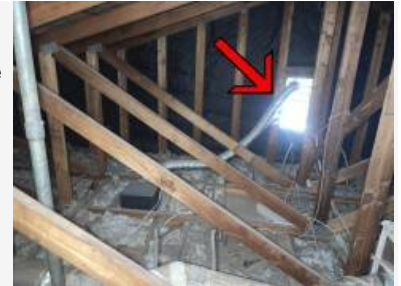
#### Defects:

- Exhaust duct: The exhaust duct terminates within the attic which is improper. The duct should terminate to the exterior through an appropriate termination hood. We recommend correction using appropriate methods.
