# **Property Inspection Report**

650 The Village, Unit 303, Redondo Beach, CA

Inspection date: 03/24/2026

## **Owner's Listing Inspection Report - Cover Page**

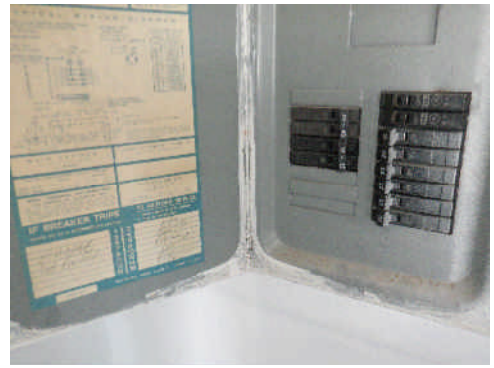
Circuit breakers.

The circuit breakers in the subpanel were labeled. The accuracy of the labeling was not verified.

The wiring within the subpanel appeared functional, with exceptions noted.

- a. [FE] There was paint/texture overspray in the panel and on the electrical components. We recommend a full evaluation and/or corrections by a specialist in the appropriate trade.
- b. [SC] There was evidence of movement and the feeder conduit was loose where the wires enter the panel. We recommend correcting the condition(s) noted.

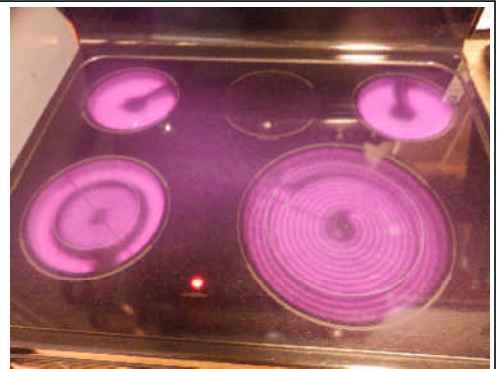
**COOKTOP(S)**

The cooktop/range burners functioned.
