ELITE GROUP

RESIDENTIAL

PROPERTY LOCATION: 700 E 50th St Los Angeles, CA 90011

INSPECTION REPORT

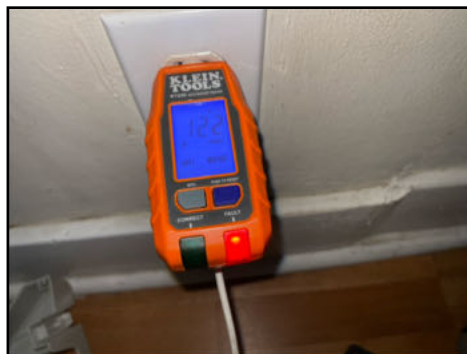
- A representative number of receptacles and switches were tested and found to be operational at time of inspection
- Loose/worn outlets/switches - typical for age consider upgrading
- **Outlet hot wired in reverse with neutral - needs to be serviced**

Outlet hot wired in reverse with neutral - needs to be serviced

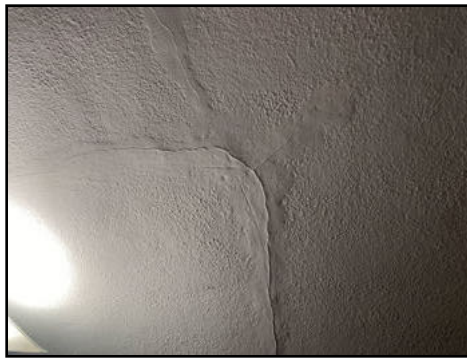
Patched/partial painted areas present - consult seller regarding patched areas

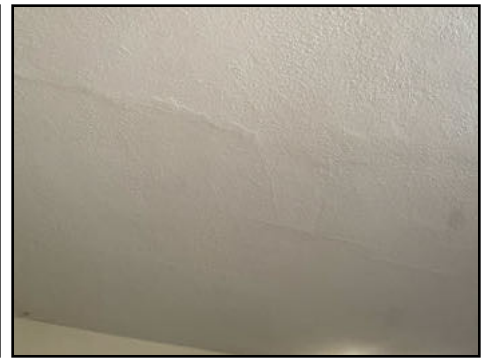
Patched/partial painted areas present - consult seller regarding patched areas

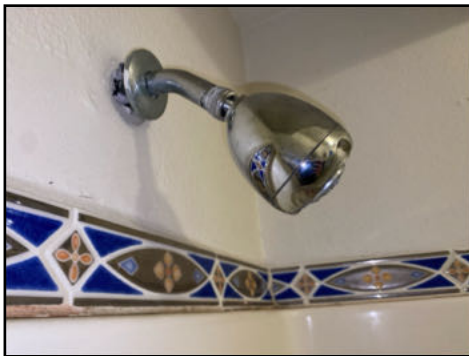
- Tub/Shower combo present - see tub notes for additional information
- Fixture was in a worn and older condition - typical for the age
- Shower arm faceplate is loose at the wall - recommend securing and sealing this area - all three
- Shower head pipe loose in wall - needs to be serviced
- Corrosion present at fixture(s) - needs to be serviced
- **Diverter does not properly divert water to shower head - needs to be serviced (hall south)**

Diverter does not properly divert water to shower head - needs to be serviced (hall south)

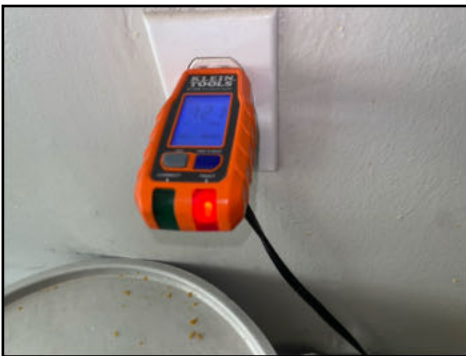
Outlet hot wired in reverse with neutral - needs to be serviced

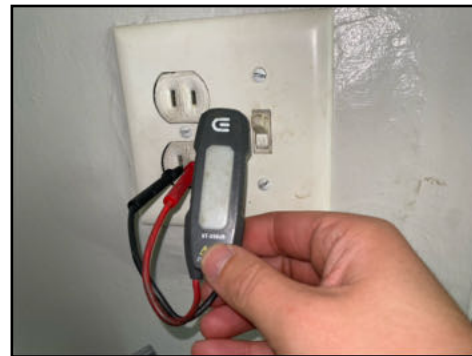
Non-energized (dead) outlet(s) - needs to be serviced

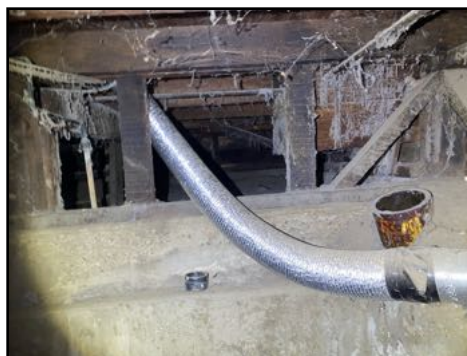
Flexible vent under structure - needs to be serviced

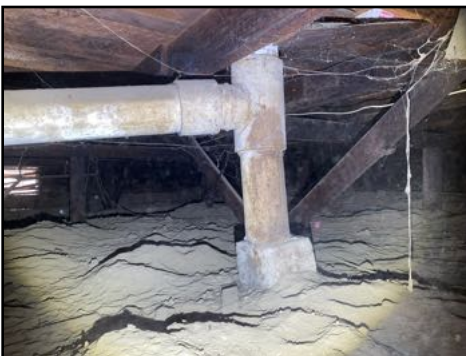
Older cement (AKA transite) flue pipe present - it is recommended to upgrade these areas

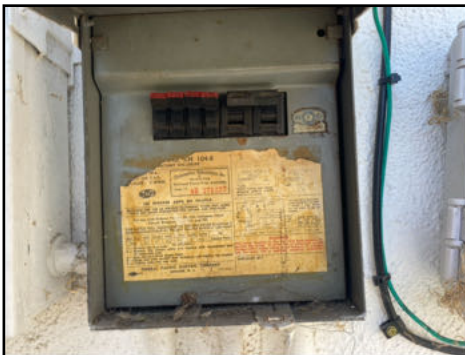
Manufacture of panel a brand (Federal Pacific) known for frequent issues - recommend further evaluation by a licensed electrician

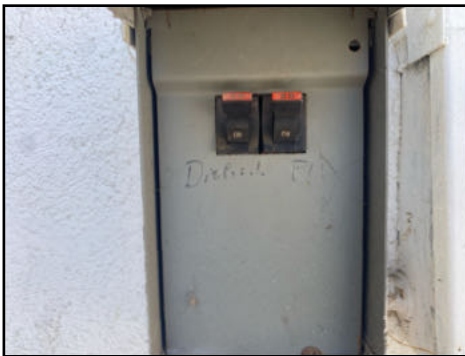
Manufacture of panel a brand (Federal Pacific) known for frequent issues - recommend further evaluation by a licensed electrician

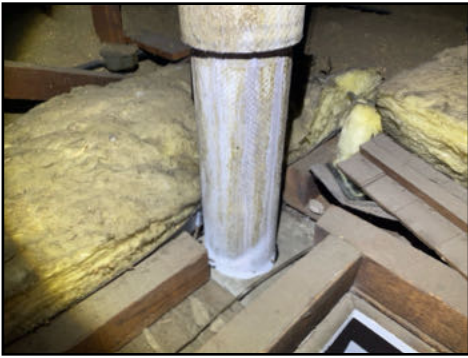
Masonry/cement/transite type vent pipe in the attic - needs to be serviced and possibly upgraded to newer style vents

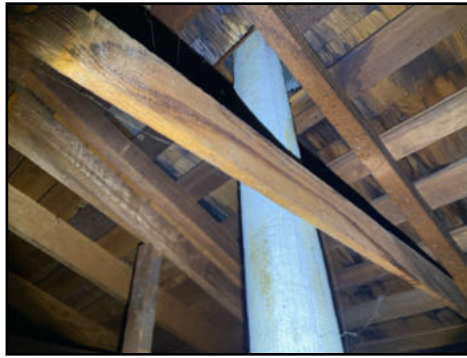
Masonry/cement/transite type vent pipe in the attic - needs to be serviced and possibly upgraded to newer style vents

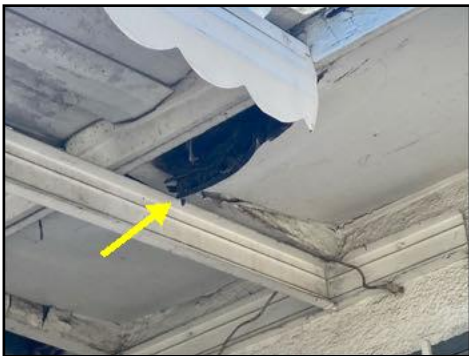
Cracking/deterioration - more than normal - needs to be serviced

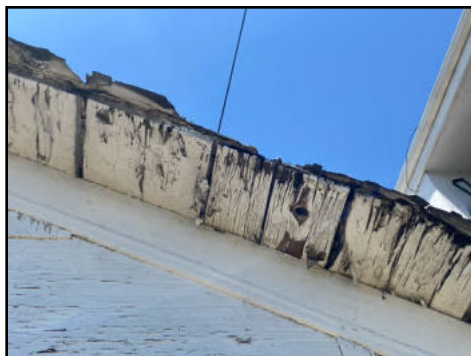
Heavily damaged - needs to be replaced

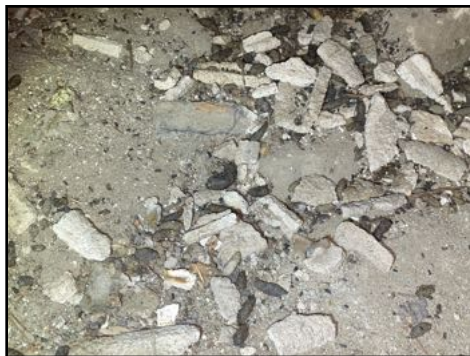
Evidence of rodent/pest activity in the crawlspace - recommend further evaluation by pest services company

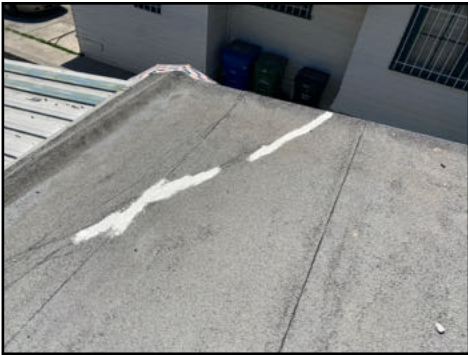
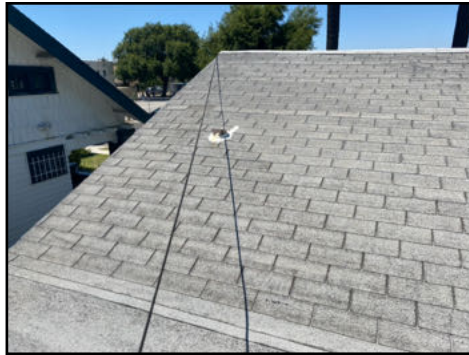
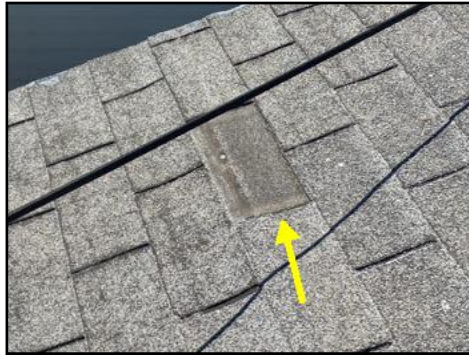
Patching observed in areas on roof materials - inspector is unable to guarantee the adequacy of these repairs - recommend maintaining a continuous water tight seal in these areas

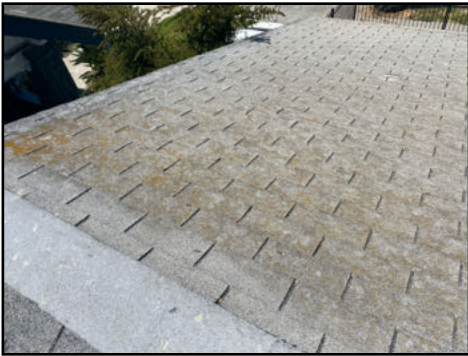
Missing/damaged shingles/tiles in areas - needs to be serviced

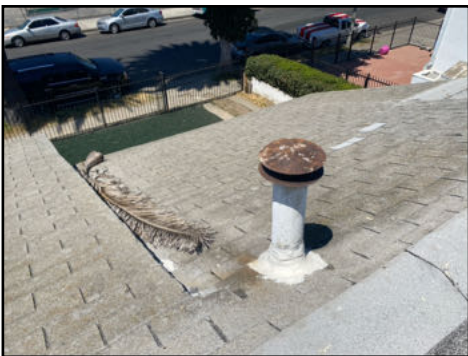
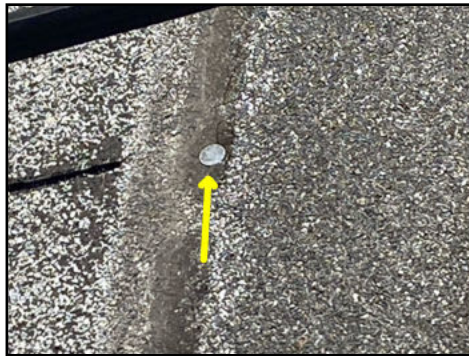
Moss growth present in areas - sign of moisture accumulation and lack of sunlight for drying - recommend servicing as part of seasonal maintenance
