Property Inspection Report

Property address: **32311 Scandia Dr, Running Springs, CA 92382**

Inspection date: **Thursday, September 7, 2023**

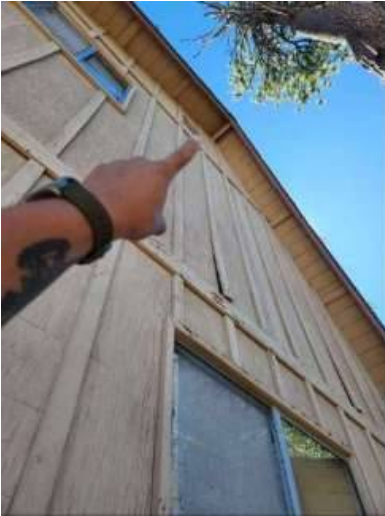
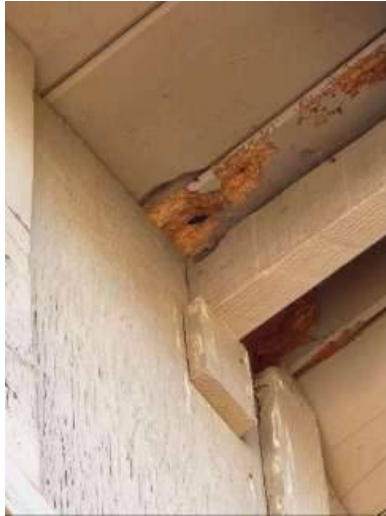
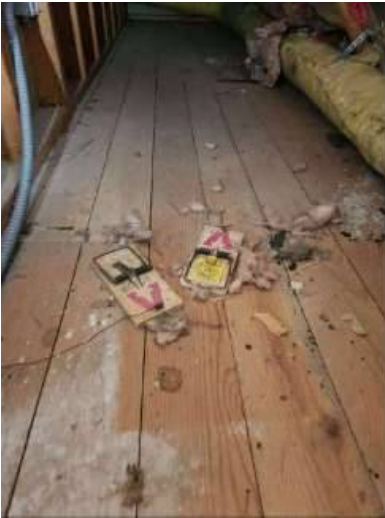
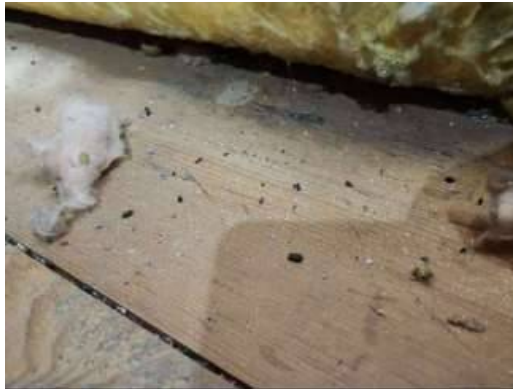
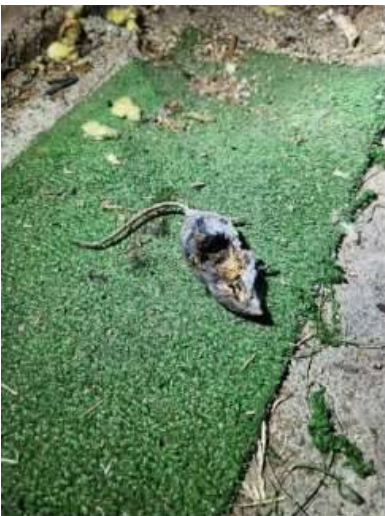
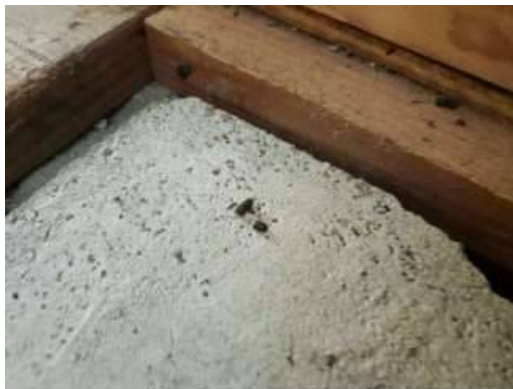
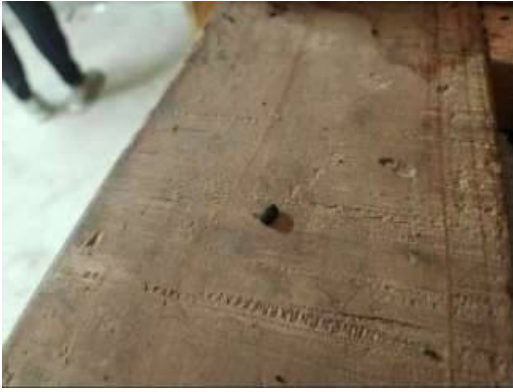
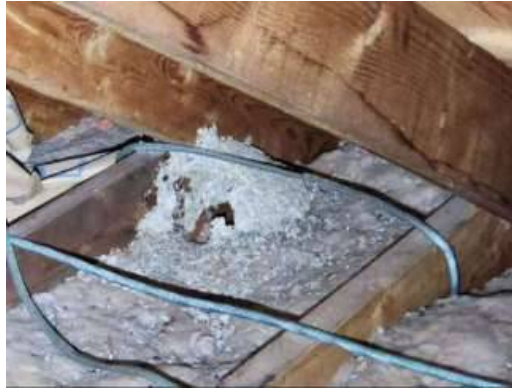
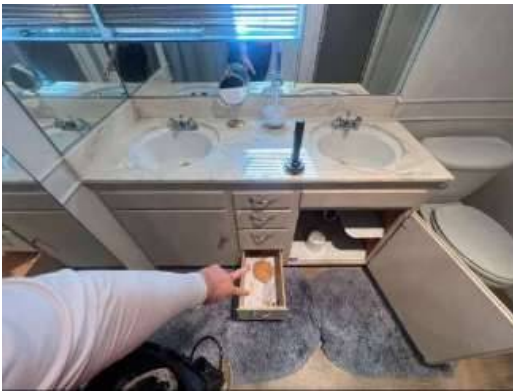
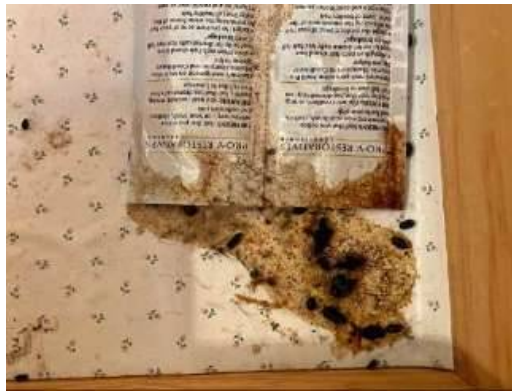
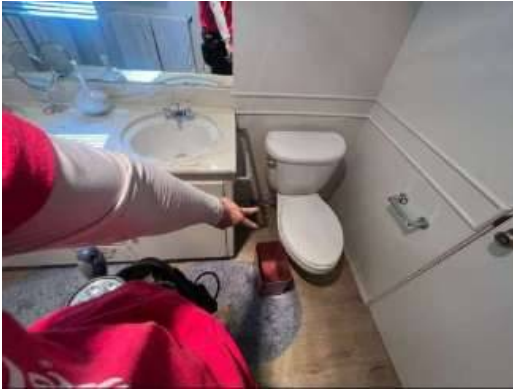
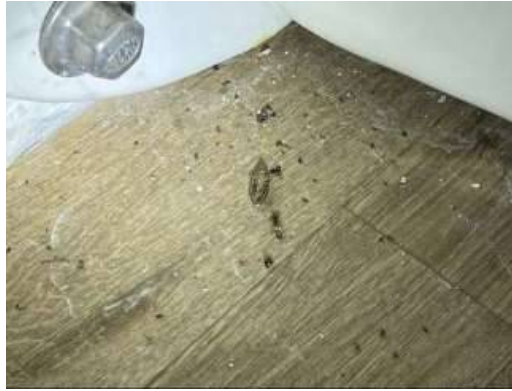
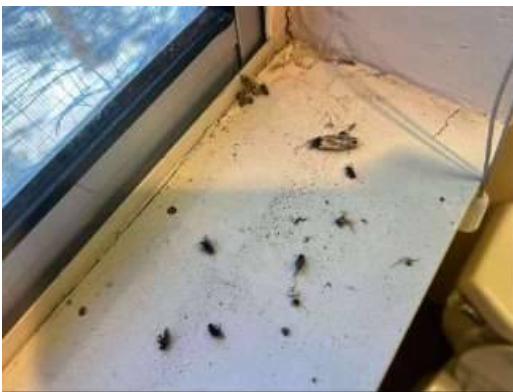
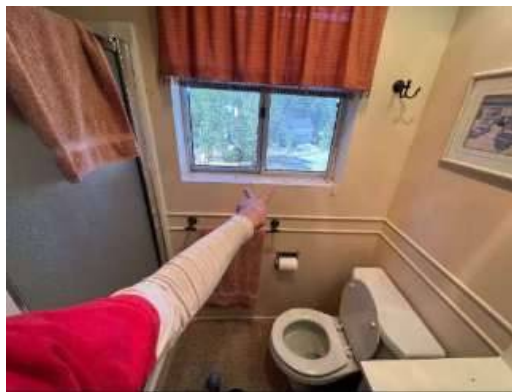
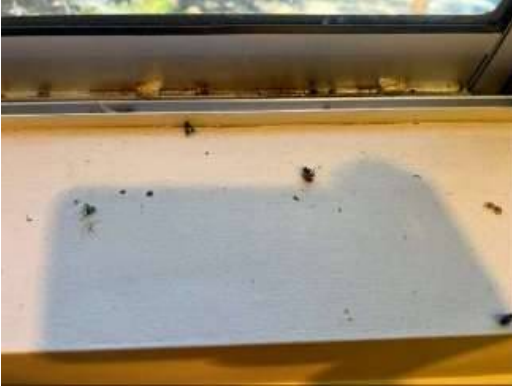
Evidence of rodent infestation was found in the form of feces, traps, nests, dead rodents and/or chew marks, dead vermin in the attic, crawl space, basement, interior rooms, bathrooms and/or exterior. Consult with the property owner about this. A qualified person should make repairs to seal openings in the structure, set traps, and clean rodent waste as necessary. Recommend following guidelines in these Center for Disease Control articles:

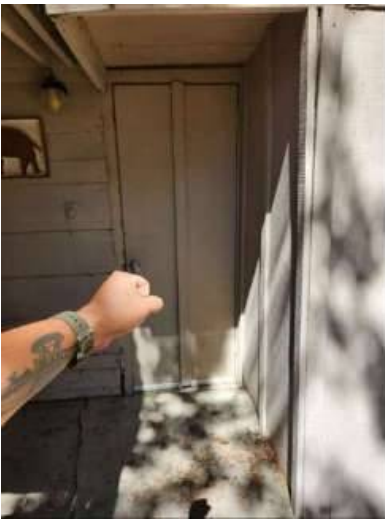
Photo 4-1

At the time of inspection one or more exterior storage rooms were locked and could not be fully evaluated.

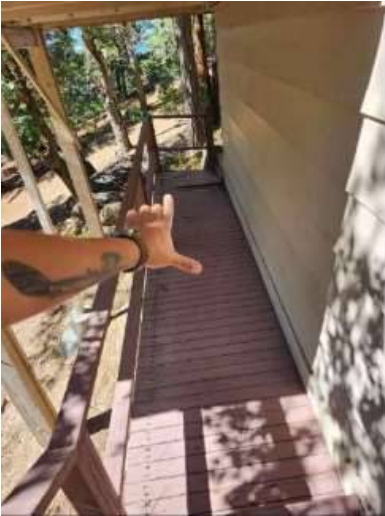
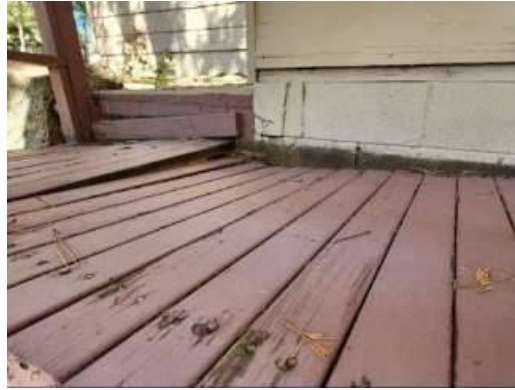
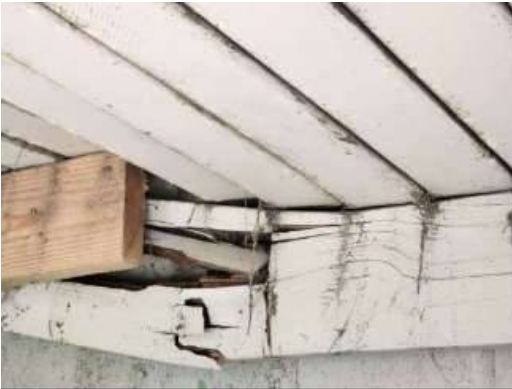
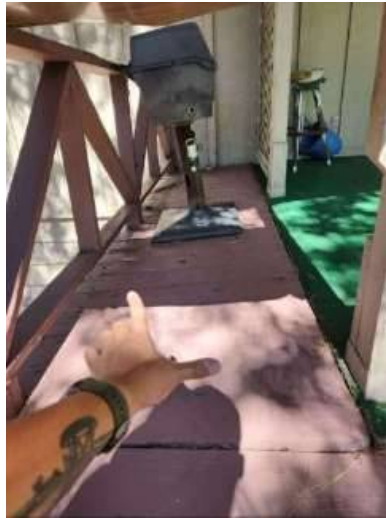
One or more decks or porches were unstable due to missing or substandard bracing, or lack of attachment to main structure. This is a safety hazard since severe movement may cause the decks or porches to collapse. A qualified contractor should repair as necessary.

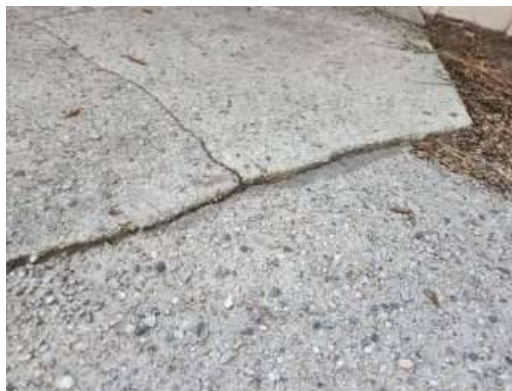
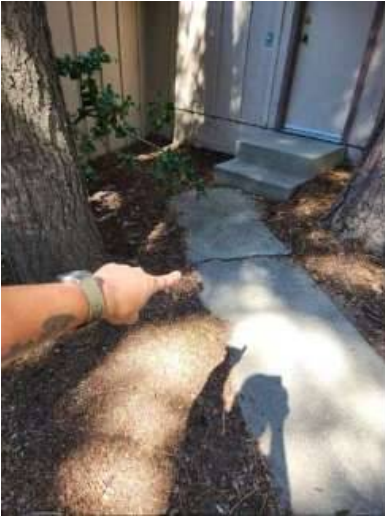
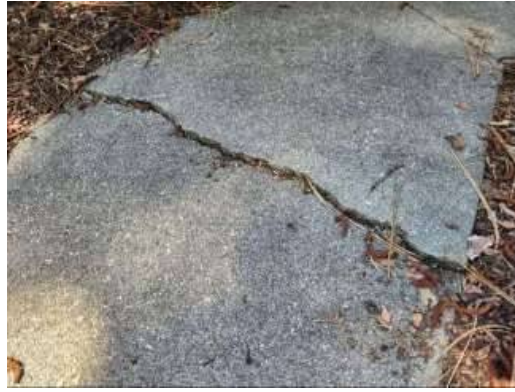
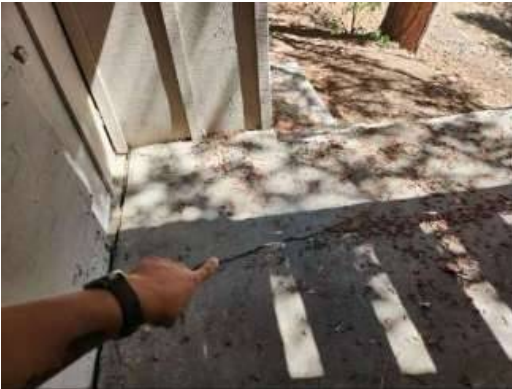
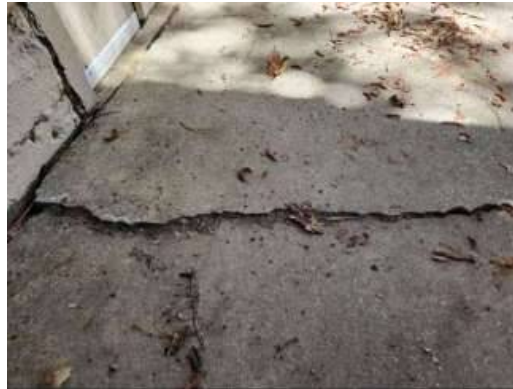
6) 🚧 Cracks, holes, settlement, heaving and/or deterioration resulting in trip hazards were found in the sidewalks or patios. For safety reasons, recommend that a qualified contractor repair as necessary to eliminate trip hazards.

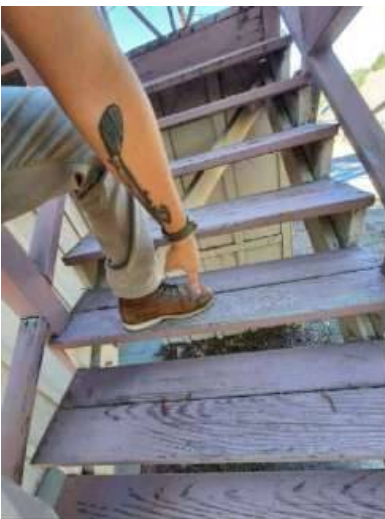
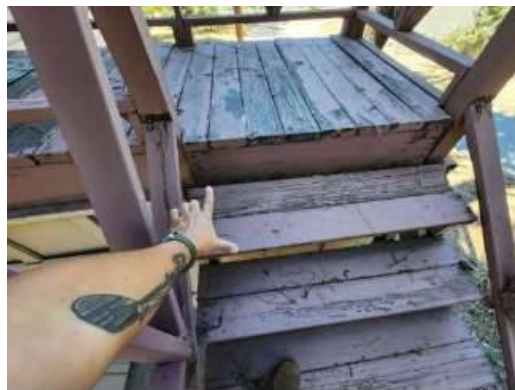
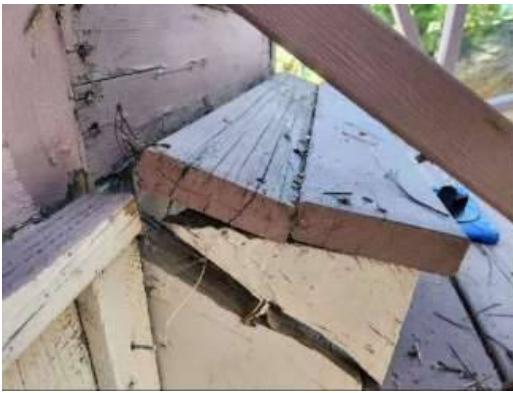
7) 🚧 One or more treads at exterior stairs were loose, flexed under load and/or were deteriorated. This is a potential fall hazard. Recommend that a qualified person repair as necessary.

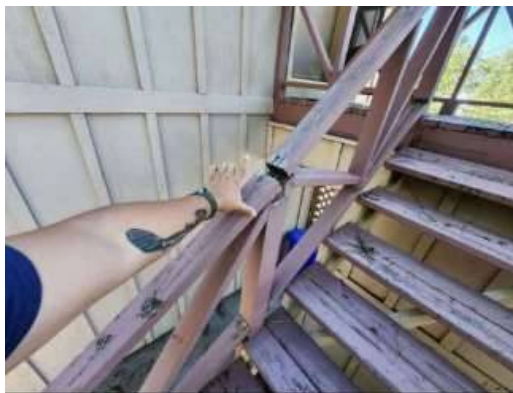
Photo 8-2

Handrails at one or more flights of stairs were loose and/or wobbly. This is a safety hazard. Recommend that a qualified person repair as necessary.

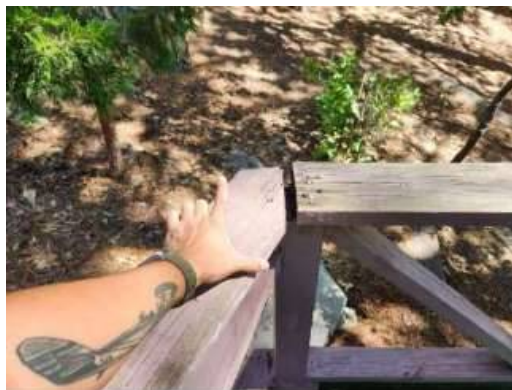
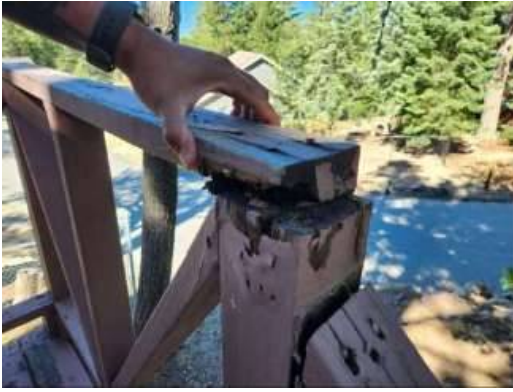
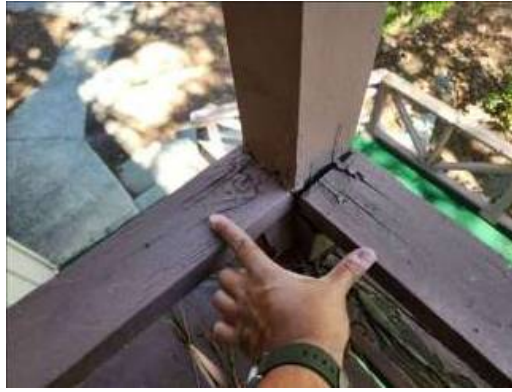
Guardrails at one or more locations with drop-offs higher than 30 inches were loose, wobbly, damaged and/or deteriorated, and pose a fall hazard. Recommend that a qualified person repair guardrails as necessary.

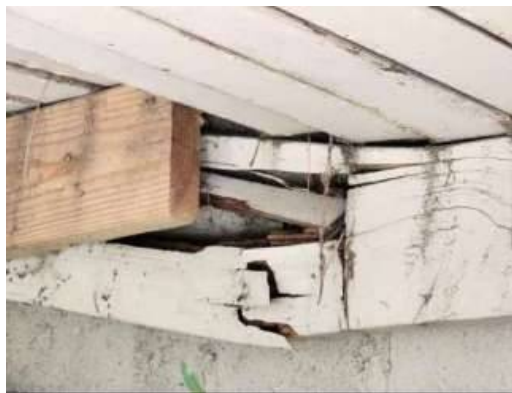
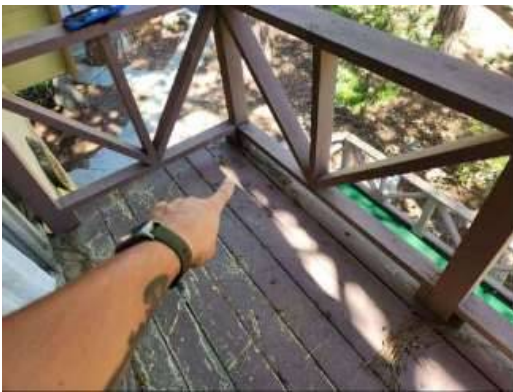
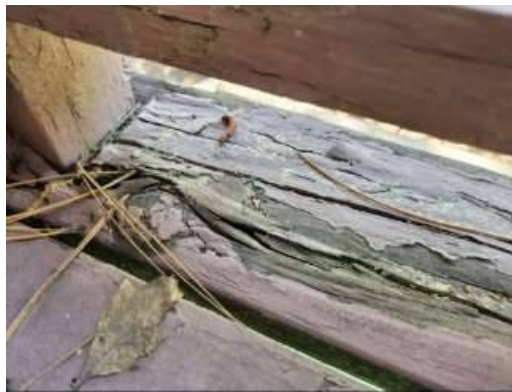
Fungal rot was found in decking boards and/or beams at one or more decks or porches. Recommend that a qualified contractor evaluate and repair as necessary. All rotten wood should be replaced.

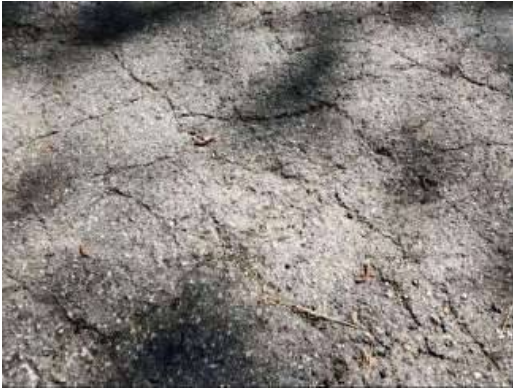
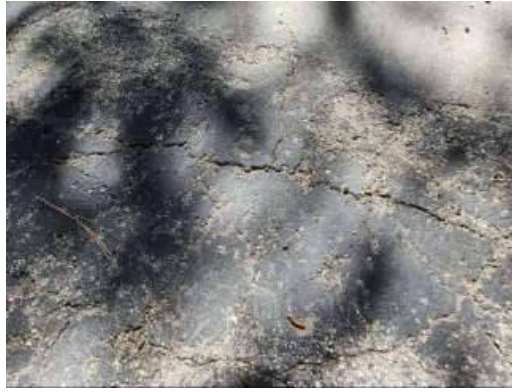
12) 🗑️ ⓘ Minor deterioration (e.g. cracks, holes, settlement, heaving) was found in the driveway, but no trip hazards were found. The client may wish to have repairs made for cosmetic reasons.

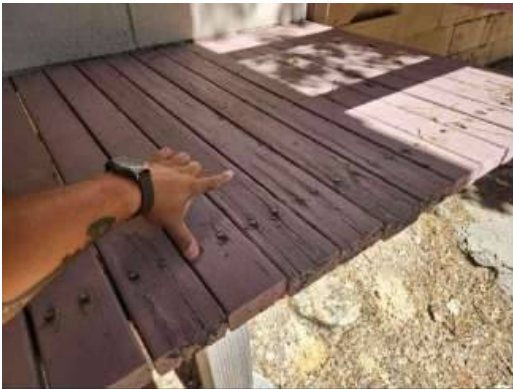
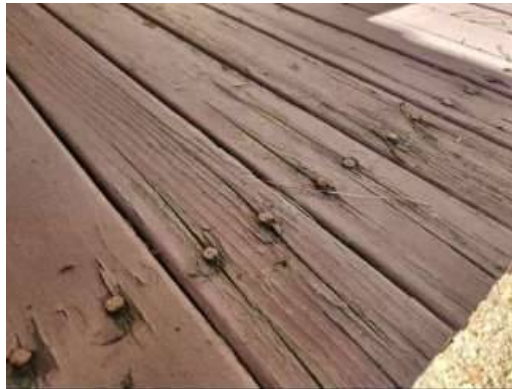
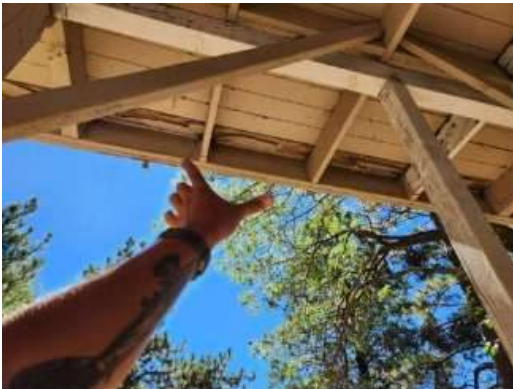
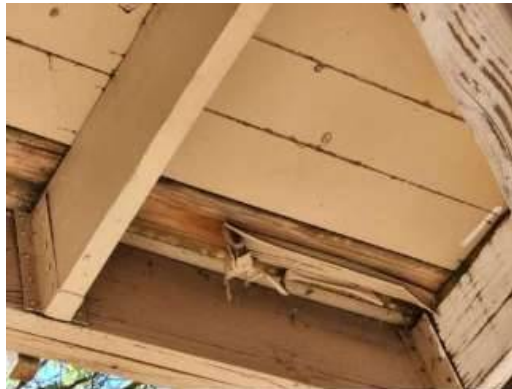
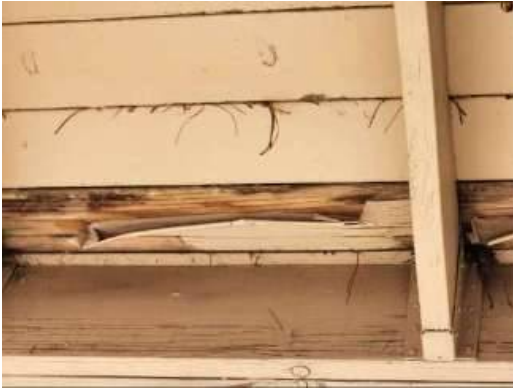
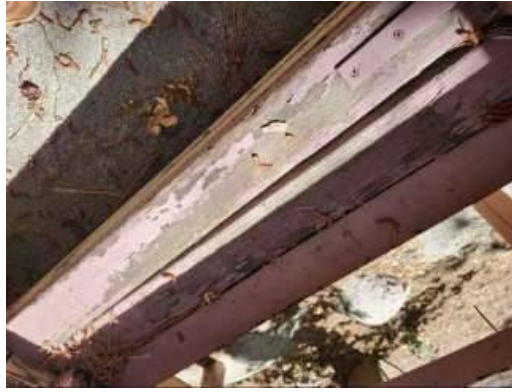
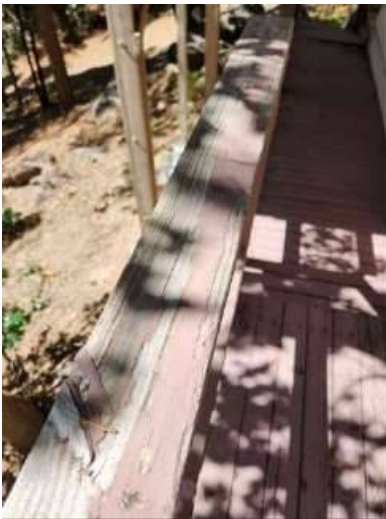
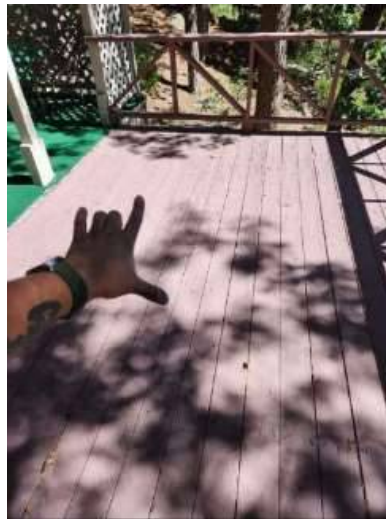
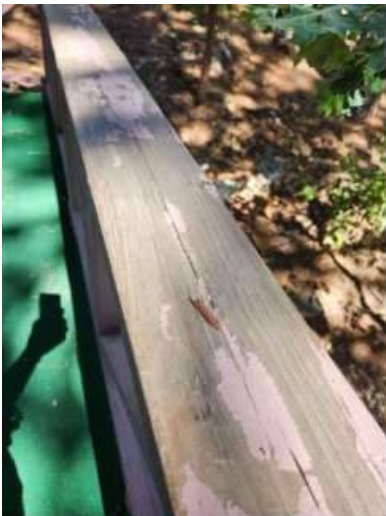
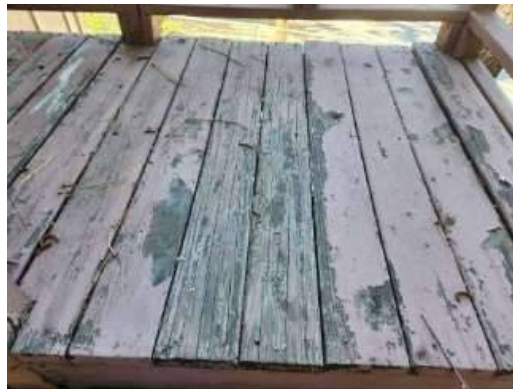
Wooden deck or porch surfaces, railings and/or stairs were overdue for normal maintenance. Recommend that a qualified person clean and preserve as necessary. Where decks have been coated with a finish such as opaque stains or paint, it may be too difficult to strip the finish and apply anything but paint or opaque stain. Where transparent stain or penetrating oil has been applied in the past, recommend that a penetrating oil be used. For more information, visit:

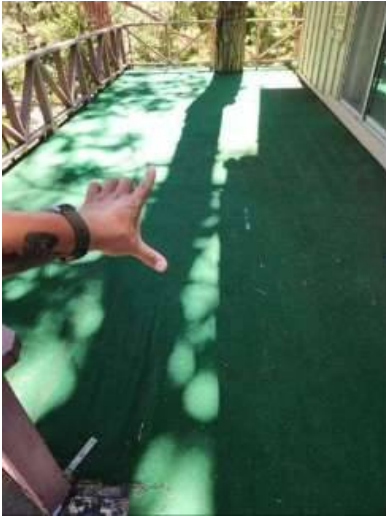
Photo 14-1

Some decks were obscured by carpeting and couldn't be fully evaluated.

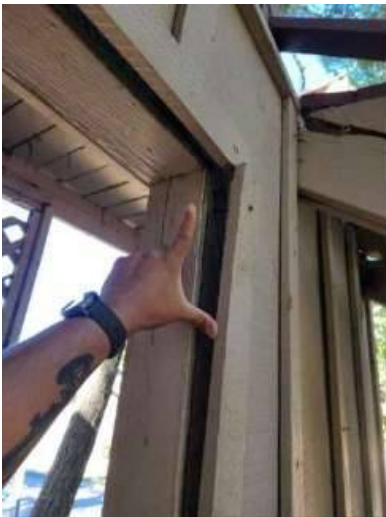
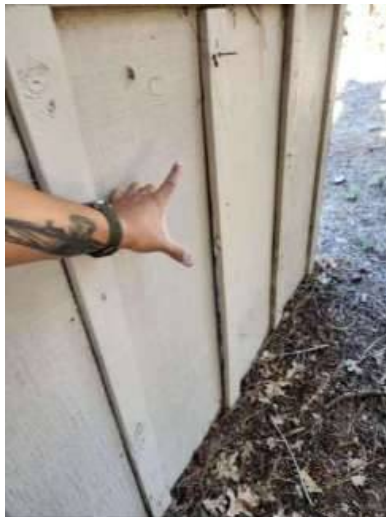
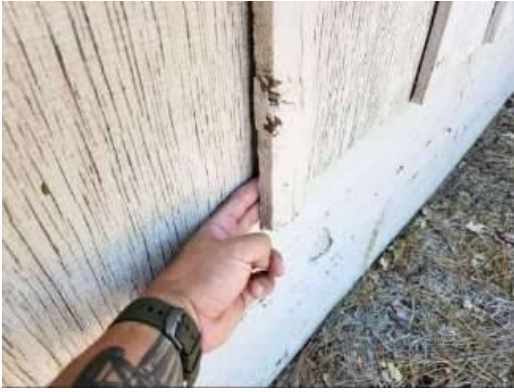
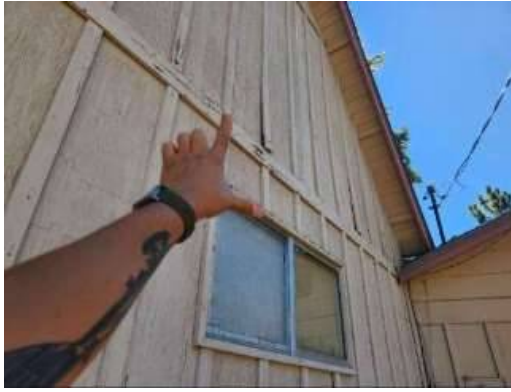
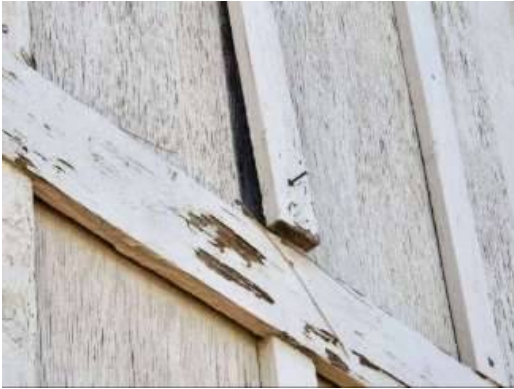
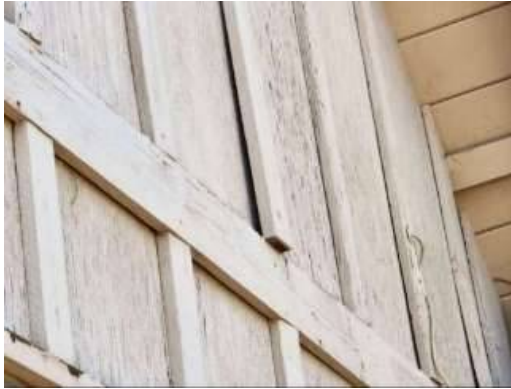
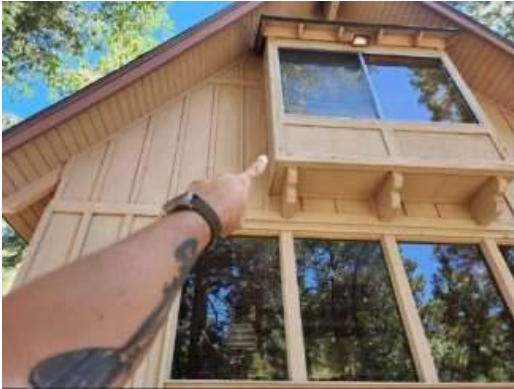
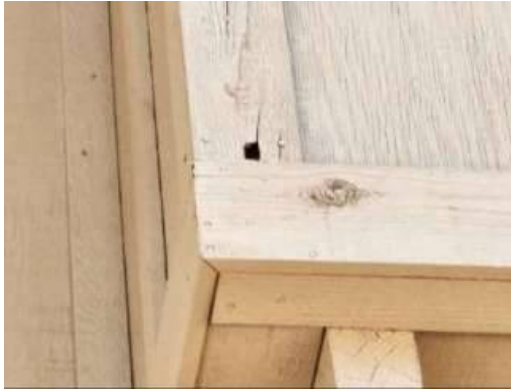
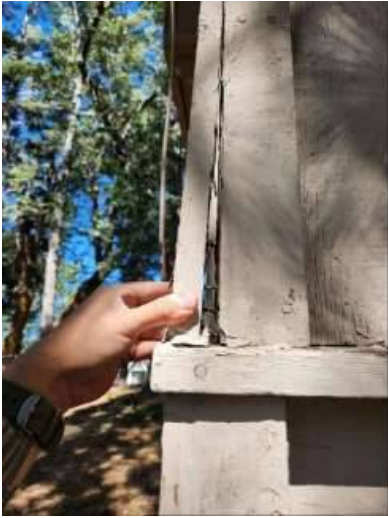
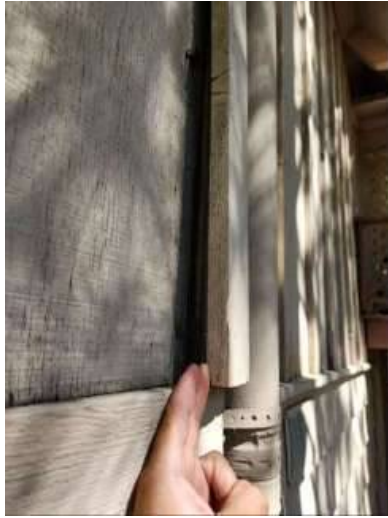
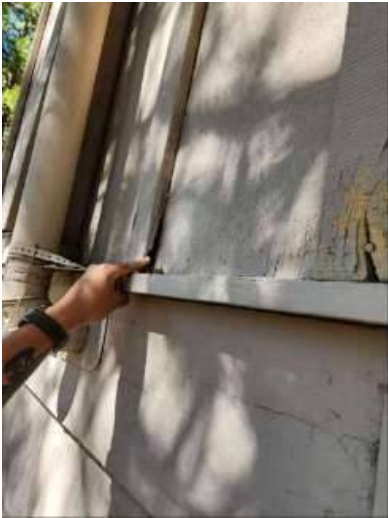
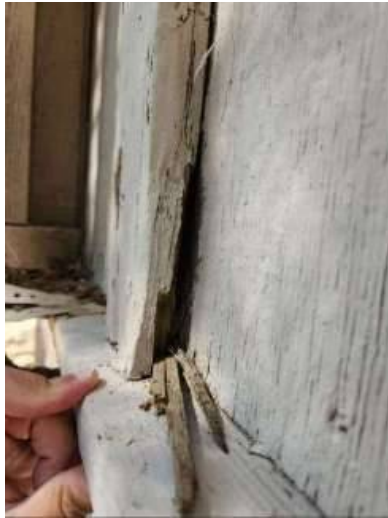
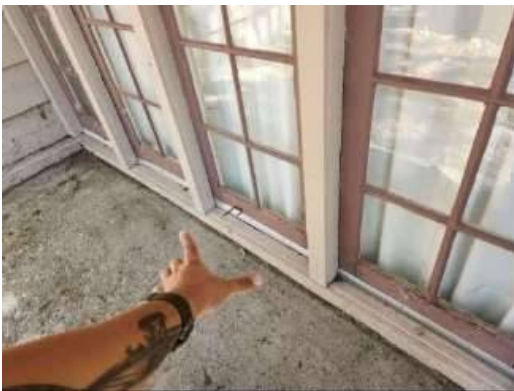
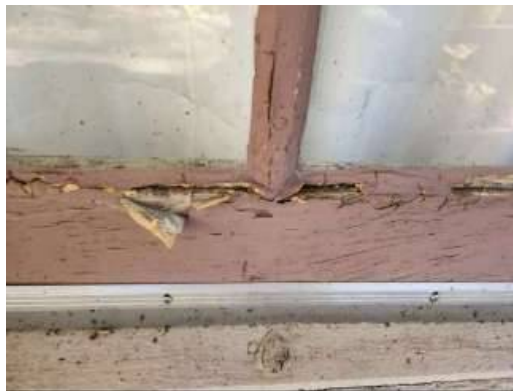
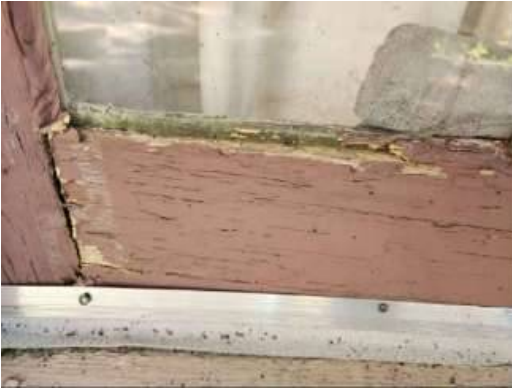
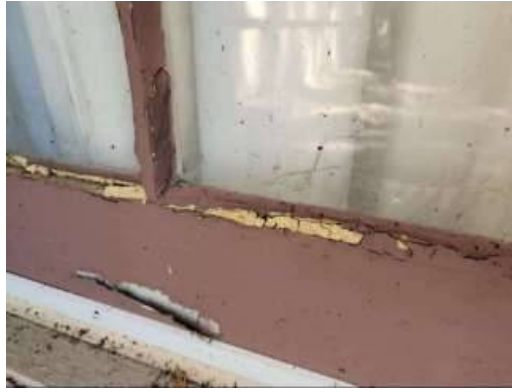
Some sections of siding and/or trim were deteriorated, loose, warped and/or damaged. Recommend that a qualified person repair, replace or install siding or trim as necessary.

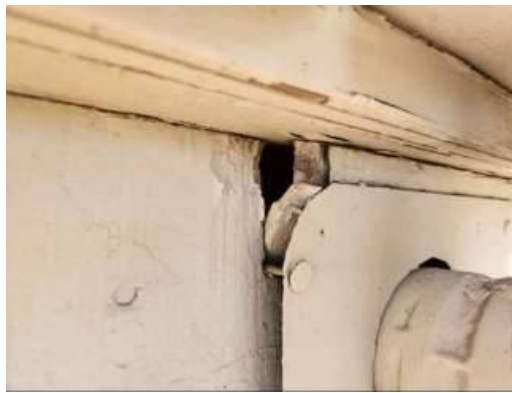
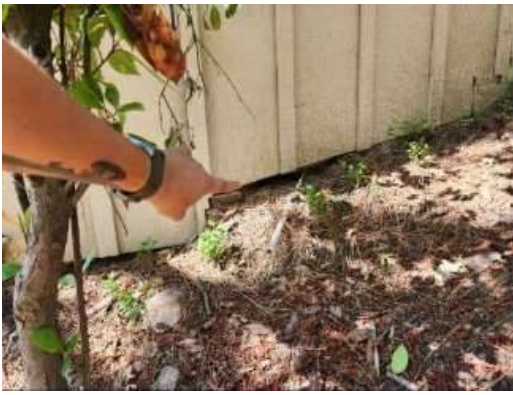
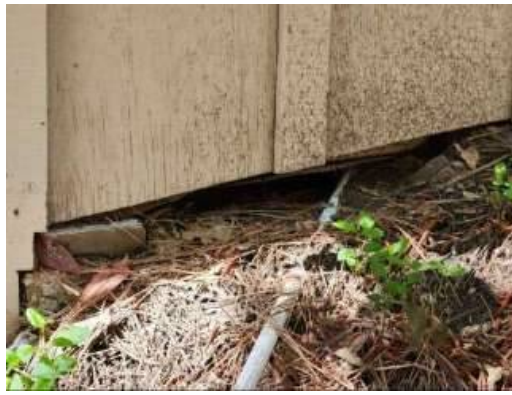
17) 🛠️ One or more holes or gaps were found in siding or trim. Vermin, insects or water may enter the structure. Recommend that a qualified person repair as necessary.

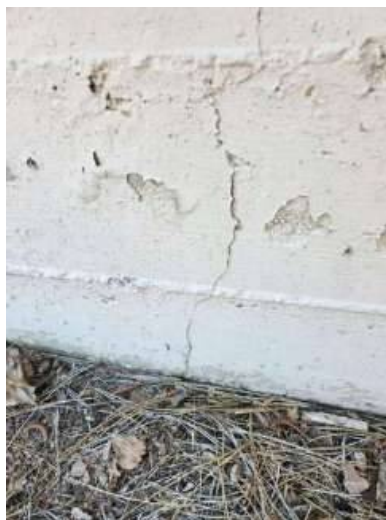
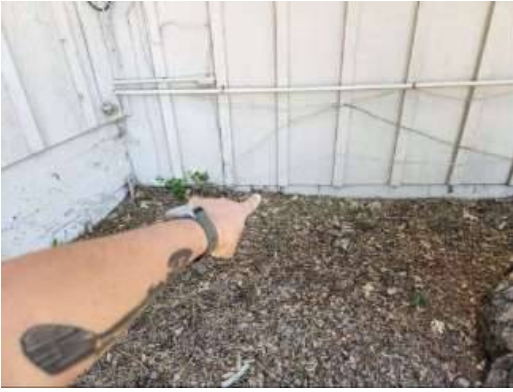
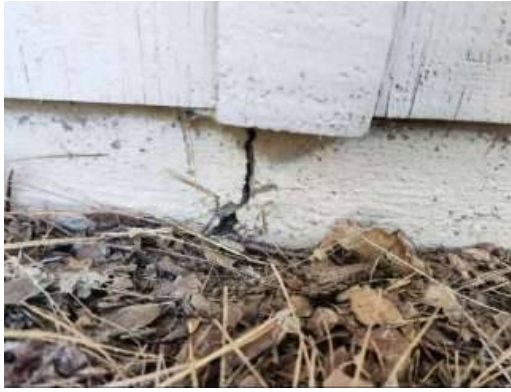
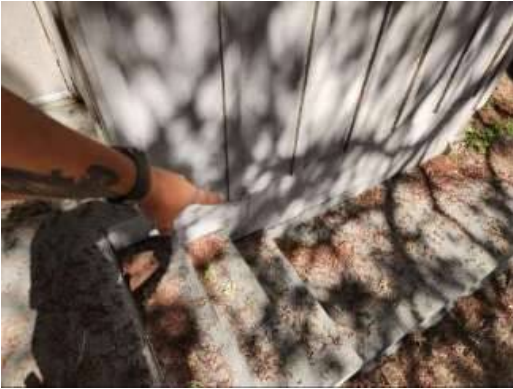
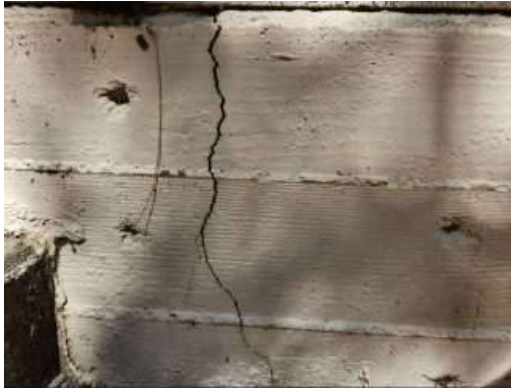
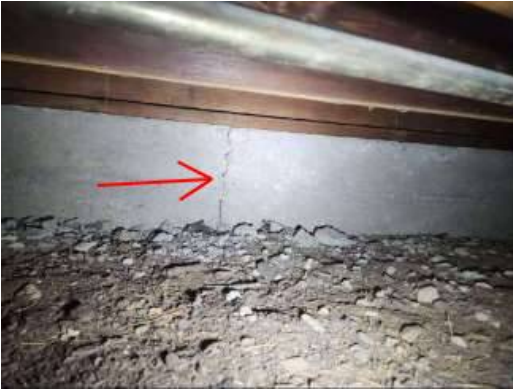
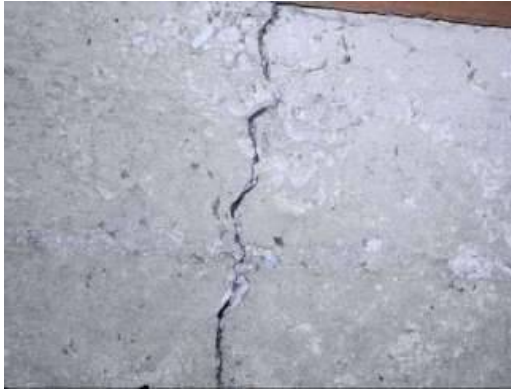
18) 🛠️ One or more minor cracks were found in the foundation. Recommend having a qualified person repair as necessary by sealing them to prevent water infiltration and monitor them in the future. Numerous products exist to seal such cracks including hydraulic cement, non-shrinking grout, resilient caulks and epoxy sealants.

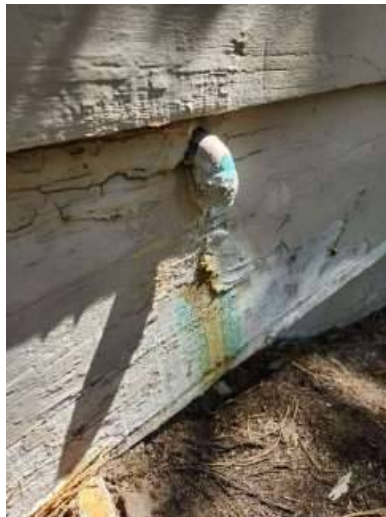
Photo 19-2

19) 🛠️ A condensate line that terminated at the exterior was damaged, or came in contact with building exterior, therefore allowing water to come in contact with the stucco and damaging it. Recommend a qualified person make repairs as necessary, so the water doesn't come in contact with the building

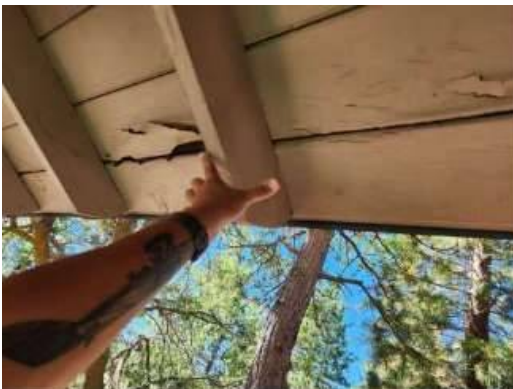
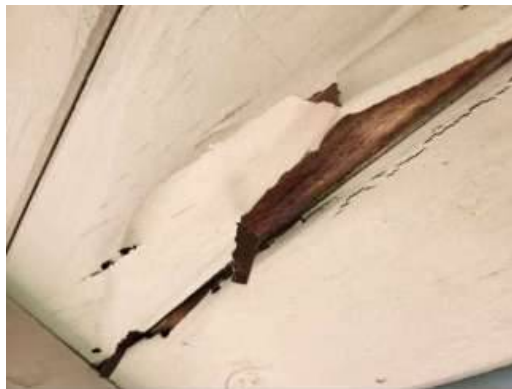
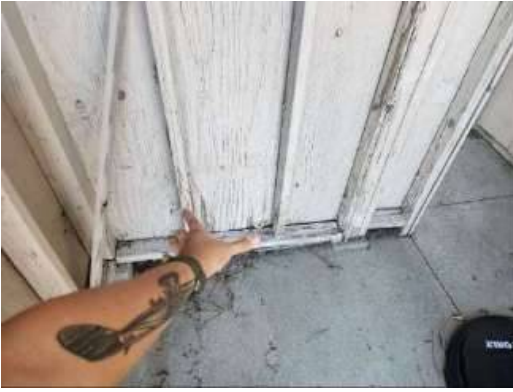
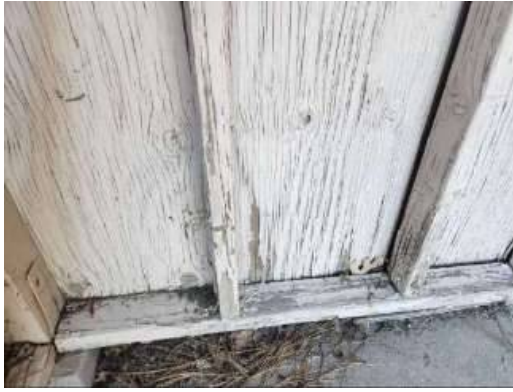
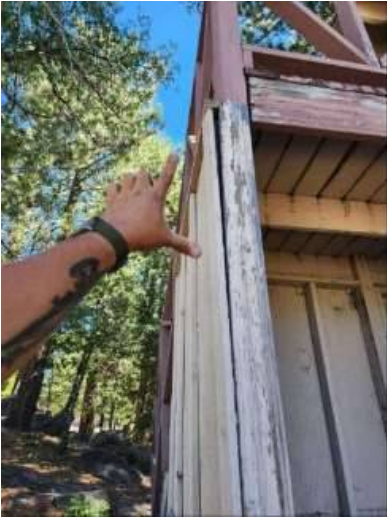
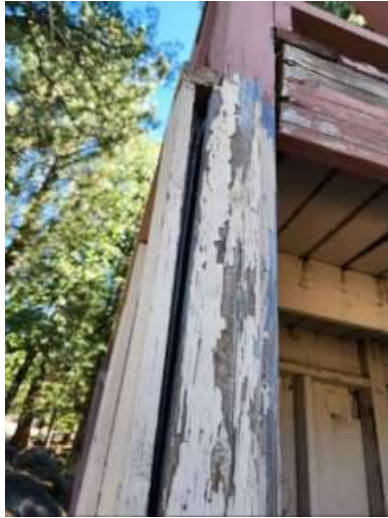
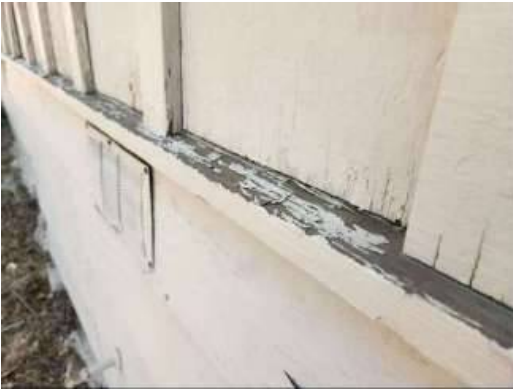
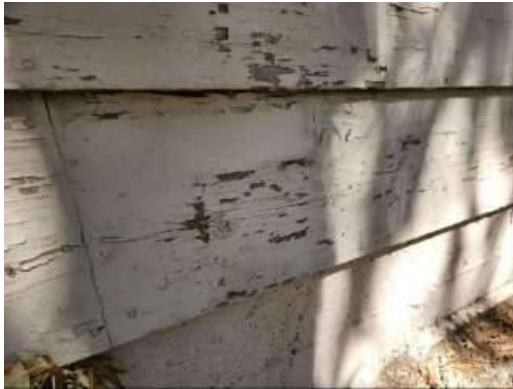
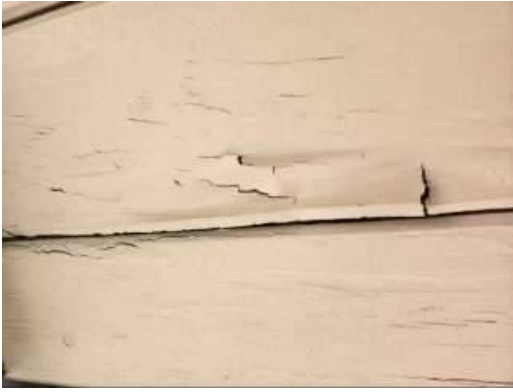
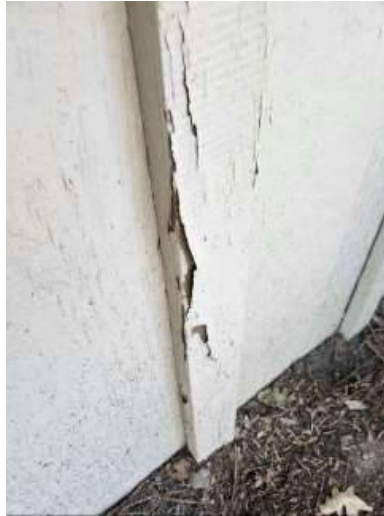
20) 🛠️ The paint or stain finish in some areas was failing (e.g. peeling, faded, worn, thinning). Siding and trim with a failing finish can be damaged by moisture. Recommend that a qualified contractor prep (e.g. clean, scrape, sand, prime, caulk) and repaint or restain the building exterior where necessary and per standard building practices. Any repairs needed to the siding or trim should be made prior to this.

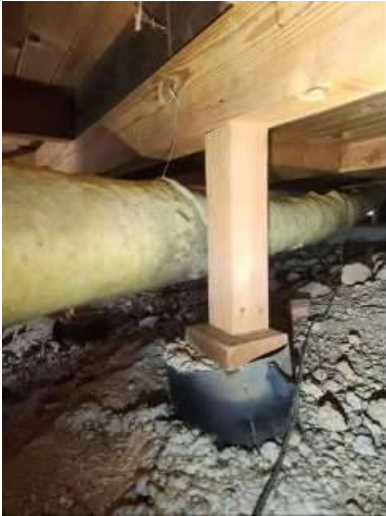
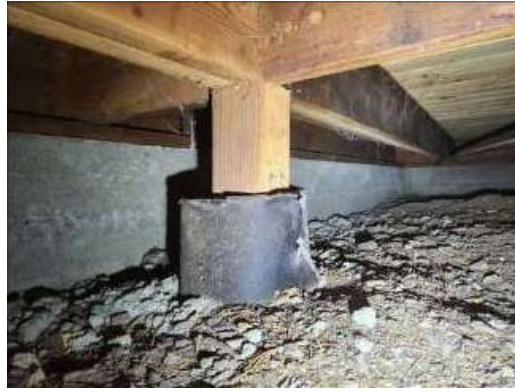
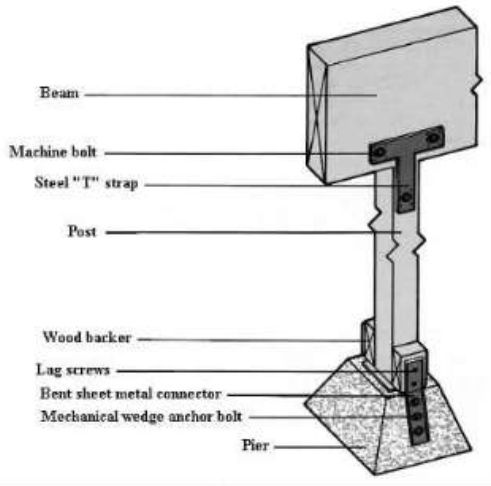
One or more support posts were not positively secured to the beam above. While this is common in older homes, current standards require positive connections between support posts and beams above for earthquake reinforcement. Recommend that a qualified contractor repair per standard building practices. For example, by installing metal plates, plywood gussets or dimensional lumber connecting posts and beams.
