Property Inspection Report

Property address: **32311 Scandia Dr, Running Springs, CA 92382**

Inspection date: **Thursday, September 7, 2023**

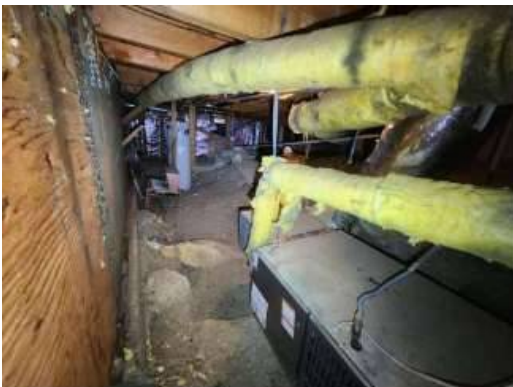
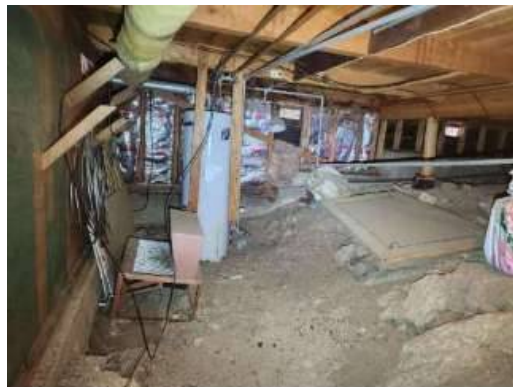
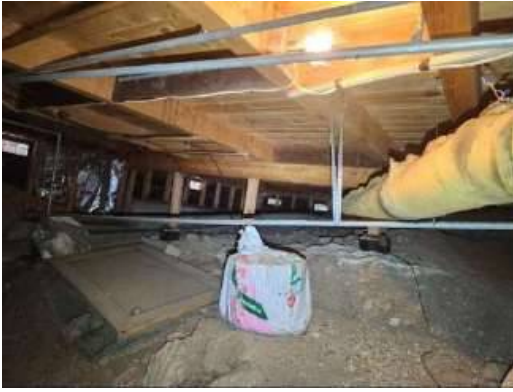
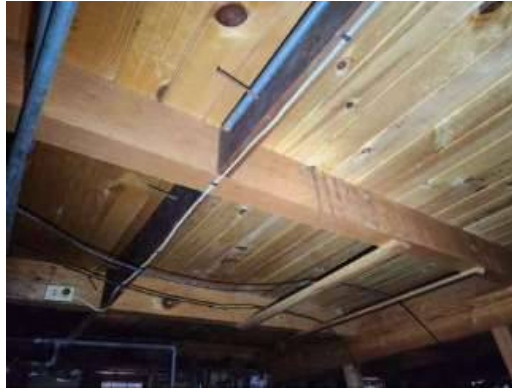
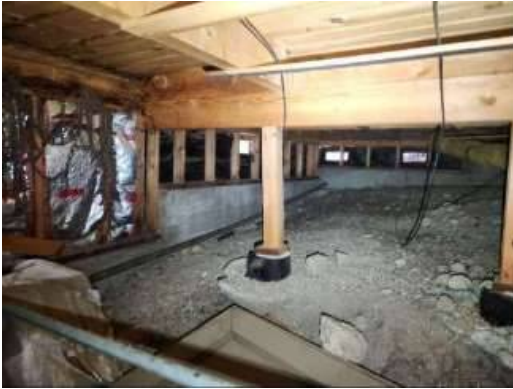
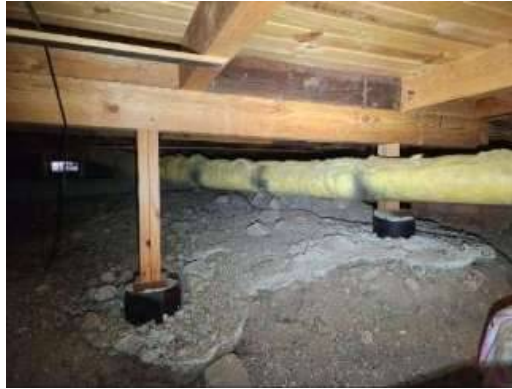
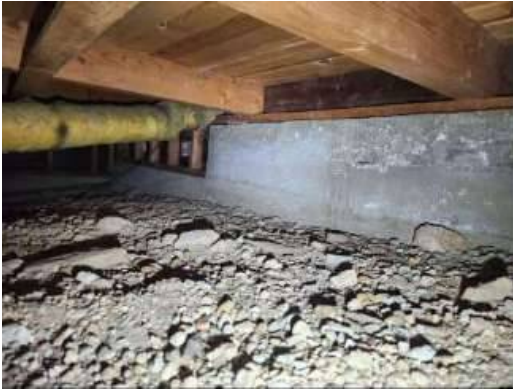
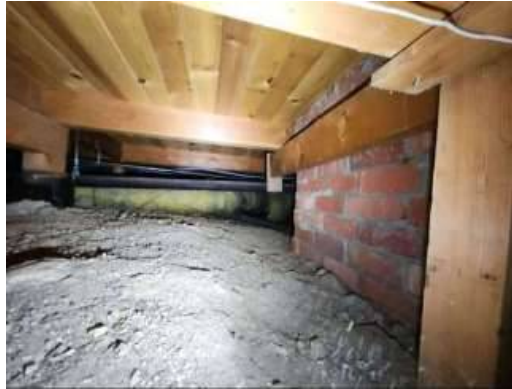
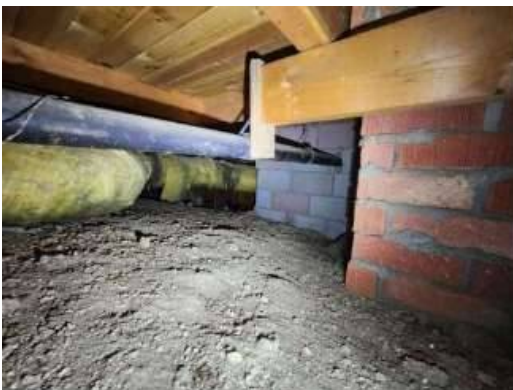
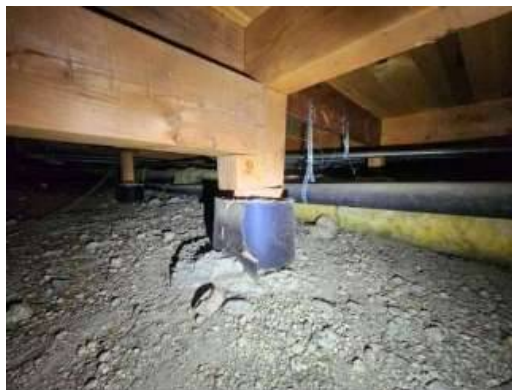
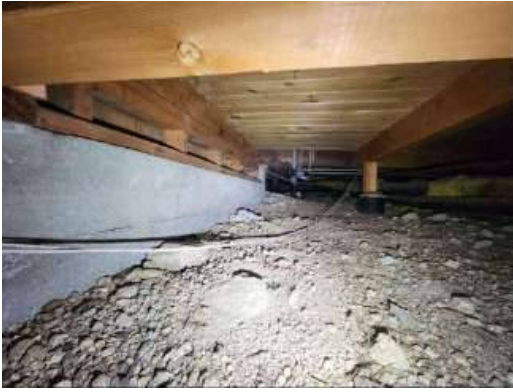
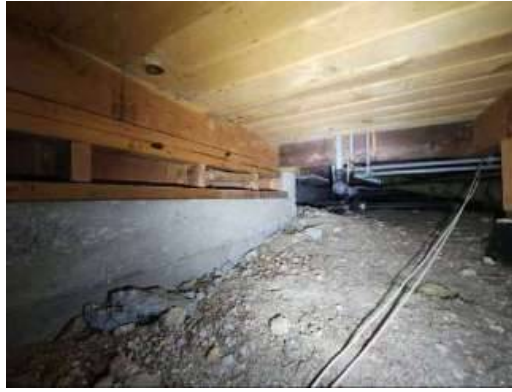
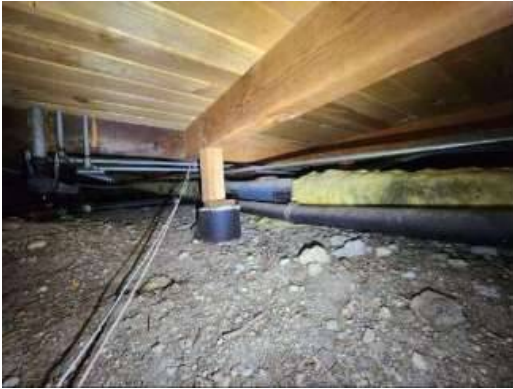
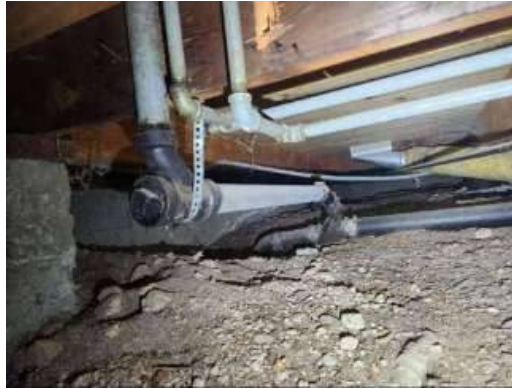
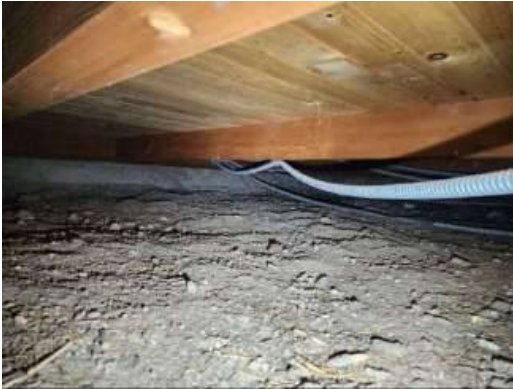
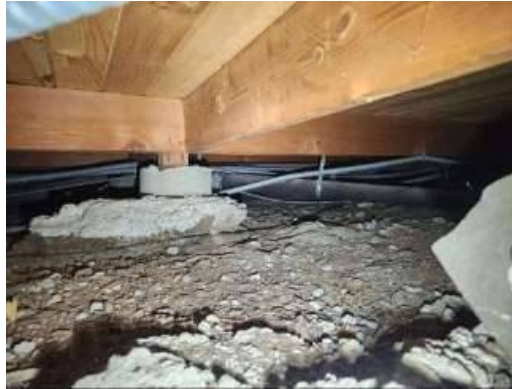
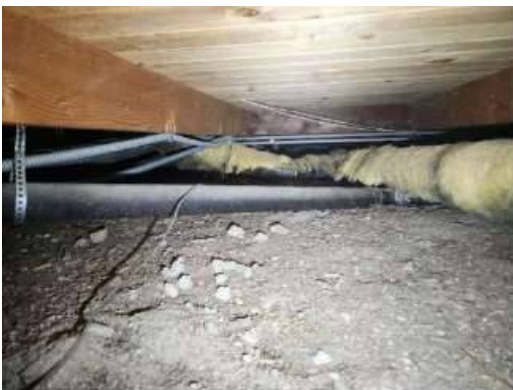
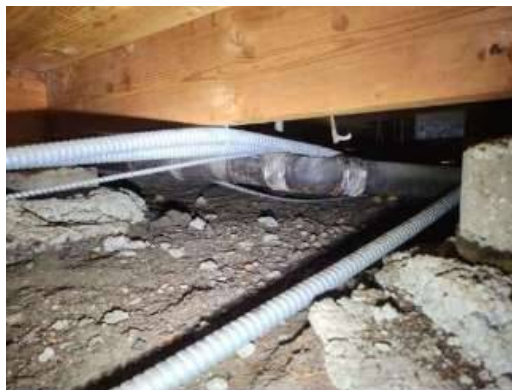
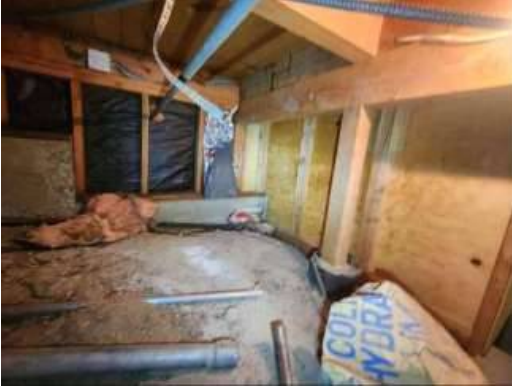
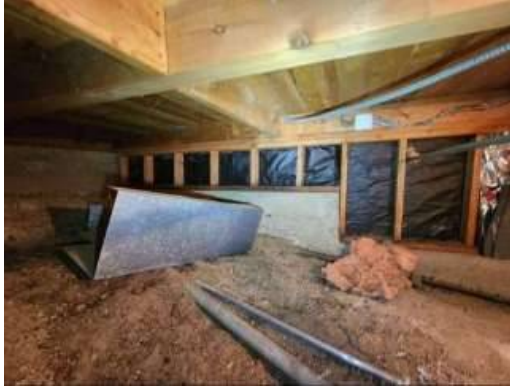
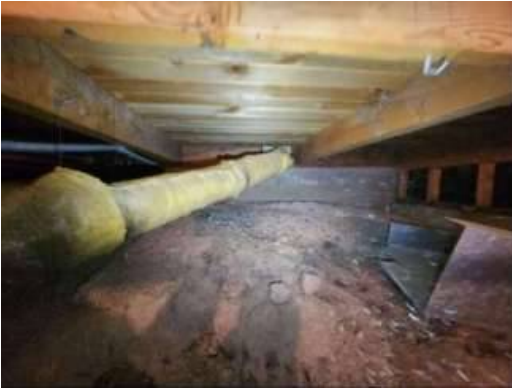
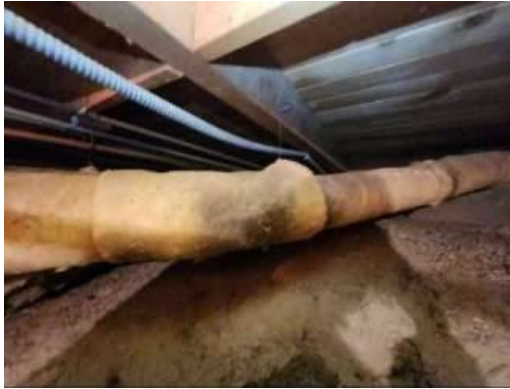
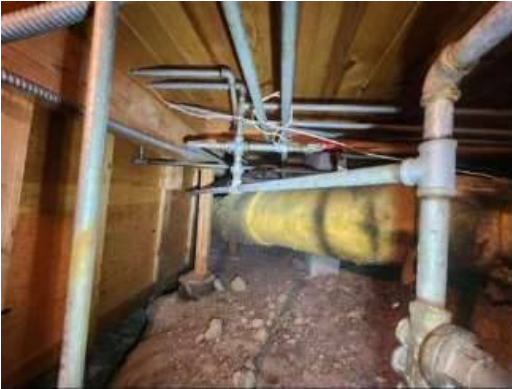
22) ✓ Crawl space overview.

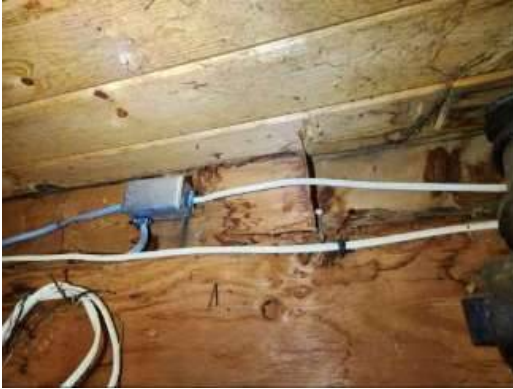
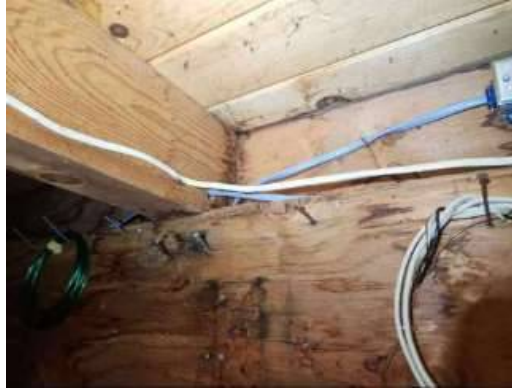
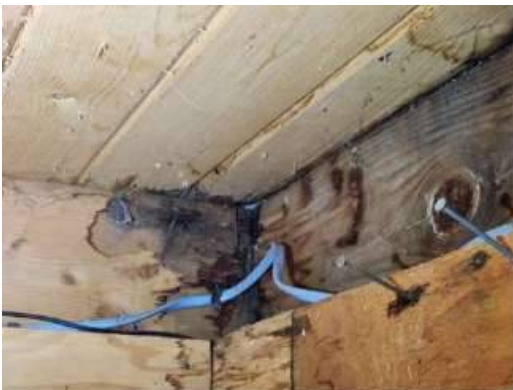
Evidence of prior water intrusion was found in one or more sections of the basement. For example, water stains or rust at support post bases, efflorescence on the foundation, etc. Accumulated water is a conducive condition for wood-destroying organisms and should not be present in the basement. Recommend reviewing any disclosure statements available and ask the property owner about past accumulation of water in the basement. The basement should be monitored in the future for accumulated water, especially after heavy and/or prolonged periods of rain. If water is found to accumulate, then recommend that a qualified contractor who specializes in drainage issues evaluate and repair as necessary. Typical repairs for preventing water from accumulating in basements include:

- Repairing, installing or improving rain run-off systems (gutters, downspouts and extensions or drain lines)
- Improving perimeter grading
- Repairing, installing or improving underground footing and/or curtain drains

Ideally, water should not enter basements, but if water must be controlled after it enters the basement, then typical repairs include installing a sump pump.

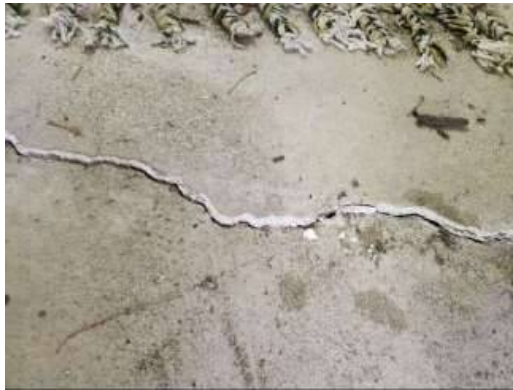
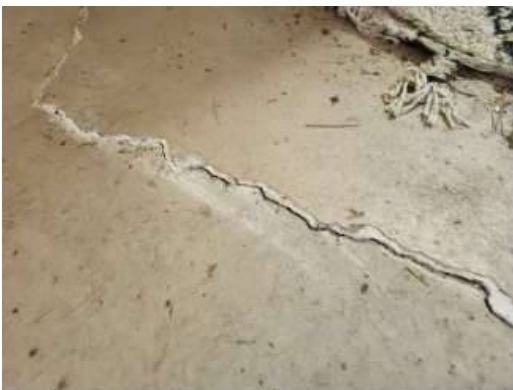
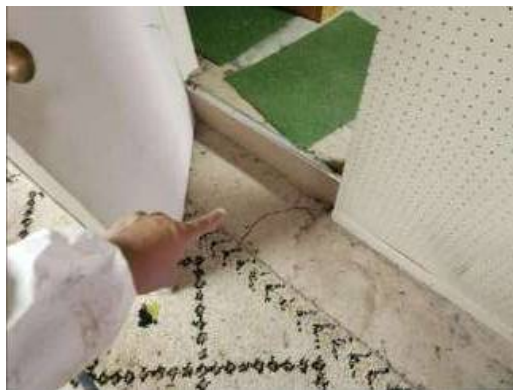
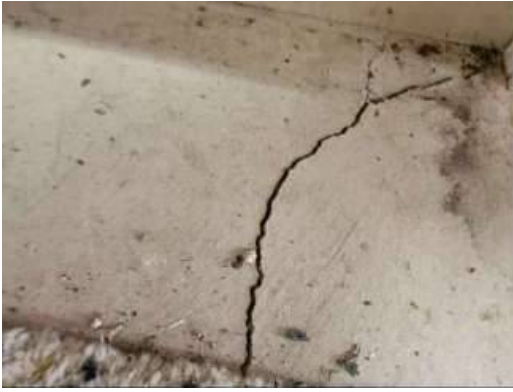
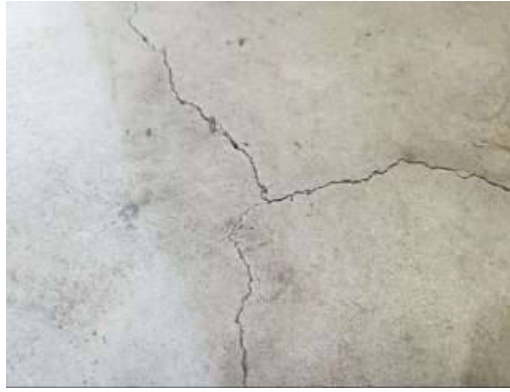
Minor cracks were found in the concrete slab floor. These are common and appeared to be only a cosmetic issue.

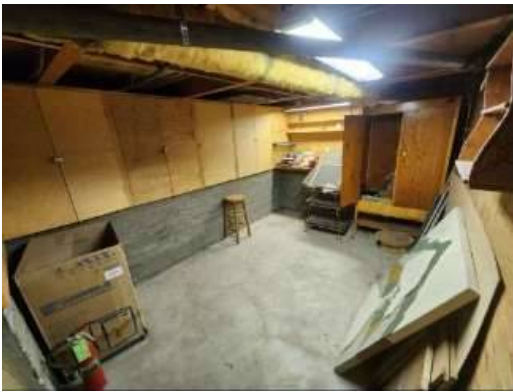
Photo 26-1

26) ✓ Basement overview.

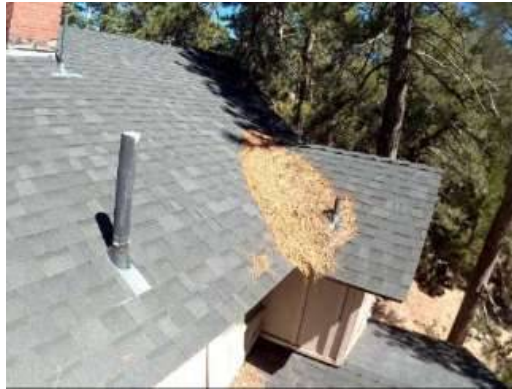
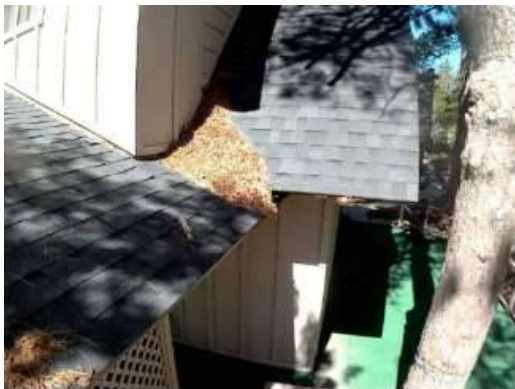
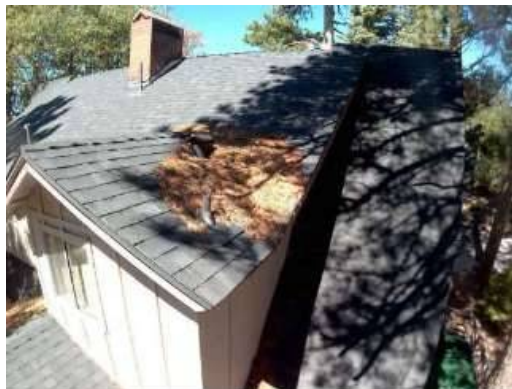
28) Significant amounts of debris such as leaves, needles, seeds, etc. have accumulated on the roof surface. Water may not flow easily off the roof, and can enter gaps in the roof surface. Leaks can occur as a result. This is a conducive condition for wood-destroying organisms. Recommend cleaning debris from the roof surface now and as necessary in the future.

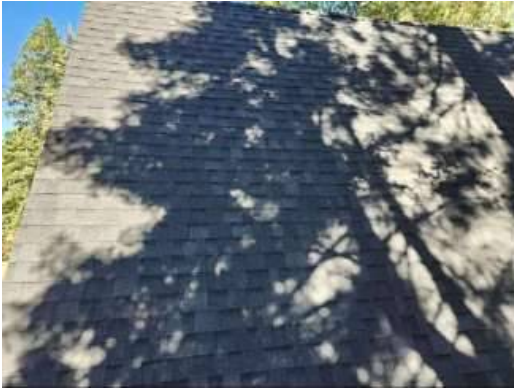
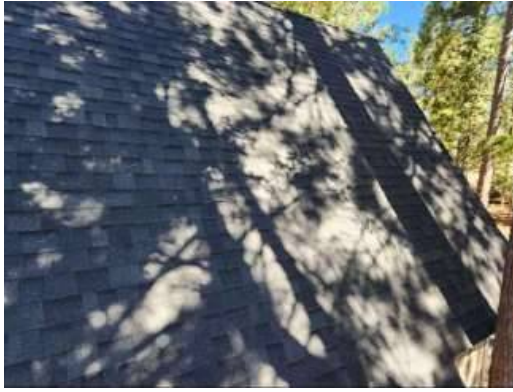
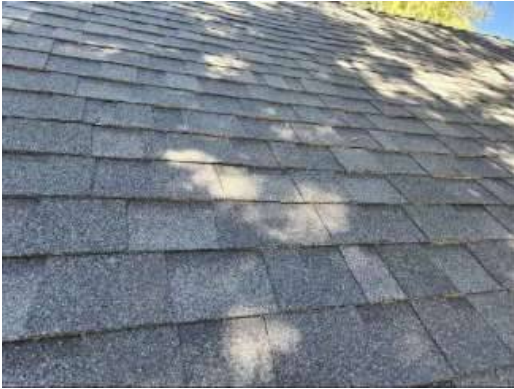
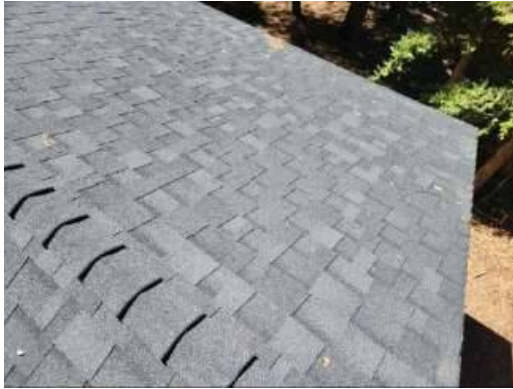
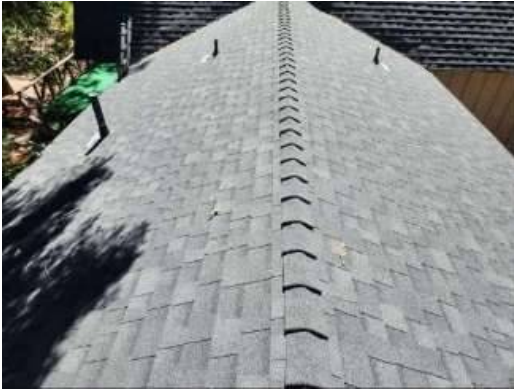
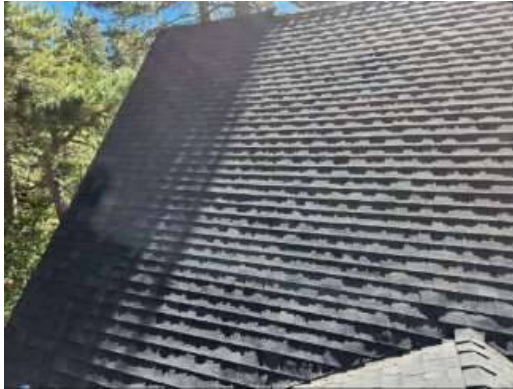
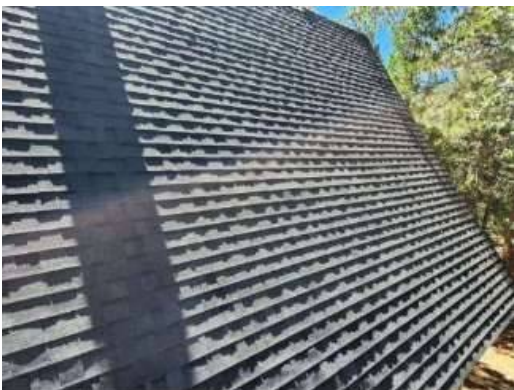
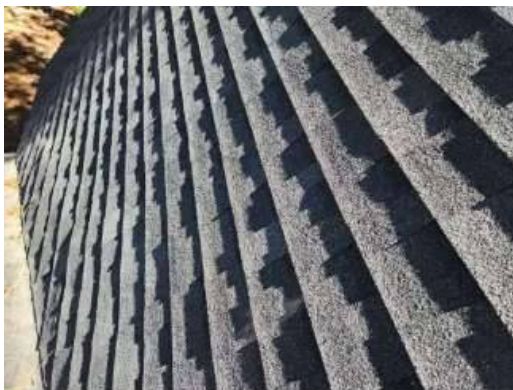
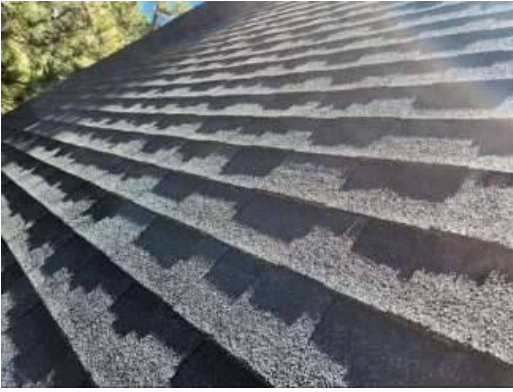
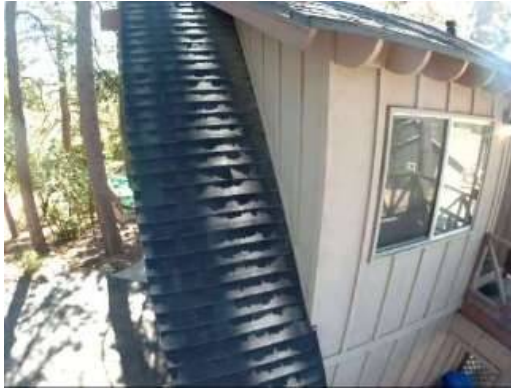
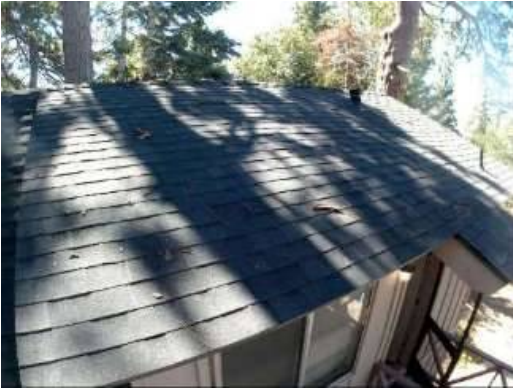
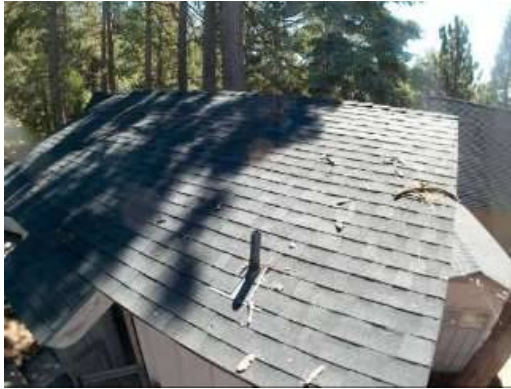
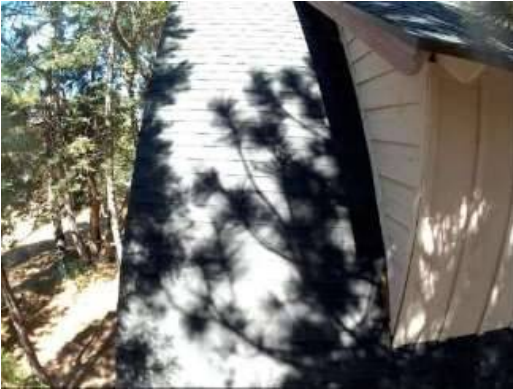
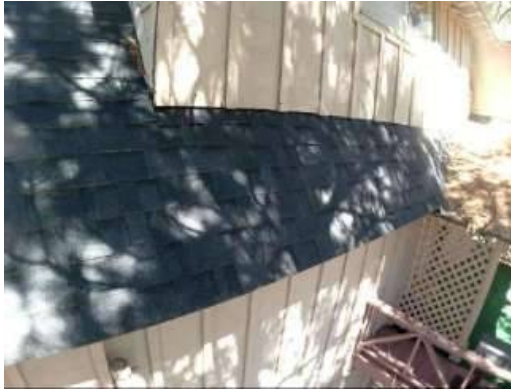
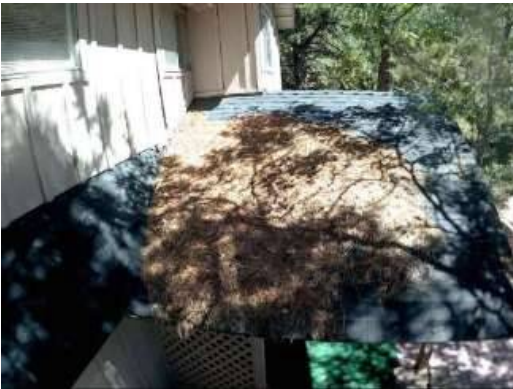
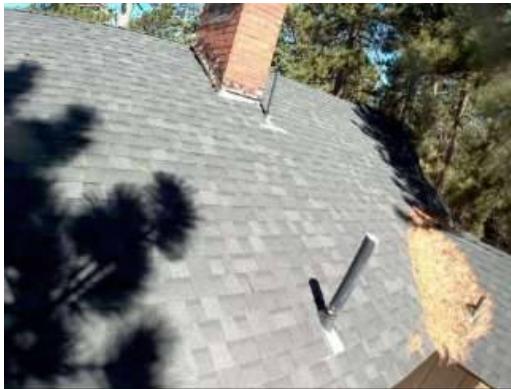
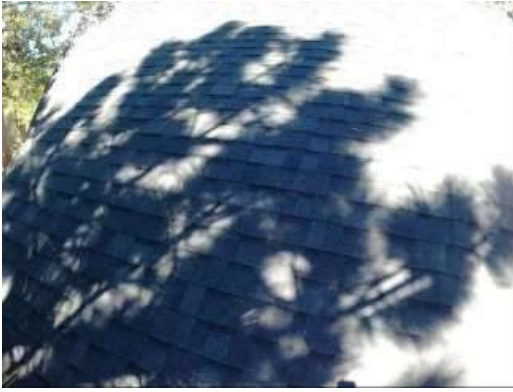
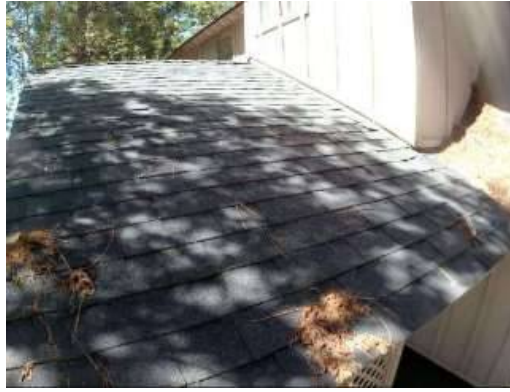
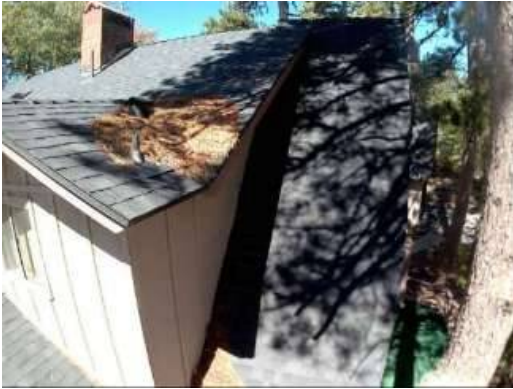
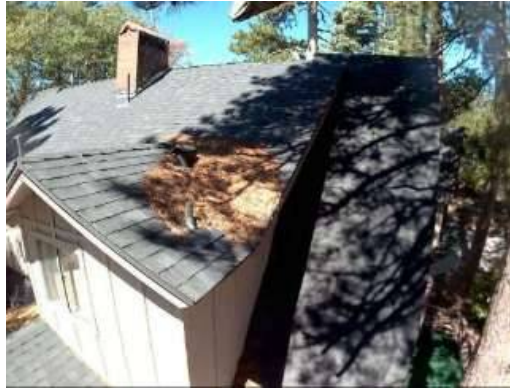
29) At the time of inspection the roof covering appeared to be in serviceable condition, except as noted.

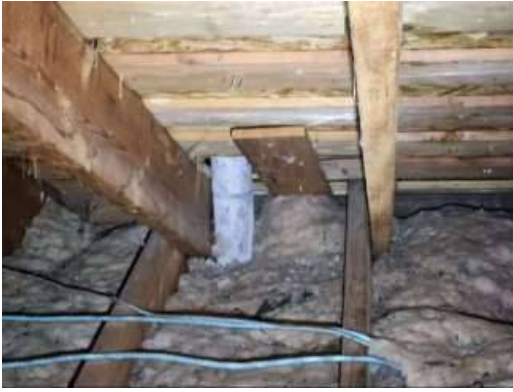
Photo 30-1

Possible asbestos wrap was found at one or more exhaust duct or vents in the attic. However, it appeared to be intact and not significantly deteriorated. Asbestos may pose a health hazard when airborne. If this is asbestos, in some cases, no action is needed except to leave this material undisturbed. The client may wish to have this material tested by a qualified specialist to determine if it is asbestos, and if it should be removed or encapsulated. For information on asbestos hazards in the home, visit:

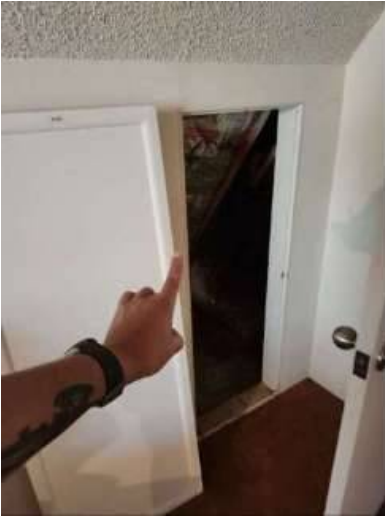
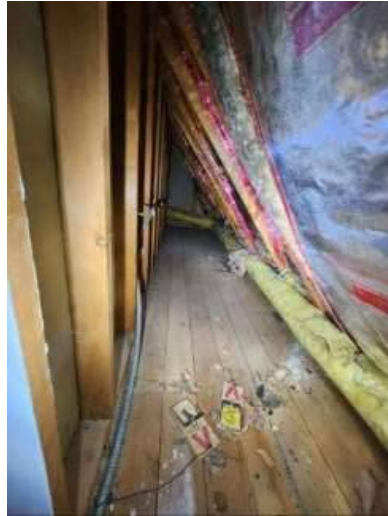
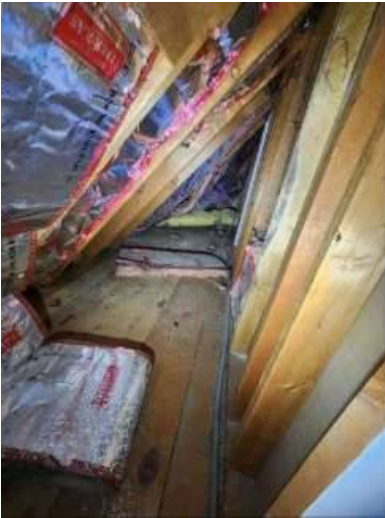
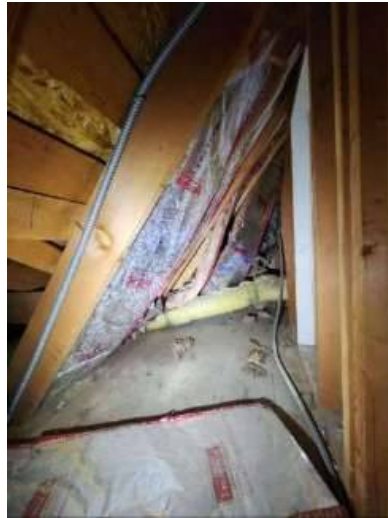
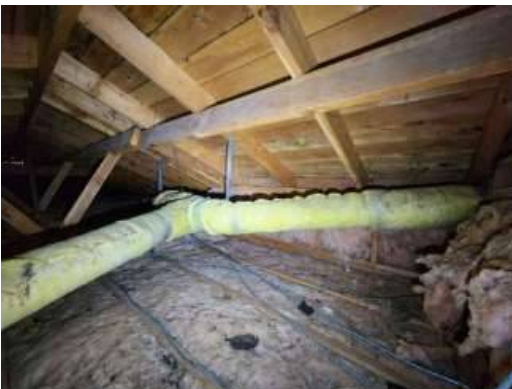
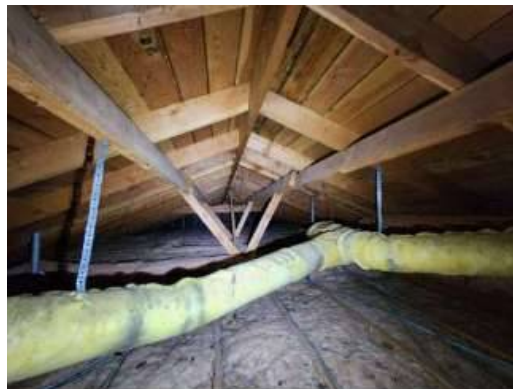
33) ✓ Attic overview #1.

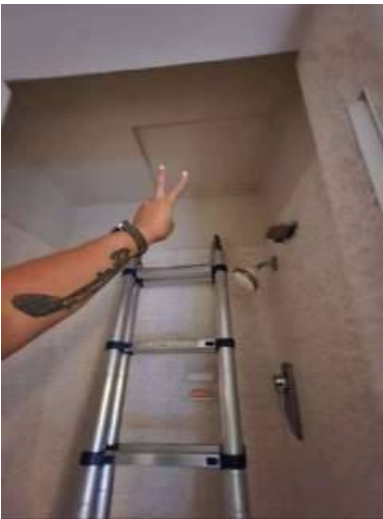
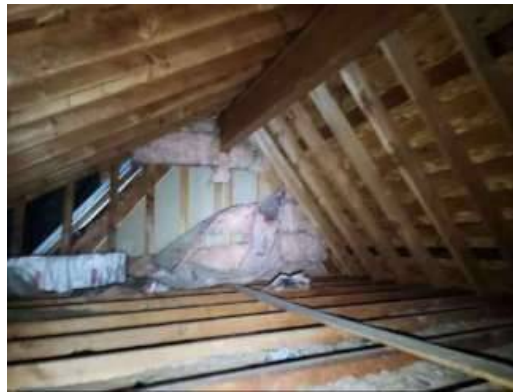
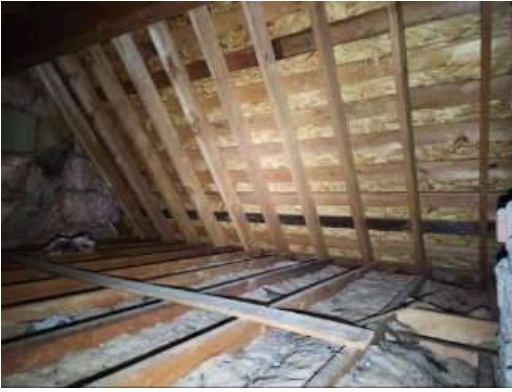
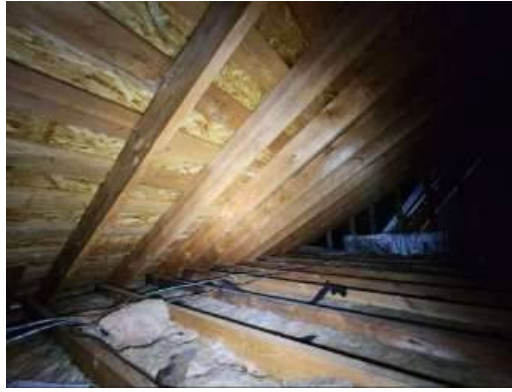
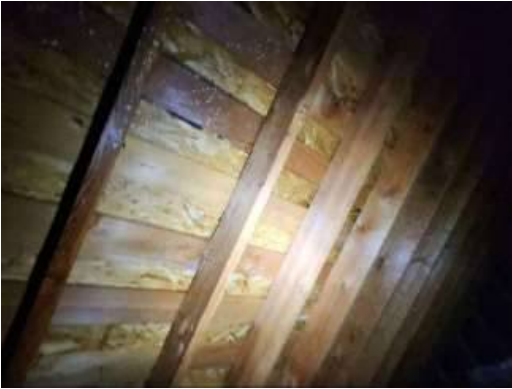
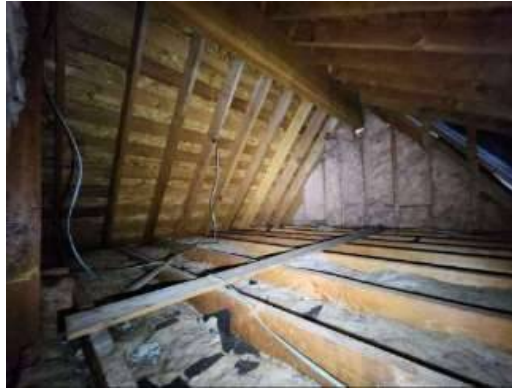
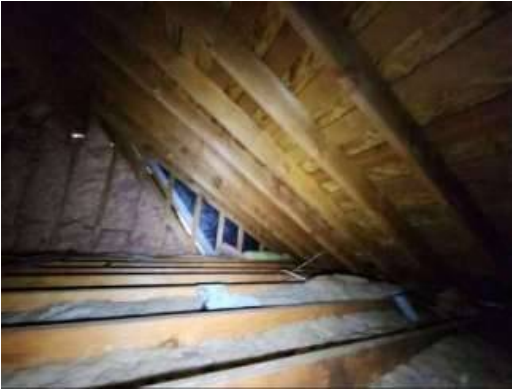
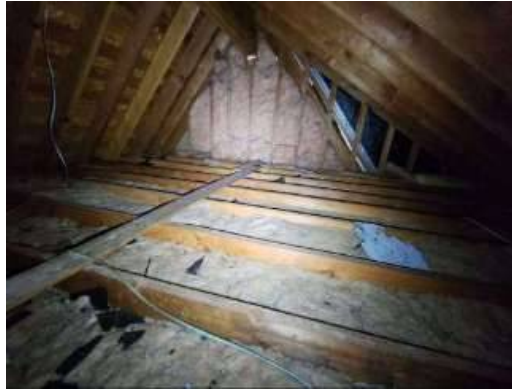
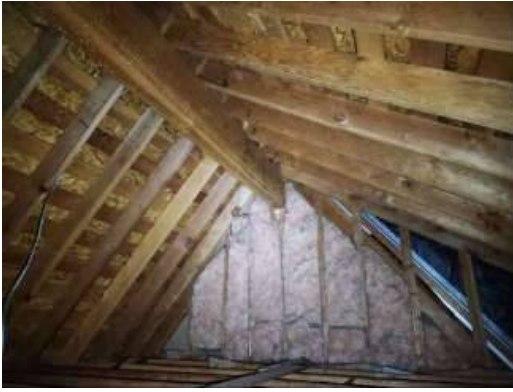
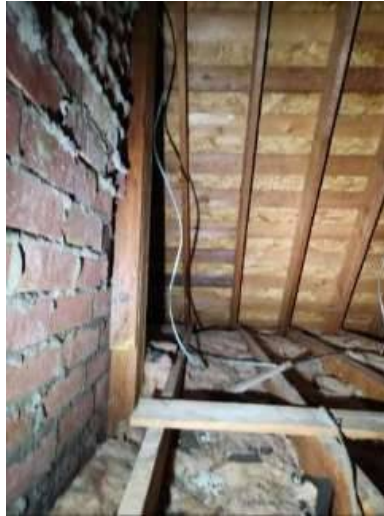
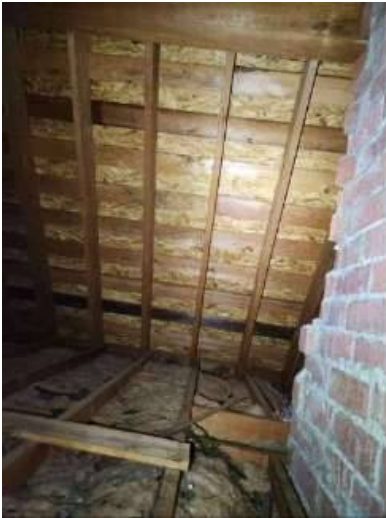
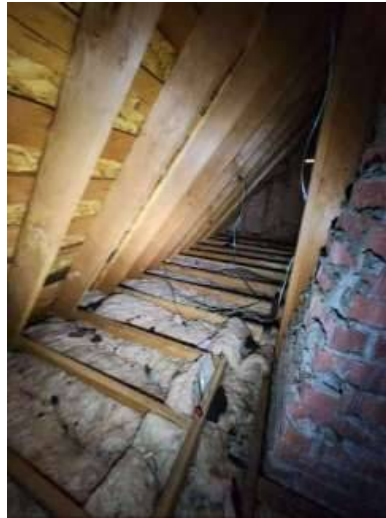
34) ✓ Attic overview #2.

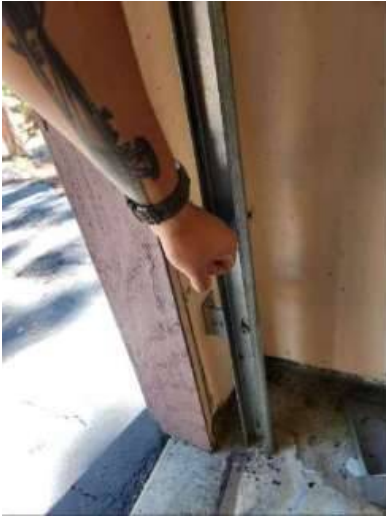
Photo 35-1

No photoelectric sensors were installed for one or more garage vehicle doors' automatic opener. These have been required on all automatic door openers since 1993 and improve safety by triggering the door's auto-reverse feature without need for the door to come in contact with the object, person or animal that is preventing the door from closing. Recommend that a qualified contractor install photoelectric sensors where missing for improved safety. For more information on garage door safety issues, visit:

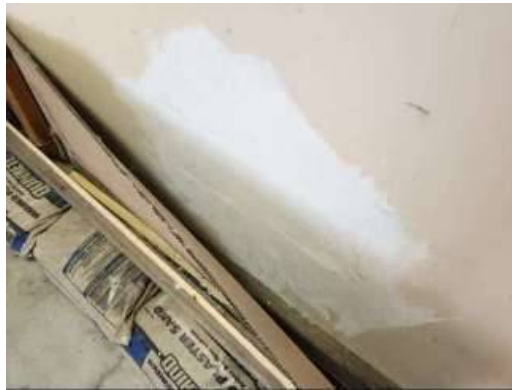
Photo 36-2

36) 🛠️ One or more walls or ceilings had evidence of repairs. The client may wish to consult with the property owner regarding these findings.

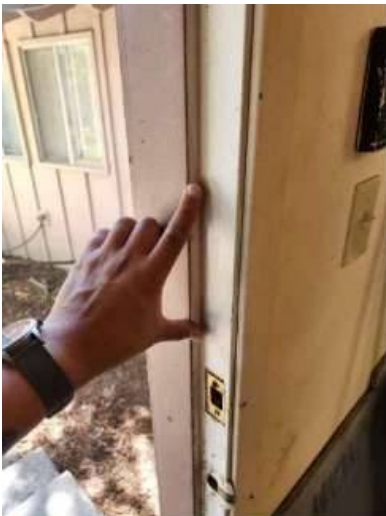
Photo 37-1

37) 🛠️ Weatherstripping around one or more exterior doors was missing. Water may enter the building, or energy efficiency may be reduced. Recommend that a qualified person repair or replace weatherstripping as necessary.

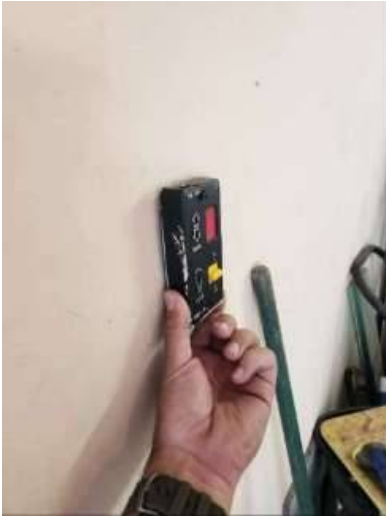
Photo 38-1

38) 🛠️ The control button or panel for operating one or more automatic garage vehicle door openers was loose. A qualified person should repair as necessary so buttons or control panels are securely attached to wall surfaces.

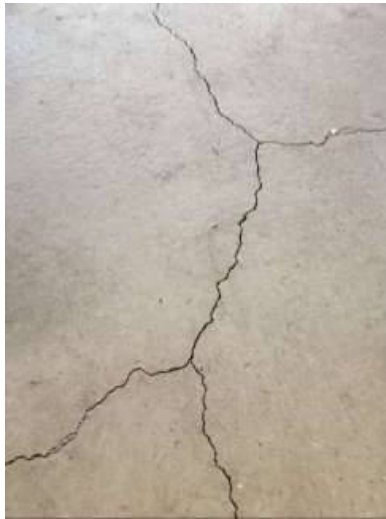
Photo 39-2

Minor cracks were found in the concrete slab floor. These are common and appeared to be only a cosmetic issue.

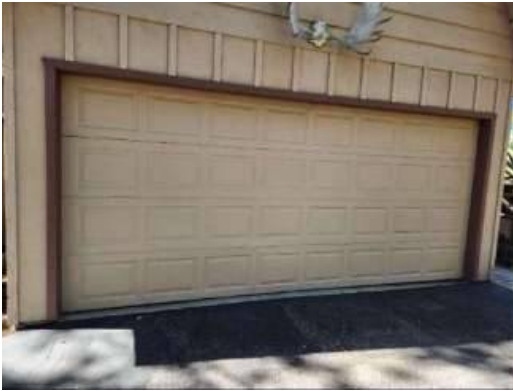
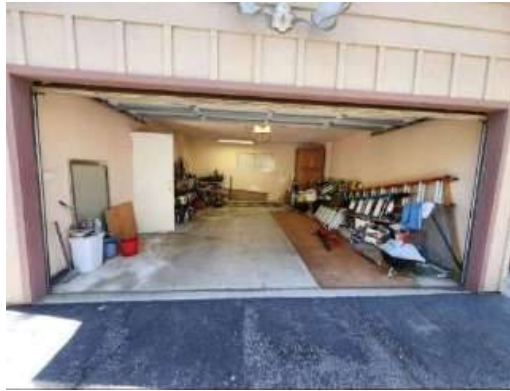
40) ✓ At the time of inspection the vehicle garage door, opener and/or safety components were tested and appear to be operational and in serviceable condition, except as noted.

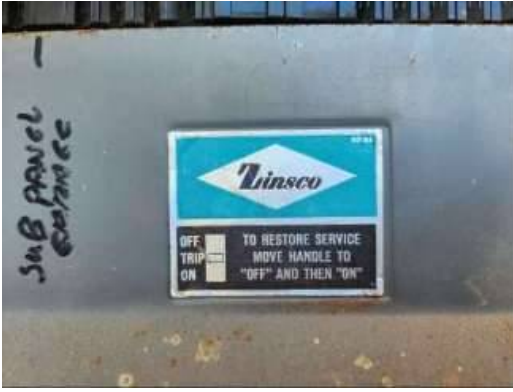
Photo 41-1

41) 🛠️ 🔍 Panel(s) #A were manufactured by the Zinsco company. These panels and their circuit breakers have a history of problems including bus bars made from aluminum that oxidize and corrode, breakers that don't trip under normal overload conditions, and breakers that appear to be tripped when they're not. This is a potential safety hazard for shock and/or fire. Recommend that a qualified electrician carefully evaluate all Zinsco brand panels and components and make repairs as necessary. Consider replacing Zinsco panels with modern panels that offer more flexibility for new, safer protective technologies like arc fault circuit interrupters (AFCIs). For more information, visit:

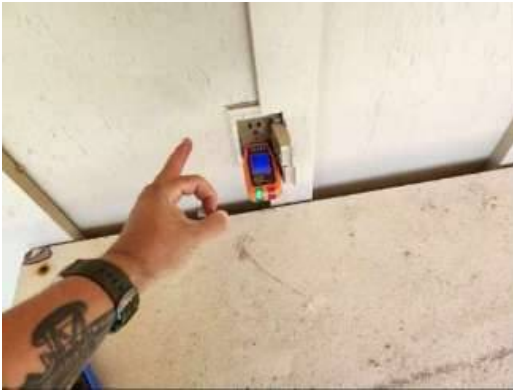
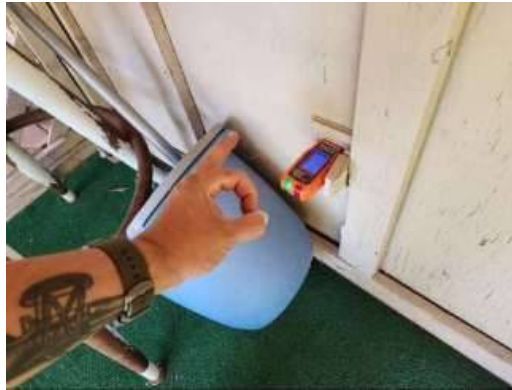
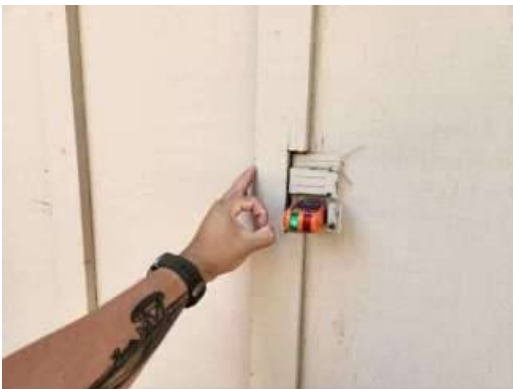
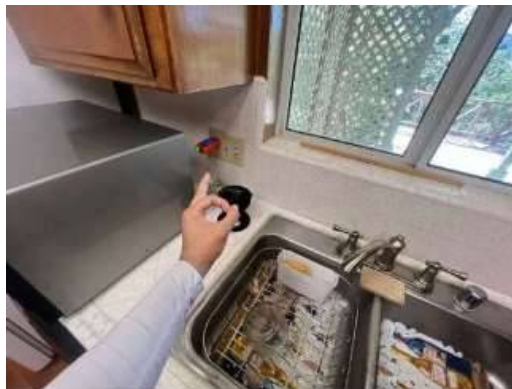
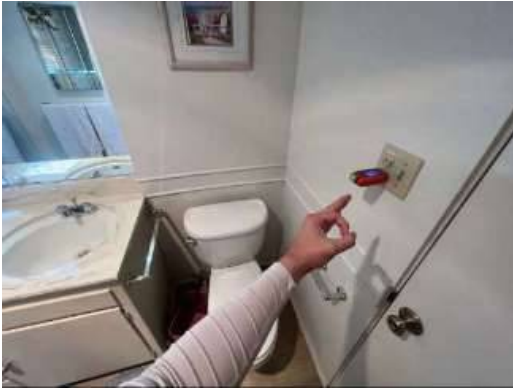
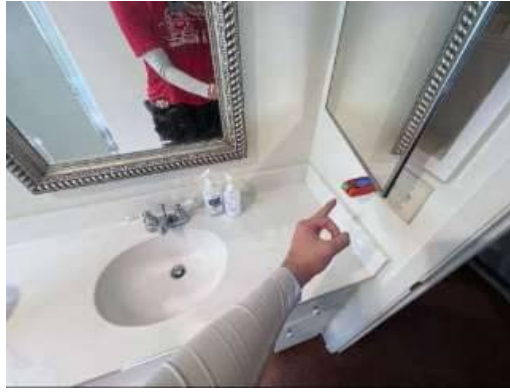
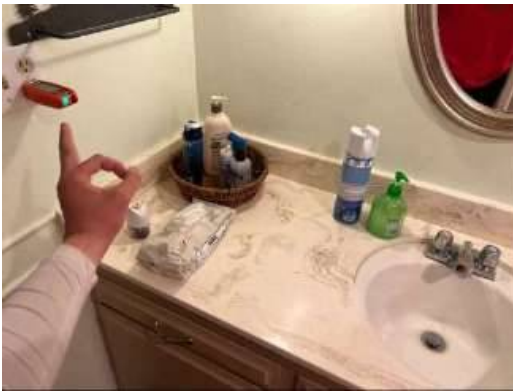
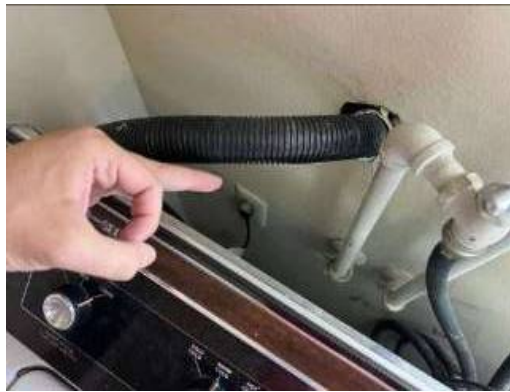
One or more electric receptacles at the kitchen, bathroom(s), laundry area and/or exterior had no visible ground fault circuit interrupter (GFCI) protection, or the inspector was unable to determine if GFCI protection was present. If not GFCI-protected, receptacles in wet areas pose a shock hazard. Recommend that a qualified electrician evaluate and install GFCI protection if necessary and per standard building practices. General guidelines for GFCI-protected receptacles include the following locations:

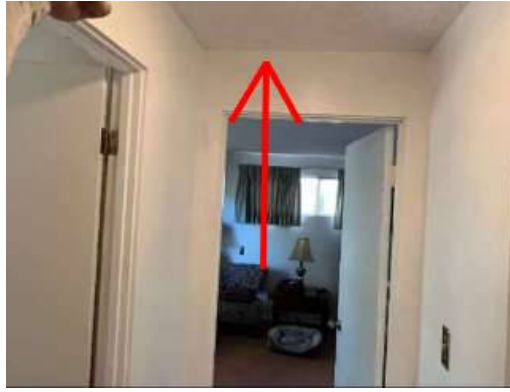
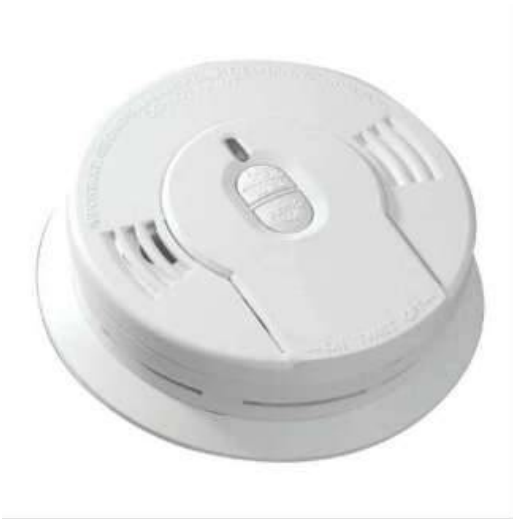
Smoke alarms were missing from one or more hallways leading to bedrooms and/or on one or more levels. Smoke alarms should be installed as necessary so a functioning alarm exists in each hallway leading to bedrooms, in each bedroom, on each level and in any attached garage. For more information, visit: <https://www.reporthost.com/?SMKALRM>

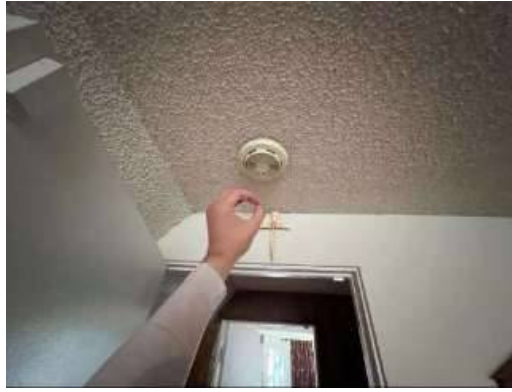
Photo 45-2

Based on the age of this structure and the appearance of existing smoke alarms, the alarms may have been installed more than 10 years ago. According to [National Fire Protection Association](https://www.nfpa.org), aging smoke alarms don't operate as efficiently and often are the source for nuisance alarms. Older smoke alarms are estimated to have a 30% probability of failure within the first 10 years. Newer smoke alarms do better, but should be replaced after 10 years. Unless you know that the smoke alarms are new, replacing them when moving into a new residence is also recommended by NFPA. For more information, visit: <https://www.reporthost.com/?SMKALRMLS>

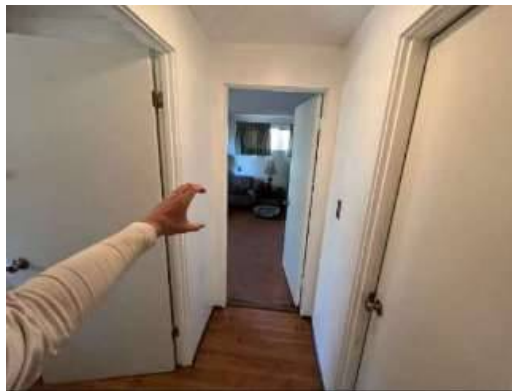
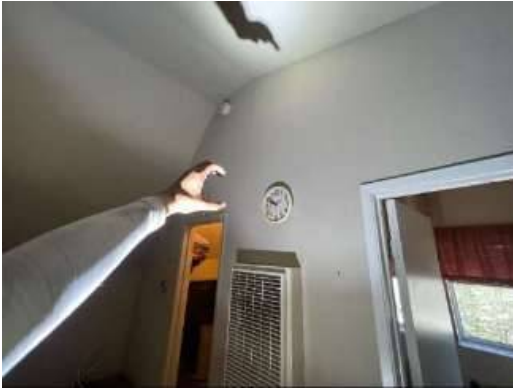
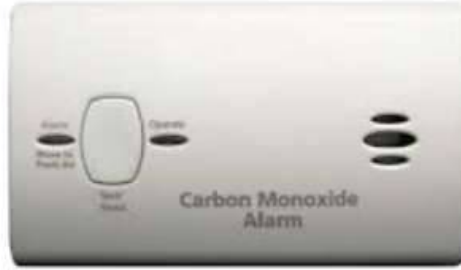
46) 🚨 No permanently installed carbon monoxide alarms were found. This is a potential safety hazard. Some states and/or municipalities require CO alarms to be installed for new construction and/or for homes being sold. Recommend installing approved CO alarms outside of each separate sleeping area in the immediate vicinity of the bedrooms on each level and in accordance with the manufacturer's recommendations. For more information, visit: <https://www.reporthost.com/?COALRM>

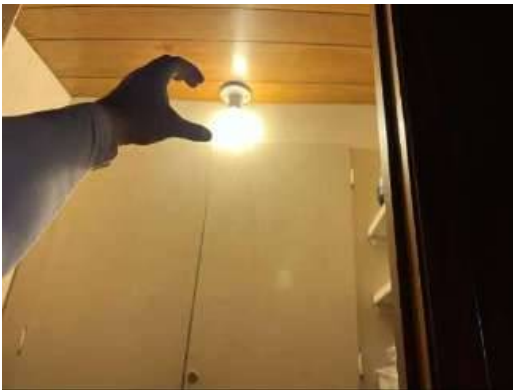
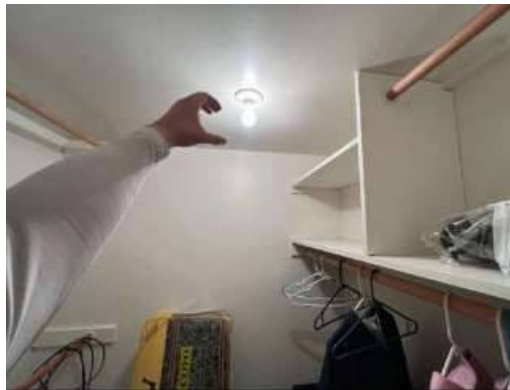
One or more globes or covers for light fixtures were missing or damaged. Recommend replacing as necessary to avoid exposed bulbs. With closet lighting or where flammable stored objects are near light fixtures, missing or broken covers can be a fire hazard.

*closets

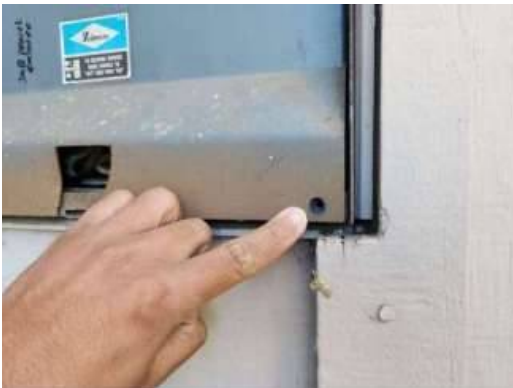
Photo 48-1

One or more screws that attach the cover or dead front to panel(s) #A were missing or not installed. Recommend installing screws where missing so the cover or dead front is secure. Only screws with blunt tips approved for this purpose should be installed, so wiring inside the panel is not damaged. Because energized wires may be located directly behind screw holes, the client should consider having a qualified electrician replace missing screws.

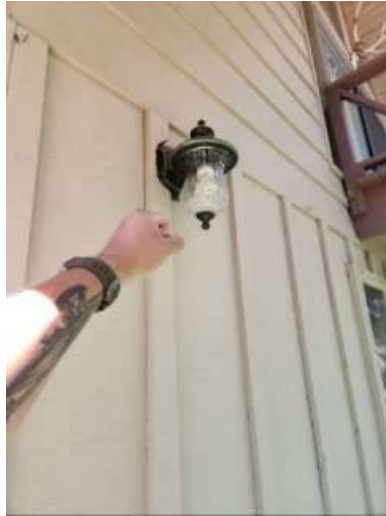
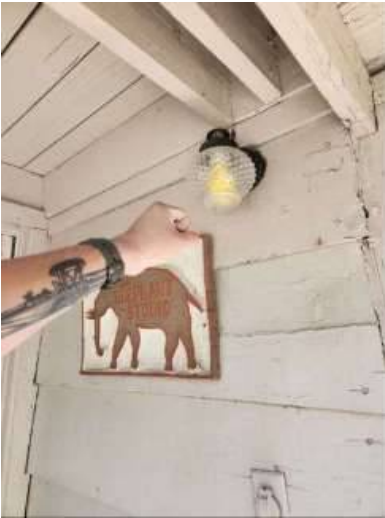
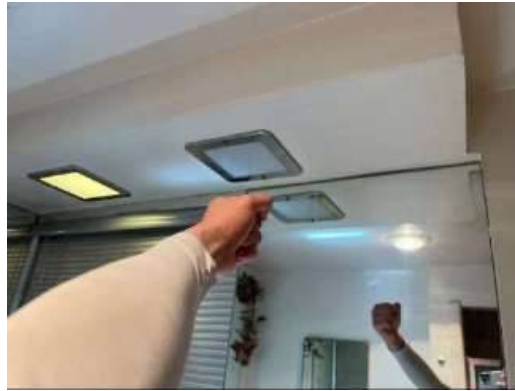
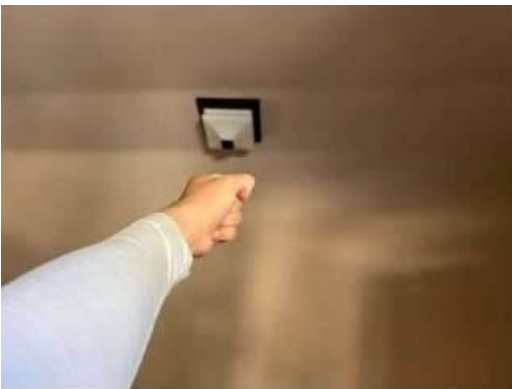
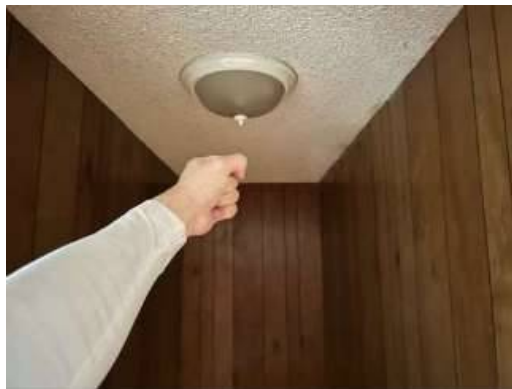
One or more light fixtures were inoperable (didn't turn on when nearby switches were operated). Recommend further evaluation by replacing bulbs and/or consulting with the property owner. If replacing bulbs doesn't work and/or no other switch(es) can be found, then recommend that a qualified electrician evaluate and repair or replace light fixtures as necessary.
