Property Inspection Report

Property address: **32311 Scandia Dr, Running Springs, CA 92382**

Inspection date: **Thursday, September 7, 2023**

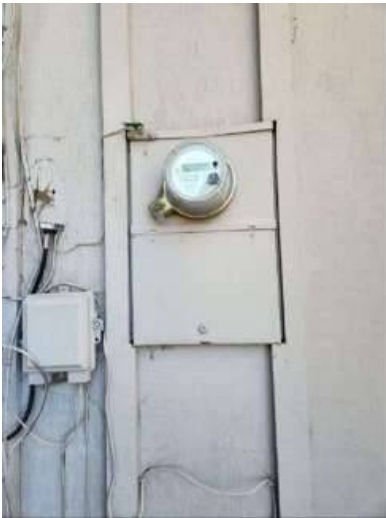
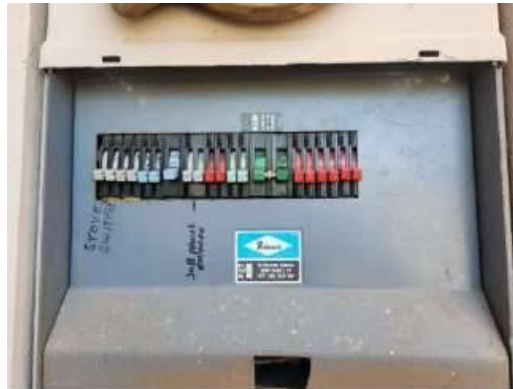
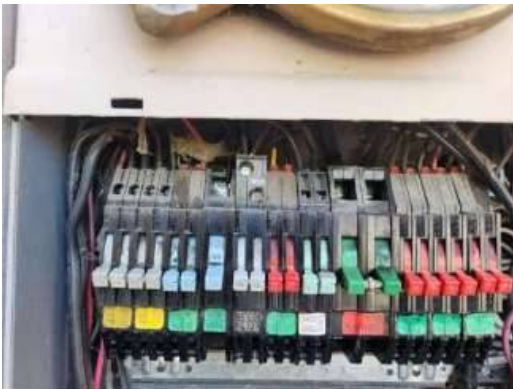
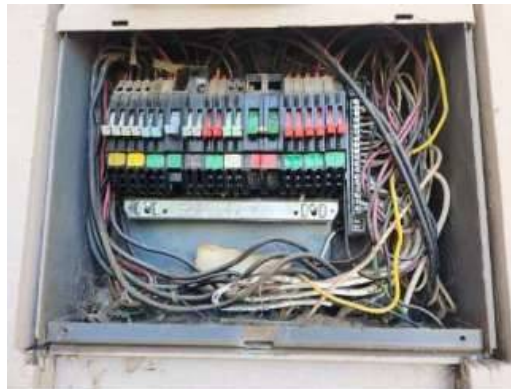
50) ✓ **i** The main service panel appeared to be at it's service life and will need upgrading in the near future. At the time of inspection the main service panel appeared to be in serviceable condition, except as noted.

Location of main service panel #A: Building exterior.

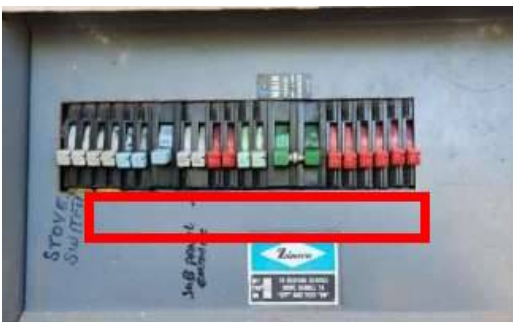
Photo 52-1

Recommend labeling panel with shut off location(s).

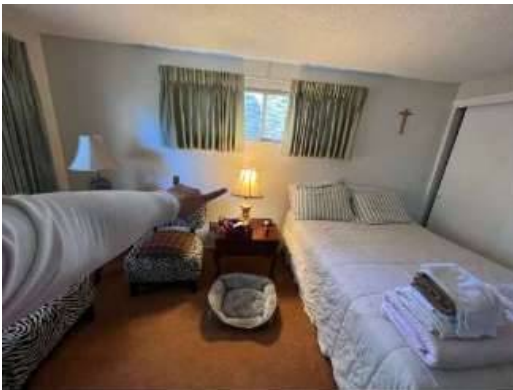
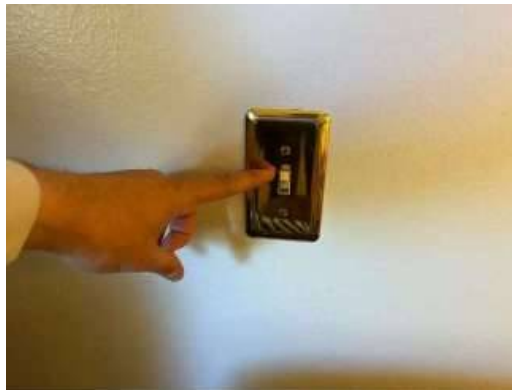
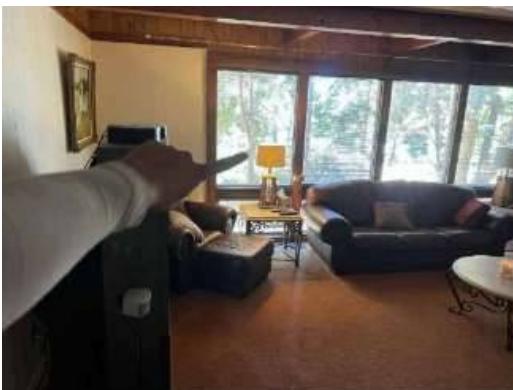
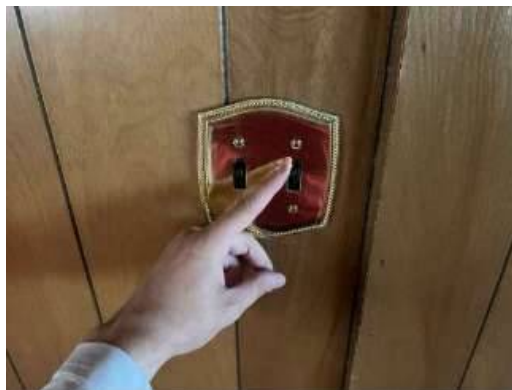
One or more interior rooms were equipped with a lamp switch.

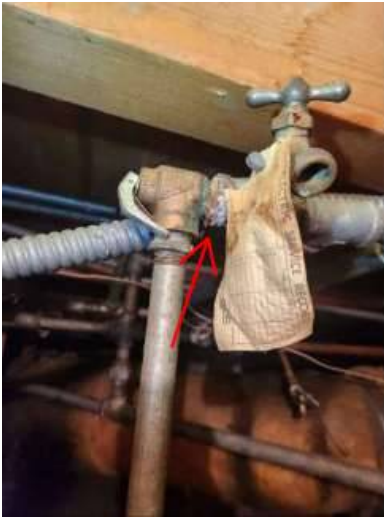
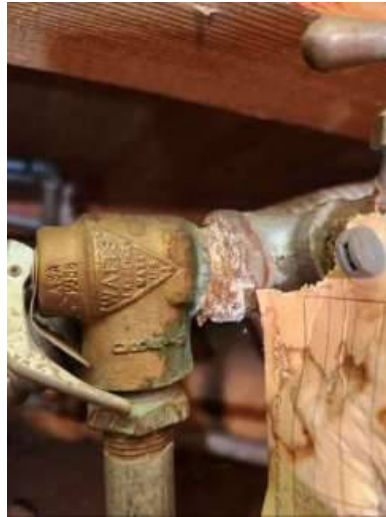
*crawl space

Significant corrosion was found in some water supply pipes or fittings. Leaks can occur as a result. Recommend that a qualified plumber evaluate and replace components as necessary.

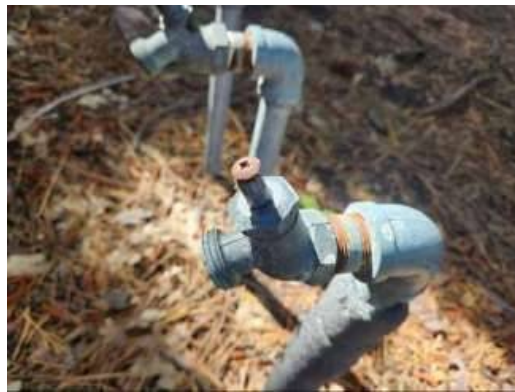
Photo 56-2

One or more hose bib handles were missing. Recommend that a qualified person replace handles or make repairs as necessary.

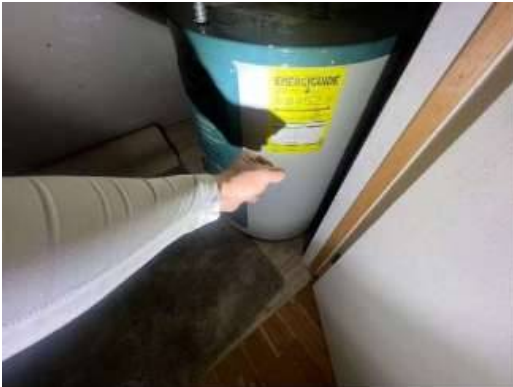
*water heater #B

The water heater did not have earthquake straps or struts installed. This is a potential safety hazard in the event of an earthquake due to the risk of the water heater tipping over, gas lines breaking if it's gas-fired, or electric wiring being damaged if powered by electricity. Leaks can also occur in water-supply pipes. Recommend that a qualified person install earthquake straps or struts as necessary and per standard building practices.

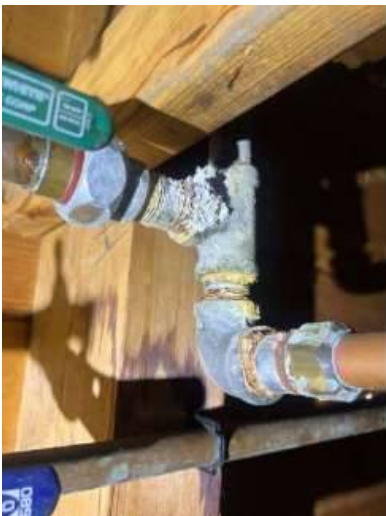
*water heater #A

Significant corrosion or rust was found at the supply pipes or fittings. This can indicate past leaks, or that leaks are likely to occur in the future. Recommend that a qualified plumber evaluate and replace components or make repairs as necessary.

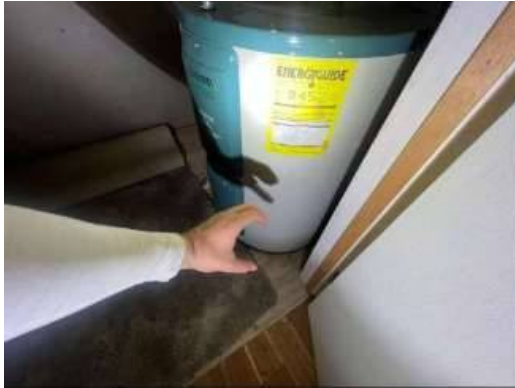
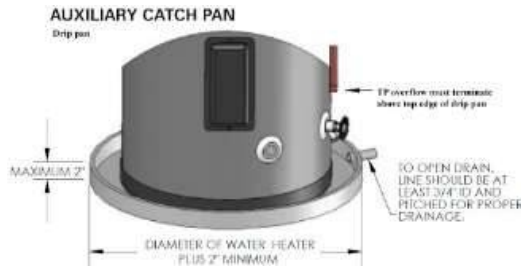
*water heater #B

A water heater was installed in or over a finished living space or in an area where leaking can cause damage, and no catch pan or drain was installed. Catch pans and drains prevent water damage to finished interior spaces below if or when the water heater leaks or is drained. If concerned, consult with a qualified contractor about installing these. Note that drain lines for catch pans are usually installed below the floor level and are difficult at best to install in an existing home.

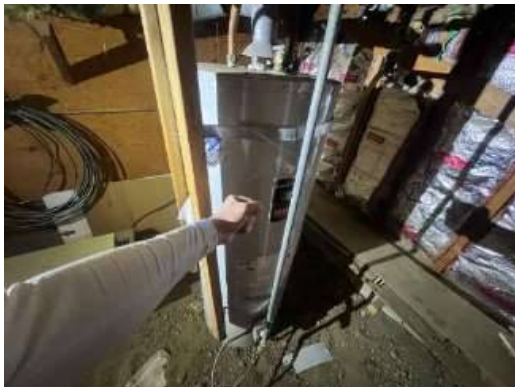
*water heater #A

The water heater's pilot light was off. The water heater and hot water supply system (e.g. faucets, controls) were not fully evaluated because of this. Recommend that a full evaluation be made by a qualified person when conditions have been corrected so the water heater is operable. Note that per the standards of practice for various professional home inspection organizations, the inspector does not operate shut-off valves, pilot lights or over-current protection devices, or any controls other than "normal controls."

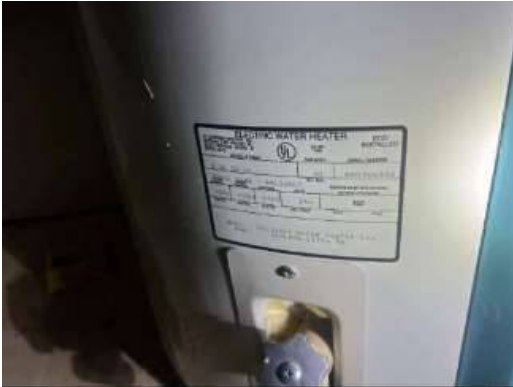
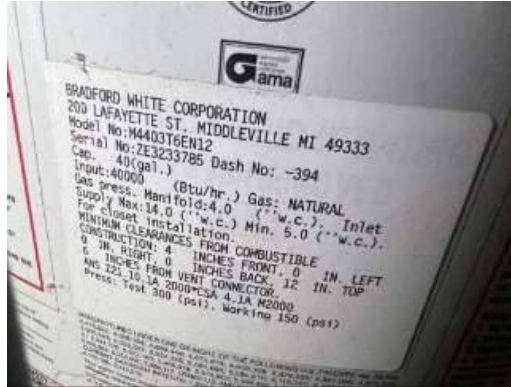
*water heaters #A and #B

and may need replacing at any time. Recommend budgeting for a replacement in the near future, or considering replacement now before any leaks occur. The client should be aware that significant flooding can occur if the water heater fails. If not replaced now, consider having a qualified person install a catch pan and drain or a water alarm to help prevent damage if water does leak.

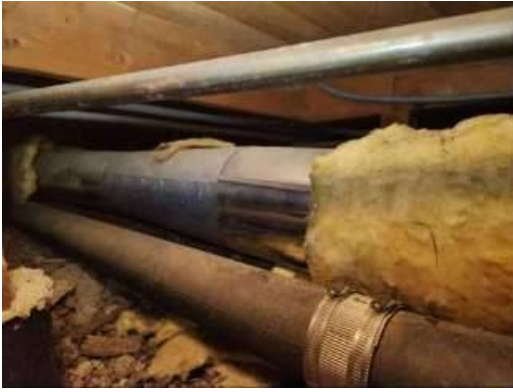
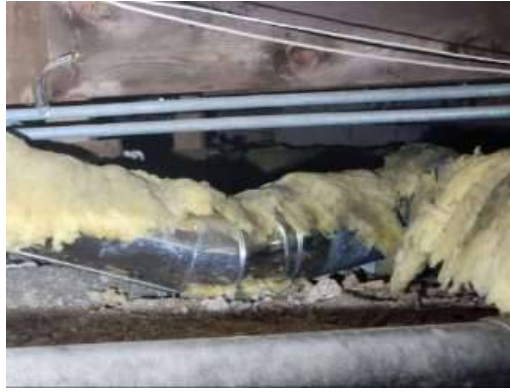
*crawlspce

One or more heating or cooling ducts in an unconditioned space (e.g. crawl space, attic or basement) were not insulated, or the insulation was damaged or deteriorated. This can result in reduced energy efficiency, moisture inside heating ducts, and/or "sweating" on cooling ducts. Recommend that a qualified person repair per standard building practices. For example, by wrapping ducts in insulation with an R-value of R-8.

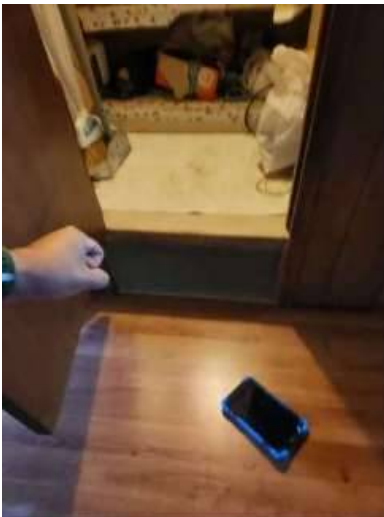
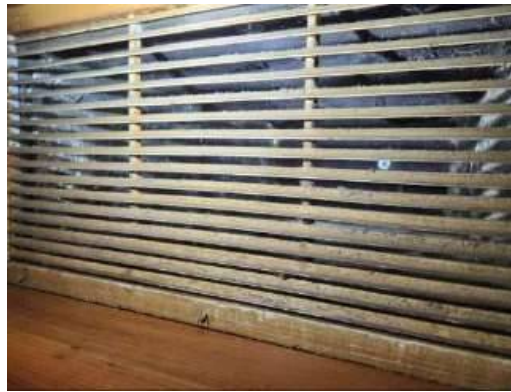
Air filters for the heating and/or cooling system were missing at one or more locations where they should have been installed. Indoor air quality will be reduced as a result. Recommend installing good quality filters at intended locations (e.g. in or at the air handler, behind return air grills). Filters should be sized correctly to minimize air gaps. Many types of filters are available. Recommend installing pleated filters or better rather than the cheapest disposable kind. For more information, visit:

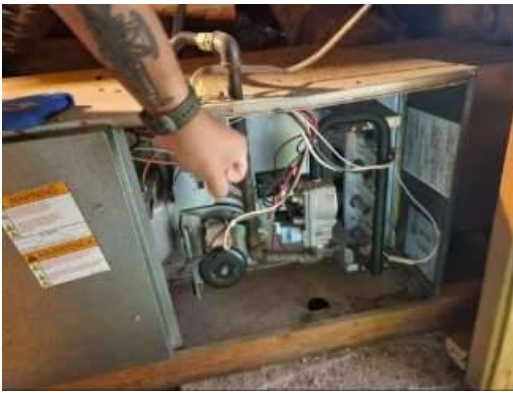
*central & wall unit

The furnace heating system was not fully evaluated because the pilot light was off and/or burners were not igniting. Recommend that a full evaluation be made by a qualified person when conditions have been corrected so the system is operable. Note that the inspector does not operate shut-off valves, pilot lights or circuit breakers, or any controls other than normal controls (thermostat).

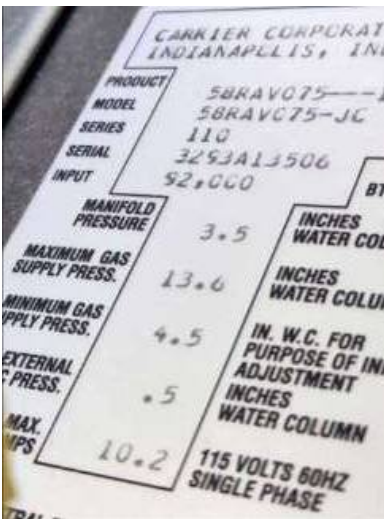
Photo 71-1

71) **i** The estimated useful life for most forced air furnaces is 15-20 years. This furnace appeared to be at and/or beyond this age and/or its useful lifespan and may need replacing or significant repairs at any time. Recommend budgeting for a replacement in the near future.

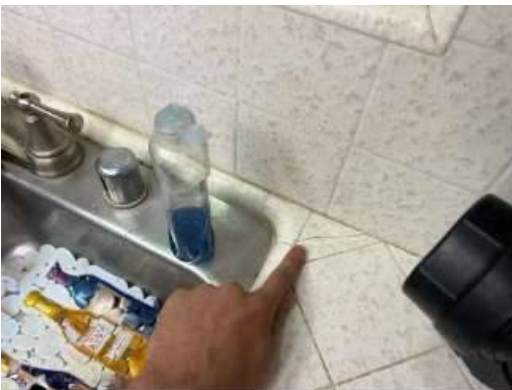
Photo 76-1

76) 🛠️👉 Countertops and/or backsplashes were damaged or deteriorated. Recommend repairing or replacing as necessary.

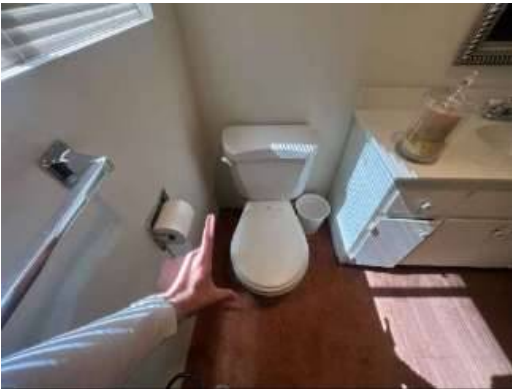
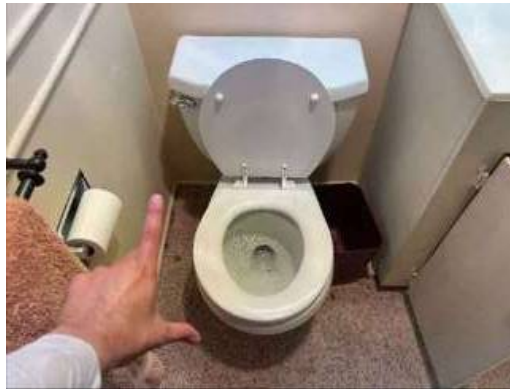
The toilet at location(s) #B and D was loose where it attached to the floor. Leaks can occur. Flooring, the sub-floor or areas below may get damaged. Sewer gases can enter living spaces. Recommend that a qualified contractor remove the toilet(s) for further evaluation and repair if necessary. A new wax ring should be installed and toilet(s) should be securely anchored to the floor to prevent movement and leaking.

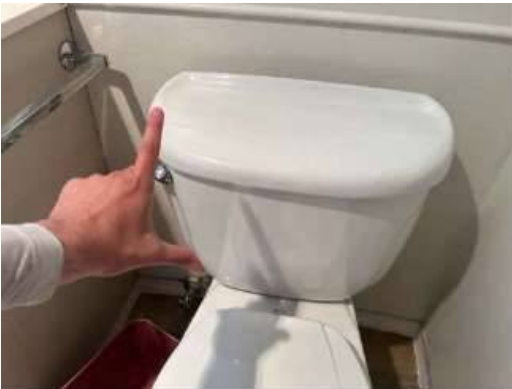
Photo 81-1

The toilet tank was loose at location(s) #A. Recommend that a qualified plumber replace toilet(s) or components as necessary. Where cracks have resulted in leaks, additional repairs due to water damage may be needed.

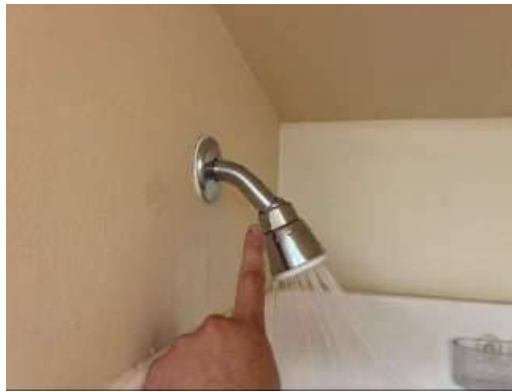
Photo 83-2

The shower head at location(s) #A and D was leaking when tested. Recommend that a qualified person repair as necessary.

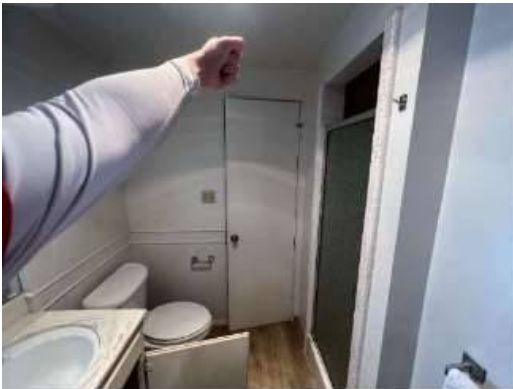
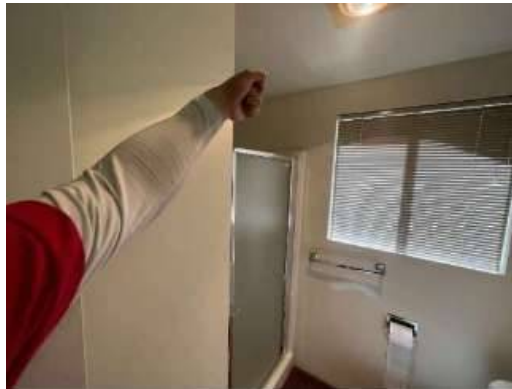
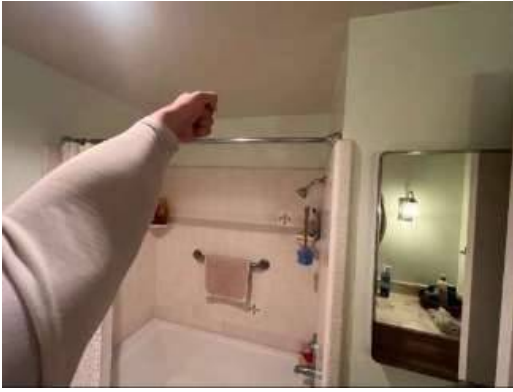
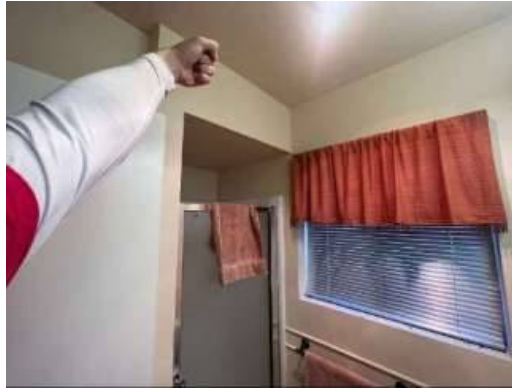
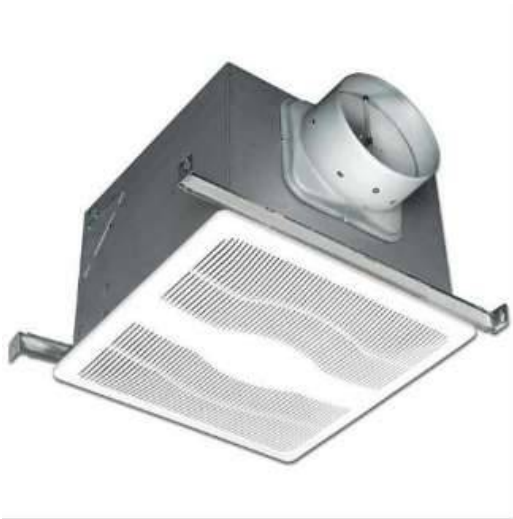
The bathroom with a shower or bathtub at location(s) #A, B, C and D didn't have an exhaust fan installed. Moisture can accumulate and result in mold, bacteria or fungal growth. Even if the bathroom has a window that opens, it may not provide adequate ventilation, especially during cold weather when windows are closed or when wind blows air into the bathroom. Recommend that a qualified contractor install exhaust fans per standard building practices where missing in bathrooms with showers or bathtubs.

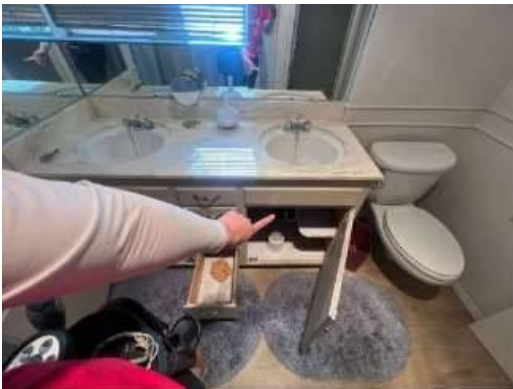
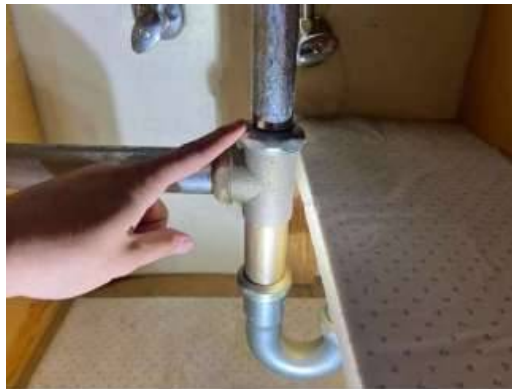
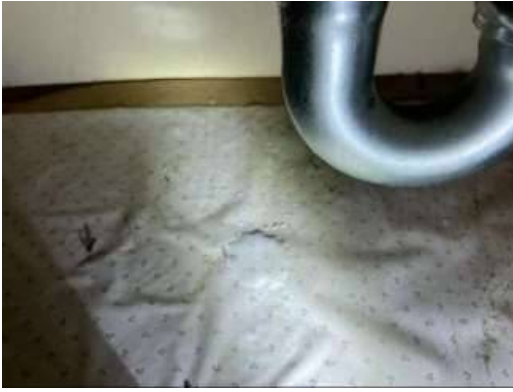
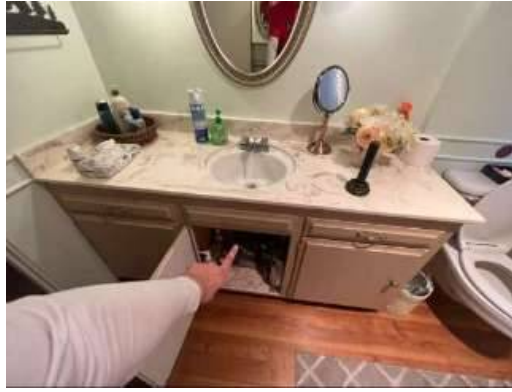
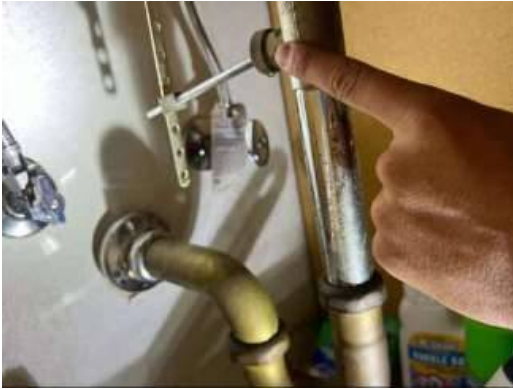
85) 🛠️ One or more sink drains were leaking at location(s) #A and #C. A qualified person should repair as necessary.

*right side sink
*drain stopper connection

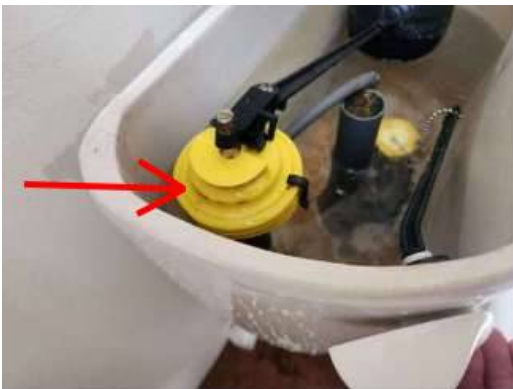
Photo 86-1

The toilet fill valve or float mechanism in the toilet at location(s) #B did not operate properly or was inoperable. Recommend that a qualified person repair as necessary.

*water sprays out of tank after flushed

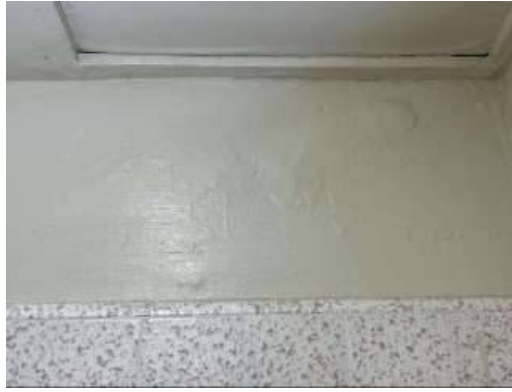
Photo 87-2

The wall by the shower at location(s) #A was water-damaged. Recommend that a qualified person repair as necessary.

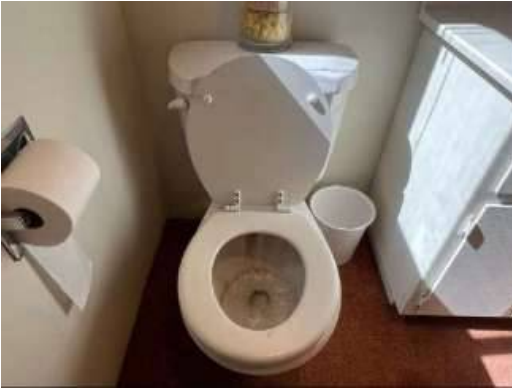
Photo 91-3

91) ✓ Bathroom #B appeared to be in serviceable condition, except as noted.

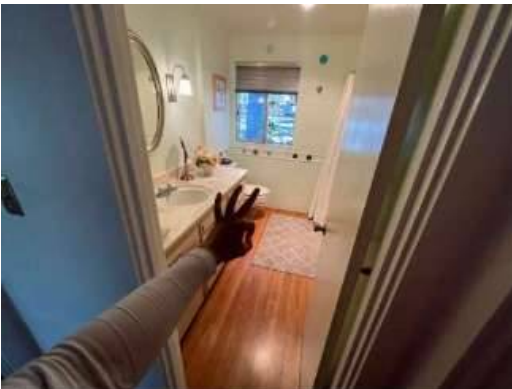
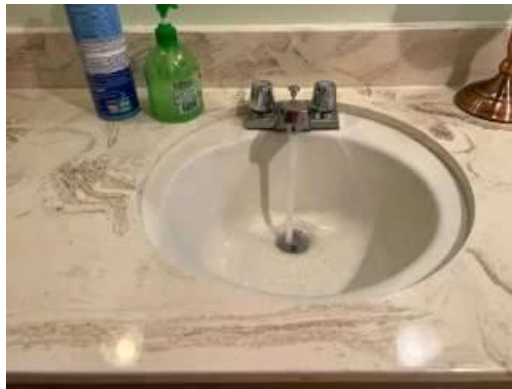
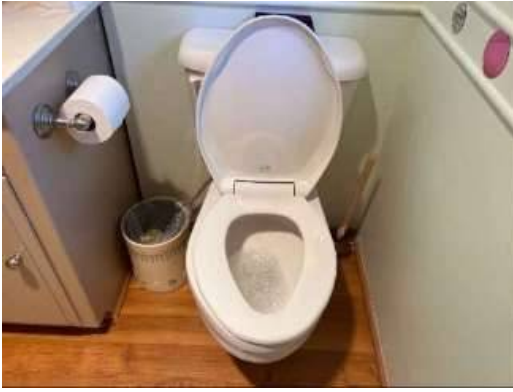
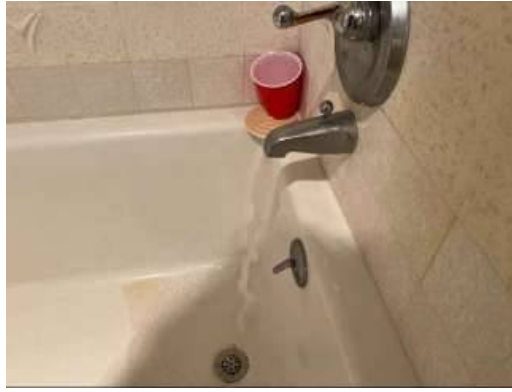
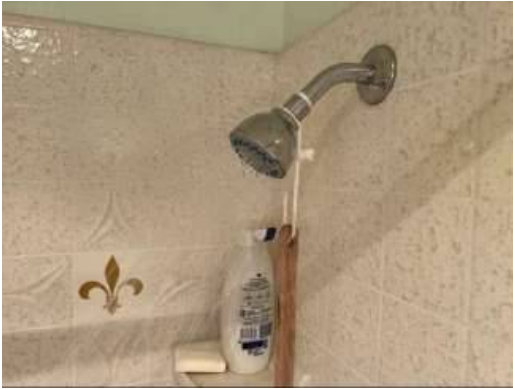
92) ✓ Bathroom #C appeared to be in serviceable condition, except as noted.

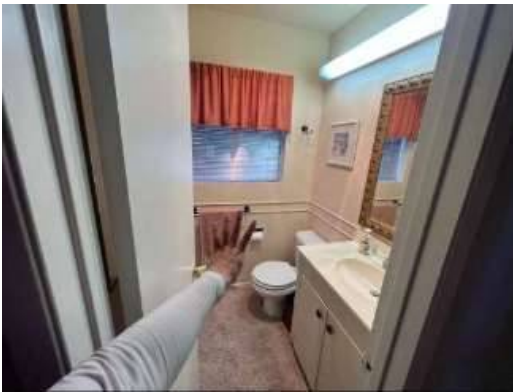
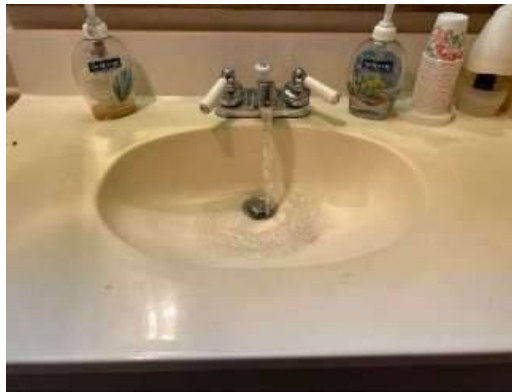
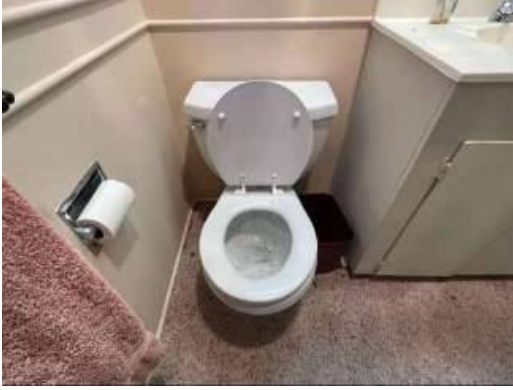
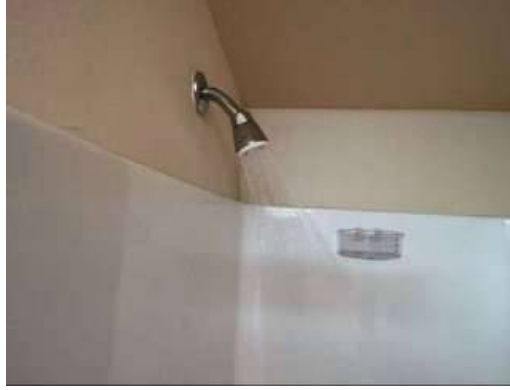
93) ✓ Bathroom #D appeared to be in serviceable condition, except as noted.

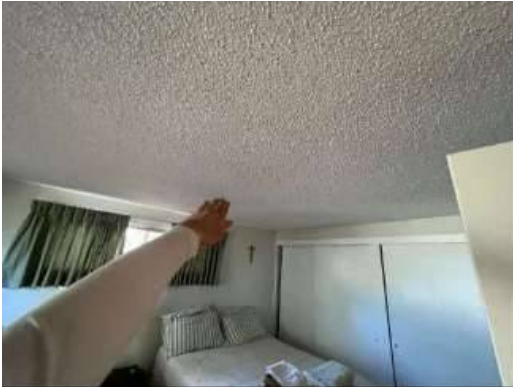
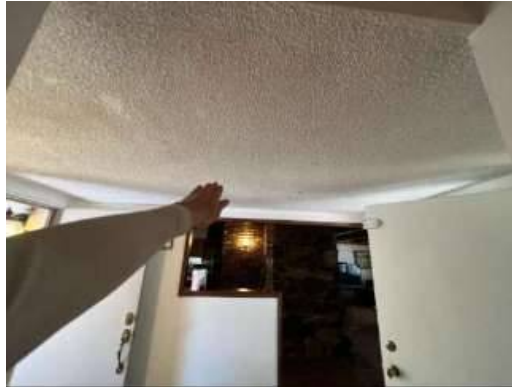
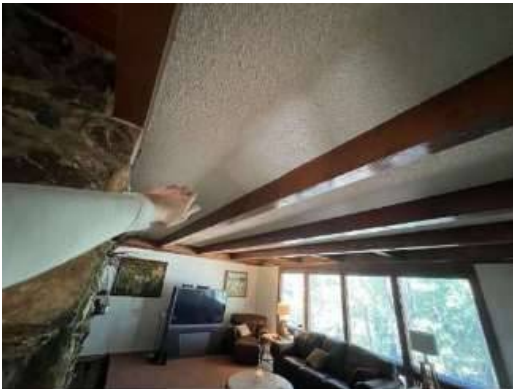
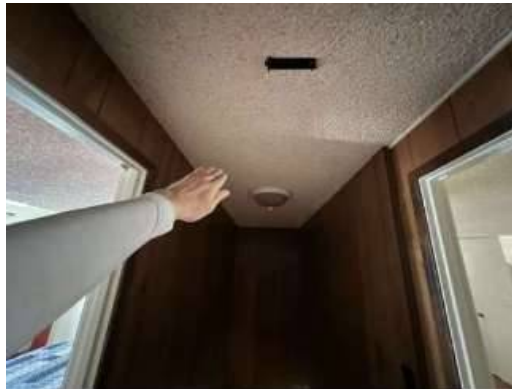
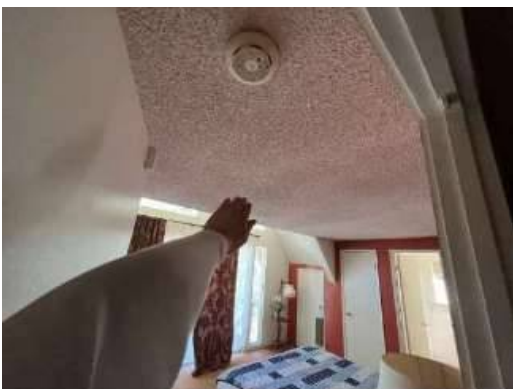
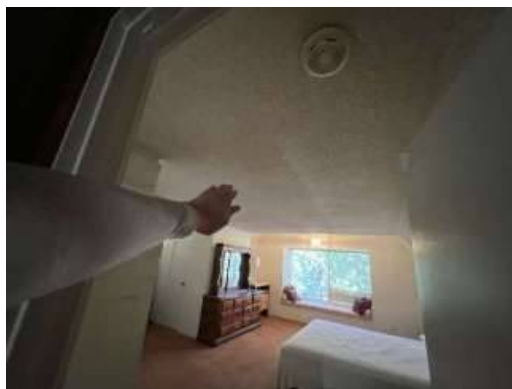
95) 🏠🔍📄 Some ceilings in this structure had ceiling texture possibly installed prior to the mid-1980s. This material may contain asbestos, which is a known health hazard. Laws were passed in the United States in 1978 prohibiting use of asbestos in residential structures, but stocks of existing materials were used for some time thereafter. The client may wish to have this ceiling material tested by a qualified lab to determine if it does contain asbestos.

In most cases, when the material is intact and in good condition, keeping it encapsulated with paint and not disturbing it may reduce or effectively eliminate the health hazard. If the client wishes to remove the material, or plans to disturb it through remodeling, they should have it tested by a qualified lab and/or consult with a qualified industrial hygienist or asbestos abatement specialist. For more information, visit:

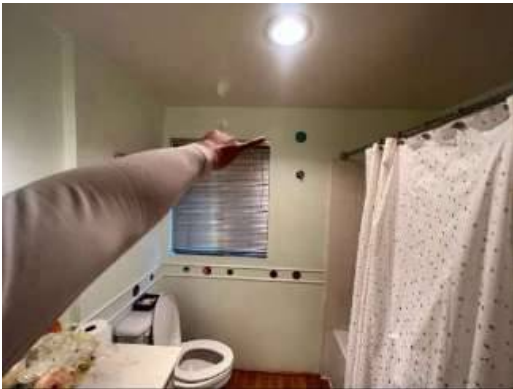
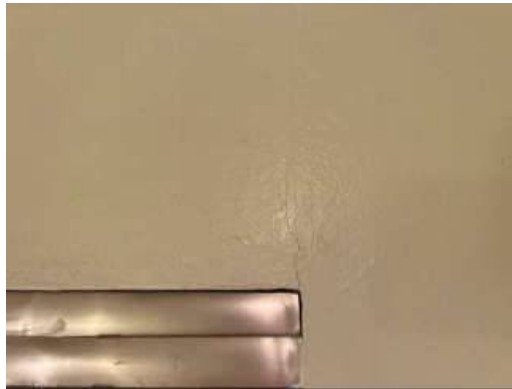
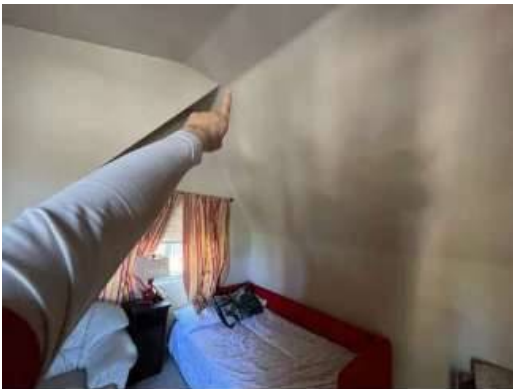
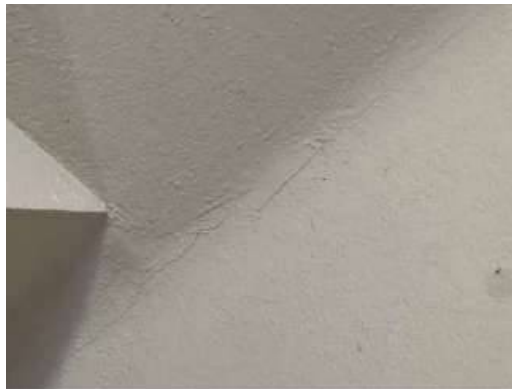
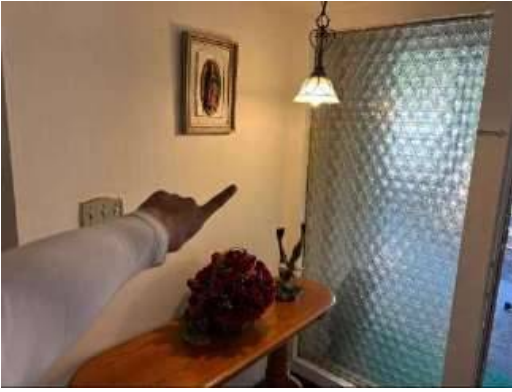
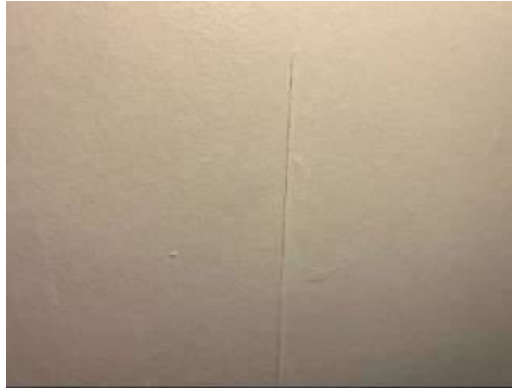
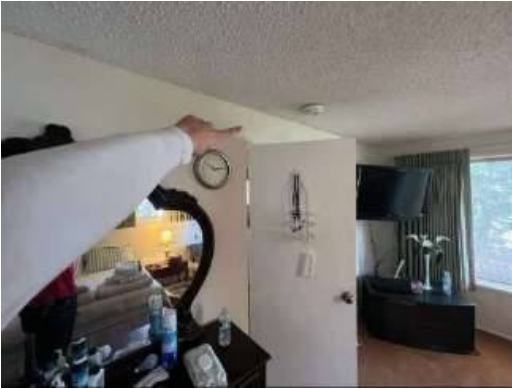
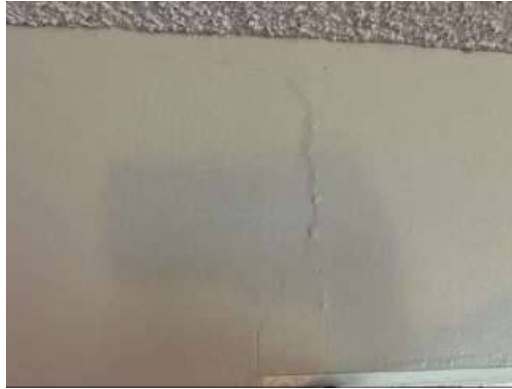
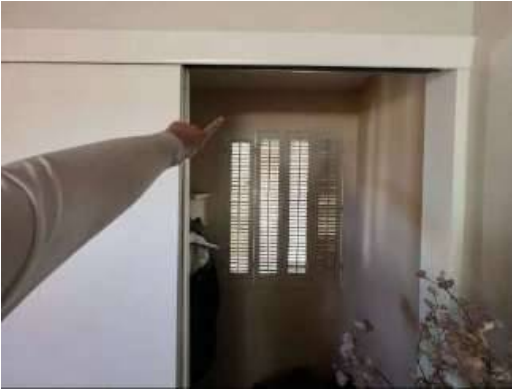
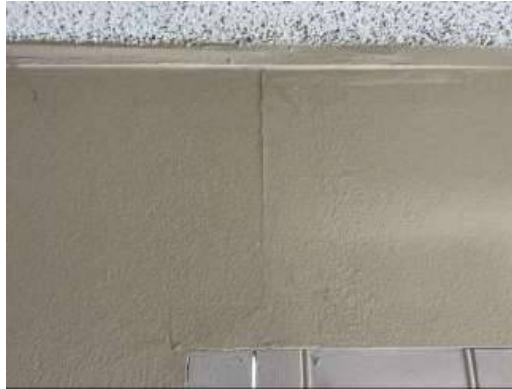
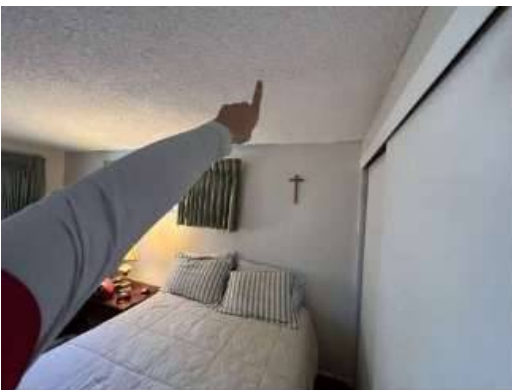
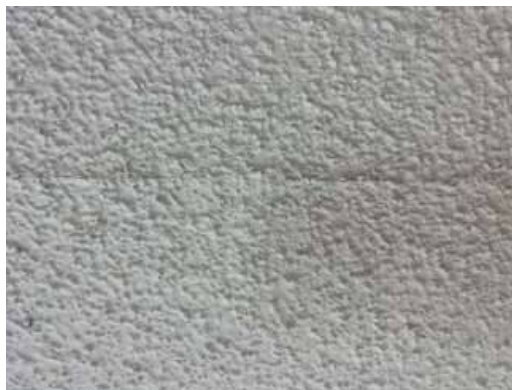
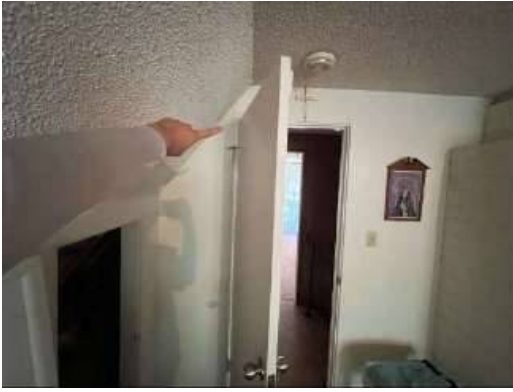
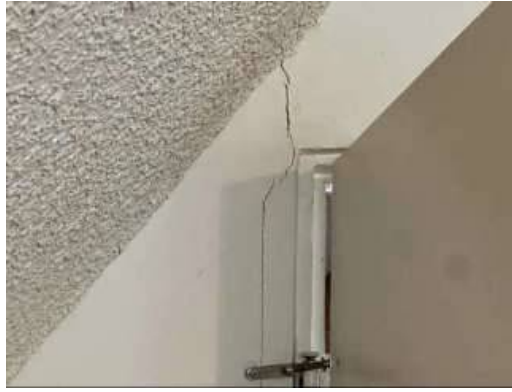
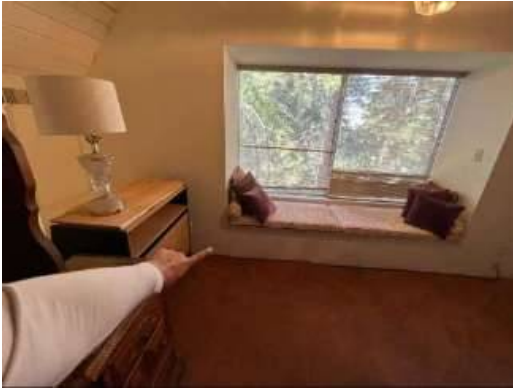
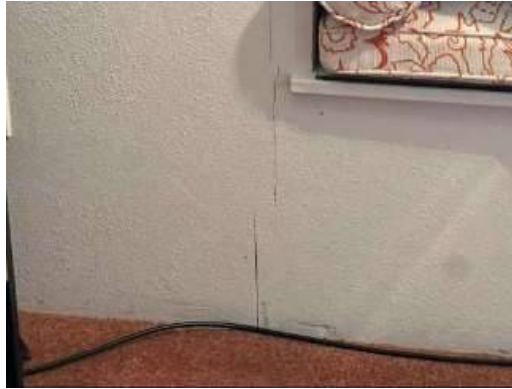
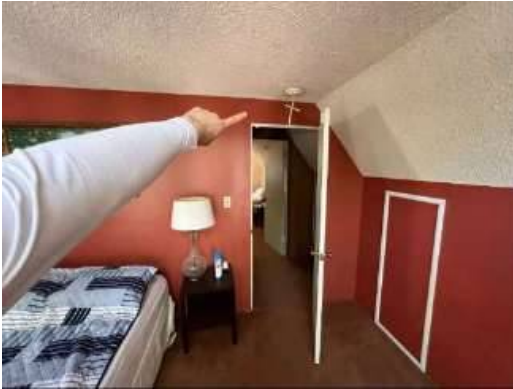
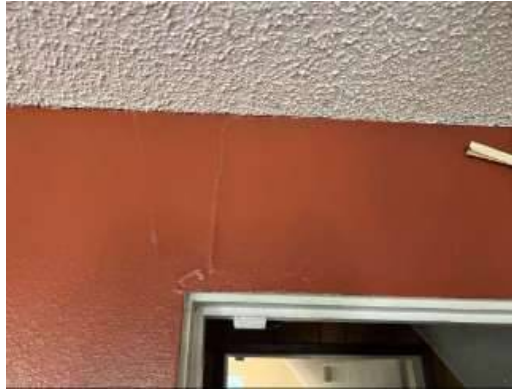
97) 🔧🔍 This structure appears to have settled based on the presence of minor cracks in walls, ceilings or junctions between them, or numerous door frames not being square, or numerous doors binding in jambs. Recommend that a qualified contractor and/or engineer evaluate further. Significant repairs may be needed. If so, a qualified contractor should make repairs.

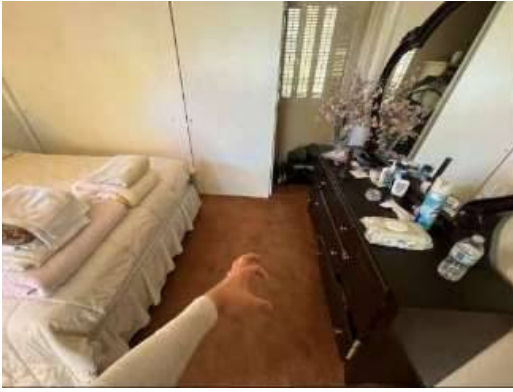
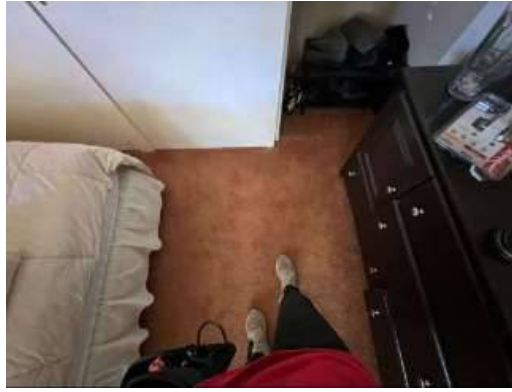
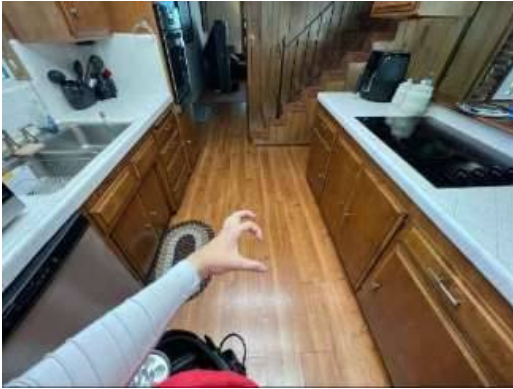
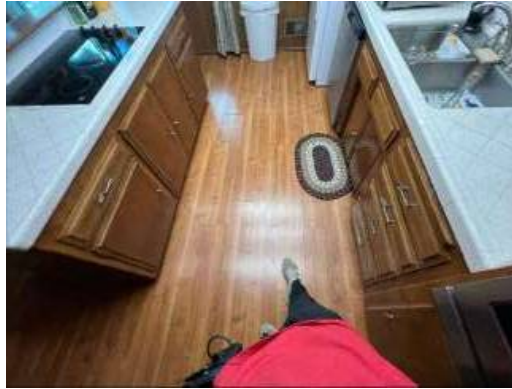
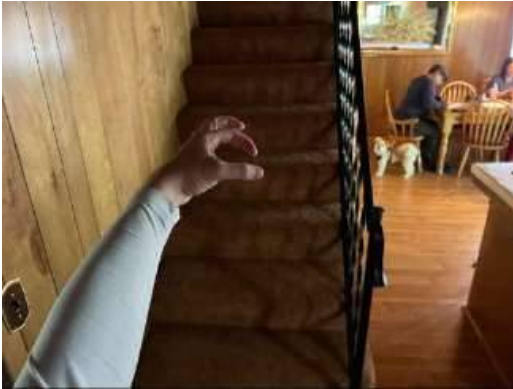
Squeaking or creaking noises occur when walking on one or more sections of flooring. This is usually caused by substandard construction practices where the sub-floor decking is not adequately fastened to the framing below. For example, not enough glue was used and/or nails were used rather than screws. In most cases, this is only an annoyance rather than a structural problem. Various solutions such as [Squeeeeeek No More and Counter Snap fasteners](#) exist to correct this. Repairs to eliminate the squeaks or creaks may be more or less difficult depending on the floor covering and the access to the underside of the sub-floor. Recommend that a qualified contractor evaluate and repair as necessary. For more information, visit: <https://www.reporthost.com/?SQUEAK>

*one or more bedrooms, kitchen & stairs

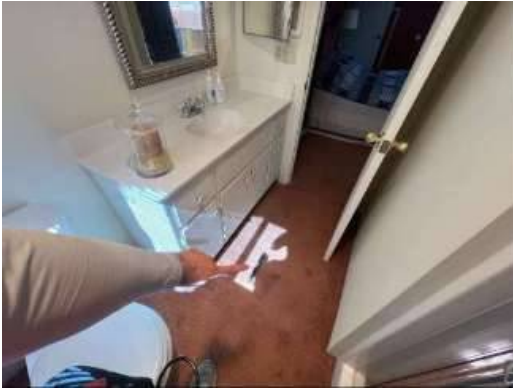
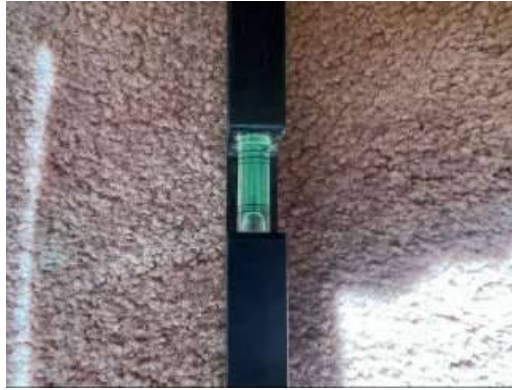
Floors in one or more areas were not level. This can be caused by foundation settlement or movement of the foundation, posts and/or beams. Significant repairs may be needed to make floors level. Recommend that a qualified contractor and/or engineer evaluate further. Repairs should be performed by a qualified contractor.

*bathom(s)

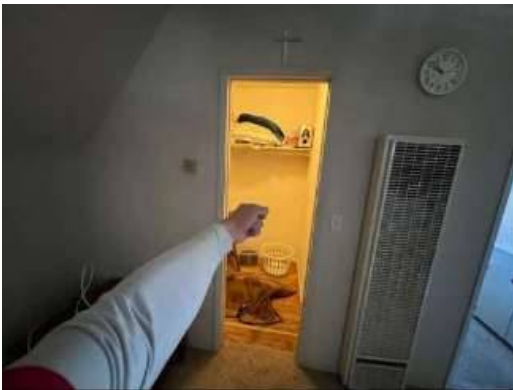
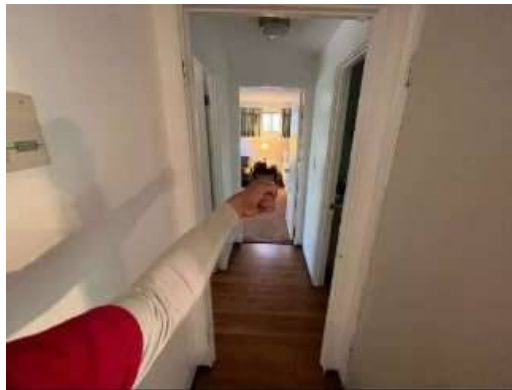
One or more interior doors were missing. Recommend that a qualified person replace or repair doors as necessary.

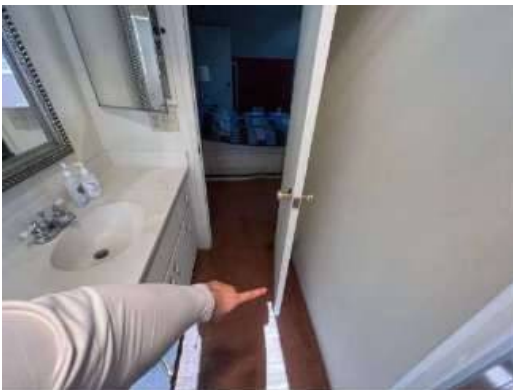
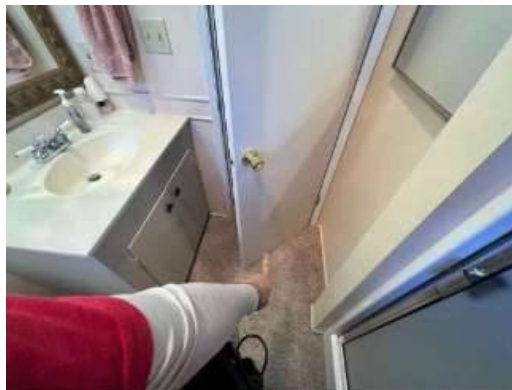
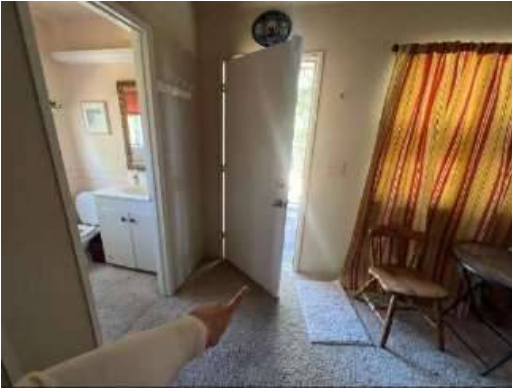
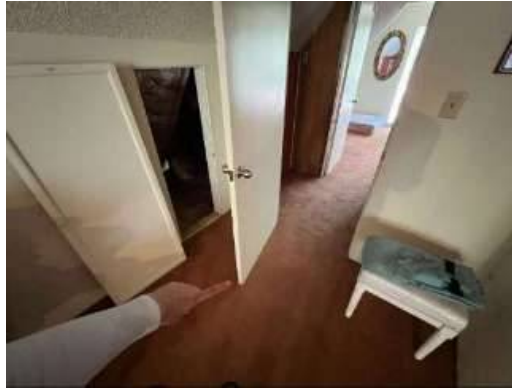
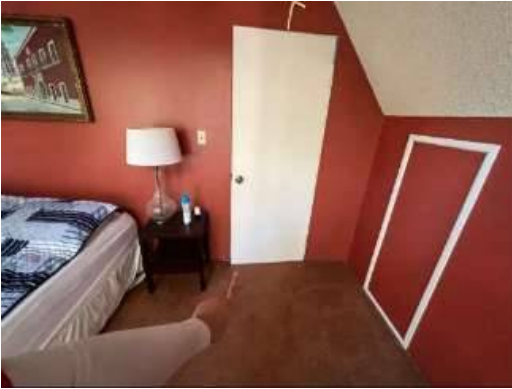
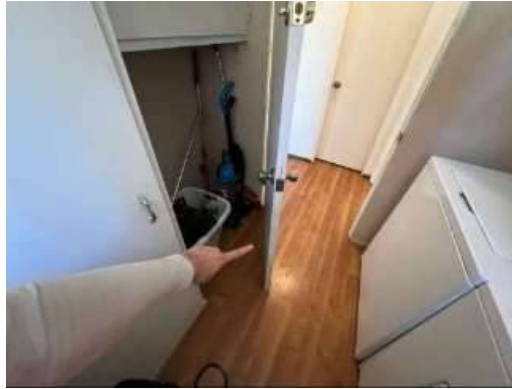
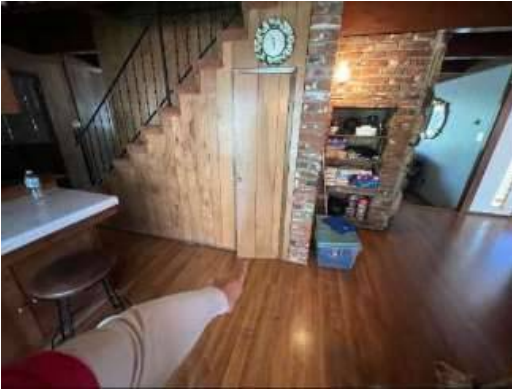
One or more doors dragged on the floor below and were difficult to open and close. Recommend that a qualified person repair as necessary. For example, by trimming bottoms of doors.

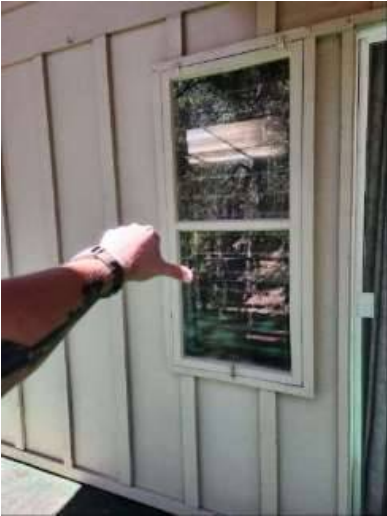
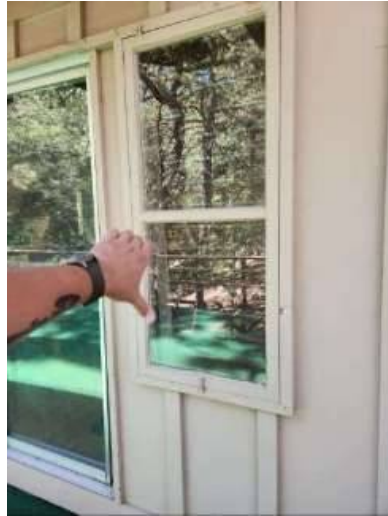
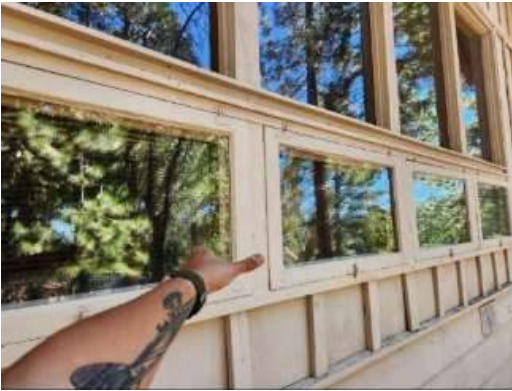
One or more windows that were designed to open and close were stuck shut and/or difficult to open and close. Recommend that a qualified person repair windows as necessary so they open and close easily.

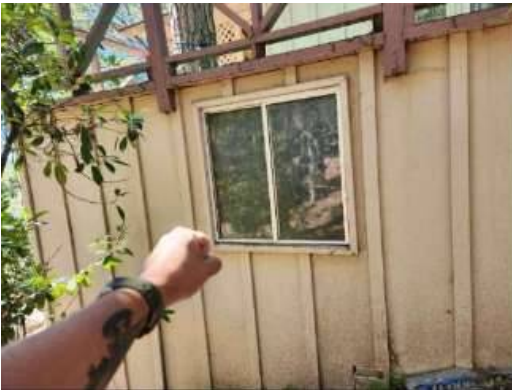
Photo 103-1

Screens were missing from one or more windows. These windows may not provide ventilation during months when insects are active.

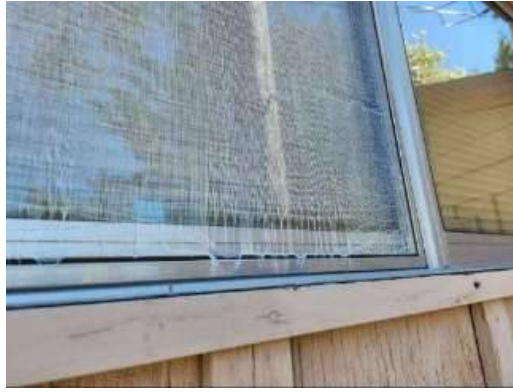
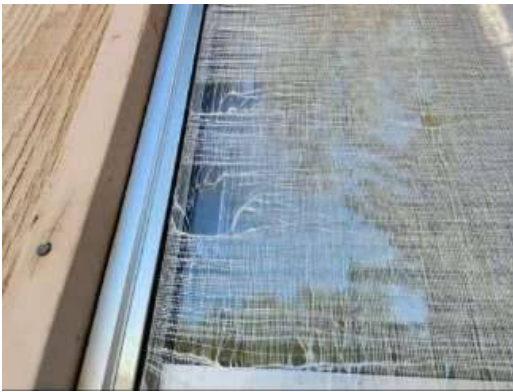
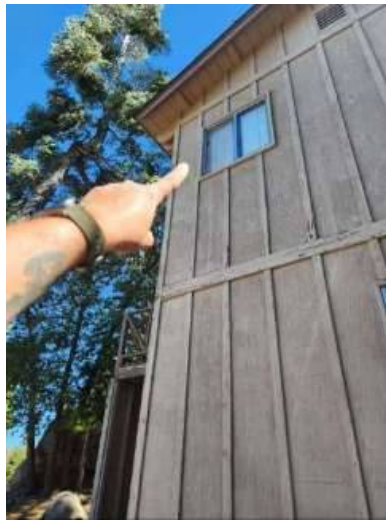
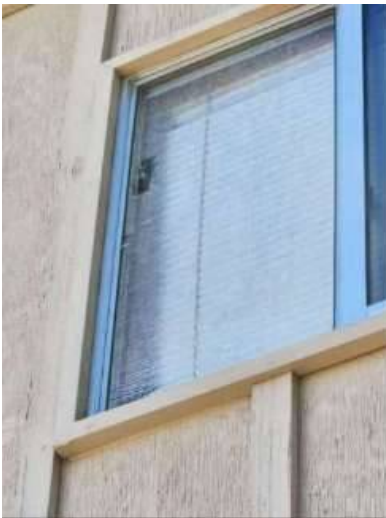
One or more window screens were damaged or deteriorated. These window(s) may not provide ventilation during months when insects are active. Recommend replacing window screens as necessary.

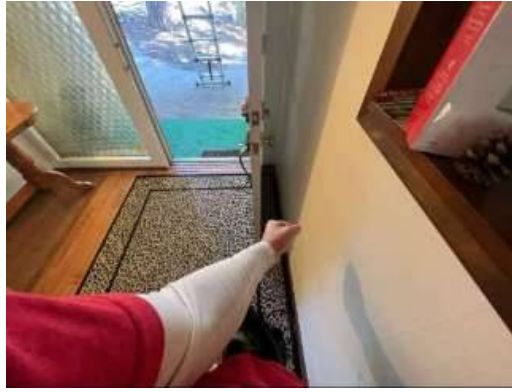
Photo 105-2

Fixtures such as door stops were missing in one or more areas. Recommend that a qualified person install missing fixtures per standard building practices.
