Property Inspection Report

Property address: **32311 Scandia Dr, Running Springs, CA 92382**

Inspection date: **Thursday, September 7, 2023**

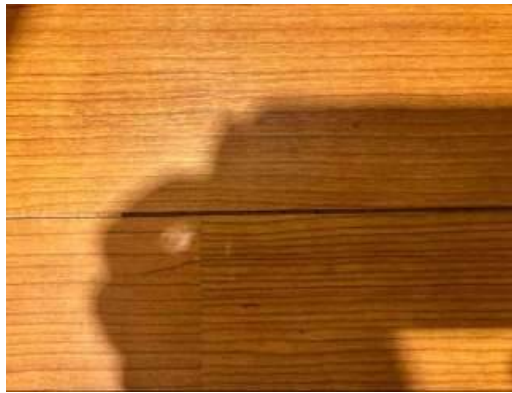
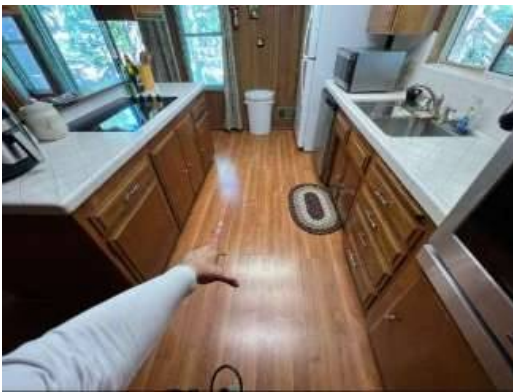
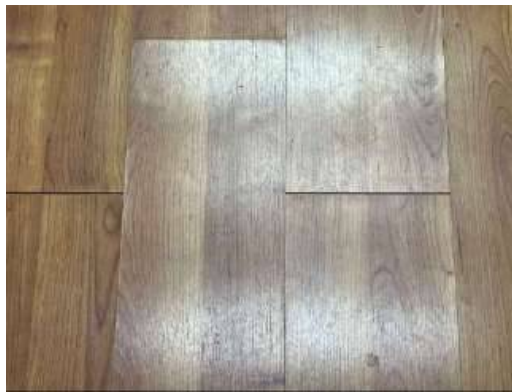
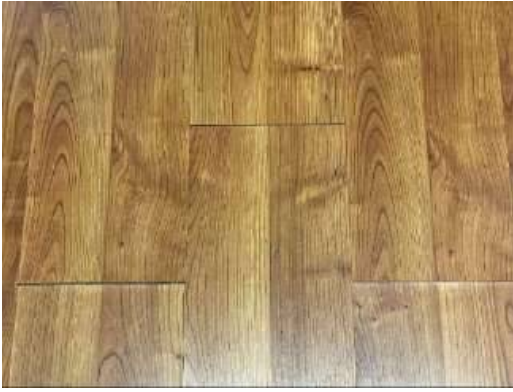
Vinyl, linoleum or marmoleum flooring in one or more areas was deteriorated and/or loose. If in a wet area, water can damage the sub-floor as a result. Recommend that a qualified contractor replace or repair flooring as necessary.

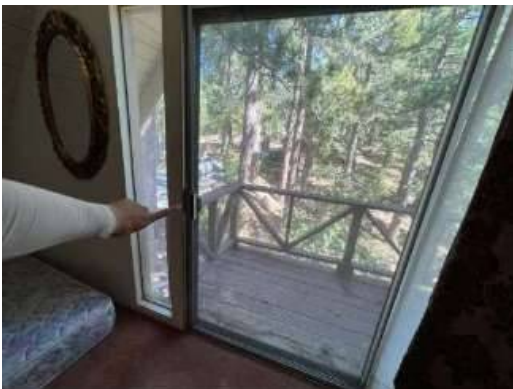
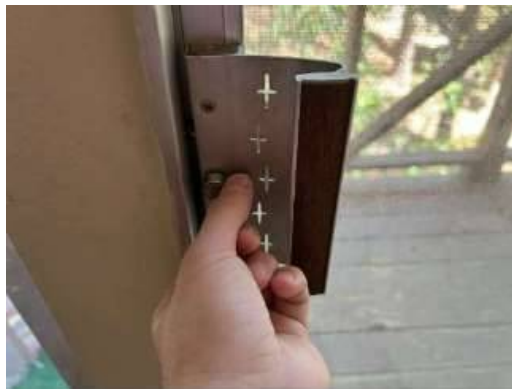
The lock mechanisms on one or more sliding glass doors were inoperable. Recommend that a qualified person repair as necessary.

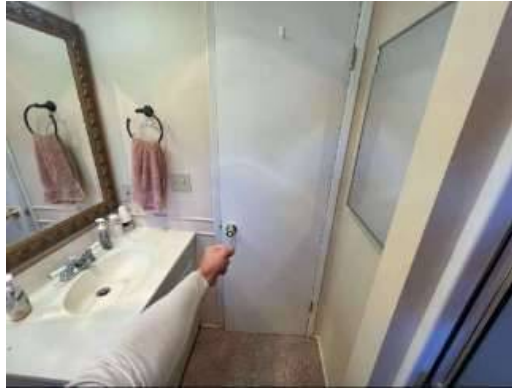
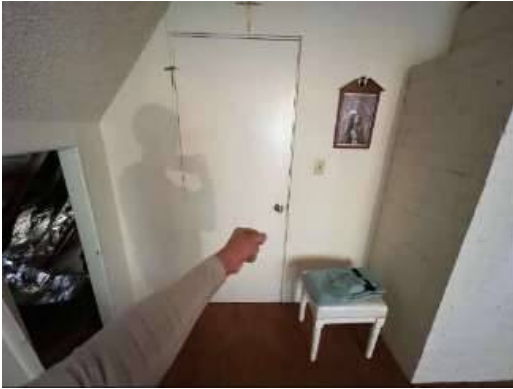
One or more interior doors wouldn't latch or were difficult to latch. Recommend that a qualified person repair as necessary. For example, by adjusting latch plates or locksets.

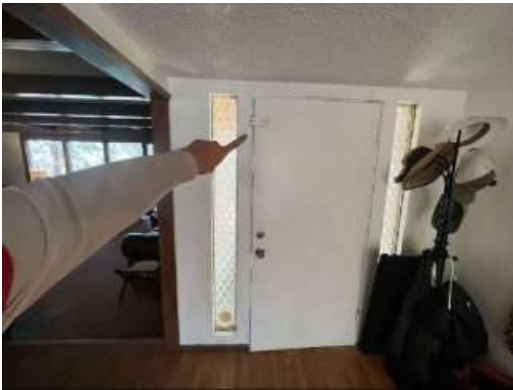
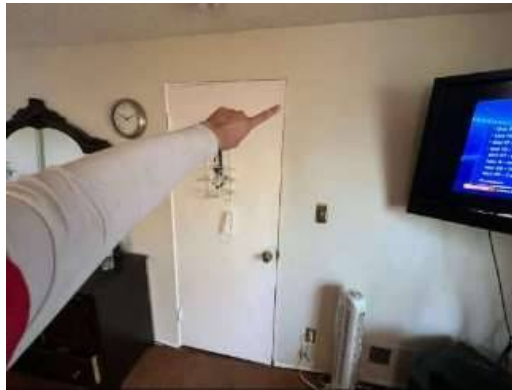
110) 🛠️ One or more interior doors were sticking in the door jamb and were difficult to operate. Recommend that a qualified person repair as necessary. For example, by trimming doors.

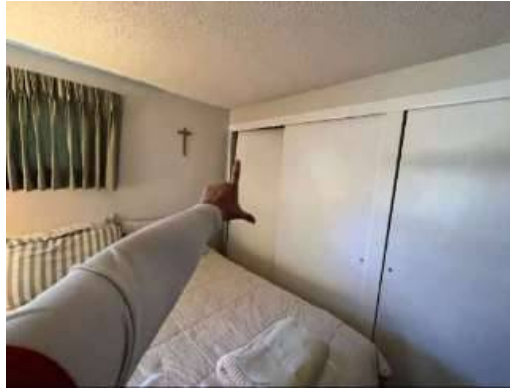
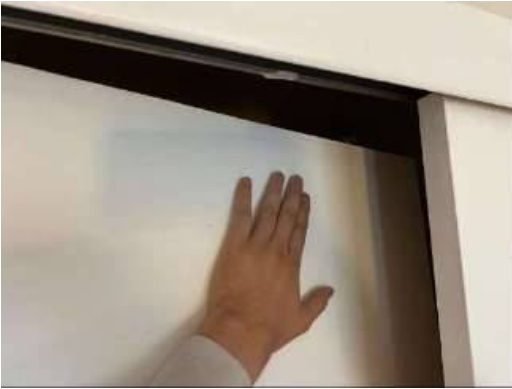
111) 🛠️ One or more sliding closet doors were off the track, stuck or difficult to slide. Recommend that a qualified person adjust or repair as necessary.

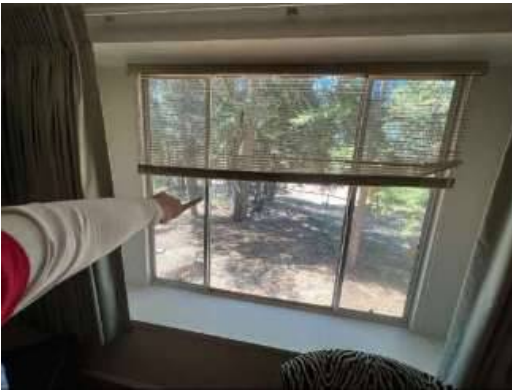
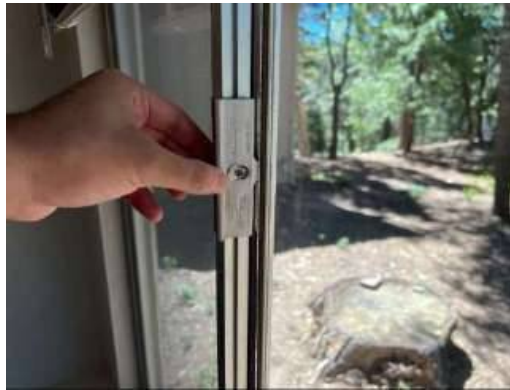
112) 🛠️ Lock mechanisms on one or more windows were inoperable. This can pose a security risk. Recommend that a qualified person repair as necessary.

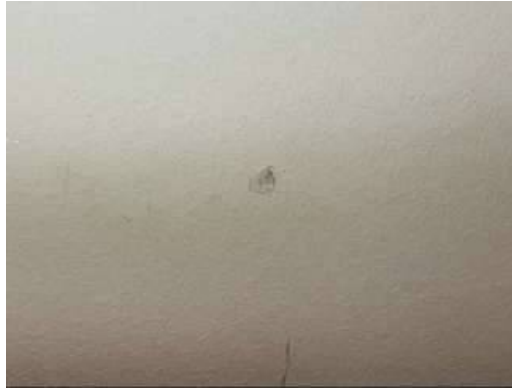
Photo 113-2

113) 🛠️ Minor cracks, nail pops and/or blemishes were found in walls and/or ceilings in one or more areas. Cracks and nail pops are common, are often caused by lumber shrinkage or minor settlement, and can be more or less noticeable depending on changes in humidity. They did not appear to be a structural concern, but the client may wish to repair these for aesthetic reasons. For recurring cracks, consider using an elastic crack covering product: <https://www.reporthost.com/?ECC>

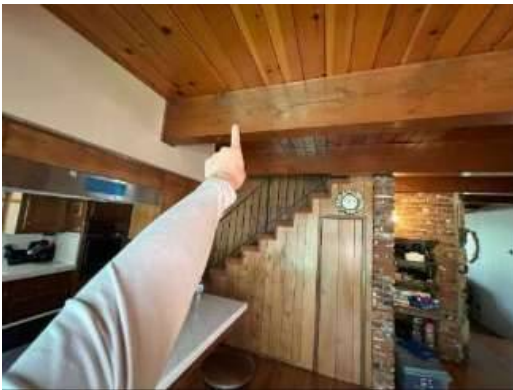
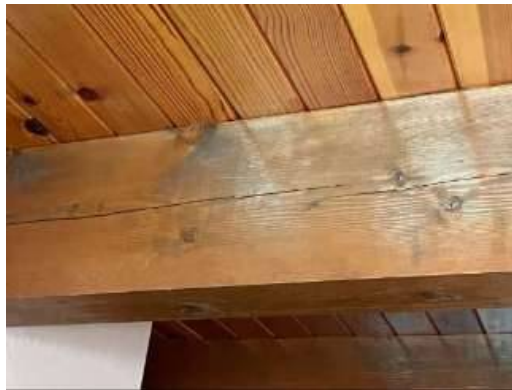
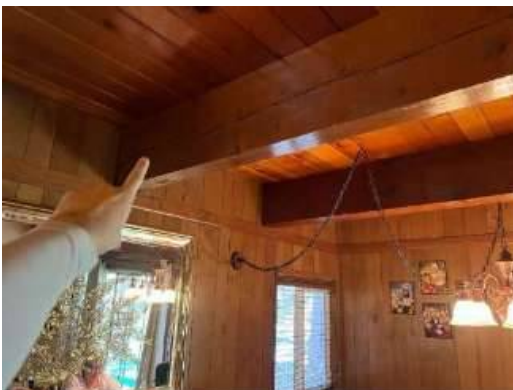
Checking was found on one or more wooden beams on the ceilings. As the moisture from solid wood posts and beams dries out and the wood cures, shrinkage produces not only checking (large cracks that are normal and are typically not a concern) but also an actual reduction in beam or posts dimensions.

While extreme loading or improper notching/boring can cause a wood post (more rarely) or beam to split, usually the splits or cracks found in wooden posts and beams are due to shrinkage as wood dries, occur along the grain, and do not raise a structural concern.

Checks are only a cosmetic concern unless they are taking in water and therefore risking leaks into the building interior or causing rot or inviting insect damage, especially where the checks lead water to a poorly-sealed window or door frame.

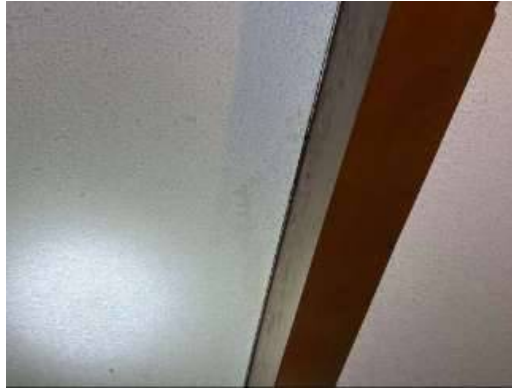
Photo 115-2

Stains were found in on or more walls or ceiling areas. However, no elevated levels of moisture were found. The stain(s) may be due to past roof and/or plumbing leaks. Consult with the property owner and monitor the stained area(s) in the future, especially after heavy or prolonged rain. If elevated moisture is found in the future, then recommend that a qualified contractor evaluate and repair as necessary.

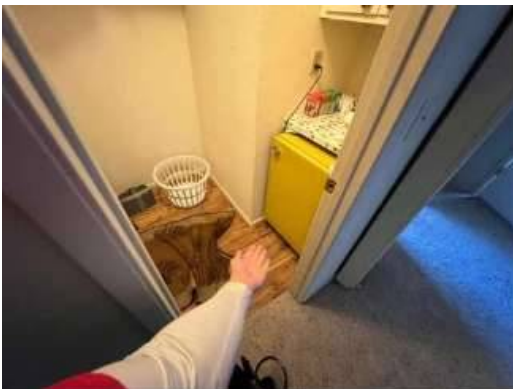
Photo 116-1

What appeared to be moisture stains were found in one or more floors. However the level of moisture were low. Consult with the property owner and monitor the area(s) in the future. If elevated moisture is found in the future, then recommend that a qualified contractor evaluate and repair as necessary.

*guest quarters
