# WOOD DESTROYING PESTS AND ORGANISMS INSPECTION REPORT

#: 20137599

| BUILDING NO<br>11456 | STREET<br>MCLAREN ST | CITY<br>NORWALK | ZIP<br>90650 | Date of Inspection<br>07/31/2025 | NUMBER OF PAGES<br>1 of 5 |

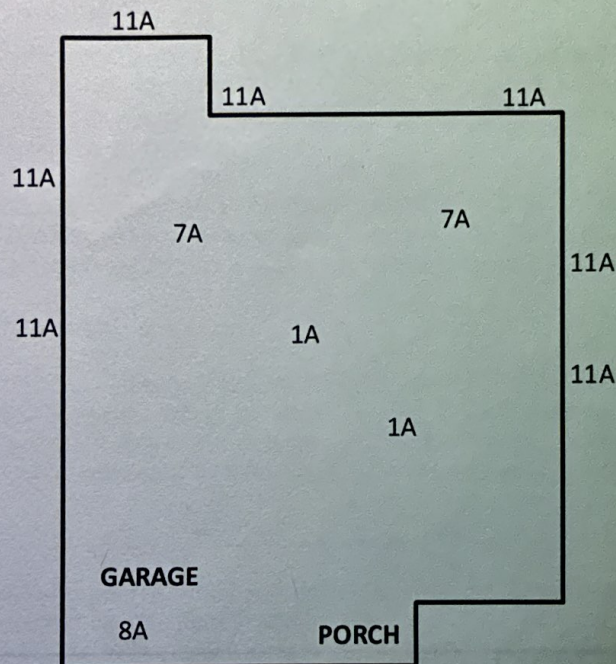
**NOTE: If diagram is not displayed here, please see the report.**

Evidence of DRYWOOD TERMITES as indicated by 11A on the diagram.  
Evidence noted in or near: EXTERIOR.

RECOMMENDATION: 11A

Fumigate (tent) the structure with vikane lethal to DRYWOOD TERMITES. Remove or cover drywood termite fecal pellets in accessible areas. See the occupants fumigation notice for further details. This company is not responsible for delays or schedule changes due to inclement weather or other agencies, nor is it responsible for damage to roof or plants as a result of the fumigation. Refer to the occupant's fumigation notice/preparation sheet (sent separately) for additional information. The fumigation has a warranty of two (2) years.
