# INSPECTION REPORT

For the Property at:  
**10675 PARAMOUNT ROAD**  
PHELAN, CA 92371

Prepared for: LILLIAN TIFFANY  
Inspection Date: Monday, June 23, 2025  
Prepared by: Scott Junk

RE: Report No. 7813  
10675 Paramount Road  
Phelan, CA  
92371

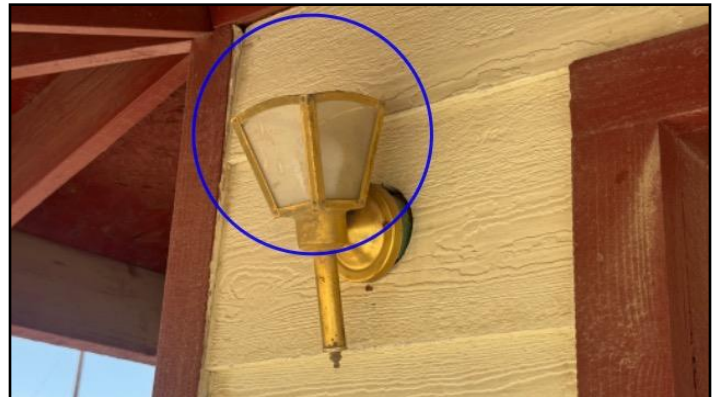
67.

## 11. Condition: • Missing Covers

Recommend installing fixture covers, to prevent disruption of the electrical system, in the event that a bulb would get broken. Light fixture cover are designed to improve the safety of the light fixture and the electrical system around the property.

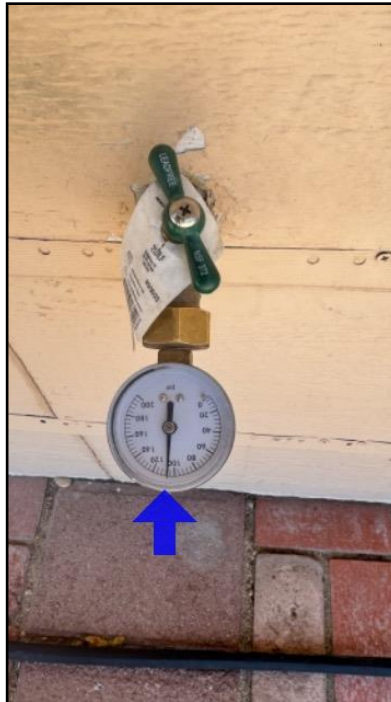
93.

**16. Condition:** • Recommended due to high supply water presssure

Recommended Water pressure is 60 psi to 80 psi. The pressure on the faucet is over 110 psi. Recommend service to lower the water pressure to prevent interior damage to the plumbing system, and further evaluation to determine the cause of the high pressure..

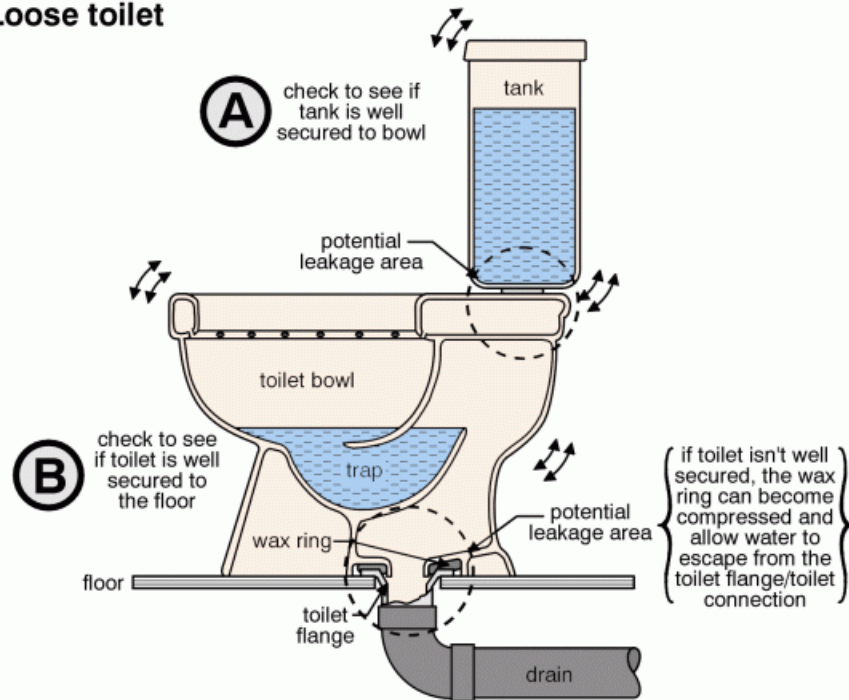
95.

**18. Condition:** • Loose

## Loose toilet

Recommend tightening and sealing the bottom of the loose toilet to prevent water damage or damage to the basin and to prevent sewage from entering the property.

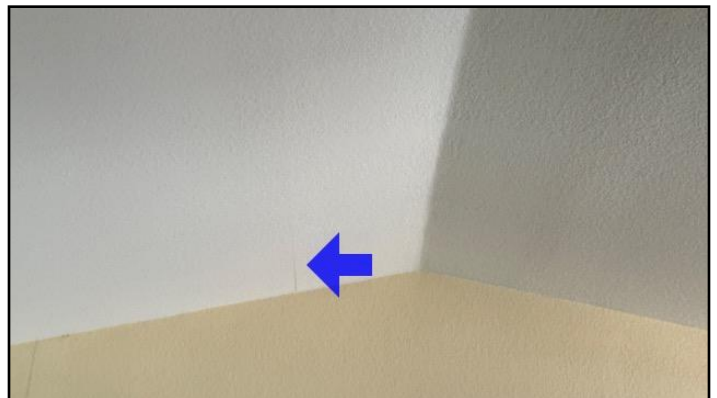
97.

**19. Condition:** • Minor Cracks

Recommend repairing and sealing the cracks in the ceiling to restore the integrity of the interior structure and to prevent further weakening of the ceiling. Cracks and blemishes left unattended will continue to deteriorate over time causing further damage.

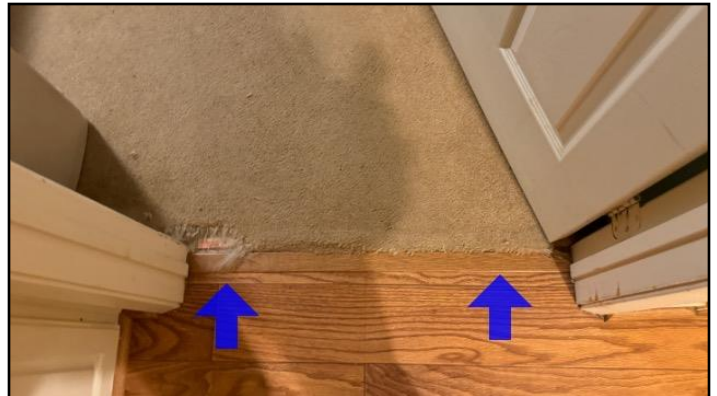
102.

### **23. Condition:** • Damaged carpeting

Recommend replacing the damaged carpeting to restore the integrity of the flooring system and prevent further damage of the flooring system in this area of the home.
