Aldis Enterprises

Property Inspection Report

15 Dream Lane, Cohasset, CA 95973
Inspection prepared for: Chad Rothe
Date of Inspection: 1/6/2022 Time: 9AM
Age of Home: 1980(?) Size: 1,400 sqft
Weather: Cool

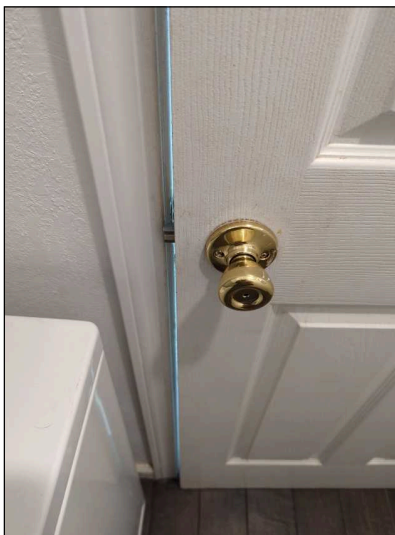
- General maintenance/repairs needed.
- Damaged door jamb noted at left side bedroom.

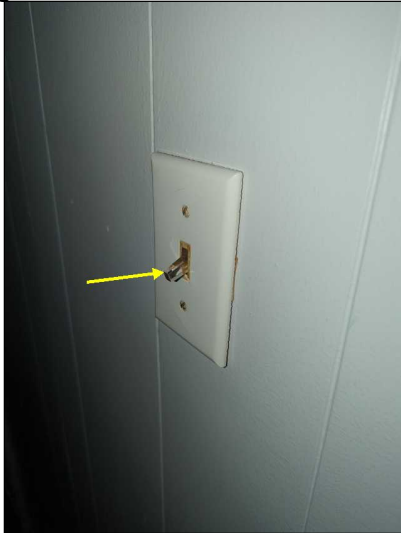
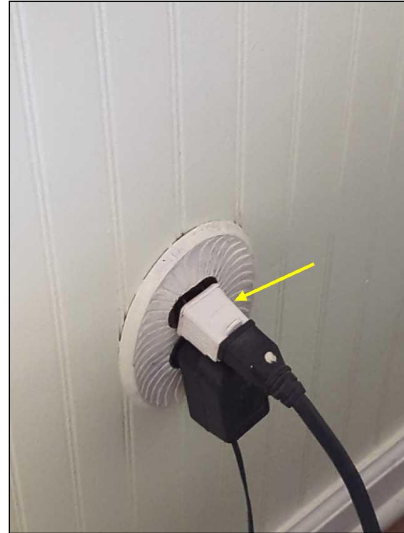
5. Electrical

- Accessible interior electrical tested good at inspection.
- Loose switch noted at left side bedroom.
- A couple old 2-wire outlets observed, indicating no equipment ground.
- Current safety standards call for bedroom and living area electrical circuits to be **AFCI** protected. Though not required for this home at the time of construction, it is worth considering this safety upgrade to the home electrical system, and may be required at such time of any major remodeling/addition work on the home involving these electrical circuits.

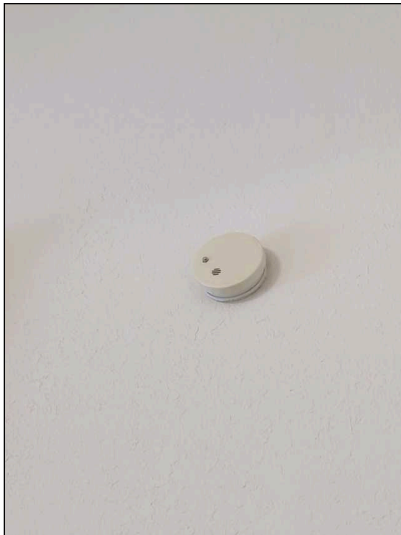
6. Smoke/CO Detectors

- Testing of all smoke and carbon monoxide alarms should be done at final walk-through to ensure all are functional prior to moving in. Alarms should then be tested monthly and replaced every 10 years or as needed.
- **Detached/damaged alarm noted at left side bedroom, needs to be replaced.**
- **Recommend adding carbon monoxide alarm at master bedroom near the door, and at hallway outside the left side bedroom.**

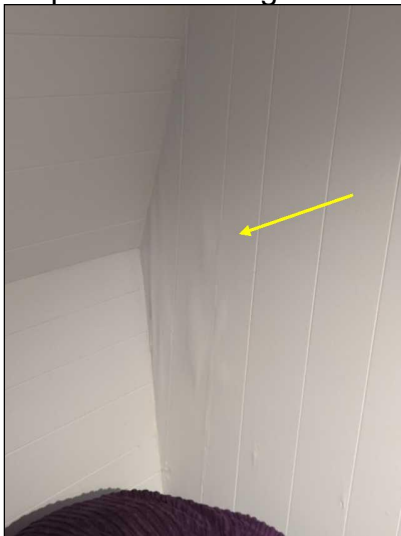
8. Wall Condition

- Appeared satisfactory, minor imperfections only.
- Evidence of possible leaking observed at left side bedroom.

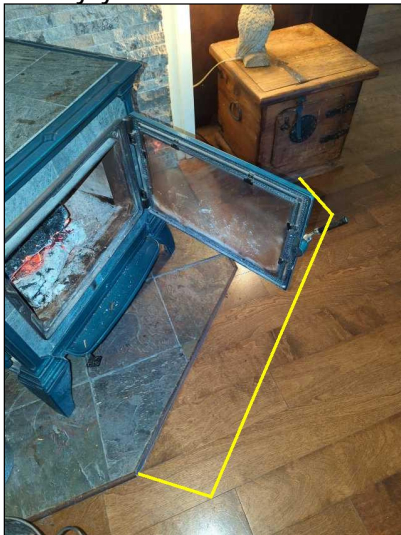
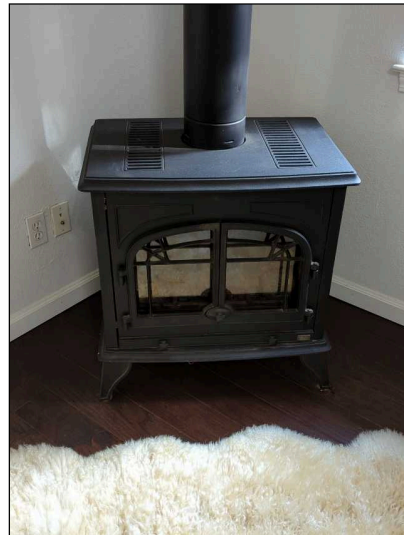
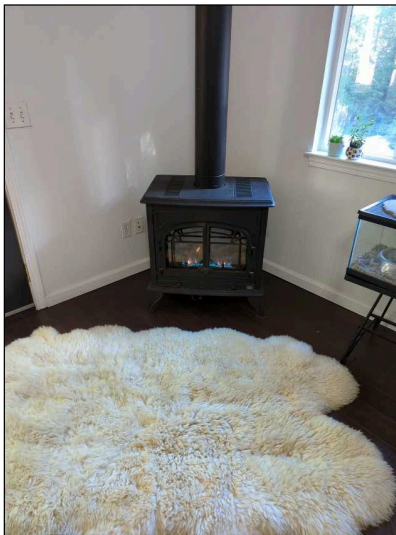
9. Fireplace/Stove Condition

- Appeared to be in serviceable condition.
- Stoves seemed to operate normally when tested.
- Doors at wood stove extend past the current hearth, should not extend over any potentially combustible materials, needs to be improved.
- Fireplaces/wood stoves, flues and chimneys should always be professionally inspected and serviced as needed by a licensed specialist/chimney sweep, and certified for safety prior to use, and then again every year thereafter for safety.

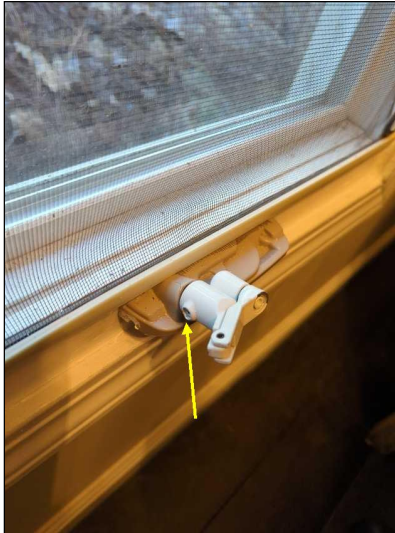
10. Window Condition

- Appeared satisfactory for age and wear.
- All accessible windows were functional at inspection.
- The crank at the casement window was loose, but still functional.

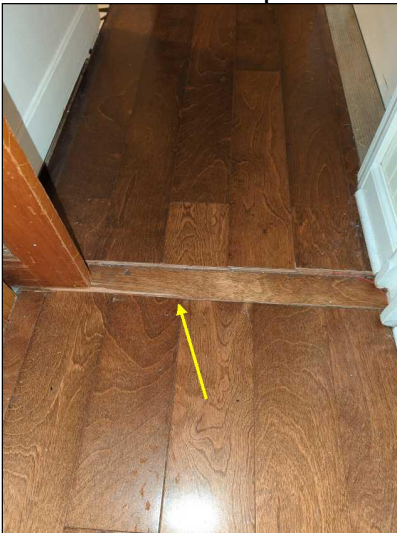
11. Floor Condition

- Appeared satisfactory for age and wear, some minor imperfections noted.
- Floors were sloped in areas, not level. This is not an uncommon condition for older/modified homes, and determining cause and cure of this condition is beyond the scope of a general home inspection. Consider having this condition further evaluated by a qualified licensed contractor. See also Foundation section of report.

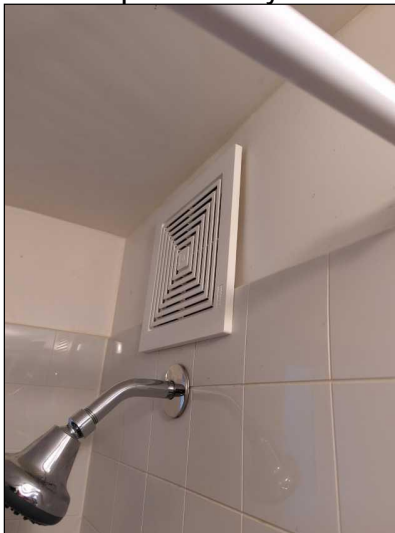
- Appeared satisfactory for age and wear.
- Functional at inspection, guest bath unit is not installed professionally.
- Bathroom exhaust fans should be cleaned periodically.

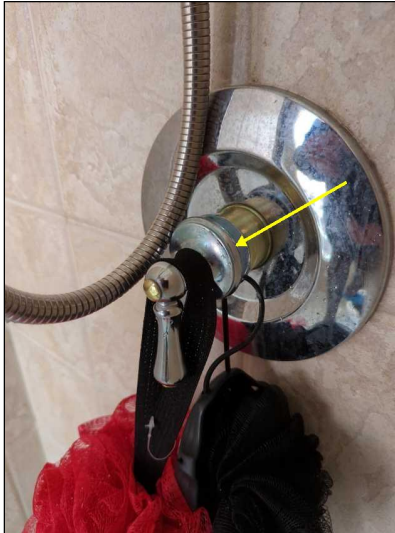
- Appeared satisfactory.
- Functional at inspection, but guest bath tub/shower seemed to have low water pressure, and master bath shower head leaked when tested.
- Control knob/handle was slightly loose at master bath.

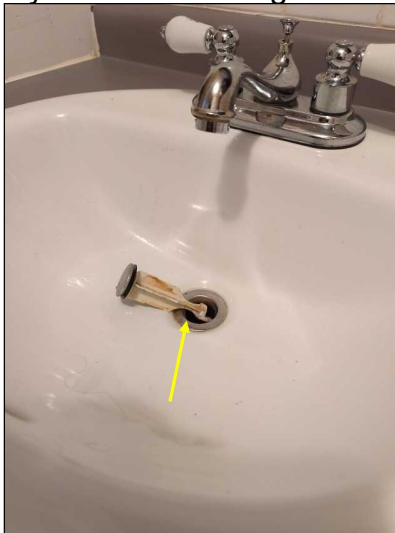
- Appeared satisfactory.
- Sinks and faucets were functional at inspection.
- Sink stopper did not operate normally when tested at guest bath, not connected.

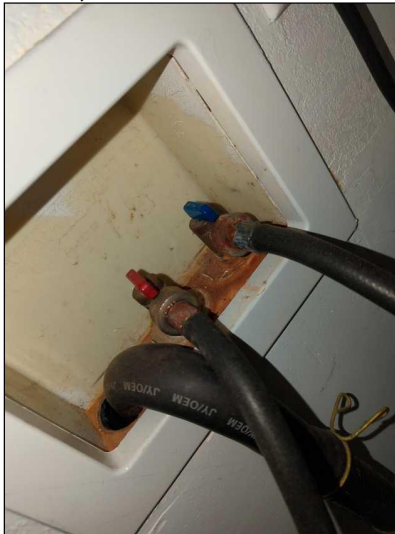
5. Plumbing

- No active leaking detected at inspection, but rust was observed. Consider updating.

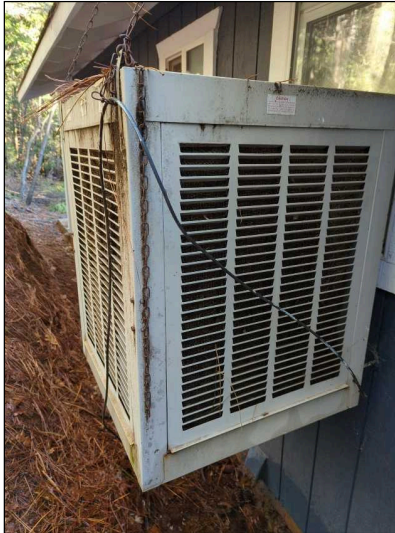
1. A/C Unit Condition

- Unit appears to be in need of general maintenance/cleaning, and may not be professionally installed.

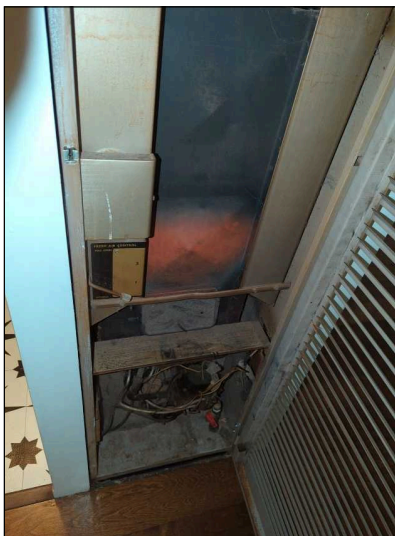
2. Heater Condition

- Heater was not tested due to condition at inspection, does not appear operational as is.
- Due to the age/condition of the heater, it is recommended to have the system further evaluated by a licensed HVAC contractor.

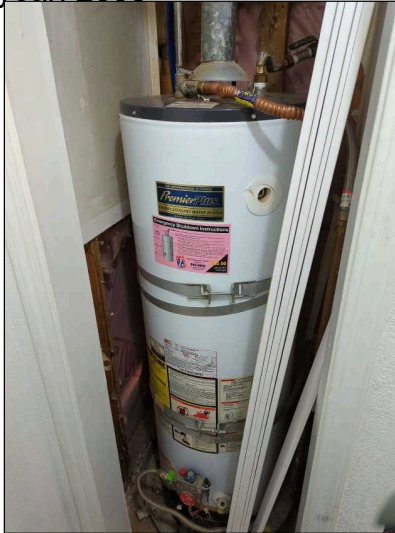
1. Water Heater Condition

- Appeared satisfactory for age and wear, functional at inspection.
- Water heaters should be flushed at least once a year, this unit is likely due to be flushed.
- Brand: Premier Plus Manufacture year: 2005

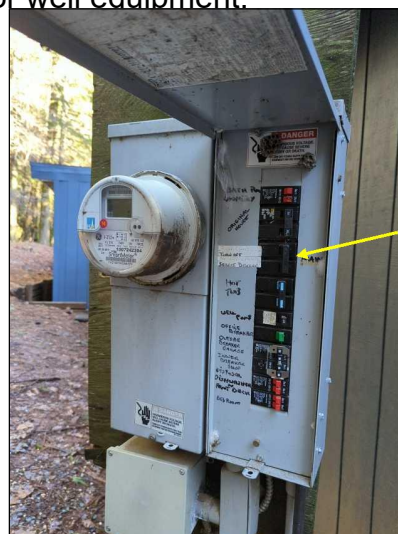
- Appeared satisfactory for age and wear.
- Some rusting observed at panel for well equipment.

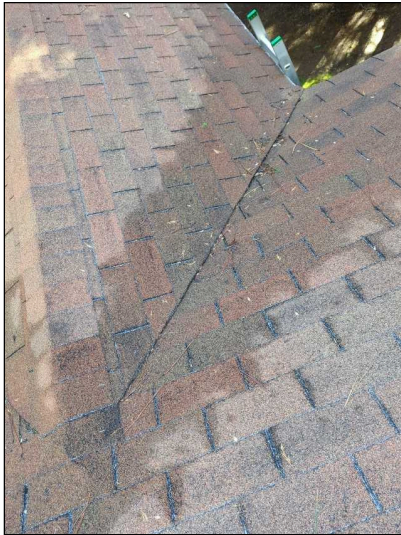
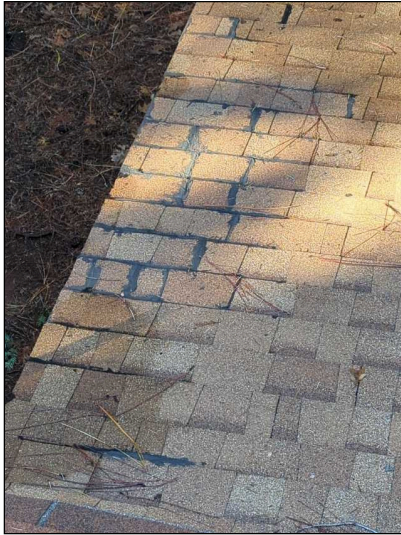
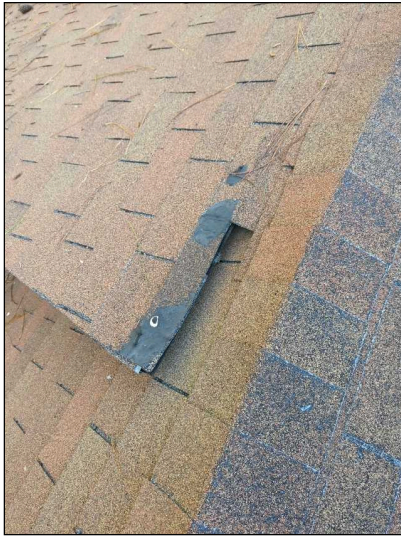
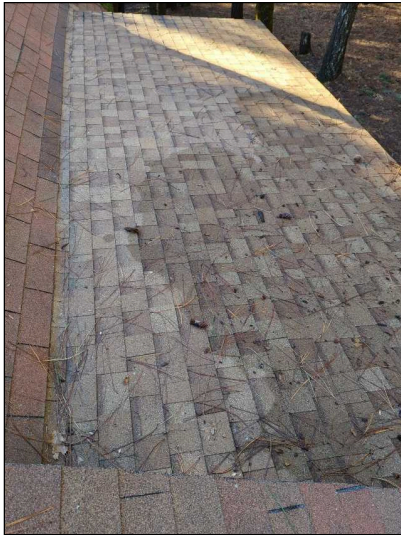
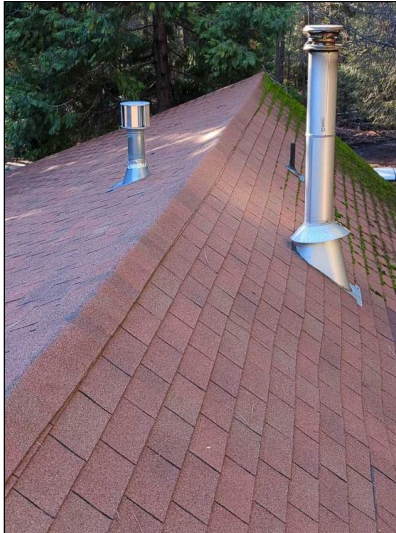
1. Roof Condition

- General maintenance needed.
- Heavy organic growth observed on roofing materials in areas.
- The rear flat roof section should be rolled, build-up roofing, or otherwise appropriate roofing other than asphalt shingles, which are designed for pitched roofs only.
- Worn/damaged shingles observed.
- Evidence of past repairs observed. Consult seller.
- Consult seller for exact age of roof in known.
- **Based on the age/overall condition of the roof, it is recommended having the roof fully evaluated with corrections as needed by a licensed roofing contractor, and having the remaining useful life determined, which may be limited.**

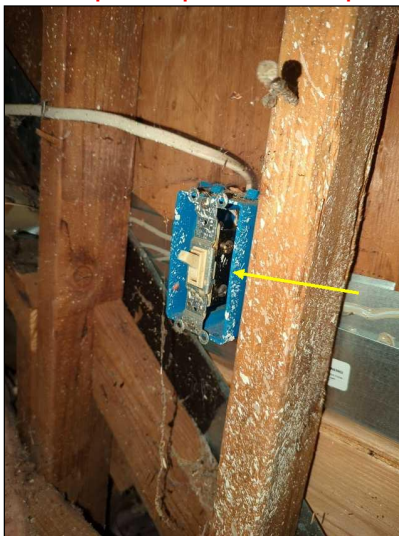
- Attic service light did not operate when tested.
- Recommend further evaluation and corrections as needed by a licensed electrician.
- **Open junction box observed at right side of home attic space, and the attic light switch was missing to cover plate, potential exposed electrical hazard.**

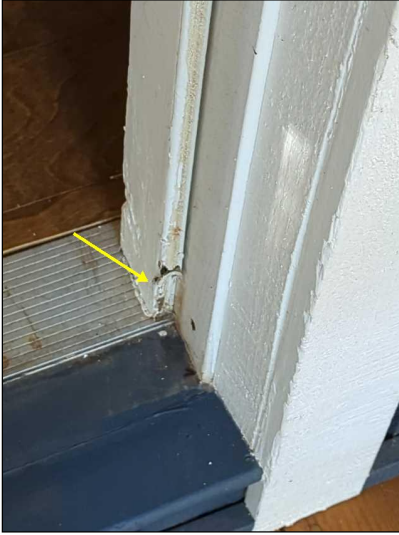
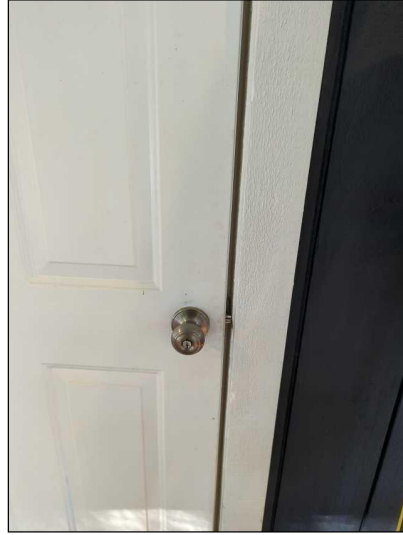
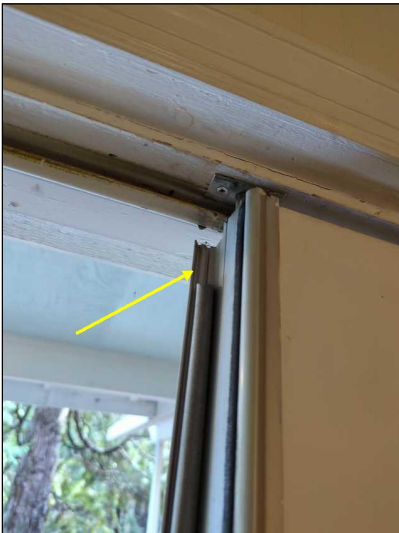
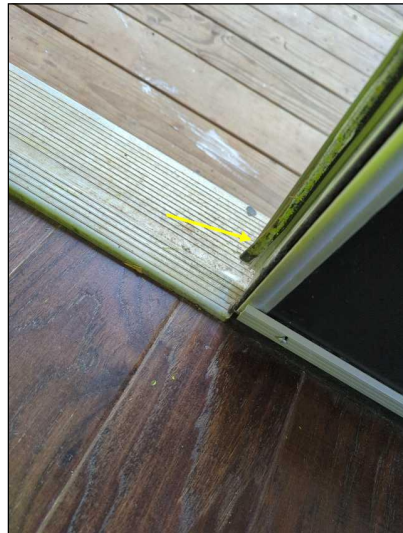
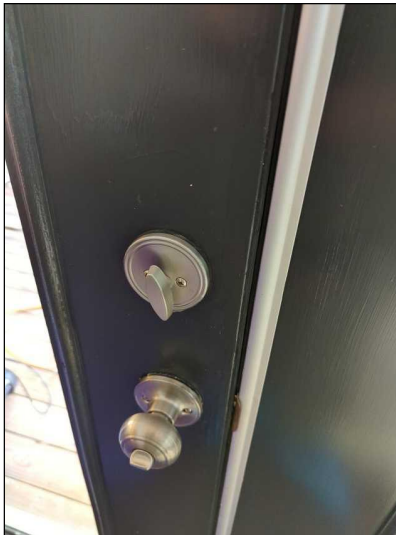
- Appeared satisfactory for age and wear.
- Exterior doors were functional at inspection.
- Weatherization should be improved at exterior doors as needed.
- Damaged door and jamb noted at shop/garage, may need to be replaced.
- Recommend adding dead bolt locks where missing for added security.

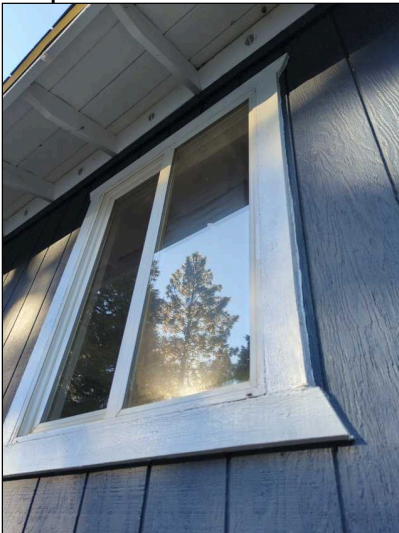
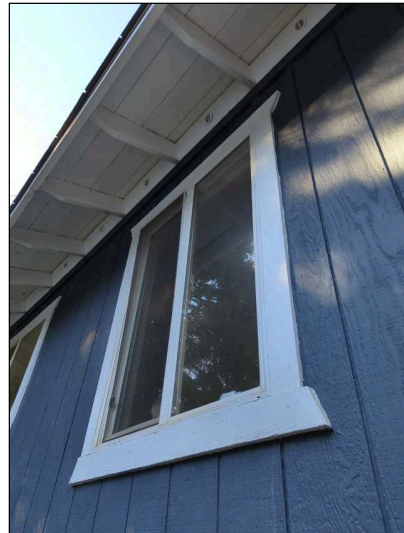
2. Window Condition

- Appeared satisfactory for age and wear.
- Stained/fogged glass observed at front of home, this condition typically means that the insulation seal has failed at the glass, reducing r-value. This condition will only become worse over time if the glass is not replaced.

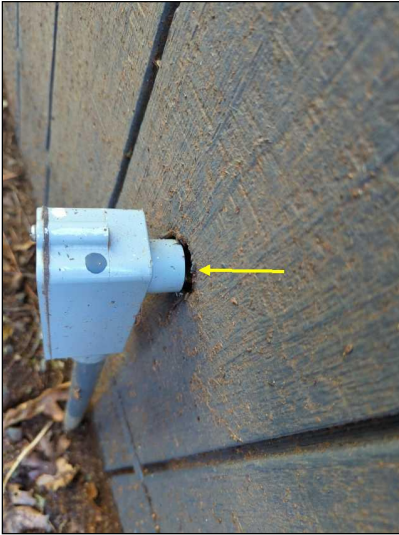
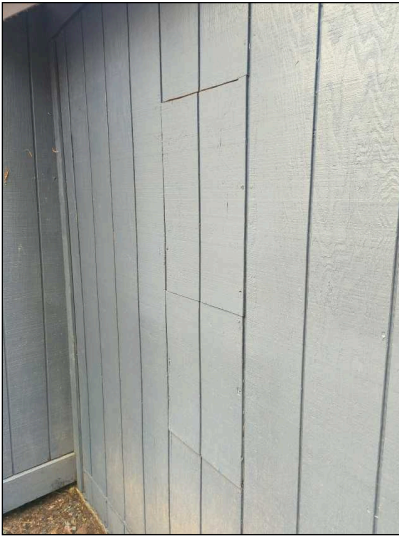
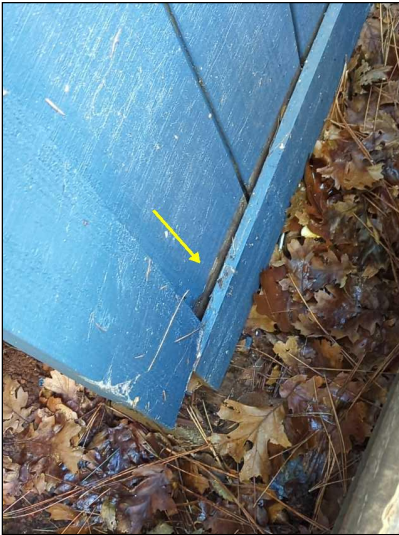
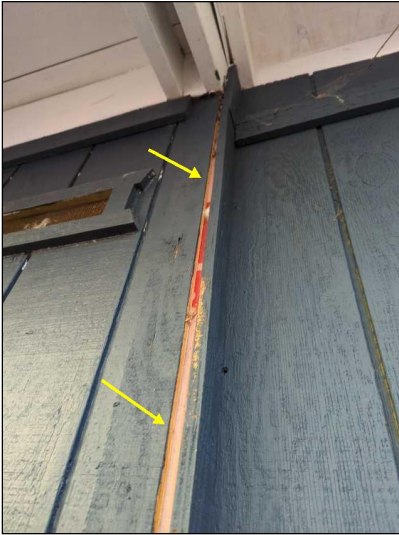
3. Siding Condition

- Appeared satisfactory for age and wear.
- Evidence of past repairs noted. Consult seller for more information.
- All gaps/cracks/openings at siding should be sealed to prevent moisture/pest intrusion.
- Recommend further evaluation of siding/trim and corrections as needed by a licensed contractor/pest control.
- **Moisture damage observed in a few areas.**

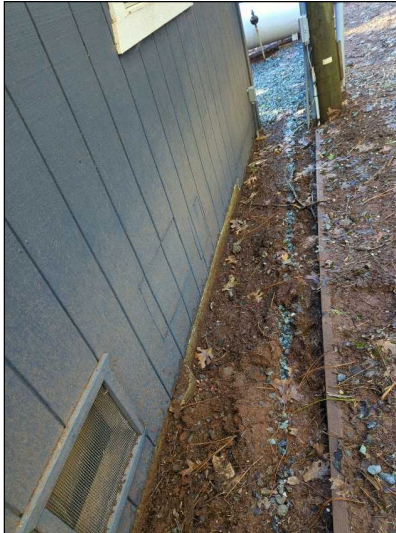
- Appeared satisfactory.
- Staining observed from mud splashback.

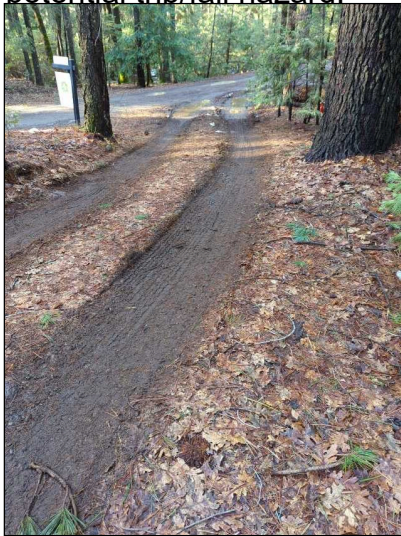
1. Driveway/Walkway Condition

- Appeared satisfactory for age and wear.
- Recommend adding rock/gravel at driveway as needed.
- A section of the front walkway is lifting at the joint, should be monitored and improved as needed to prevent potential trip/fall hazard.

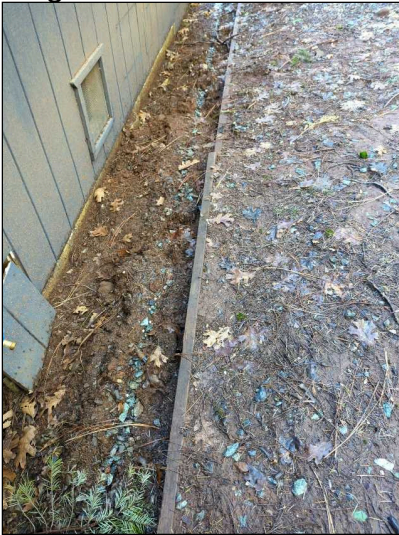
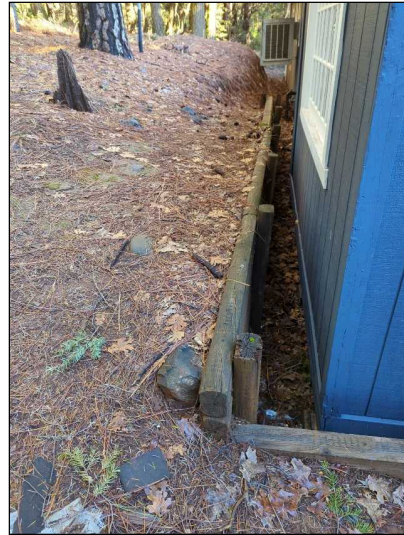
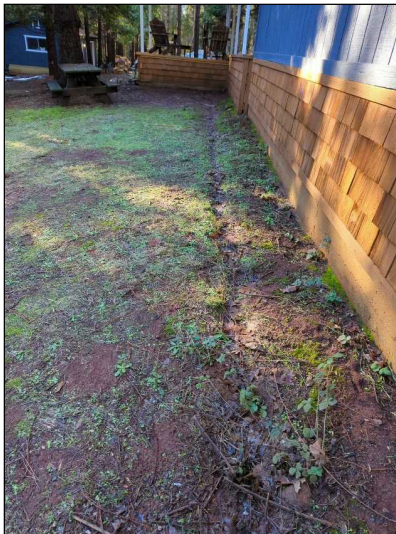
2. Grading/Drainage

- Negative grade observed at rear of home.
- Recommend adding landscape rock/gravel at bare soil around home perimeter as needed to help control drainage and erosion.

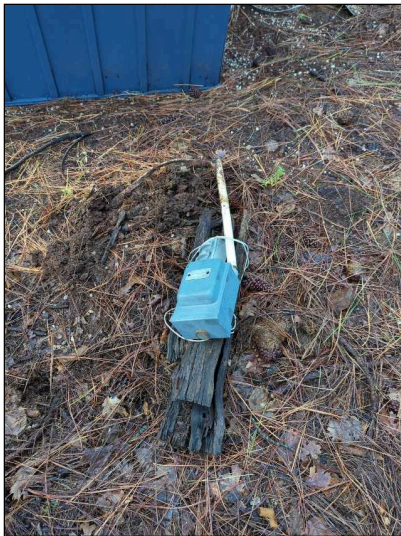
- Outlet at front porch area tested for no power. Had power in, but no power out.
- Some abandoned electrical observed by small storage shed. Consult seller.
- Recommend further evaluation of grounds and shop/garage electrical with corrections as needed by a licensed electrical contractor.
- **Improper/unprofessional wiring practices observed at well equipment area, missing outlet cover plate noted at shop/garage structure.**

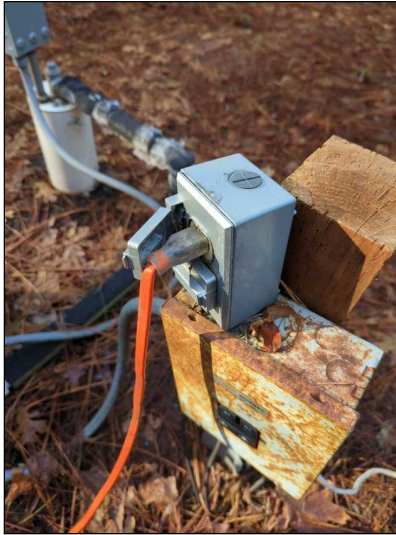
5. GFCI Protection

- **No GFCI protection detected at grounds or shop/garage structure. Recommend adding GFCI protection as needed for safety, work should be done by a licensed electrical contractor.**

Not GFCI protected.

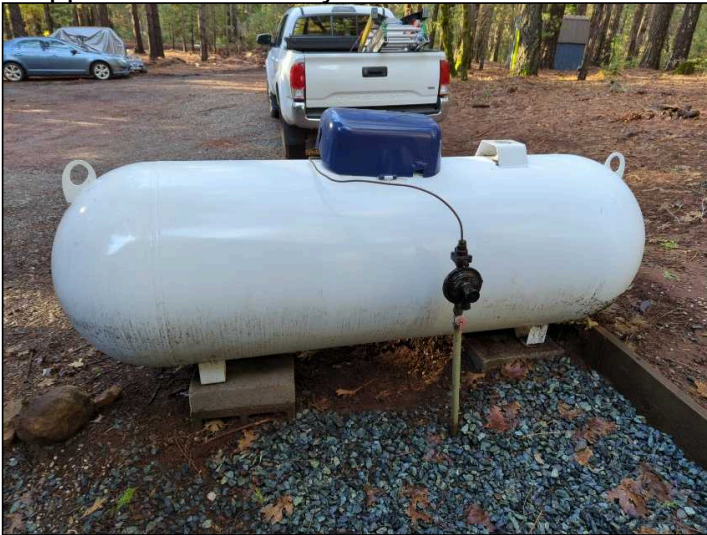
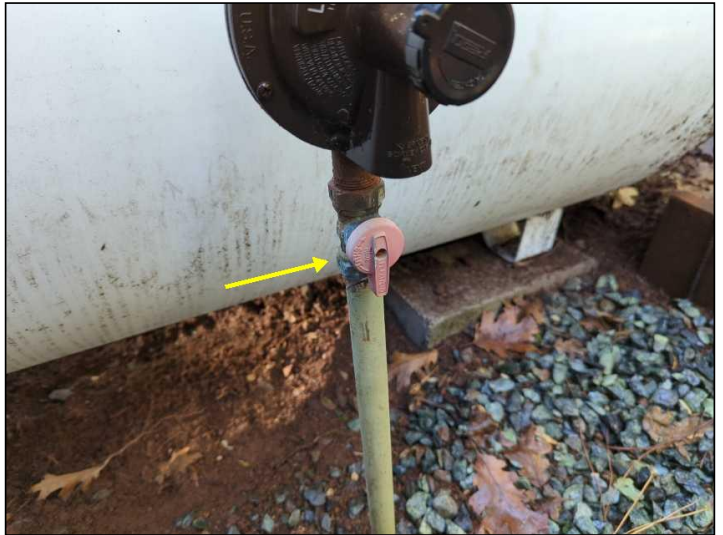
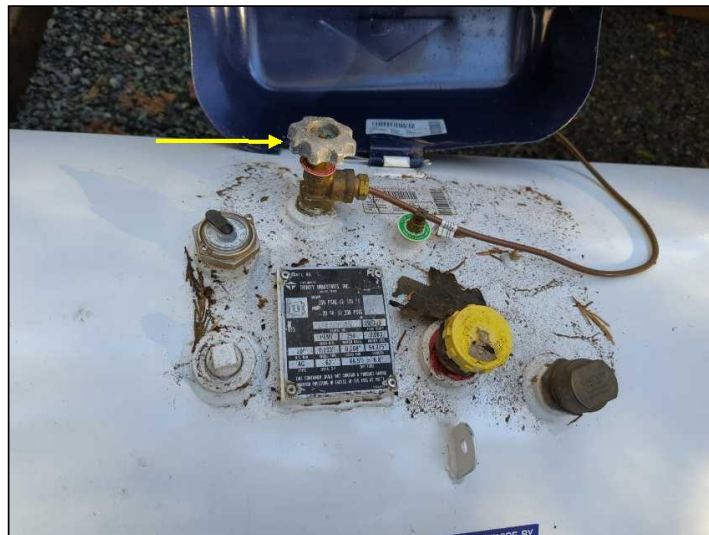
6. Main Gas Valve Condition

- Appeared satisfactory.

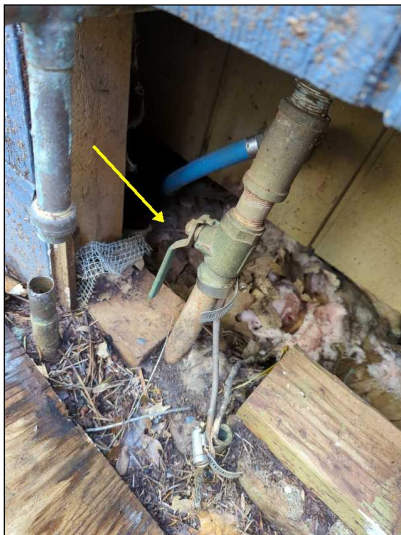
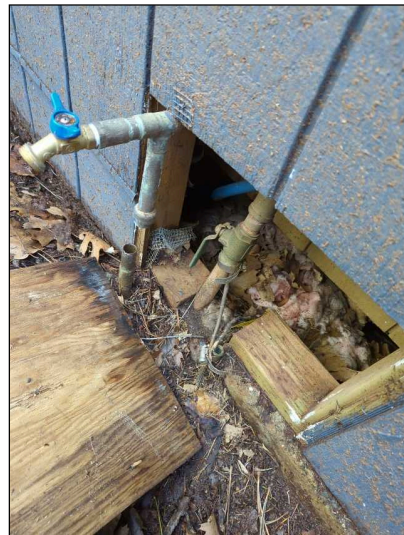
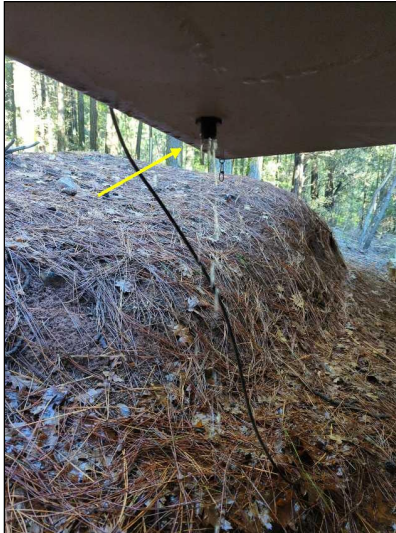
7. Plumbing Condition

- Appeared satisfactory for age and wear, no active leaking observed.
- Water main supply shut off located at rear of home.
- **Active leaking observed at the swamp cooler.**

Float may be stuck at swamp cooler.
