Inspection Report

Address: 354 S Court St Baywood-Los Osos, CA 93402

05/27/2024

Inspector: Taylor Vreeken, CCI

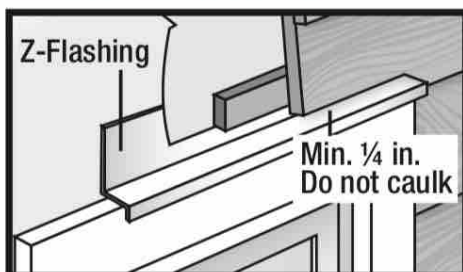
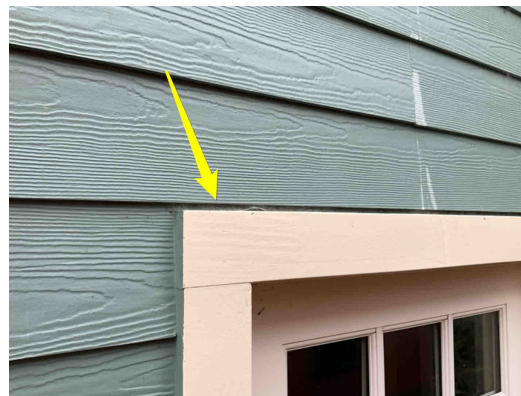
MR DS 26: Disclosure: No visible water shed / "Z" bar flashing at areas of the exterior siding at the horizontal transitions such as over doors and windows: SOUTHWEST SIDE ONLY

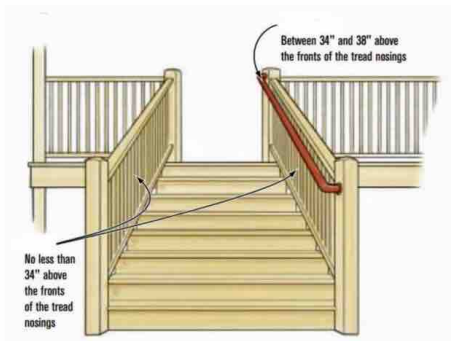
SC 35: Uneven step tread rise noted at the exterior stairway off the BACKYARD PATIO. Potential trip/fall hazard.

SU 36: Recommend a proper graspable handrail at the exterior stairway OFF THE BACKYARD PATIO for safety.

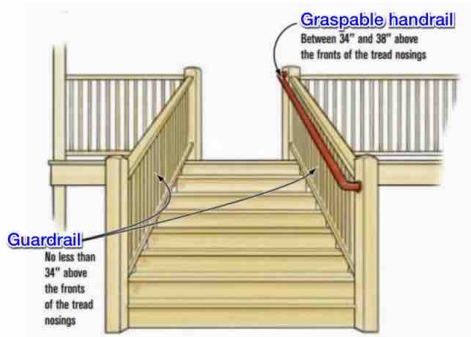
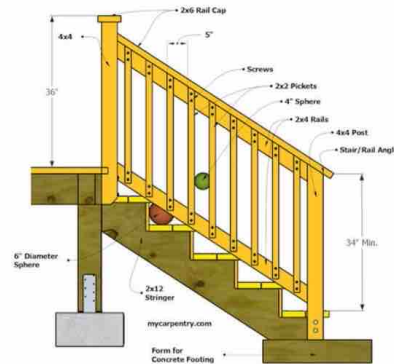
SC 37: Missing the proper and required guardrails and graspable handrail at the exterior stairway: OFF THE ENTRY PATIO. A Guardrail and graspable handrail is required on all exterior stairs where the potential fall from the stairway it's greater than 30 inches.

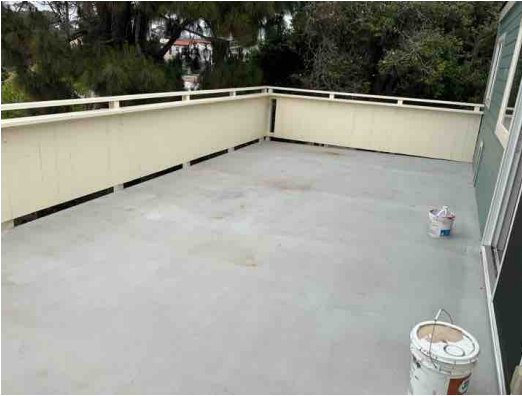
38: DECK LOCATION: UPSTAIRS DECK OFF THE LIVING ROOM

E&C 39: Areas of minor deterioration found at the waterproof deck coating at the UPSTAIRS DECK OFF THE LIVING ROOM. Maintenance or repairs needed. Recommend further review and/or repairs by a certified or licensed waterproof deck coating professional familiar with minimum requirements.

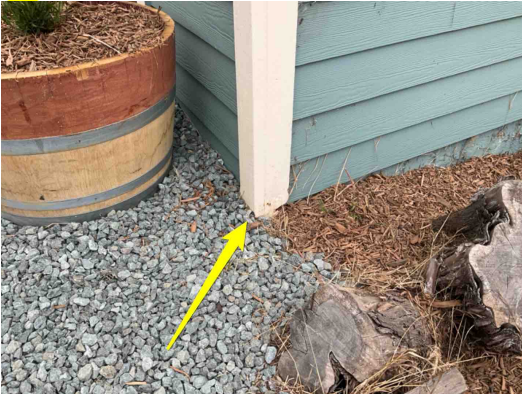
MR 42: Earth-to-wood contact noted at areas of the exterior siding or trim. Proper landscape grading warranted.

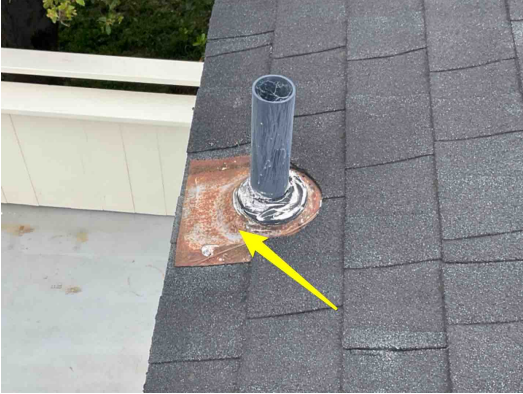
E&C MR 51: Some roof flashings found rusted and deteriorated. Maintenance recommended.

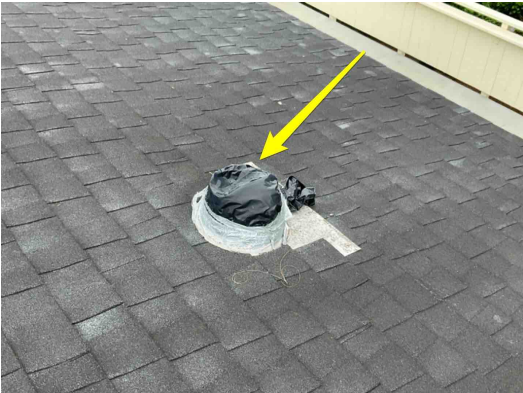
E&C s-52: Improper repair of the former kitchen cooktop exhaust termination on the roof. Recommend further evaluation and Installation of a screened "T" cap per minimum codes and standards.

E&C 52: Improper repair of the former kitchen cooktop exhaust termination on the roof. Recommend further evaluation and Installation of a screened "T" cap per minimum codes and standards.

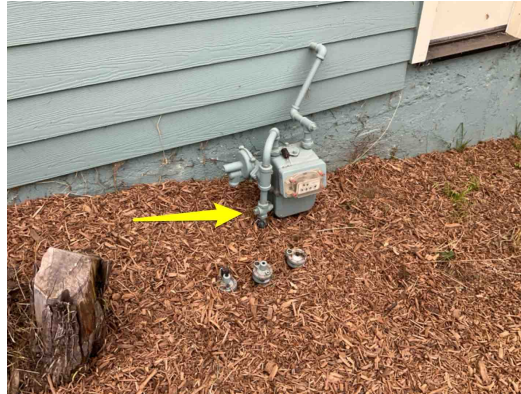
MR 80: Gas meter and/or shutoff valve in contact with ground or soil. Deterioration may occur. Maintenance, upgrades recommended.

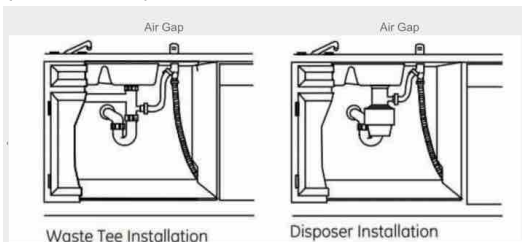
E&C 101: Improper installation of the dishwasher drain hose. Missing the Air Gap Device at the dishwasher drain per minimum codes and standards (California does not allow for high-loop methods or direct waste connections). {CPC 801.2}

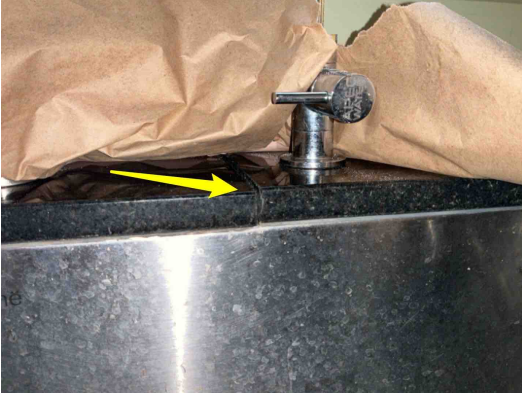
MR 106: Disclosure: Some separations noted at the kitchen counter.

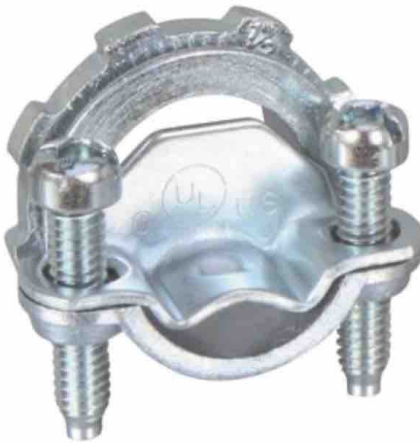
SC 108: Missing a proper electrical wire-bushing clamp at bottom of kitchen sink disposal.

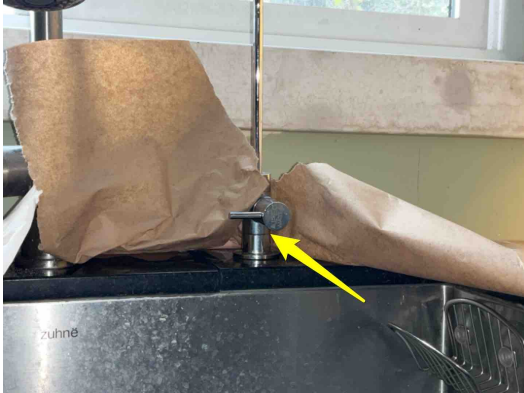
MR 113: The faucet at the filtered drinking water system at the Kitchen sink found loose and in need of maintenance or repair.

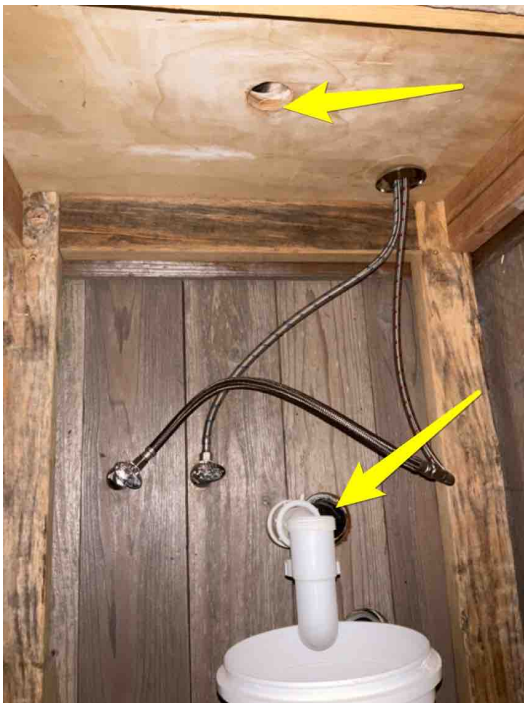
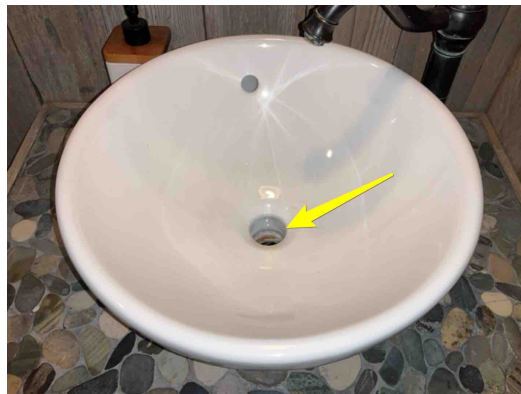
128: DISCLOSURE: The entry area bathroom sink is partially deconstructed and currently non-operational.

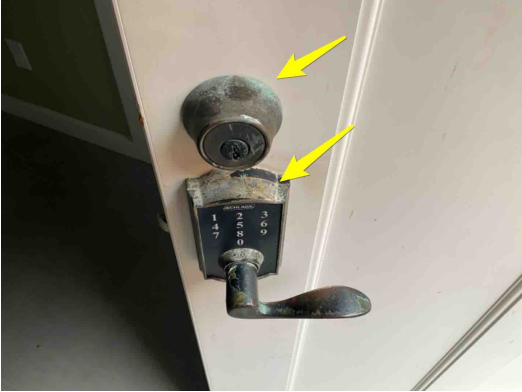
MR 138: Deteriorated/ corroded door latching hardware and/ or hinges noted at exterior doors. Maintenance recommended.

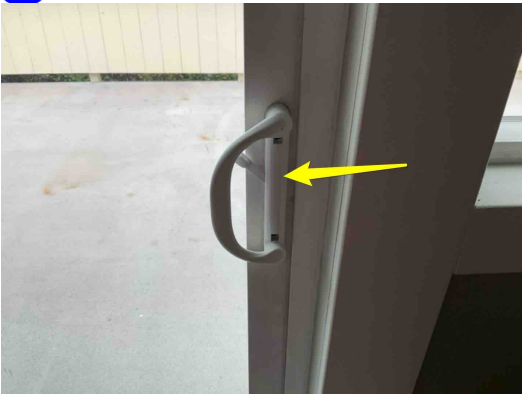
SU 139: The locking hardware found difficult to operate at the LIVING ROOM exterior sliding glass door.

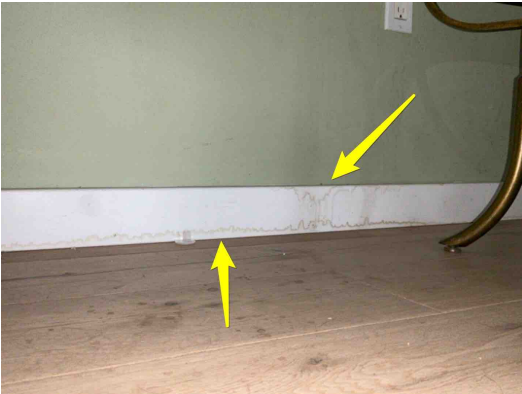
FI 155: Evidence of moisture stains and/or damage at the walls in the UPSTAIRS LOFT (SOUTH WALL). Recommend further review of the water stains to determine the cause, the current condition and if repairs are needed.

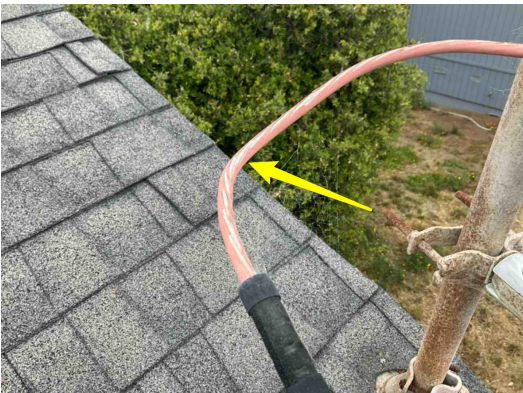
SC 170: Improper use of non-exterior rated wire as the coating on the wire found excessively damaged with exposed metal wire at the main electrical main overhead service where the wires enter the electrical mast. Recommend contacting a qualified electrical professional to evaluate and correct. This is considered a safety hazard and warrants repair.

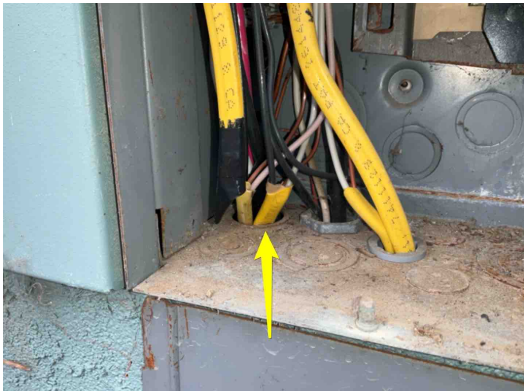
SU 175: Missing a bushing clamp as wires are passing into the MAIN ELECTRICAL PANEL. Wires are improperly rubbing on the sharp metal edge of the electrical panel as they pass through.

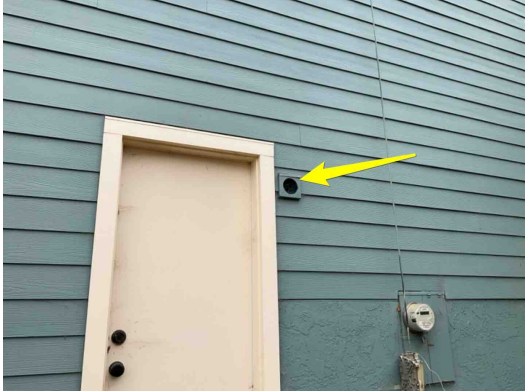
SC s-186: Light fixture is missing, exposed wiring. Recommend repair or replacement: OFF GARAGE EXTERIOR PEDESTRIAN DOOR EAST SIDE

SC 186: Light fixture is missing, exposed wiring. Recommend repair or replacement: OFF GARAGE EXTERIOR PEDESTRIAN DOOR EAST SIDE

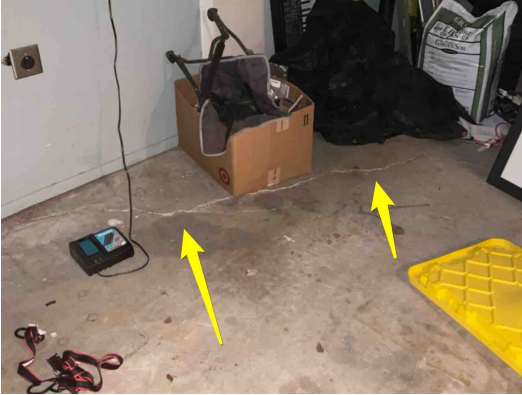
FI DS 196: Some moderate cracks with visible separations, settlement and displacement found in the garage concrete floor and/or foundation system. The concrete floor is separated, raised or settled and is uneven causing a trip hazard. Client should contact a qualified Civil engineer to evaluate the cause, current condition and potential future issues.

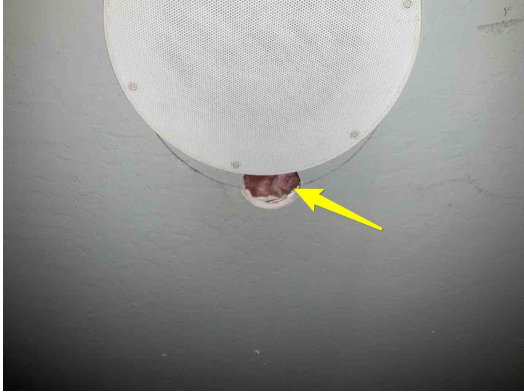
SC 201: **Some** small holes or openings found in the garage firewall. Recommend sealing all holes and openings through the garage firewall for fire safety per minimum standards.

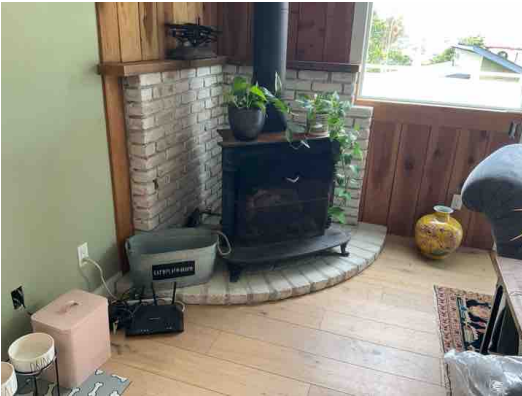
210: **LIVING ROOM**

s-211: The living room fireplace appears to have been improperly altered and does not conform to minimum installation standards. Too many individual defects to list. Recommend further evaluation by a qualified/ licensed fireplace- chimney professional familiar with minimum codes and clearance requirements.

211: The living room fireplace appears to have been improperly altered and does not conform to minimum installation standards. Too many individual defects to list. Recommend further evaluation by a qualified/ licensed fireplace- chimney professional familiar with minimum codes and clearance requirements.
