Inspection Report

Property Address:
560 S. 12th St.
Grover Beach CA 93433

6/13/2025

Harper Homes: Home Inspection Services

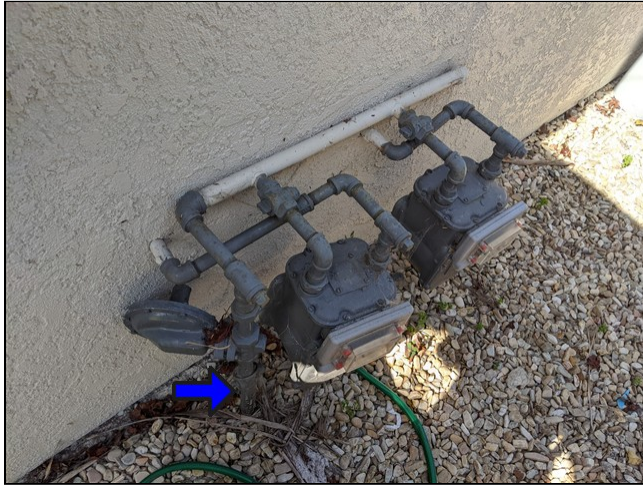
4.3 Item 1(Picture)

The gas shutoff is located at the right exterior of the home. To turn the gas off turn the valve perpendicular to the piping.

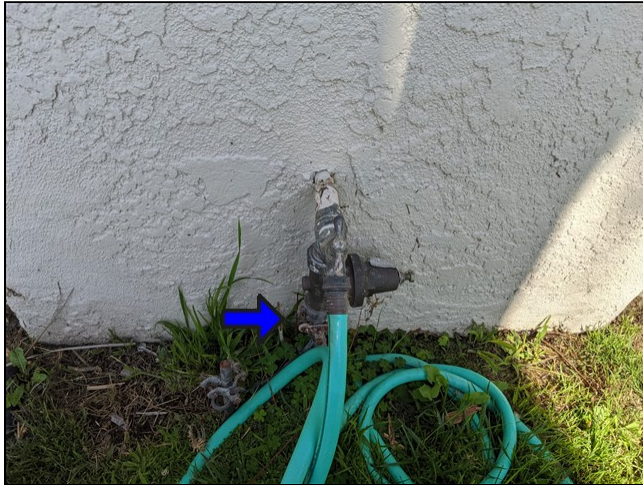
4.4 Item 1(Picture)

The water shutoff is located at the front exterior of the home. To turn the water off turn the handle perpendicular to the piping.
