Property Inspection Report

27608 Saddle Road, Rolling Hills Estates, CA

Inspection date: 05/23/2023

Property Professor, Inc.

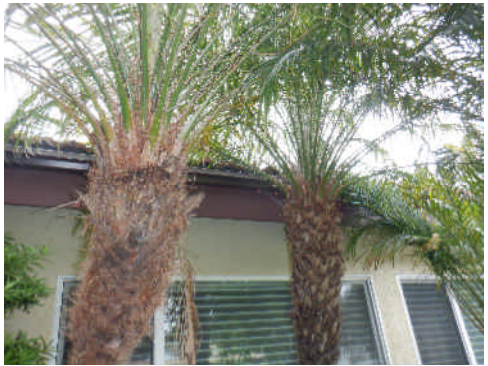
SITE GRADING	The site grading around the building appeared adequate to drain excess surface water away from the foundation, with exceptions noted.
SITE DRAINAGE	[NOTE] An underground drainage system was installed, but it was not water tested during the inspection. We make no representations as to its effectiveness and recommend its operation be noted during adverse weather.
LANDSCAPING	<p>The vegetation and landscaping appeared manicured, with exceptions noted.</p> <p>a. [CR] Trees were touching or overhanging the roof. We recommend they be trimmed to prevent damage to the roofing surface, and allow free flow of roof runoff.</p>

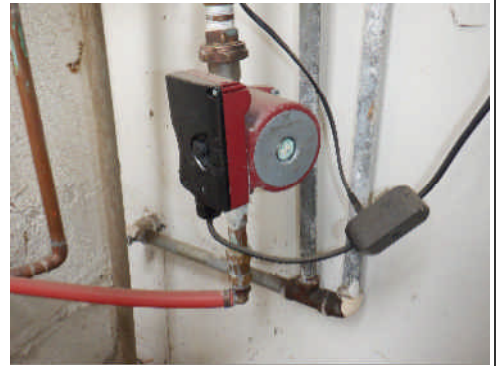
[FE] These system(s) are outside the scope of the inspection and are not timed or inspected in detail. We recommend consulting with a plumbing specialist regarding the operation and maintenance of this system.

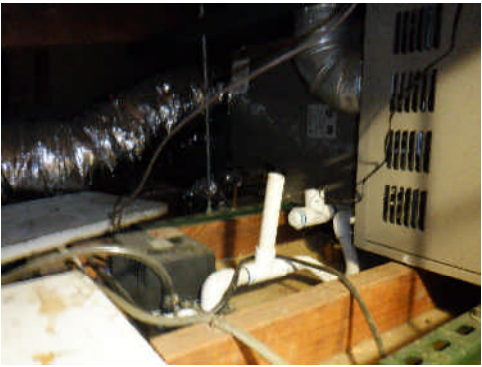
ENERGY SUPPLY(S)	An electrical disconnect was present, in sight of and providing power to the condensing unit.
CONDENSING UNIT(S)	[NOTE] The condenser was functional, but it was an older unit and beyond the end of its expected service life. We recommend budgeting for a replacement.
SYSTEM CONDITION(S)	The system responded to normal operating controls and the temperature differential between the supply and return air grills was within the normal range of (13 - 22) degrees.
CONDENSATE DRAIN LINE(S)	The visible areas of the condensate drain line(s) appeared functional.

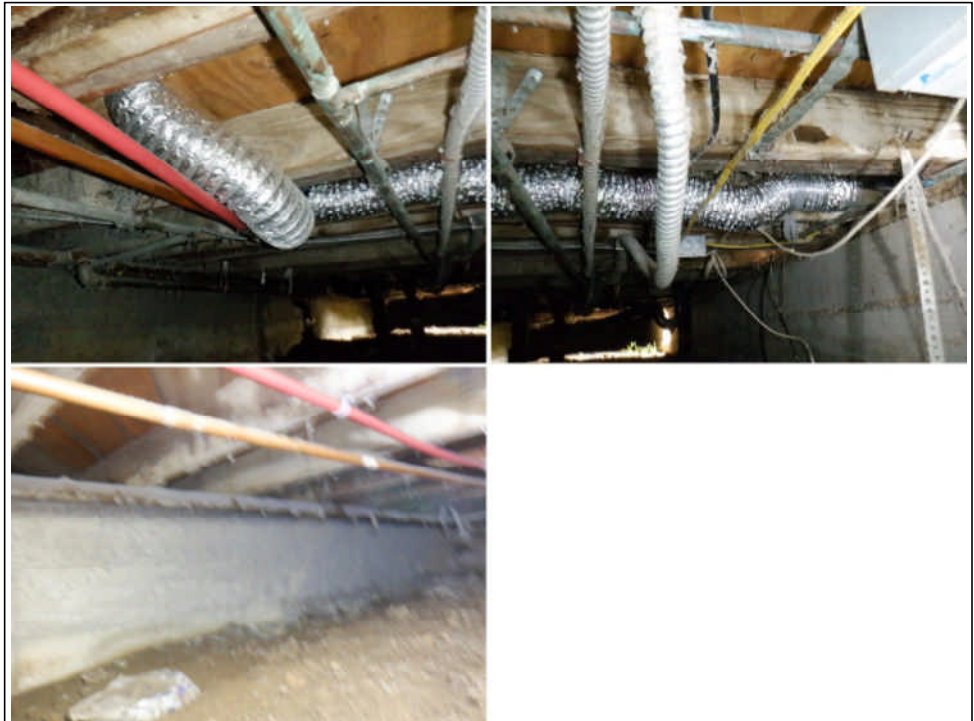
DRYER VENT(S)

Dryer venting was provided and terminated at the exterior, with exceptions noted.

- a. [CR] The dryer vent exhaust pipe was noted to be flexible plastic/aluminum in the crawl space under the building. This is an improper installation. We recommend correcting the condition(s) noted.
- b. [CR] There was lint debris accumulated in the crawl space. We recommend correcting the condition(s) noted.

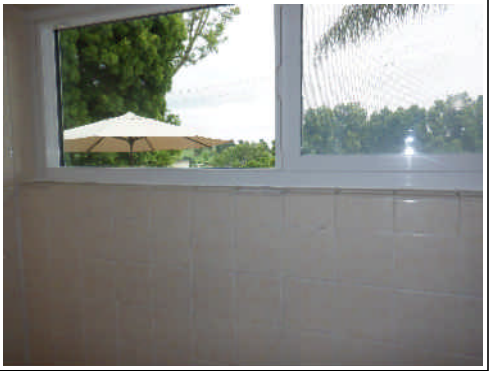
WINDOW(S)	[SC] There were no visible safety glass markings on the glass in the window within 60 inches above the walking surface of the tub or floor. We recommend the glass be confirmed as safety type or upgraded.

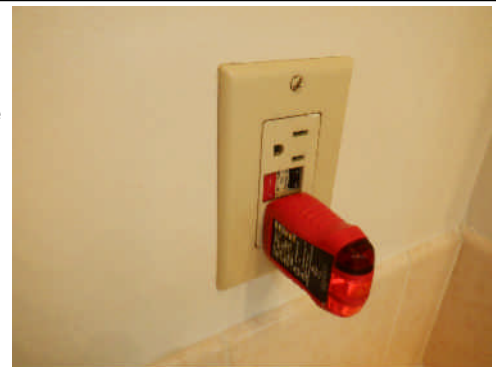
[SC] Power was still present after the "Test Button" of the GFCI receptacle was pushed. This condition is a safety hazard. We recommend correcting the condition(s) noted.

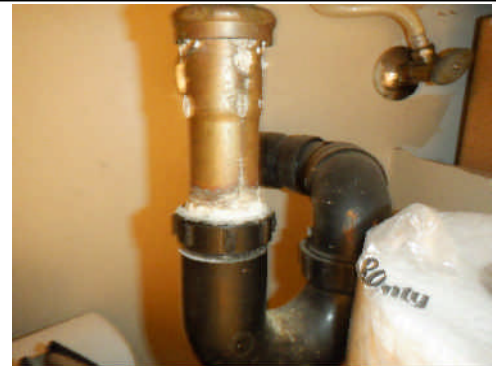
[NOTE] Corrosion/ evidence of past leakage was noted at the drain piping under the sink(s). We recommend monitoring this area for future leaks.

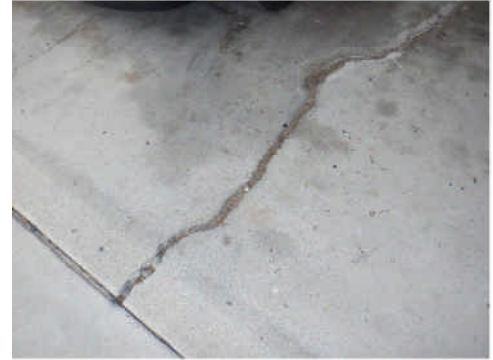
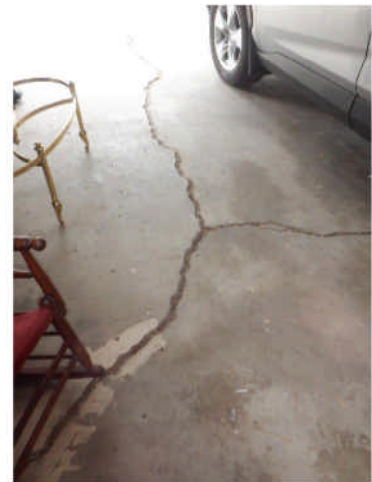
a. [CR] There were cracks in the garage floor. We recommend correcting the condition(s) noted.

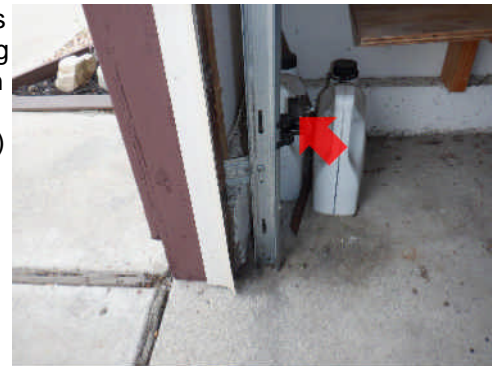
a. [SC] The secondary safety system (electric eyes) were mounted higher than the manufacturer's recommendation of 4" to 6" above the floor. We recommend correcting the condition(s) noted.
