General Summary

Ferguson Home Inspections

Kevoork & Susan Toumalan

1608 Cataluna Pl
Palos Verdes Estates CA 90274

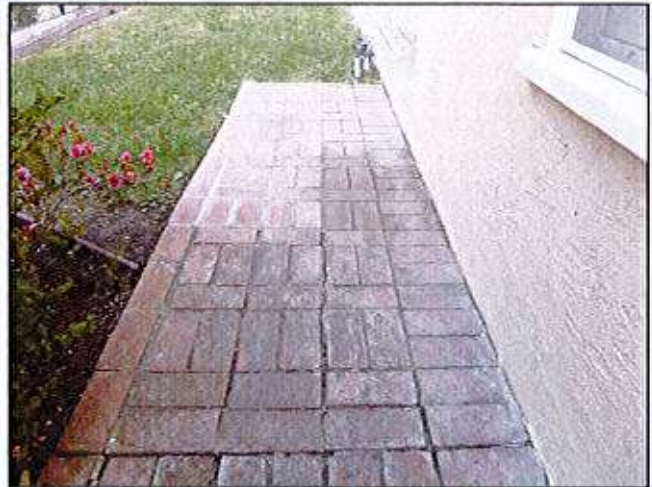
1.1 Item 2 (Picture)

Settling and heaving noted at various areas, this is a potential trip hazard. Suggest review with a licensed contractor for repair/replacement costs as needed.

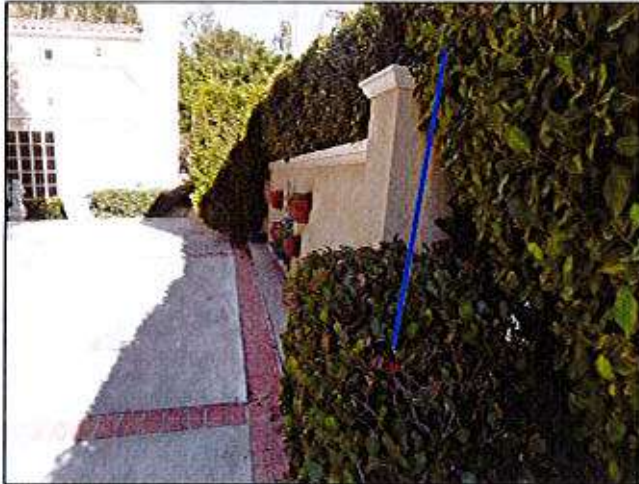
1.2 Item 1 (Picture)

(1) The stucco fence on the right side is leaning, suggest review with a licensed contractor for repairs as needed.

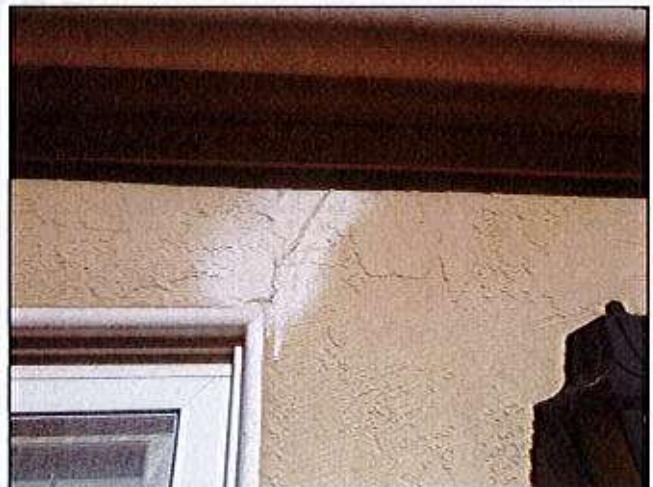
1.3 Item 4 (Picture)

(2) Settling cracks noted at various areas of the stucco siding, suggest maintenance as needed.

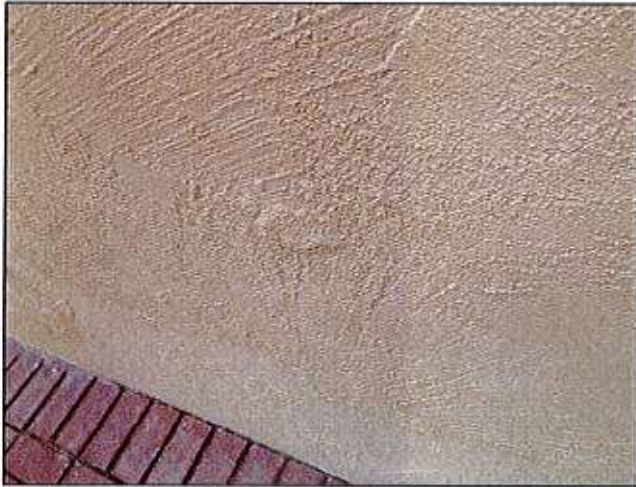
1.3 Item 6 (Picture)

(3) Minor deterioration and blistering stucco noted at various areas. See the Lot/Drainage comments and review with a licensed contractor to repair as needed and divert water away from the foundation areas.

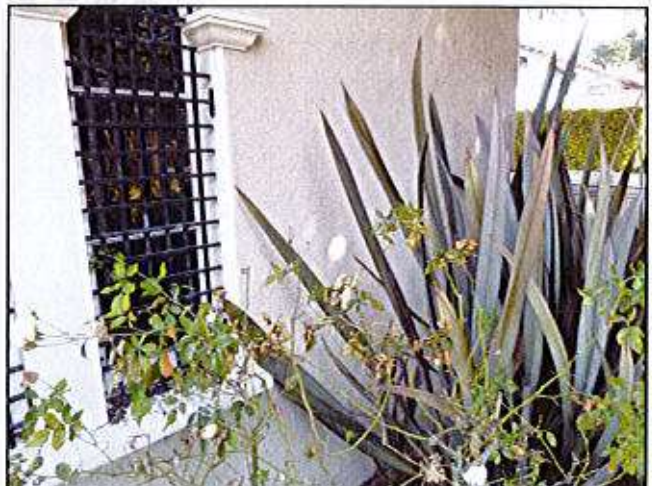
1.3 Item 9 (Picture)

(4) Multiple trees and bushes are in contact with the siding. Suggest trimming them away from the siding to prevent any future damage.

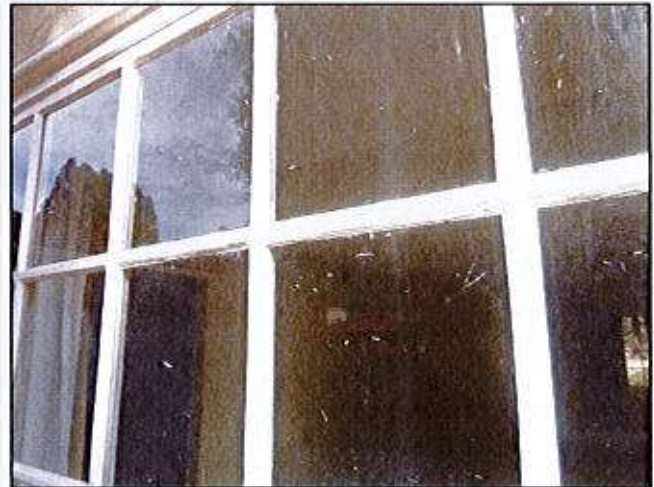
1.5 Item 2 (Picture)

The wood trim/frames are peeling paint at various windows, further deterioration may occur if not repaired. Suggest review by a licensed contractor and repair/replace as needed.

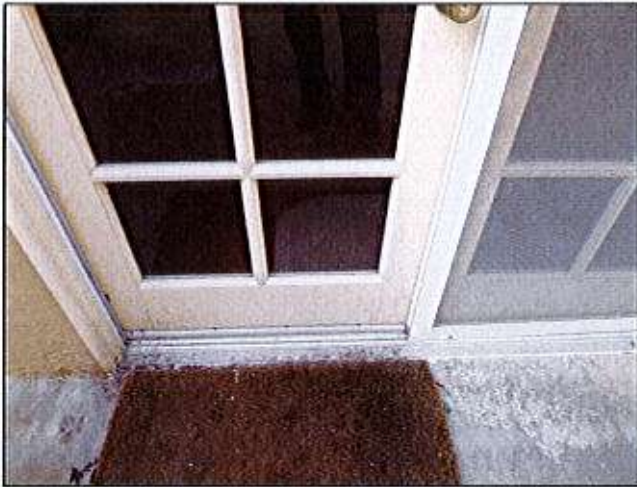
1.6 Item 1 (Picture)

Various wood doors are weathered and deteriorated. Suggest review with termite company and/or a licensed contractor and repair/replace as needed.

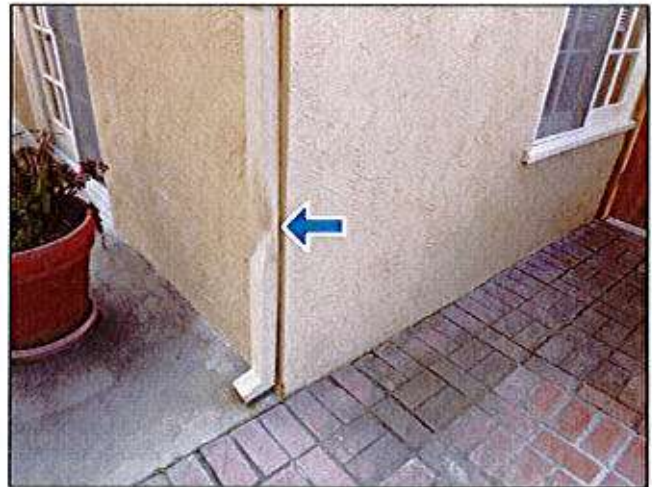
1.8 Item 2 (Picture)

(1) The gutters/downspouts are damaged, rusted and deteriorated at various areas, suggest replacing the gutters/downspouts as needed.

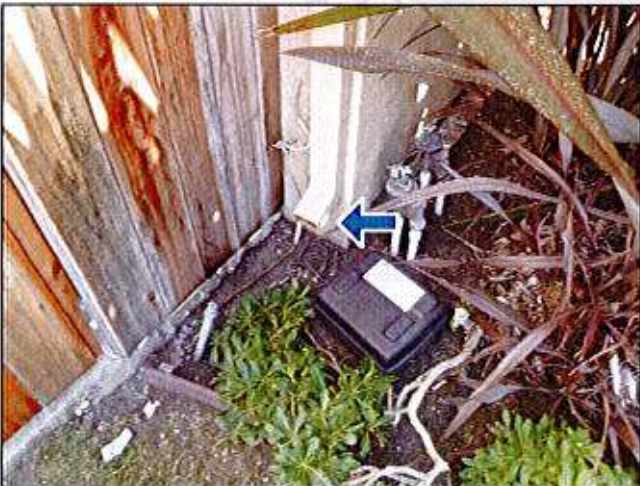
1.8 Item 4 (Picture)

(2) Suggest redirecting the downspouts out of the planters to reduce ponding during the rainy season.

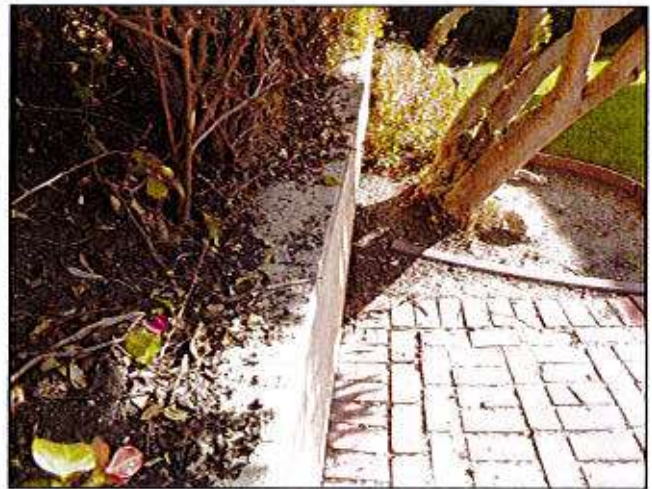
1.9 Item 2 (Picture)

(1) The retaining wall at the rear shows some settlement and movement cracks, but appears stable. Suggest review with a licensed contractor for repair/replacement costs as needed.

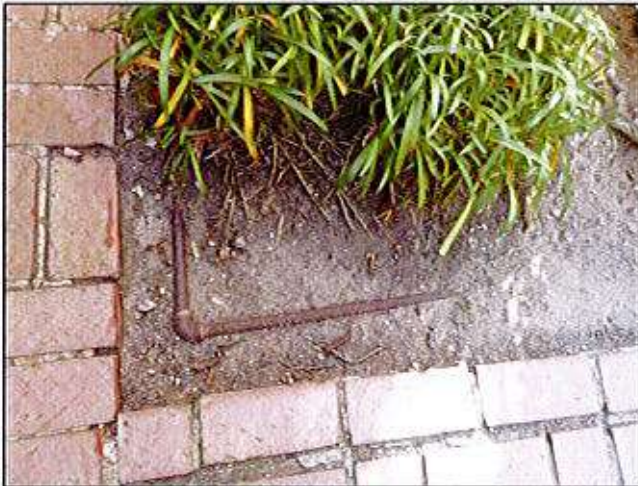
1.12 Item 1 (Picture)

- (1) Suggest review of trees and root structures to prevent future damage to the property, drainage systems and structures.
- (2) Old and decommissioned/abandoned gas lines and water lines were noted in various planters, suggest removal as needed.

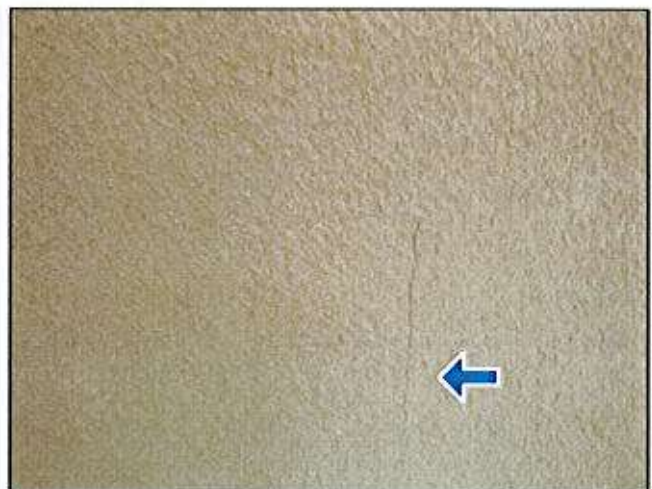
3.0 Item 2 (Picture)

(1) Settling was observed at the front right section of the structure. Suggest review with a licensed foundation contractor and/or a soil/geo-technical engineer and make any repairs as needed.

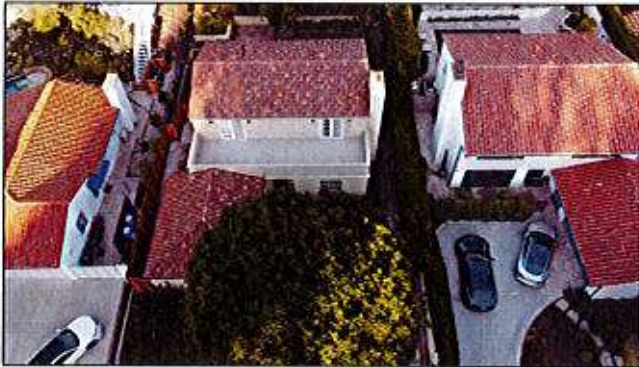
4.0 Item 1 (Picture)

(1) Chipped and lifted/ajar areas of the roof tiles were noted, suggest review by a licensed roofer for repair/ replacement costs as needed to prevent any future leakage during the rainy season.

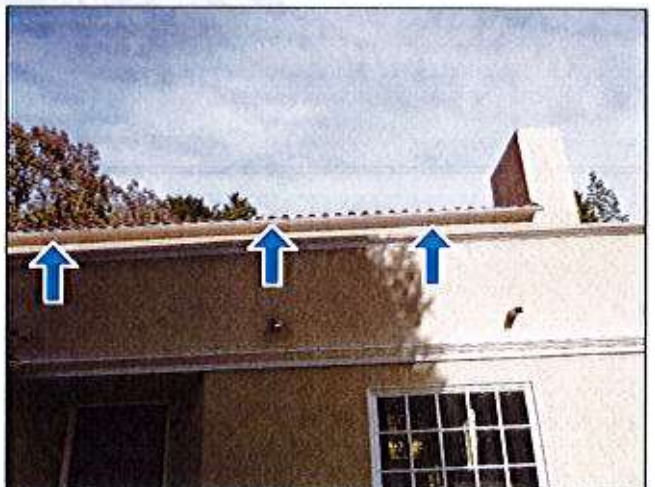
4.0 Item 6 (Picture)

(2) The tile bird stops were missing at various areas, suggest review with a licensed roofer for installation costs as needed.

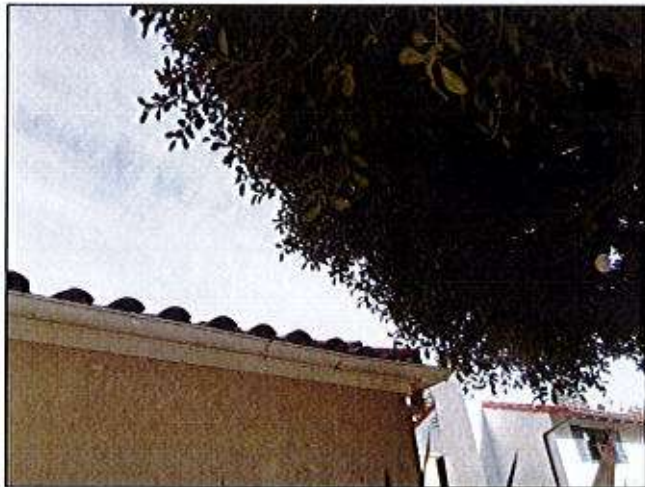
4.0 Item 7 (Picture)

(3) The tree limbs that are in contact with roof or hanging near roof should be trimmed to prevent damaging the roof. Suggest trimming as needed.

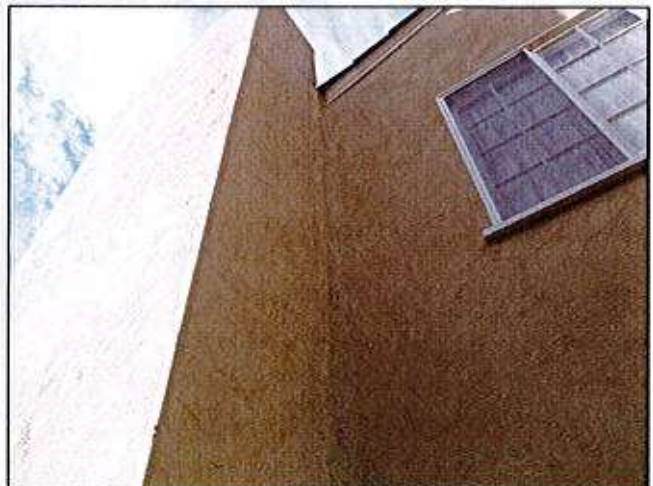
4.2 Item 2 (Picture)

(1) Excessive stucco patching was noted at the chimney structure. The stucco patches are separating/failing, indicating that the chimney structure is settling at different rate(s) than the dwelling. Suggest review by a licensed chimney contractor and a licensed contractor to make repairs as needed to reduce/eliminate the settling of both the chimney structure and dwelling and to repair the exterior stucco to prevent water intrusion as needed.

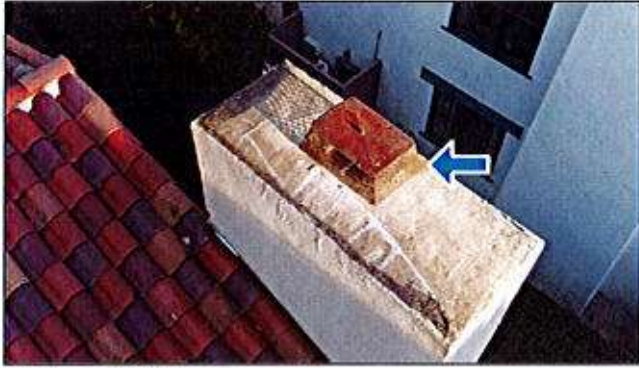
4.2 Item 4 (Picture)

(2) The chimney rain cap and spark arrester are rusted and deteriorated, suggest replacing as needed to prevent future water intrusion at this area.

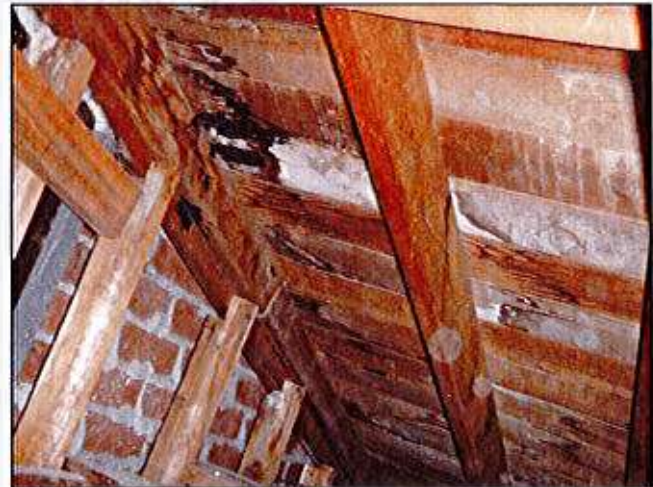
5.0 Item 2 (Picture)

(1) Moisture stains noted at various areas of the attic sheathing/framing, see roof comments and repair as needed.

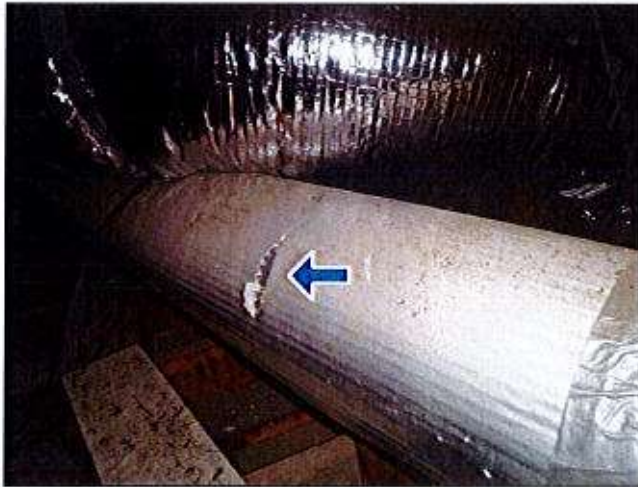
5.4 Item 1 (Picture)

(1) Possible asbestos like ducting material, tape and wrap noted at ducting and joints. Tape and wrap, torn and loose in the several areas, suggest review by licensed contractor for repairs/replacement or removing material or encapsulating the damaged areas.

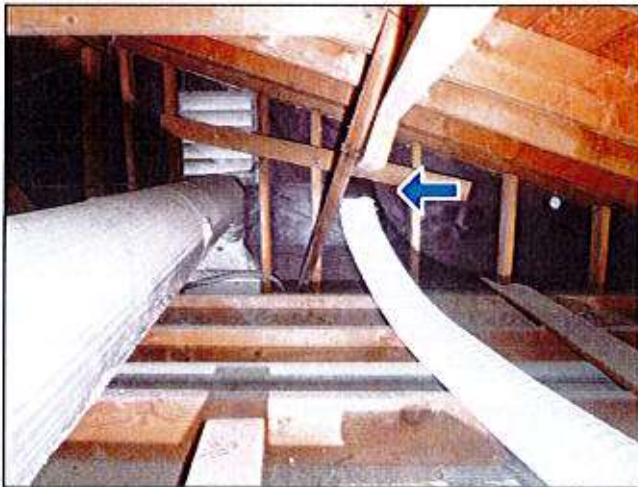
5.6 Item 1 (Picture)

The exhaust fan systems for the bathrooms currently vent into attic, suggest review by a licensed contractor to vent to the exterior as required.

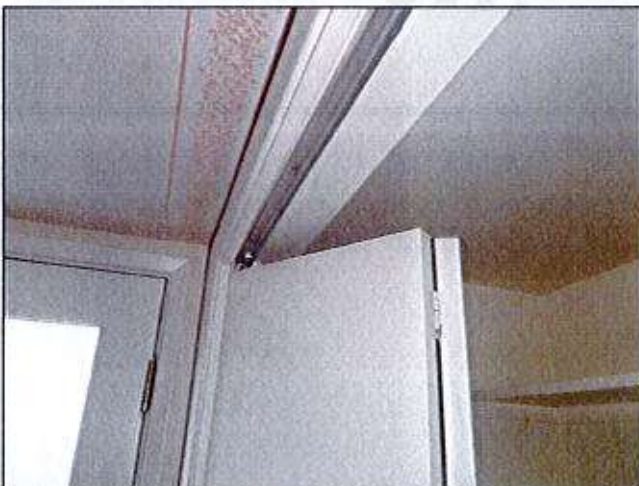
6.3 Item 2 (Picture)

(2) The doors are off their tracks, suggest repair as needed.

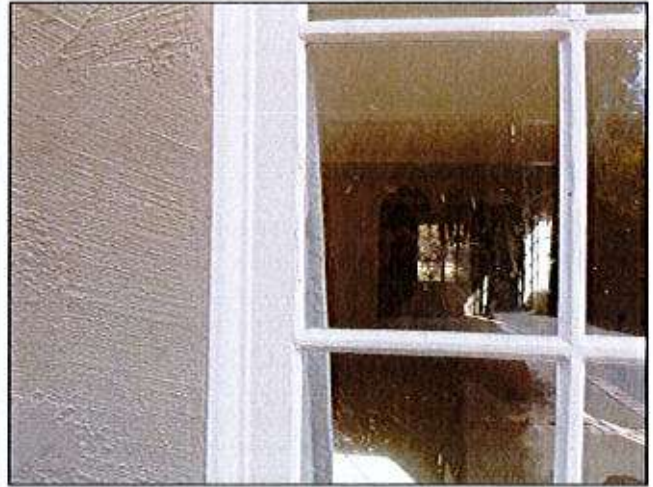
7.3 Item 2 (Picture)

Wood deterioration noted at various windows (temporary silicone repairs were noted at this area). Suggest review with termite company and/or a licensed contractor and repair/replace as needed.

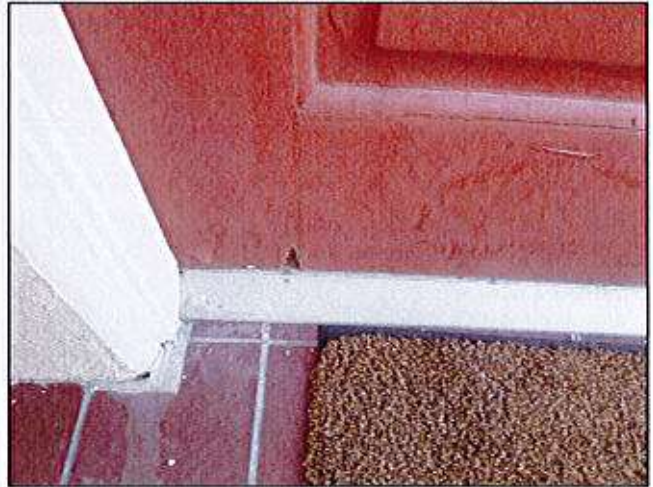
7.4 Item 2 (Picture)

The door is weathered and deteriorated, suggest maintenance and repairs as needed.

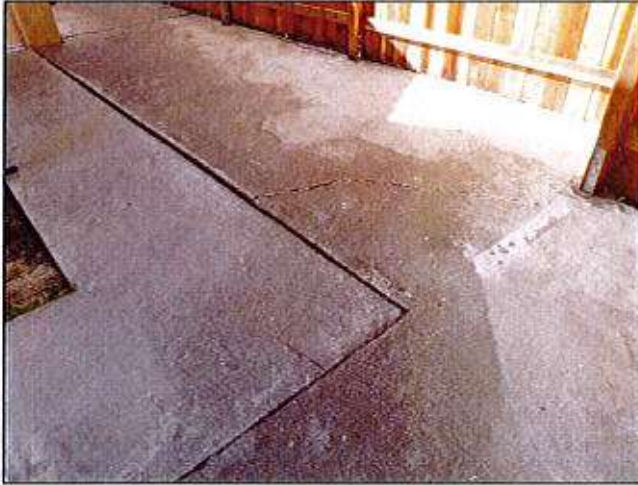
8.0 Item 1 (Picture)

Expansion and settling cracks noted, suggest review with a licensed contractor and repair/replace as needed.

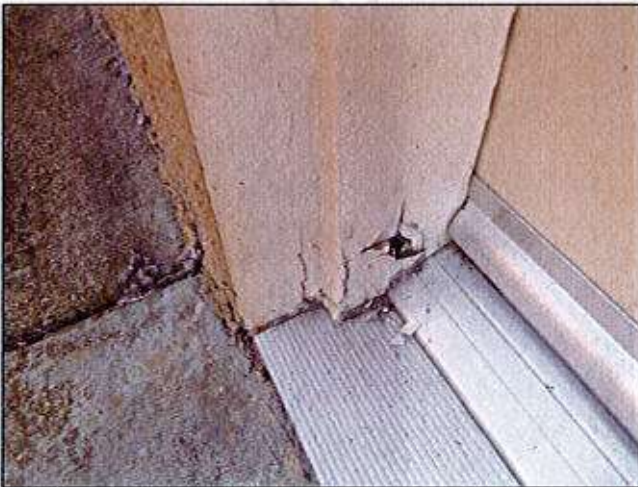
8.2 Item 1 (Picture)

(1) Unable to determine if tempered glass is installed at this area (no labelling/etching is visible). Windows and doors with glass 18 inches off the floor area or windows within doors should have safety glass. Suggest review of these areas for possible costs to upgrade and to enhance safety as needed.

(2) Wood deterioration noted at the door frame. Suggest review by a licensed contractor for repair/replacement costs as needed.

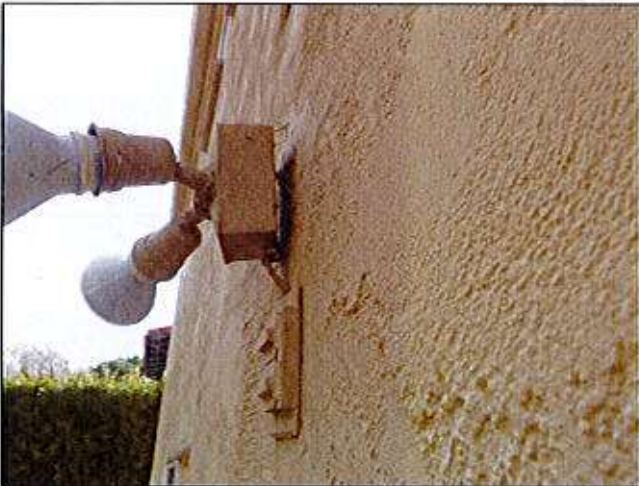
9.1 Item 2 (Picture)

(2) The light fixture is loose, suggest repair/replace as needed.

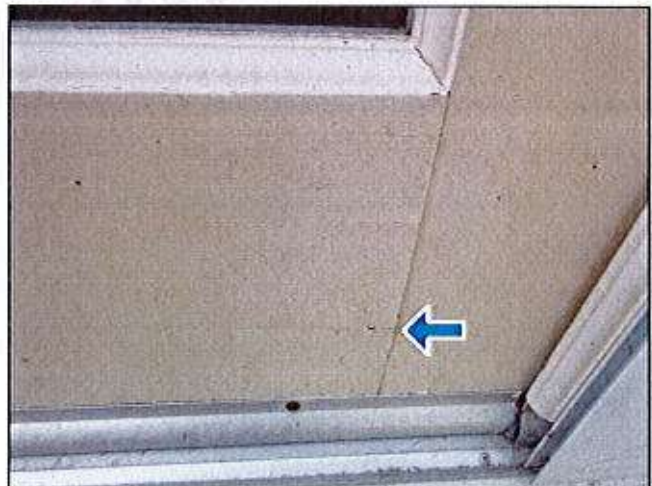
9.3 Item 2 (Picture)

Wood deterioration noted at the doors and frame. Suggest review by a licensed contractor for repair/replacement costs as needed.

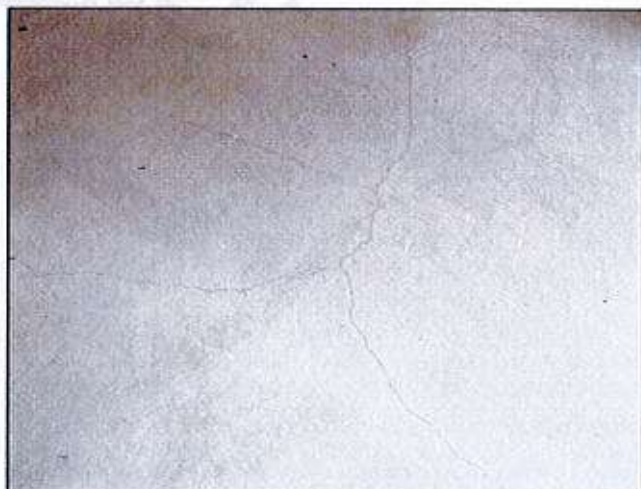
11.0 Item 2 (Picture)

A large expansion crack was noted at the garage slab. This is common for the age of the structure due to the expansion soil and generally there was no steel installed at the garage slab. Suggest review with a licensed contractor for repair/replacement costs as needed.

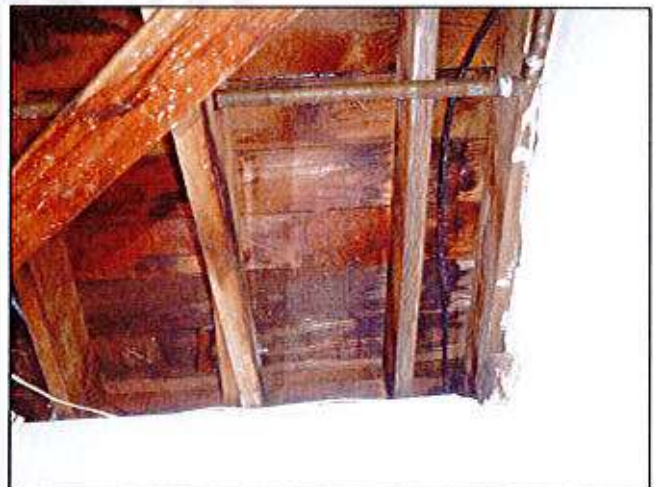
11.6 Item 2 (Picture)

(1) Water stains and deterioration noted at the ceiling, see the roof comments and repair/replace as needed.

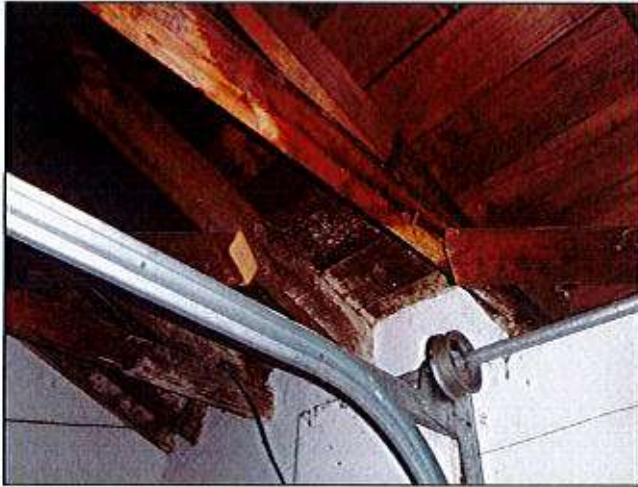
11.6 Item 4 (Picture)

(2) Various areas of the garage framing were incorrectly cut and/or damaged, suggest review with a licensed contractor for repairs as needed.

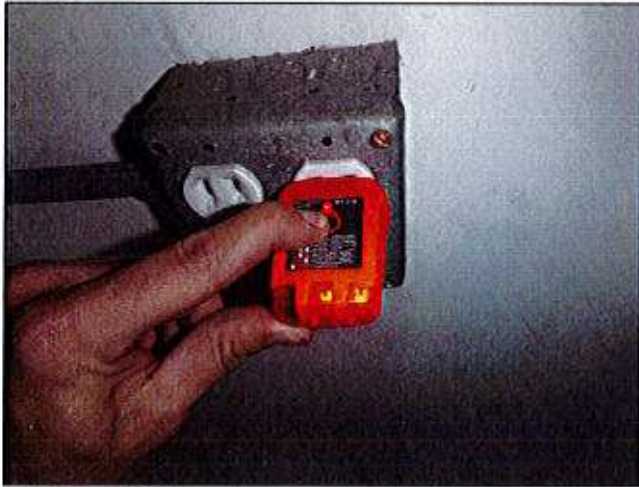
11.7 Item 5 (Picture)

(6) No GFCI outlet or protection installed in this garage. GFCI coverage has been required in garages since 1978, suggest review by a licensed electrician for installation as required for safety.

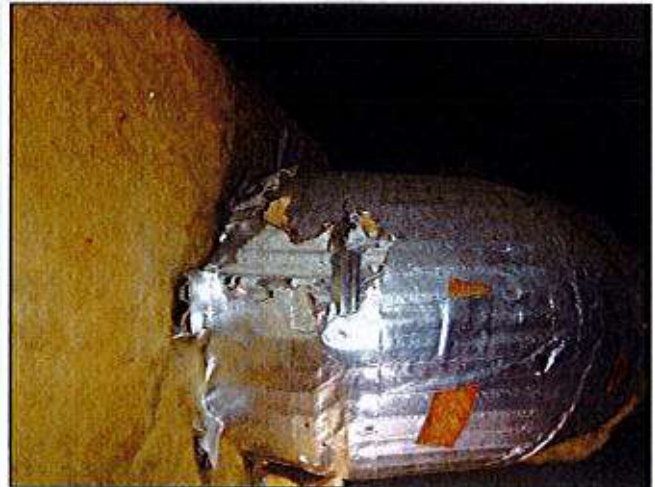
12.3 Item 2 (Picture)

(1) Possible asbestos like ducting material, tape and wrap noted at ducting and joints. Tape and wrap, torn and loose in the several areas, suggest review by licensed contractor for repairs/replacement or removing material or encapsulating the damaged areas.

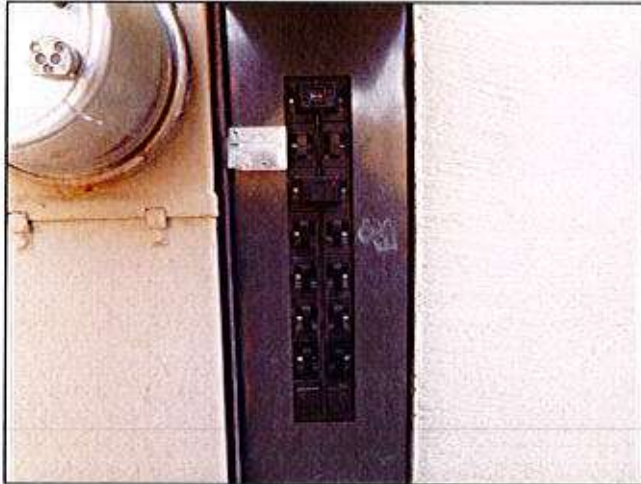
13.1 Item 1 (Picture)

(1) The electrical panel(s) are a Bulldog breaker system. Problems with this style panel include circuit breakers (depending on the vintage) with a dismal performance record and the possibility of unbalanced multi-wire circuits. Also, please be aware that various insurance companies will not insure homes with this style of electrical panel. Suggest review by a licensed electrician for replacement costs as needed.

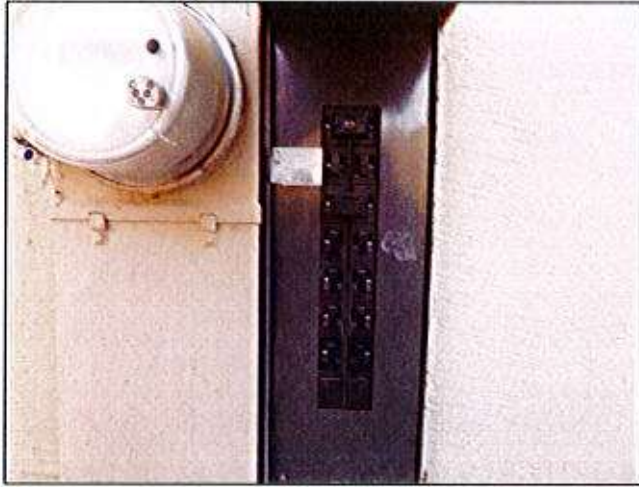
13.1 Item 5 (Picture)

- (4) Suggest adding correct/complete indexing/labelling to all breakers for identification of each circuit for safety.

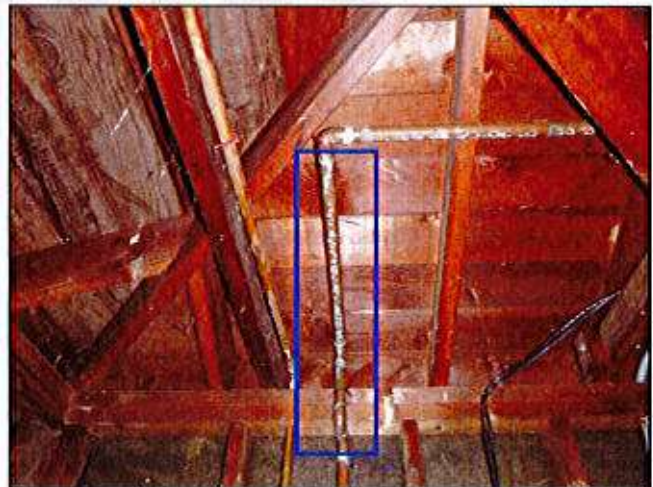
14.0 Item 2 (Picture)

(1) Corroded plumbing and fittings noted at various areas within the dwelling. Suggest further review by a licensed plumber for repair/replacement costs as needed to prevent future leakage, pin hole leaks and possible stains/damage to the interior of the dwelling.

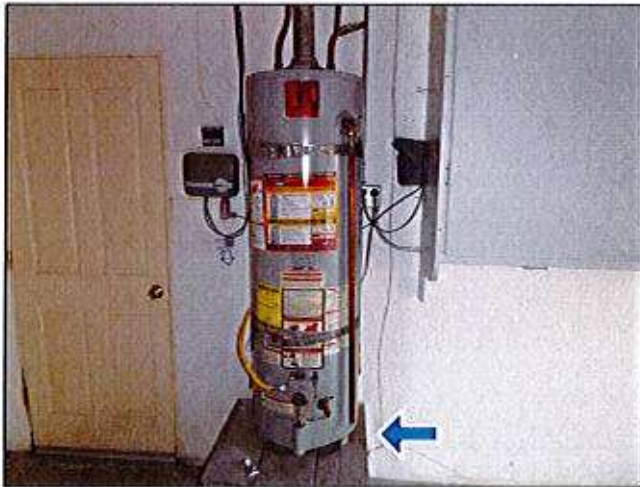
16.0 Item 3 (Picture)

(2) Suggest review by a licensed plumber and extend the TP discharge drain down to within 4-6 inches of the grade/ deck as required for safety.

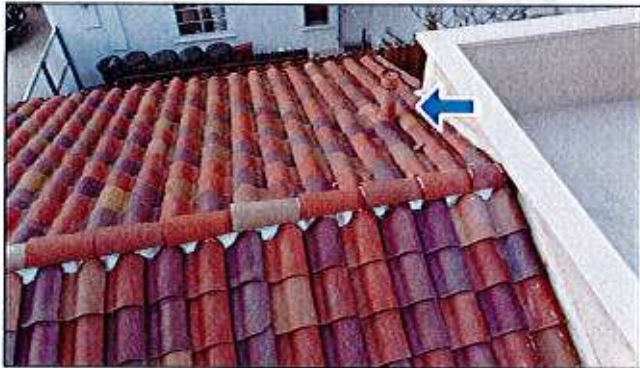
16.1 Item 2 (Picture)

(2) The water heater vent is currently incorrectly installed and is a potential safety hazard. Suggest review by a licensed plumbing contractor for costs to extending the venting to 12 inches above the second level roof line as required.

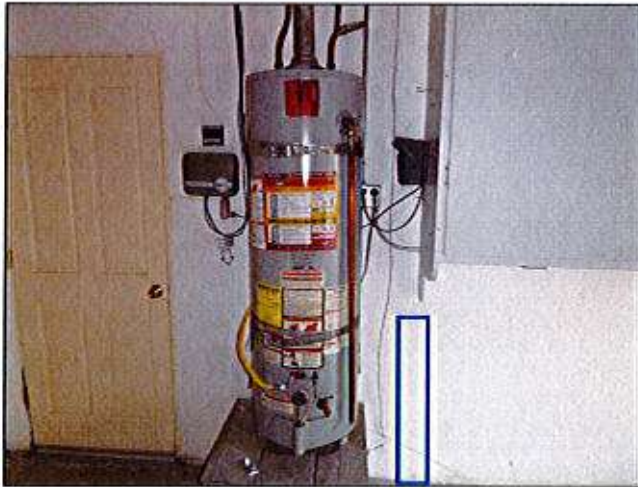
16.2 Item 2 (Picture)

(2) Potential safety hazard due to no impact barrier installed. Suggest review with a licensed contractor for installation costs for an impact barrier as required due to the water heater being located in the garage.
